**AEROJET**  
Environmental Remediation

**FIGURE 1-1**  
Location of Sites Included  
in PGOU Solls RI/FS

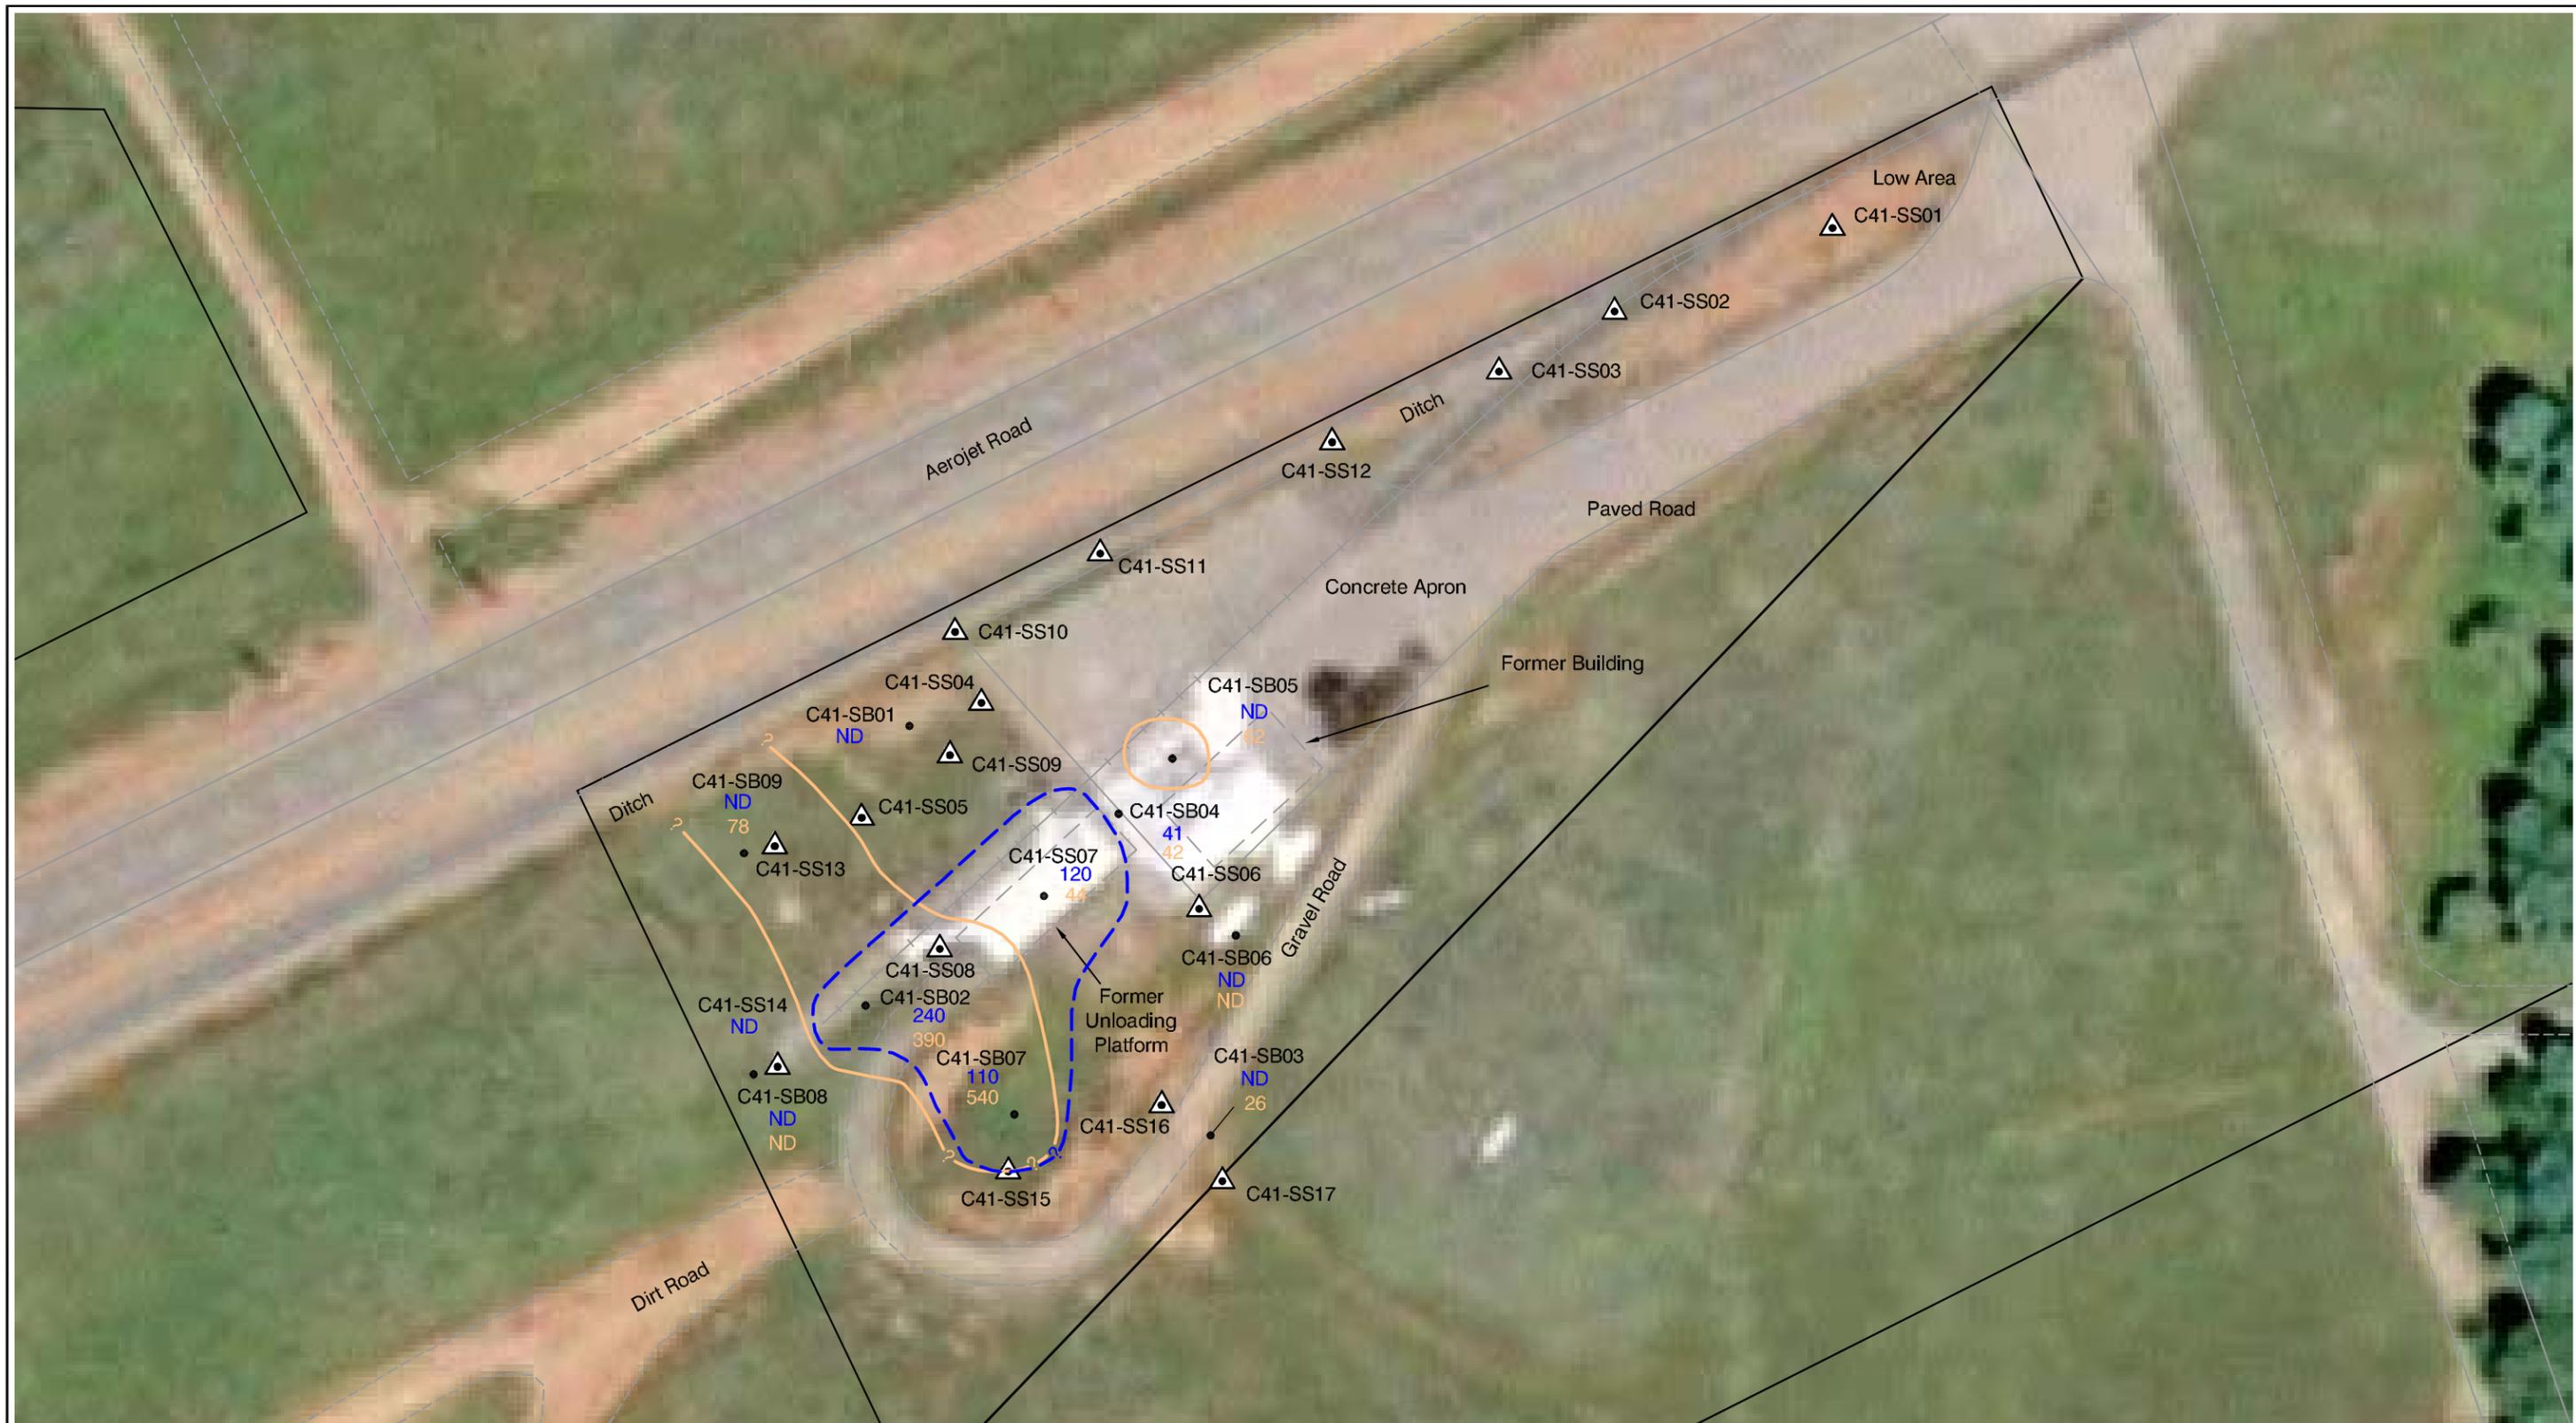
**FIGURE 4-36**  
**Perchlorate in Soil**  
**30 and 35 Feet BGS**  
**Site C41**

- ▲ Soil Sampling Location
- Soil Boring Location
- 140 Perchlorate Concentration at 30 ft Below Ground Surface
- 570 Perchlorate Concentration at 35 ft Below Ground Surface
- ND Not Detected
- Extent of Perchlorate >60 µg/Kg at 30 ft Below Ground Surface
- Extent of Perchlorate >60 µg/Kg at 35 ft Below Ground Surface

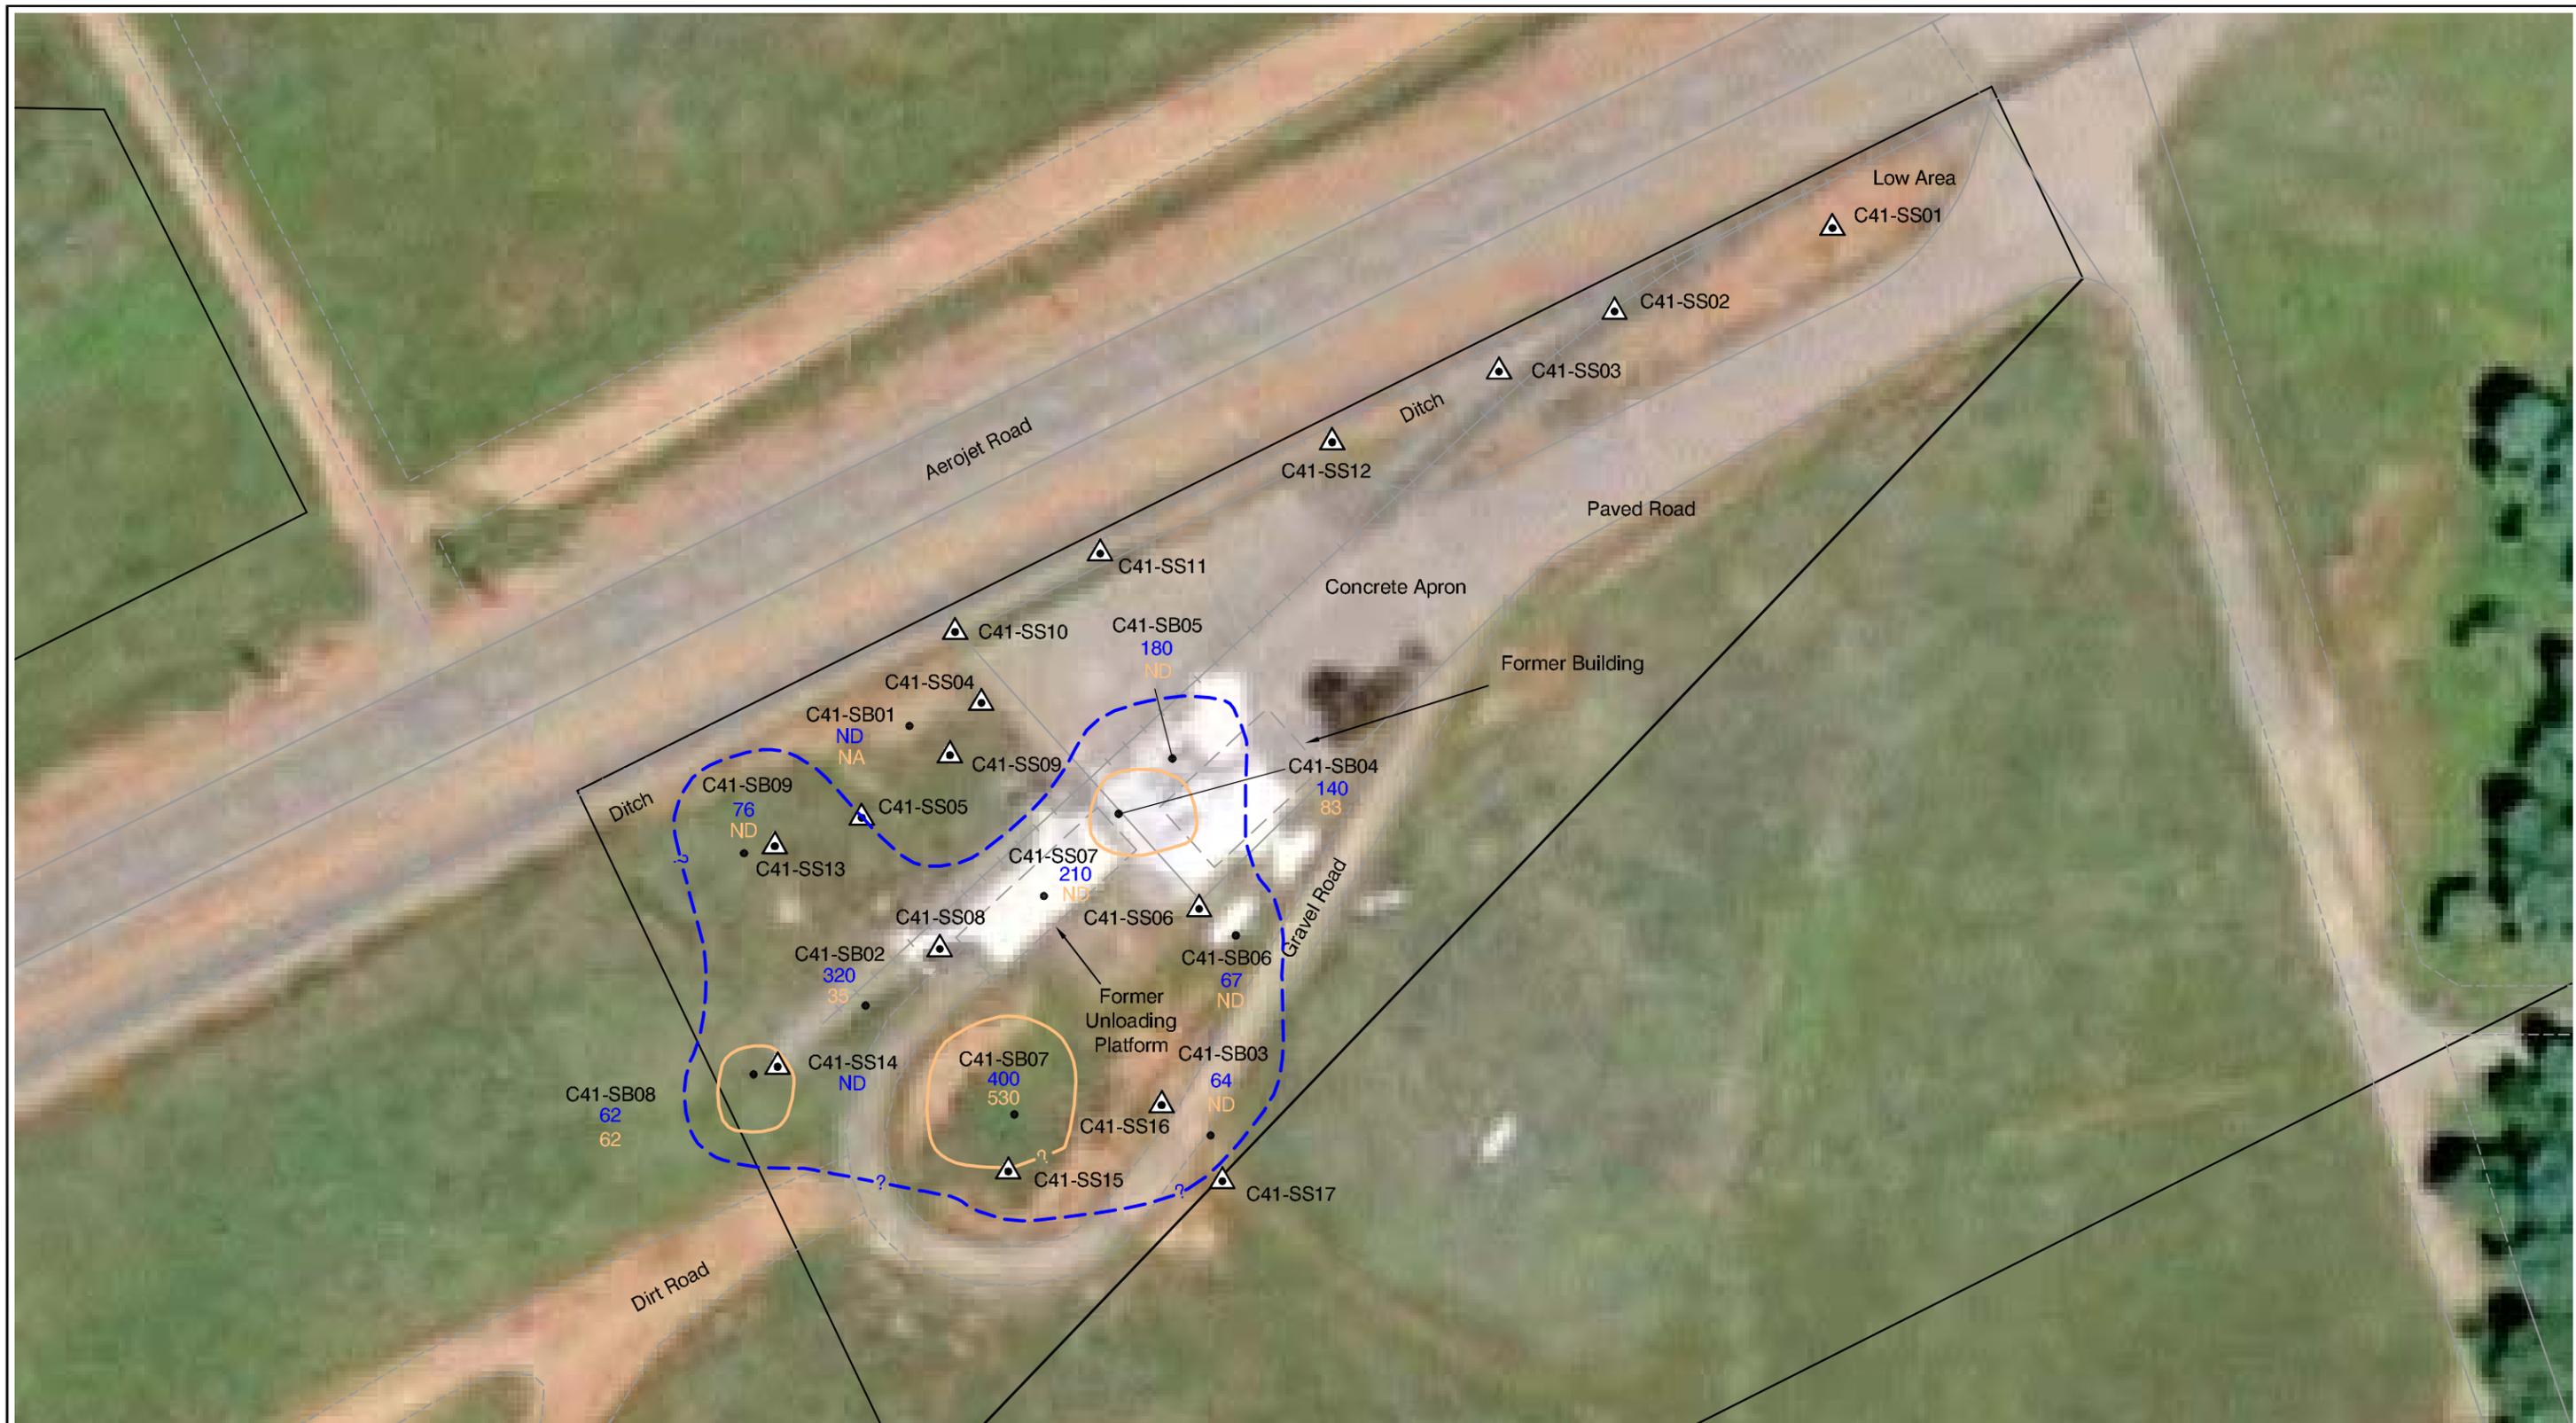
**FIGURE 4-37**  
**Perchlorate in Soil**  
**40 and 45 Feet BGS**  
**Site C41**

- ▲ Soil Sampling Location
- Soil Boring Location
- 140 Perchlorate Concentration at 40 ft Below Ground Surface
- 570 Perchlorate Concentration at 45 ft Below Ground Surface
- ND Not Detected
- NA Not Analyzed
- Extent of Perchlorate >60 µg/Kg at 40 ft Below Ground Surface
- Extent of Perchlorate >60 µg/Kg at 45 ft Below Ground Surface
- Site C41 Boundary
- Railroad Track

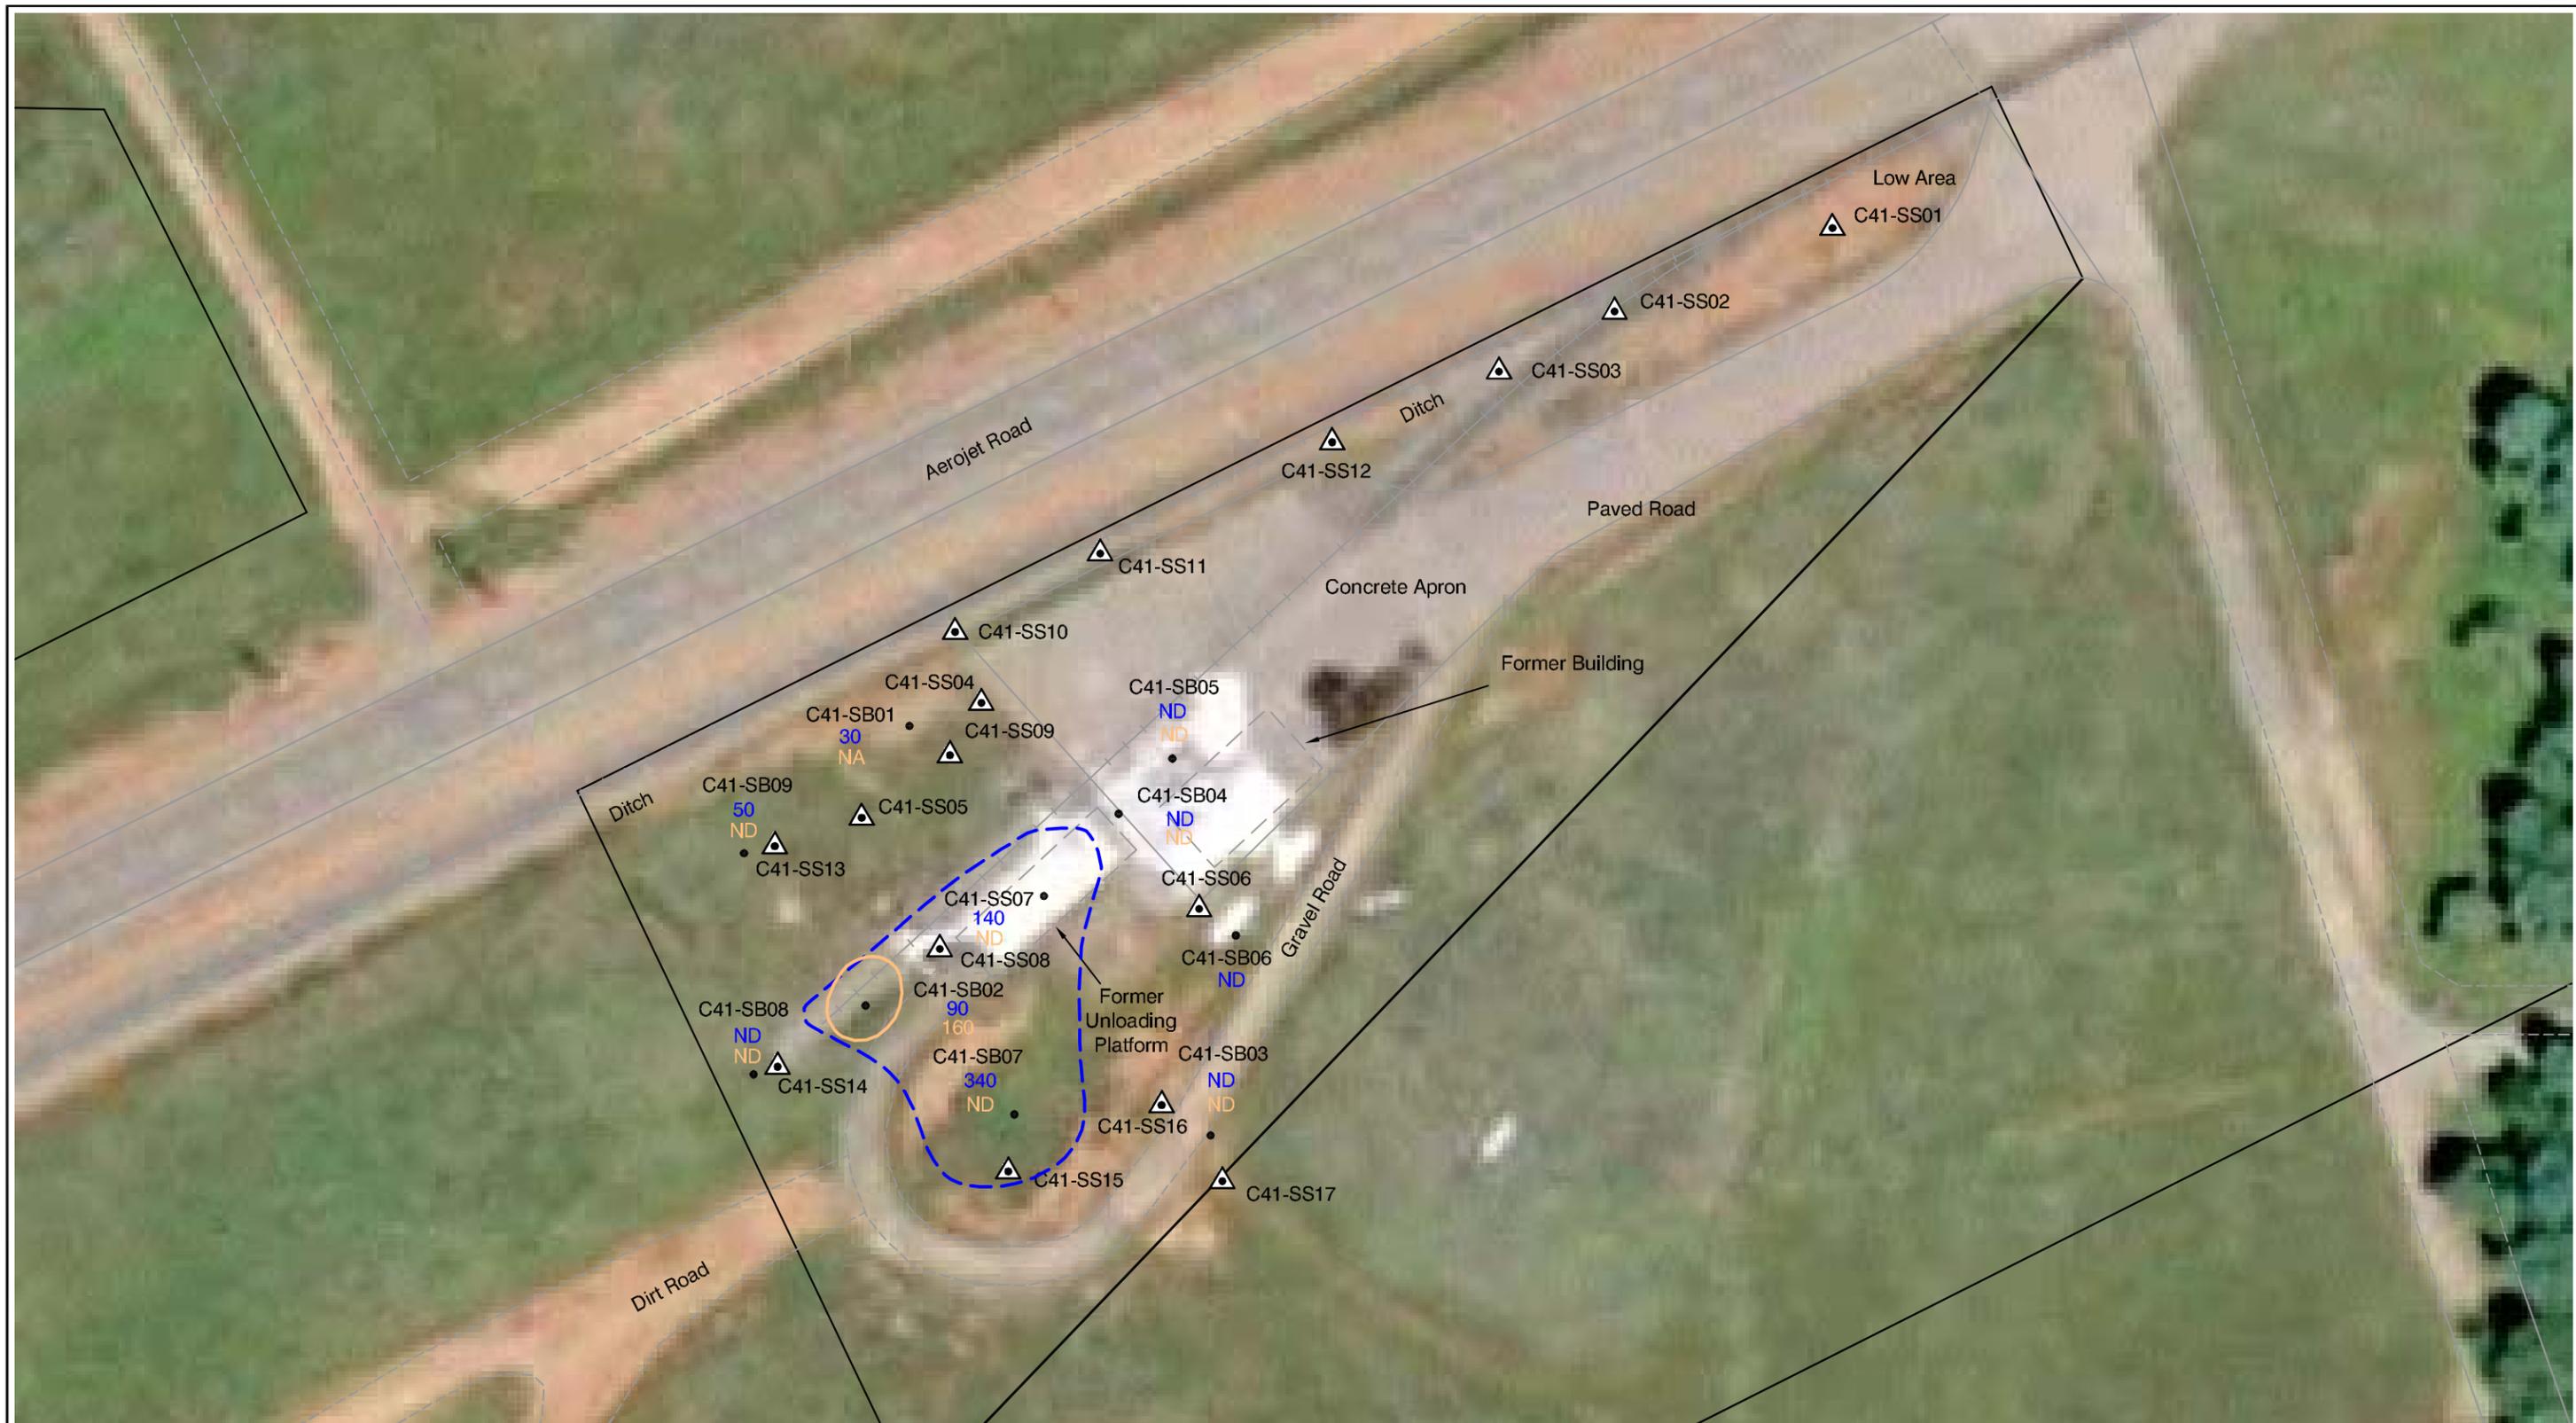
**FIGURE 4-38**  
**Perchlorate in Soil**  
**50 and 55 Feet BGS**  
**Site C41**

- ▲ Soil Sampling Location
- Soil Boring Location
- 140 Perchlorate Concentration at 50 ft Below Ground Surface
- 570 Perchlorate Concentration at 55 ft Below Ground Surface
- ND Not Detected
- NA Not Analyzed
- Extent of Perchlorate >60 µg/Kg at 50 ft Below Ground Surface
- Extent of Perchlorate >60 µg/Kg at 55 ft Below Ground Surface
- Site C41 Boundary
- Railroad Track

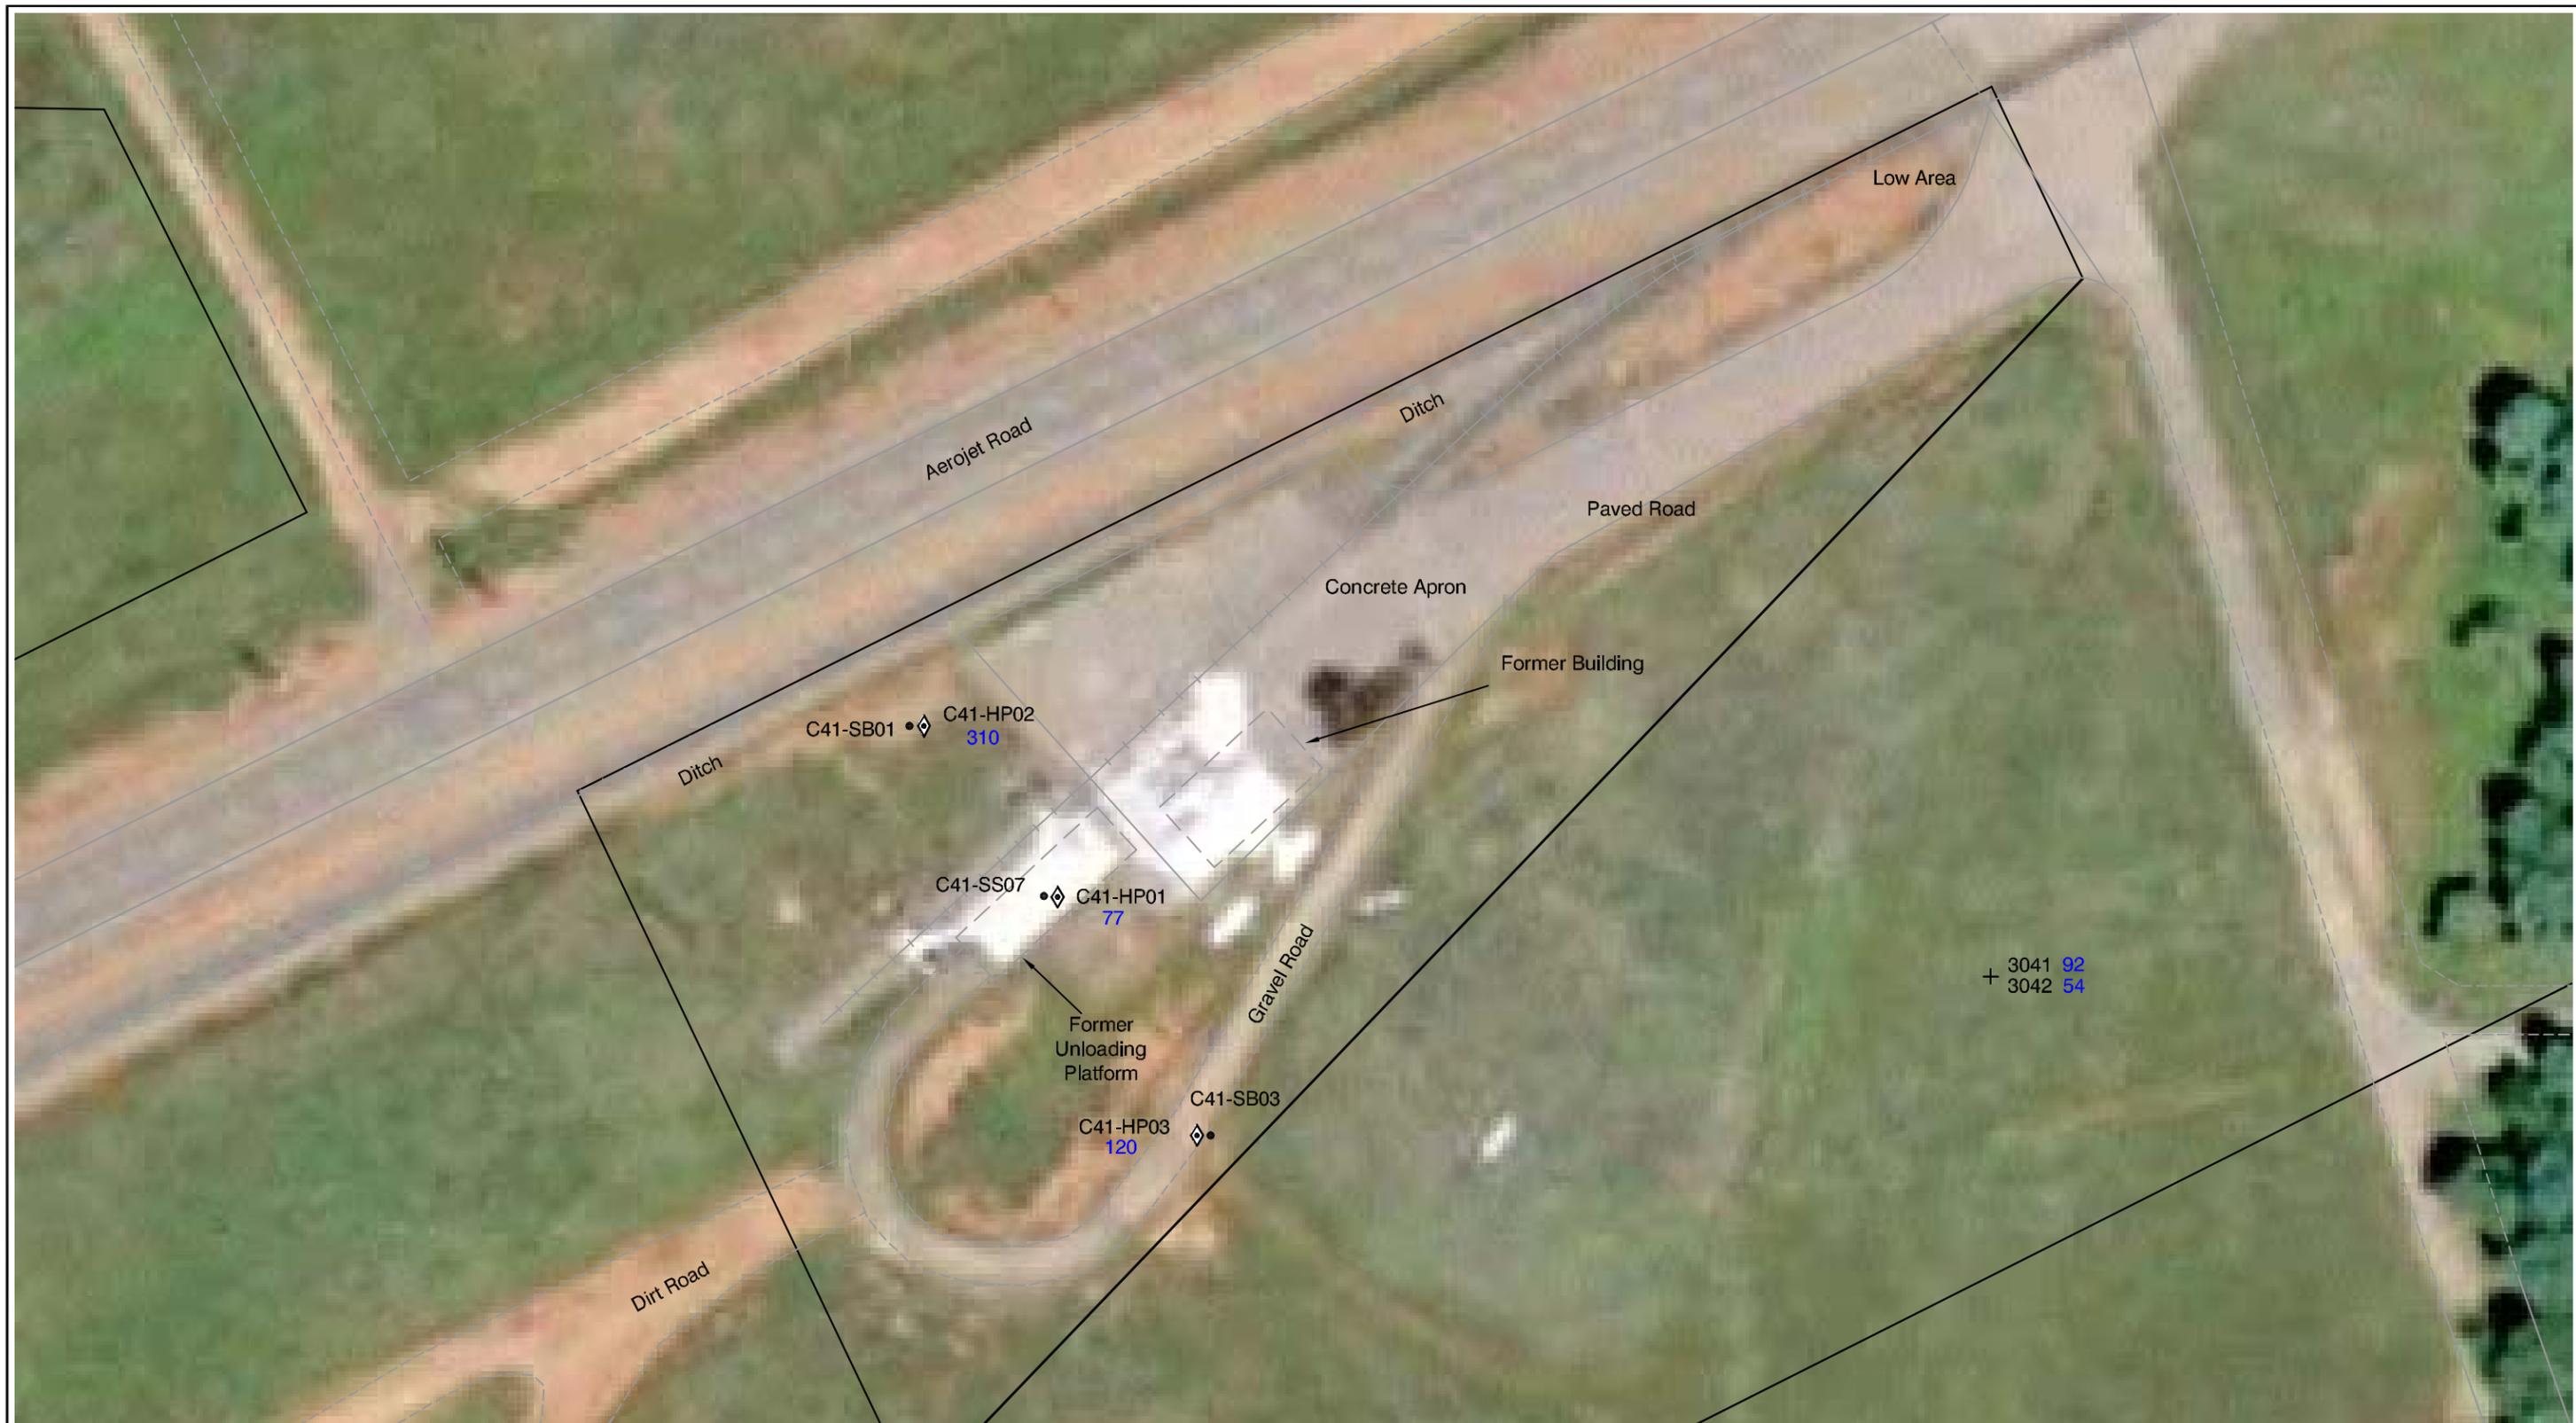
**FIGURE 4-39**  
**Perchlorate Concentrations in Groundwater**  
**Site C41**

- ◆ 310 Hydropunch Location with Perchlorate Concentration in Micrograms per Liter (µg/L)
- + 92 Monitor Well with Perchlorate Concentration (Feb/Mar 2005)
- Site C41 Boundary
- +— Railroad Track

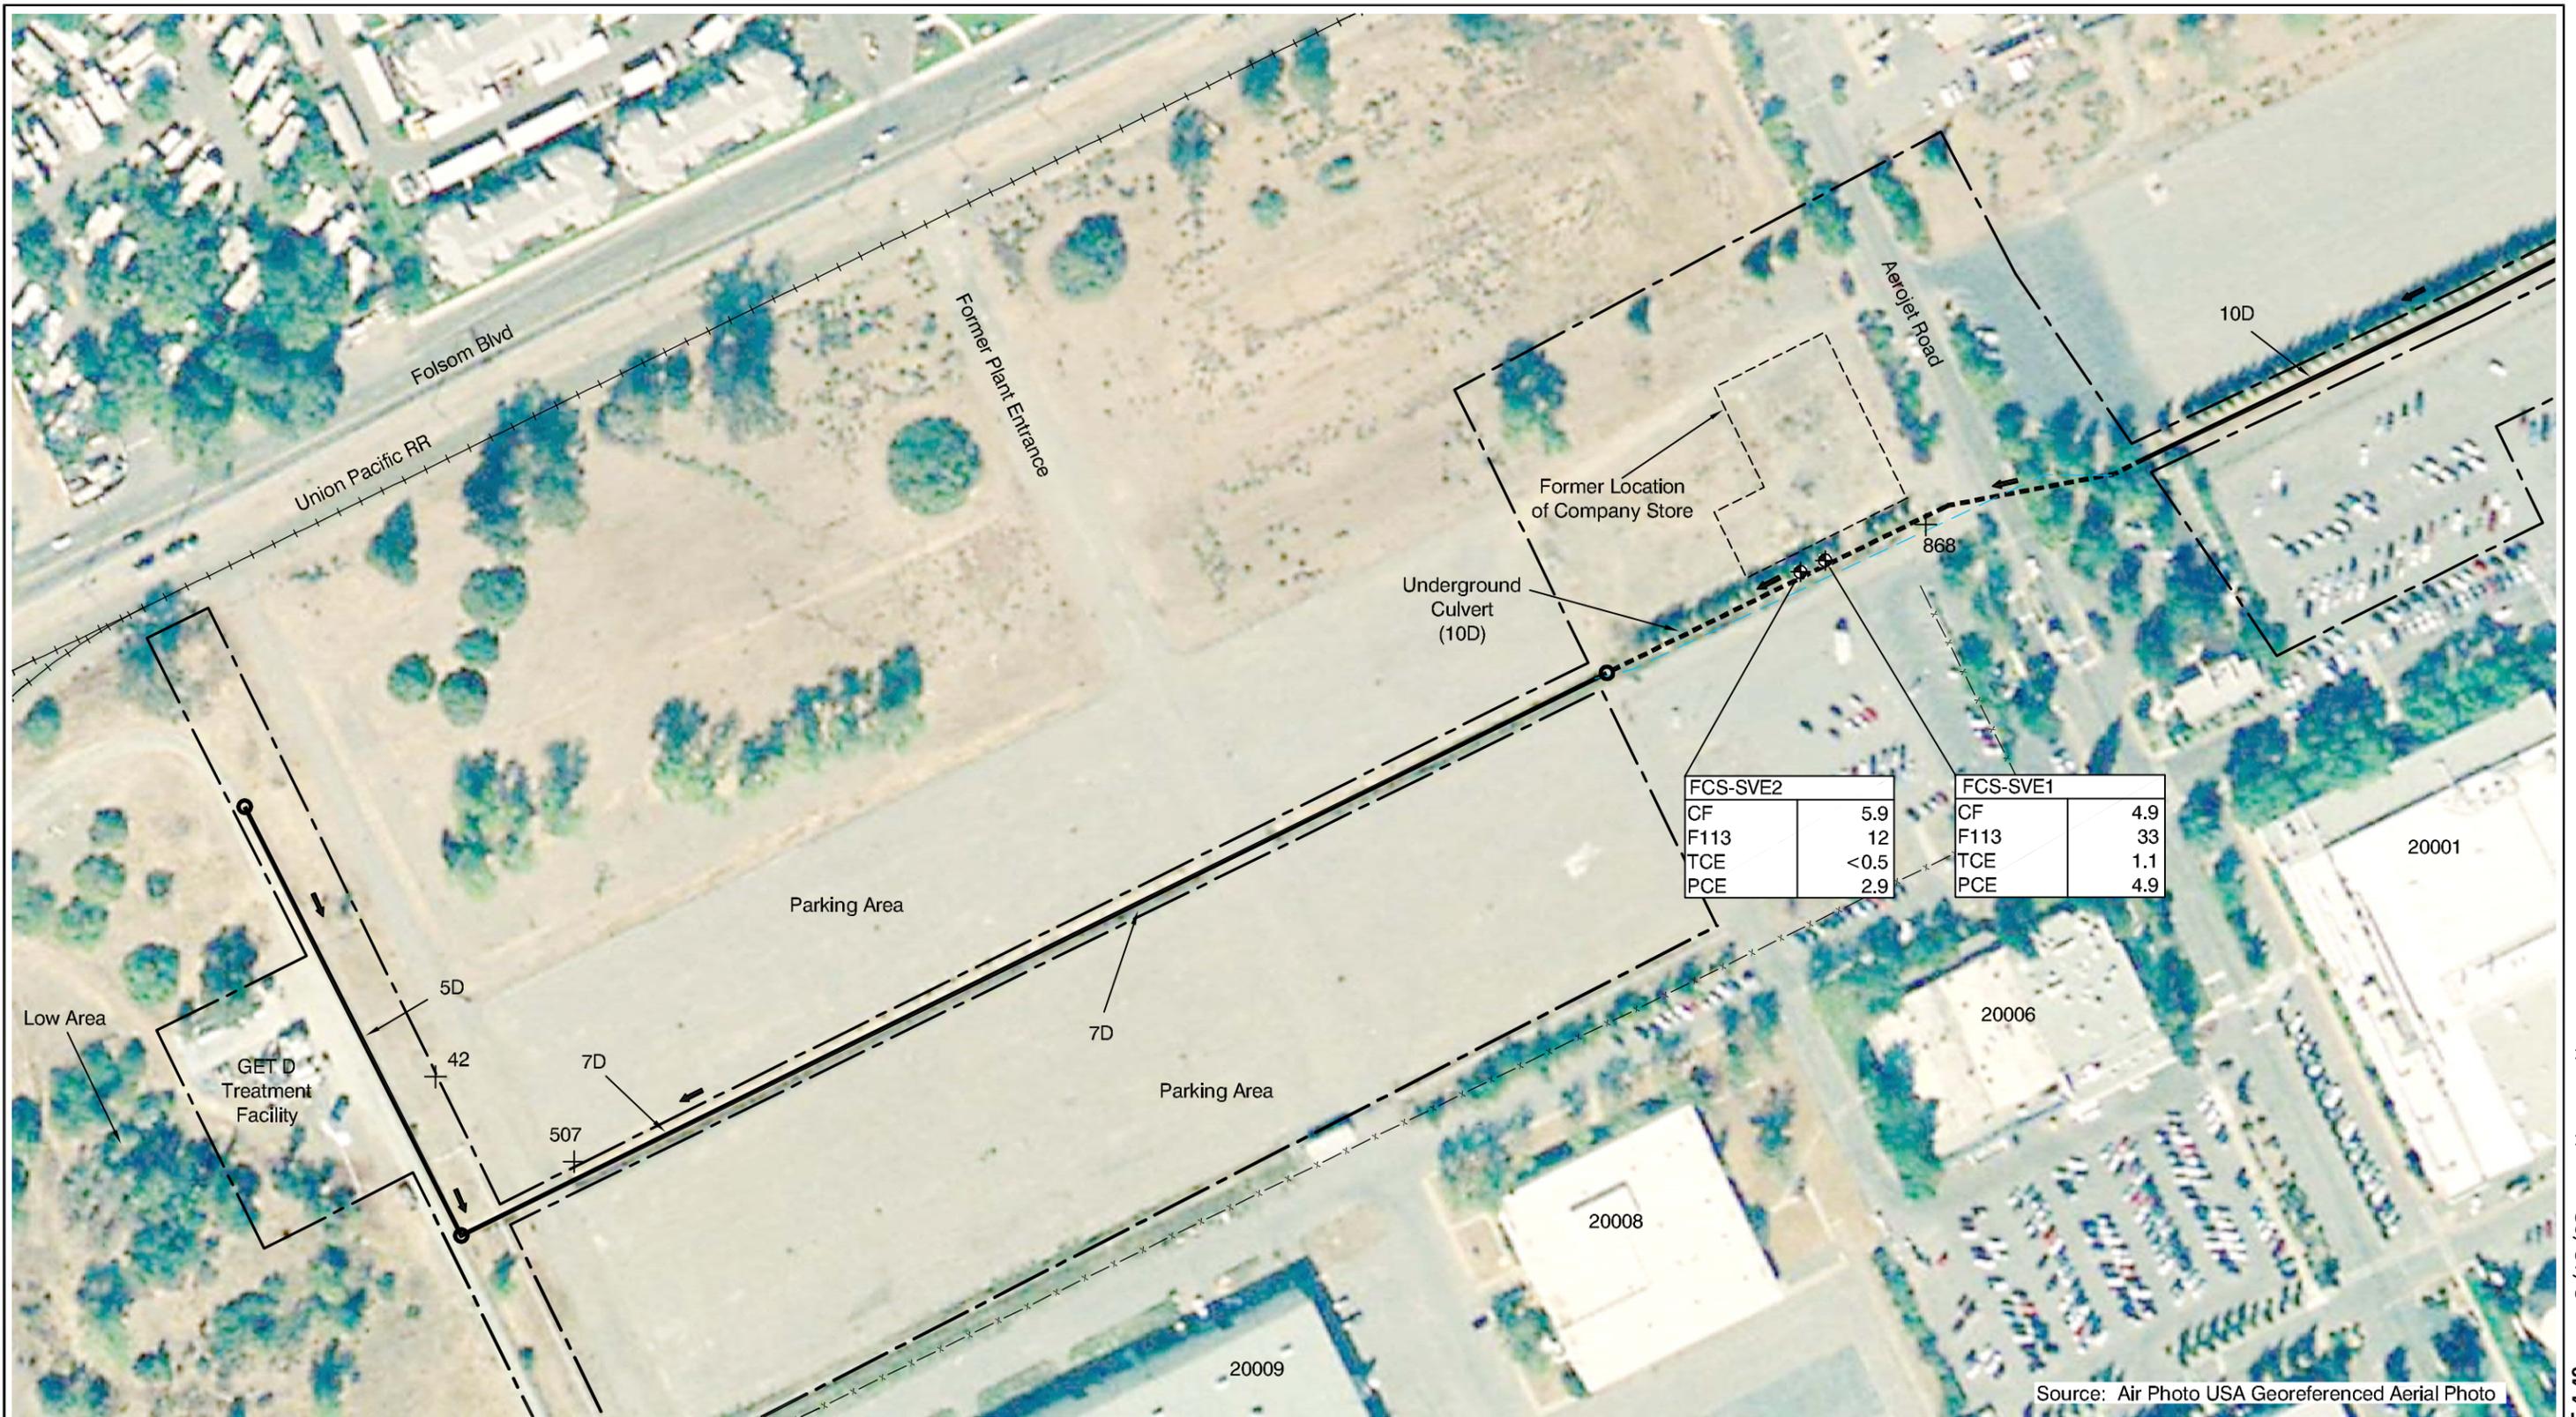
**FIGURE 4-40**  
**Constituents Detected in Unconfined Groundwater Samples from Wells FCS-SVE1 and FCS-SVE2**

FCS-SVE2	
CF	5.9
F113	12
TCE	<0.5
PCE	2.9

FCS-SVE1	
CF	4.9
F113	33
TCE	1.1
PCE	4.9

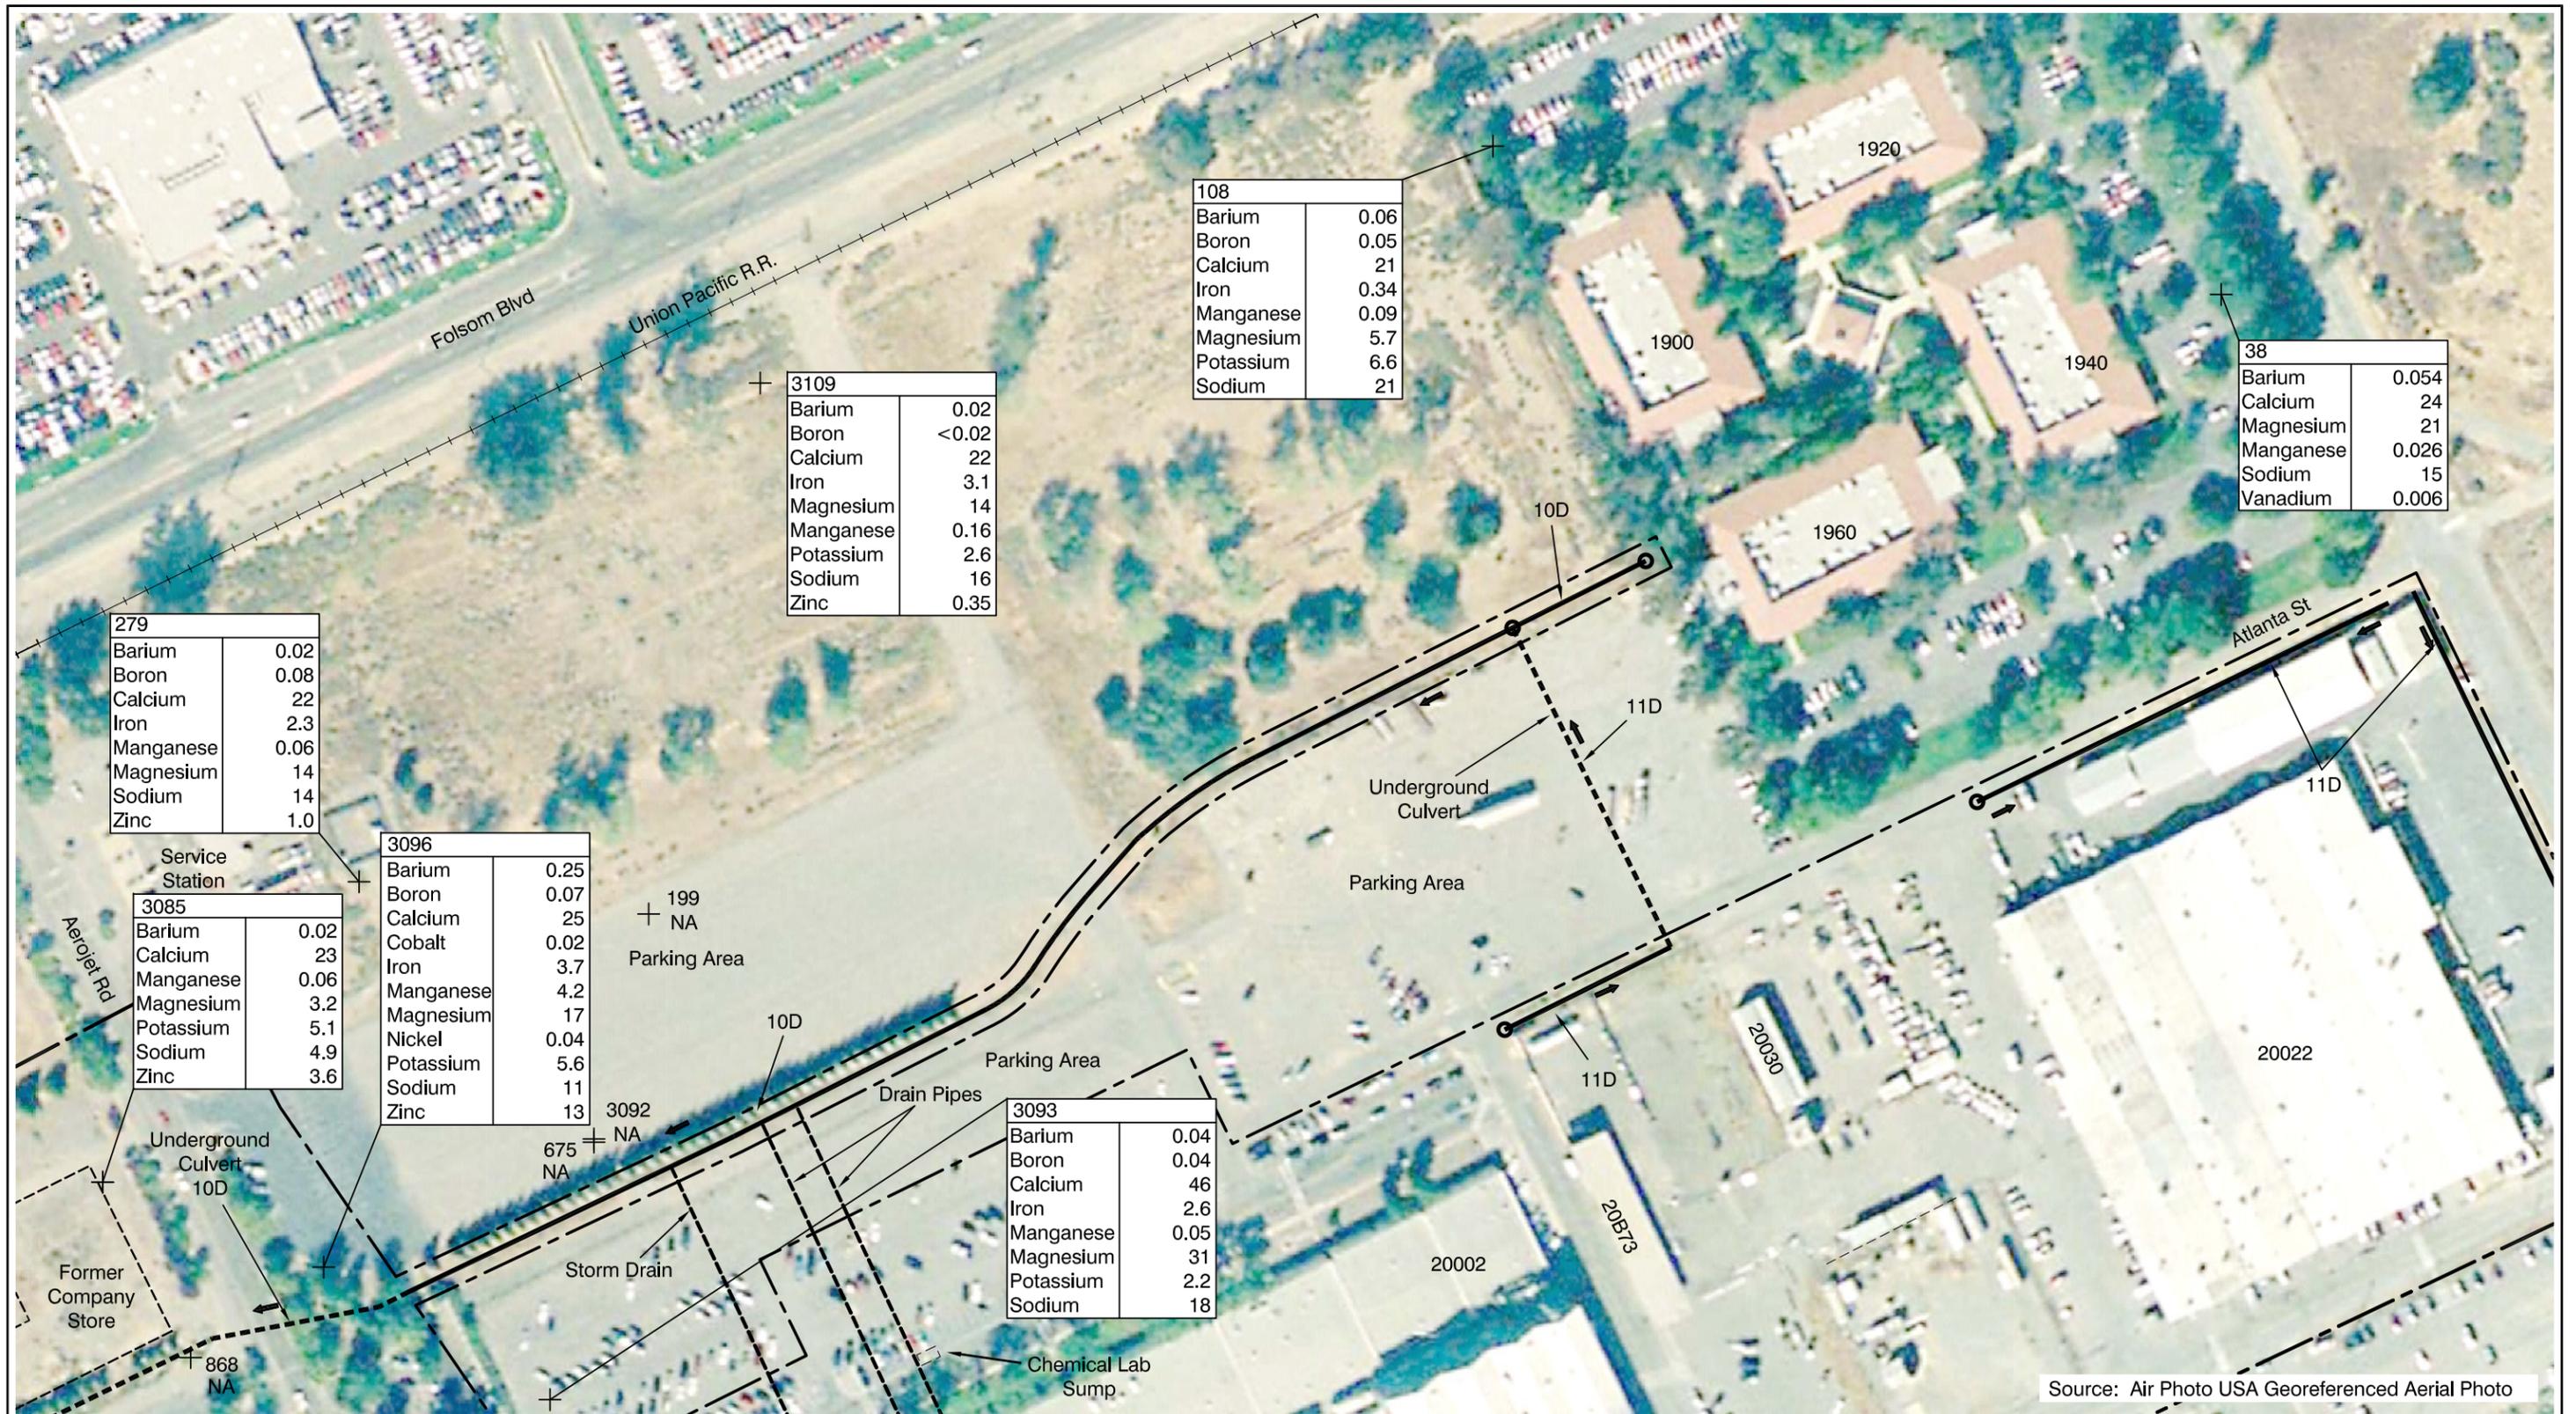
**FIGURE 4-41**  
**Dissolved Concentrations of Metals**  
**Detected in Groundwater**  
**Area 20**

108	
Barium	0.06
Boron	0.05
Calcium	21
Iron	0.34
Manganese	0.09
Magnesium	5.7
Potassium	6.6
Sodium	21

3109	
Barium	0.02
Boron	<0.02
Calcium	22
Iron	3.1
Magnesium	14
Manganese	0.16
Potassium	2.6
Sodium	16
Zinc	0.35
