**AEROJET**  
Environmental Remediation

**FIGURE 1-1**  
Location of Sites Included  
in PGOU Solls RI/FS

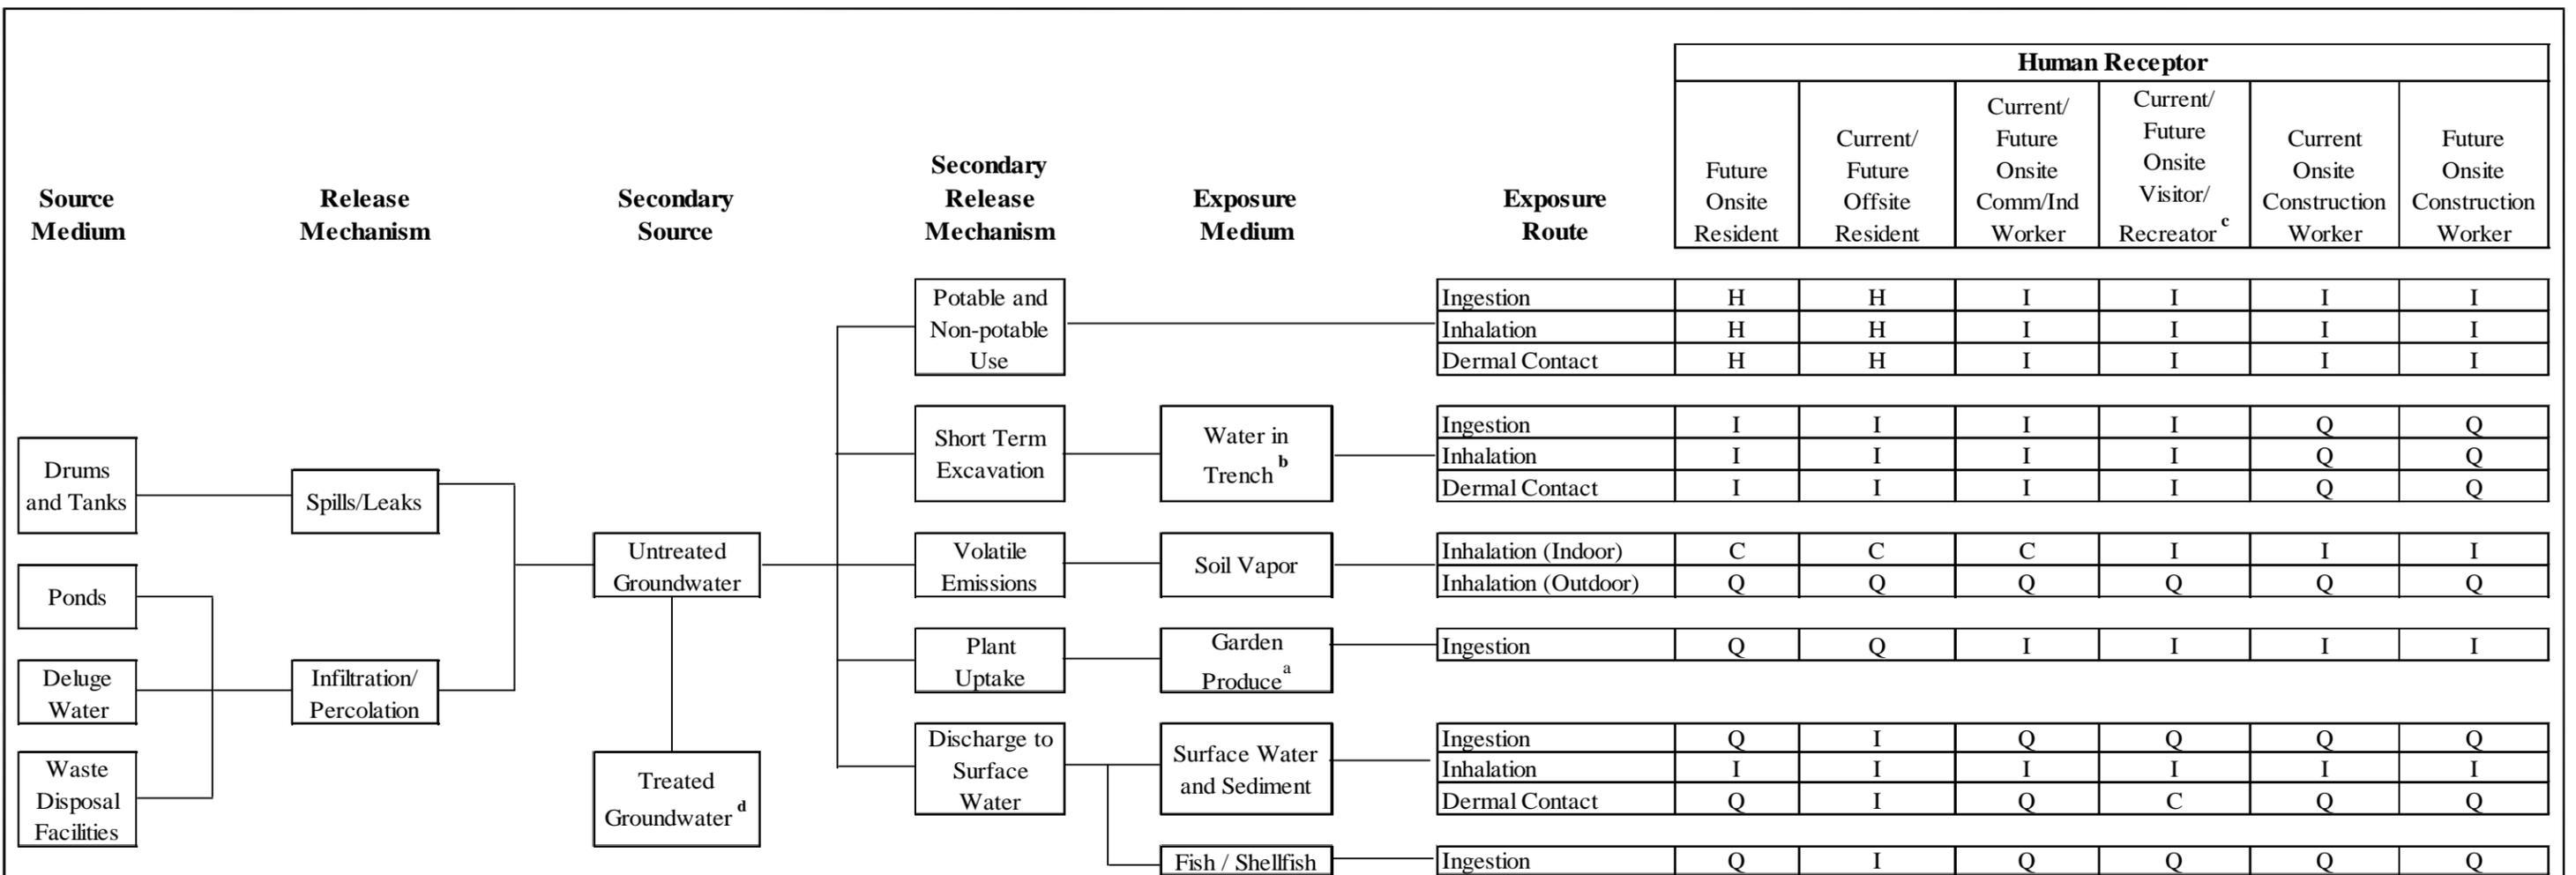
**FIGURE 6-1b**  
**Conceptual Site Model for the PGOU Groundwater Exposure Pathways for Human Health Groundwater Exposure Pathways for Human Receptors**

- b Although construction workers may briefly encounter the shallow water table in some OUs, construction activities in saturated trench conditions are generally avoided and dewatering is performed to avoid work in a wet and slippery trench. Dermal exposures to contaminants in trench water would be incomplete as steady state absorption and penetration of the skin is unlikely, given short exposure times.

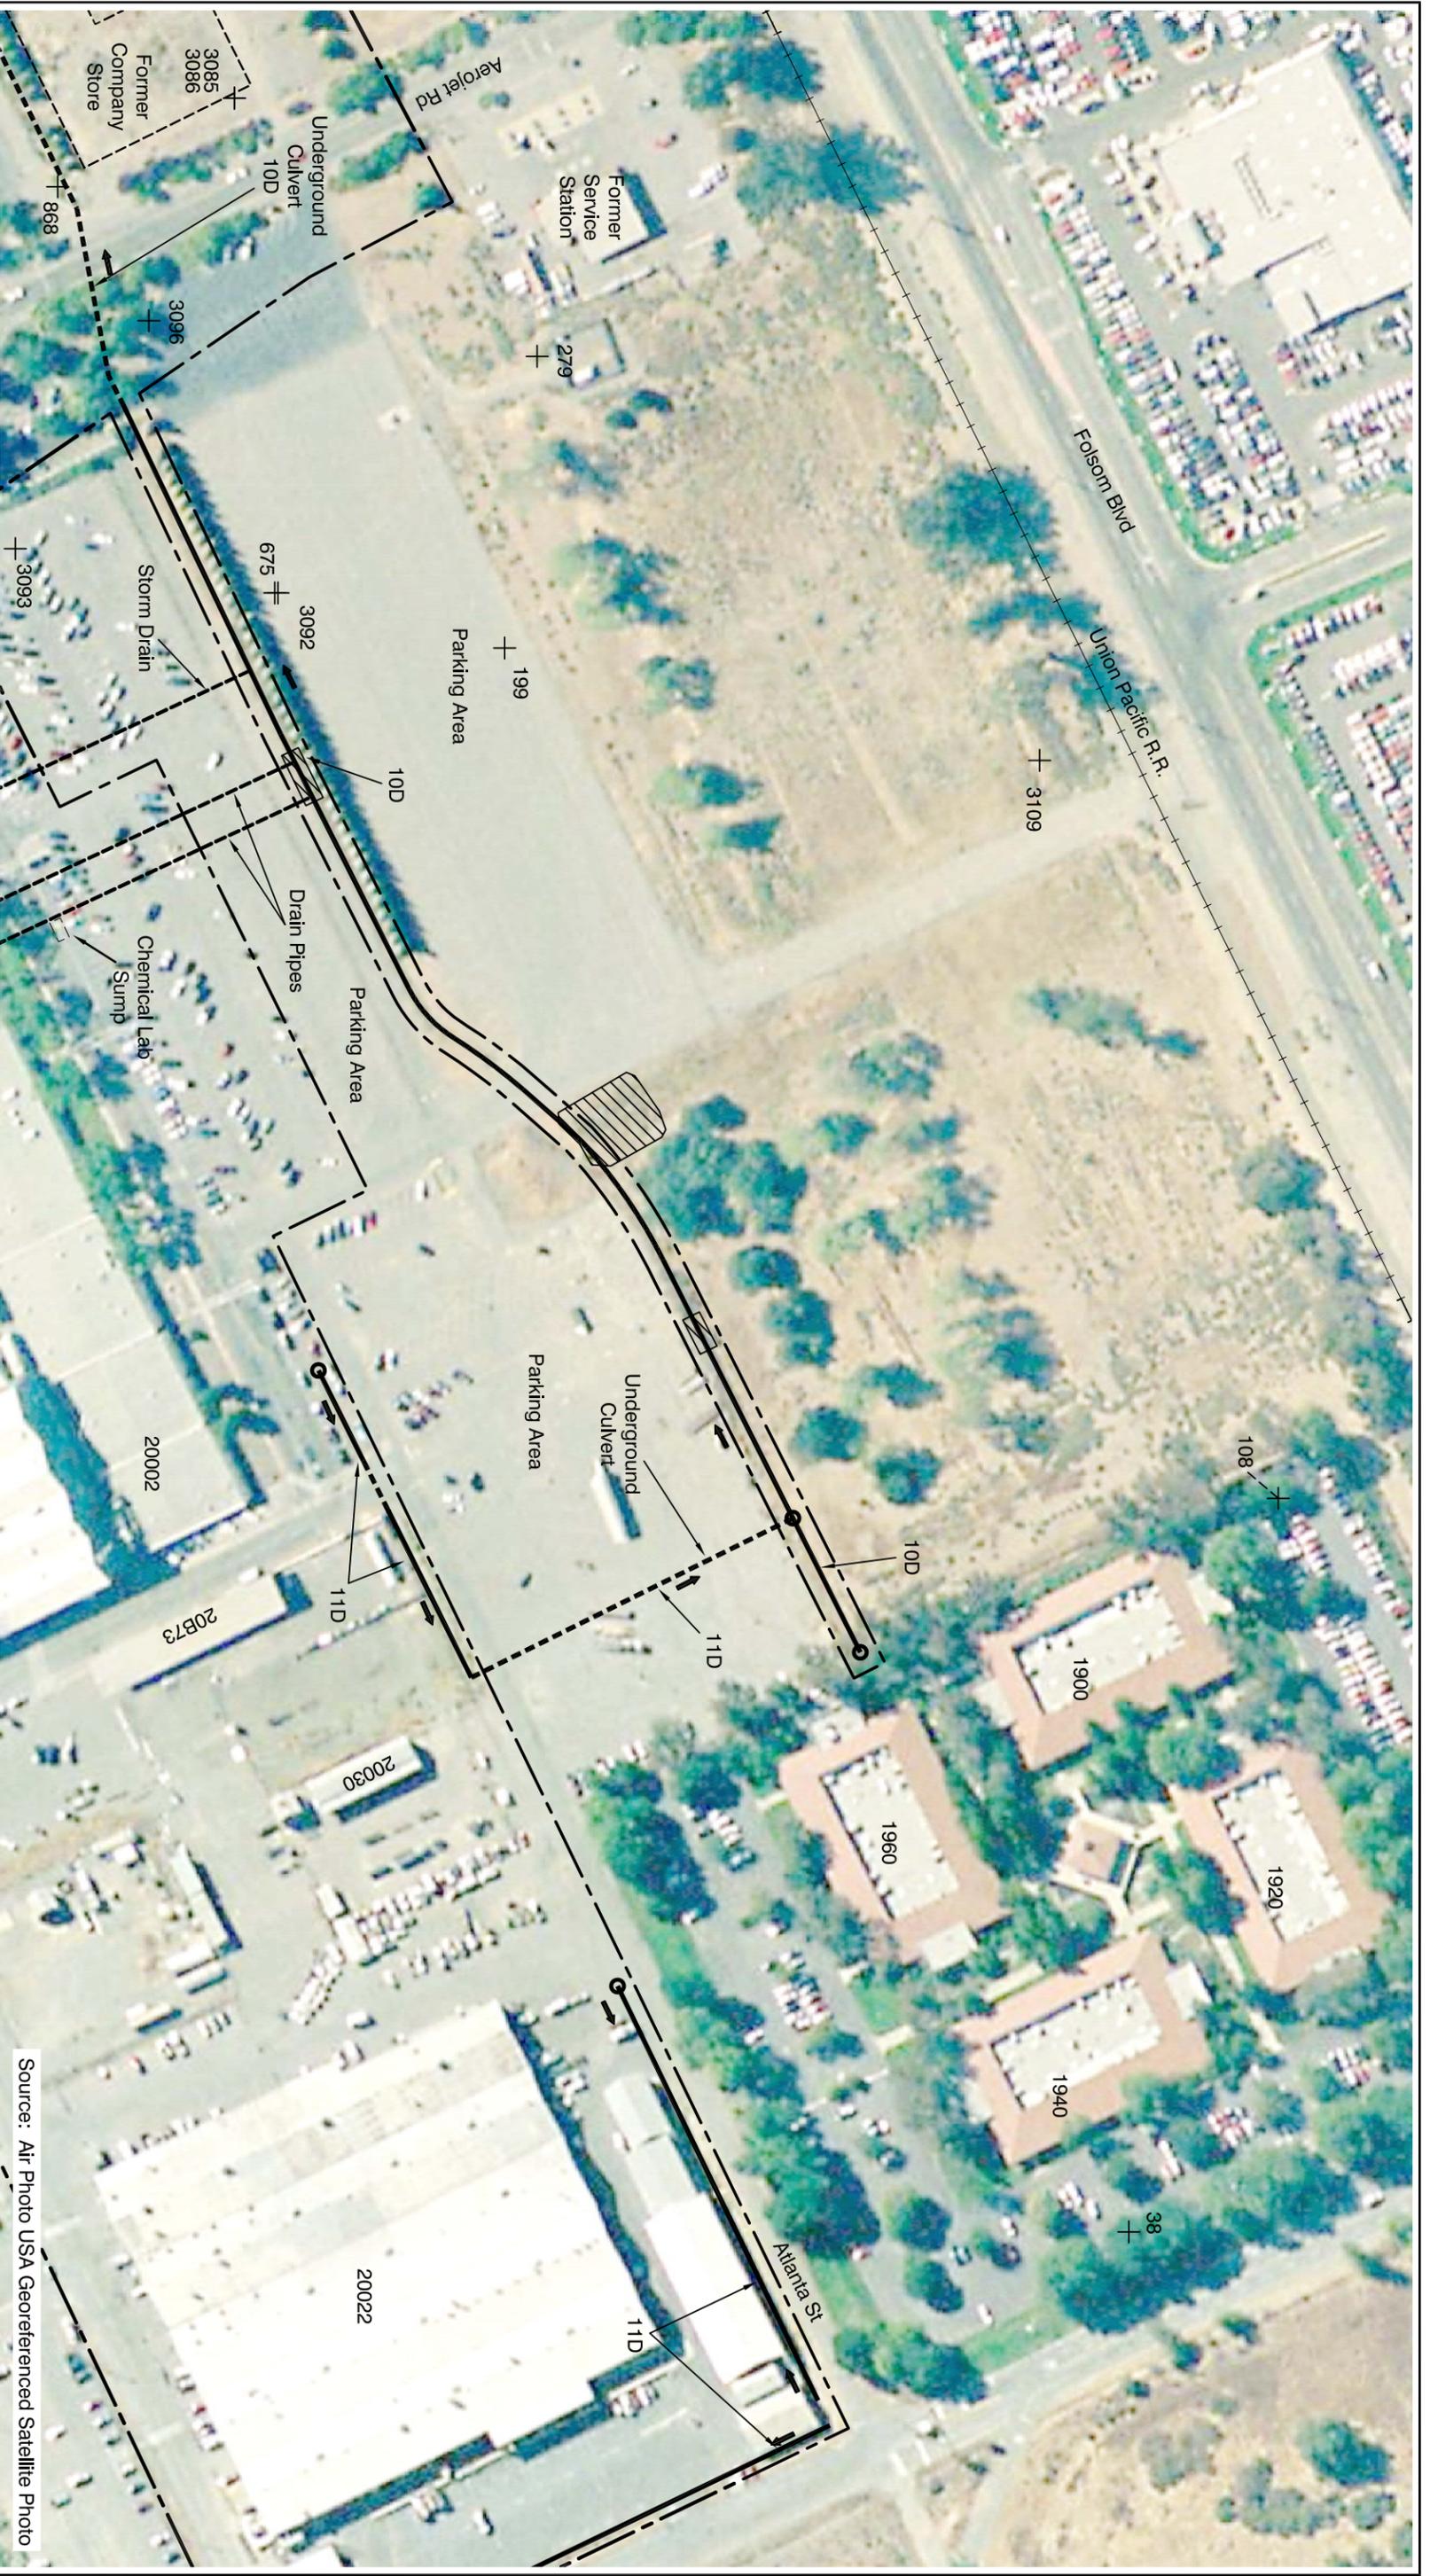
Excavation Limits for Remedial Alternative A20-1C  
Potential Source Sites 10D & 11D

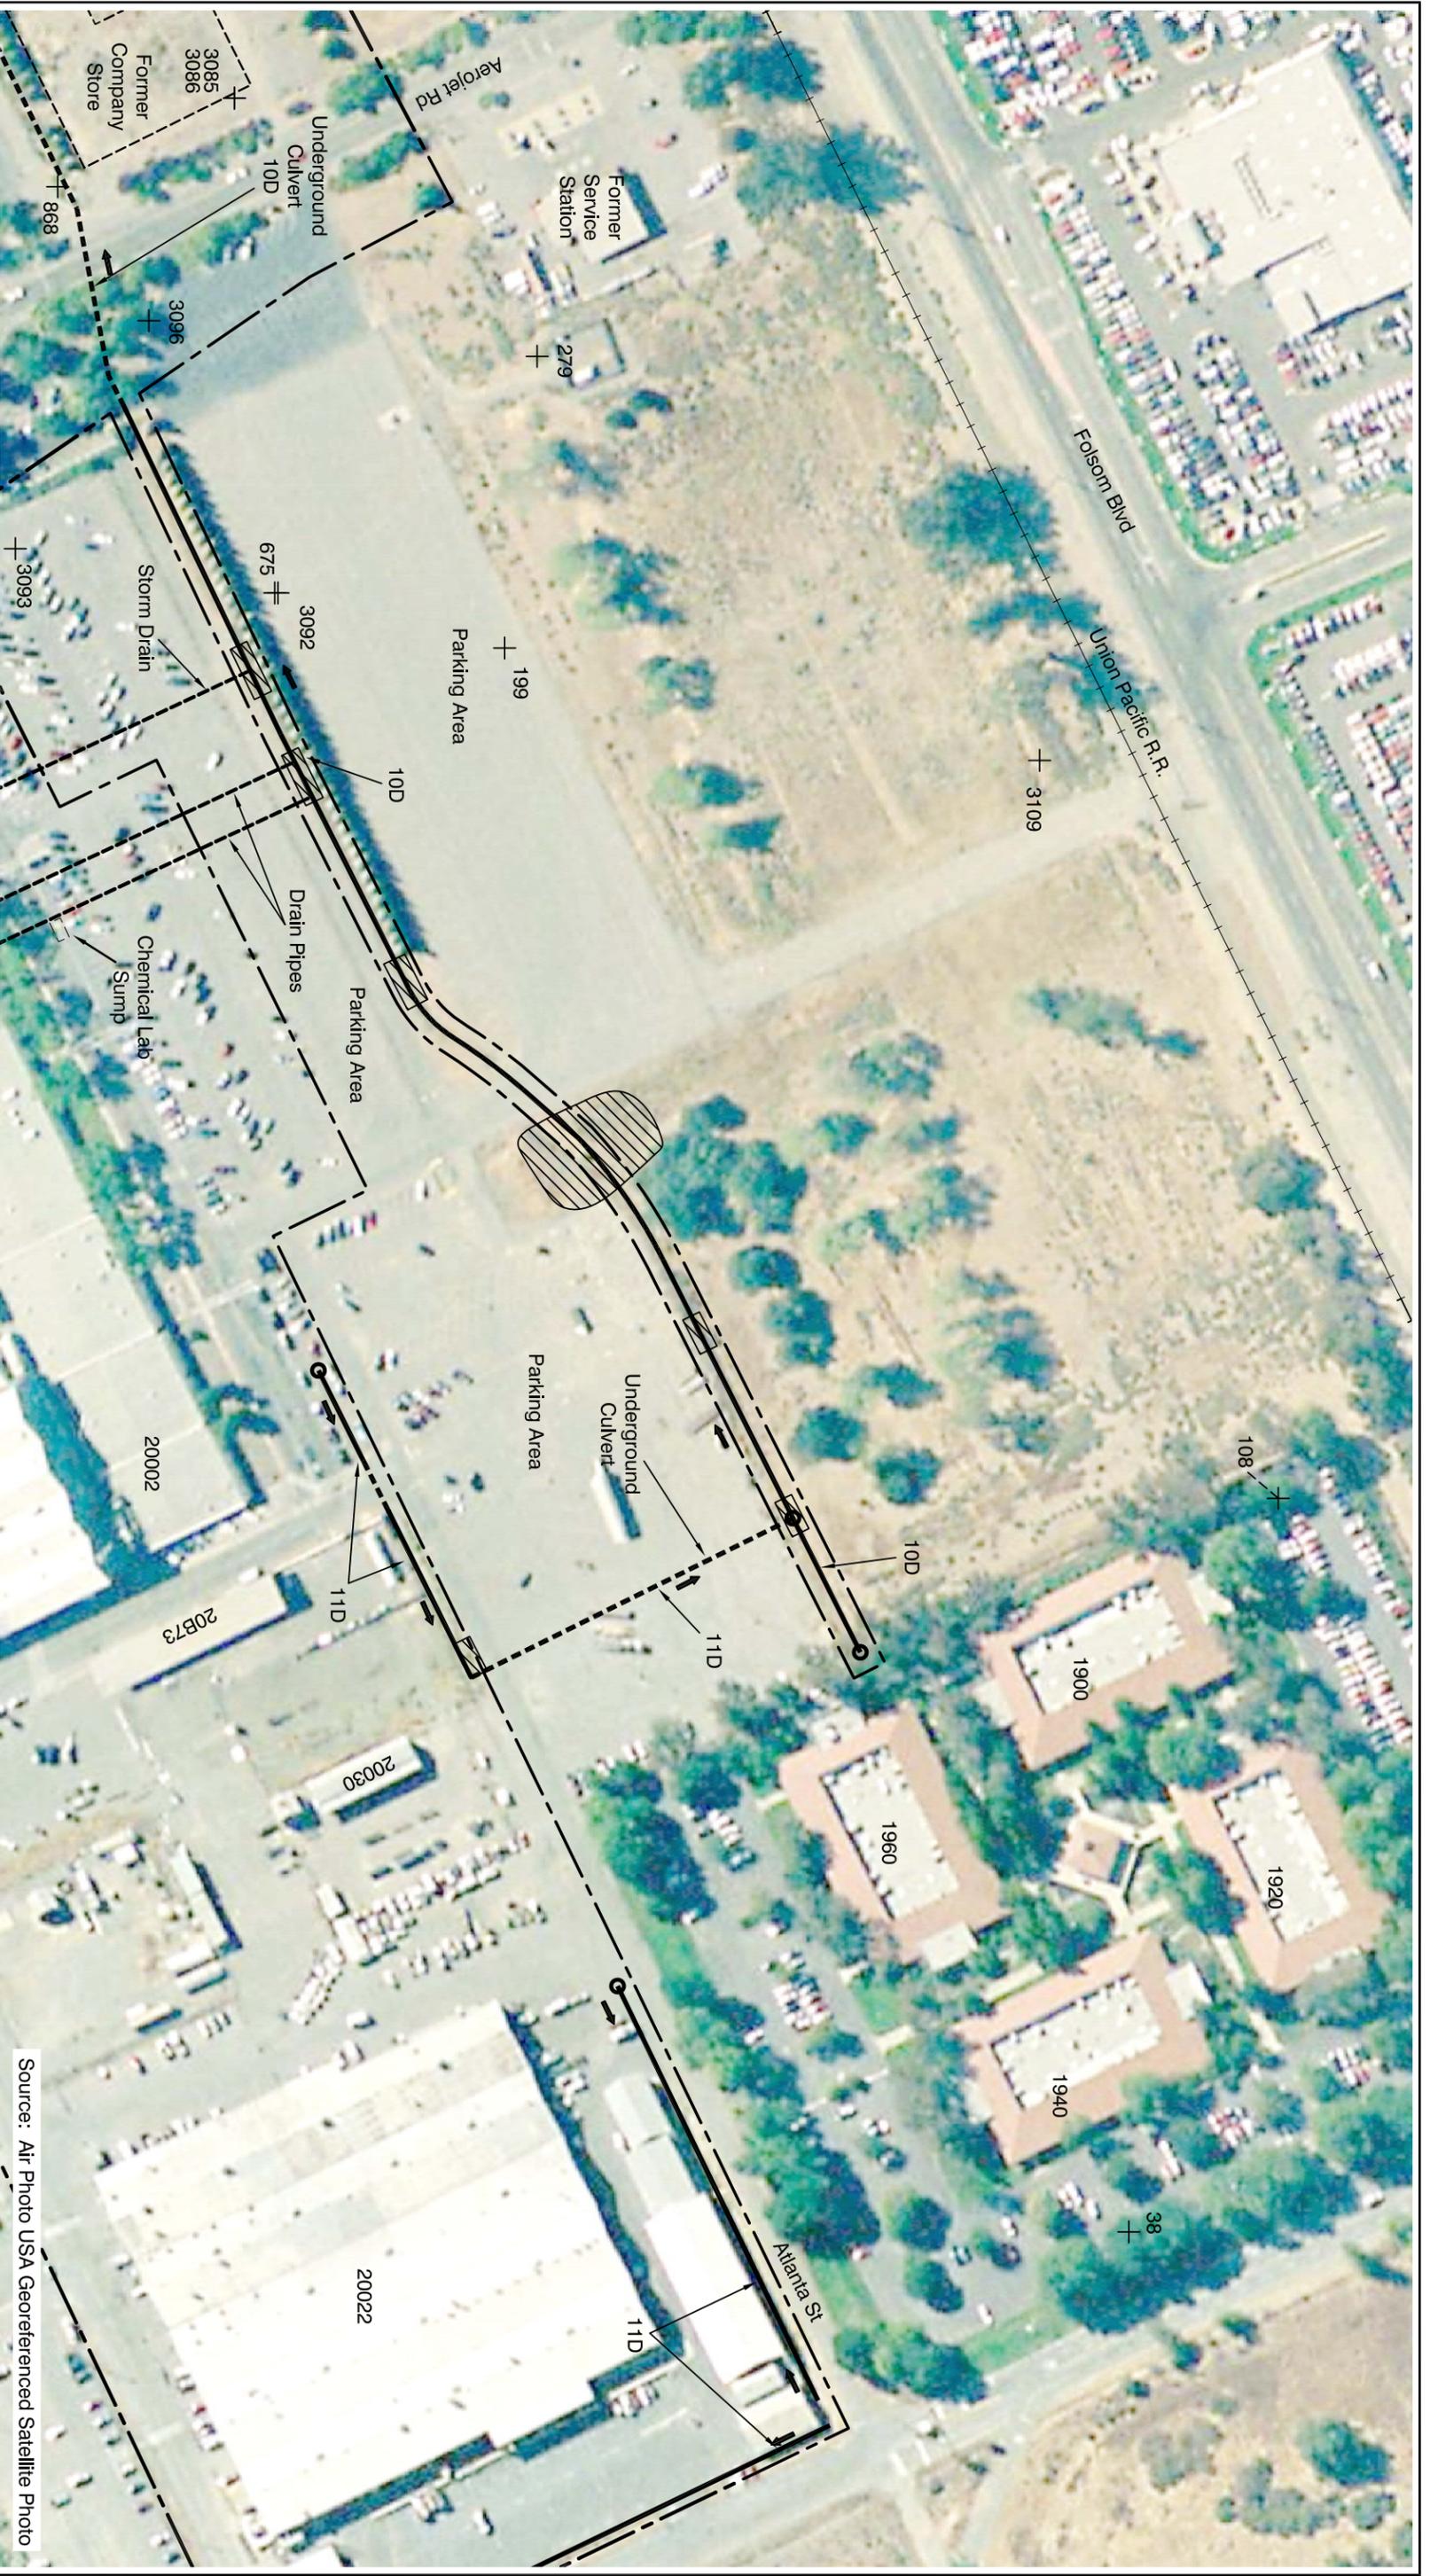
Excavation Limits for Remedial Alternative A20-1B  
Potential Source Sites 10D & 11D
