**2010 Oversight Summary Report
Leviathan Mine Superfund Site
Alpine County, California**

June 2011

**Burleson Consulting, Inc.
950 Glenn Drive, Suite 245
Folsom, California 95630**

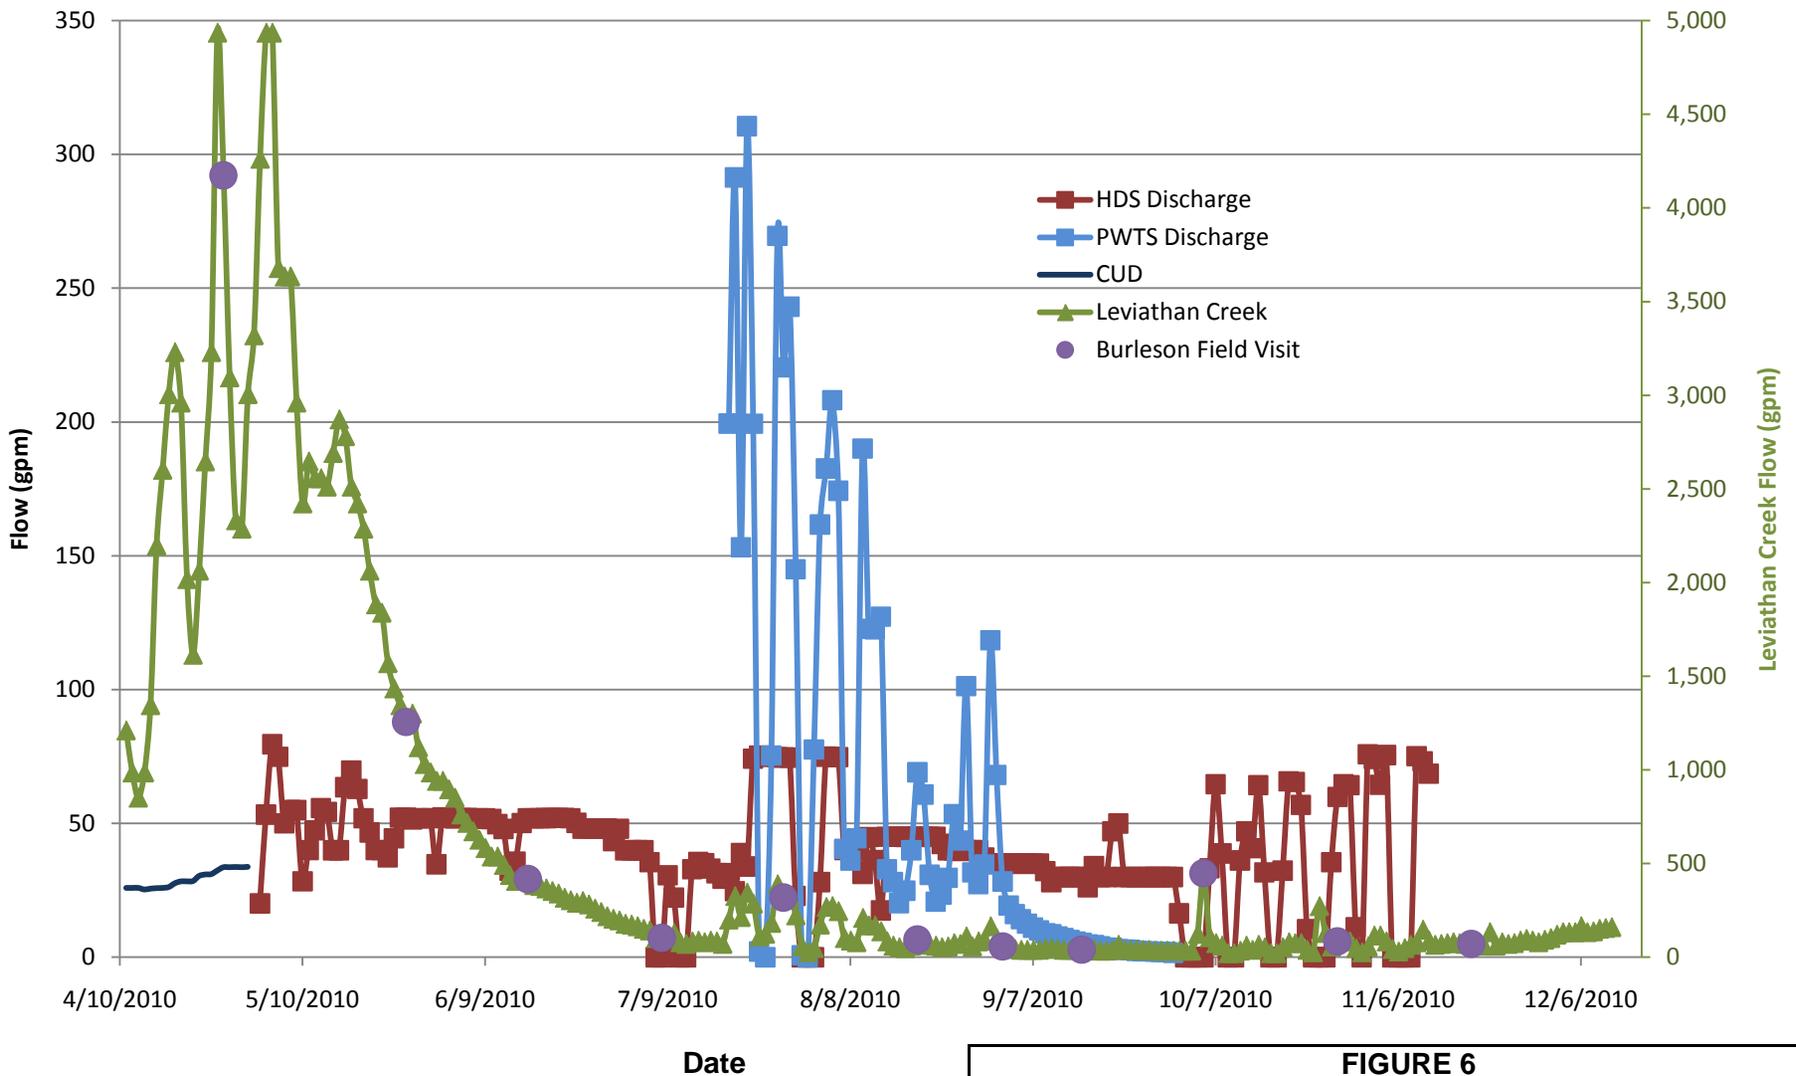
FIGURE 6
TREATMENT SYSTEM DISCHARGE AND
FLOW AT STATION 15 (LEVIATHAN CREEK)
LEVIATHAN MINE SUPERFUND SITE
ALPINE COUNTY, CALIFORNIA

Treatment system discharges are shown diagrammatically and are not accurate depictions of actual flow rate
 CUD and Leviathan Creek flow rates are from the U.S. Geological Survey 2010.
 Recent Daily Water for California, Accessed online at: <http://waterdata.usgs.gov/ca/nwis/current?type=flow>

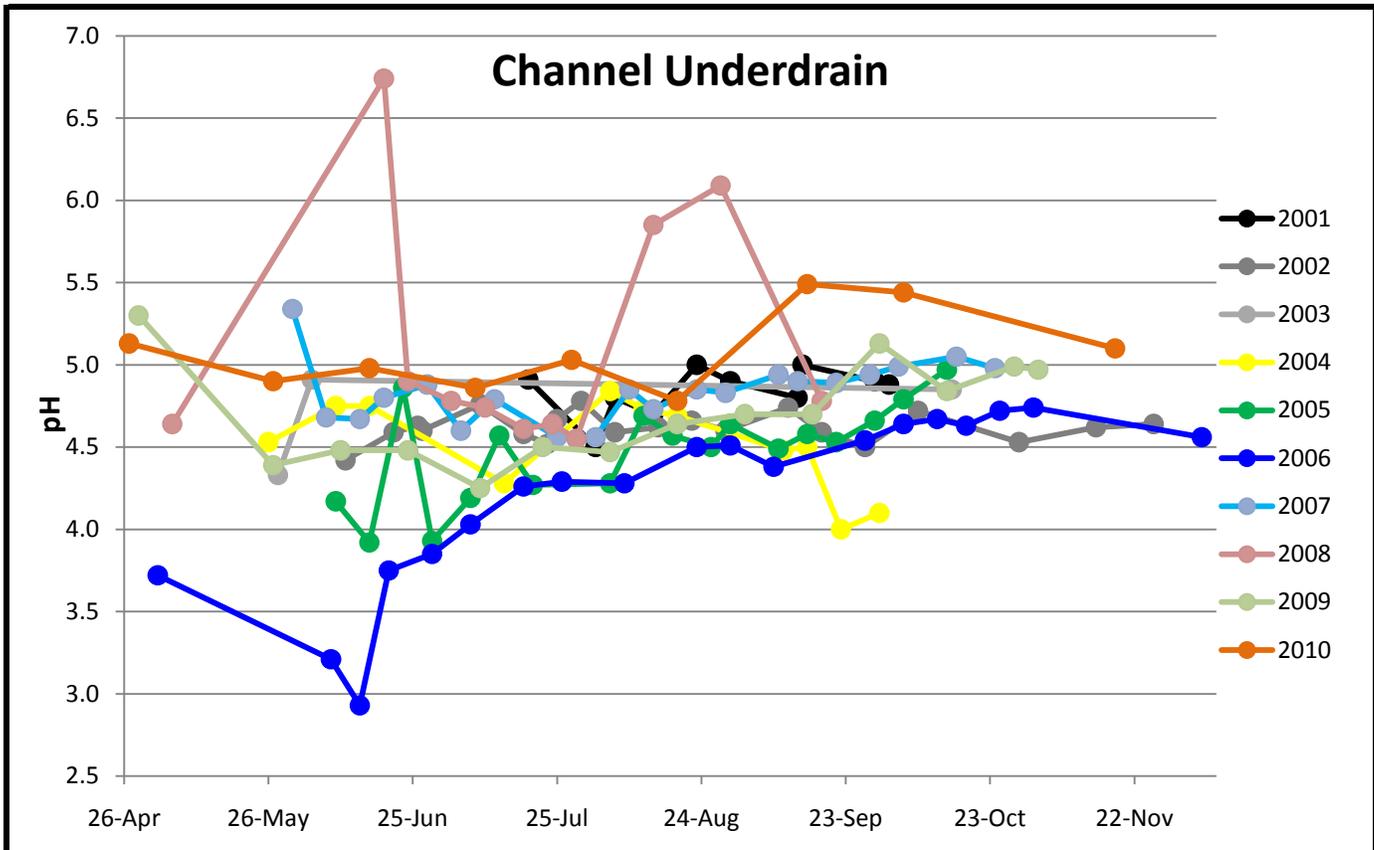
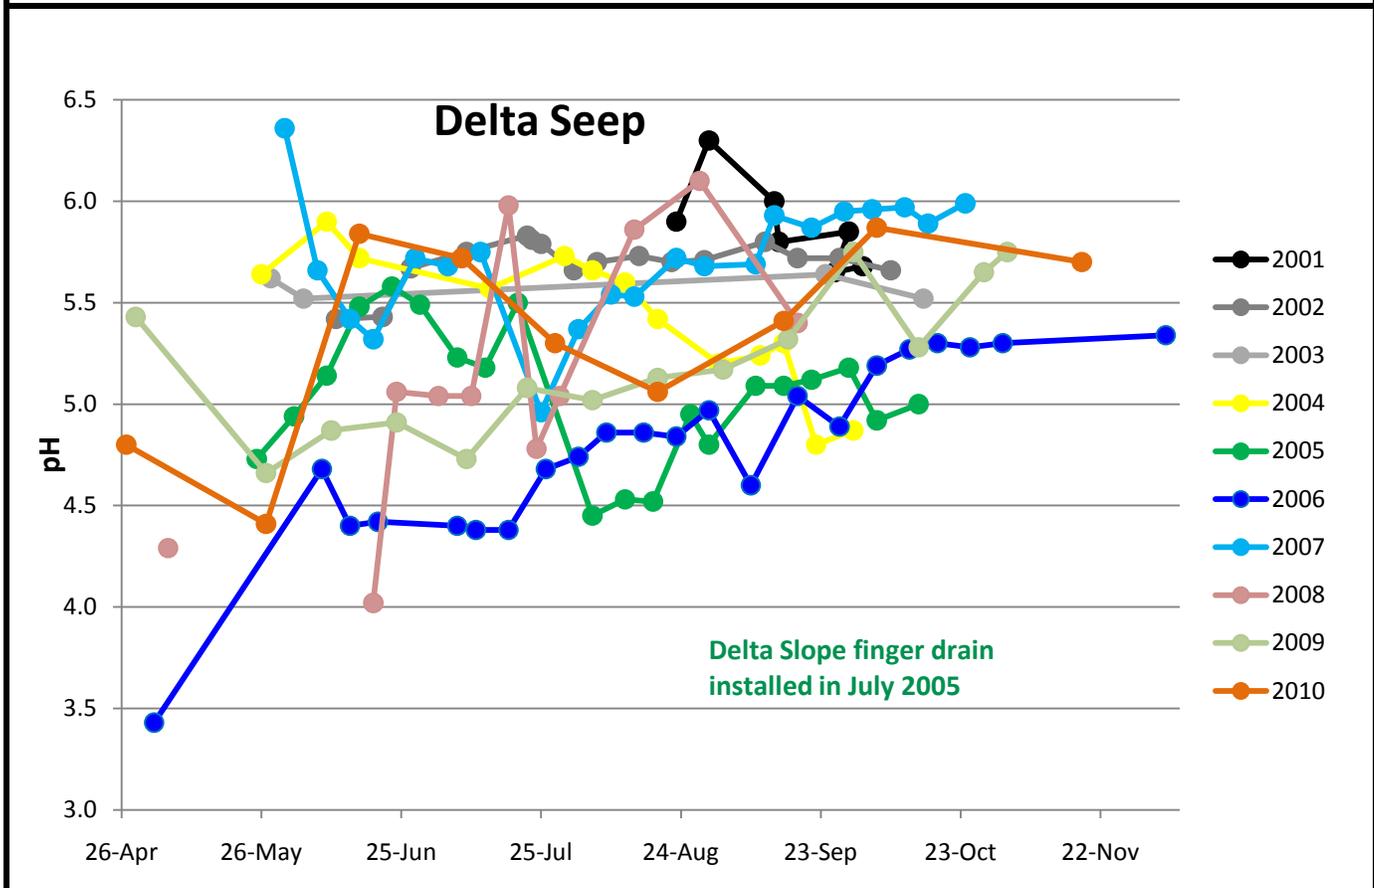
FIGURE 16
CUD AND DELTA SEEP pH
LEVIATHAN MINE SUPERFUND SITE
ALPINE COUNTY, CALIFORNIA

Note:
Delta Seep data since July 2005 represent the mixture of seepage and discharge from the Delta Slope finger drain.

The range of pH measurements at the CUD and DS in 2010 was similar to the pH range observed during treatment seasons between 2001 and 2009, (see Figure 16). These pH trends may reflect flushing of oxidation products from the variably saturated volume of the aquifer during the high rainfall years (2005 and 2006) and increased retention of material above the water table during recent, drier years.

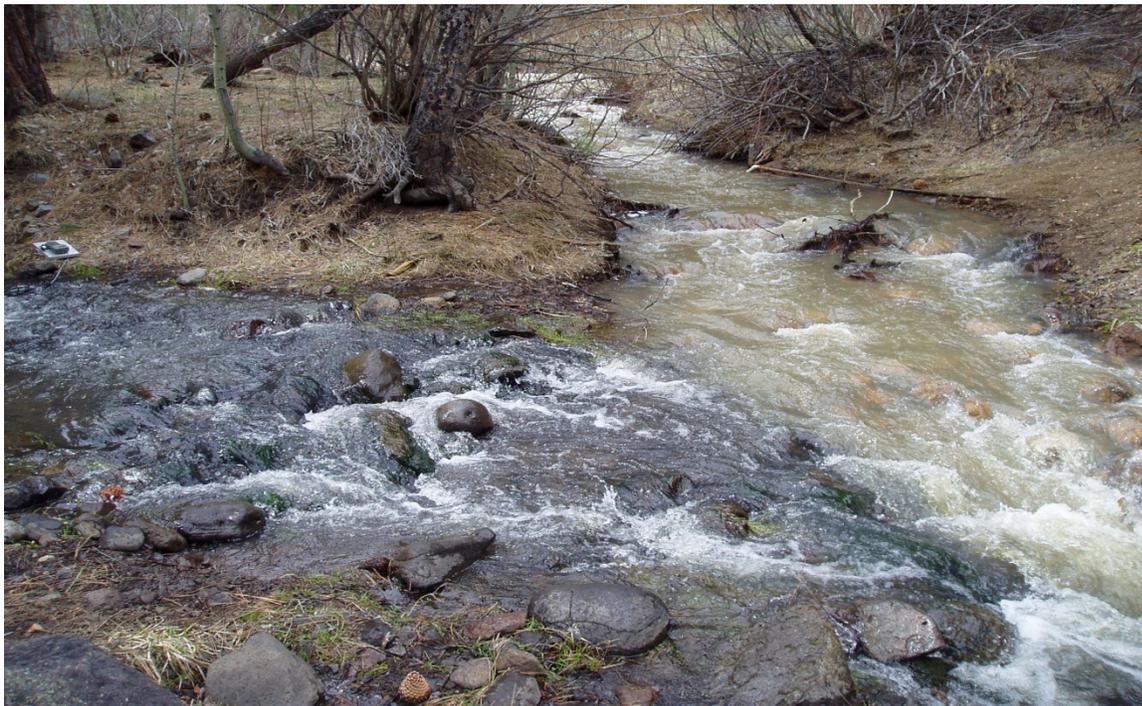
Mountaineer Creek (on left) and Leviathan Creek, before capture of Channel Underdrain and Delta Seep, April 27, 2010

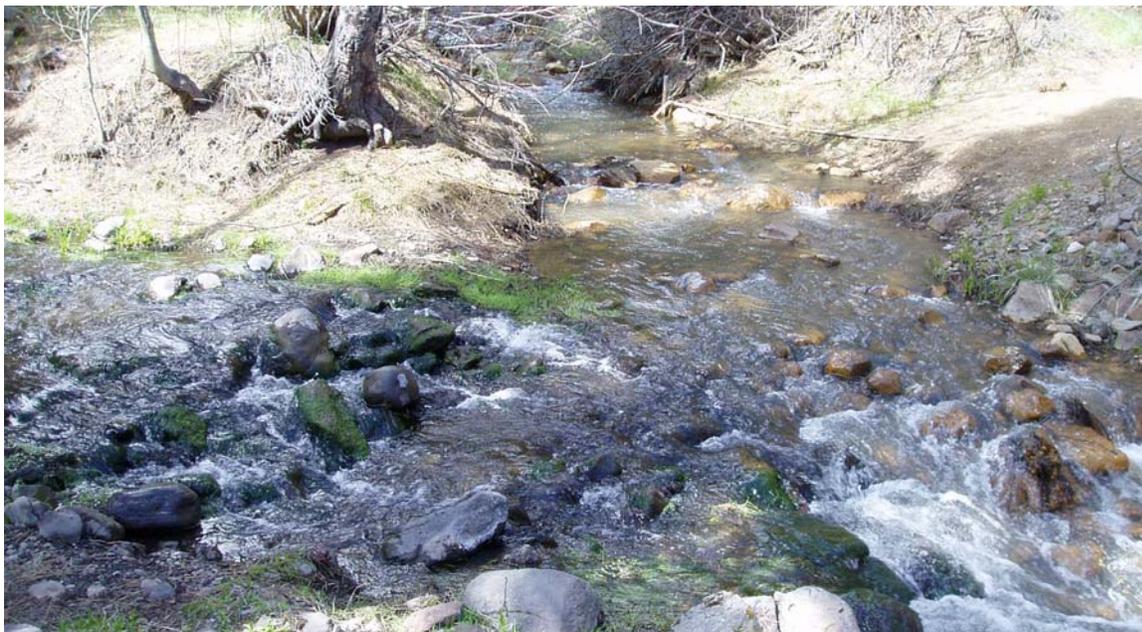
Mountaineer Creek (on left) and Leviathan Creek, after capture and treatment of Channel Underdrain and Delta Seep, May 27, 2010

The visual appearance of Leviathan Creek began to improve in late May 2010 after Atlantic Richfield began capturing CUD and DS discharge. Flow in Leviathan Creek downstream became clearer, and orange chemical staining in the creek bed began dissipating.

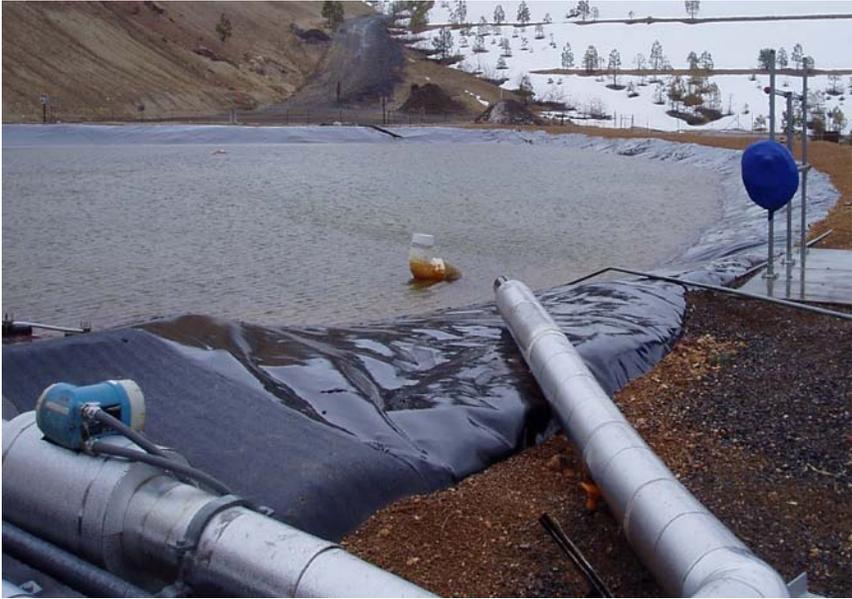
Photo Number	Photo Description	Photo
<p>B-1</p>	<p>View of Pond 4 before the 2010 treatment season. View to south.</p> <p>April 27, 2010</p>

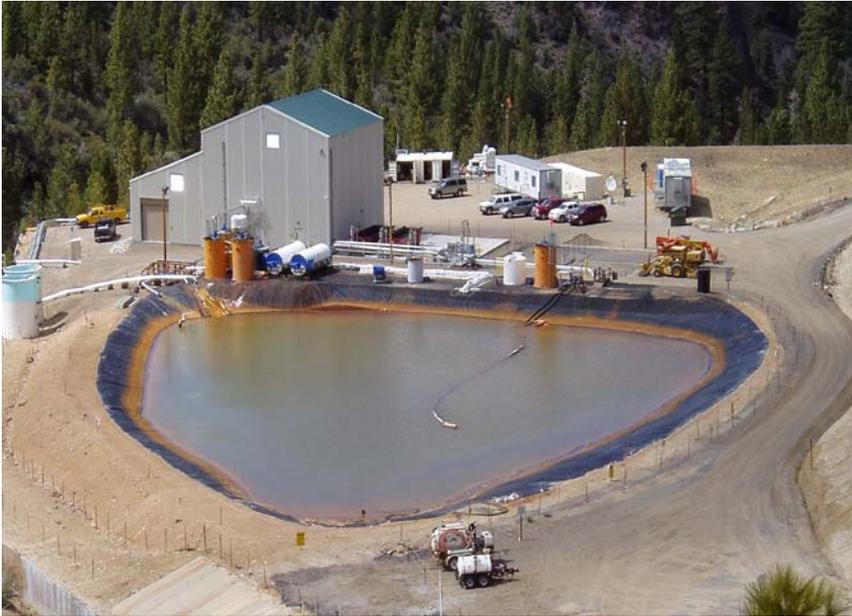
<p>B-2</p>	<p>Overview of Pond 4 at the beginning of the 2010 season. Note pale blue water color. View to northwest.</p> <p>May 27, 2010</p>

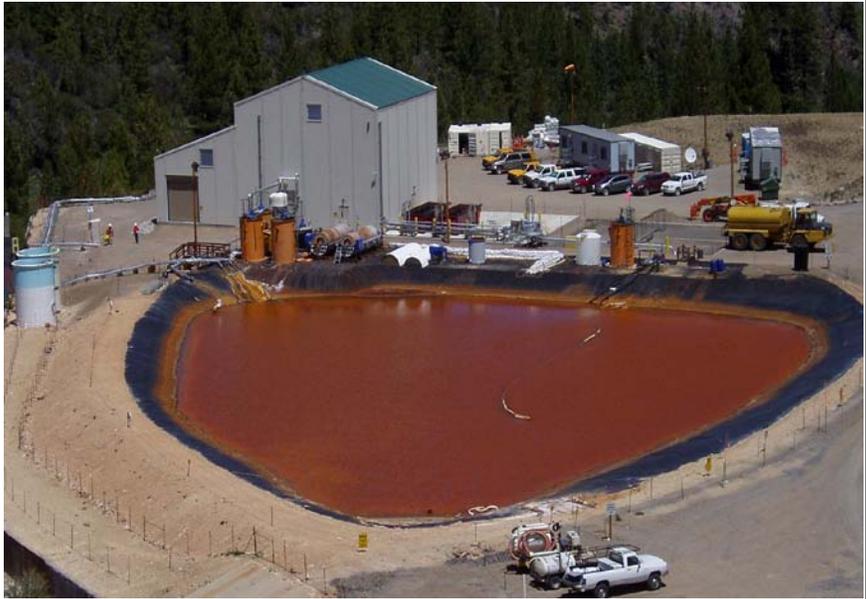
Photo Number	Photo Description	Photo
<p style="text-align: center;">B-3</p>	<p>View of HDS at Pond 4. Note the red color of pond. View to North.</p> <p>June 16, 2010</p>

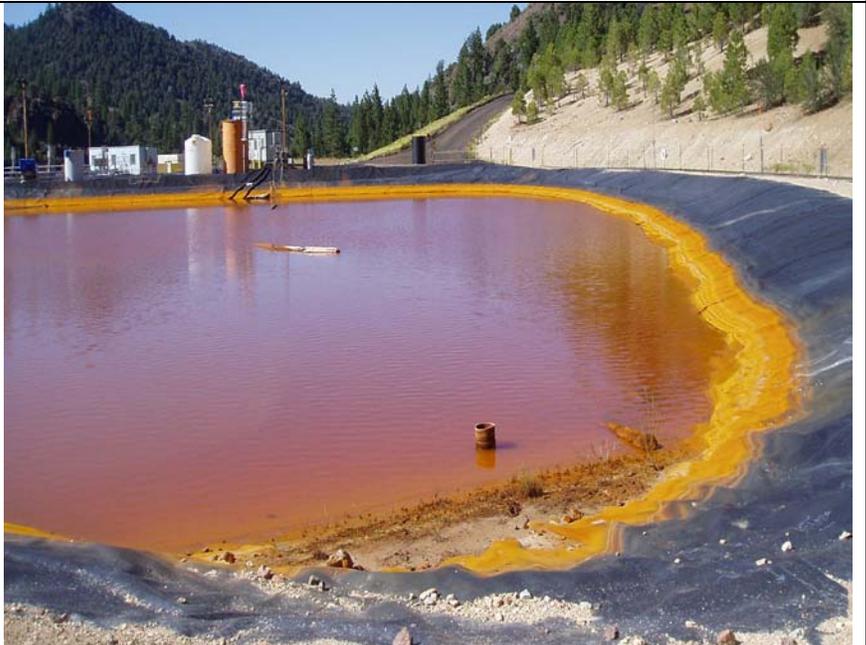
Photo Number	Photo Description	Photo
<p style="text-align: center;">B-5</p>	<p>Sludge bins used for the HDS at Pond 4. View to North.</p> <p>July 28, 2010</p>

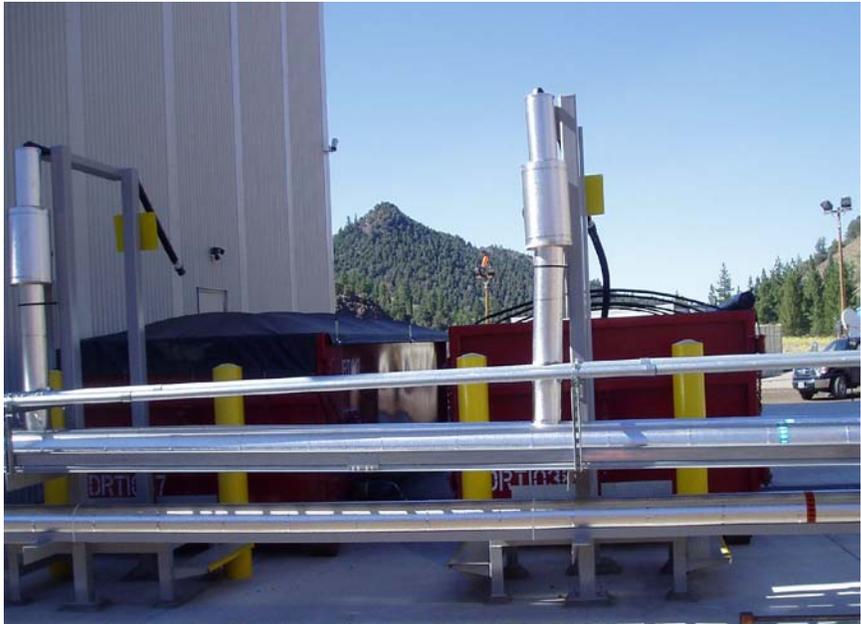
<p style="text-align: center;">B-6</p>	<p>Sludge bins used for the HDS at Pond 4. View to South.</p> <p>September 15, 2010</p>

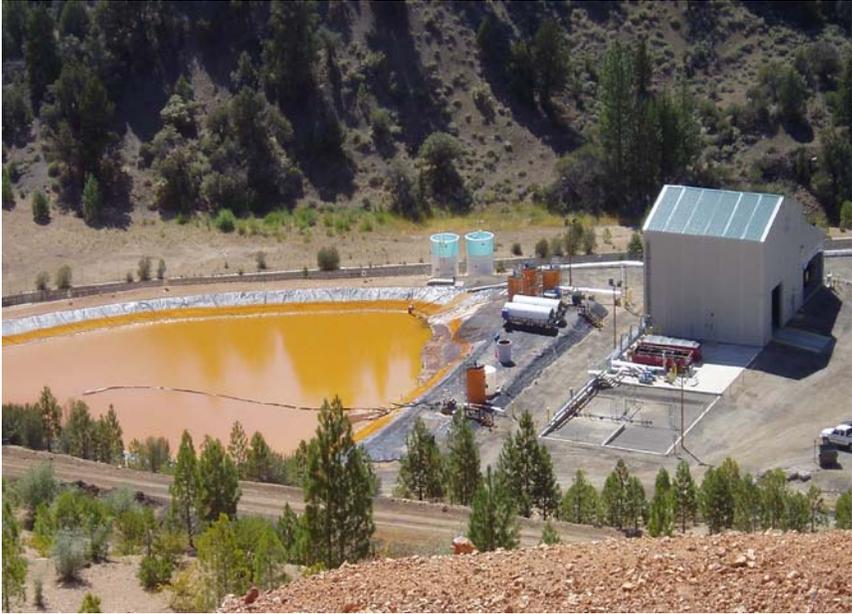
Photo Number	Photo Description	Photo
<p style="text-align: center;">B-7</p>	<p>Overview of HDS treatment plant operations. View to West.</p> <p>September 2, 2010</p>

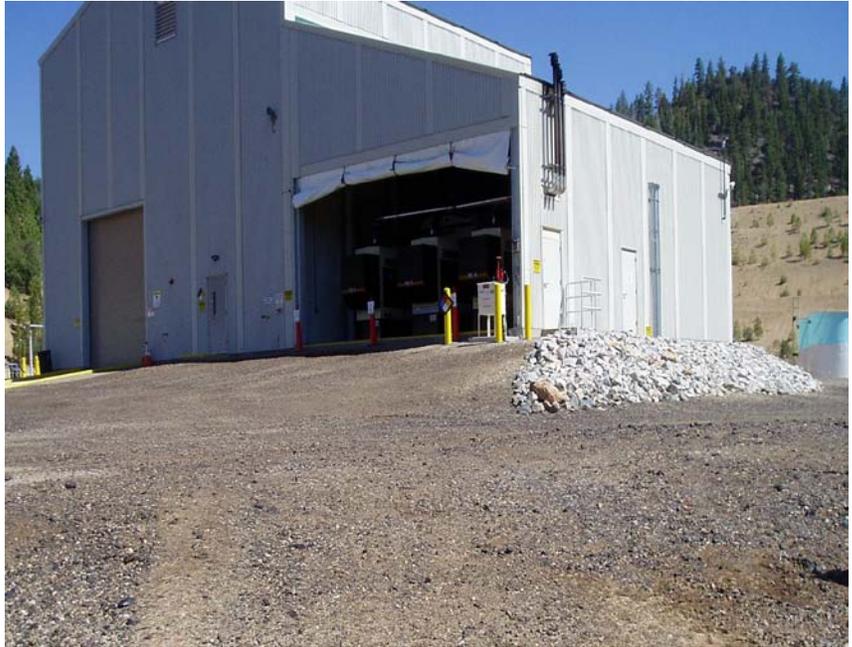
Photo Number	Photo Description	Photo
<p style="text-align: center;">B-9</p>	<p>View of lime treatment system components at Pond 4. Lime slurry tanks, lime dilution tanks, emergency shower. View to East.</p> <p>July 28, 2010</p>

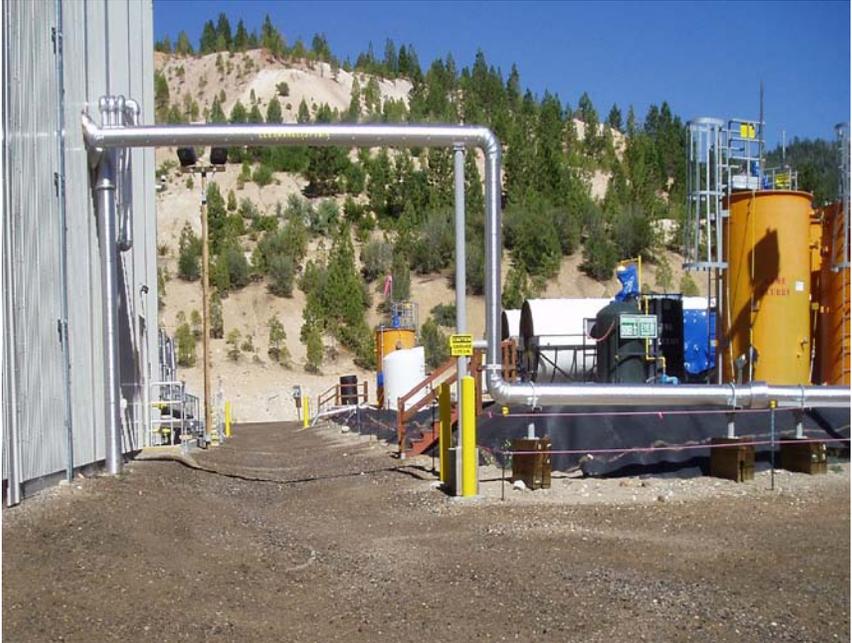
<p style="text-align: center;">B-10</p>	<p>Fresh water tanks and sludge drying beds outside of HDS building. View to South.</p> <p>July 28, 2010</p>

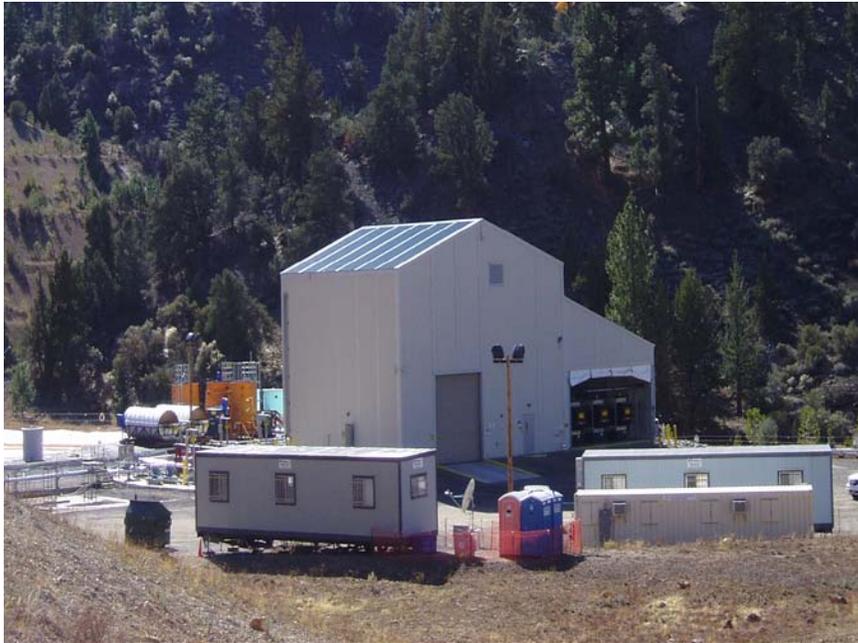
Photo Number	Photo Description	Photo
<p style="text-align: center;">B-11</p>	<p>Overview of HDS building and operations area. View to Southwest.</p> <p>October 27, 2010</p>

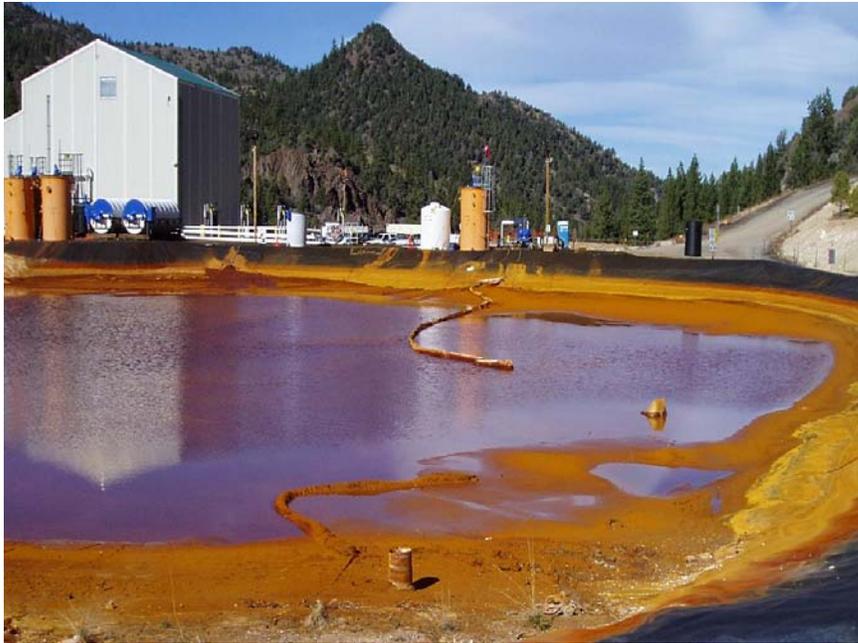
Photo Number	Photo Description	Photo
<p style="text-align: center;">B-13</p>	<p>Pond 4 at the end of 2010 treatment season. Note bright orange sludge. View to West.</p> <p>November 18, 2010</p>

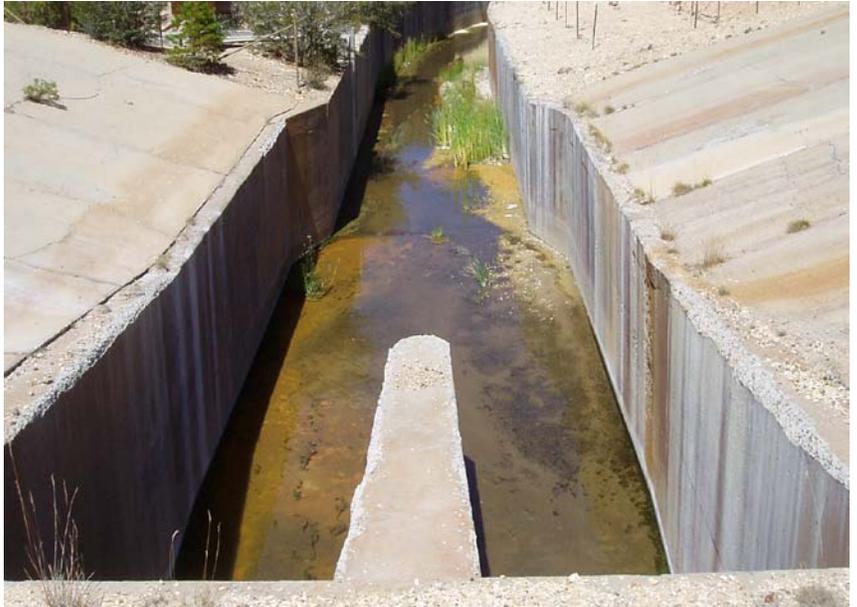
<p style="text-align: center;">B-14</p>	<p>Leviathan Creek at Pond 4, note vegetation growing in sediment. View to northwest.</p> <p>August 19, 2010</p>

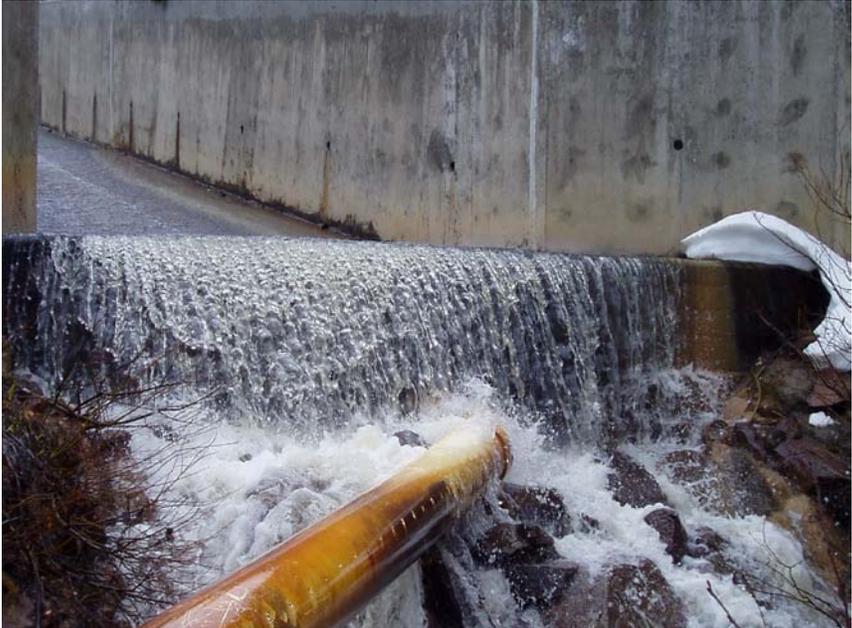
Photo Number	Photo Description	Photo
<p>B-15</p>	<p>View of Leviathan Creek concrete channel at CUD before treatment season. View to Southwest.</p> <p>April 27, 2010</p>

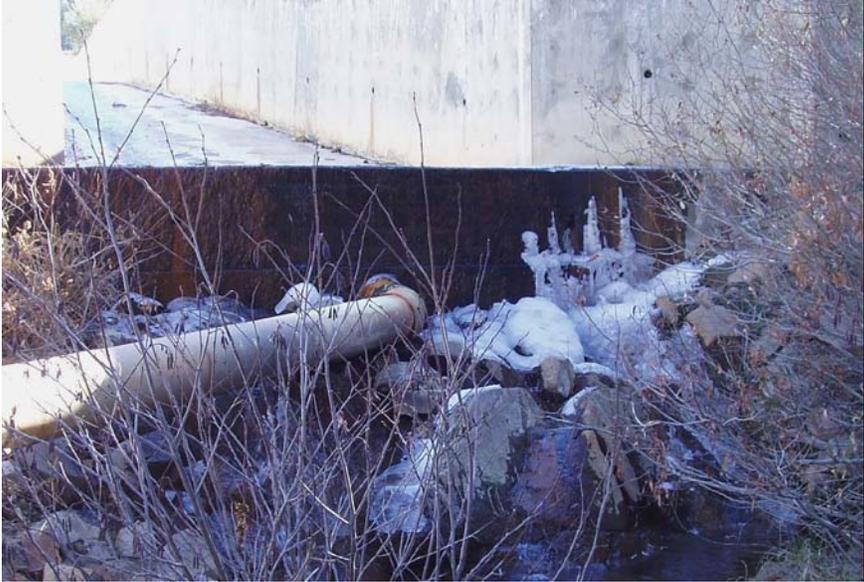
<p>This photograph shows a concrete channel with a spillway. Water is cascading over the spillway and flowing into a large, yellowish-brown pipe. The background is a concrete wall.</p>
<p>B-16</p>	<p>View of Leviathan Creek concrete channel at CUD after treatment season. View to Southwest.</p> <p>November 18, 2010</p>

<p>This photograph shows the same concrete channel and pipe as in B-15, but after the treatment season. The pipe is now white and surrounded by dry, brown brush and debris. The water flow is no longer visible.</p>

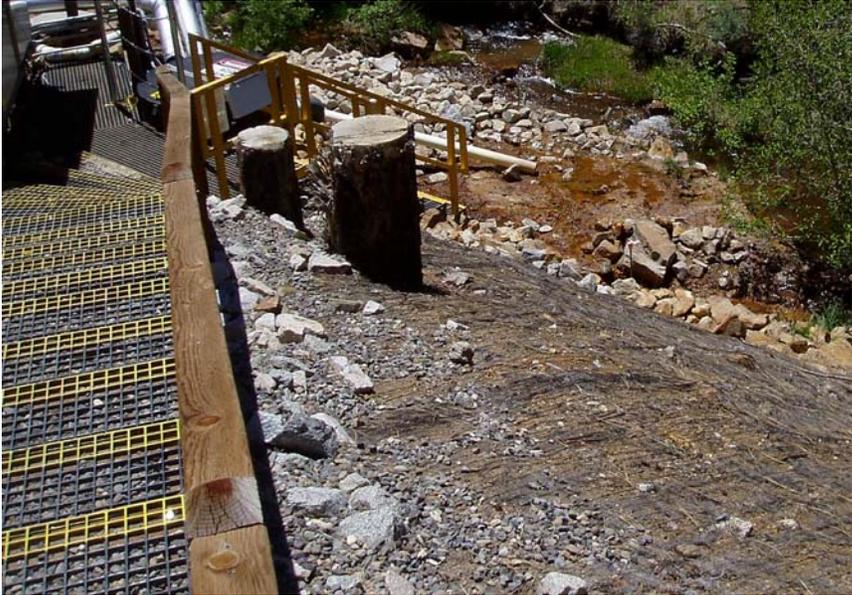
Photo Number	Photo Description	Photo
<p style="text-align: center;">B-17</p>	<p>Embankment at CUD with deteriorating erosion control matting. View to Southwest</p> <p>June 16, 2010</p>

<p style="text-align: center;">B-18</p>	<p>CUD embankments with new erosion control matting. View to Northeast.</p> <p>July 28, 2010</p>

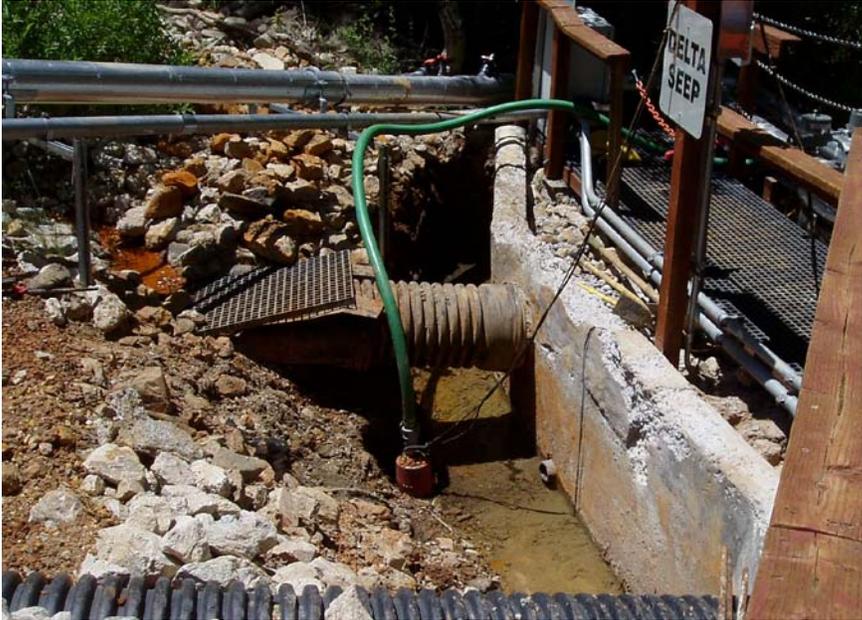
Photo Number	Photo Description	Photo
<p style="text-align: center;">B-19</p>	<p>View of repairs to Delta Seep capture system in progress. Rip rap and gravel are removed along with the sump. View to West.</p> <p>July 8, 2010</p>

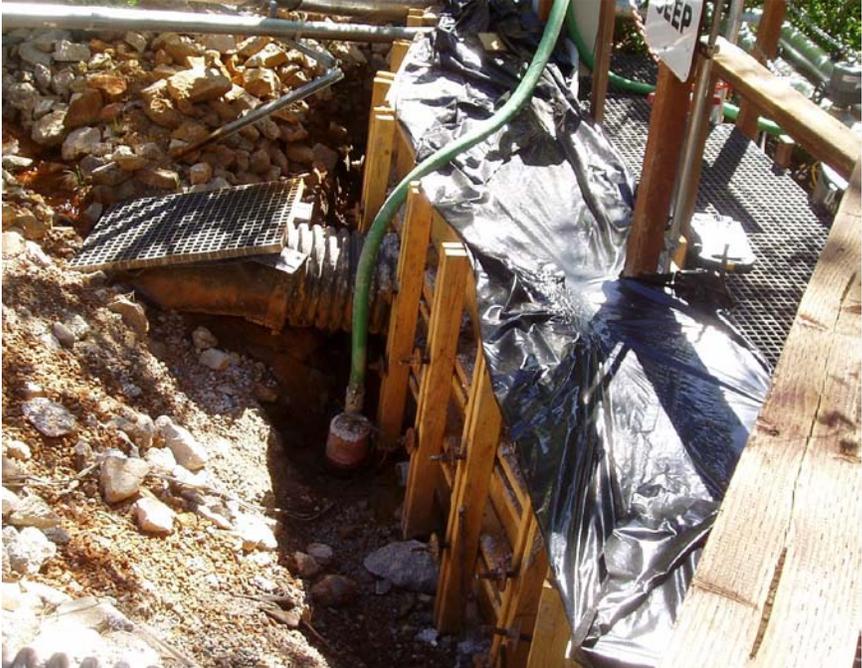
<p style="text-align: center;">B-20</p>	<p>View of repairs to Delta Seep capture system in progress. Concrete forms in place while the concrete cures. View to West.</p> <p>July 28, 2010</p>

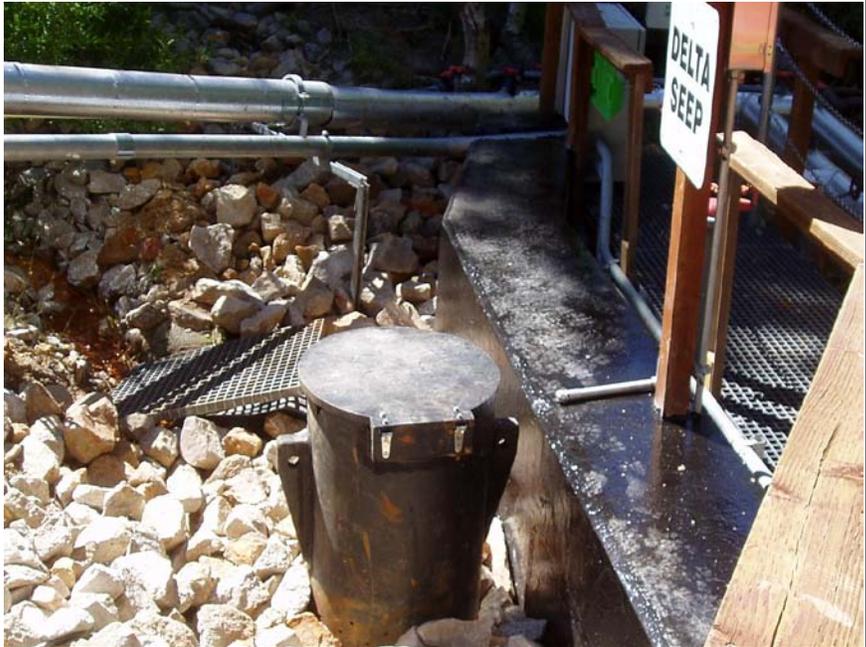
Photo Number	Photo Description	Photo
<p style="text-align: center;">B-21</p>	<p>Delta Seep capture system repair complete. Concrete wall coated with sealant. Sump, rip rap, and gravel replaced. View to West.</p> <p>September 15, 2010</p>

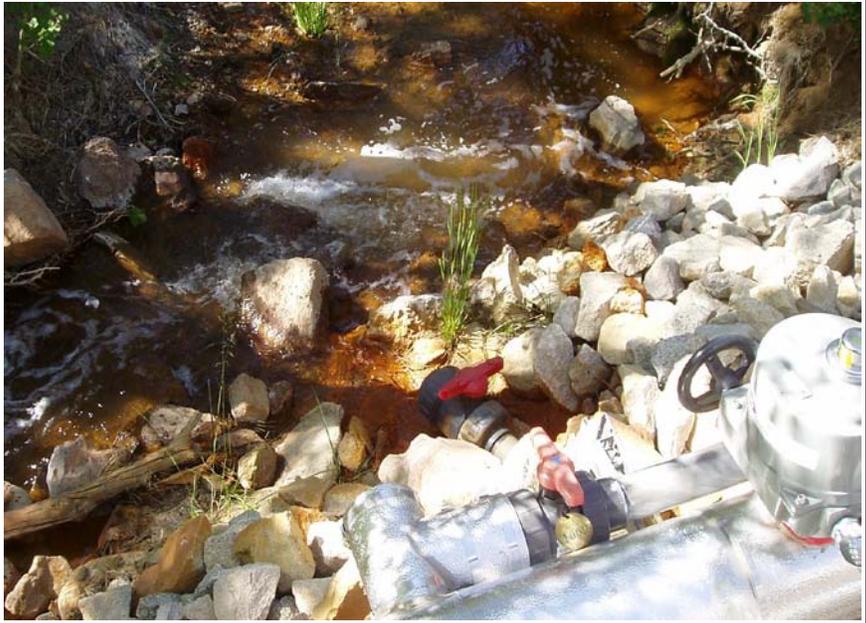
<p style="text-align: center;">B-22</p>	<p>Leviathan Creek at Delta Seep, creek flows from left to right. Facing Northwest.</p> <p>July 28, 2010</p>

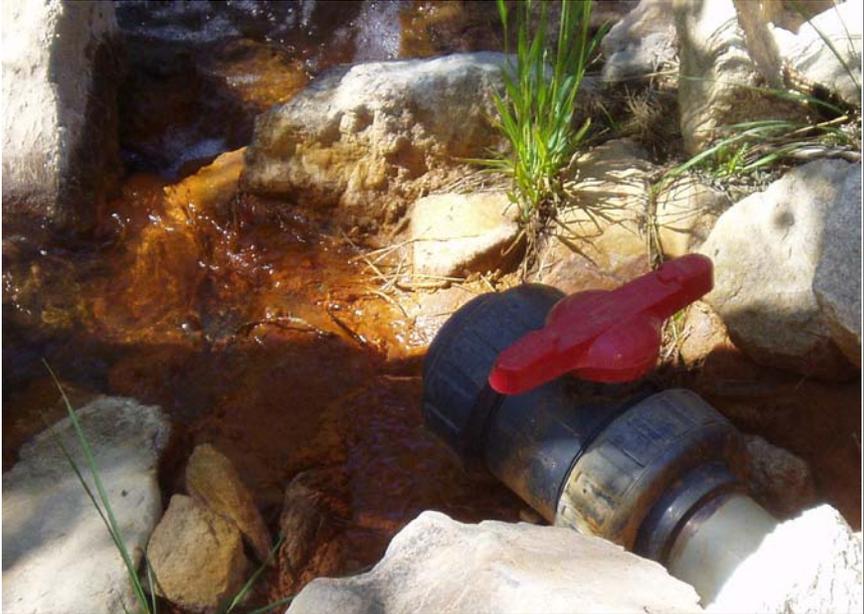
Burlison noted that seepage from the east bank of Leviathan Creek beneath and immediately up and downstream from the DS collection tank observed during 2008 continued through the 2010 treatment season. Seepage flowed freely into Leviathan Creek for about 10 feet along the stream bank, and red staining was evident in the stream bank sediment (See Photograph B-22 and B-23 Appendix B). The presence of the seep suggests that shallow, acidic groundwater is present that is not intercepted by the DS collection system.

Photo Number	Photo Description	Photo
B-23	Close up of seepage below Delta Seep Capture system. View to North. July 28, 2010

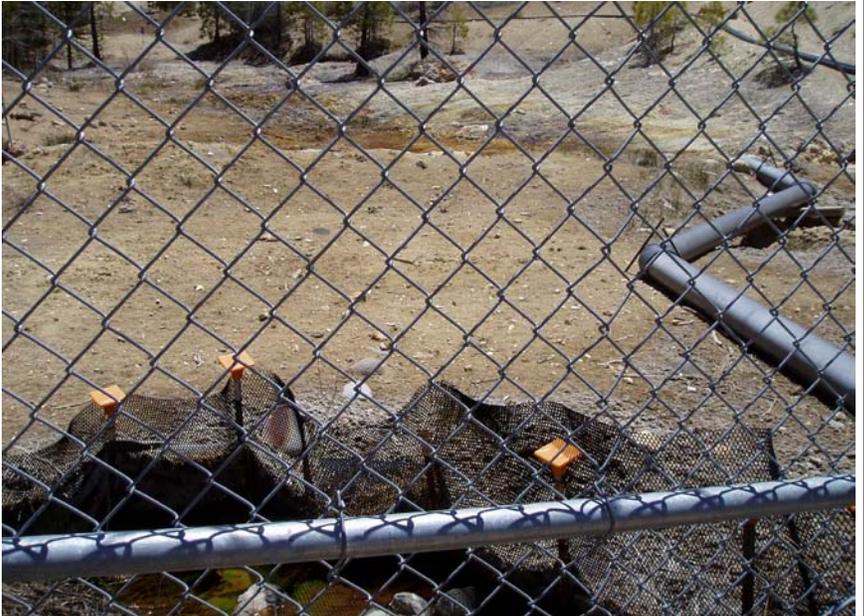
B-24	Aspen Seep with gray overflow pipe in foreground. View to Southeast. May 27, 2010

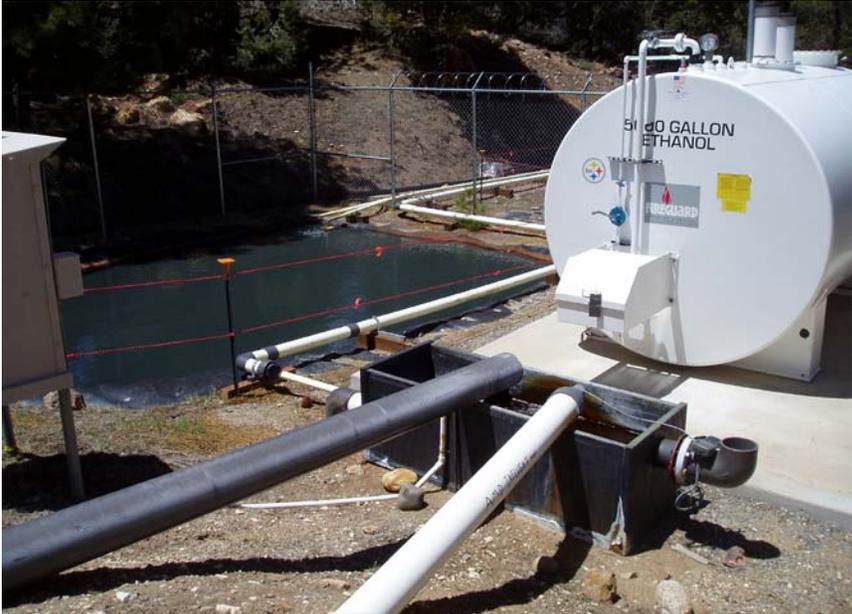
Photo Number	Photo Description	Photo
<p style="text-align: center;">B-25</p>	<p>View of Ethanol feed tank, sodium hydroxide basin, and Aspen Seep influent pipe. View to West.</p> <p>May 27, 2010</p>

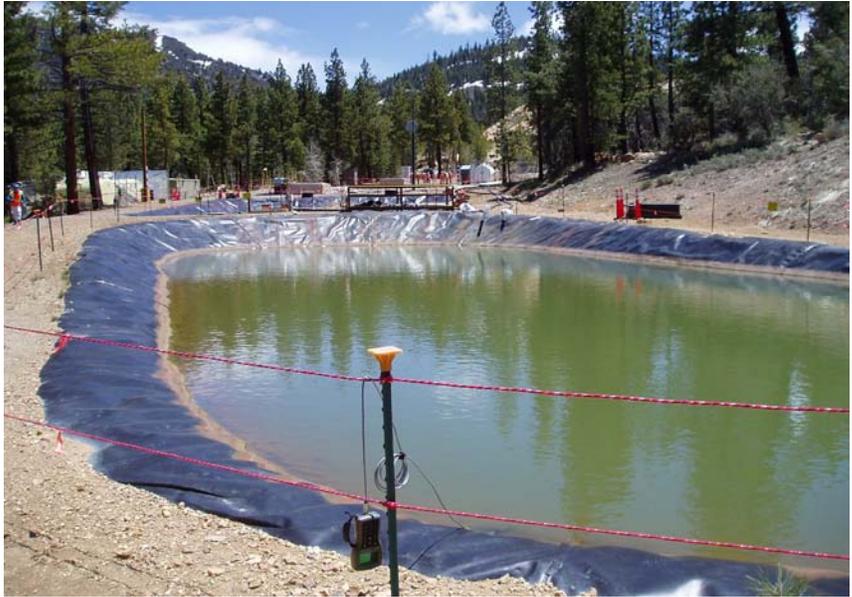
<p style="text-align: center;">B-26</p>	<p>View of ASBR settling pond 2. View to southwest.</p> <p>June 16, 2010</p>

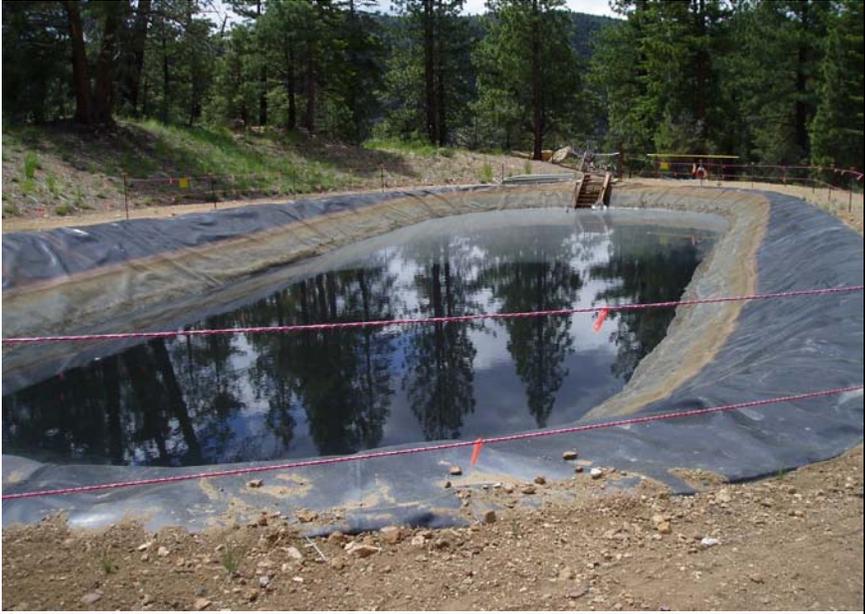
Photo Number	Photo Description	Photo
<p>B-27</p>	<p>ASBR settling pond 2 during flushing. View to North.</p> <p>July 8, 2010</p>

<p>A photograph of a large, irregularly shaped settling pond lined with black plastic. The pond is filled with water, and the surrounding area is a mix of dirt and gravel. A red safety line is stretched across the foreground. The background shows a dense forest of tall evergreen trees under a clear sky.</p>
<p>B-28</p>	<p>Discharge of bioreactor effluent into settling pond 1. View to West.</p> <p>August 19, 2010</p>

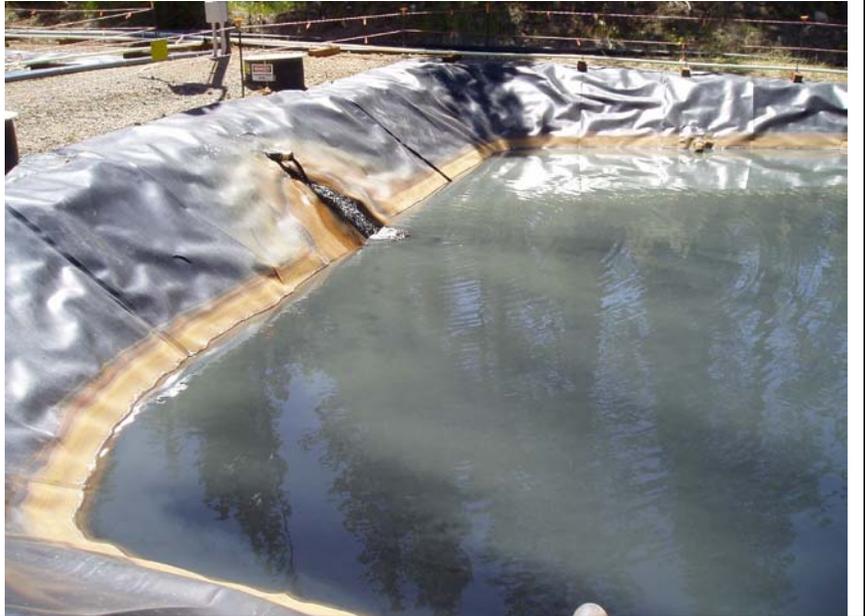
<p>A photograph showing a discharge pipe or channel leading into a settling pond. The pond is lined with black plastic and contains water. The surrounding area is a mix of dirt and gravel. The background shows a dense forest of tall evergreen trees under a clear sky.</p>

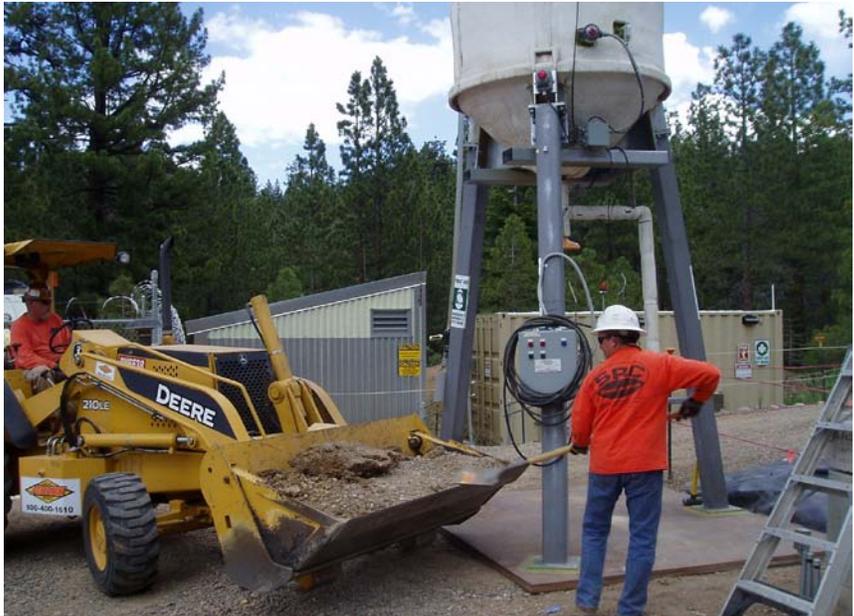
Photo Number	Photo Description	Photo
B-31	Close-up view of emergency shower. View to east. July 8, 2010

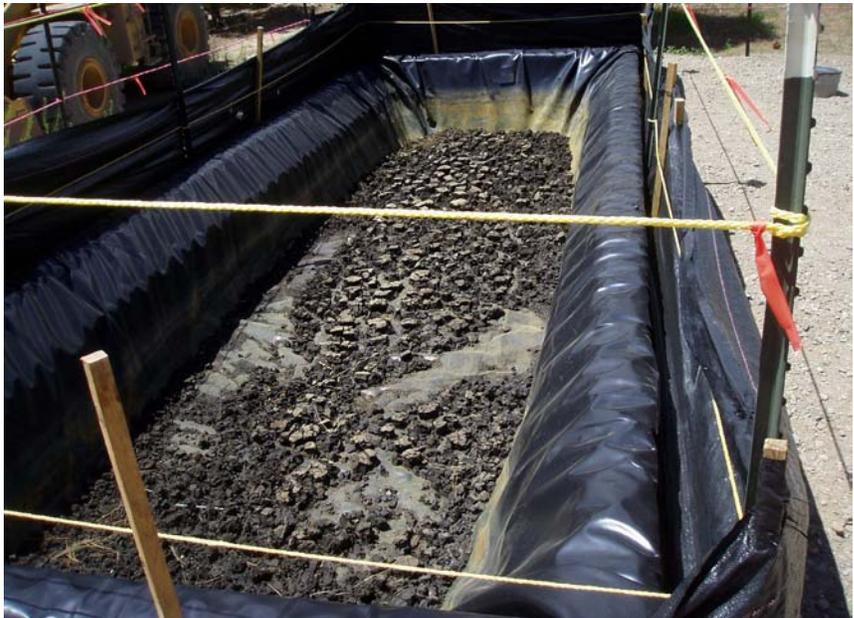
B-32	Close-up view of sludge bin for Phase 1 sludge drying bed pilot test. View to North. July 8, 2010

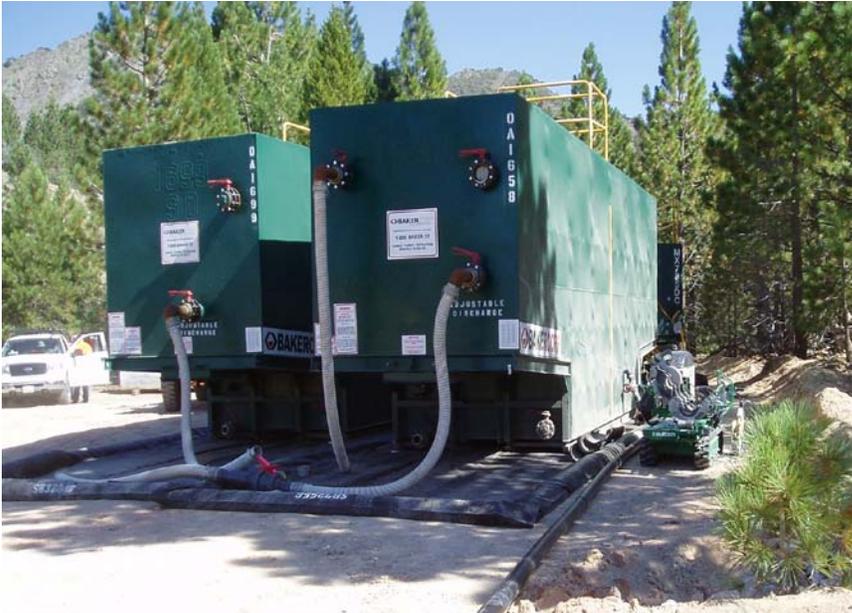
<p>B-34</p>	<p>View of sludge dewatering components in preparation for new sludge dewatering system and centrifuge. View to Southeast.</p> <p>September 2, 2010</p>

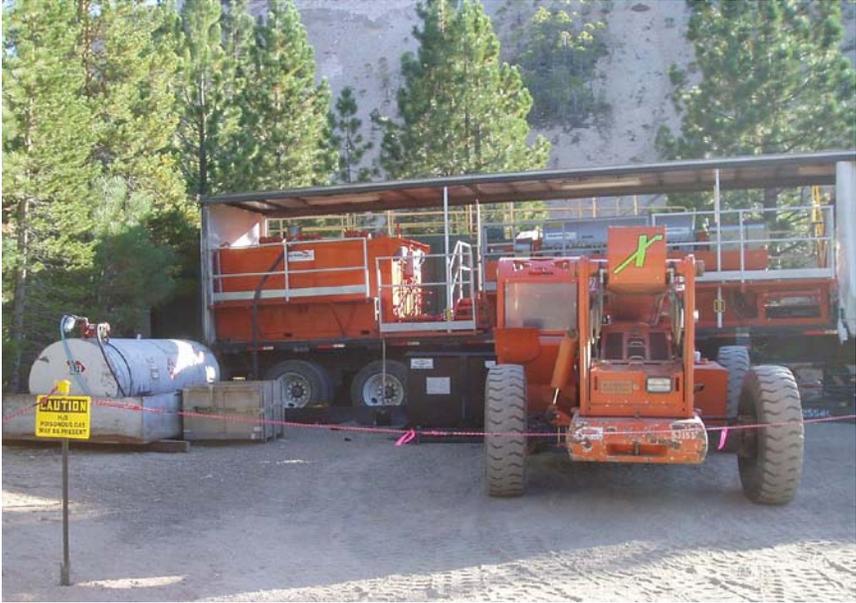
Photo Number	Photo Description	Photo
<p>B-35</p>	<p>View of ASBR sludge dewatering system and centrifuge. View to South.</p> <p>September 15, 2010</p>
