**2010 Oversight Summary Report
Leviathan Mine Superfund Site
Alpine County, California**

June 2011

**Burleson Consulting, Inc.
950 Glenn Drive, Suite 245
Folsom, California 95630**

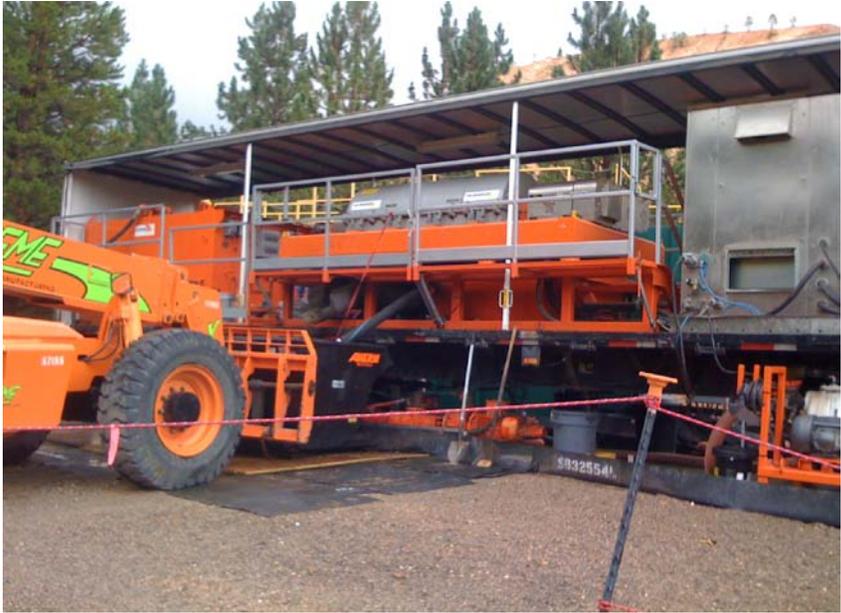
<p>B-36</p>	<p>View of ASBR sludge dewatering system and centrifuge. View to Southwest.</p> <p>October 5, 2010</p>

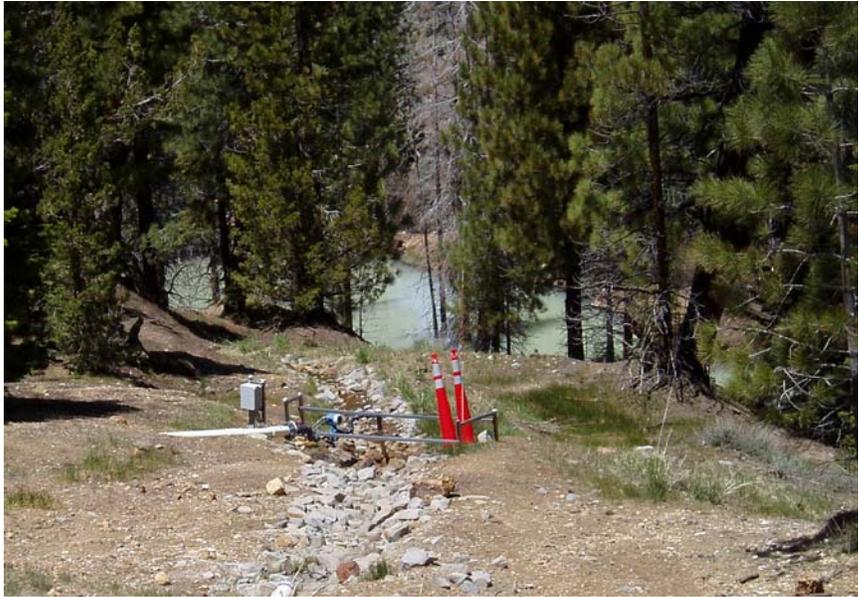
Aspen Creek. The infiltration pond is located on the margin of the Leviathan Canyon Landslide. Water in the infiltration pond is cloudy, and a chemical odor is present in area. Photograph B-38 in Appendix B shows a view of the infiltration pond.

<p>A photograph showing a small, shallow pond or infiltration area surrounded by dense evergreen trees. The water appears cloudy. In the foreground, there are rocks and some equipment, including two orange traffic cones.</p>

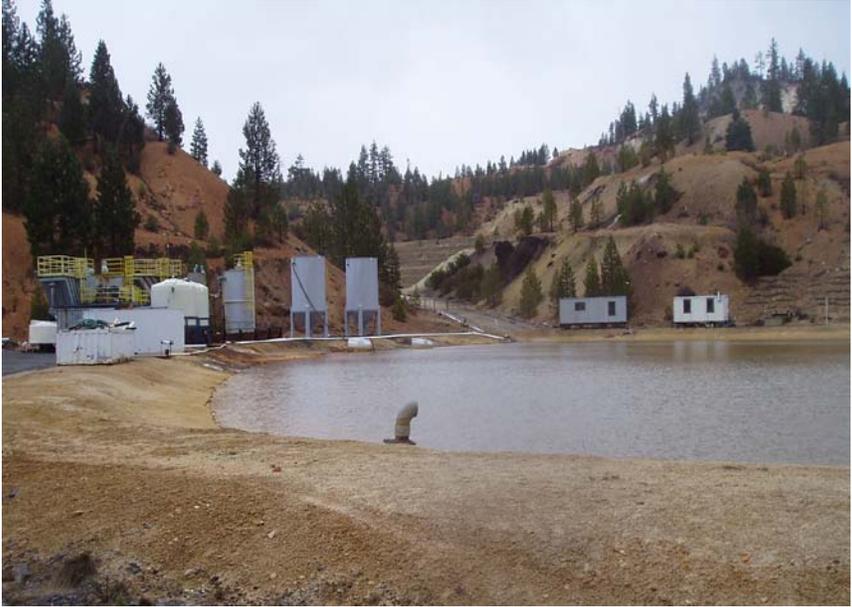
Photo Number	Photo Description	Photo
<p>B-39</p>	<p>Winterized pond water treatment system before treatment season with Pond 1 in foreground. View to northeast.</p> <p>April 27, 2010</p>

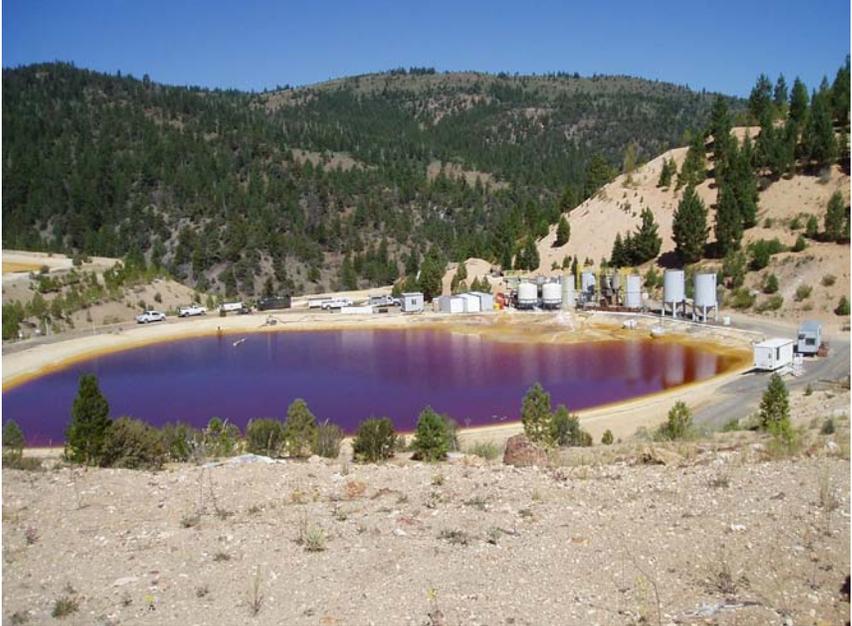
<p>B-40</p>	<p>Overview of PWTS and Pond 1 during treatment season. Note reddish hue of water in Pond 1. View to Northwest.</p> <p>August 19, 2010</p>

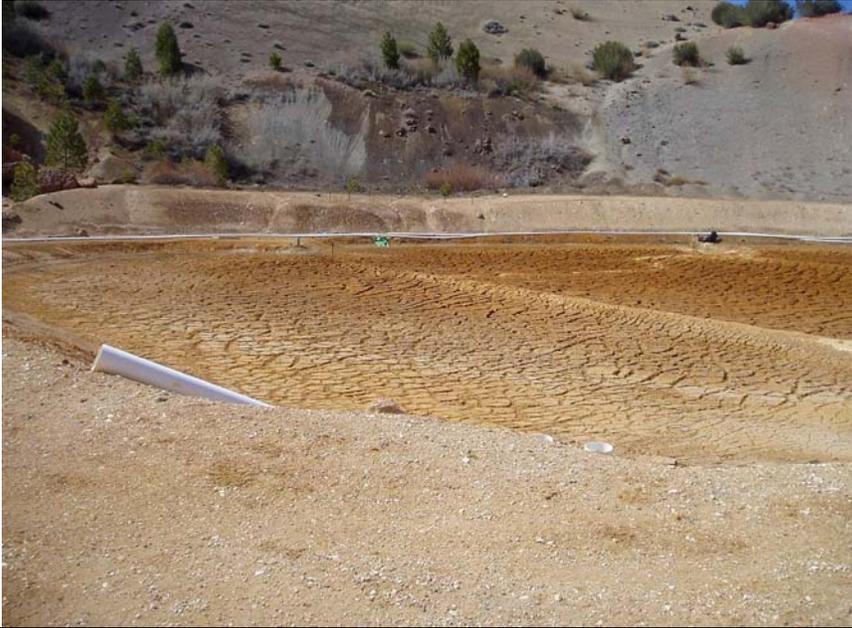
Photo Number	Photo Description	Photo
<p>B-41</p>	<p>View of pit clarifier before sludge removal from 2009 treatment season. View to Northwest.</p> <p>May 27, 2010</p>

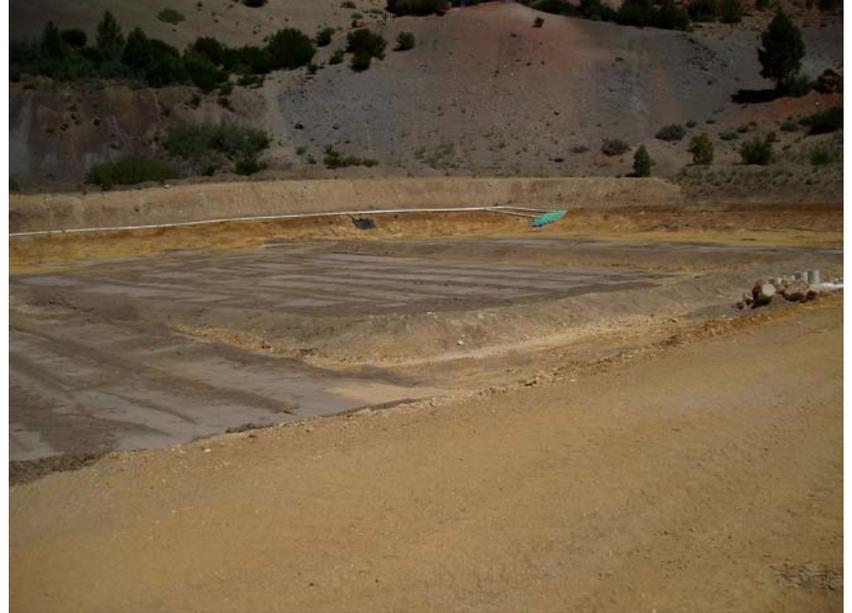
<p>B-42</p>	<p>View of pit clarifier after removal of sludge from 2009 treatment season. View to Northwest.</p> <p>July 8, 2010</p>

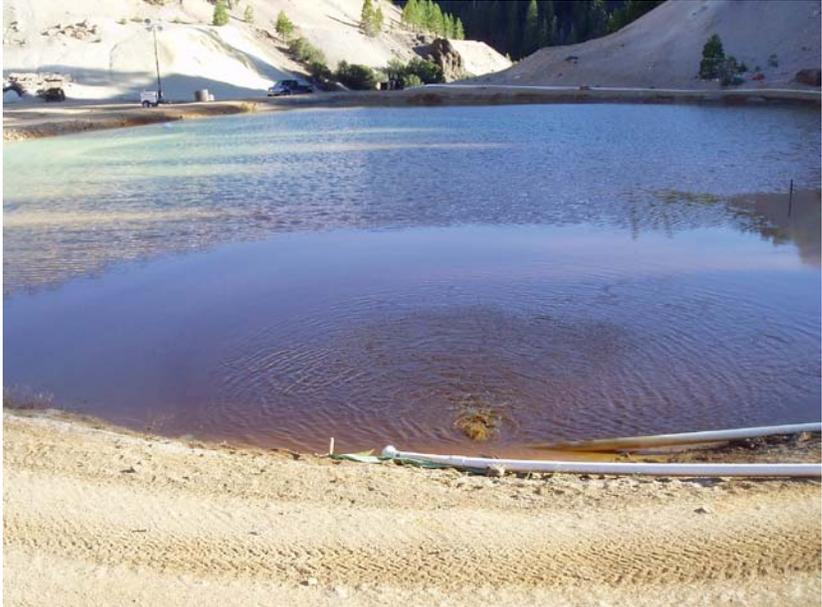
Photo Number	Photo Description	Photo
B-43	Discharge from PWTS to pit clarifier. View to west. July 28, 2010

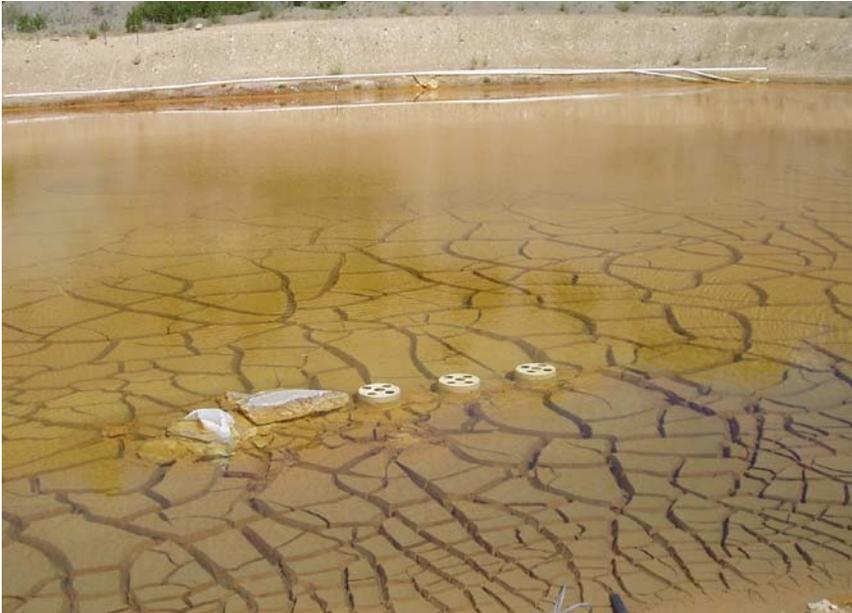
B-44	Decant structure in Pit Clarifier. View to Northwest. August 19, 2010

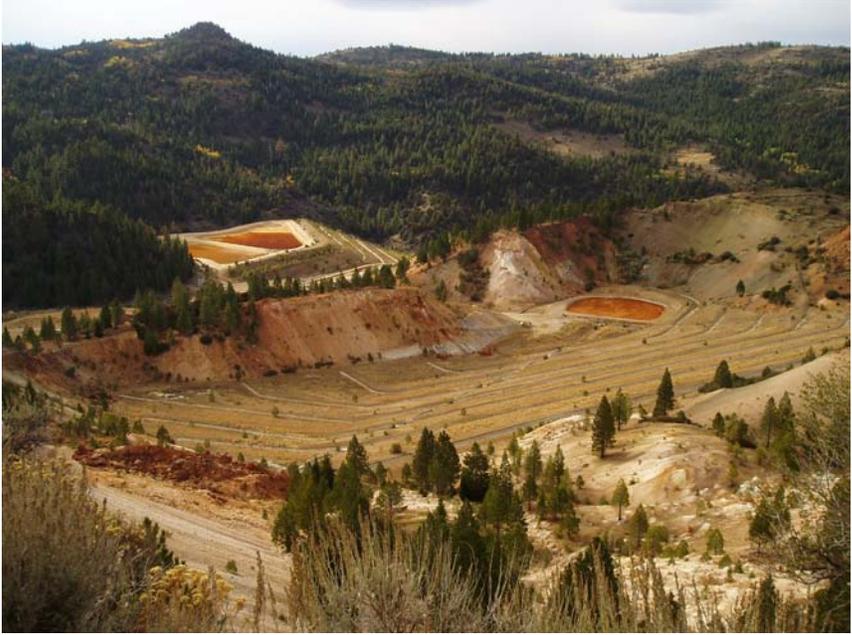
Photo Number	Photo Description	Photo
<p>B-45</p>	<p>Overview of open pit after 2010 treatment season. View to Northwest.</p> <p>October 27, 2010</p>

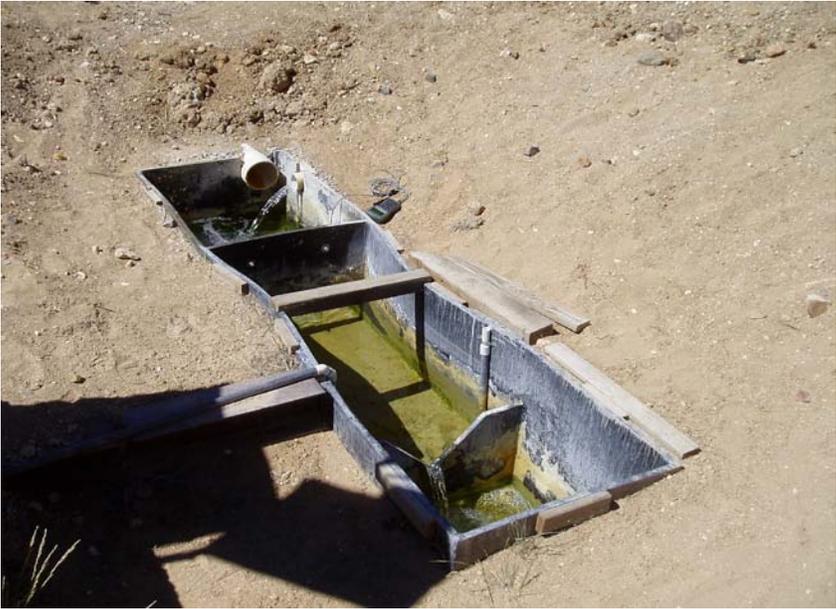
<p>B-46</p>	<p>Pit Clarifier weir box during discharge of treated water from the Pit Clarifier. View to West.</p> <p>August 19, 2010</p>

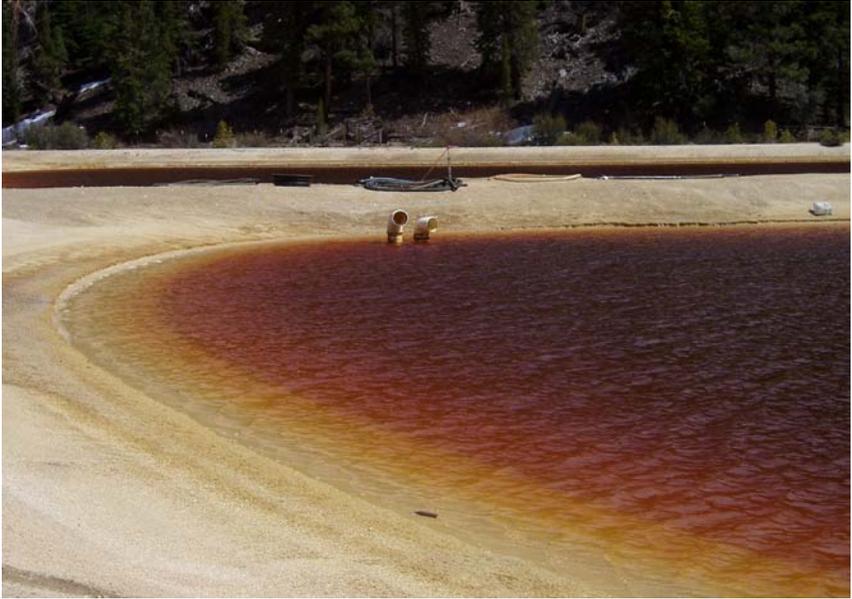
Photo Number	Photo Description	Photo
<p>B-47</p>	<p>View of Pond 2N in foreground before the treatment season. View to South.</p> <p>May 27, 2010</p>

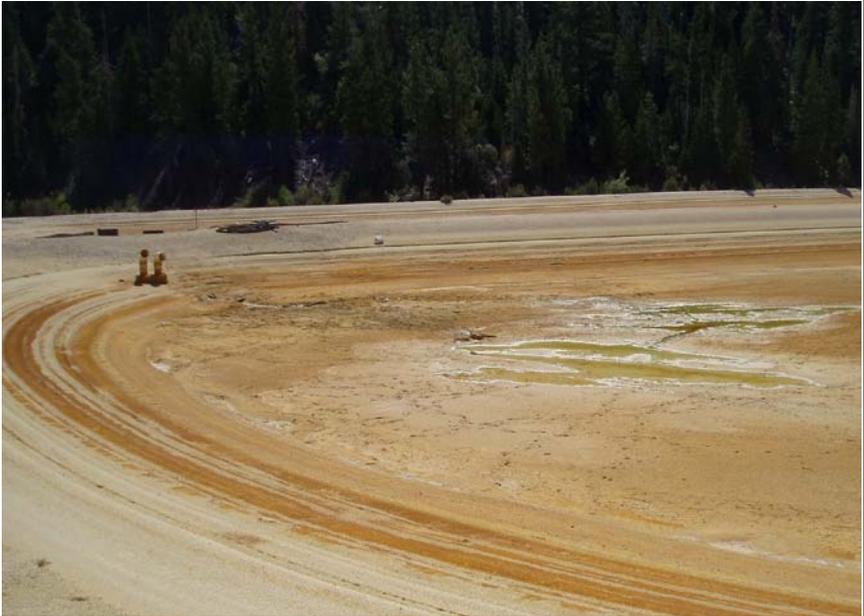
<p>B-48</p>	<p>View of Pond 2N after the treatment season. View to South.</p> <p>September 15, 2010</p>

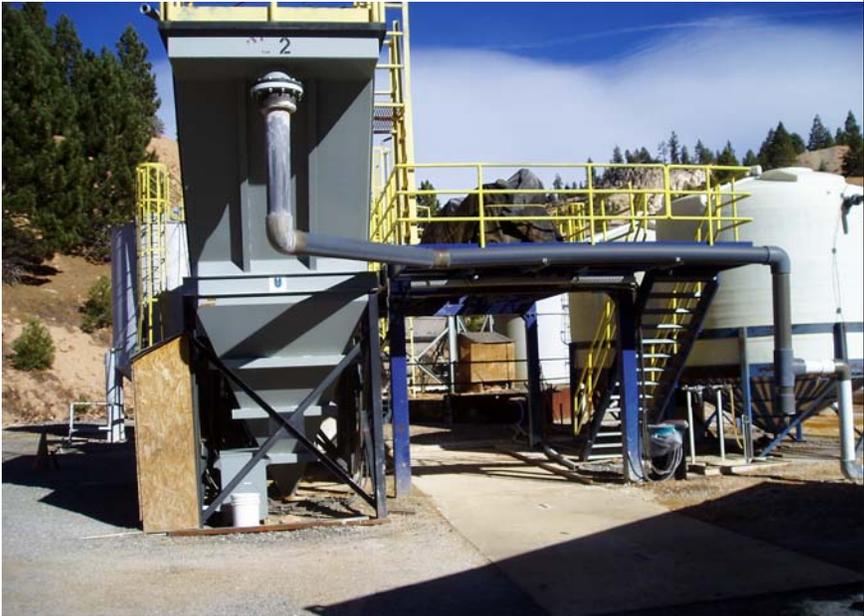
Photo Number	Photo Description	Photo
<p>B-49</p>	<p>Winterized PWTS following 2010 treatment season. View to East.</p> <p>November 18, 2010</p>

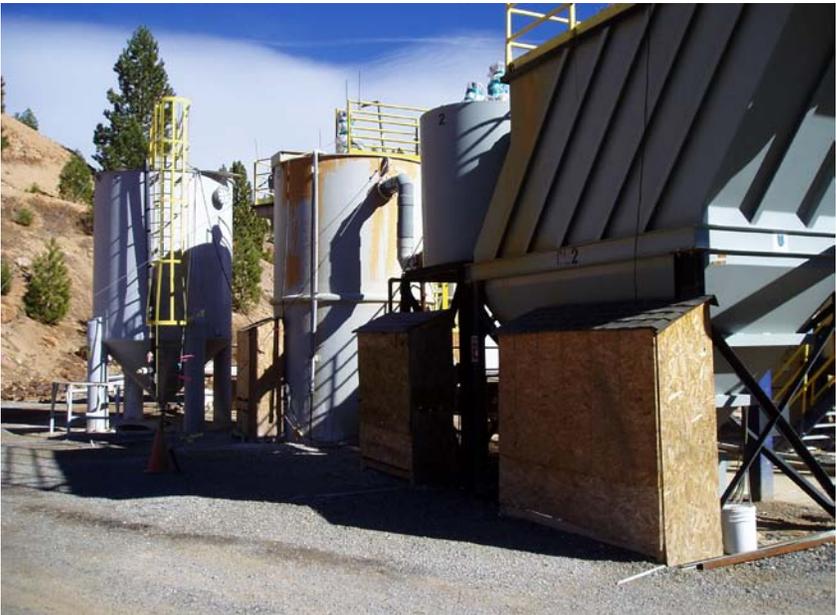
<p>B-50</p>	<p>Winterized PWTS components (note plywood electrical panel enclosures and plastic wrapped around motors at tops of tanks). View to Southeast.</p> <p>November 18, 2010</p>

The seasonal pond water treatment activities are complete. The PWTS appeared to be winterized with valves covered in plastic, and enclosures in place over control panels. Decon personnel were not observed on-site. Water was not visible in the Pit Clarifier and the surface of the solids is crossed by cracks. About four gallons per minute of water continues to drain through the pit clarifier weir box.

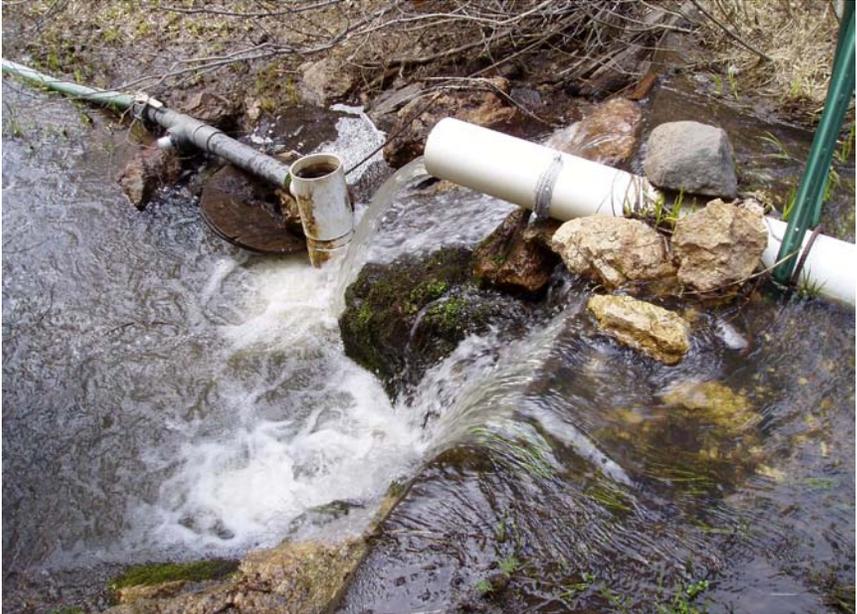
Photo Number	Photo Description	Photo
<p>B-51</p>	<p>Leviathan Creek at Station 1 before 2010 treatment season and without diversion to Pond Water Treatment System. View to East.</p> <p>May 27, 2010</p>

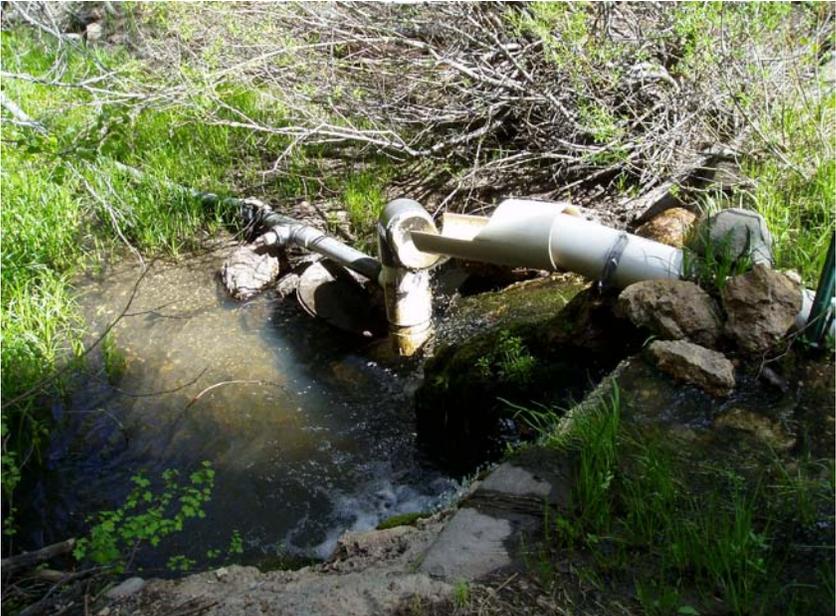
<p>B-52</p>	<p>Leviathan Creek at Station 1 with diversion to Pond Water Treatment System in place. View to East.</p> <p>June 16, 2010</p>

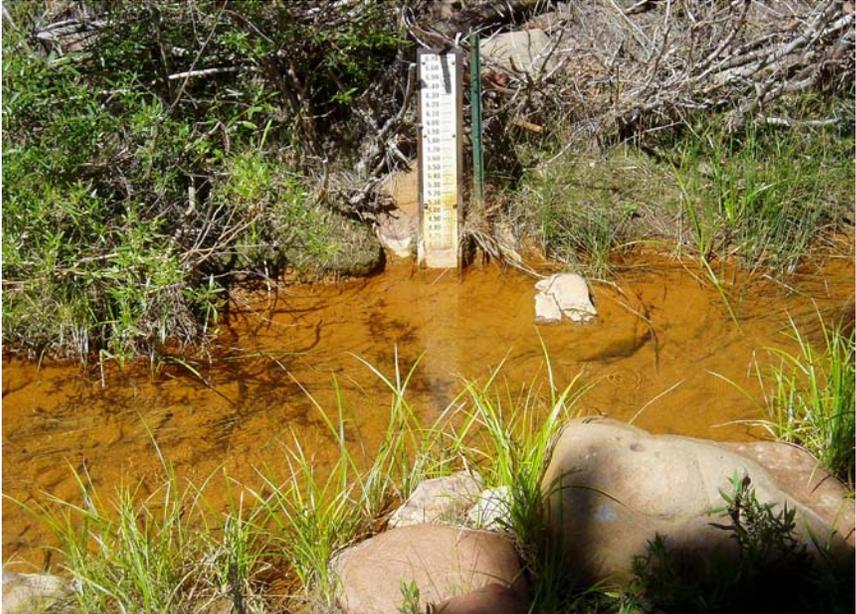
Photo Number	Photo Description	Photo
B-53	Leviathan Creek at Station 15. View to West. August 19, 2010

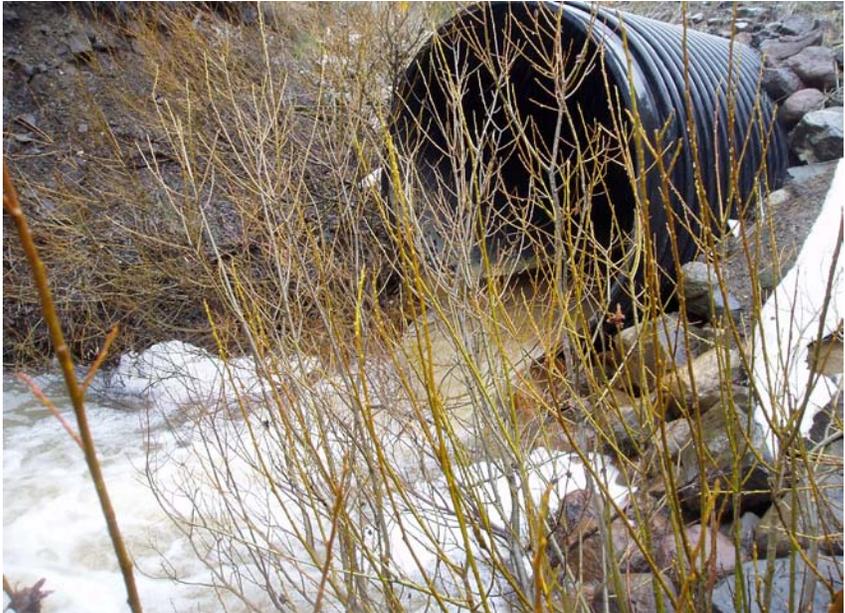
Photo Number	Photo Description	Photo
<p style="text-align: center;">B-55</p>	<p>Leviathan Creek-Mountaineer Creek confluence before treatment season looking upstream. View to South.</p> <p>April 27, 2010</p>

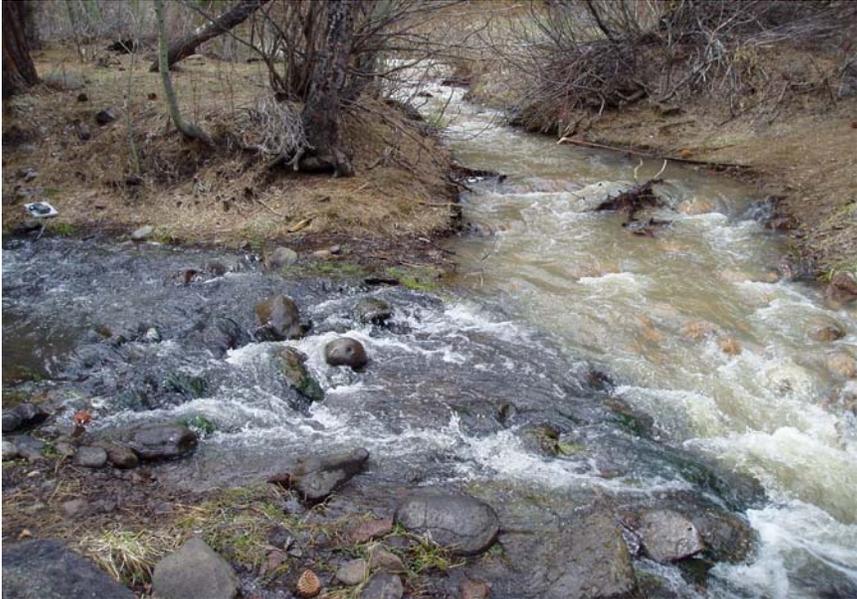
<p style="text-align: center;">B-56</p>	<p>Leviathan Creek-Mountaineer Creek confluence after treatment season looking upstream. View to South.</p> <p>November 18, 2010</p>

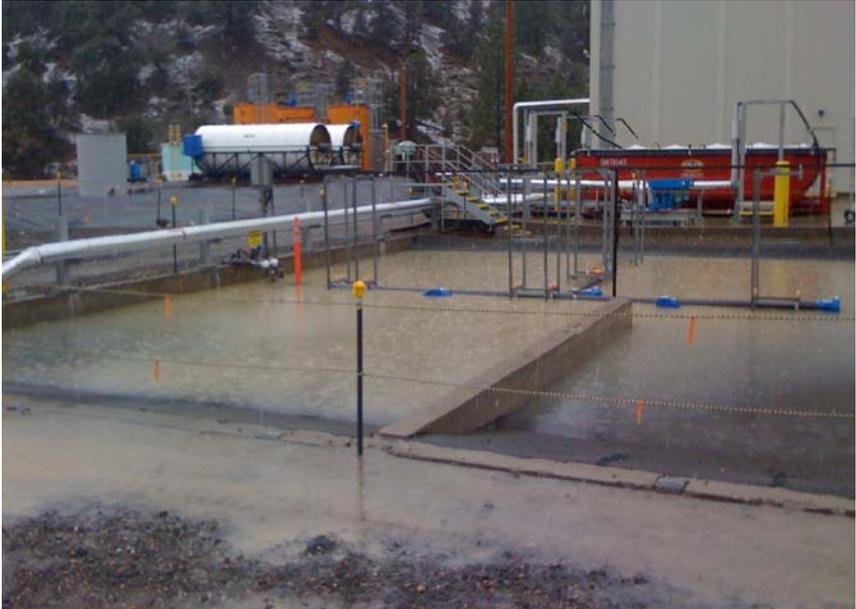
B-58	View of stormwater inlet/outlet pipe adjacent to HDS plant during rain event. View to South. October 5, 2010

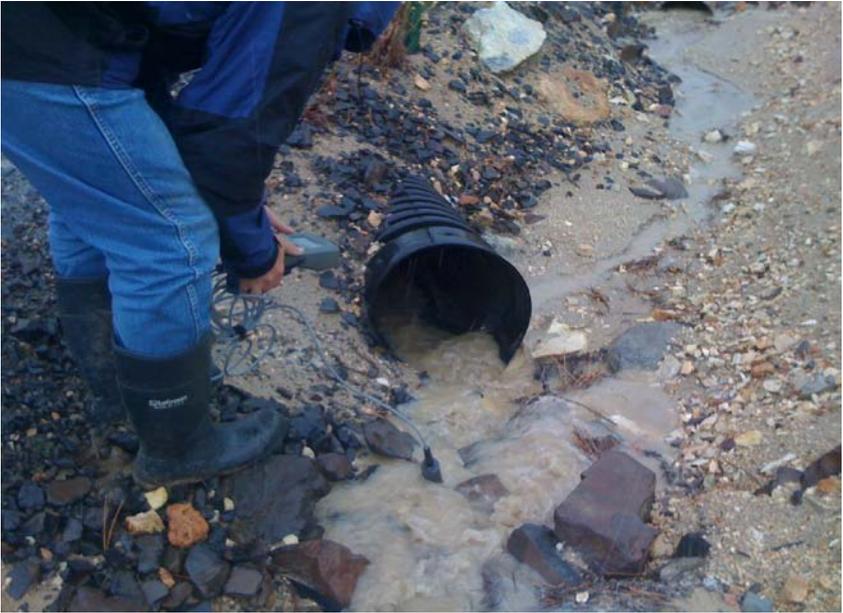
Photo Number	Photo Description	Photo
B-59	<p>View of sediment clogged stormwater inlet/outlet pipe adjacent to HDS plant during rain event. View to North.</p> <p>October 5, 2010</p>

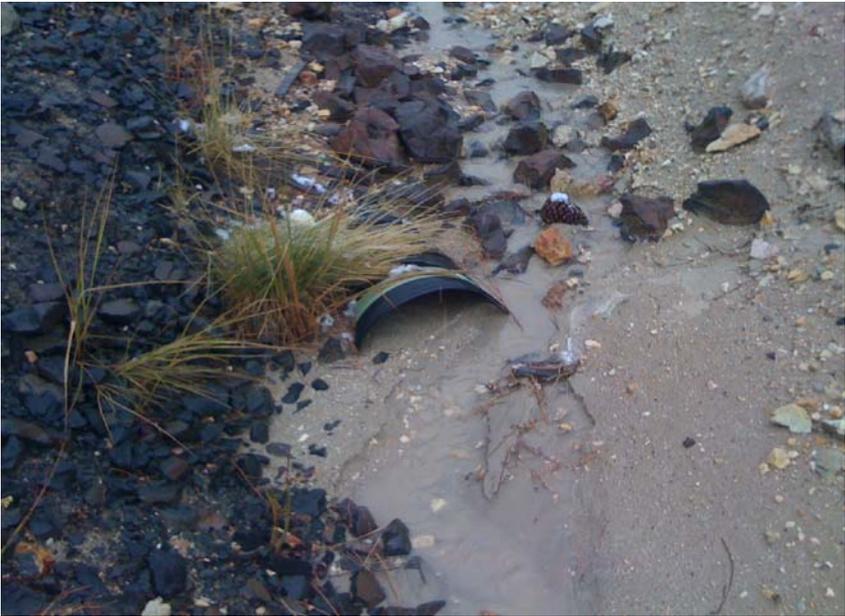
B-60	<p>View of stormwater run-off and rills at HDS trailers during rain event. View to East.</p> <p>October 5, 2010</p>

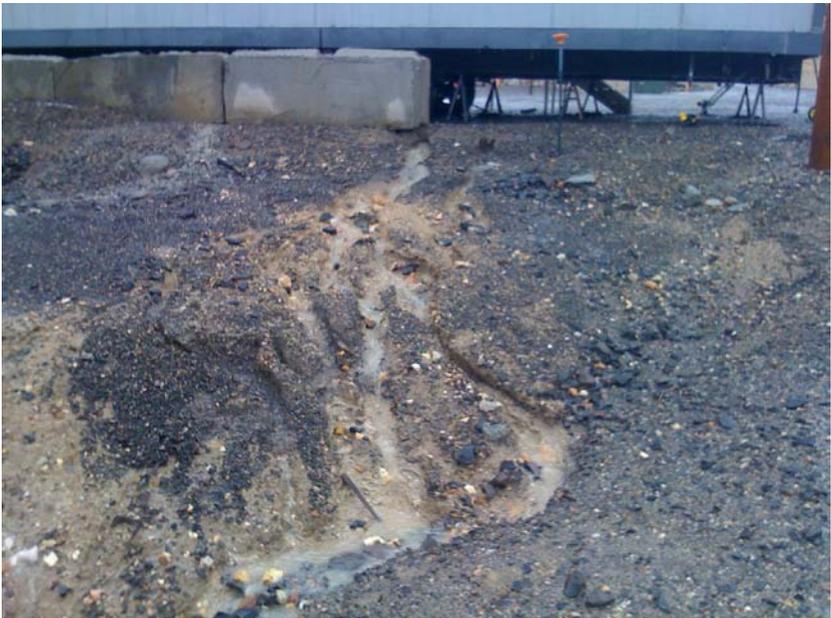
Photo Number	Photo Description	Photo
B-61	View of stormwater run-off and rills on pathway between CUD and Delta Seep during rain event. View to North. October 5, 2010

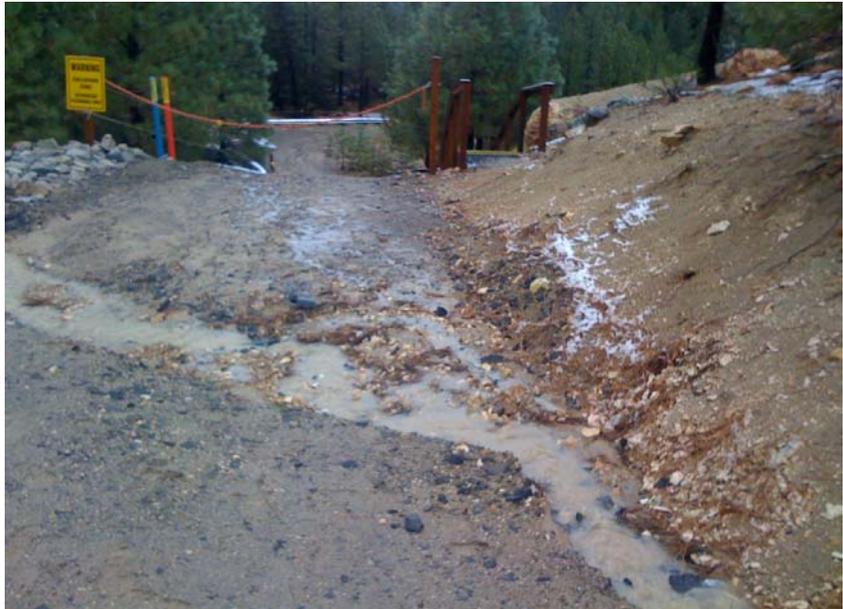
B-62	View of stormwater inlet/outlet pipe adjacent to Delta Seep during rain event. View to Southeast. October 5, 2010

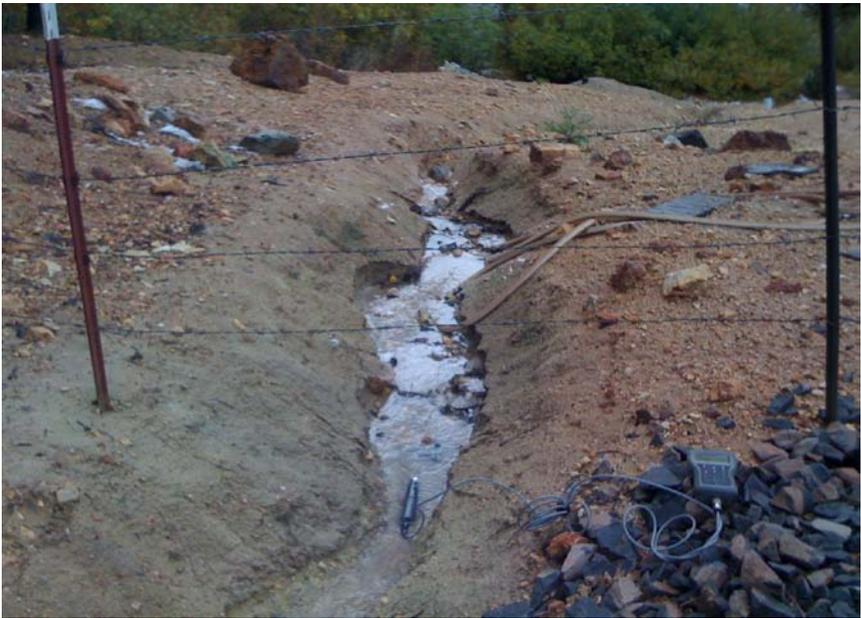
<p>B-64</p>	<p>View of stormwater runoff in rills adjacent to MW-1 during rain event. View to West.</p> <p>October 5, 2010</p>

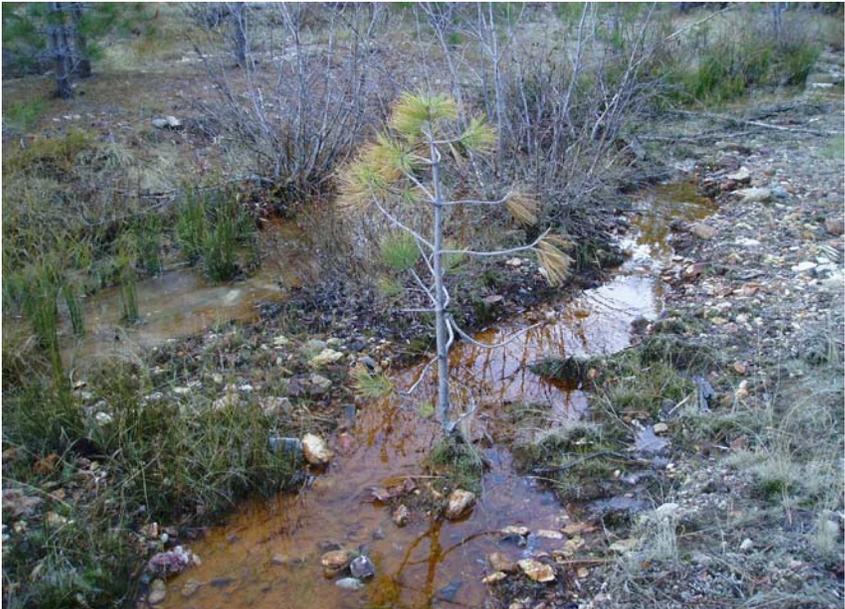
B-70	View of orange precipitate in outfall adjacent to main beaver pond. View to East. November 18, 2010

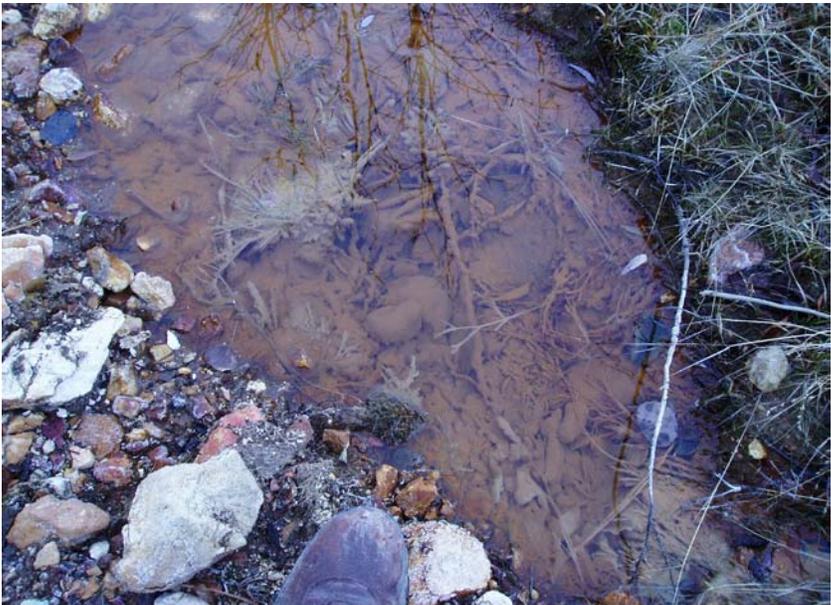
Photo Number	Photo Description	Photo
<p style="text-align: center;">B-71</p>	<p>View of the erosion gully in overburden pile below former pond. View to South.</p> <p>September 2, 2010</p>

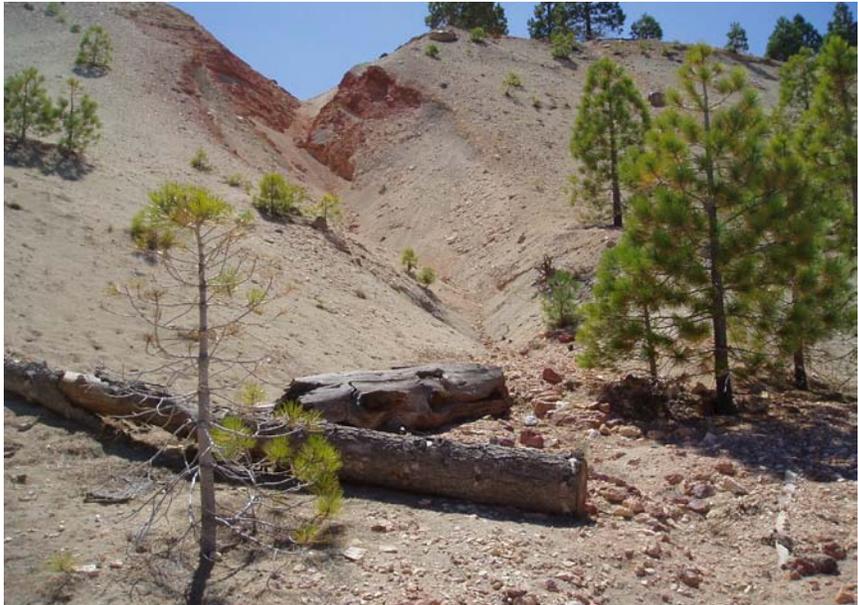
<p style="text-align: center;">B-72</p>	<p>View of drainage pattern of stormwater runoff in former pond area at upper end of erosion gully. View to North.</p> <p>September 2, 2010</p>

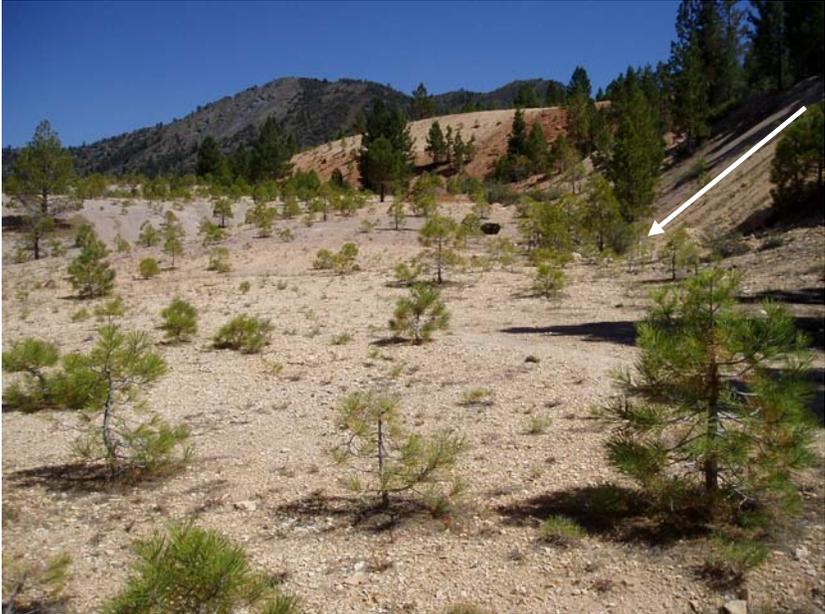
<p>B-74</p>	<p>View of the erosion gully in the overburden pile. View to Northwest.</p> <p>September 2, 2010</p>

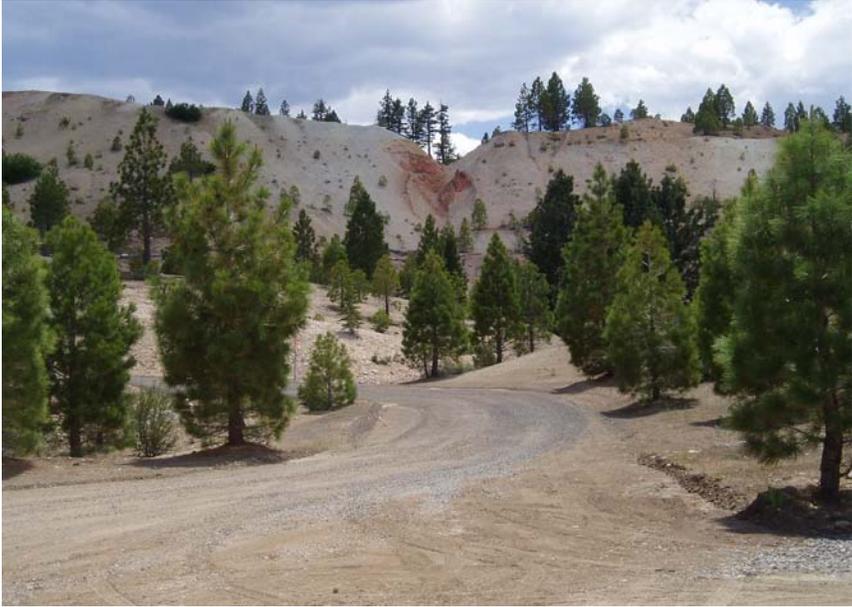
Photo Number	Photo Description	Photo
B-75	View of erosion gully in the overburden pile (red area above trees in middle of photo). View to South July 8, 2010
