Subject: **2014 Annual Progress Report – Former Fairchild Buildings 1-4, 9, and 18**  
Middlefield-Ellis-Whisman (“MEW”) Area  
Mountain View, California

**2014 ANNUAL PROGRESS REPORT  
FORMER FAIRCHILD  
BUILDINGS 1-4, 9, AND 18  
MOUNTAIN VIEW, CALIFORNIA**

Project Number: WR1133C

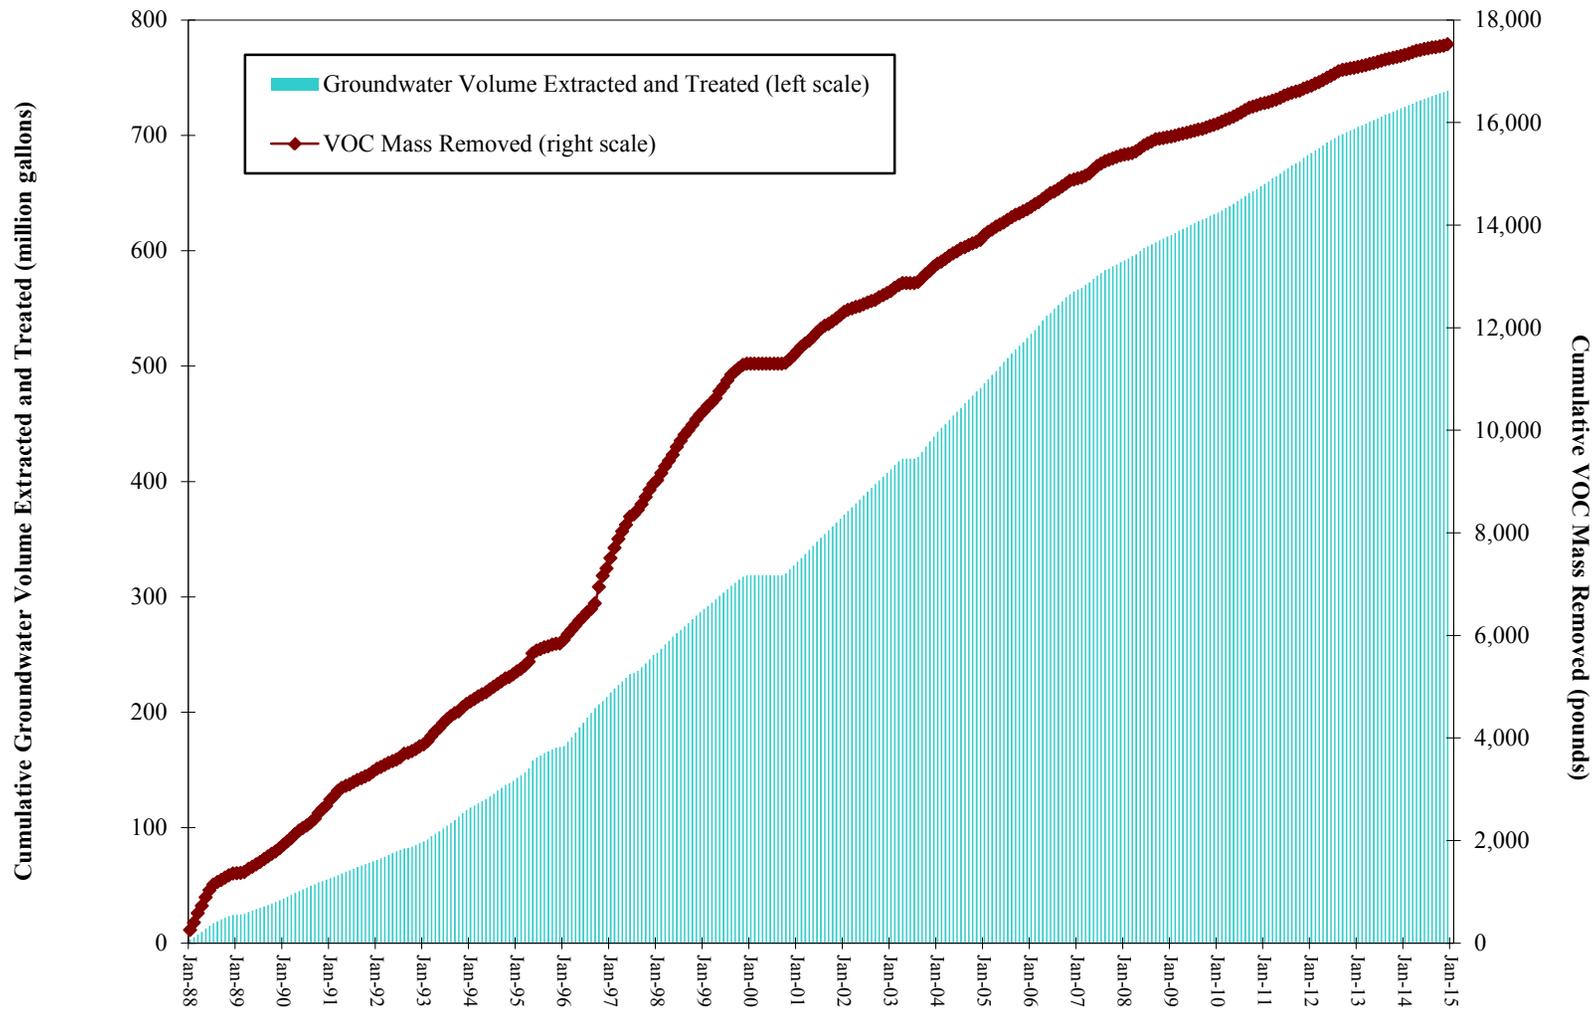
**Cumulative Groundwater Extracted and VOC Mass Removed, System 1**

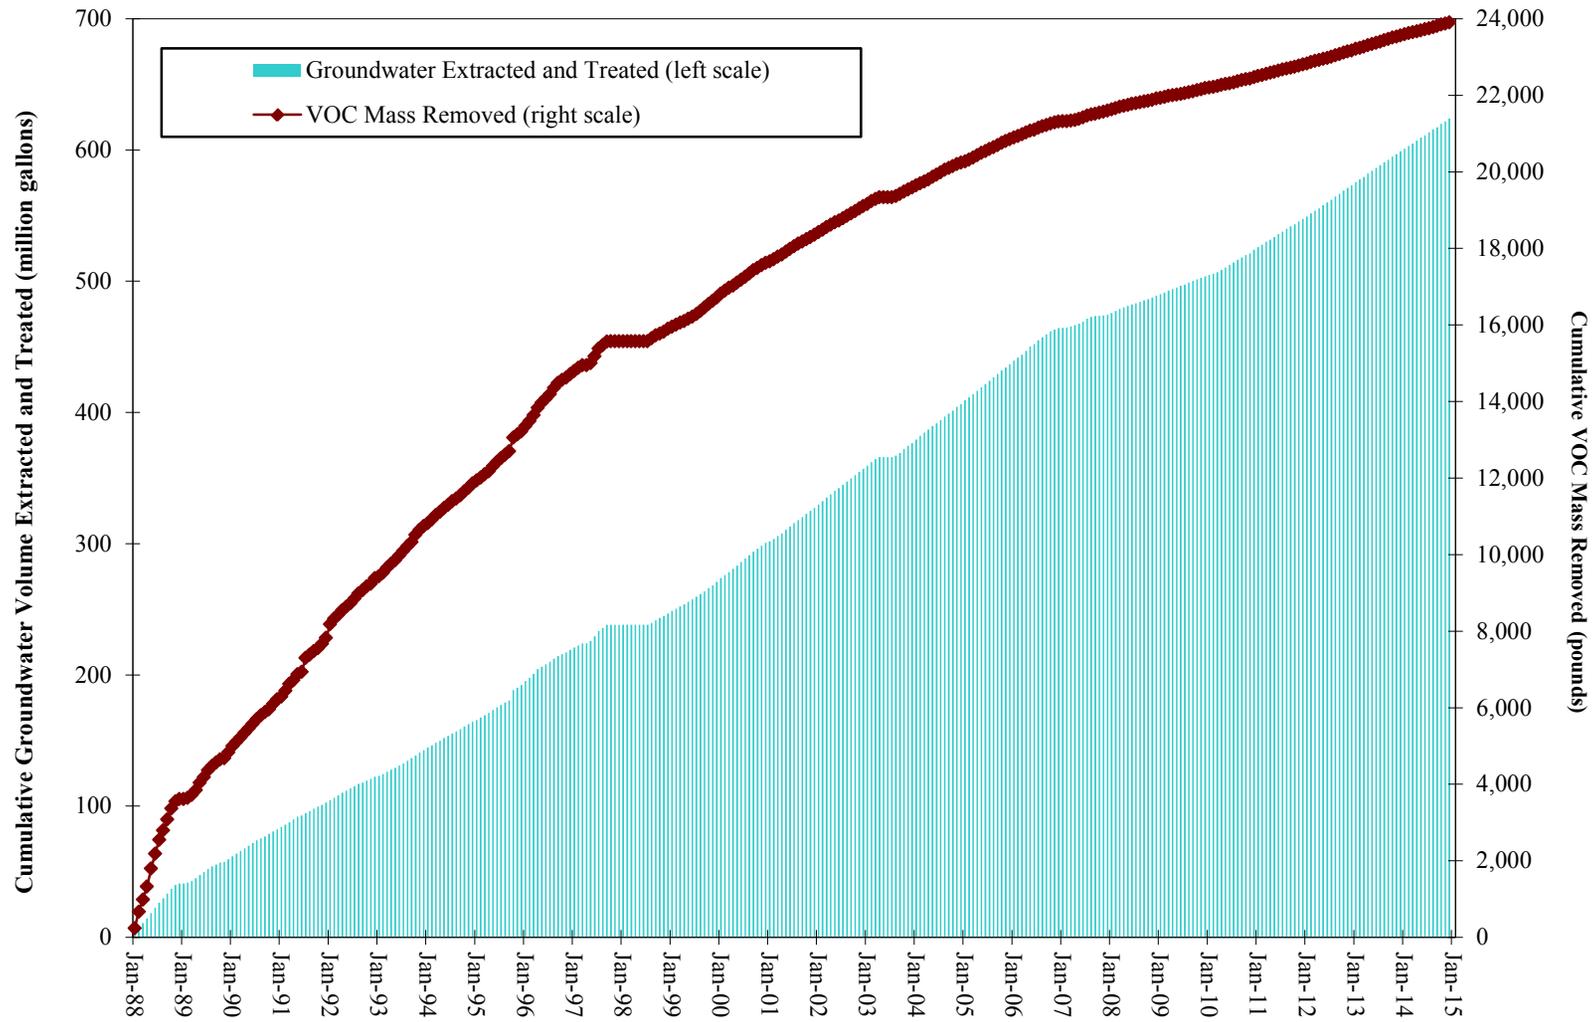
**Cumulative Groundwater Extracted and  
VOC Mass Removed, System 3**

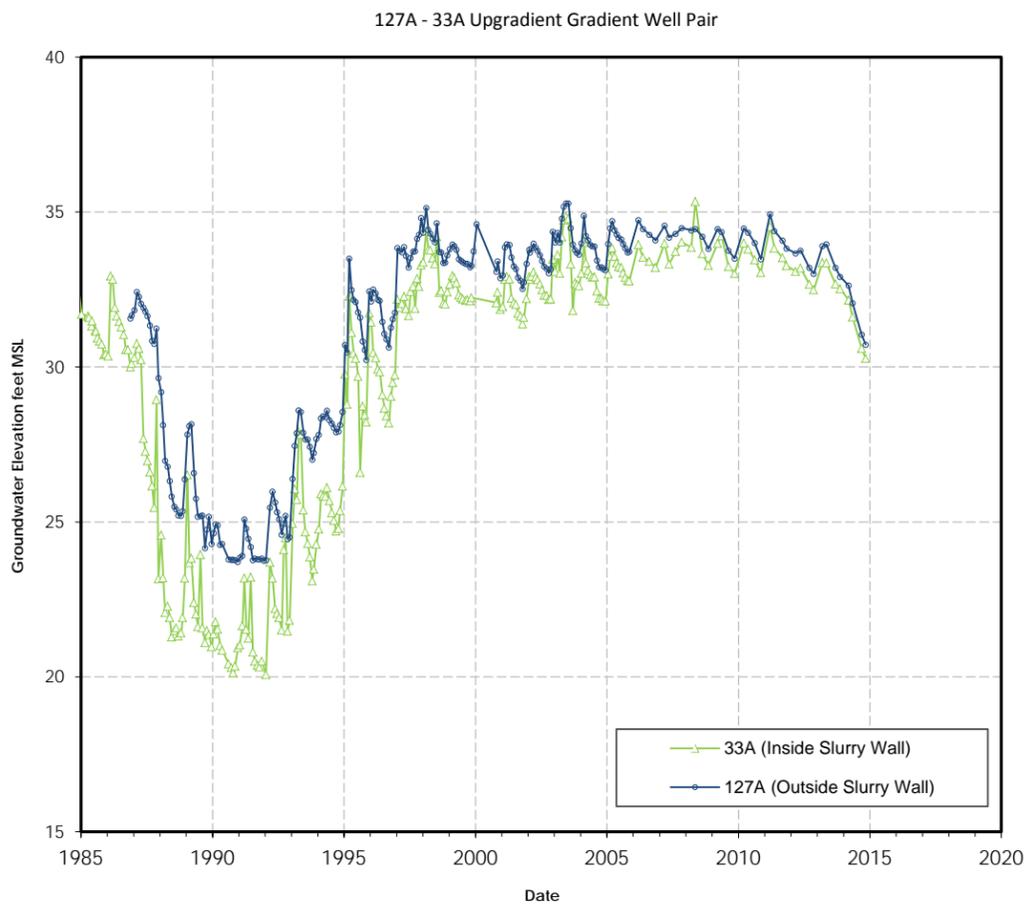
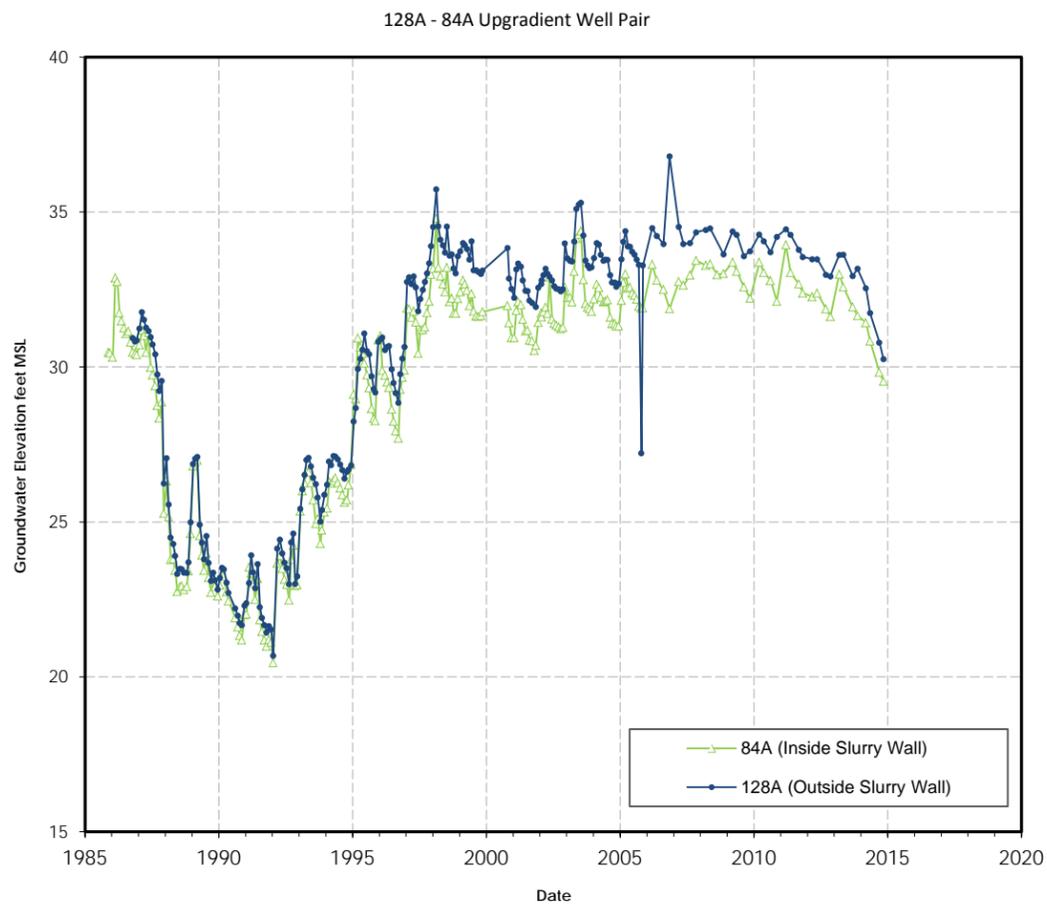
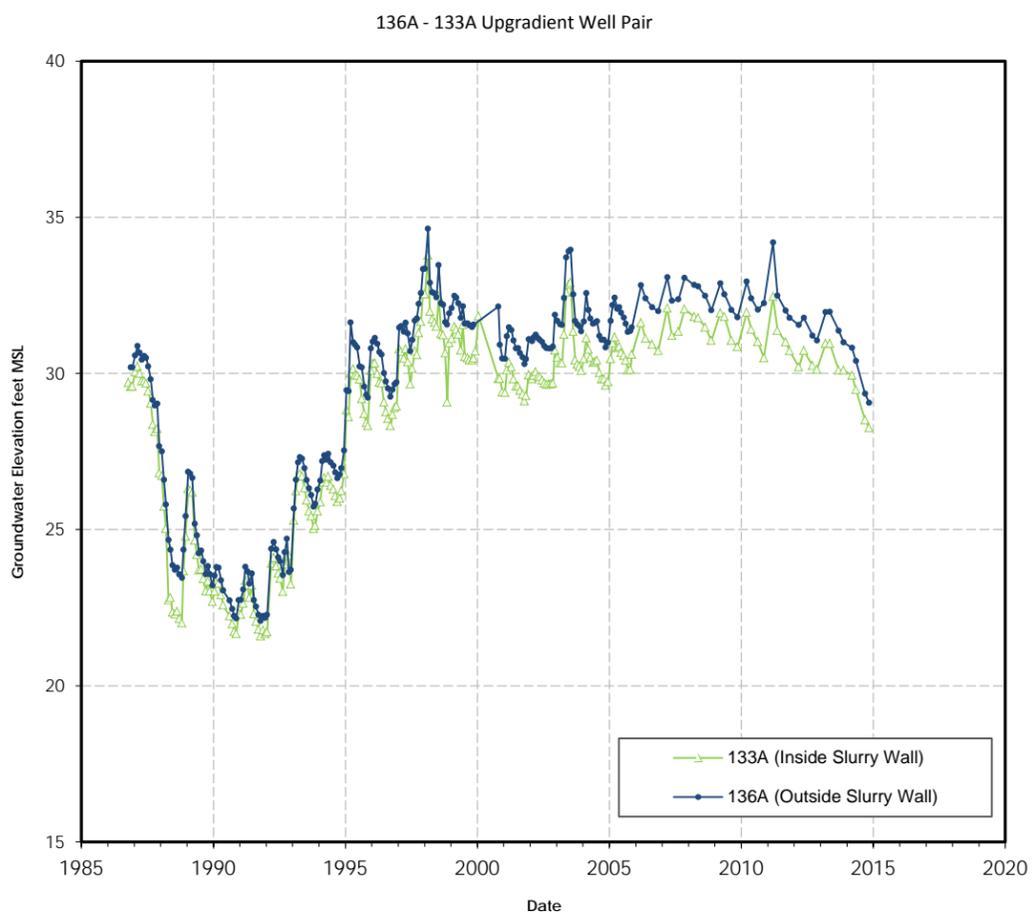
Figure  
**6**

**Hydrographs**  
**Buildings 1-4 Upgradient A Zone Slurry Wall Well Pairs**  
 MEW Former Fairchild Buildings 1-4, 9, and 18 Groundwater Remediation Programs  
 Mountain View, California

- **Horizontal Gradients:** During this reporting period, inward gradients were consistently observed at well pair 123A/122A located on the upgradient side of the slurry wall, well pair 138A/127A located on the eastern cross gradient side

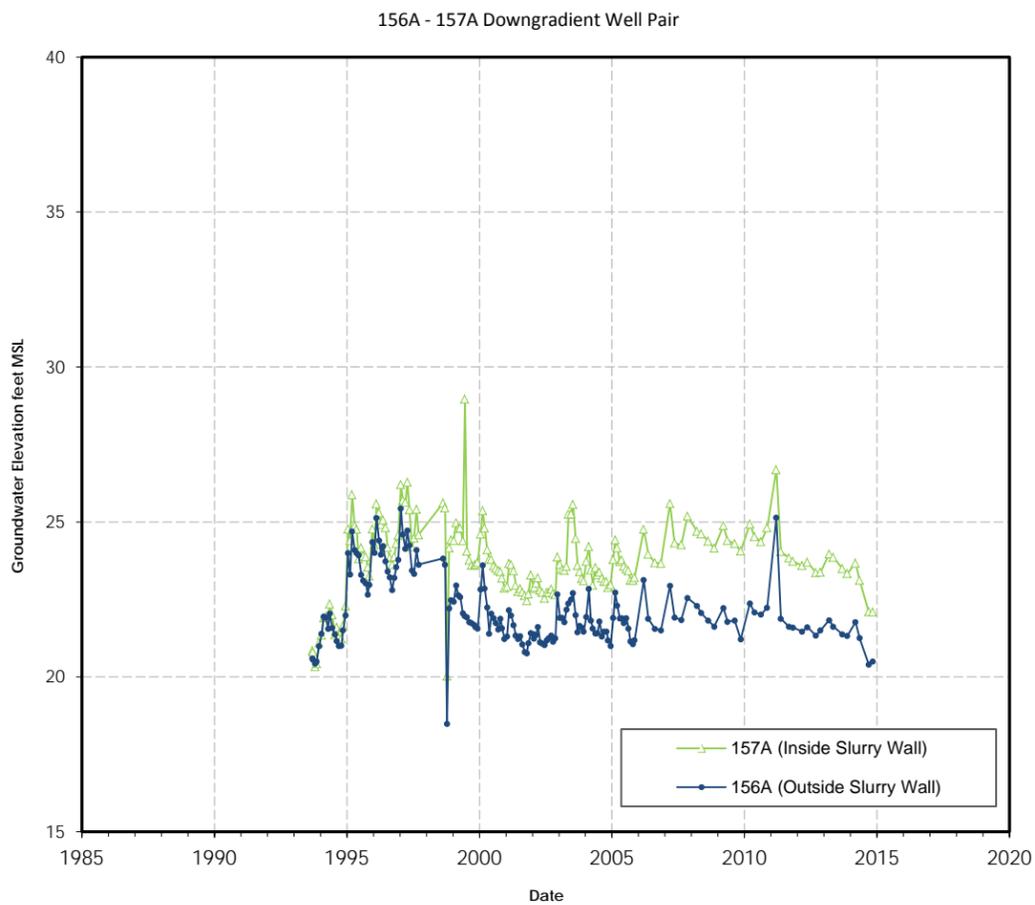
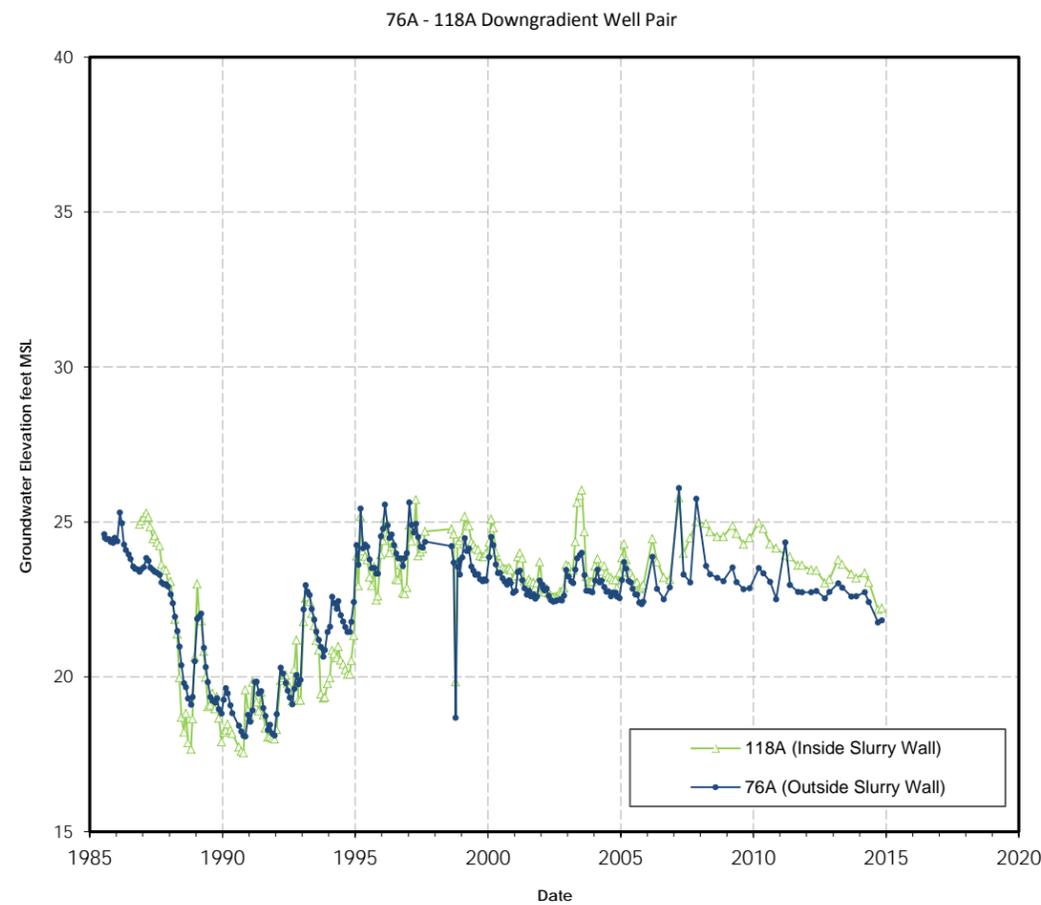
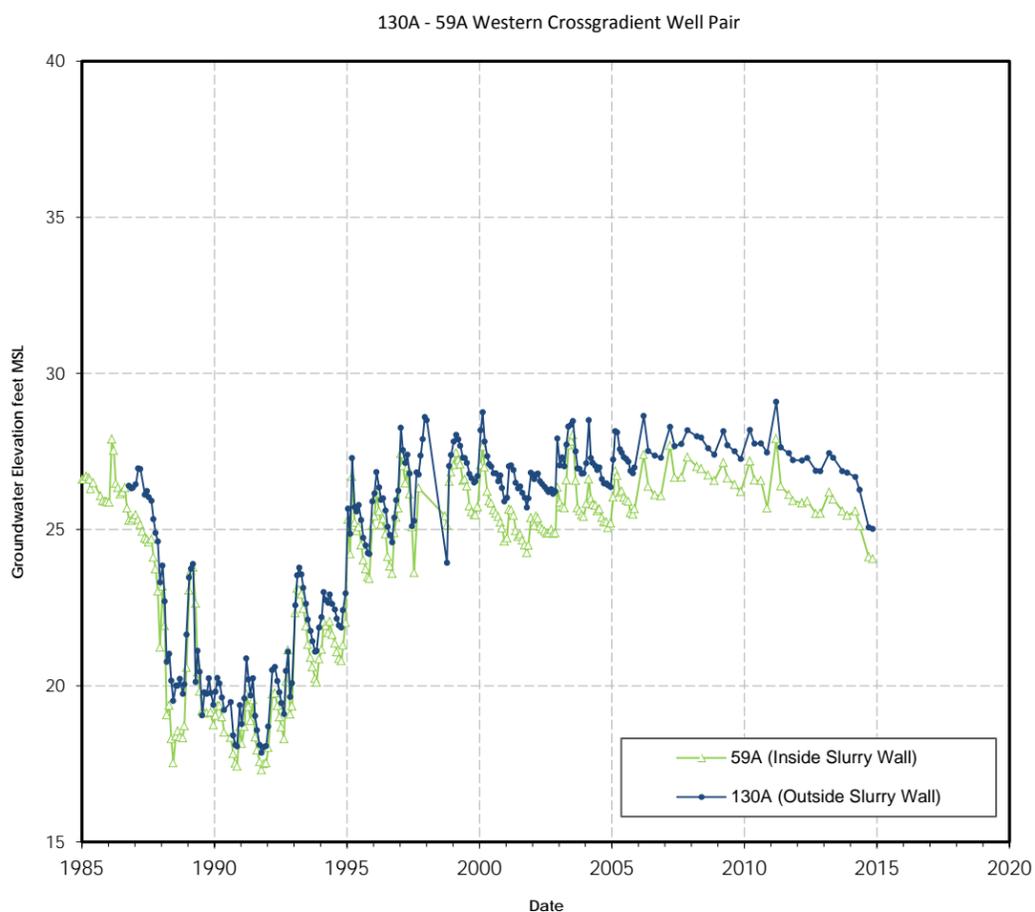
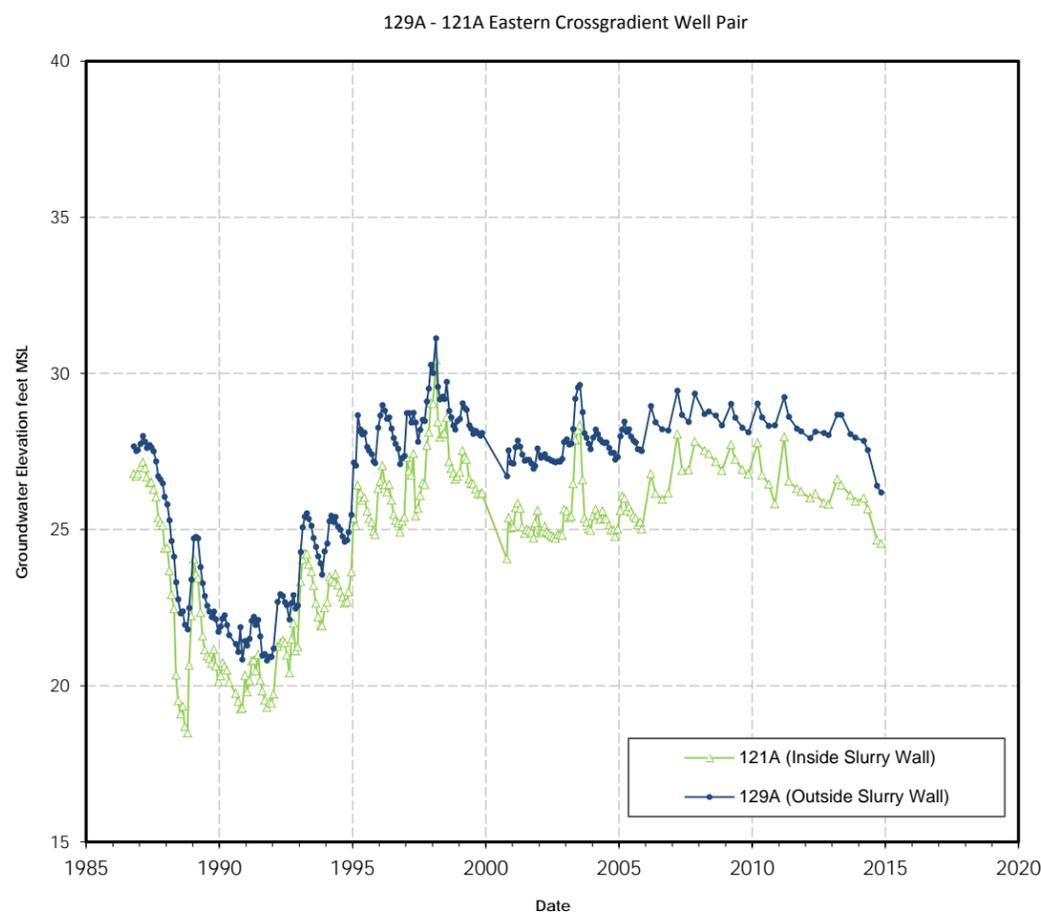
**Hydrographs**  
**Buildings 1-4 Crossgradient and Downgradient A Zone Slurry Wall Well Pairs**  
 MEW Former Fairchild Buildings 1-4, 9, and 18 Groundwater Remediation Programs  
 Mountain View, California

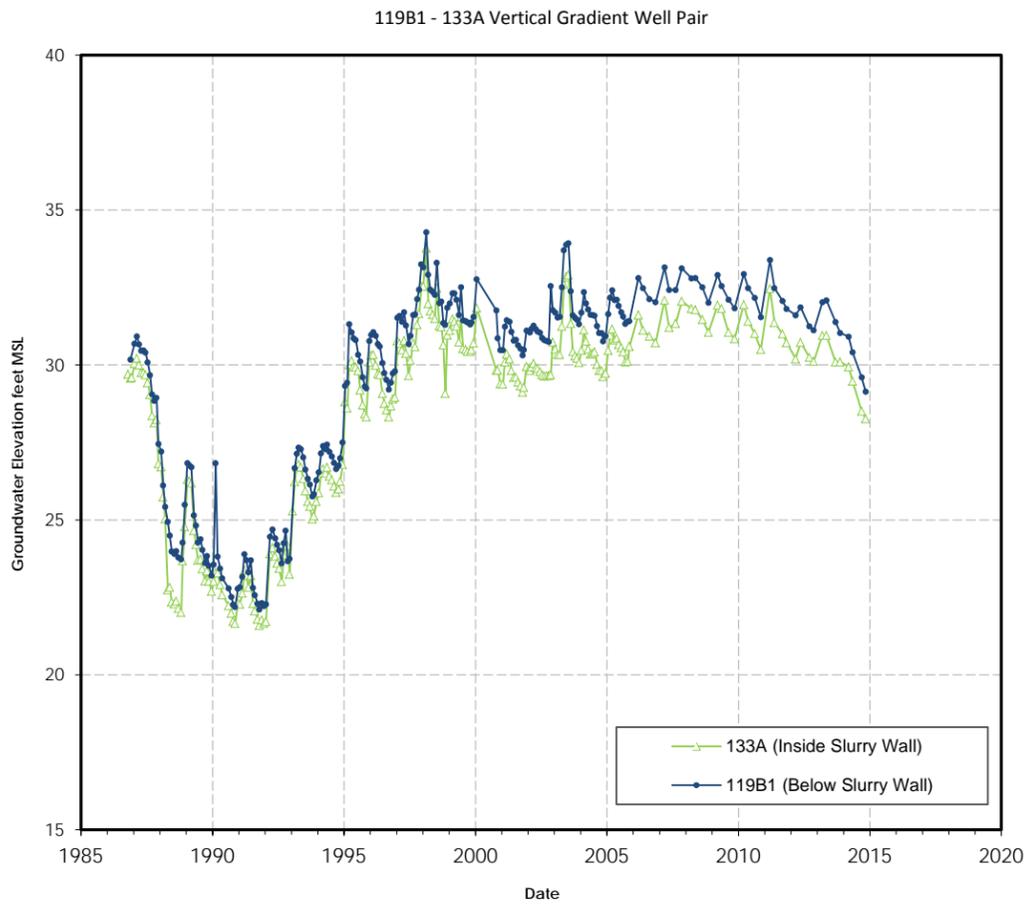
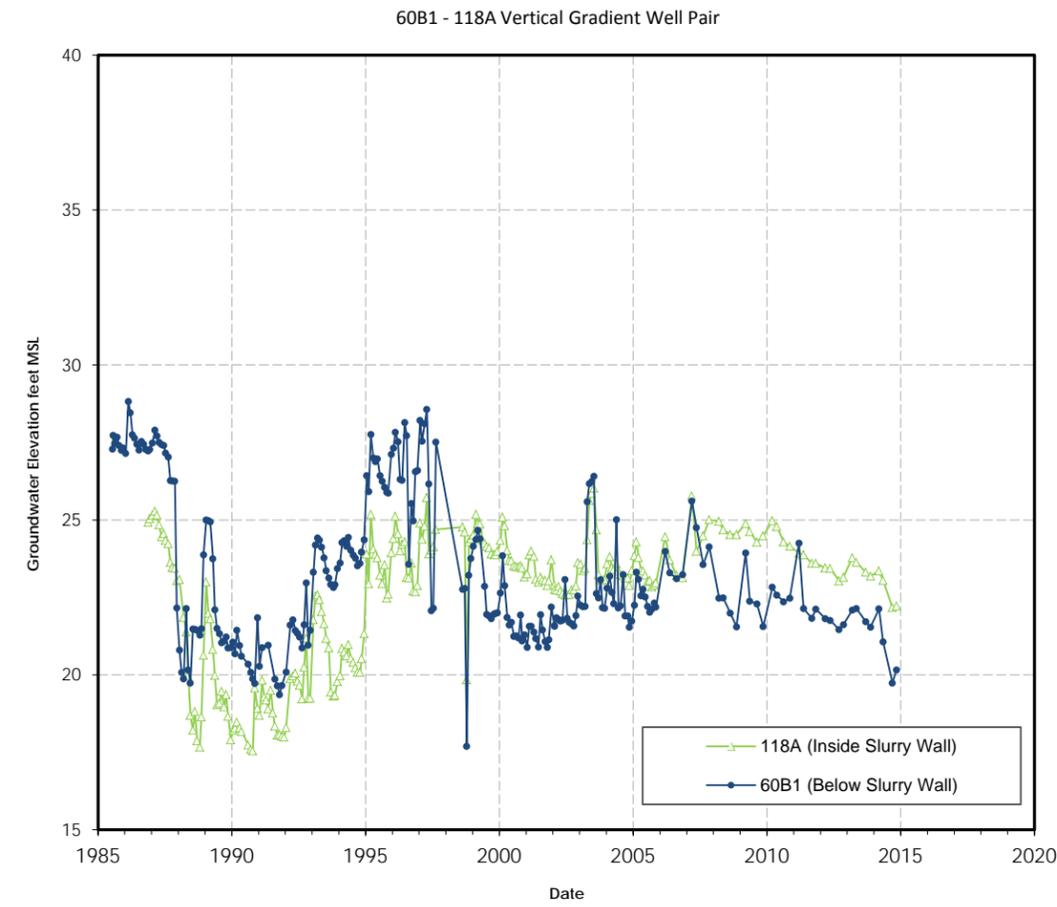
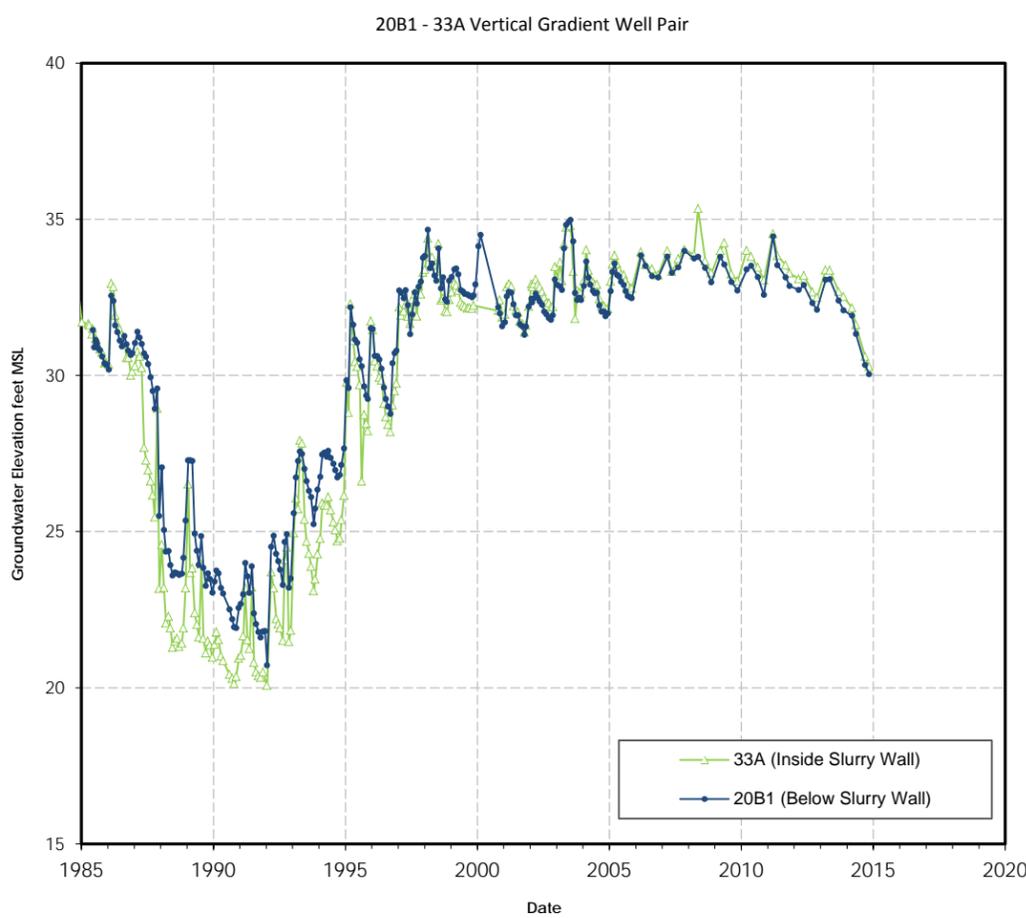
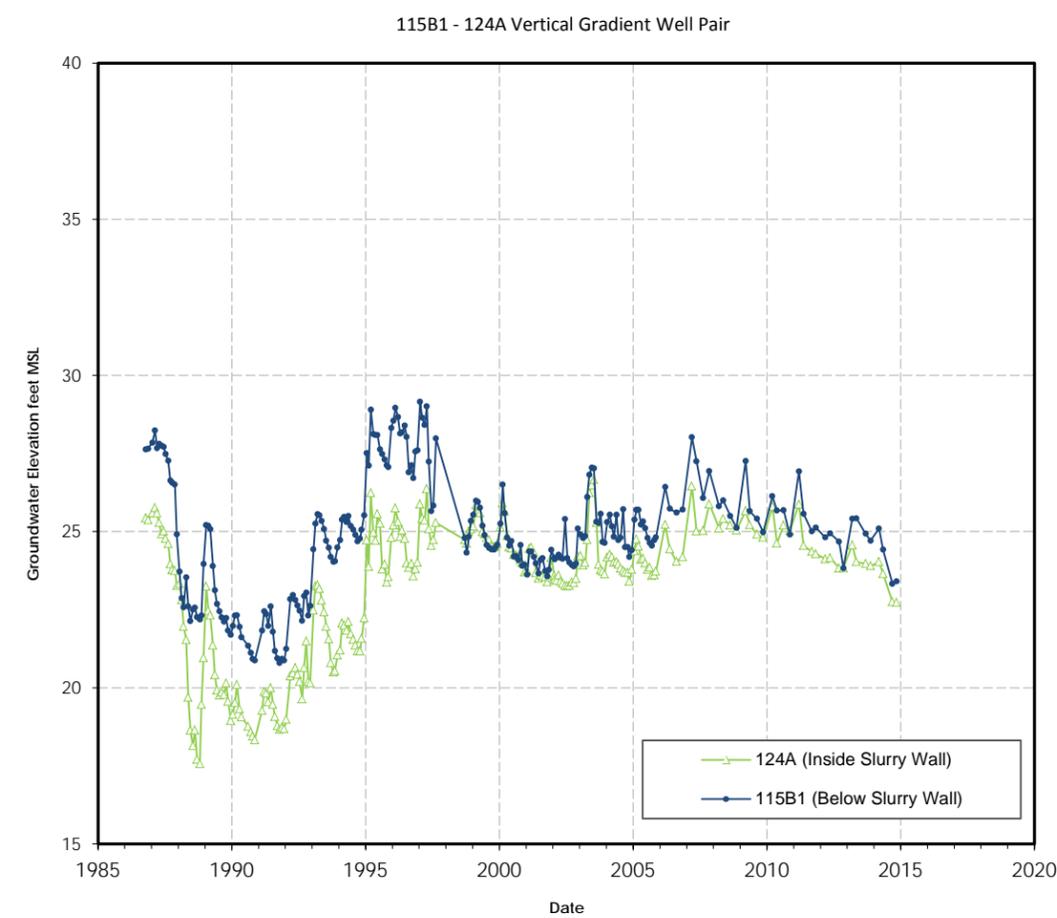
Figure  
**8**

**Hydrographs**  
**Buildings 1-4 Slurry Wall Well Pairs Across Water-Bearing Zones**  
 MEW Former Fairchild Buildings 1-4, 9, and 18 Groundwater Remediation Programs  
 Mountain View, California

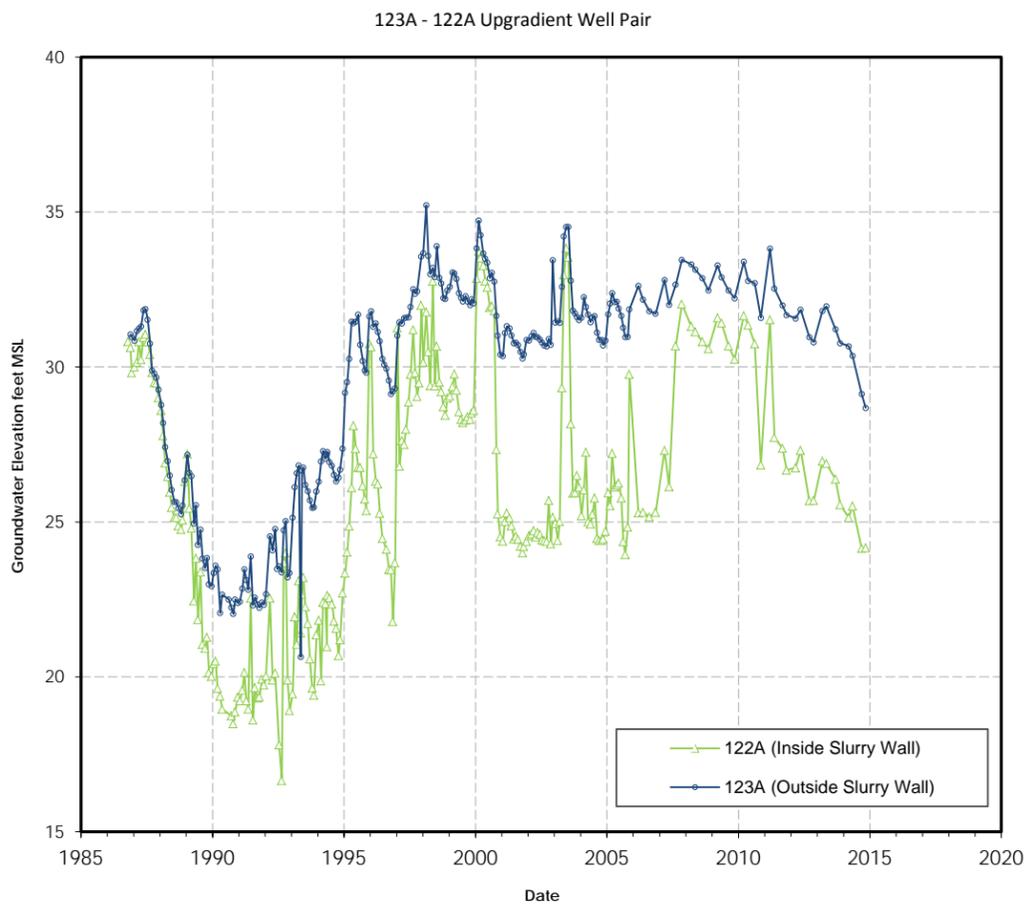
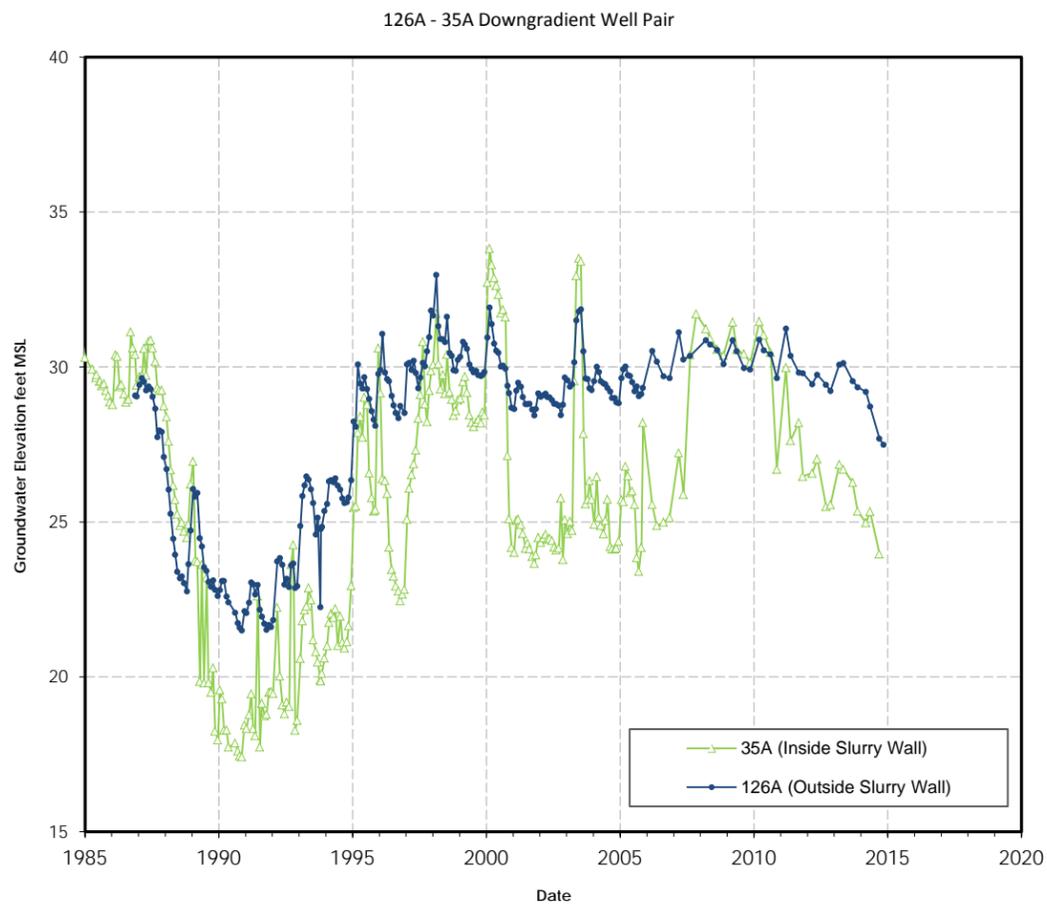
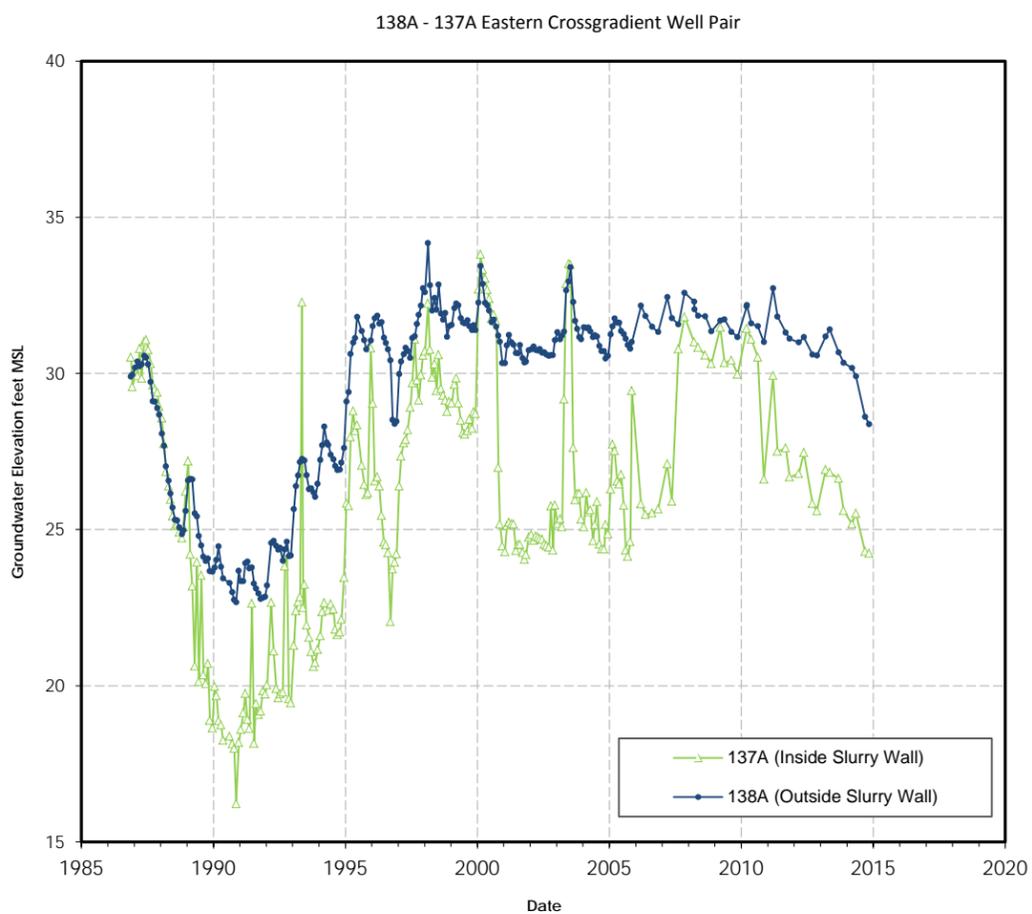
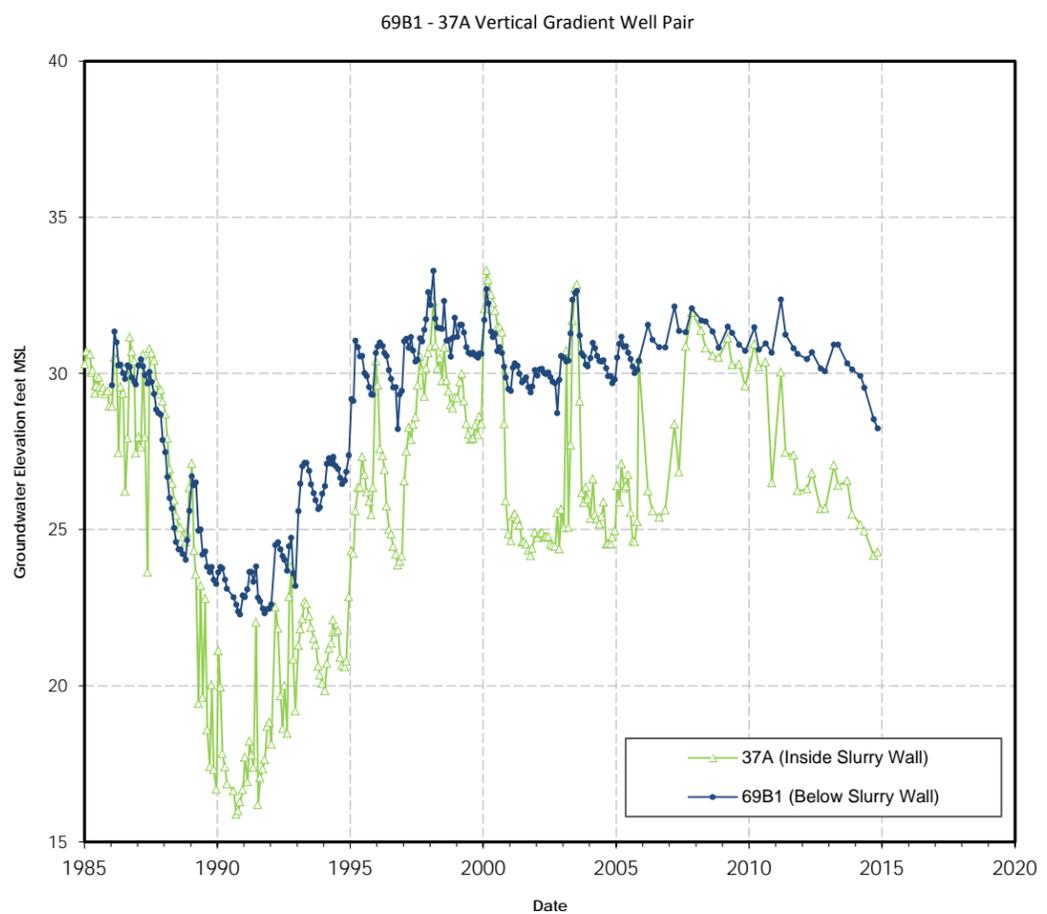
**Figure**  
**9**

**Hydrographs**  
**Building 9 Slurry Wall Well Pairs**  
 MEW Former Fairchild Building 1-4, 9, and 18 Groundwater Remediation Programs  
 Mountain View, California

The horizontal and vertical gradients recorded during this reporting period are generally consistent with historical observations. The inward and upward gradients observed at the Building 9 site provide hydraulic containment.

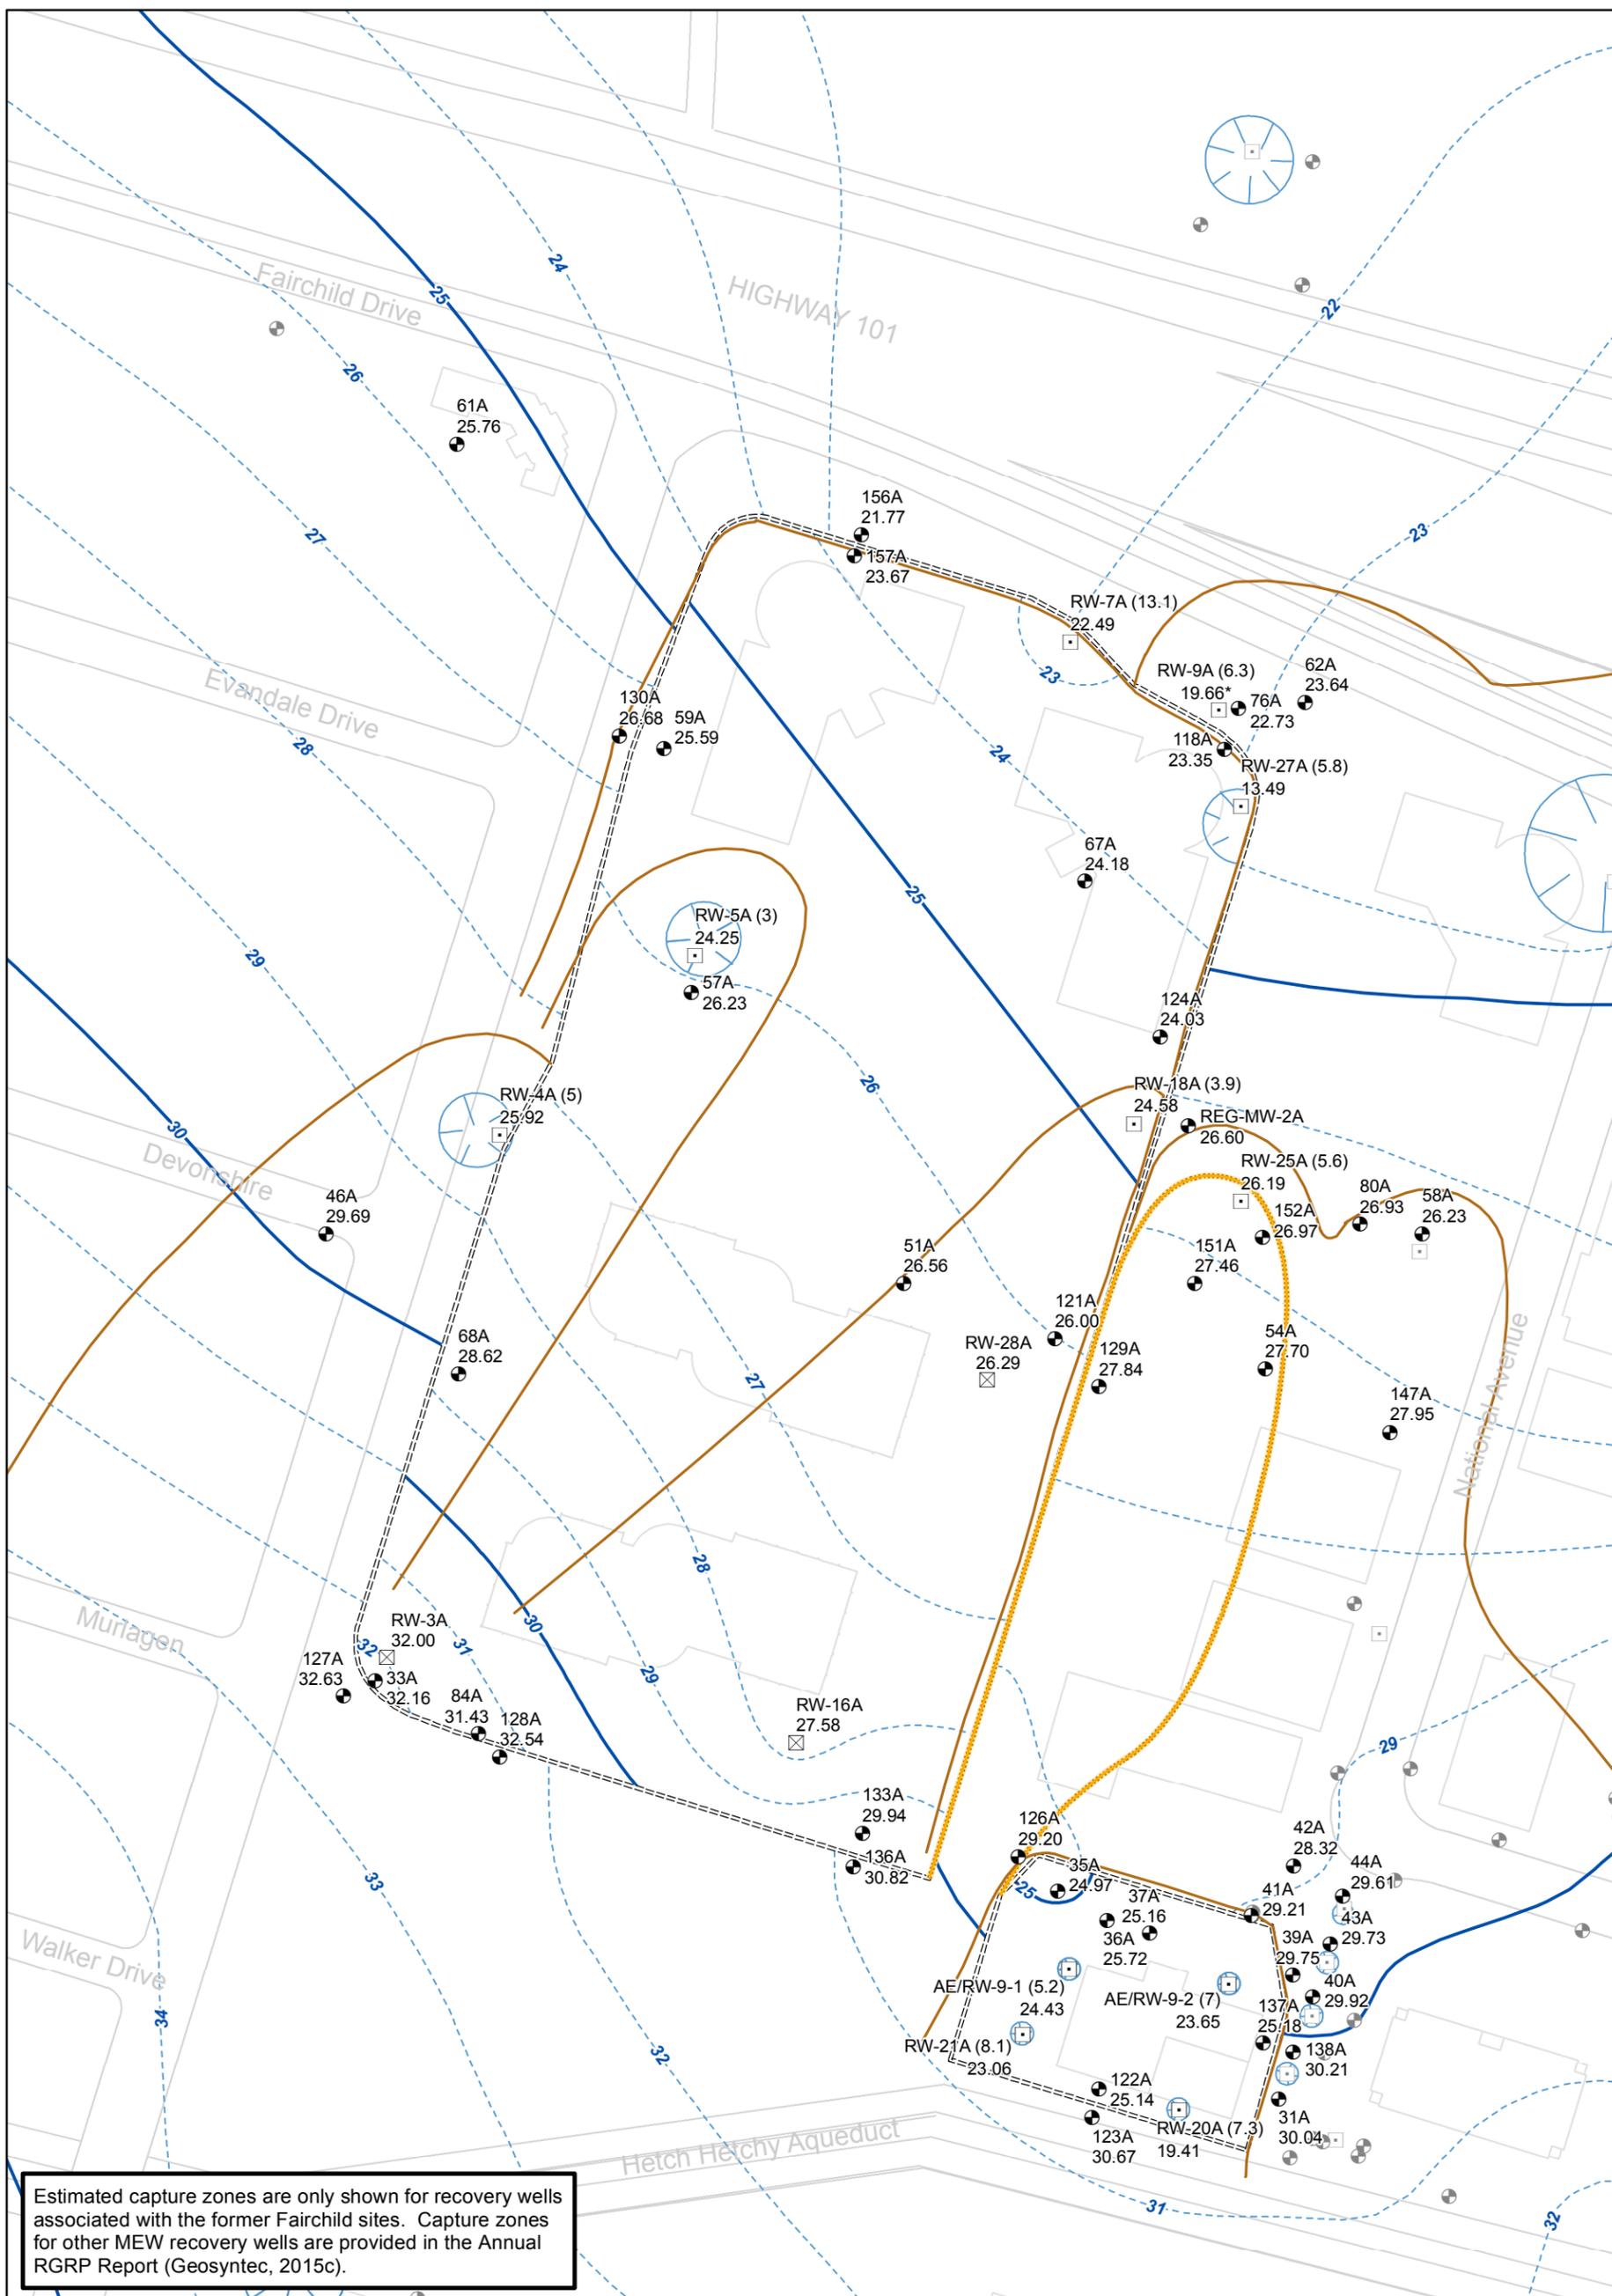
Estimated capture zones are only shown for recovery wells associated with the former Fairchild sites. Capture zones for other MEW recovery wells are provided in the Annual RGRP Report (Geosyntec, 2015c).

Groundwater elevation contour and capture zone maps from March and September show that there is no significant seasonal change in groundwater flow or extraction well capture across the study area. As stated in a 13 February 2015 letter to EPA, it is recommended that the frequency of groundwater level monitoring be reduced from semi-annual to annual, coincident with the September/October sampling event (Geosyntec, 2015b).
