Subject: **2014 Annual Progress Report – Former Fairchild Buildings 1-4, 9, and 18**  
Middlefield-Ellis-Whisman (“MEW”) Area  
Mountain View, California

**2014 ANNUAL PROGRESS REPORT  
FORMER FAIRCHILD  
BUILDINGS 1-4, 9, AND 18  
MOUNTAIN VIEW, CALIFORNIA**

Project Number: WR1133C

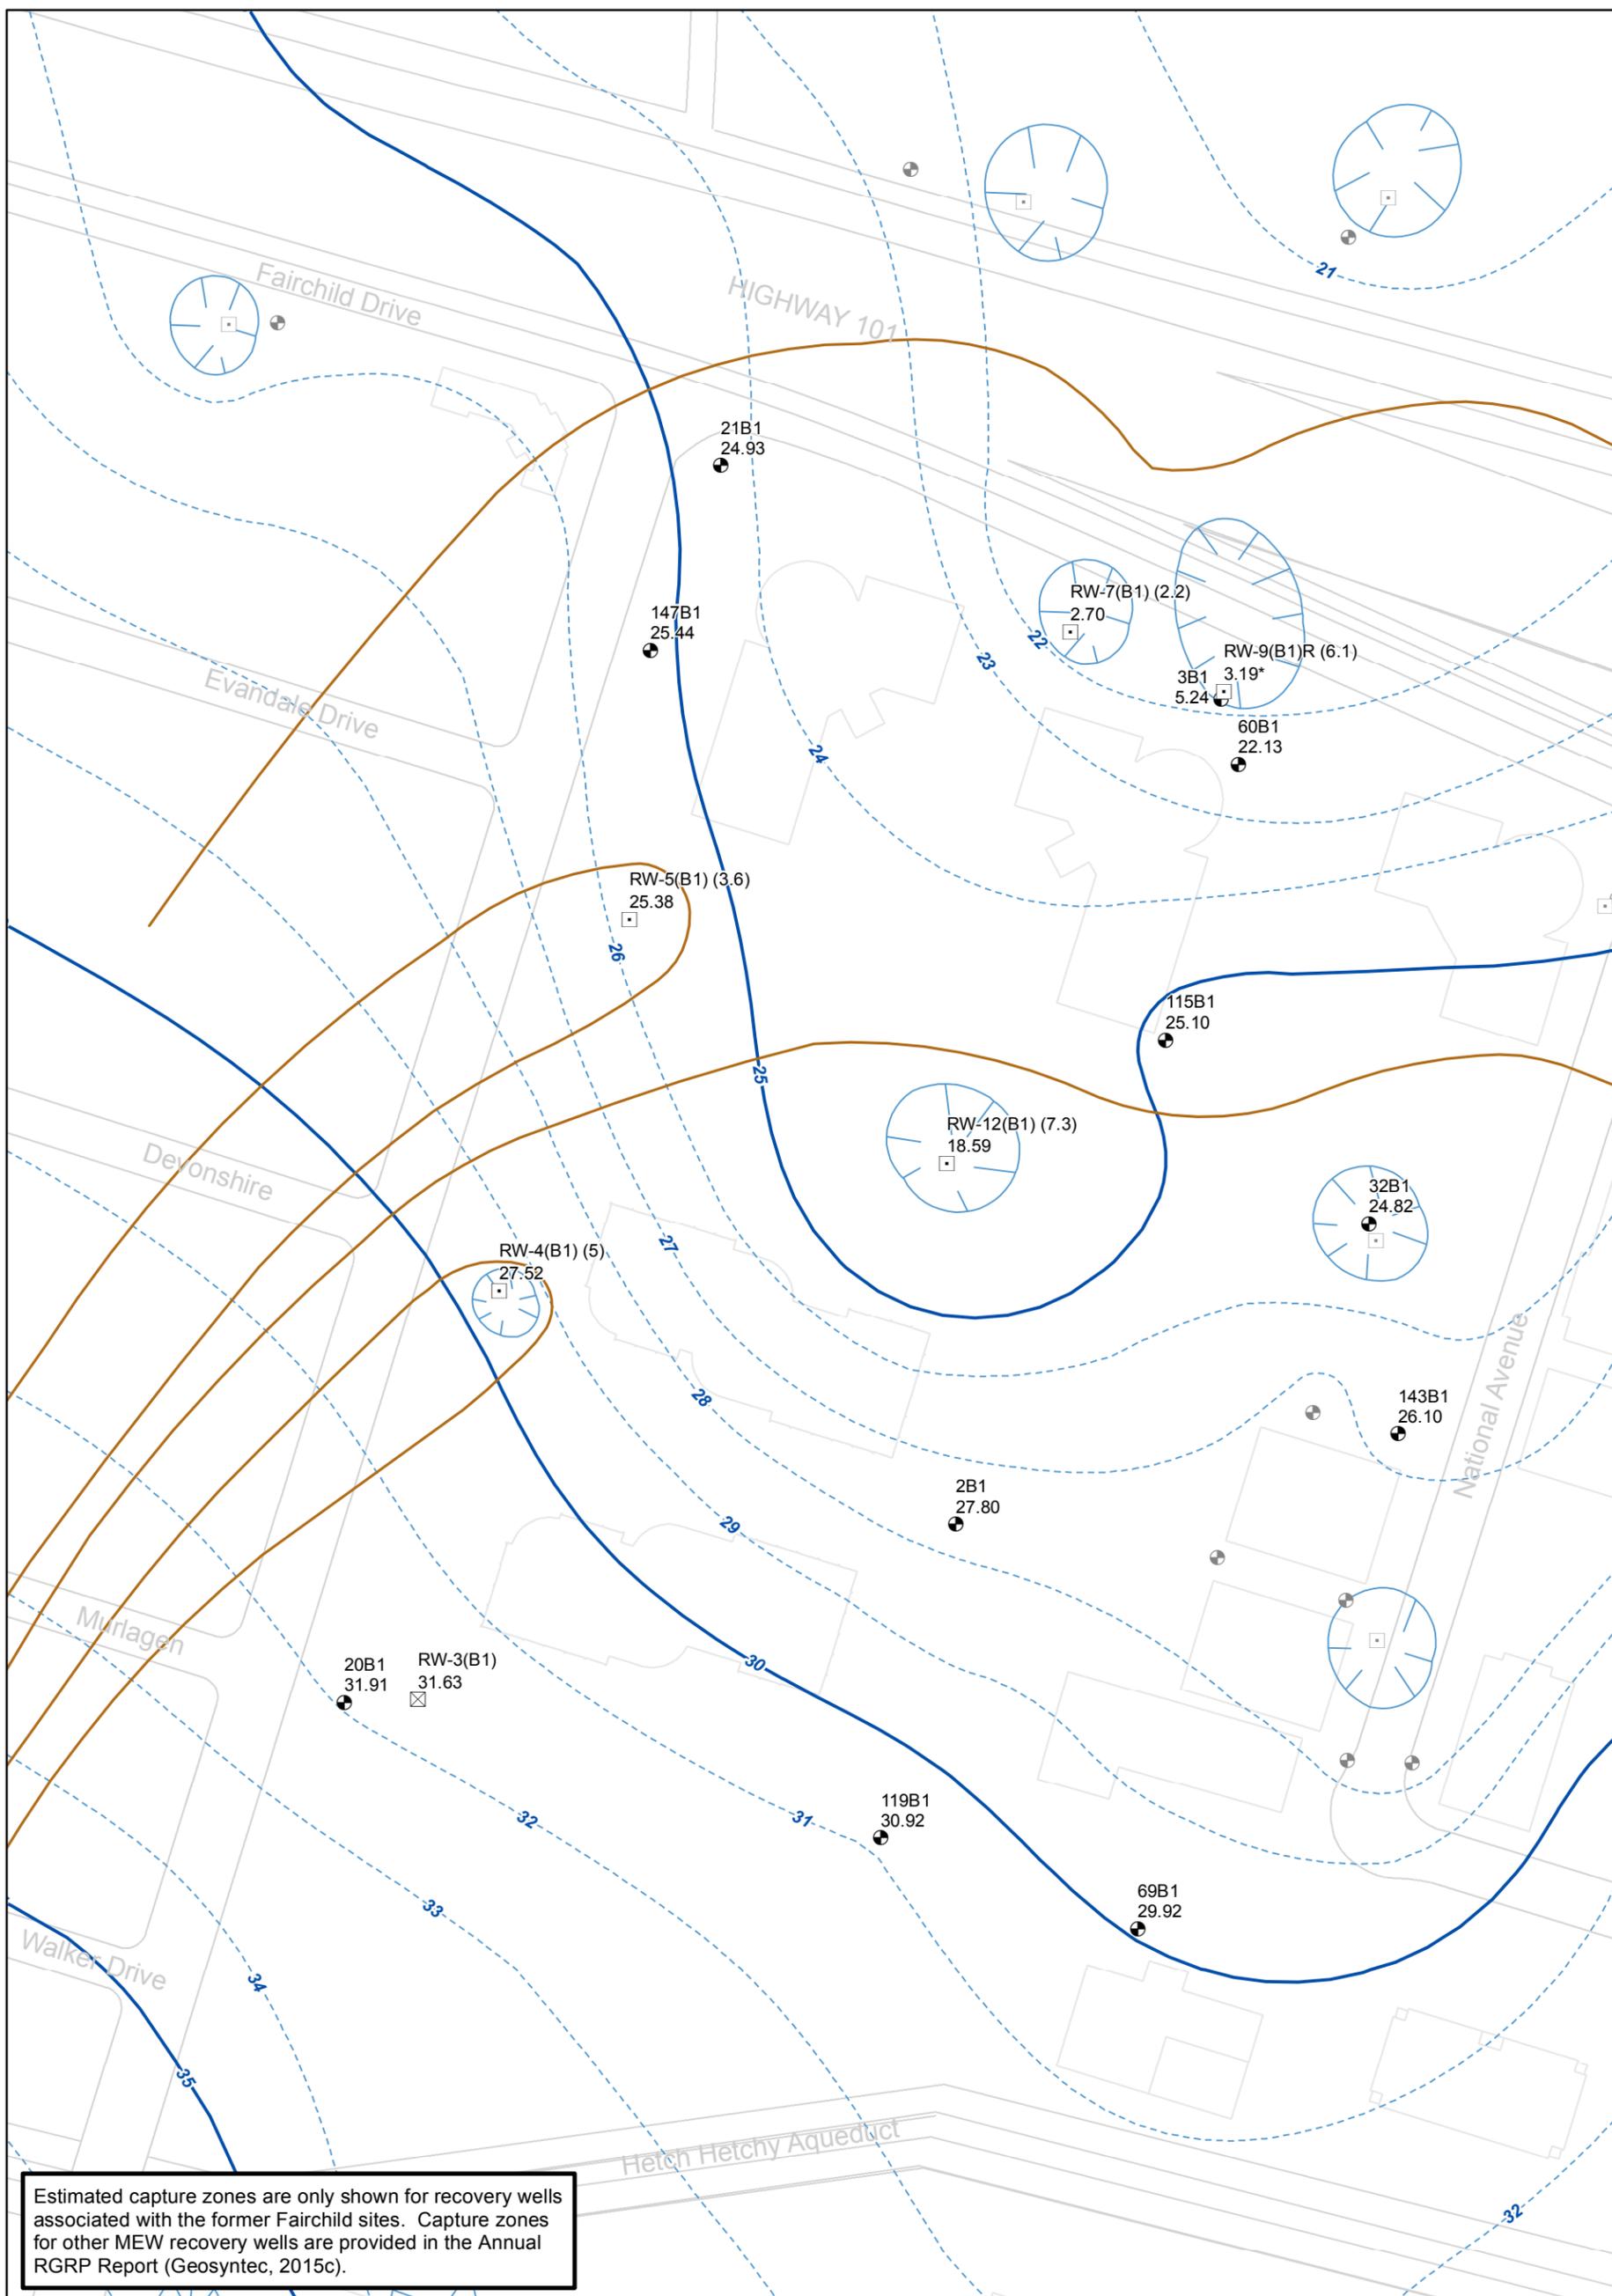
<b>Figure</b> <b>12</b>
Oakland	April 2015

Estimated capture zones are only shown for recovery wells associated with the former Fairchild sites. Capture zones for other MEW recovery wells are provided in the Annual RGRP Report (Geosyntec, 2015c).

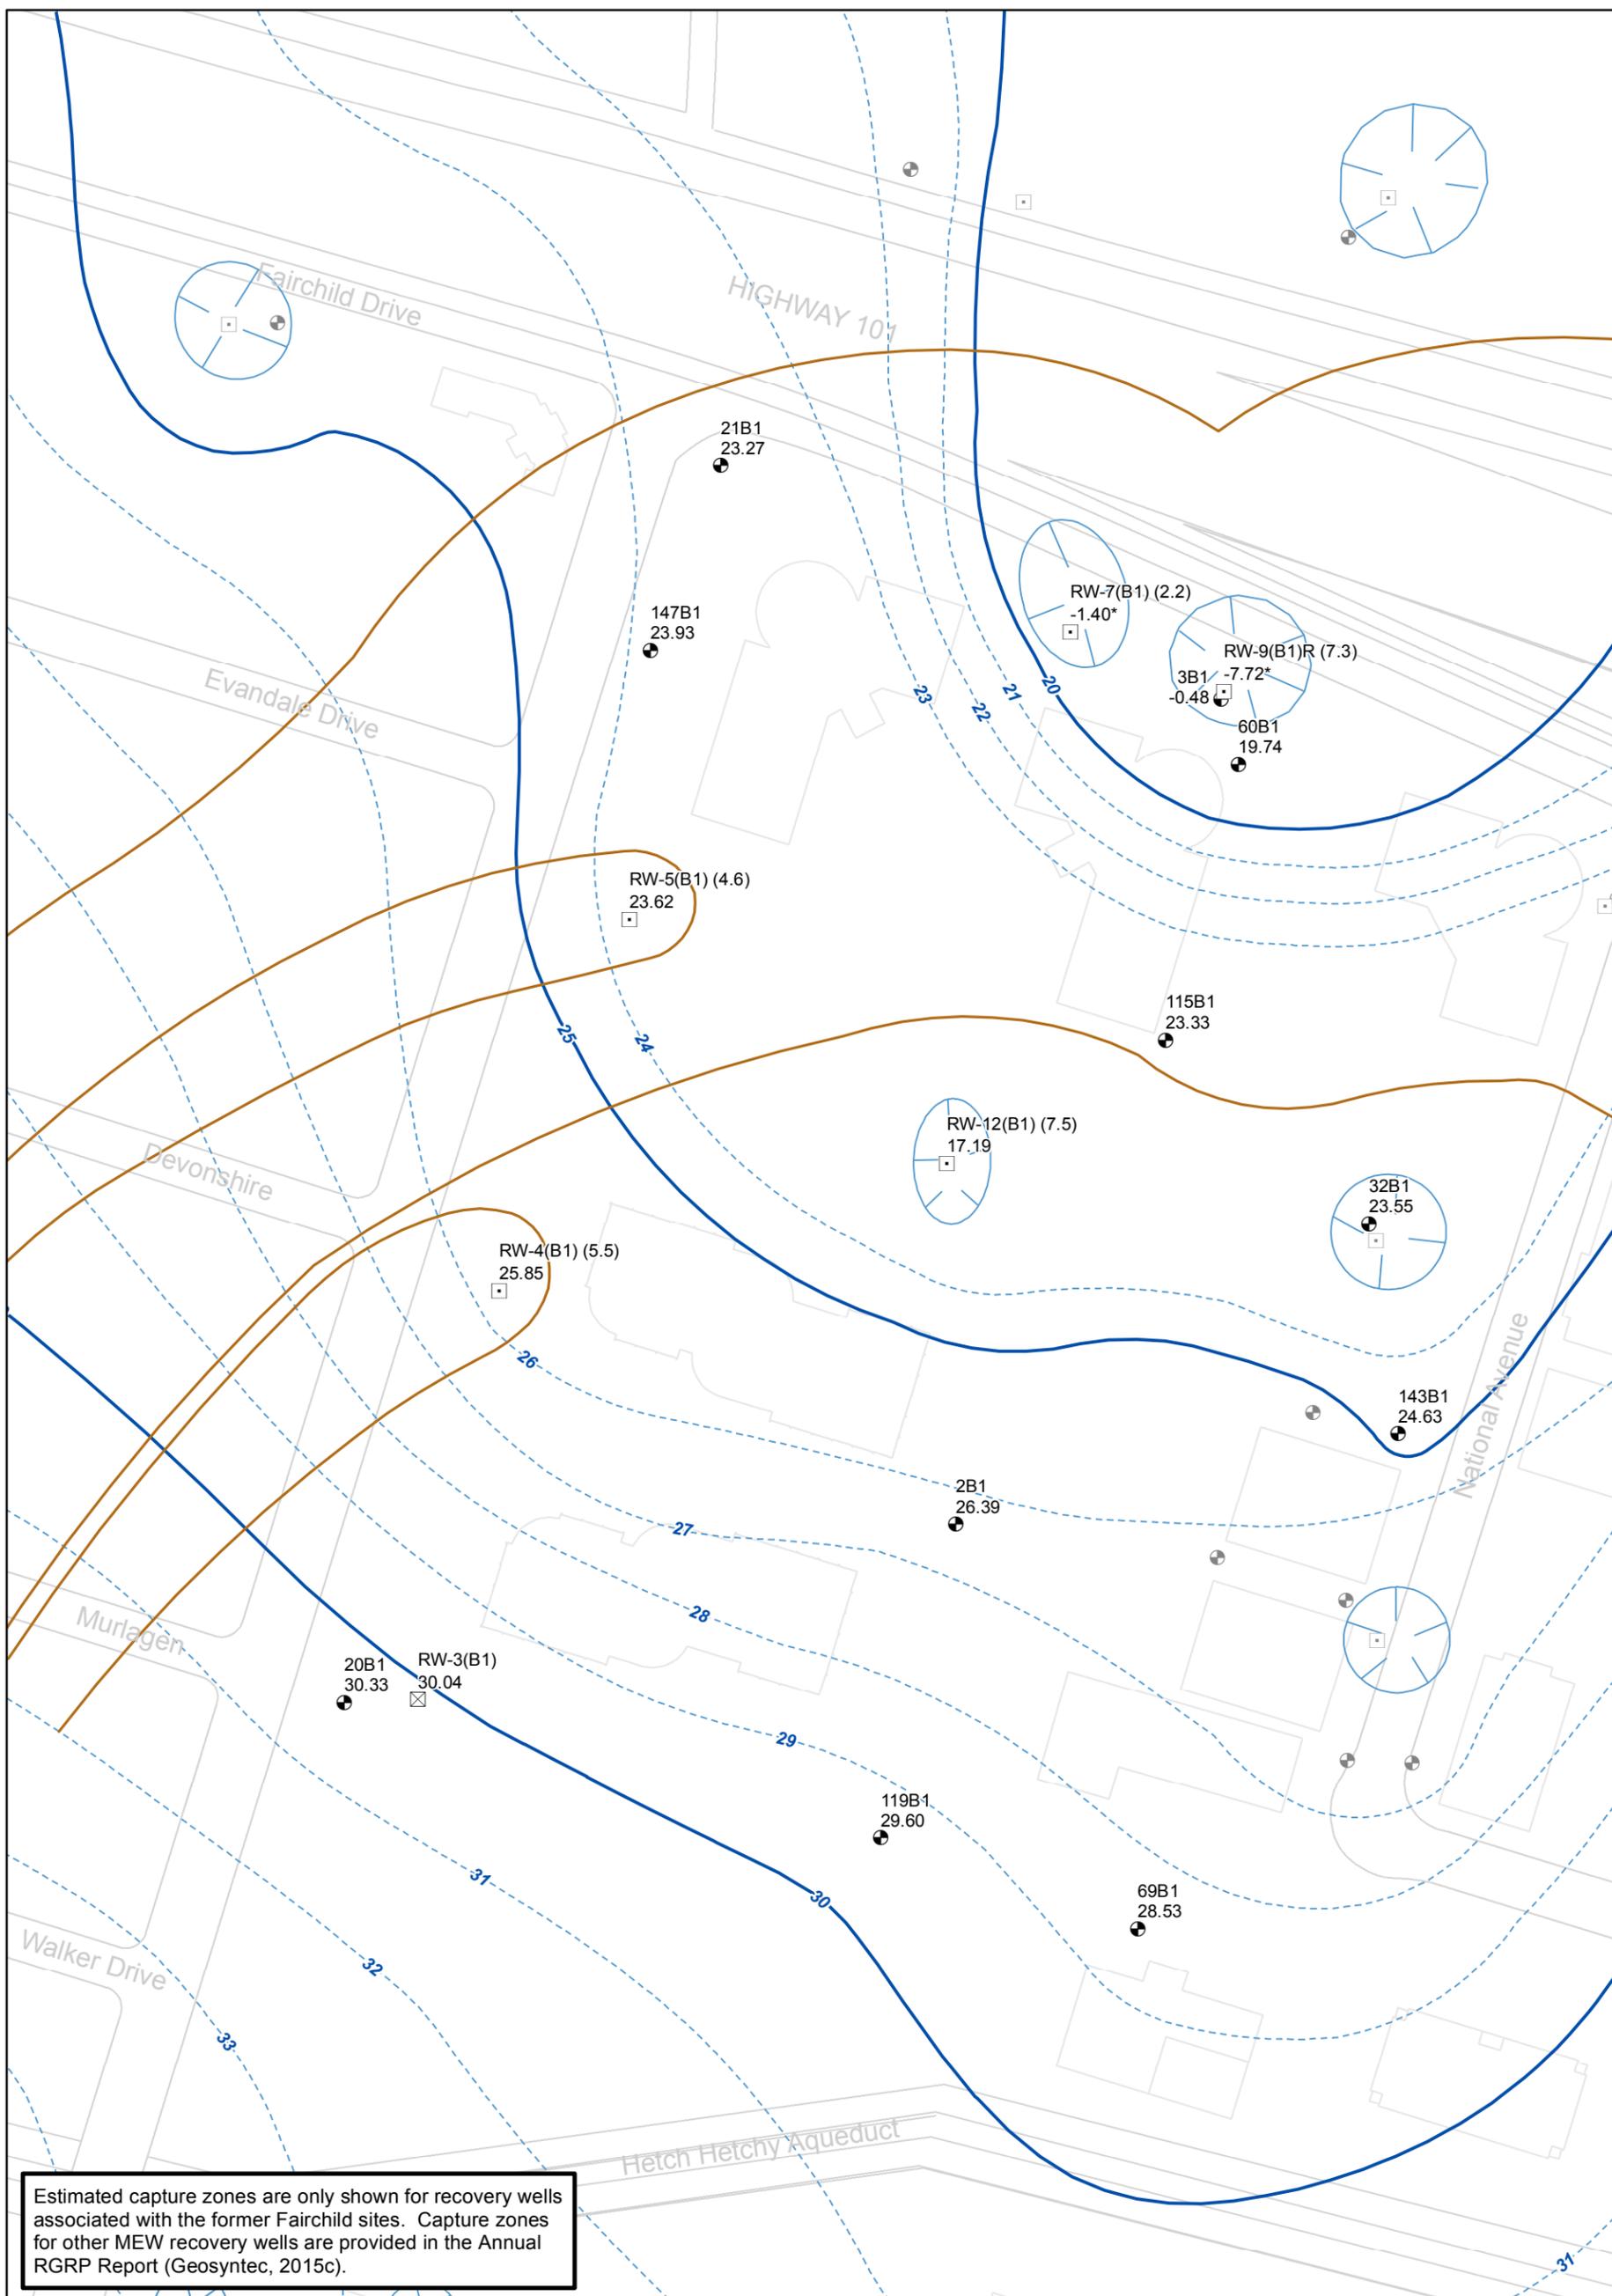
**Figure**  
**13**

Estimated capture zones are only shown for recovery wells associated with the former Fairchild sites. Capture zones for other MEW recovery wells are provided in the Annual RGRP Report (Geosyntec, 2015c).

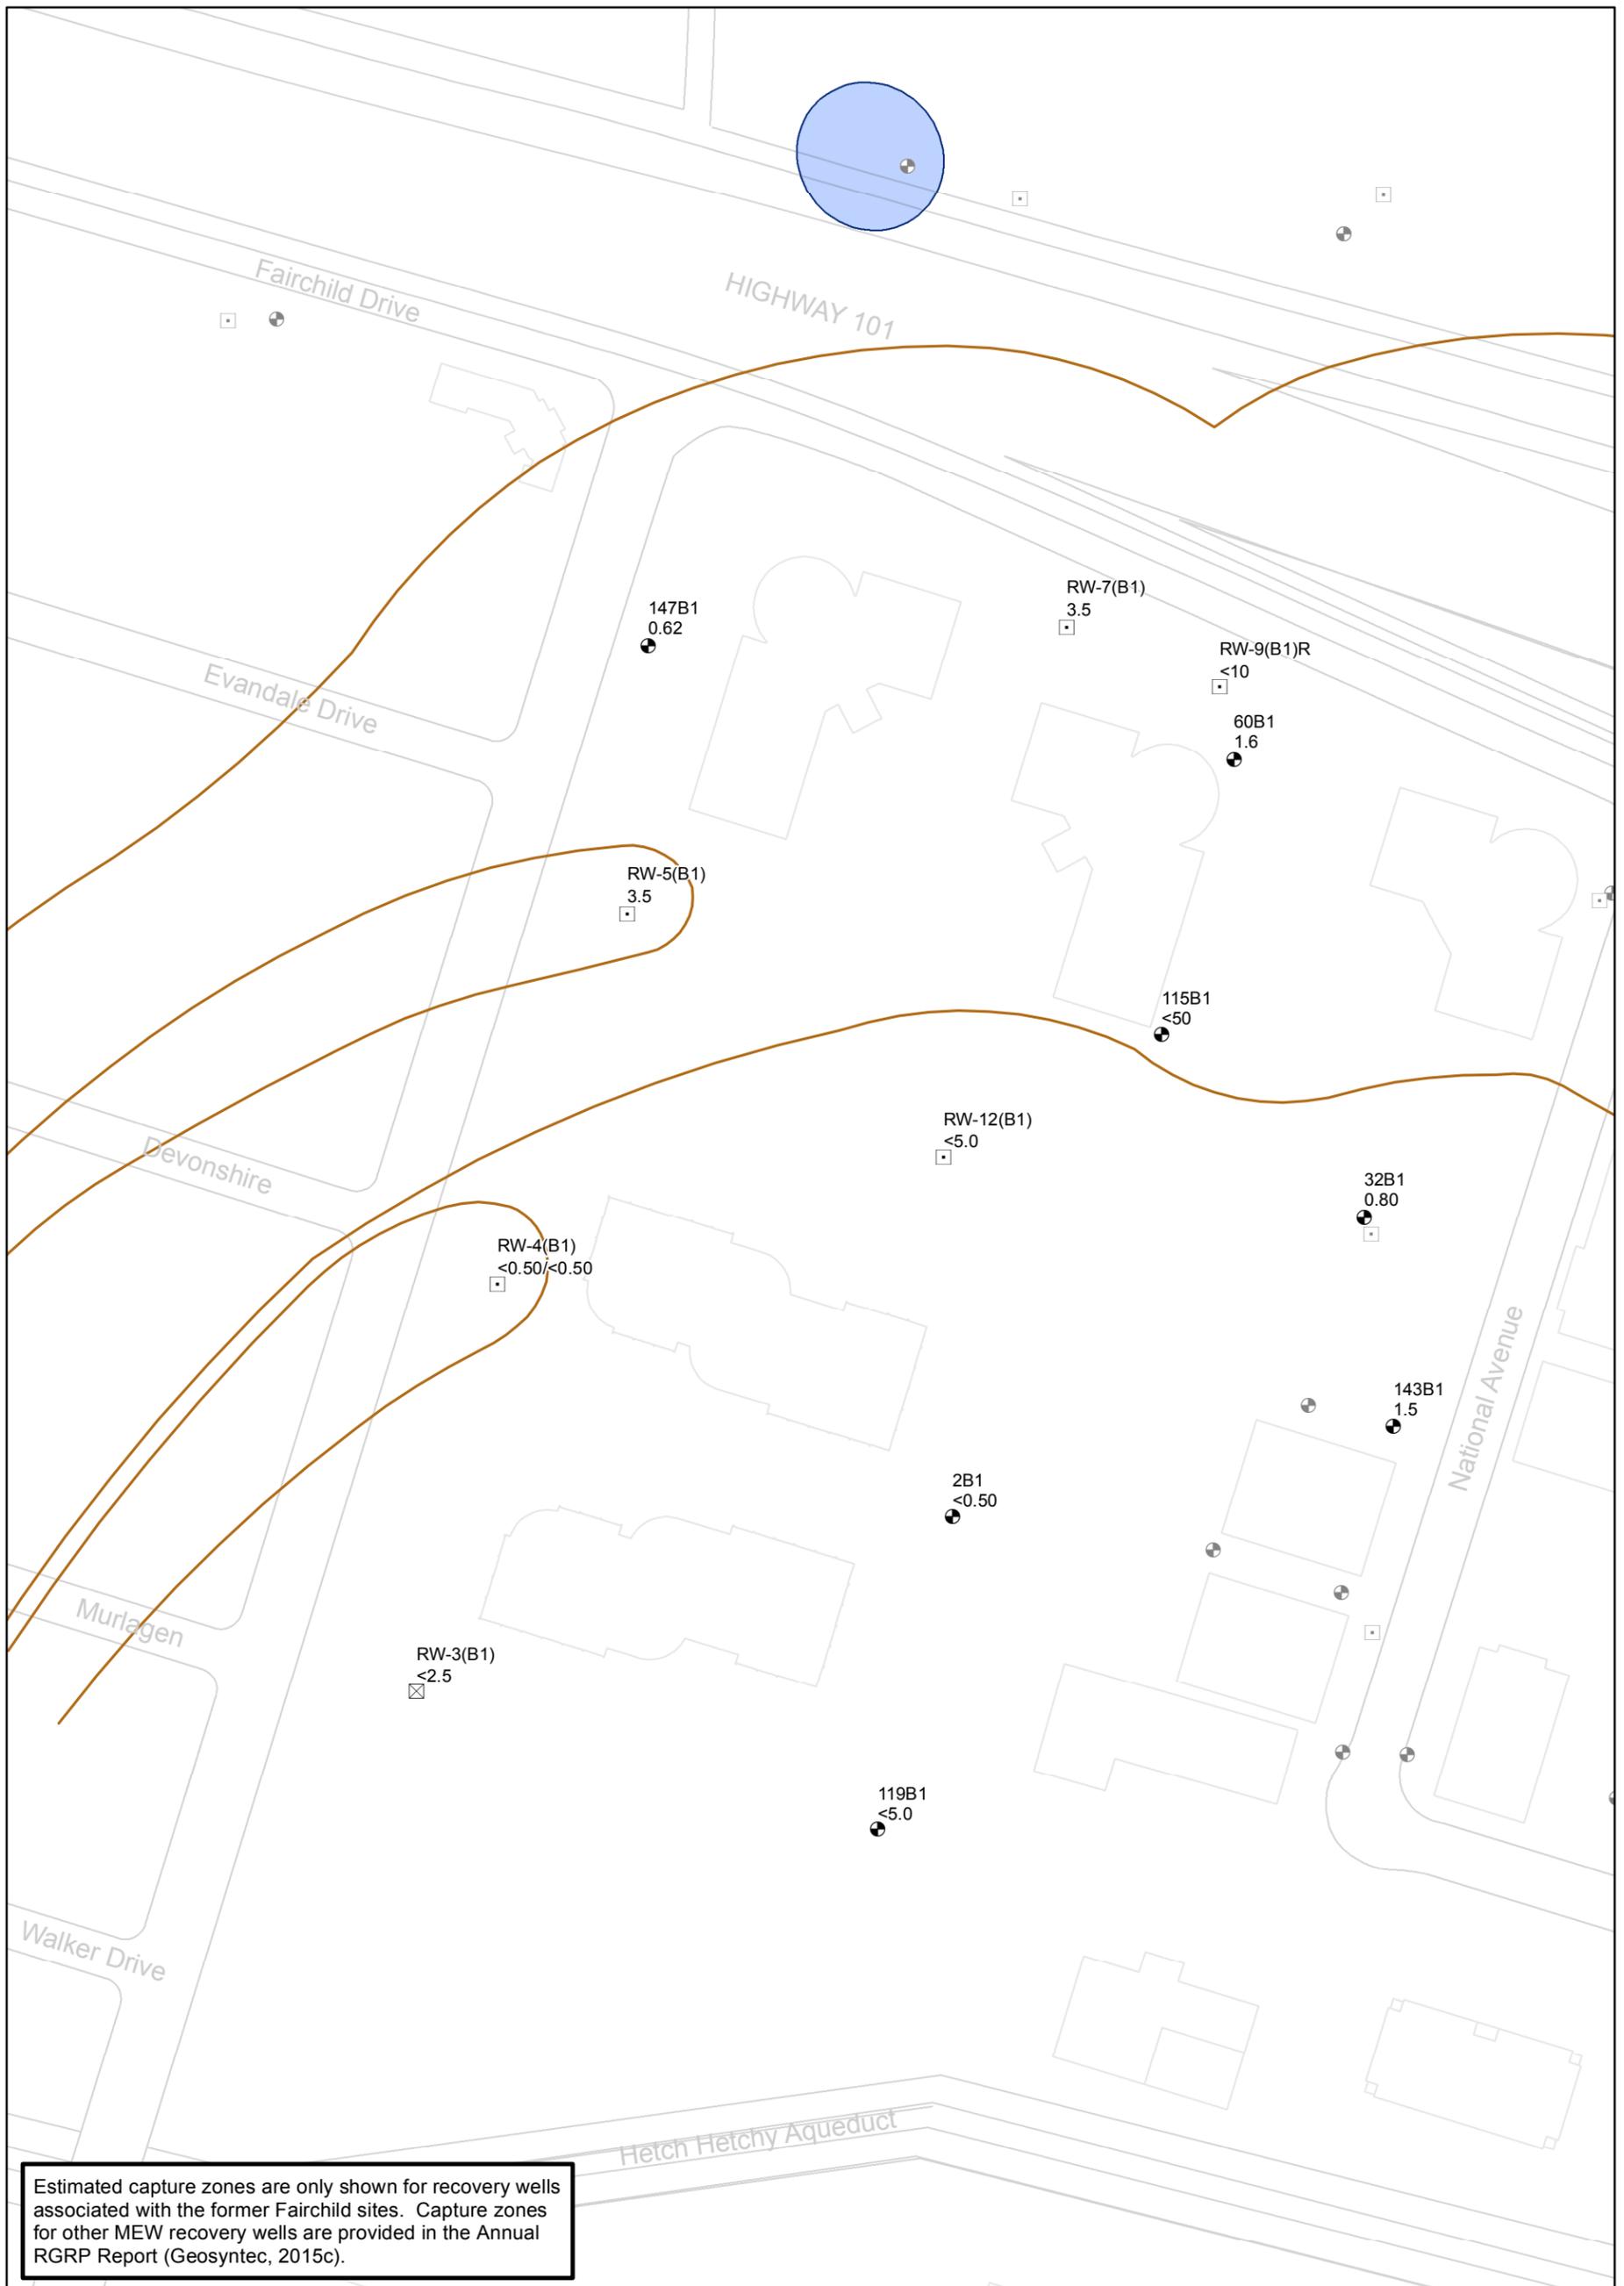
- Monitoring Well
- Recovery Well On
- Recovery Well Off
- PCE Concentration 5 - 100 ug/L
- PCE Concentration 100 - 1,000 ug/L
- PCE Concentration 1,000 - 10,000 ug/L
- PCE Concentration Greater than 10,000 ug/L
- Estimated Capture zone
- Slurry Wall
- Building
- Road
