Subject: **2015 Annual Progress Report – Former Fairchild Buildings 13, 19, and 23**  
Middlefield-Ellis-Whisman ("MEW") Area  
Mountain View, California

**2015 ANNUAL PROGRESS REPORT  
FORMER FAIRCHILD  
BUILDINGS 13, 19, AND 23  
MOUNTAIN VIEW, CALIFORNIA**

**2015 Annual Progress Report  
Former Fairchild Buildings 13, 19, and 23  
Middlefield-Ellis-Whisman Study Area  
Mountain View, California**

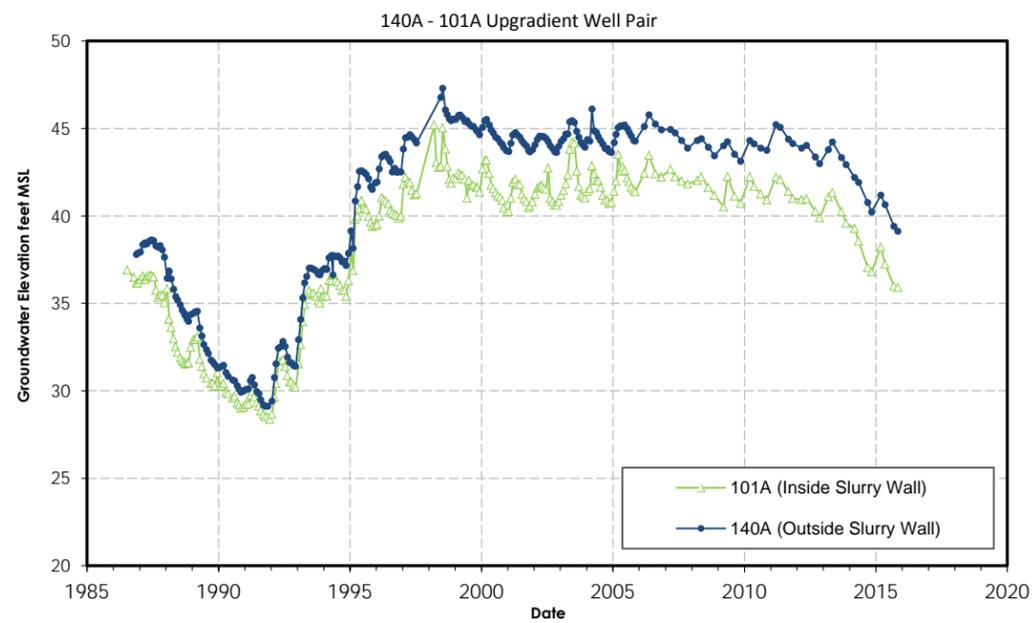
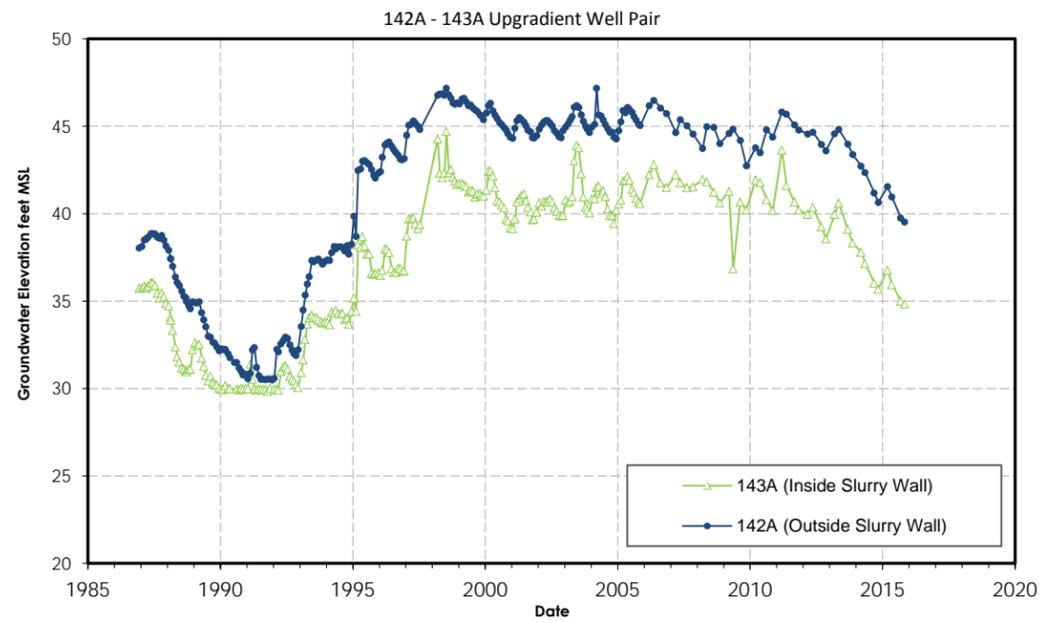
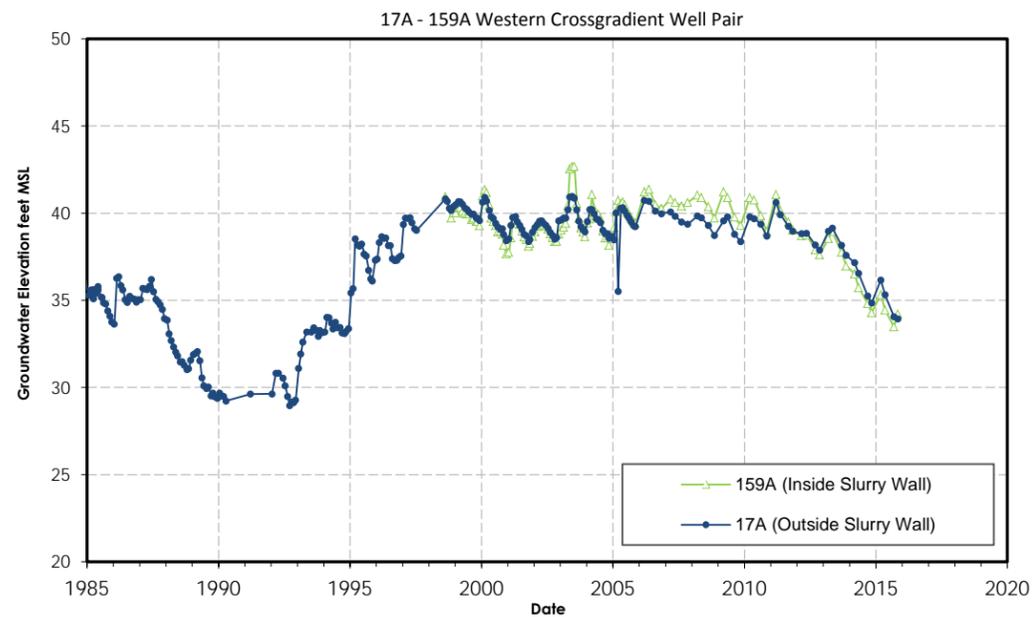
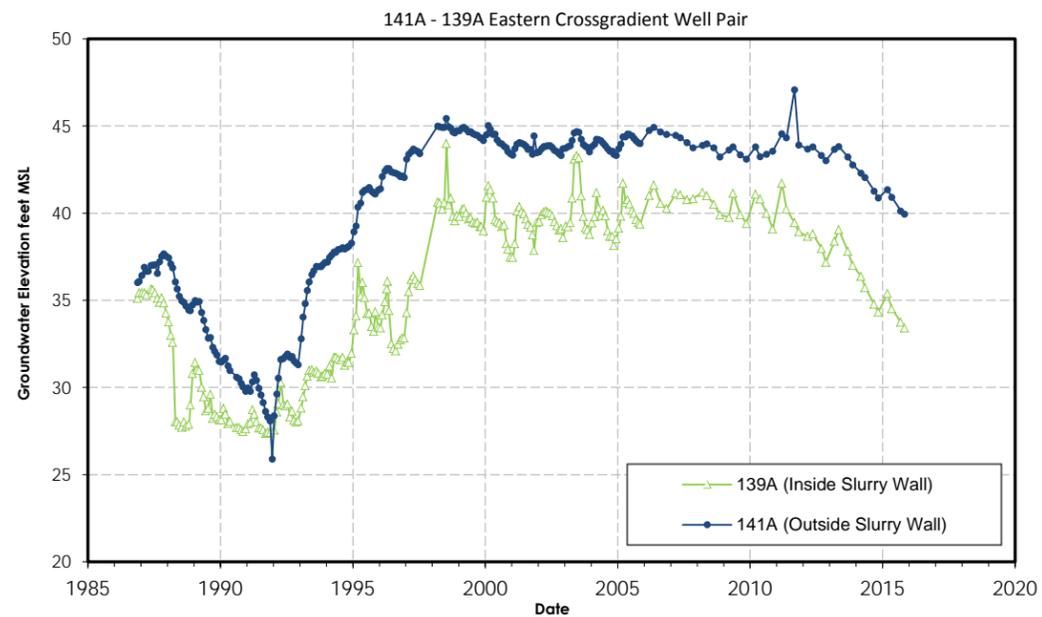
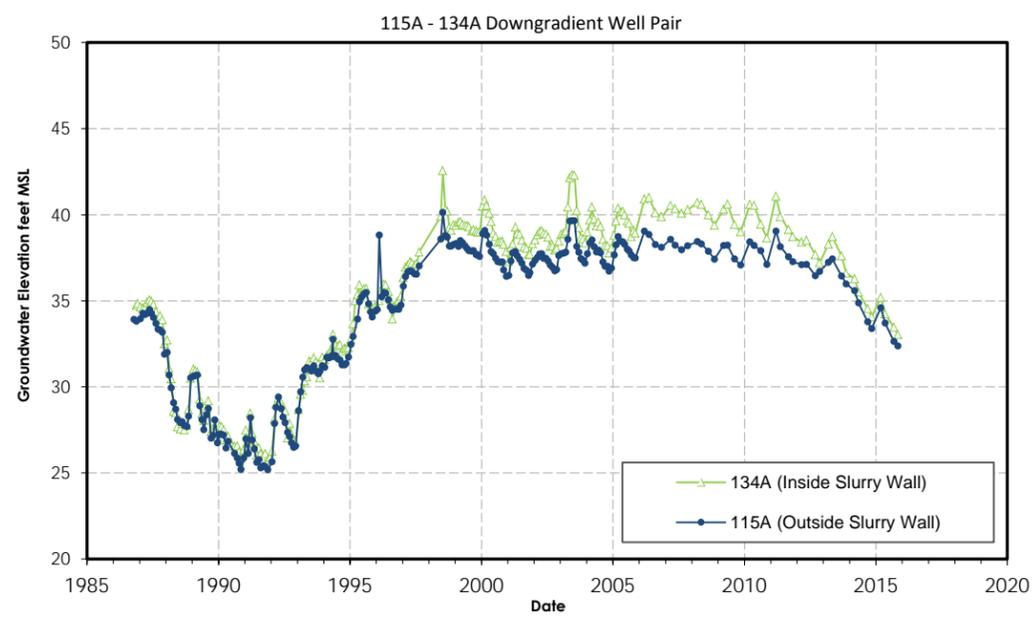
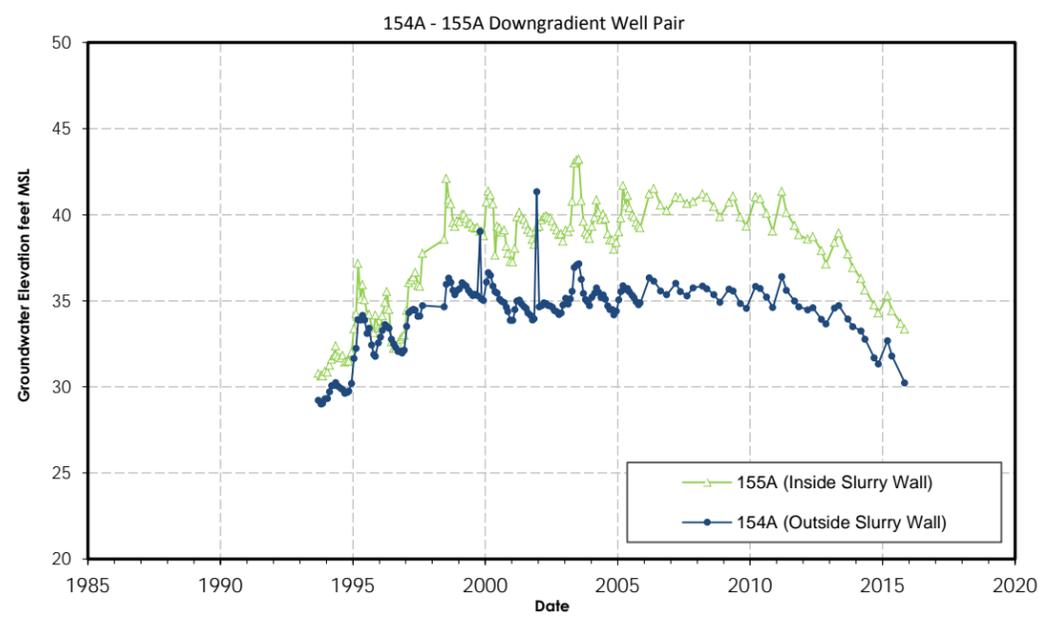
Figure  
**4**

**Hydrographs - Slurry Wall Well Pairs**  
 MEW Former Fairchild Buildings 13, 19, and 23 Groundwater Remediation Program  
 Mountain View, California

In recent years, water levels have declined in the A Zone, B1 Zone, and B2 Zone both at the Site and throughout the southern portion of the MEW study area. Figures 4 and 5 illustrate the decline in water levels that has been ongoing for the last three years, with water levels measured in 2015 approximately 4 to 5 feet lower than water levels prior to 2013. Water levels remain significantly higher than historical levels observed in the early 1990s and groundwater elevation contour maps from March and September show that while there are minor seasonal fluctuations in groundwater elevations, there is no significant seasonal change in groundwater flow or extraction well capture across the Site.

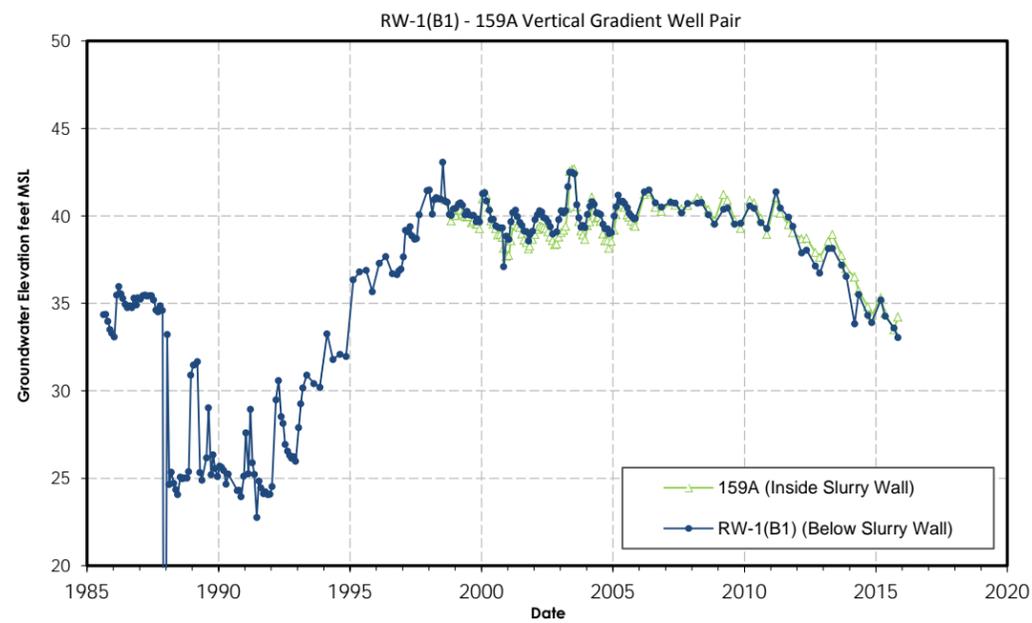
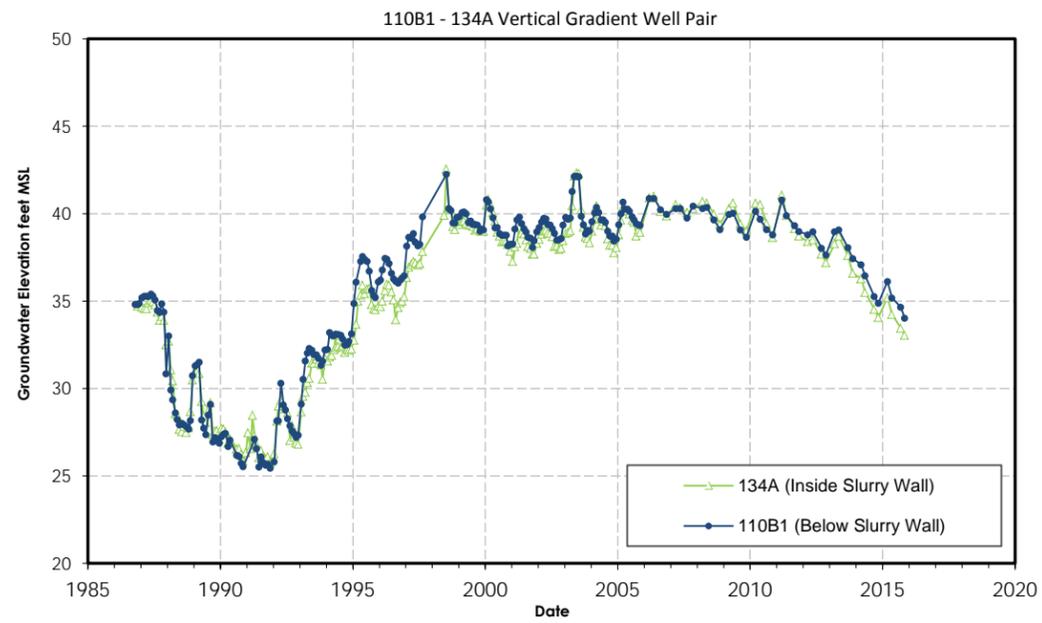
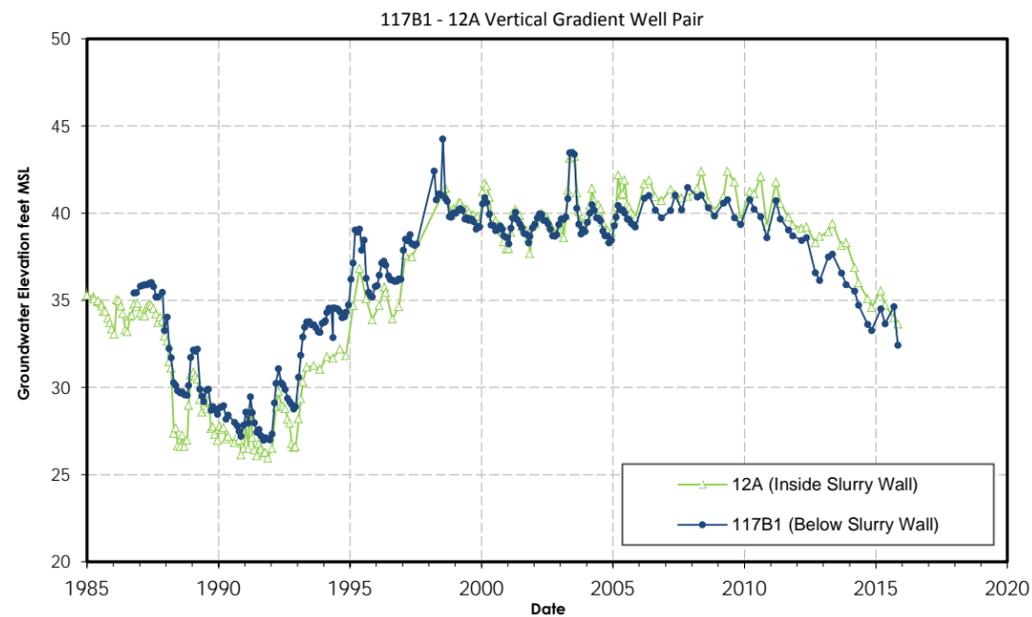
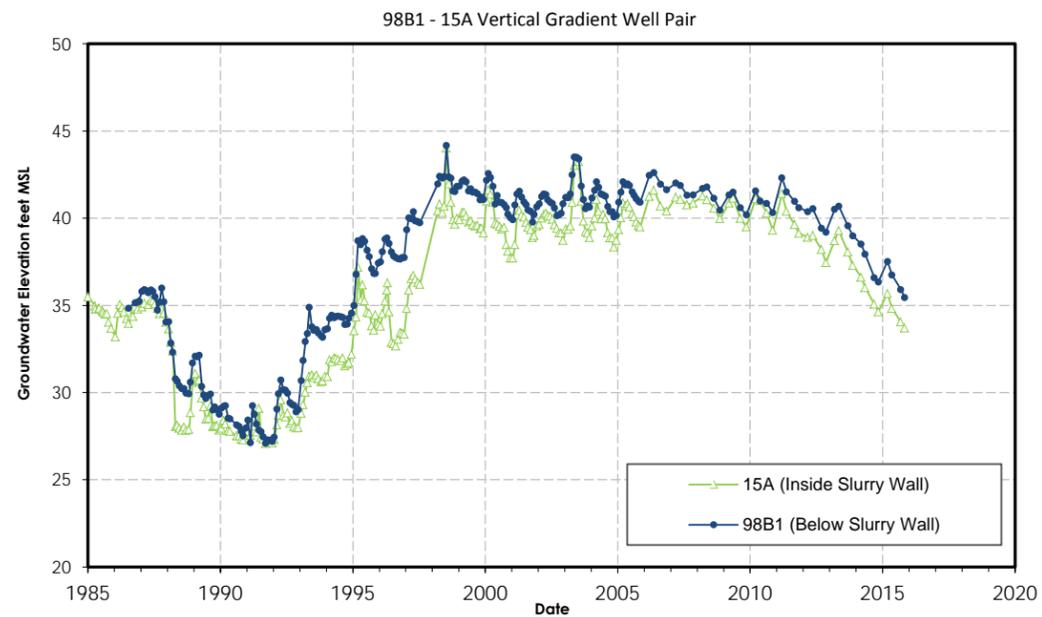
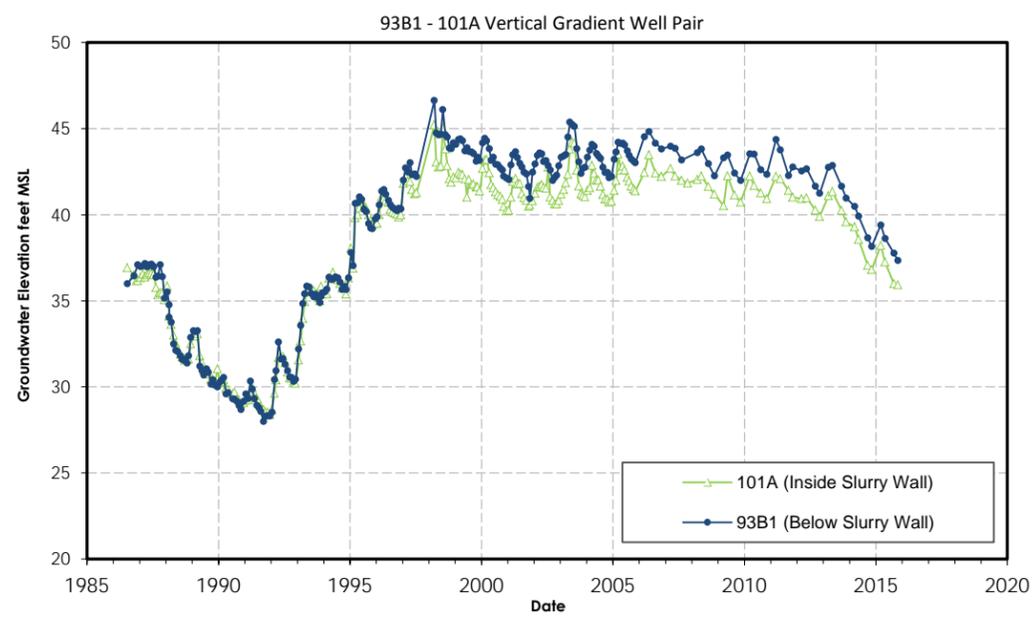
**Hydrographs - Slurry Wall Well Pairs Across Water-Bearing Zones**

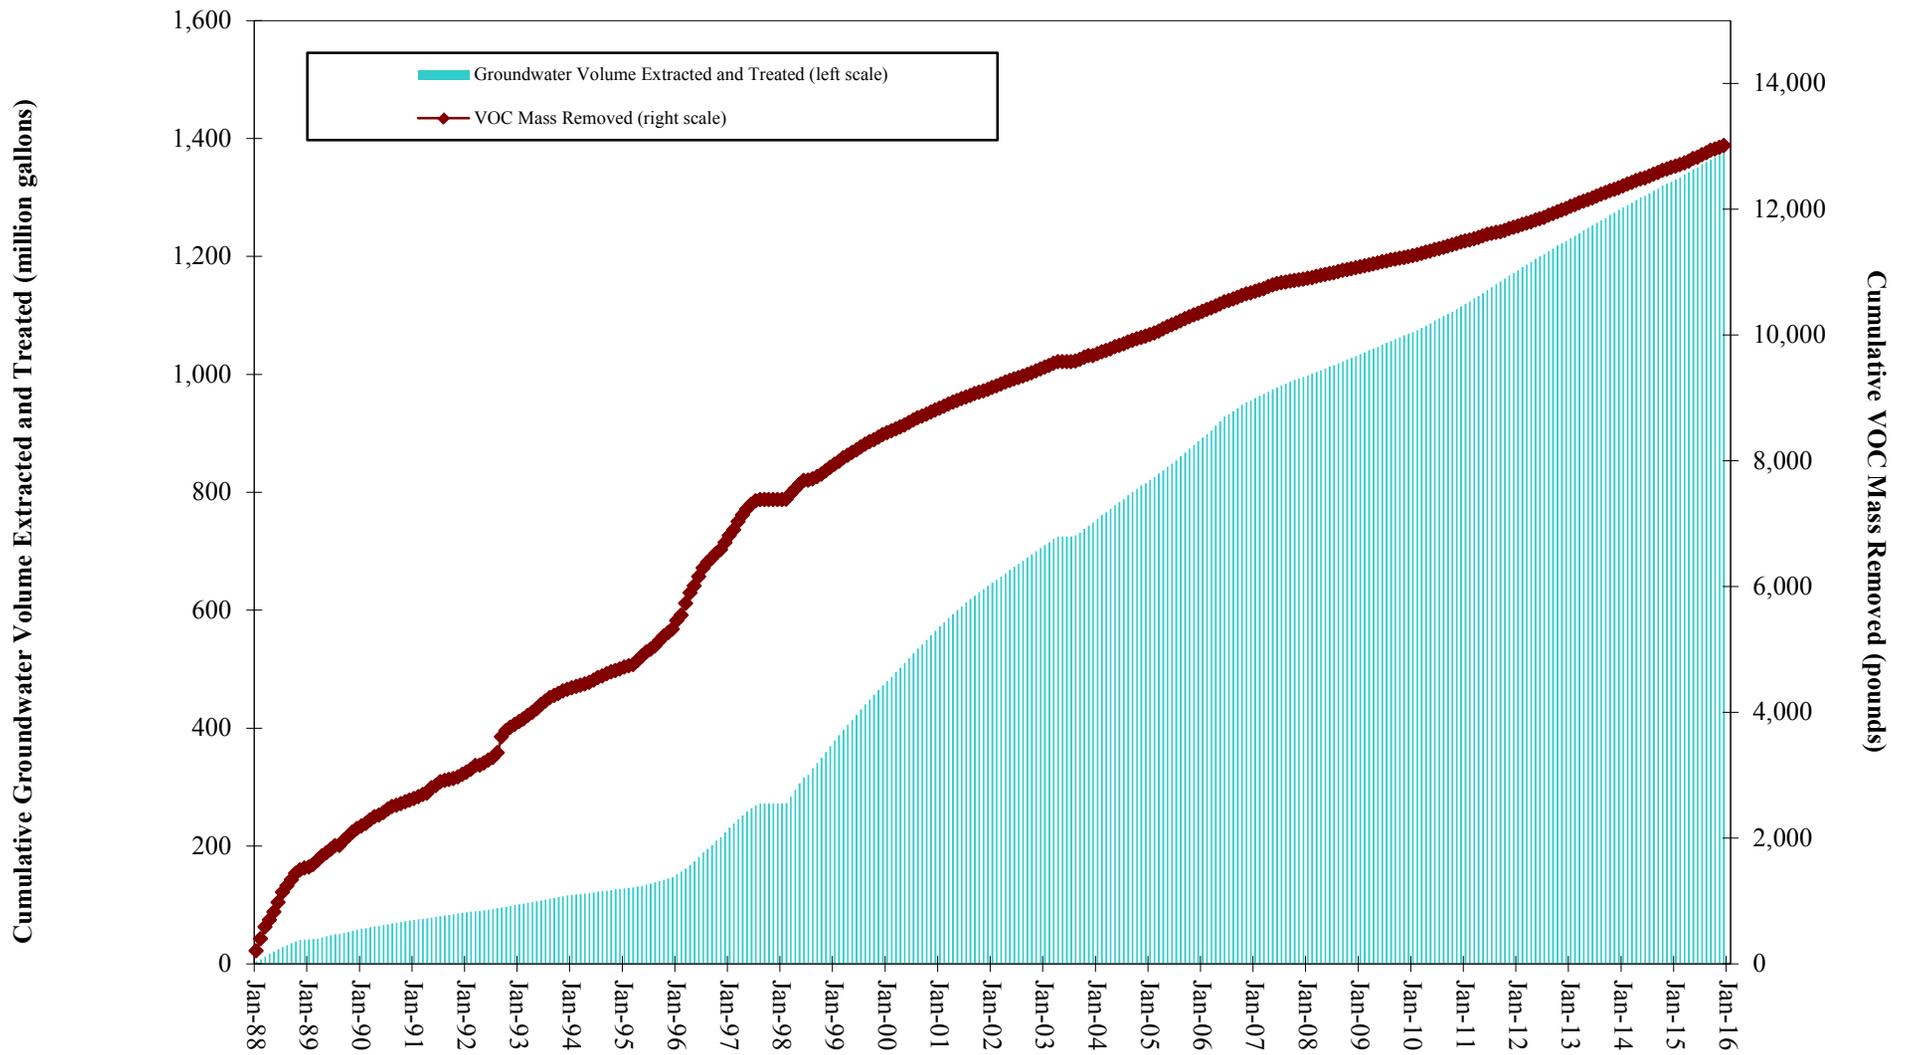
**Cumulative Groundwater Extracted and VOC Mass Removed, System 19**  
MEW Former Fairchild Buildings 13, 19 and 23 Groundwater Remediation Program  
Mountain View, California

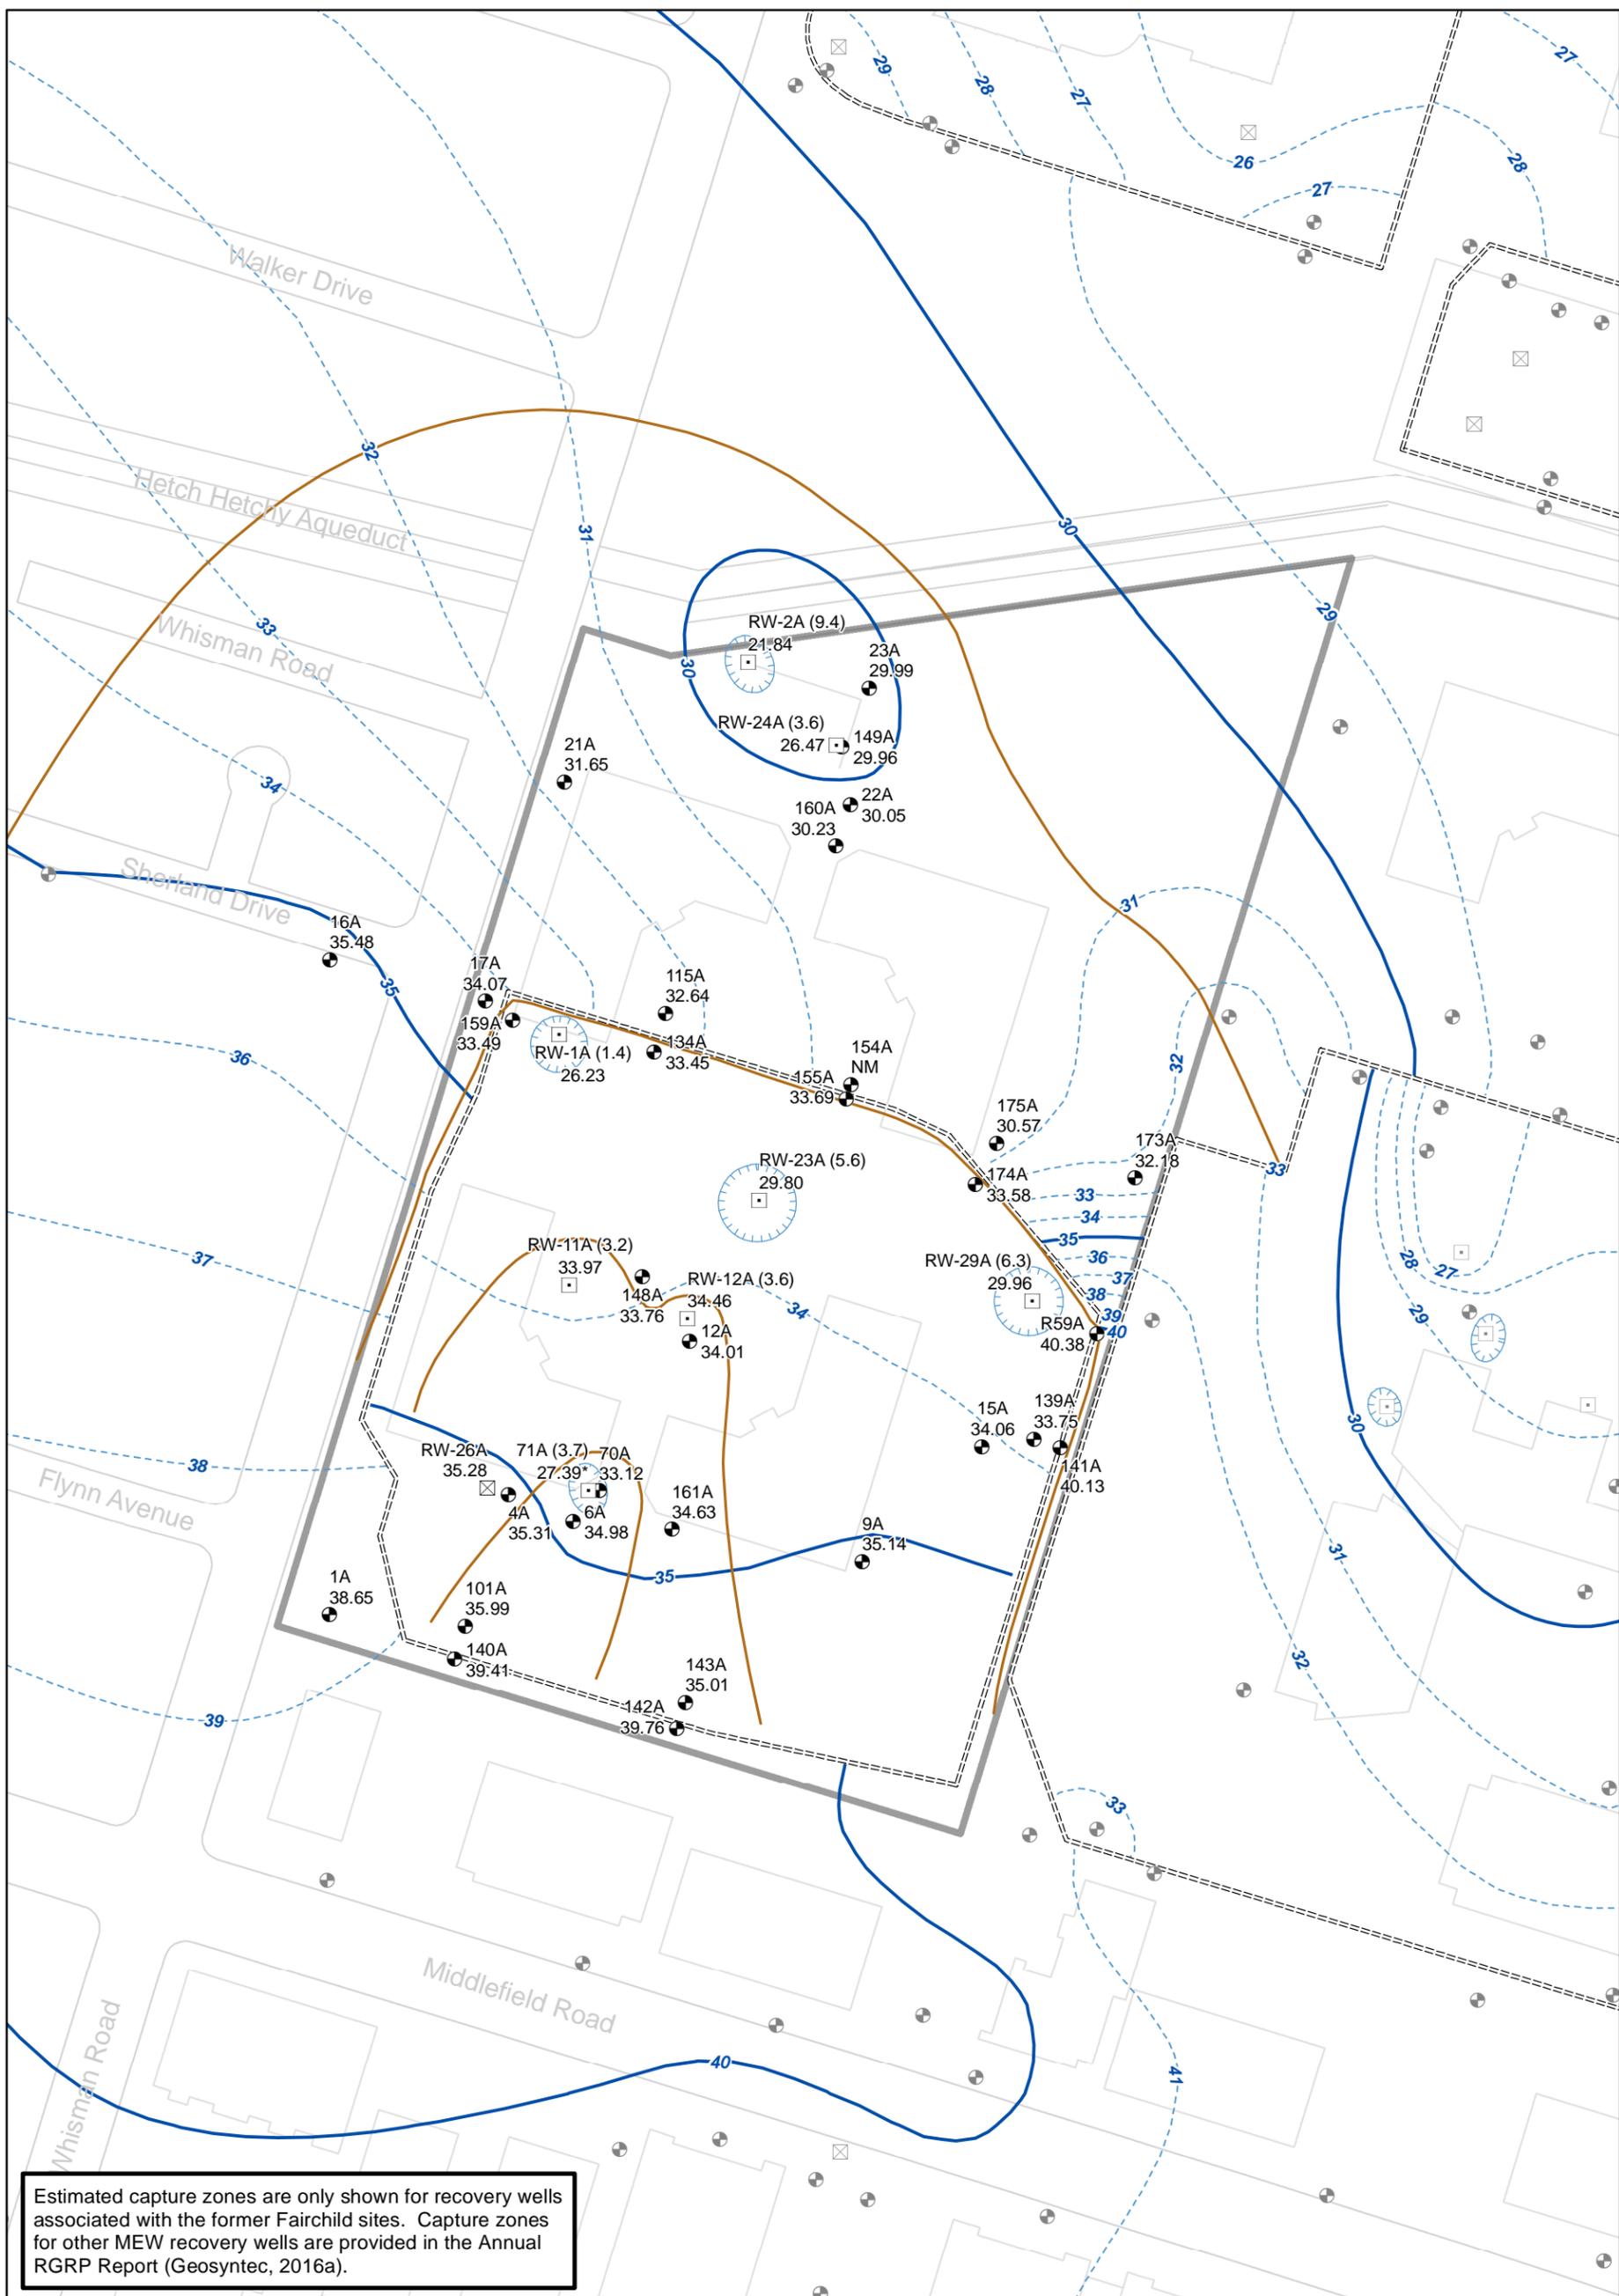
Estimated capture zones are only shown for recovery wells associated with the former Fairchild sites. Capture zones for other MEW recovery wells are provided in the Annual RGRP Report (Geosyntec, 2016a).

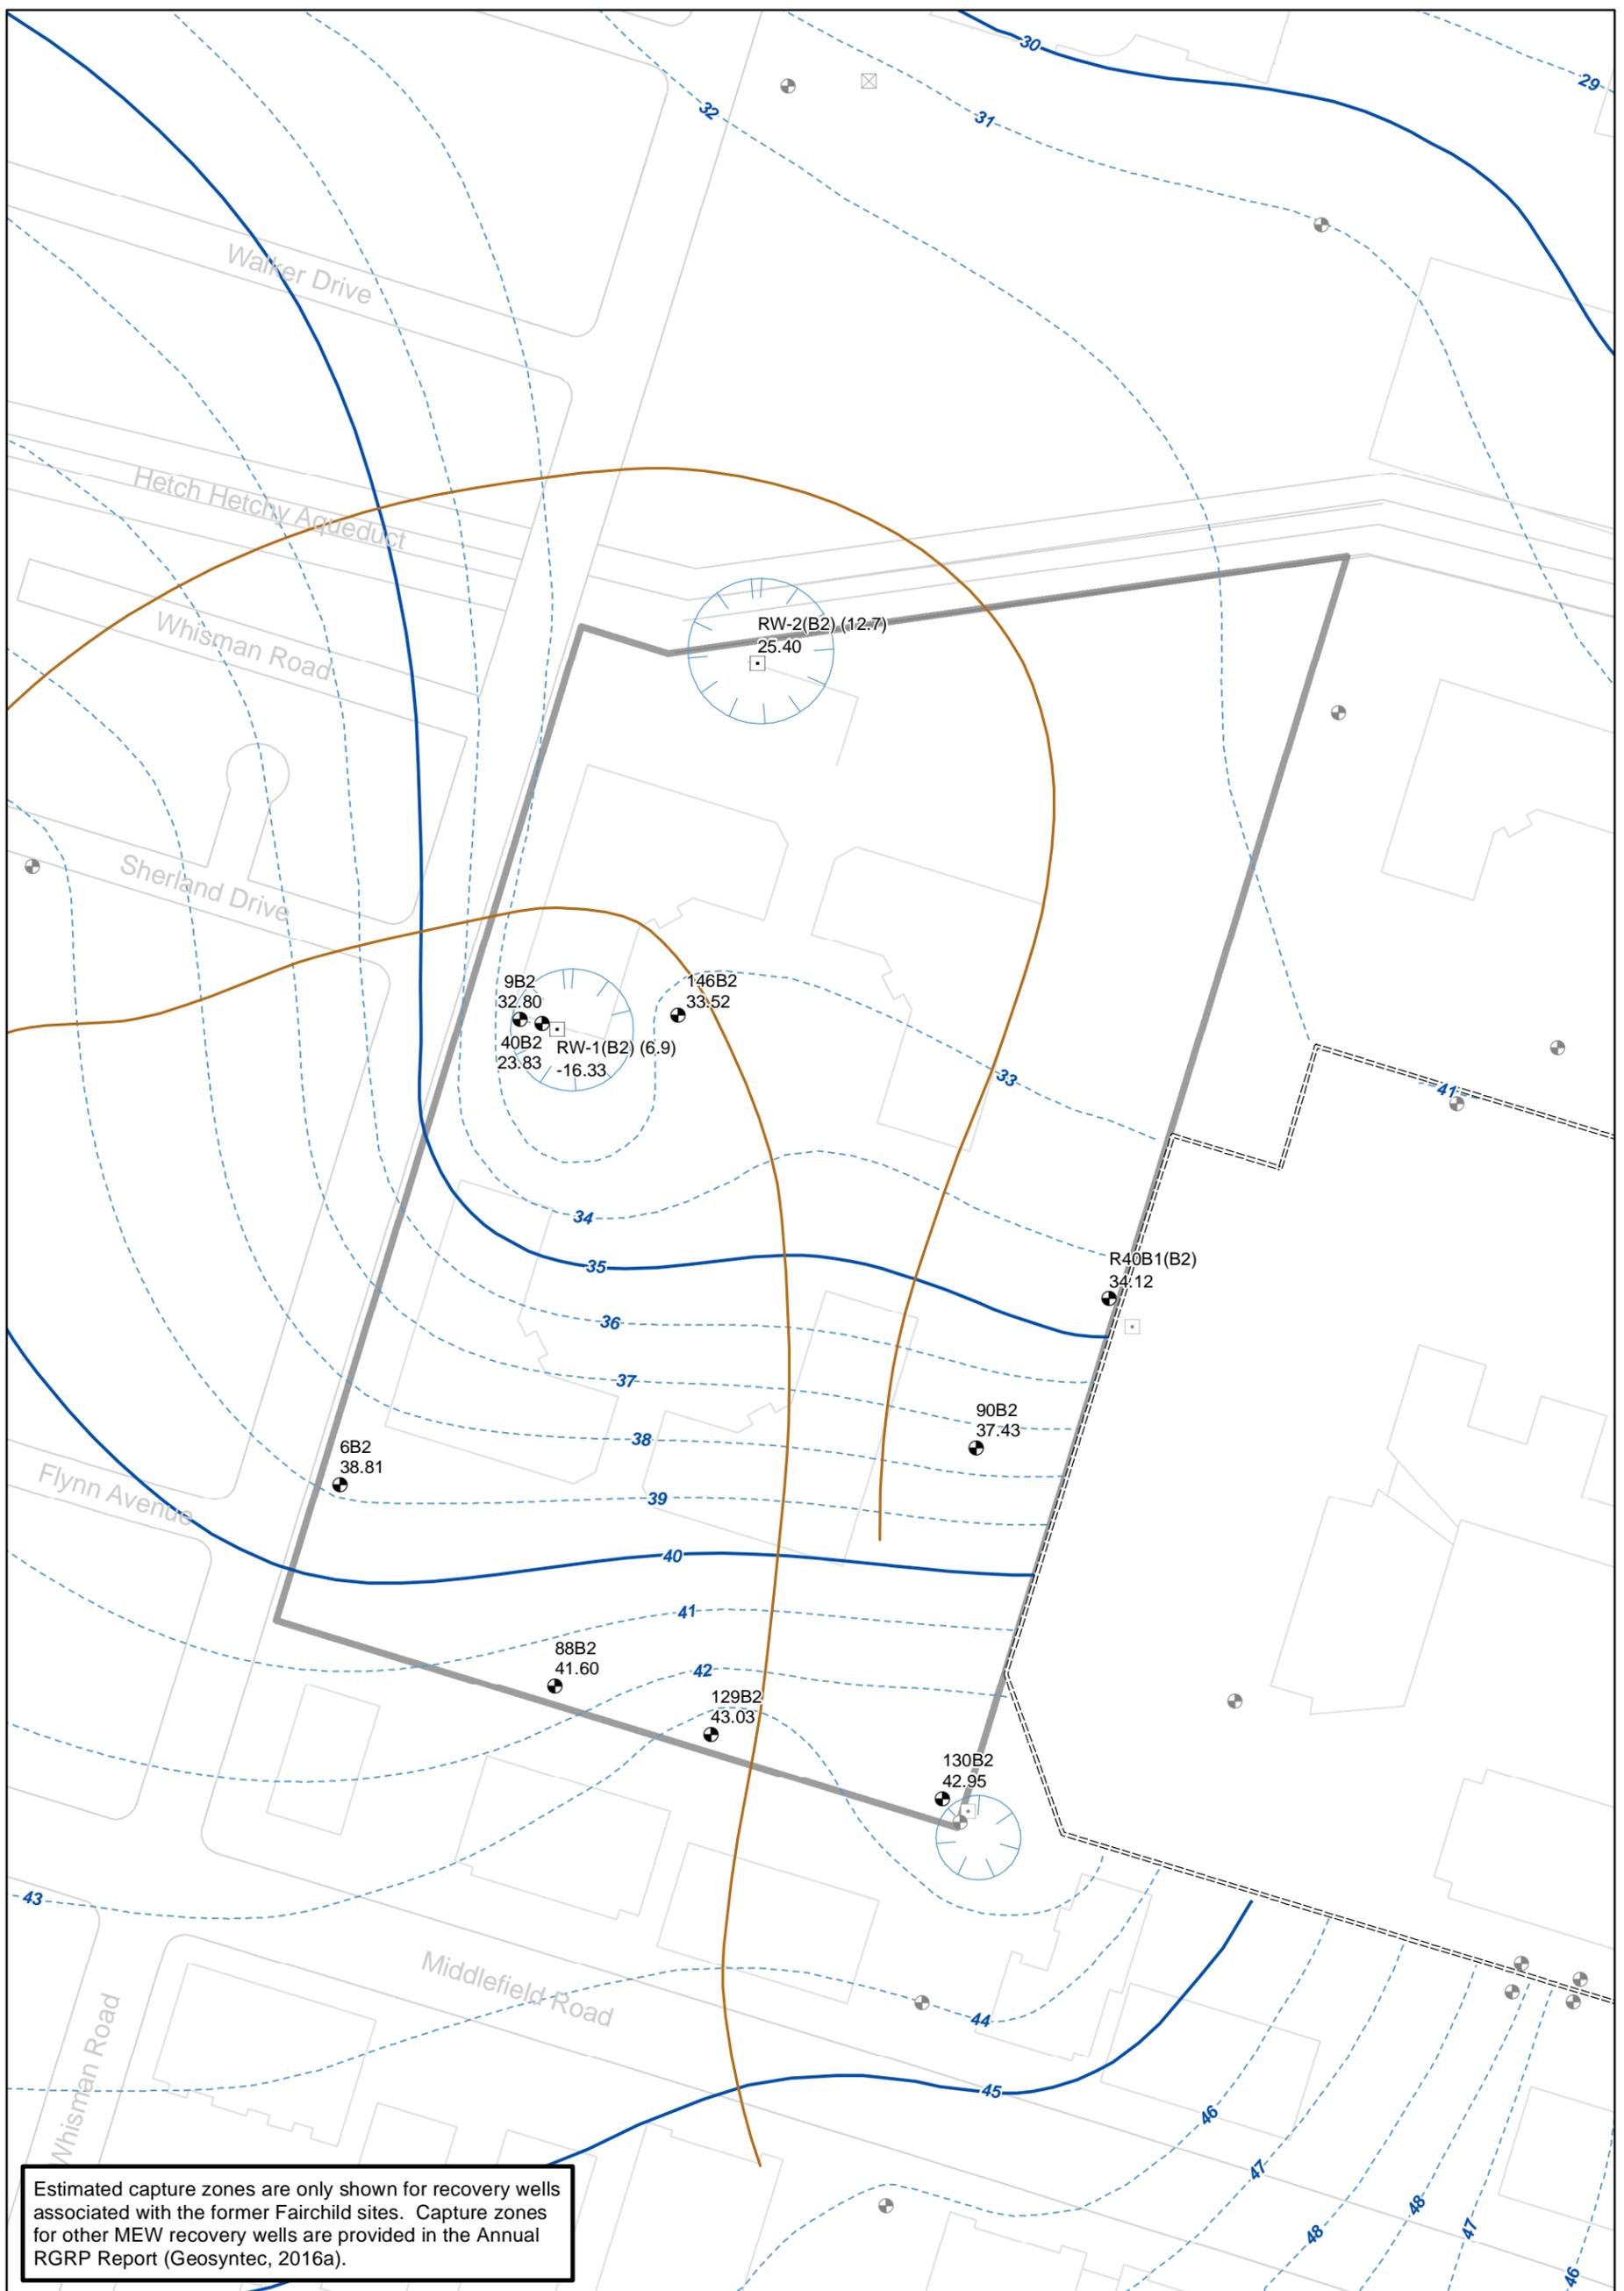
9a

Estimated capture zones are only shown for recovery wells associated with the former Fairchild sites. Capture zones for other MEW recovery wells are provided in the Annual RGRP Report (Geosyntec, 2016a).

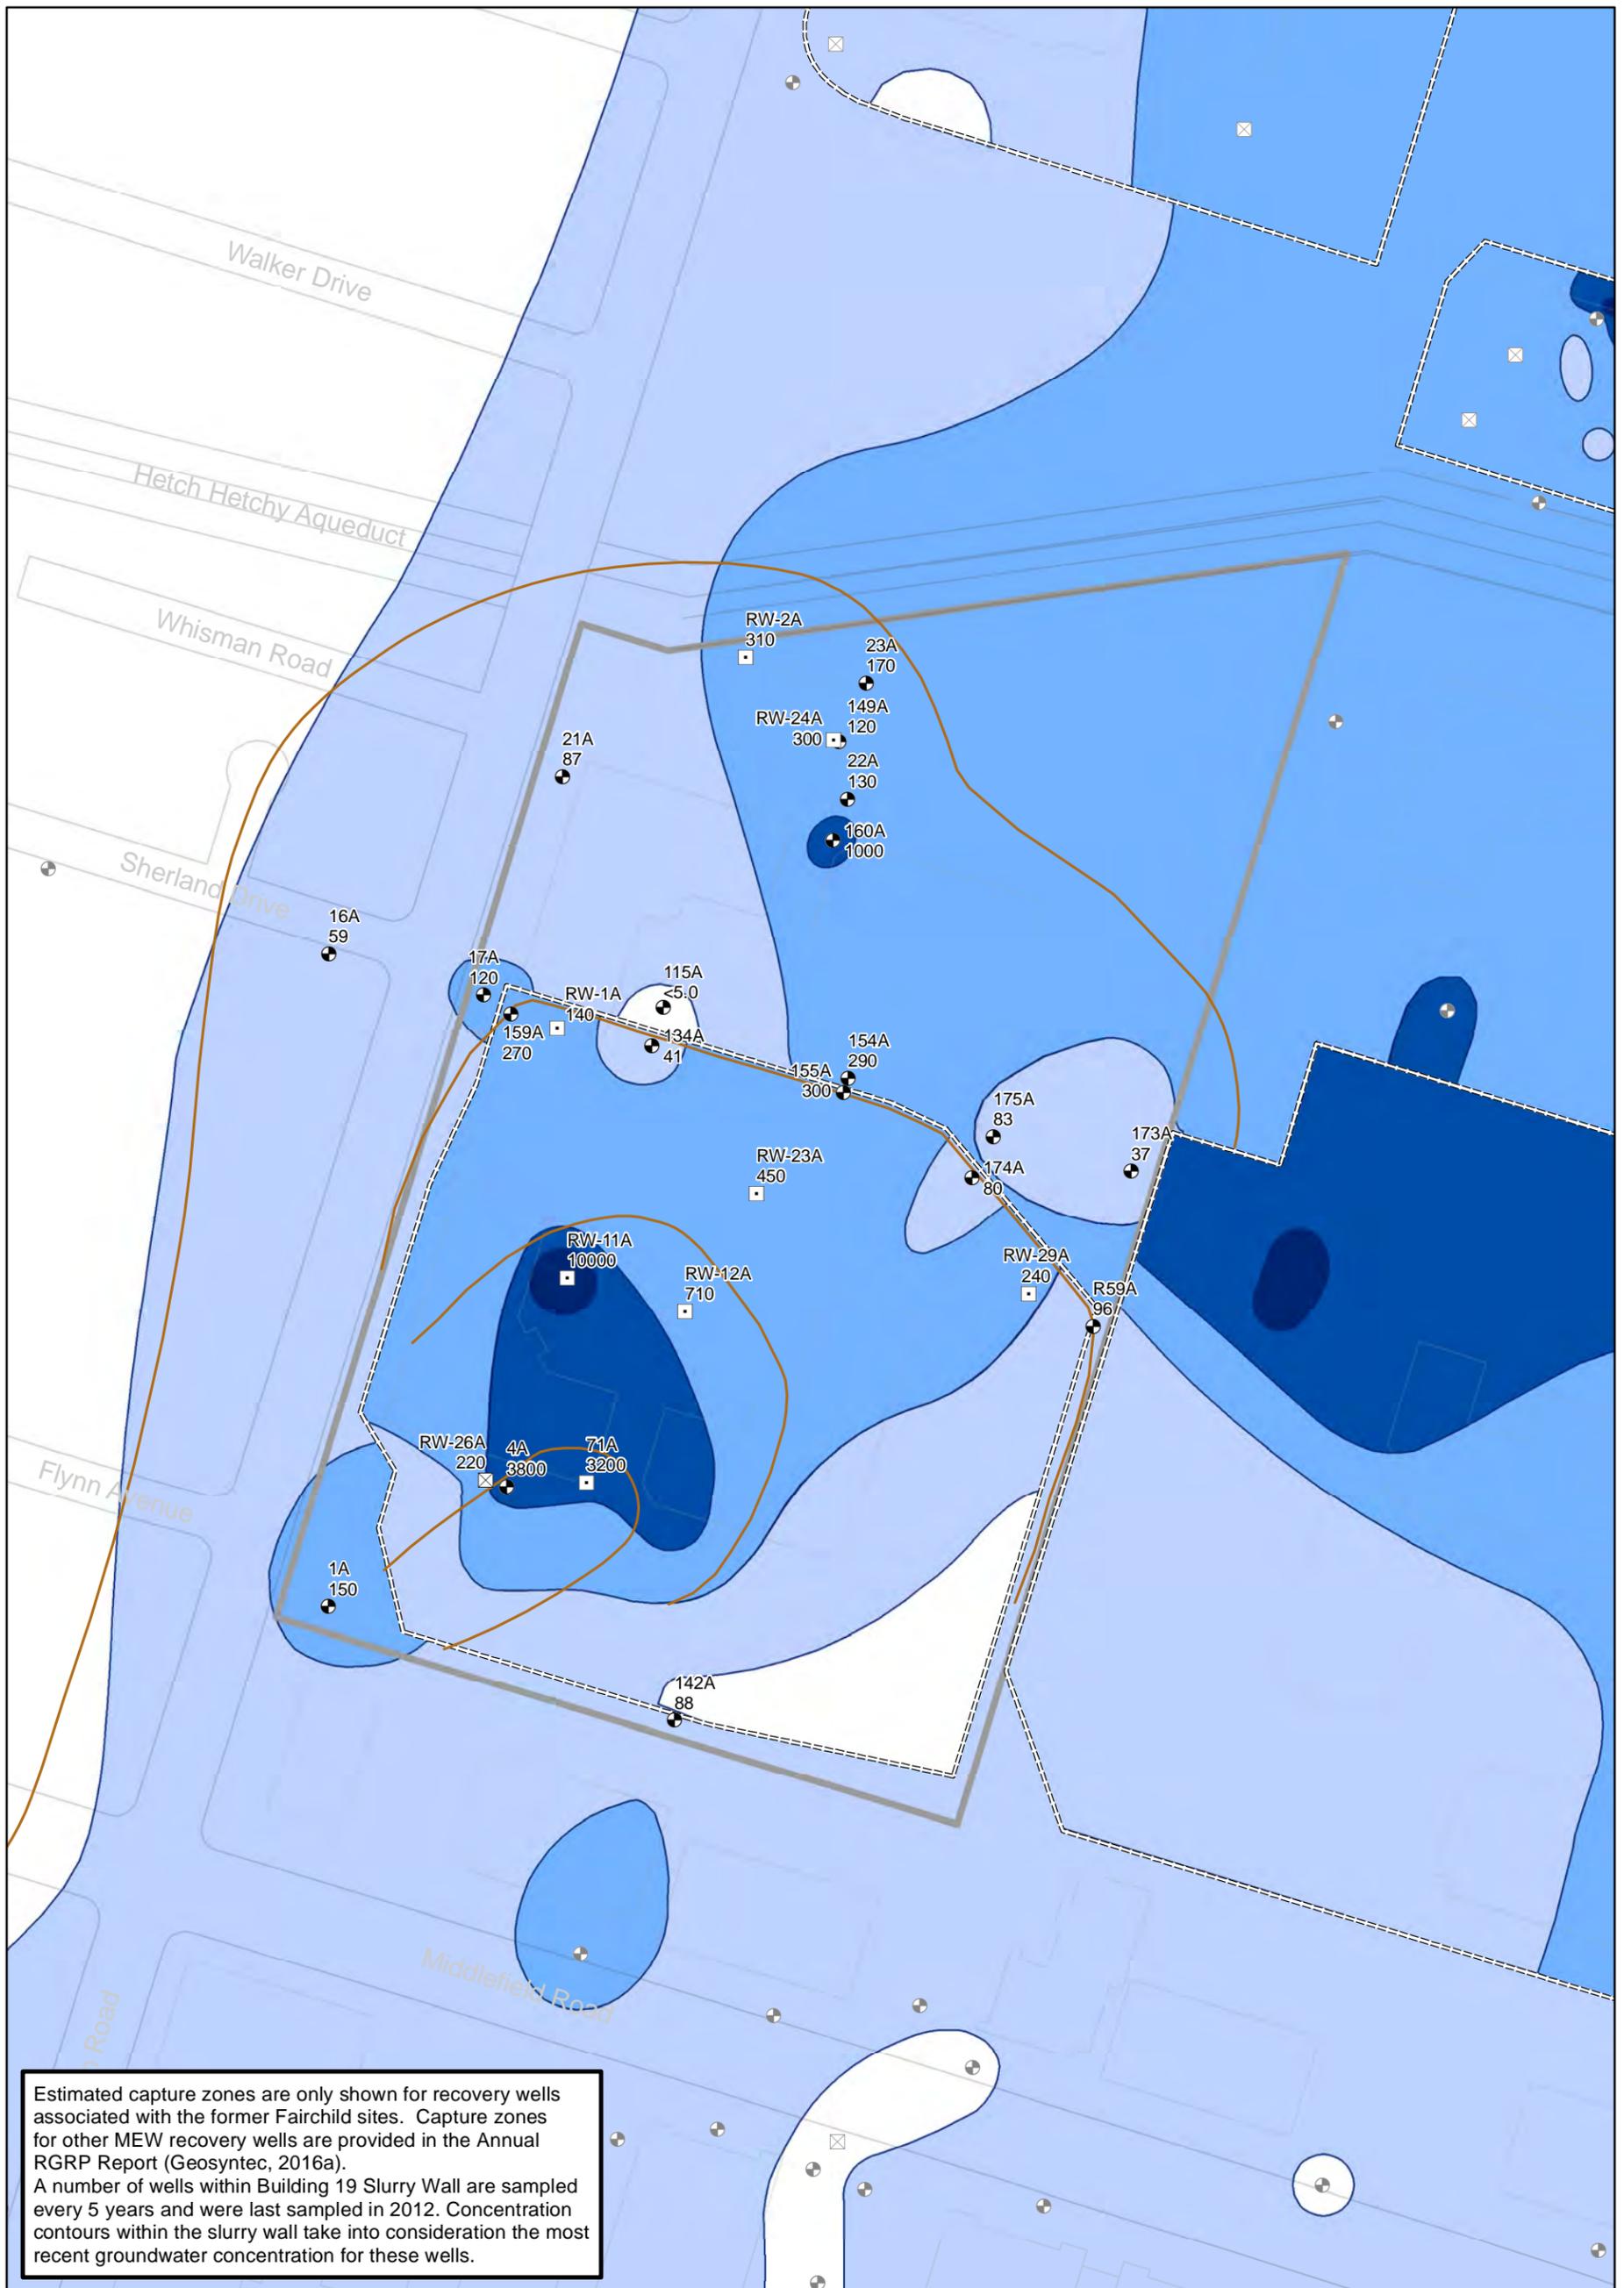
10a

Estimated capture zones are only shown for recovery wells associated with the former Fairchild sites. Capture zones for other MEW recovery wells are provided in the Annual RGRP Report (Geosyntec, 2016a). A number of wells within Building 19 Slurry Wall are sampled every 5 years and were last sampled in 2012. Concentration contours within the slurry wall take into consideration the most recent groundwater concentration for these wells.
