Subject: **2015 Annual Progress Report – Former Fairchild Buildings 13, 19, and 23**  
Middlefield-Ellis-Whisman ("MEW") Area  
Mountain View, California

**2015 ANNUAL PROGRESS REPORT  
FORMER FAIRCHILD  
BUILDINGS 13, 19, AND 23  
MOUNTAIN VIEW, CALIFORNIA**

**2015 Annual Progress Report  
Former Fairchild Buildings 13, 19, and 23  
Middlefield-Ellis-Whisman Study Area  
Mountain View, California**

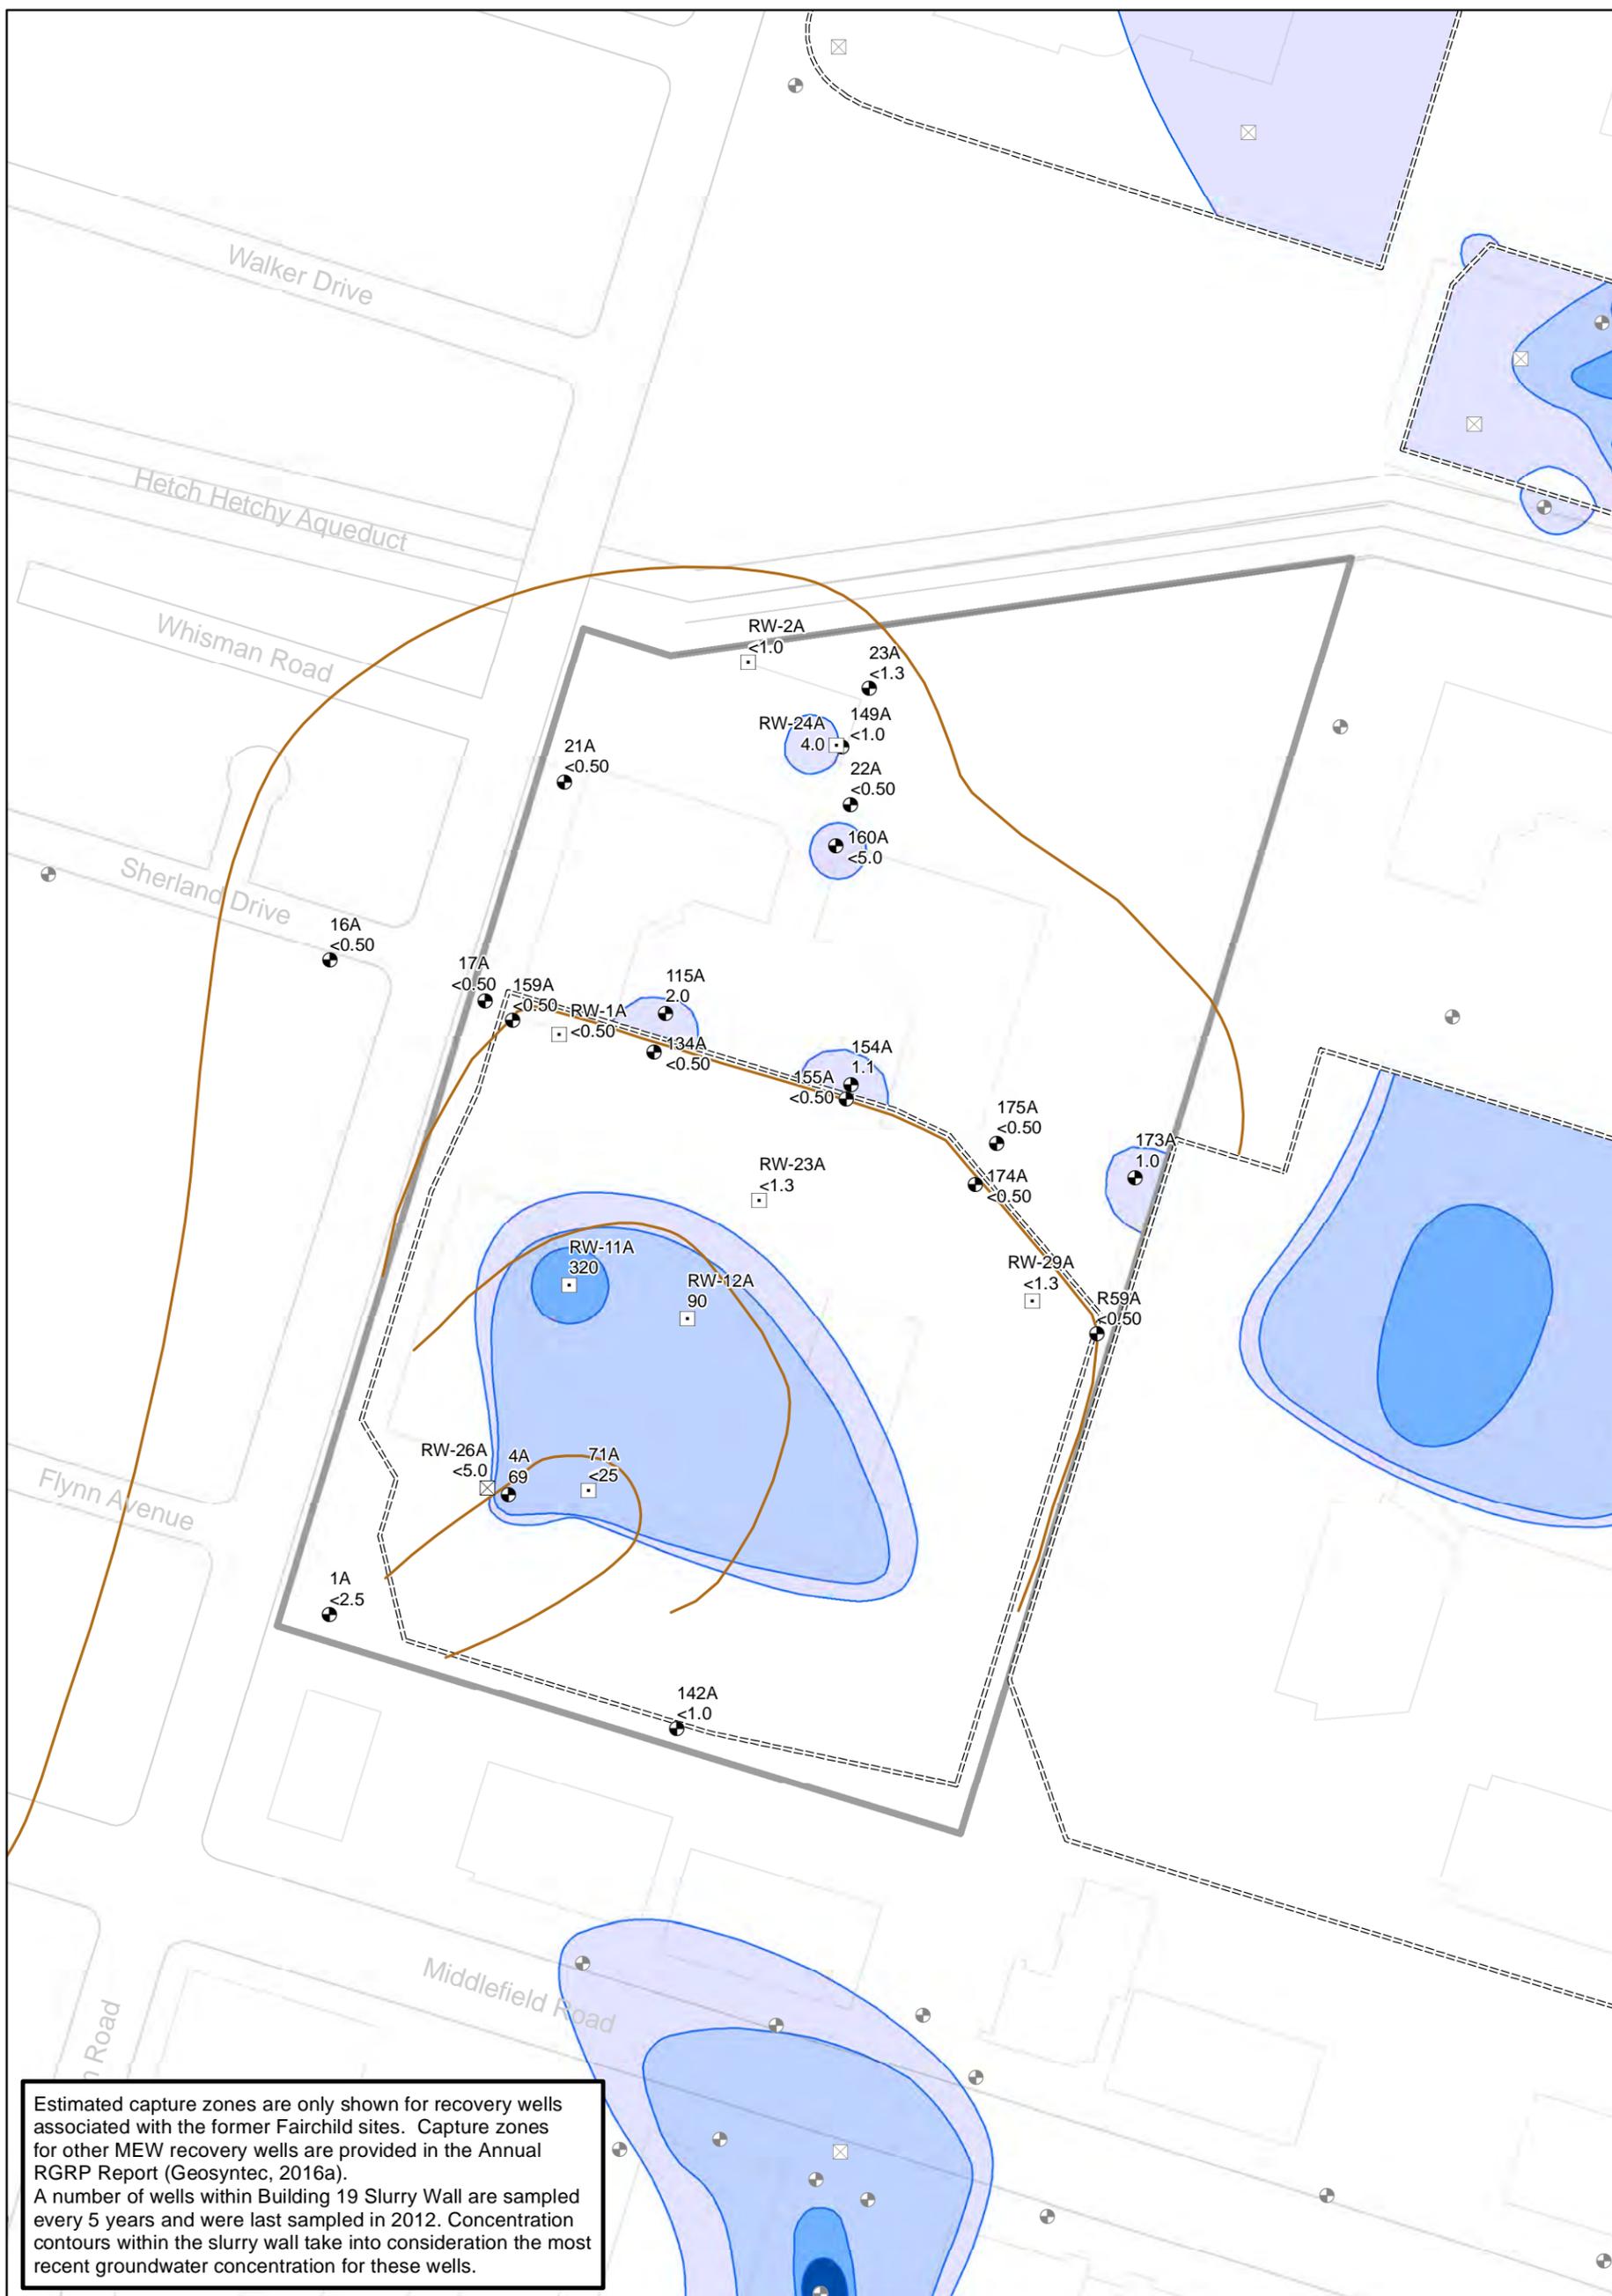
**10b**

Estimated capture zones are only shown for recovery wells associated with the former Fairchild sites. Capture zones for other MEW recovery wells are provided in the Annual RGRP Report (Geosyntec, 2016a). A number of wells within Building 19 Slurry Wall are sampled every 5 years and were last sampled in 2012. Concentration contours within the slurry wall take into consideration the most recent groundwater concentration for these wells.

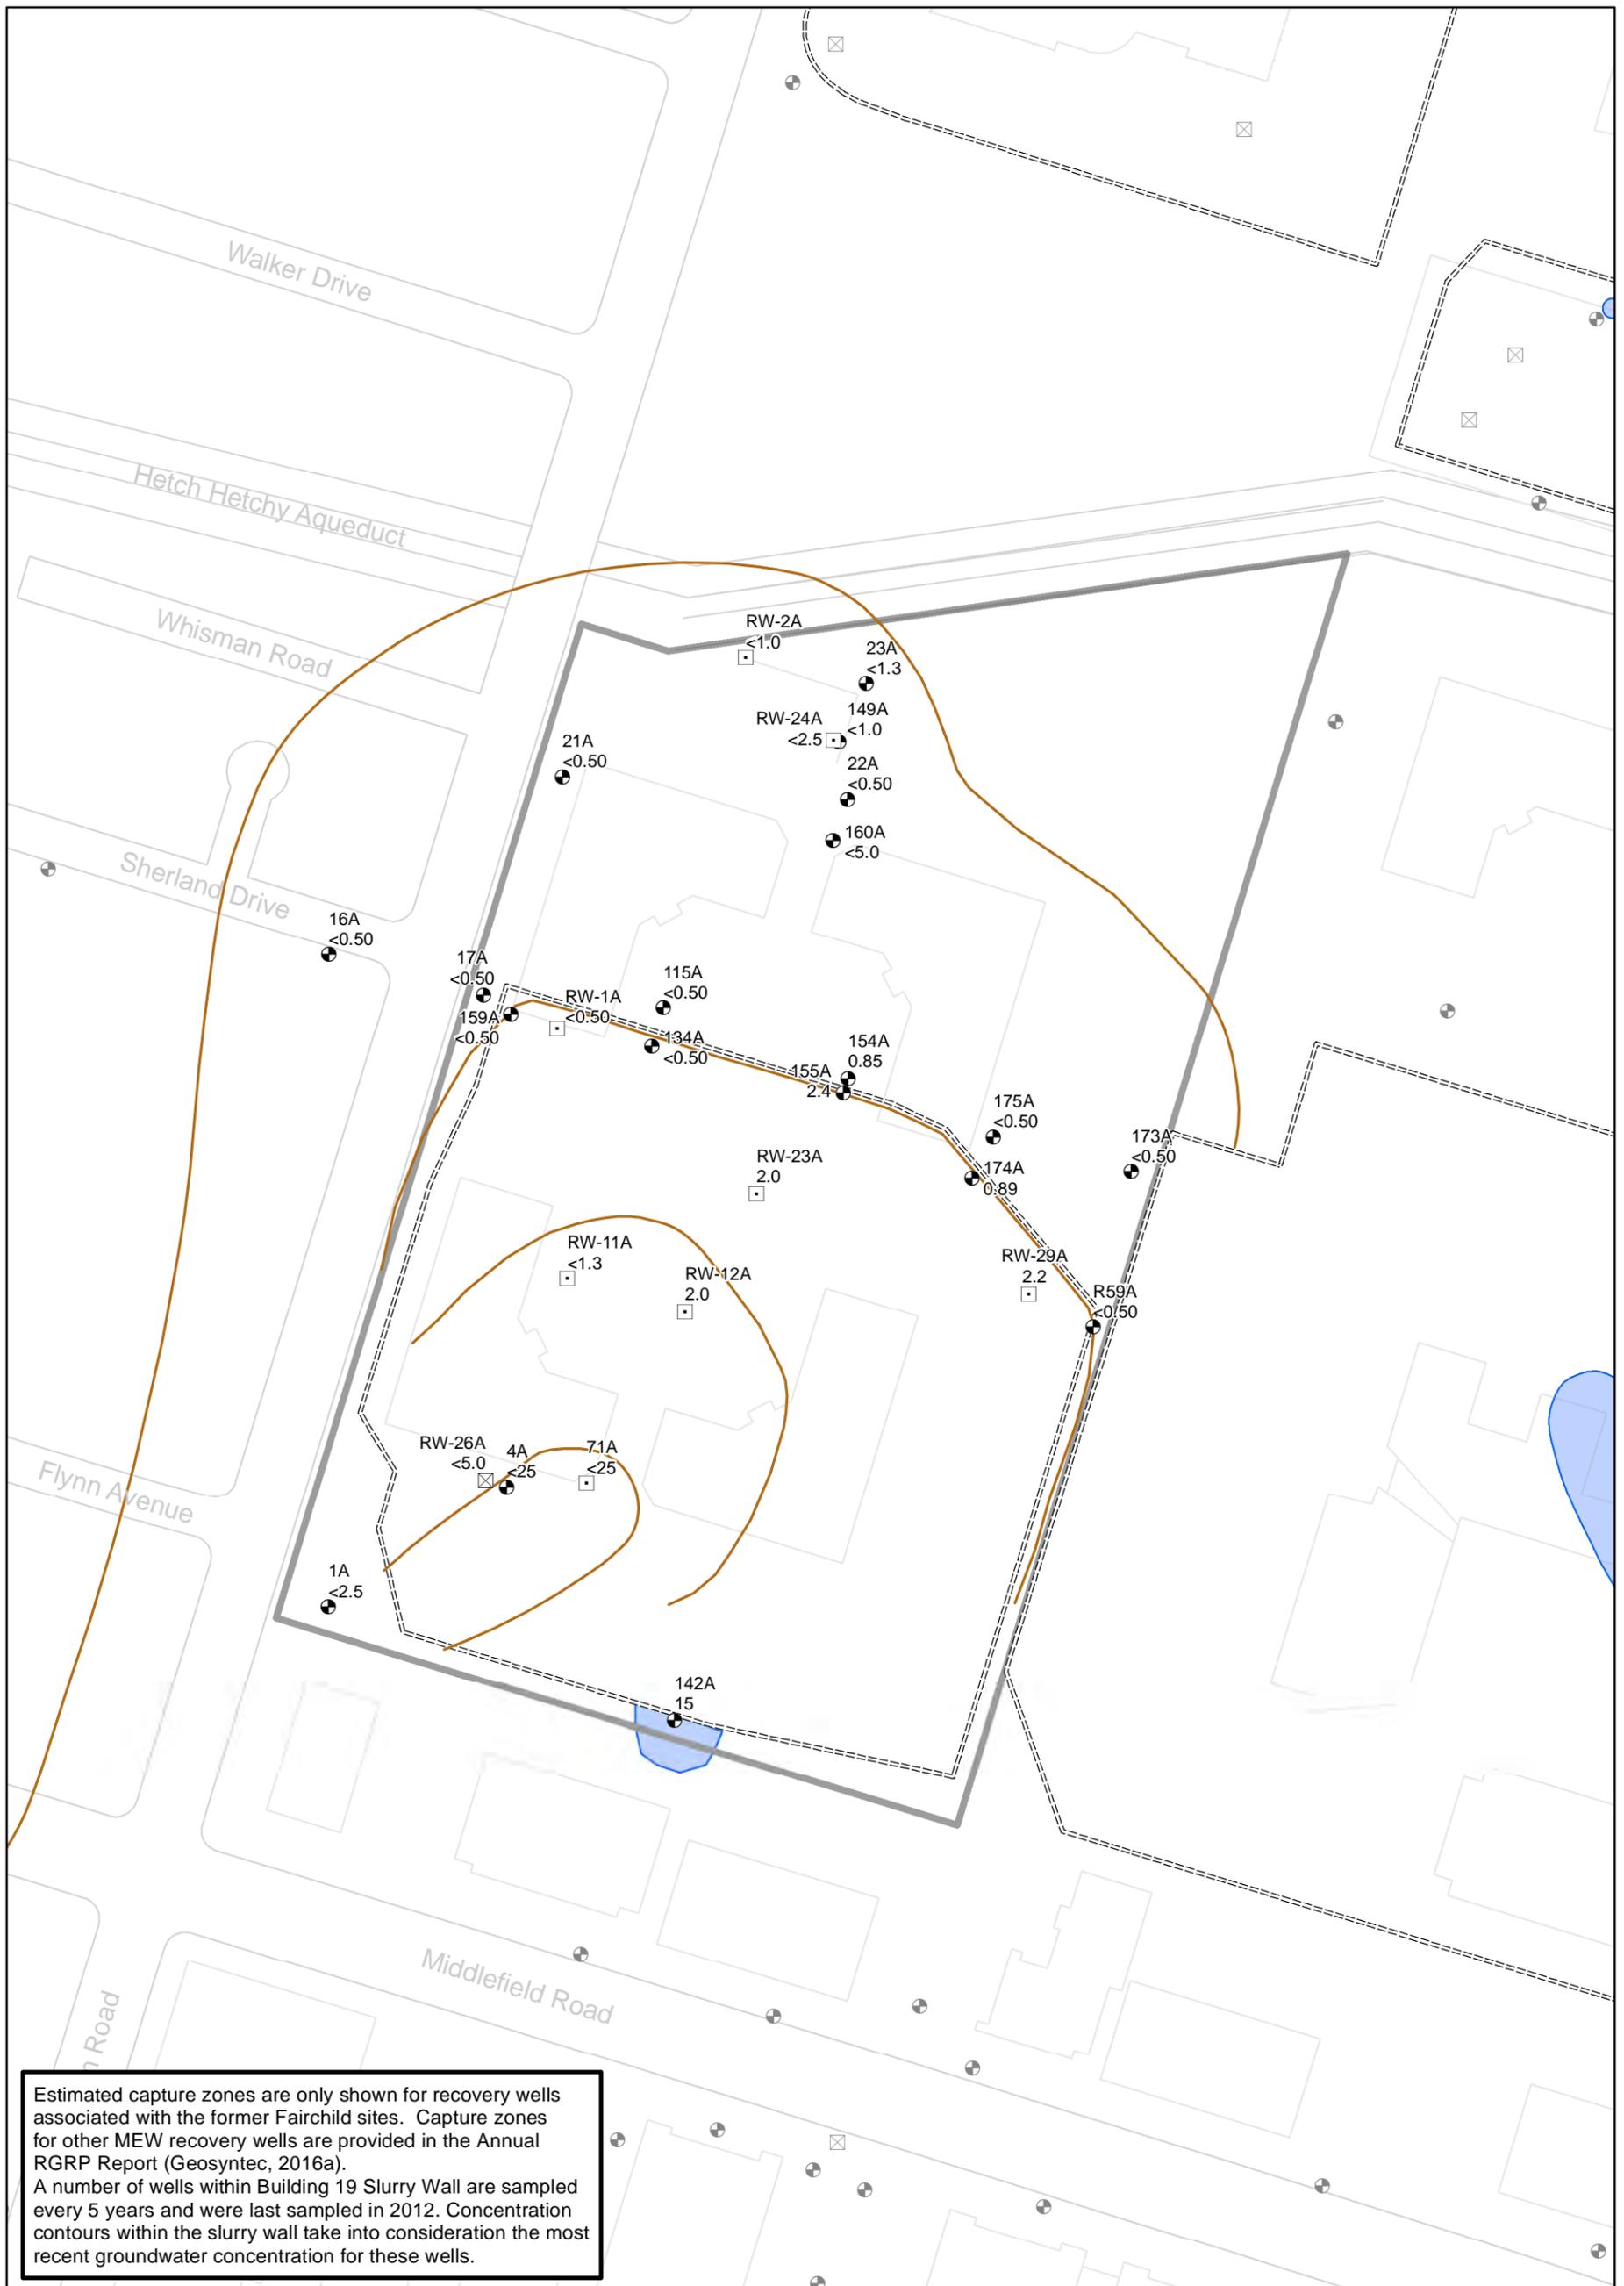
<b>Legend</b> ● Monitoring Well ◻ Recovery Well On ⊠ Recovery Well Off Notes: PCE = Tetrachloroethene ug/L = micrograms per liter Figure shows only those wells sampled and analyzed for PCE in 2014. Wells not associated with the Former Fairchild Buildings 13, 19, and 23 Site are shown in gray.		<b>PCE Concentration (2014)</b> 5 - 100 ug/L 100 - 1,000 ug/L 1,000 - 10,000 ug/L Greater than 10,000 ug/L	— Estimated Capture zone (2015) - - - Slurry Wall — Building — Road ▭ Site Boundary	N  <b>2014 A Zone PCE Concentrations and March 2015 Estimated Capture Zones</b> MEW Former Fairchild Buildings 13, 19, and 23 Groundwater Remediation Program Mountain View, California  Oakland      April 2016	<b>Figure 10d</b>
---	--	--	---	--	-------------------

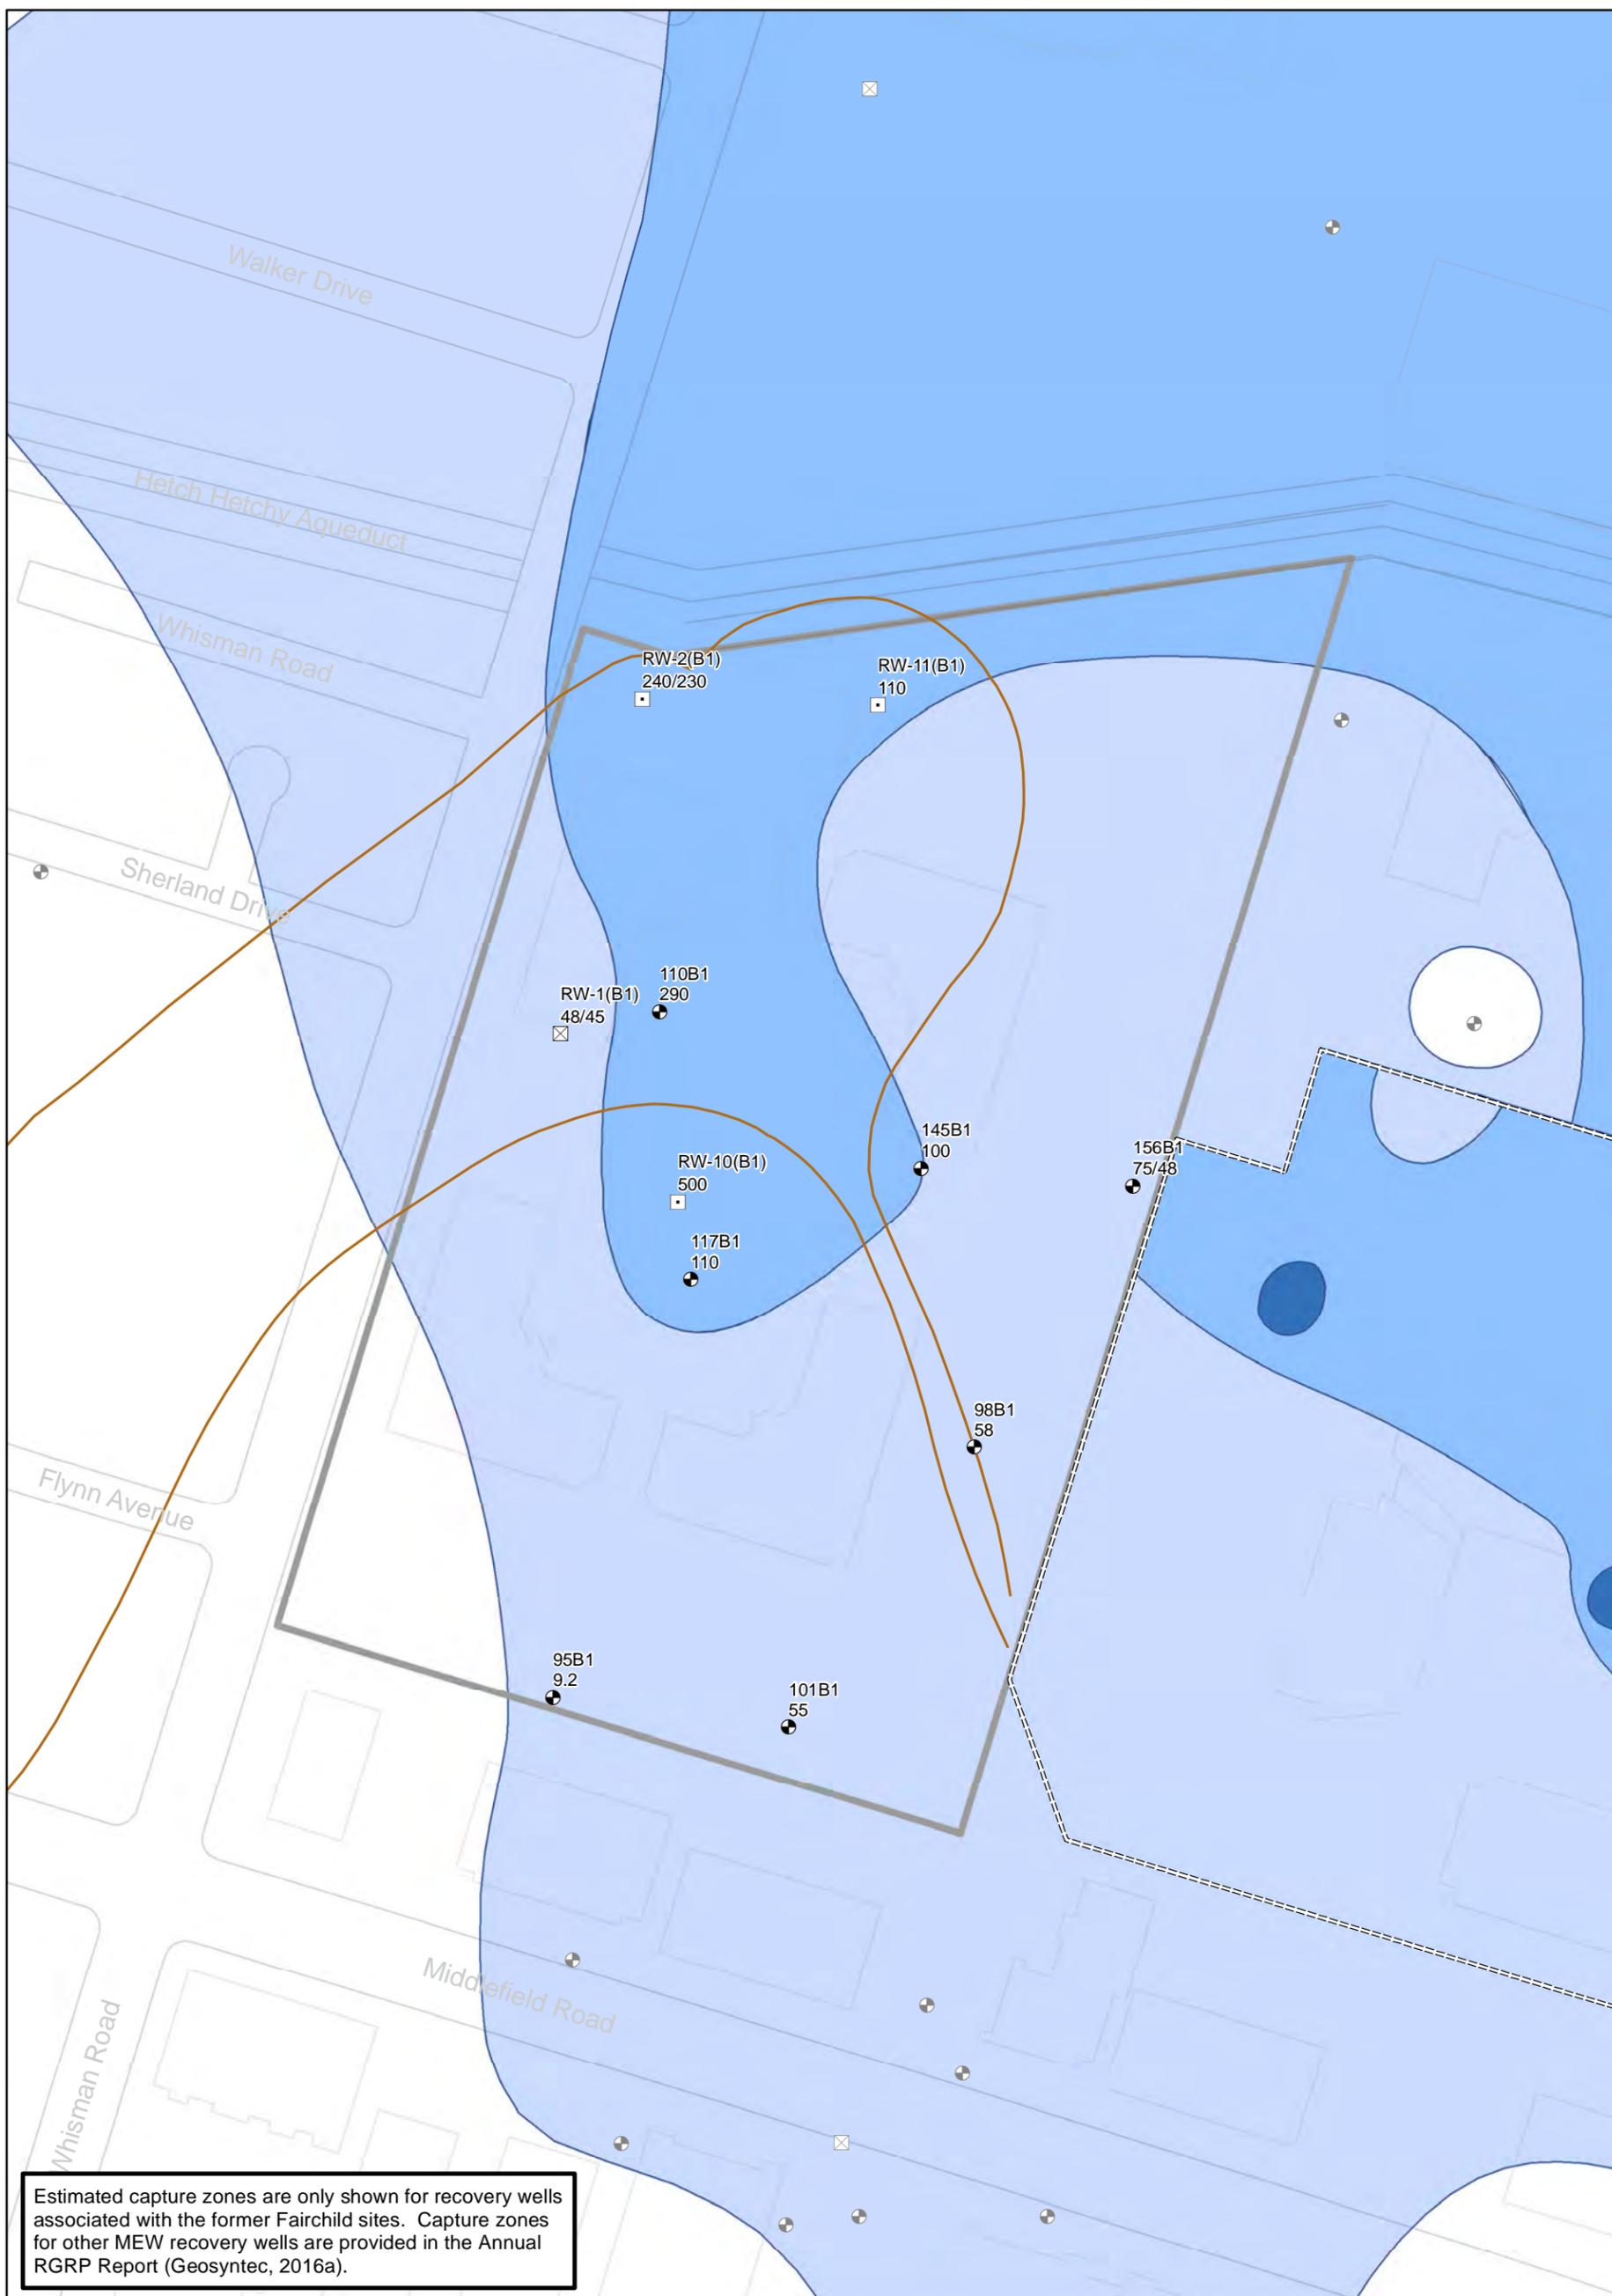
<b>Legend</b> ● Monitoring Well □ Recovery Well On ⊠ Recovery Well Off Notes: TCE = Trichloroethene ug/L = micrograms per liter Figure shows only those wells sampled and analyzed for TCE in 2014. Wells not associated with the Former Fairchild Buildings 13, 19, and 23 Site are shown in gray.		<b>TCE Concentration (2014)</b> Light Blue: 5 - 100 ug/L Medium Blue: 100 - 1,000 ug/L Dark Blue: 1,000 - 10,000 ug/L Darkest Blue: Greater than 10,000 ug/L		— Estimated Capture zone (2015) - - - Slurry Wall — Building — Road □ Site Boundary		N  150 75 0 150 Feet 	<b>2014 B1 Zone TCE Concentrations and March 2015 Estimated Capture Zones</b> MEW Former Fairchild Buildings 13, 19, and 23 Groundwater Remediation Program Mountain View, California		<b>Figure 11a</b>
							Oakland	April 2015

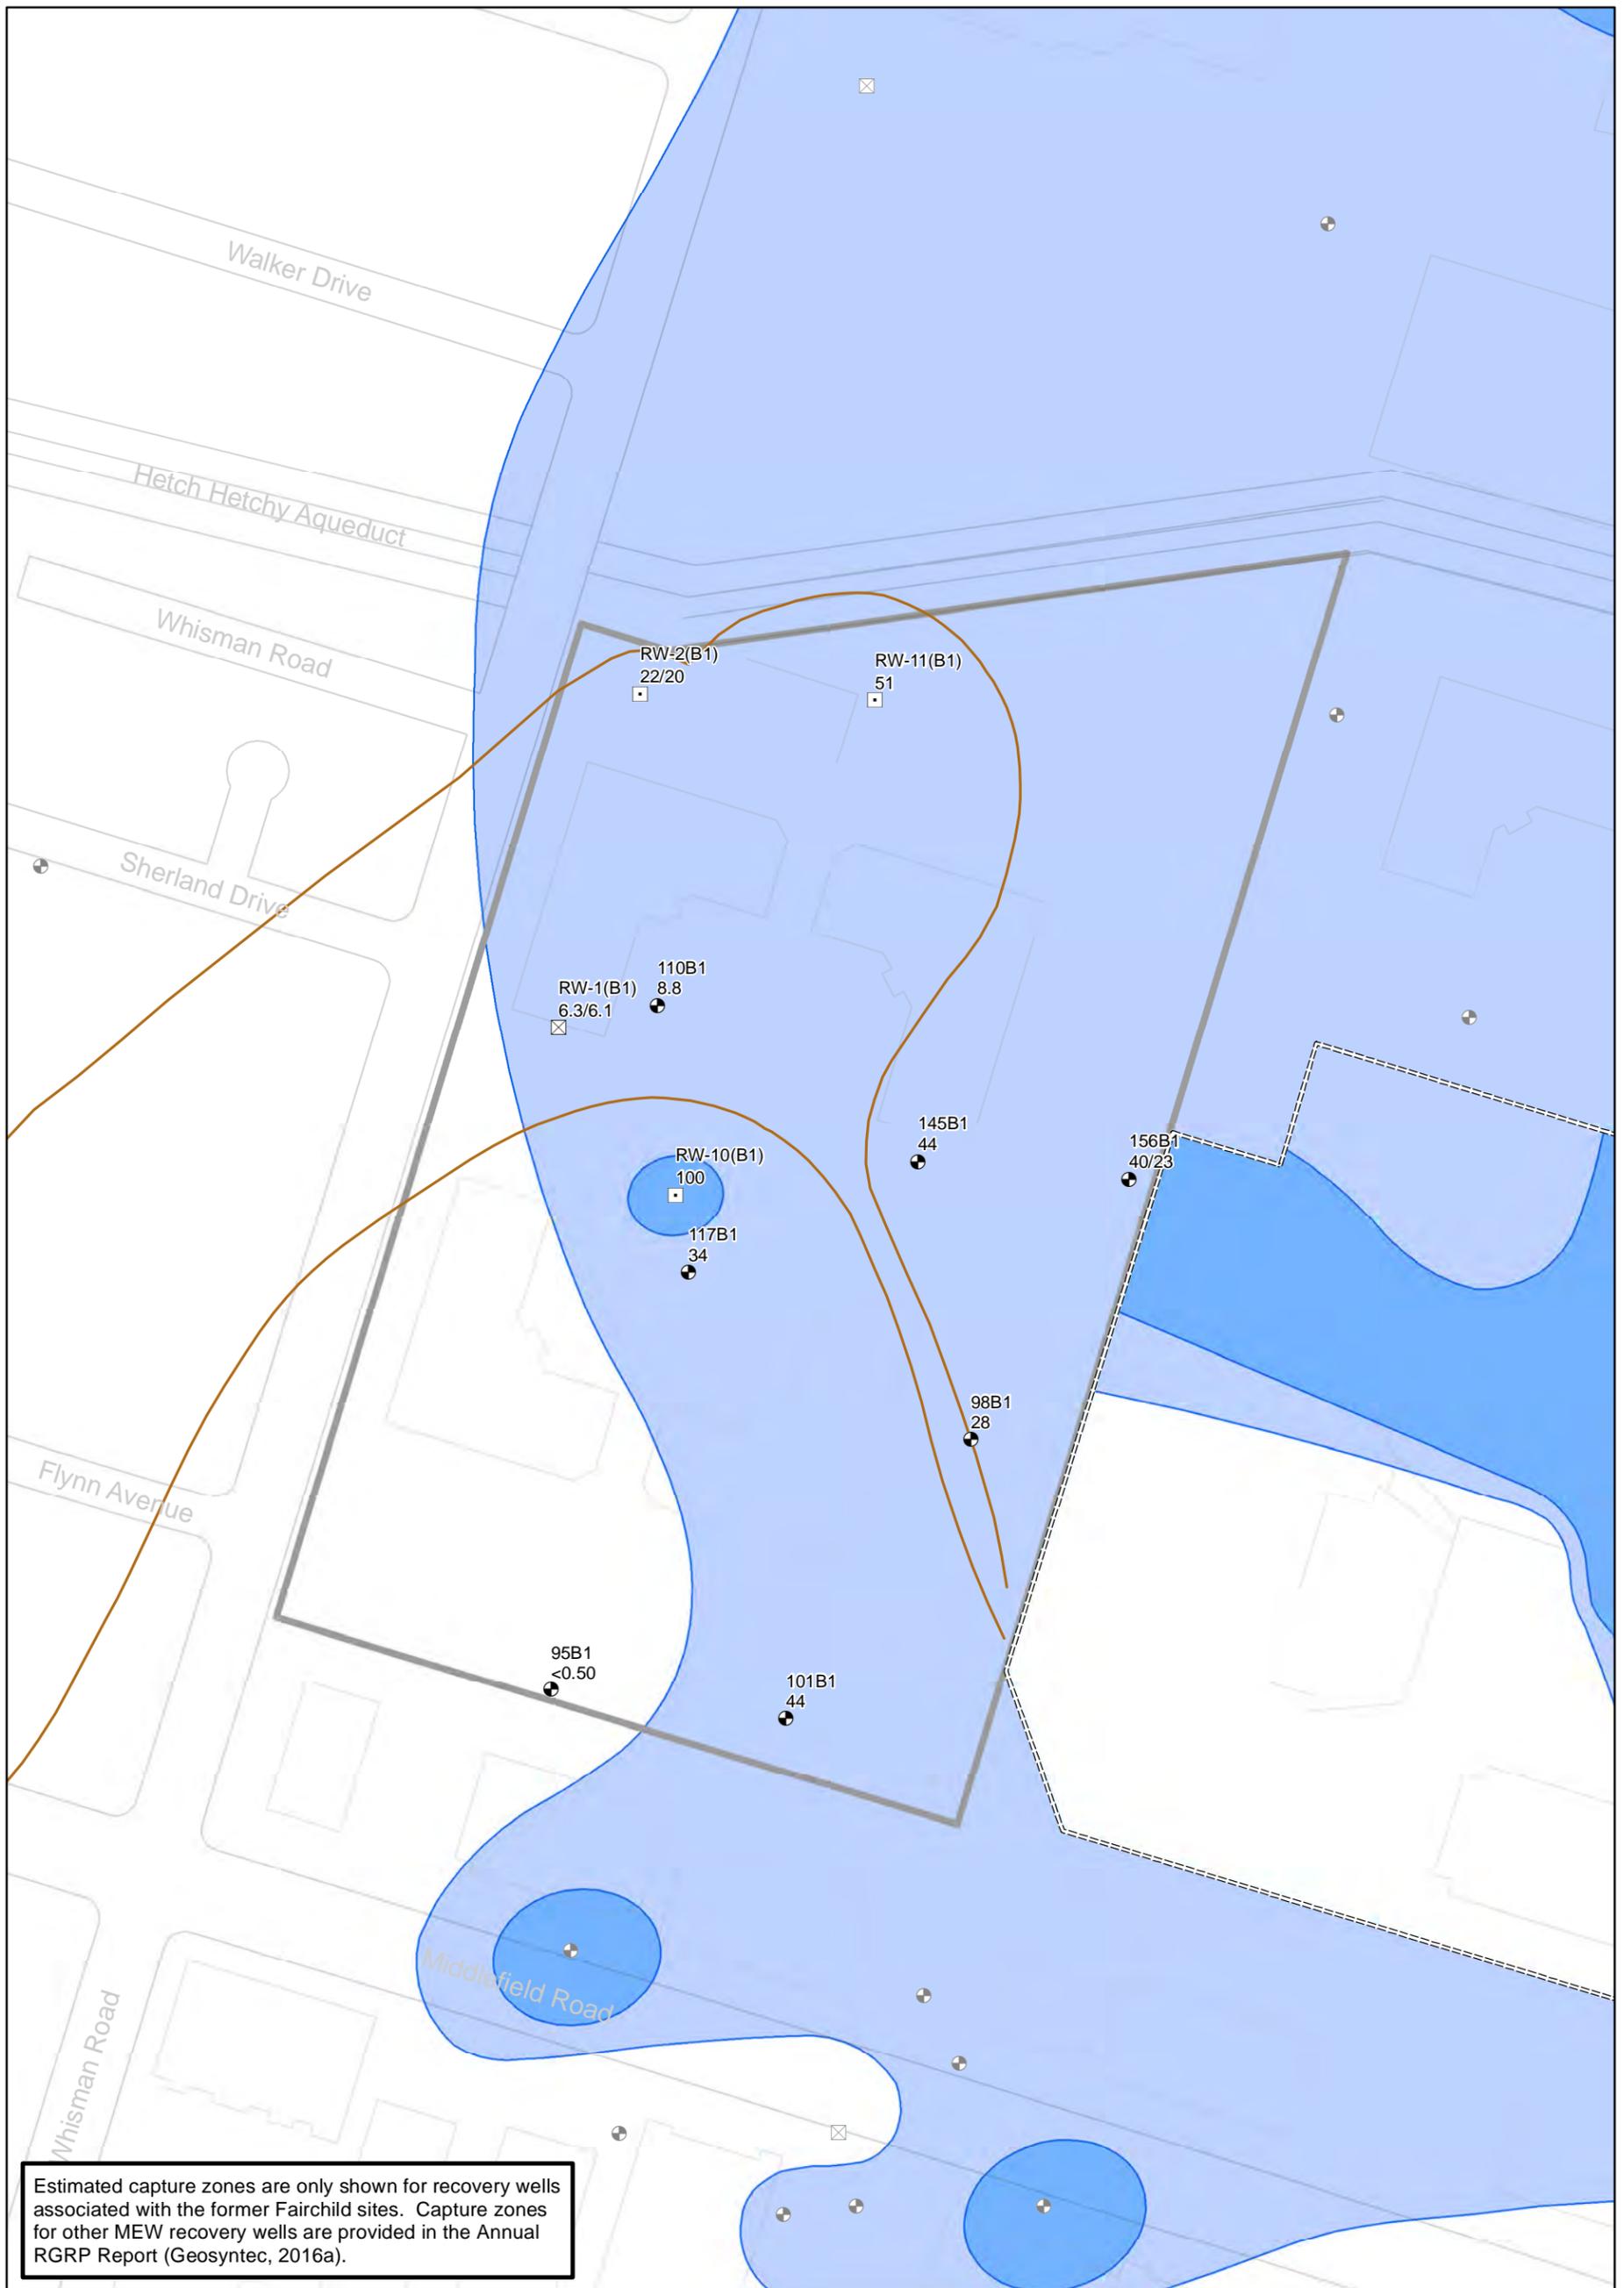
<b>Legend</b> ● Monitoring Well □ Recovery Well On ⊠ Recovery Well Off Notes: cDCE = cis-1,2-Dichloroethene ug/L = micrograms per liter Figure shows only those wells sampled and analyzed for cDCE in 2014. Wells not associated with the Former Fairchild Buildings 13, 19, and 23 Site are shown in gray.		<b>cDCE Concentration (2014)</b> Light Blue: 5 - 100 ug/L Medium Blue: 100 - 1,000 ug/L Dark Blue: 1,000 - 10,000 ug/L Darkest Blue: Greater than 10,000 ug/L		— Estimated Capture zone (2015) - - - Slurry Wall — Building — Road □ Site Boundary		N  150 75 0 150 Feet 	<b>2014 B1 Zone cDCE Concentrations and March 2015 Estimated Capture Zones</b> MEW Former Fairchild Buildings 13, 19, and 23 Groundwater Remediation Program Mountain View, California		<b>Figure 11b</b>
							Oakland April 2016

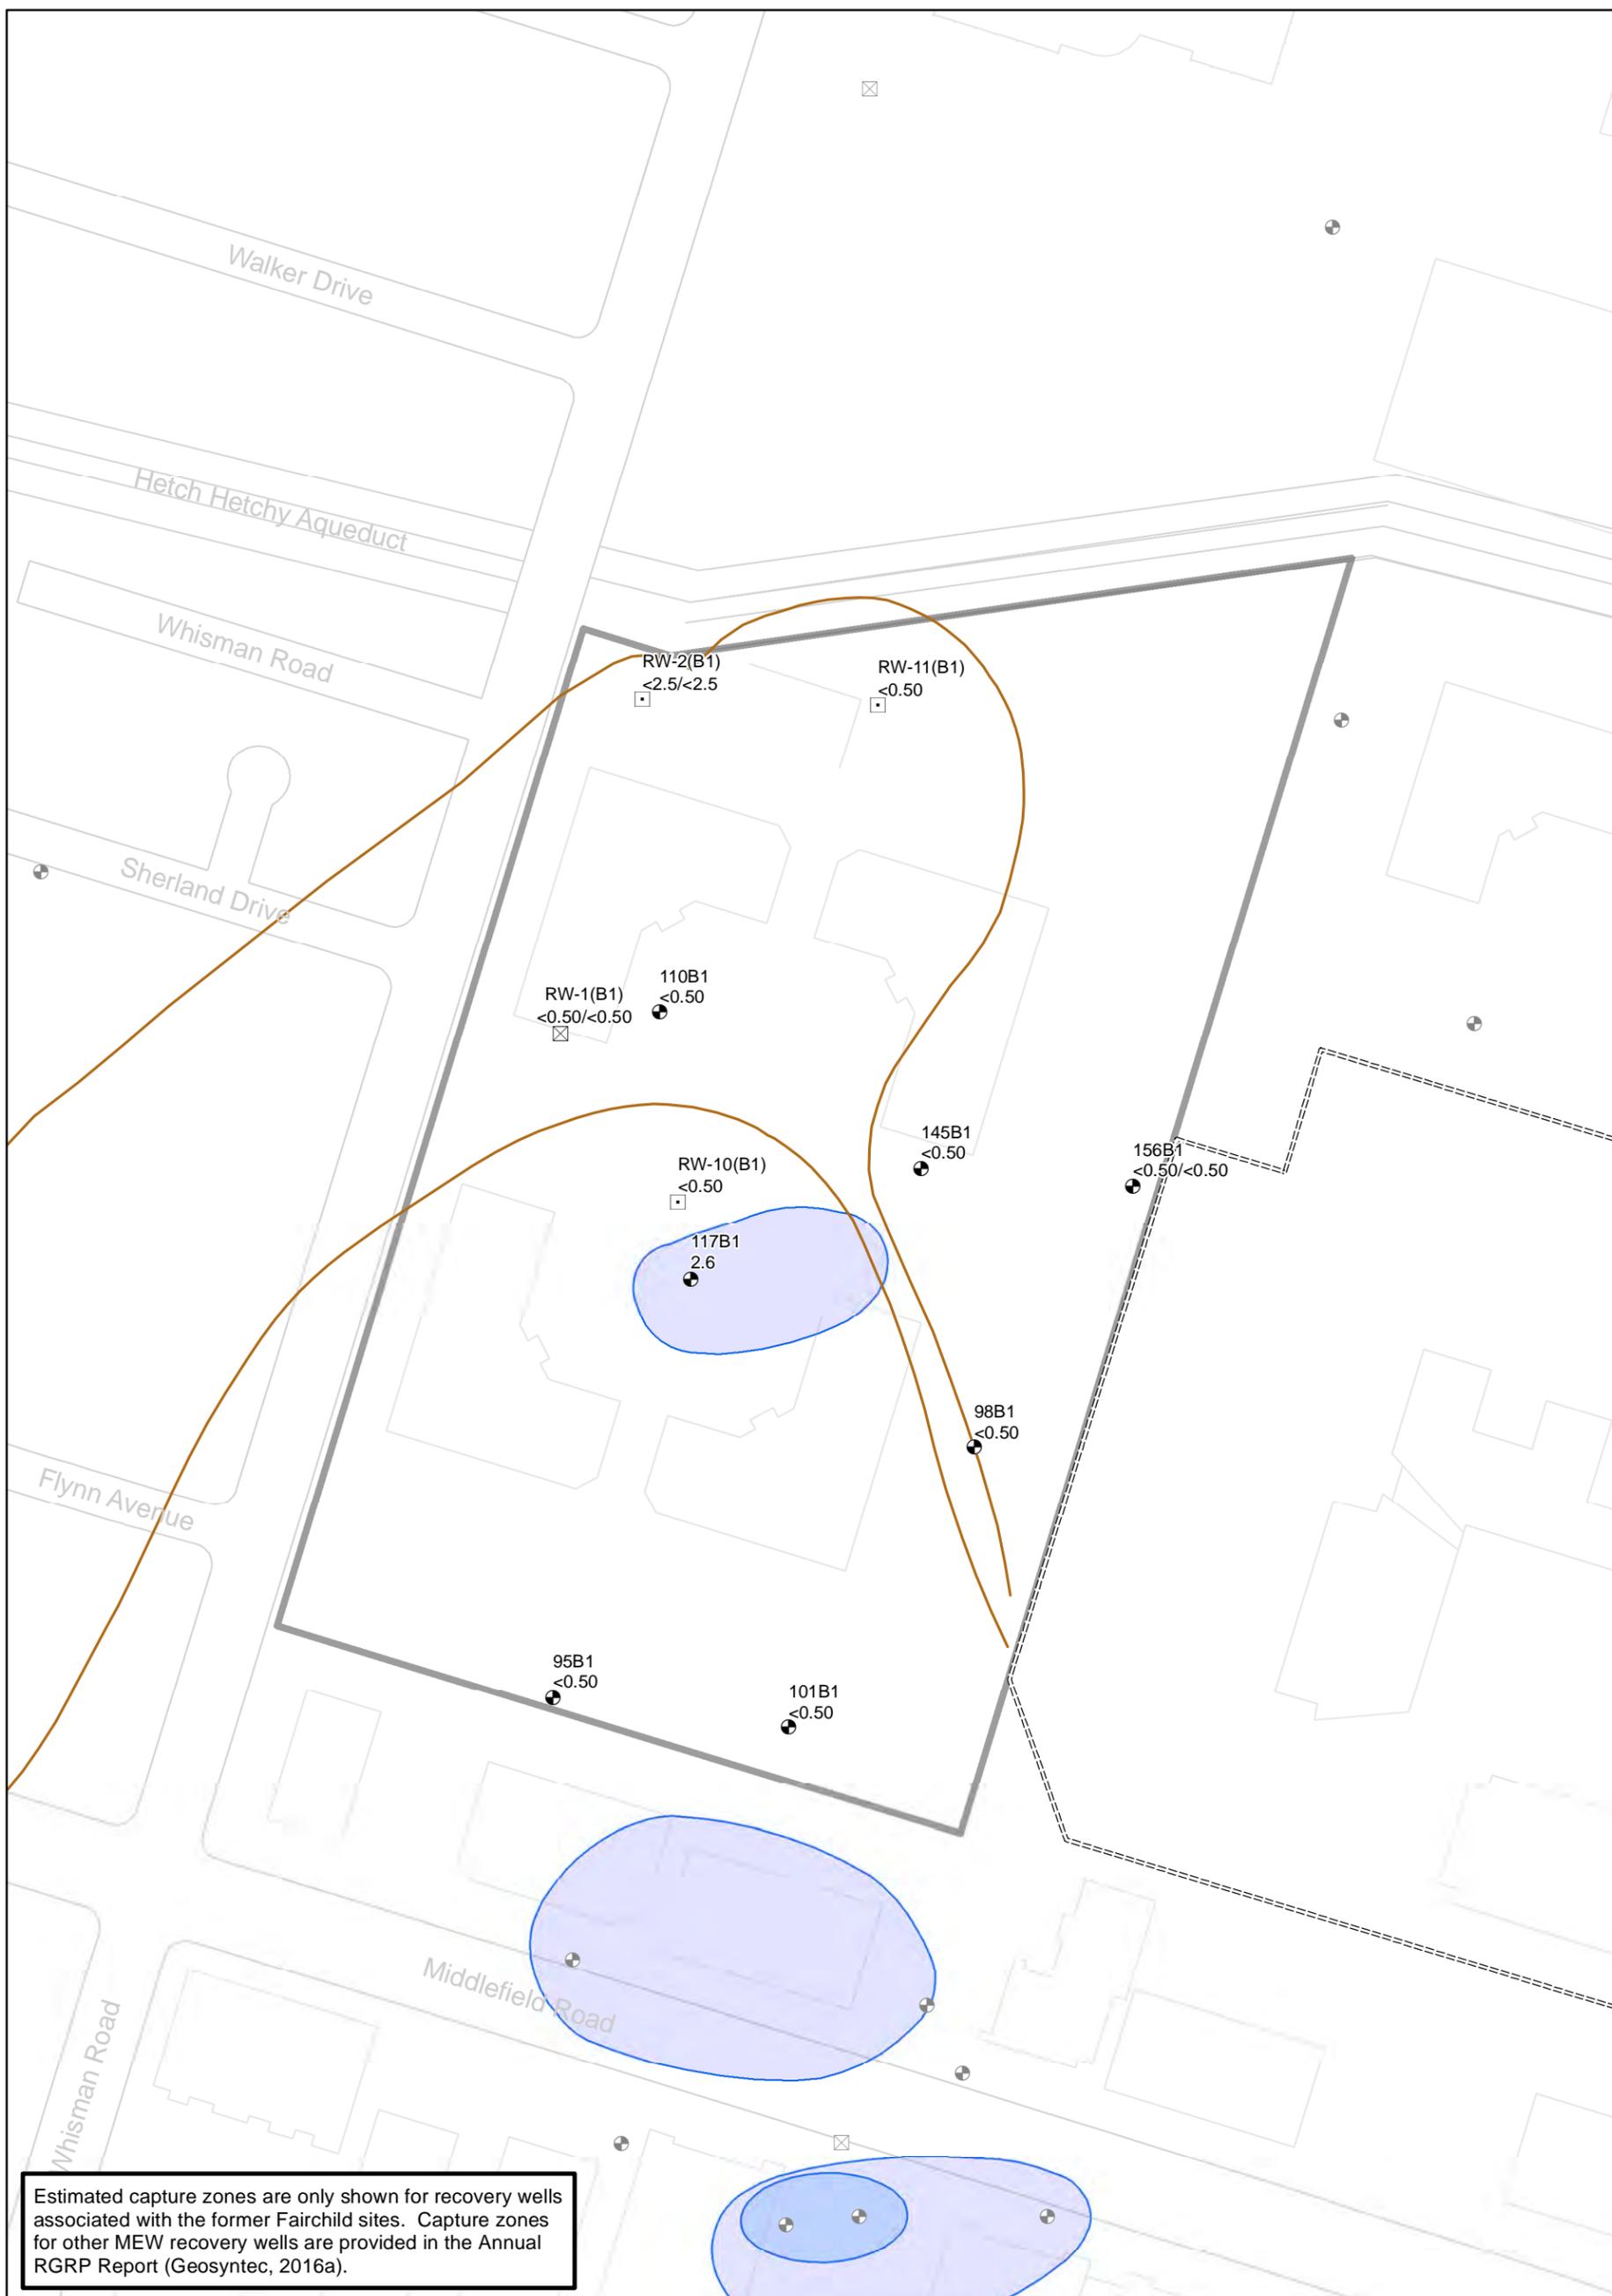
Estimated capture zones are only shown for recovery wells associated with the former Fairchild sites. Capture zones for other MEW recovery wells are provided in the Annual RGRP Report (Geosyntec, 2016a).
