Subject: **2015 Annual Progress Report – Former Fairchild Buildings 13, 19, and 23**  
Middlefield-Ellis-Whisman ("MEW") Area  
Mountain View, California

**2015 ANNUAL PROGRESS REPORT  
FORMER FAIRCHILD  
BUILDINGS 13, 19, AND 23  
MOUNTAIN VIEW, CALIFORNIA**

**2015 Annual Progress Report  
Former Fairchild Buildings 13, 19, and 23  
Middlefield-Ellis-Whisman Study Area  
Mountain View, California**

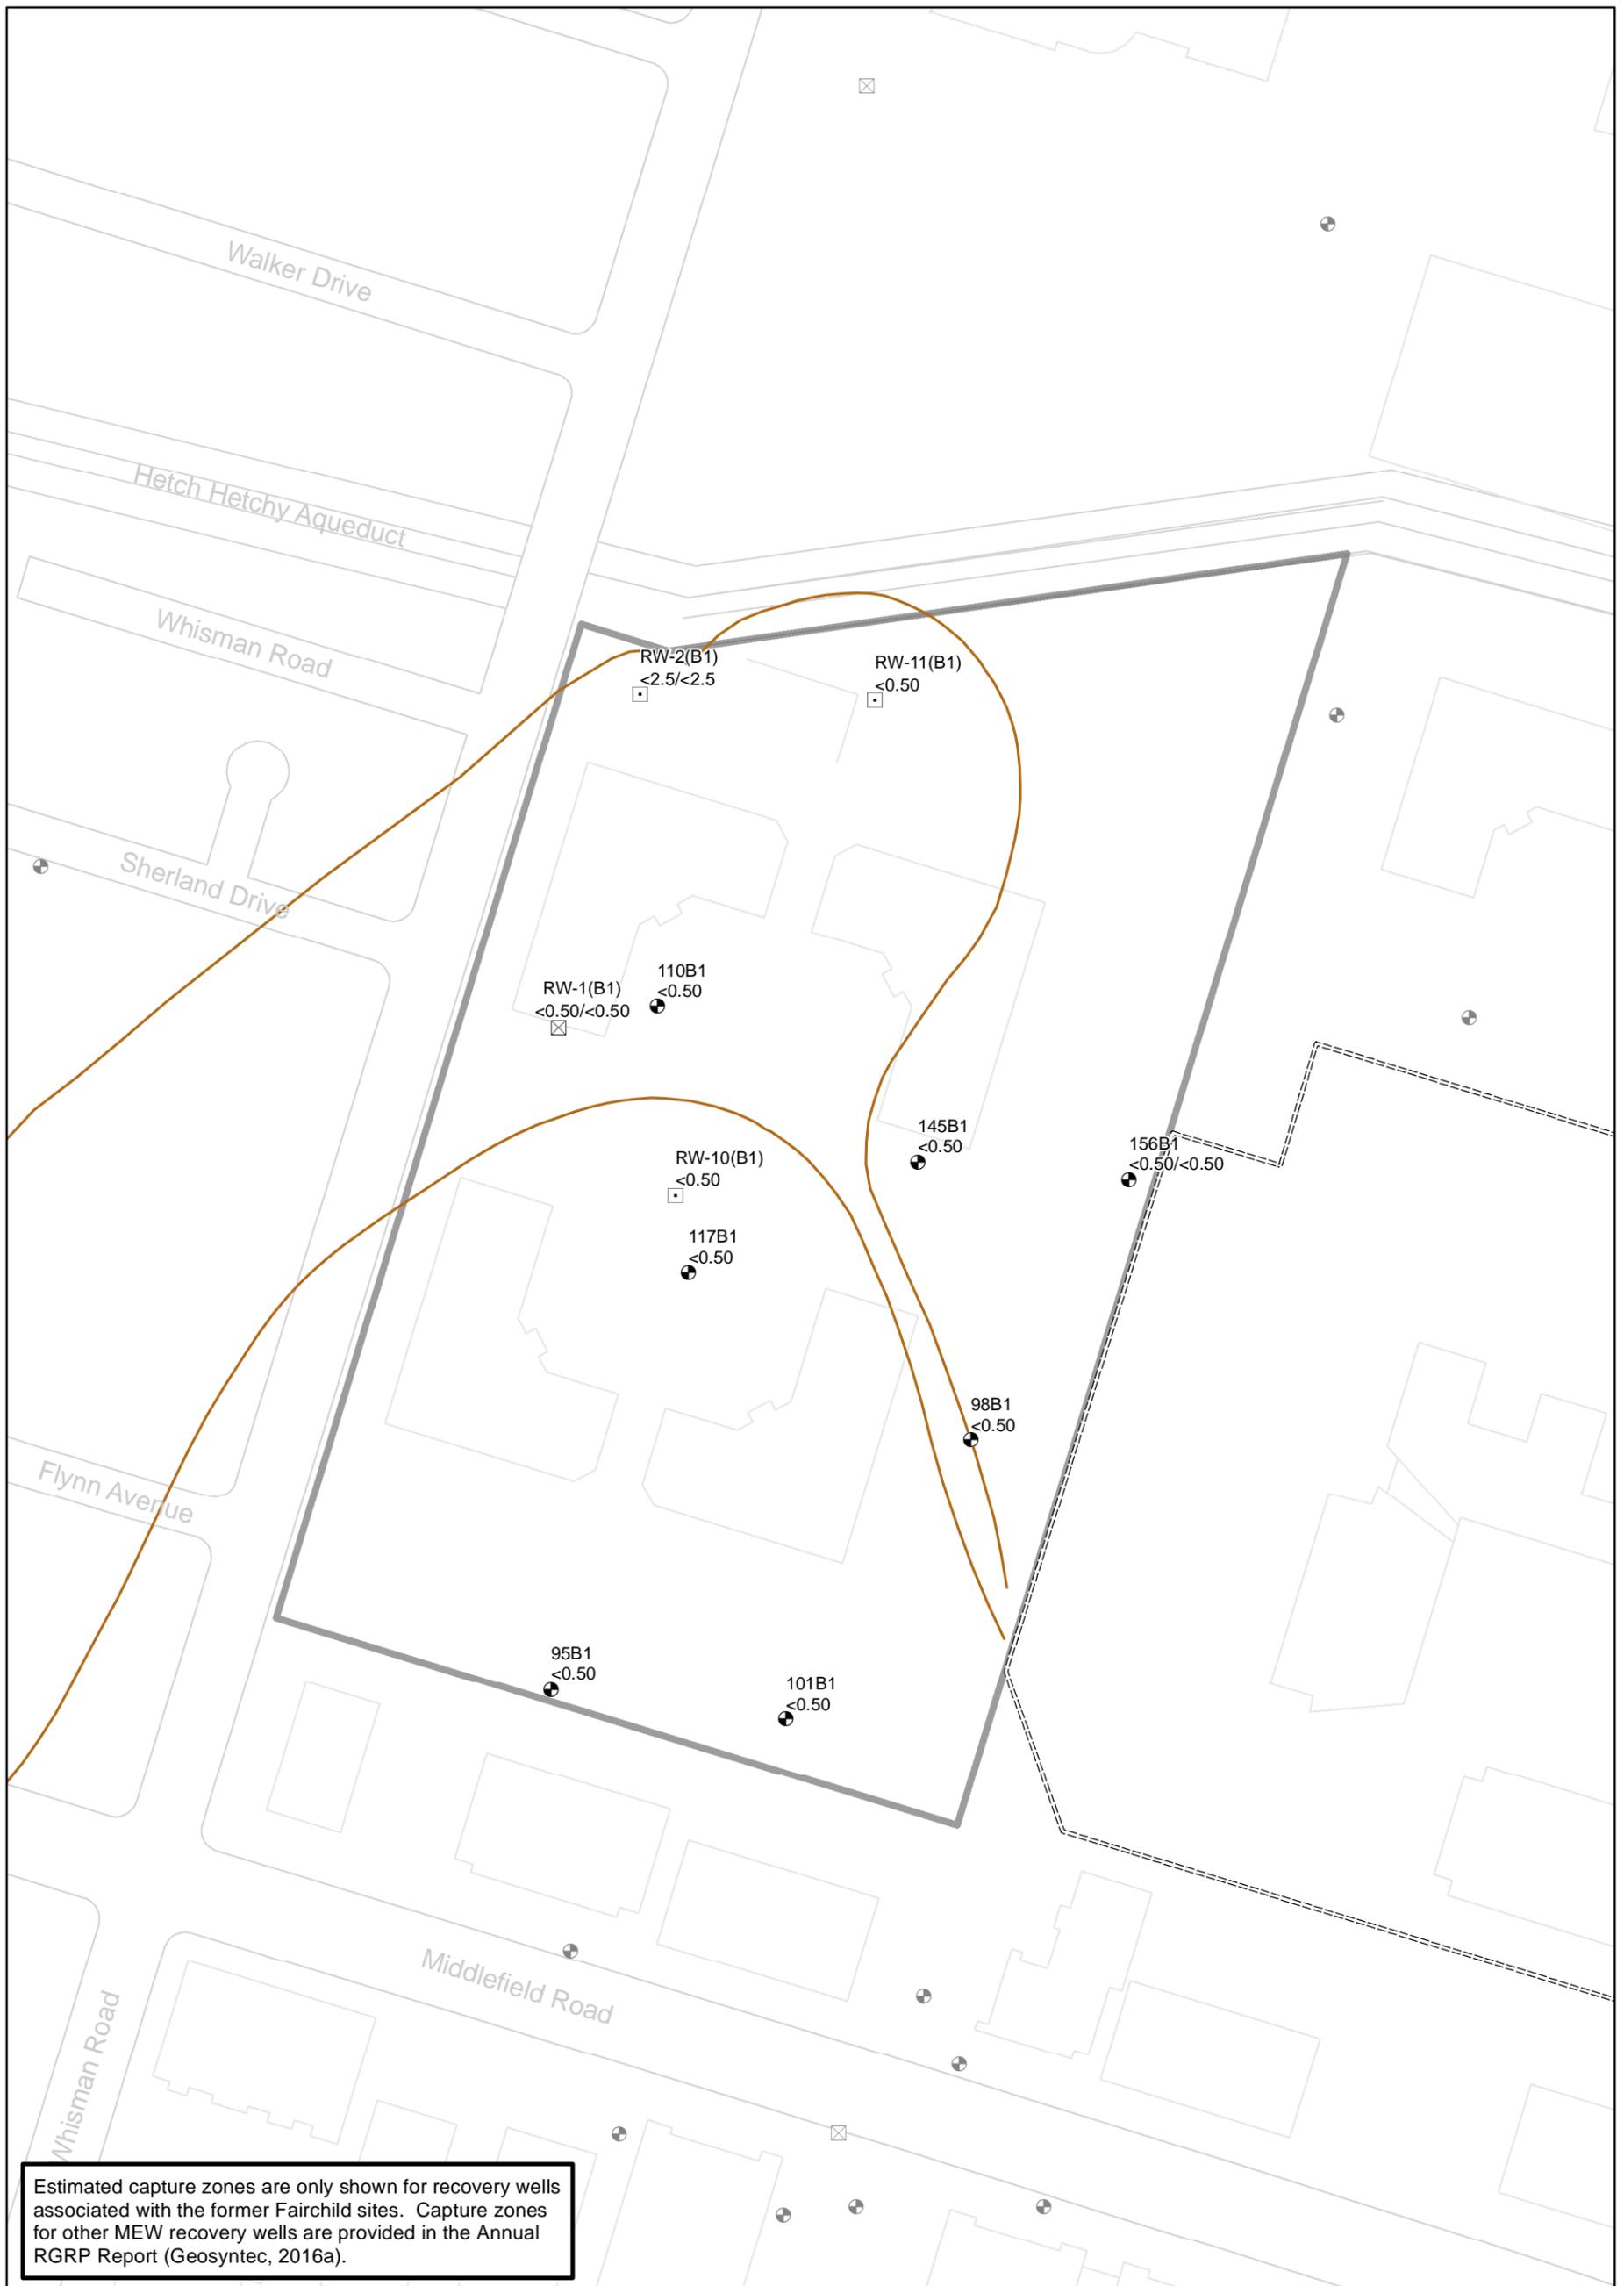
<b>Legend</b> ● Monitoring Well □ Recovery Well On ⊠ Recovery Well Off Notes: PCE = Tetrachloroethene ug/L = micrograms per liter Figure shows only those wells sampled and analyzed for PCE in 2014. Wells not associated with the Former Fairchild Buildings 13, 19, and 23 Site are shown in gray.		<b>PCE Concentration (2014)</b> 5 - 100 ug/L 100 - 1,000 ug/L 1,000 - 10,000 ug/L Greater than 10,000 ug/L		— Estimated Capture zone (2015) - - - - Slurry Wall — Building — Road □ Site Boundary		N  150 75 0 150 Feet 	<b>2014 B1 Zone PCE Concentrations and March 2015 Estimated Capture Zones</b> MEW Former Fairchild Buildings 13, 19, and 23 Groundwater Remediation Program Mountain View, California		<b>Figure 11d</b>
							Oakland April 2016

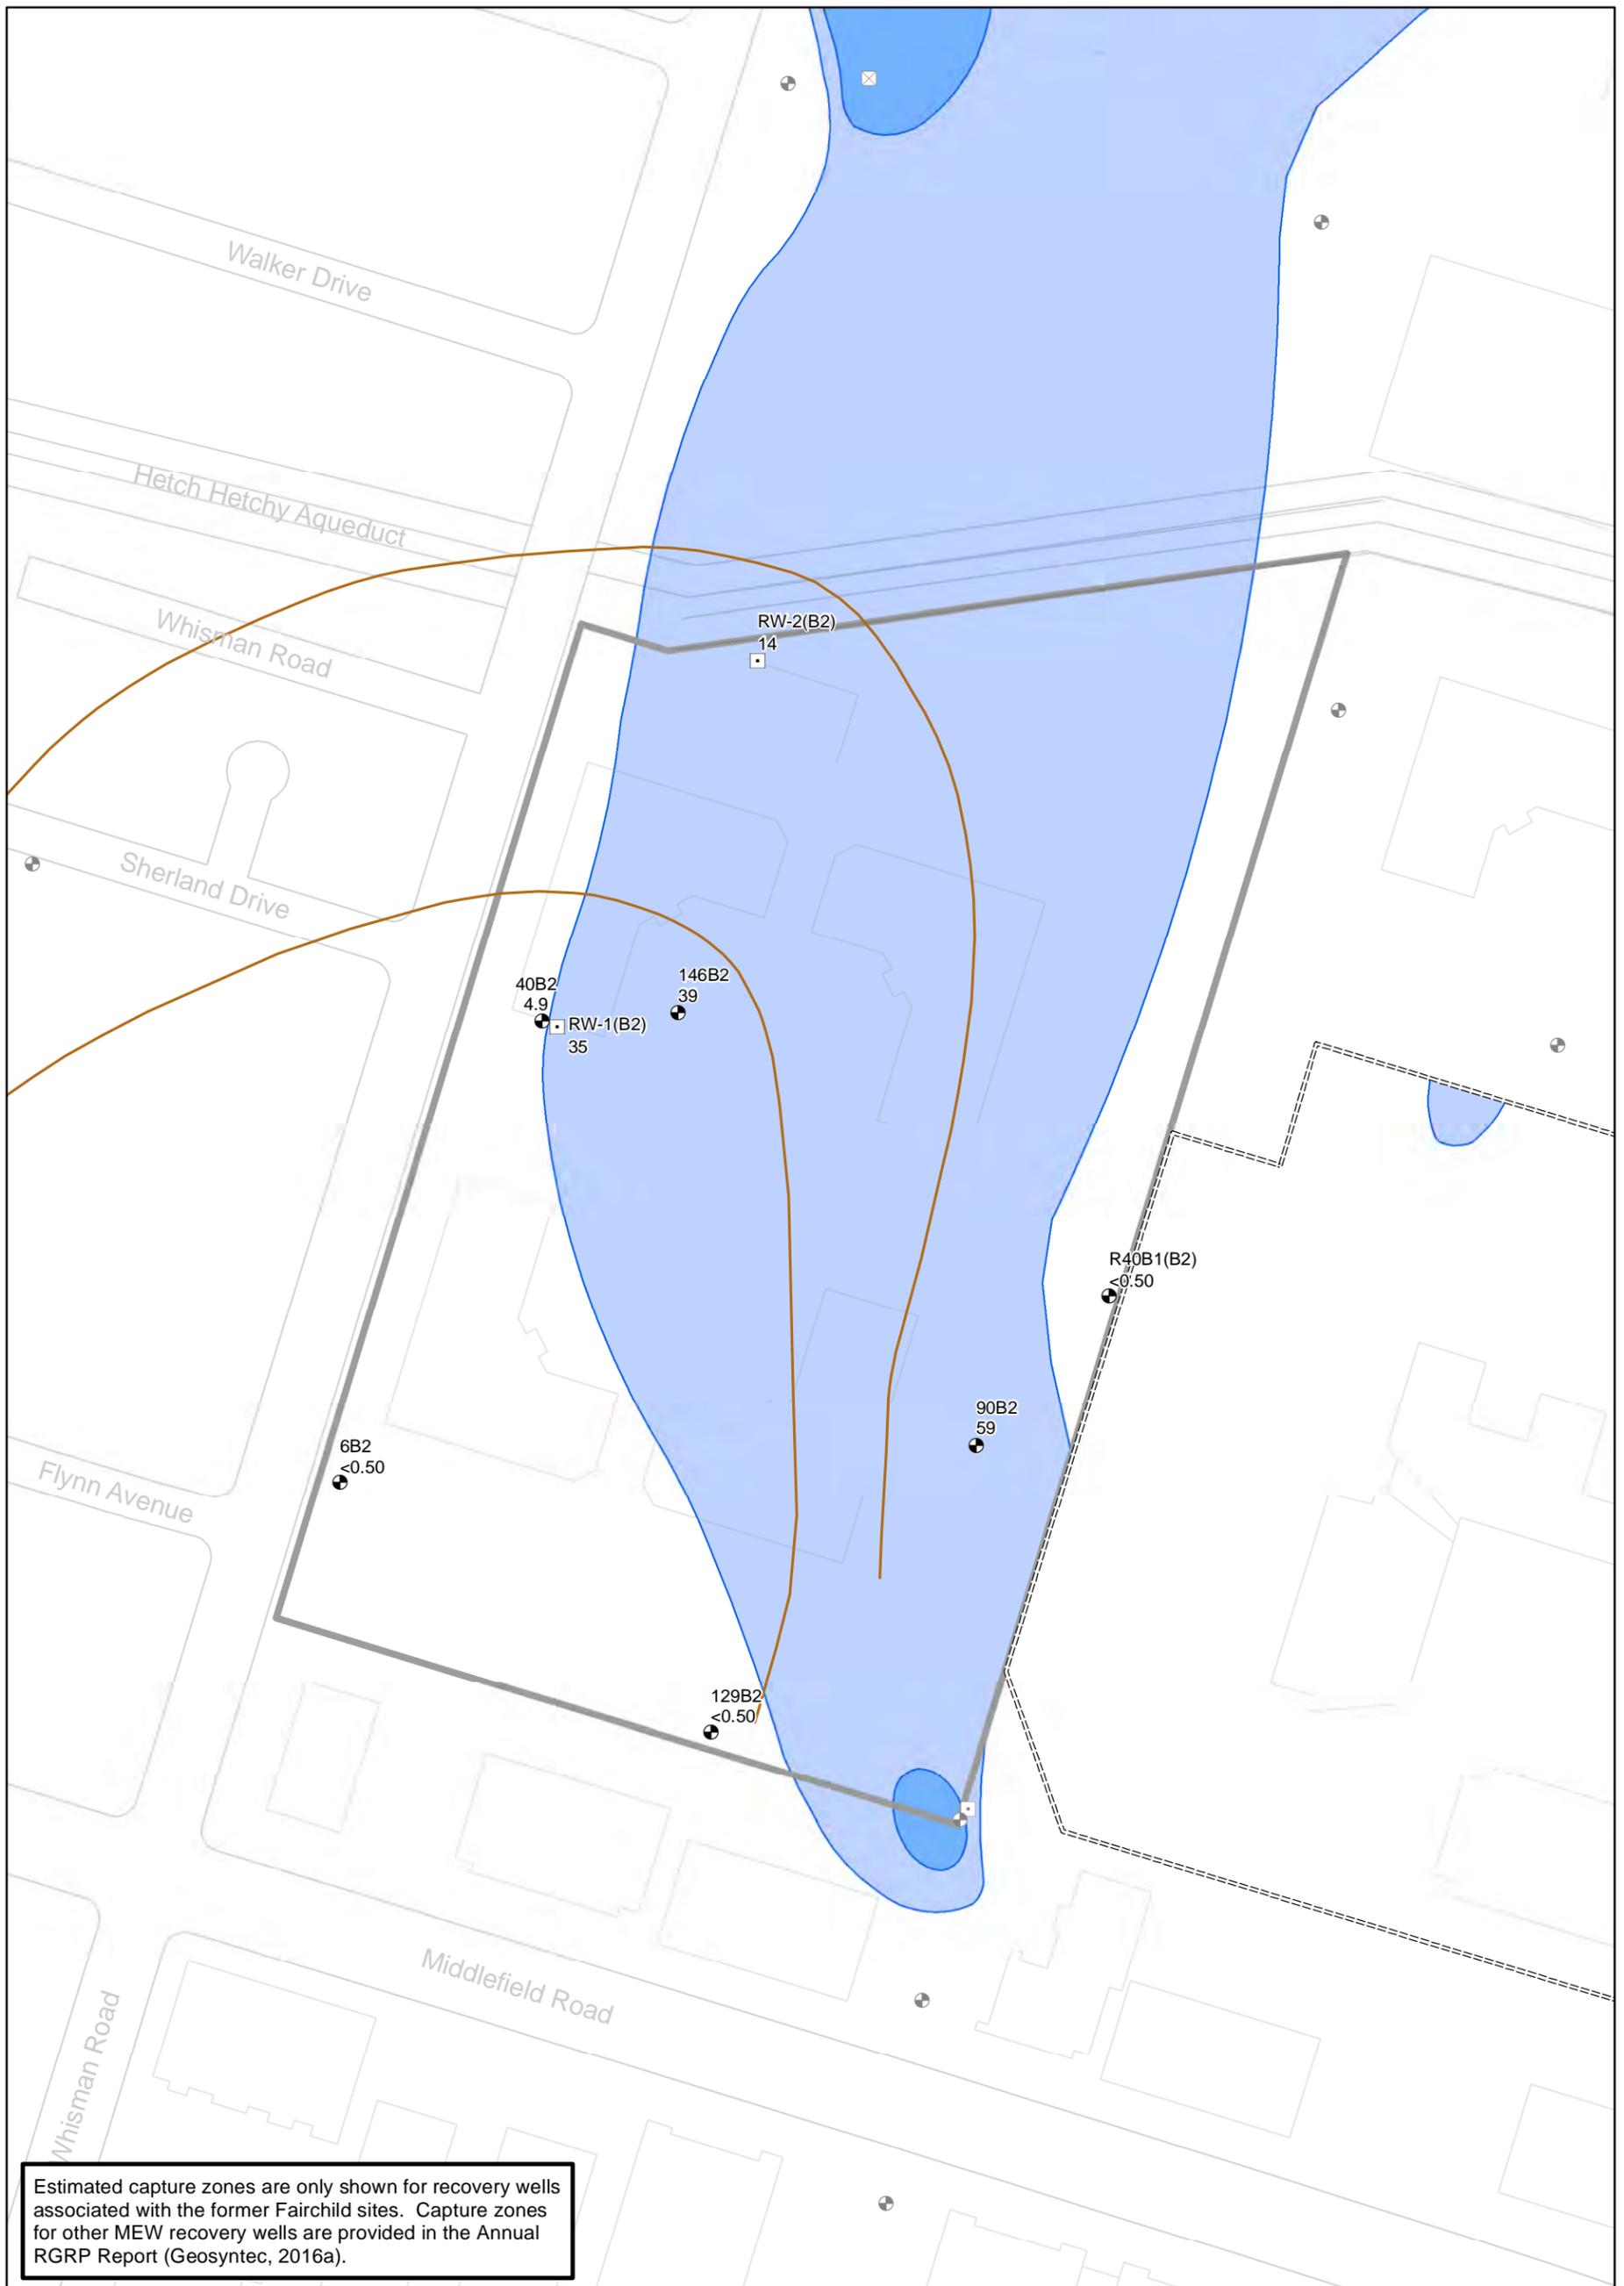
Estimated capture zones are only shown for recovery wells associated with the former Fairchild sites. Capture zones for other MEW recovery wells are provided in the Annual RGRP Report (Geosyntec, 2016a).

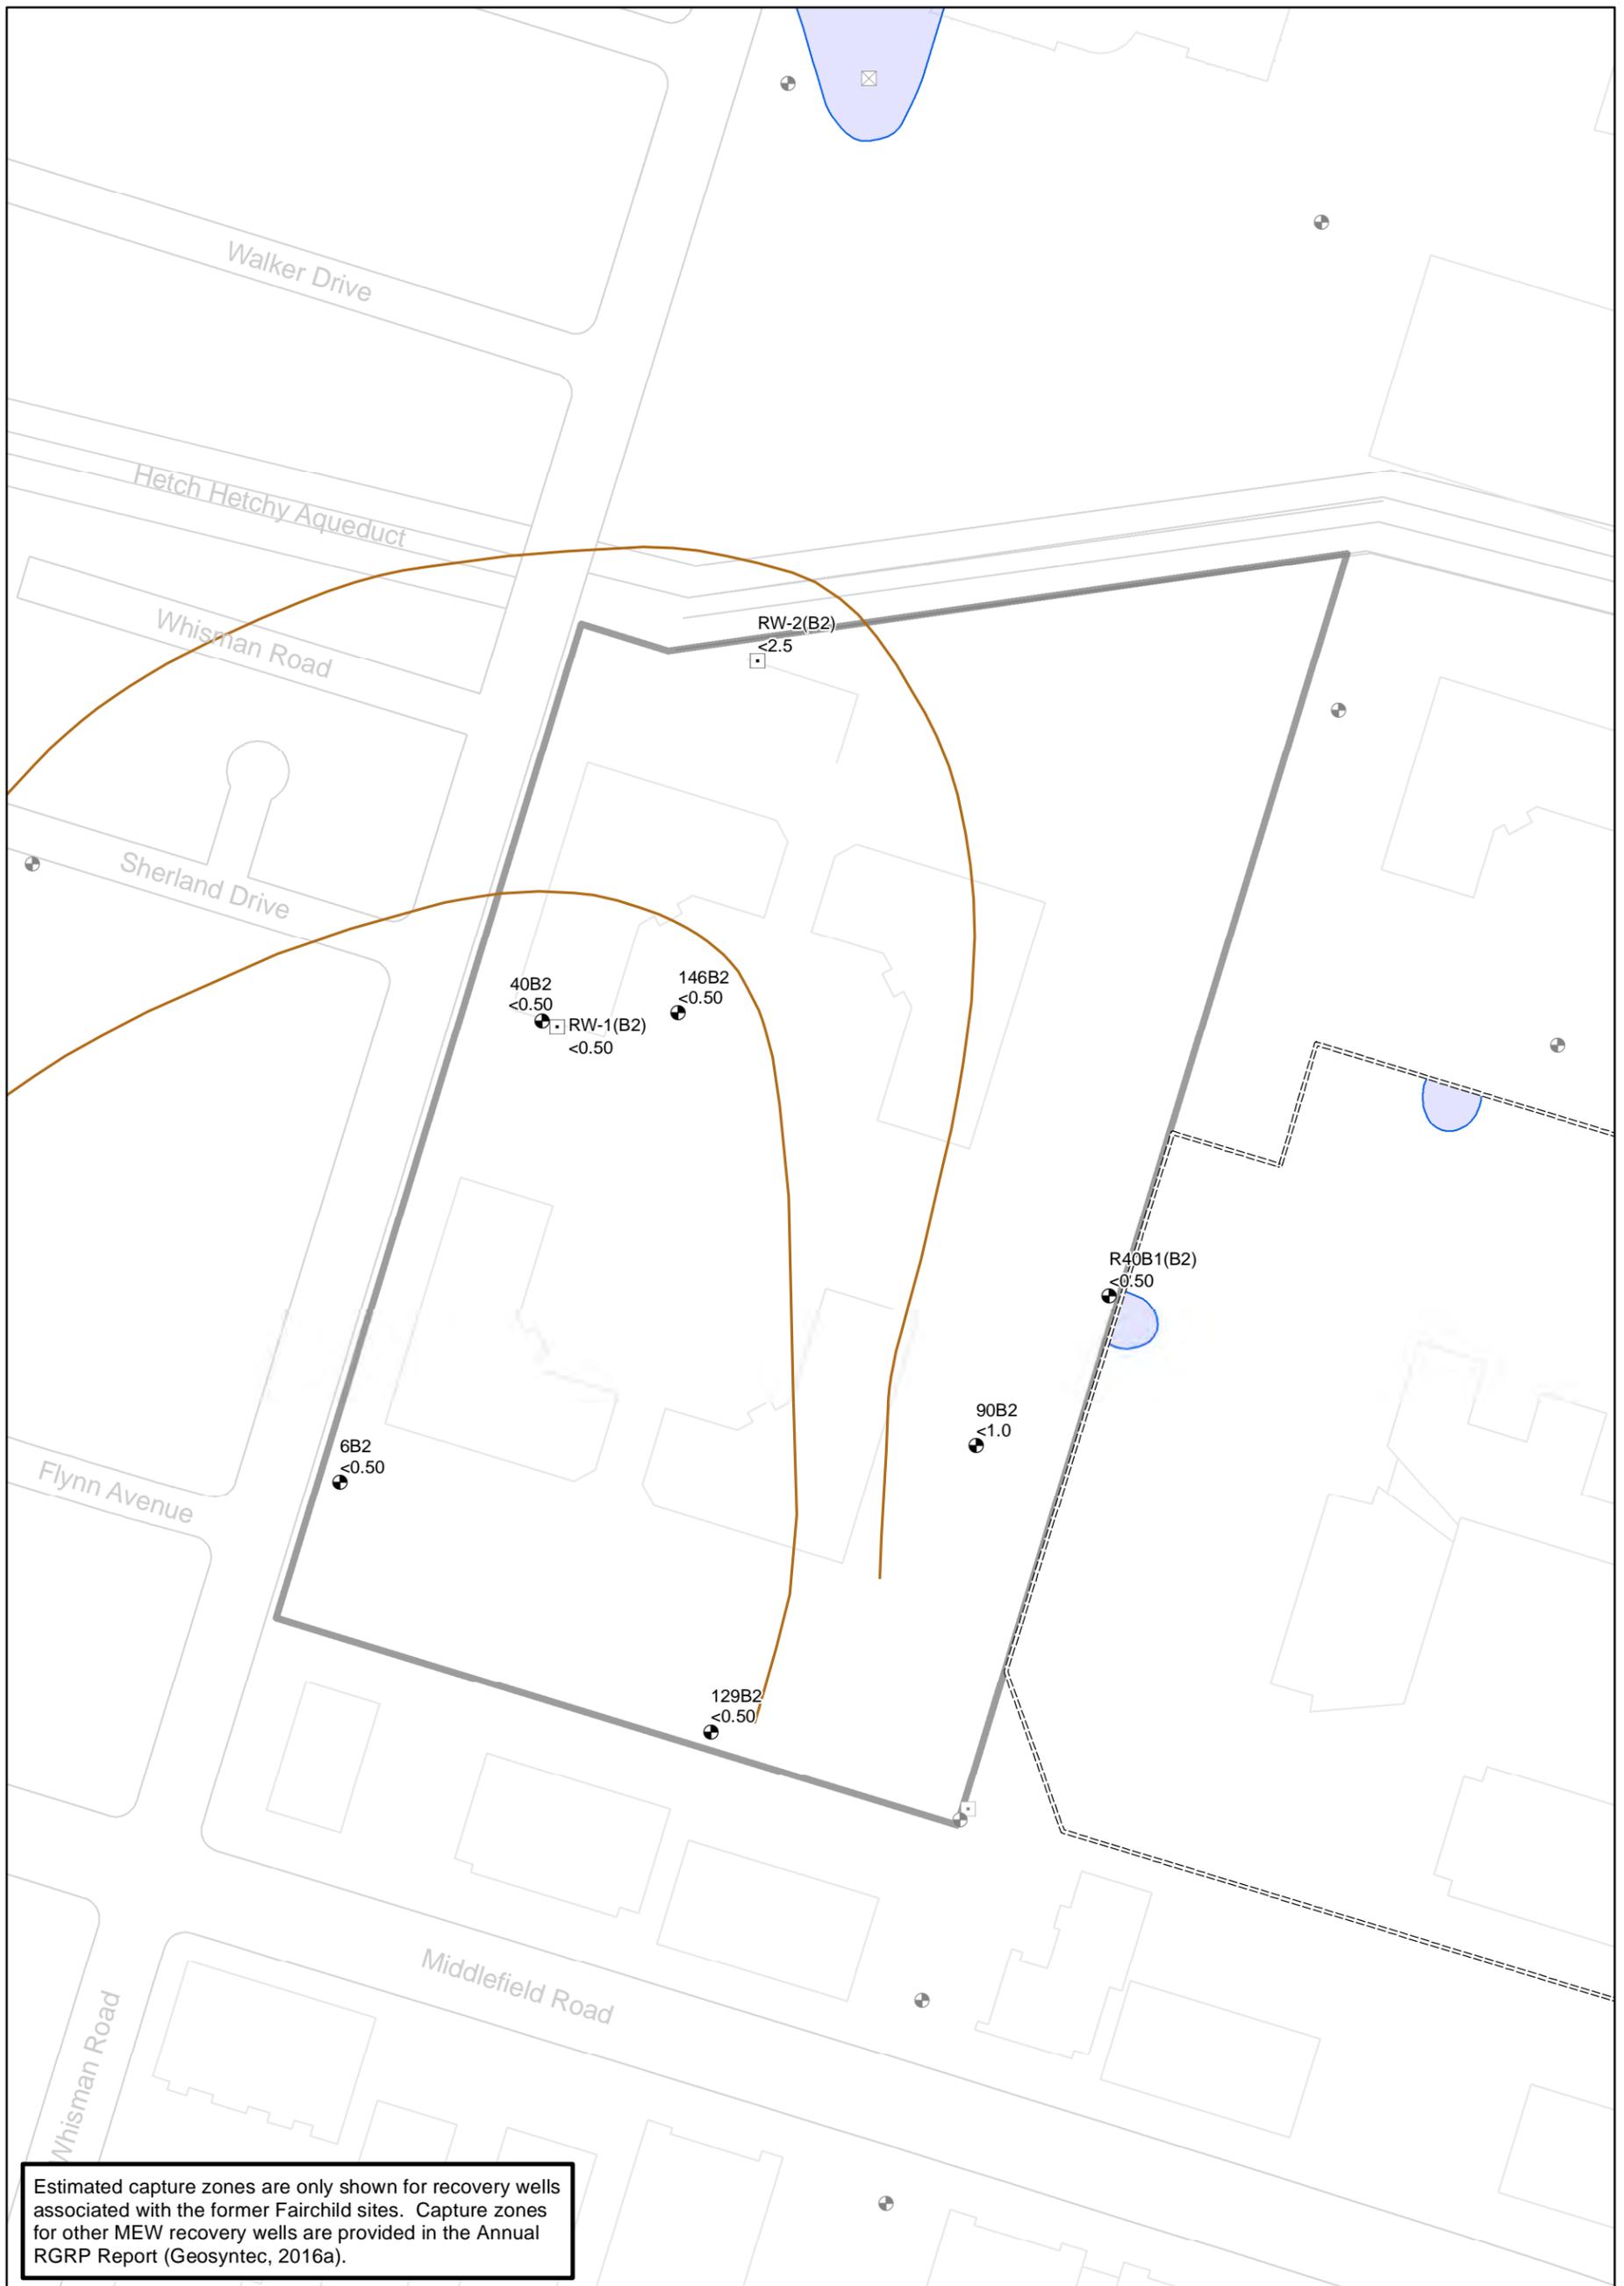
<b>Legend</b> ● Monitoring Well ◻ Recovery Well On ⊠ Recovery Well Off Notes: VC = Vinyl Chloride ug/L = micrograms per liter Figure shows only those wells sampled and analyzed for VC in 2014. Wells not associated with the Former Fairchild Buildings 13, 19, and 23 Site are shown in gray.		<b>VC Concentration (2014)</b> 0.5 - 5 ug/L 5 - 100 ug/L 100 - 1,000 ug/L 1,000 - 10,000 ug/L Greater than 10,000 ug/L		— Estimated Capture zone (2015) === Slurry Wall — Building — Road ◻ Site Boundary		N  150 75 0 150 Feet 	<b>2014 B2 Zone VC Concentrations and March 2015 Estimated Capture Zones</b> MEW Former Fairchild Buildings 13, 19, and 23 Groundwater Remediation Program Mountain View, California		<b>Figure 12c</b>
							Oakland      April 2016

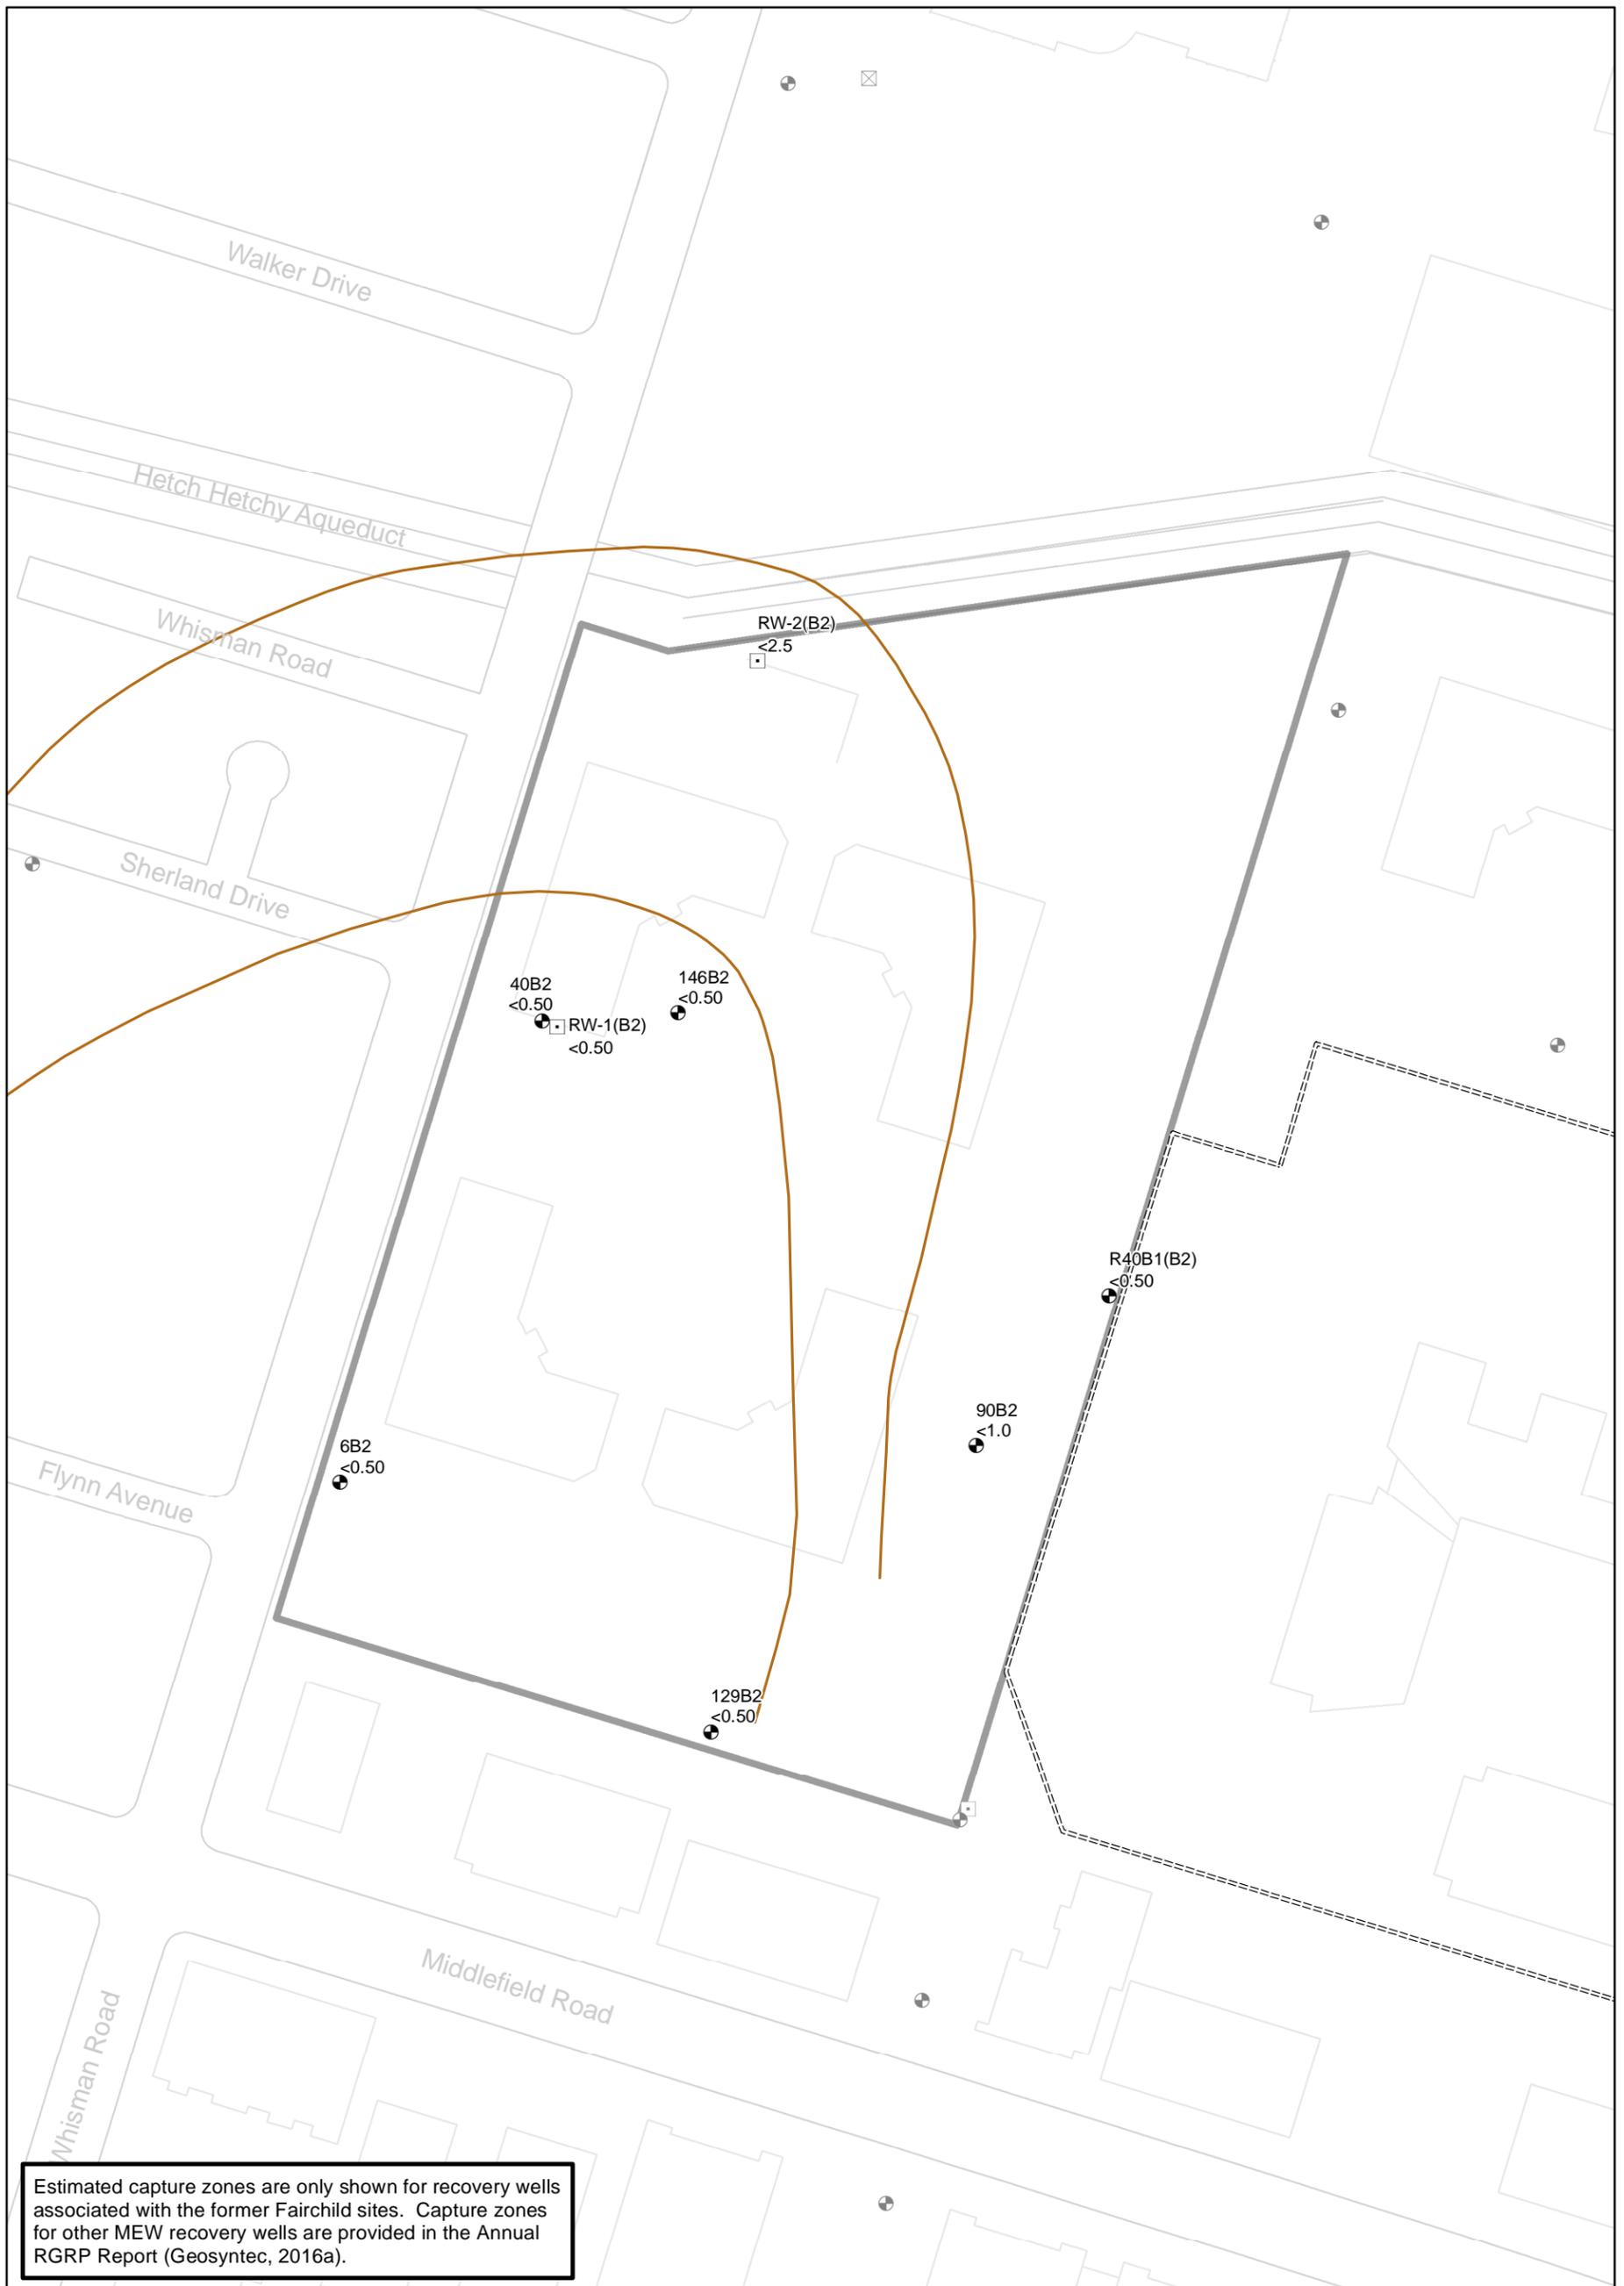
<b>Legend</b> ● Monitoring Well □ Recovery Well On ⊠ Recovery Well Off Notes: PCE = Tetrachloroethene ug/L = micrograms per liter Figure shows only those wells sampled and analyzed for PCE in 2014. Wells not associated with the Former Fairchild Buildings 13, 19, and 23 Site are shown in gray.		<b>PCE Concentration (2014)</b> Light Blue: 5 - 100 ug/L Medium Blue: 100 - 1,000 ug/L Dark Blue: 1,000 - 10,000 ug/L Darkest Blue: Greater than 10,000 ug/L		— Estimated Capture zone (2015) - - - Slurry Wall — Building — Road □ Site Boundary		N  150 75 0 150 Feet 	<b>2014 B2 Zone PCE Concentrations</b> <b>March 2015 Estimated Capture Zones</b> MEW Former Fairchild Buildings 13, 19, and 23 Groundwater Remediation Program Mountain View, California		<b>Figure</b> <b>12d</b>
							Oakland	April 2016
