SUBAREA 6 FSP ADDENDUM
SANTA SUSANA FIELD LABORATORY SITE
AREA IV RADIOLOGICAL STUDY

TO: Craig Cooper, EPA Region 9 RPM
FROM: T. Stewart Williford, HGL Associate Manager
THROUGH: L. Steven Vaughn, R.G., HGL Project Manager
Rene R. Rodriguez, P.E., HGL Deputy Project Manager
CC: Mary Aycock, EPA Region 9 RPM
Nicole Moutoux, EPA Region 9 RPM
Gregg Dempsey, Technical Advisor
DATE: June 29, 2011
SUBJECT: FSP Addendum for Subarea 6
CONTRACT NO: EP-S7-05-05
TASK ORDER NO: 0038

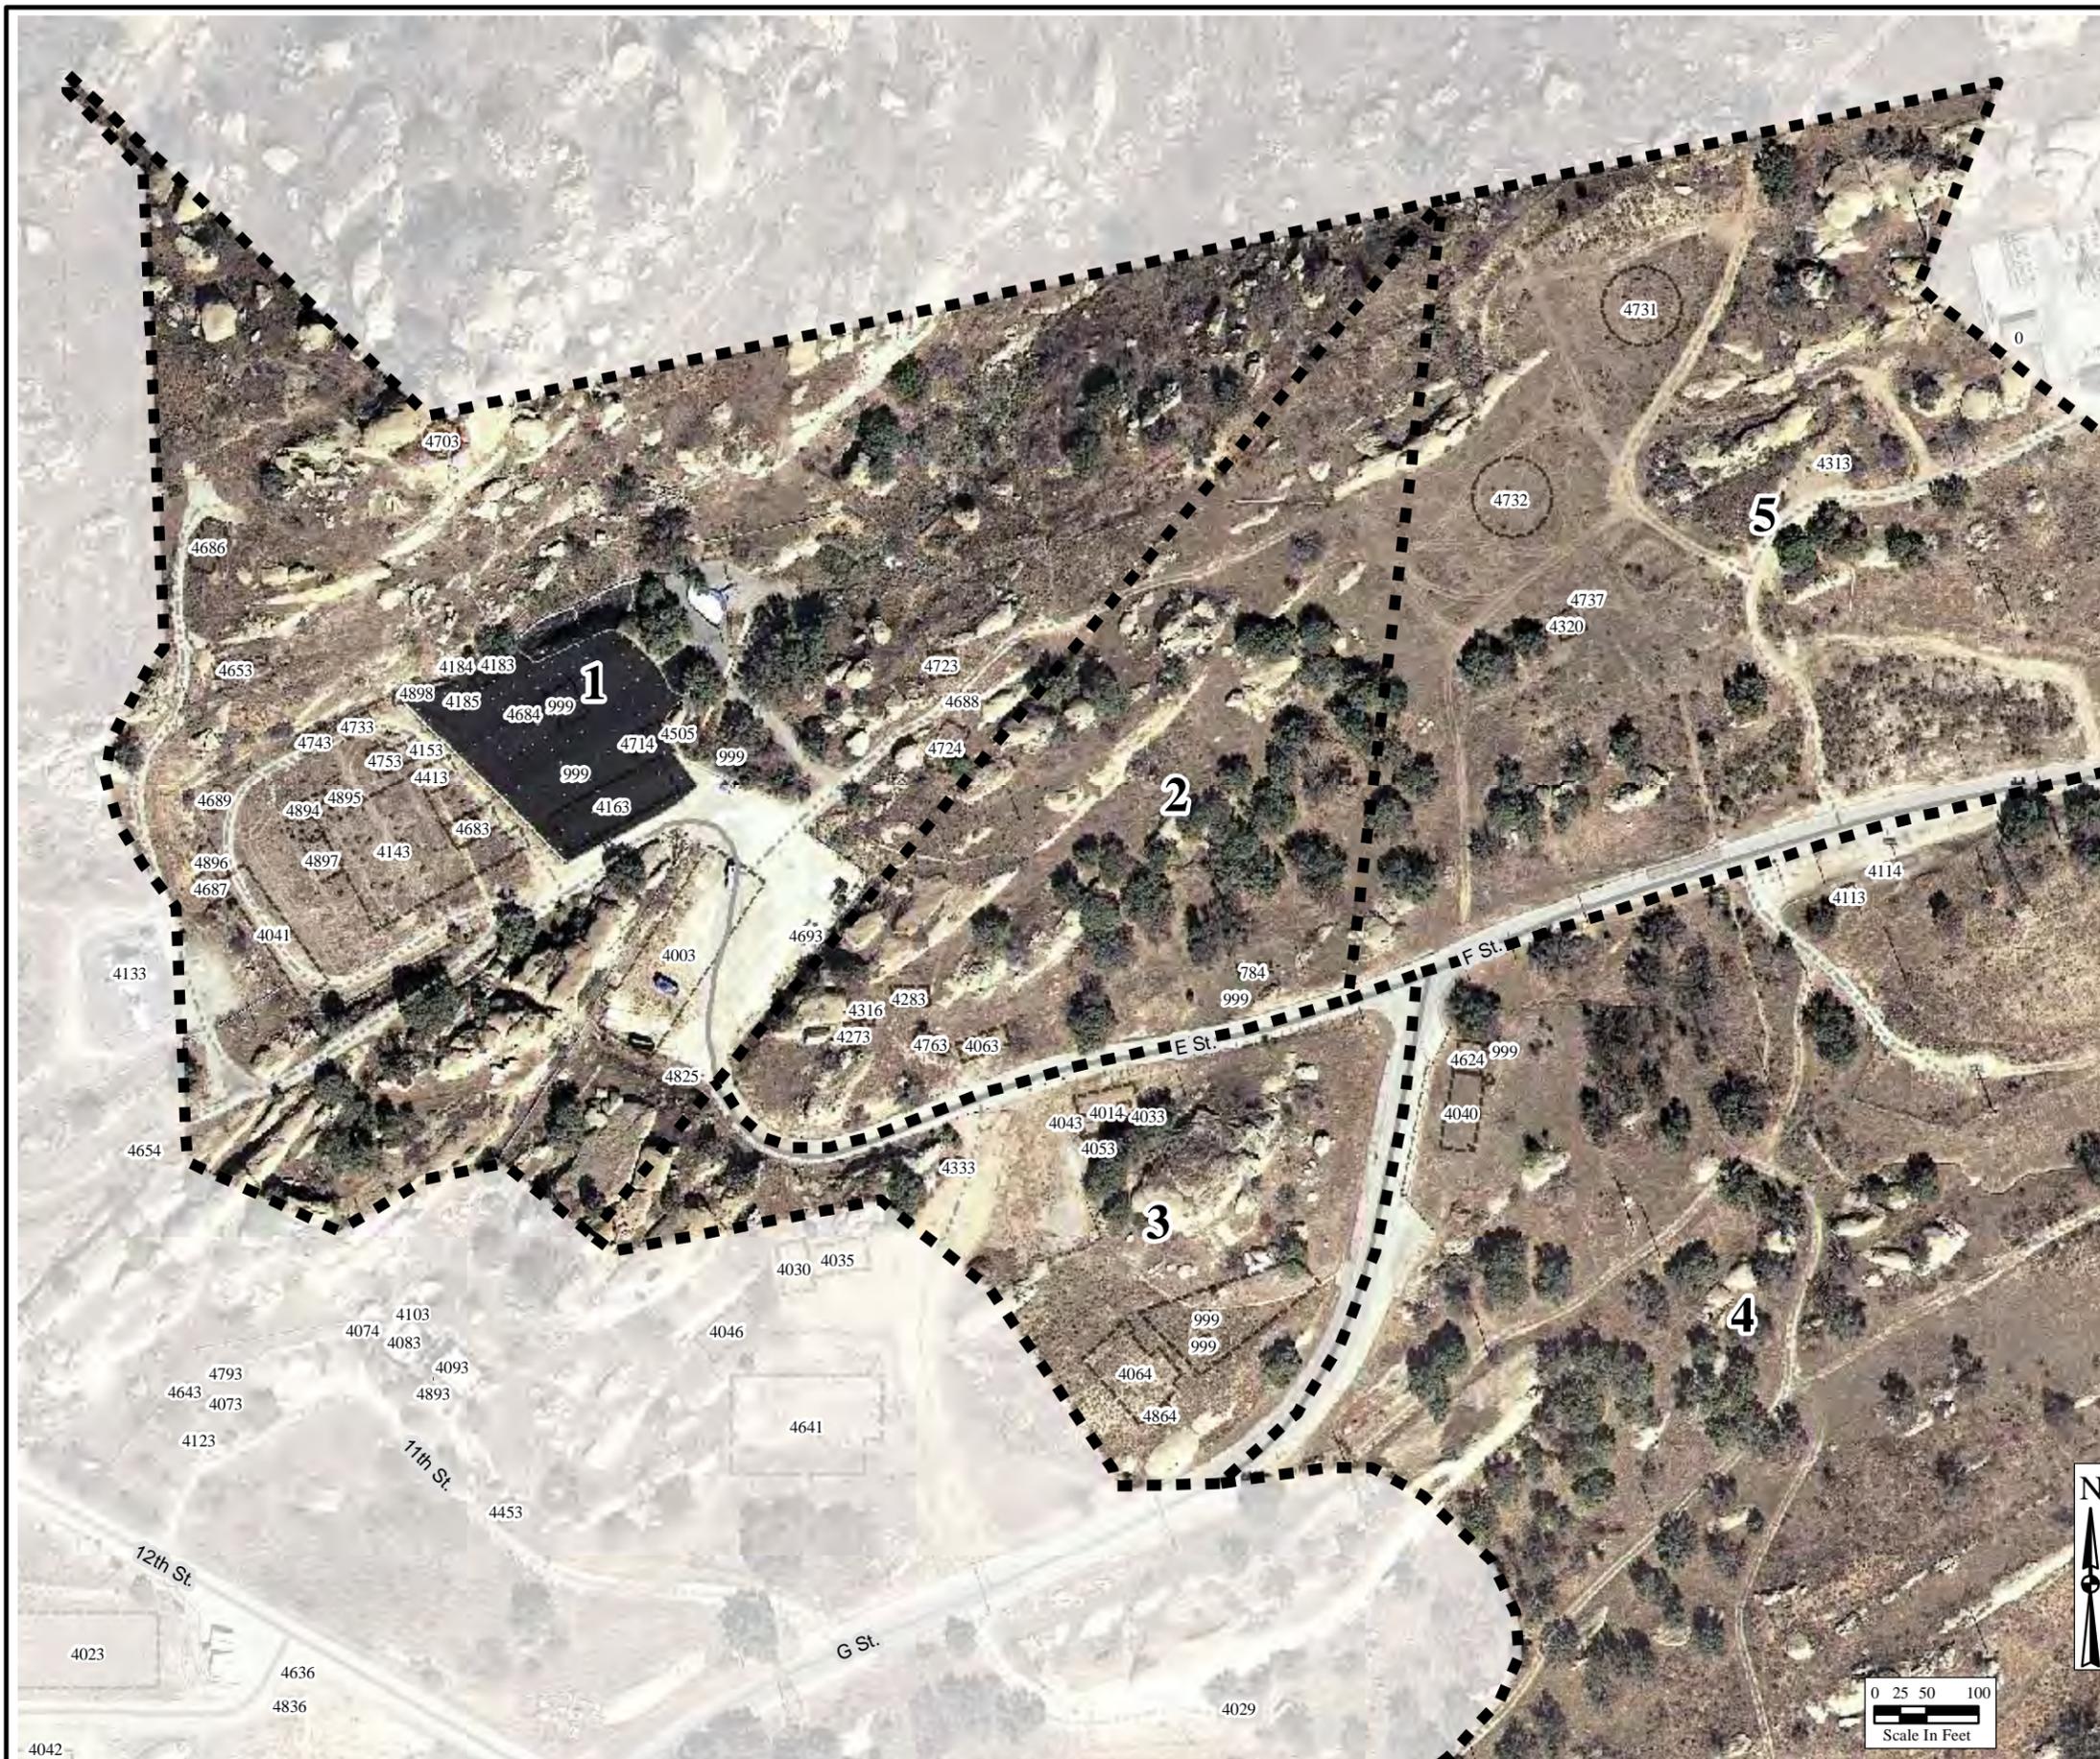
Subarea 6 Groups

Figure 1 provides a base map that shows the location of each subgroup within Subarea 6. The location and type (e.g. surface, subsurface, drainage) of each sample within each of the five Subarea 6 groupings are shown in Figures 2 through 6 in Attachment 2. Table 2 provides a summary of sample numbers by subarea group.

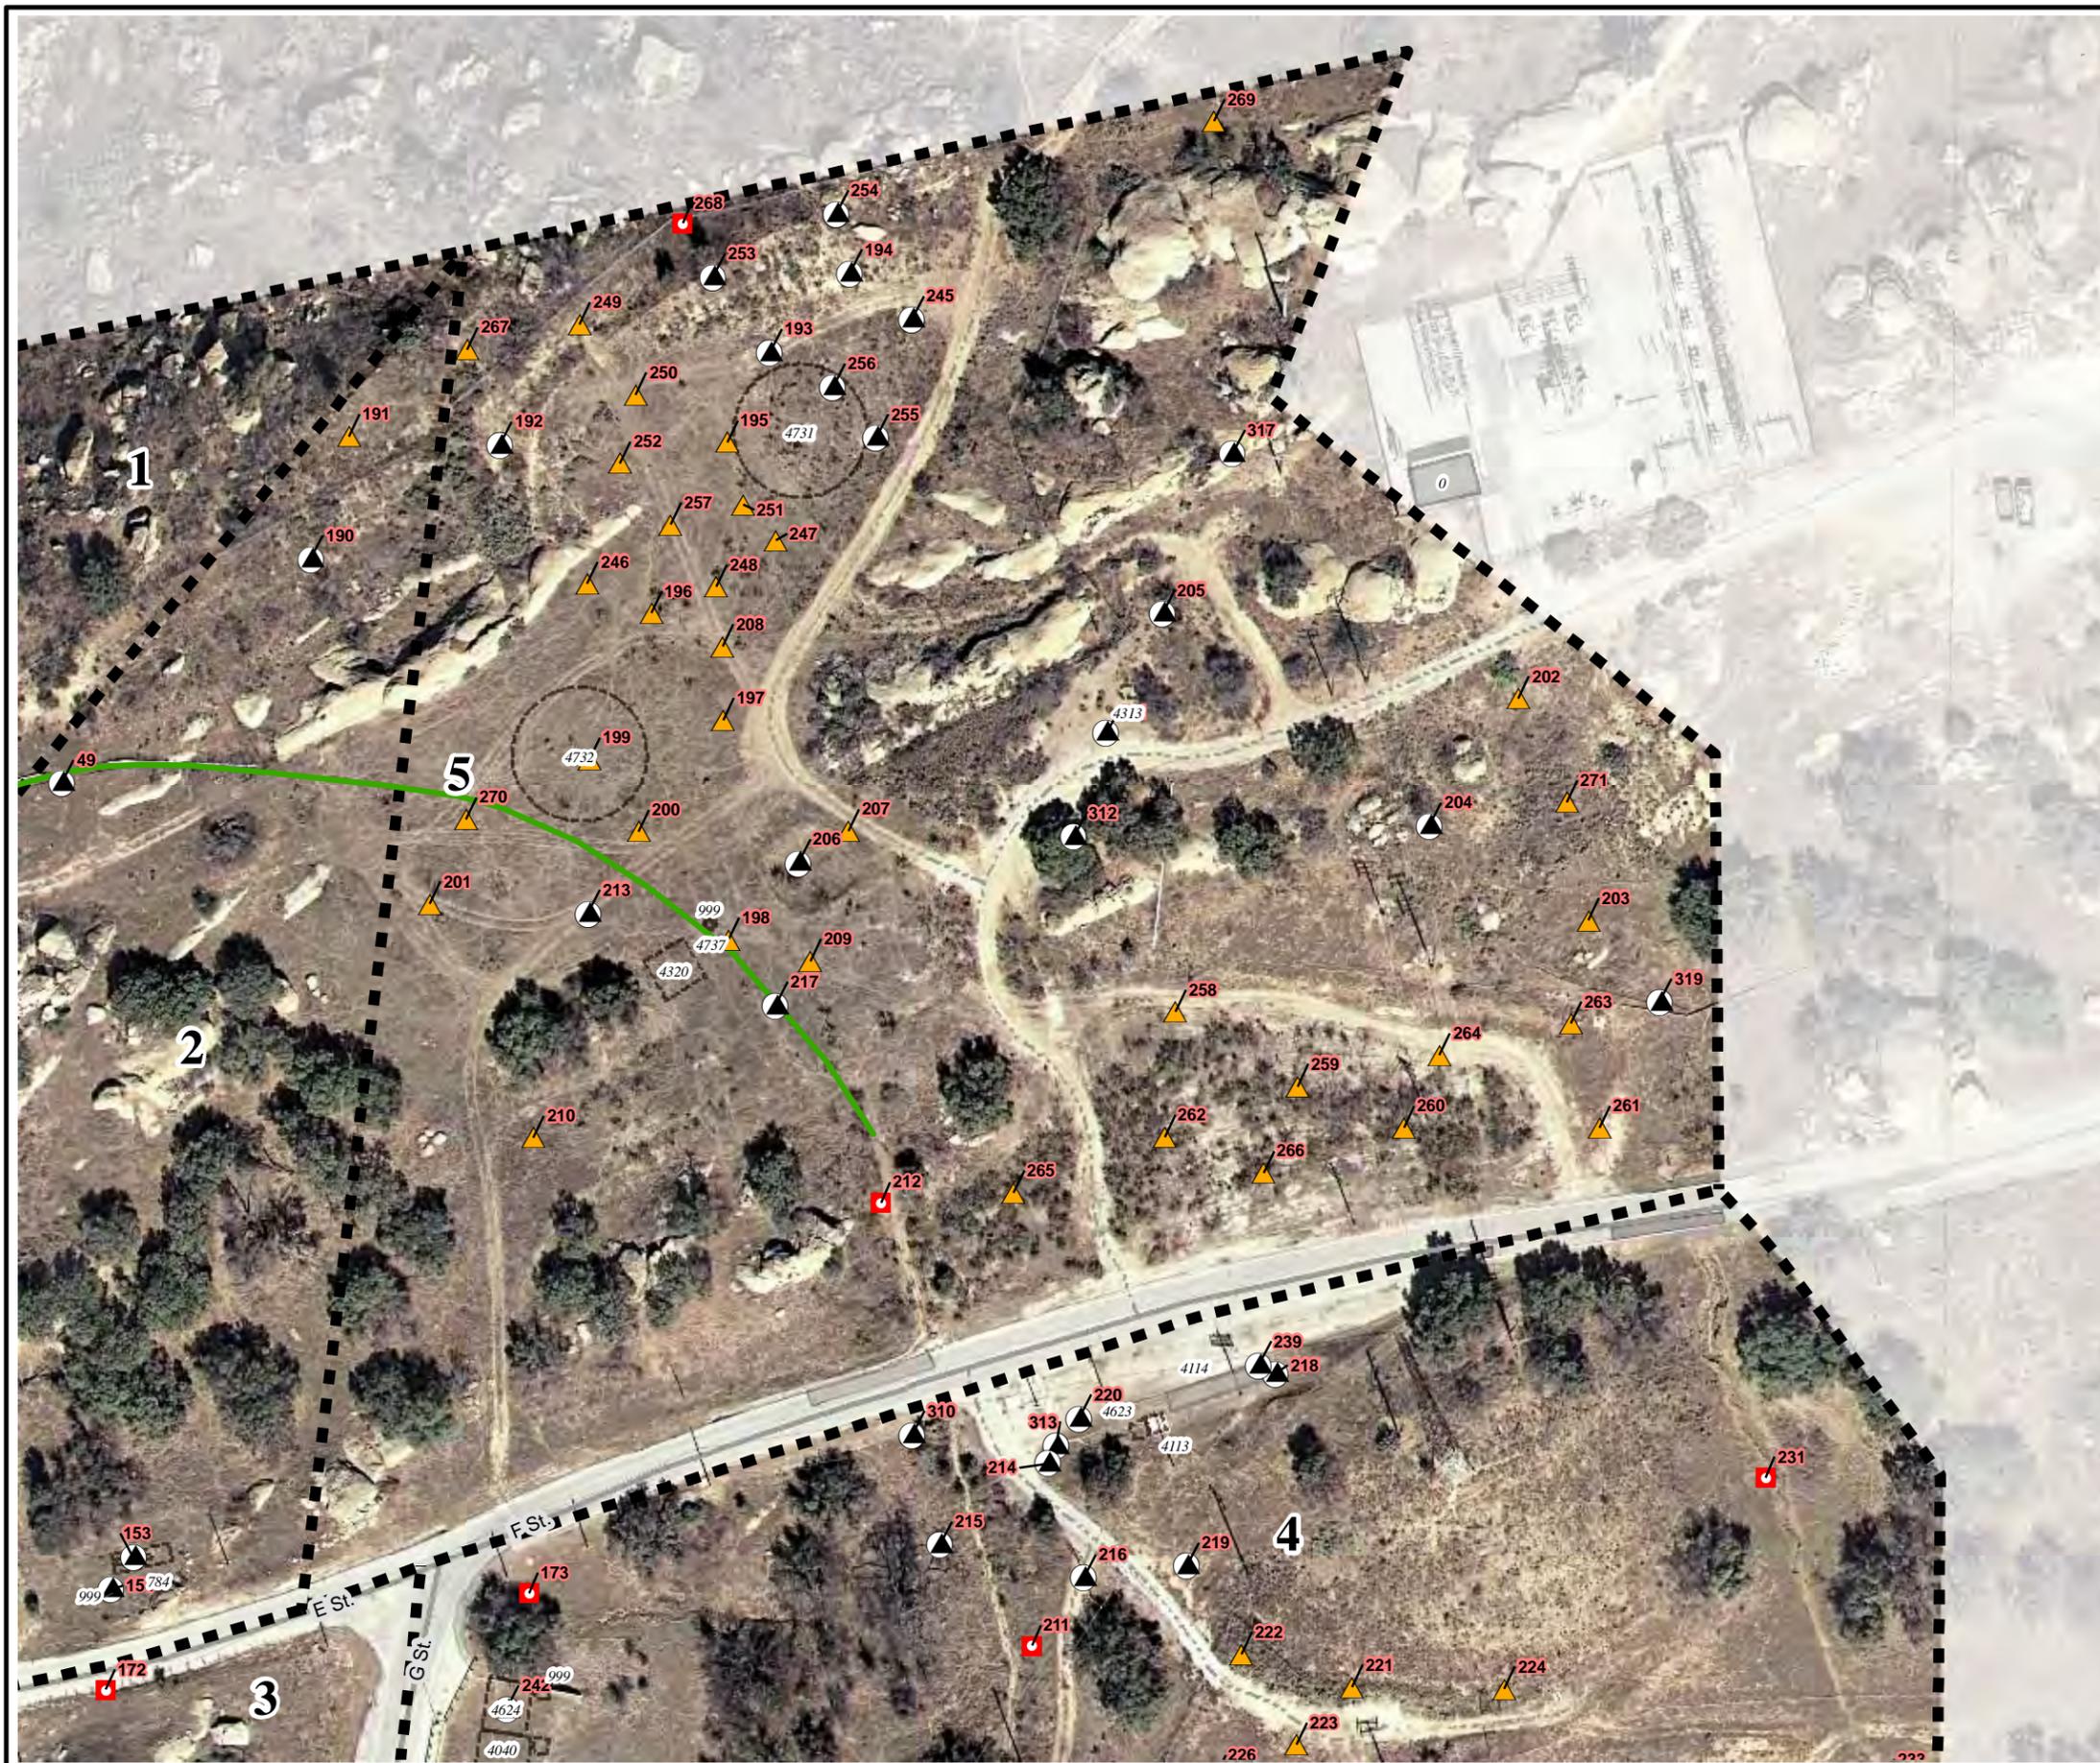
Y:\Santa_Susana\EP9038\temp\triagencymaps\
(6)Group5ProposedSampleLocations_11x17_6SRtransferline.mxd
6/29/2011_sdrallos-kopecky
Source:HGL 2010, CIRGIS 2007

Subsurface Sample

Surface and Subsurface Sample
