**ELECTRICAL HAZARDS
REMOVAL ACTION COMPLETION REPORT
YERINGTON MINE SITE**

August 19, 2010

Atlantic Richfield Company

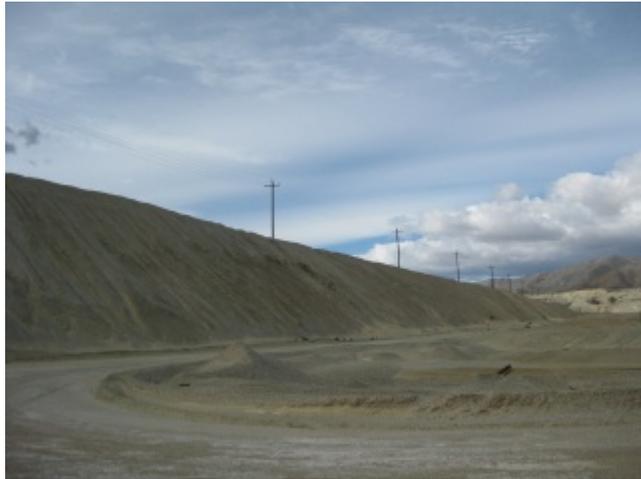
The approximate 3,000-foot northeast extension of the north distribution line (the portion between the Unlined Evaporation Pond and the Sulfide Tailings that extends to the Pumpback Well System (PWS) no longer had active service requirements, with the exception of providing power to air monitoring station AM-5. This extension (Photo 2-1) connects to the north distribution line at a tap junction, and remains charged to serve the VLT pump station, the Mega Pond and the Blue Shop.

Photo 2-1.
Northeast extension overhead power line located along sulfide tailings embankment (looking southwest).

On January 13, 2010, PAR reconnected the dangling wire to the cutout switch, and left the fuse doors open but still attached for both cutouts (Photo 2-3). This would allow for availability of electricity to the AM-5 location, if needed. The northeast extension of the north distribution power line, shown in Photo 2-1, is still energized.

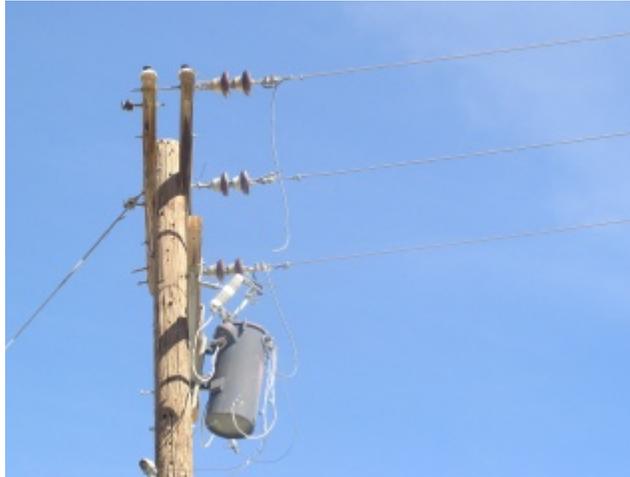
A pole-mounted transformer, removed from service by opening one of the fuse connectors, is attached to the last power pole along the extension. Because the primary connection on one of the lines was loose, it was subject to wind movement and potential contact with one of the other lines on the pole, which could result in faulting, arc flash or service disruption on the remainder of the line (Photo 2-2).

Photo 2-2.
Dangling wire on terminal pole near transformer (pre-removal).

ARC proposed to re-attach the dangling electrical wire to the fuse cut-out and remove the power pole cut-out fuses from the transformer in order to be able to re-store electrical power to air monitoring station AM-5. This approach would allow for the potential re-activation of AM-5 if needed, and would eliminate the potential electrical hazard associated with the dangling wire.

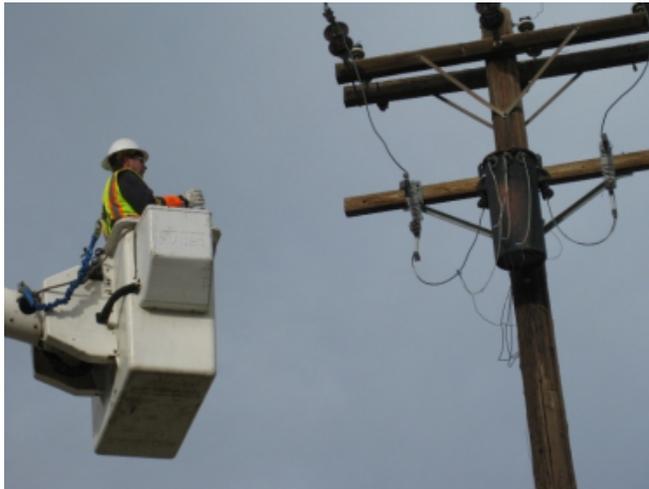
Photo 2-3.
Dangling wire was reconnected, and the fuse cutout switch doors left attached but open. (1/13/10)

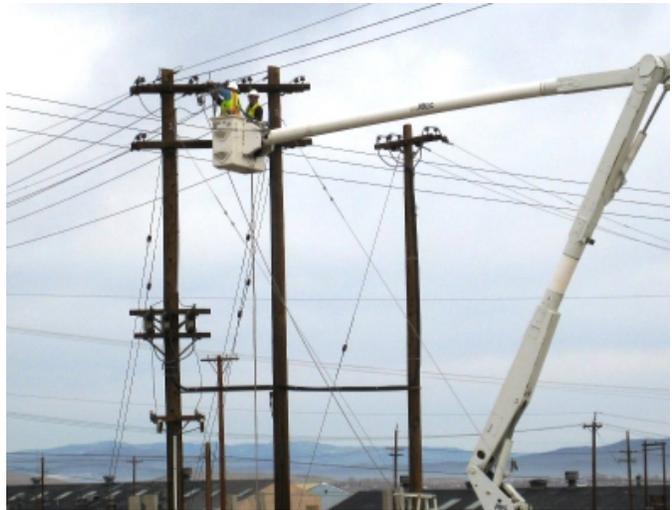
Photo 3-1.
Attaching guy wires and moving jumpers to southeast power line. (1/14/10)

Removal of the South Distribution Line was completed by PAR Electric from January 14 to 19, 2010. To complete this activity, PAR de-energized the entire south side electrical service at the Site substation, and transferred jumpers to the southeast line to allow continued power service to the Phase I pond and pumps after the system was re-energized. Initial planning documents for the Removal Action Work Plan identified these power lines as 4,160 alternating current (AC) volts. However, during the removal action they were confirmed to be 2,400 AC volts as are all other distribution lines on the Site. PAR installed guy wires on the twin poles at the lab transformer to provide strength and stability once the south lines were disconnected and removed (Photo 3-1).

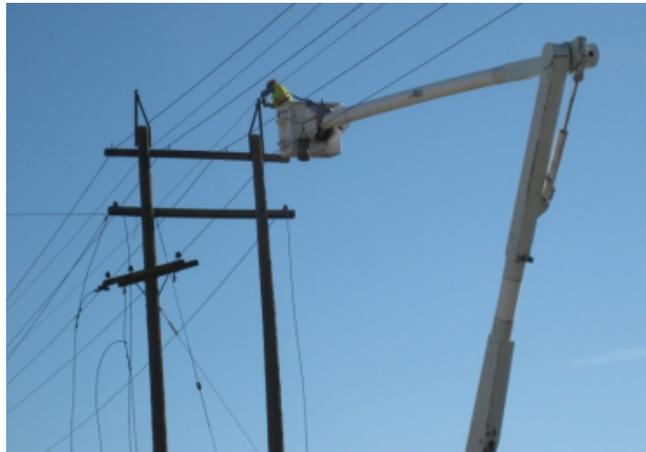
Photo 3-2.
Disconnecting wire and removing insulators from power poles. (1/15/10)

Six 0000 gauge copper wire lines and two steel wire lines were disconnected from the insulators and the insulators were removed from each of the twin poles for the entire length of the south distribution line from the lab transformer to the end poles located near the Slot Heap Leach Pad. Poles were primarily accessed with the use of a bucket truck (Photo 3-2), but several poles had limited access and the linemen climbed the poles using standard climbing safety procedures and equipment (Photo 3-3).

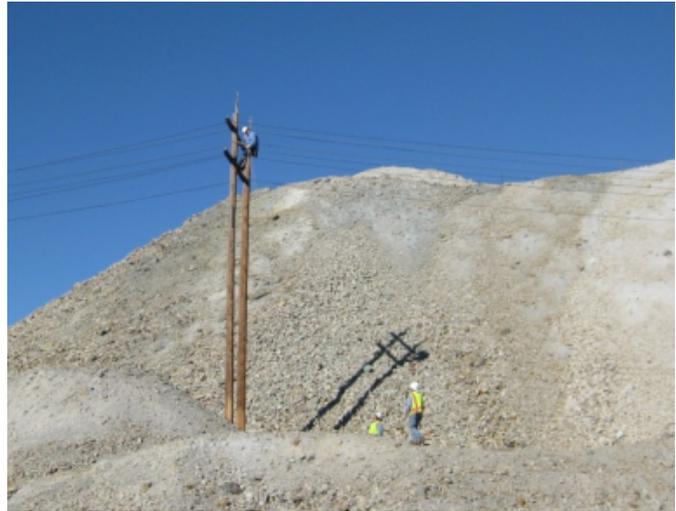
Photo 3-3.
Climbing poles where bucket truck could not access. (1/15/10)

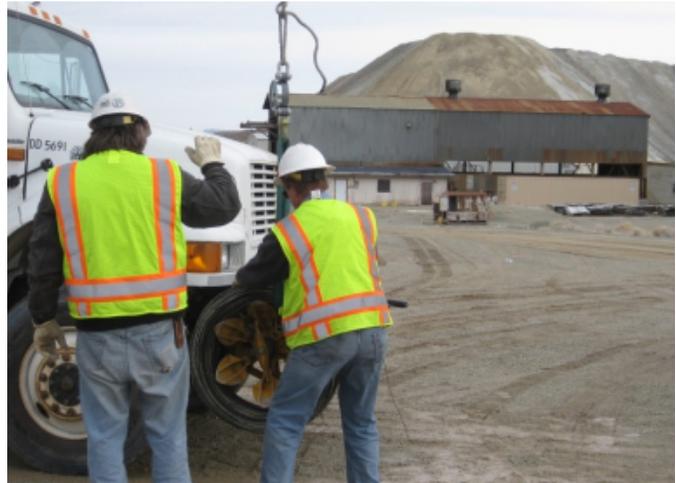
Photo 3-4.
Coiling of wire using spool mechanism on line truck. (1/15/10)

The disconnected wire was gathered into coils of approximately 300-350 foot lengths using a spool mounted to the front bumper of the line truck (Photo 3-4). The coils were placed on wood pallets and stored in a secured cargo container on the Site. (Photo 3-5). Power poles were left in position because they do not represent a safety hazard for continues site activities (Photo 3-6), however, it is recommended they be inspected and evaluated for suitability if they are to be reused for re-installation of power lines in the future.

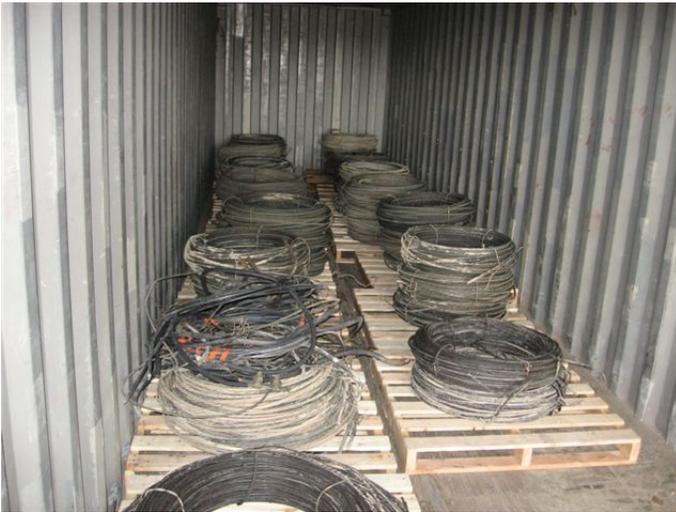
Photo 3-5.
Pallets of coiled wire in a secure storage area. (1/20/10)

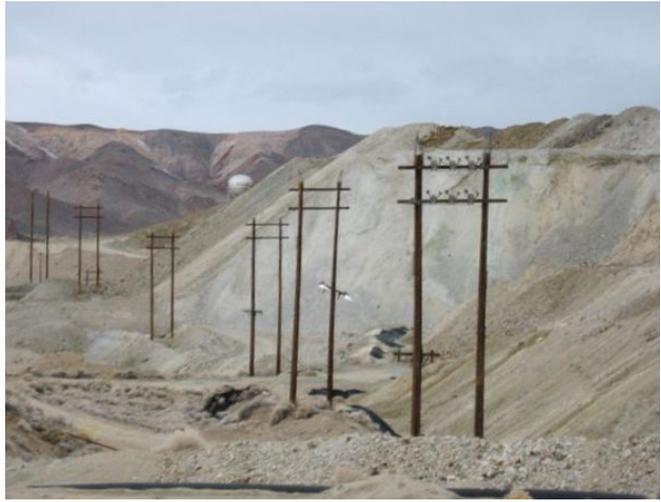
Photo 3-6.

Remaining power poles with wire and insulators removed at completion of job. (1/20/10)

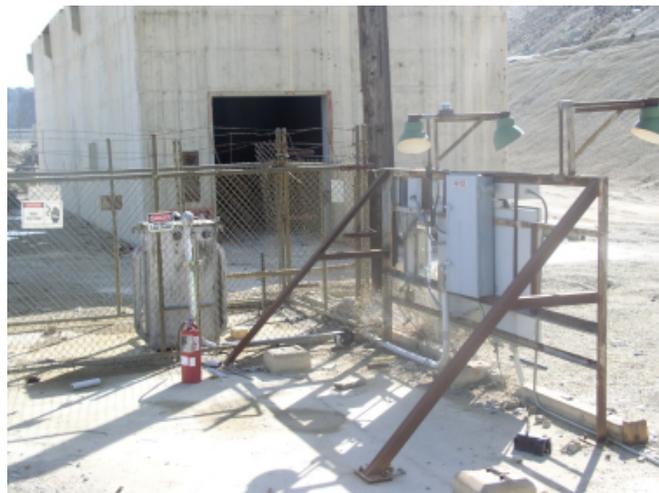
The Mega Pond and associated pump station were used to collect and transfer drain-down solutions from the Arimetco Phase III South Heap Leach Pad, including fluids collected in the leak detection system (Photo 4-1). In 2007, EPA replaced the Mega Pond with a French drain that allowed the fluids to flow by gravity, which eliminated the need for electrical power to this location. The distribution lines and electrical panels to the Mega Pond facilities are still energized, resulting in a potential safety risk to Site workers.

Photo 4-1.
Mega Pond pump station transformer and electric service panels.

The determination was made in December 2009 that pumping capability at the Mega Pond sump would not be necessary for the FMS because: 1) the Mega Pond had been removed; 2) the only solutions entering the sump would be small amounts of leak detection solutions during storm events; and 3) these volumes could be managed by alternative methods, if needed. The decision was made to remove the electrical control panel and transformer during Phase I removal activities. On January 13, 2010, PAR de-energized the north distribution line and opened the cutout switch to isolate the Mega Pond transformer. The transformer was disconnected and removed from the fenced enclosure using the crane on the line truck to lift it over the fence and set it nearby behind the crusher building, where a similar transformer is stored.

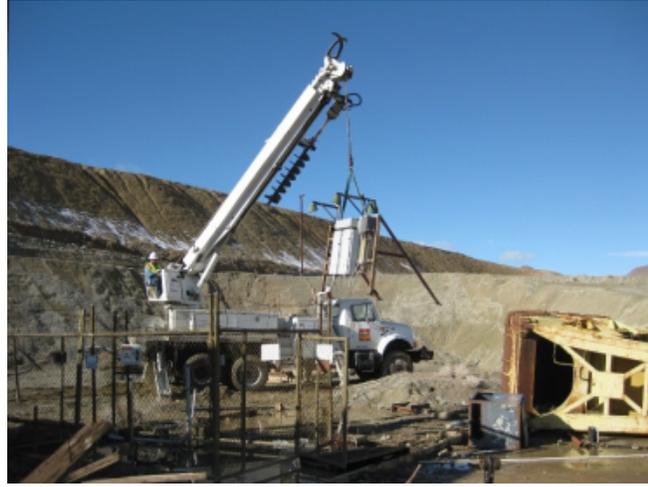
Photo 4-2.

Removal of the electrical control panel using the line truck crane. (1/13/10)

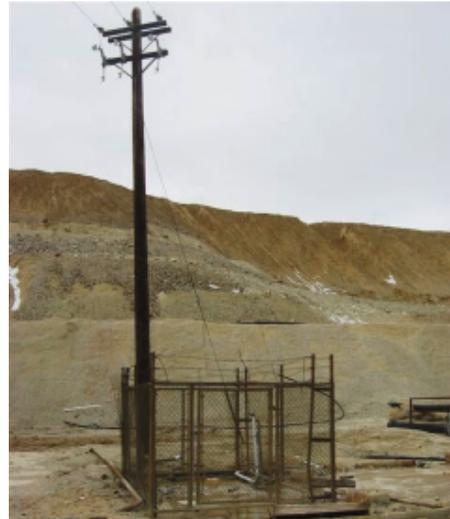
Photo 4-3.

Mega Pond transformer area after transformer, control panel and pole conduit have been removed. (1/13/10)

EPA tested the oil in this transformer during their transformer removal activities in 2006, and had marked this transformer as free of non-polychlorinated biphenyl (PCB). The wires to the electrical control panel were pulled, and the entire structure of the panel was removed in one piece by cutting it from the anchor bolts in the concrete pad (Photo 4-2). The control panel was moved to a secure storage area on the Site. The conduit that was attached to the side of the power pole for carrying electrical lines from the overhead wire to the transformer was removed and set aside (Photo 4-3).

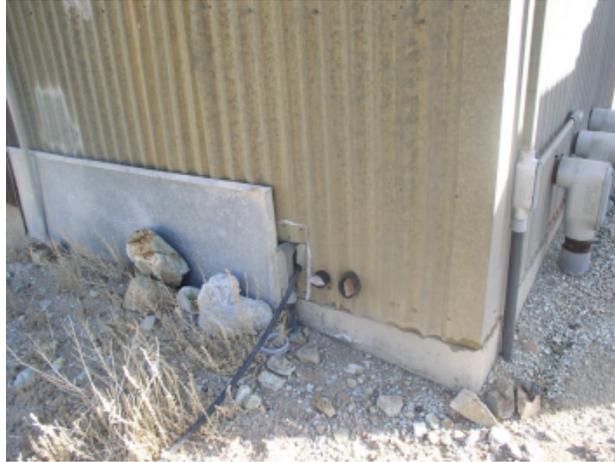
Photo 5-1.

Electrical service to the Slot Pond pump station consisted of a heavy-duty service cord suitable for outdoor applications with an oil-resistant outer jacket (SO-type cable), which has been installed on the ground surface where it is exposed to potential damage from vehicle and/or foot traffic. The cable enters the electrical equipment building through an unprotected opening in the metal siding on the west side of the building (Photos 5-1, 5-2 and 5-3).

This cable serves a pump starter which has been set in place as a temporary installation for the purpose of transferring drain-down solutions from the Slot Pond. The cable is not adequately protected and is subject to damage, which could result in: 1) temporary loss of power to the pump, inability to transfer fluids out of the pond and possible loss of containment; and 2) Site worker exposure to hazardous electrical shock/arc flash.

Unprotected cable as it enters the electrical equipment building at the Slot Pond.

On March 1, 2010, trenches were constructed at the Slot Pond to place wire in protected conduit below the traffic area. New fused disconnect switches were installed, and new wire was placed in buried conduits (Photo 5-4). Surface mounted weather proof safety switches on pump house exterior provide Lockout/Tagout (LOTO) safety levels and well as conduit termination points. The original cable was re-attached at the pond J-Box (Photo 5-5) so motor starter pedestal location could be flexible.

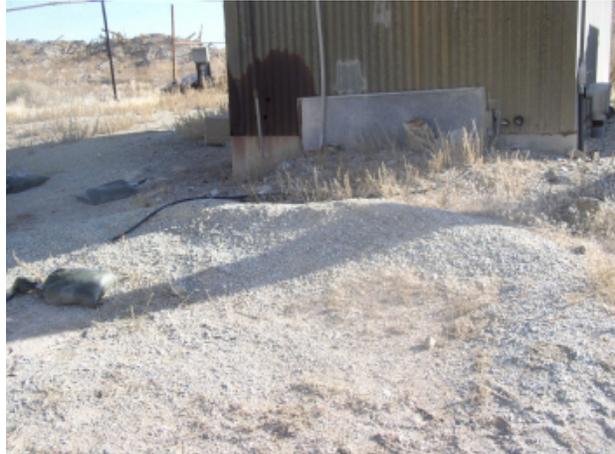
Photo 5-2.

Unprotected electrical cable on the ground surface as it crosses the roadway towards the pump motor starter.

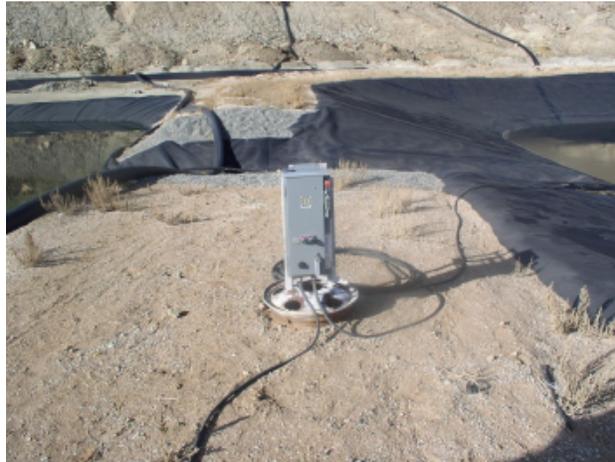
Photo 5-3.

Pump motor starter for the 20-horsepower pump in Slot Pond.

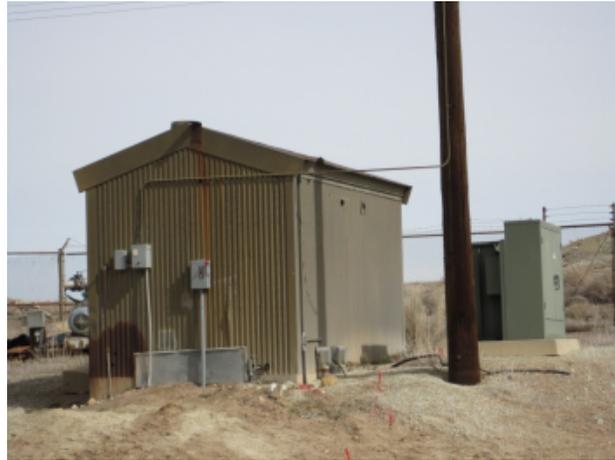
Photo 5-4.

New Fused Safety Switch with conduit riser.

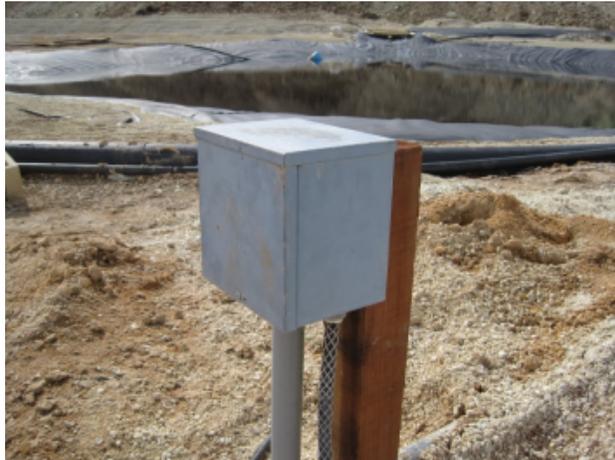
Photo 5-5.

Motor starter termination J-Box enclosure at pond side.

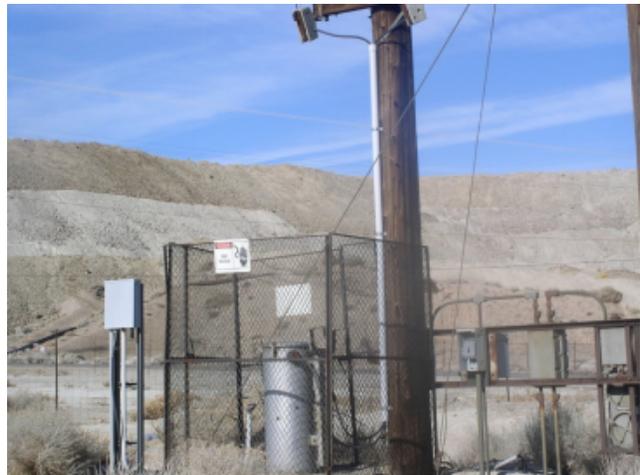
Photo 6-1.
Lab Building transformer.

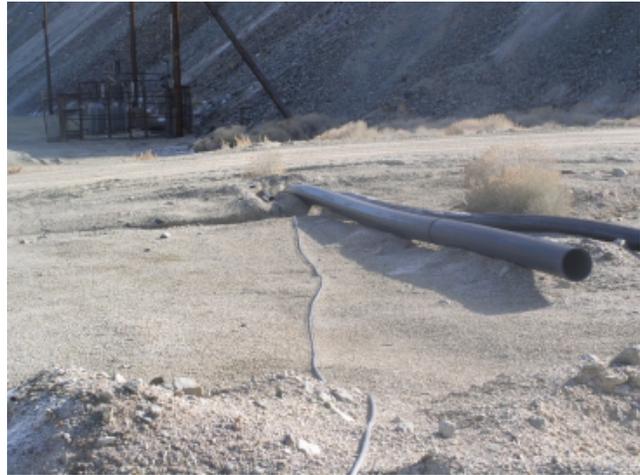
Photo 6-2.

The service cable (120/240 AC volt) to the Lab Building is an SO-type cable designed for heavy-duty outdoor service, and was installed on the ground surface where it is exposed to potential damage from vehicle or foot traffic (Photo 6-2). The cable is locally protected in a shallow buried conduit as it crosses the roadway (Photo 6-3), but is unprotected as it enters the Lab building. The cable is subject to damage, which could result in electrical shock/arc flash and/or service disruptions that could jeopardize the use of stored samples.

Unprotected electrical cable on ground surface and entering conduit as it crosses roadway.

On March 1, 2010, 180 feet of trench was constructed for installation of new 1-1/2" Polyvinyl Chloride (PVC) conduit from transformer to Lab Building exterior wall. Number 2 type water resistance wire was installed in the conduit. The electrical service to the building was increased to accommodate an additional storage facility, if needed (Photos 6-4, 6-5, and 6-6).

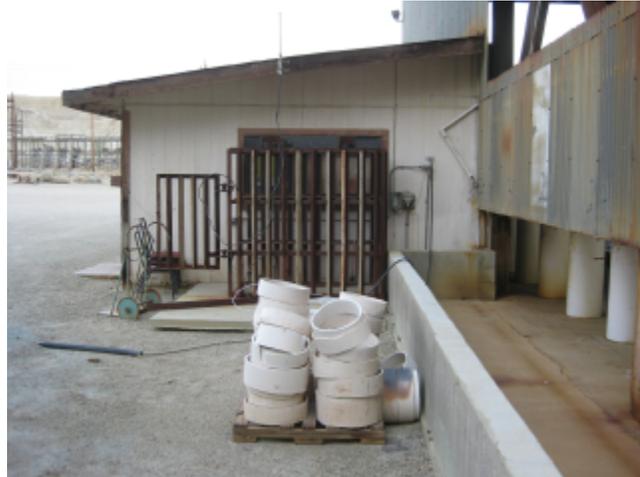
Photo 6-3.

Unprotected electrical cable exiting conduit and entering the south side of the Lab Building.

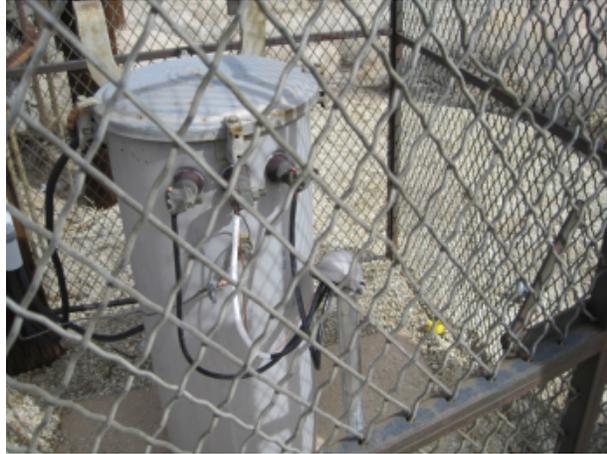
Photo 6-4.

Transformer No 2 wire for full 100 Amp service

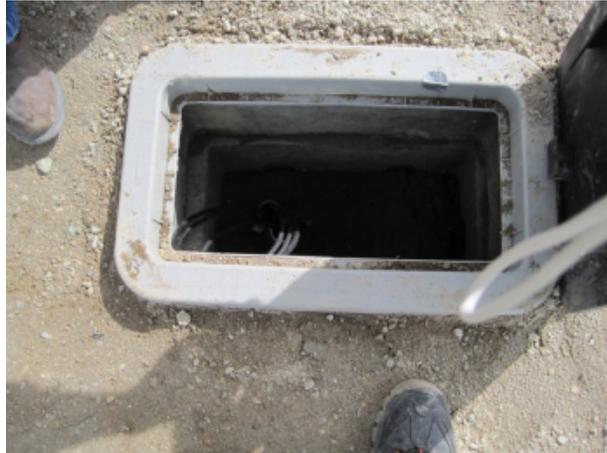
Photo 6-5.

Two Pull Boxes installed

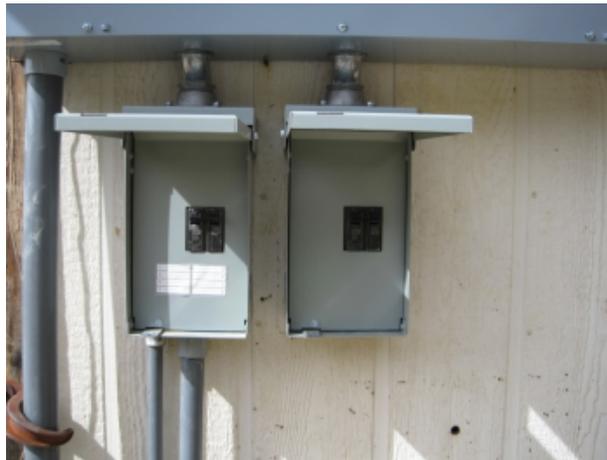
Photo 6-6.

Lab service termination into wireway with one disconnect switch, providing a new building main. A second safety switch was installed to service additional storage facility, if needed.

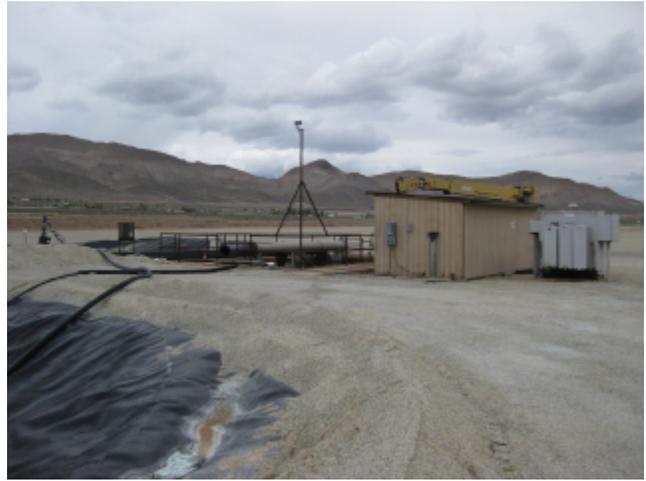
Photo 7-1.

The VLT Pond pump station service cable consists of heavy-duty service cord suitable for outdoor applications with an oil-resistant outer jacket (SO-type cable). The cable was installed on the ground surface, where it is exposed to potential damage from vehicle and/or foot traffic, and enters the electrical equipment building through an unprotected opening in the metal siding on the west side of the building (Photo 7-1). The cable serves a pump starter (Photo 7-2), which is temporary installation to assist in the transfer of drain-down solutions from the VLT Pond to the FMS Evaporation Pond via a 20-hp pump (Photo 7-3). In addition, a priming pump is operated by plugging an extension cord into a non-weather proof outdoor outlet at the switchbox. The identified potential hazards at this location include: 1) inadequate cable protection and potential damage; and 2) the extension cord plugged into a non-weather proof and non-GFCI outlet creates a risk of electrical shock to Site workers.

VLT pumping station looking northwest with electrical equipment building and encased transformer.

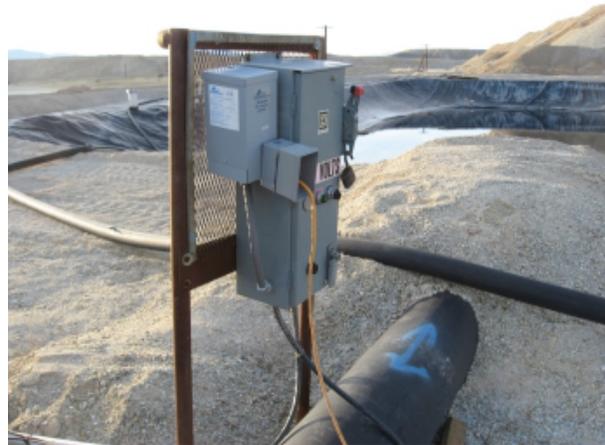
Photo 7-2.

VLT pump starter with GFI receptacle and associated step-down transformer.

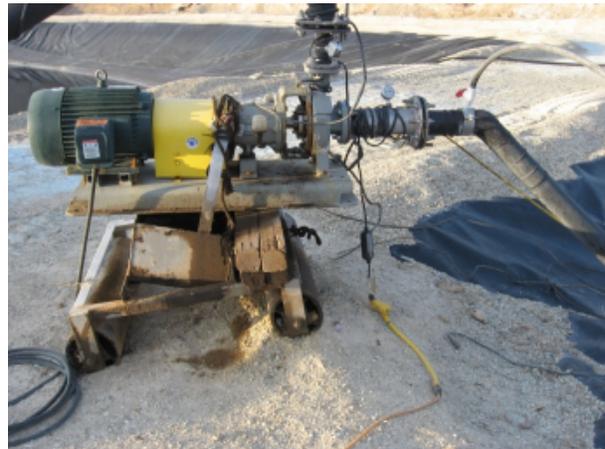
Photo 7-3.

20-horsepower pump

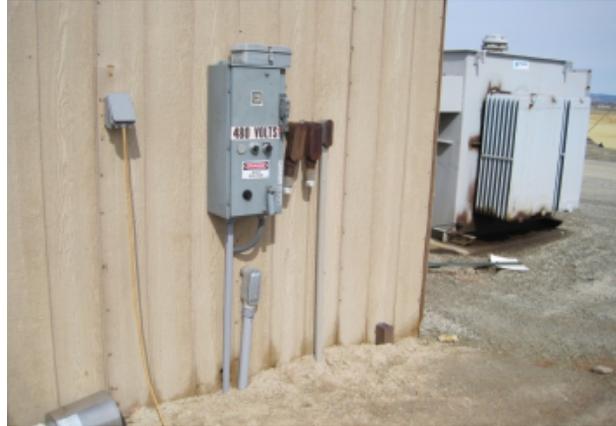
Photo 7-4.

New conduits dress out of the VLT Pump Building and routed below grade. GFI receptacle was relocated the building wall.

On March 1, 2010, trenches were constructed at the VLT to place wire in protected conduit below the traffic area. New wire placed in buried conduits (Photo 7-4). A surface-mounted weatherproof J Box for connecting the pump panels was set on red wood post. The original cable was re-attached at the starter (Photo 7-5). The EPA transfer pump was repositioned and secured (Photo 7-6).

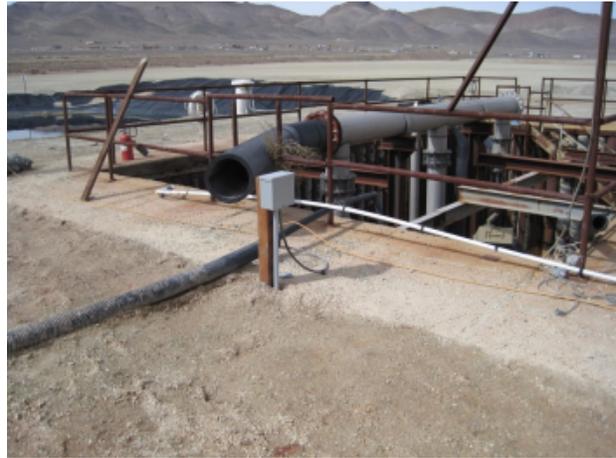
Photo 7-5.

Pump interconnect J-Box provided a protected installation.

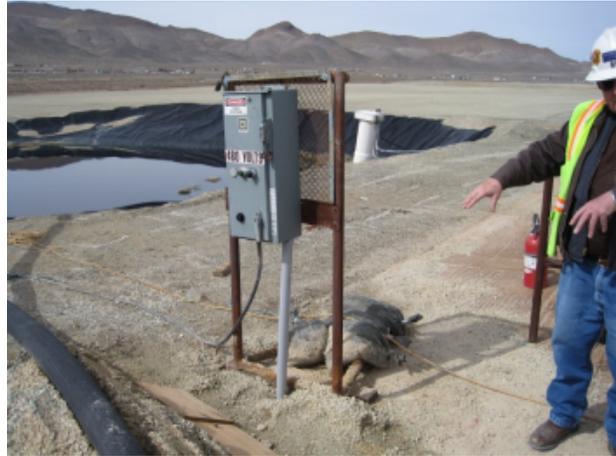
Photo 7-6.

Pump feed conduit riser to pump starter from Pumphouse.

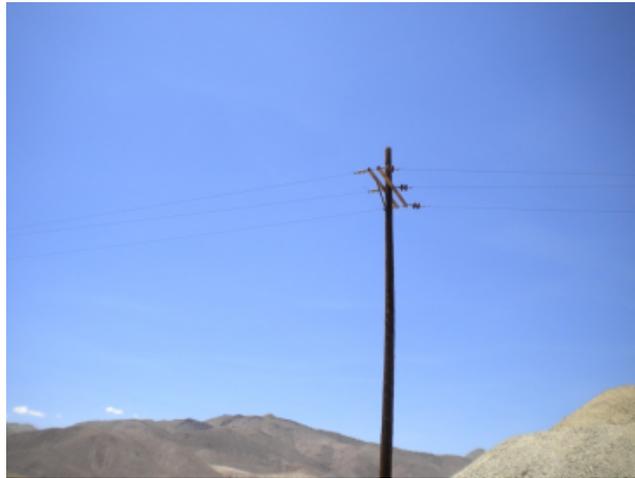
Photo 8-1.

The two cross-arms on the power pole have been separated, and the jumper wire was set over each insulator have been removed by NV Energy.

This activity was completed during Phase 1A of the removal action on January 13, 2010 by PAR. Prior to completing this wire removal activity, NV Energy detached the site wire from the utility owned pole located at the mine boundary fence. PAR used the bucket truck to access the poles to detach three parallel strands of #4 bare copper wire from the insulators and remove the insulators from the pole, leaving the pin attached to the pole (Photo 8-2). The insulators were also removed from the transformer bank location (Photo 8-3). The wire was coiled and banded into approximate 300-350 pound coils, which were placed on pallets and put into a secure storage area (Photo 8-4). Poles were left in place (Photo 8-5).

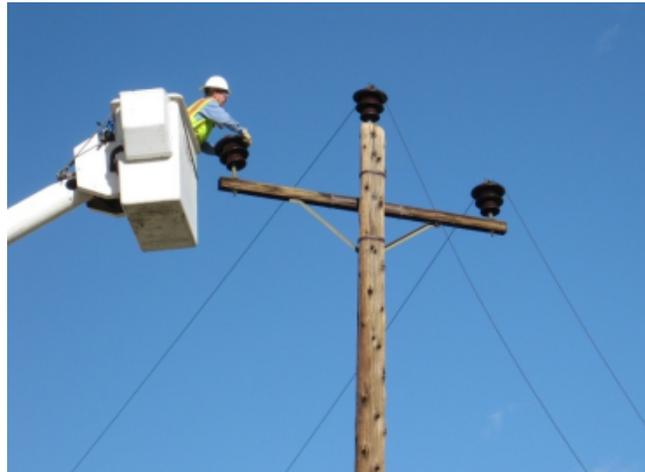
Photo 8-2.

Disconnecting the wire and removal of insulators. (1/13/10)

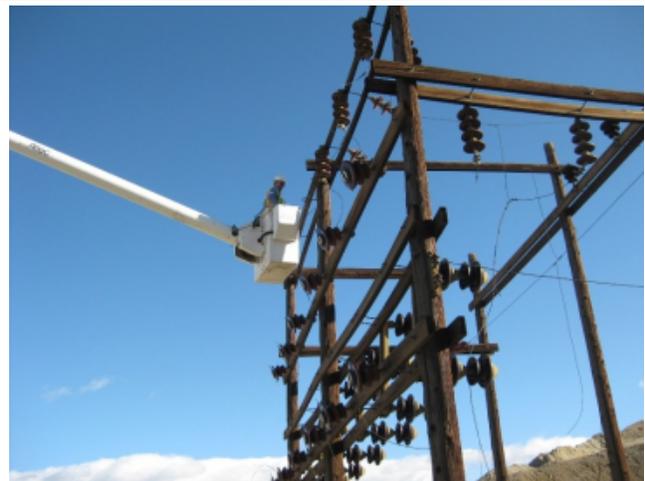
Photo 8-3.

Removing the insulators at the old transformer bank location at north end of Phase III power line. (1/13/10)

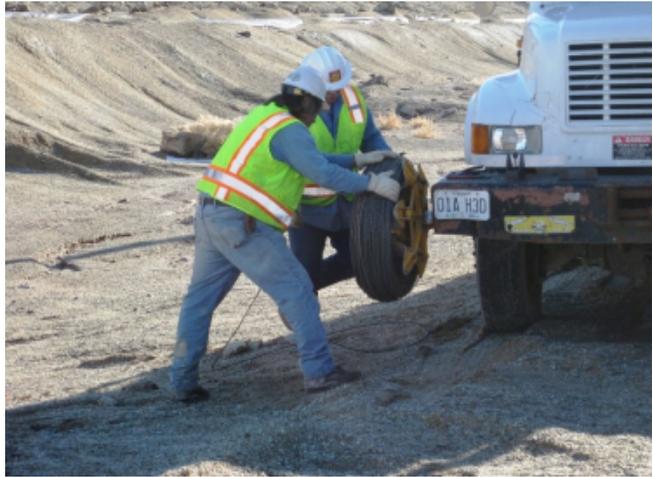
Photo 8-4.
Coiling the wire. (1/13/10)

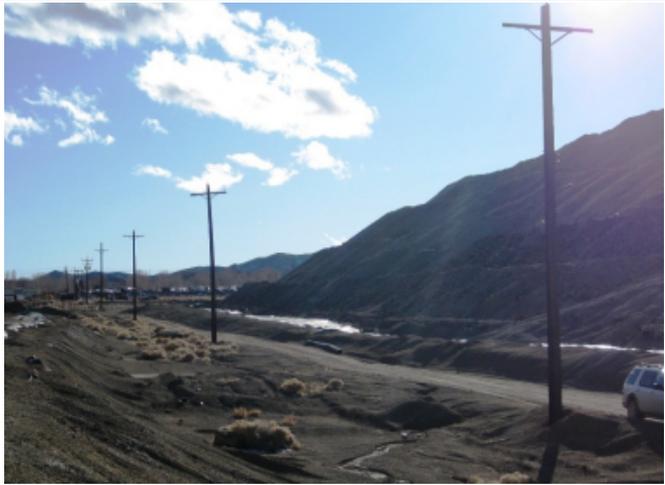
Photo 8-5.
Remaining power poles after power line removal was completed. (1/13/10)

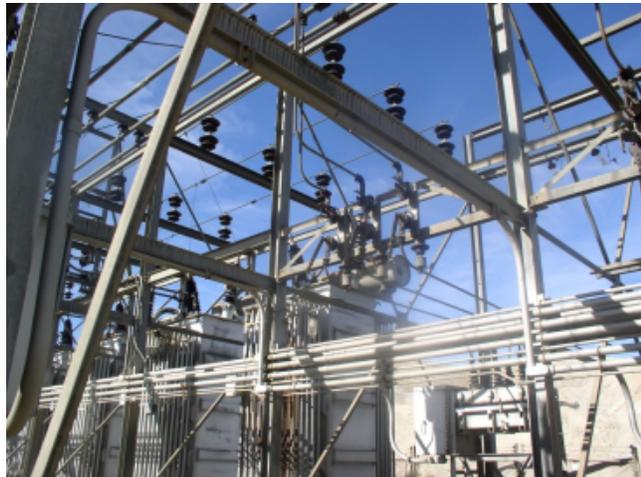
Photo 1-1.

Electrical service provided by NV Energy through the Site substation supported a 5 mega-volt-ampere (5,000 KVA) demand. A load survey estimated a much lower demand for the Site. The substation originally supported eight distribution lines. Only the north and south overhead distribution lines remained active prior to the removal action. The substation received little or no maintenance over the past 10 years, and the condition of the equipment was not known. If the equipment sufficiently degraded since it was last maintained, operational efficiency and safety issues could result. Photos 1-1, -2 and -3 show the substation and interior of the control center.

Site substation and transformers, located on Burch Drive.

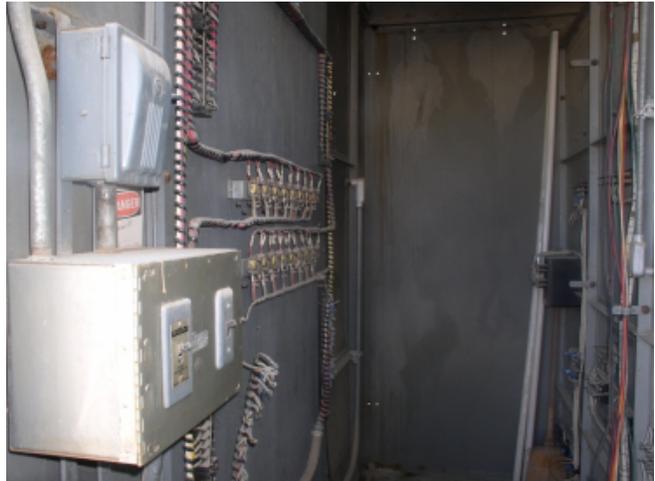
Photo 1-2.
Substation control center

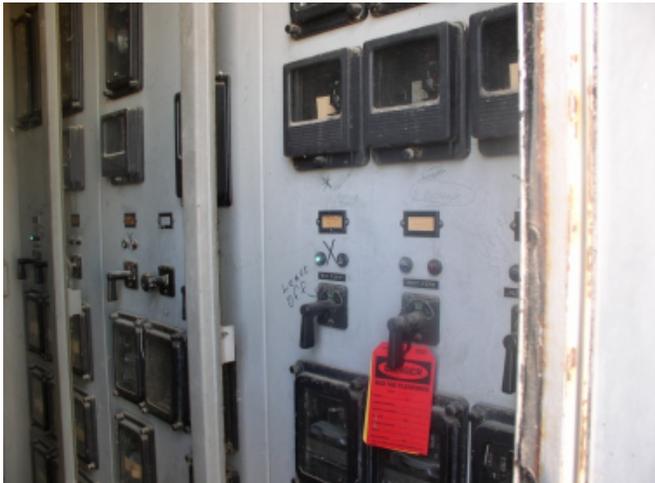
Photo 1-3.
Control center (inactive meter recorders)

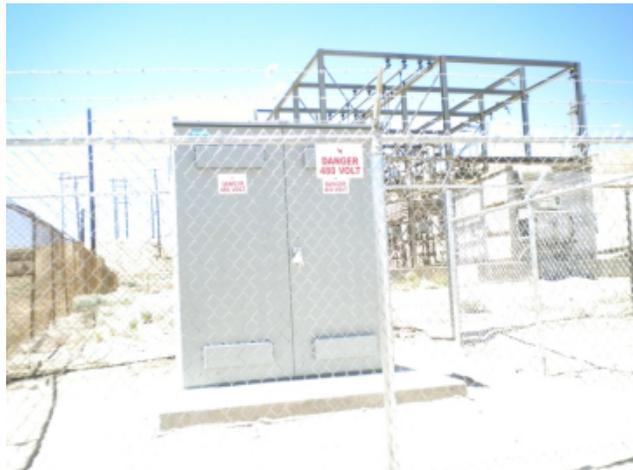
Photo 1-4.
New Switchboard with security fence.

Trenching and the installation of conduits occurred during the period April 20 through May 4, 2010. The sub-grade for new transformer pads, and the concrete pour of the pads, occurred through May 7, 2010. There was a delay in receiving all three transformers, and the last transformer arrived on May 20, 2010. Subsequently, electrical connections were made, circuit breakers were installed, fences and signage were erected and bollards were installed around the new equipment. Testing and pre-service energizing activities occurred through June 13, 2010. The system was energized on June 16, 2010 and a walk-through with NV Energy on June 17, 2010 completed the project. Photo 1-4 shows the new switchboard and security fence with signage.
