2010 ANNUAL PROGRESS REPORT

**Former Fairchild Buildings 13, 19, and 23
369/441 North Whisman Road
Middlefield-Ellis-Whisman Study Area
Mountain View, California**

June 10, 2011

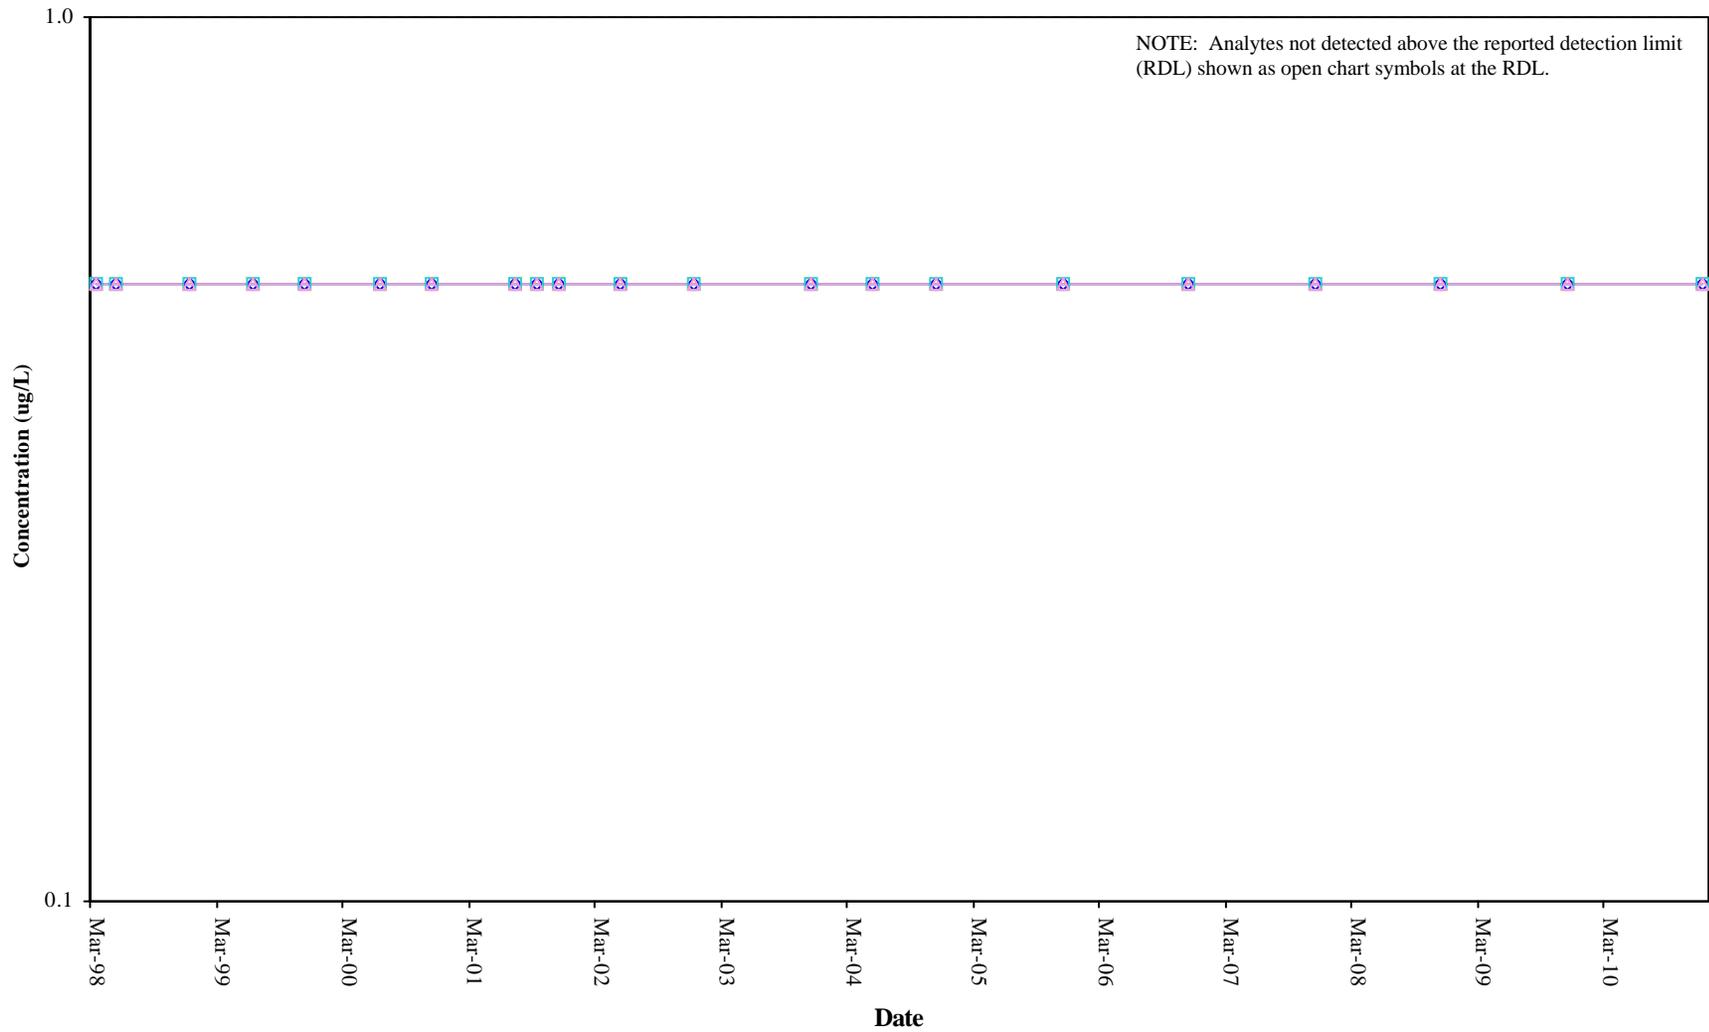
- ◆ TCE
- cis-1,2-DCE
- ▲ Vinyl Chloride

NOTE: Analytes not detected above the reported detection limit (RDL) shown as open chart symbols at the RDL.
