**FINAL**  
**SUBAREA 5D ROUND 2 ADDENDUM**  
**TO THE FINAL FSP FOR SOIL SAMPLING**  
**SANTA SUSANA FIELD LABORATORY SITE**  
**AREA IV RADIOLOGICAL STUDY**

**TO:** Andrew Bain, EPA Region 9 RPM  
**FROM:** T. Stewart Williford, P.G., HGL  
**THROUGH:** L. Steven Vaughn, R.G., HGL Project Manager  
Rene R. Rodriguez, P.E., HGL Deputy Project Manager  
**CC:** Mary Aycock, EPA Region 9 RPM  
Yarissa Martinez, P.E., EPA Region 9 RPM  
Shiann-Jang Chern, Ph. D., P.E., EPA Region 9 RPM  
Gregg Dempsey, Technical Advisor  
**DATE:** August 10, 2012  
**SUBJECT:** FSP Addendum for Subarea 5D Round 2

**CONTRACT NO:** EP-S7-05-05  
**TASK ORDER NO:** 0038

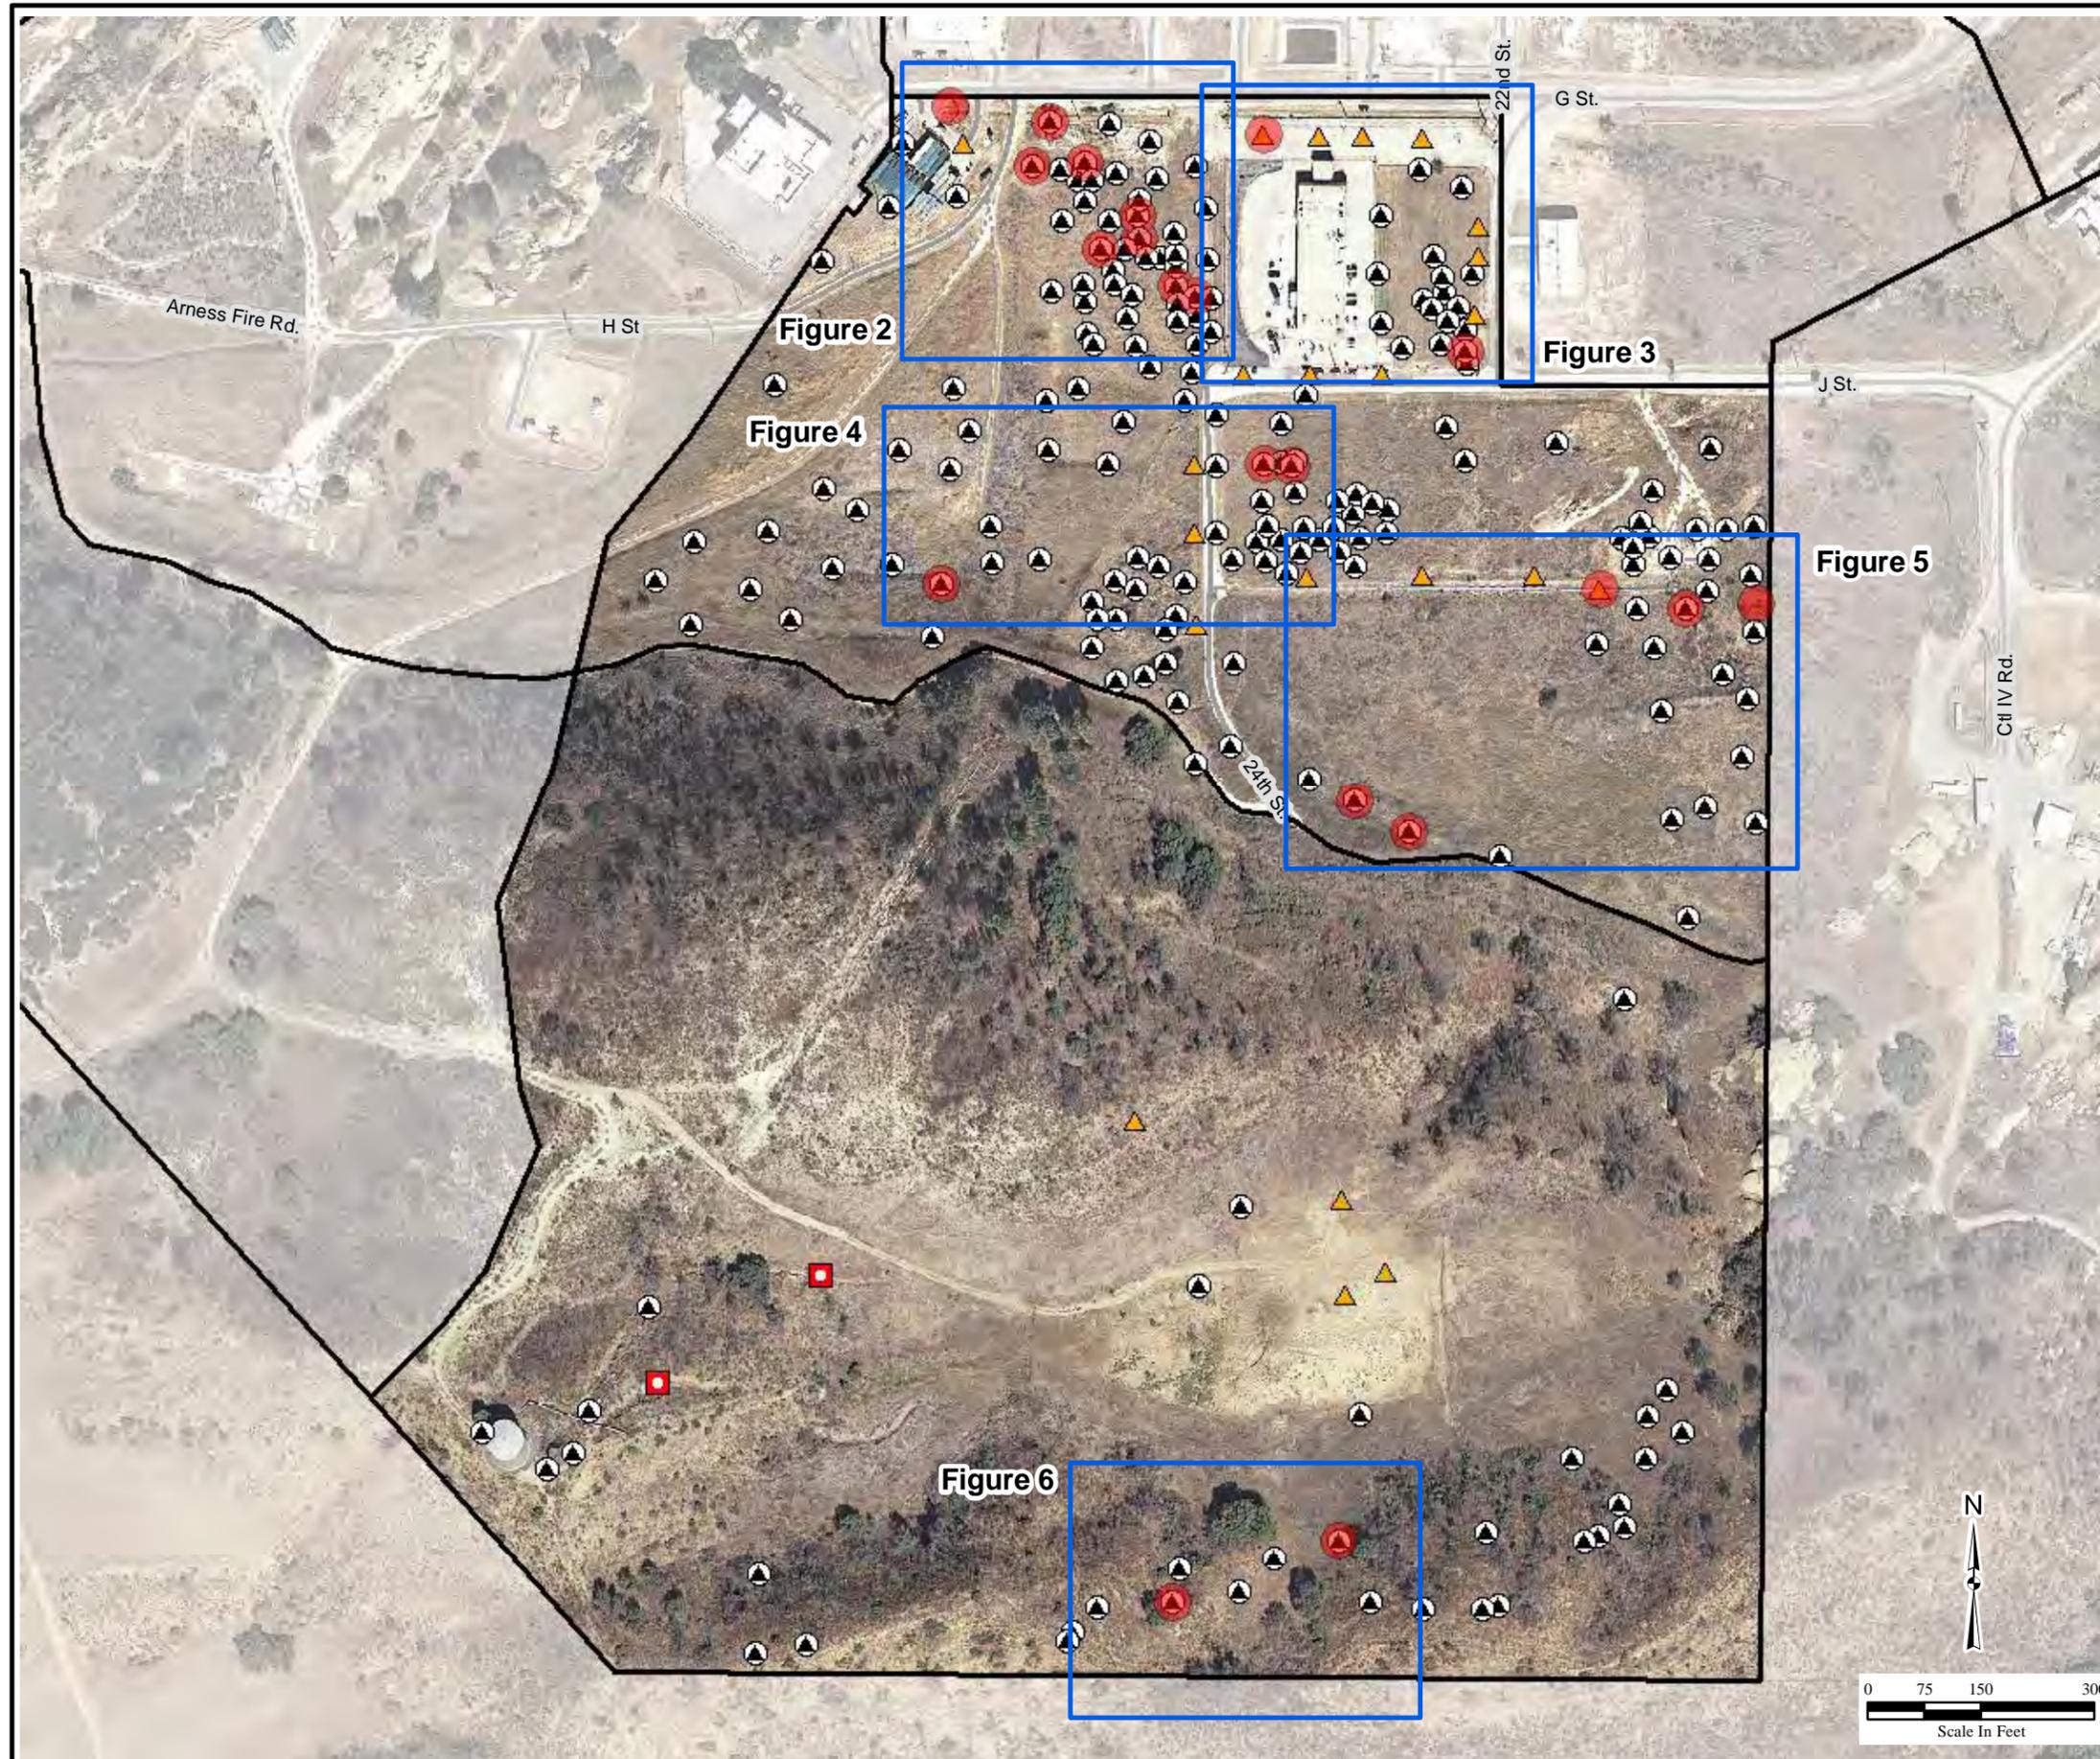
Table 3 summarizes the radionuclides and range of activity detected within each of these areas. Figure 1 provides an overview map showing the location of each round 1 sample with radionuclide activities exceeding RTLs (Attachment 2). Round 1 soil sample results are presented in the Technical Memorandum Subarea 5D Round 1 Soil Sample Results (HGL, 2012b).

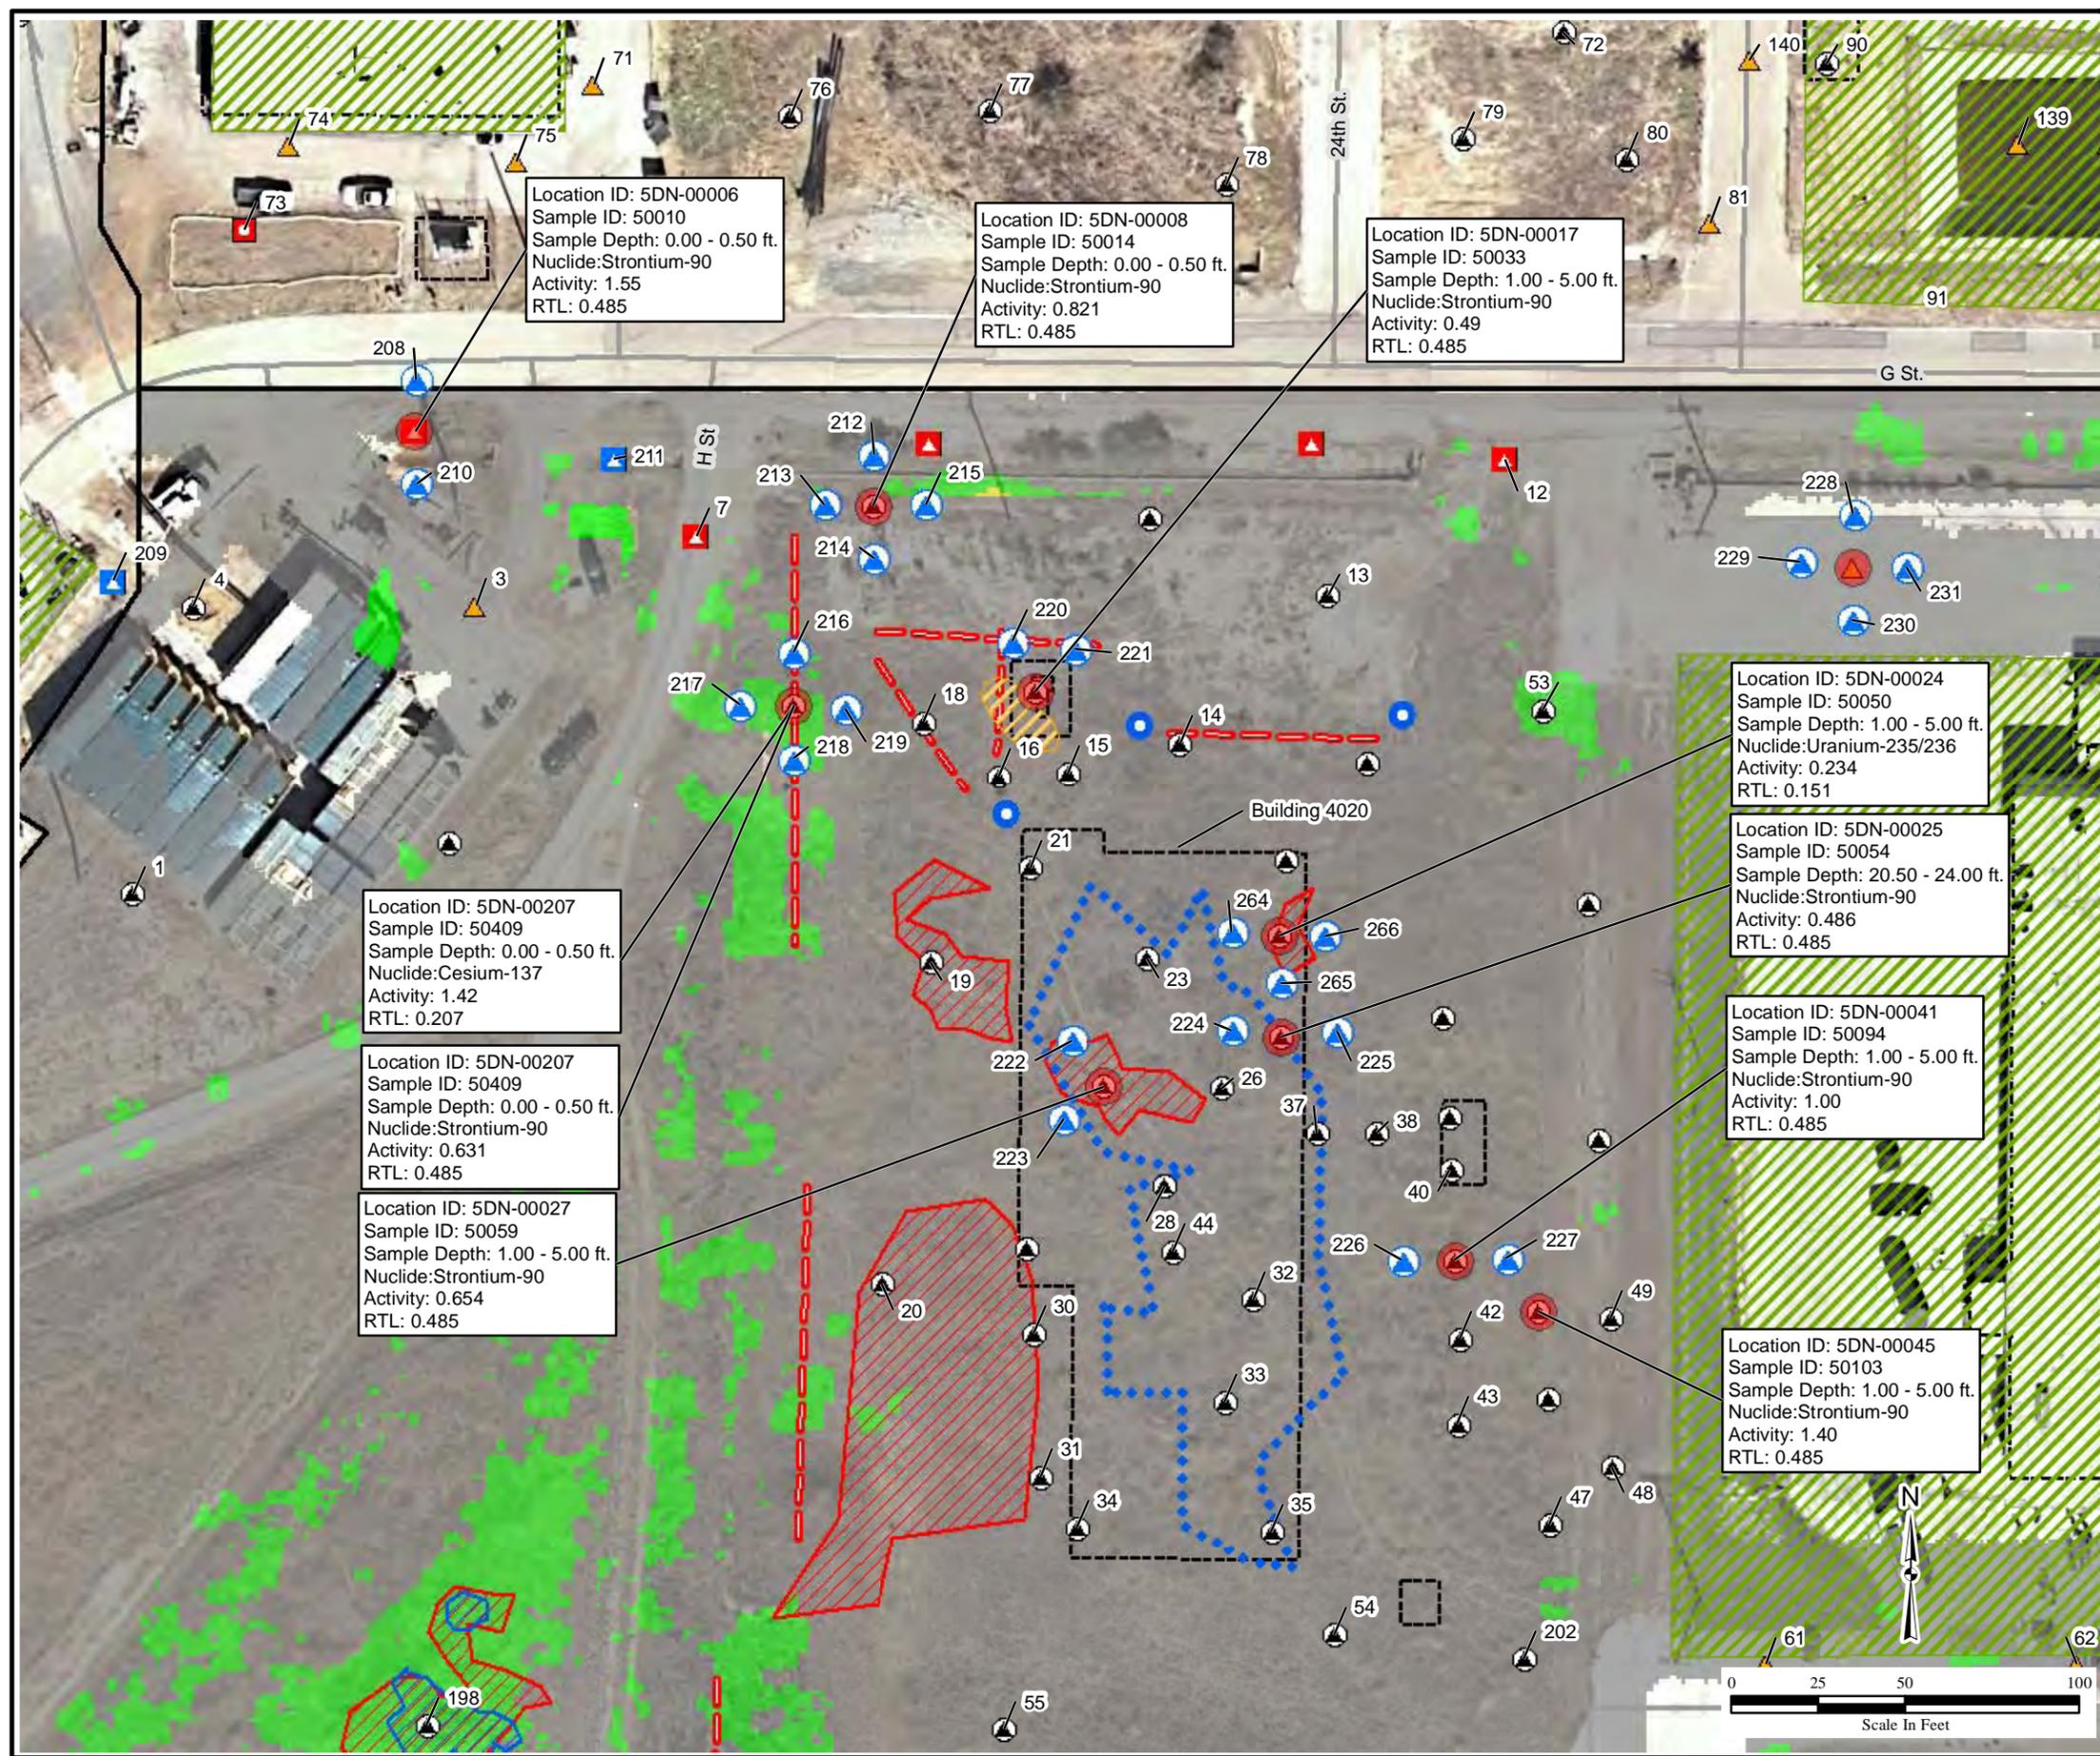
**Figure 2**  
**Hot Lab (former Building 4020)**  
**Subarea 5D, Round 2**  
**Santa Susana Field Laboratory**

Location ID: 5DN-00006  
 Sample ID: 50010  
 Sample Depth: 0.00 - 0.50 ft.  
 Nuclide:Strontium-90  
 Activity: 1.55  
 RTL: 0.485

Location ID: 5DN-00008  
 Sample ID: 50014  
 Sample Depth: 0.00 - 0.50 ft.  
 Nuclide:Strontium-90  
 Activity: 0.821  
 RTL: 0.485

Location ID: 5DN-00045  
 Sample ID: 50103  
 Sample Depth: 1.00 - 5.00 ft.  
 Nuclide:Strontium-90  
 Activity: 1.40  
 RTL: 0.485

which exceeded RTLs. The sample contained a concentration of uranium (U)-235/236 at 0.234 picocuries per gram (pCi/g) which exceeded the RTL of 0.151 pCi/g. Three round 2 step-out samples are planned for this location (Figure 2).

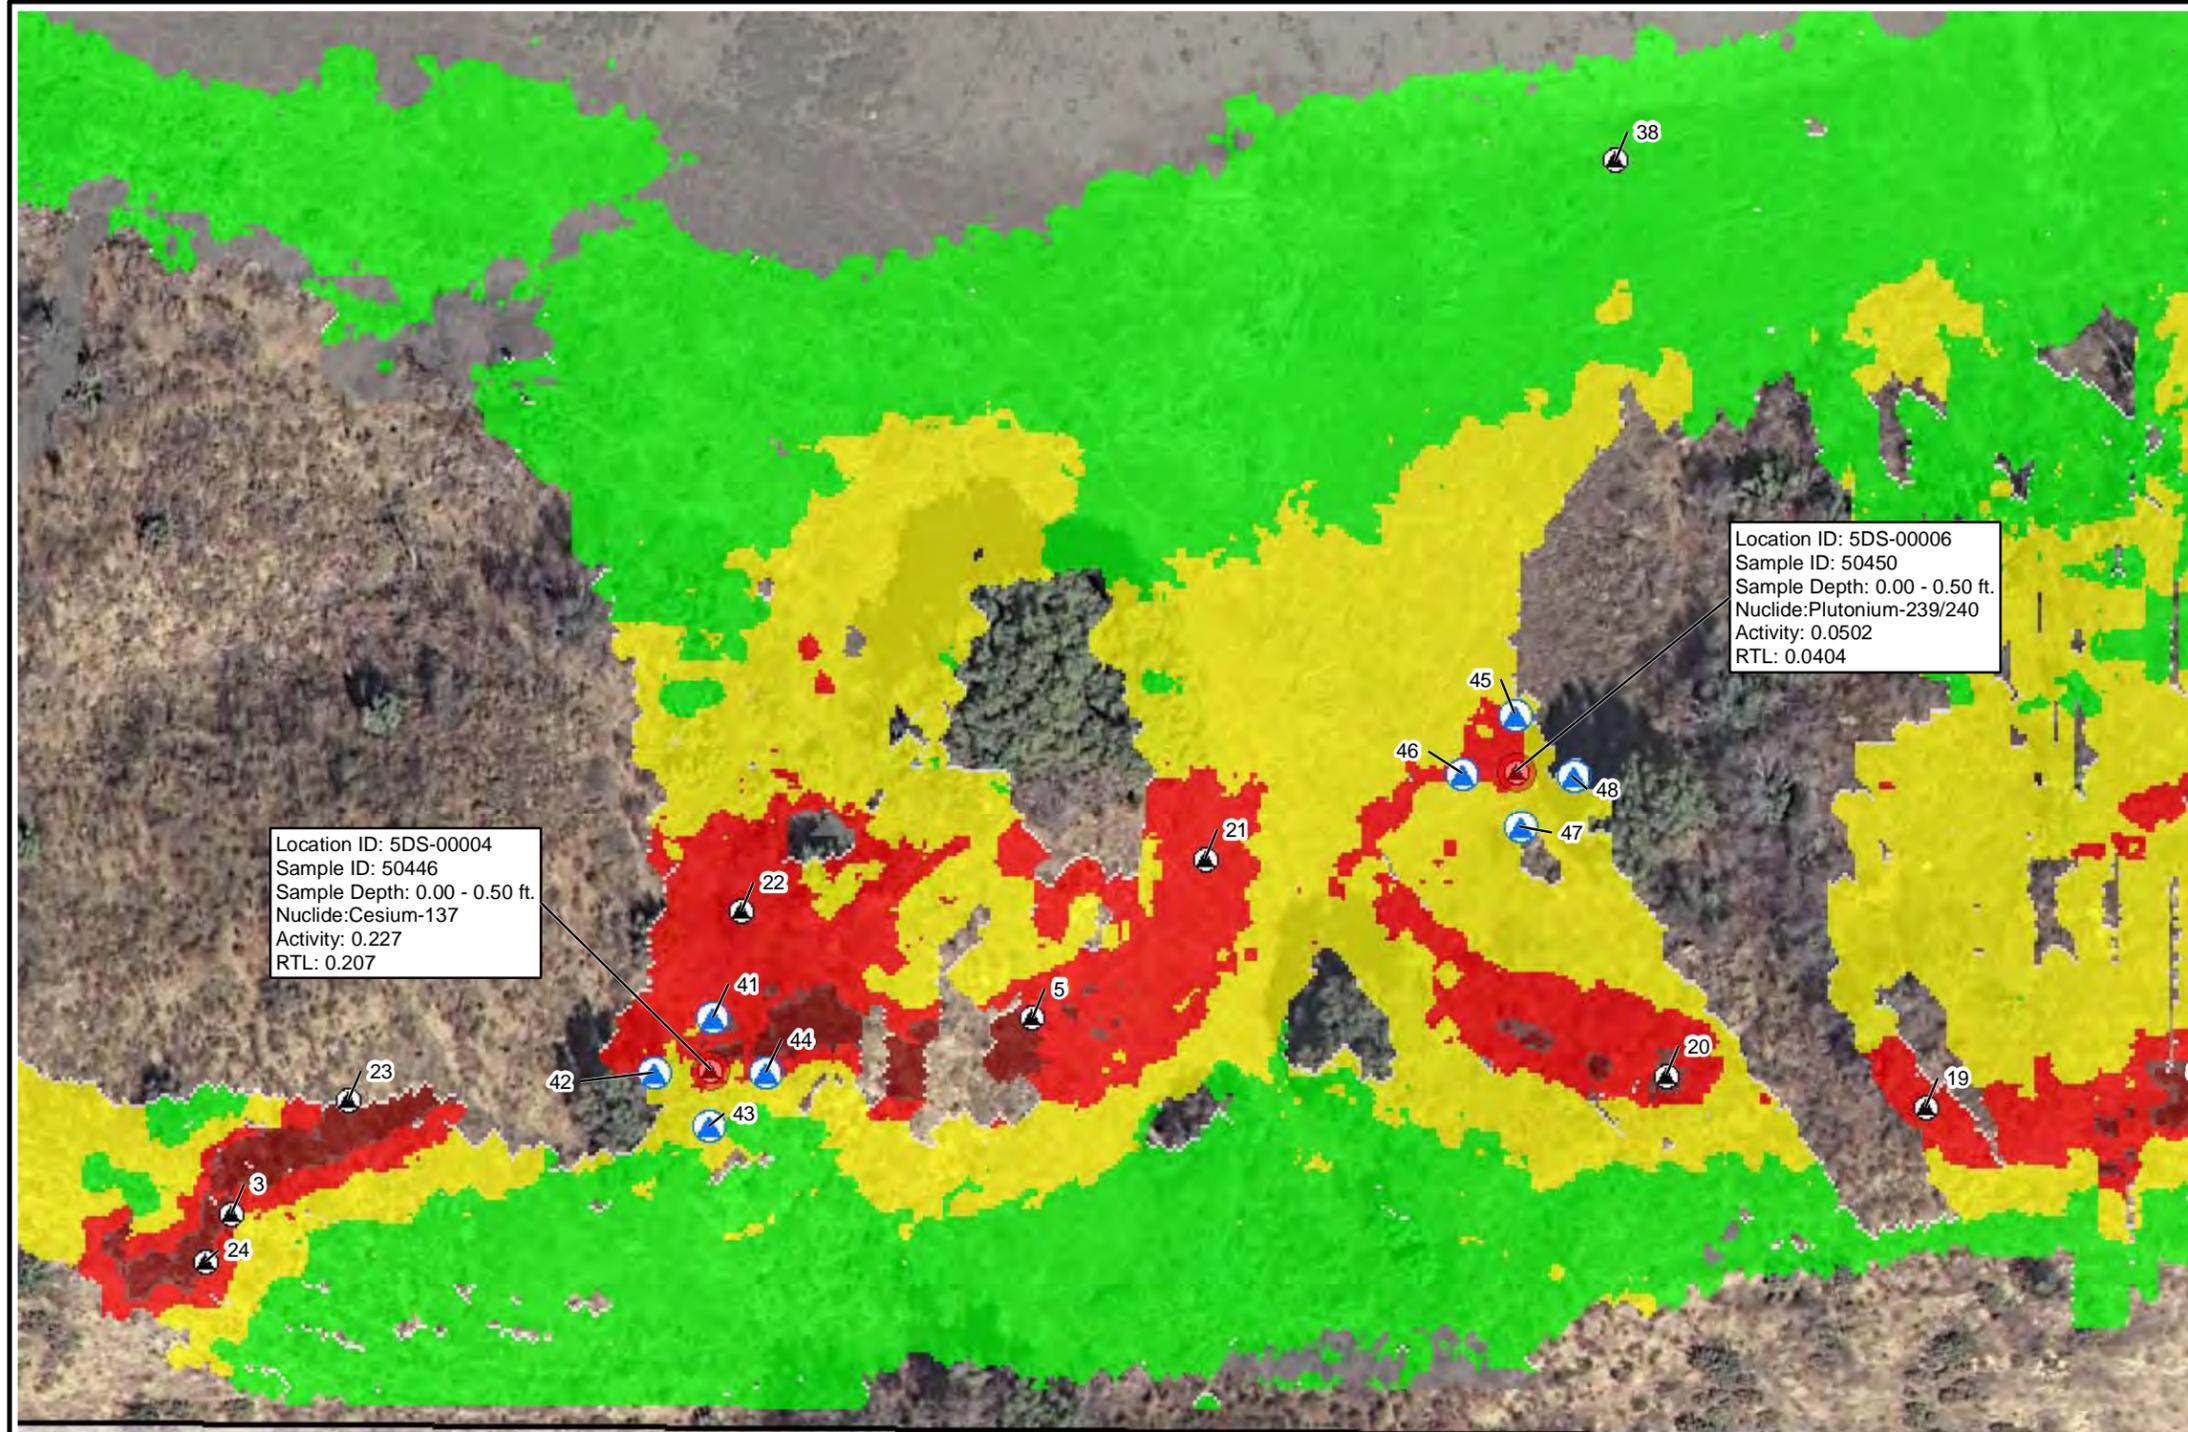
**Figure 6**  
**Subarea 5D-South**  
**Subarea 5D, Round 2**  
**Santa Susana Field Laboratory**

Location ID: 5DS-00004  
 Sample ID: 50446  
 Sample Depth: 0.00 - 0.50 ft.  
 Nuclide: Cesium-137  
 Activity: 0.227  
 RTL: 0.207

Location ID: 5DS-00006  
 Sample ID: 50450  
 Sample Depth: 0.00 - 0.50 ft.  
 Nuclide: Plutonium-239/240  
 Activity: 0.0502  
 RTL: 0.0404
