FINAL
SUBAREA 8 ROUND 2 ADDENDUM
TO THE FINAL FSP FOR SOIL SAMPLING
SANTA SUSANA FIELD LABORATORY
AREA IV RADIOLOGICAL STUDY

TO: Andrew Bain, EPA Region 9 RPM
FROM: T. Stewart Williford, P.G., HGL
THROUGH: L. Steven Vaughn, R.G., HGL Project Manager
Rene R. Rodriguez, P.E., HGL Deputy Project Manager
CC: Mary Aycock, EPA Region 9 RPM
Yarissa Martinez, P.E., EPA Region 9 RPM
Shiann-Jang Chern, Ph. D., P.E., EPA Region 9 RPM
Gregg Dempsey, Technical Advisor
DATE: July 13, 2012
SUBJECT: Subarea 8 Round 2 Addendum to the Final Field Sampling Plan for Soil Sampling

CONTRACT NO: EP-S7-05-05
TASK ORDER NO: 0038

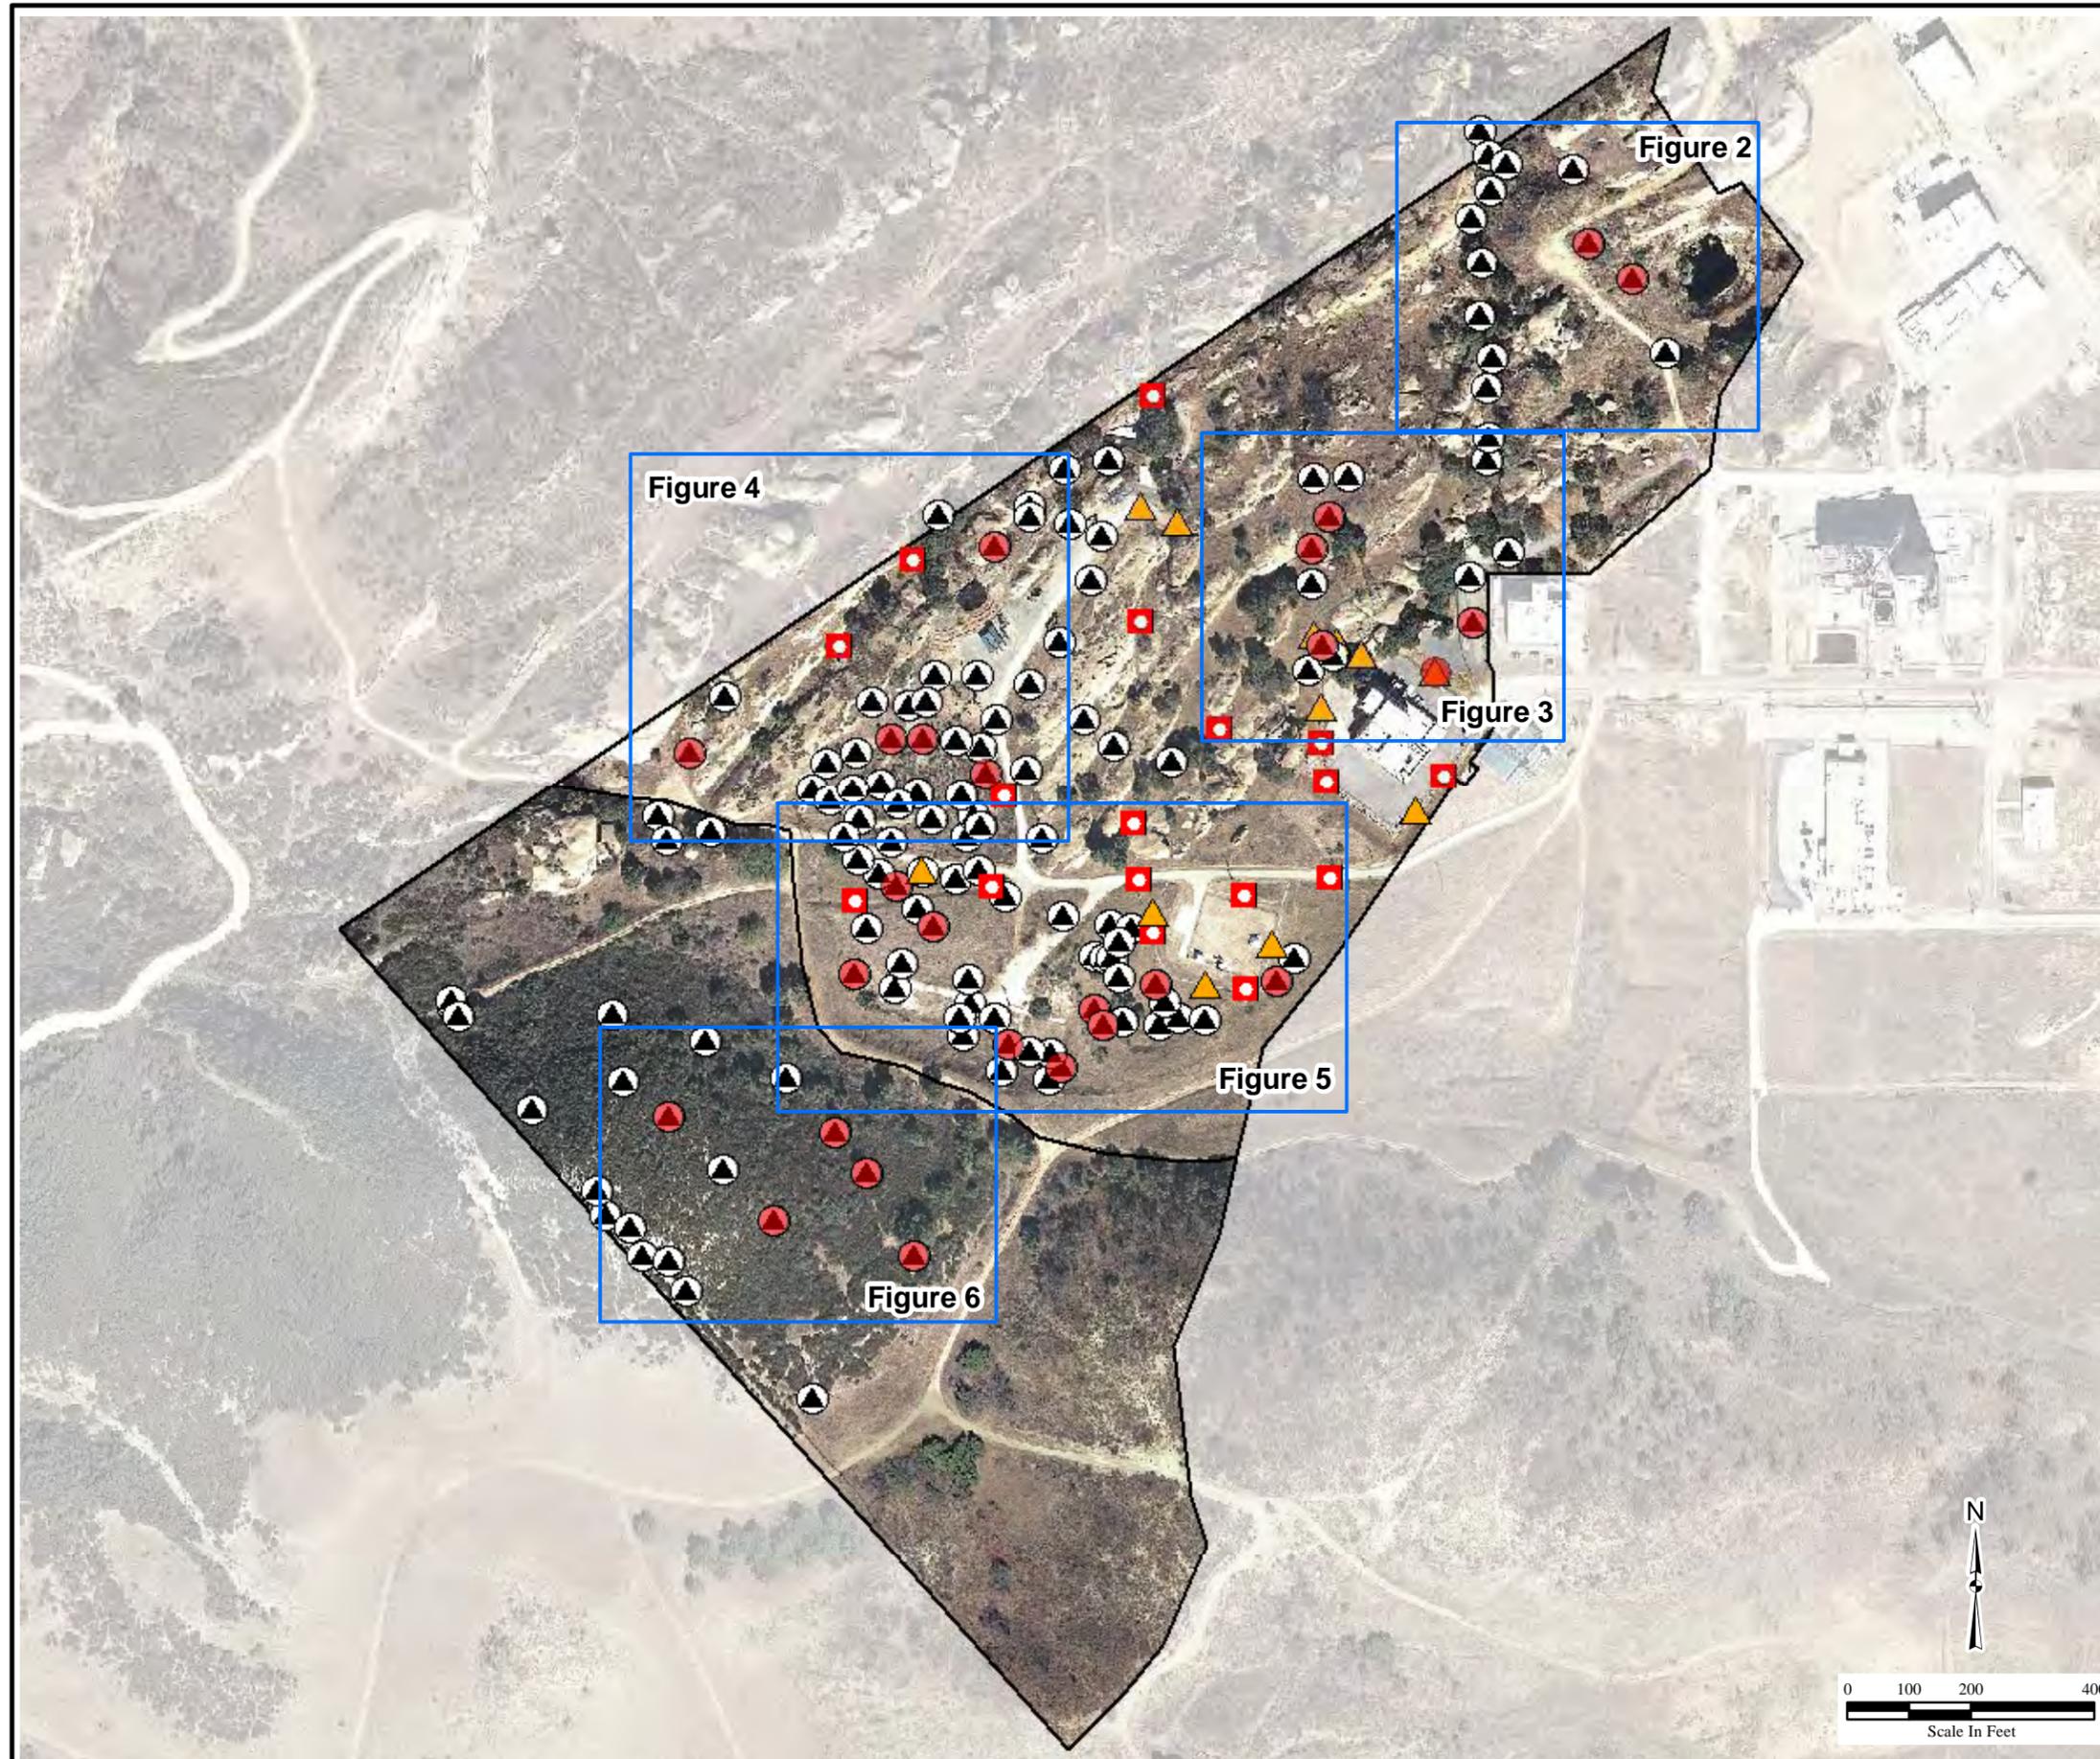
Figure 1
Round 1 Sample Locations
Subarea 8, Round 2
Santa Susana Field Laboratory

Table 3 summarizes the radionuclides and the range of activity detected at each of these areas. Figure 1 provides an overview map showing the location of each round 1 sample with radionuclide activities exceeding RTLs (Attachment 2). Round 1 soil sample results will be presented in the Technical Memorandum Subarea 8 Round 1 Soil Sample Results (HGL, 2012b).

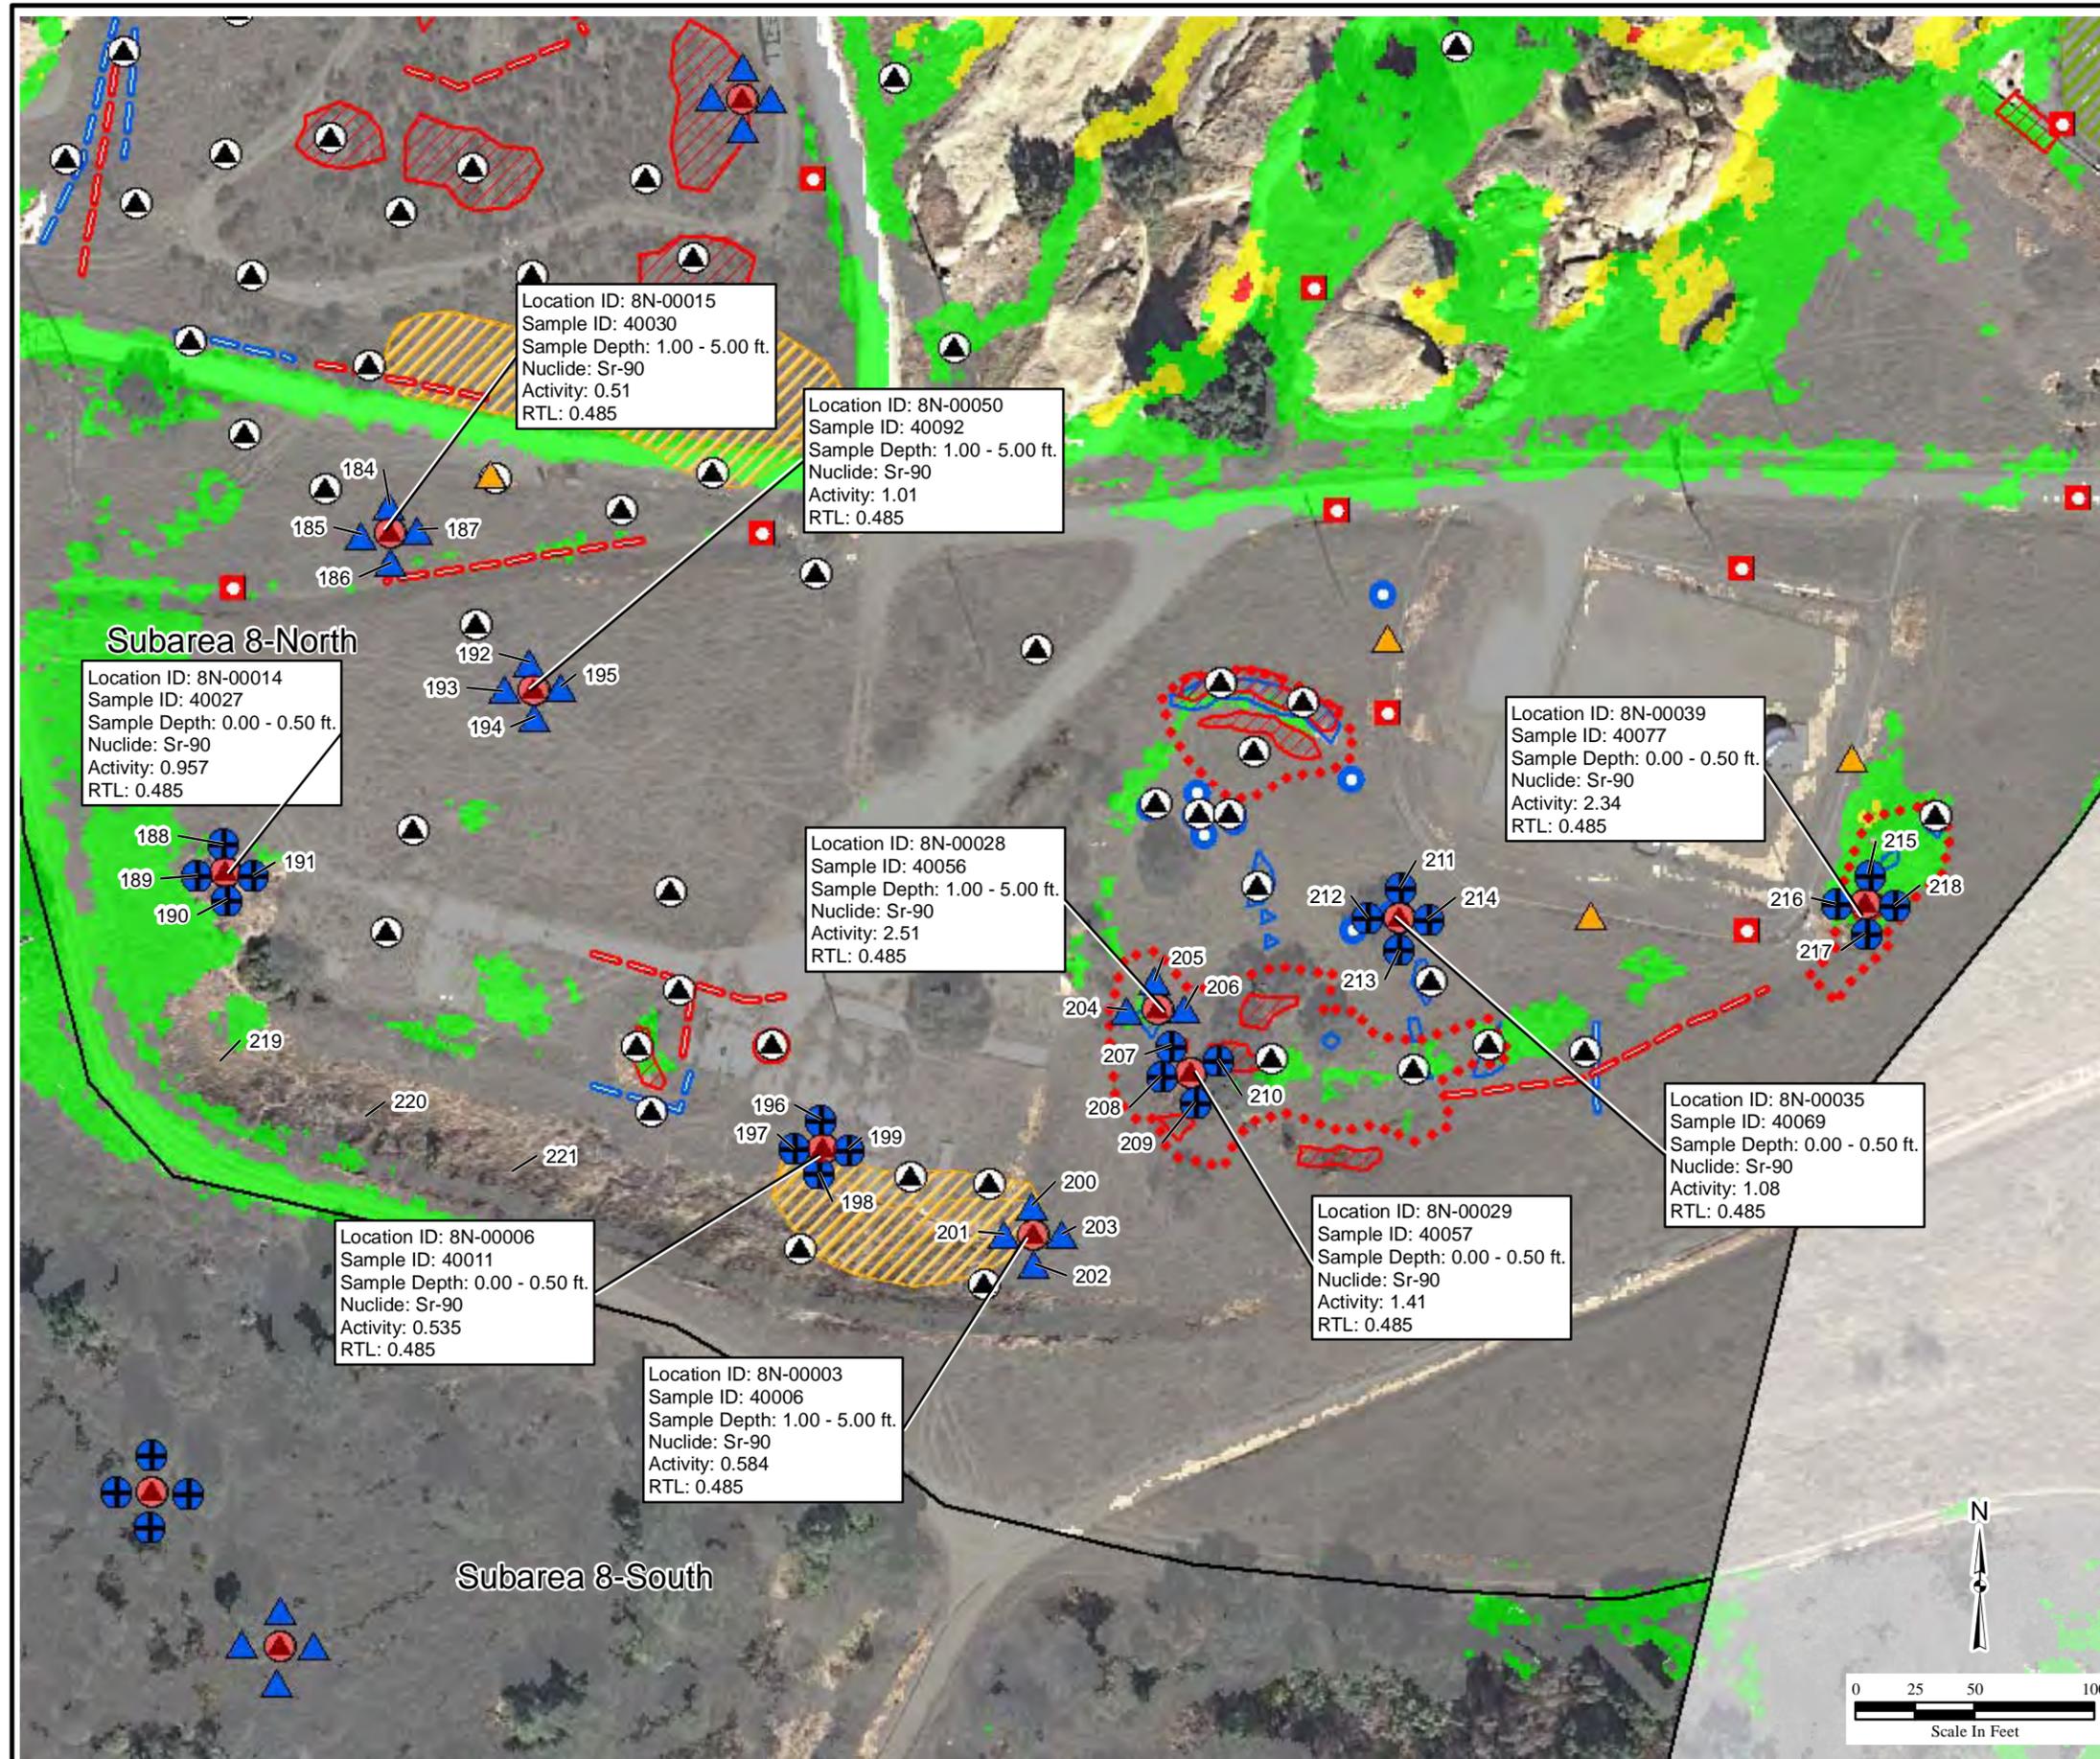
Figure 5
Empire State Atomic Development Authority Step-out Plan
Subarea 8, Round 2
Santa Susana Field Laboratory

Location ID: 8N-00015
 Sample ID: 40030
 Sample Depth: 1.00 - 5.00 ft.
 Nuclide: Sr-90
 Activity: 0.51
 RTL: 0.485

Location ID: 8N-00050
 Sample ID: 40092
 Sample Depth: 1.00 - 5.00 ft.
 Nuclide: Sr-90
 Activity: 1.01
 RTL: 0.485

Location ID: 8N-00014
 Sample ID: 40027
 Sample Depth: 0.00 - 0.50 ft.
 Nuclide: Sr-90
 Activity: 0.957
 RTL: 0.485

Location ID: 8N-00039
 Sample ID: 40077
 Sample Depth: 0.00 - 0.50 ft.
 Nuclide: Sr-90
 Activity: 2.34
 RTL: 0.485

Location ID: 8N-00028
 Sample ID: 40056
 Sample Depth: 1.00 - 5.00 ft.
 Nuclide: Sr-90
 Activity: 2.51
 RTL: 0.485

Location ID: 8N-00035
 Sample ID: 40069
 Sample Depth: 0.00 - 0.50 ft.
 Nuclide: Sr-90
 Activity: 1.08
 RTL: 0.485

Location ID: 8N-00006
 Sample ID: 40011
 Sample Depth: 0.00 - 0.50 ft.
 Nuclide: Sr-90
 Activity: 0.535
 RTL: 0.485

Location ID: 8N-00029
 Sample ID: 40057
 Sample Depth: 0.00 - 0.50 ft.
 Nuclide: Sr-90
 Activity: 1.41
 RTL: 0.485

Location ID: 8N-00003
 Sample ID: 40006
 Sample Depth: 1.00 - 5.00 ft.
 Nuclide: Sr-90
 Activity: 0.584
 RTL: 0.485
