PHOTOGRAPHIC RECORD

OU1 Site Inspection

FIVE-YEAR REVIEW SITE INSPECTION CHECKLIST

Site Name: Motorola 52 nd Street Superfund Site	EPA ID: AZD009004177
Review Report: 2011 Sitewide Five-Year Review	Review Period: August 2006 - October 2010
Treatment Facility Name: Integrated GW Treatment Plant	Operable Unit Region: OU1

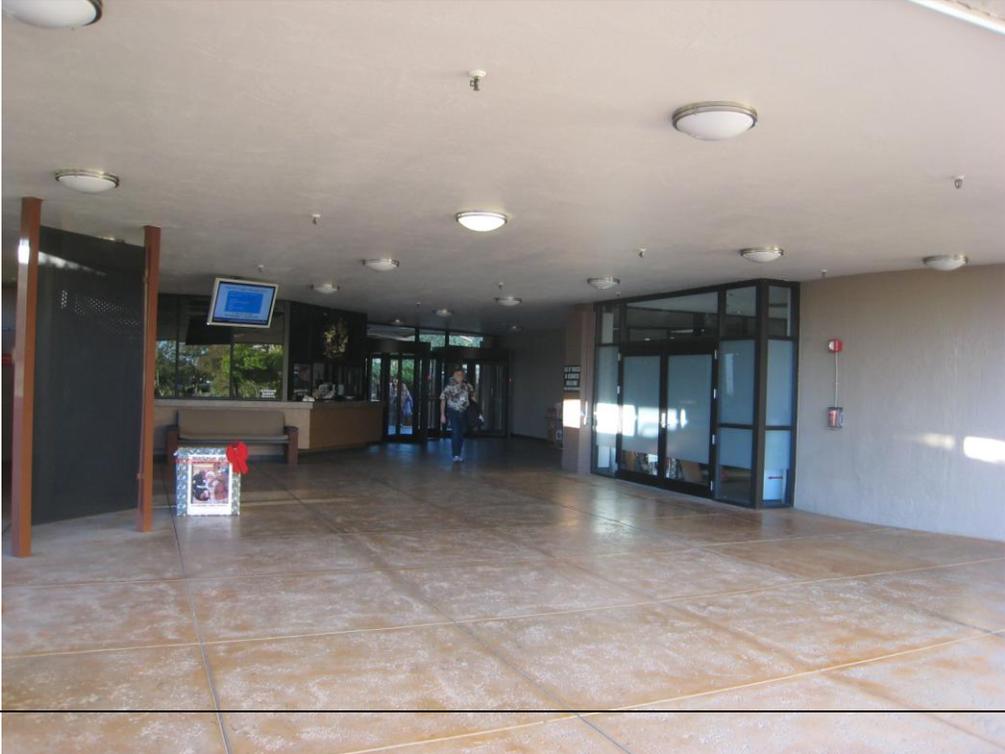
Photo No. 1

Description:
The OU1 treatment system (IGWTP) is located within a completely enclosed and secured industrial facility (On Semiconductor). This is the site security main facility entrance.

Remarks: On Semiconductor campus access gates include the main security portal for site personnel (see Photo 1) and various gates (off McDowell and Roosevelt) for vehicular access (see Photos 3 and 4). All gates are monitored by On Semiconductor security personnel. Routine site personnel are logged into the campus via electronic key card readers. Site visitors must be logged in by campus security. All vehicles and associated personnel must provide appropriate site access documentation and are logged by campus security.

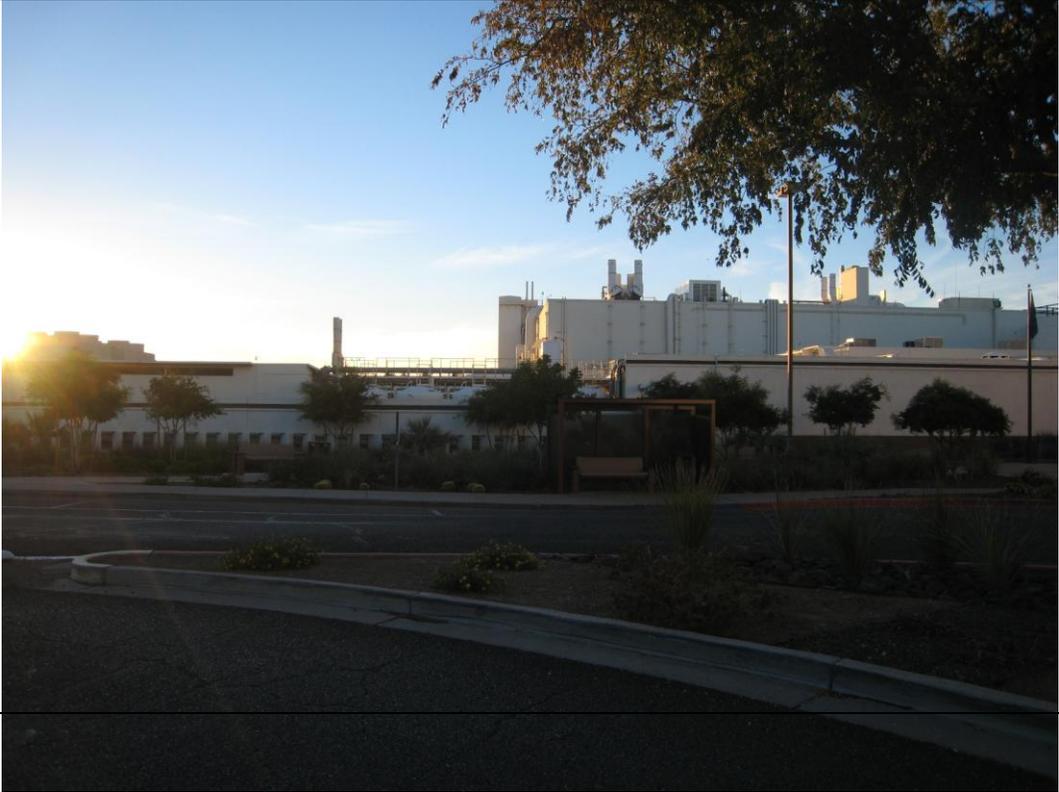
Photo No. 2

Description:
ON Semiconductor site security walls showing the facility behind the security wall.

Remarks: The IGWTP is located within the 52nd Street On Semiconductor campus. Access to the campus is restricted by perimeter fencing. Campus perimeter fencing is a combination of block walls and chain link fencing approximately 6 to 8 ft high (see Photos 2, 3 and 4 in the attached OU1 Site Inspection Photographic Record). Within the campus, a low block wall and rolling gate enclose the IGWTP area from surrounding unrelated operations (see Photo 15) and a locked chain-link fence surrounds the SWPL area (see Photo 8). Perimeter fencing is also present around the OCC extraction well Motor Control Center (MCC) building located outside the campus area (see Photo 11).

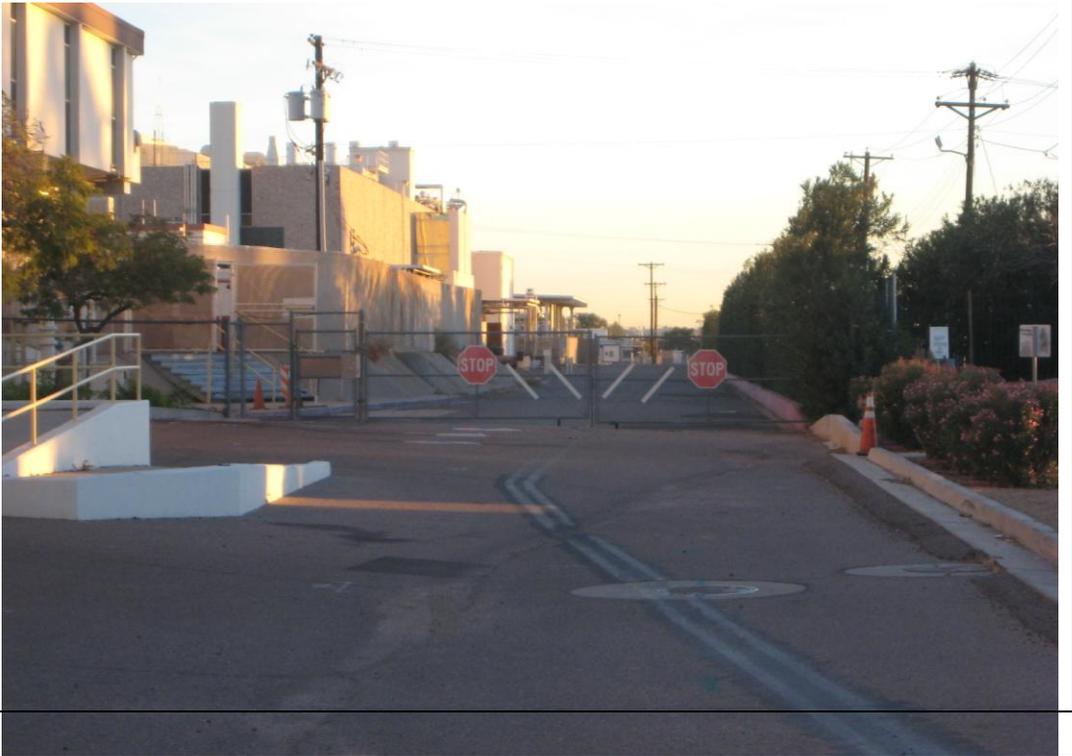
Photo No. 3

Description:
Site security fencing showing
northern fence gate which is
kept closed unless opened
from the inside of the facility.

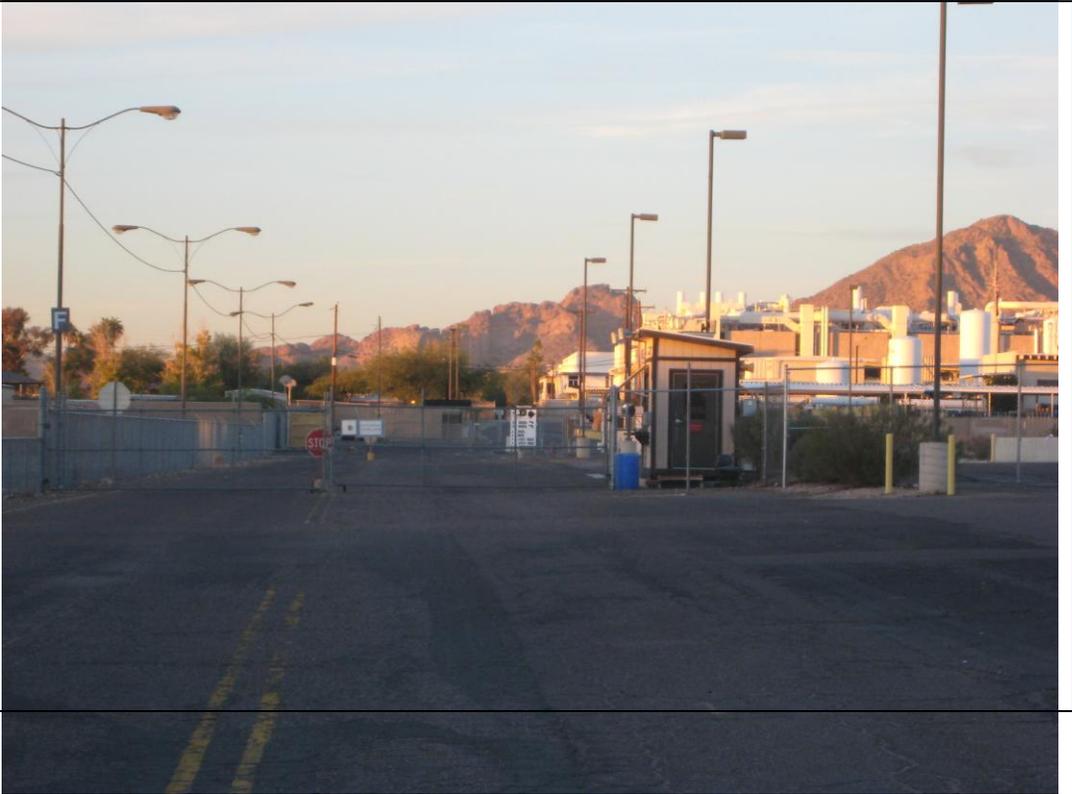
Photo No. 4

Description:
Site security fencing along the
southern perimeter of the
property.

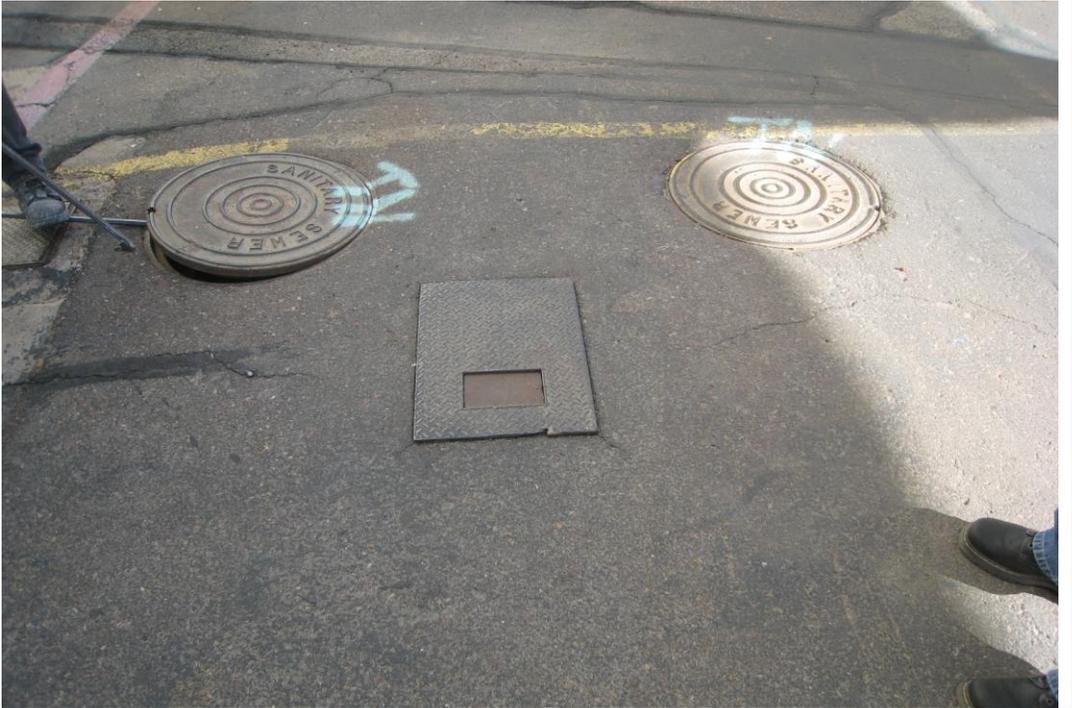
Photo No. 5
View Direction of Photo:
Looking East in Courtyard
Date: 12/2/10
Description:
Courtyard Extraction Wells
DM301 and DM302.

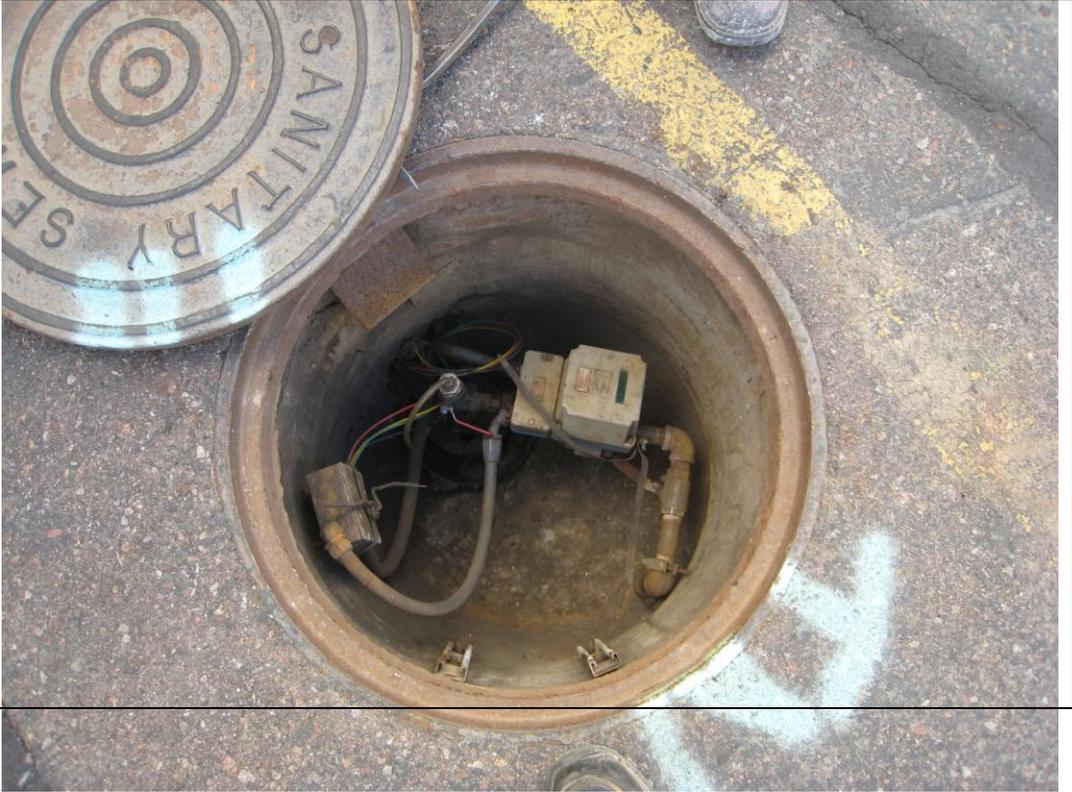
Photo No. 6
View Direction of Photo:
East
Date: 12/2/10
Description:
DM301 Wellhead.

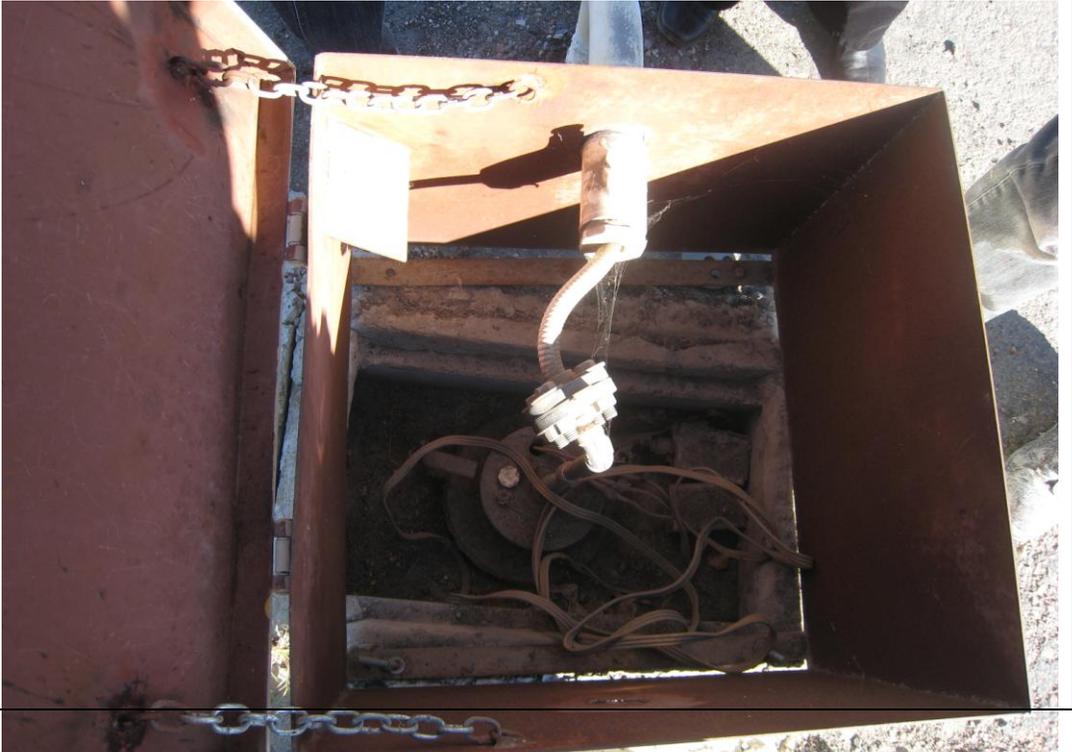
Photo No. 7

Description:
Southwest Parking Lot
Extraction Wellhead.

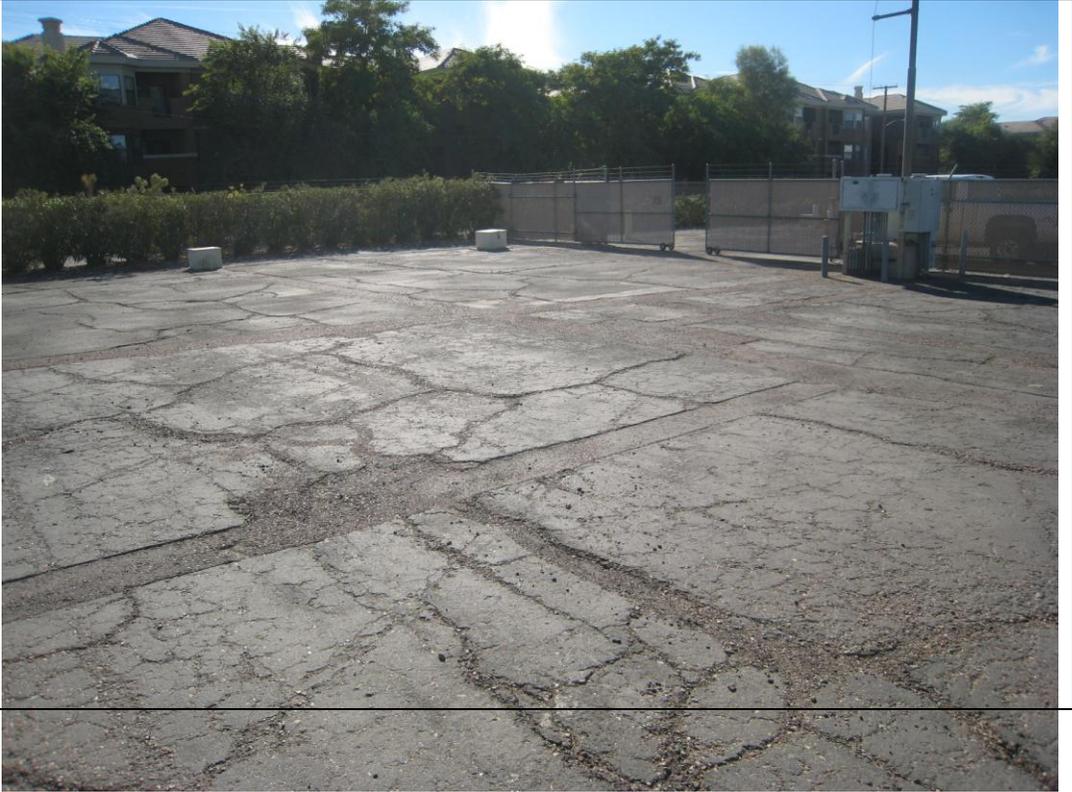
Photo No. 8

Description:
SWPL Parking Lot Extraction
Wells.

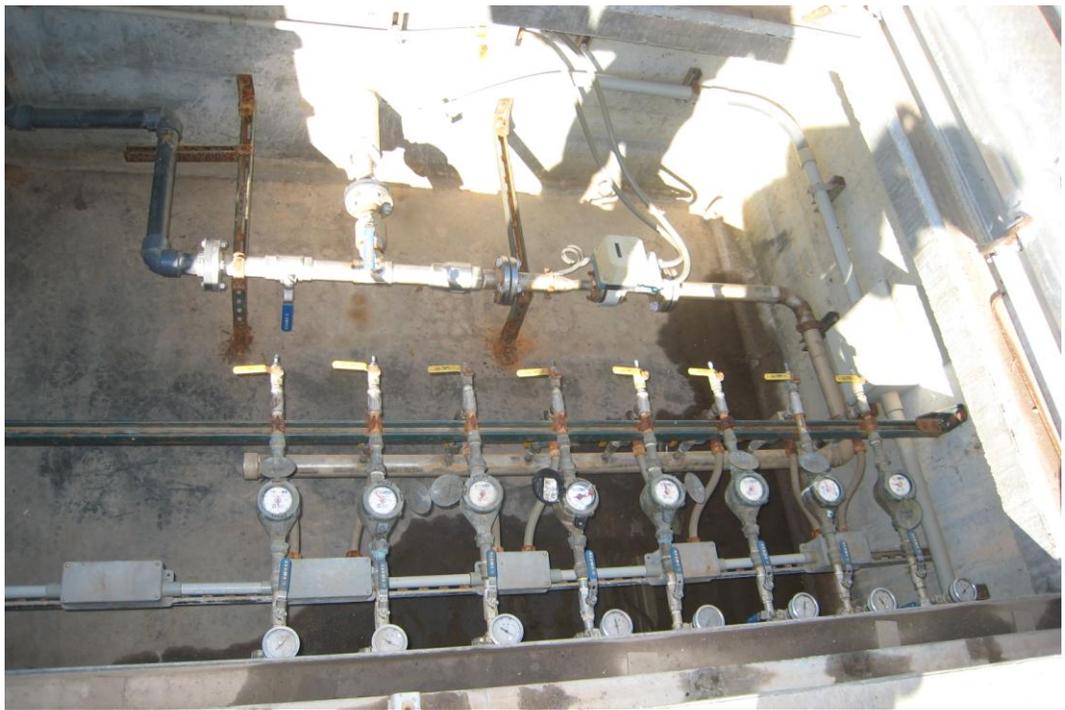
Photo No. 9
View Direction of Photo: North from inside SWPL Compound
Date: 12/2/10
Description: SWPL Extraction Well piping, sampling ports, and valve vault.

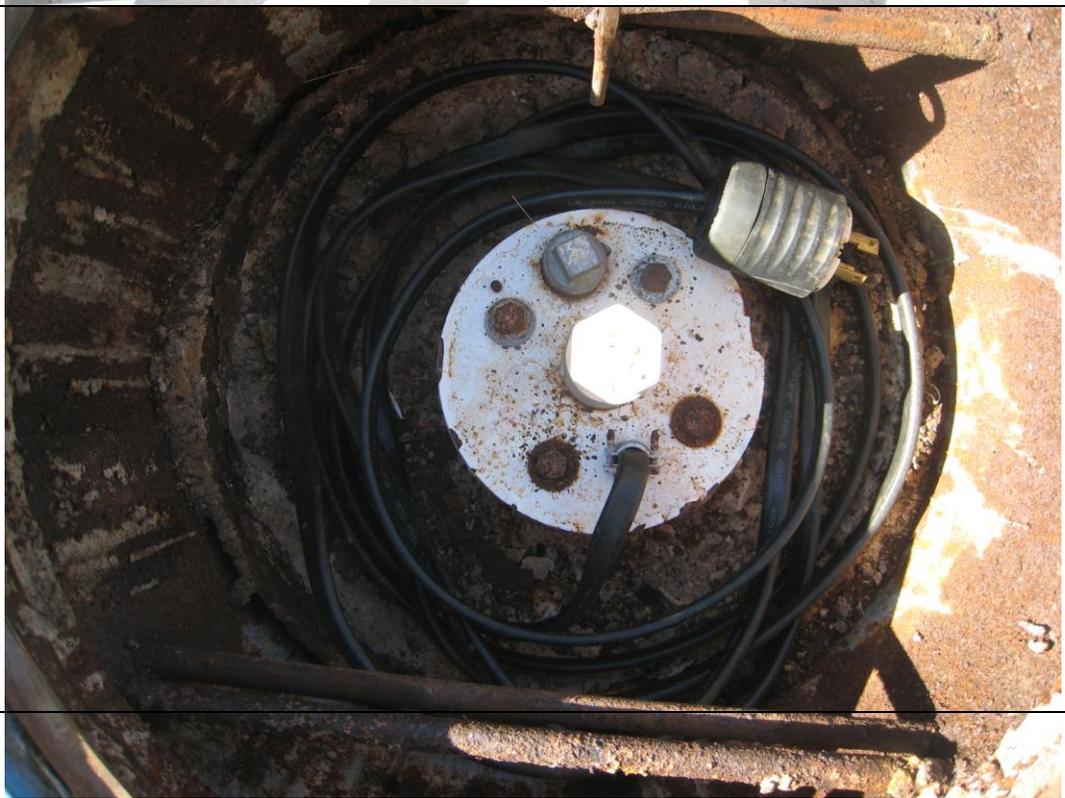
Photo No. 10
View Direction of Photo: West at bedrock pilot test well
Date: 12/2/10
Description: Monitoring well used during testing.

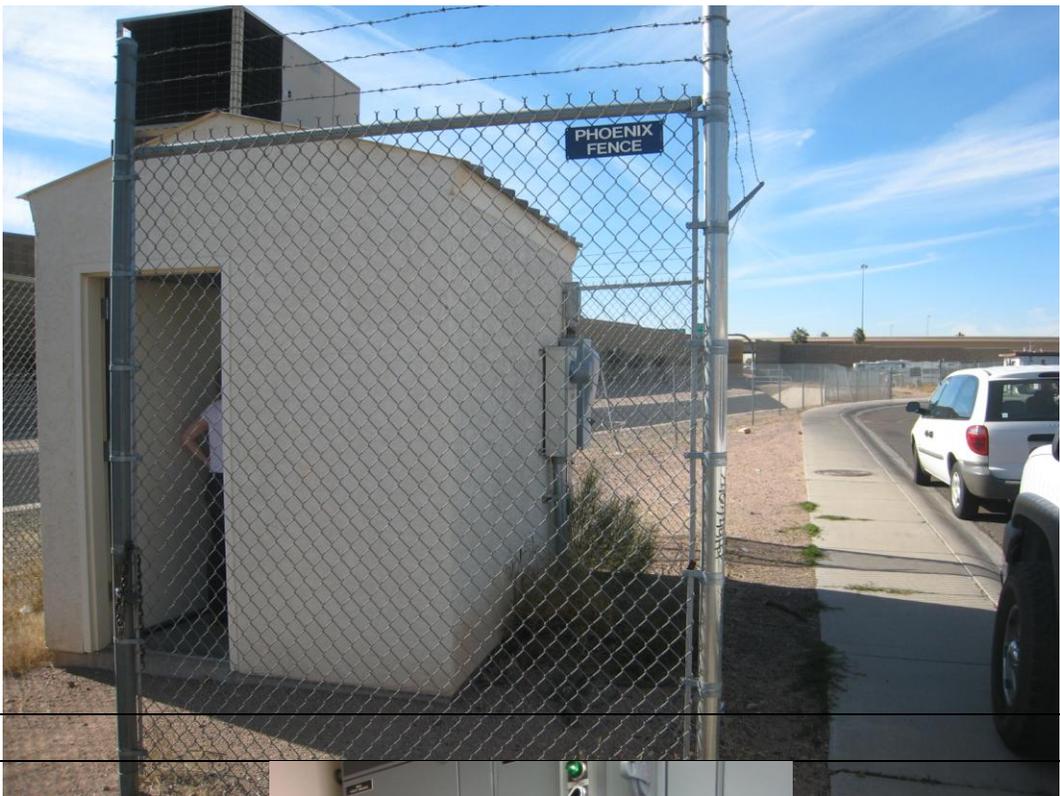
Photo No. 11

Description:
Old Crosscut Canal Motor Control building exterior with security fence.

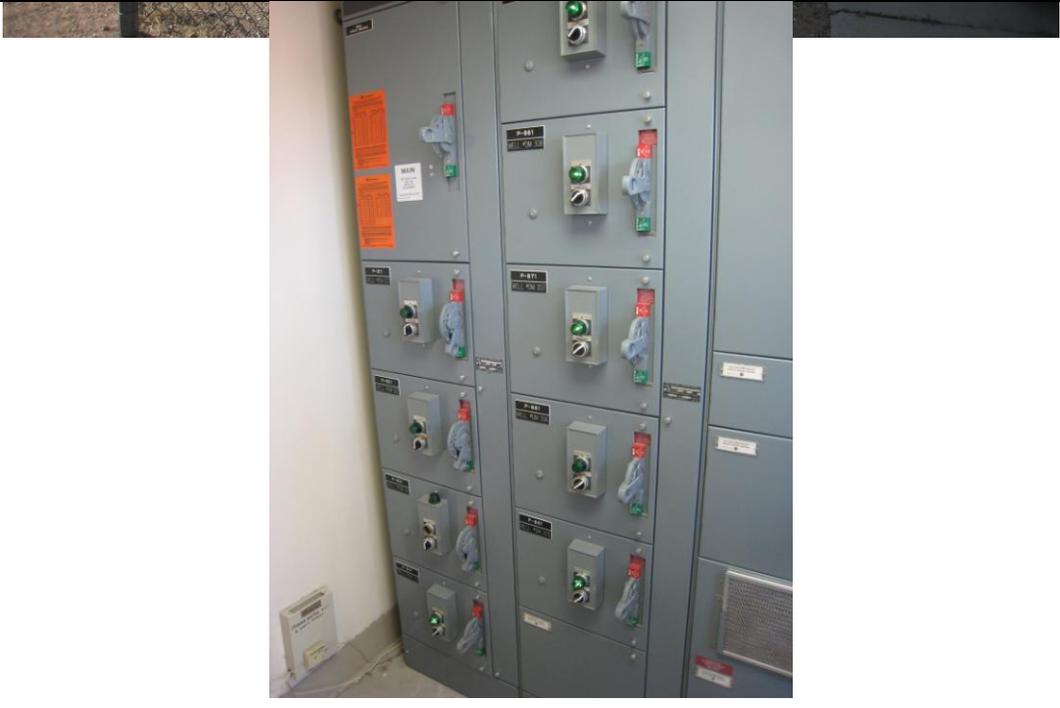
Photo No. 12

Description:
Well Control panels for each of the OCC Extraction Wells for OU1.

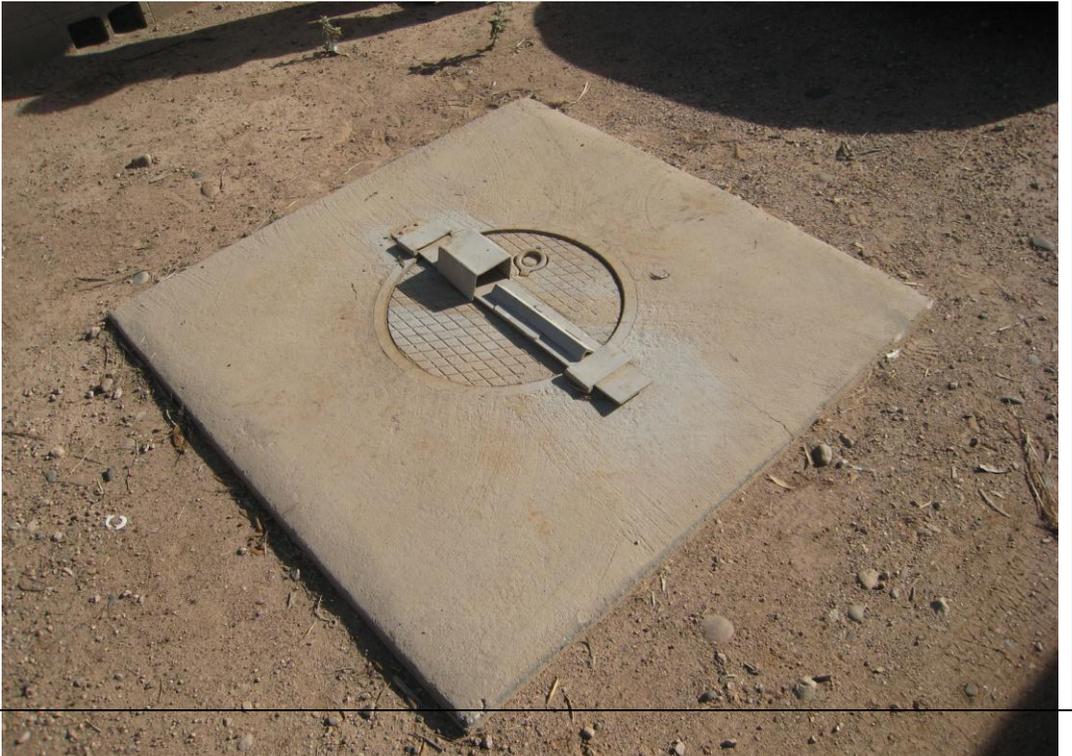
Photo No. 13
View Direction of Photo: Looking down on an OCC Wellhead
Date: 12/2/10
Description: OCC extraction well vault cover, pad, and lock.

Remarks: Signs are posted notifying personnel of access restrictions at all access gates. Campus security personnel regularly patrol the campus. Extraction wellheads located outside the campus area are secured with locks (see Photo 13).

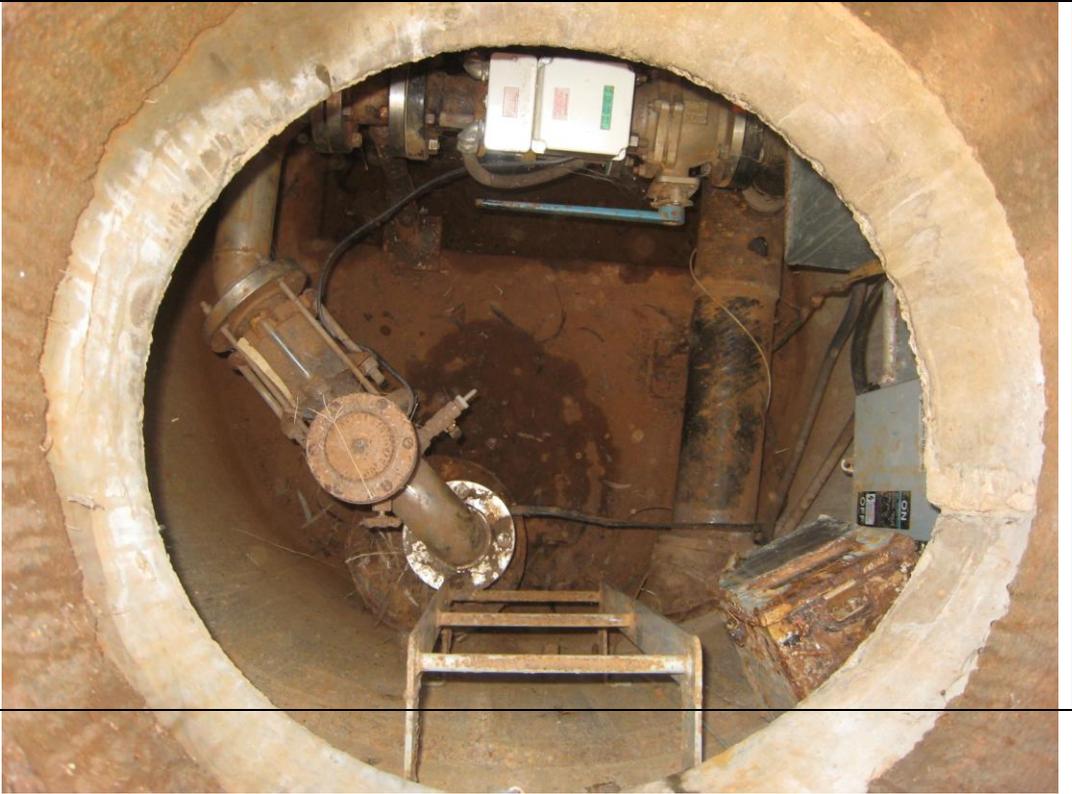
Photo No. 14
View Direction of Photo: Looking down into an OCC extraction well
Date: 12/2/10
Description: Well vault for an OCC extraction well shows wellhead, discharge piping, flowmeter, and electrical boxes for well power and transducer.

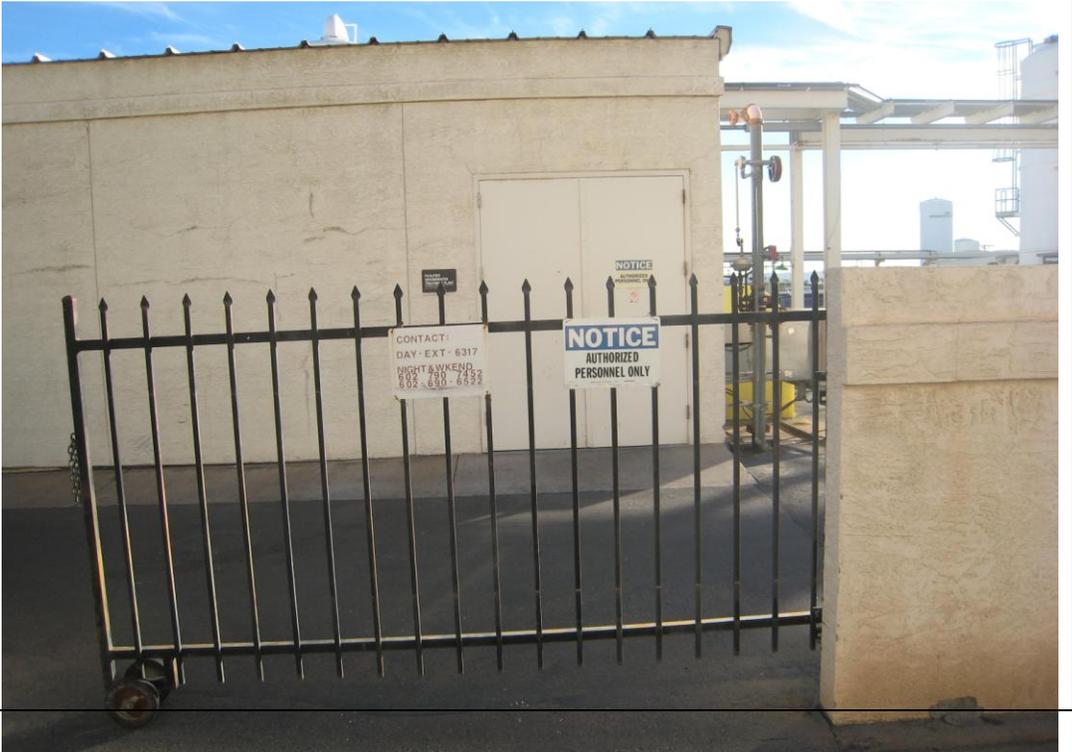
Photo No. 15

Description:
IGWTP control building, treatment plant behind, and security fencing in front.

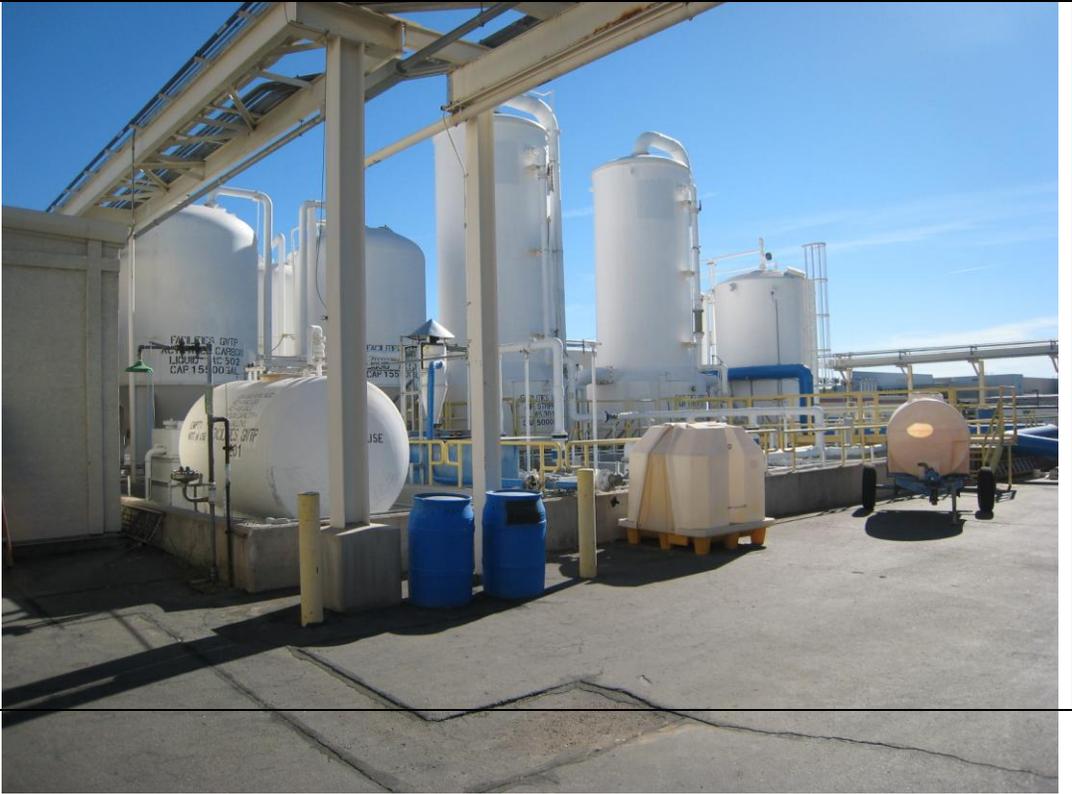
Photo No. 16

Description:
Treatment plant operational tanks and piping.

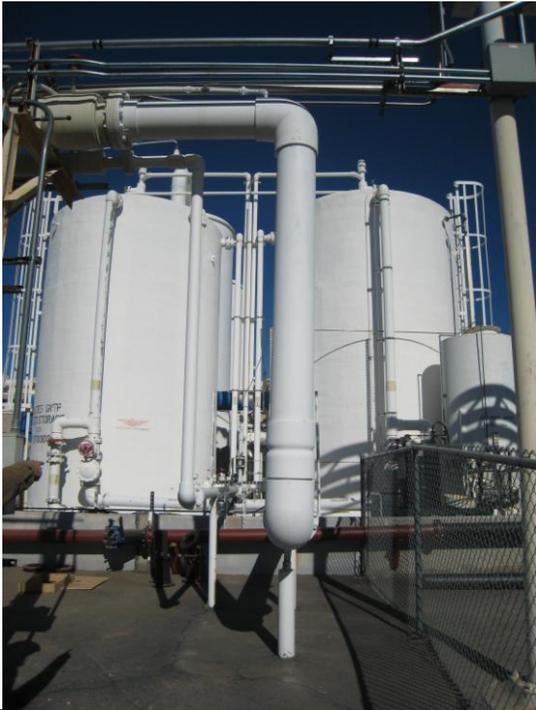
Photo No. 17
View Direction of Photo: North towards IGWTP compound
Date: 12/2/10
Description: Inlet water equalization tanks with associated inlet and outlet piping.

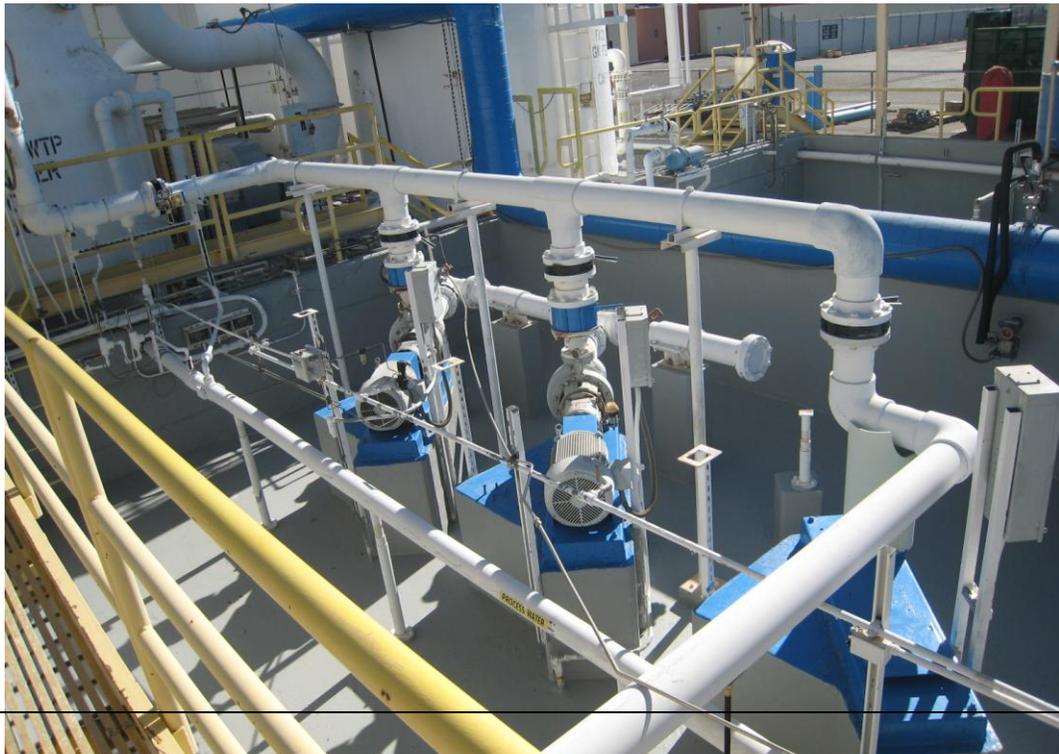
Photo No. 19

Description:
Transfer pumps for transfer of untreated water from the equalization tanks to the first air stripping vessel. A third process pump was previously located in this containment region – a system retrofit removed the pump and installed additional process piping.

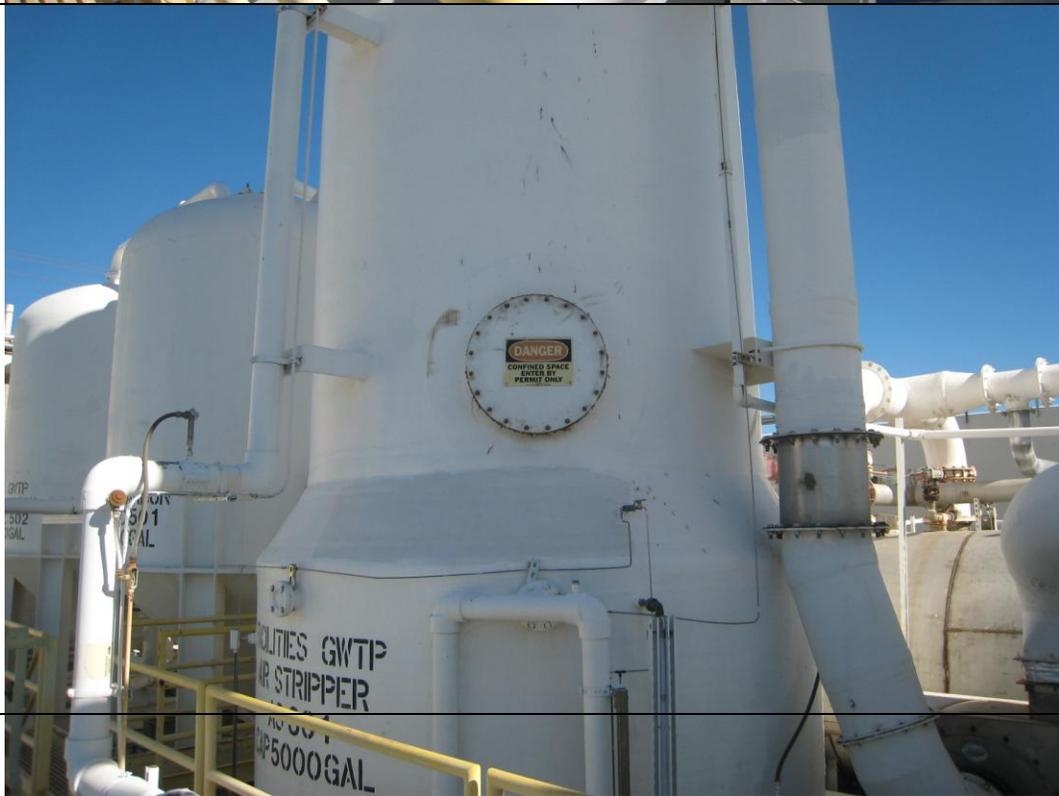
Photo No. 20

Description:
Close-up view of the second air stripping unit for IGWTP.

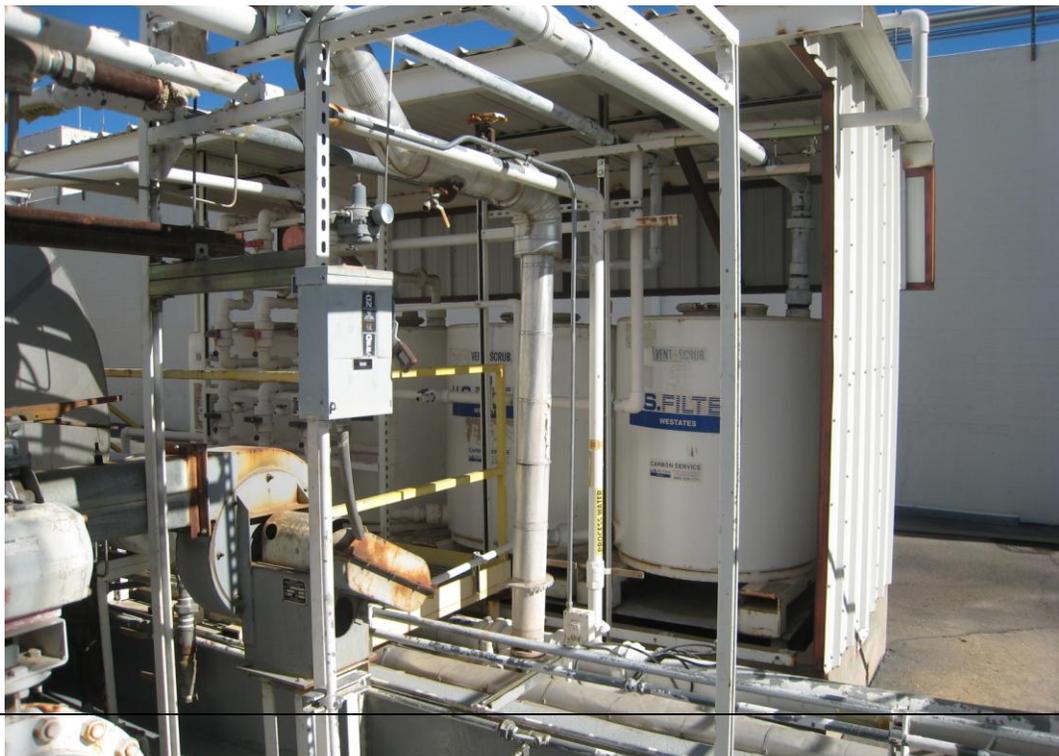
Photo No. 21
View Direction of Photo: Northeast
Date: 12/2/10
Description: Current passive vent carbon adsorption system (tank and process pressure relief vents discharge into this system).

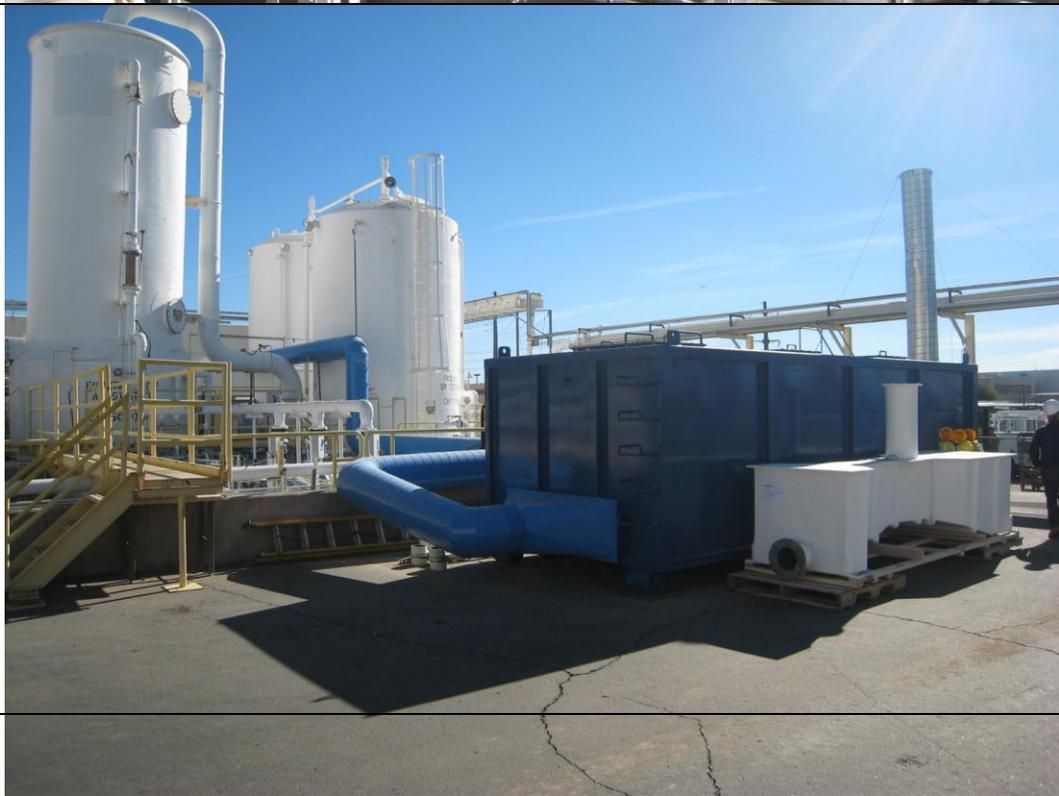
Photo No. 22
View Direction of Photo: Southeast
Date: 12/2/10
Description: Vapor phase GAC vessel. The large blue piping in the foreground is the untreated vapor inlet with the silver discharge stack in the background to the right.
