**Leviathan Mine
Supplemental Environmental Project
2010 Annual Report
(First Annual Report)**

**Atlantic Richfield Company
March 23, 2010**

**Prepared by E. R. Mancini & Associates
Camarillo, California**

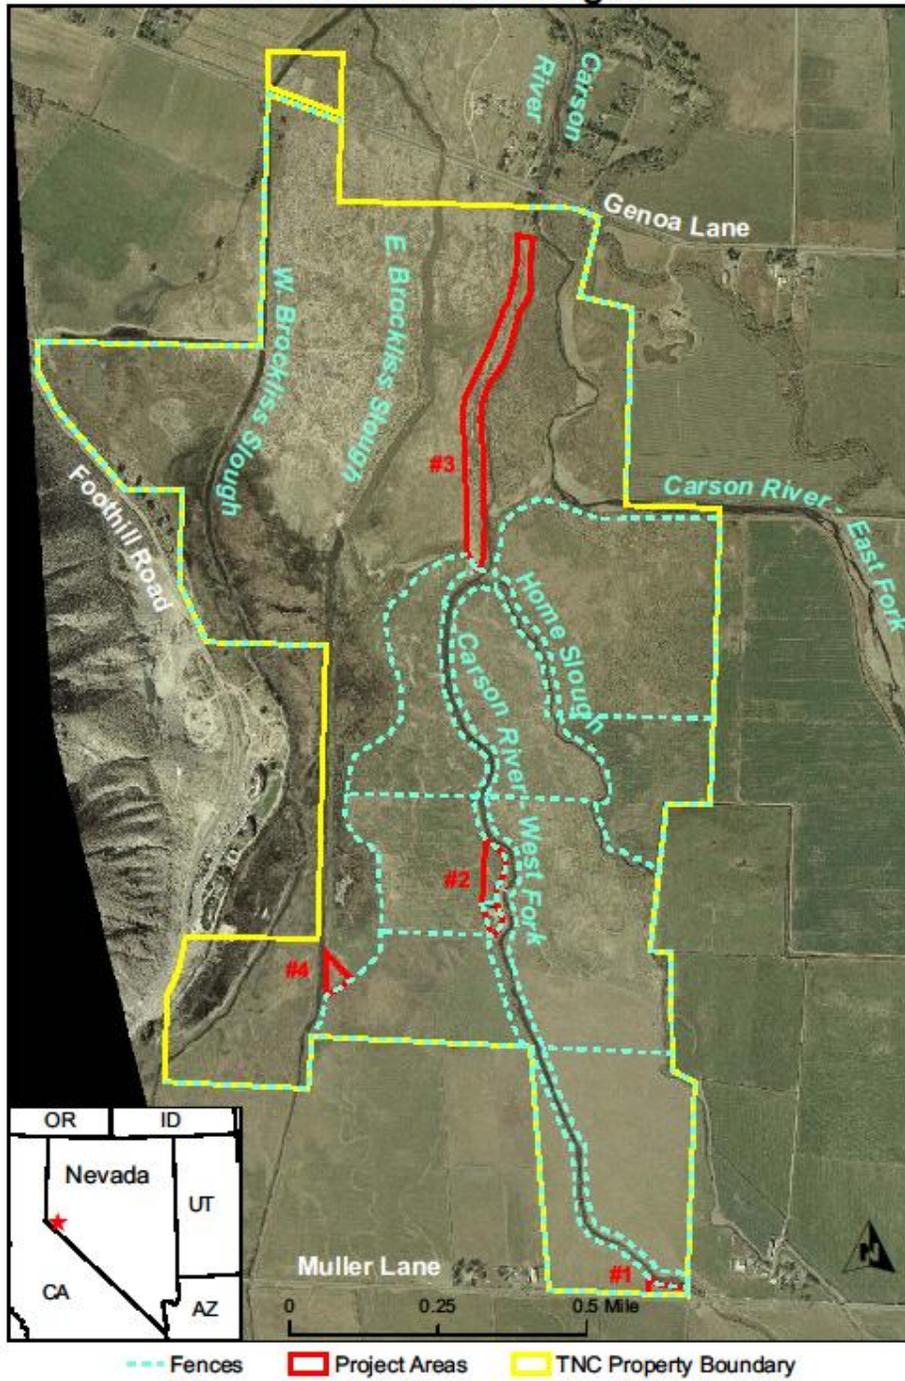
River Fork Ranch Figure 1

Figure 1. River Fork Ranch, Douglas County, NV indicating the locations of SEP restoration areas numbers 1 through 4 (TNC, 2009).

The primary goal of the conservation and restoration activities at River Fork Ranch is restoration of historic geomorphological characteristics (channel and riparian structure) and related floodplain habitat resources like wetlands and related fish/wildlife and vegetative community diversity (The Nature Conservancy, 2007 and 2008). Plant and bird community monitoring data and information are provided. The primary and discrete elements of the SEP have been or will be implemented at one or more of the identified project restoration areas (Area #1 through #4) or along the existing West Fork Carson River riparian corridor within the property identified in Figure 1.

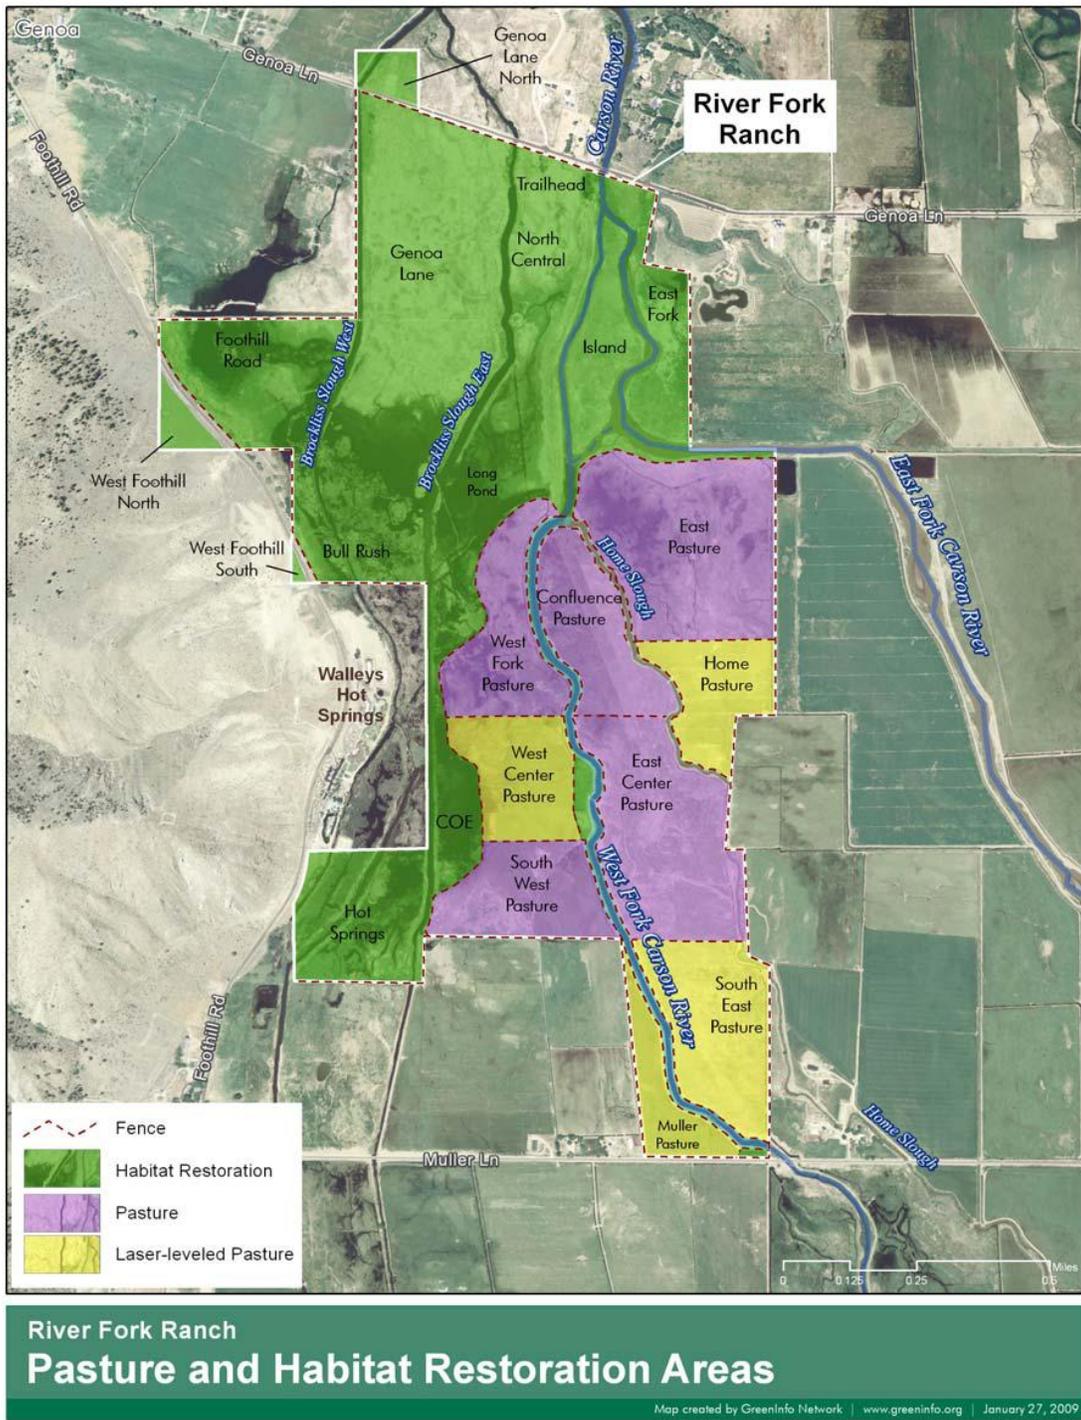
Figure 2. River Fork Ranch, Douglas County, NV indicating pastures and habitat restoration areas (green) including SEP areas as identified in Figure 1 (from McBain & Trush, 2010).

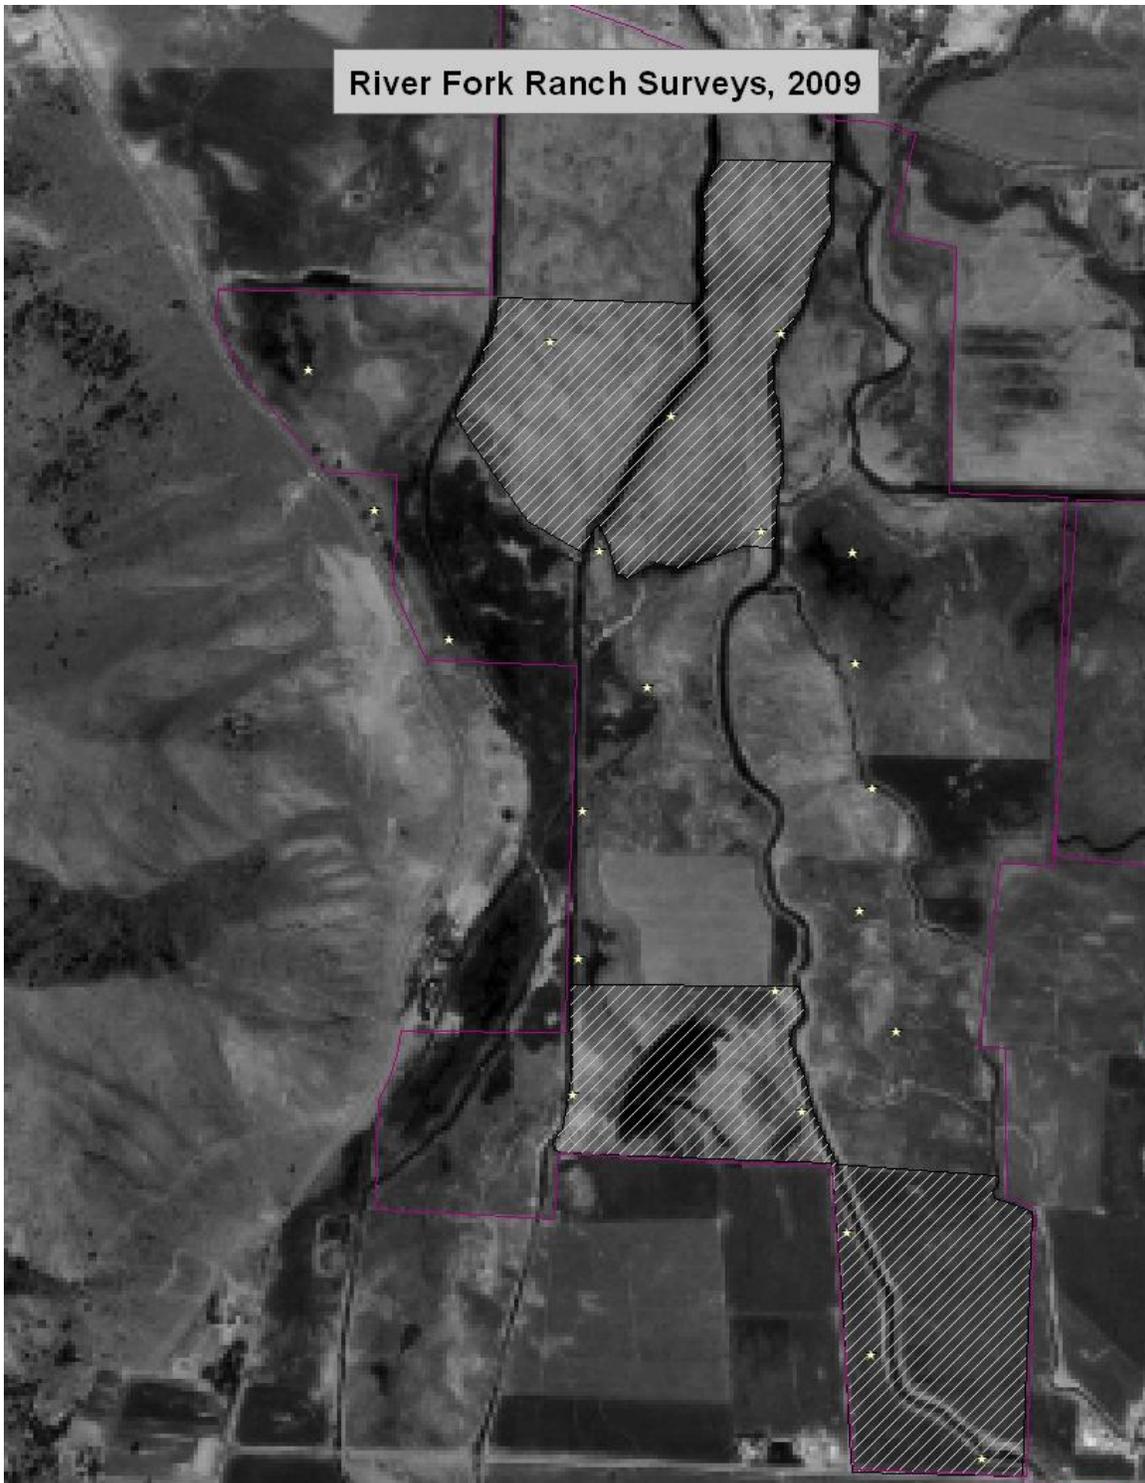
Figure 3. Bird monitoring area search plots (hatch marks) and point count survey locations (stars) at River Fork Ranch, 2009 (from GBBO, 2010).

The Great Basin Bird Observatory (GBBO; Reno, NV) has conducted bird monitoring surveys at River Fork Ranch since 2002 and has reported both historical and 2009 monitoring data in a recent Progress Report (GBBO, 2009). Both point count survey and spot-mapping/area search data are provided in the report and these methodologies are described in detail at the GBBO website (www.gbbo.org/Programs/Projects). Between 2002 and 2009, GBBO has identified 95 bird species including 56 riparian/wetland associated species. In 2009, 56 species including 37 riparian/wetland species were documented across River Fork Ranch property from a combination of point count and area search surveys. Table 2 provides a summary of species detected or quantified within or proximate to the SEP Areas #1 through #4 in 2009. Figure 3 identifies search plot and point count survey locations from the 2009 monitoring program.

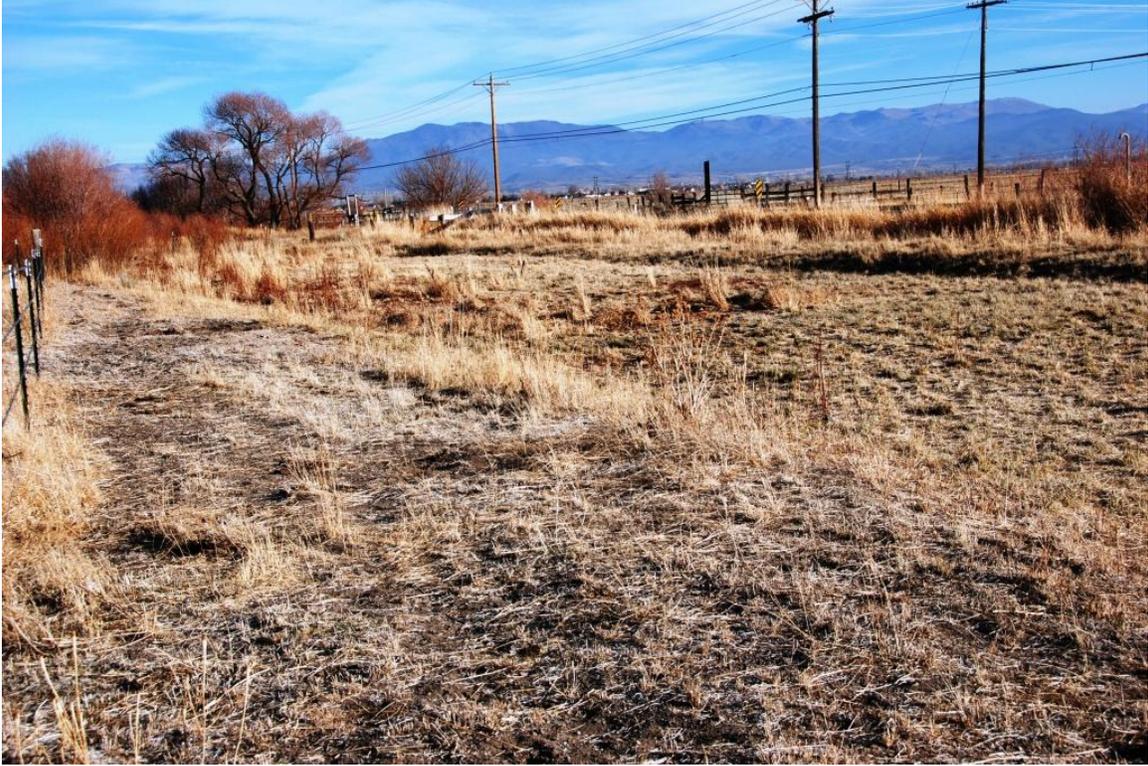
Photograph 1. Area #1 prior to exclusion fence installation and cottonwood tree plantings.

Exclusion fencing was completed in Area #1 in July and this area was planted with cottonwood trees in October and November. Twenty four (24) 3/4-inch diameter and six (6) 2-3-inch diameter cottonwoods were planted by volunteers and/or Tree Nursery personnel. Trees were spaced in random patterns to replicate natural recruitment characteristics. All trees were staked and chicken wire was installed around the bases of the trees to discourage voles. Fence cages were also installed to protect against beaver damage. All of the trees produced buds but several show vole damage including girdling and/or root damage. Additional protective taping was installed around the tree bases and repellent use is under consideration. These trees will be monitored to determine the impact on cottonwood survival rates. Photographs #1, #2 and #3 (Appendix A) show Area #1 before and after the installation of exclusion fencing and after cottonwood tree planting was completed.

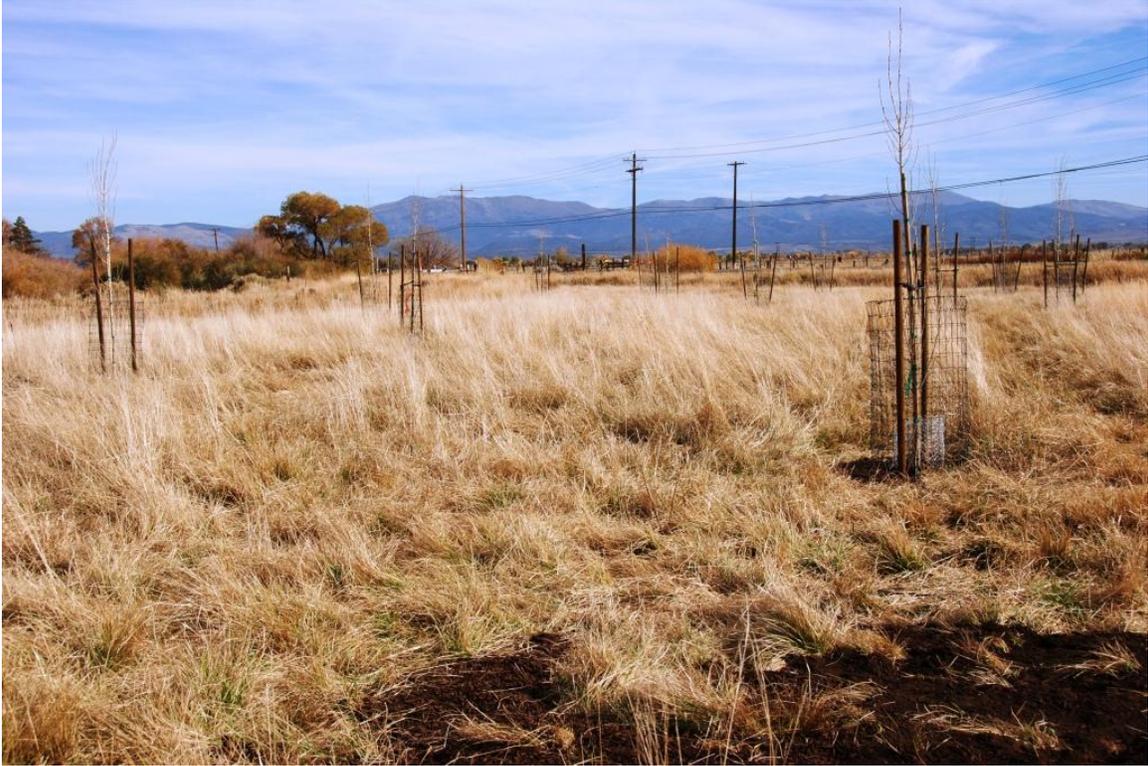
Photograph 2. Area #1 after fencing installation and cottonwood tree planting.

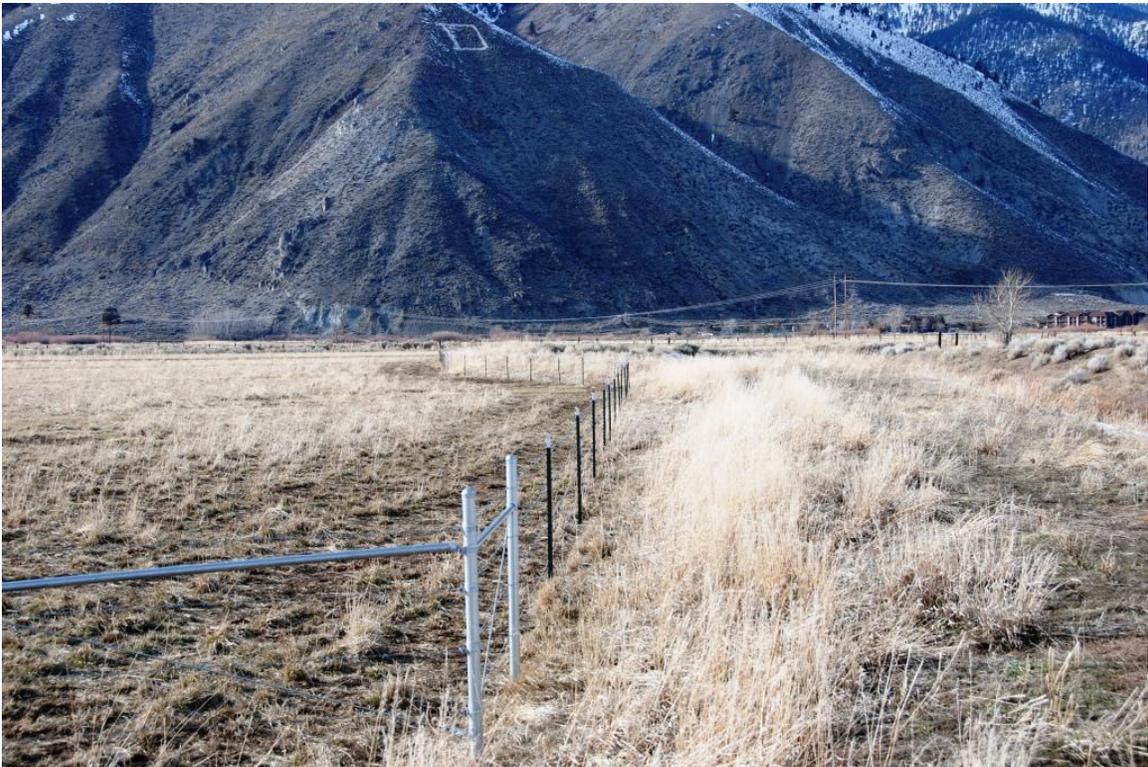
Photograph 3. New exclusion fencing installed at Area #1. Note grazing impact to the left side of the fence and reduced impact to the right side of the fence within Area #1.

In July, approximately 5000' of cattle exclusion fencing was installed. All of the SEP Areas are now excluded from grazing and protected by fencing. Approximately 300' of this fencing was installed to establish and protect Area #1 resulting in a dedicated 2 acre area adjacent to the West Fork Carson River for revegetation efforts as described below. This restoration area was originally planned as less than 1 acre of protected habitat but exclusion fencing was used to protect ~ 2acres of habitat for revegetation. Approximately

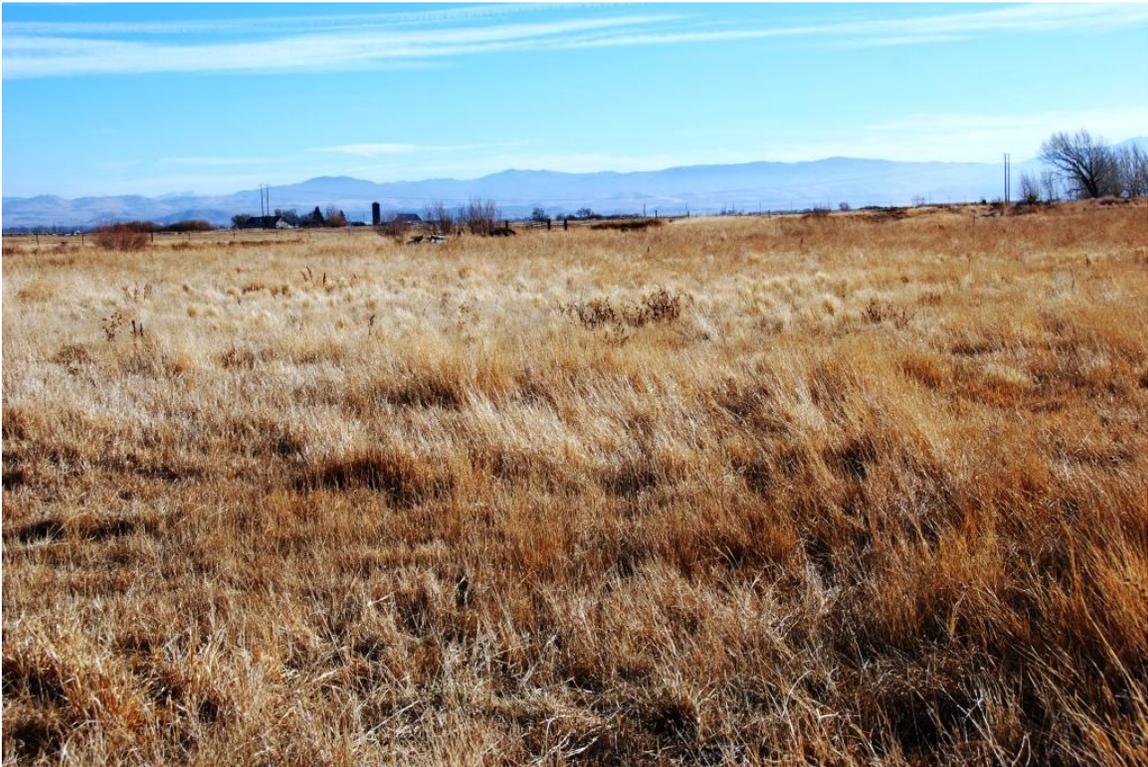
Photograph 4. Protected Area #2 showing remnant alfalfa and grasses prior to earth moving and revegetation.

Area #2 is protected from grazing impacts, restoration planning and design are complete and earth moving will begin in the spring when the ground is sufficiently dry. Revegetation seeding will be conducted to compete with invasive weeds after earth moving has been concluded. This will be followed with multi-age cottonwood and willow plantings.

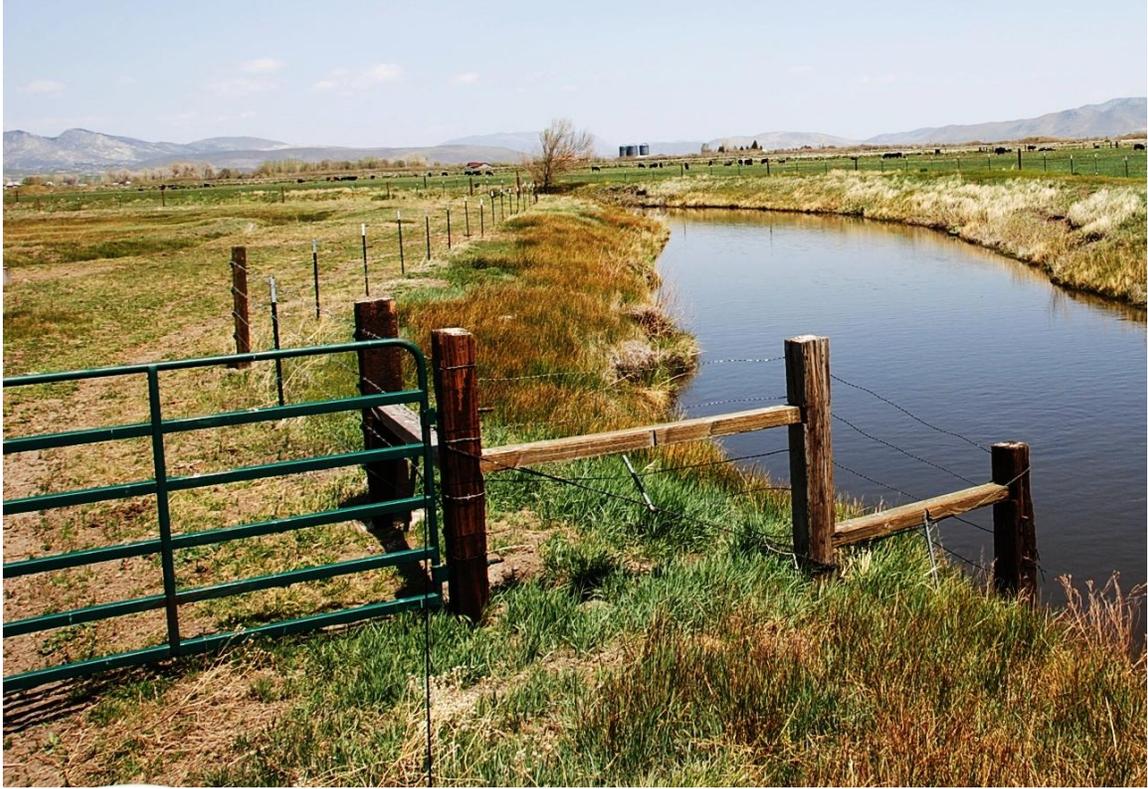
Photograph 5. West Fork Carson River corridor north of Area #2 prior to fence relocation.

4750' of cattle exclusion fencing was also installed and/or relocated to widen the riparian corridor along the river by ~20' between the northern end of Area #1 and the southern end of Area #3. This expanded corridor resulted in the additional protection of about 5 acres of riparian habitat. This additional area will allow wider willow and cottonwood recruitment as the riverbed continues aggrading, building inset floodplains and reestablishing hydrologic connections during seasonal flooding.

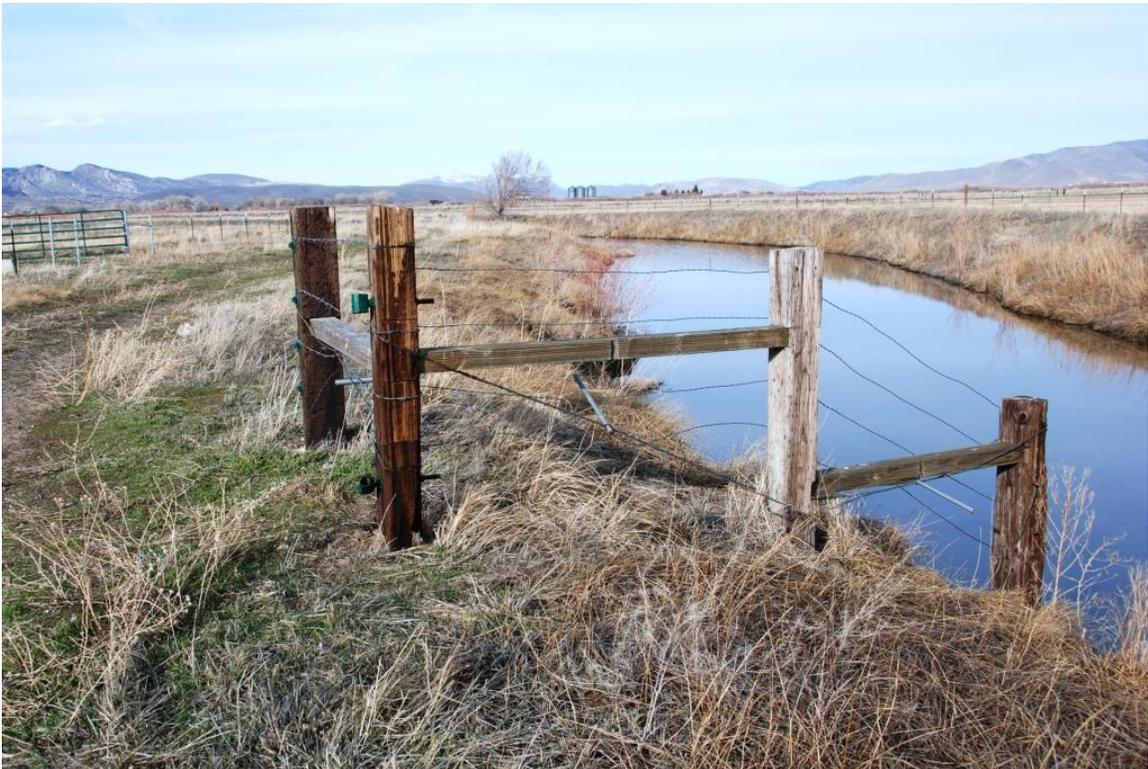
Photograph 6. West Fork Carson River corridor north of Area #2 after fence installation and relocation to provide a wider, protected riparian corridor for passive and active restoration.

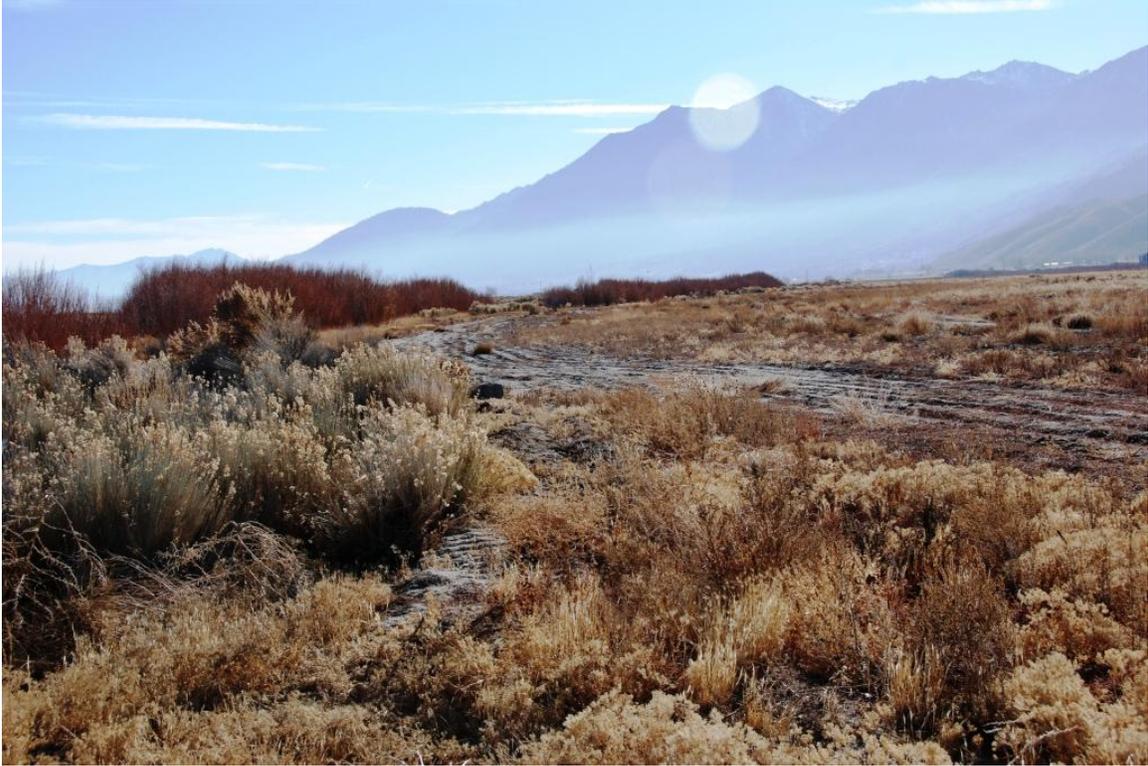
Photograph 7. Protected Area #3 with riparian willow growth along the river (left) and prior to earth moving and restoration activities.

Area #3 is now protected from cattle access, restoration planning and design are complete and earth moving is planned for spring. Revegetation seeding with a meadow mix will be conducted to compete with invasive weeds. This area provides an extensive riparian and wetland restoration potential along and adjacent to the West Fork Carson River proximate to the TNC offices at the north end of the ranch.

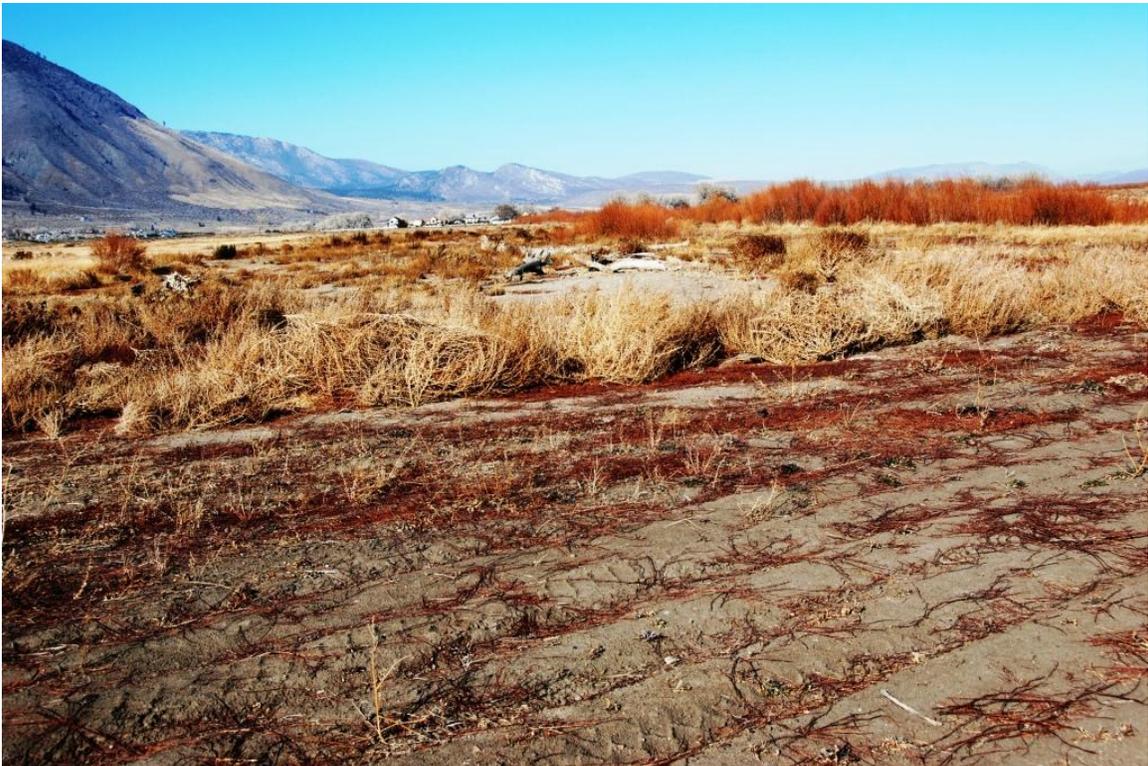
Photograph 8. Area #3 after dredged material berm removal and prior to non-native plant treatment/removal and active revegetation.

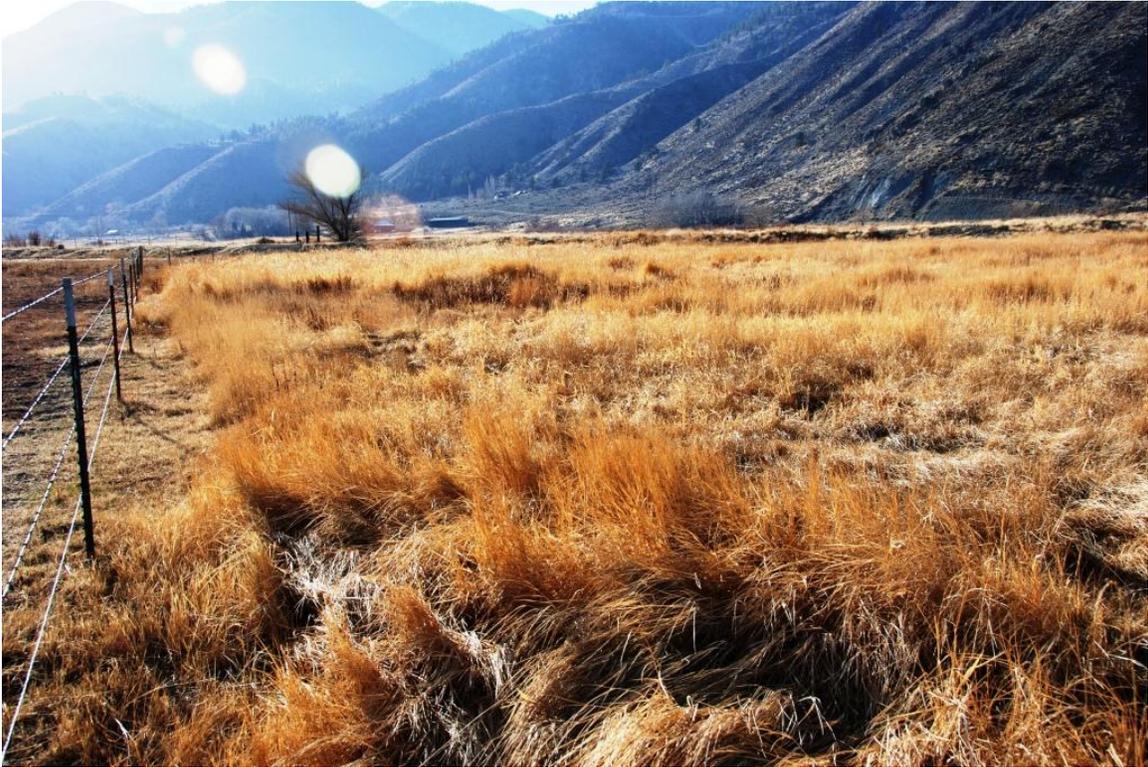
Photograph 9. Protected Area #4 adjacent to East Brockliss Slough prior to treatment/removal of non-native vegetation and grading to enhance and expand wetland habitat. Note grazing impact left of fence.

Area #4 is protected from cattle access, has been treated to remove exotic annual vegetation and earth moving is planned for spring. This restoration area adjacent to East Brockliss Slough is intended to expand localized wetlands by encouraging seasonal flooding and natural wetland plant recruitment from adjacent wetland habitat. In addition, cattail and bulrush will be transplanted within the wetted area.
