## **Remedial Action Completion Report for Parcels UC-1 and UC-2**

**Hunters Point Naval Shipyard  
San Francisco, California**

**February 2013**

**Engineering/Remediation Resources Group, Inc.  
115 Sansome Street, Suite 200  
San Francisco, California 94104**

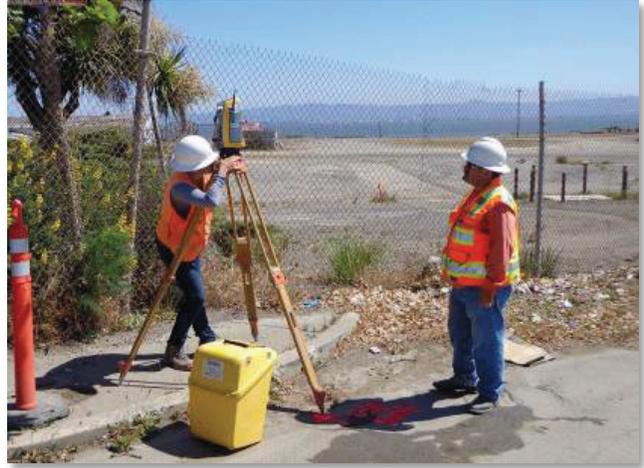
Photograph 1. Surveyors performing the pre-construction survey.

During construction, surveying was conducted on a regular basis to maintain ground control throughout the project area. Grade checking was performed throughout excavation work using string line techniques to confirm target elevations for placement of soil cover. A professional civil engineer oversaw all surveying and grade checking activities.

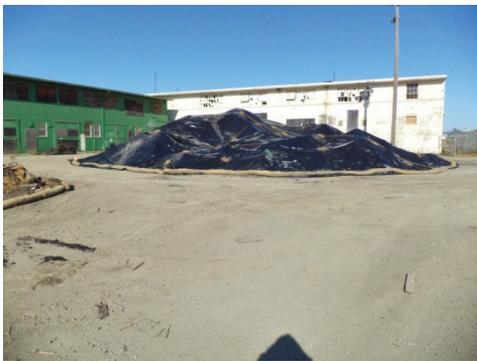
Photograph 2 Environmental BMPs implemented and maintained throughout construction.

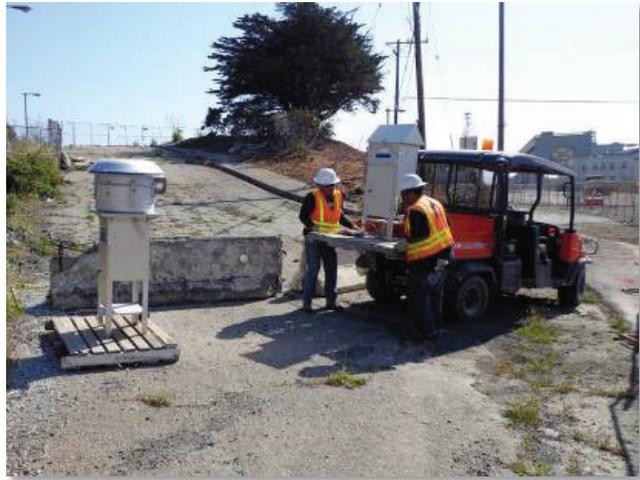
Photograph 3 Setup of high-volume air monitoring station.

Site-specific air monitoring stations were set up in each work area during mobilization and operated throughout the entire period of construction in accordance with the project Dust Control Plan included in Appendix E of the RAWP ([ERRG, 2012b](#); photograph 3). Each monitoring station included separate monitoring systems for (1) total suspended particulates, arsenic, chromium, lead, and manganese; (2) particulate matter larger than 10 microns in size; and (3) asbestos. The Air Monitoring Summary Report provided in [Appendix C](#) describes (1) where and how air monitoring samples were collected, (2) what test methods were used to analyze air monitoring samples, and (3) how air monitoring data were evaluated.

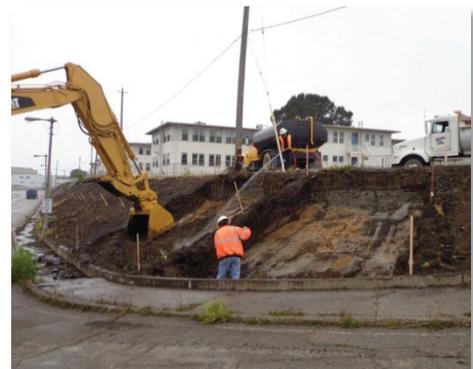
**Photograph 4** Hillslope excavation along Fisher Avenue.

- Demolition, clearing, and grubbing
- Excavation of slopes (photograph 4)
- Import of soil cover materials
- Placement and compaction of soil cover material

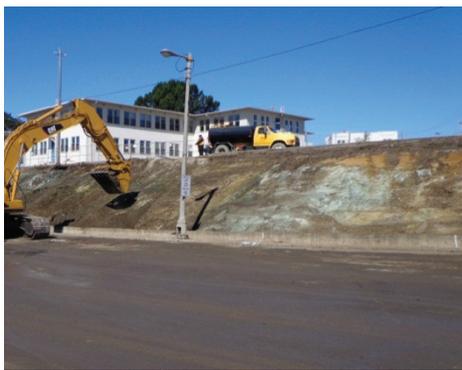
**Photograph 5** Exposed bedrock on excavated hillside.

Excavation work started at the northwest end of Parcel UC-2 along Fisher Avenue and proceeded in a southwesterly direction along the hill slope. Excavations were performed using an excavator positioned at the bottom of the slope on Fisher Avenue. A minimum of 2 feet of soil was removed from each designated excavation location in most areas. In some areas, bedrock was encountered along the hill slope within 0.3 feet and 2 feet below original grade (see sheets C2-1 and C2-2 in [Appendix F](#)). Two feet of soil could not be removed in areas where bedrock was located within less than 2 feet of the original grade.

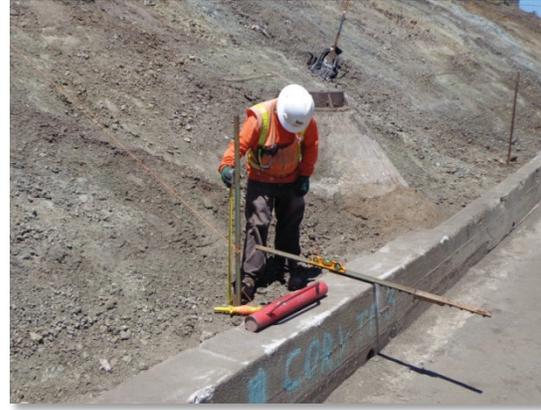
Photograph 6 Grade checker verifying excavation grades.

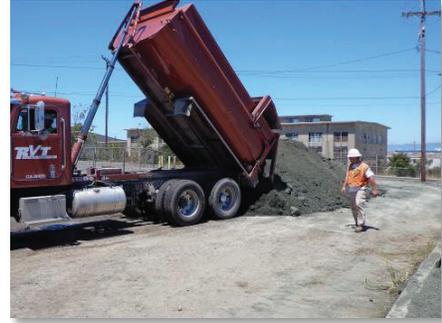
Photograph 7. Clean backfill imported by truck.

Imported fill was transported to Parcels UC-1 and UC-2 by truck, as needed, and placed upon arrival to reduce the need to create large stockpiles of clean soil at the site (photograph 7). Direct placement of soil imported to the site by trucks minimized the risk of generating windblown dust and reduced stockpile erosion.

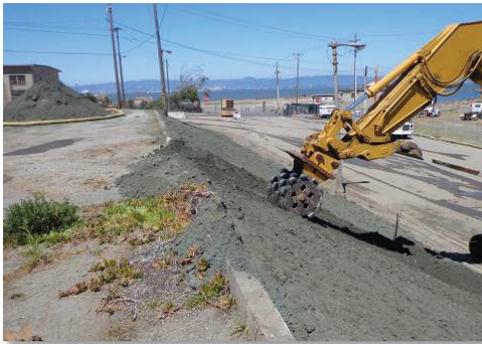
Photograph 8 Compaction of soil cover material with excavator wheel attachment.

For the less compacted layer of the soil cover (i.e., material within 6 inches of the final grade; identified as the erosion-resistant cover layer in the RD [ChaduxTt, 2010a]), each lift was compacted to no greater than 85 percent of the maximum dry density at optimum moisture content in accordance with ASTM D6938-10 (ASTM, 2010) and ASTM D1557-12 (ASTM, 2012), as specified in the RD (ChaduxTt, 2010a). Compaction of the erosion-resistant cover layer was achieved using the bucket of the excavator, which created a smooth surface upon which to place the erosion control blankets.

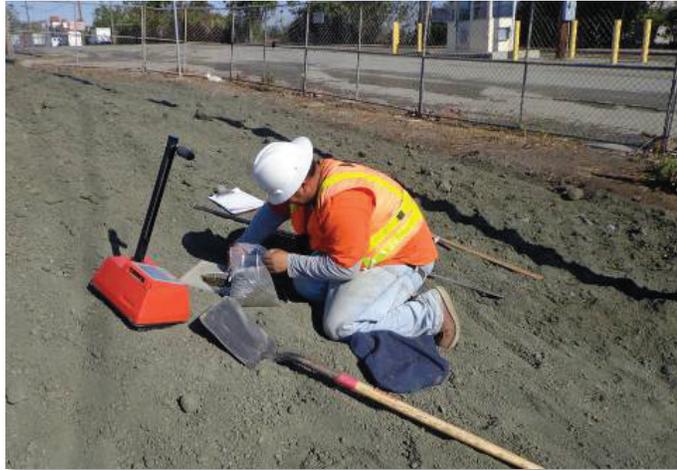
**Photograph 9** Nuclear density gauge and sand cone testing to verify soil cover compaction.

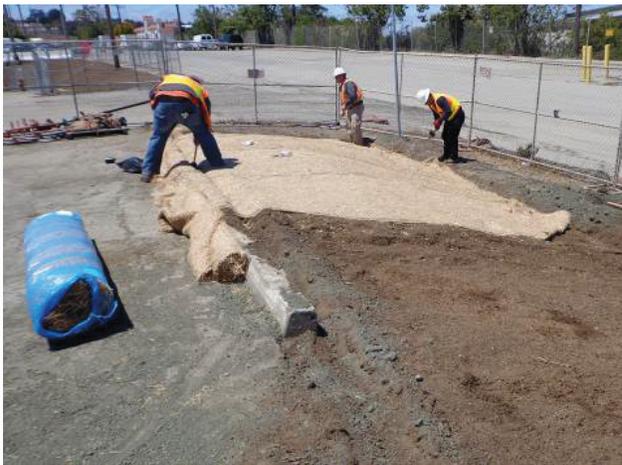
**Photograph 10** Installation of erosion control blanket over soil cover.

recommended pinning pattern and frequency. The CQC Manager verified the pin placement to ensure that the manufacturer's specifications were met.

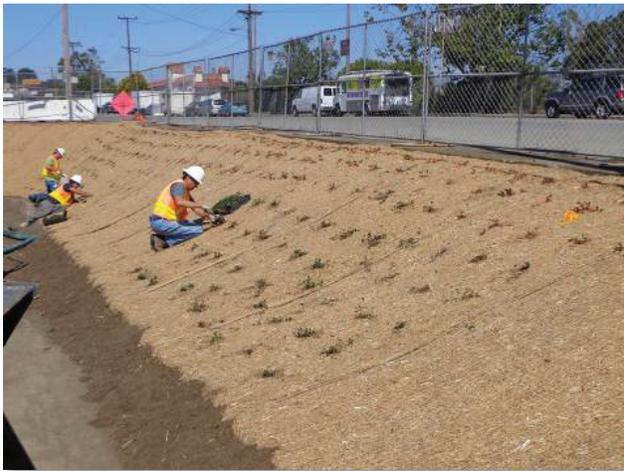
Photograph 11. Installation of live plants by hand on soil cover.

Plant locations were marked out on the ground and installed by hand in accordance with the planting schedule specified in the RD (photograph 11; ChaduxTt, 2010a). At each plant location, the erosion control blanket was cut in a cross pattern. Then, a hole large enough to accommodate the root ball was dug and the plant was placed inside the hole. Soil was then replaced around the plant root ball and stem and compacted by hand. The erosion control fabric flaps were then replaced around the plant to stabilize the cover surface around the base of the plant. The CQC

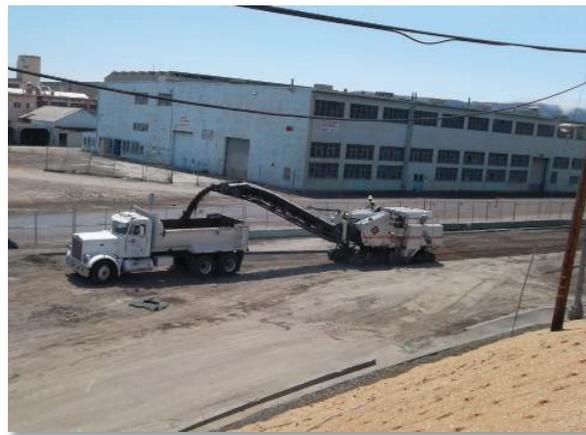
Photograph 12 Grinding of damaged asphalt pavement.

A grinding machine was mobilized to Parcels UC-1 and UC-2 on August 14, 2012 (photograph 12). The grinding machine was used to mill away the original asphalt to varying depths based on the degree of degradation (see sheets C2-1 and C2-2 in Appendix F). The grinding machine milled 4 inches in locations where only the AC needed to be replaced. An 8-inch grind was performed in locations where both the AC and AB needed to be replaced. A conveyor belt was used to transfer AC and AB rubble generated by the grinding machine into dump trucks, which transported the waste to the

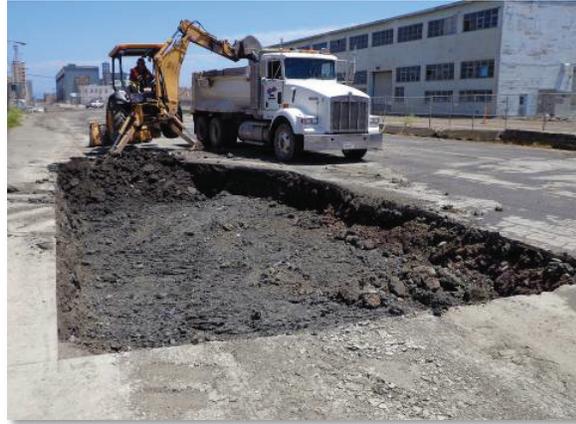
**Photograph 13.** Asphalt subgrade excavation in areas where former asphalt pavement was sagging below the surrounding grade.

SG was removed in areas where original asphalt was observed to be sagging below the surrounding grade (photograph 13). The areas where SG was removed were delineated with spray paint, and a walk-behind saw cutter was used to cut clean edges into the original AC to minimize disturbance to the surrounding original AC during removal of the SG. An excavator directly loaded the removed SG spoils into dump trucks at the area of concern. The CQC Manager, a licensed professional engineer, oversaw all SG removal activities to ensure that all SG areas requiring replacement were removed to an

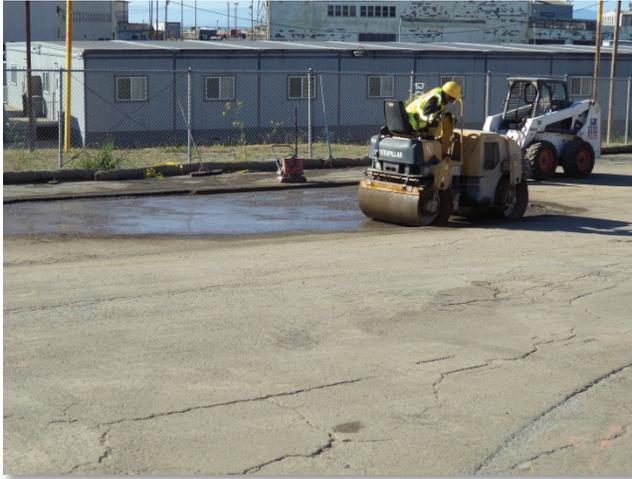
**Photograph 14.** Compacting aggregate base using a smooth drum compactor.

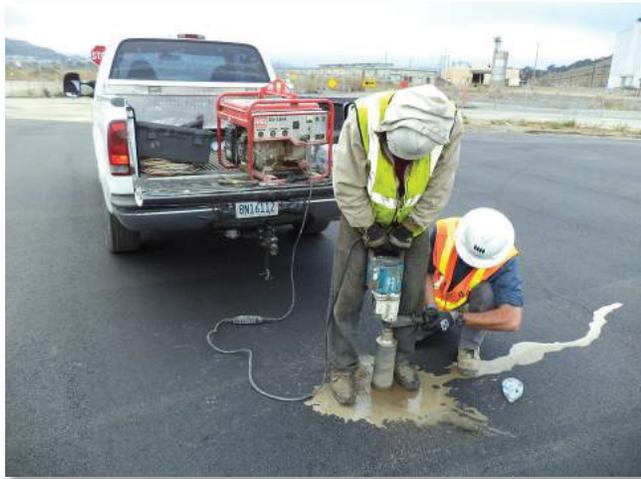
**Photograph 15.** Coring to collect AC sample for offsite analysis by a certified material testing laboratory.

AC was placed on smooth working surfaces comprising either original or new AB. Before installing new AC on the compacted AB, the area was swept with a commercial street sweeper to remove loose material on the surface to be paved. AC meeting the project specifications was imported from a nearby AC manufacturing plant using dump trucks. The AC was loaded directly into an AC paving machine as it applied 2-inch lifts of AC over the areas to be paved. Each lift was placed and compacted with a smooth drum roller until the AC was 4 inches thick (i.e., two lifts thick). The CQC Manager, a licensed professional civil engineer, oversaw installation of the AC. A third-party company (and a certified offsite laboratory) tested all installed AC to verify that the material type and placement met the requirements of the design specification in the RD (photograph 15; ChaduxTt, 2010a). AC testing results are included in the CQC submittals (see Appendix D).

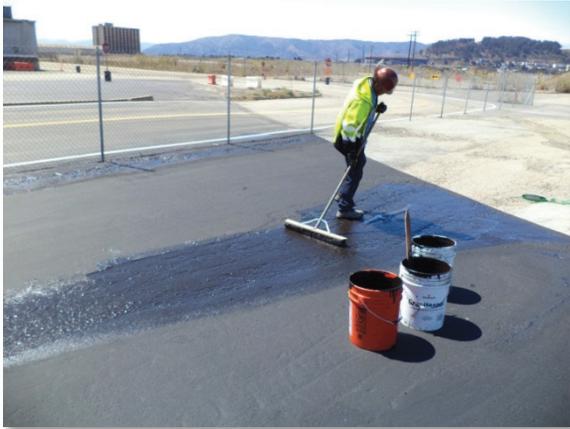
**Photograph 16** Asphalt seal application at intersection of Spear Avenue and Crisp Road.

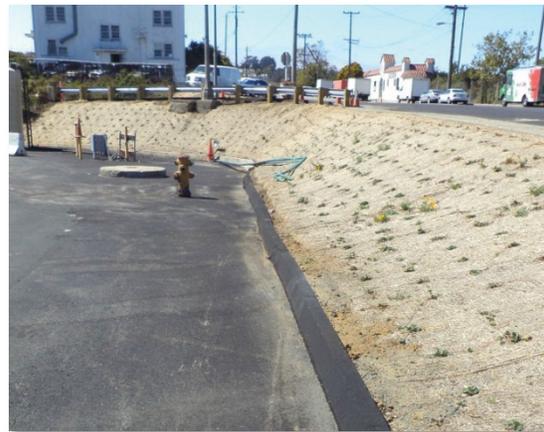
**Photograph 17.** New AC curb installed where damaged or missing.

Although not specified as a requirement in the RD (ChaduxTt, 2010a) and not directly required to meet the RAOs in the RODs (Navy, 2009a and 2009b), the Navy made reasonable efforts to improve drainage at Parcels UC-1 and UC-2 to minimize future ponding of rainwater that might compromise the lifespan of the new asphalt cover. To improve site drainage, the most significant topographic depressions along Fisher and Spear Avenues were filled with asphalt so they more closely matched the surrounding final grades. Additionally, new AC was sloped to the extent practicable toward existing drain inlets in the roadways and drain inlets were cleared of debris to improve their ability to convey water to the drainage swales in Parcels C and G. Also, existing curbs and gutters were inspected to ensure they were intact and would adequately prevent water from eroding the new soil cover. Where damaged or missing, new AC curb was installed (photograph 17). The CQC Manager, a licensed professional civil engineer, prescribed all drainage improvements following an evaluation of the pre-construction survey data and inspections and in consultation with the Navy RPM.

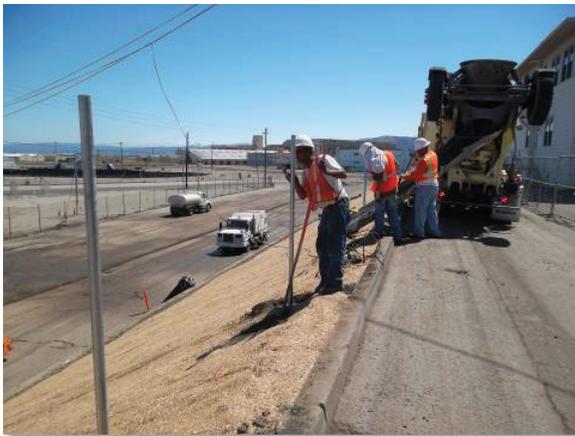
Photograph 18. Installation of fence posts along top of hillslope.

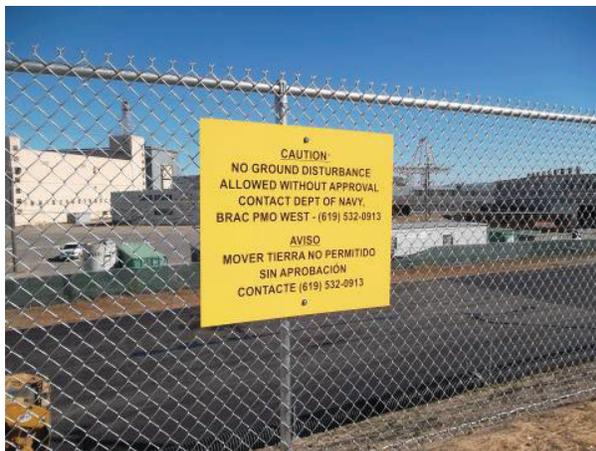
Photograph 19. Informational sign installed along new fence.

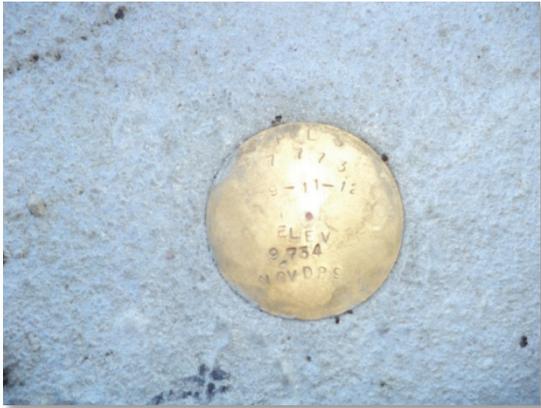
Photograph 20. Stamped settlement monument medallion.

A California-licensed land surveyor performed the post-construction (as-built) survey to document as-built conditions, including final site grades, installation locations, and elevations of key site features. The results of the post-construction survey were used to generate as-built drawings included in [Appendix F](#). The post-construction survey was conducted to an accuracy of 0.1 foot horizontally and 0.01 foot vertically. All horizontal coordinates were based on the following surveying control datum: (basis of bearings) North American Datum 27 Zone-III. All vertical elevations were based on the following surveying control datum: (benchmark) National Geodetic Vertical Datum 29 (corrected).

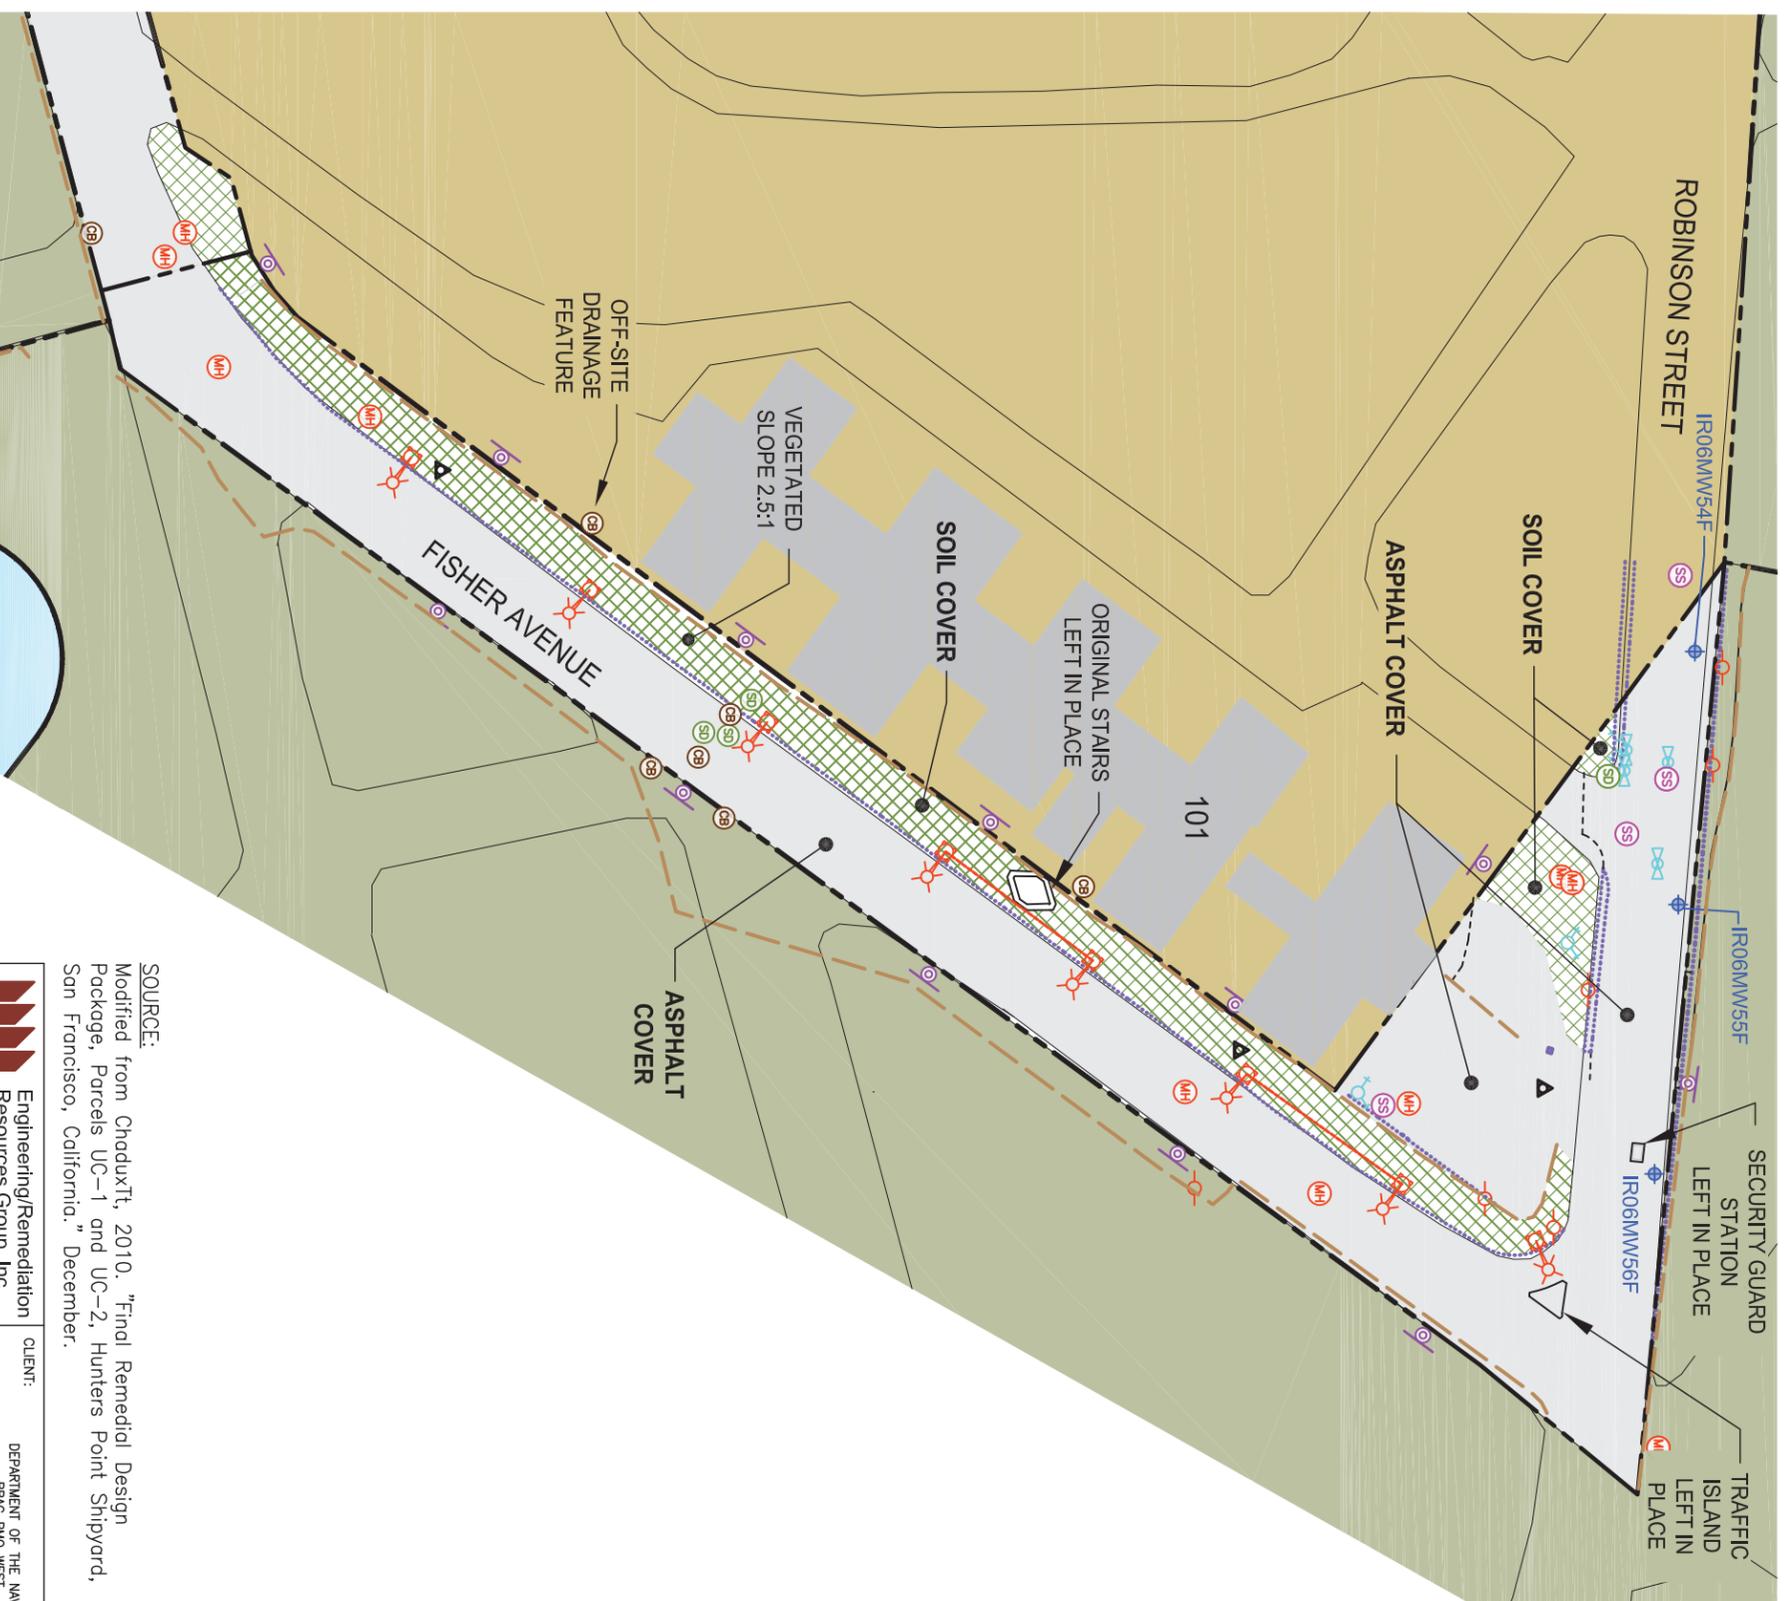
CLIENT:	DEPARTMENT OF THE NAVY, BRAC PMO WEST	DRAWN BY:	SC 02/08/13	CHECKED BY:	JS 02/08/13	PROJECT NO.	2011-147	FIG NO.	4
LOCATION:	HUNTERS POINT NAVAL SHIPYARD SAN FRANCISCO, CALIFORNIA	DURABLE COVERS FOR PARCEL UC-2

The roadways at Parcels UC-1 and UC-2 have been in place since the original construction of HPNS in the 1940s. Minor portions of Parcels UC-1 and UC-2 were used as parking areas for nearby buildings, including Buildings 819 and 823 and Buildings 101 and 110, which are former barracks adjacent to Parcel UC-2 (Figure 4).

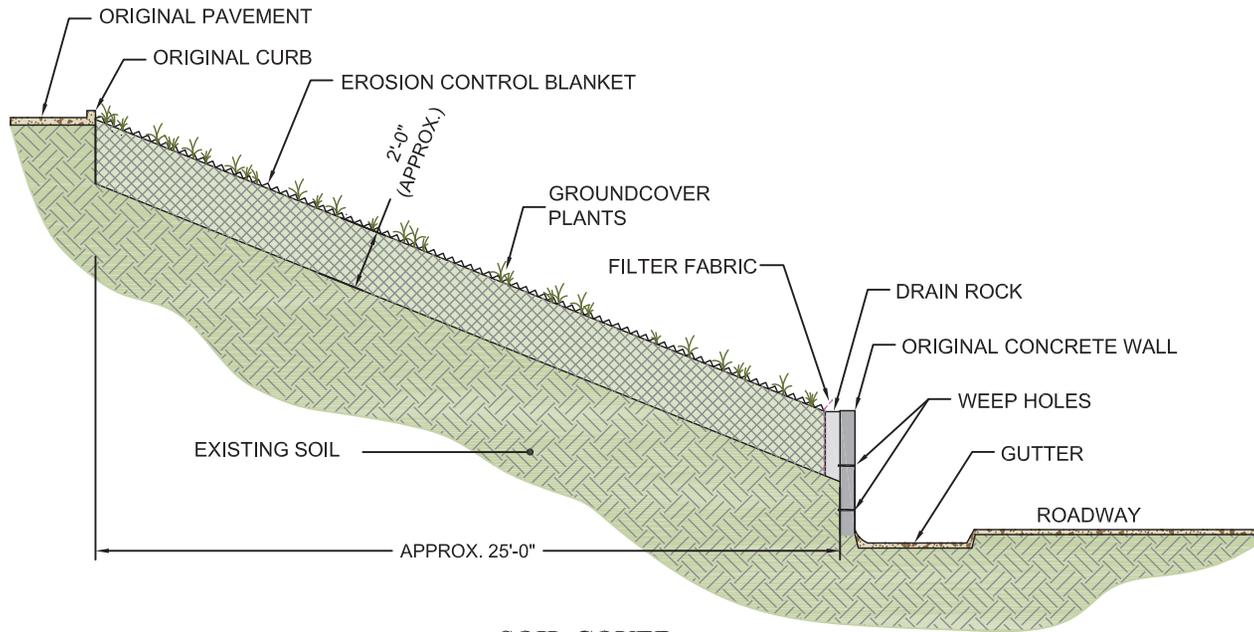
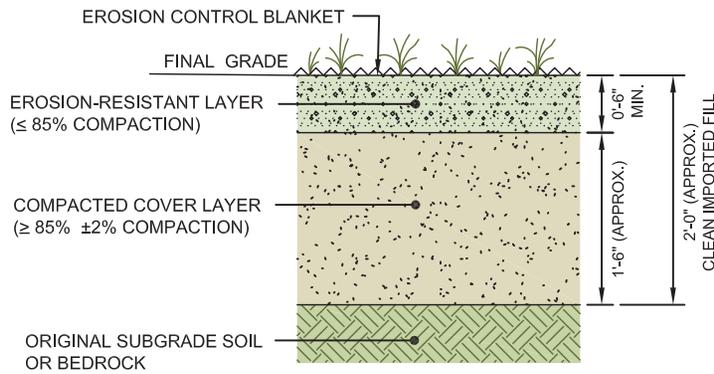
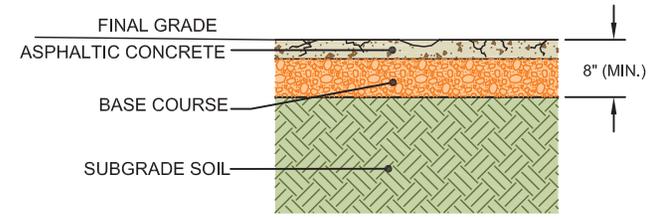
In accordance with the Remedial Design, an 8-inch asphalt cover, comprising 4 inches (minimum) of asphaltic concrete (AC) and 4 inches (minimum) of aggregate base (AB), was installed to minimize exposure of humans and wildlife to potential COCs in underlying soil. Existing AC covers that were in good condition were left in place and incorporated into the final asphalt cover. Existing AC covers that had degraded were repaired by removing and replacing the AC; the AC and AB; or the AC, AB, and subgrade material, depending on the extent of the degradation. AC covers exhibiting minor cracking were restored by applying an asphalt seal to fill in the cracks. Concrete building foundations and sidewalks were also restored and incorporated into the durable cover. Cracks and penetrations in concrete covers were filled with non-shrink grout.

**SOIL COVER**

**ASPHALT PAVEMENT REPAIR**

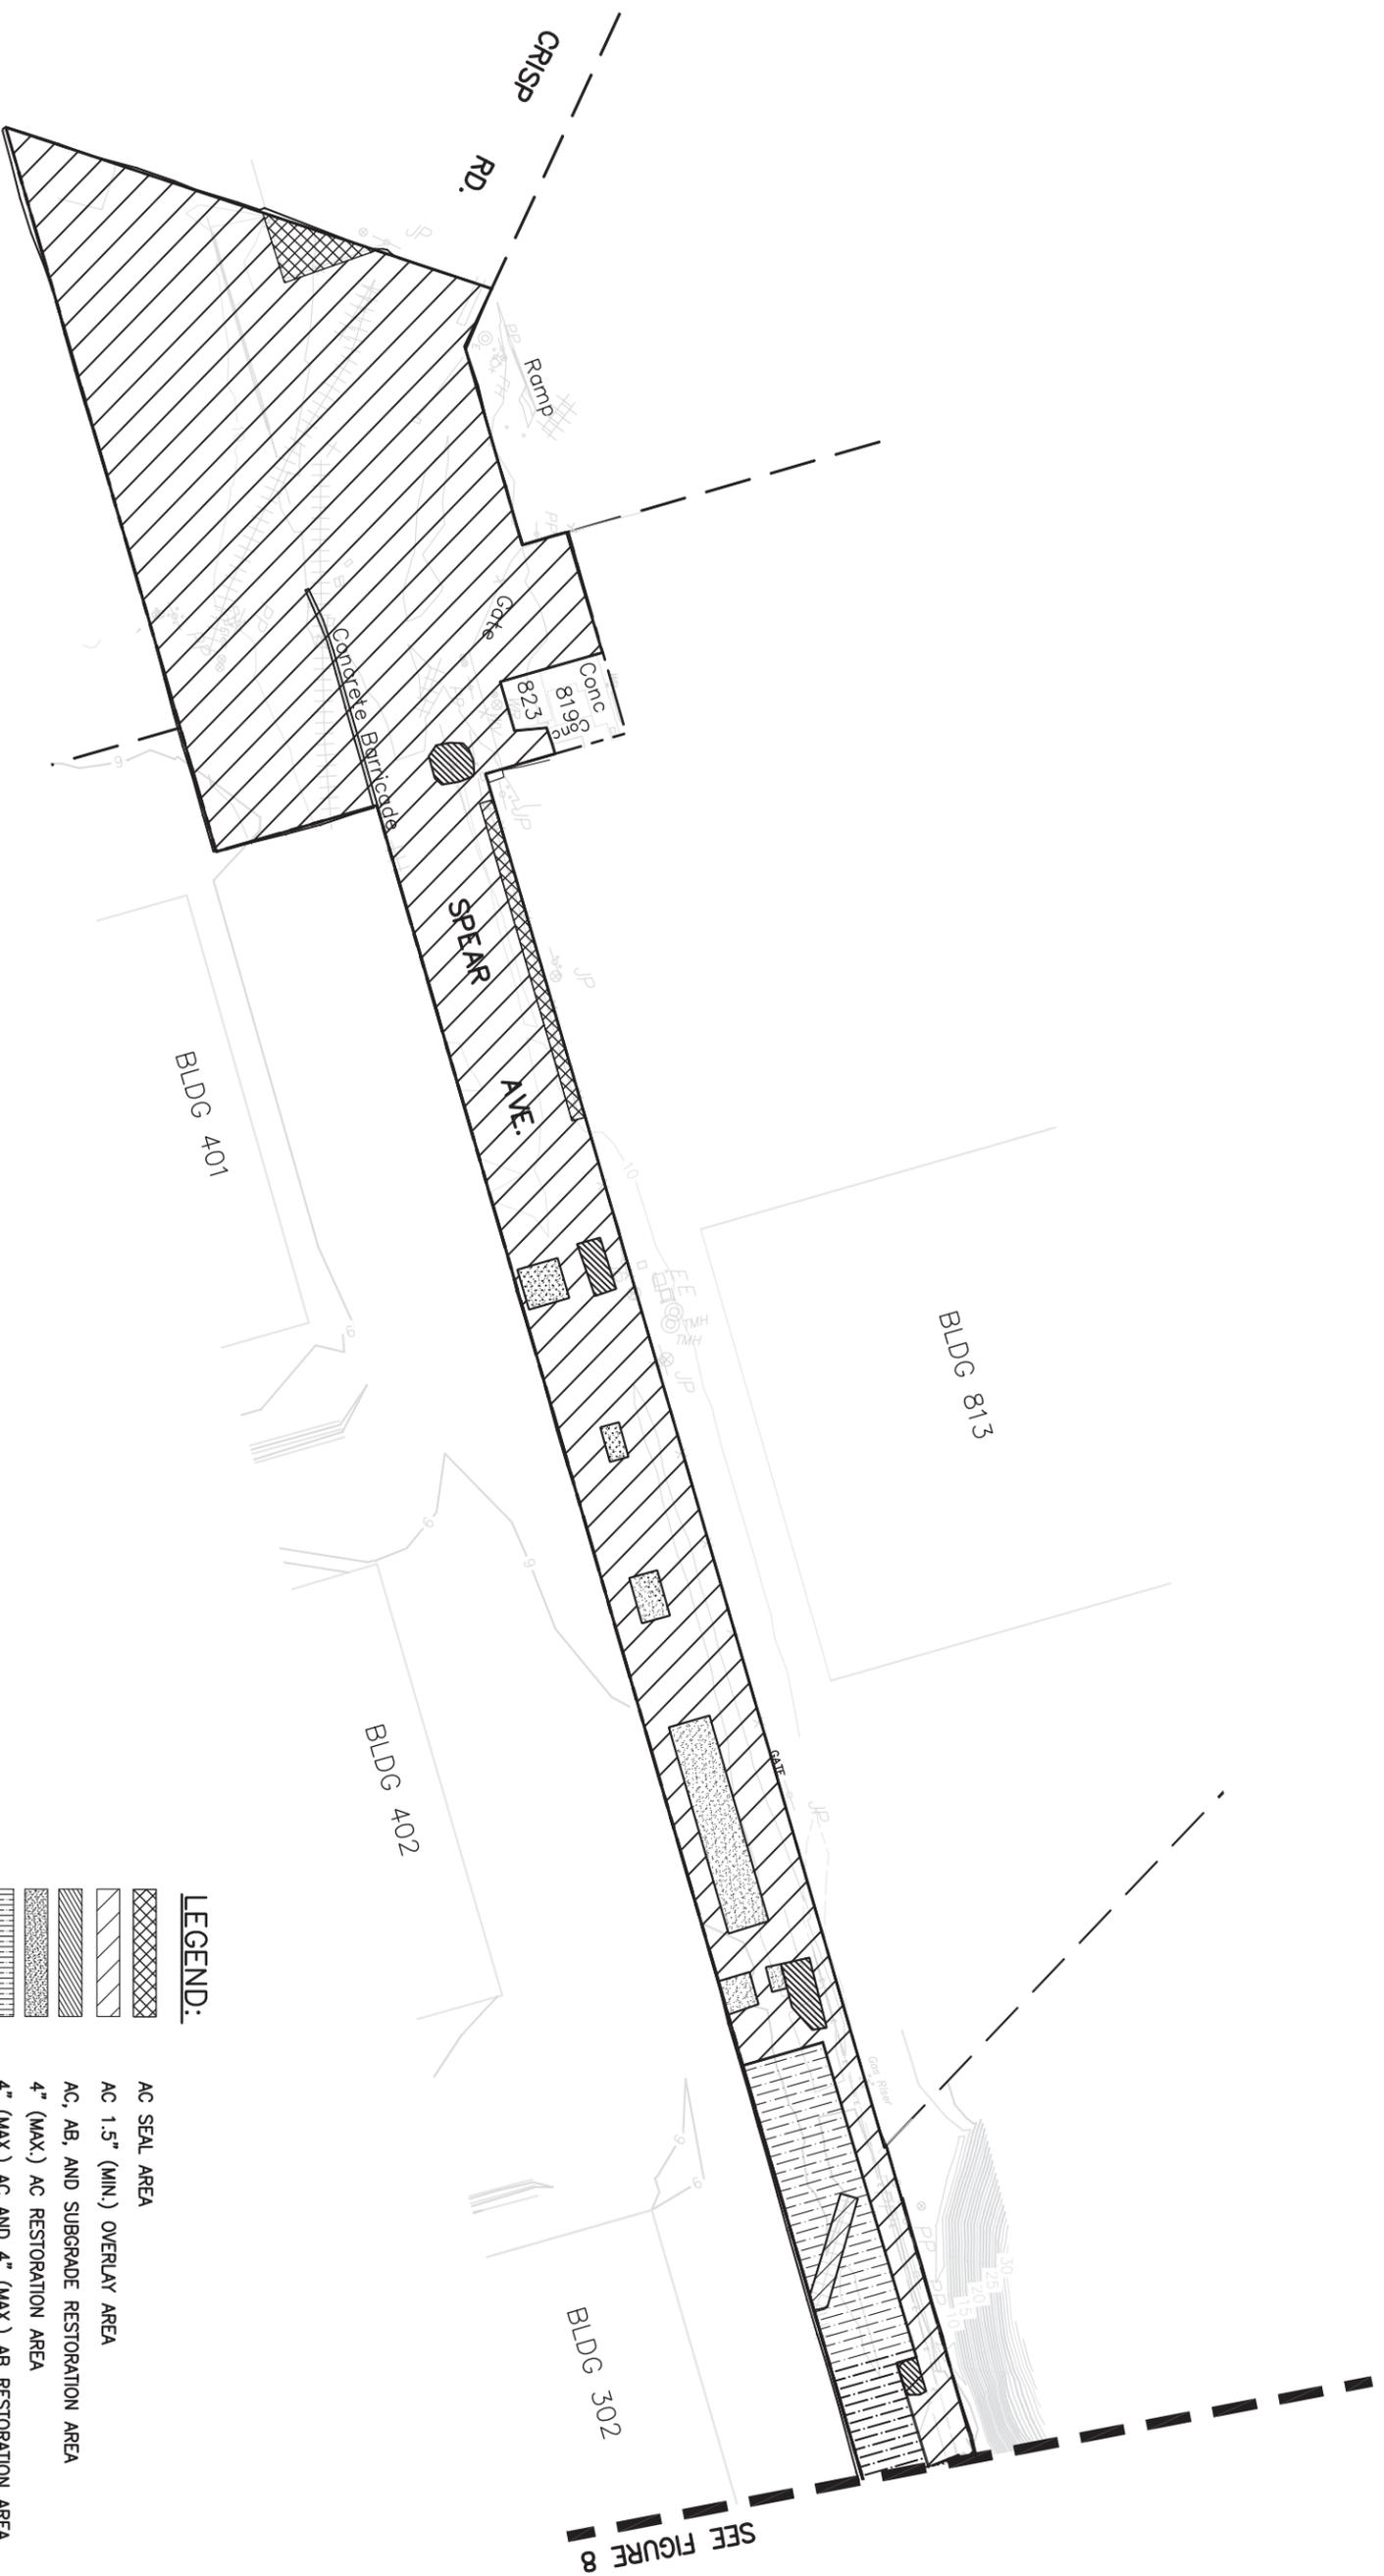
CLIENT:	DEPARTMENT OF THE NAVY, BRAC PMO WEST	ROADWAY AND HILLSLOPE RESTORATION FOR PARCEL UC-1	PROJECT NO. 2011-147
LOCATION:	HUNTERS POINT NAVAL SHIPYARD SAN FRANCISCO, CALIFORNIA	DRAWN BY: SC 02/08/13	CHECKED BY: JS 02/08/13
			FIG NO. 7

Figures 7 and 8 and the as-built drawings (Appendix F) identify the paved areas that received the different repair treatments and the final site grades.

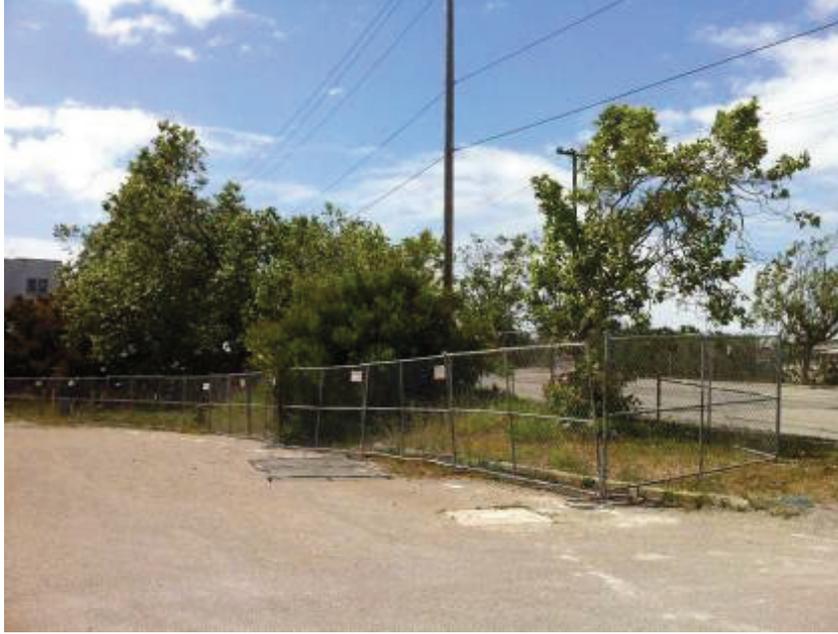
*Photograph A-1: Mobilization – Installation of temporary fence around vegetation near Building 101 in preparation for tree removal, clearing, and grubbing.*

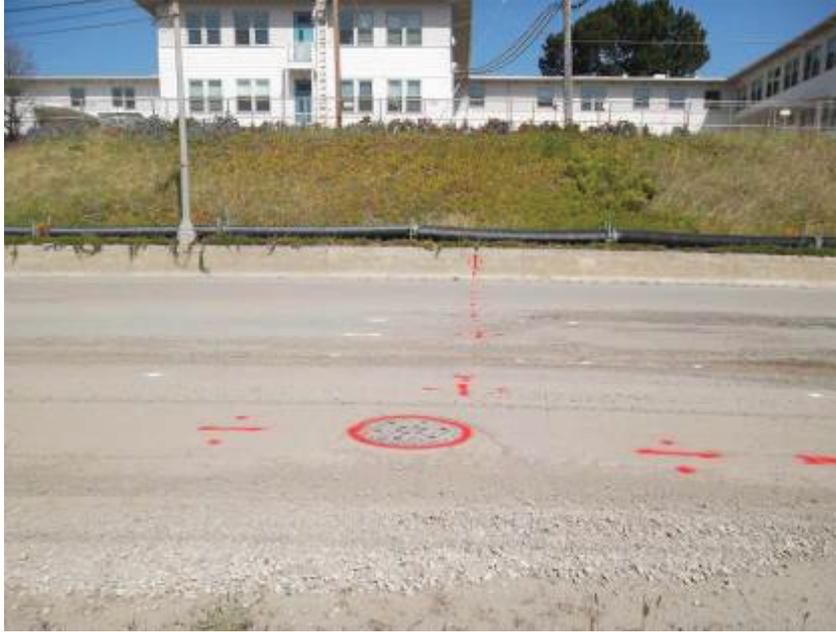
*Photograph A-5: Mobilization – Subsurface utilities location and demarcation prior to start of intrusive work.*

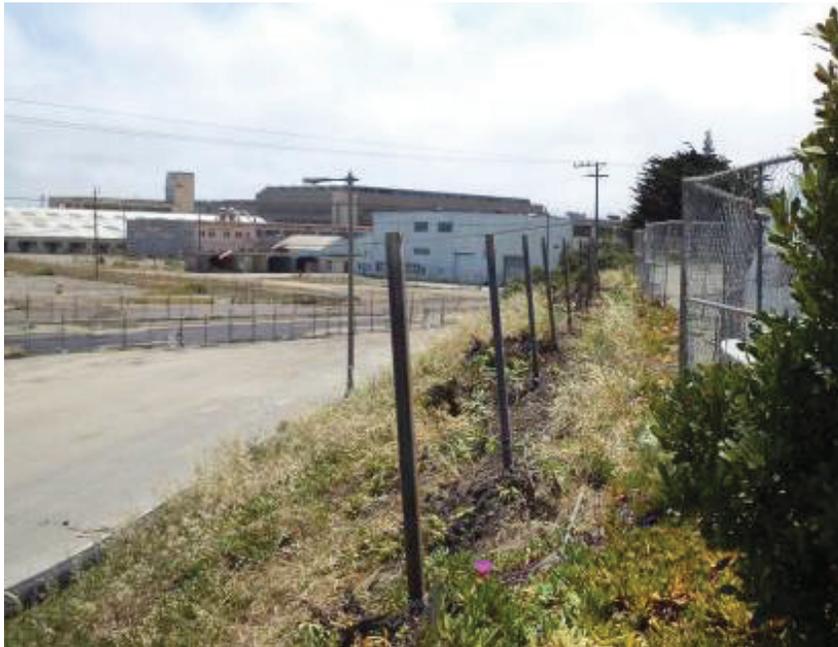
*Photograph A-8: Site Clearing and Demolition – Removal of fence fabric and horizontal bars from existing fence along the top of slope in Parcel UC-2.*

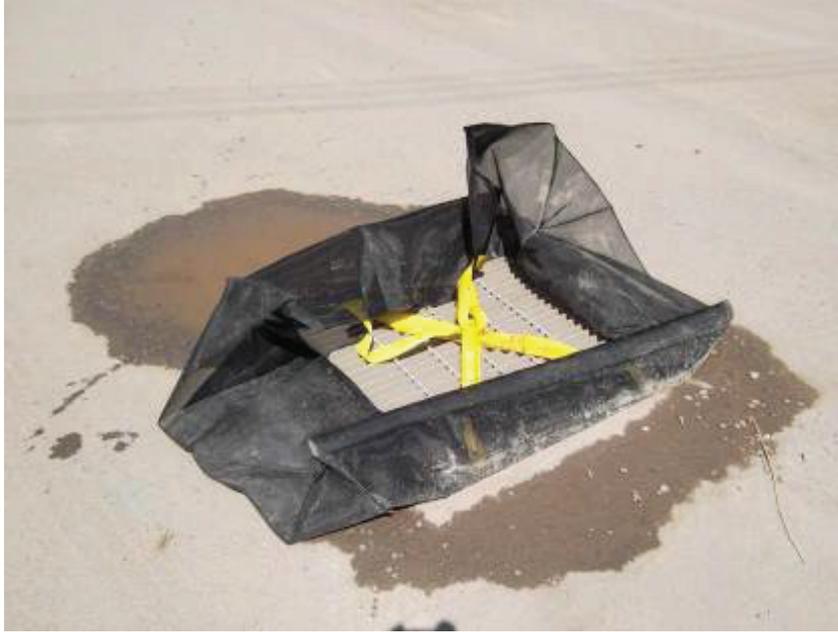
*Photograph A-11: Mobilization – Installation of drop inlet filter screens to prevent sediment from entering the drop inlet.*

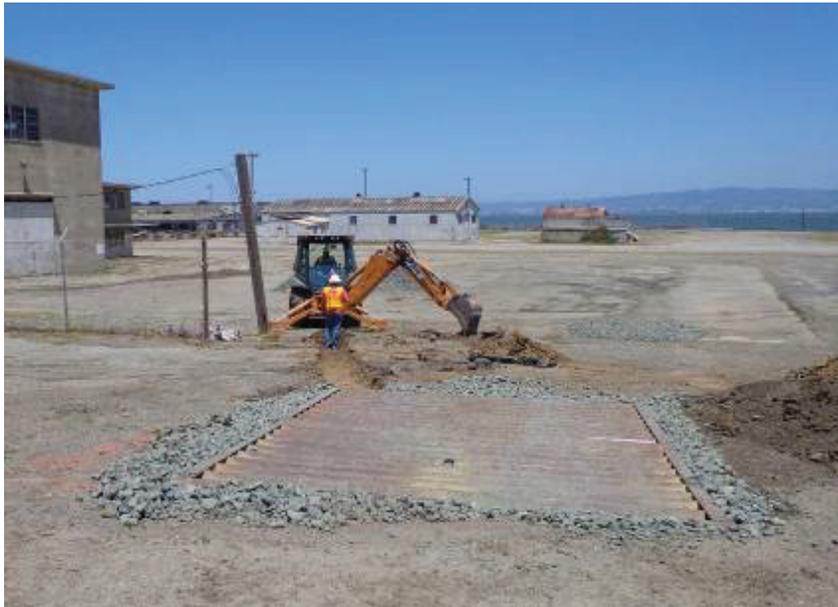
*Photograph A-12: Mobilization – Installation of tire wash station near the intersection of Lockwood St and Robinson Street in Parcel B. Digging trench to drain wash water to a sump for collection.*

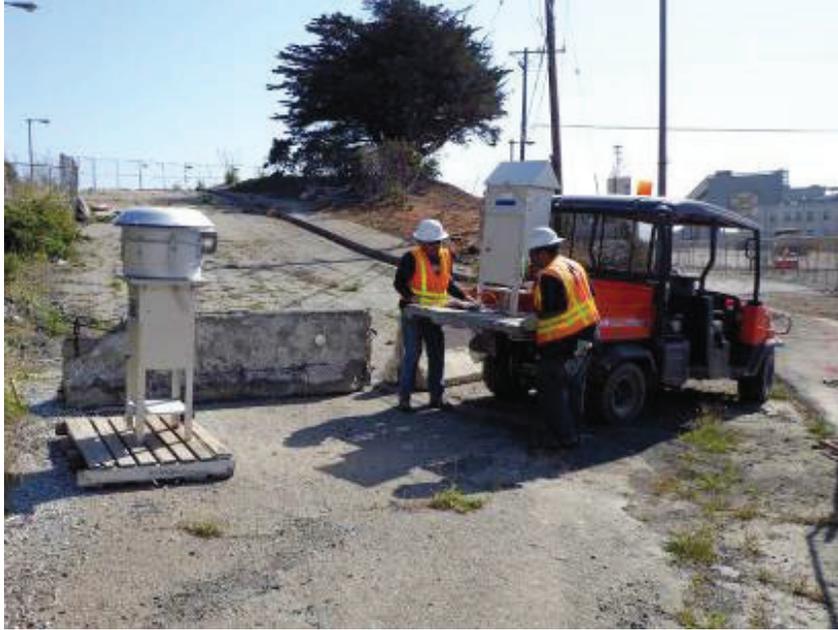
*Photograph A-13: Mobilization – Setup of high volume air monitor upwind of the Parcel UC-2 work zone.*

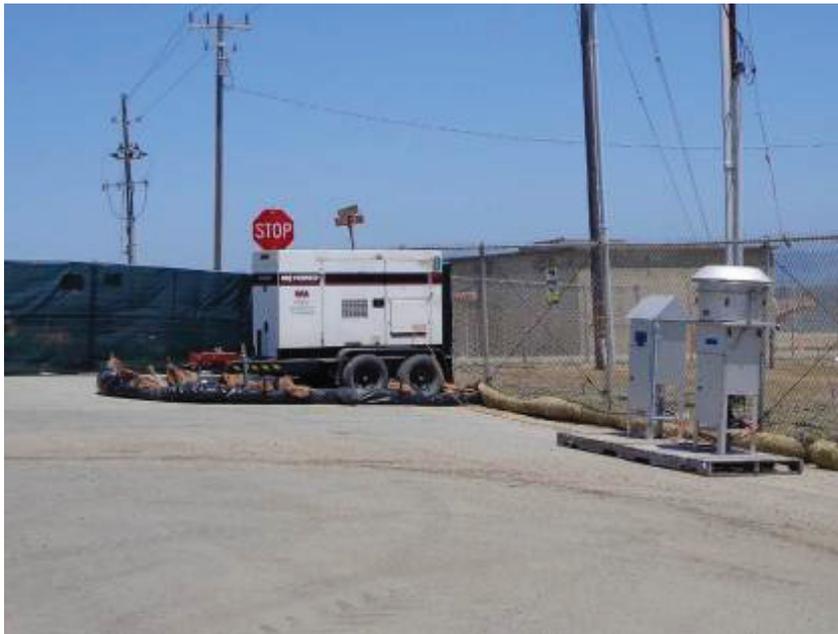
*Photograph A-14: Mobilization – High volume air monitor downwind of the Parcel UC-2 work zone. Installed wattle along fence separating Parcel UC-2 from Parcel C to prevent sediment from leaving the site.*

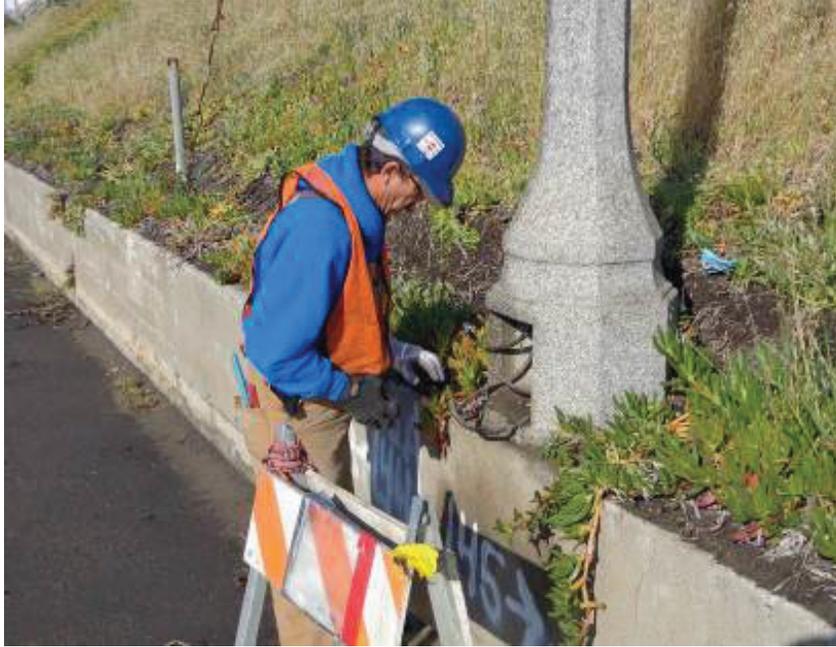
*Photograph A-15: Site Clearing and Demolition – Electrician checking street lights in Parcel UC-2 to determine if power lines hanging between poles are inactive and can be removed.*

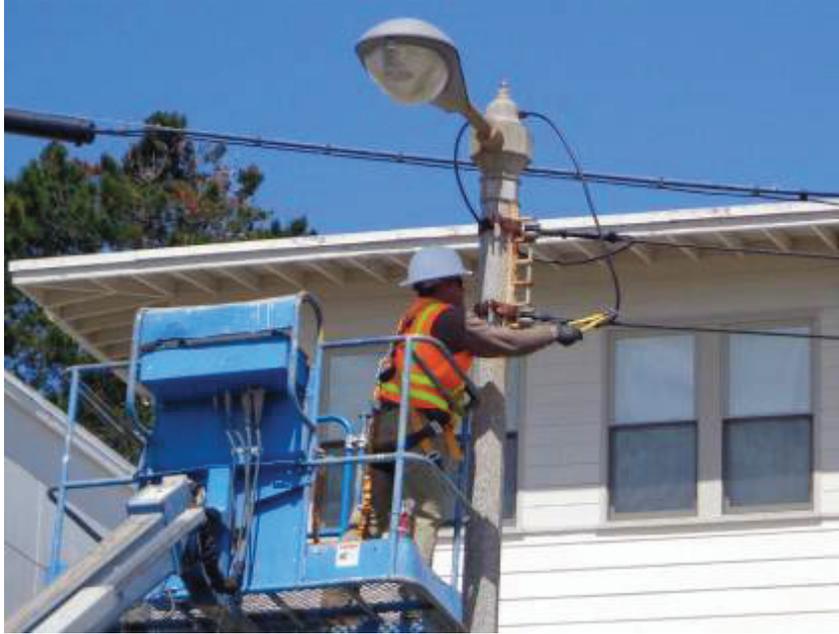
*Photograph A-17: Site Clearing and Demolition – Cutting dead electrical lines between street lights in Parcel UC-2 to reduce overhead hazards during excavation of the slope.*

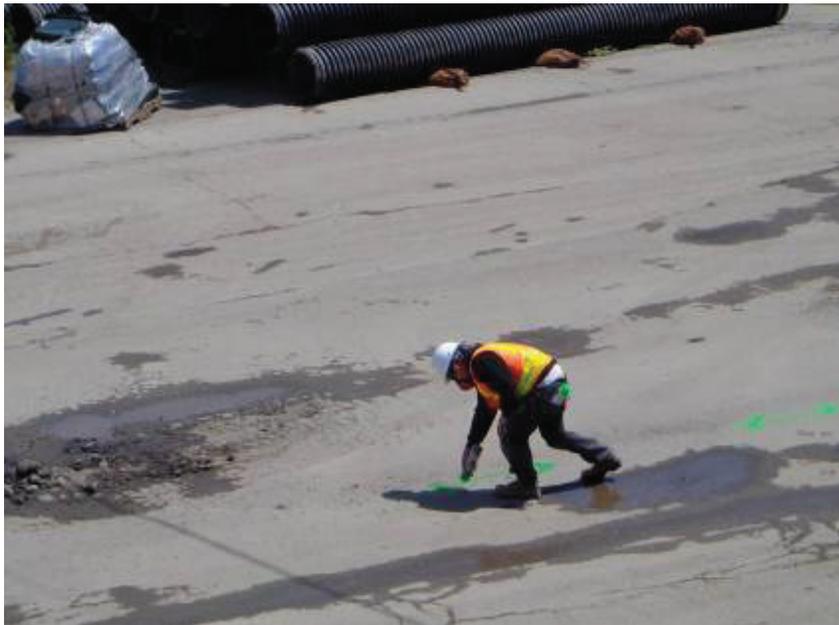
*Photograph A-18: Site Clearing and Demolition – Marking out damaged asphalt areas to be replaced. Areas will be saw cut for removal prior to paving operations.*

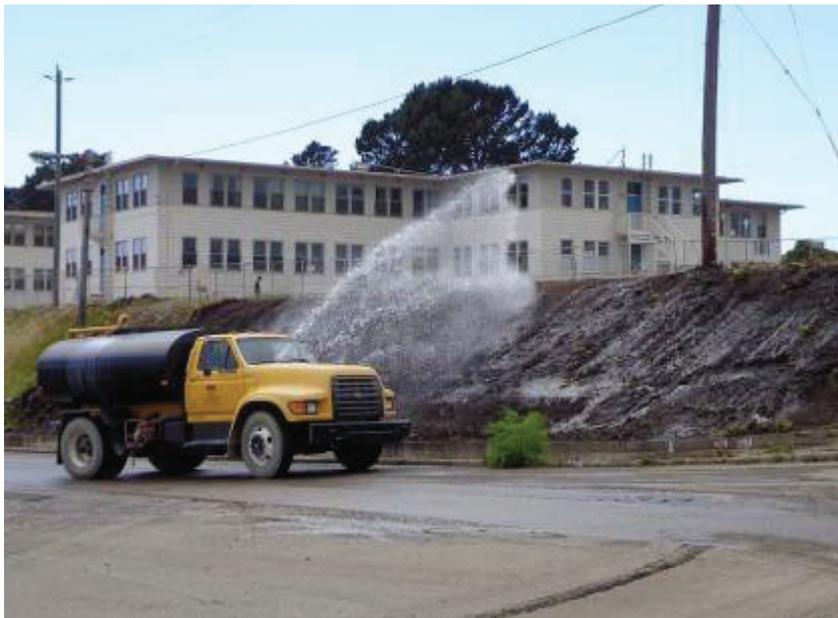
*Photograph A-20: Site Clearing and Demolition – Applying soil tackifier to cleared sloped at the end of the day to protect exposed soil from erosion.*  
**Remedial Action at Parcels UC-1 and UC-2, HPNS, San Francisco, CA**

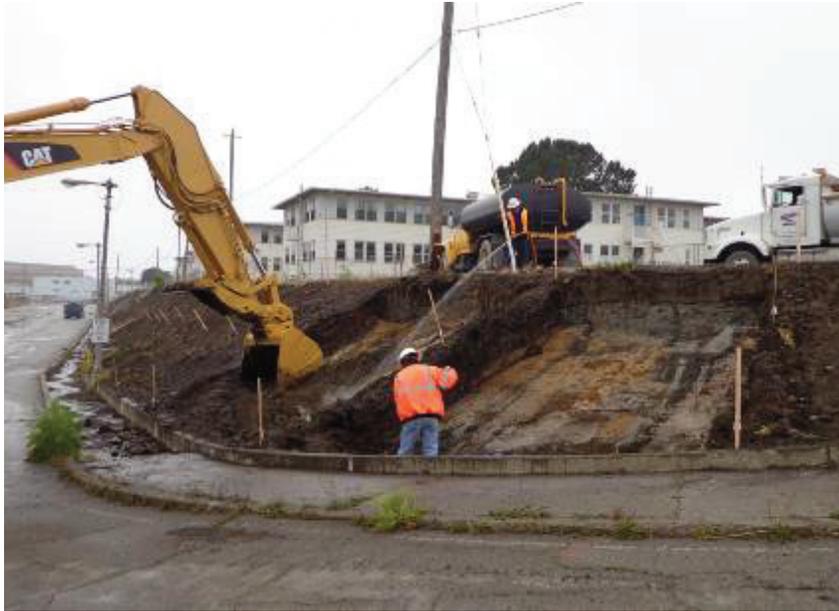
*Photograph A-23: Soil Excavation and Placement – Excavation of slope near intersection of Fisher Avenue and Robinson Avenue. Hand digging around base of slope to protect existing retaining wall.*

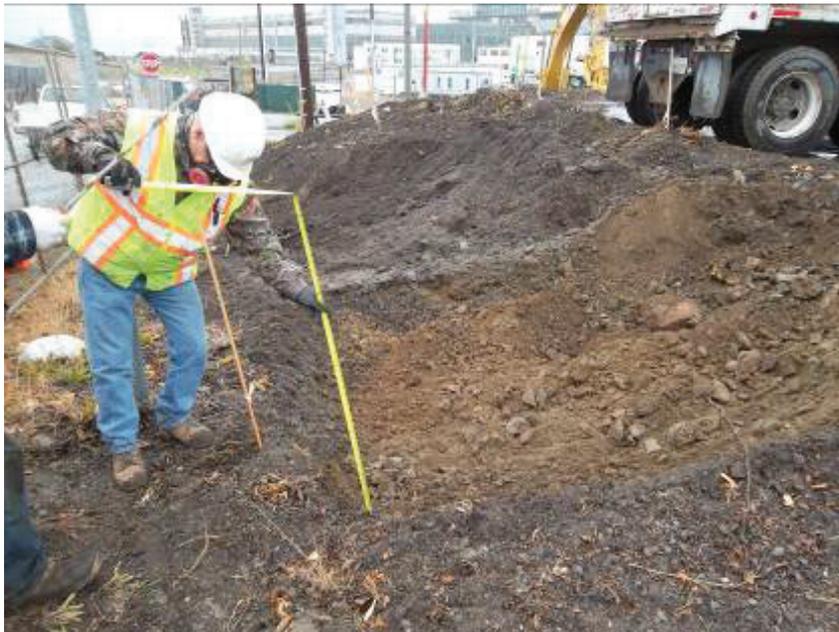
*Photograph A-24: Soil Excavation and Placement – Excavation of slope near intersection of Fisher Avenue and Robinson Avenue. Checking excavation depths to ensure that 2 feet of material was removed from the slope.*
