## **Remedial Action Completion Report for Parcels UC-1 and UC-2**

**Hunters Point Naval Shipyard  
San Francisco, California**

**February 2013**

**Engineering/Remediation Resources Group, Inc.  
115 Sansome Street, Suite 200  
San Francisco, California 94104**

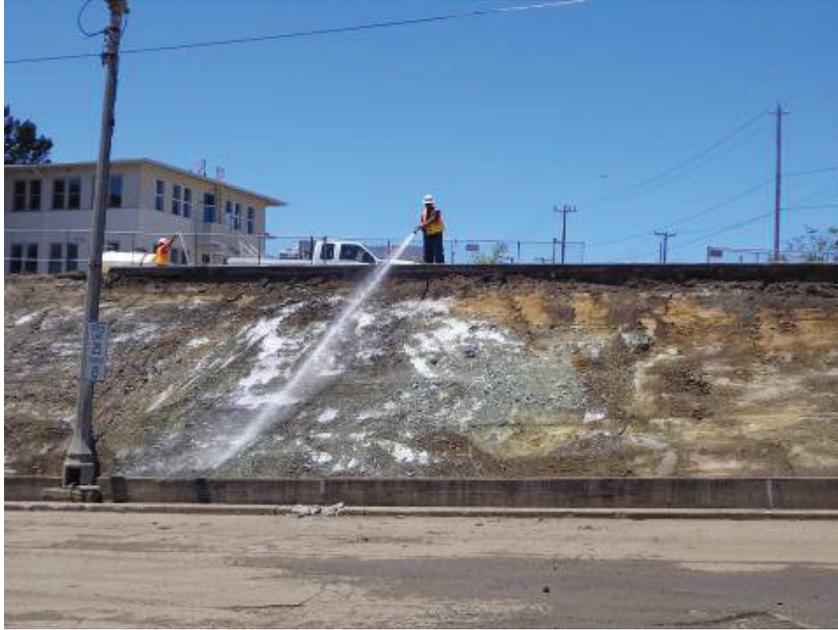
*Photograph A-25: Soil Excavation and Placement – Applying soil tackifier to the exposed slopes at the end of the day to minimize erosion.*

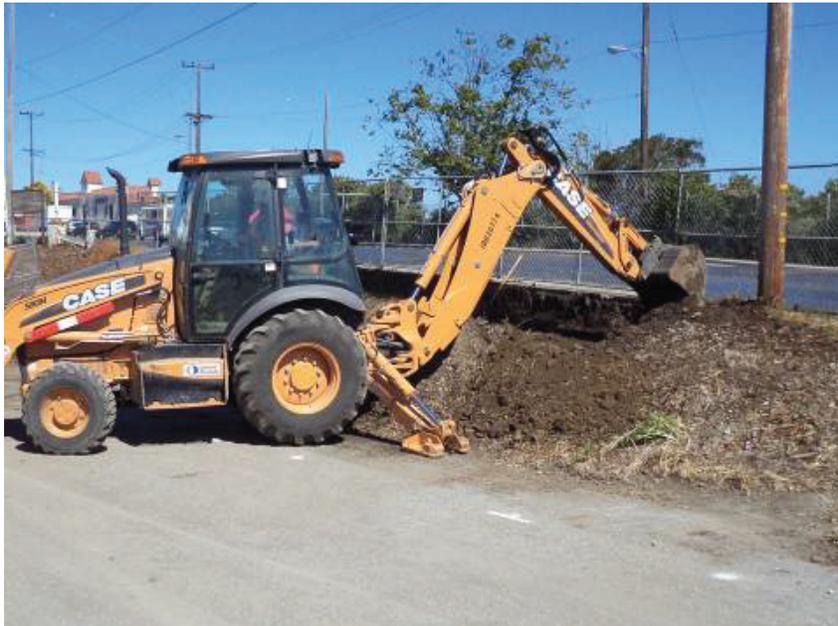
*Photograph A-26: Soil Excavation and Placement – Excavation of slope along Robinson Avenue with the backhoe. Excavating 2 feet down from the sidewalk at the top of slope to 2 feet below the back of the exposed curb.*

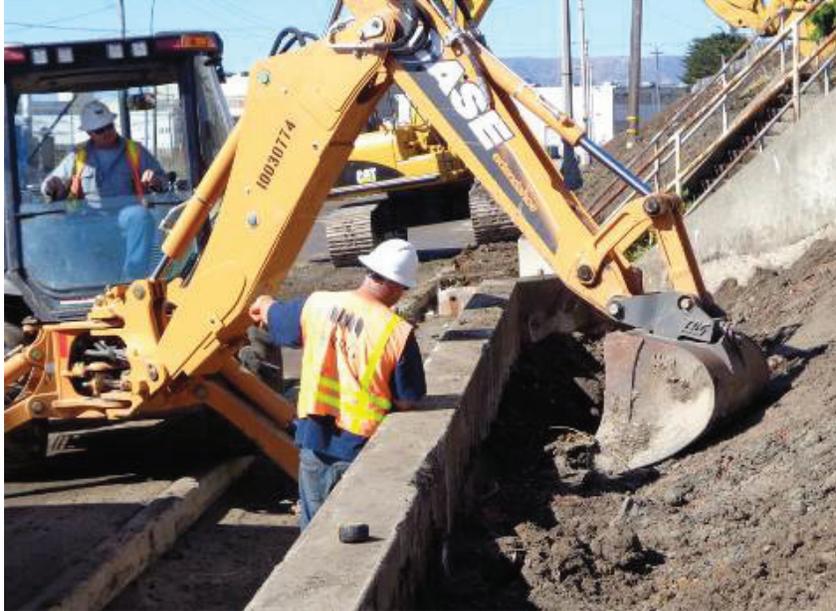
*Photograph A-27: Soil Excavation and Placement – Excavation of slope along Fisher Avenue with the backhoe. Using a spotter to excavate near the existing retaining wall.*

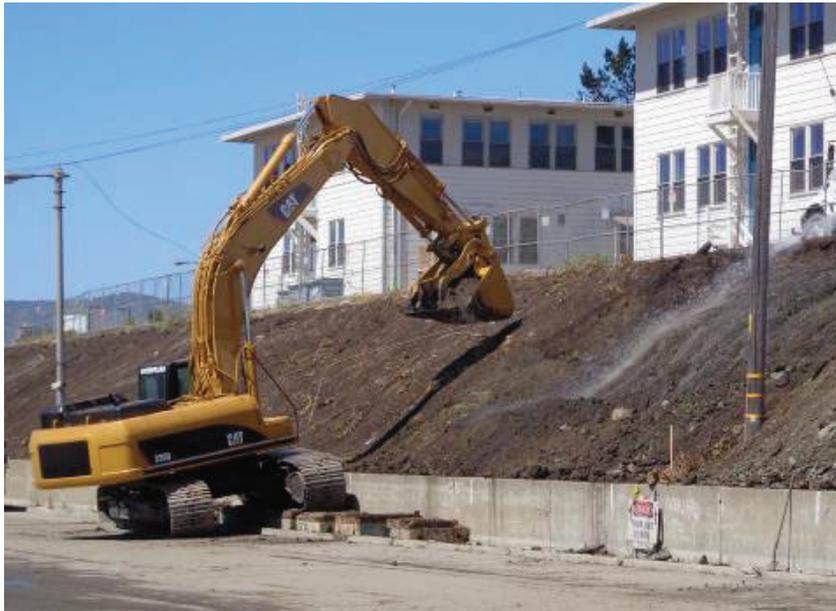
*Photograph A-28: Soil Excavation and Placement – Excavation of slope along Fisher Avenue with the excavator. Excavating to the west of the stairs. Using keel blocks to bridge gutter and protect existing concrete curb.*

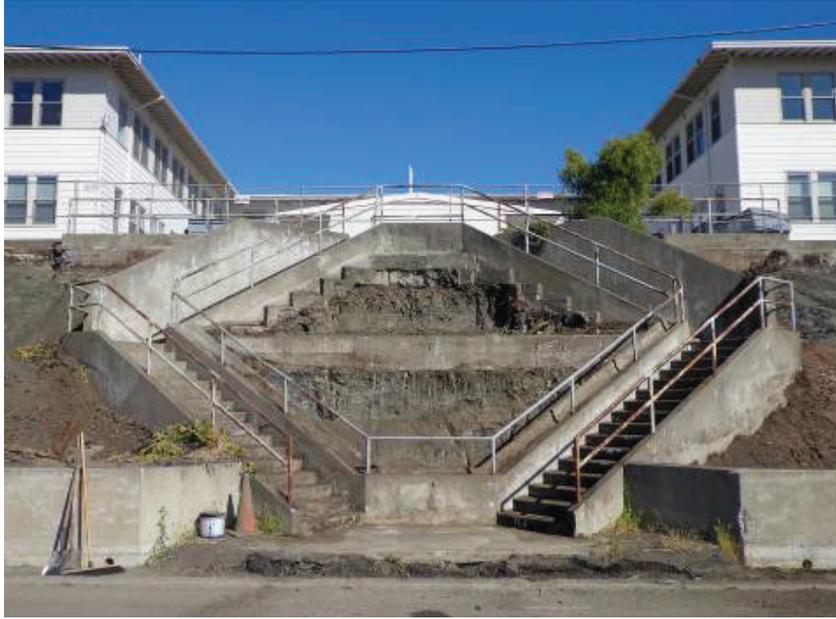
*Photograph A-29: Soil Excavation and Placement – Excavated slope between the stairs on Fisher Avenue.*

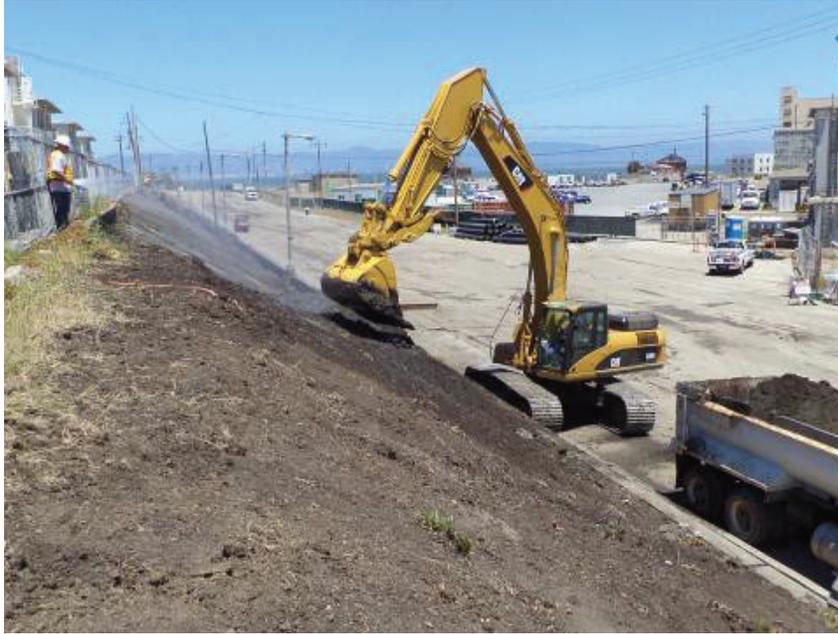
*Photograph A-31: Soil Excavation and Placement – Excavation of slope along Fisher Avenue with the excavator to the west of the stairs.*  
**Remedial Action at Parcels UC-1 and UC-2, HPNS, San Francisco, CA**  
Photographed by: Michael Babst (ERRG) Date: June 12, 2012

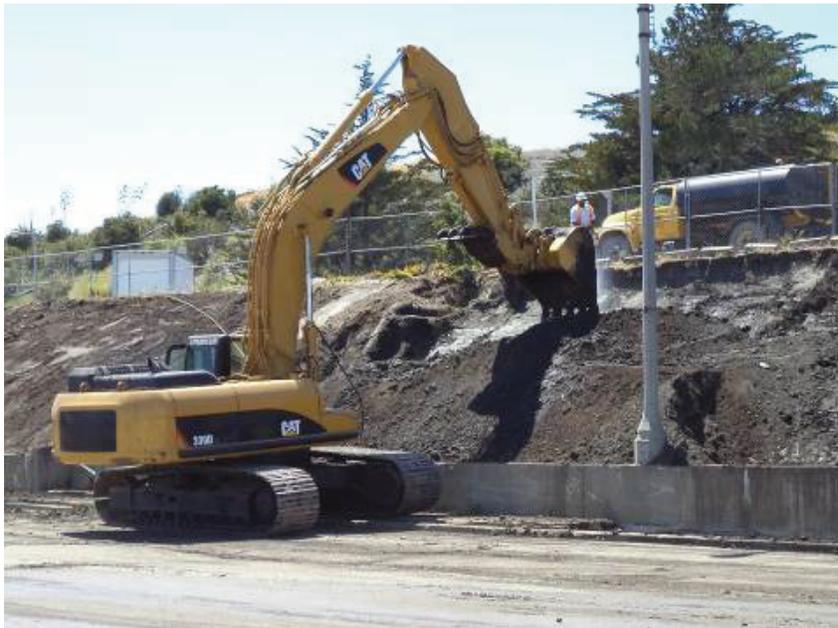
*Photograph A-32: Soil Excavation and Placement – Excavation of slope along Fisher Avenue with the excavator to the west of the stairs.*  
**Remedial Action at Parcels UC-1 and UC-2, HPNS, San Francisco, CA**  
Photographed by: Kevin Woodhouse (ERRG) Date: June 13, 2012
