**EPA Radiation and Indoor Environments National
Laboratory Scanner Van Survey of the Yerington Mine Site
and Surrounding Areas**

**Yerington, Nevada
April 18 - 26, 2005**

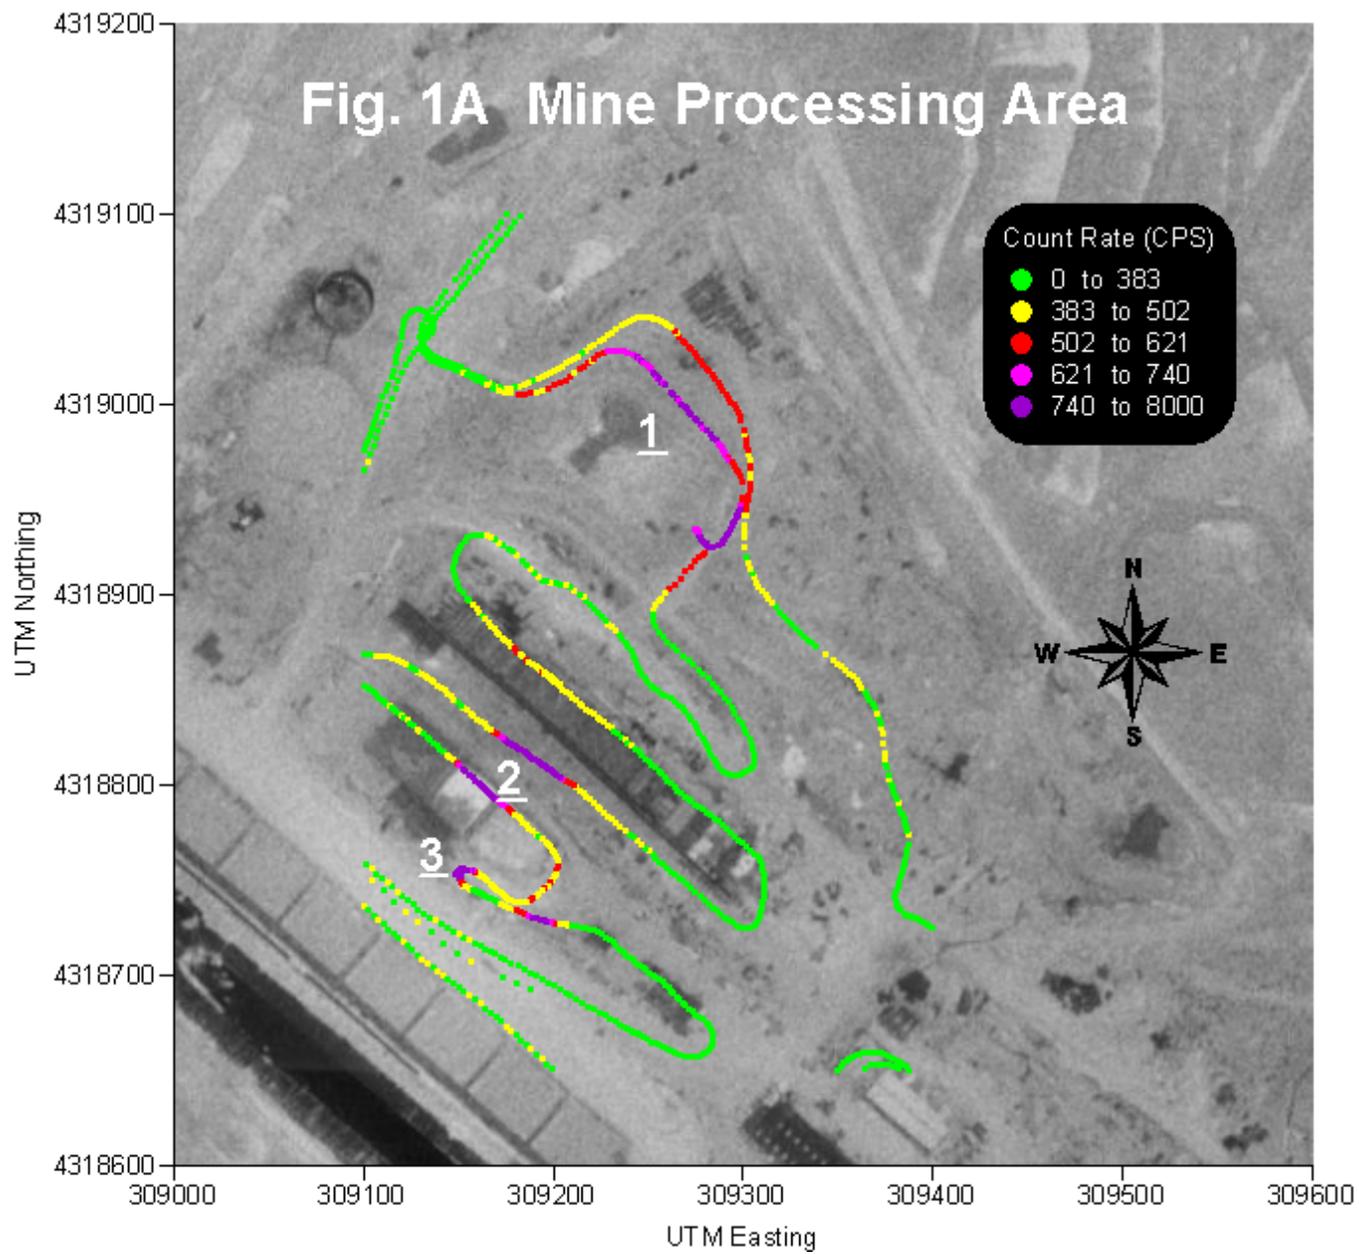
Continuous count rates above 502 cpm were first encountered in the lower processing unit immediately north of the iron precipitate launder unit (Fig.1A, 1). The activity appeared to be related to soils in the basin and berms of the area and may have been deposited as residual sediments in impoundments. Further scans of the processing and facility areas showed the highest readings of the study north and south of the iron precipitate launder unit (Fig.1A, 2). The strongest activity was found on the south side of the unit and had been previously designated as a radioactive area. Scanner van count rates exceeded 7500 cps and the gamma radioactivity appeared to be associated with metal piping and other debris. A microR reading on one piece of pipe at the location exceeded 5 mR/hr on contact.

The acid solution storage tank area (Fig.1A, 3) south of the launder unit had highly localized areas that exceeded 2700 cps. The activity appeared to be associated with debris and single point sources on the ground that may be indicative of buried materials or pipe scale. MicroR readings at these locations varied from 1 mR/hr to 3 mR/hr on contact.

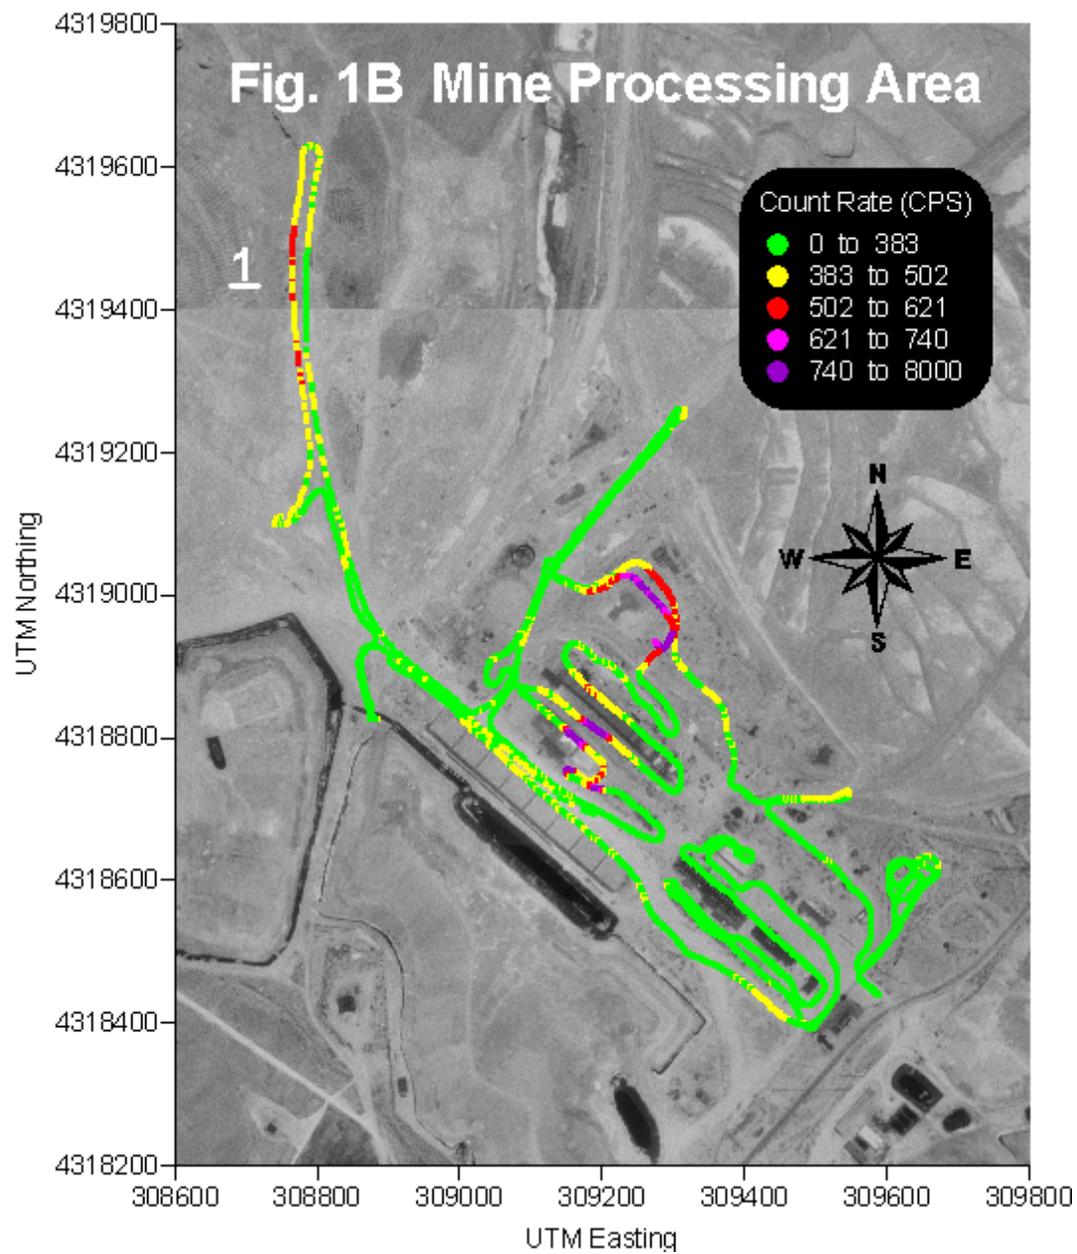
The road scan north of the FX Pad along the oxide tailings pile (Fig.1B, 1) showed multiple locations with readings greater than 502 cps east of the road. This is due to the effect of the mass of material and close proximity of the tailings pile to the right side of the van (and the detector) on the return scan while moving south.
