**Soil Vapor Extraction System  
Construction Completion Report  
and Operations and Maintenance  
Schedule**

Former Spectra-Physics Site  
1245 Terra Bella Avenue  
Mountain View, California

May 22, 2015

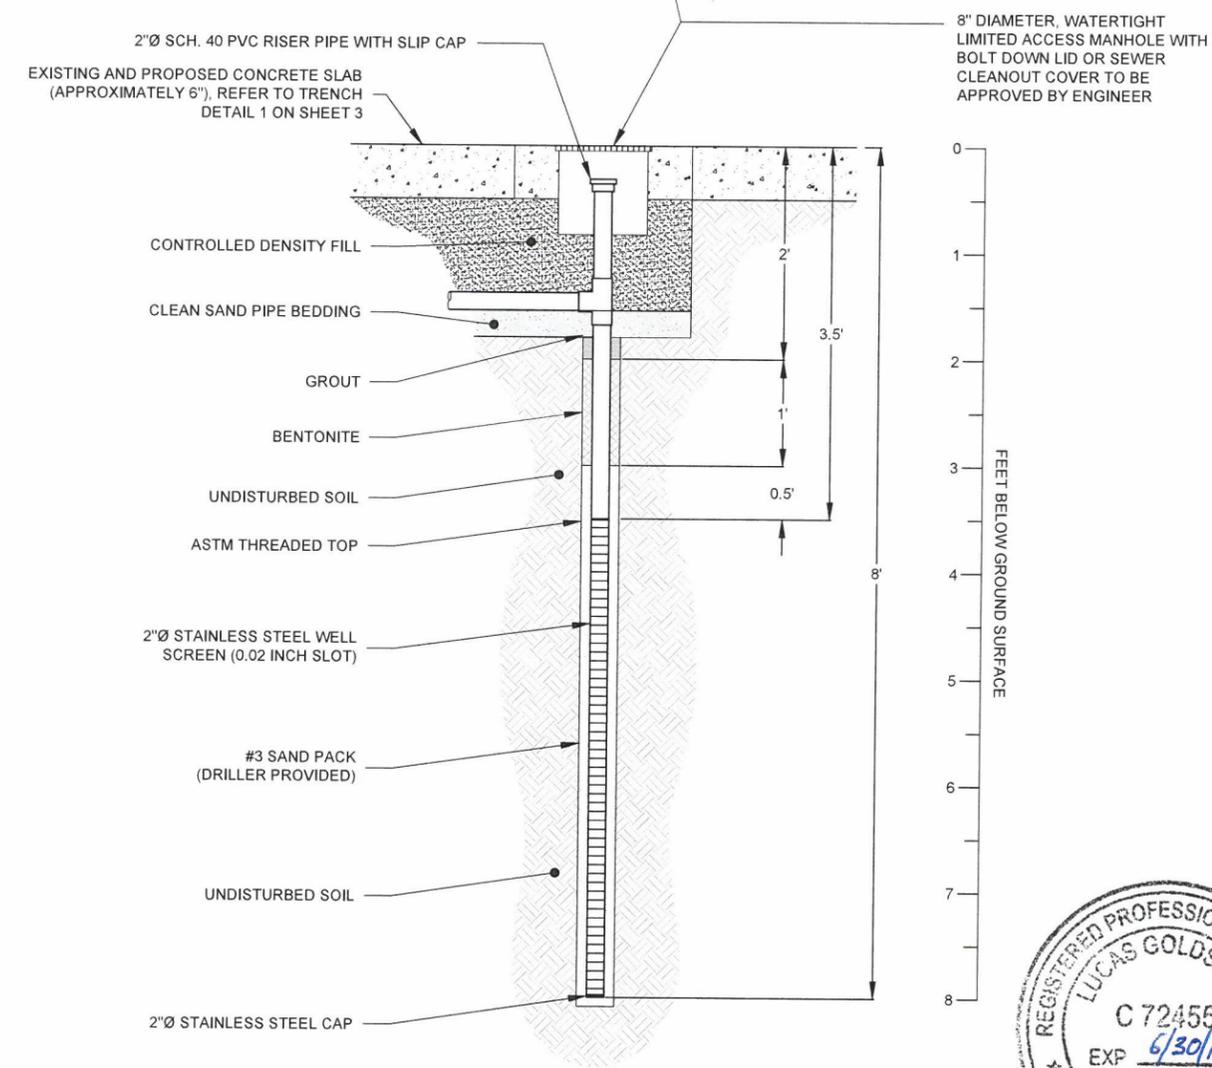
1  
C-2  
**PROPOSED SOIL-VAPOR EXTRACTION WELL DETAIL**  
NOT TO SCALE

The two SVE wells VE-1 and VE-2 (formerly SVE-1 and SVE-2 during the pilot study), and the new soil vapor monitoring wells (VE-3 through 6) were installed by hand augering down to 8 feet below ground surface (bgs). Soil lithology was logged during installation of each boring. Following completion of the boring, all SVE wells (VE-1 through VE-6) were constructed of 2-inch-diameter white polyvinyl chloride (PVC) riser pipe with 0.020-inch stainless steel wire-wrapped screen located from 3 to 8 feet bgs. The annular space around the well screen and casing was filled with No. 3 sand from 3 to 8 feet bgs, and sealed with hydrated bentonite from 2 to 3 feet bgs and then cement grout to 2 inches below the point where the conveyance line connects to the well casing. Each of the SVE wells were connected to the SVE remediation compound via conveyance lines during full scale construction activities in February 2015. As-built well construction details are presented in Drawing C-2 in Appendix A, and well boring logs are presented in Appendix B.

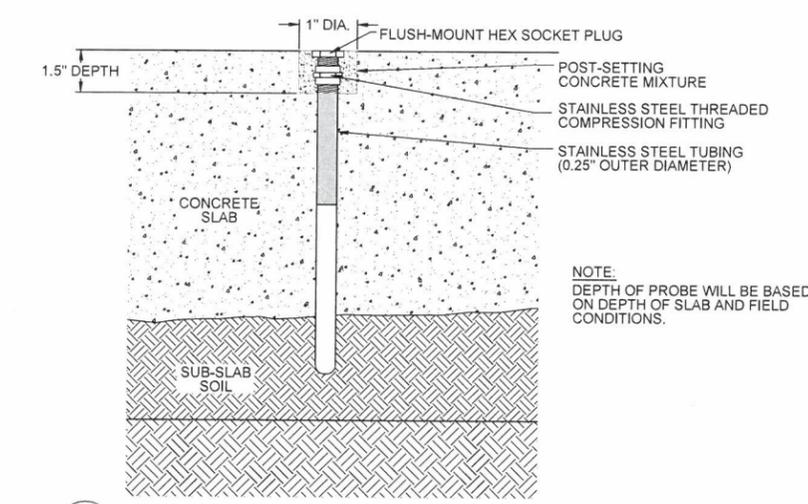
2  
C-2  
**SUB-SLAB VAPOR PROBE DETAIL**  
NOT TO SCALE

The sub-slab monitoring point (SSMP) construction details are provided on Figure C-2 of Appendix A. For each SSMP, a hammer-drill equipped with a 3/8-inch masonry bit was advanced below the slab until native material was encountered. Drill cuttings were evacuated with a low pressure air pump, and the SSMP was completed with 1/4-inch stainless steel tubing and sealed in accordance with the details shown on Figure C-2 of Appendix A.

NOTE:  
DEPTH OF PROBE WILL BE BASED ON DEPTH OF SLAB AND FIELD CONDITIONS.

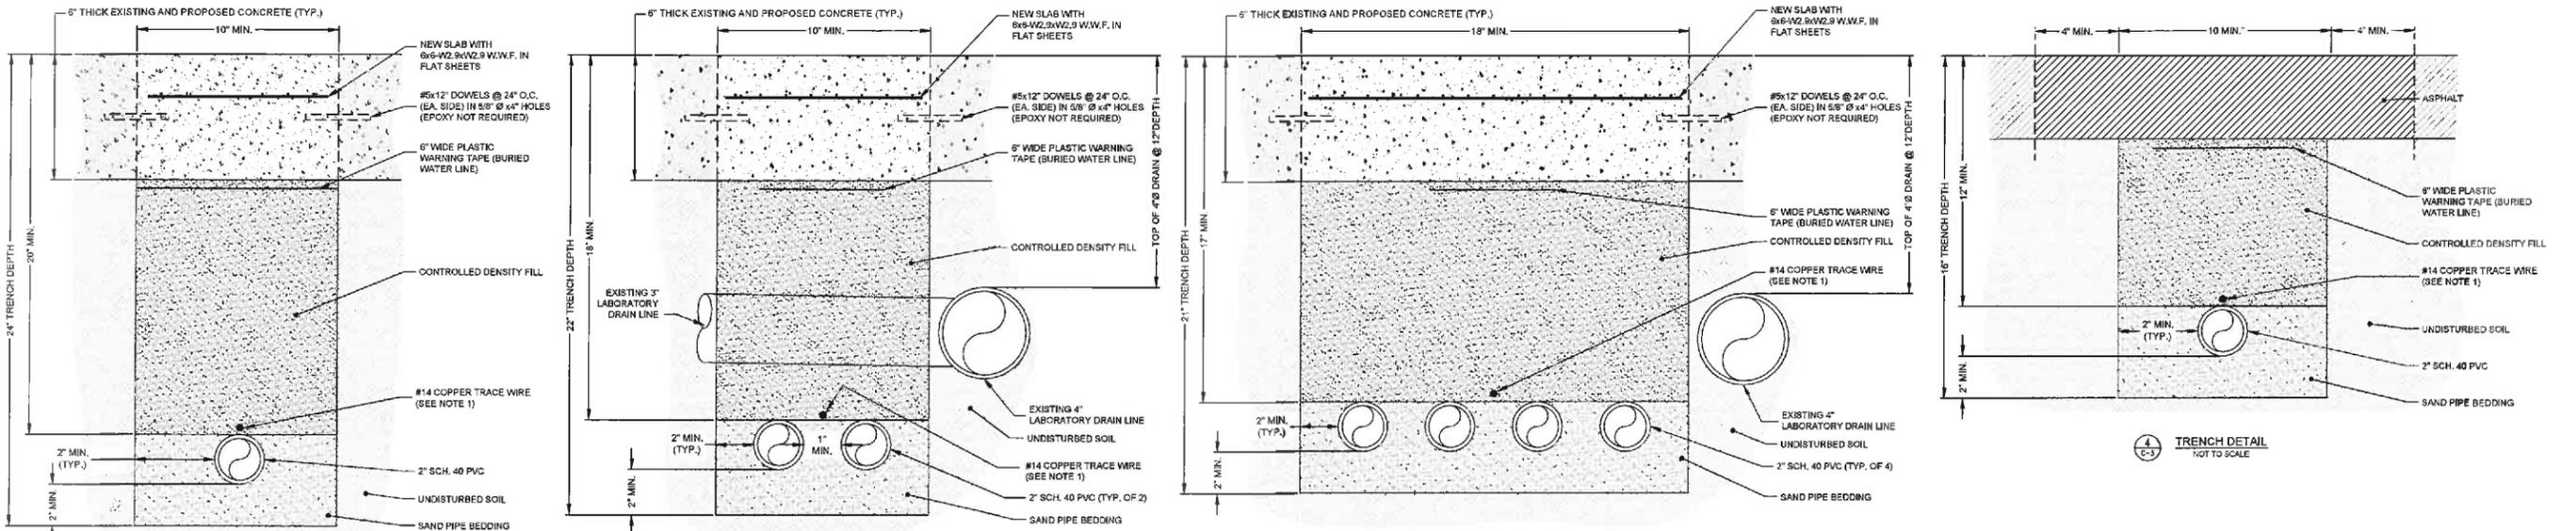
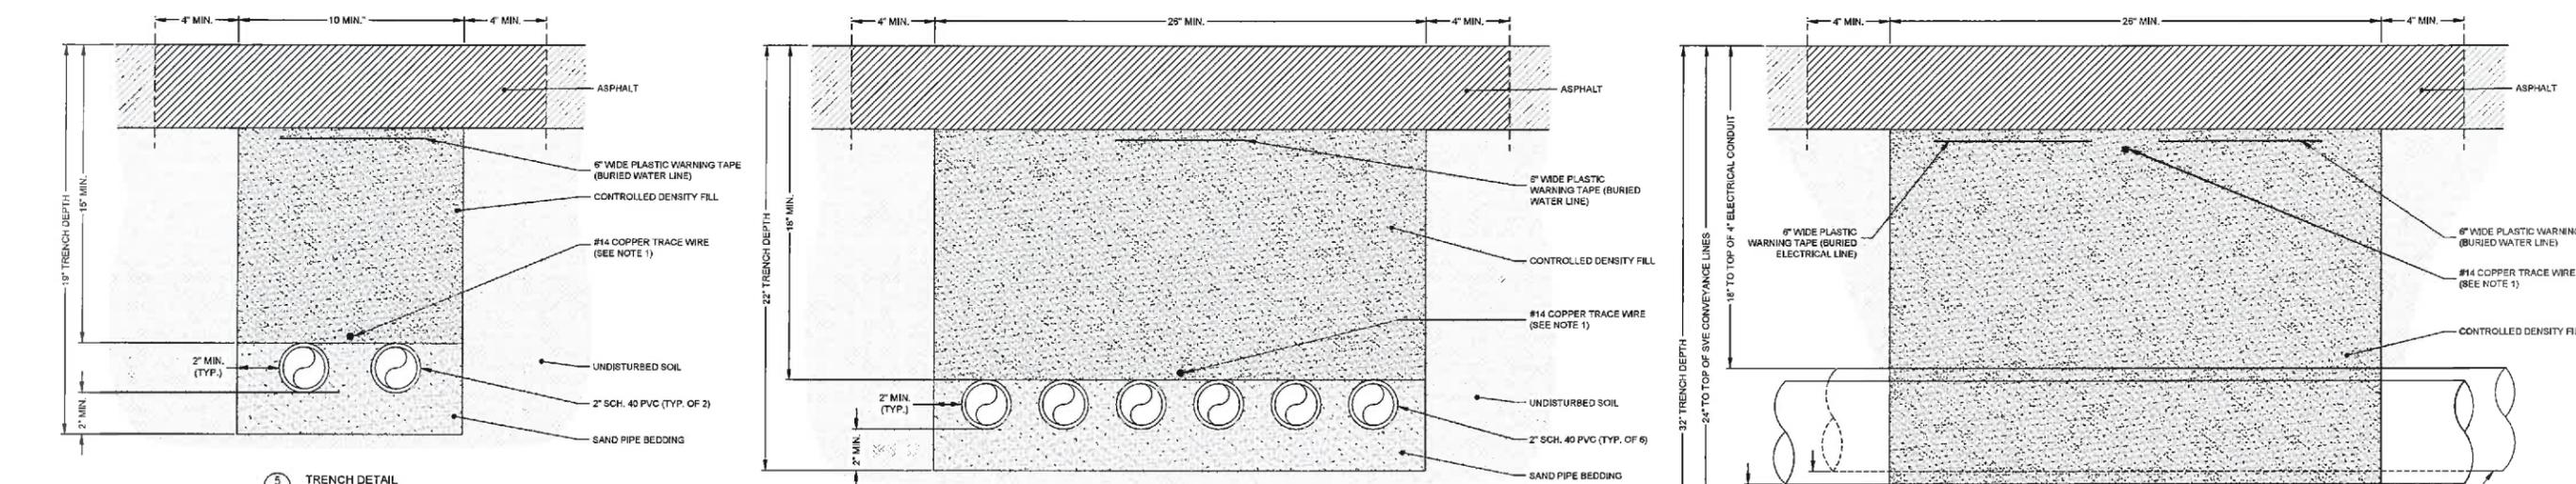
- NOTES:**
- TRACER WIRE IS #14 AWG COPPER AND HAS YELLOW (GAS) 30 ML POLYETHYLENE INSULATION OR APPROVED EQUAL TRACER WIRE PLACED DIRECTLY ABOVE THE CENTER MOST PIPE IN THE TRENCH. TRACER WIRE HAS ONLY ONE TRACER LINE PER TRENCH, AND IS CONNECTED WITH CONDUCTIVE LUGS (OR EQUIVALENTS) AT TRENCH JUNCTIONS. TRACER WIRE IS DAY-LIGHTED AT THE WELLHEAD AND ALL WALLS TO FACILITATE EMERGING BY UTILITY LOCATORS.

- A MINIMUM OF TWO INCHES OF PIPE BEDDING WAS MAINTAINED BETWEEN CONVEYANCE PIPING AND THE TRENCH EXTENTS. ADDITIONALLY, A MINIMUM OF TWO INCHES OF PIPE BEDDING WAS PLACED BETWEEN ADJACENT PIPES.

- DESIGN PURSUANT TO ACI 318-08, SECTION 6.3.3 AND SECTION 6.3.5.2
  - NO PERIMETER FOUNDATION WAS ENCOUNTERED WHERE THE SVE CONVEYANCE LINES EXIT THE BUILDING. PERIMETER FOUNDATION PENETRATION DETAILS PROVIDED IN CONSTRUCTION DRAWING SET WERE NOT APPLICABLE.

A perimeter foundation was expected where the trench exits the southern side of the building, however no structural feature was observed. Therefore, the additional construction details associated with providing additional space between the pipes as they exited the building was no longer necessary.

No building perimeter foundation was encountered during the installation, and therefore no related changes were made during surface restoration following installation.

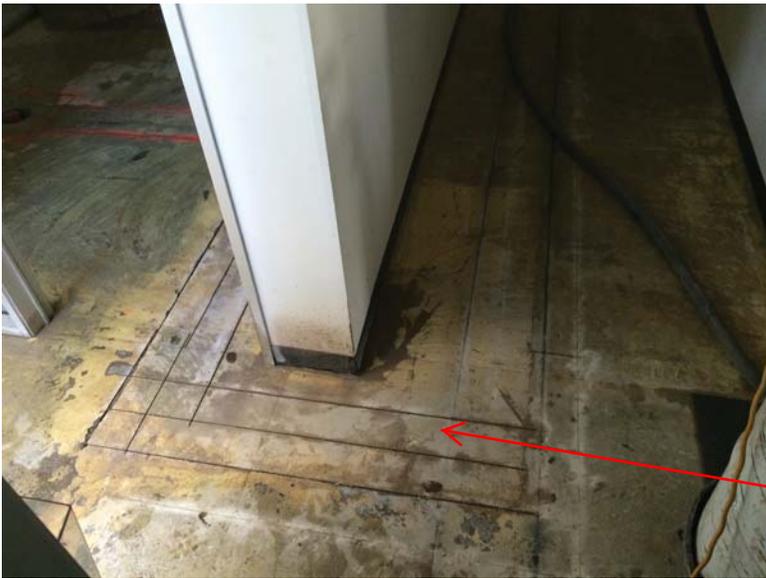
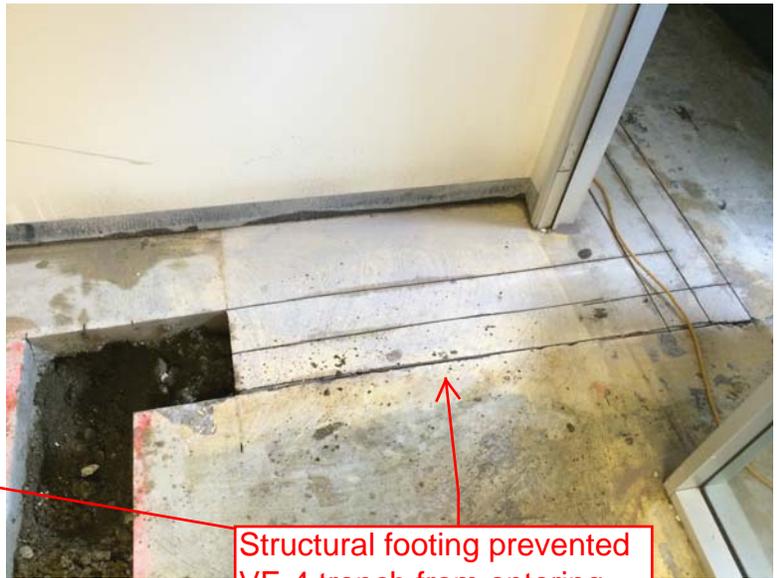
Structural footing prevented VE-4 trench from entering west hallway

The trenching layout to VE-4, located in the northern portion of the building was modified based on observed field conditions. The trench to VE-4 was proposed to pass through the west hallway, but had to be rerouted to the east hallway based on the presence of a structural footing. To reach the second hallway on the east side of the building, the trench was constructed under two non-load bearing walls to avoid several additional structural footings. As Cornerstone continued to dig the VE-4 trench down the east hallway, an unexpected concrete feature was encountered that was not included in the structural drawings. This feature required a concrete corer to horizontally drill through about 4.5 feet of concrete in order to pass the conveyance line through and connect it to the SVE remediation compound (Appendix D).

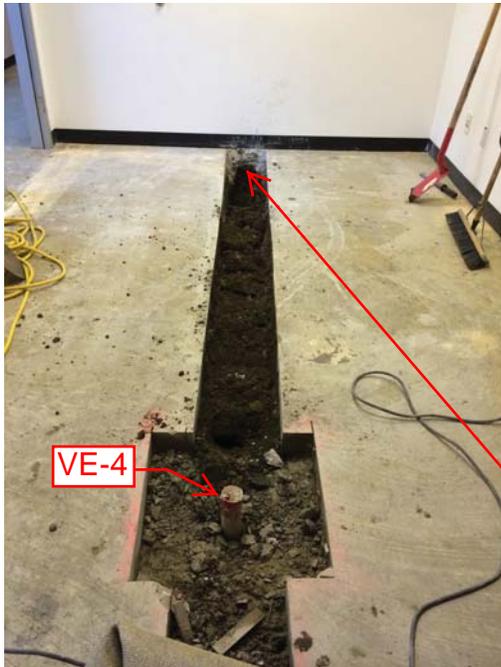
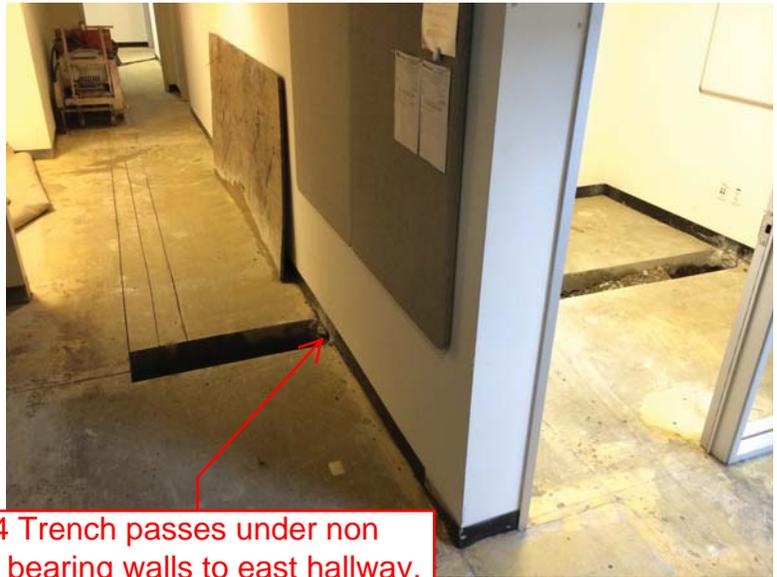
VE-4 Trench passes under non load bearing walls to east hallway.

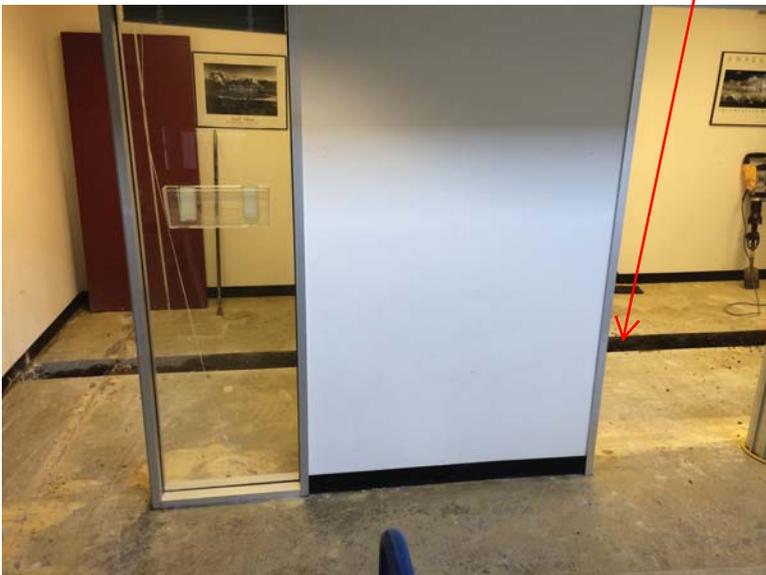
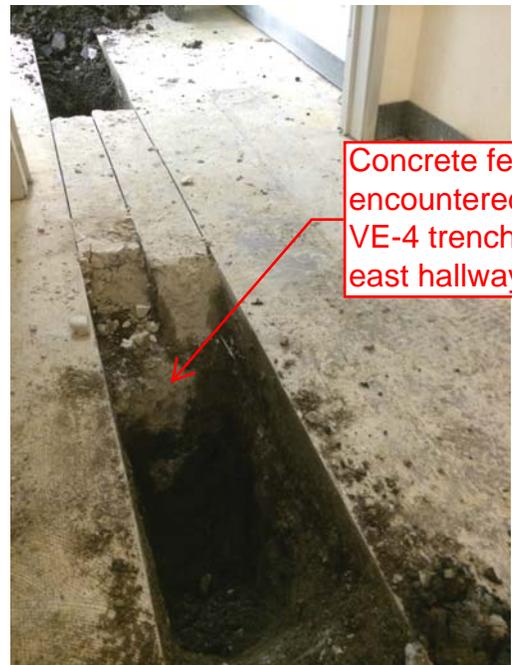
Concrete feature encountered in VE-4 trench in the east hallway.

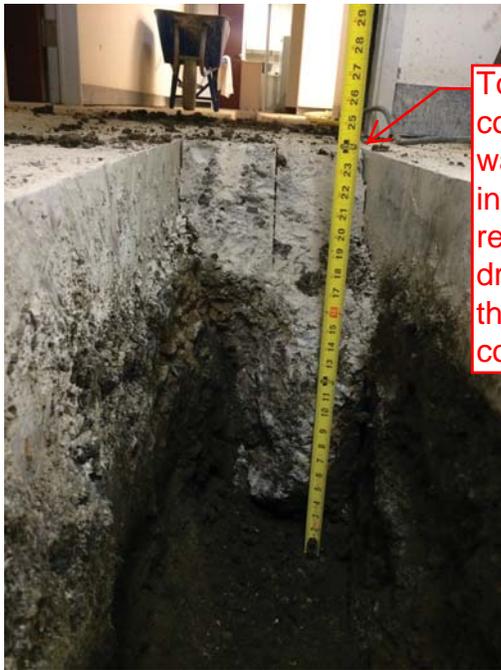
Total depth of concrete feature was about 24 inches below floor, required concrete drill to pass through conveyance line

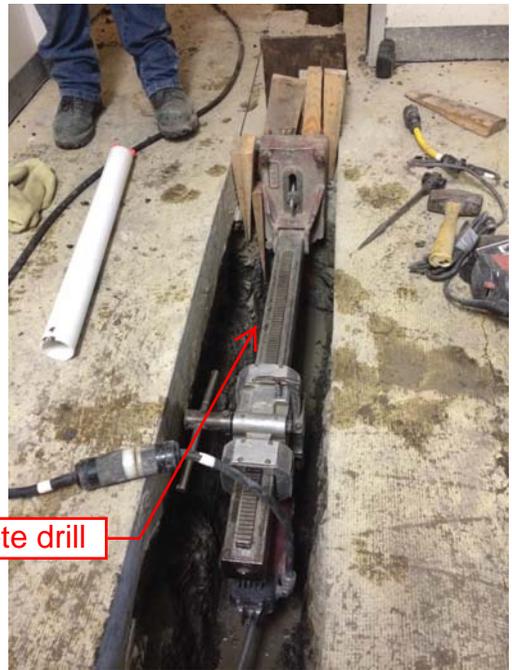
Concrete drill

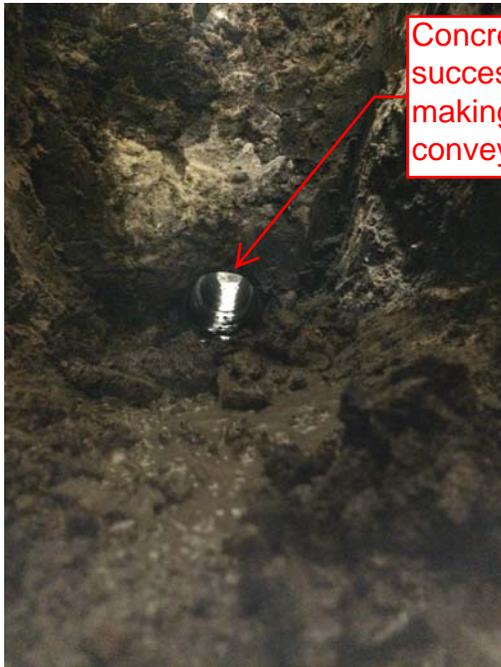
Concrete was successfully drilled, making way for VE-4 conveyance line.

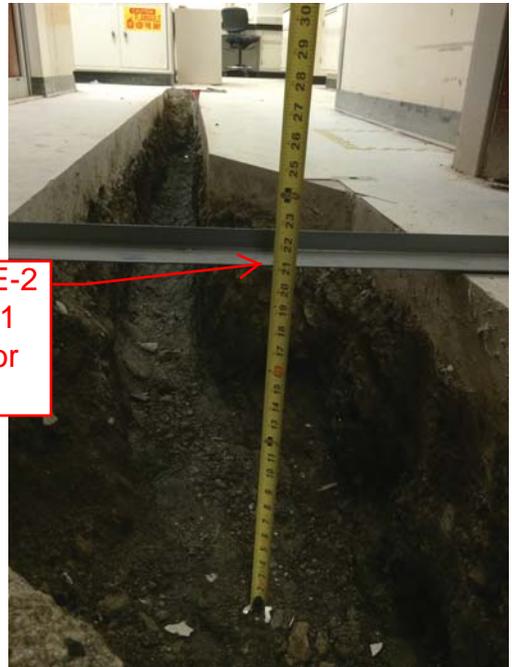
Total depth of VE-2 trench is about 21 inches below floor surface.

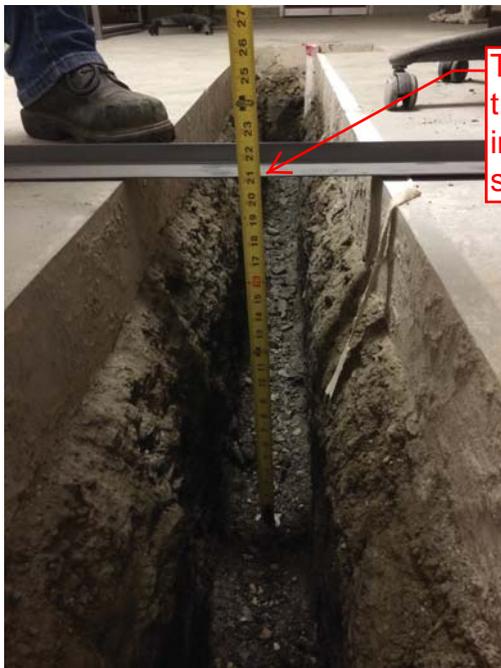
Total depth of VE-1 trench is about 21 inches below floor surface.

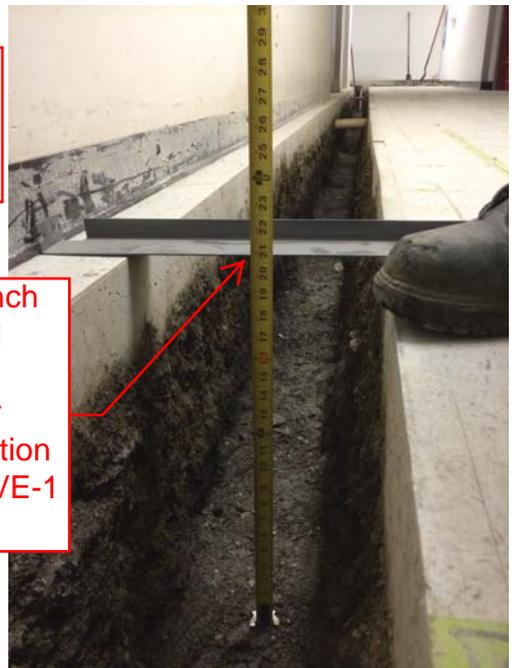
Total depth of trench going to VE-3 and VE-4 is about 21 inches below floor surface, near junction with trenches for VE-1 and VE-2

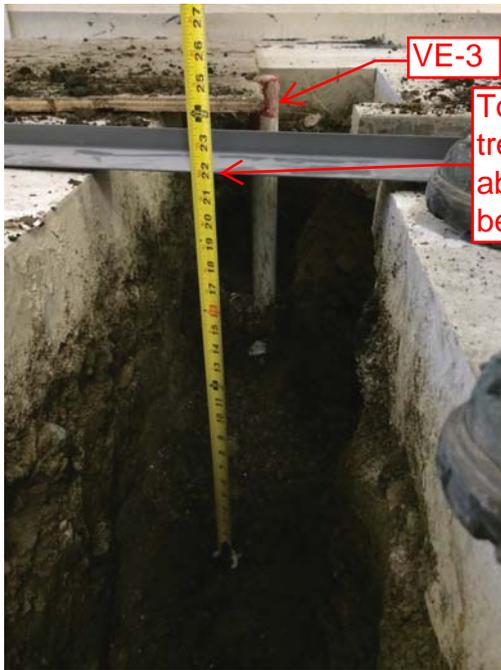
Total depth of trench near VE-3 is about 22 inches below floor surface.

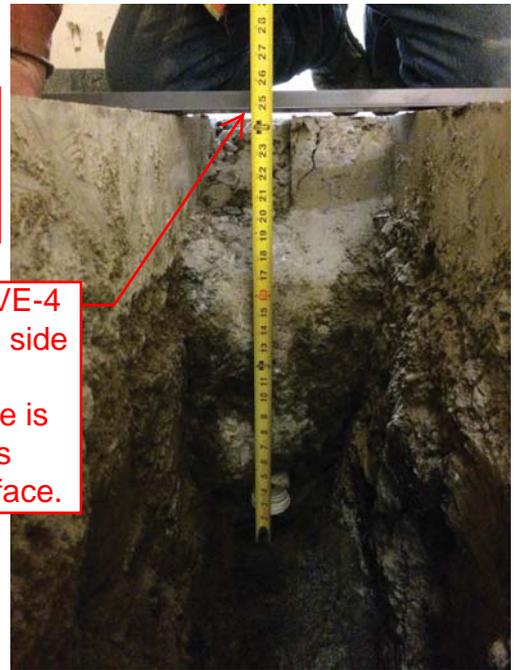
Total depth of VE-4 trench on north side of the drilled concrete feature is about 25 inches below floor surface.

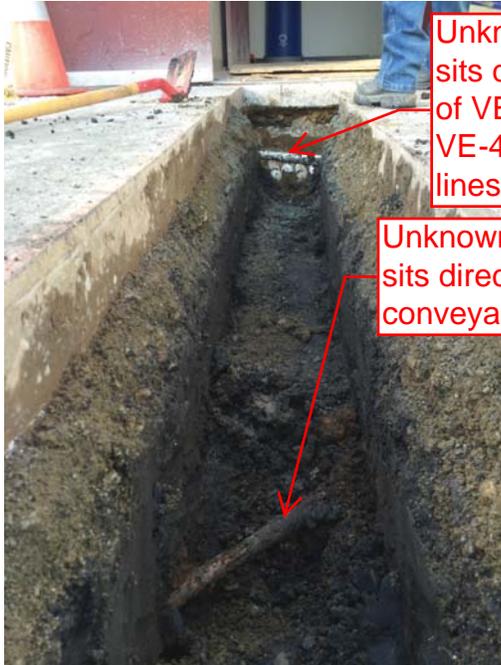
Unknown PVC pipe sits directly on top of VE-1 through VE-4 conveyance lines.

Unknown metal pipe sits directly below conveyance lines.

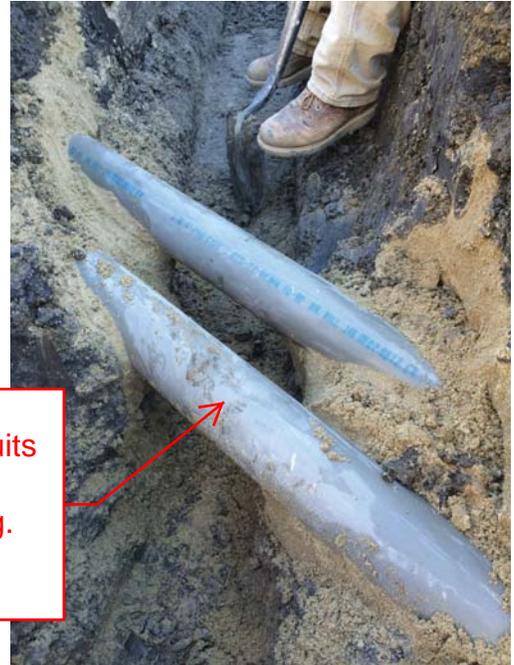
Two 4-inch electrical conduits encountered in back of building. Utility owner unknown.

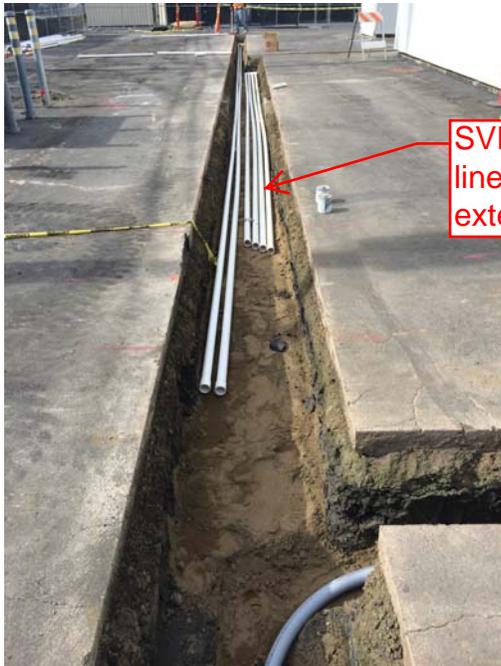
SVE conveyance lines in place in exterior trench.

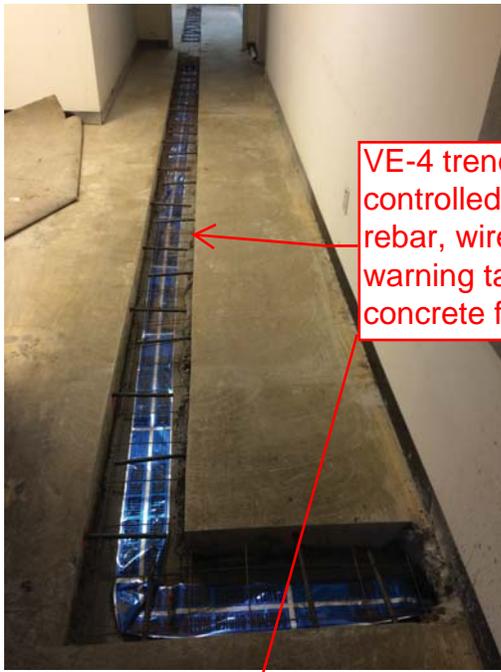
VE-4 trench with controlled density fill, rebar, wire mesh, and warning tape, ready for concrete finishing.

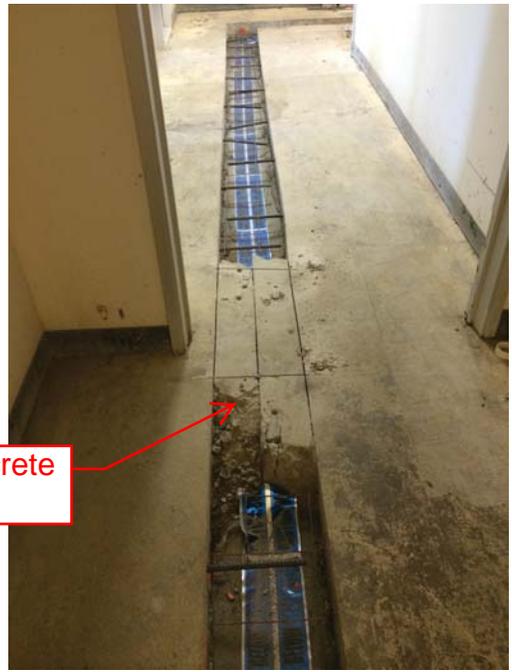
Unknown concrete feature

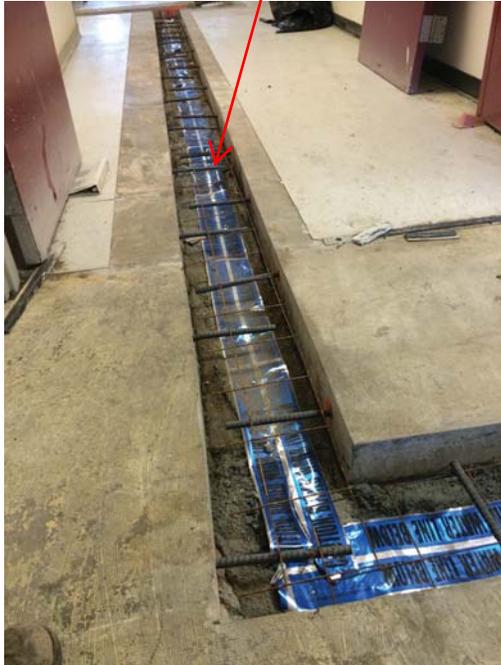
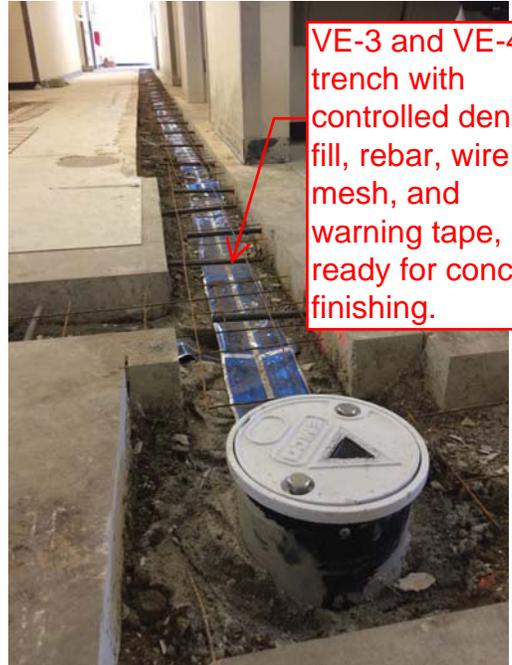
VE-3 and VE-4 trench with controlled density fill, rebar, wire mesh, and warning tape, ready for concrete finishing.

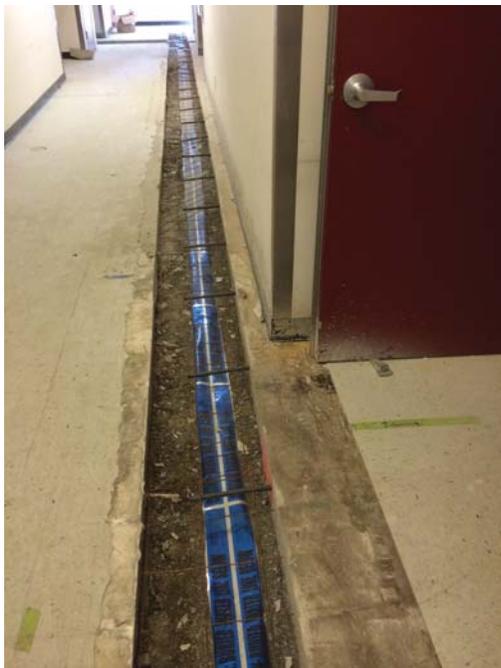
VE-1 trench with controlled density fill, rebar, wire mesh, and warning tape, ready for concrete finishing.

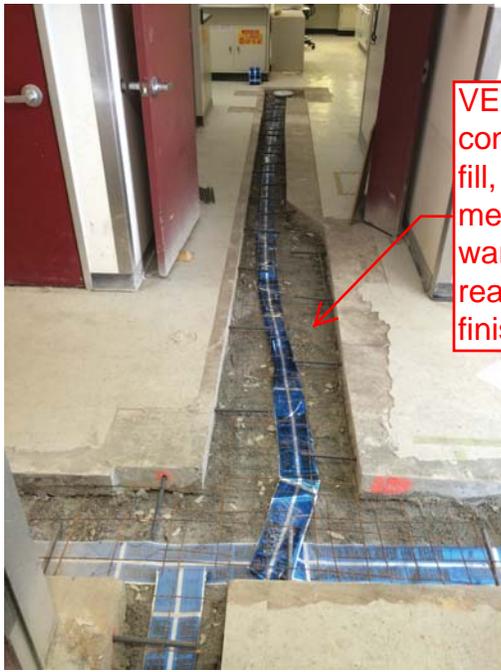
VE-1 trench with controlled density fill, rebar, wire mesh, and warning tape, ready for concrete finishing.

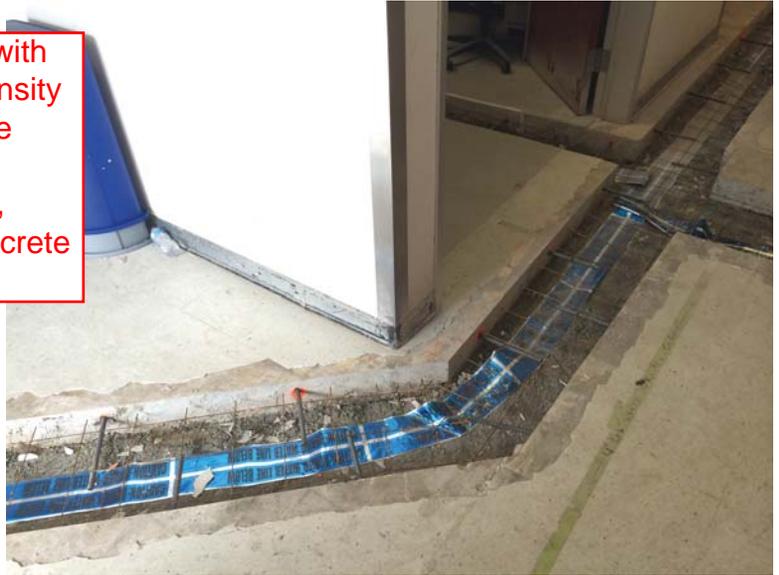
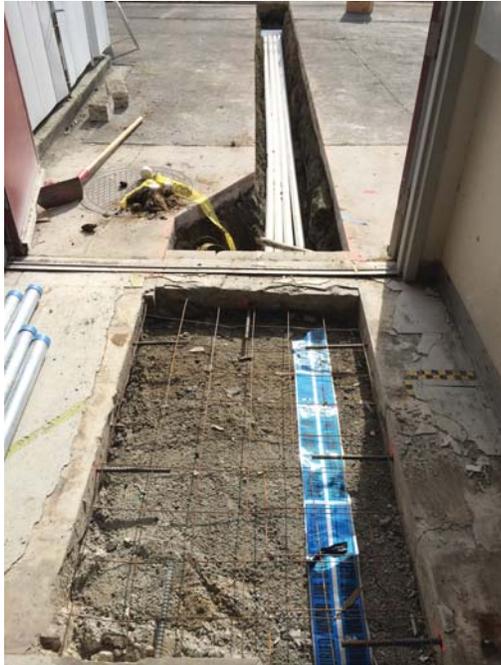
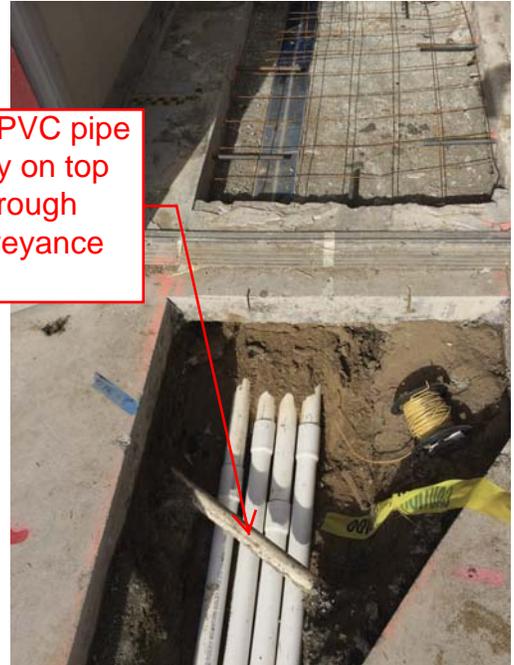
Unknown PVC pipe sits directly on top of VE-1 through VE-4 conveyance lines.

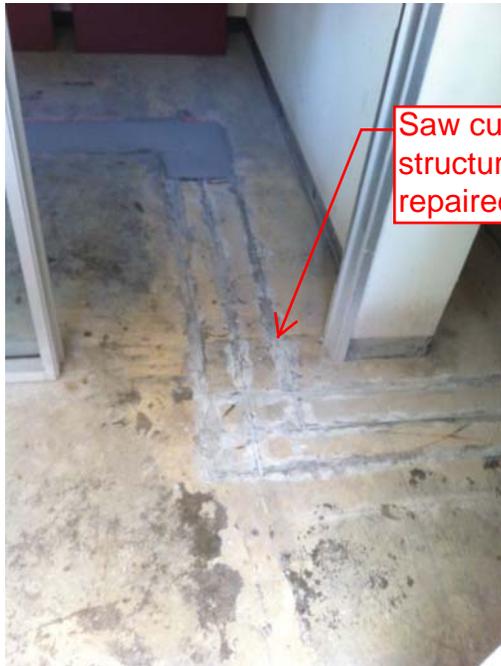
Saw cuts in structural footing repaired.

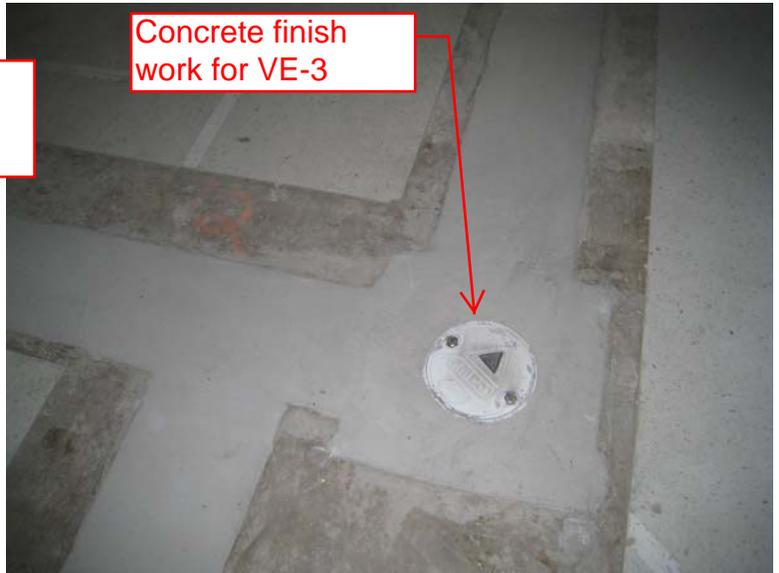
Concrete finish work for VE-3
