**Former NAS Moffett Field**  
U.S. Department of the Navy,  
BRAC PMO West, San Diego, California

Five-Year Review: IR Sites 1, 22, 26, and 28  
Former NAS Moffett Field, CA

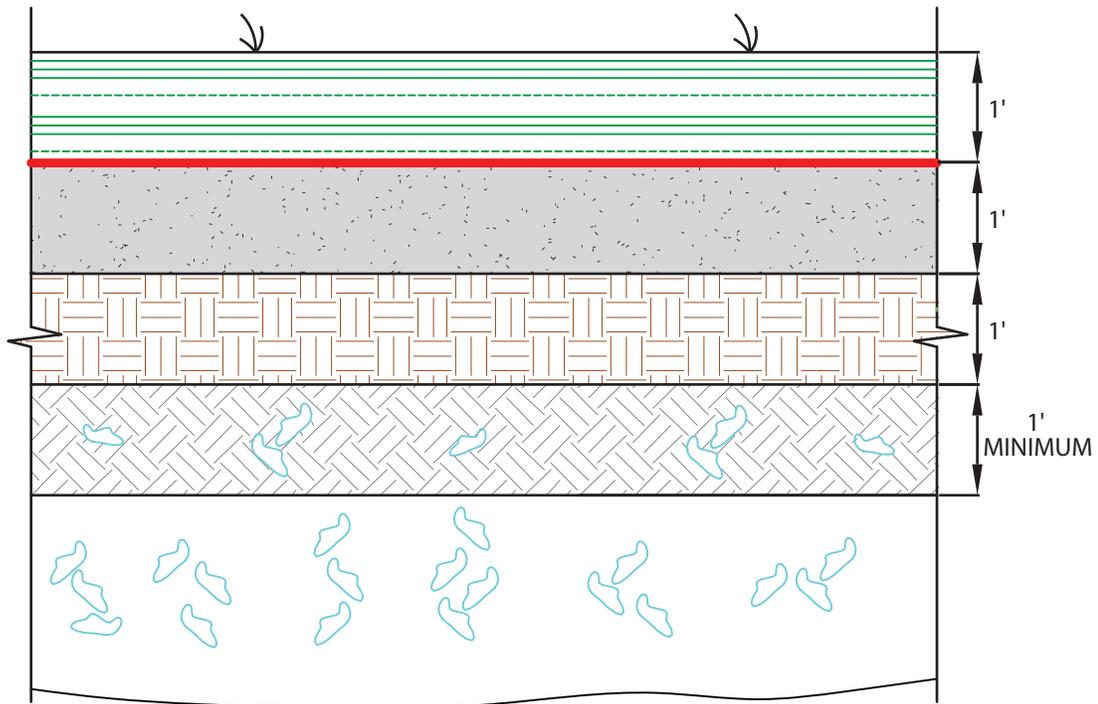
**Figure 7**  
**Site 1 Landfill Cap Schematic**

VEGETATIVE COVER

BIOTIC BARRIER  
(10 OZ/YD<sup>2</sup> NON-WOVEN GEOTEXTILE)

LOW PERMEABILITY CLAY LAYER (PALO ALTO CLAY, 1x10<sup>-6</sup> CM/SEC)

UPPER FOUNDATION LAYER

LOWER FOUNDATION LAYER

EXISTING REFUSE

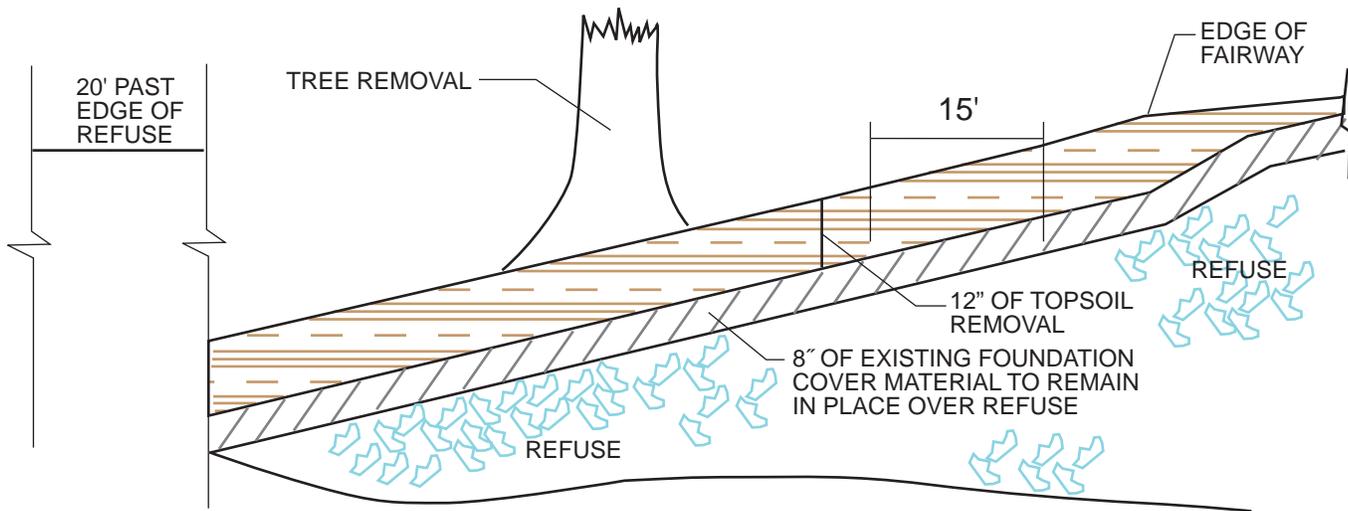
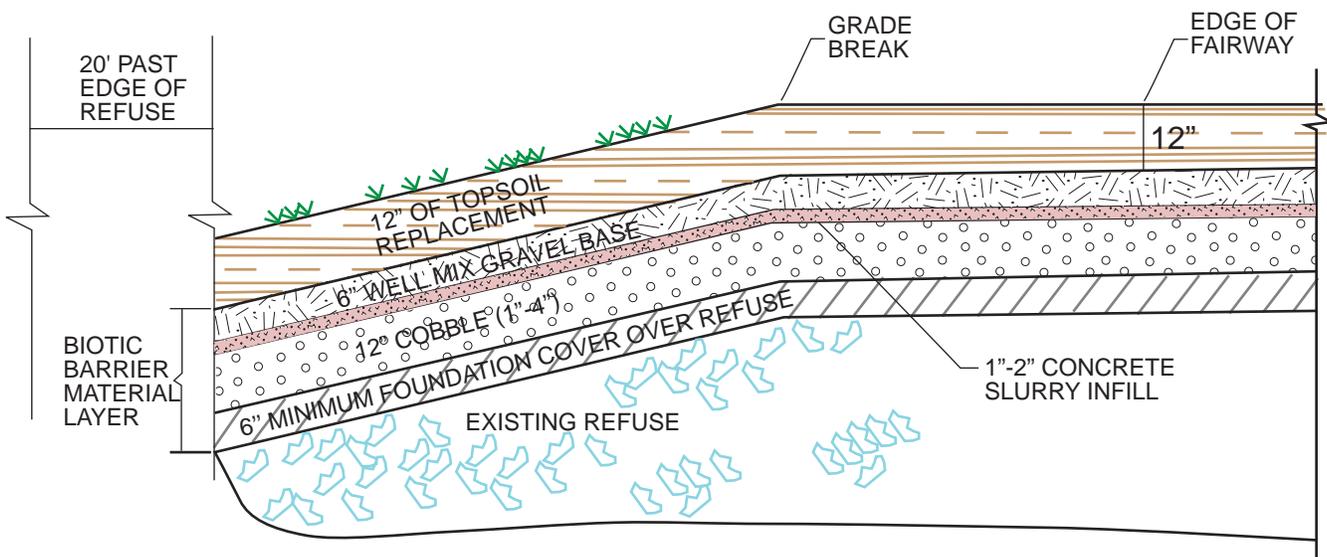
**Figure 8**  
**Site 22 Landfill Cap Schematic**

**TYPICAL SOIL REMOVAL**

**BIOTIC BARRIER COVER**

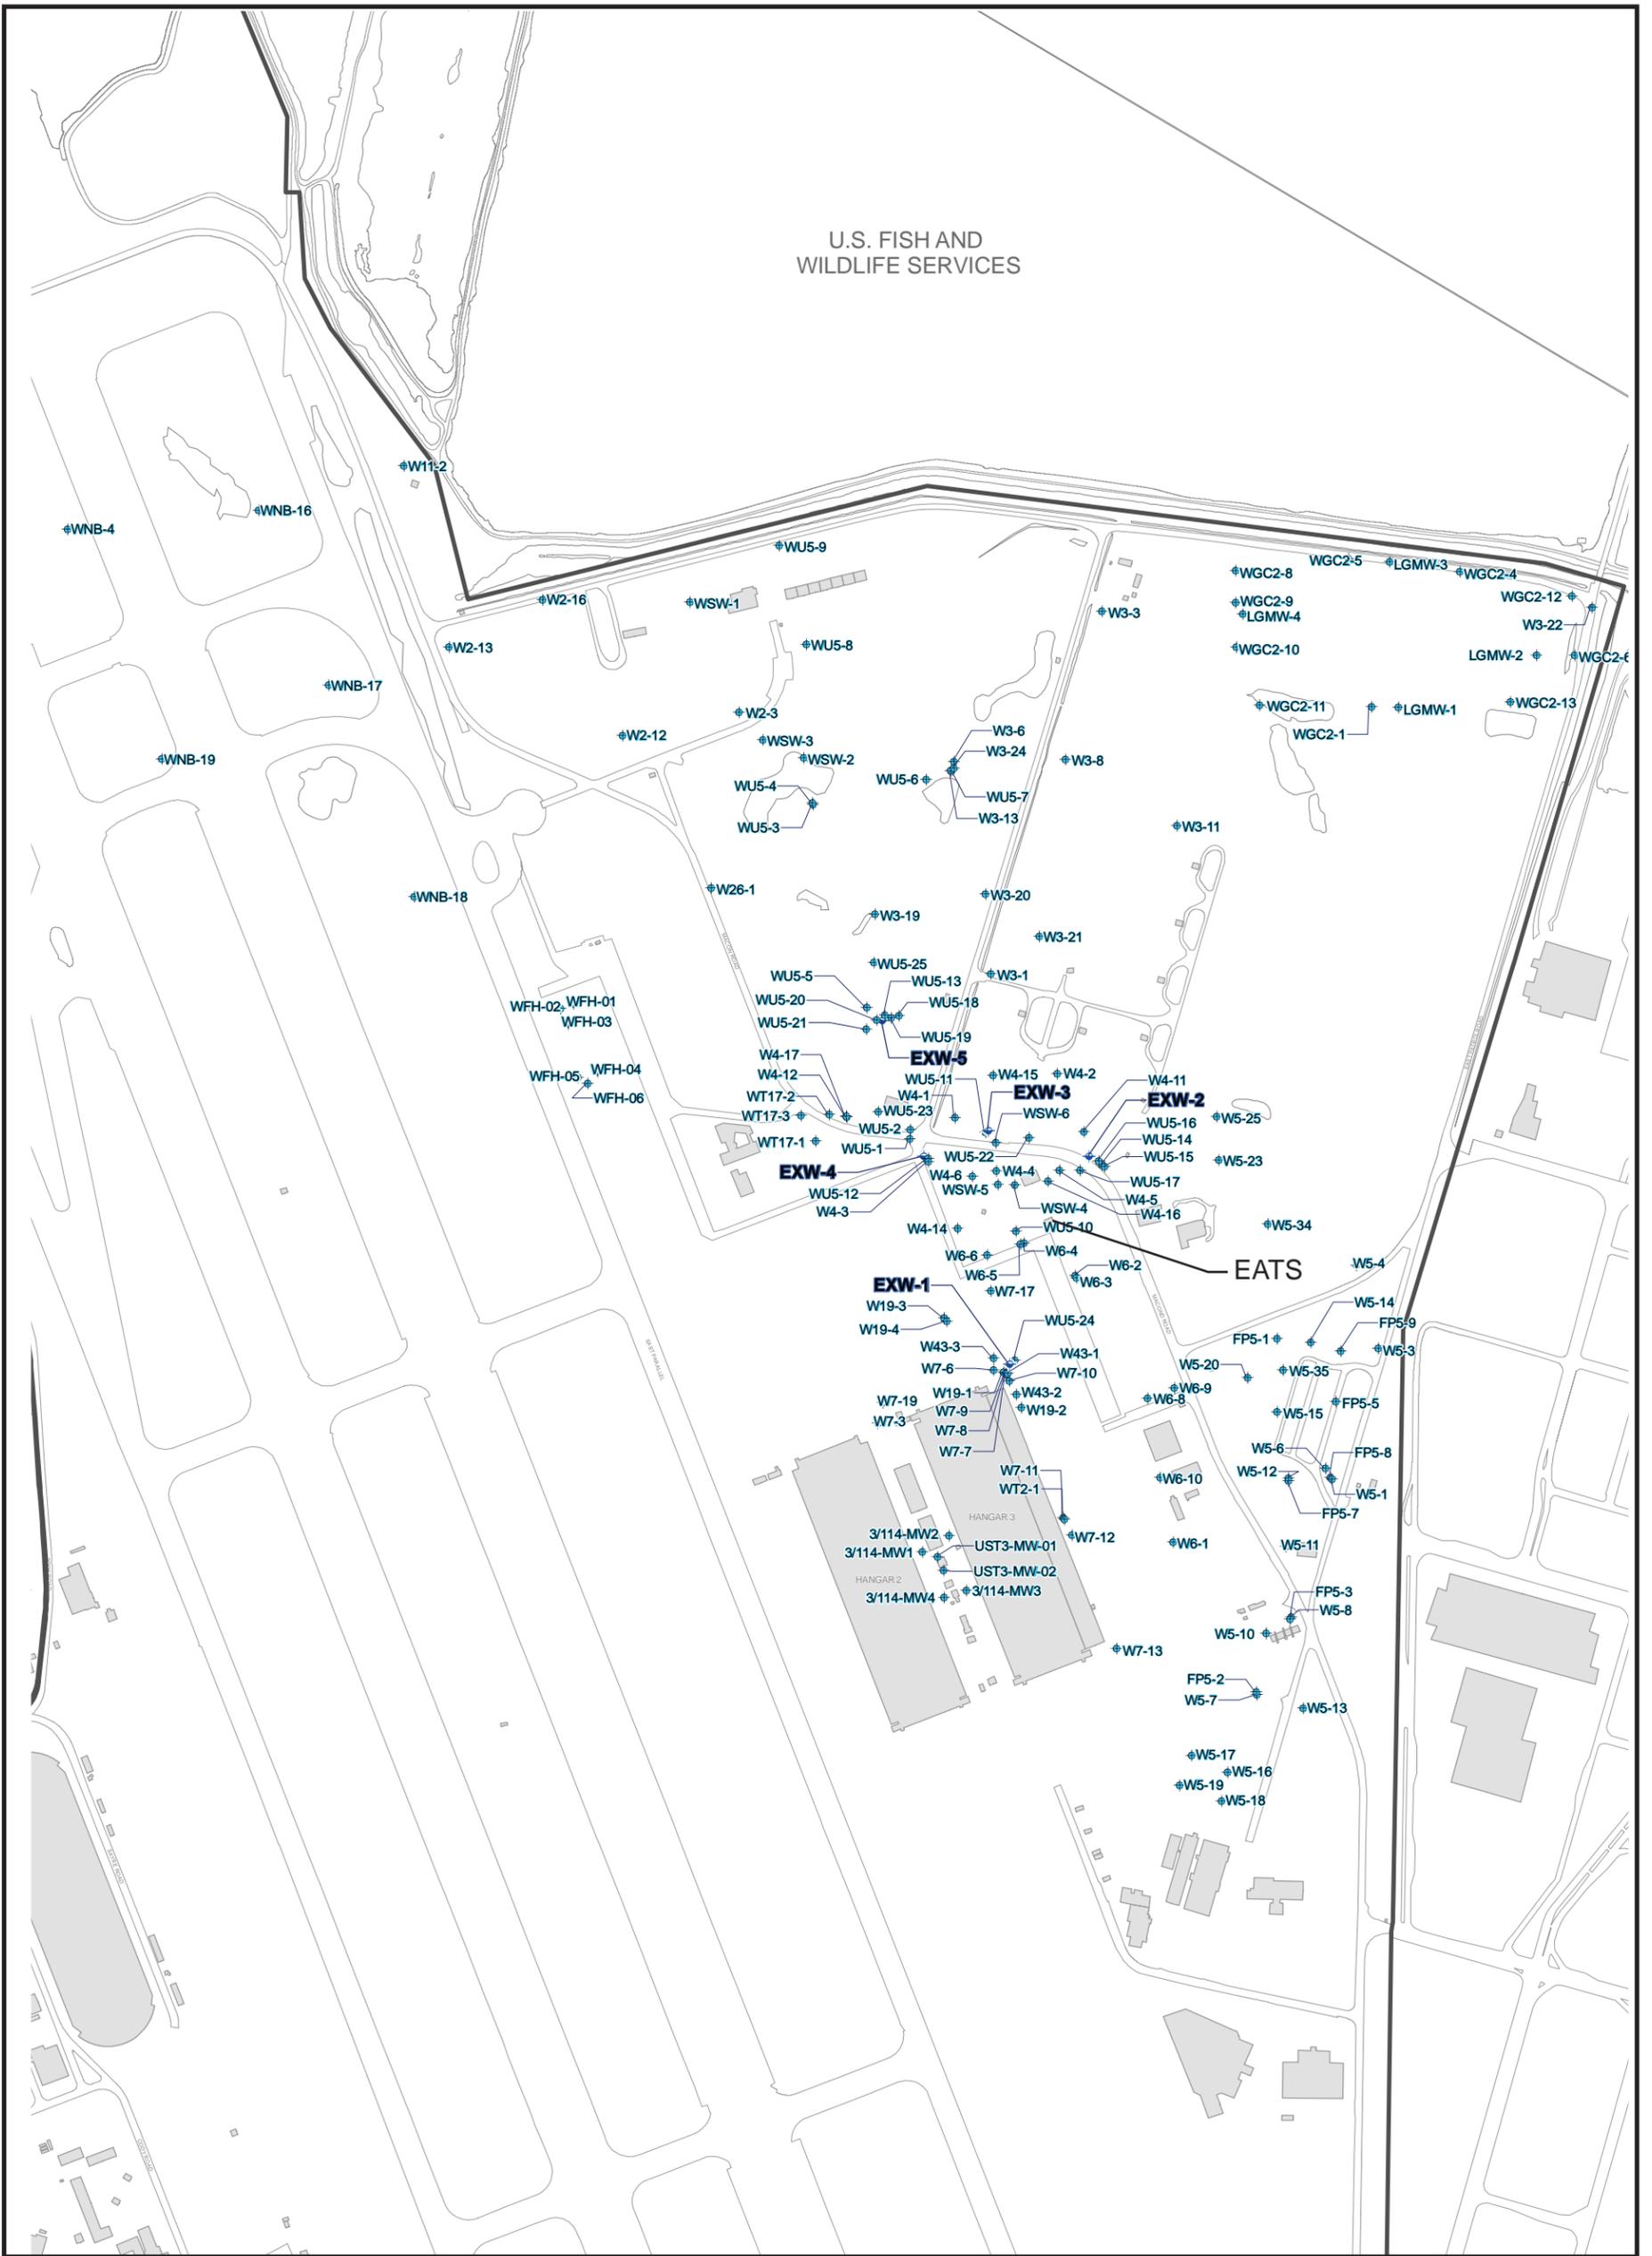
**Figure 9**  
**Location of Site 26**  
**Extraction and Monitoring Wells**

- WU4-19 + NAVY MONITORING WELL
- EA2-1 + NAVY EXTRACTION WELL
- ROAD
- BUILDING
