**FOURTH FIVE-YEAR REVIEW REPORT  
FOR  
NINETEENTH AVENUE LANDFILL SUPERFUND SITE  
MARICOPA COUNTY, ARIZONA**

**US Army Corps of Engineers, Seattle District  
for  
U.S. Environmental Protection Agency  
Region IX  
San Francisco, California**

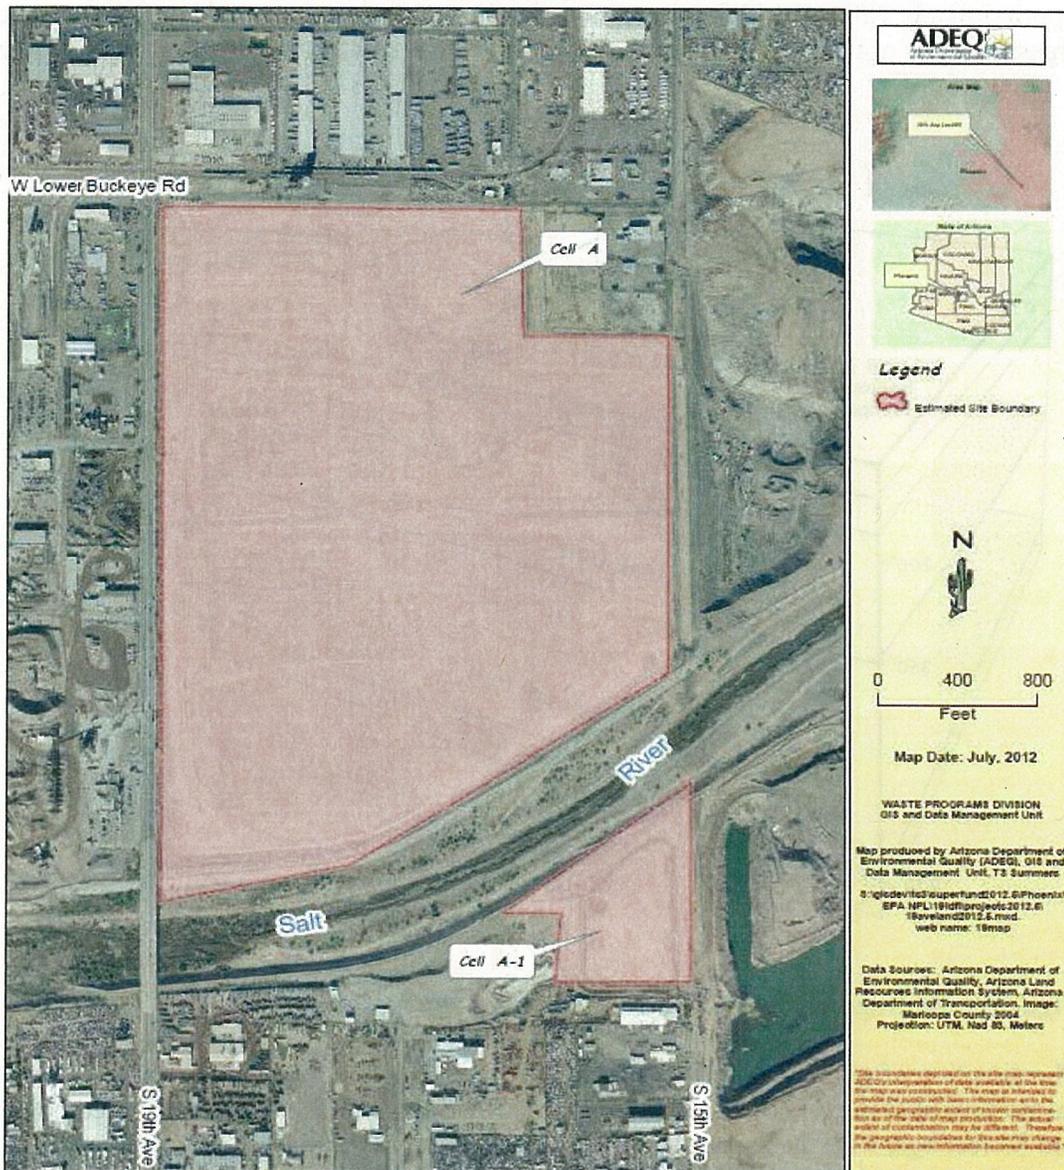
Figure 2. Detail Map for the 19<sup>th</sup> Avenue Landfill Superfund Site

The remaining 13-acre portion of the landfill, referred to as Cell A-1, is located south of the Salt River (Figure 2). Sometime before 1971, Cell A-1 was mined for sand and gravel, by late 1972, this cell was completely filled with refuse. The pit was excavated to a depth of 30 to 34 feet bgs in most of the southern two-thirds of the cell and to 10 to 20 feet bgs in the northern third.

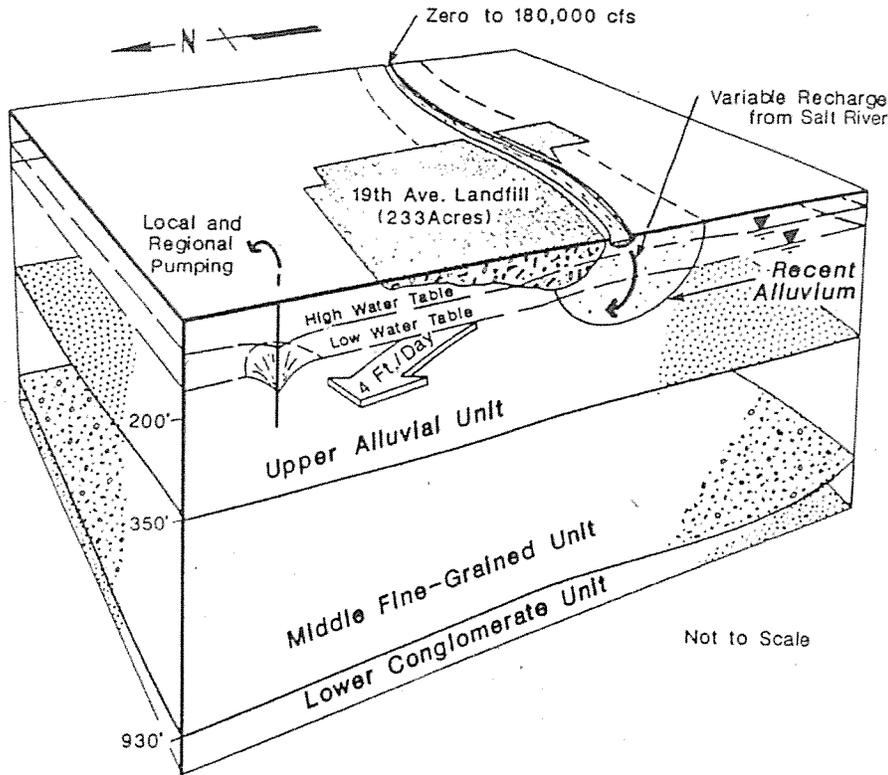
**Figure 3. Hydrogeologic Conceptual Diagram for 19<sup>th</sup> Ave. Landfill**

The Site is situated in the southeastern portion of the west sub-basin of the Salt River Basin in central Arizona. The landfill is underlain by alluvial materials deposited within the structurally depressed basins of the region. These materials can be divided into five different units which extend 350 feet bgs. There is a 15 foot surface layer composed of silty sand. Beneath this layer there are approximately 100 feet of cobbles and coarse gravels. The next three units below this layer are divisions within the Upper Alluvial Unit (Figure 3).

The alluvial materials beneath the site can transmit a relatively large amount of water because they are generally coarse grained. The transmissivity of the materials between a depth of approximately 100 and 150 feet is estimated to be 190,000 gallons per day per foot. The transmissivity of the cobble and gravel deposits above 100 feet is probably even greater.

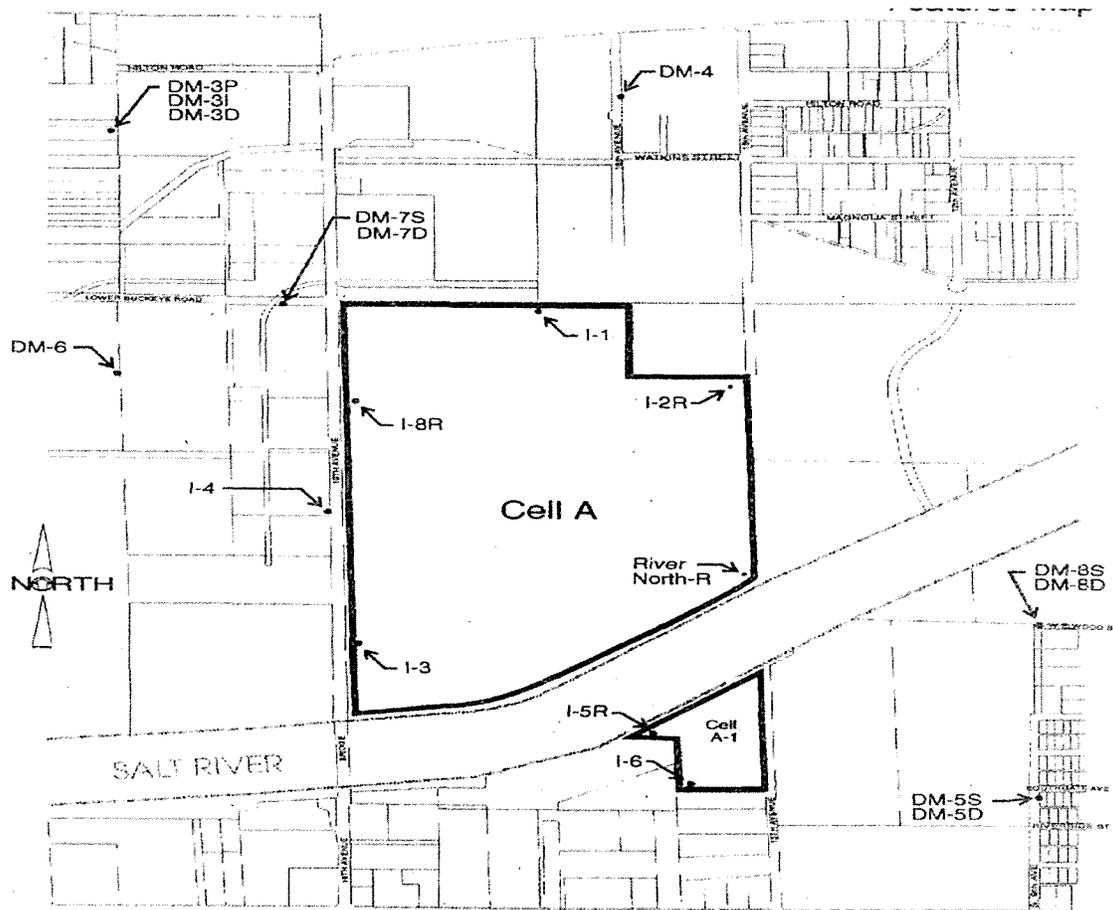
Figure 4. Groundwater Monitoring Wells

The Site originally contained 19 monitoring wells installed in the Upper Alluvial unit as shown on Figure 4. However, one of the original wells, identified as Well I-8, was abandoned in 1996 (p. 2 "Well Inventory Study", Tetra Tech 2014) and replaced by Well I-8R (River North R) that is no longer monitored,

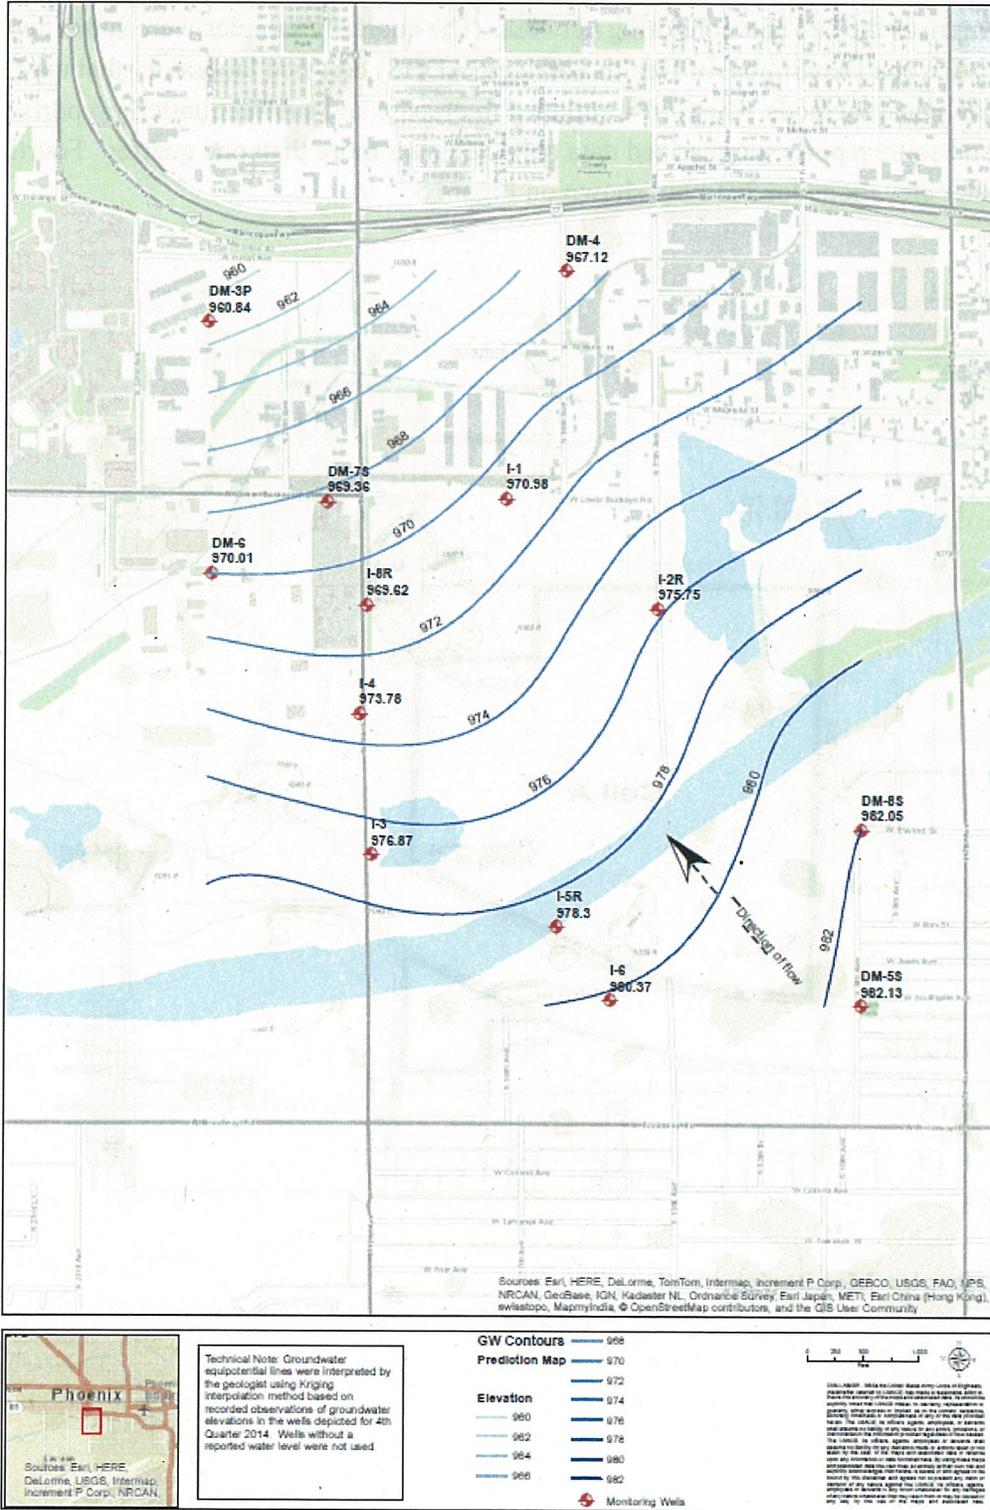
Figure 5. Groundwater Elevation Map Fourth Quarter 2014

During the period leading up to the 2015 FYR, the COP continued to conduct quarterly groundwater sampling and depth to groundwater measurements at the 18 monitoring wells (Table 8) that comprises the current monitoring network. The quarterly samples were submitted for analysis to an Arizona Department of Health Services (ADHS) certified laboratory that used State-approved analytical methods. The COP continued to prepare and submit quarterly reports to the agencies, and some reports summarized data collected over more than one quarter. Fourth quarter groundwater elevations for 2014 are shown on Figure 5.

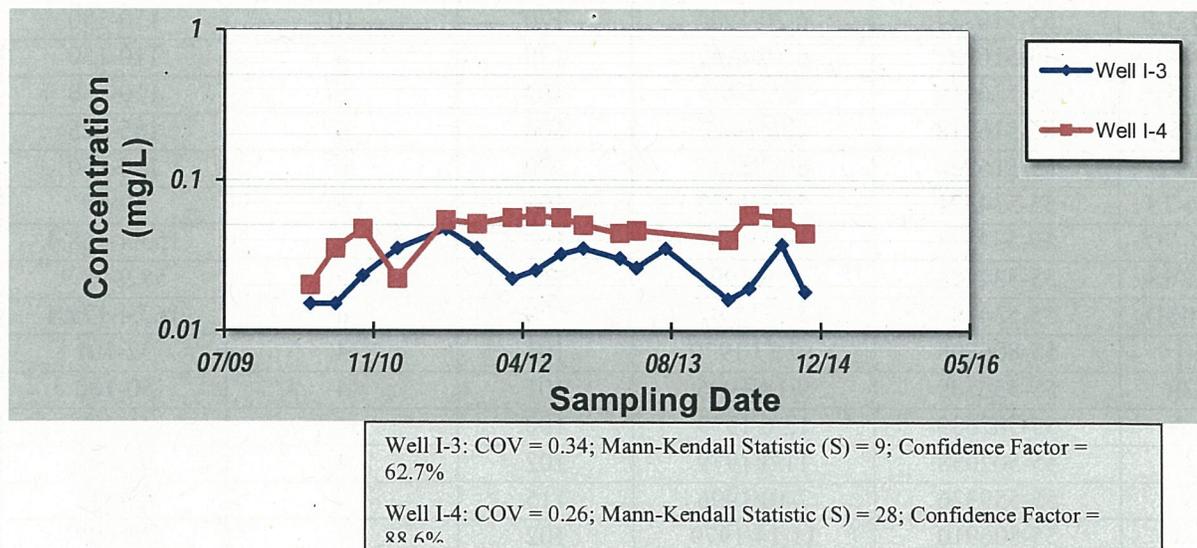
**Figure 6. Trend Analyses for Arsenic Concentrations at Wells I-3 and I-4**

The current data strongly support the 2004 Technical Memorandum conclusion that the arsenic is naturally occurring in the aquifer sediments and is mobilized at the water table surface by reducing conditions beneath the capped area of the landfill, but is relatively immobile in the naturally oxidizing conditions outside the capped area. As groundwater moves from beneath the capped area, naturally oxidizing conditions precipitate the dissolved arsenic (and related redox-sensitive metals) as oxide minerals of low solubility within a very short distance. The 2010-2014 site data shows the same patterns and continues to support the conclusions of the 2004 tech memo. The arsenic concentrations

downgradient, and in all other site wells, continue to remain near or below the MCL of 10 µg/L (see analysis in Appendix H of 2010 FYR Report). Therefore, it appears the same oxidizing conditions continue to be present. Regardless, arsenic will continue to be monitored at the Site to ensure the conditions observed in the past and current FYR remain the same.

- Notes:
1. sampling event in 3<sup>rd</sup> quarter 2013 was unavailable for Well I-4 because the well was dry; it was not considered in the analysis.
  2. Confidence in trend = confidence (%) that constituent concentration is increasing ( $S > 0$ ) or decreasing ( $S < 0$ ):  $>95\%$  = increasing or decreasing;  $\geq 90\%$  = probably increasing or probably decreasing;  $< 90\%$  and  $S > 0$  = no trend;  $< 90\%$ ,  $S \leq 0$ , and  $COV \geq 1$  = no trend;  $< 90\%$  and  $COV < 1$  = stable.
  3. Methodology based on "MAROS: A Decision Support System for Optimizing Monitoring Plans", J.J. Aziz, M. Ling, H.S. Rifai, C.J. Newell, and J.R. Gonzales, *Groundwater*, 41(3):355-367, 2003.

However, the COP should reassess groundwater contaminant data reported from 2010 through 2013 and correct the quarterly reports. The inaccurate threshold used for arsenic monitoring (as well as thallium) may have led to confusing or inaccurate conclusions in the COP's quarterly reports because the incorrect MCL was being used as a monitoring threshold. The reports failed to accurately communicate the extent of the presence of arsenic even if the groundwater in this area is not used for drinking water.

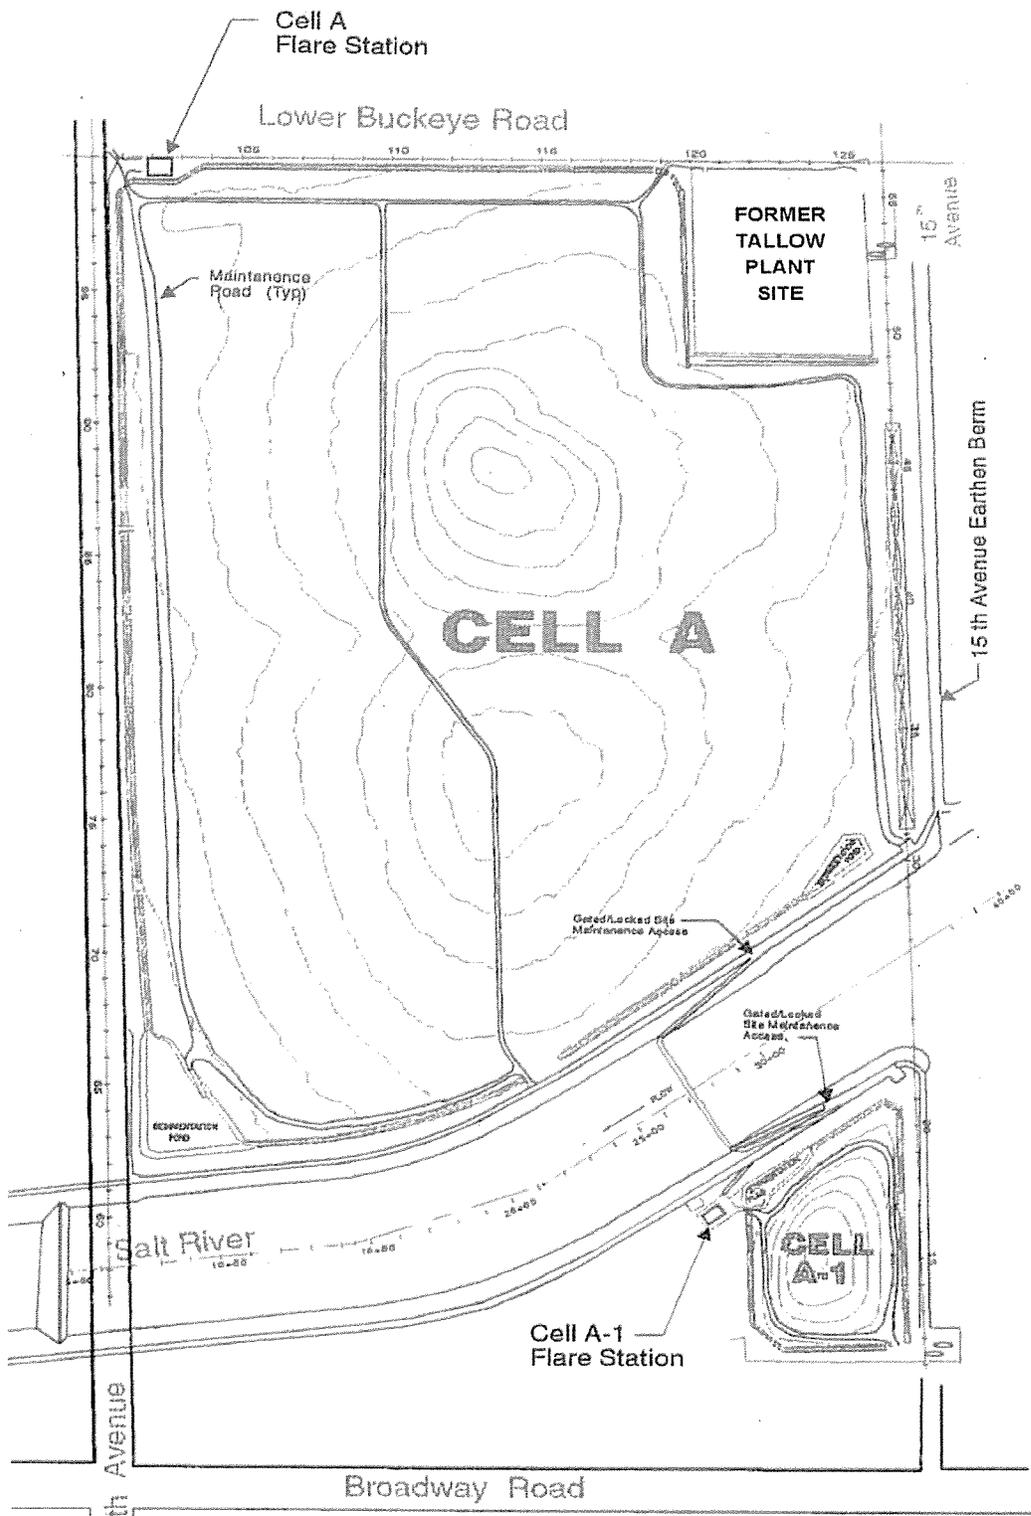
Figure 7. Location of Flare Stations

As a means of controlling subsurface migration of landfill gases to off-site locations, the COP installed a gas extraction and treatment (flaring) system which is monitored on a monthly basis (Figure 7). Annual average air concentrations, resulting from landfill emissions, were within general background levels typically found in the urban Phoenix area (ROD 1989). After the system was renovated, subsurface concentrations of methane decreased at most off-site locations. A follow-up engineering study indicated that the concentrations at all locations dropped below the lower explosive limit (LEL) for methane.

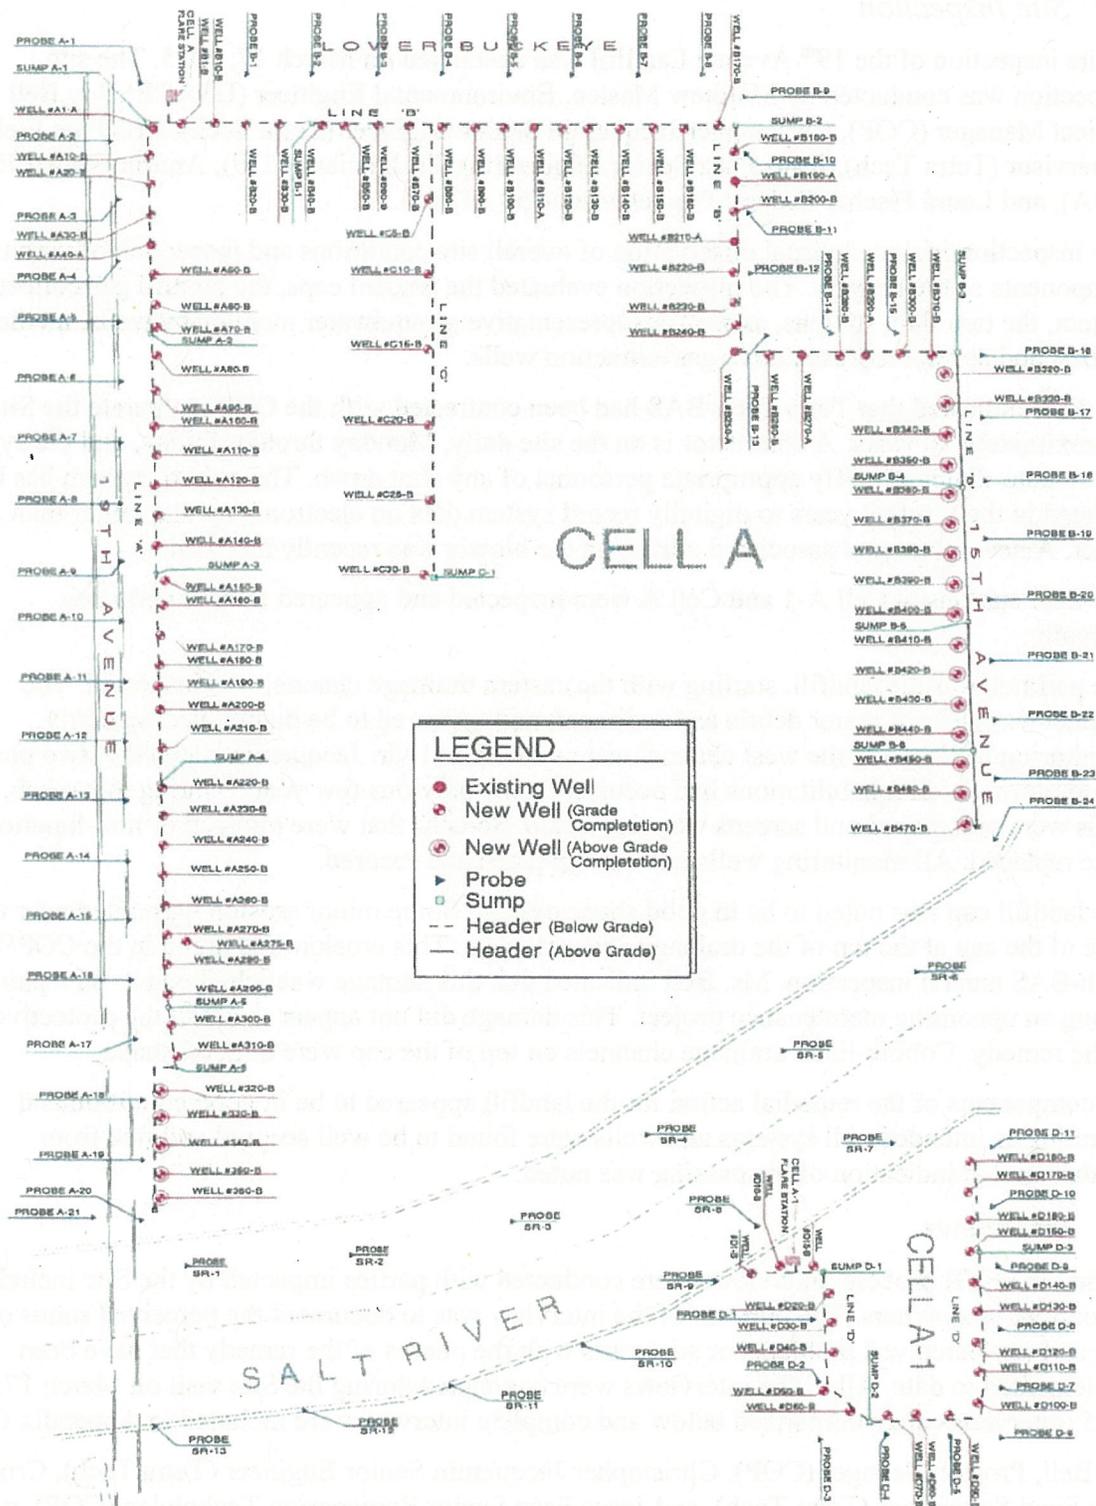
Figure 8. Landfill Gas Extraction System Features Map

The COP performs landfill gas monitoring on a monthly basis. The system includes 43 dual depth monitoring probes at Cell A, 11 dual depth probes at Cell A-1, 8 probes in the Salt River channel and 5 triple depth probes on the south bank of the Salt River (Figure 8). Between 2005 and 2012, the 19<sup>th</sup> Ave Landfill reduced the total emissions from approximately 5,000 to less than 1,000 tons, a 90 percent decrease. In 2012, the landfill collected and flared 84 tons of methane and released 15 tons of methane which is equivalent to 322 MT CO<sub>2e</sub> (metric tons carbon dioxide equivalent emissions) (COP 2013). The 19<sup>th</sup> Avenue Landfill probes were below five percent methane by volume for the entire reporting period in 2010, 2012, 2013, and 2014. In October 2011, the methane concentrations at perimeter probe LG19B12 at the 19<sup>th</sup> Avenue Landfill Cell A were detected above five percent by volume of the LEL. Detection of methane over five percent by volume at this probe was made at the deep monitoring level only. This probe

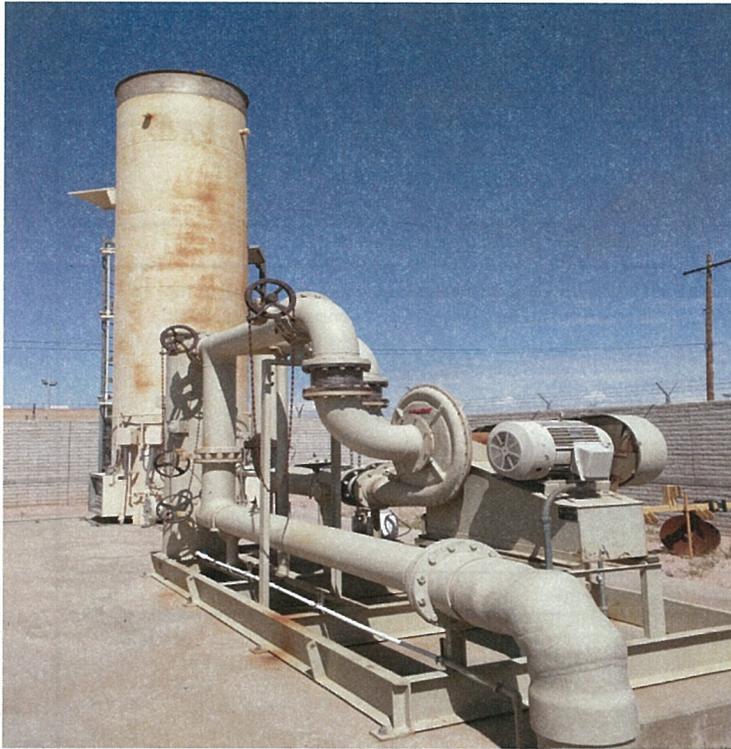
Photo 1 - Cell A flare and blower

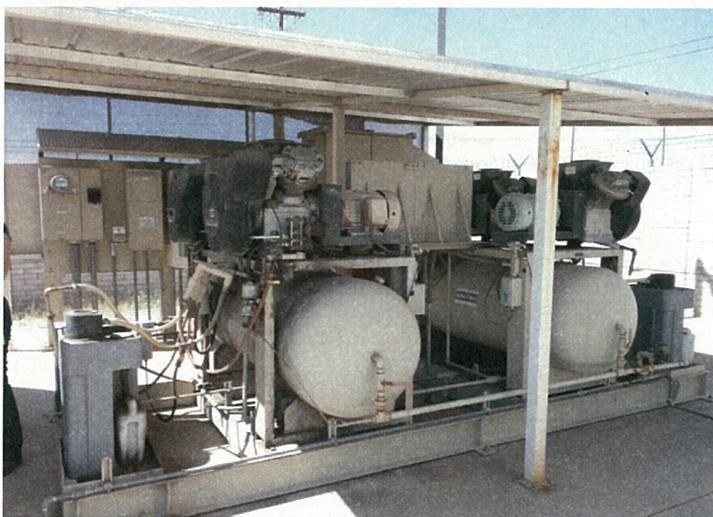
Photo 2 - Cell A flare, redundant air compressors

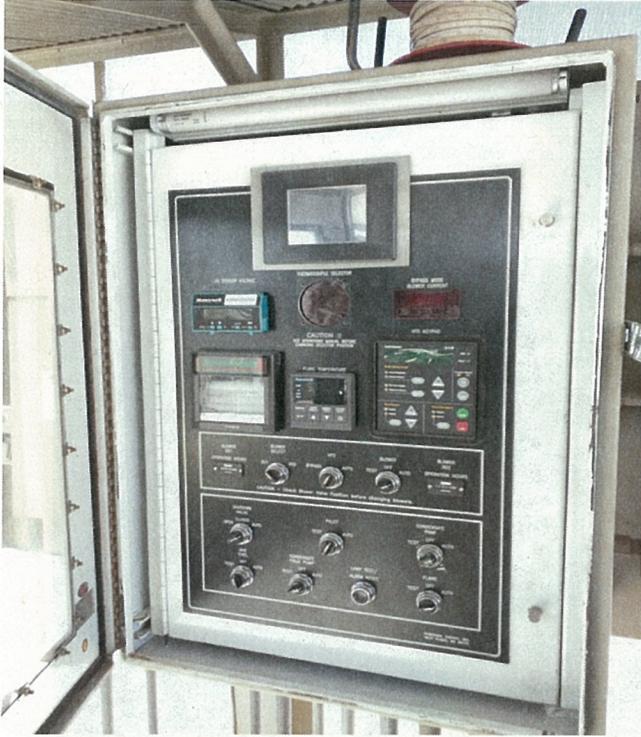
Photo 3 - Cell A flare operating panel

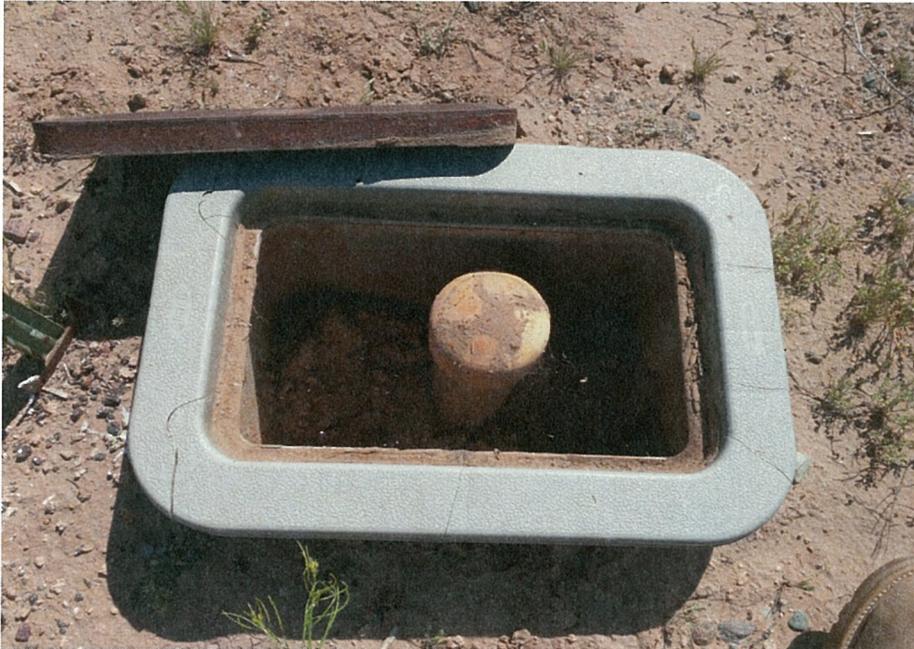
Photo 4 - Capped methane extraction well

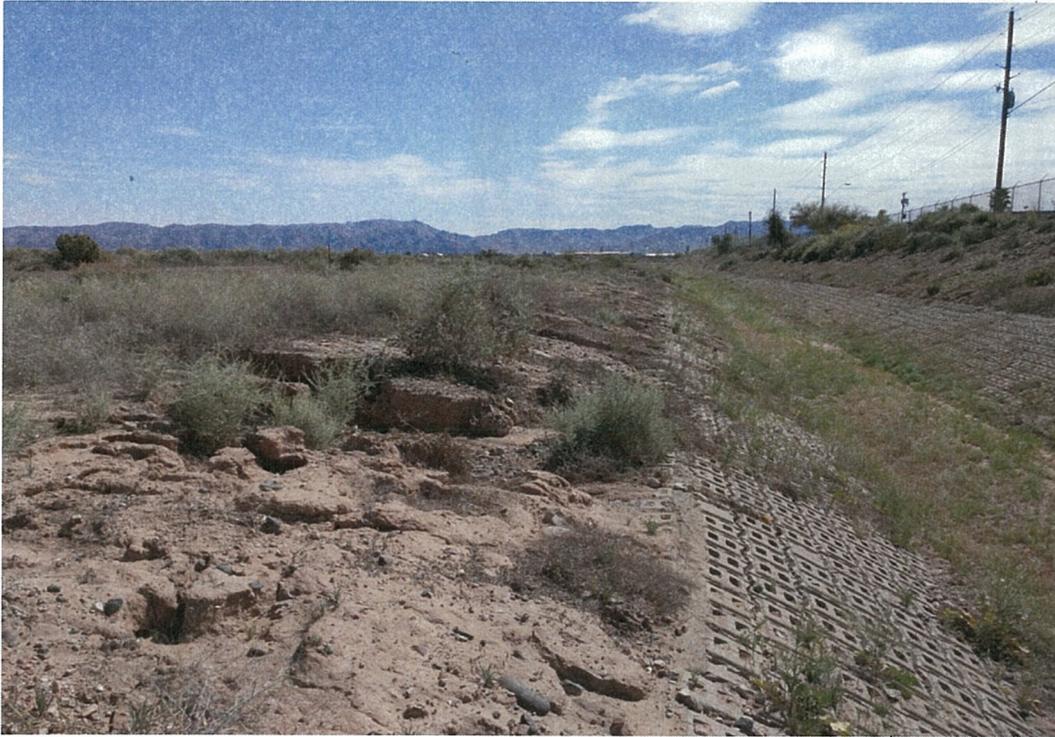
The landfill cap was noted to be in good shape overall. Some minor erosion was noted near the edge of the cap at the top of the drainage channel walls. This erosion was noted in the COP/Tetra Tech-BAS annual inspection. Ms. Bell indicated that this damage was scheduled to be repaired during an upcoming maintenance project. This damage did not appear to affect the protectiveness of the remedy. Cobble-lined drainage channels on top of the cap were in good shape.

Photo 5 - Erosion along west drainage channel

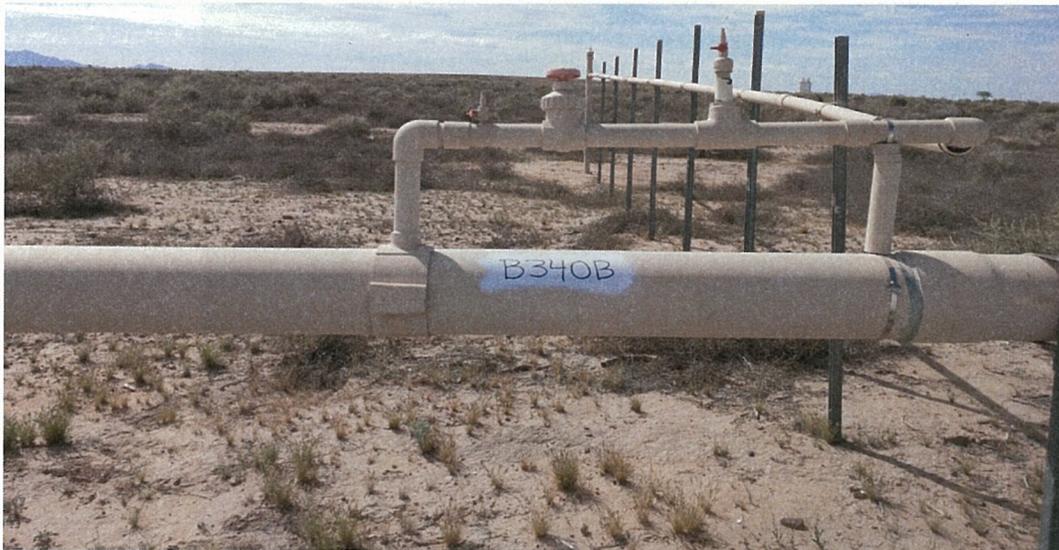
Photo 6 - Gas collection system, above-grade

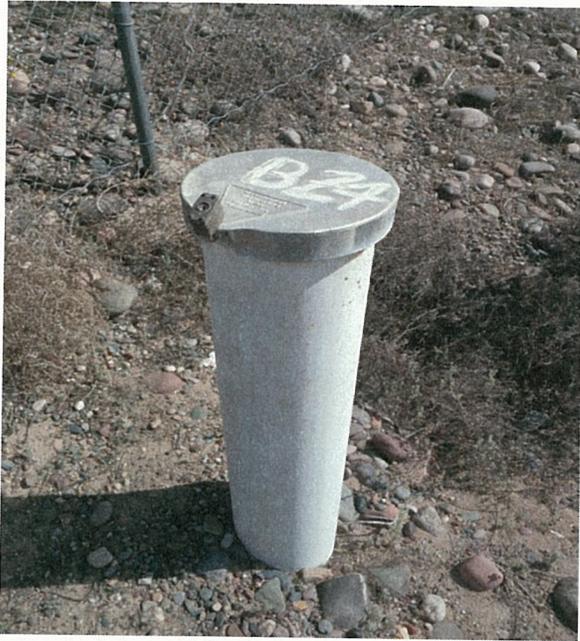
The perimeter of the landfill, starting with the eastern drainage channel was inspected. The channel was clear of major debris and sediment, and appeared to be maintained regularly. Monitoring wells along the west channel were viewed and Mr. Jacquemin stated that two phases of monitoring well rehabilitations had occurred in the previous few years. During this rehab, wells were videotaped and screens were inspected. Screens that were plugged or non-functioning were replaced. All monitoring wells had caps in place and secured.

Photo 7 - Secured monitoring well, BZ4

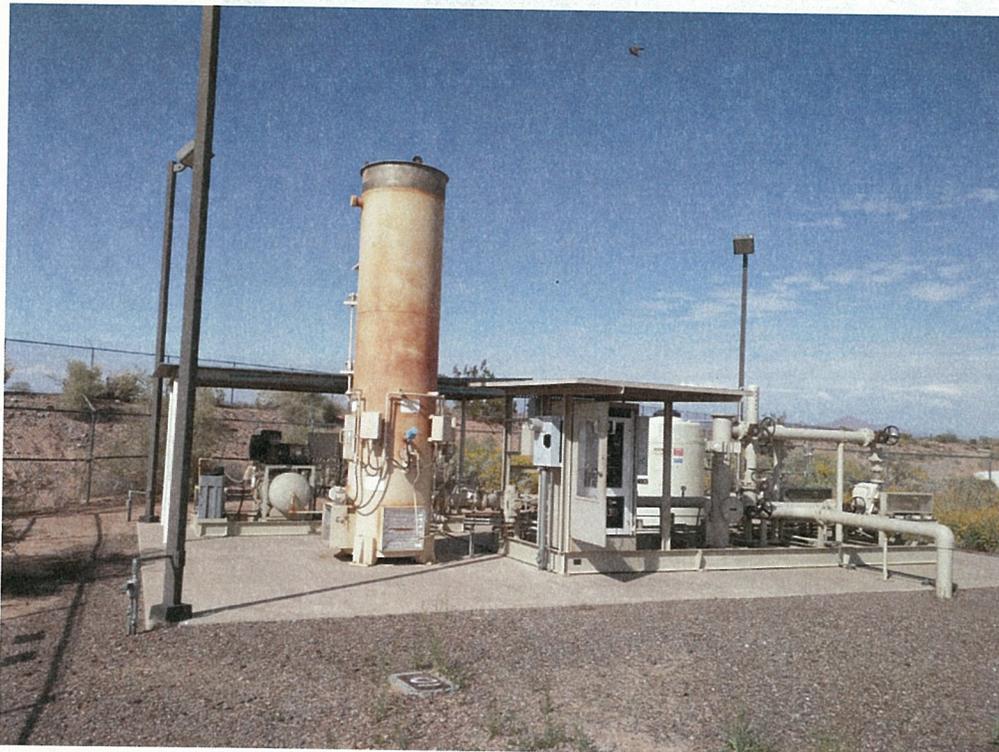
Photo 8 - Cell A-1 flare

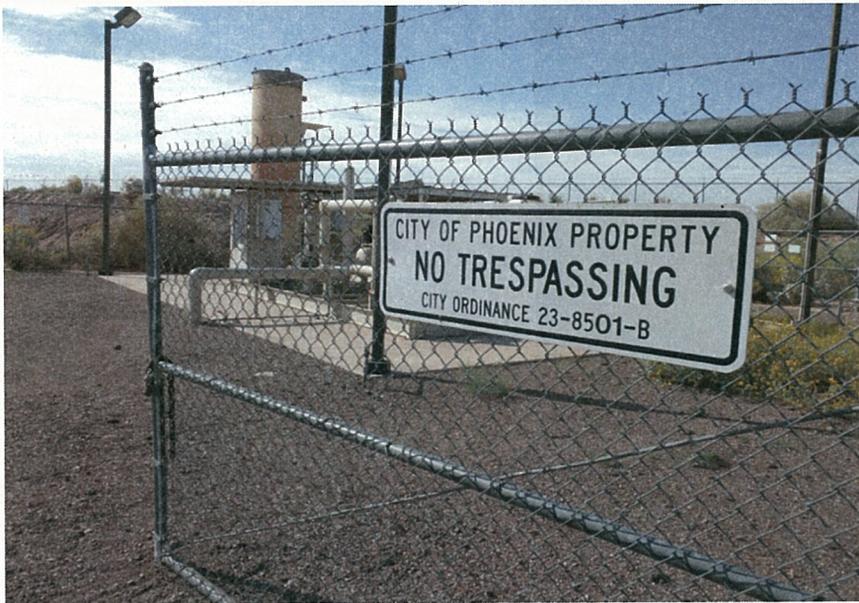
Photo 9 - Signage at Cell A-1 flare

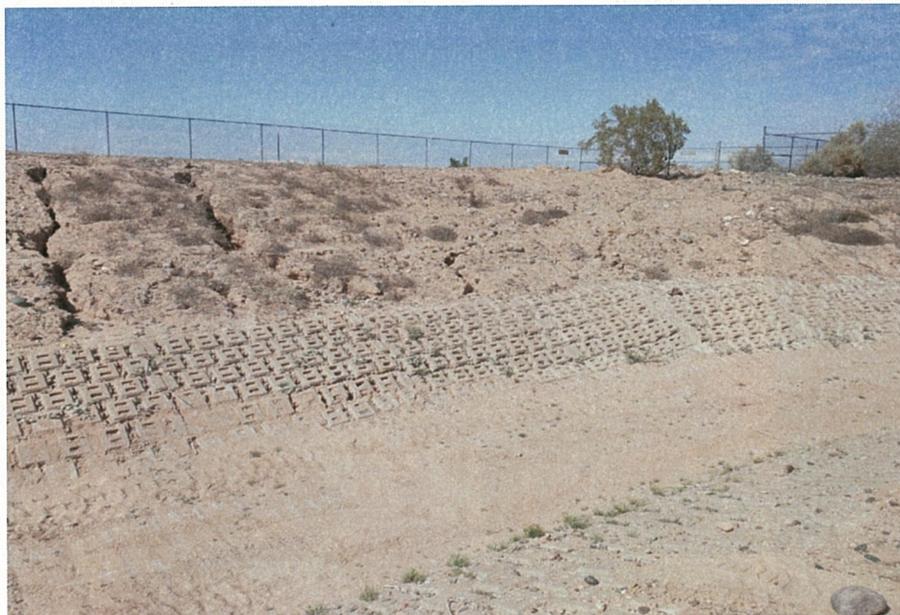
Photo 10 - Cell A-1, levee side erosion, looking north
