Subject: **2011 Annual Progress Report – Former Fairchild Buildings 1-4**
Middlefield-Ellis-Whisman (“MEW”) Area
Mountain View, California

**2011 ANNUAL PROGRESS REPORT FOR
FORMER FAIRCHILD BUILDINGS 1-4
MOUNTAIN VIEW, CALIFORNIA**

**2011 Annual Progress Report for Former
Fairchild Buildings 1-4
515/545 Whisman Road and 313 Fairchild Drive
Middlefield-Ellis-Whisman Area
Mountain View, California**

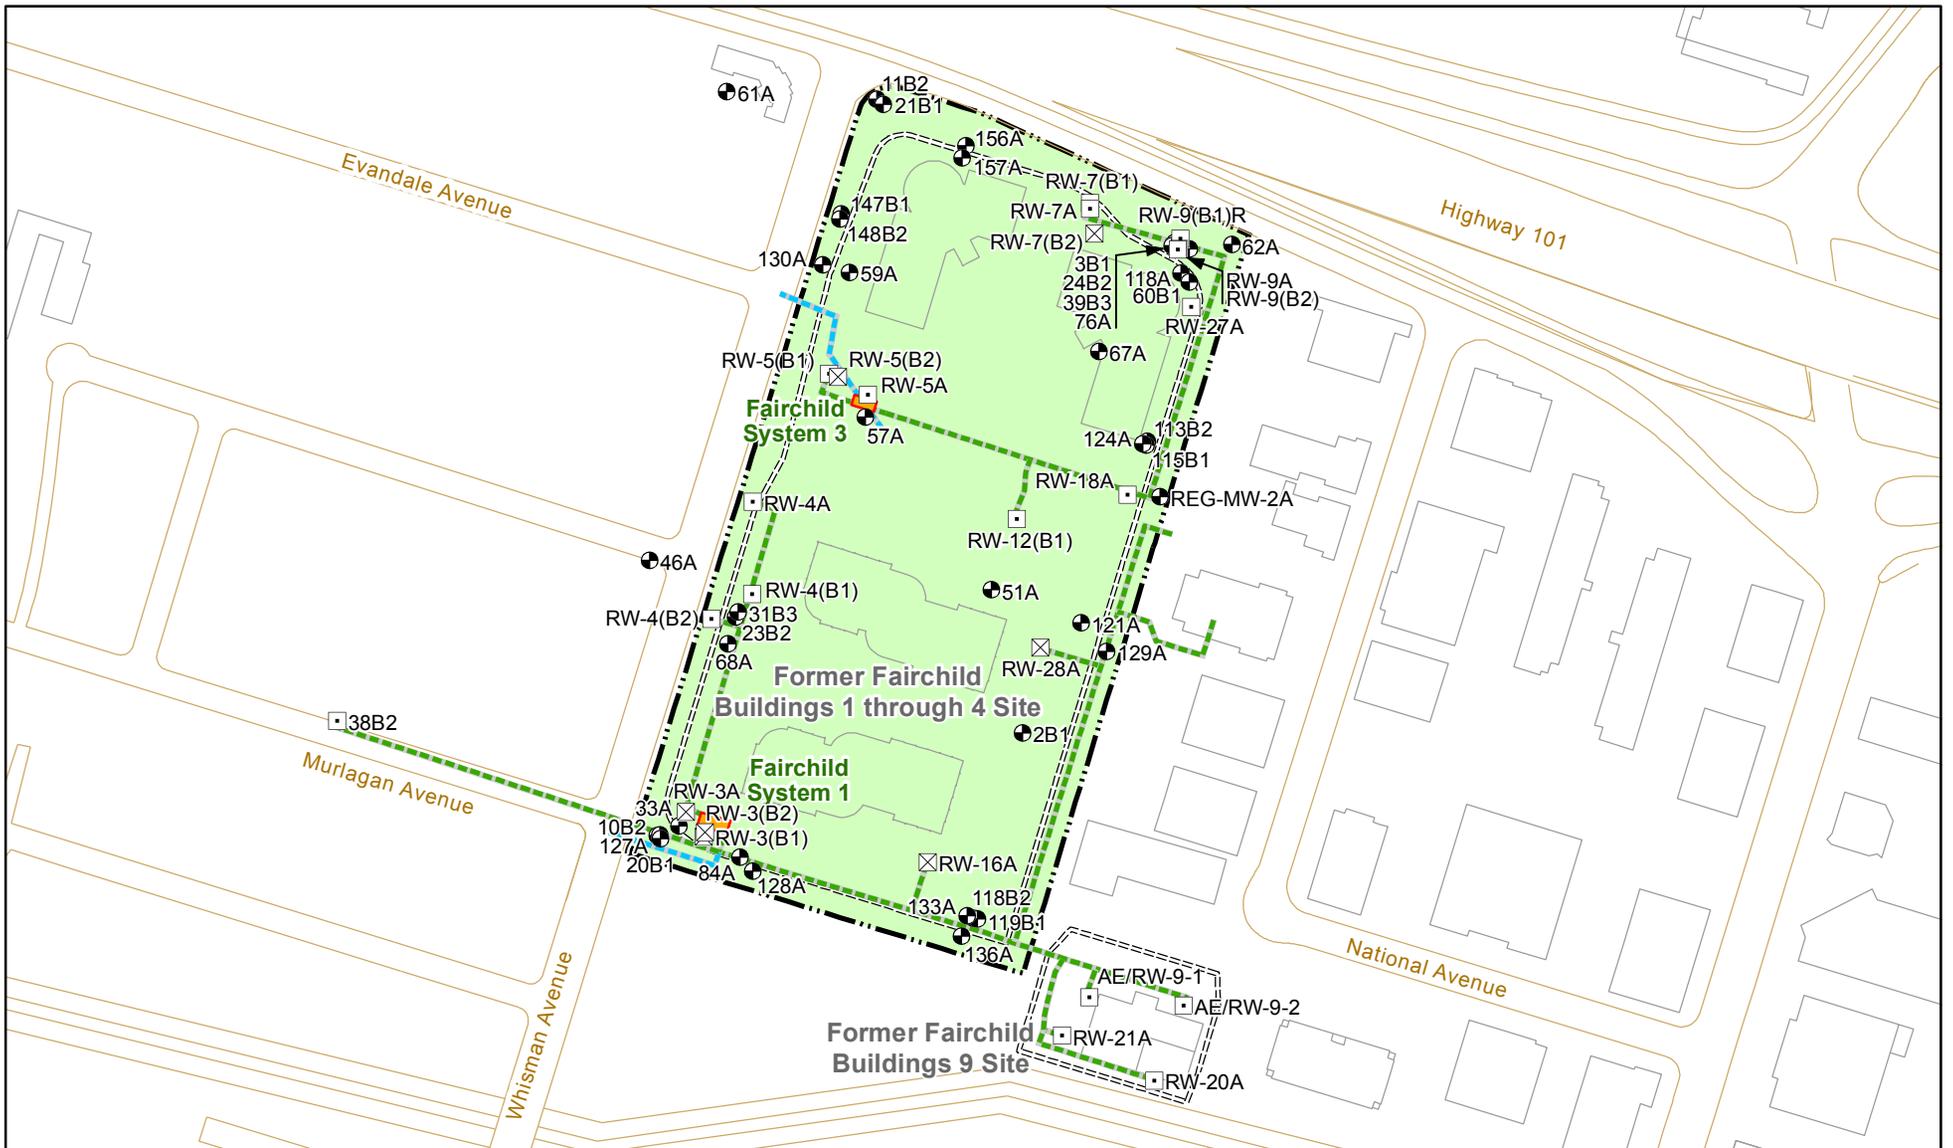
**Figure
2**

- Recovery and Monitoring Wells
- Monitoring Well (black circle with dot)
- Recovery Well, On (square with dot)
- Recovery Well, Off (square with X)
- Former Fairchild Buildings 1-4 Site - 515/545 North Whisman Road and 313/323 Fairchild Drive (light green fill)
- Fairchild Groundwater Treatment Systems 1 and 3 (orange fill)
- Treatment System Pipeline (dashed green line)
- Treatment-System Discharge Pipeline (dashed blue line)
- Slurry Wall (dashed orange line)
- Building (grey outline)
- Road (orange line)

The Site lies within the Middlefield-Ellis-Whisman (MEW) study area, an approximate quarter square-mile area bounded by Middlefield Road on the south, Ellis Street on the east, Whisman Road on the west, and Highway 101 on the north, in Mountain View, California (Figure 2).
