Figure B-14a

Summary Analytical Results
Inorganics Detected Above Screening Levels
Administration Building Area

Final Remedial Investigation Report
 Casmalia Resources Superfund Site
 January 2011

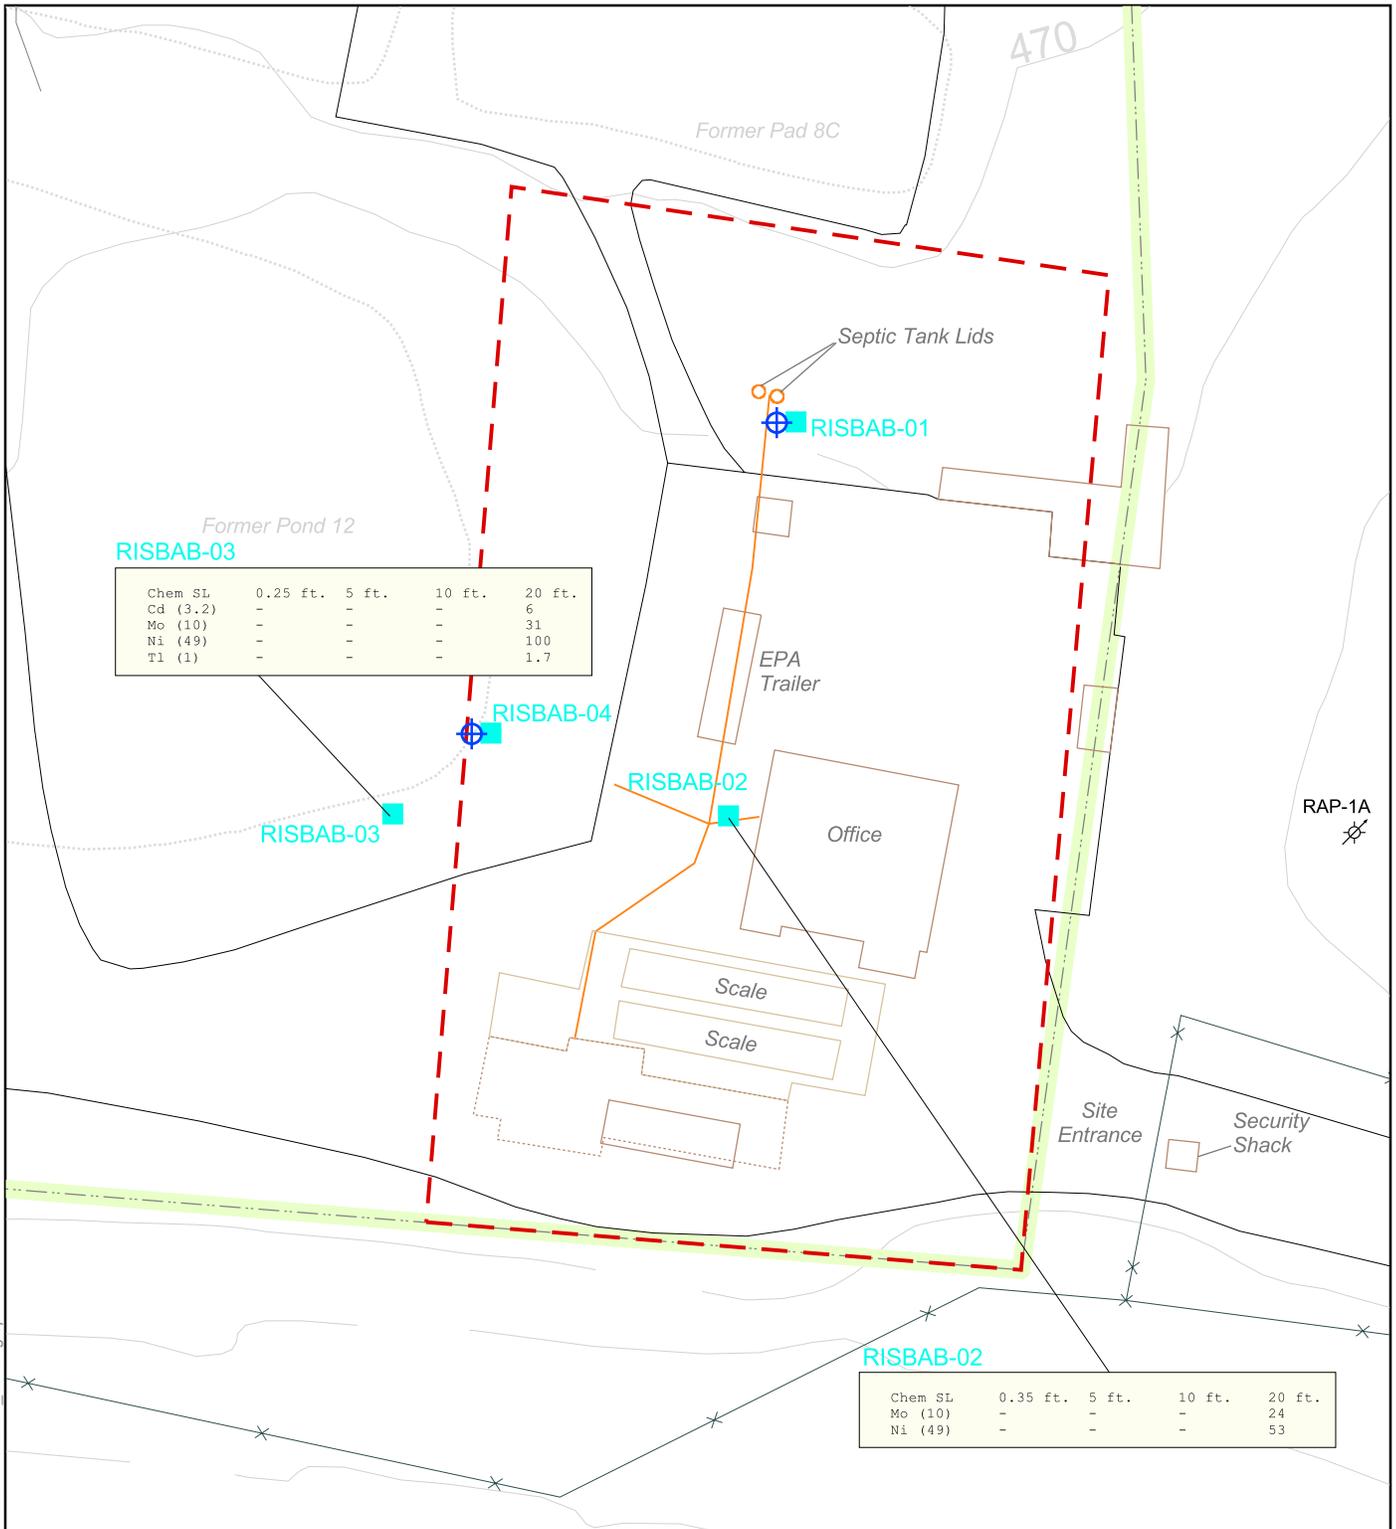
Soil Sample Locations

- Surface to Deep Soil (Type 5)
- ⊕ NAPL (Type 7)

All Values in mg/kg
