Figure B-17c
Summary Analytical Results and Field Observations
Former Ponds and Pads Subarea
 Final Remedial Investigation Report
 Casmalia Resources Superfund Site
 January 2011

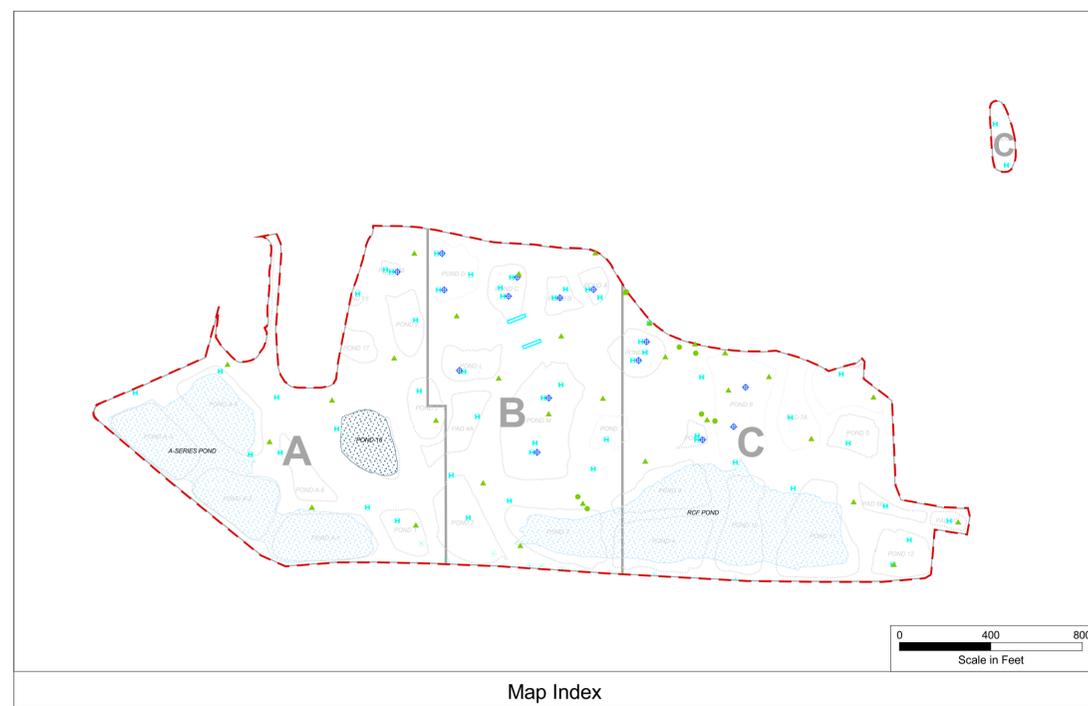
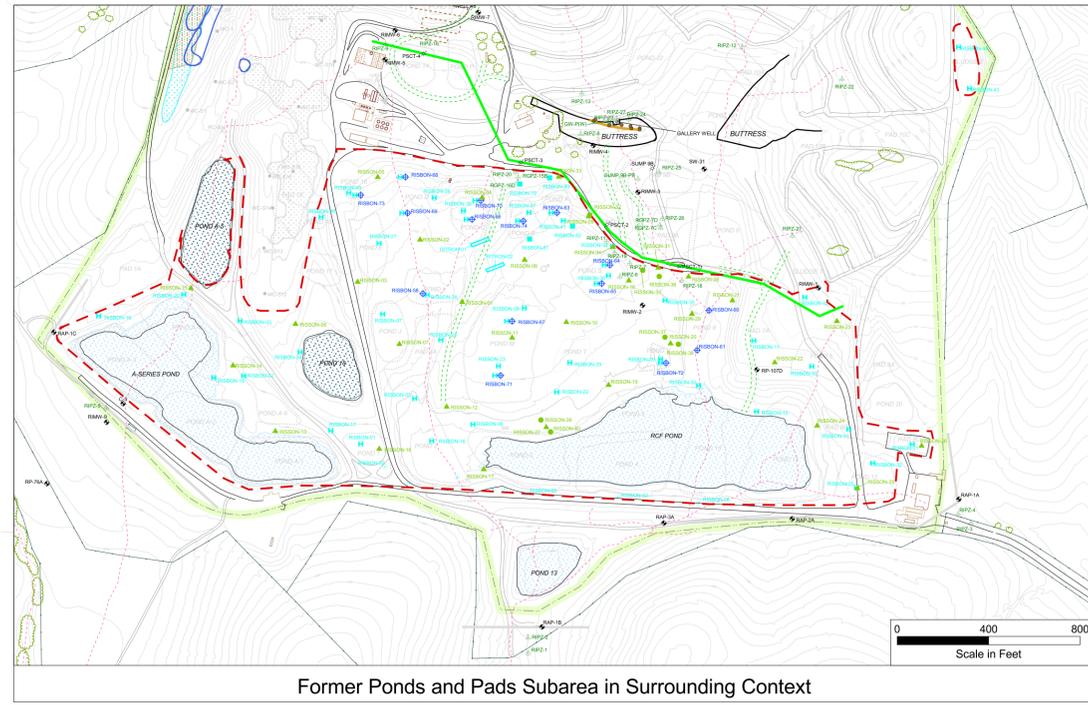
MAP B

Notes:
Laboratory Analytical Results
 ND = None Detected
 xxx = Reported Concentration
 • D/F in ng/kg
 • All others in mg/kg
 blank space = No Test Conducted at Particular Depth

Visual (V) and/or (O) Field Observations
 N = None
 L = Light
 M = Moderate
 H = Heavy
