Figure B-20a

**Summary Analytical Results
Inorganics Detected Above Screening Levels
Treated Liquid Impoundments**

Final Remedial Investigation Report
Casmalia Resources Superfund Site

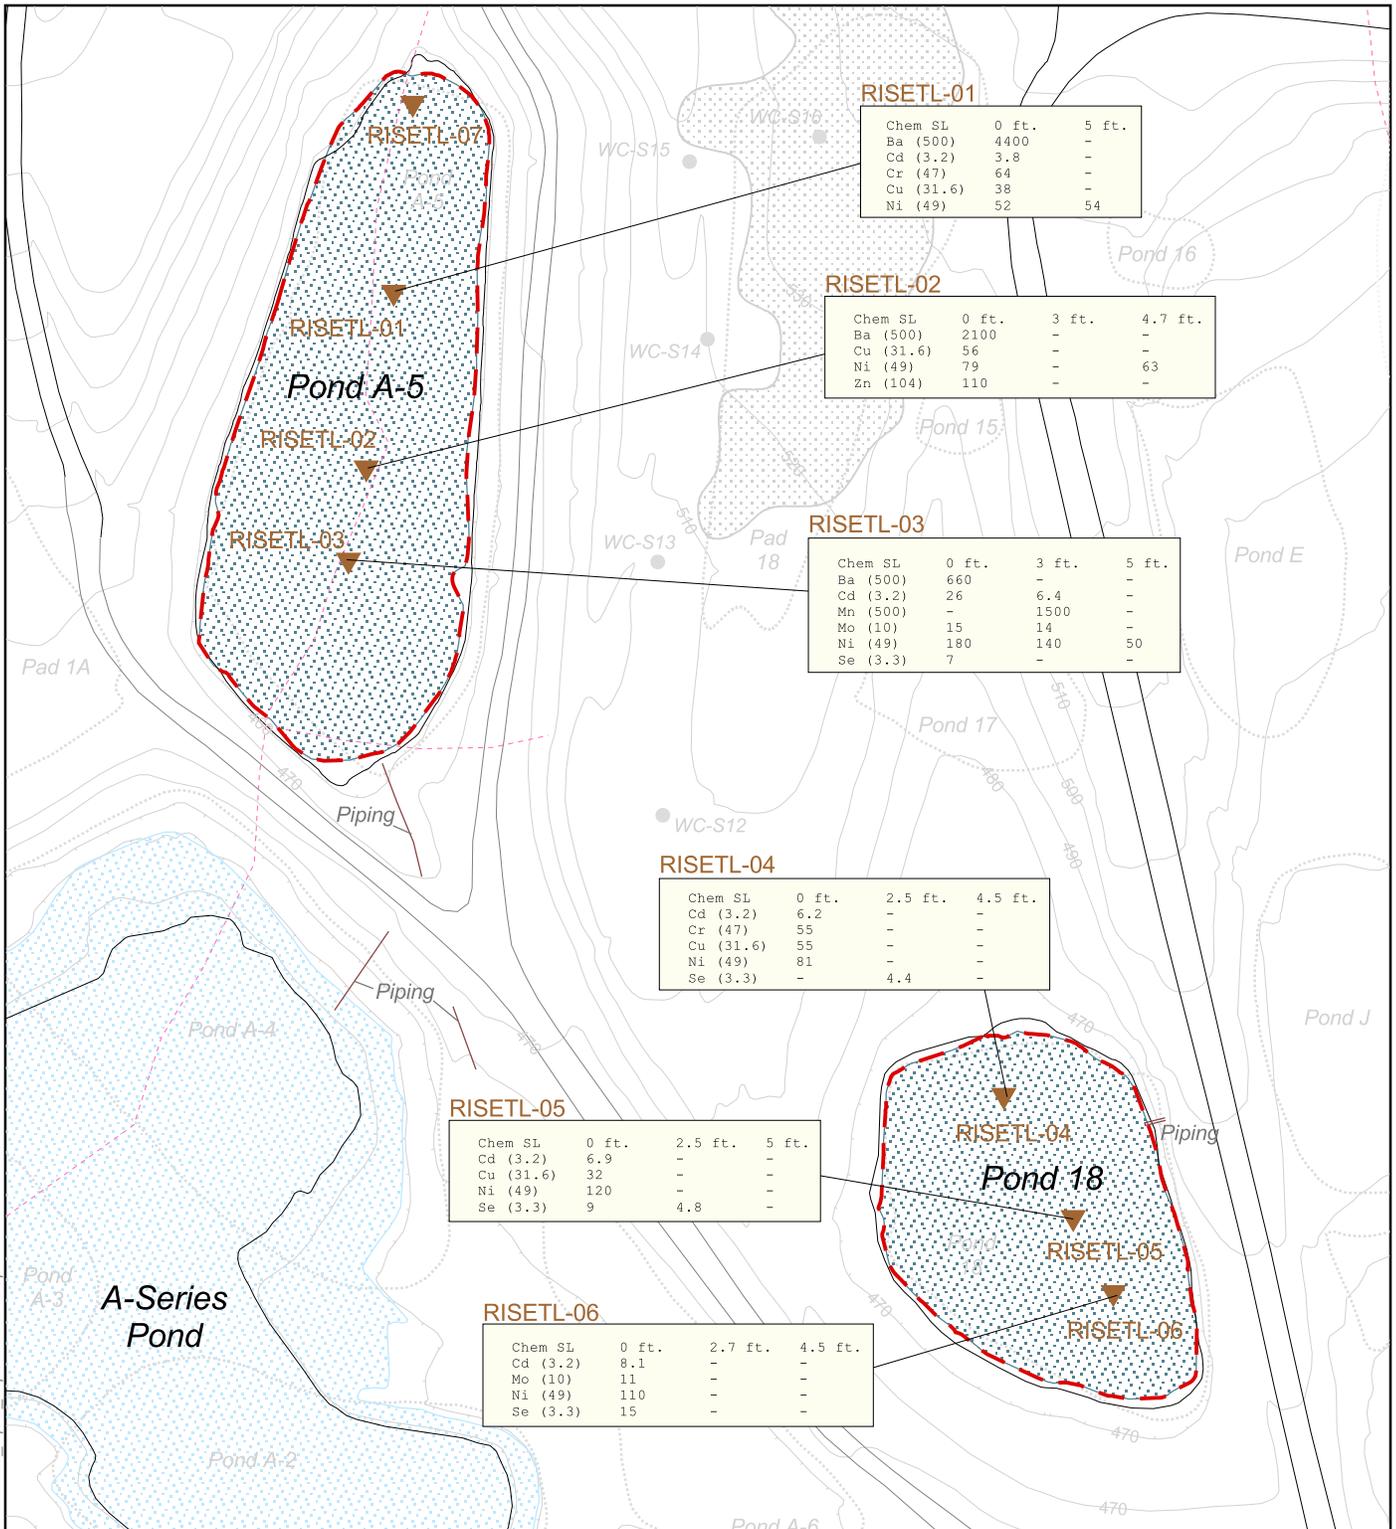
All Values in mg/kg
