MFA Leasehold EIMP Appendix A - Part 1

APPENDIX A

NASA EEC Statements

SITE NAME:	Site 1: Runway Landfill				
Version:	Final	Date:	02/21/2015		
RESPONSIBLE PARTY					
Organization	Department of the Navy, BRAC				
Address	1455 Frazee Rd., Suite 900 San Diego, CA 92108				
Contact	Scott Anderson				
	scott.d.anderson@navy.mil				
	619-532-0938				
LOCATION					
Facility Name	Moffett Federal Airfield	Site Location			
Facility Address	Mountain View, CA	Latitude	37.430918° N		
	Santa Clara County	Longitude	122.052779° W		
Regulatory Program	Lead Agency(ies)	Site Status			
		Open	Closed	ROD	Current Phase
CERCLA	EPA/RWQCB	X		OU1 1997	O&M
SITE SUMMARY					
<p>The Site 1 landfill covers approximately 12 acres at the northern portion of the former Naval Air Station Moffett Field (NASMF) and is northeast of Runway 32R (14L). Figure 1 depicts the location of Site 1 with respect to the former NASMF. Figure 2 is an aerial view of Site 1. The landfill is surrounded on three sides by fencing while the northern portion is bordered by the Storm Water Retention Pond (SWRP). The western portion of the landfill is flat with an elevation of 7 feet above mean sea level while the eastern portion is moun

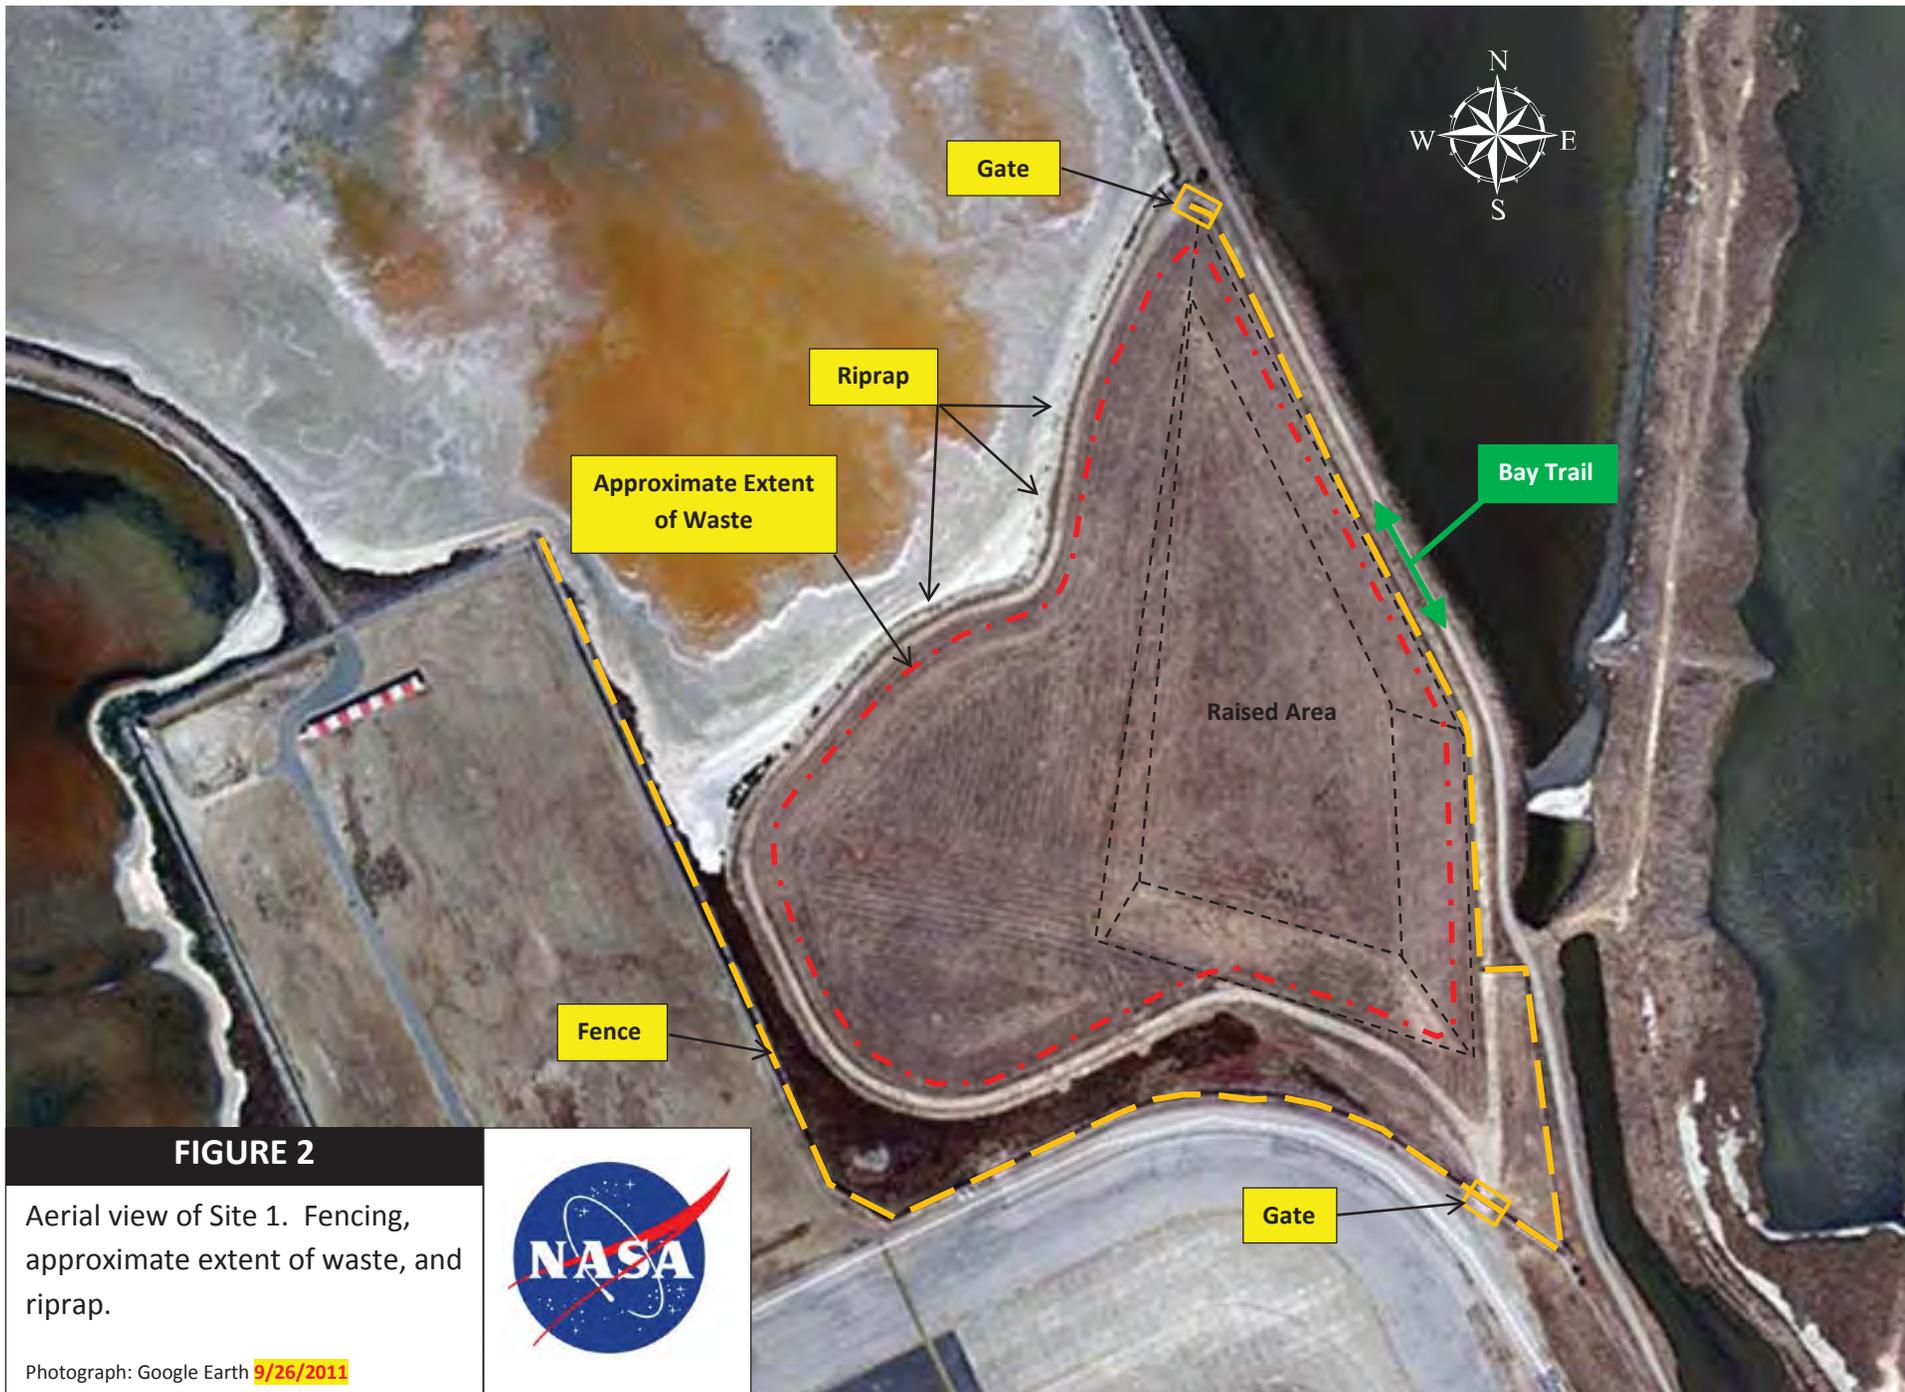
FIGURE 2

Aerial view of Site 1. Fencing, approximate extent of waste, and riprap.

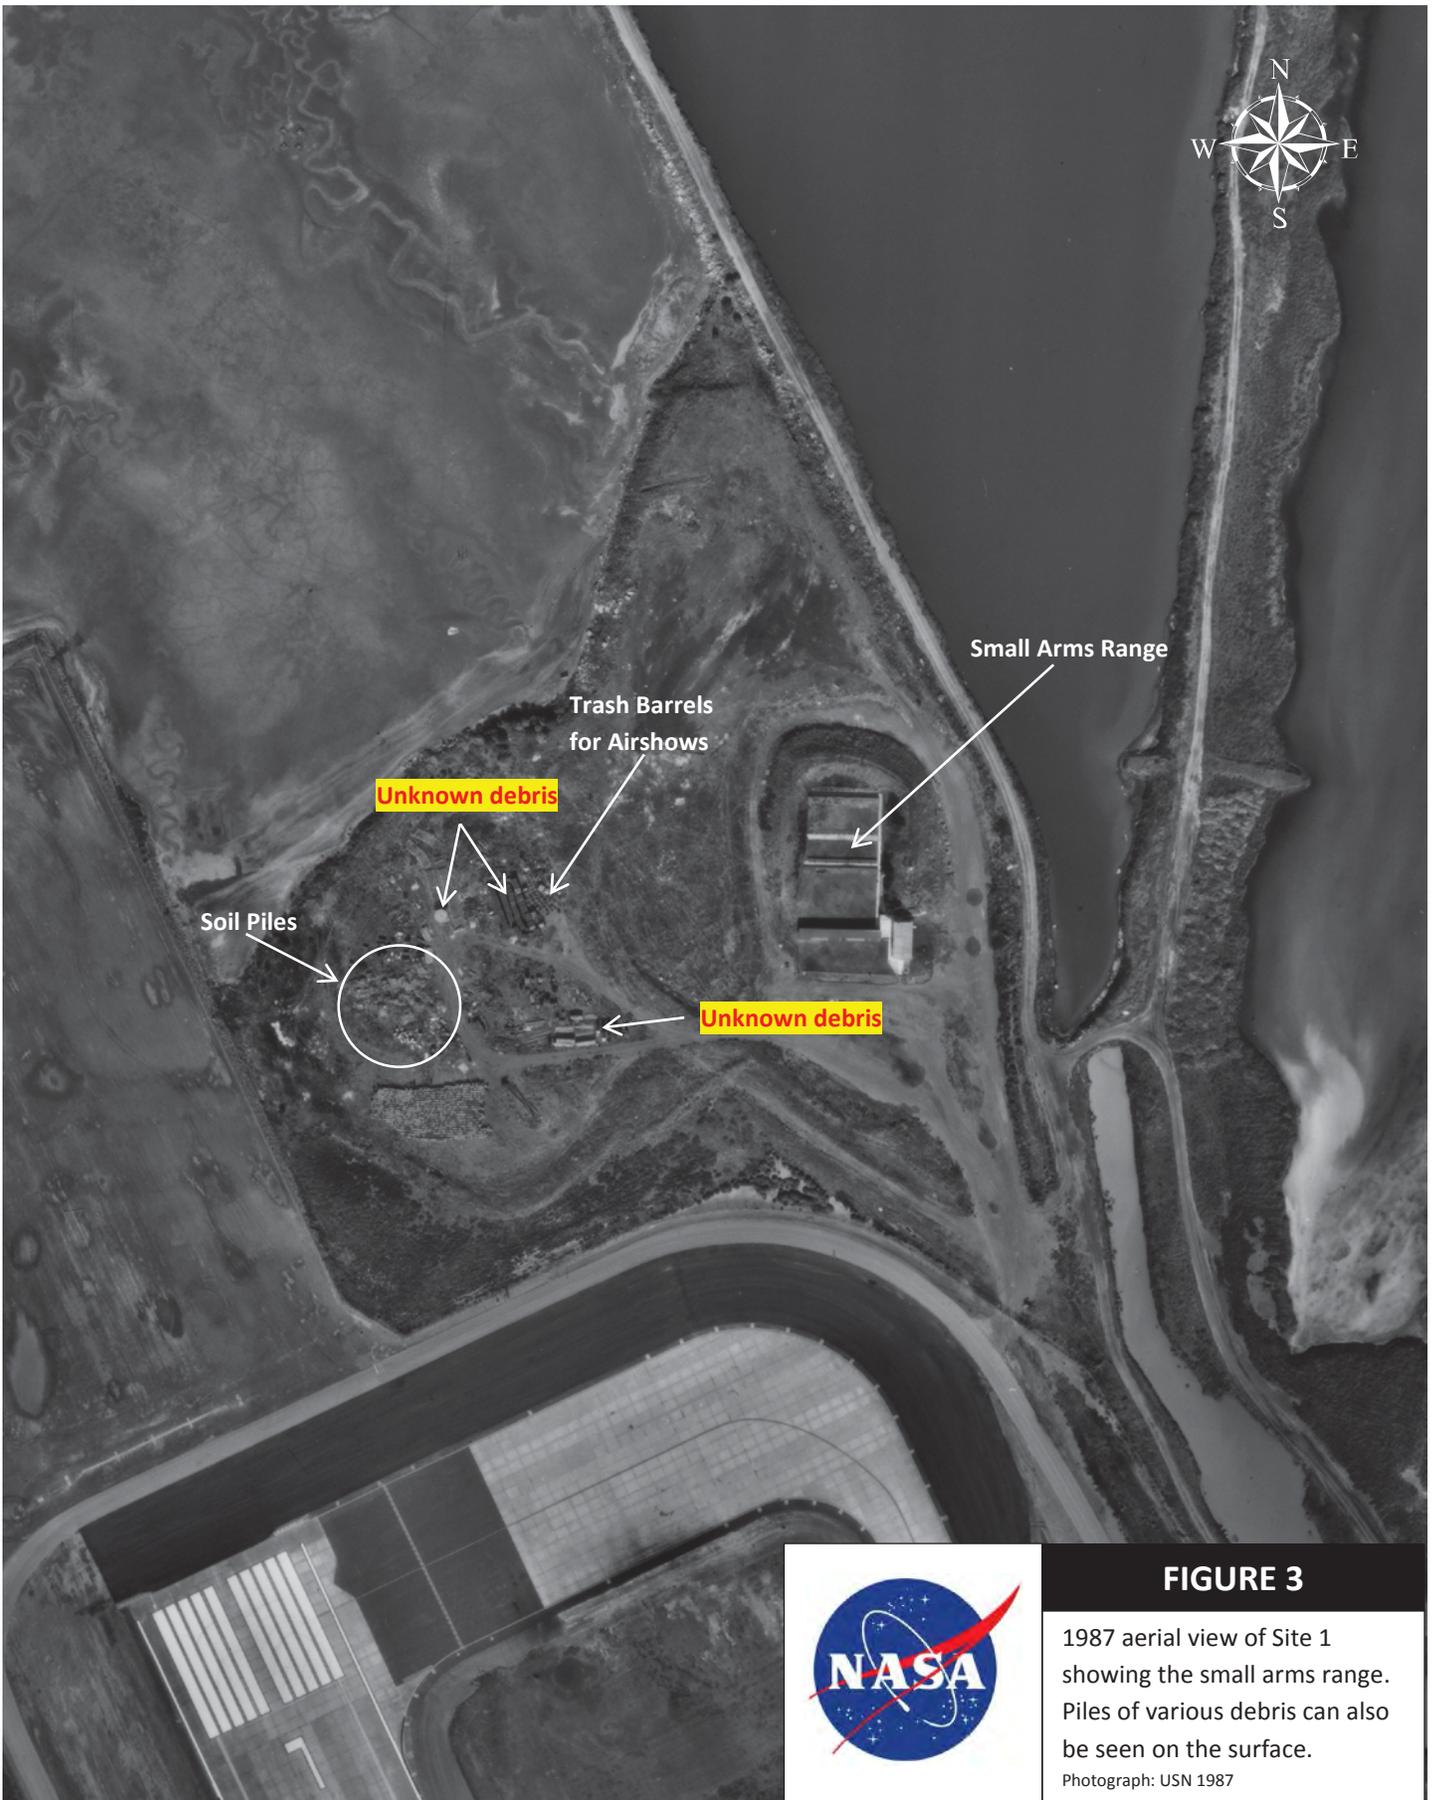
FIGURE 3
1987 aerial view of Site 1 showing the small arms range. Piles of various debris can also be seen on the surface.
Photograph: USN 1987

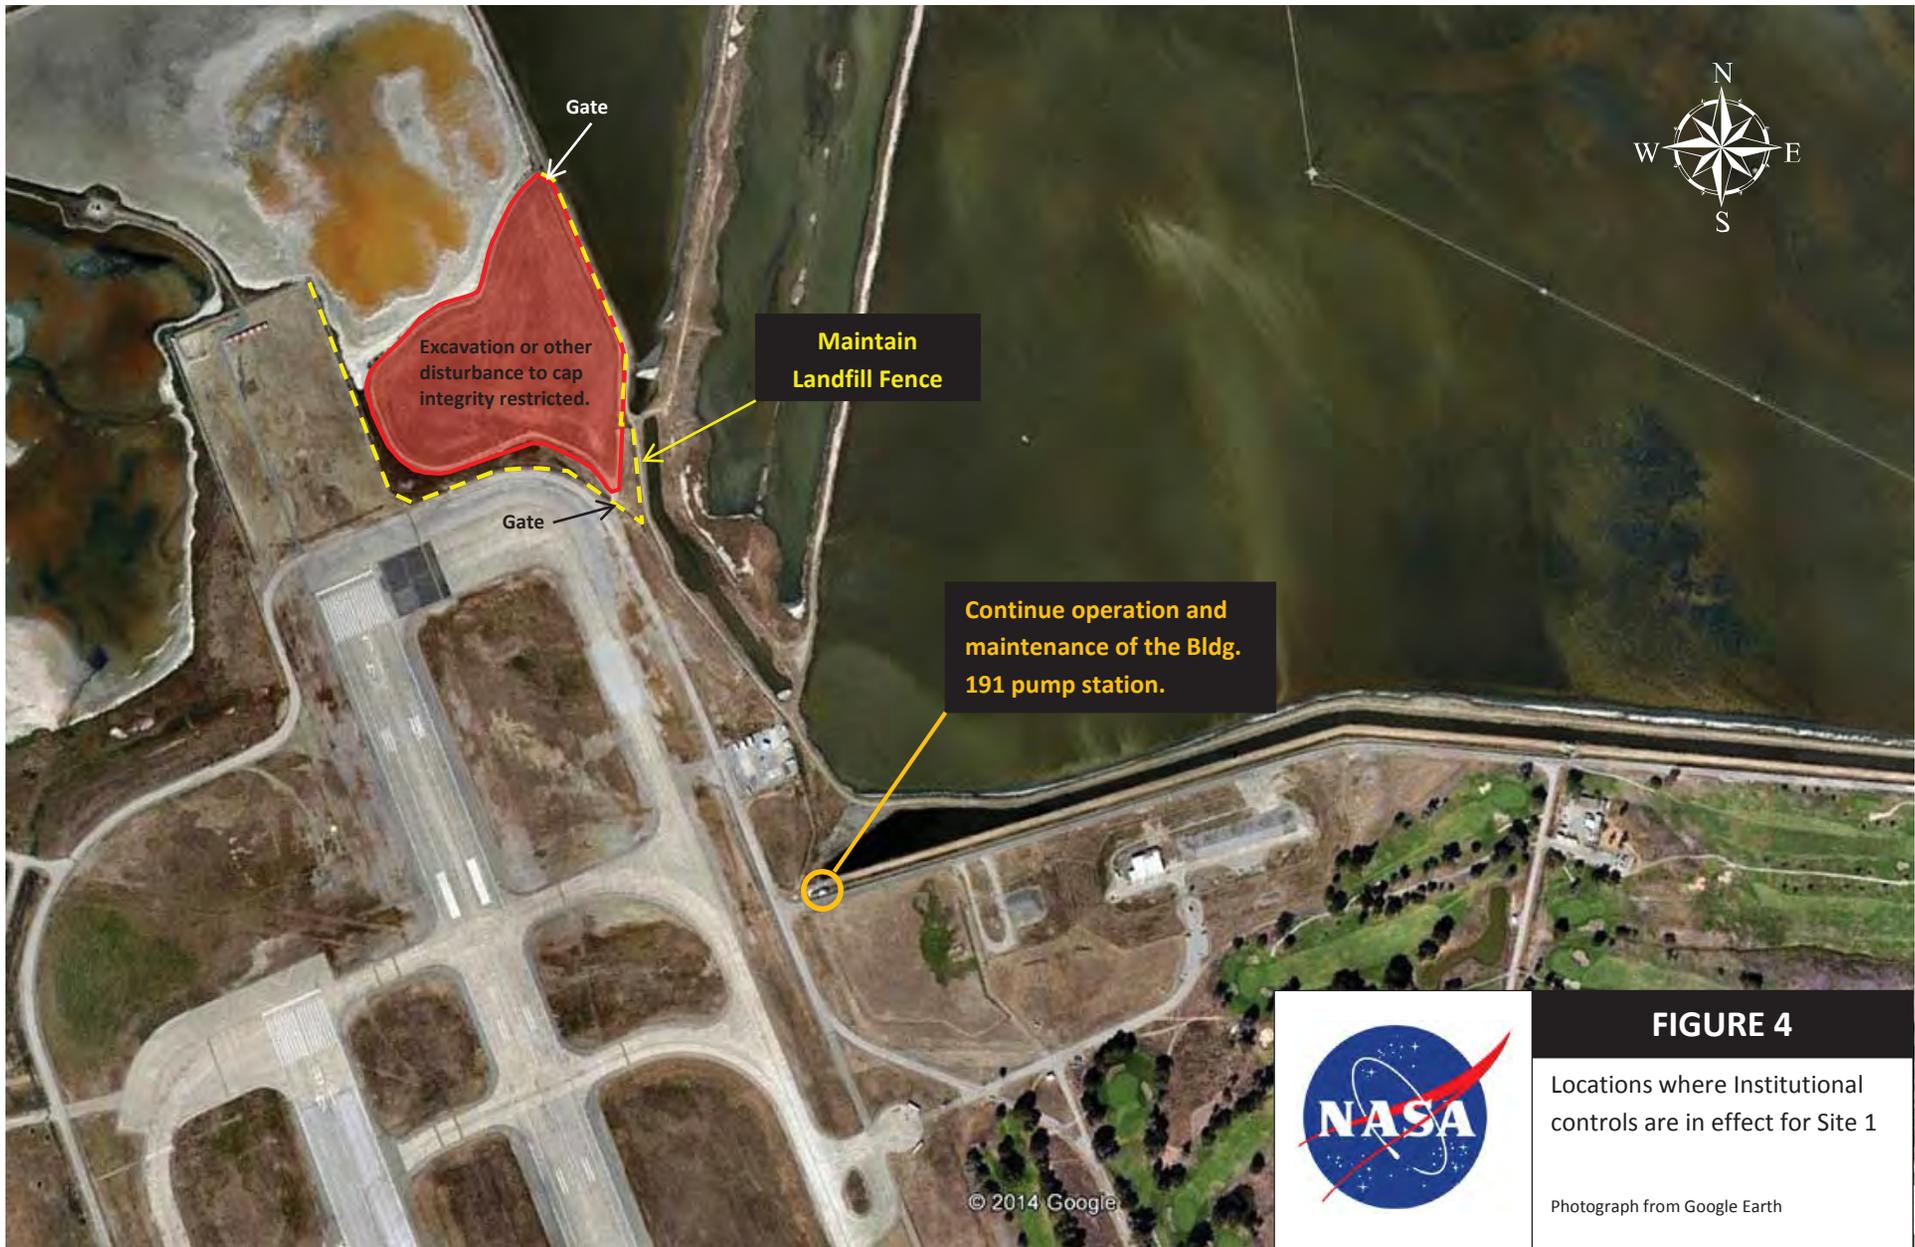
FIGURE 4

Locations where Institutional controls are in effect for Site 1

The OU1 remedy also includes institutional controls. These controls include restrictions on cap disturbances and O&M of the Building 191 pump station and drain/subdrain system. O&M of the pump station was included as a component of the remedy to prevent potential flooding of OU1. The necessity of these restrictions and actions will be noted in the land use planning documents and real property records. The Navy will resolve any issues with NASA regarding the process to develop appropriate restrictive provisions to ensure continued O&M of the Building 191 pump station and to maintain the integrity of the Site 1 cap. The Navy will enter into an agreement with NASA or develop necessary restrictive provisions within 1 year of the date of this ROD. In the event of a future conveyance of the property, the necessity of pump station O&M and use restrictions at Site 1, will be addressed by appropriate notices and land use covenants; however, subsequent landowners may propose remedy modifications to the Navy and, if appropriate, the remedy may be modified in accordance with CERCLA Section 120 and the NCP.

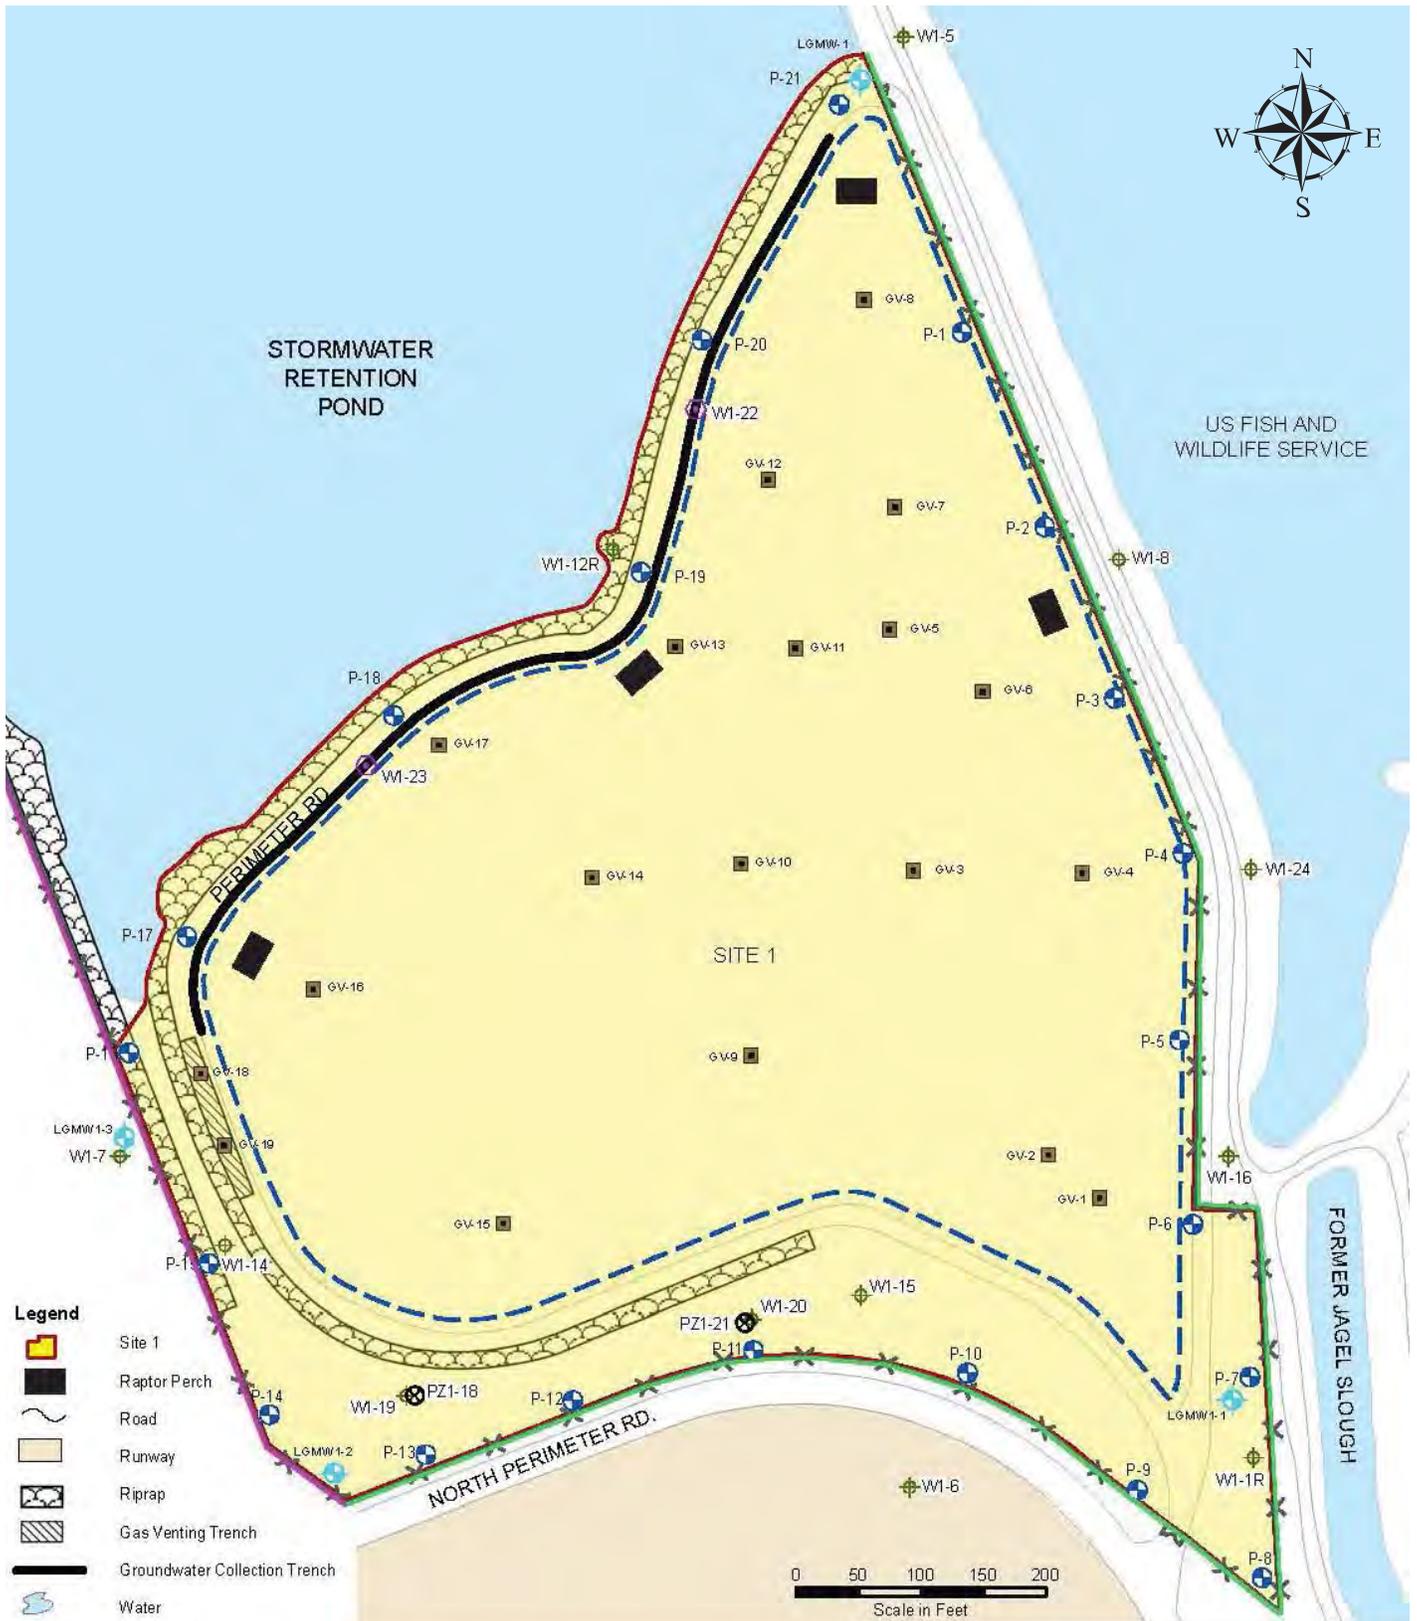
FIGURE 5
 Monitoring points for groundwater and landfill gas sampling locations.
 Map from 2010 5-year review Sites 1, 22, 26, 28

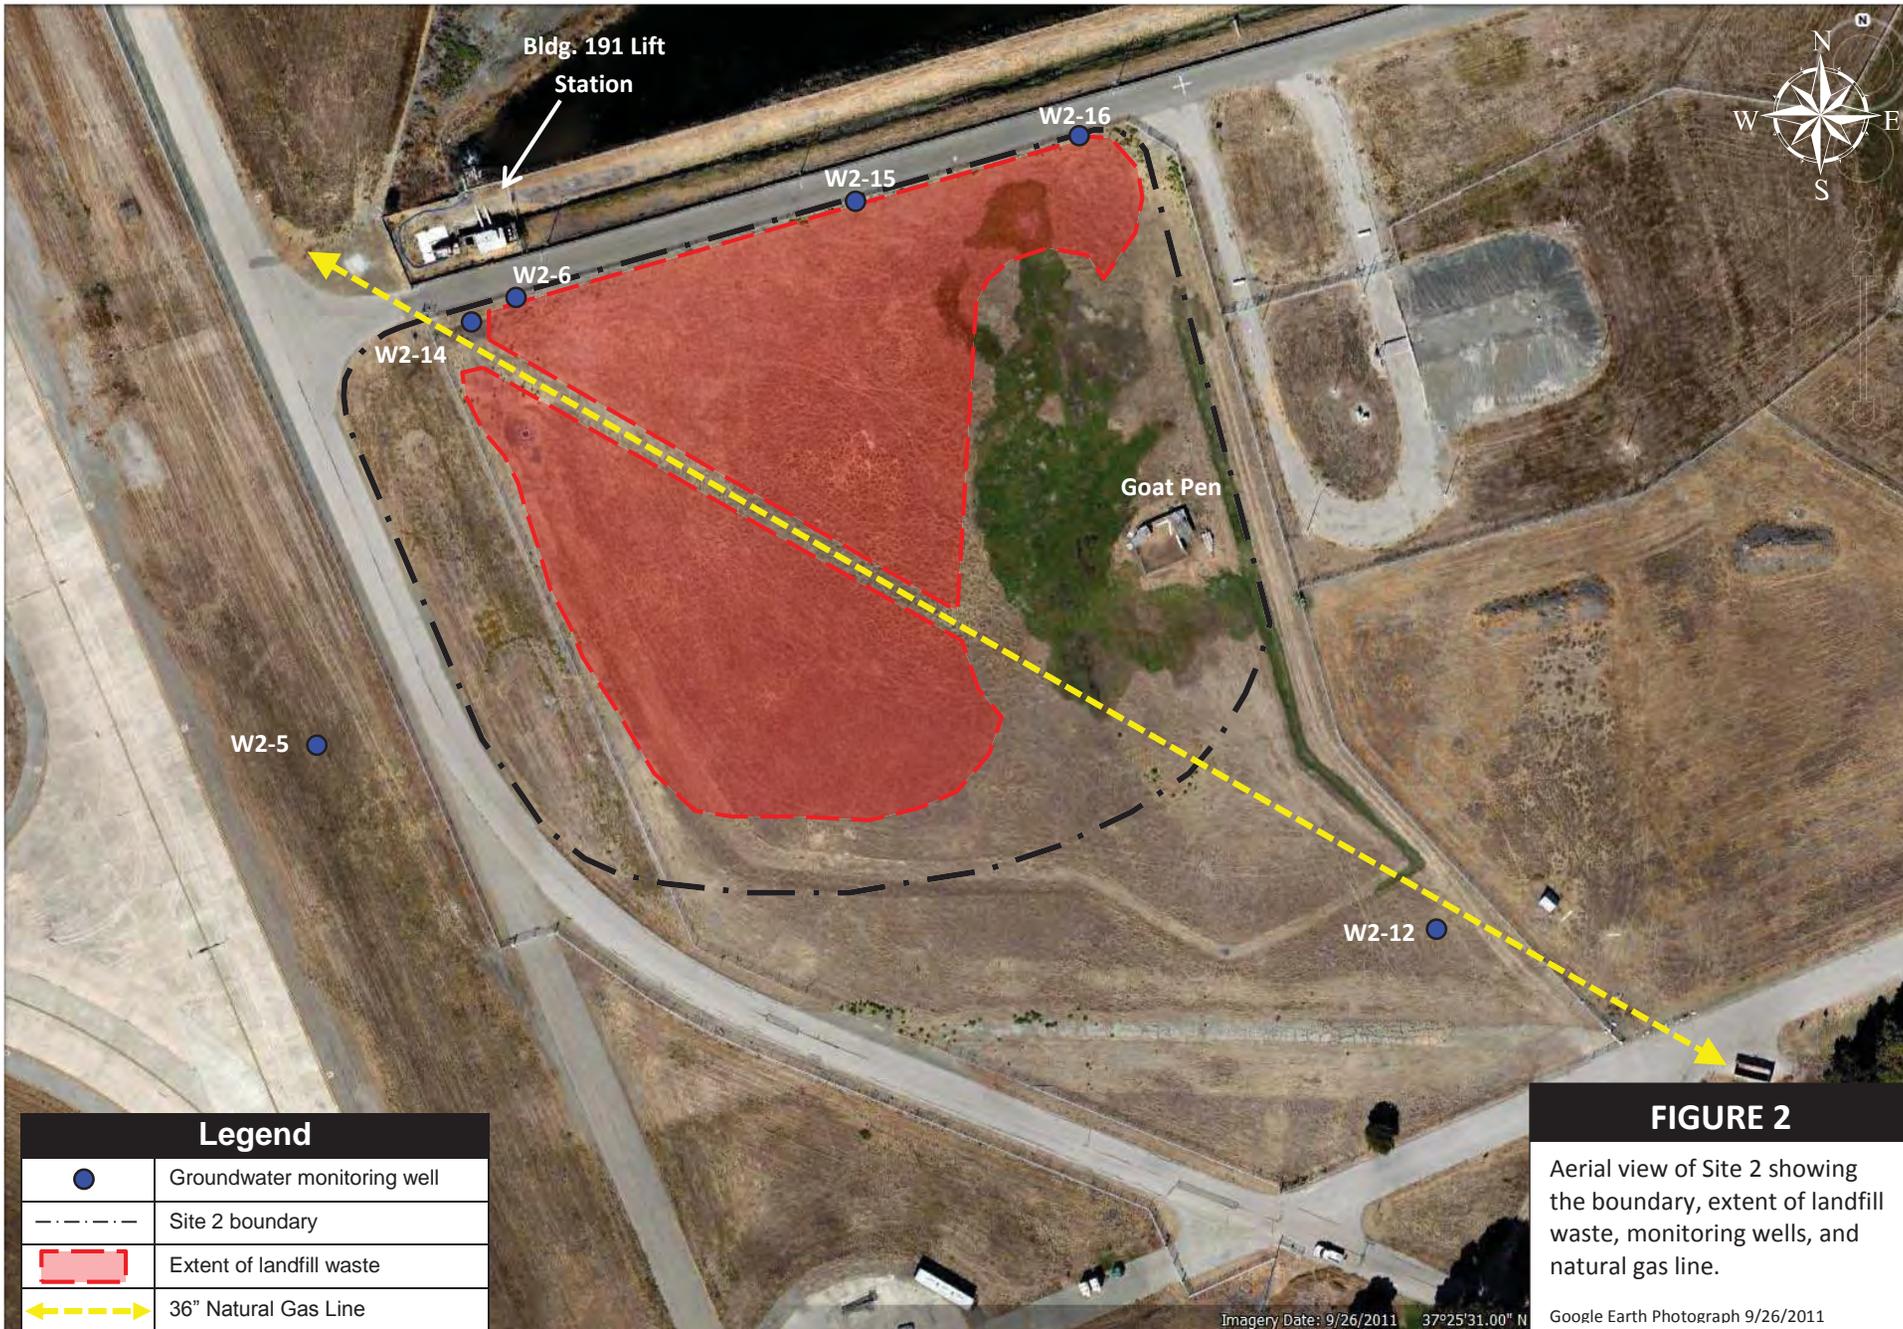
FIGURE 2
 Aerial view of Site 2 showing the boundary, extent of landfill waste, monitoring wells, and natural gas line.
 Imagery Date: 9/26/2011 37°25'31.00" N Google Earth Photograph 9/26/2011

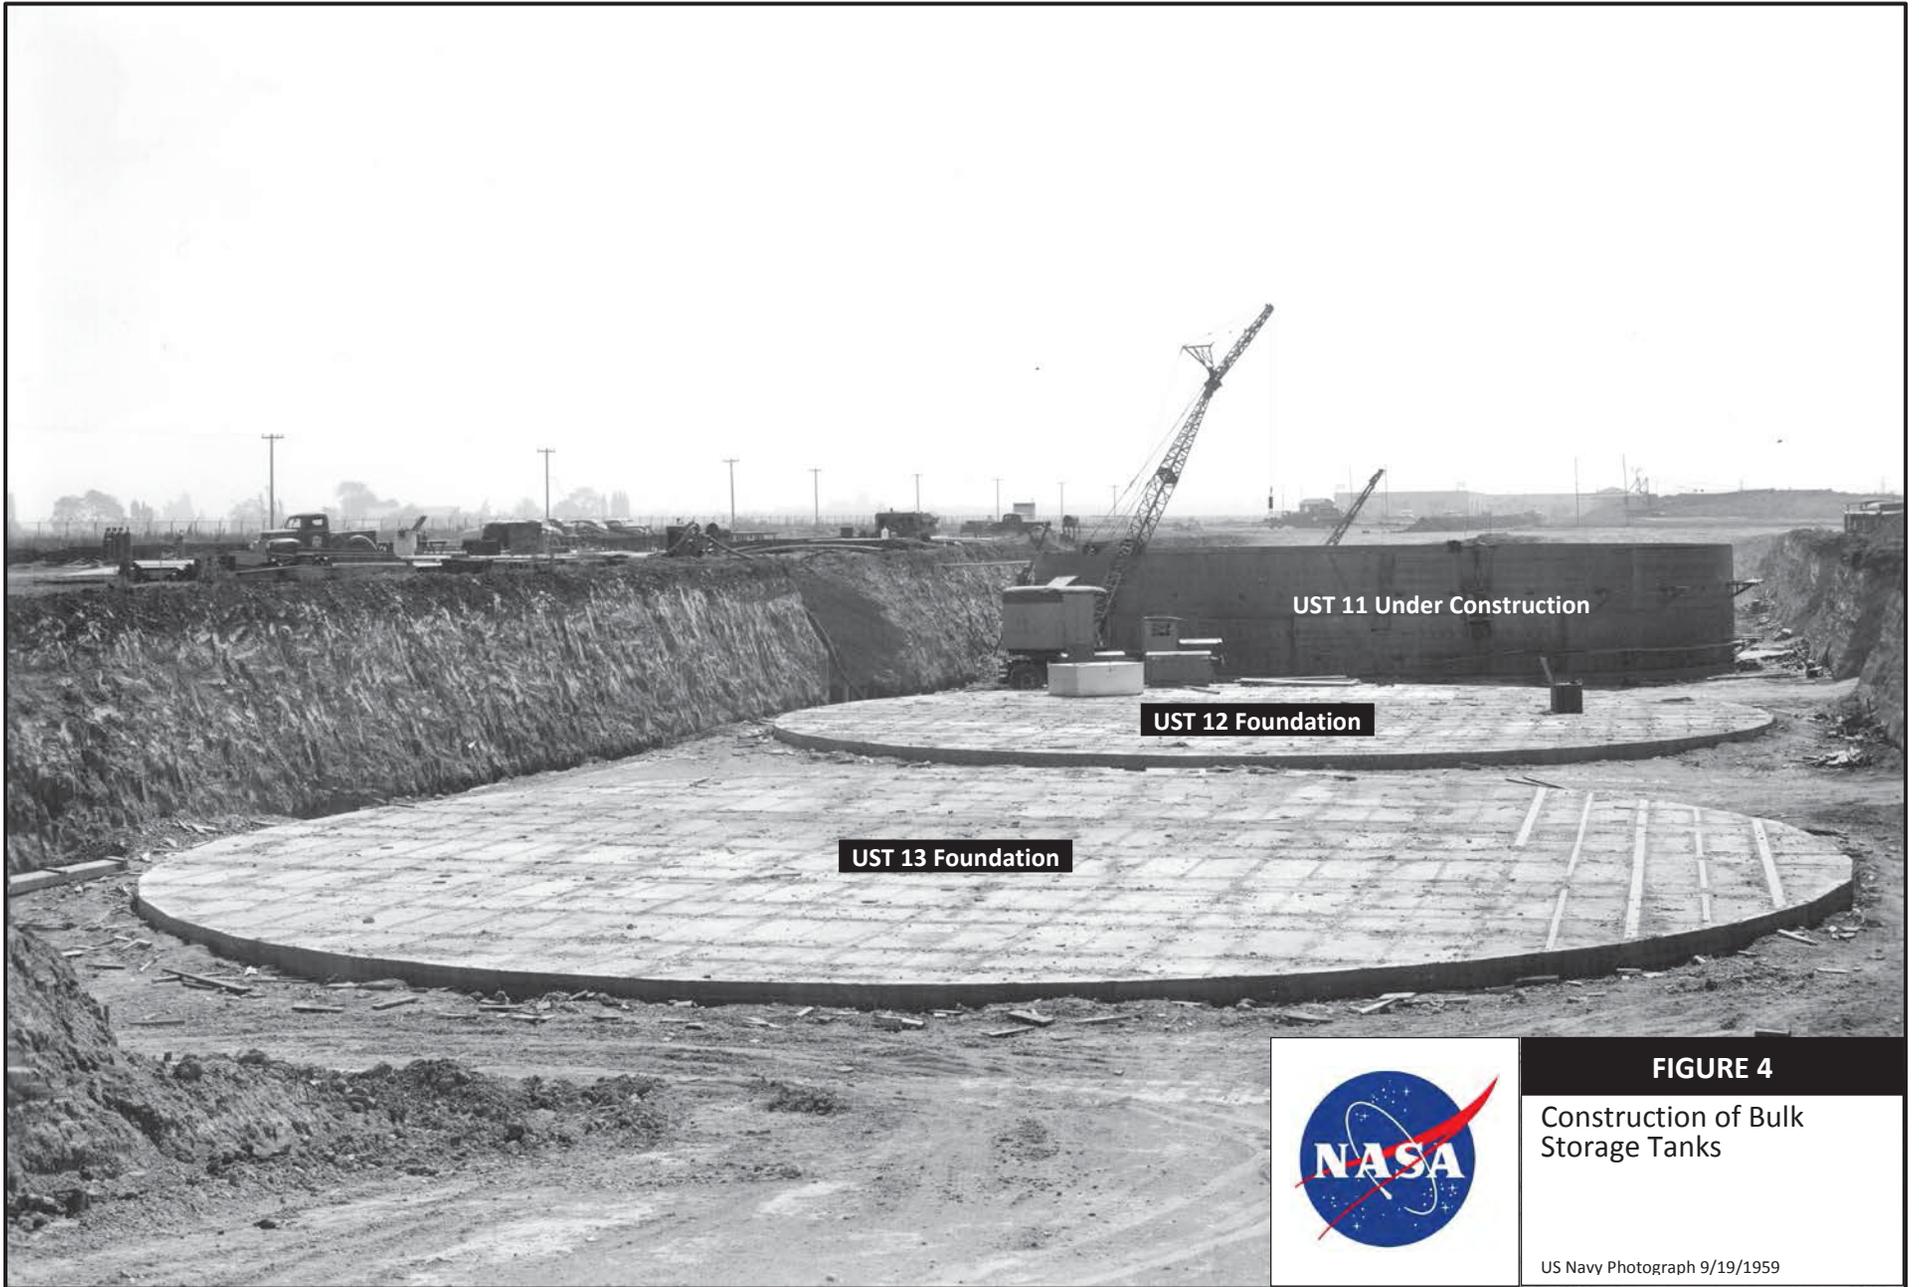
FIGURE 4
Construction of Bulk
Storage Tanks

US Navy Photograph 9/19/1959

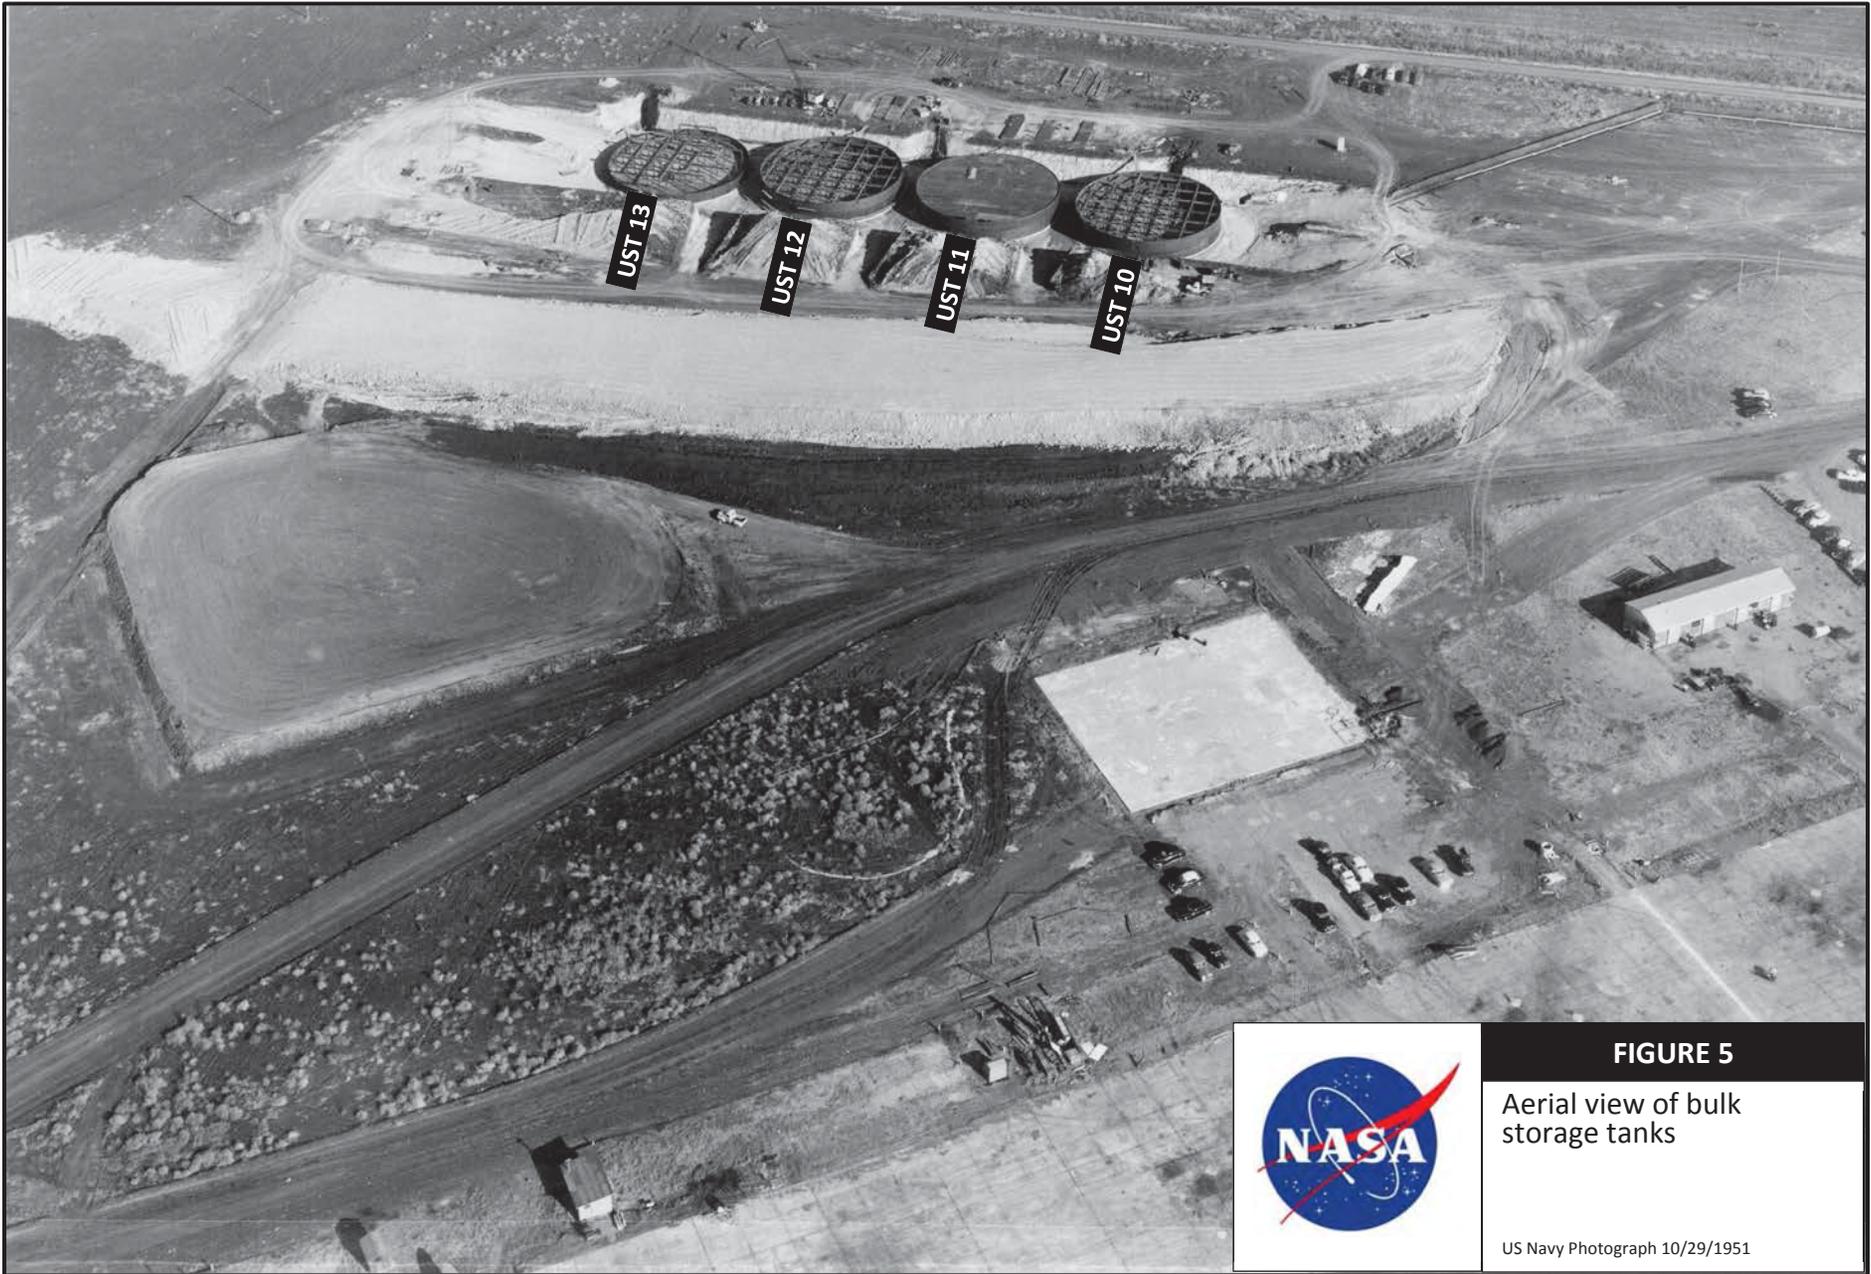
FIGURE 5
Aerial view of bulk storage tanks
US Navy Photograph 10/29/1951

The tanks are 88 feet in diameter and are 13 feet high. The tanks are made of steel sides with an interior support framework (Figure 5). A large area was excavated for the installation of the tanks. The tanks were built on concrete foundations on the bottom of the excavation. A concrete layer was constructed on the tops of the tanks. The excavation was backfilled.

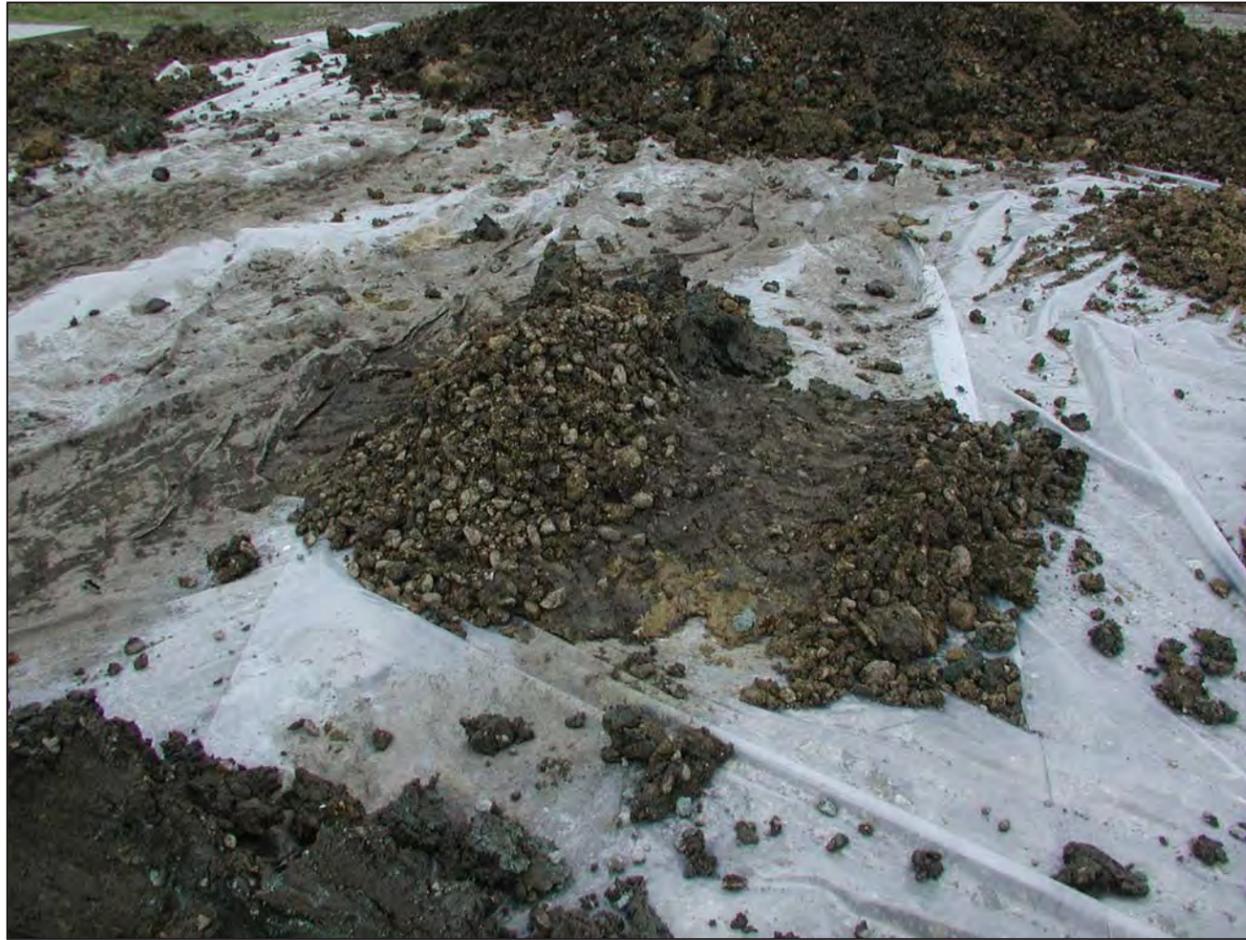
Photograph of soil and gravel removed from one of the dry wells at Site 5.

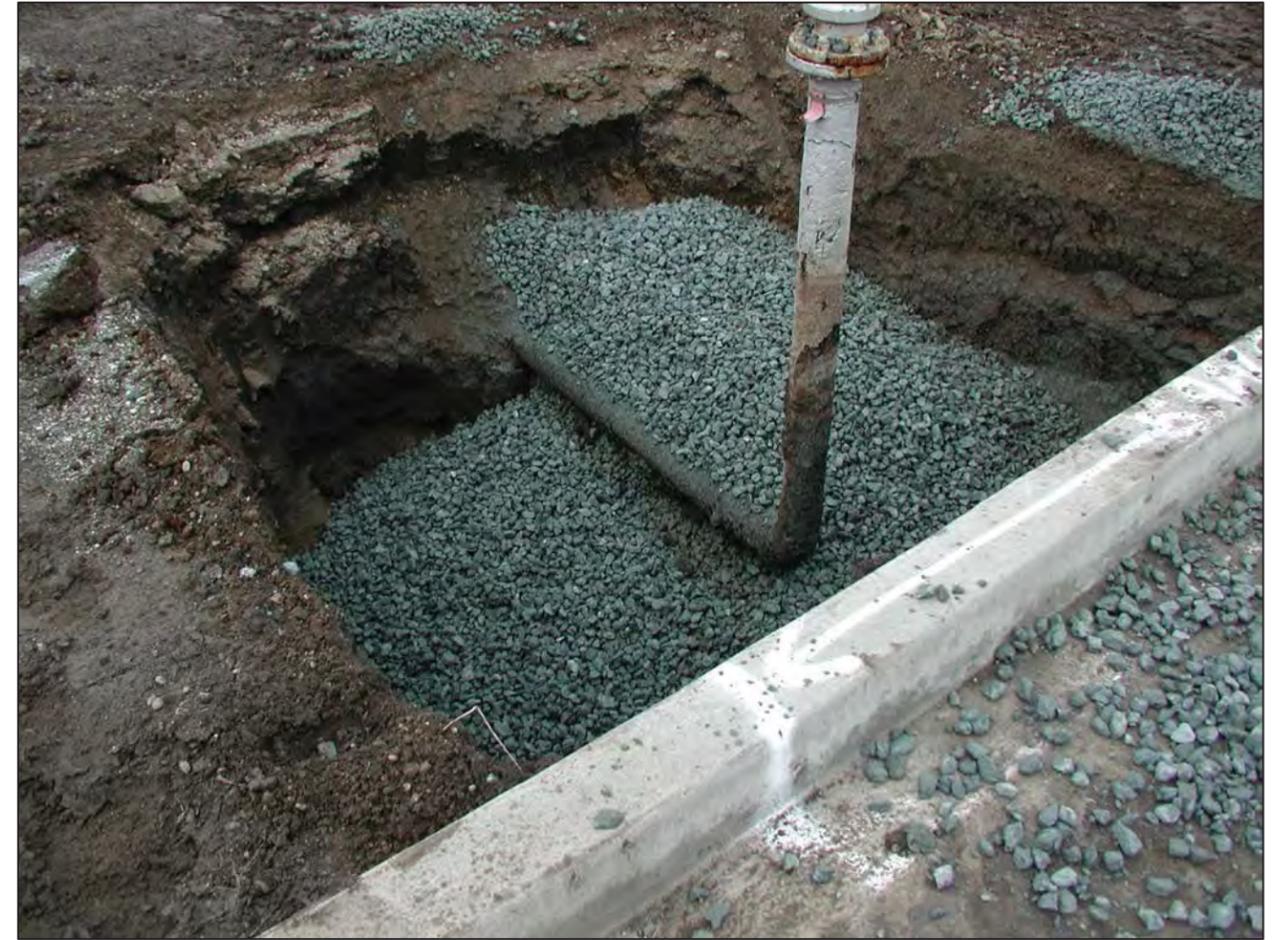
Photograph of dry well excavation with backfill material.

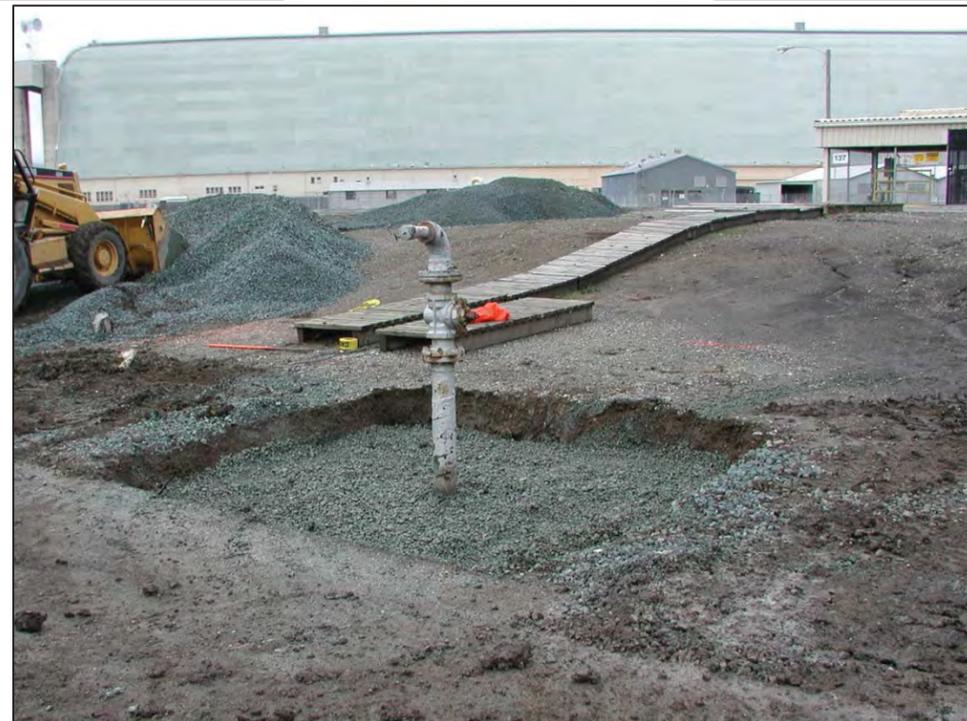
Photograph of backfilled dry well excavation. Water and fuel were discharged through the standpipe in the center of the dry well. The standpipe remained in place for each dry well location.

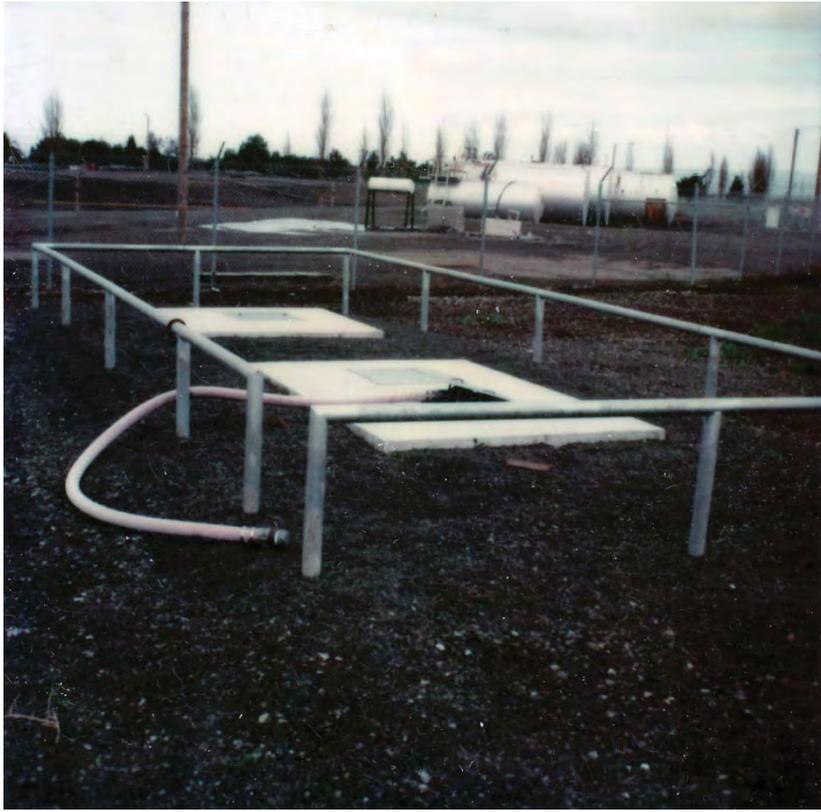
Photograph of UST 26 and waste oil transfer hose (date unknown).

Tank 26 was a 10,000-gallon fiberglass UST located within the North Fuel Farm area. Solvents, PCB oils, and other waste oils were stored in the tank. The tank would be pumped out when full and the liquids were disposed as hazardous wastes. Tank 26 was installed in 1977 and removed in June 1991. During tank removal, the tank appeared to be in good condition and no obvious holes were observed. A sheen was observed on groundwater in the excavation and discolored soil was observed on the sidewalls (Figure 7).

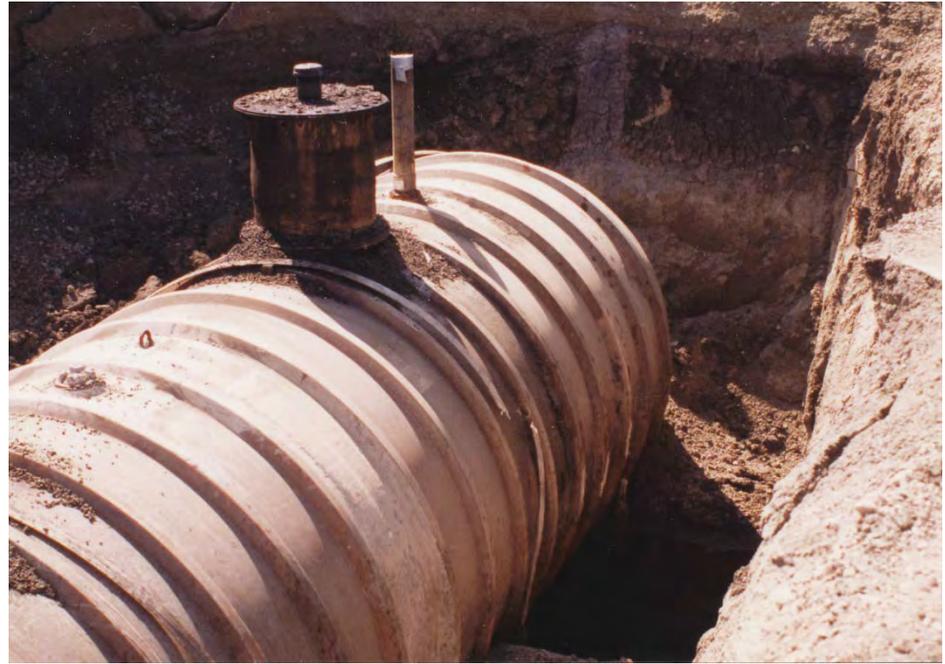
UST 26 in excavation before removal (June 1991).
