MFA Leasehold EIMP Appendix A - Part 1

APPENDIX A

NASA EEC Statements

SITE NAME:	Site 1: Runway Landfill				
Version:	Final	Date:	02/21/2015		
RESPONSIBLE PARTY					
Organization	Department of the Navy, BRAC				
Address	1455 Frazee Rd., Suite 900 San Diego, CA 92108				
Contact	Scott Anderson				
	scott.d.anderson@navy.mil				
	619-532-0938				
LOCATION					
Facility Name	Moffett Federal Airfield	Site Location			
Facility Address	Mountain View, CA	Latitude	37.430918° N		
	Santa Clara County	Longitude	122.052779° W		
Regulatory Program	Lead Agency(ies)	Site Status			
		Open	Closed	ROD	Current Phase
CERCLA	EPA/RWQCB	X		OU1 1997	O&M
SITE SUMMARY					
<p>The Site 1 landfill covers approximately 12 acres at the northern portion of the former Naval Air Station Moffett Field (NASMF) and is northeast of Runway 32R (14L). Figure 1 depicts the location of Site 1 with respect to the former NASMF. Figure 2 is an aerial view of Site 1. The landfill is surrounded on three sides by fencing while the northern portion is bordered by the Storm Water Retention Pond (SWRP). The western portion of the landfill is flat with an elevation of 7 feet above mean sea level while the eastern portion is moun

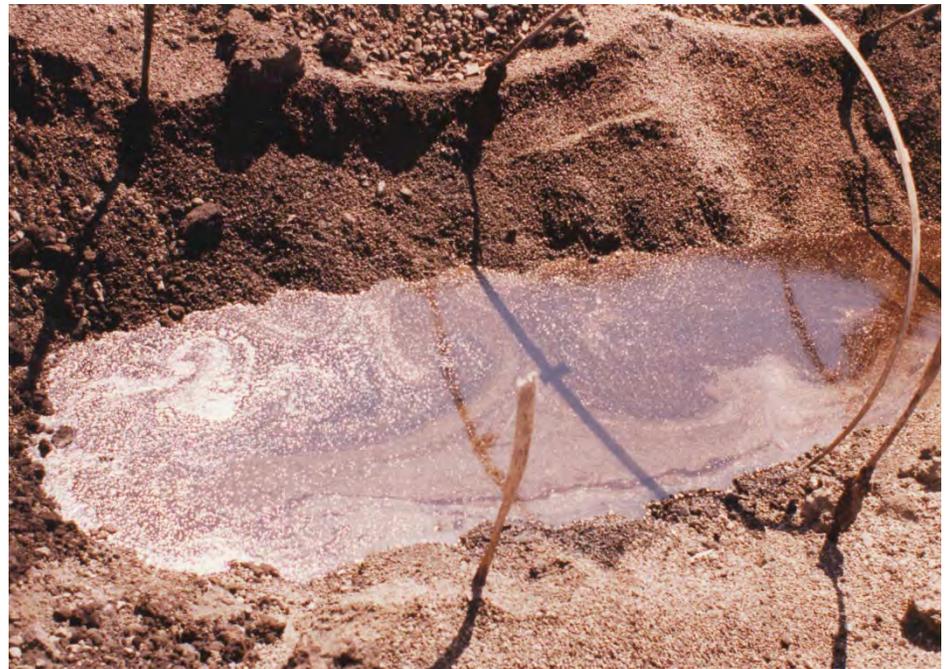
Groundwater in UST excavation with floating product (June 1991).

Tank 26 was a 10,000-gallon fiberglass UST located within the North Fuel Farm area. Solvents, PCB oils, and other waste oils were stored in the tank. The tank would be pumped out when full and the liquids were disposed as hazardous wastes. Tank 26 was installed in 1977 and removed in June 1991. During tank removal, the tank appeared to be in good condition and no obvious holes were observed. A sheen was observed on groundwater in the excavation and discolored soil was observed on the sidewalls (Figure 7).

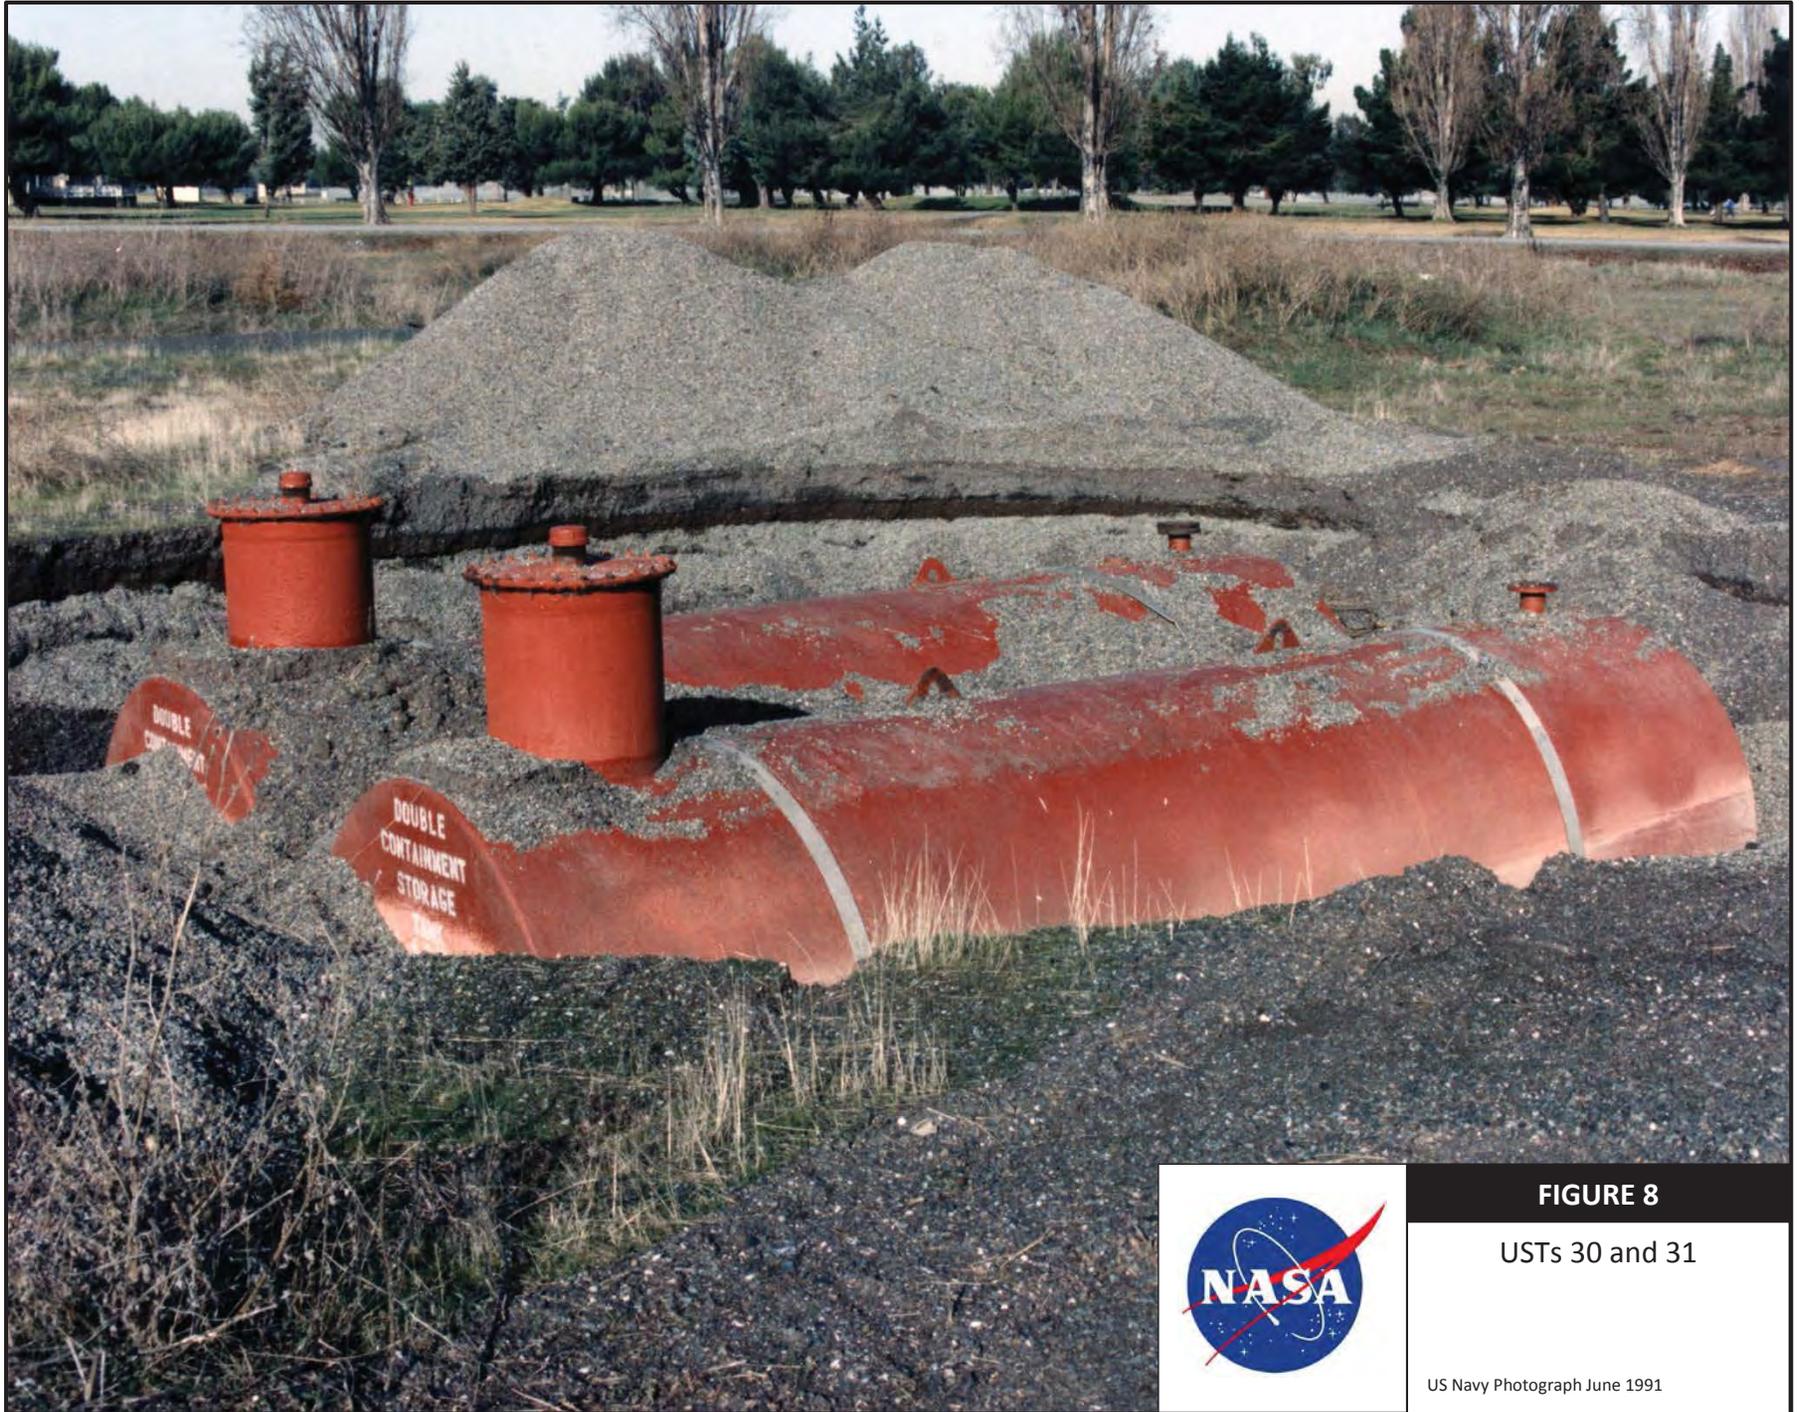
FIGURE 8
USTs 30 and 31
US Navy Photograph June 1991

Tanks 30 and 31 were located slightly north of the North Fuel Farm Area (Figure 3). The tanks were installed in 1984. The tanks were to be a replacement for UST 26 to store liquid hazardous wastes. These 4,000-gallon steel tanks (Figure 8) were never put into operation and were removed in December 1992. In a letter dated 11/6/2000, RWQCB concurred with the Navy that no further action was required.

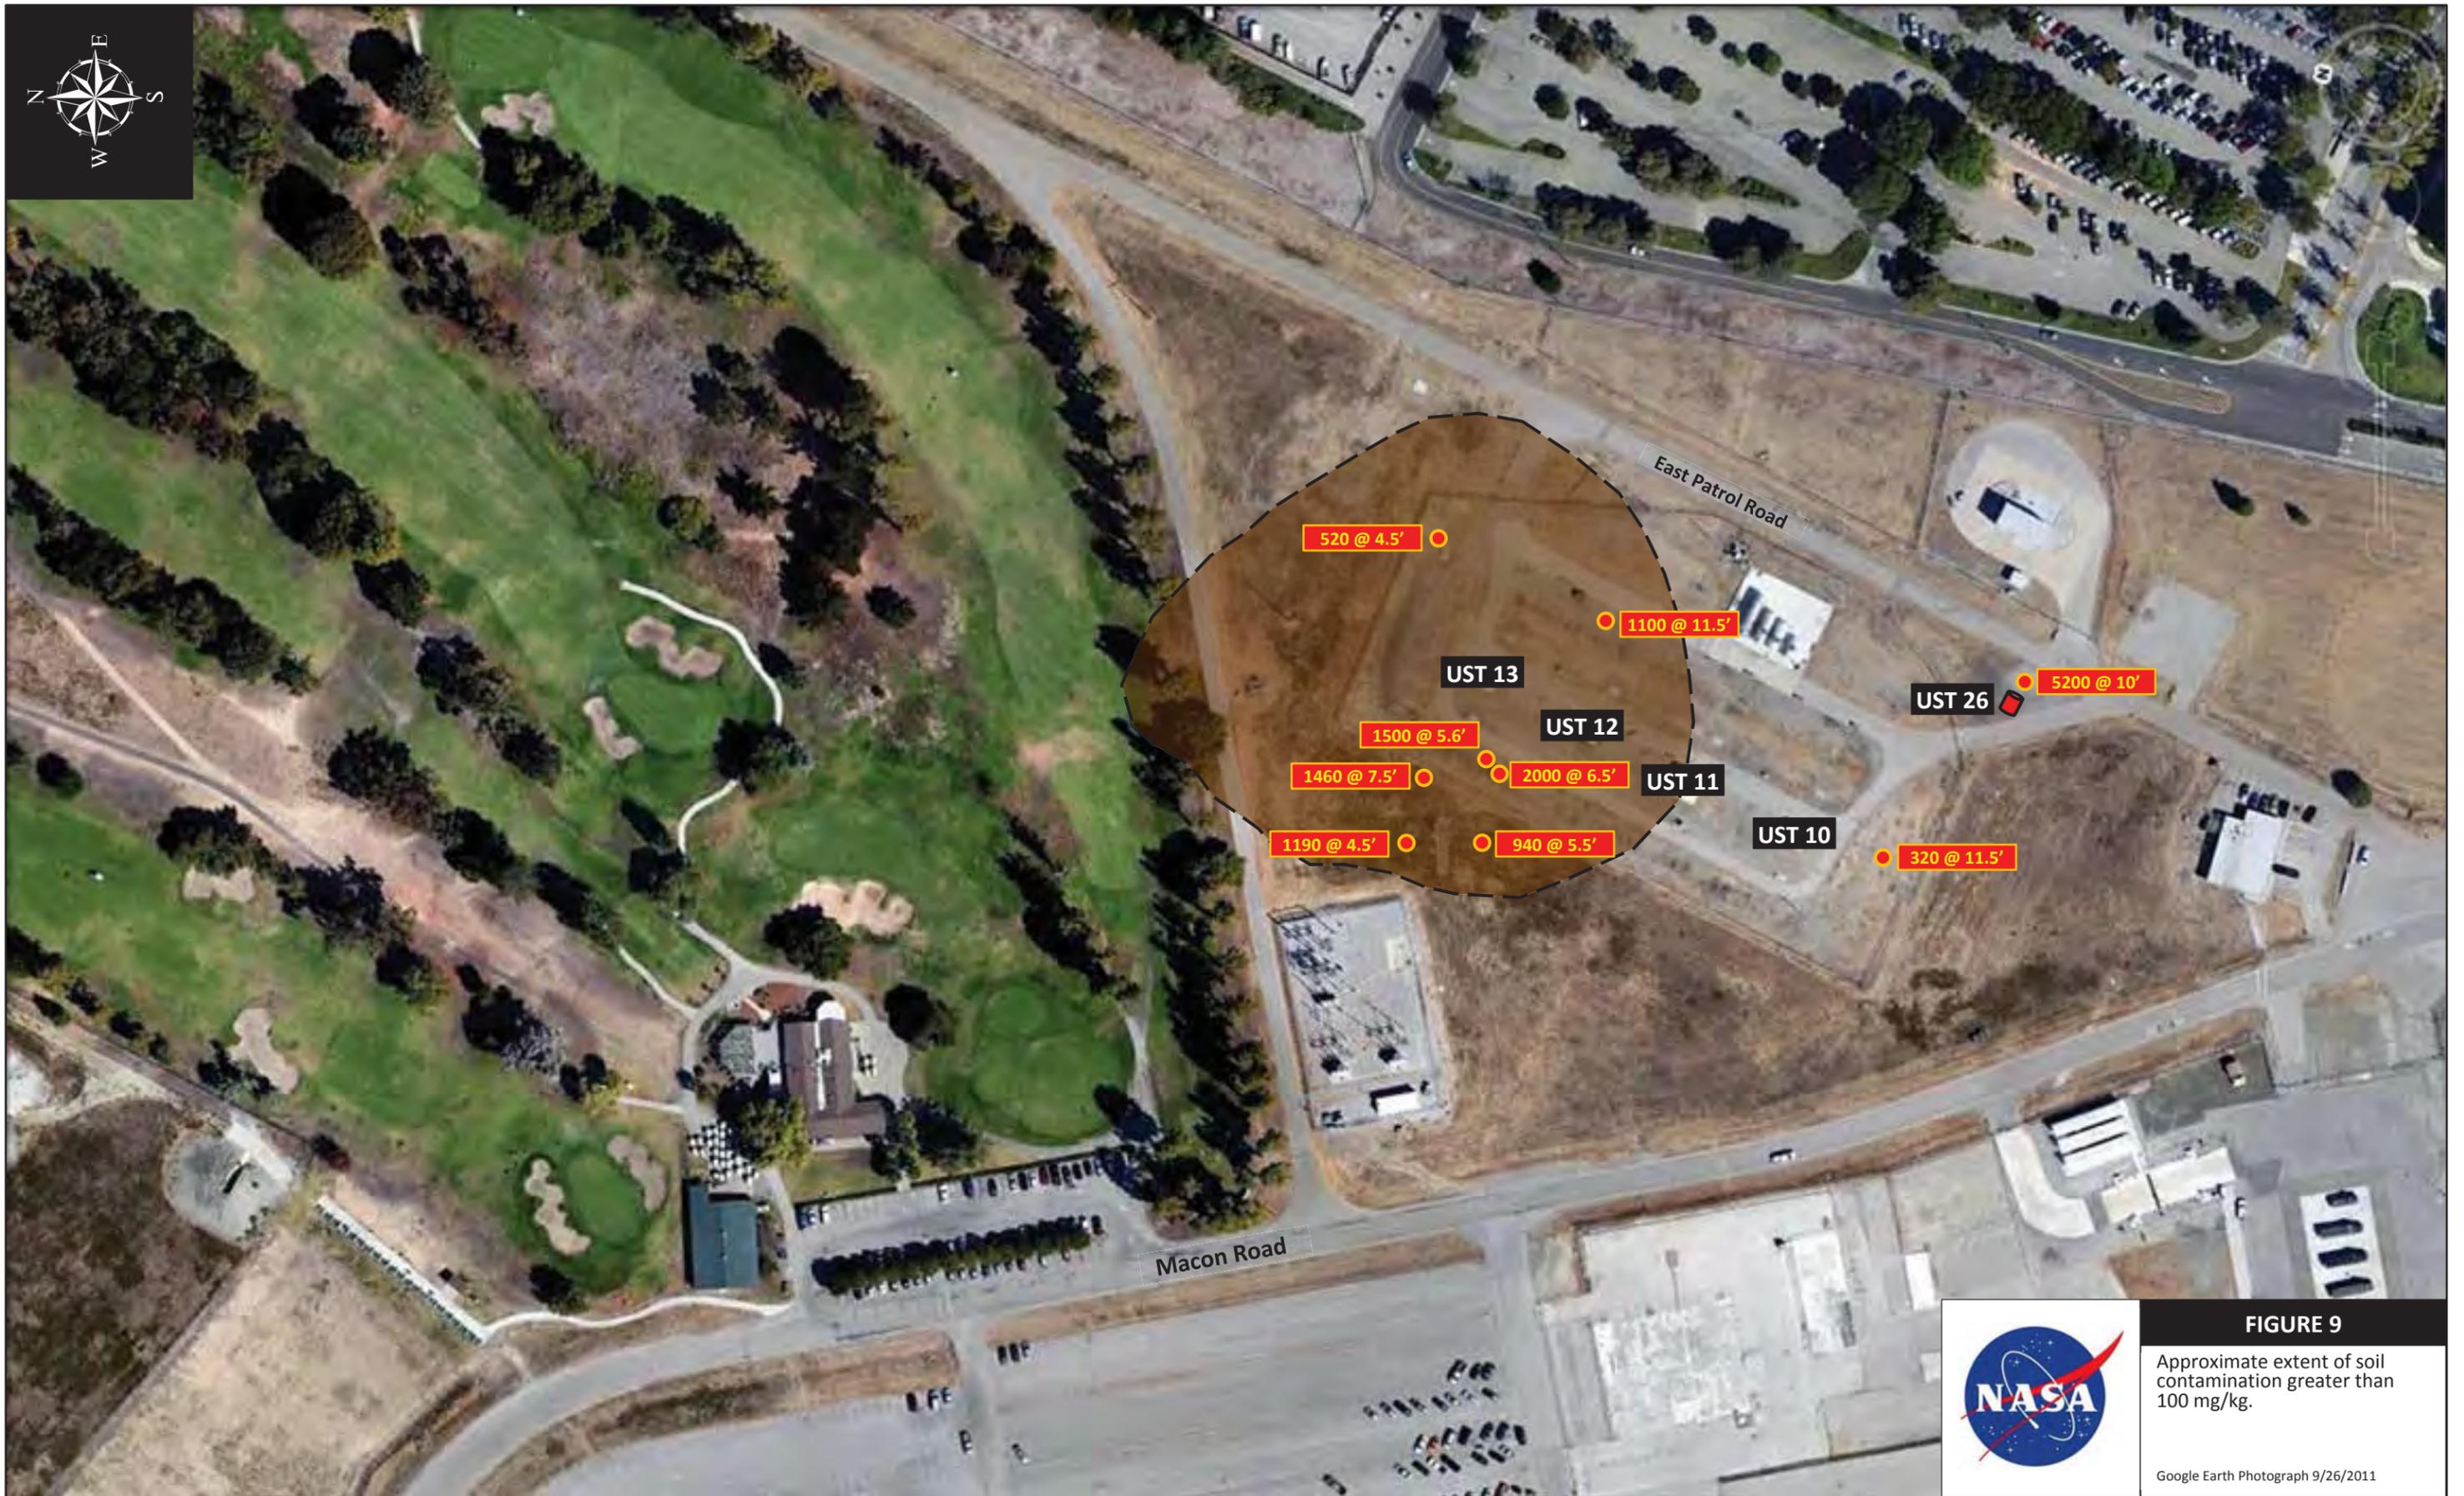
FIGURE 9
Approximate extent of soil contamination greater than 100 mg/kg.
Google Earth Photograph 9/26/2011

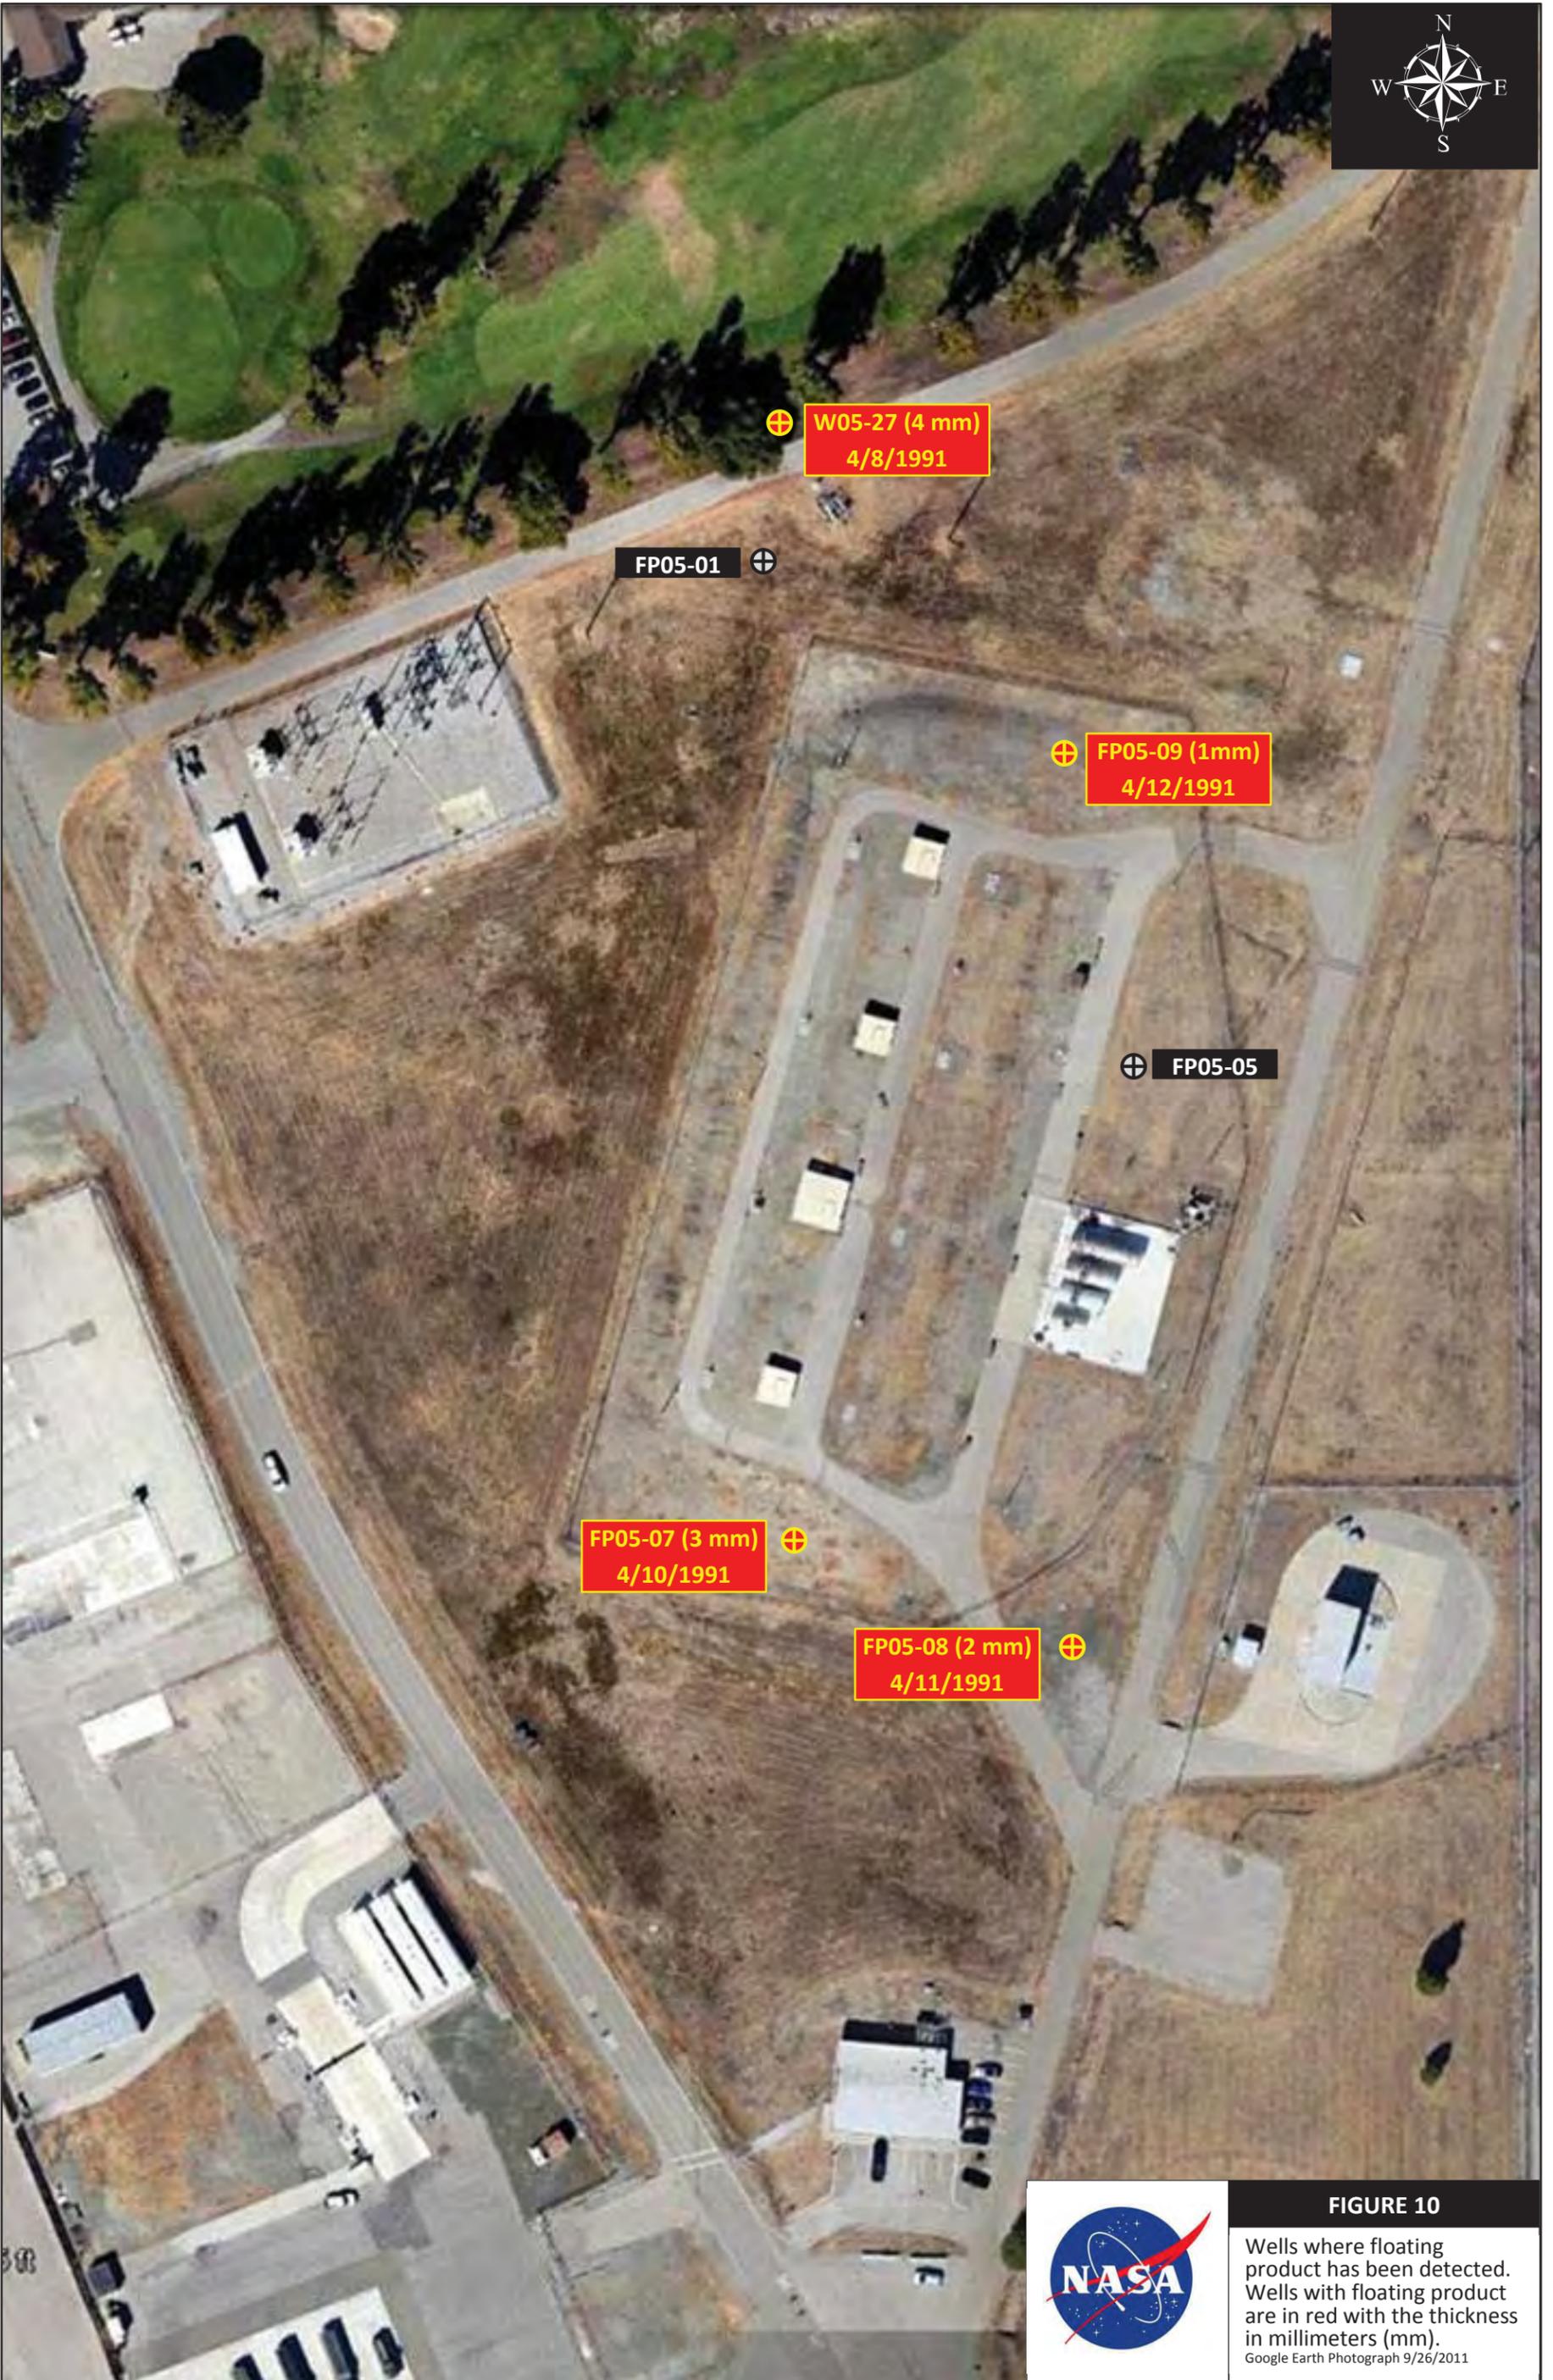
FIGURE 10

Wells where floating product has been detected. Wells with floating product are in red with the thickness in millimeters (mm).
Google Earth Photograph 9/26/2011

Free product was recovered from wells near the bulk storage tanks of the NFF. Several free product wells were installed in 1991 in the NFF. Free phase hydrocarbons were observed in three of the wells during installation: FP05-07 (3 mm), FP05-08 (2 mm), and FP05-09 (1 mm) (Figure 10). Free phase was not seen in later sampling events. Free phase hydrocarbons were observed in W05-27(A1) (4 mm) (installed in 1991) after a 24-hour pump test. FP05-01, had a concentration for TPH as kerosene of 2,000,000 µg/L in the December 1993 sampling event.

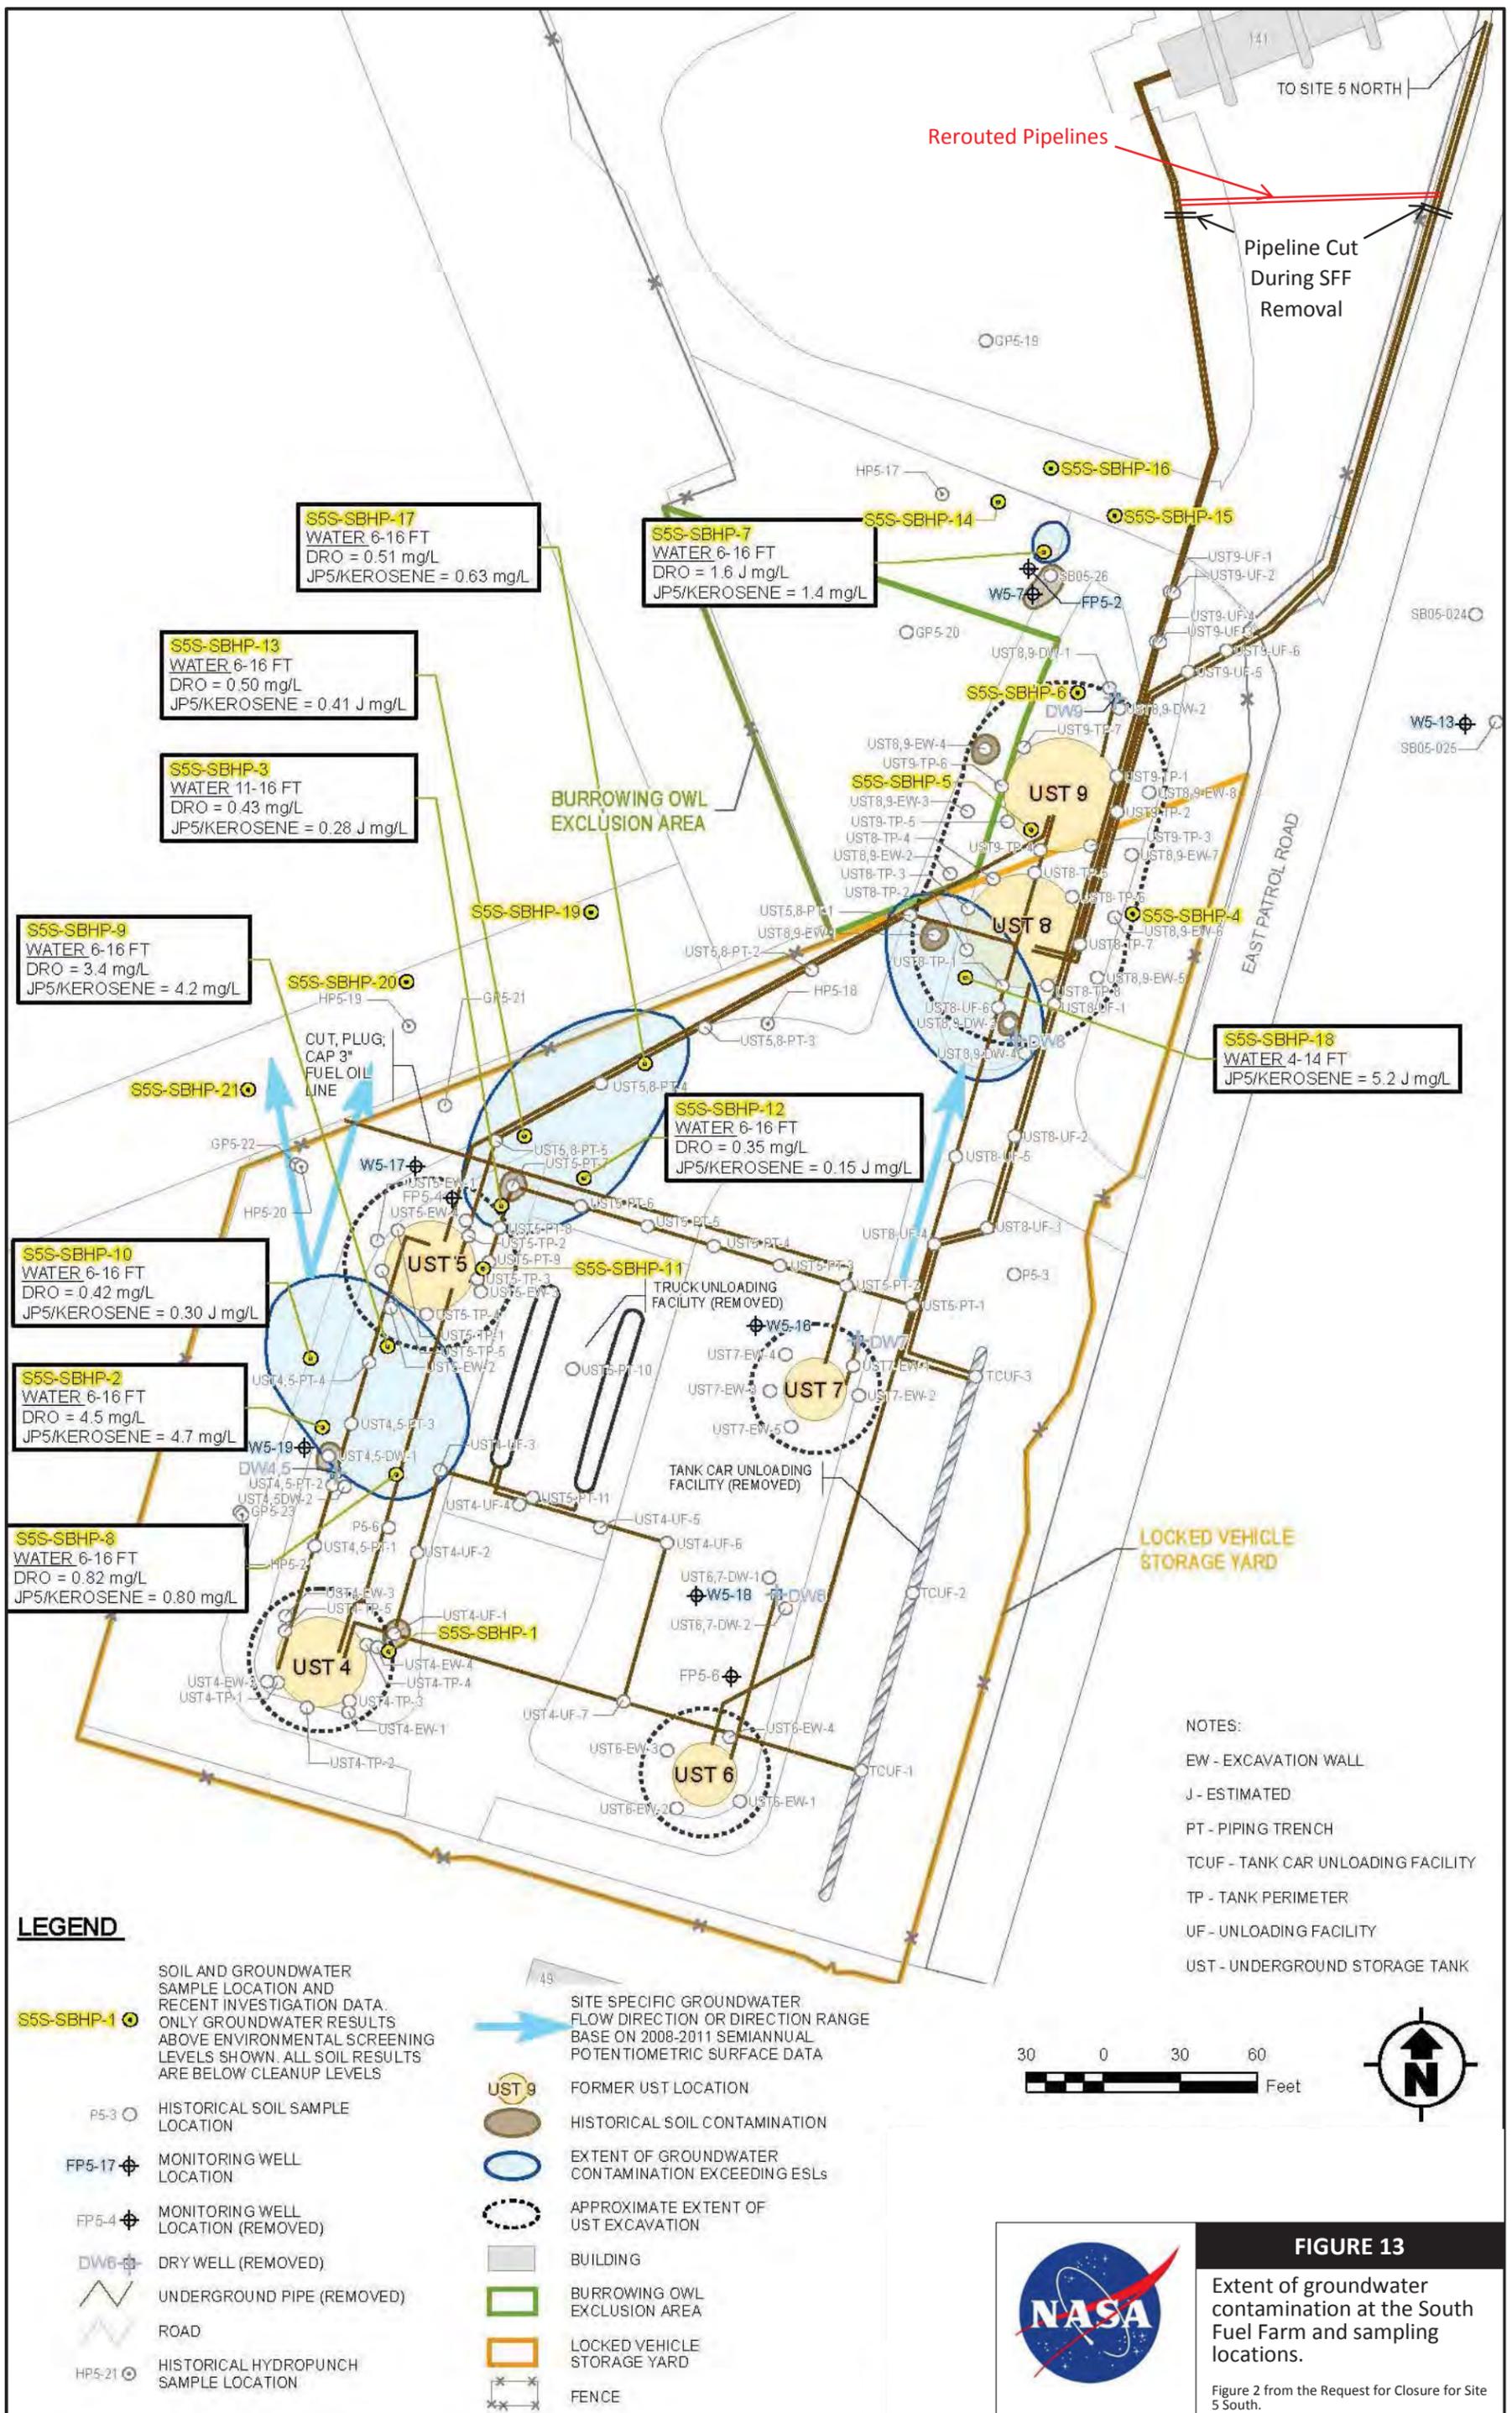
FIGURE 13
 Extent of groundwater contamination at the South Fuel Farm and sampling locations.

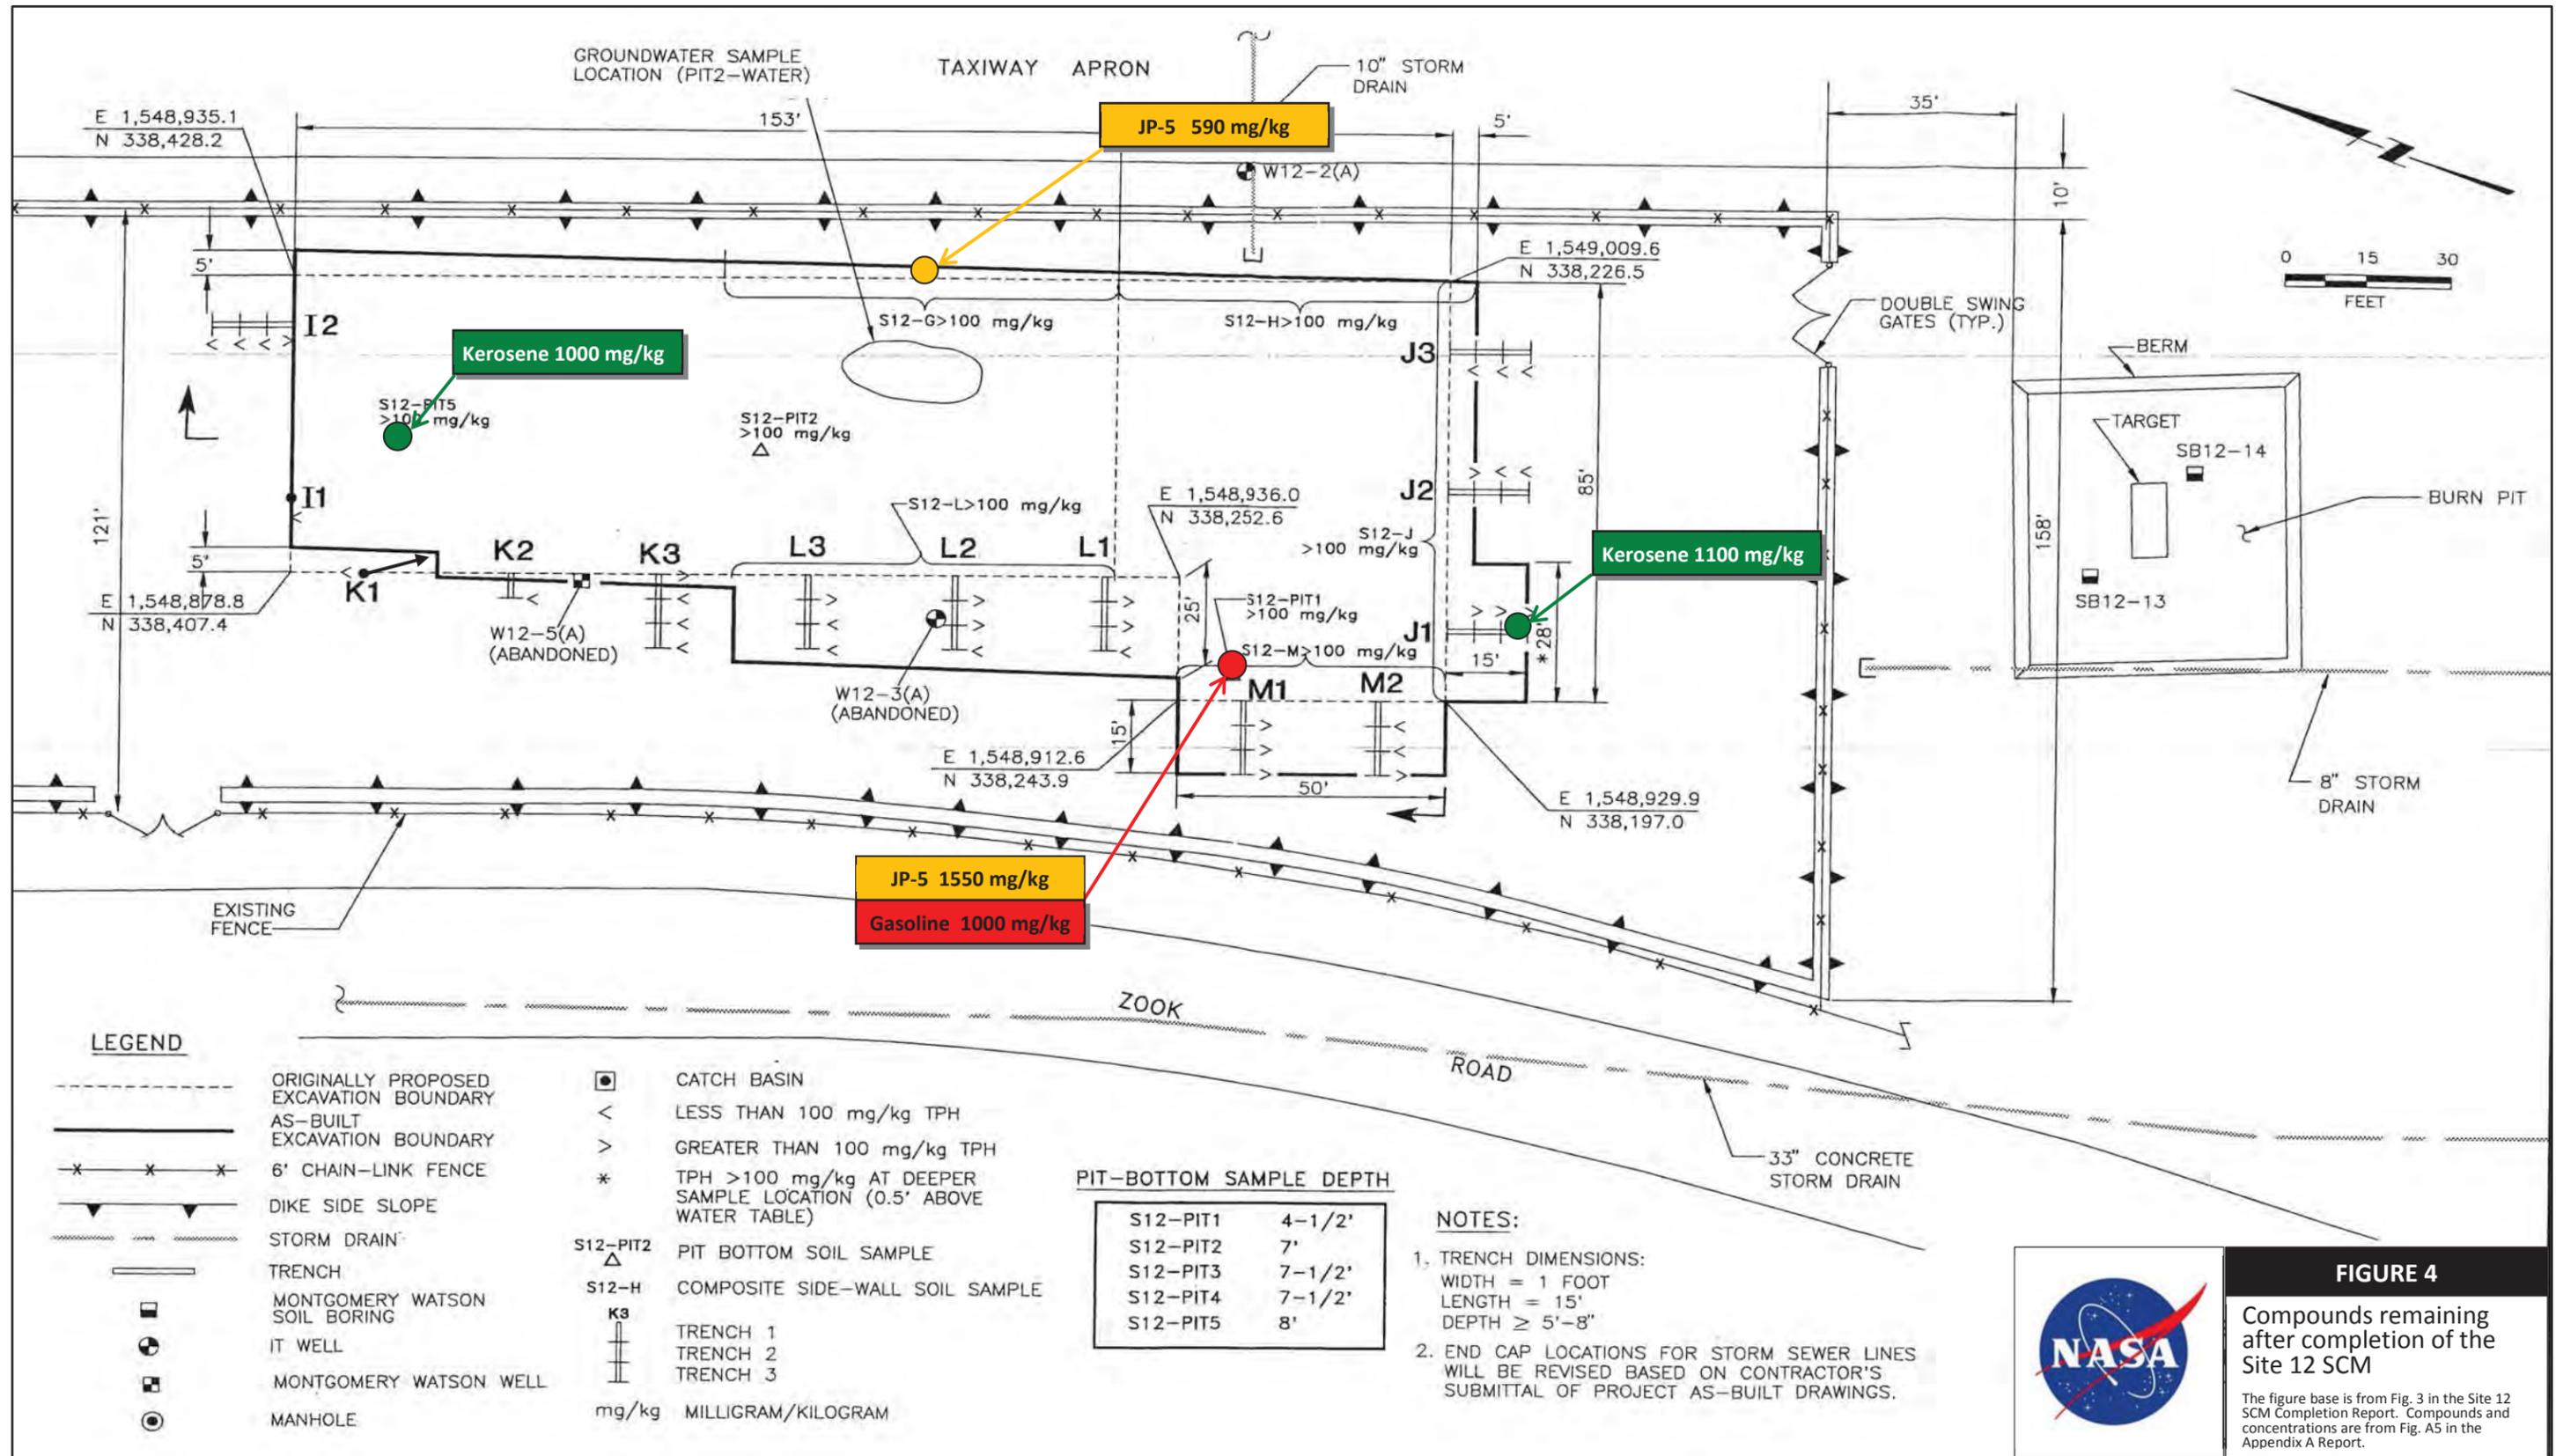
FIGURE 4
Compounds remaining after completion of the Site 12 SCM
 The figure base is from Fig. 3 in the Site 12 SCM Completion Report. Compounds and concentrations are from Fig. A5 in the Appendix A Report.

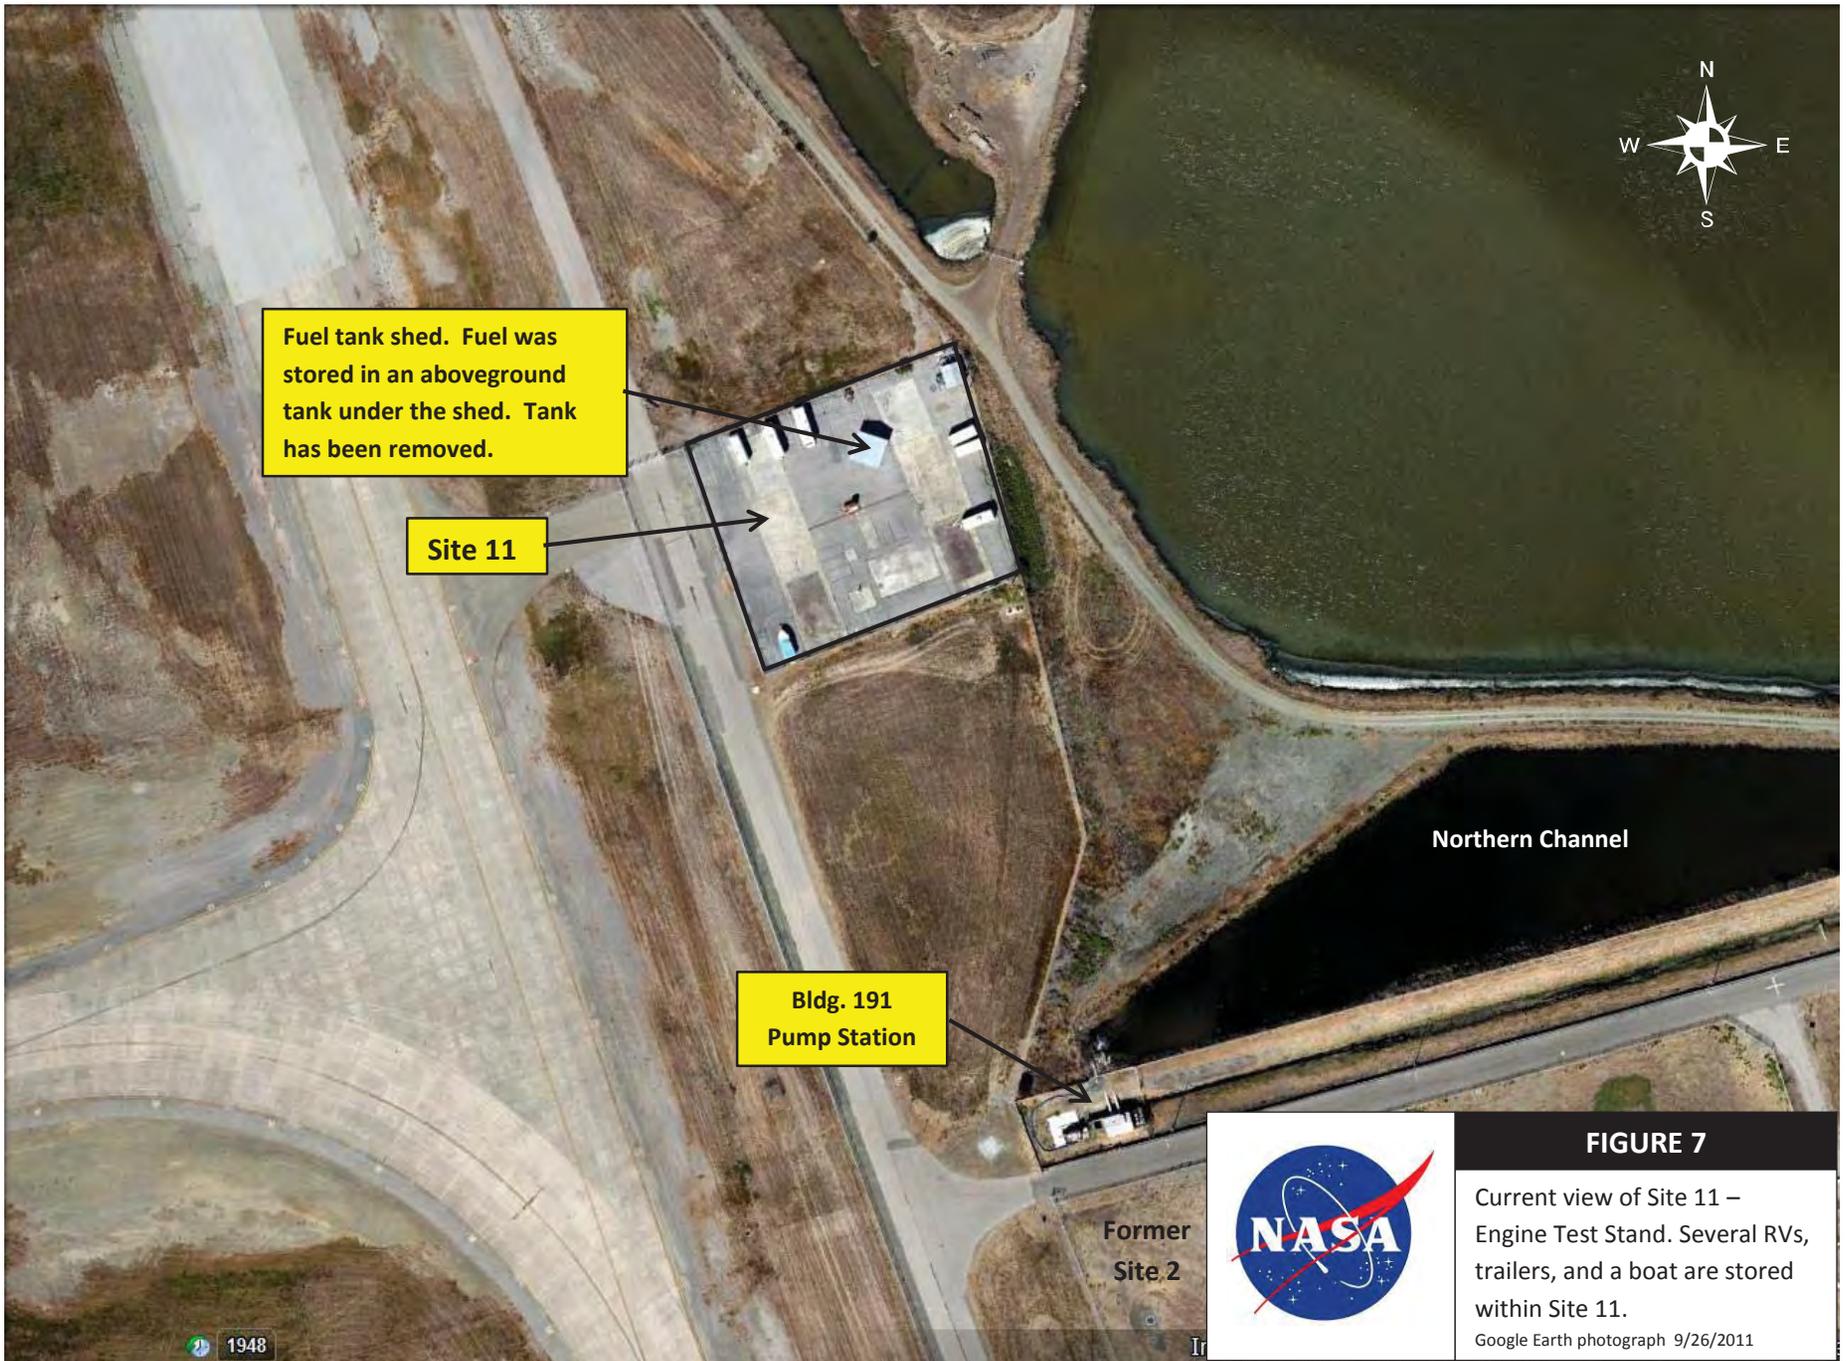
Fuel tank shed. Fuel was stored in an aboveground tank under the shed. Tank has been removed.
