MFA Leasehold EIMP Appendix A - Part 1

APPENDIX A

NASA EEC Statements

SITE NAME:	Site 1: Runway Landfill				
Version:	Final	Date:	02/21/2015		
RESPONSIBLE PARTY					
Organization	Department of the Navy, BRAC				
Address	1455 Frazee Rd., Suite 900 San Diego, CA 92108				
Contact	Scott Anderson				
	scott.d.anderson@navy.mil				
	619-532-0938				
LOCATION					
Facility Name	Moffett Federal Airfield	Site Location			
Facility Address	Mountain View, CA	Latitude	37.430918° N		
	Santa Clara County	Longitude	122.052779° W		
Regulatory Program	Lead Agency(ies)	Site Status			
		Open	Closed	ROD	Current Phase
CERCLA	EPA/RWQCB	X		OU1 1997	O&M
SITE SUMMARY					
<p>The Site 1 landfill covers approximately 12 acres at the northern portion of the former Naval Air Station Moffett Field (NASMF) and is northeast of Runway 32R (14L). Figure 1 depicts the location of Site 1 with respect to the former NASMF. Figure 2 is an aerial view of Site 1. The landfill is surrounded on three sides by fencing while the northern portion is bordered by the Storm Water Retention Pond (SWRP). The western portion of the landfill is flat with an elevation of 7 feet above mean sea level while the eastern portion is moun

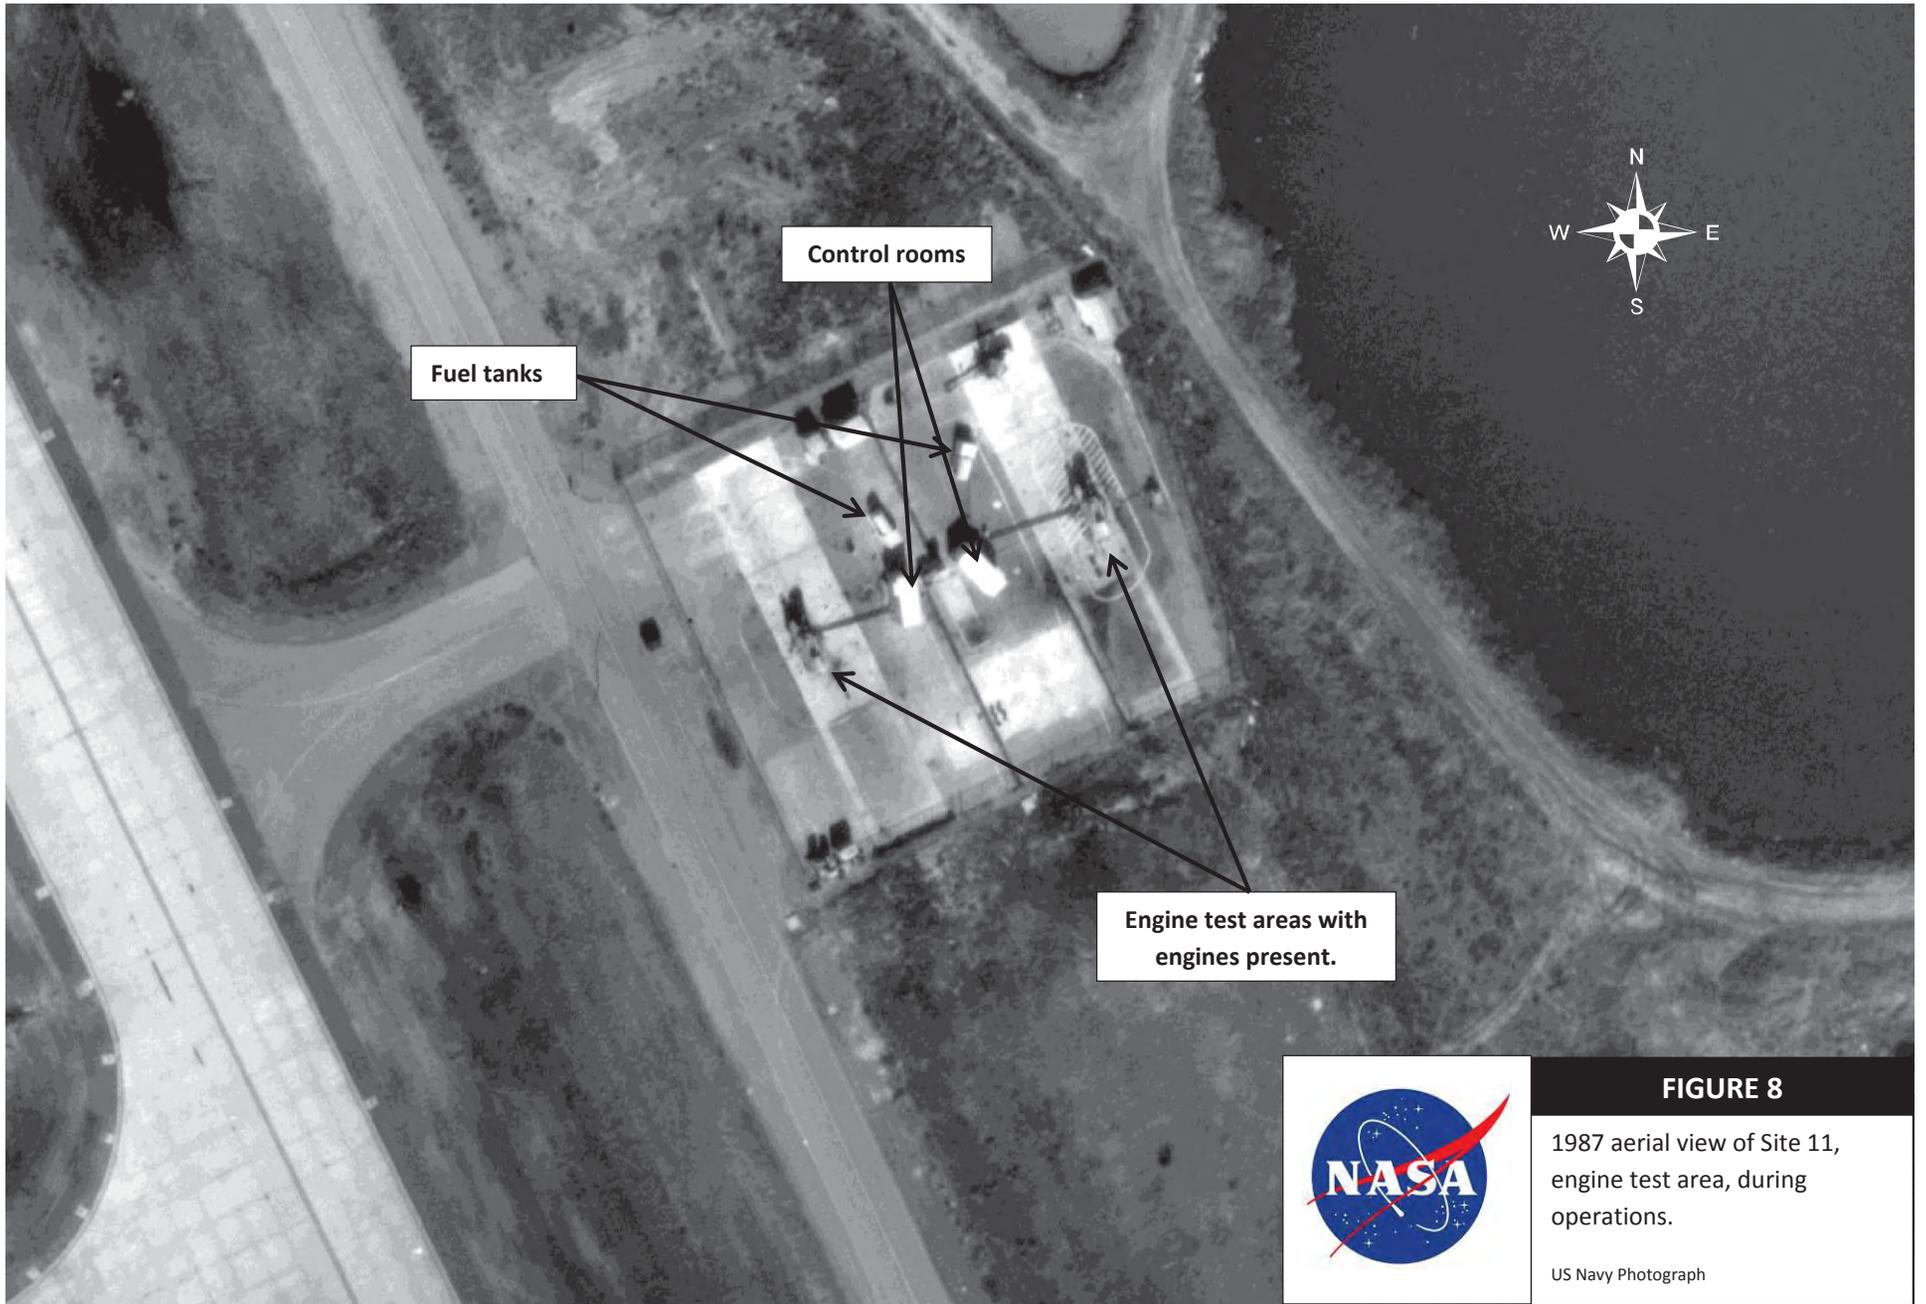
FIGURE 8
1987 aerial view of Site 11, engine test area, during operations.
US Navy Photograph

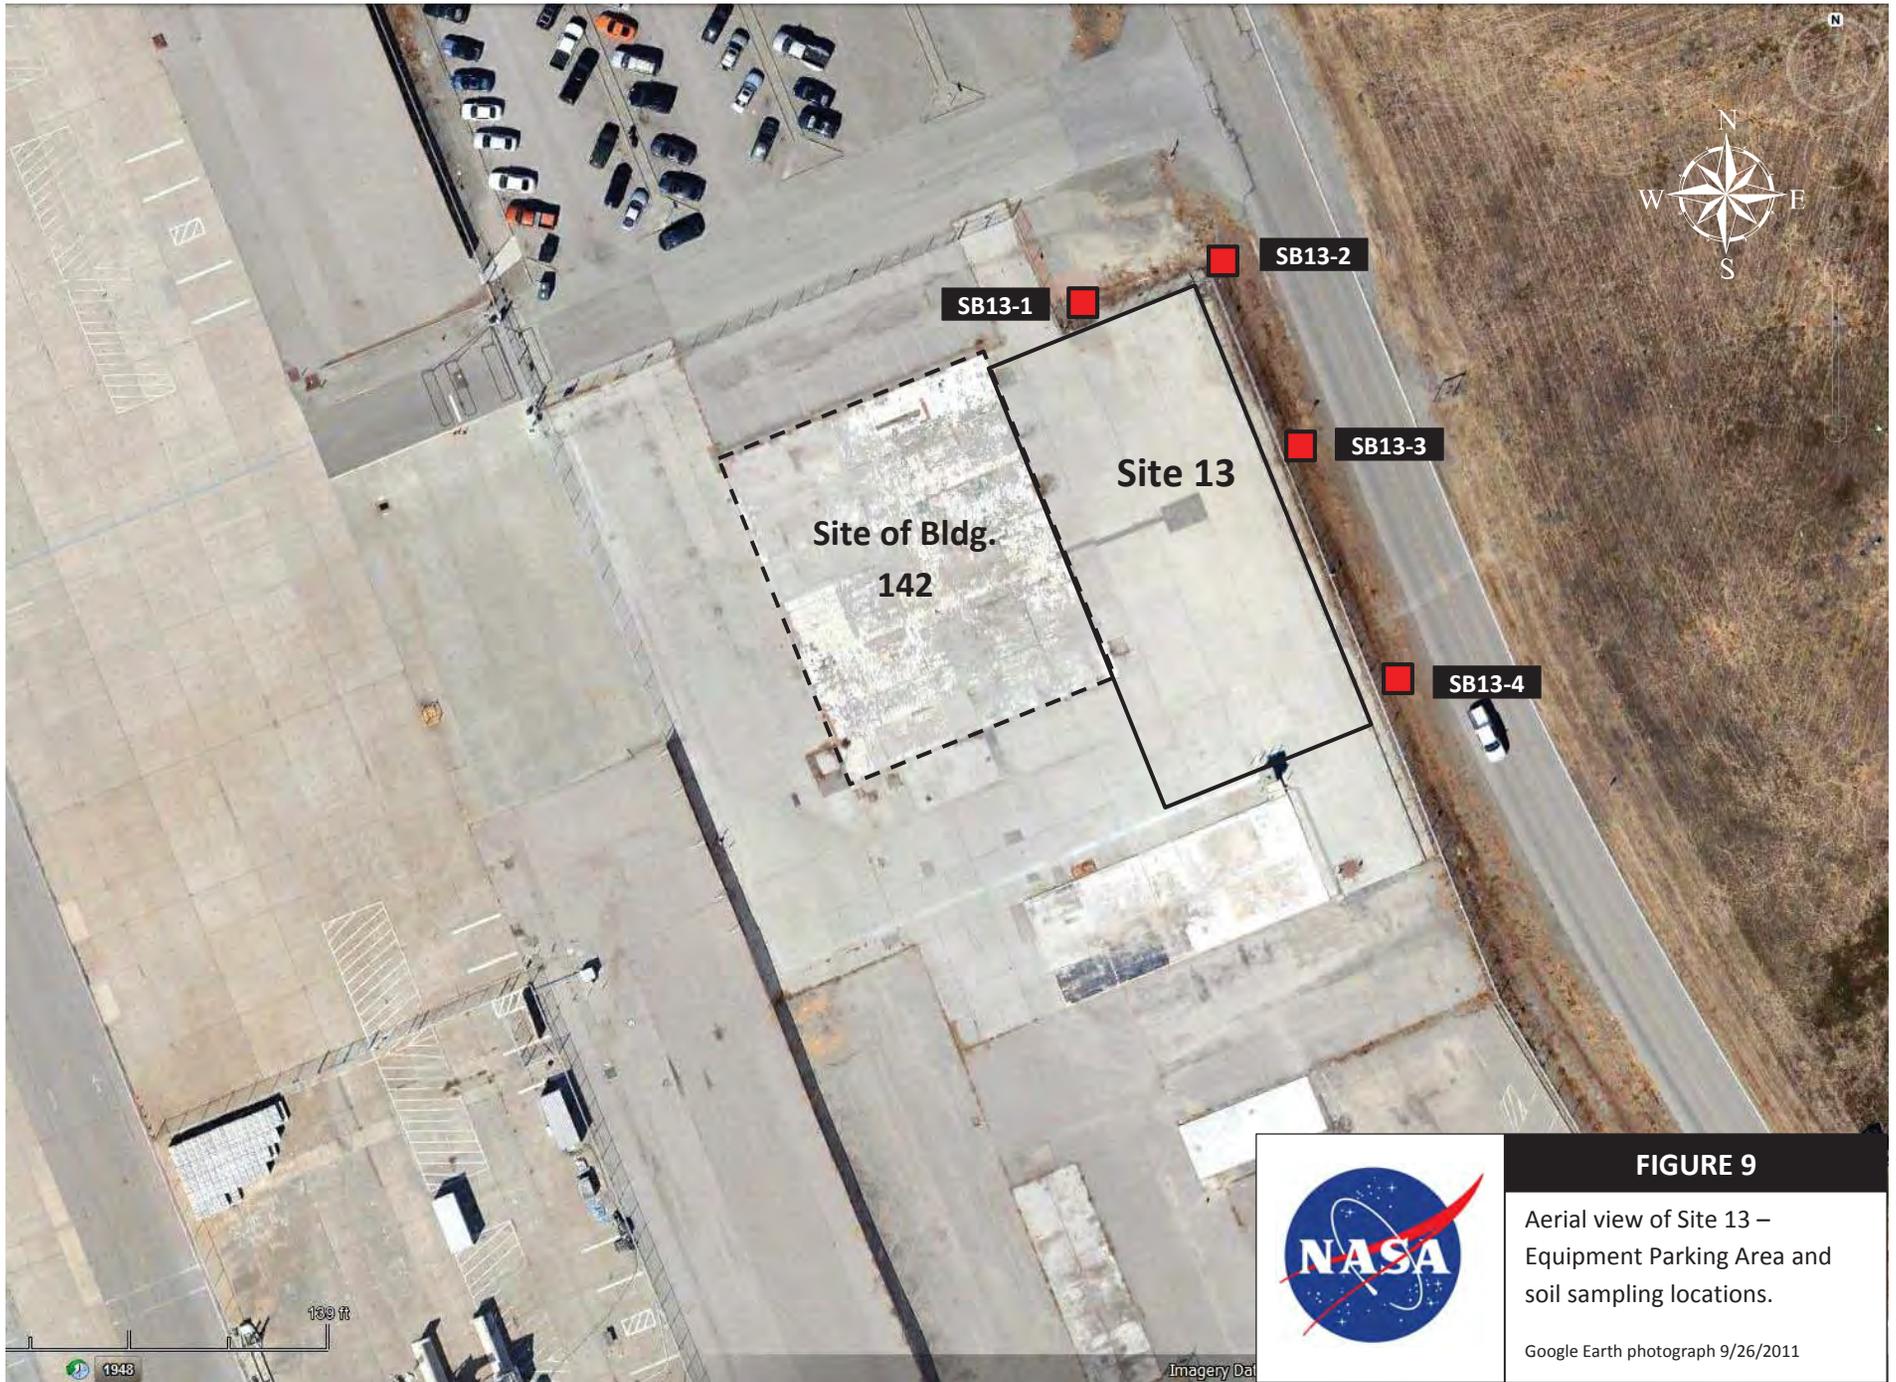
FIGURE 9

Aerial view of Site 13 –
Equipment Parking Area and
soil sampling locations.

Oil and grease were detected in all eight samples ranging from 6 mg/kg to 1150 mg/kg. The highest concentration was found in SB13-4 @ 5 – 10 feet. JP-5 was detected @ 110 mg/kg in SB13-4 @ 5 – 10 feet. Arsenic was found in all eight samples ranging from 2.3 mg/kg to 10.2 mg/kg. The highest concentration was found in SB13-3 @ 5 – 10 feet. Lead was found in SB13-3 @ 462 mg/kg @ 1 – 3 feet.

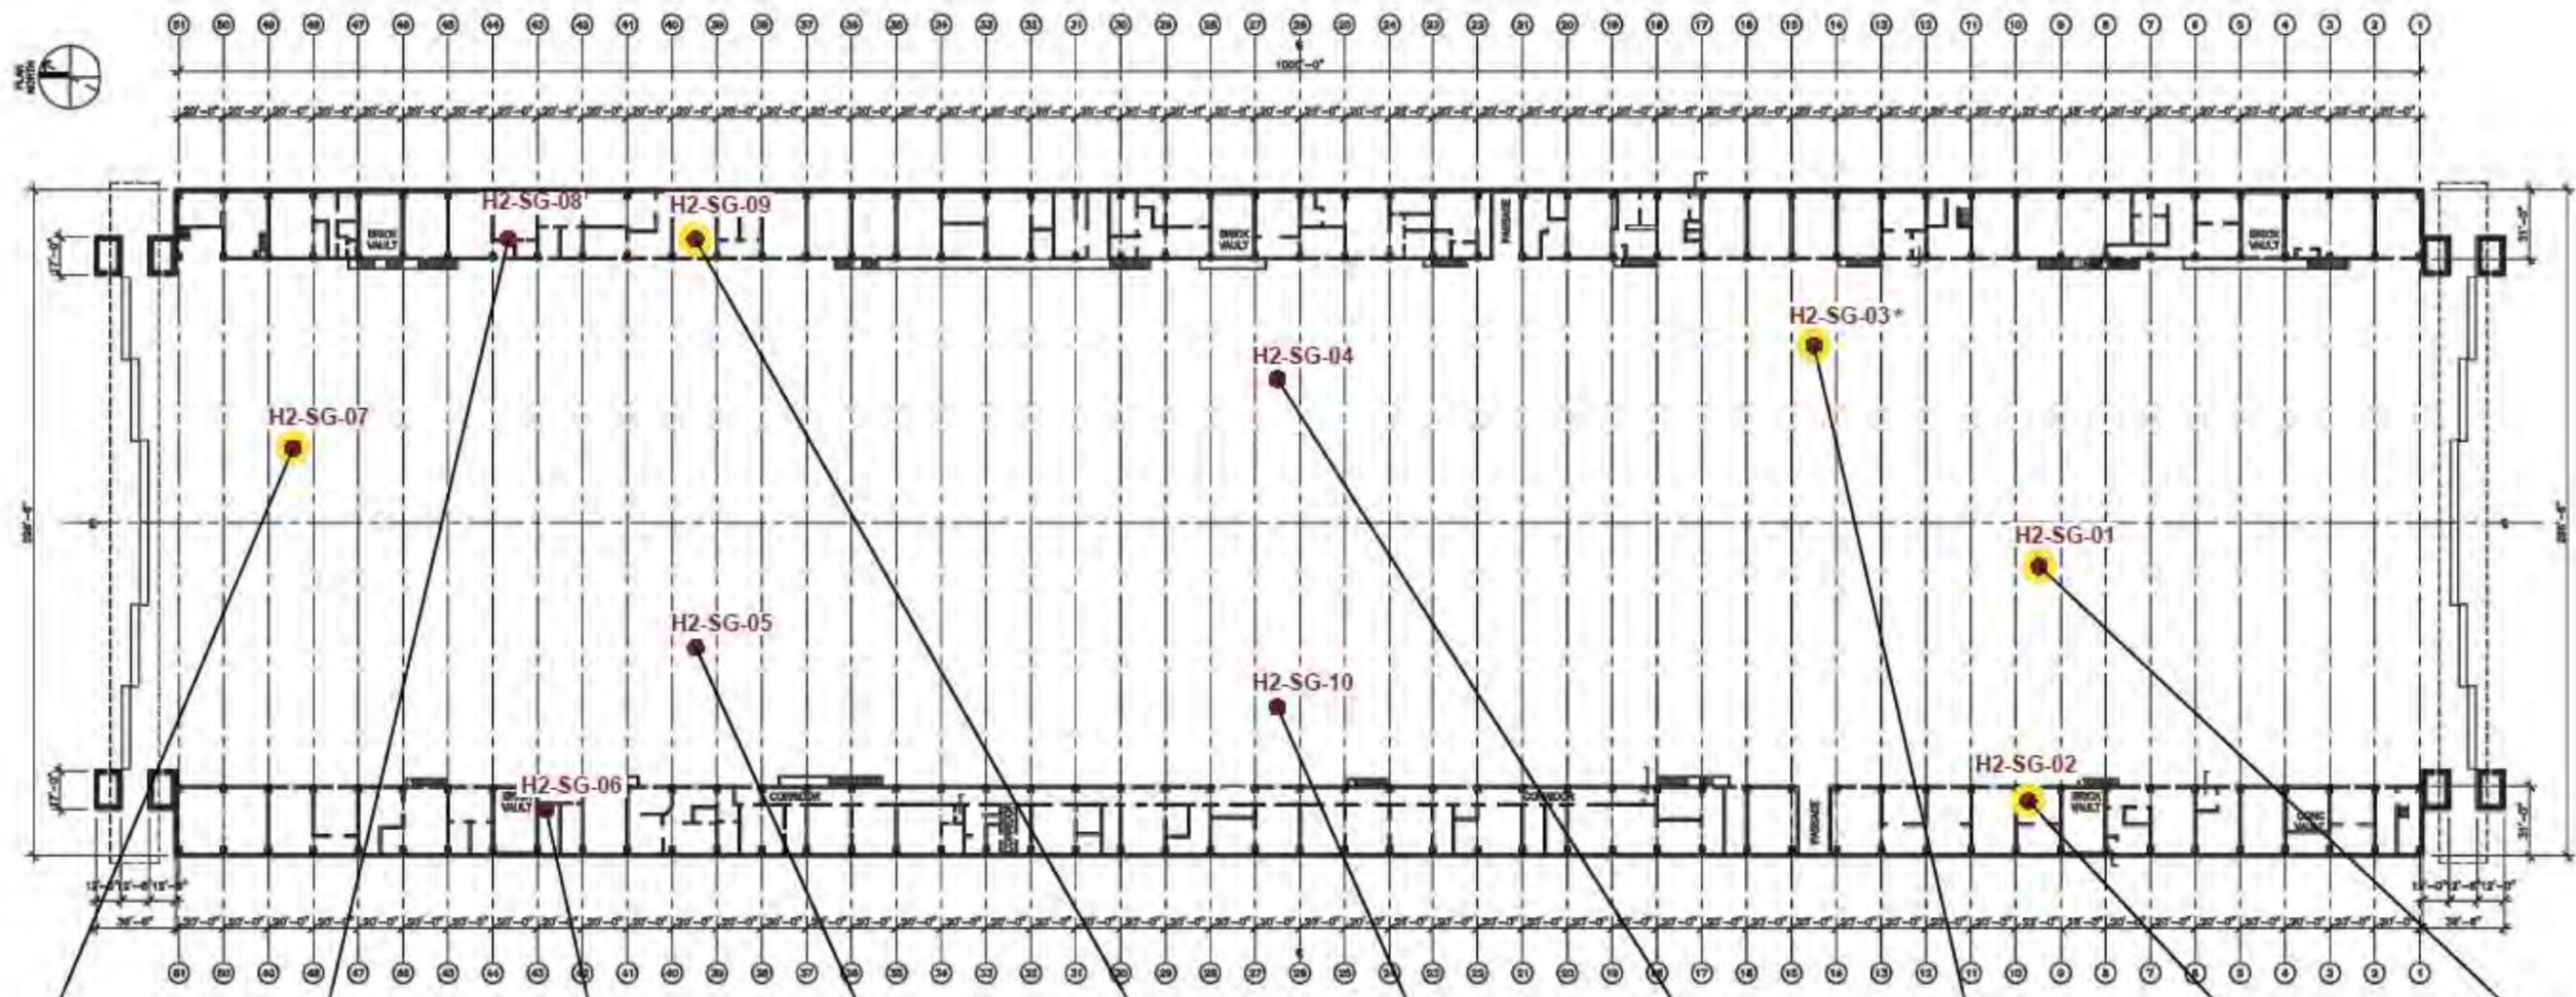
Erler & Kalinowski, Inc.
 Sub-Slab Vapor TCE, PCE, Carbon Tetrachloride and Chloroform⁵ Concentrations in Hangar 2

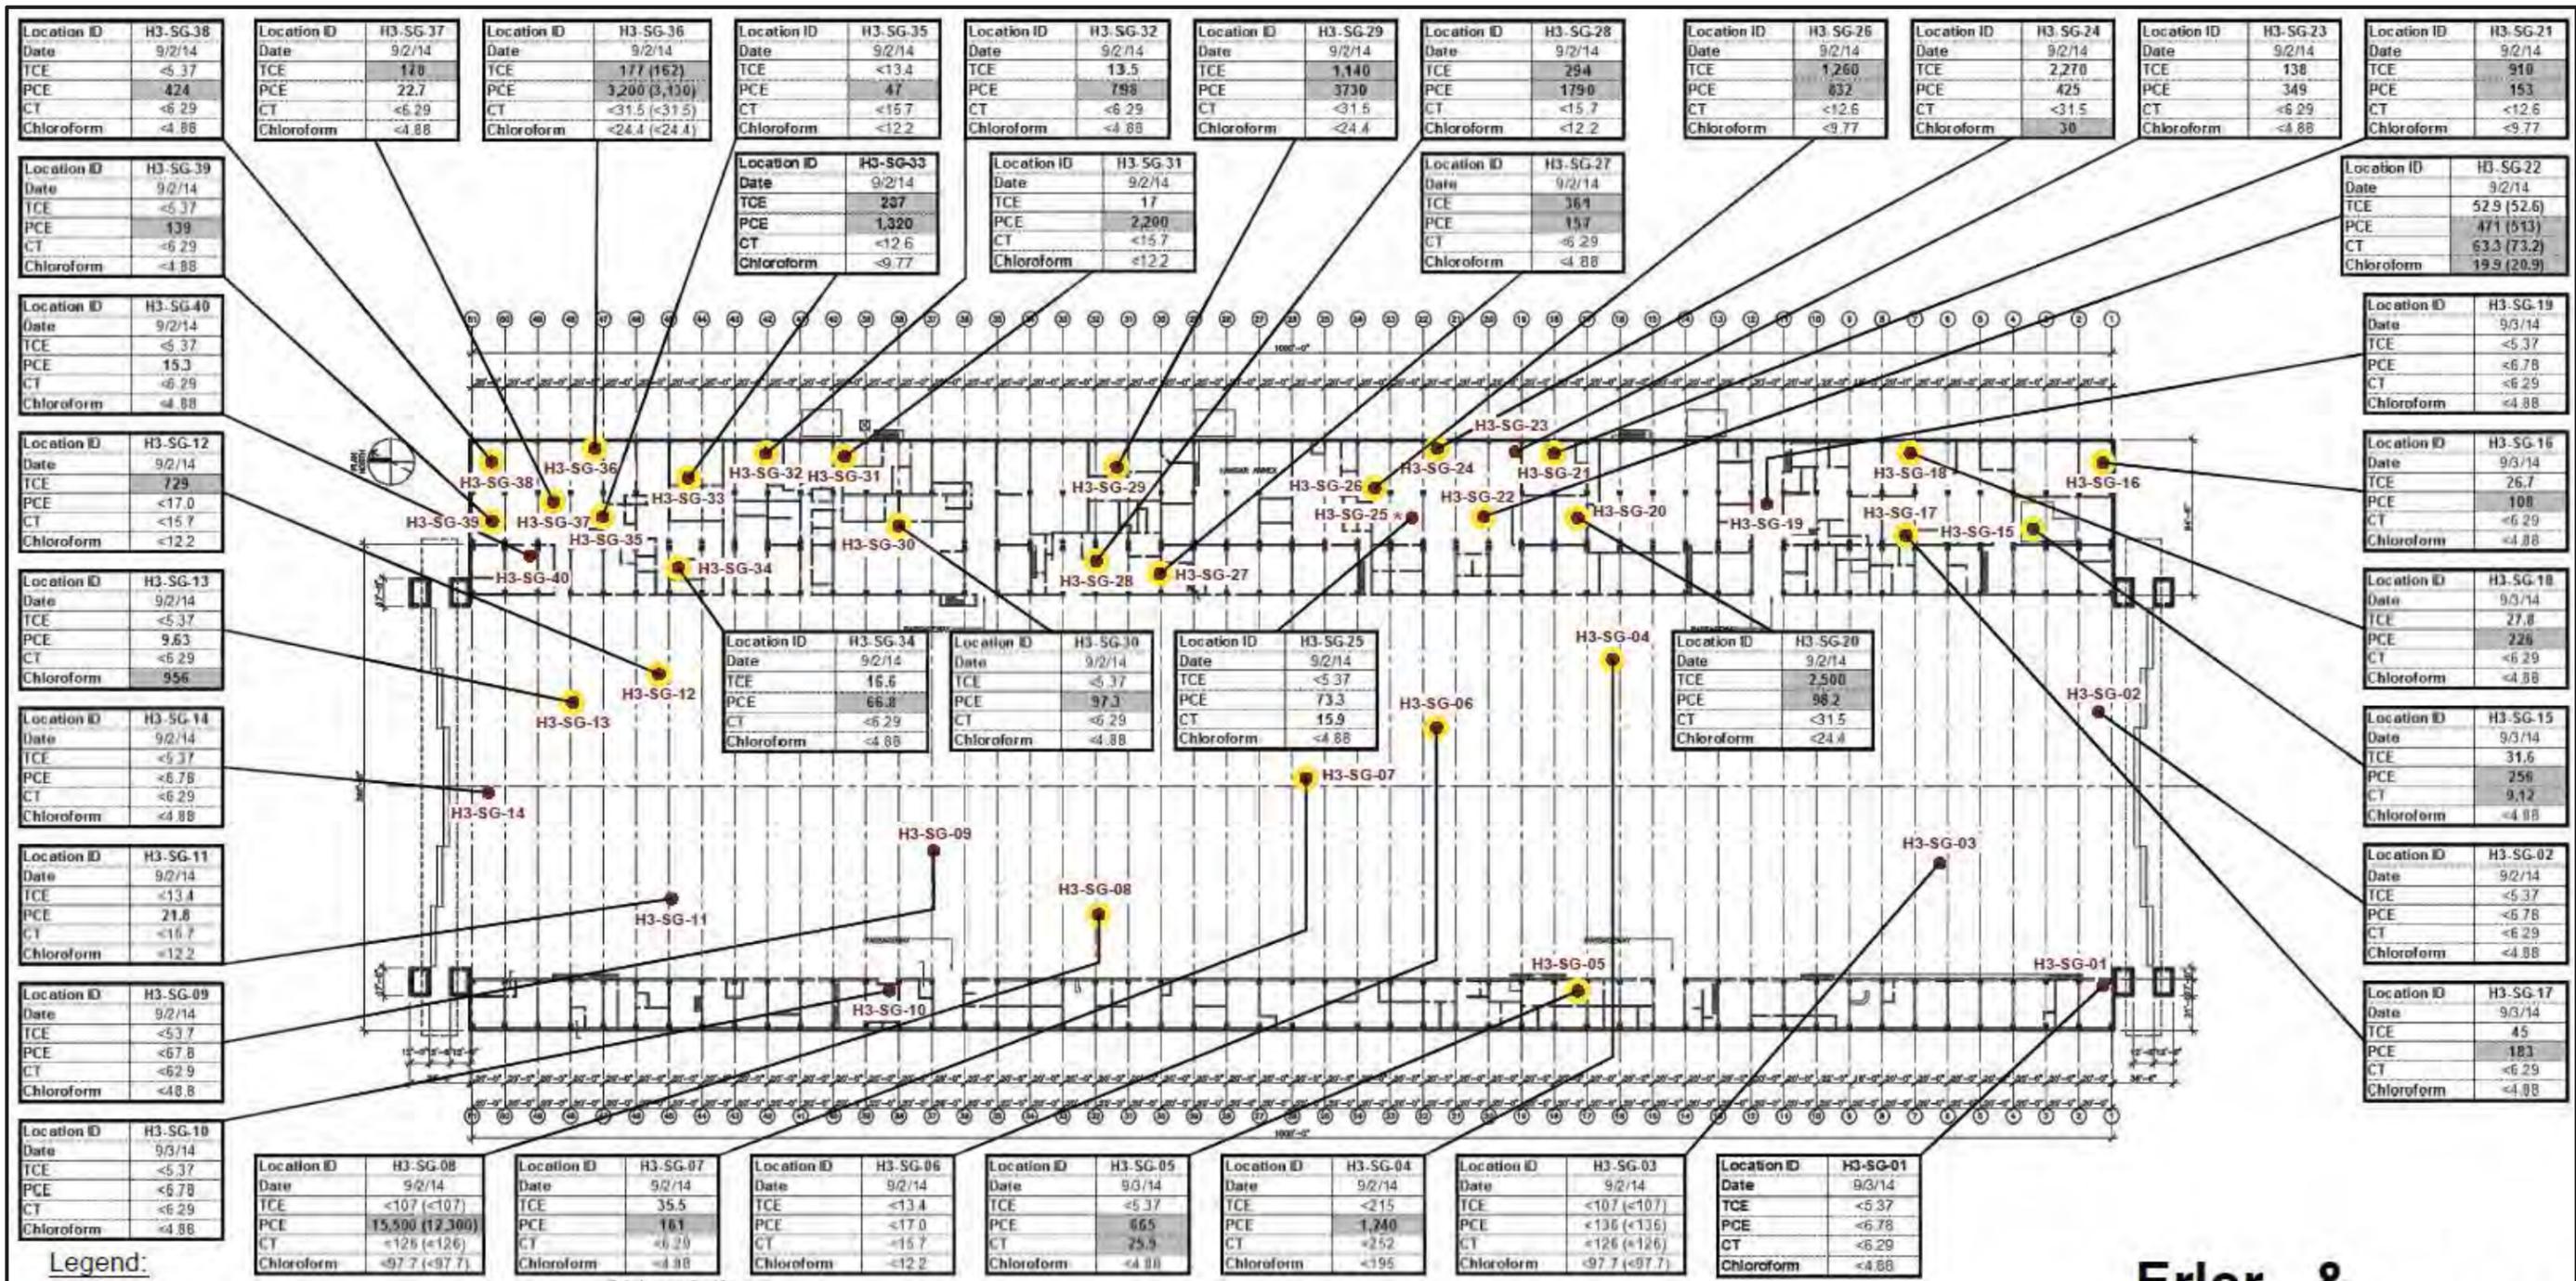
Sub-Slab Vapor TCE, PCE, Carbon Tetrachloride, and Chloroform⁵ Concentrations in Hangar 3

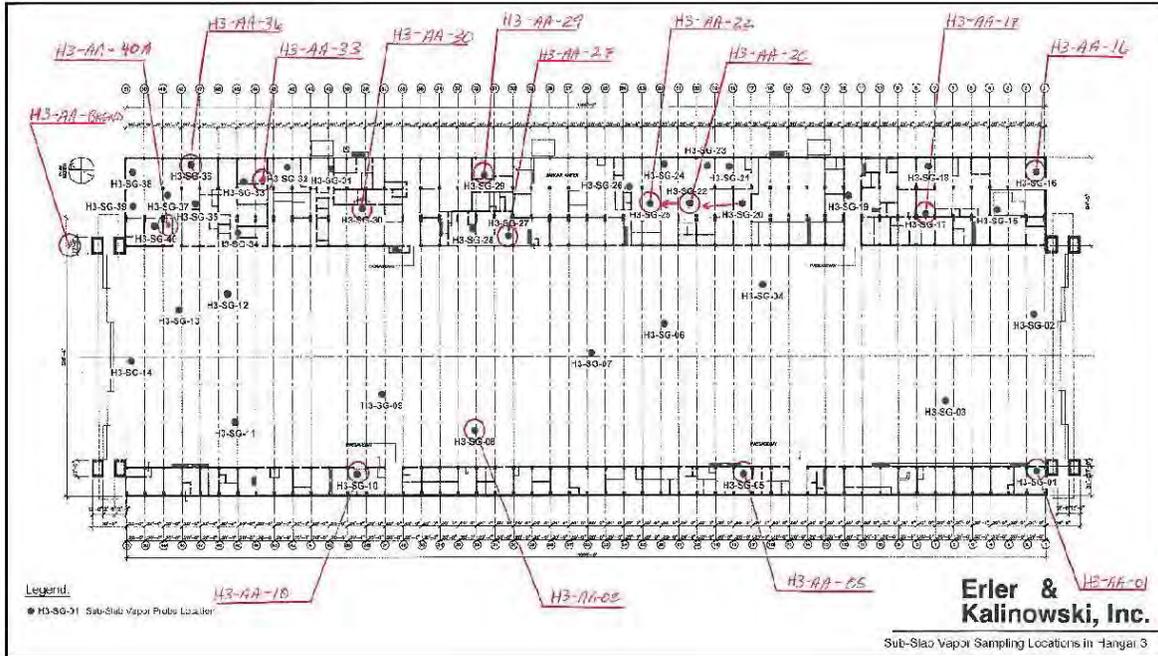
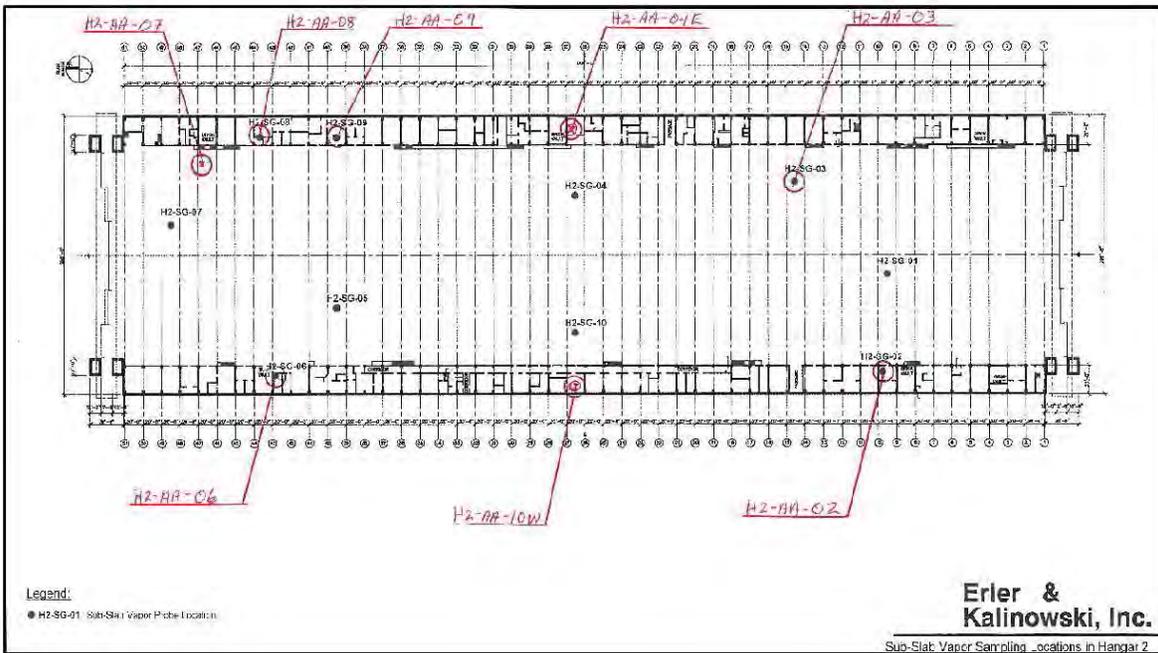
FIGURE 12
 Vapor intrusion sampling locations.
 Figure 1 from the NASA vapor intrusion Report of Findings

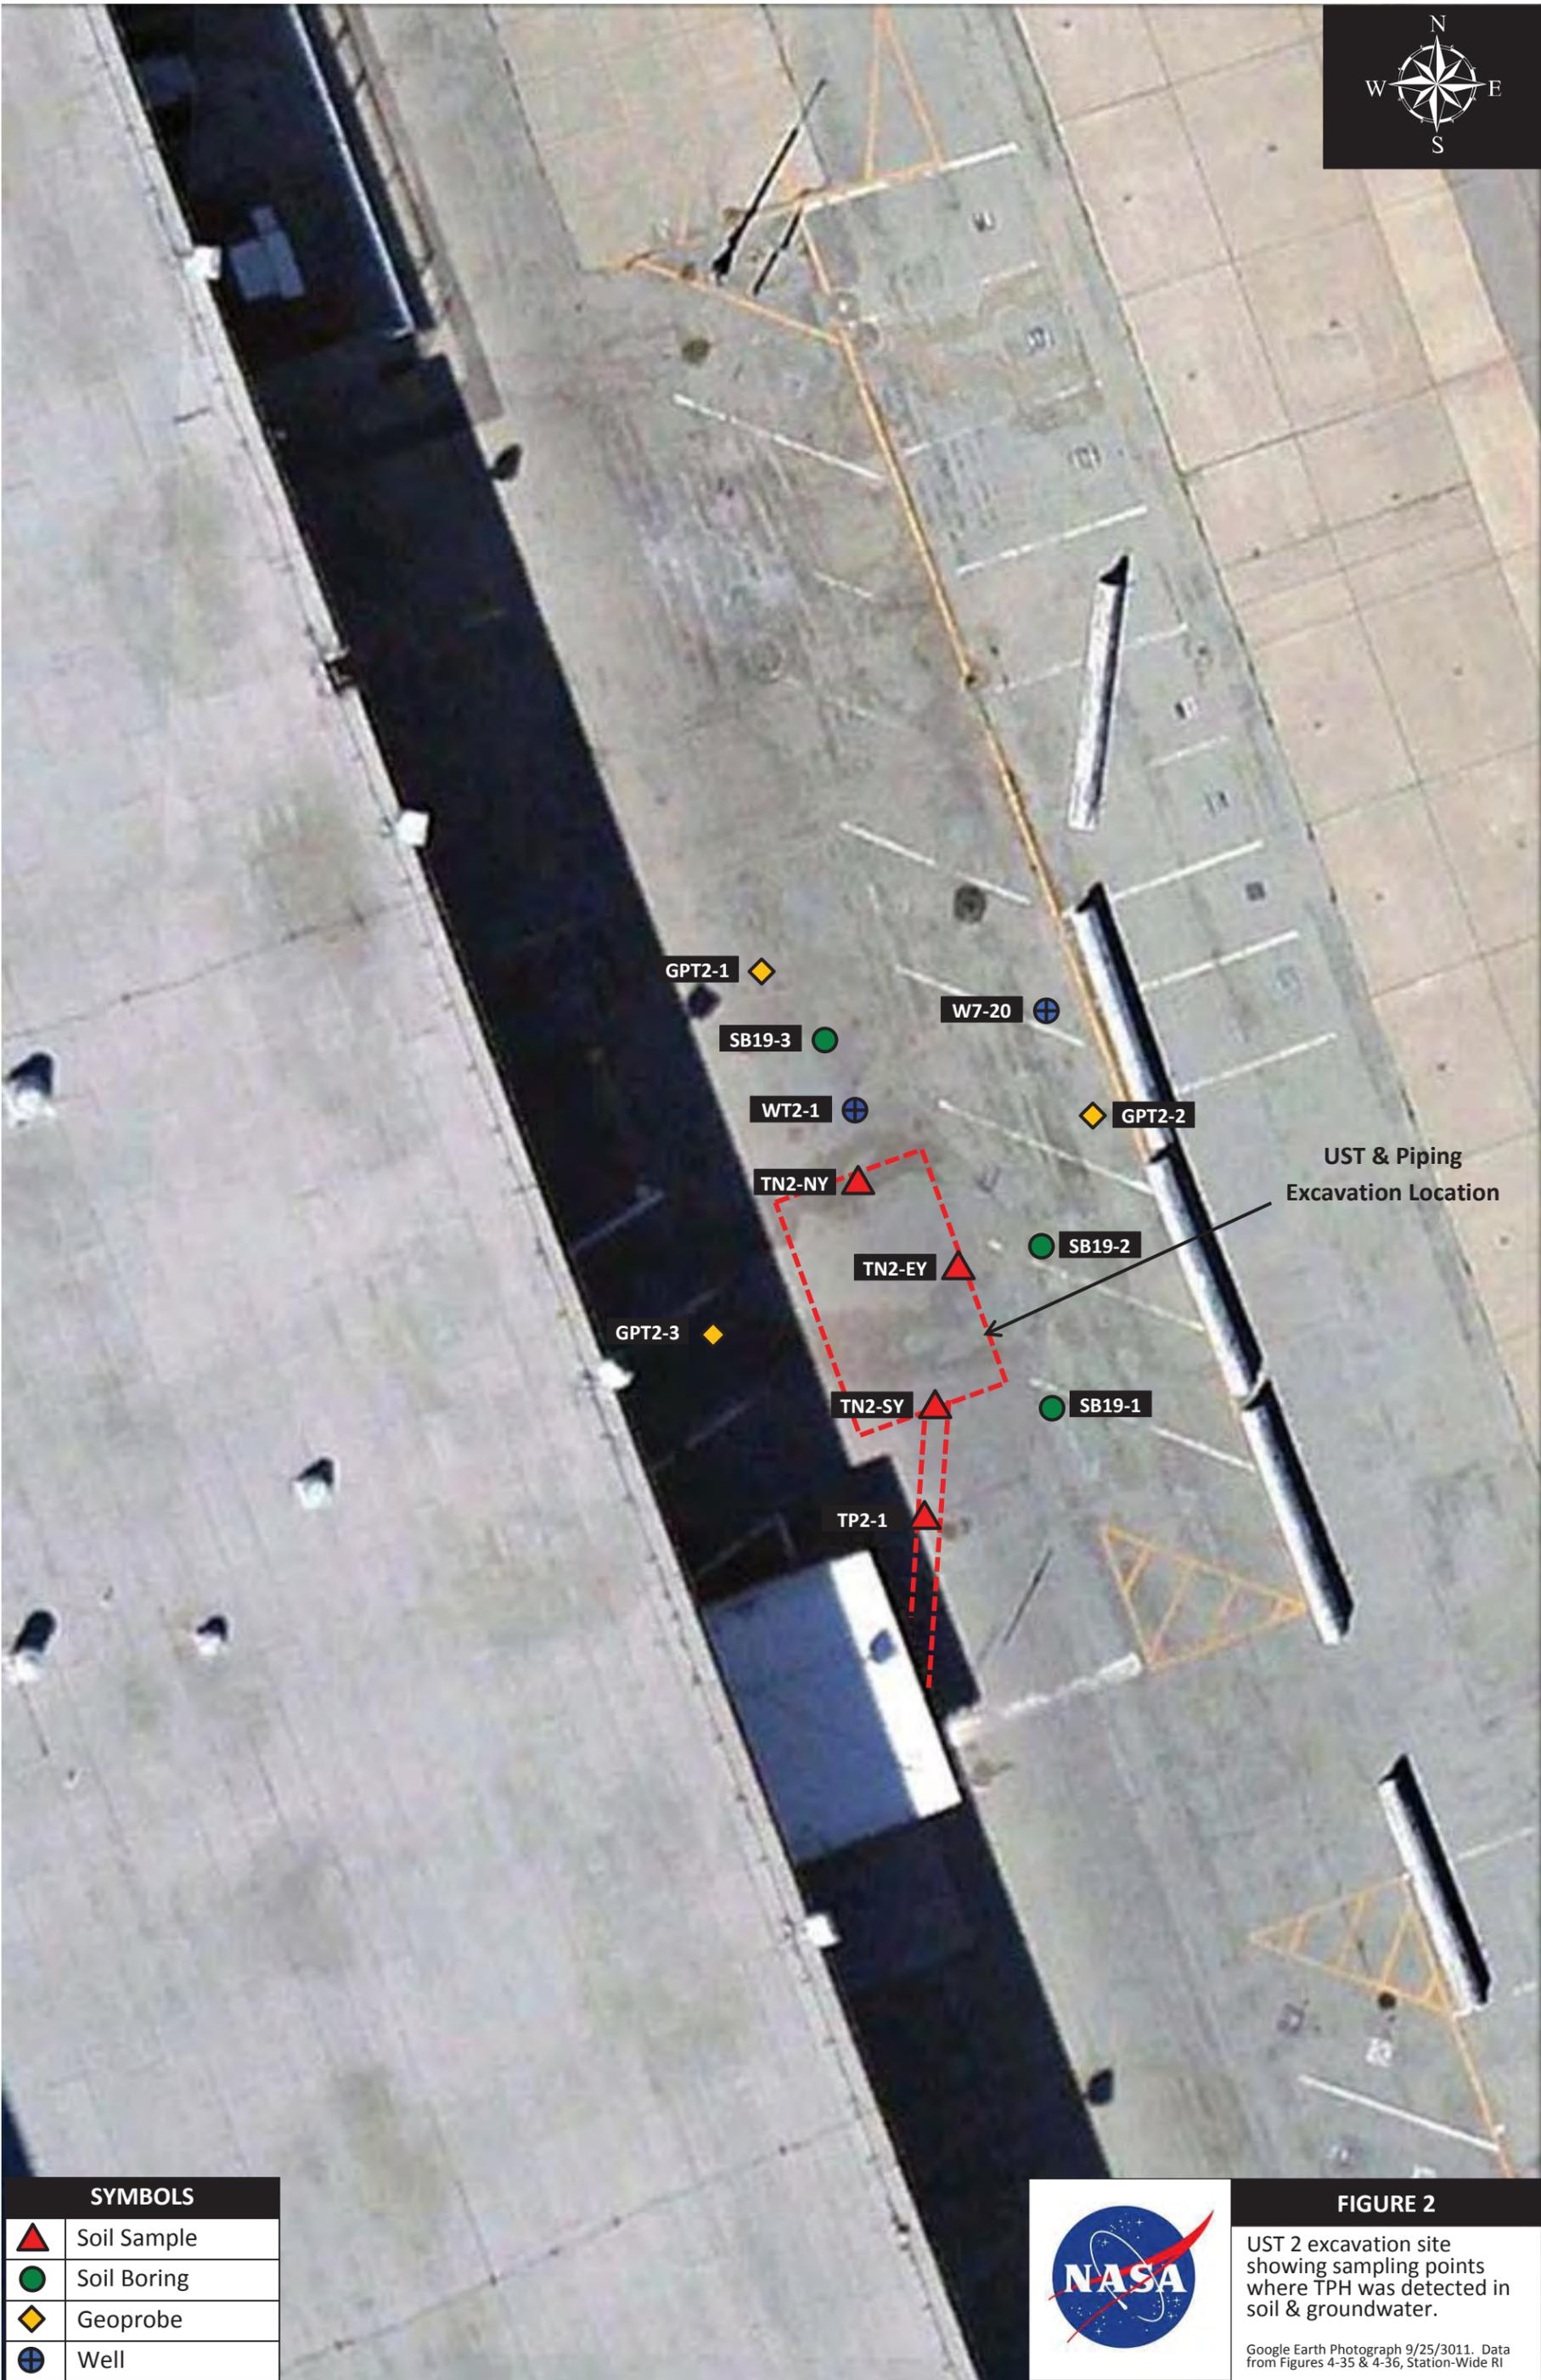
FIGURE 2
 UST 2 excavation site showing sampling points where TPH was detected in soil & groundwater.
 Google Earth Photograph 9/25/3011. Data from Figures 4-35 & 4-36, Station-Wide RI

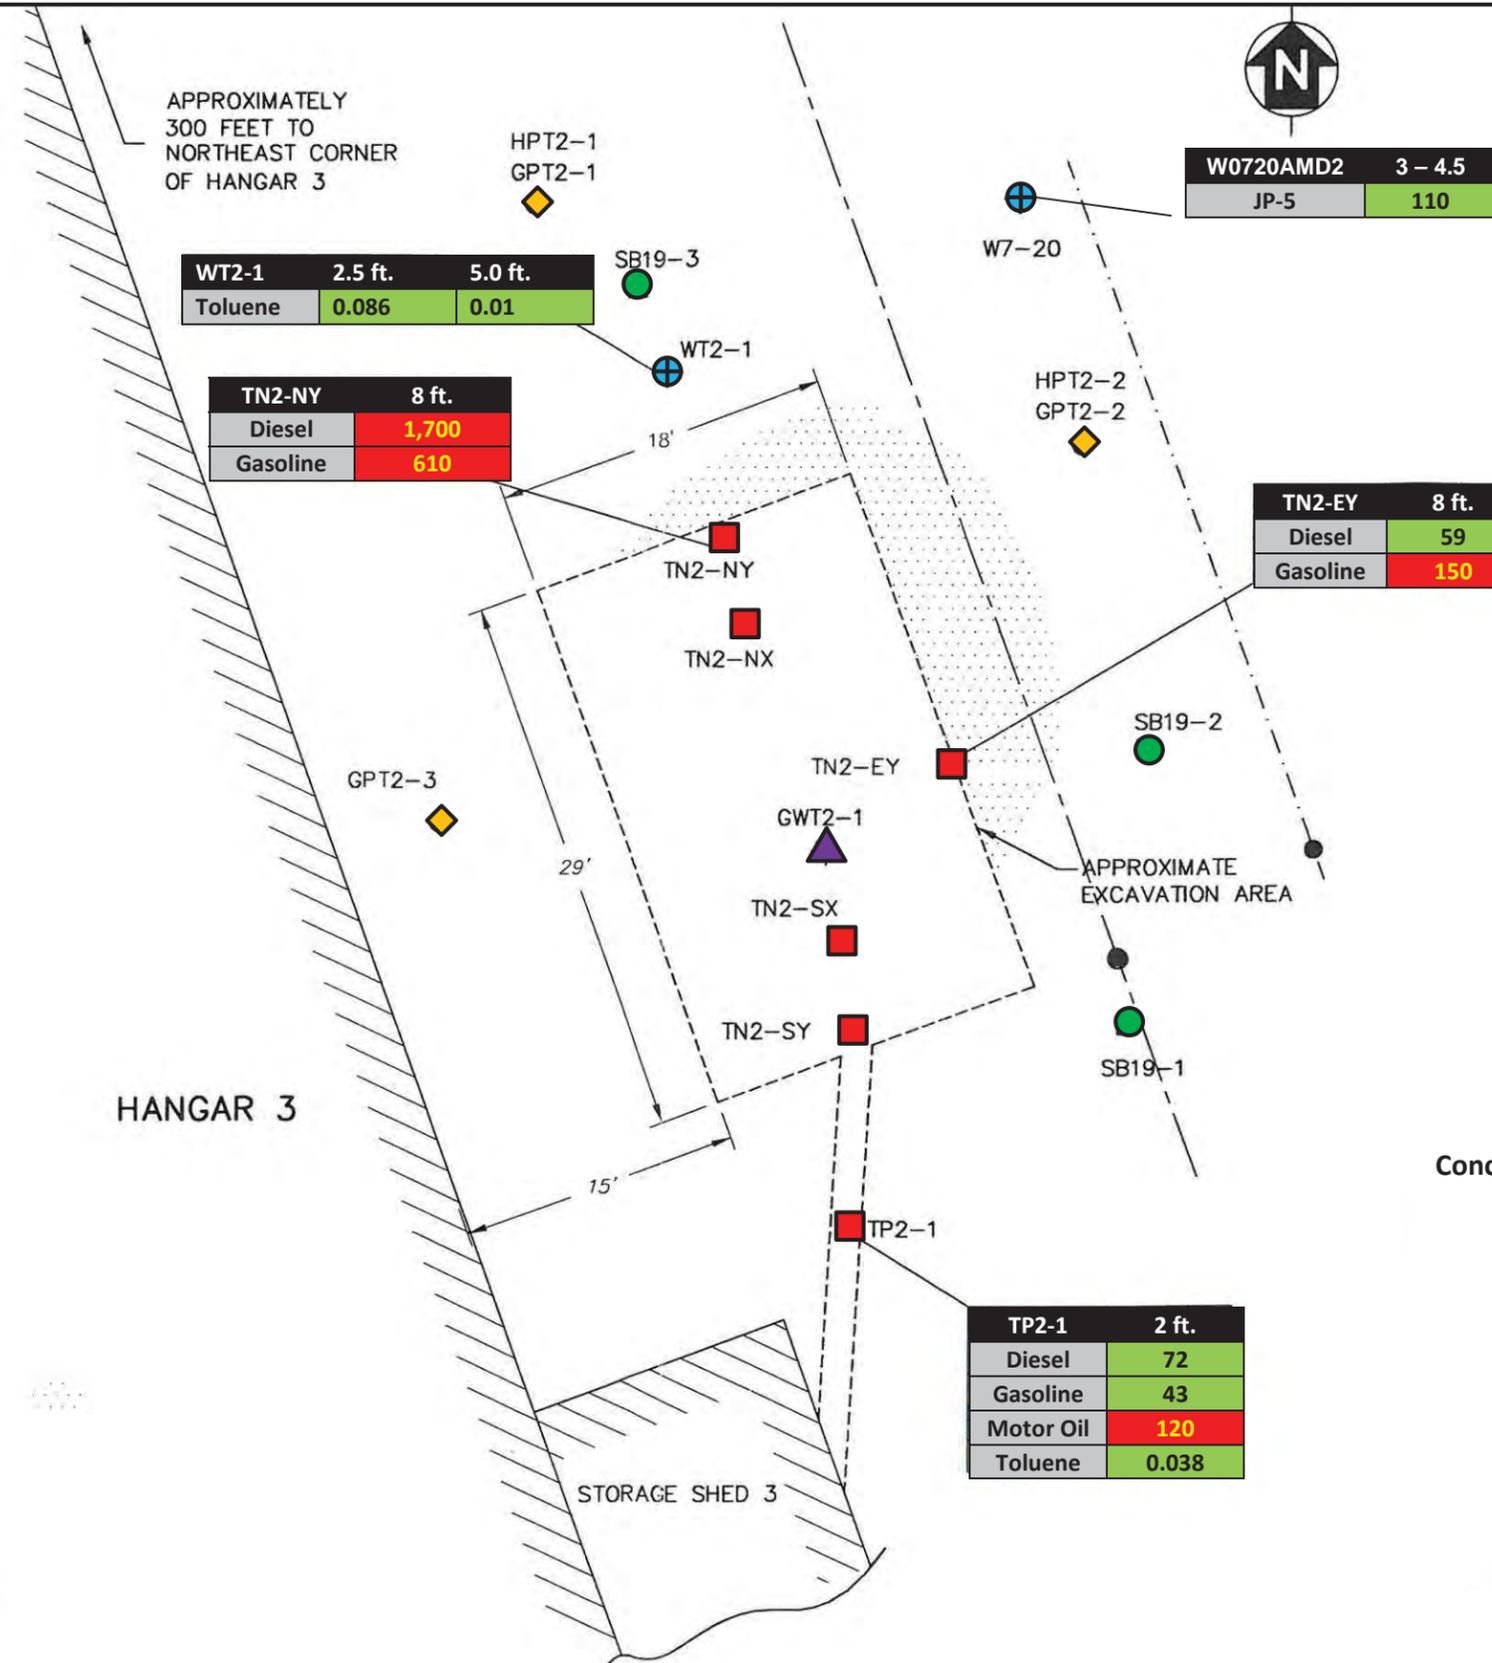
FIGURE 3
 Petroleum compounds detected in soil at UST 2.
 Figure based on Figure D8 from Basewide Petroleum Sites Tech Memo Appendix D.

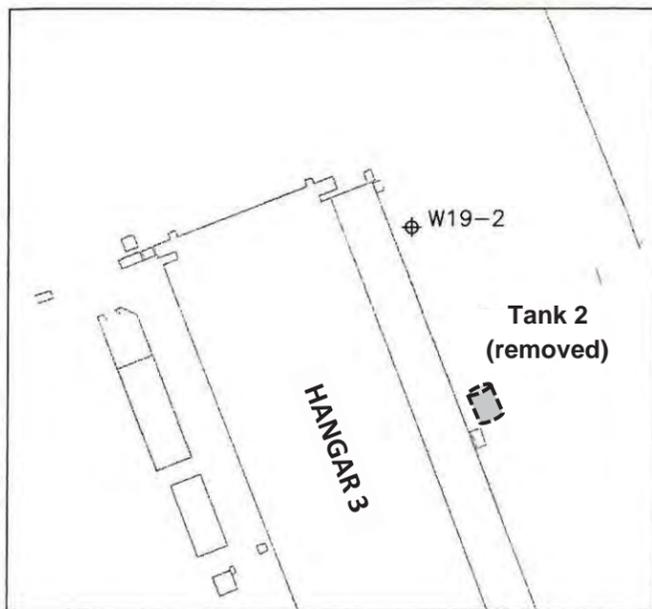
FIGURE 5
 Selected petroleum contaminants detected in groundwater at UST 2.
 Figure and data from Figure D10 in the Basewide Petroleum Sites Appendix D.

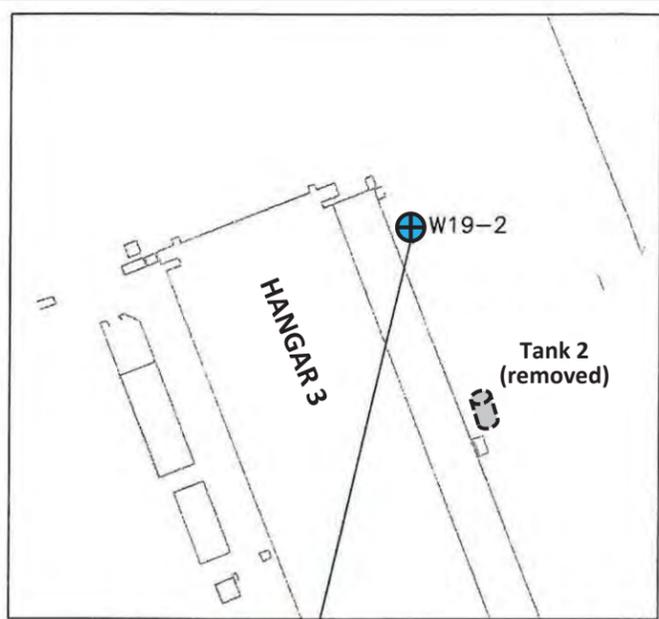
FIGURE 6
 CERCLA contamination detected in groundwater at UST2.
 Figure based on Figure D11 from Basewide Petroleum Sites Tech Memo Appendix D.
