MFA Leasehold EIMP Appendix A - Part 1

APPENDIX A

NASA EEC Statements

SITE NAME:	Site 1: Runway Landfill				
Version:	Final	Date:	02/21/2015		
RESPONSIBLE PARTY					
Organization	Department of the Navy, BRAC				
Address	1455 Frazee Rd., Suite 900 San Diego, CA 92108				
Contact	Scott Anderson				
	scott.d.anderson@navy.mil				
	619-532-0938				
LOCATION					
Facility Name	Moffett Federal Airfield	Site Location			
Facility Address	Mountain View, CA	Latitude	37.430918° N		
	Santa Clara County	Longitude	122.052779° W		
Regulatory Program	Lead Agency(ies)	Site Status			
		Open	Closed	ROD	Current Phase
CERCLA	EPA/RWQCB	X		OU1 1997	O&M
SITE SUMMARY					
<p>The Site 1 landfill covers approximately 12 acres at the northern portion of the former Naval Air Station Moffett Field (NASMF) and is northeast of Runway 32R (14L). Figure 1 depicts the location of Site 1 with respect to the former NASMF. Figure 2 is an aerial view of Site 1. The landfill is surrounded on three sides by fencing while the northern portion is bordered by the Storm Water Retention Pond (SWRP). The western portion of the landfill is flat with an elevation of 7 feet above mean sea level while the eastern portion is moun

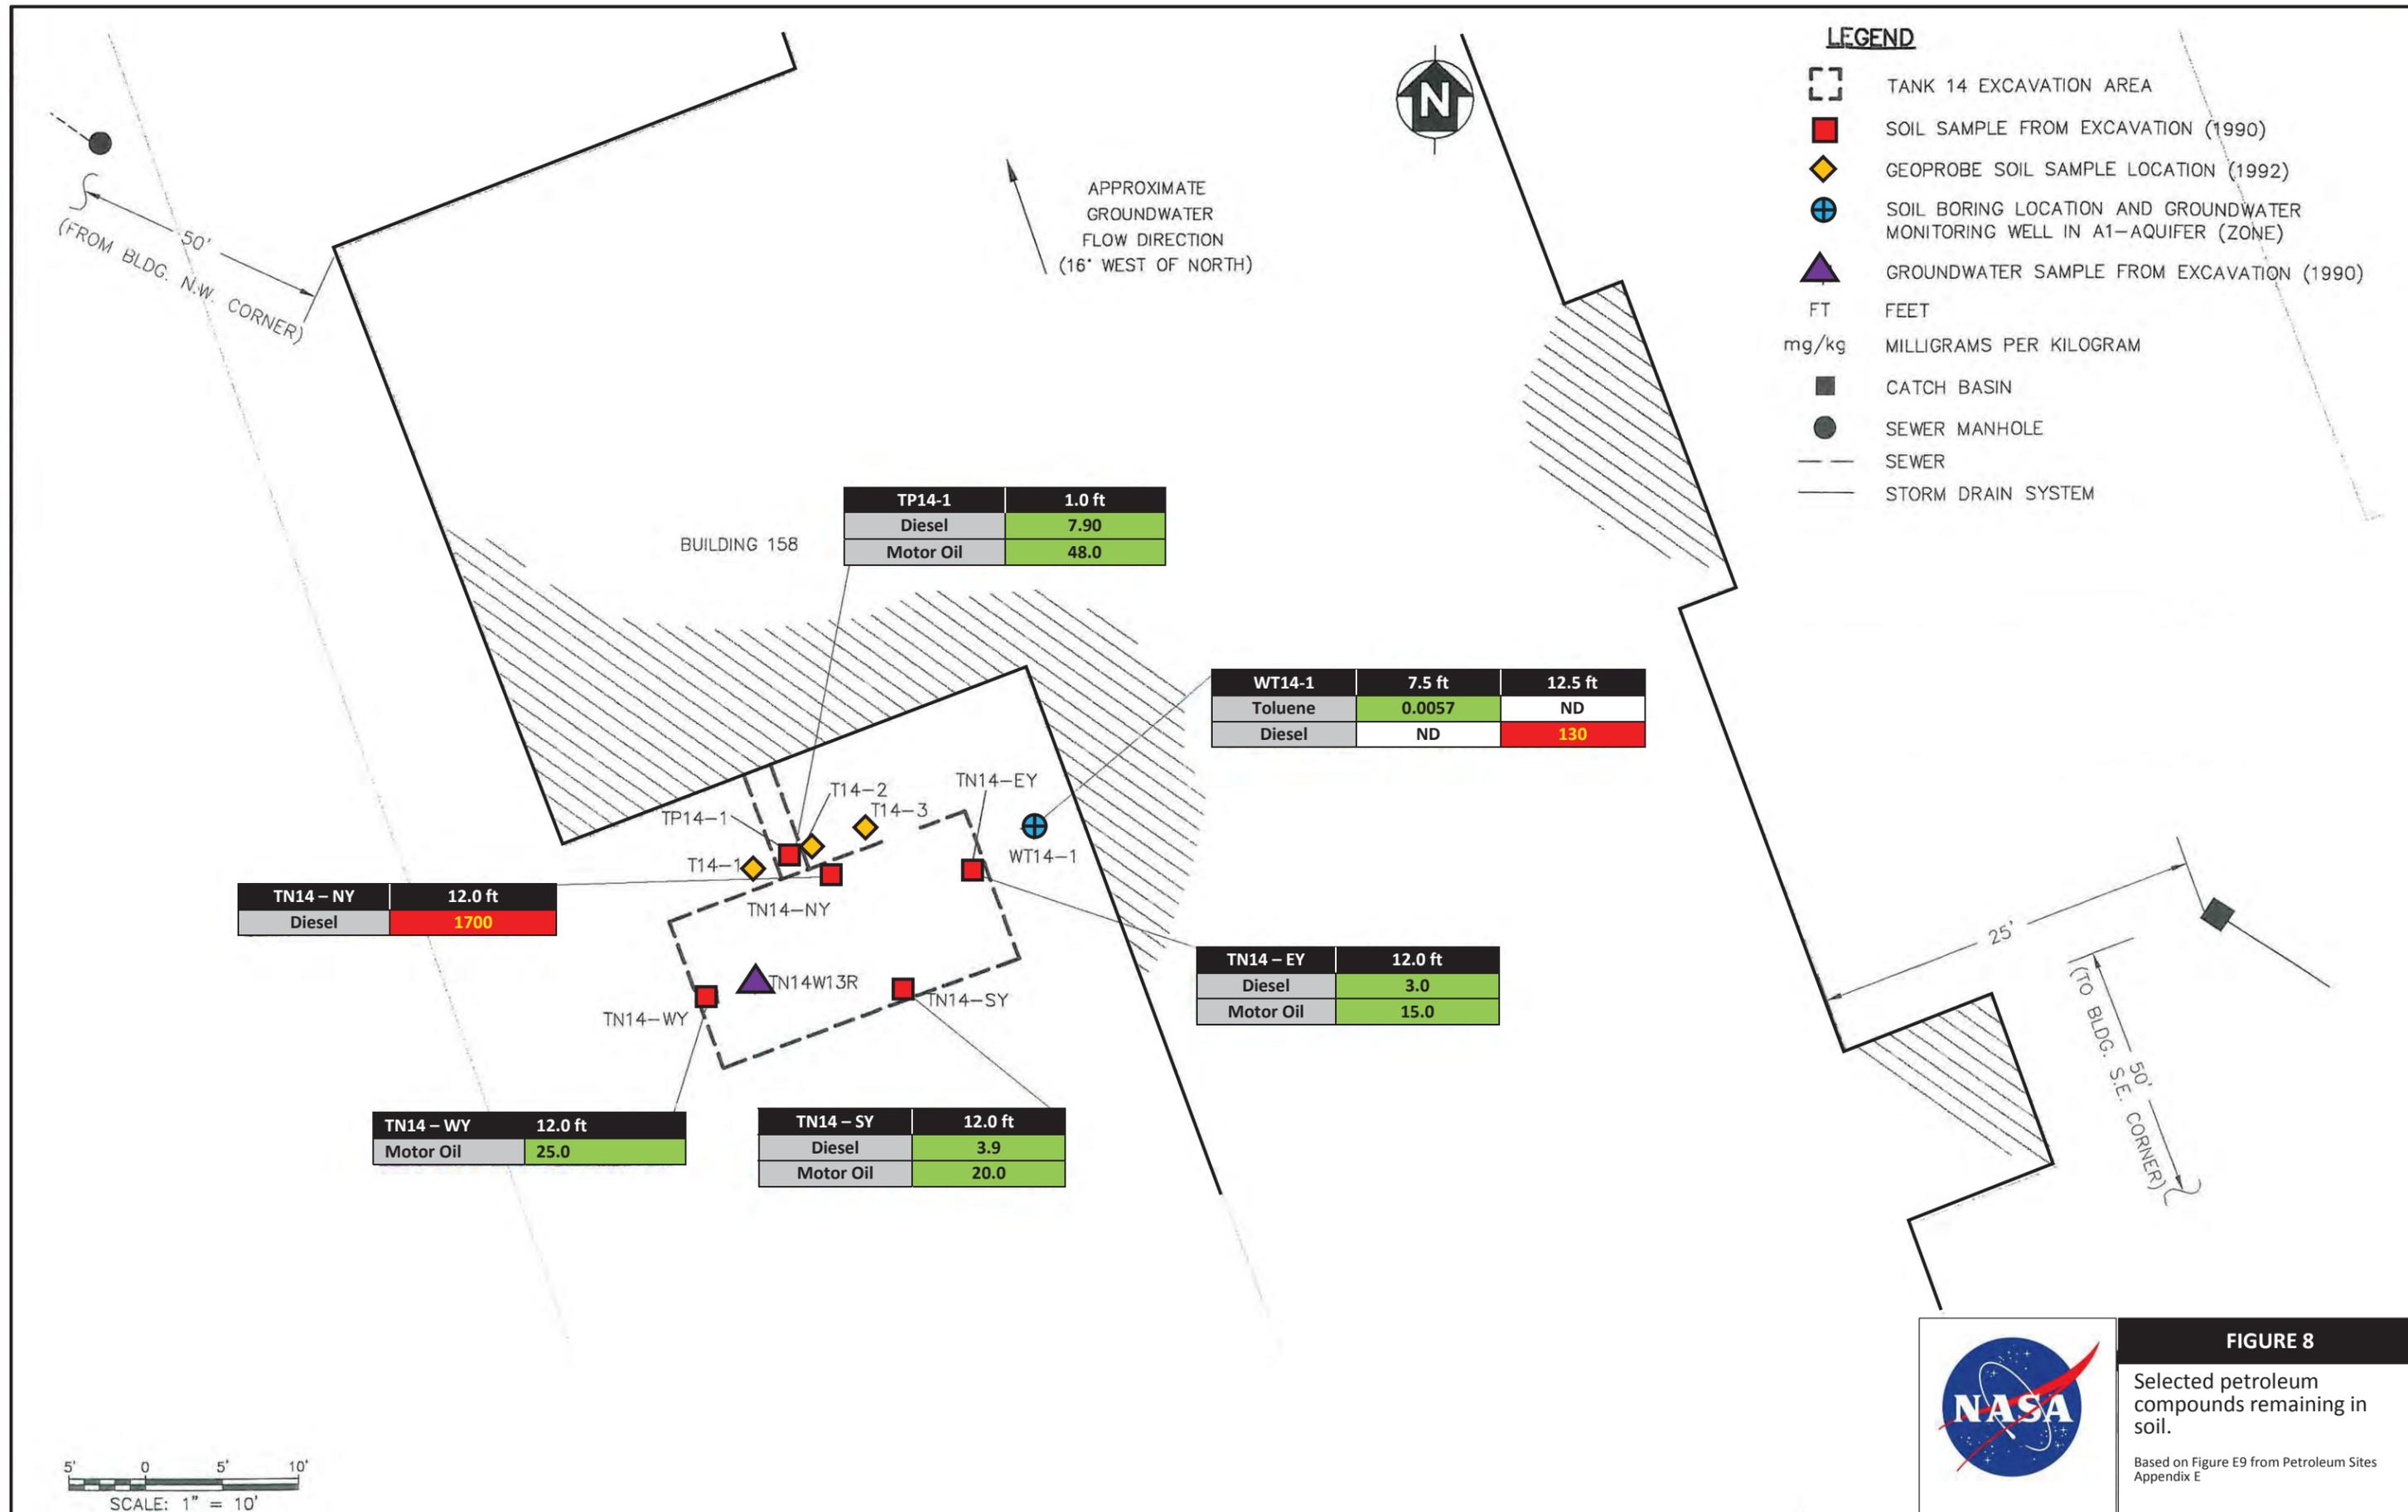
FIGURE 8

Selected petroleum compounds remaining in soil.

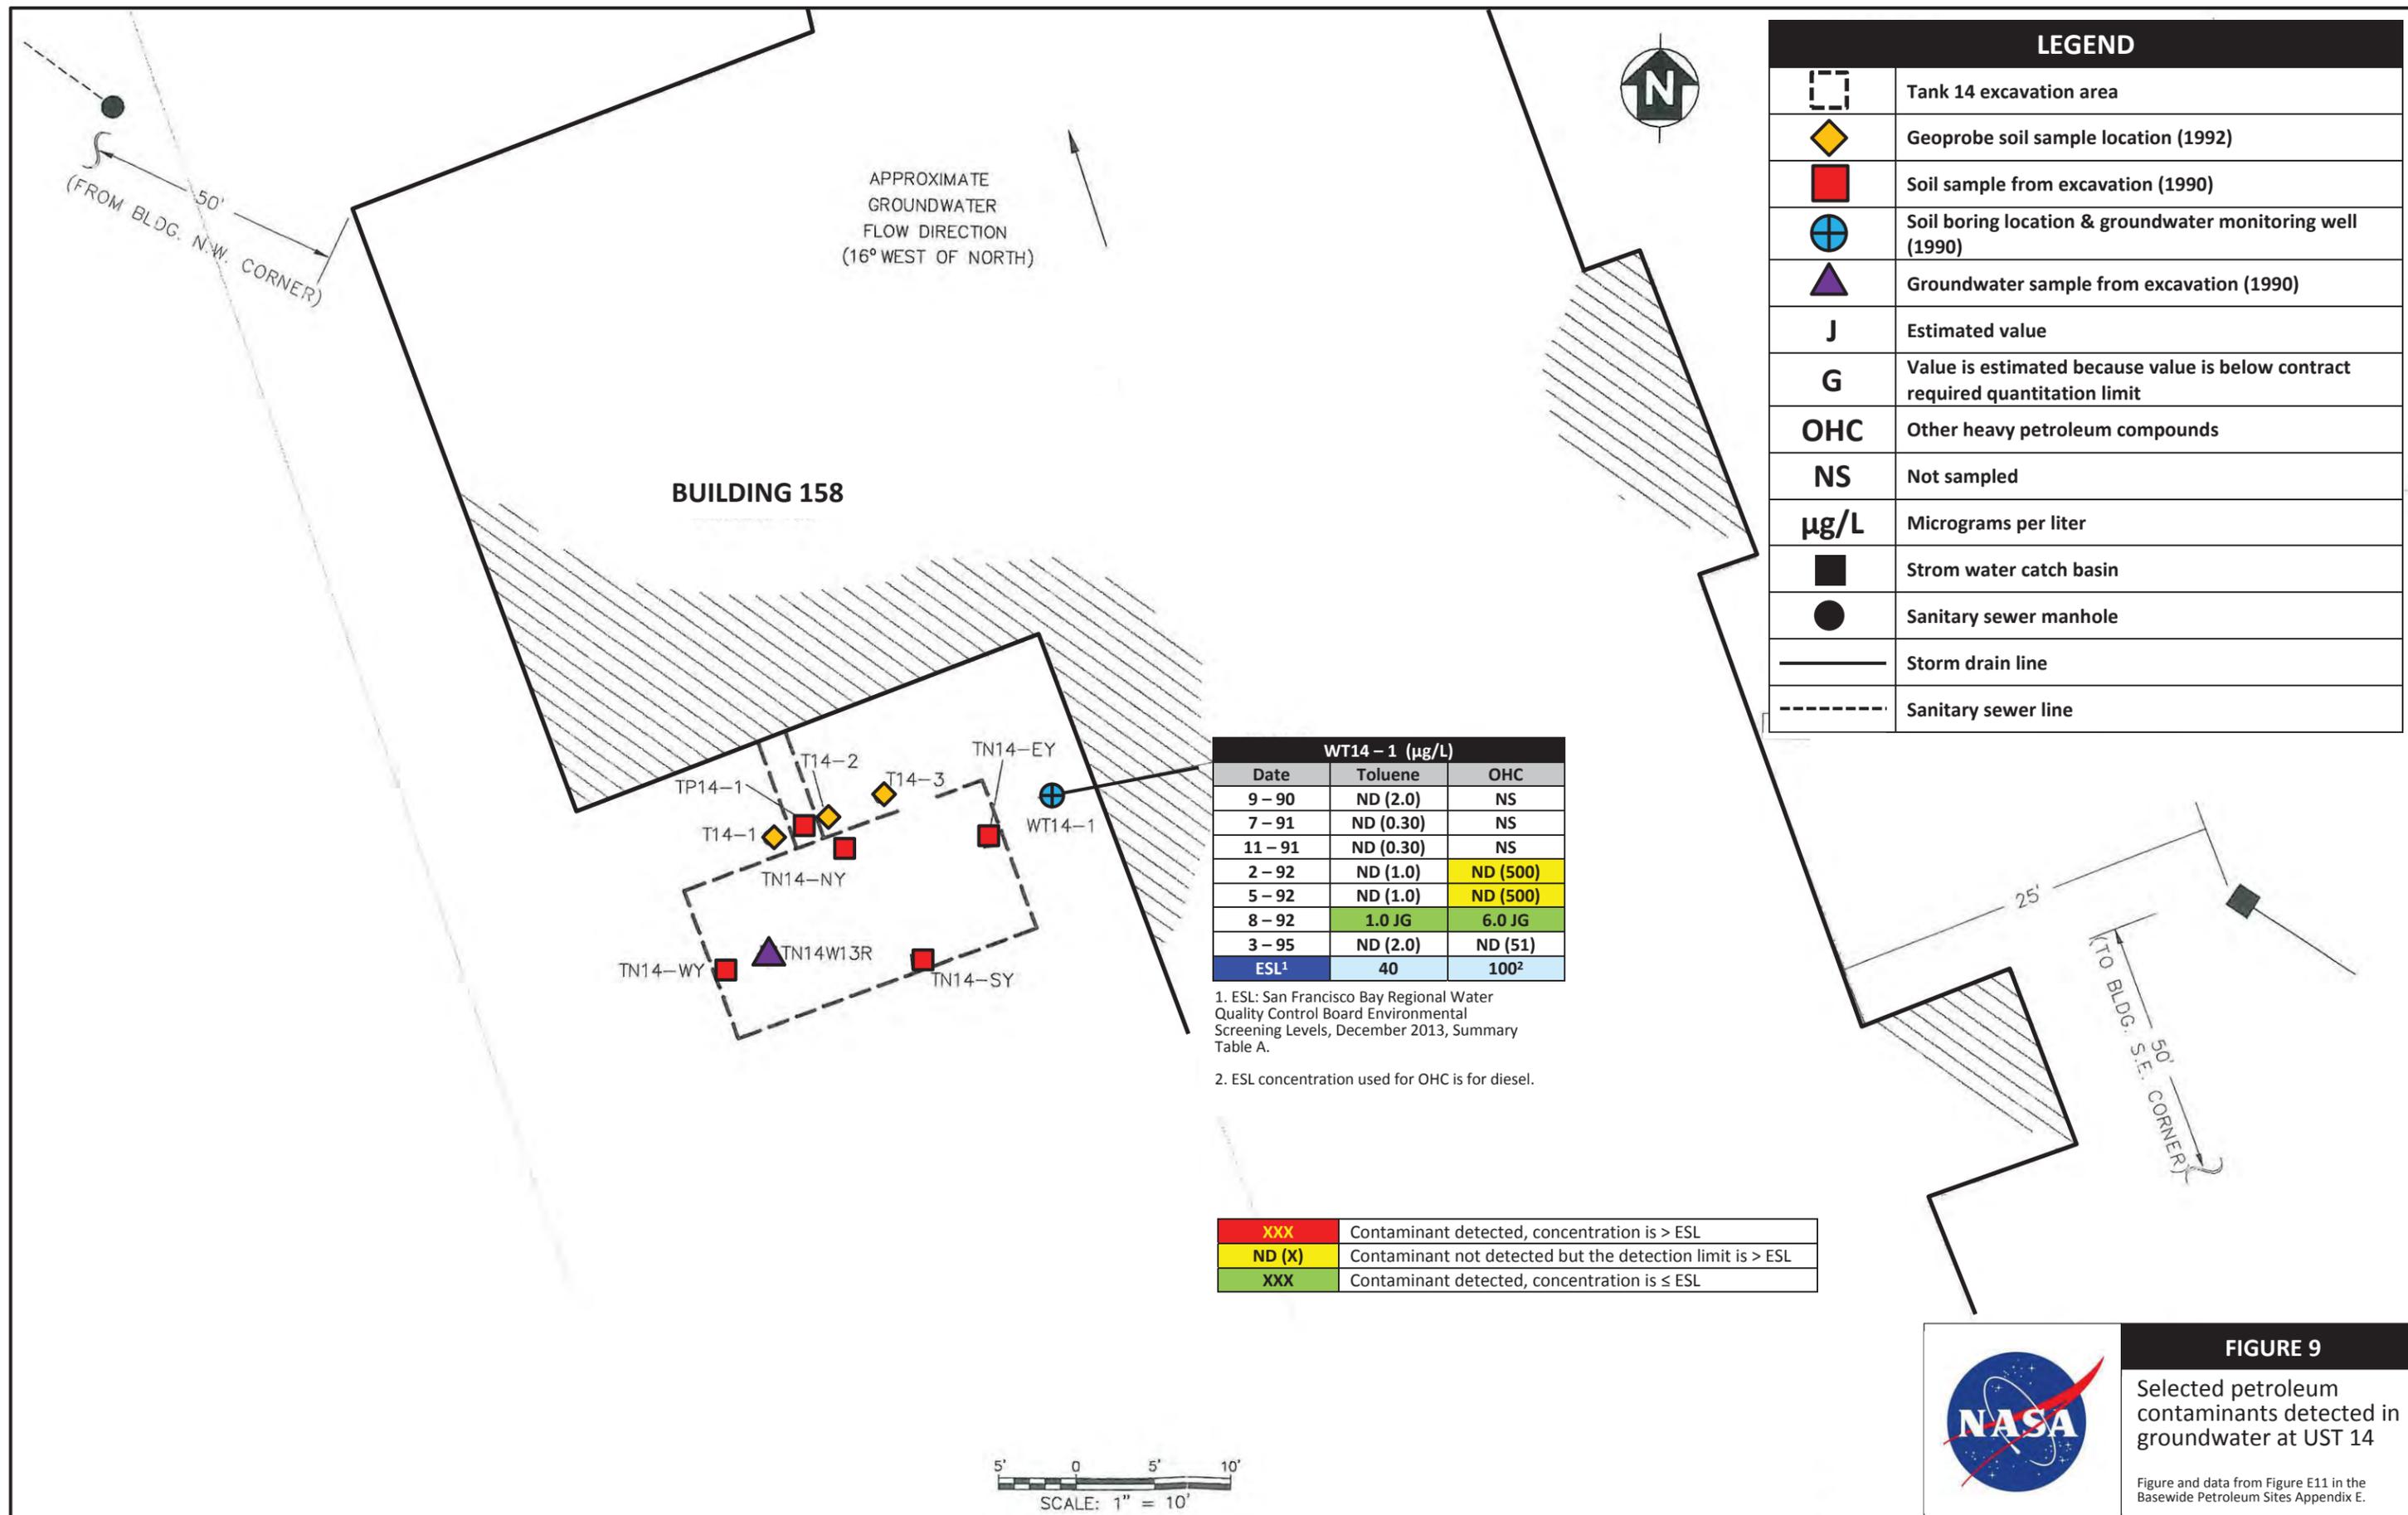
FIGURE 9
 Selected petroleum contaminants detected in groundwater at UST 14

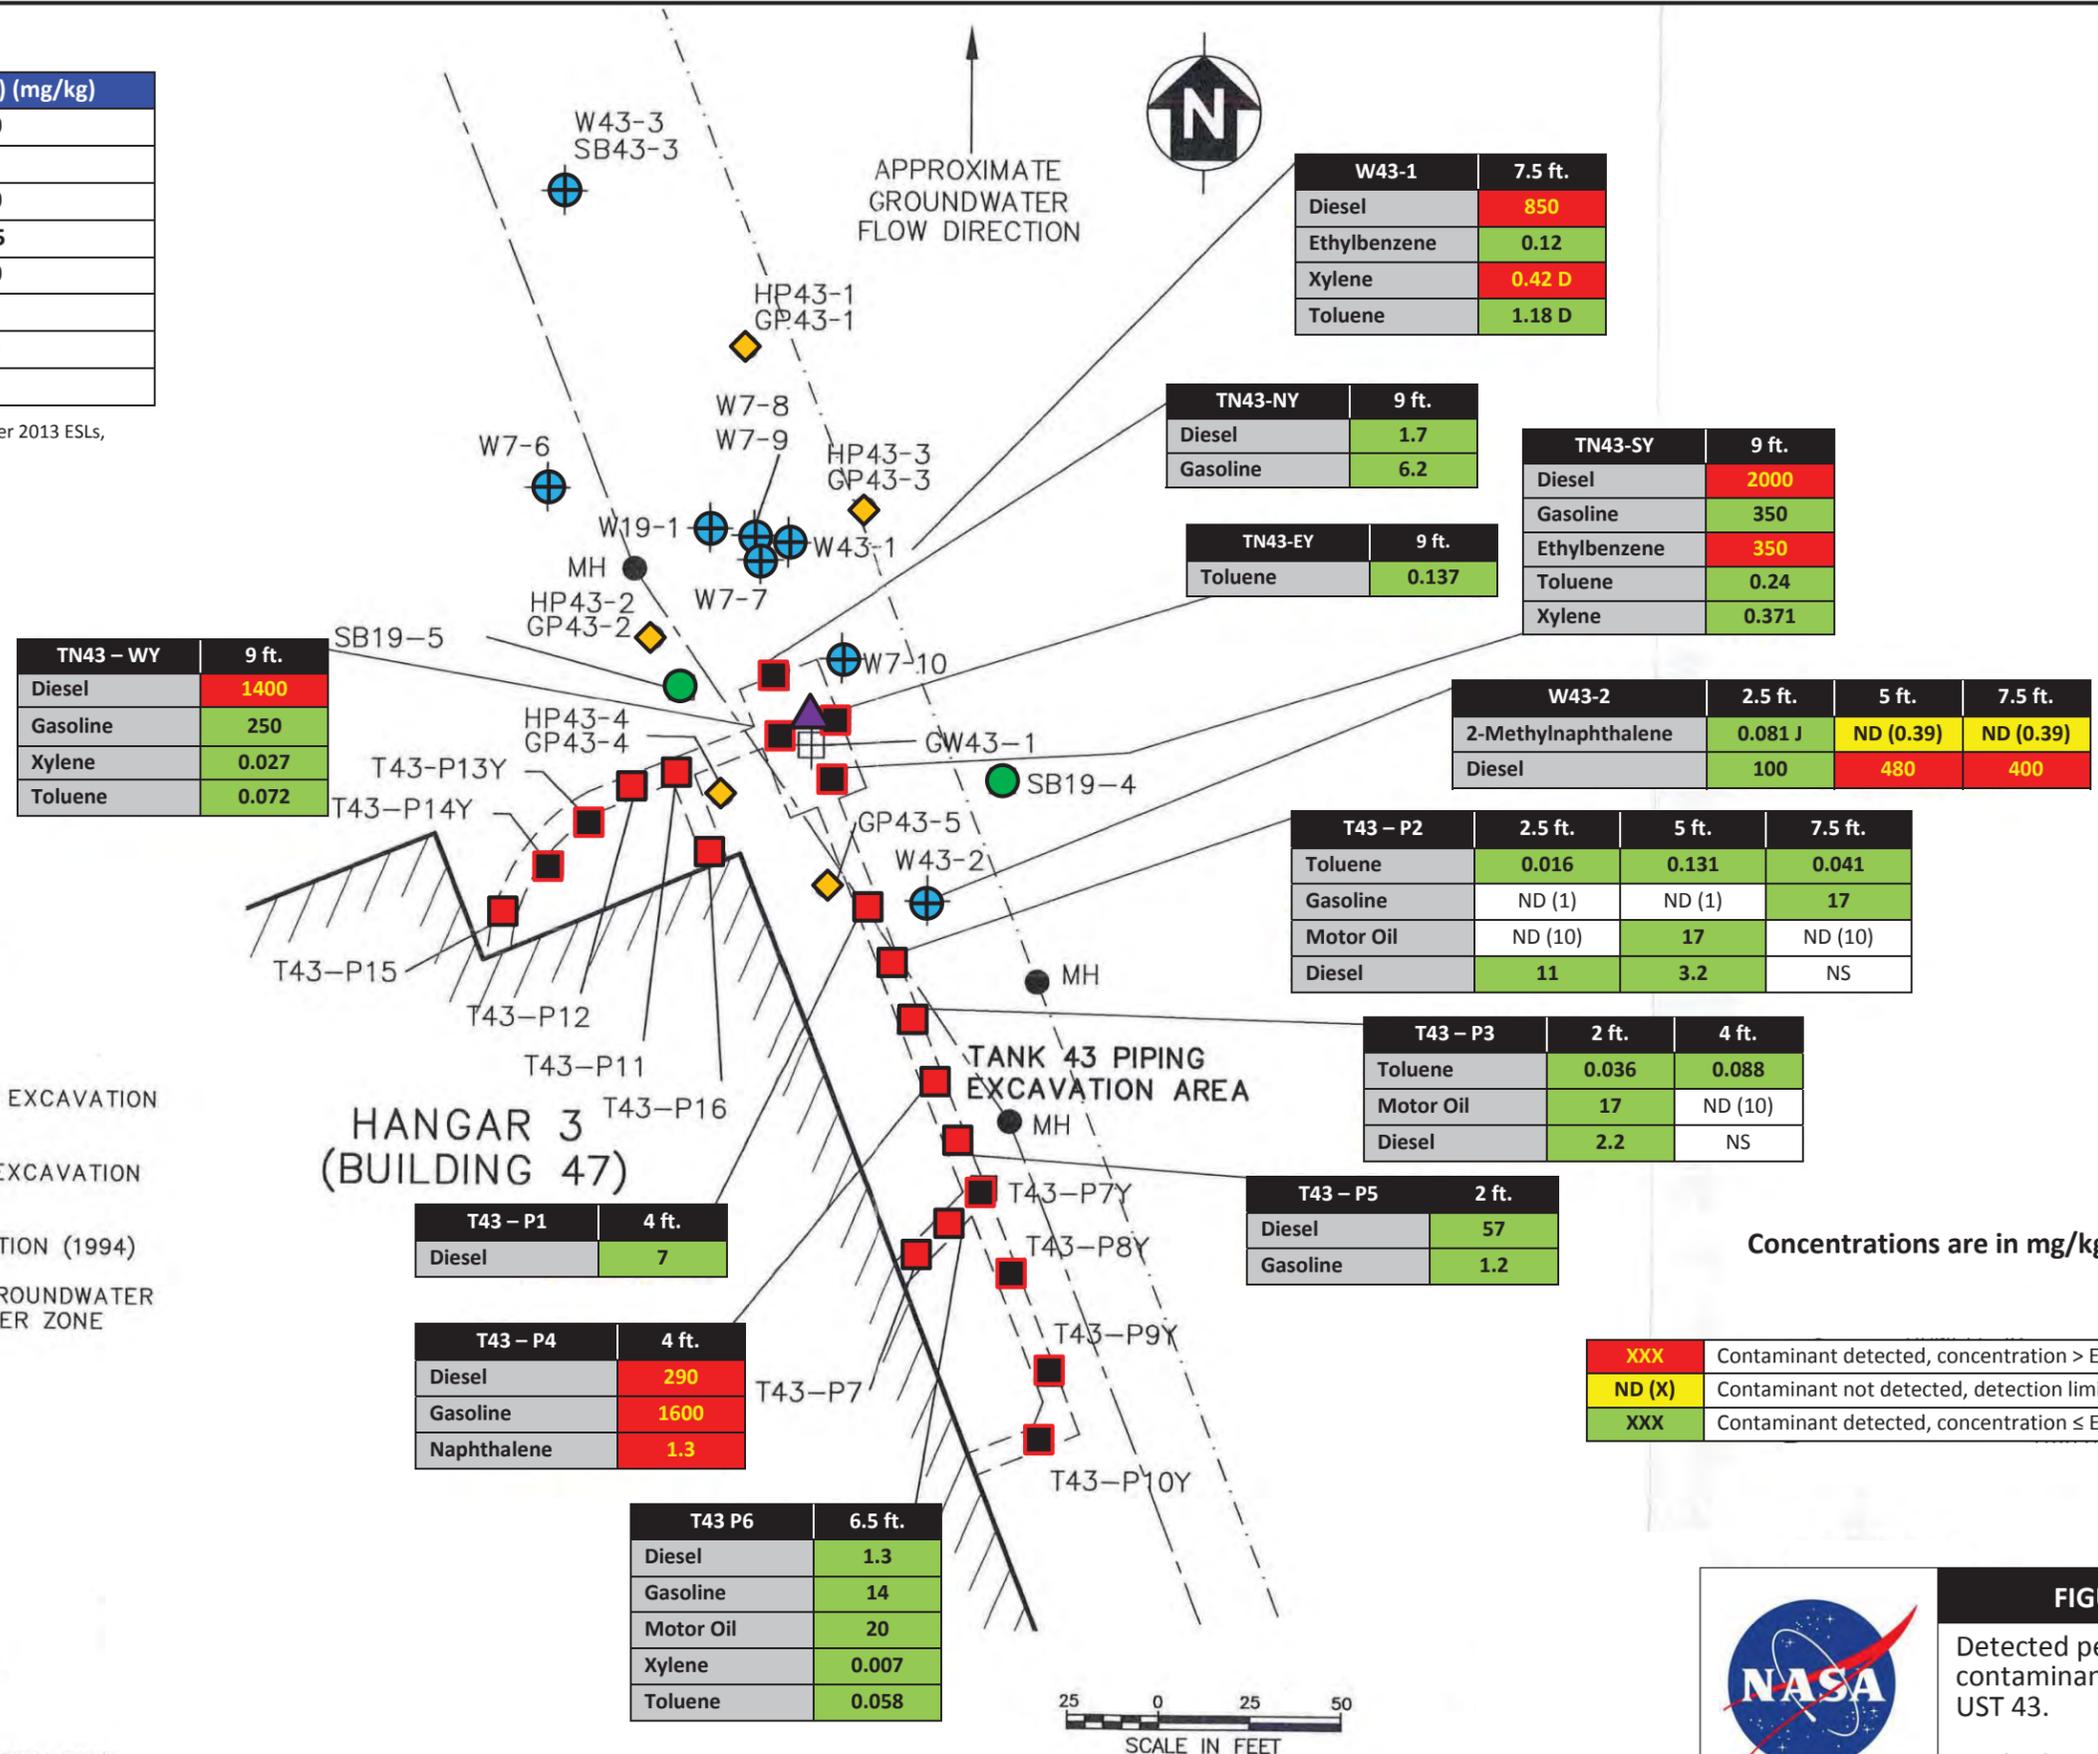
FIGURE 11
Detected petroleum contaminants in soil at UST 43.
Figure based on Figure 8 from the Phase II Basewide Tank Closure Report

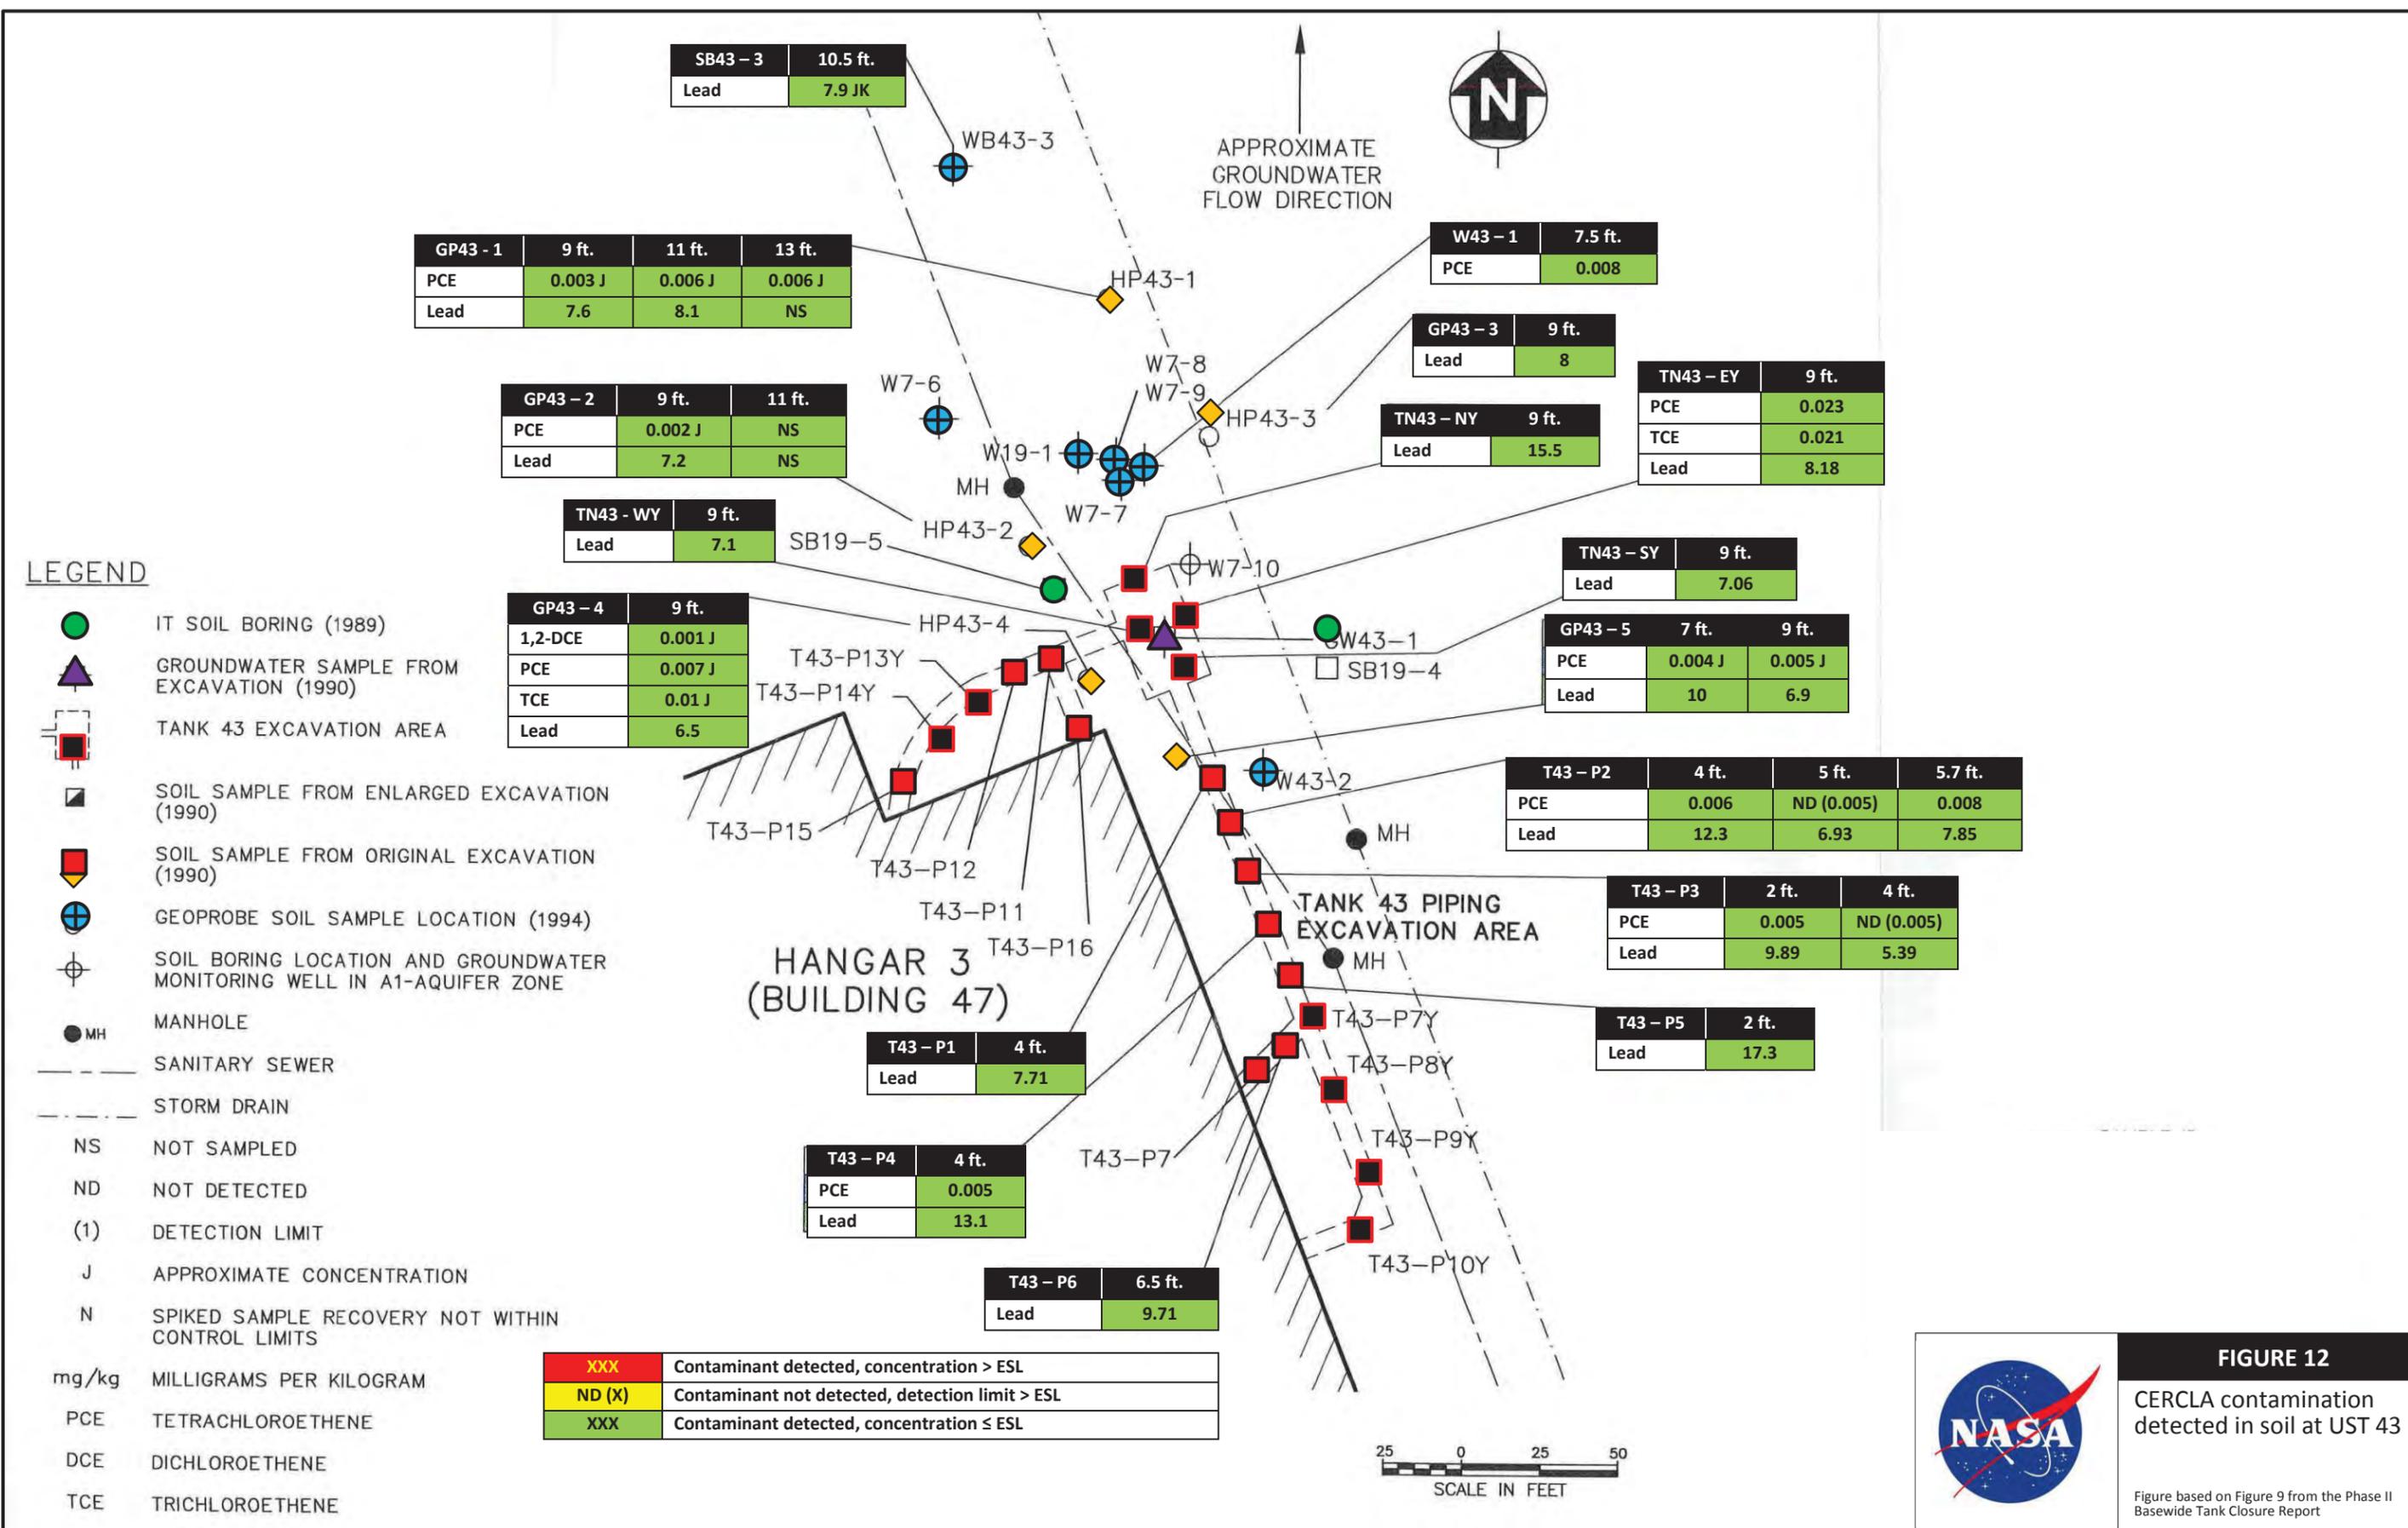
FIGURE 12

CERCLA contamination detected in soil at UST 43

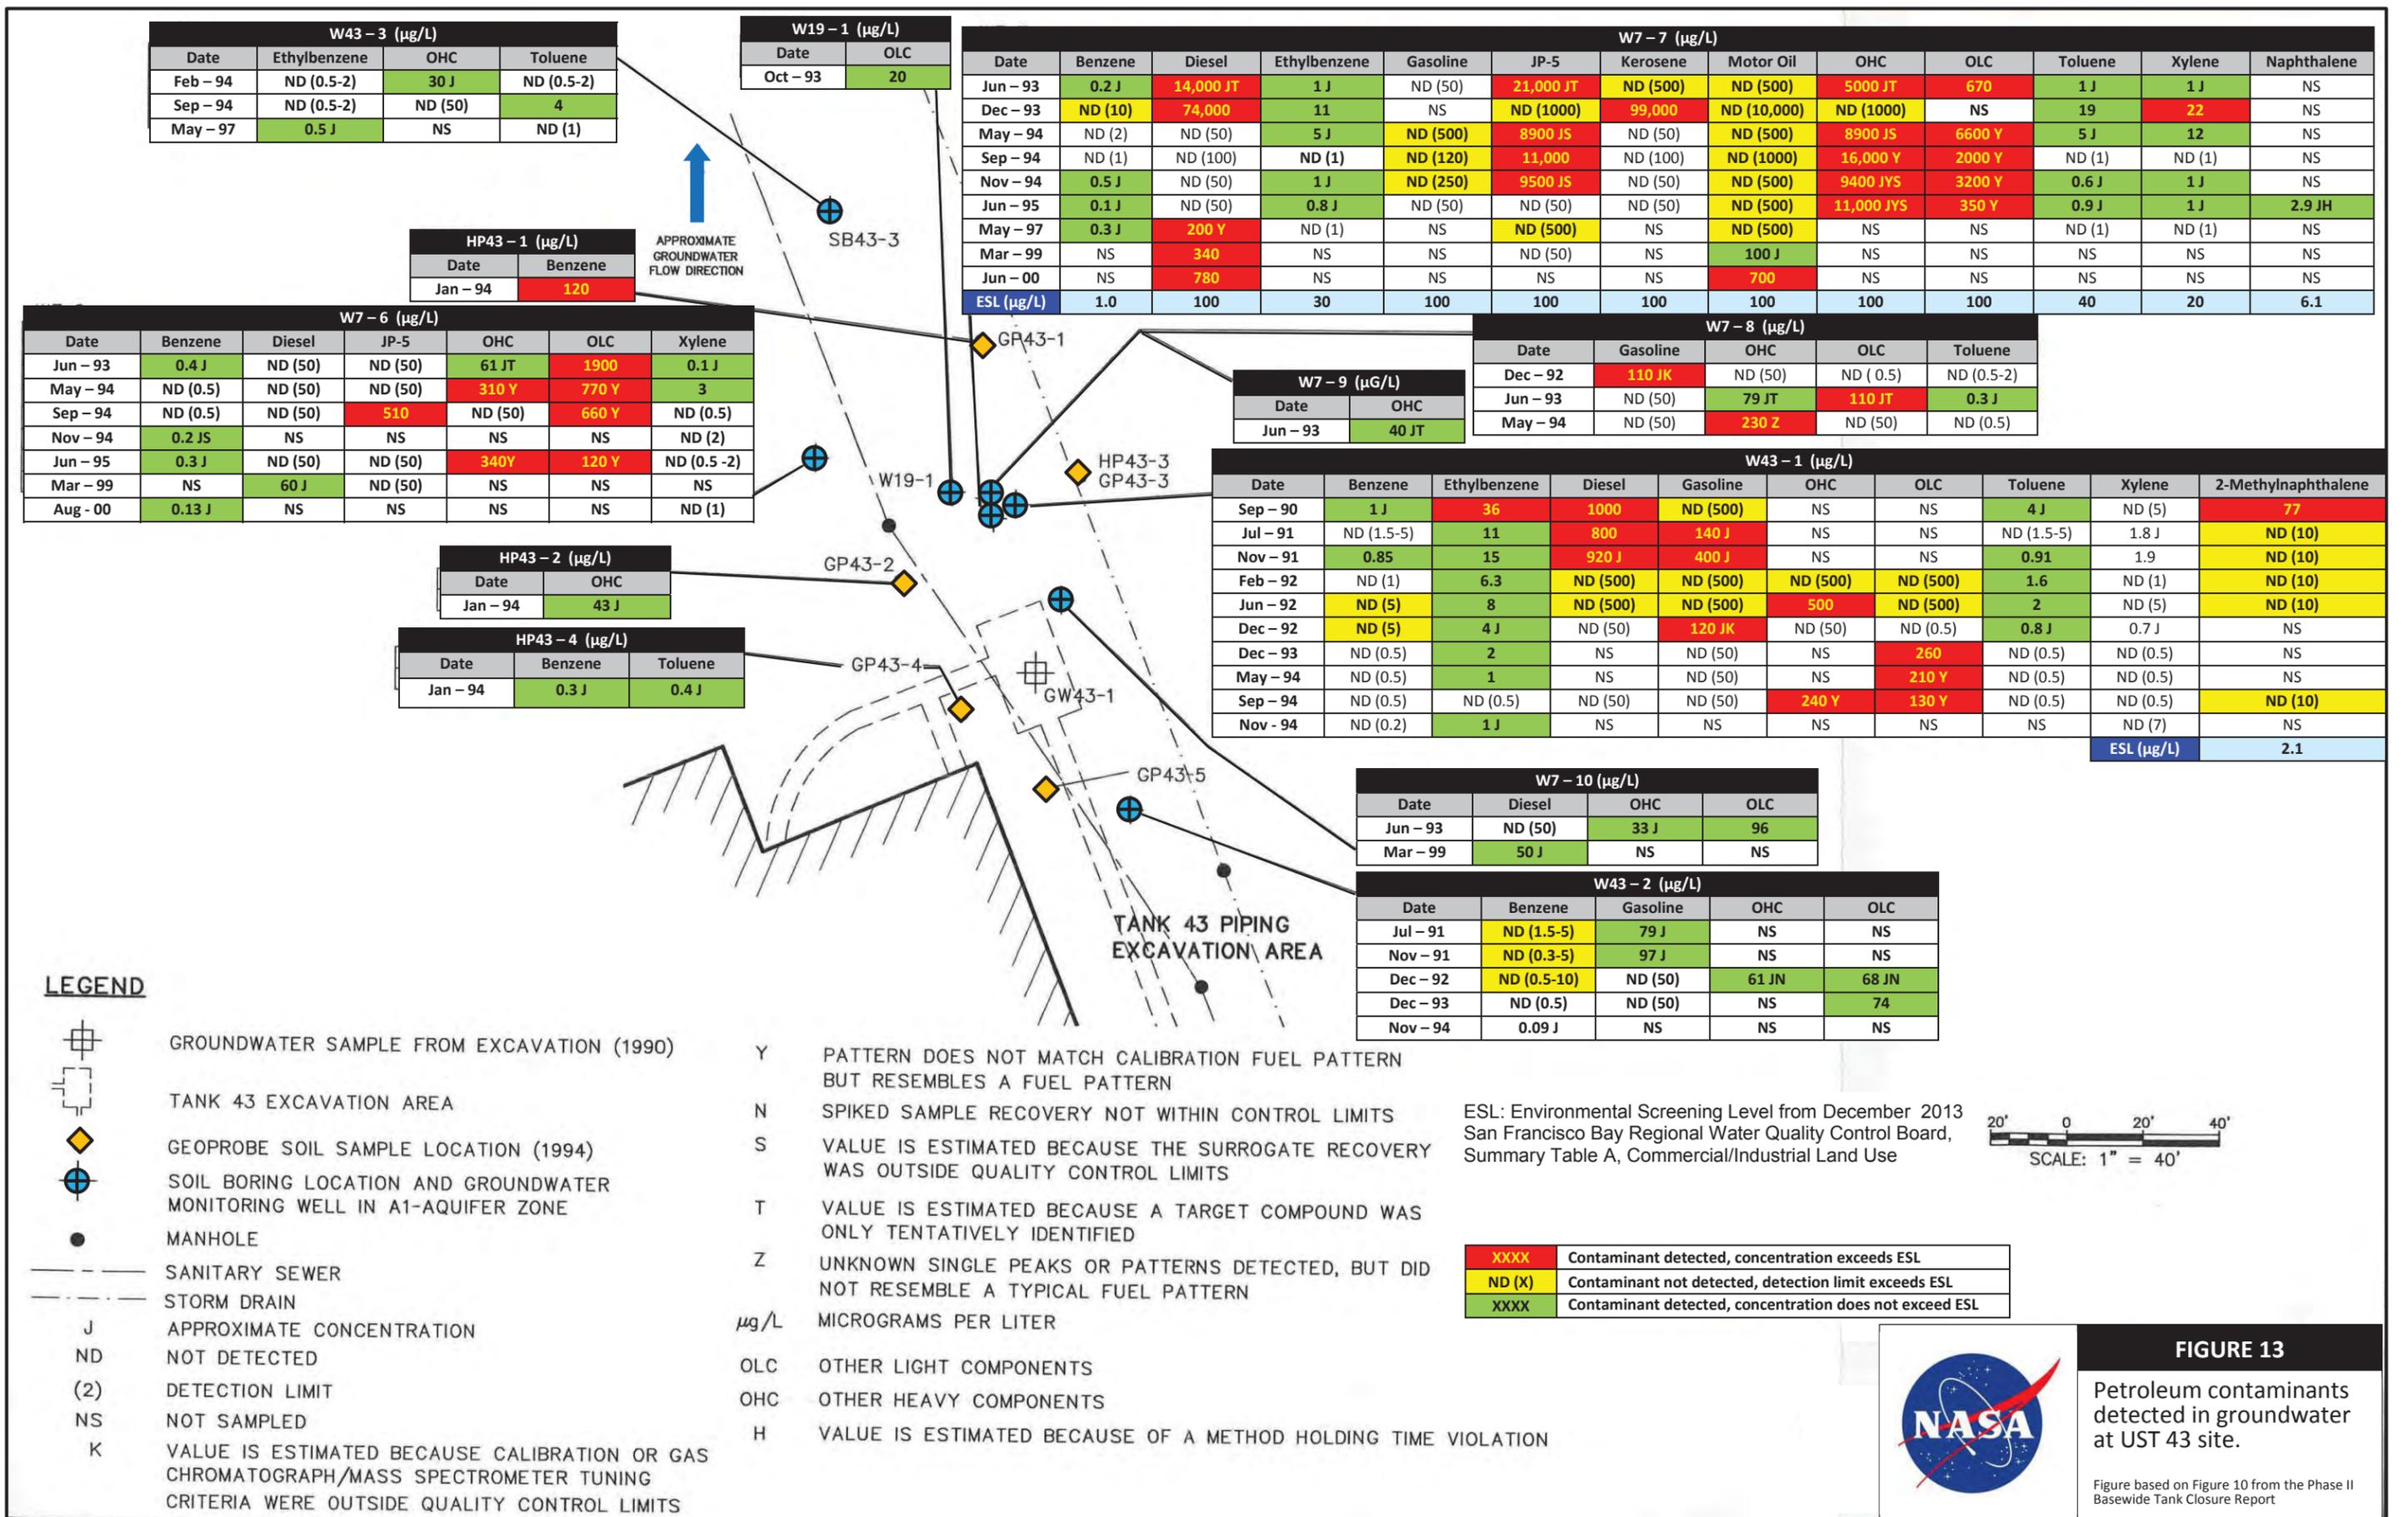
FIGURE 13
 Petroleum contaminants detected in groundwater at UST 43 site.
 Figure based on Figure 10 from the Phase II Basewide Tank Closure Report

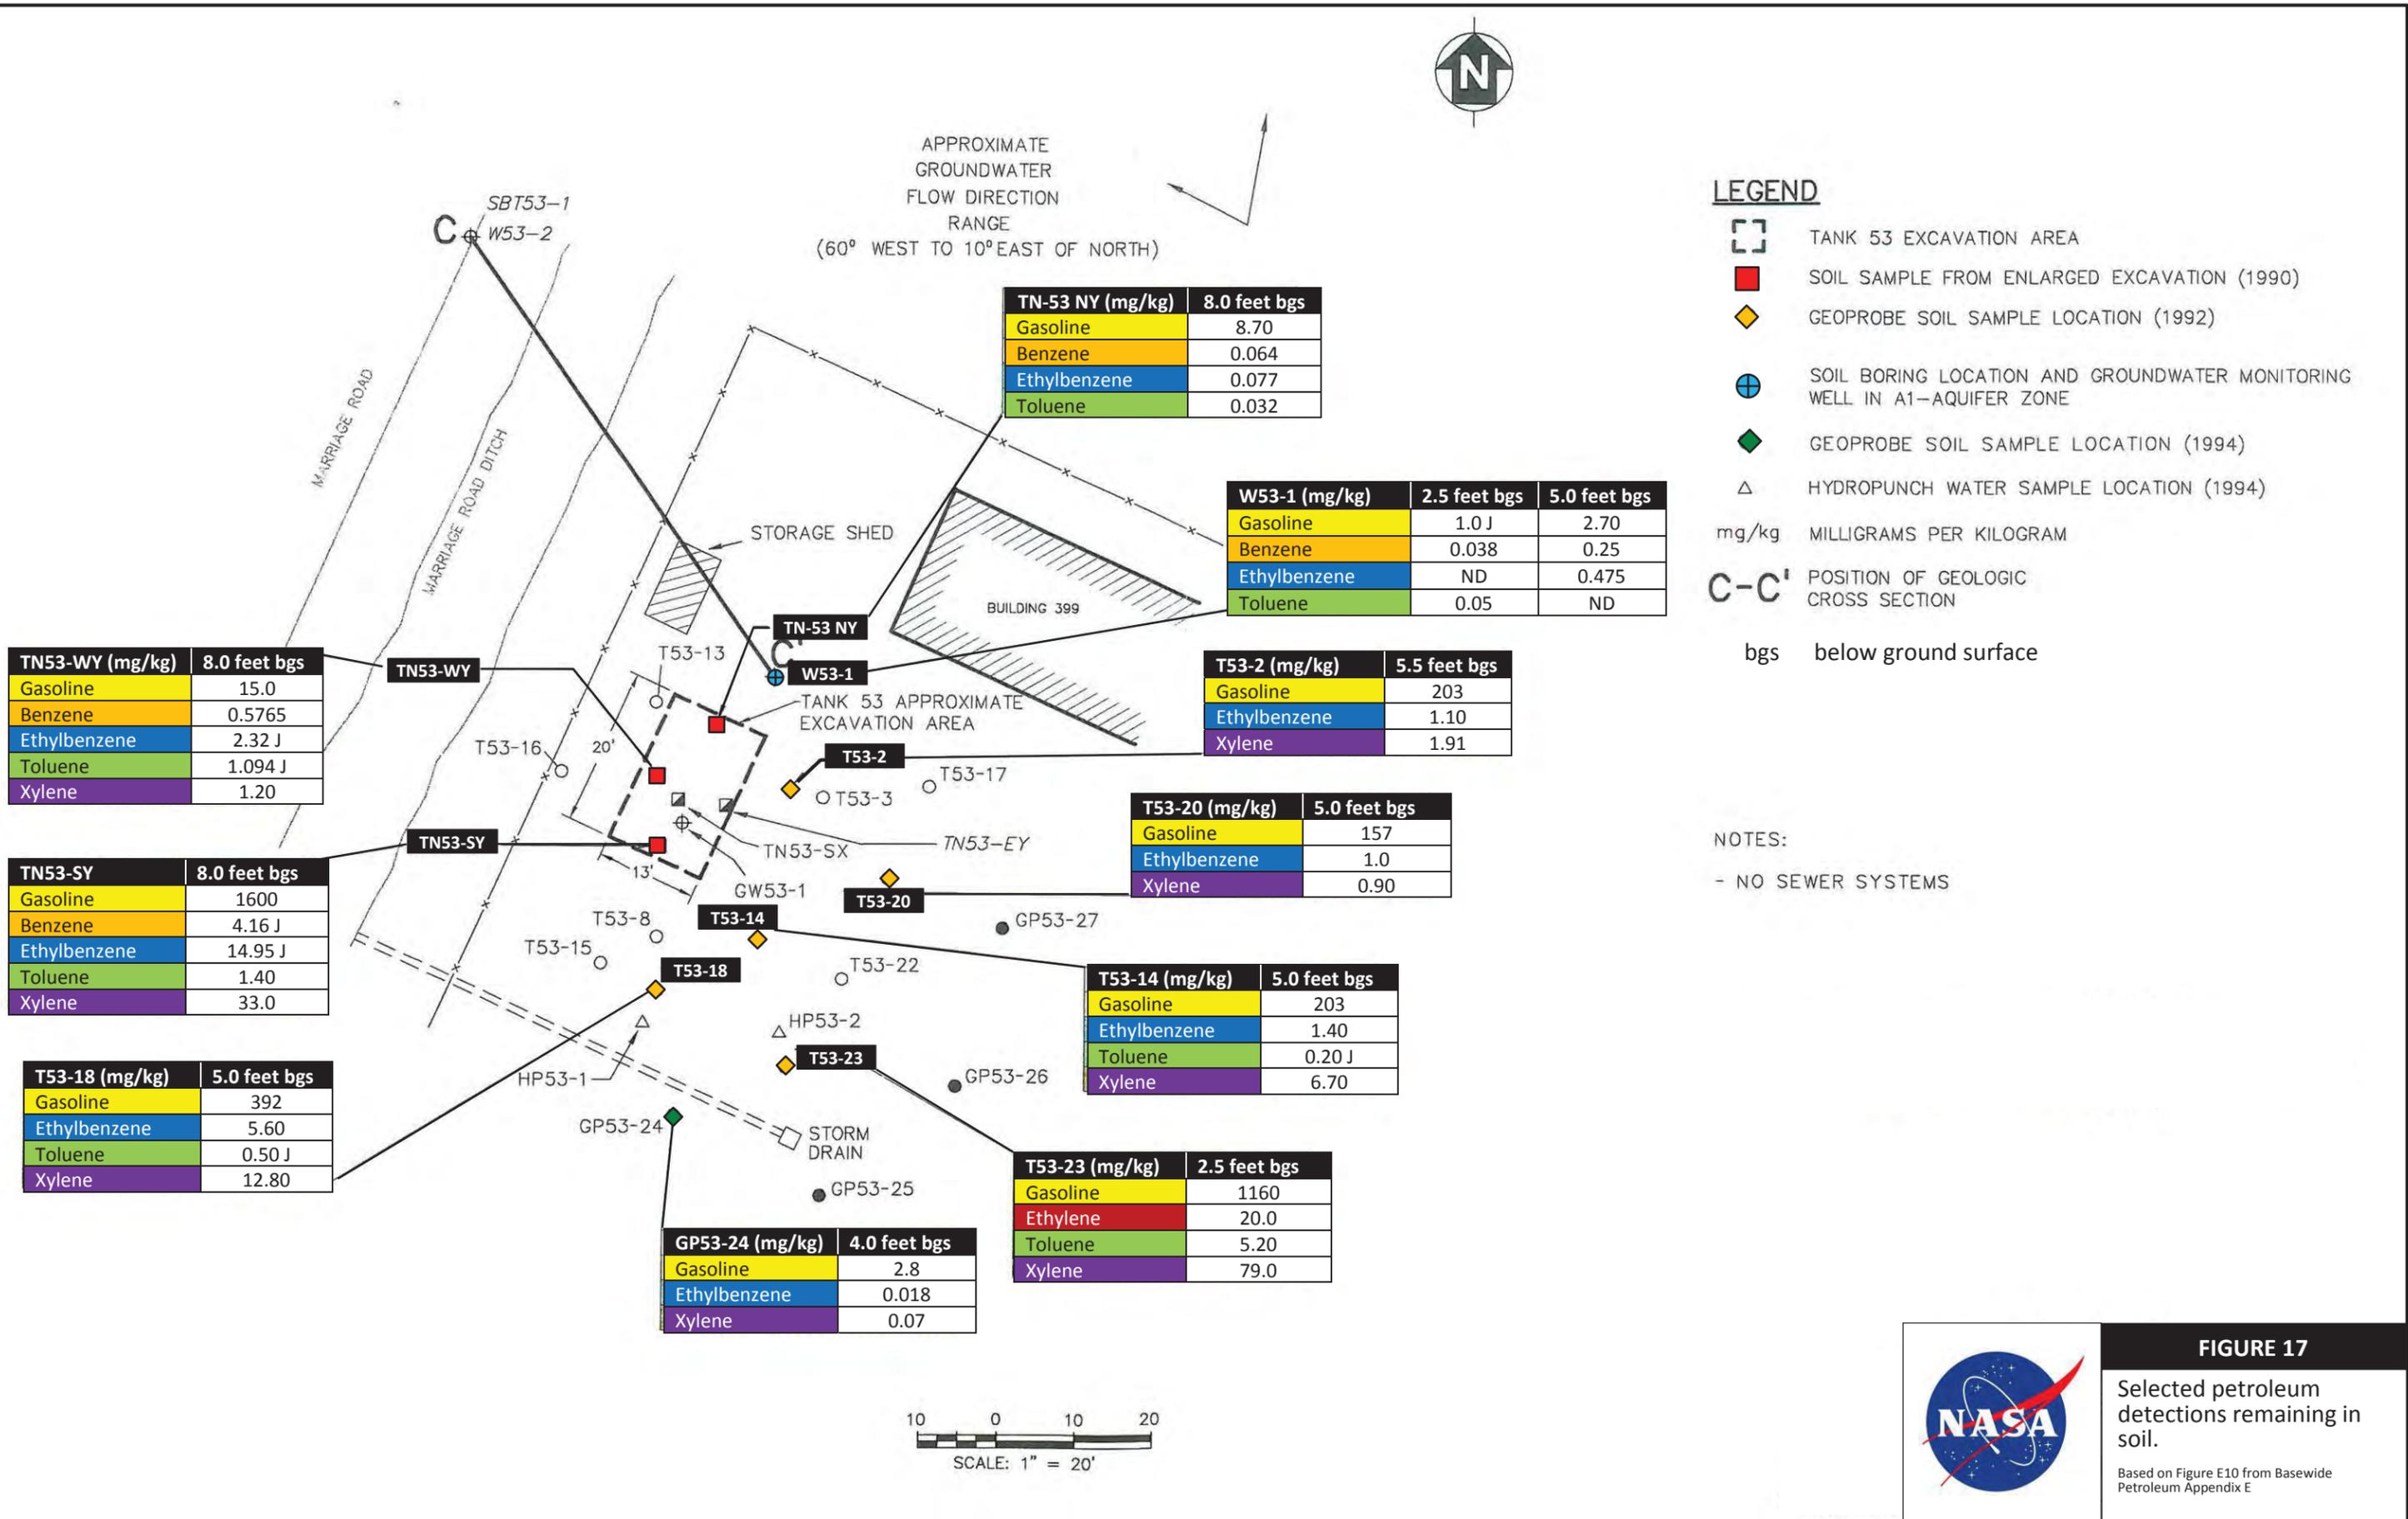
FIGURE 17

Selected petroleum detections remaining in soil.
