MFA Leasehold EIMP Appendix A - Part 2

3 March 2015

APPENDIX A

NASA EEC Statements

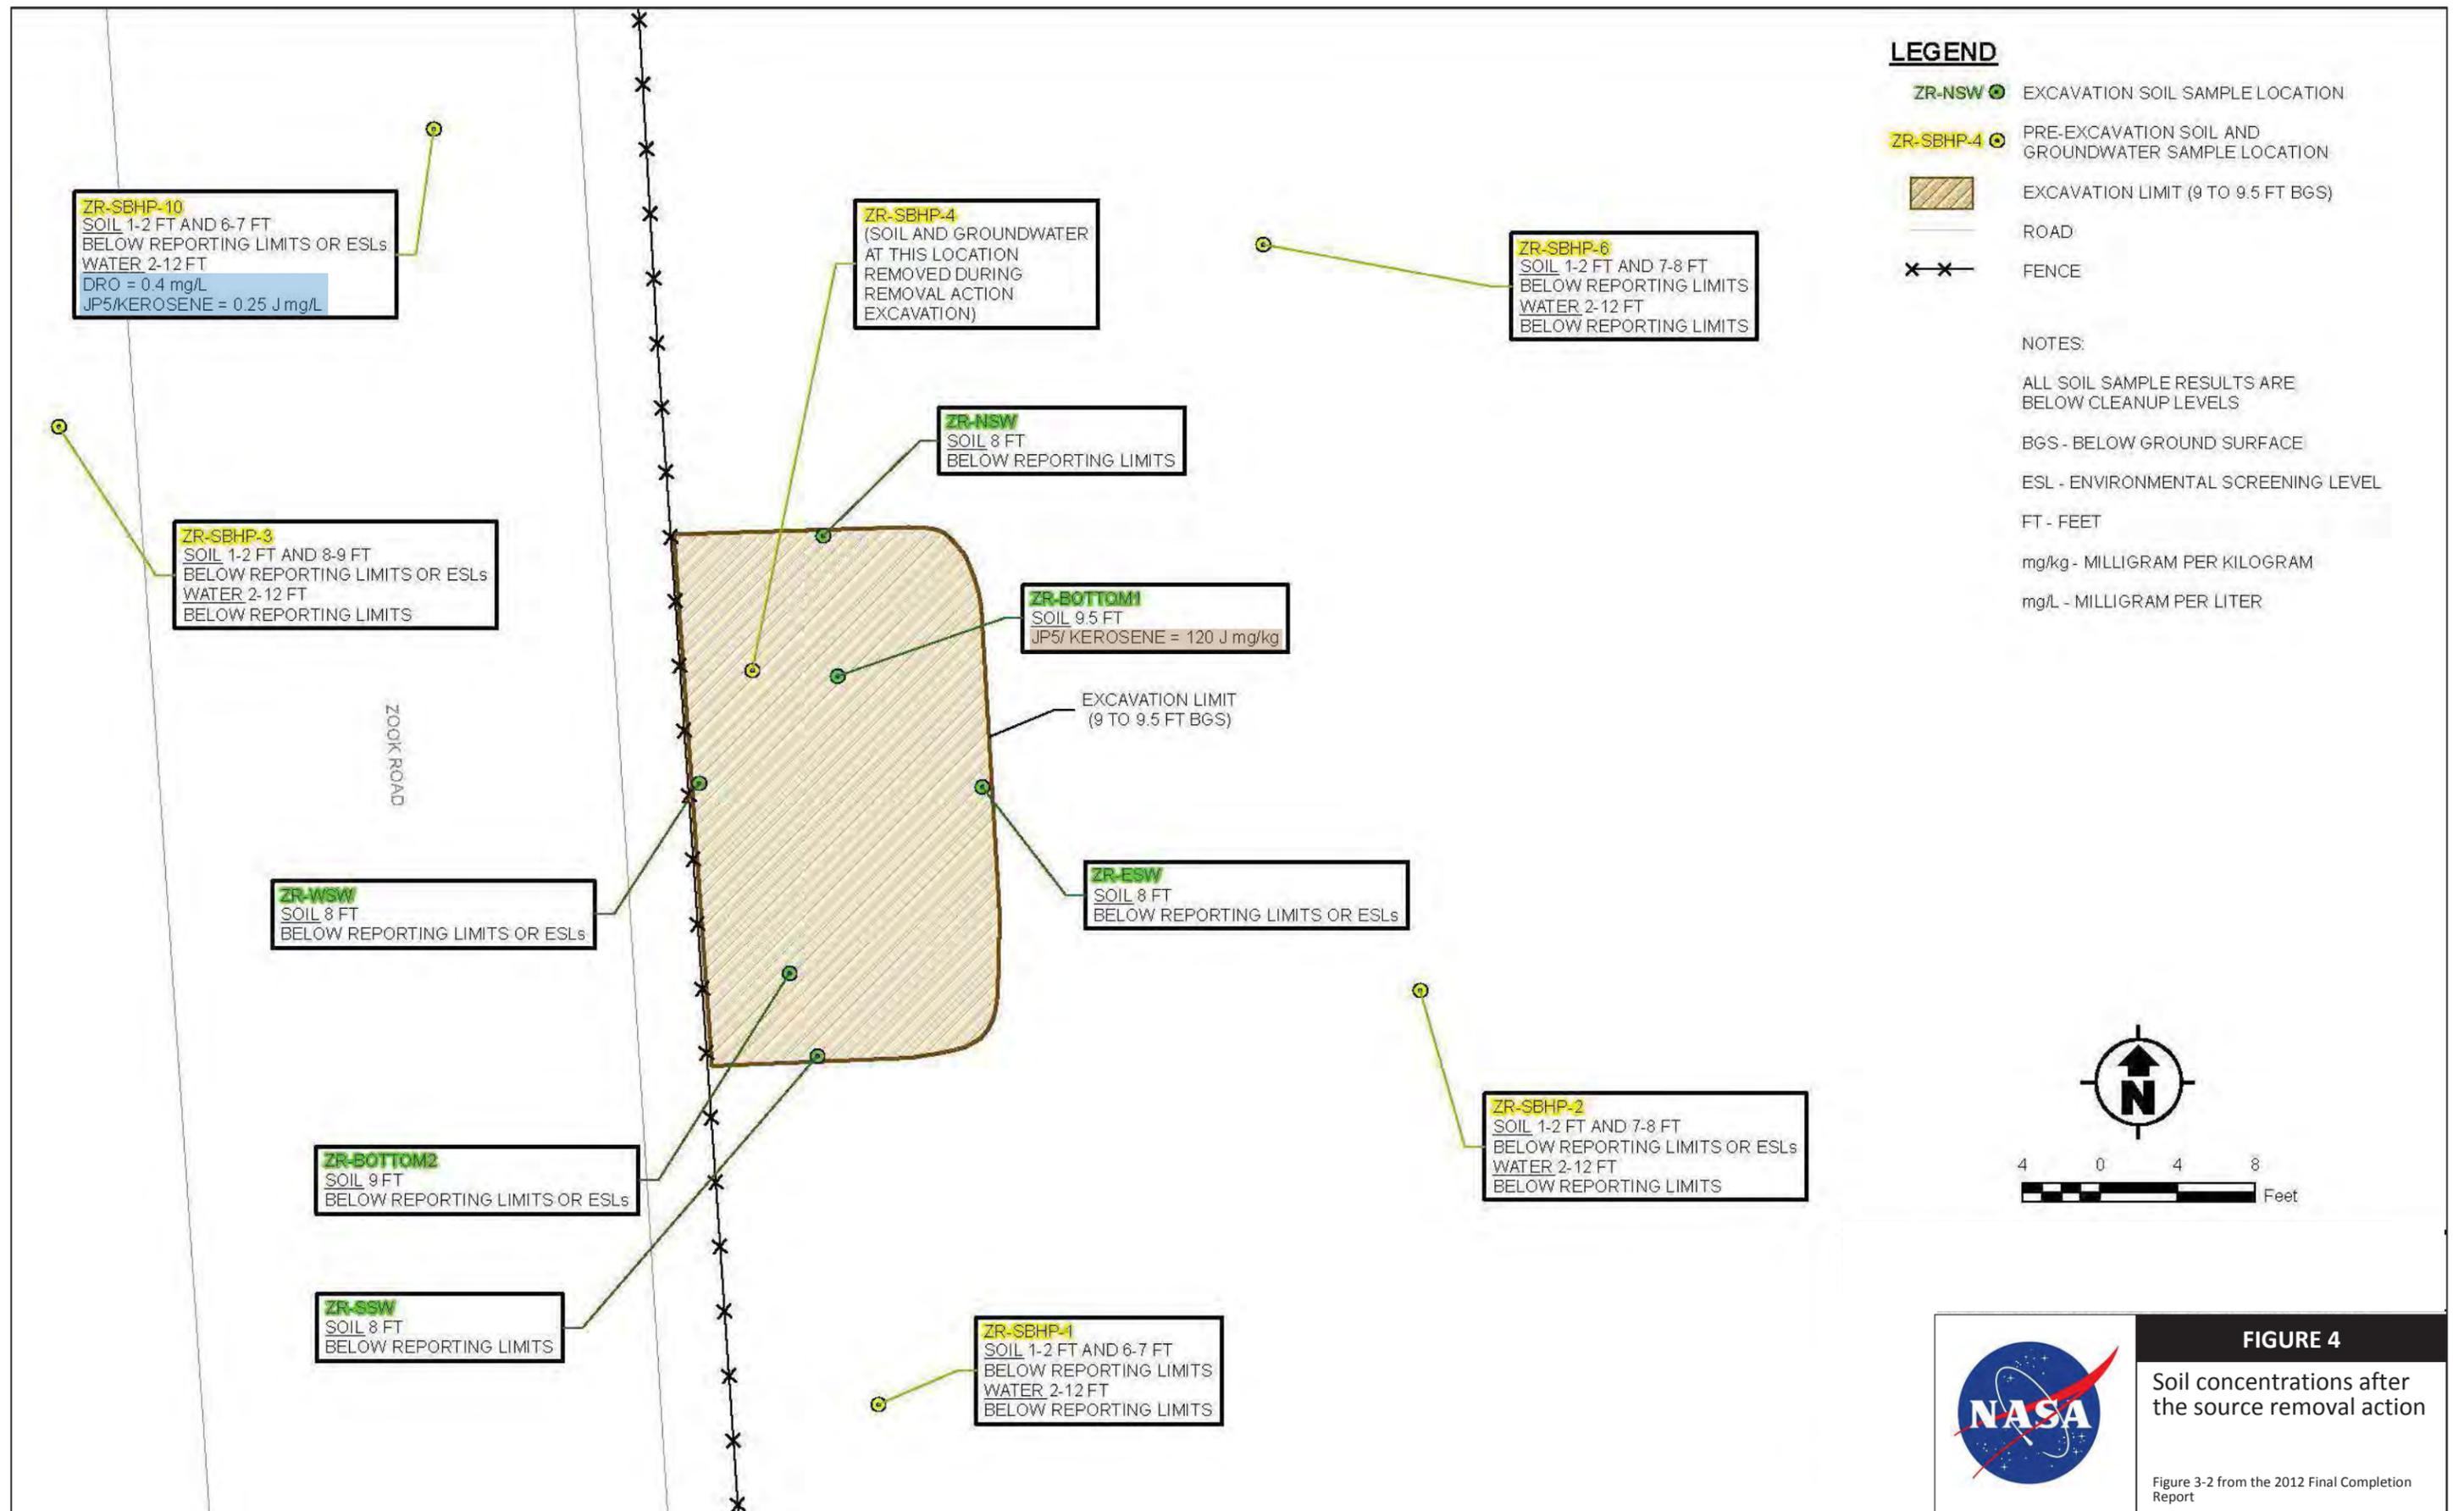
FIGURE 4
Soil concentrations after the source removal action

Figure 3-2 from the 2012 Final Completion Report

Post-excavation confirmation soil samples collected from the excavation sidewalls and were analyzed for TPH-e. TPH-e was either not detected or was less than cleanup goals (the maximum observed concentration in these samples was 120 mg/kg of TPH-e as JP-5/kerosene) (Figure 4).

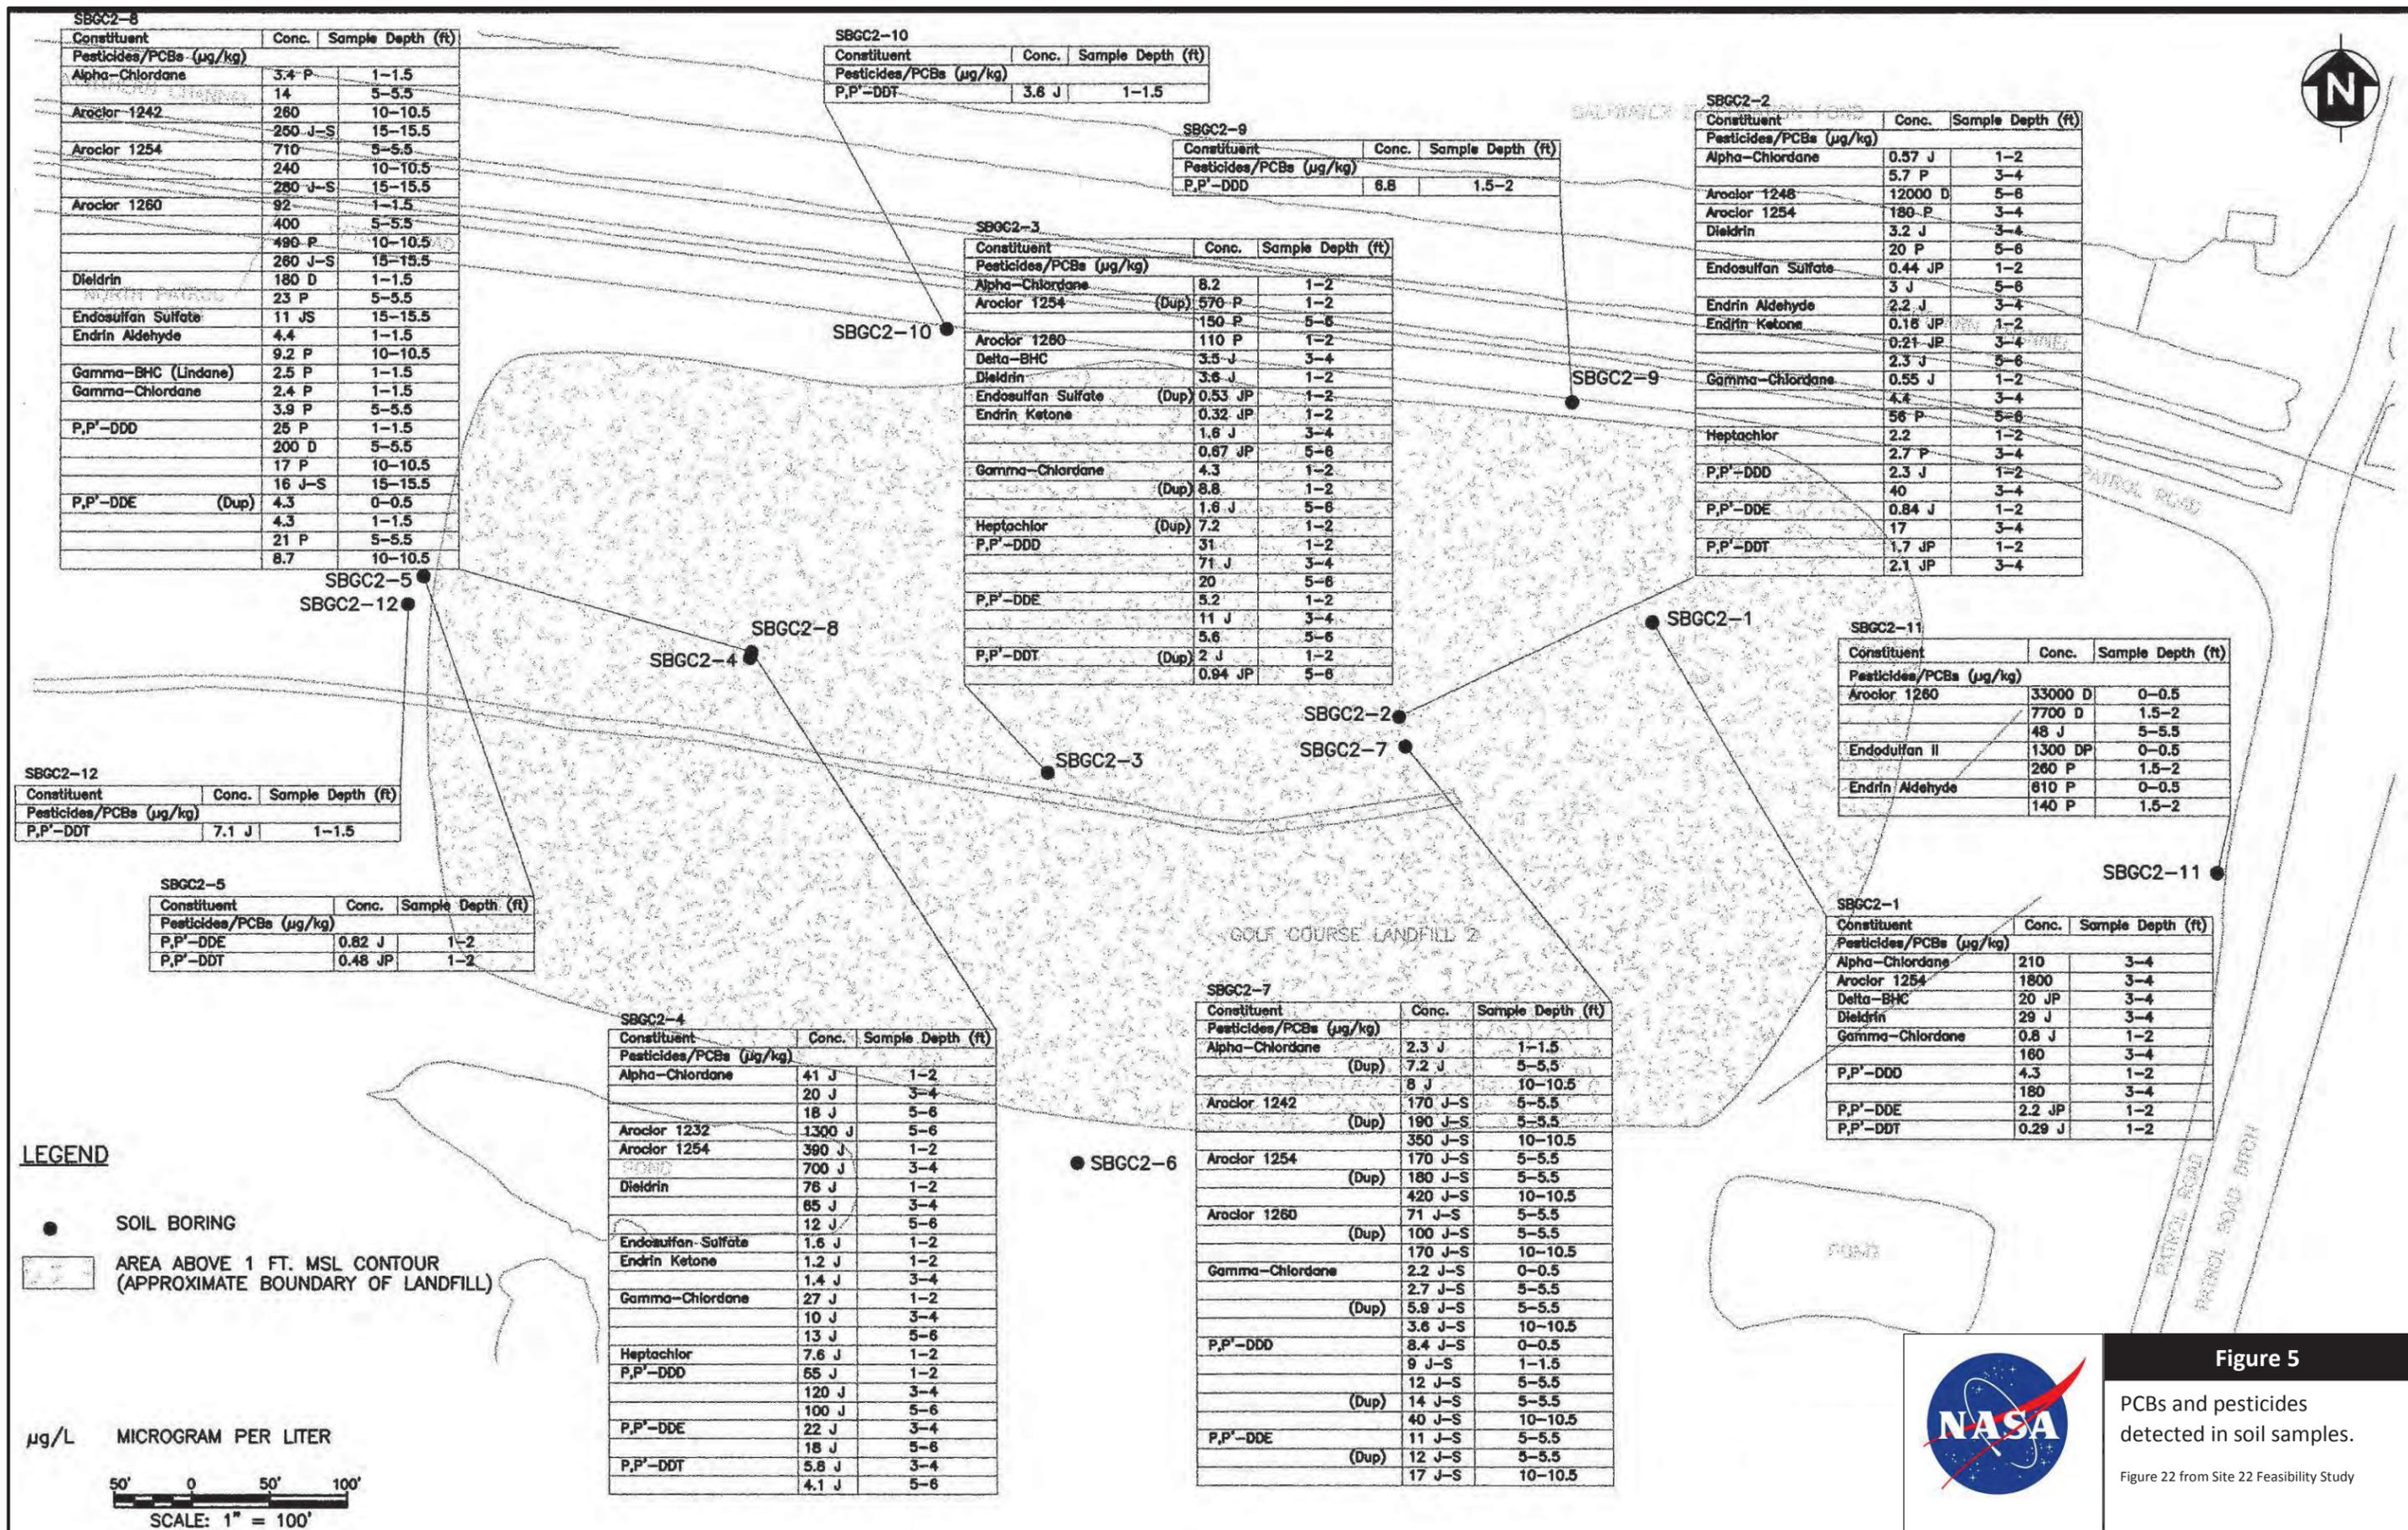
Figure 5

PCBs and pesticides detected in soil samples.

Figure 22 from Site 22 Feasibility Study

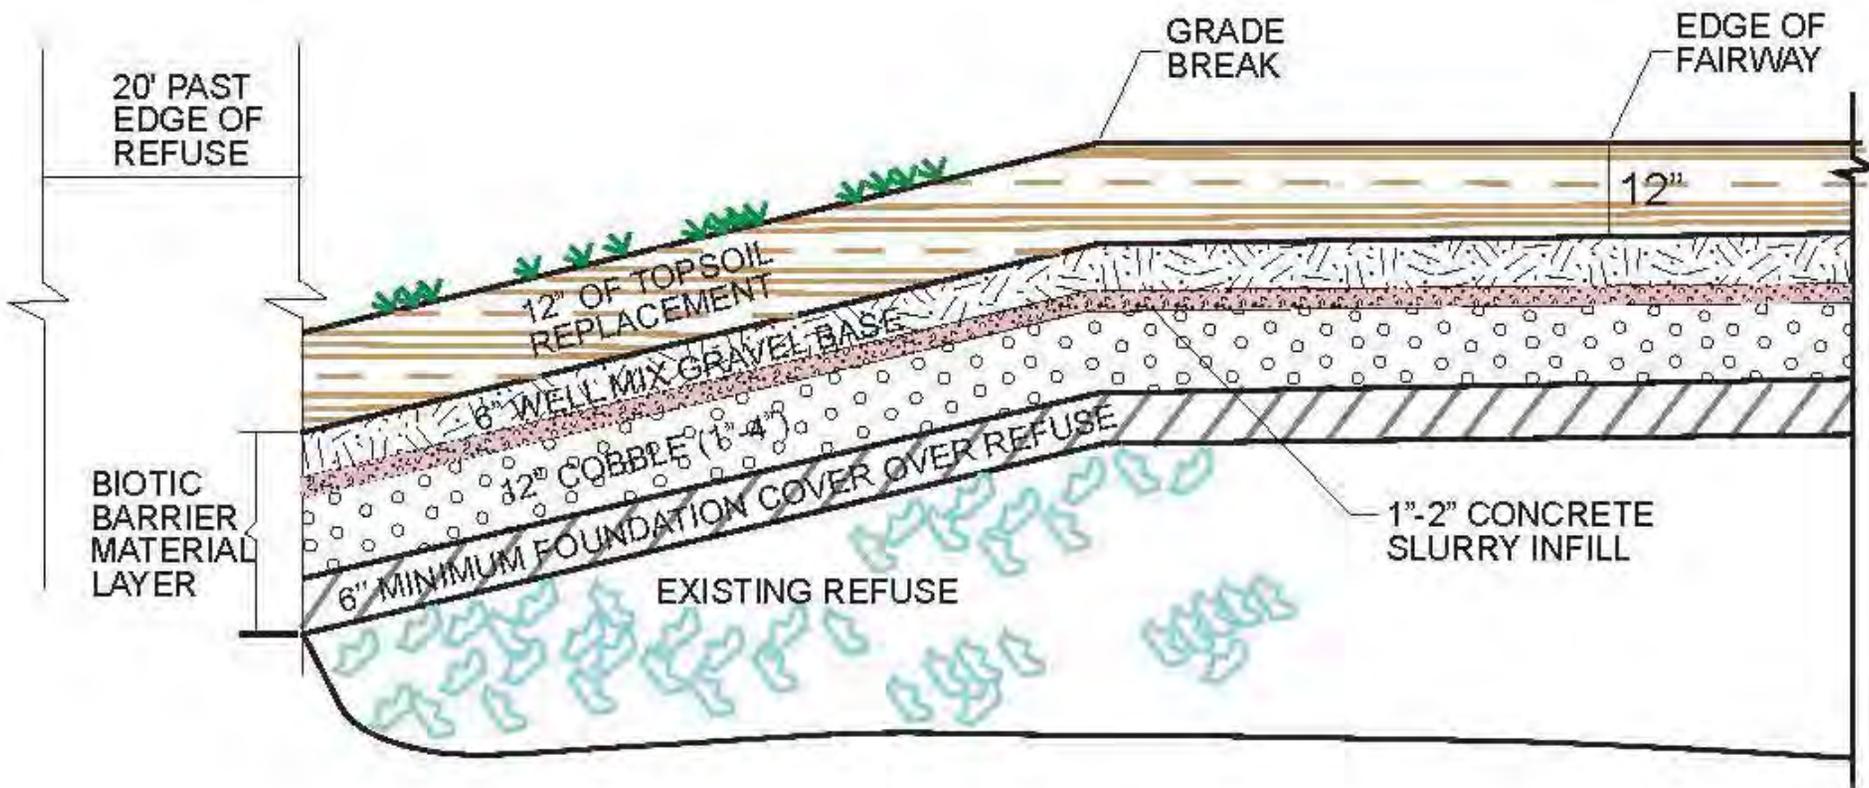
BIOTIC BARRIER COVER

FIGURE 6
 Schematic of Site 22 Biotic Barrier Cover.
 Source: Five-Year Review: IR Sites 1, 22, 26, and 28

Remedy	Biotic Barrier (Figures 6 & 7)	Begin Date	Jan 2003	End Date	Aug 2003
<p>Cover (from bottom to top):</p> <ul style="list-style-type: none"> • 6-inch foundation layer • 12-inch layer of 4- to 8-inch cobblestone cover with a concrete & sand slurry • 6-inch coarse granular 3/8-inch pea gravel drainage layer • 8-ounce geotextile fabric layer • 8-inch topsoil layer capped a four-inch layer of sand <p>Tree wells were installed to allow the planting of trees at the golf course while not disturbing the biotic barrier. The tree wells consisted of a six-foot diameter plastic liner extending from the ground surface to the foundation layer.</p> <p>A new drainage swale was installed to carry water from the drainage layer on the northern portion of Site 22. The swale directed water into the North Patrol Road ditch through 2 1-foot diameter culverts.</p> <p>The cover was graded to direct sheet-flow water away from the landfill.</p>		<p>The golf course holes were restored on the surface of the landfill.</p>

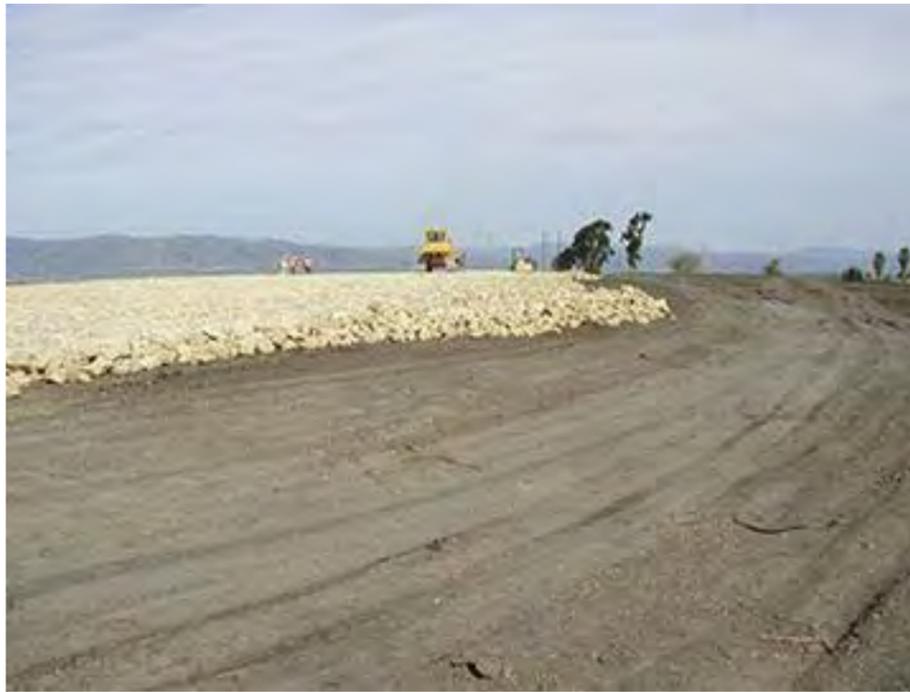
Photograph showing foundation layer with cobblestone layer being installed

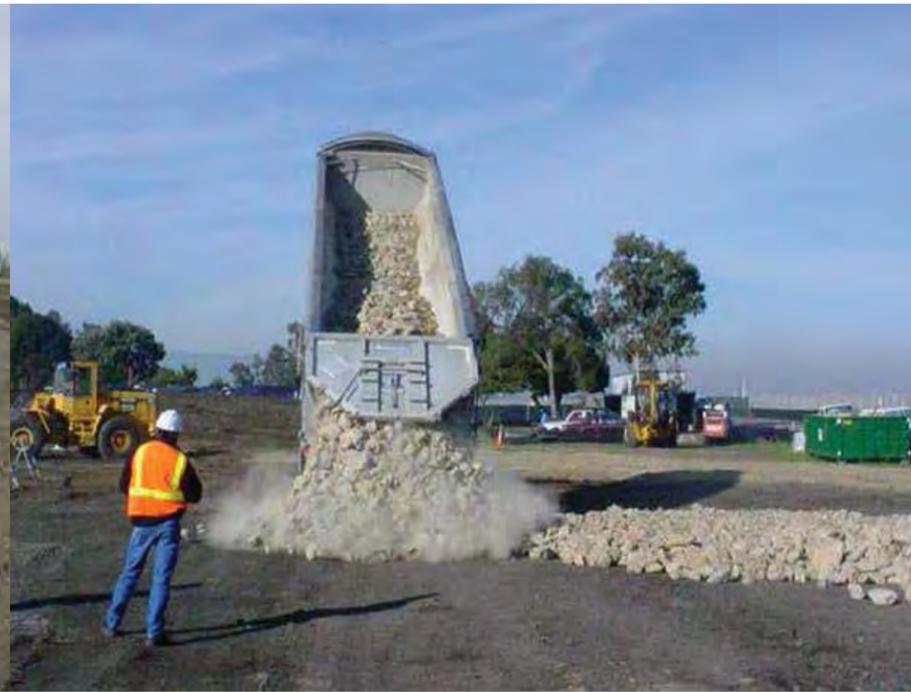
Cobblestone being placed on top of the foundation layer

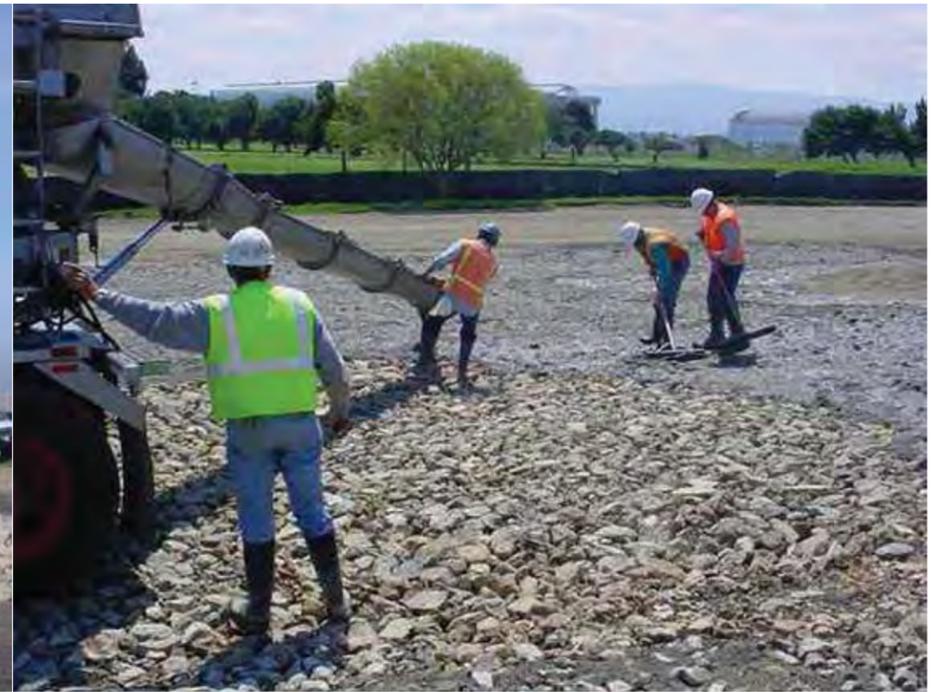
Placement of concrete and sand slurry to top of cobble layer

Photographs showing the various construction phases of the biotic barrier.

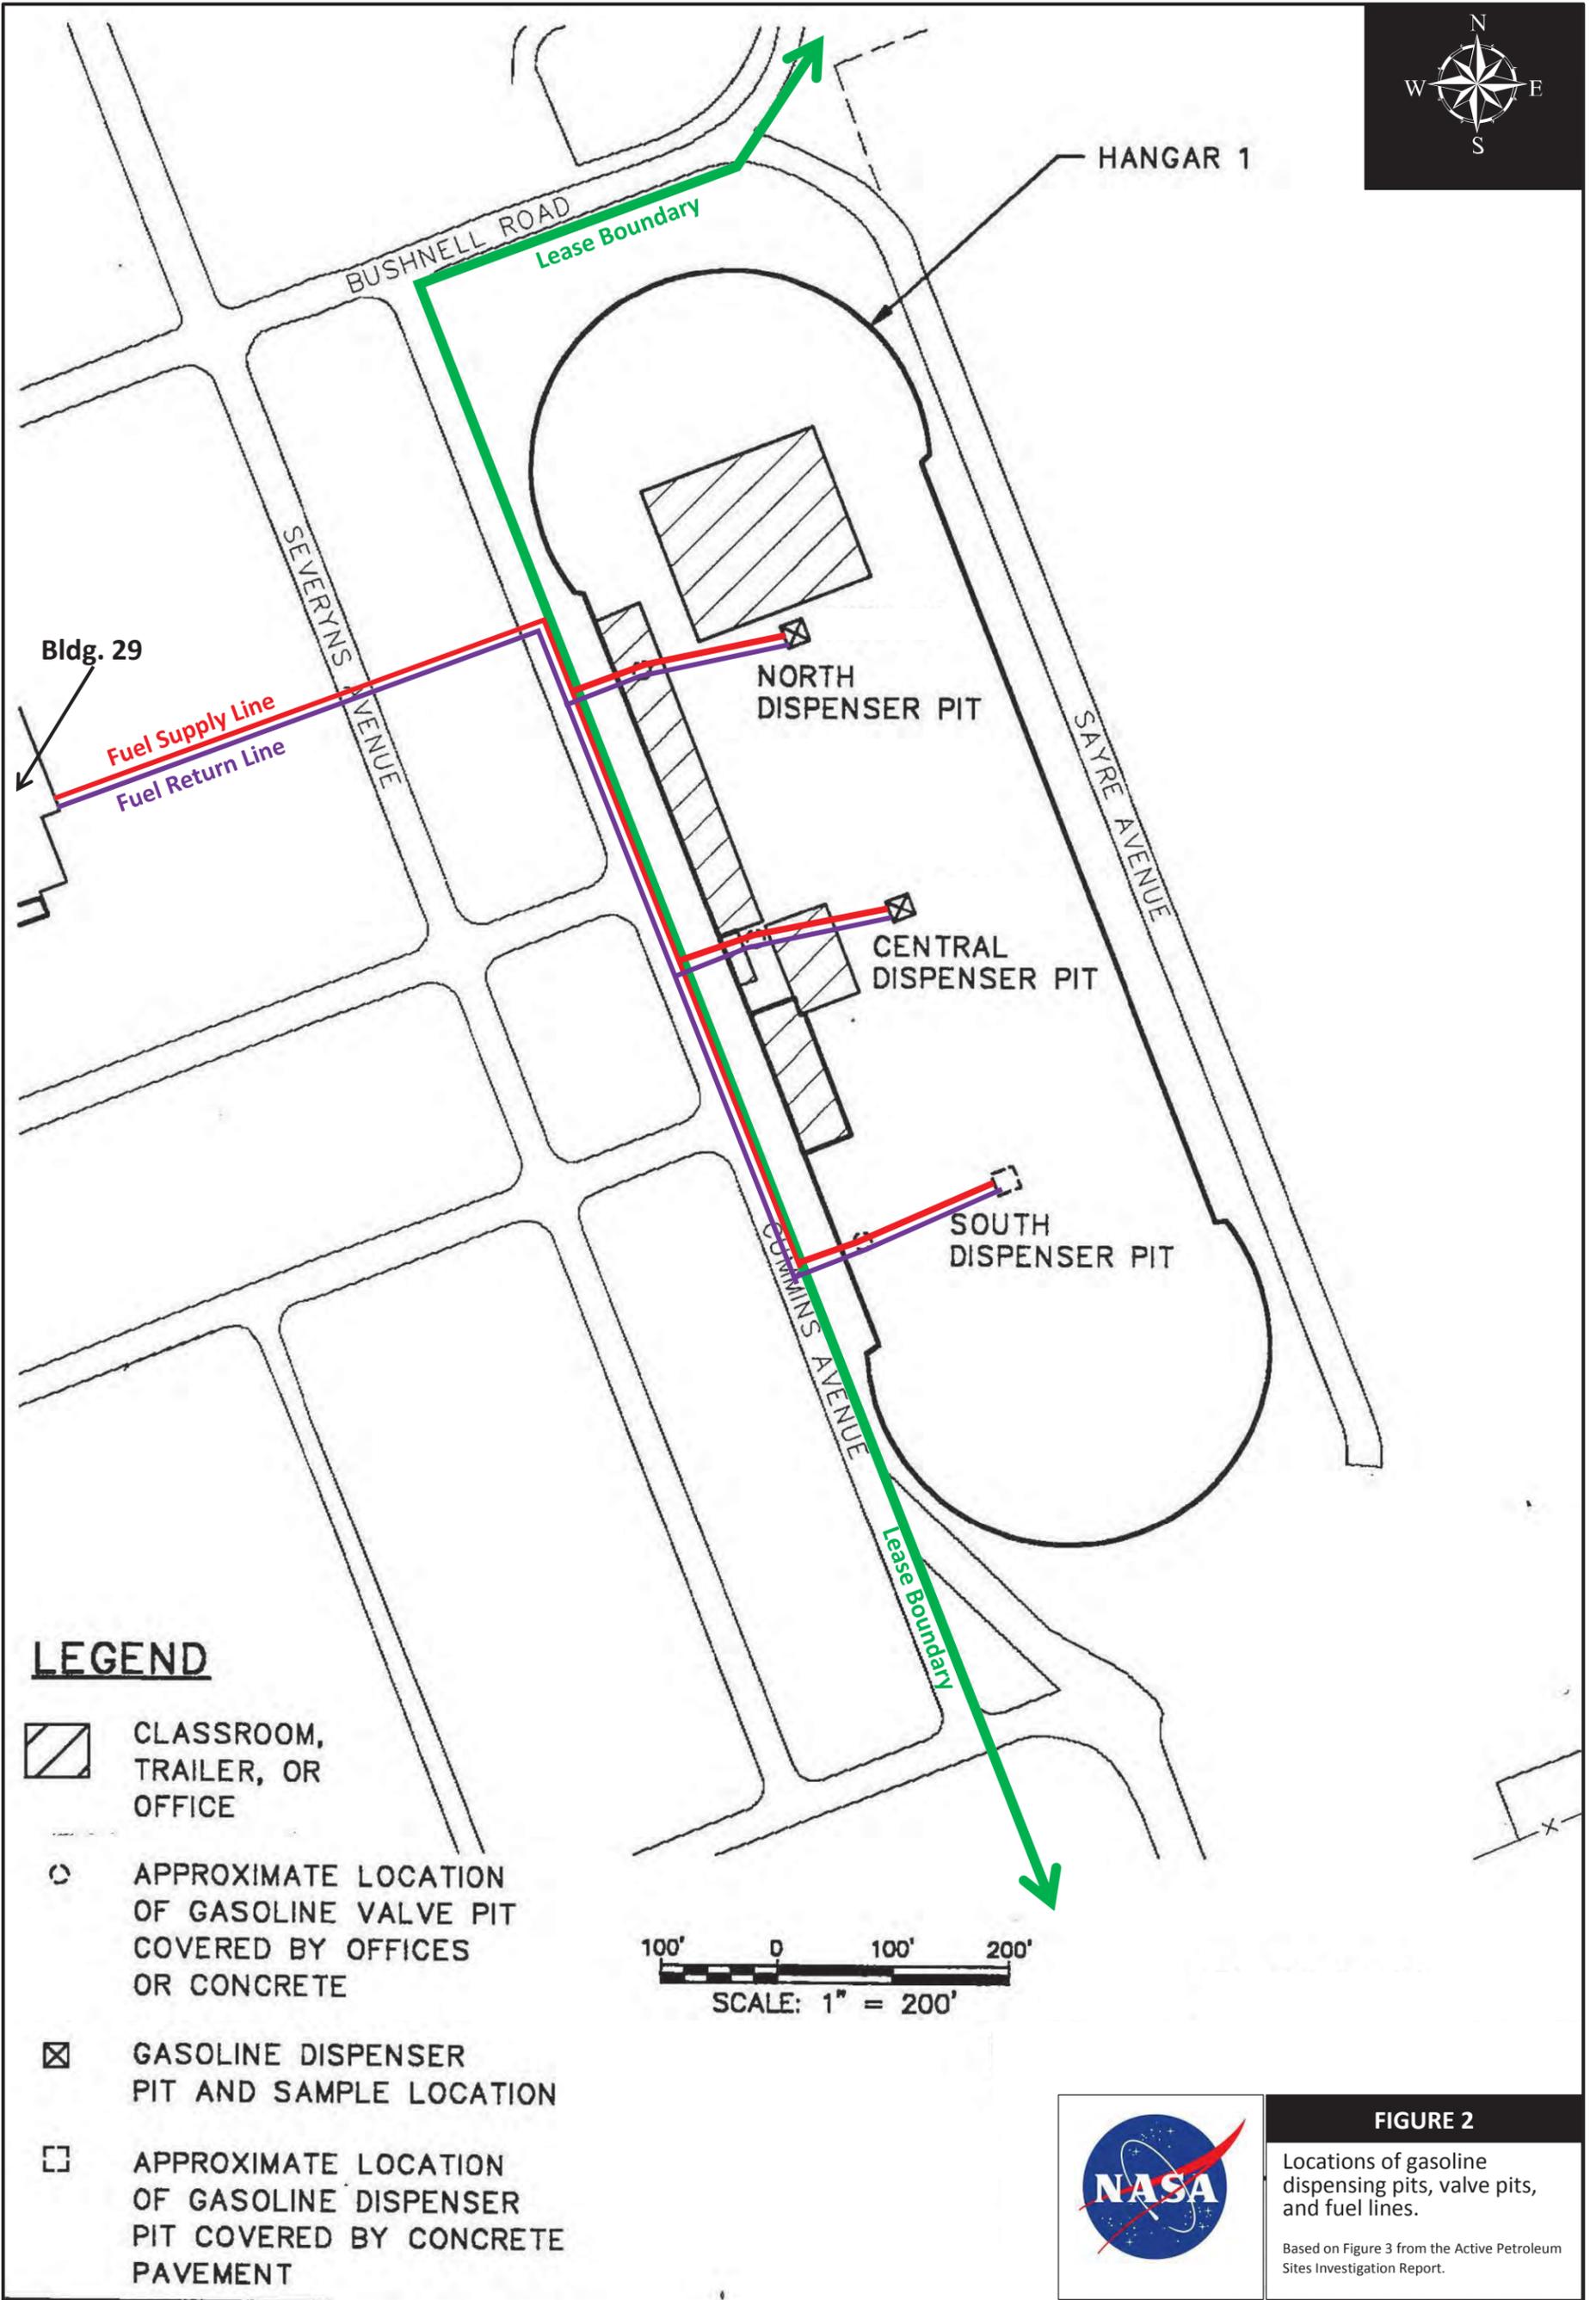
FIGURE 2
Locations of gasoline dispensing pits, valve pits, and fuel lines.
Based on Figure 3 from the Active Petroleum Sites Investigation Report.

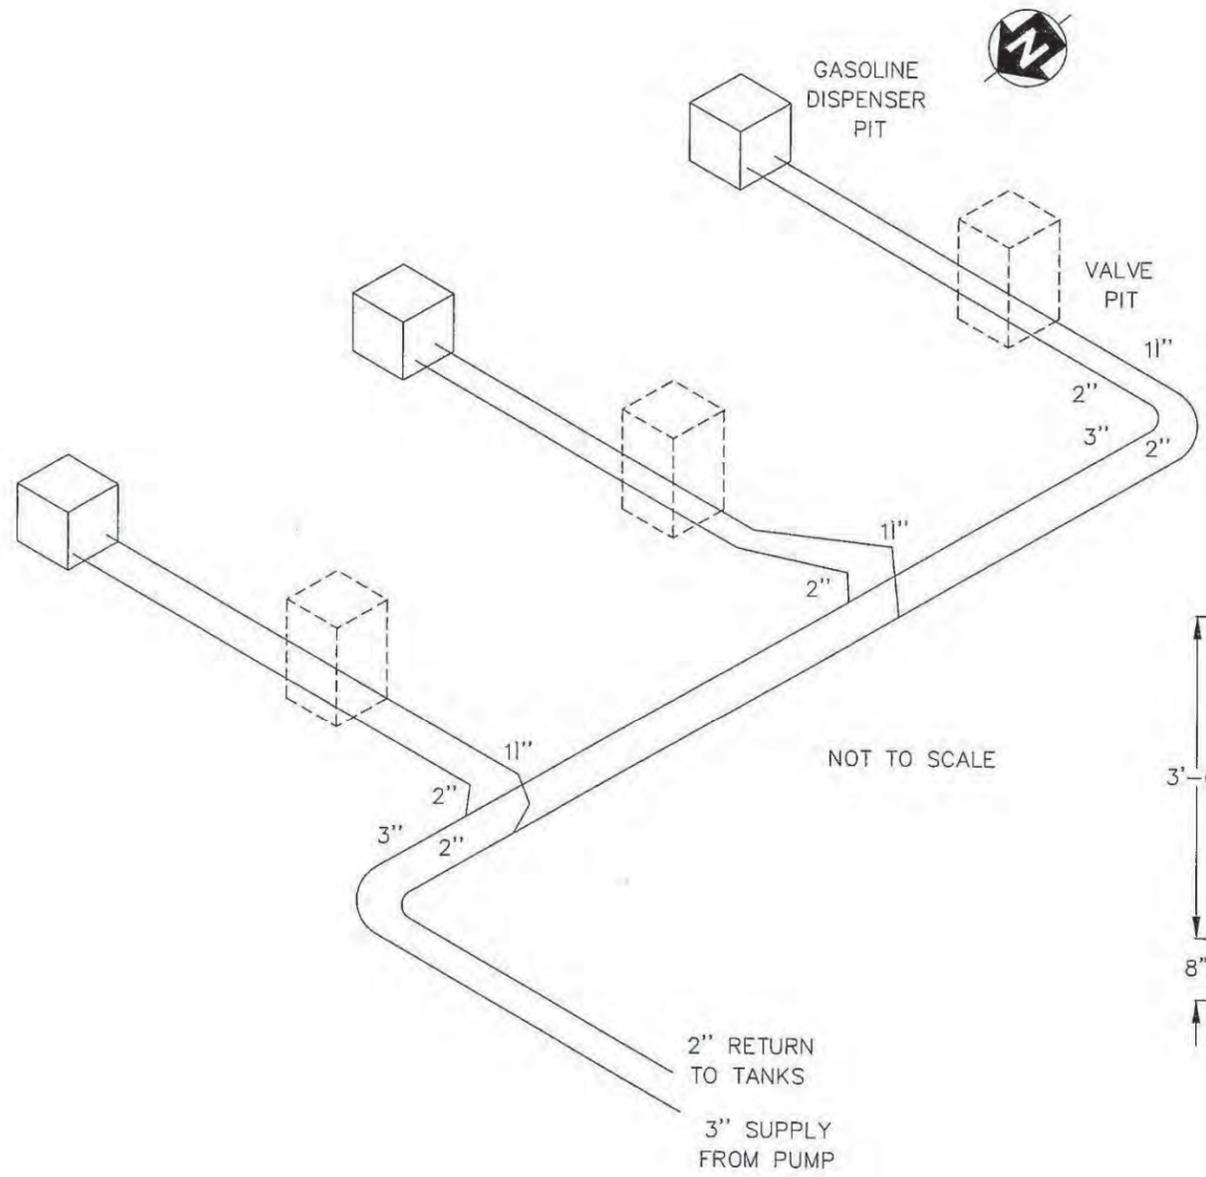
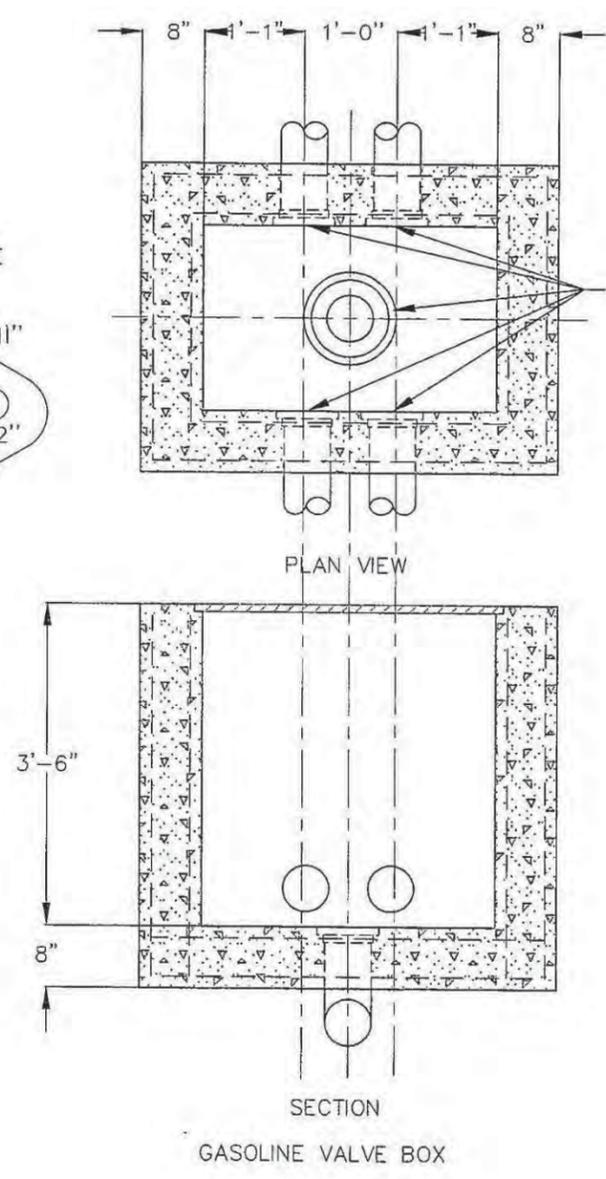
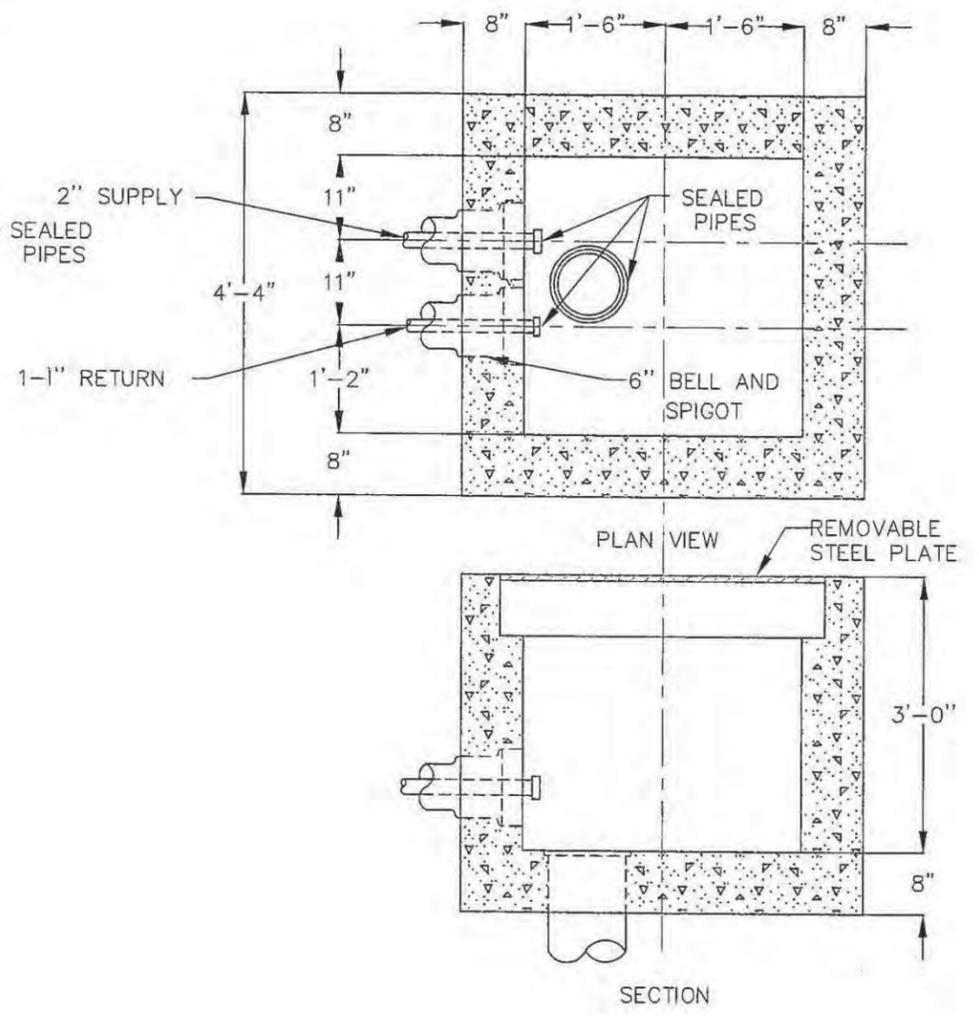
FIGURE 3

Typical construction details of the fuel pits and valve boxes and schematic of the pipelines.

From Figure J3 in Appendix J: Site 24 Petroleum Evaluation

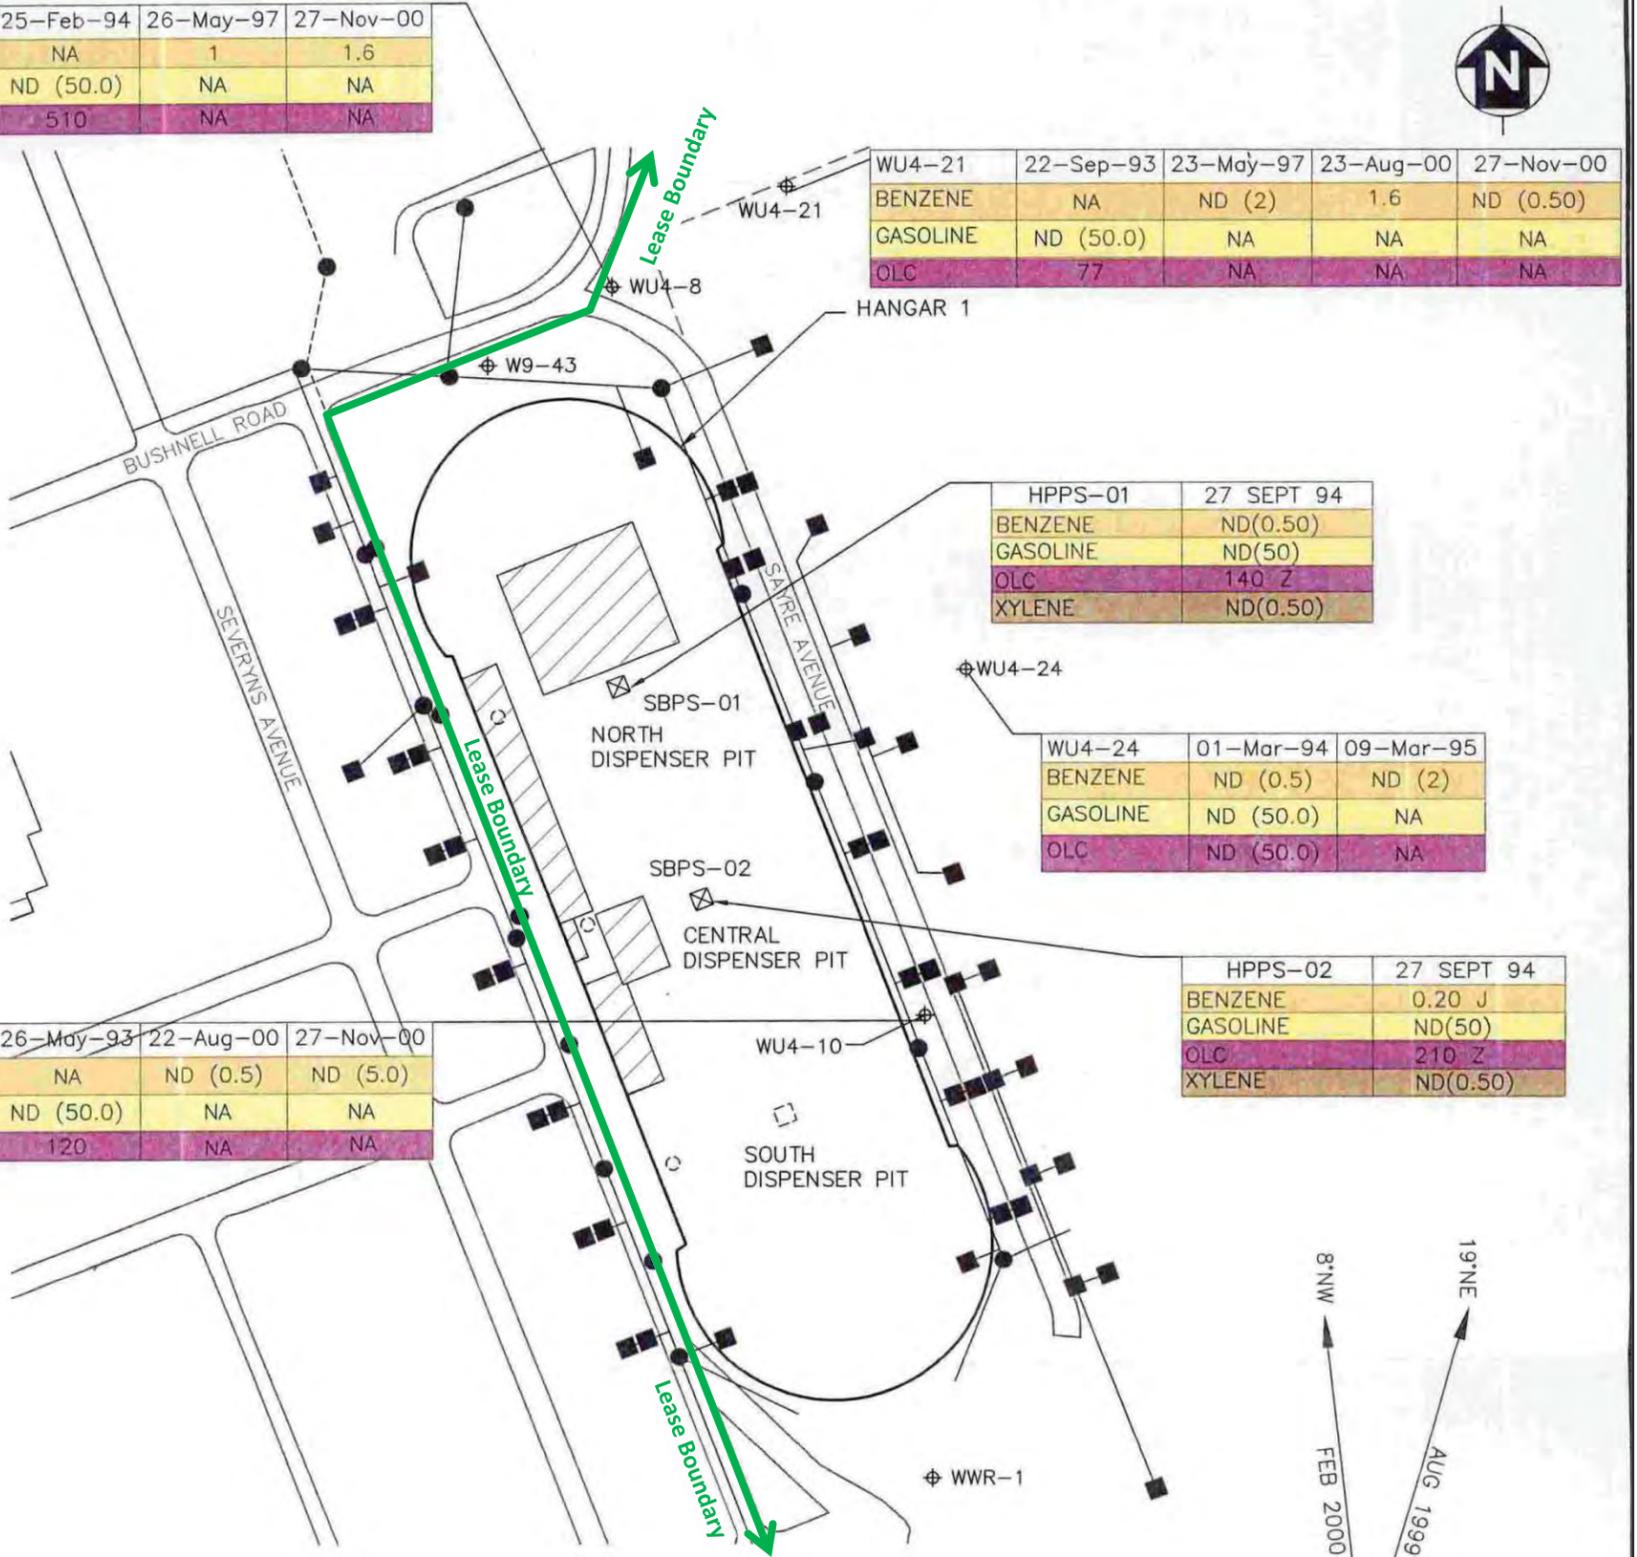
FIGURE 5
Selected petroleum constituents in groundwater
Figure J9 in Appendix J
