MFA Leasehold EIMP Appendix A - Part 2

3 March 2015

APPENDIX A

NASA EEC Statements

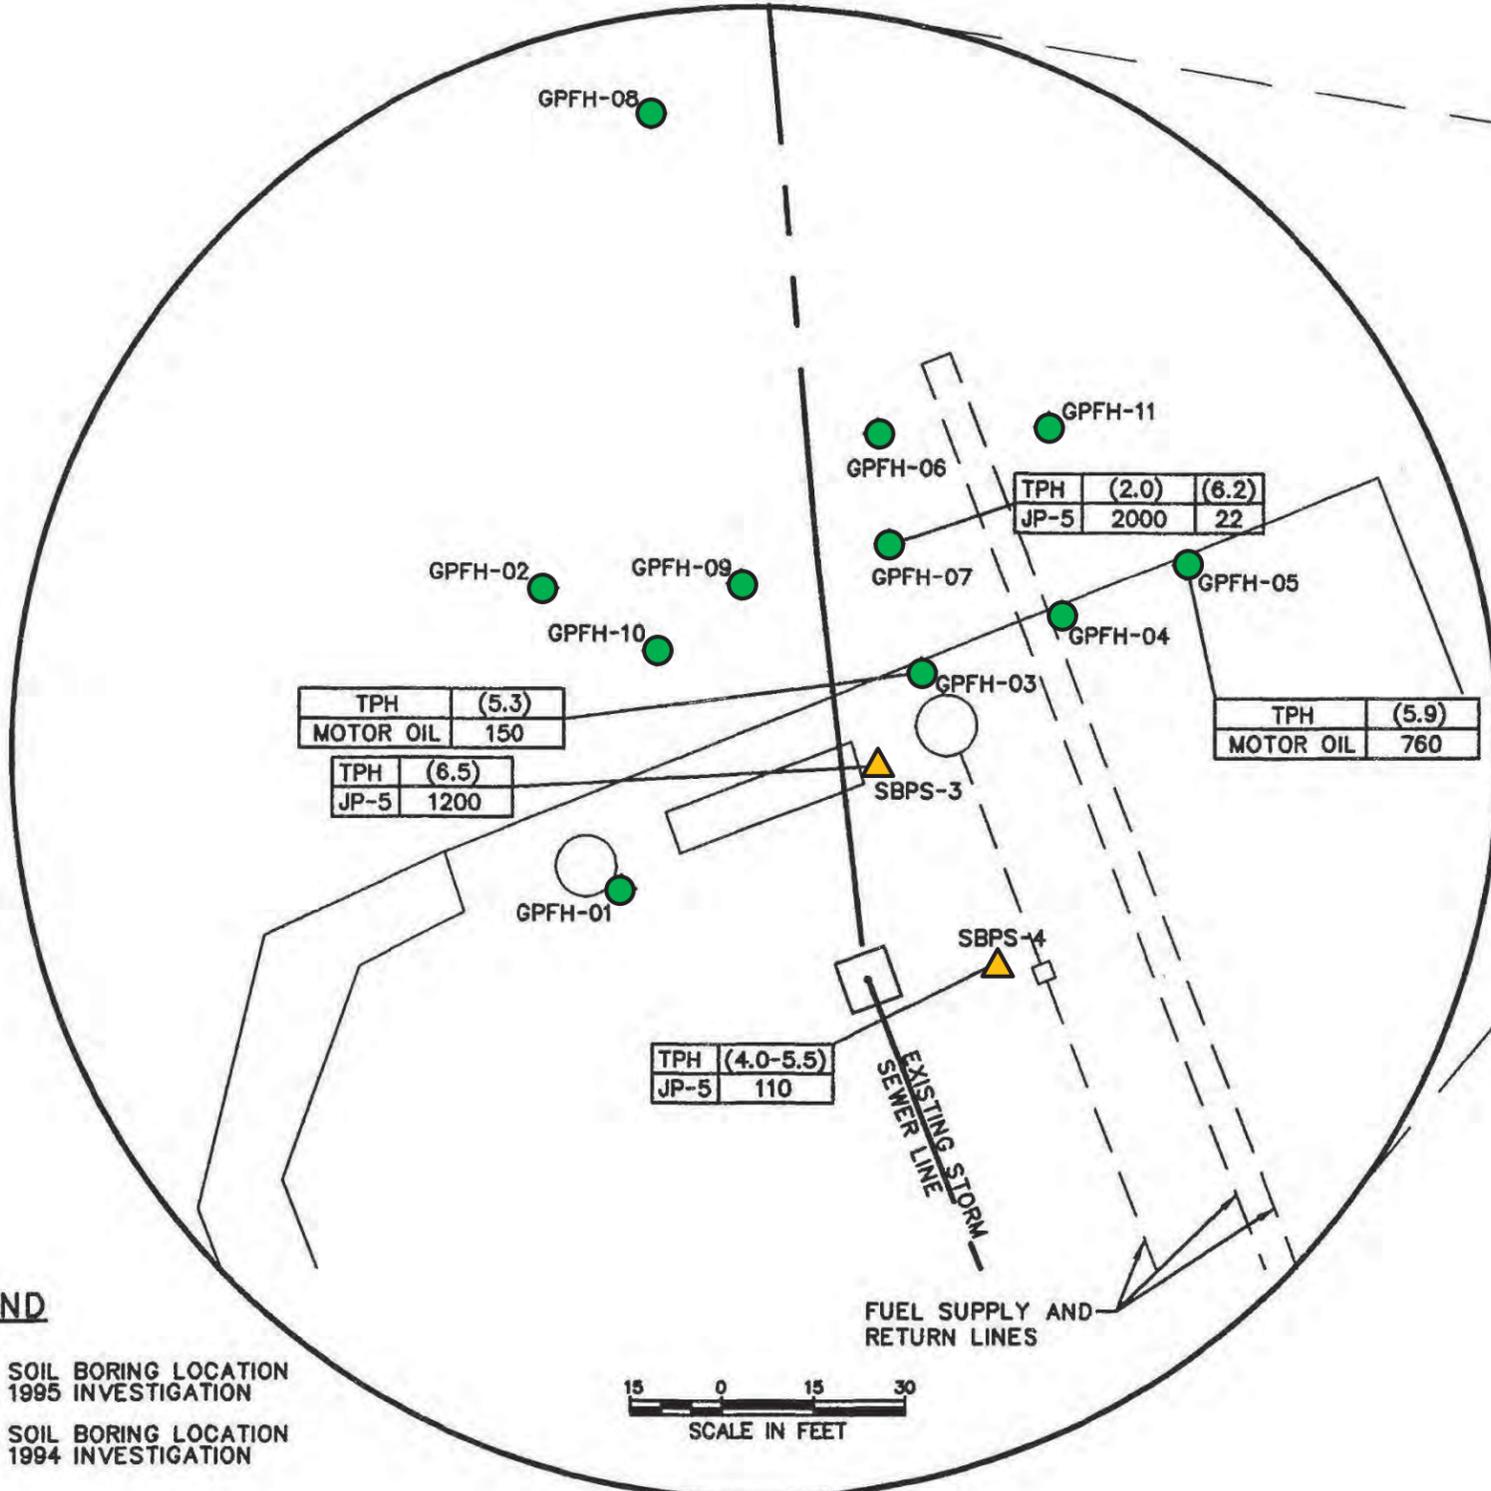
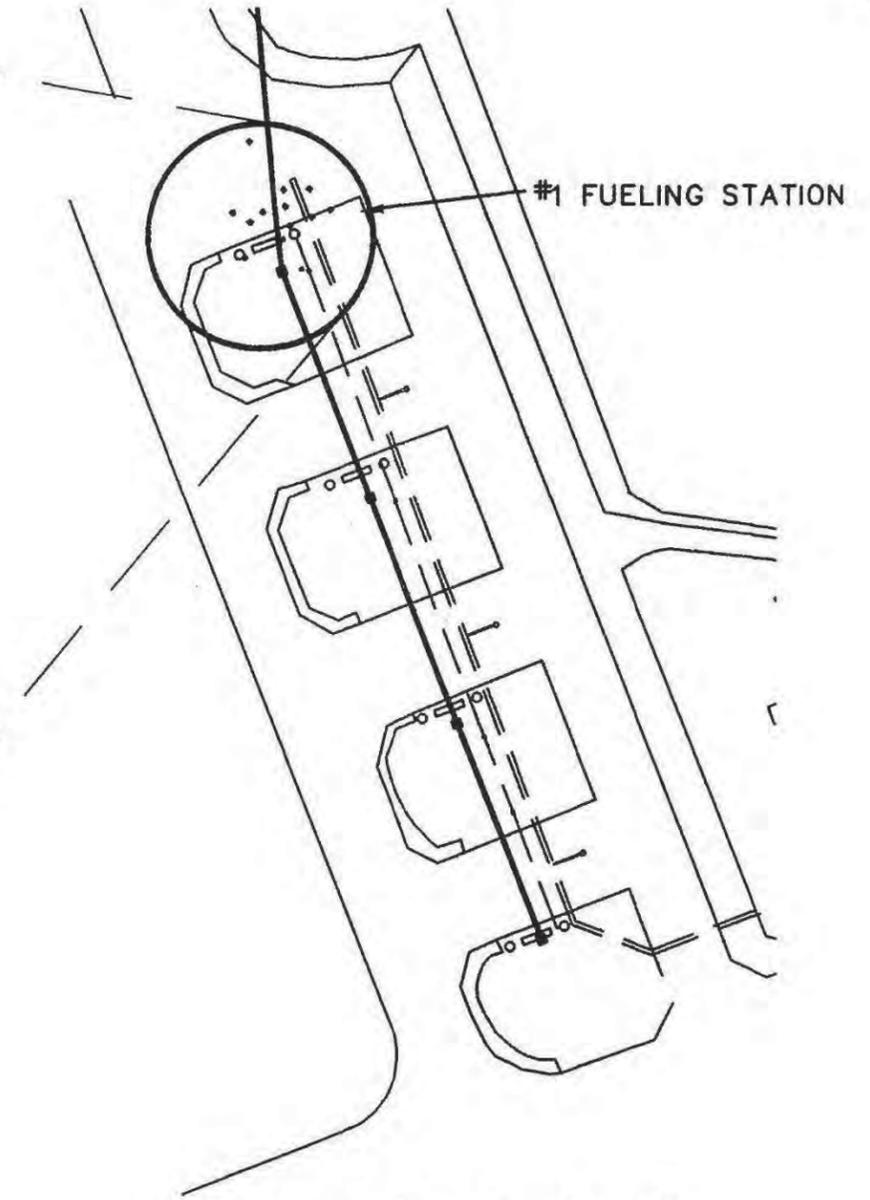
FIGURE 9
TPH-e sampling results in soil for Hydrant 1.
Figure 8 from Active Petroleum Sites Investigation

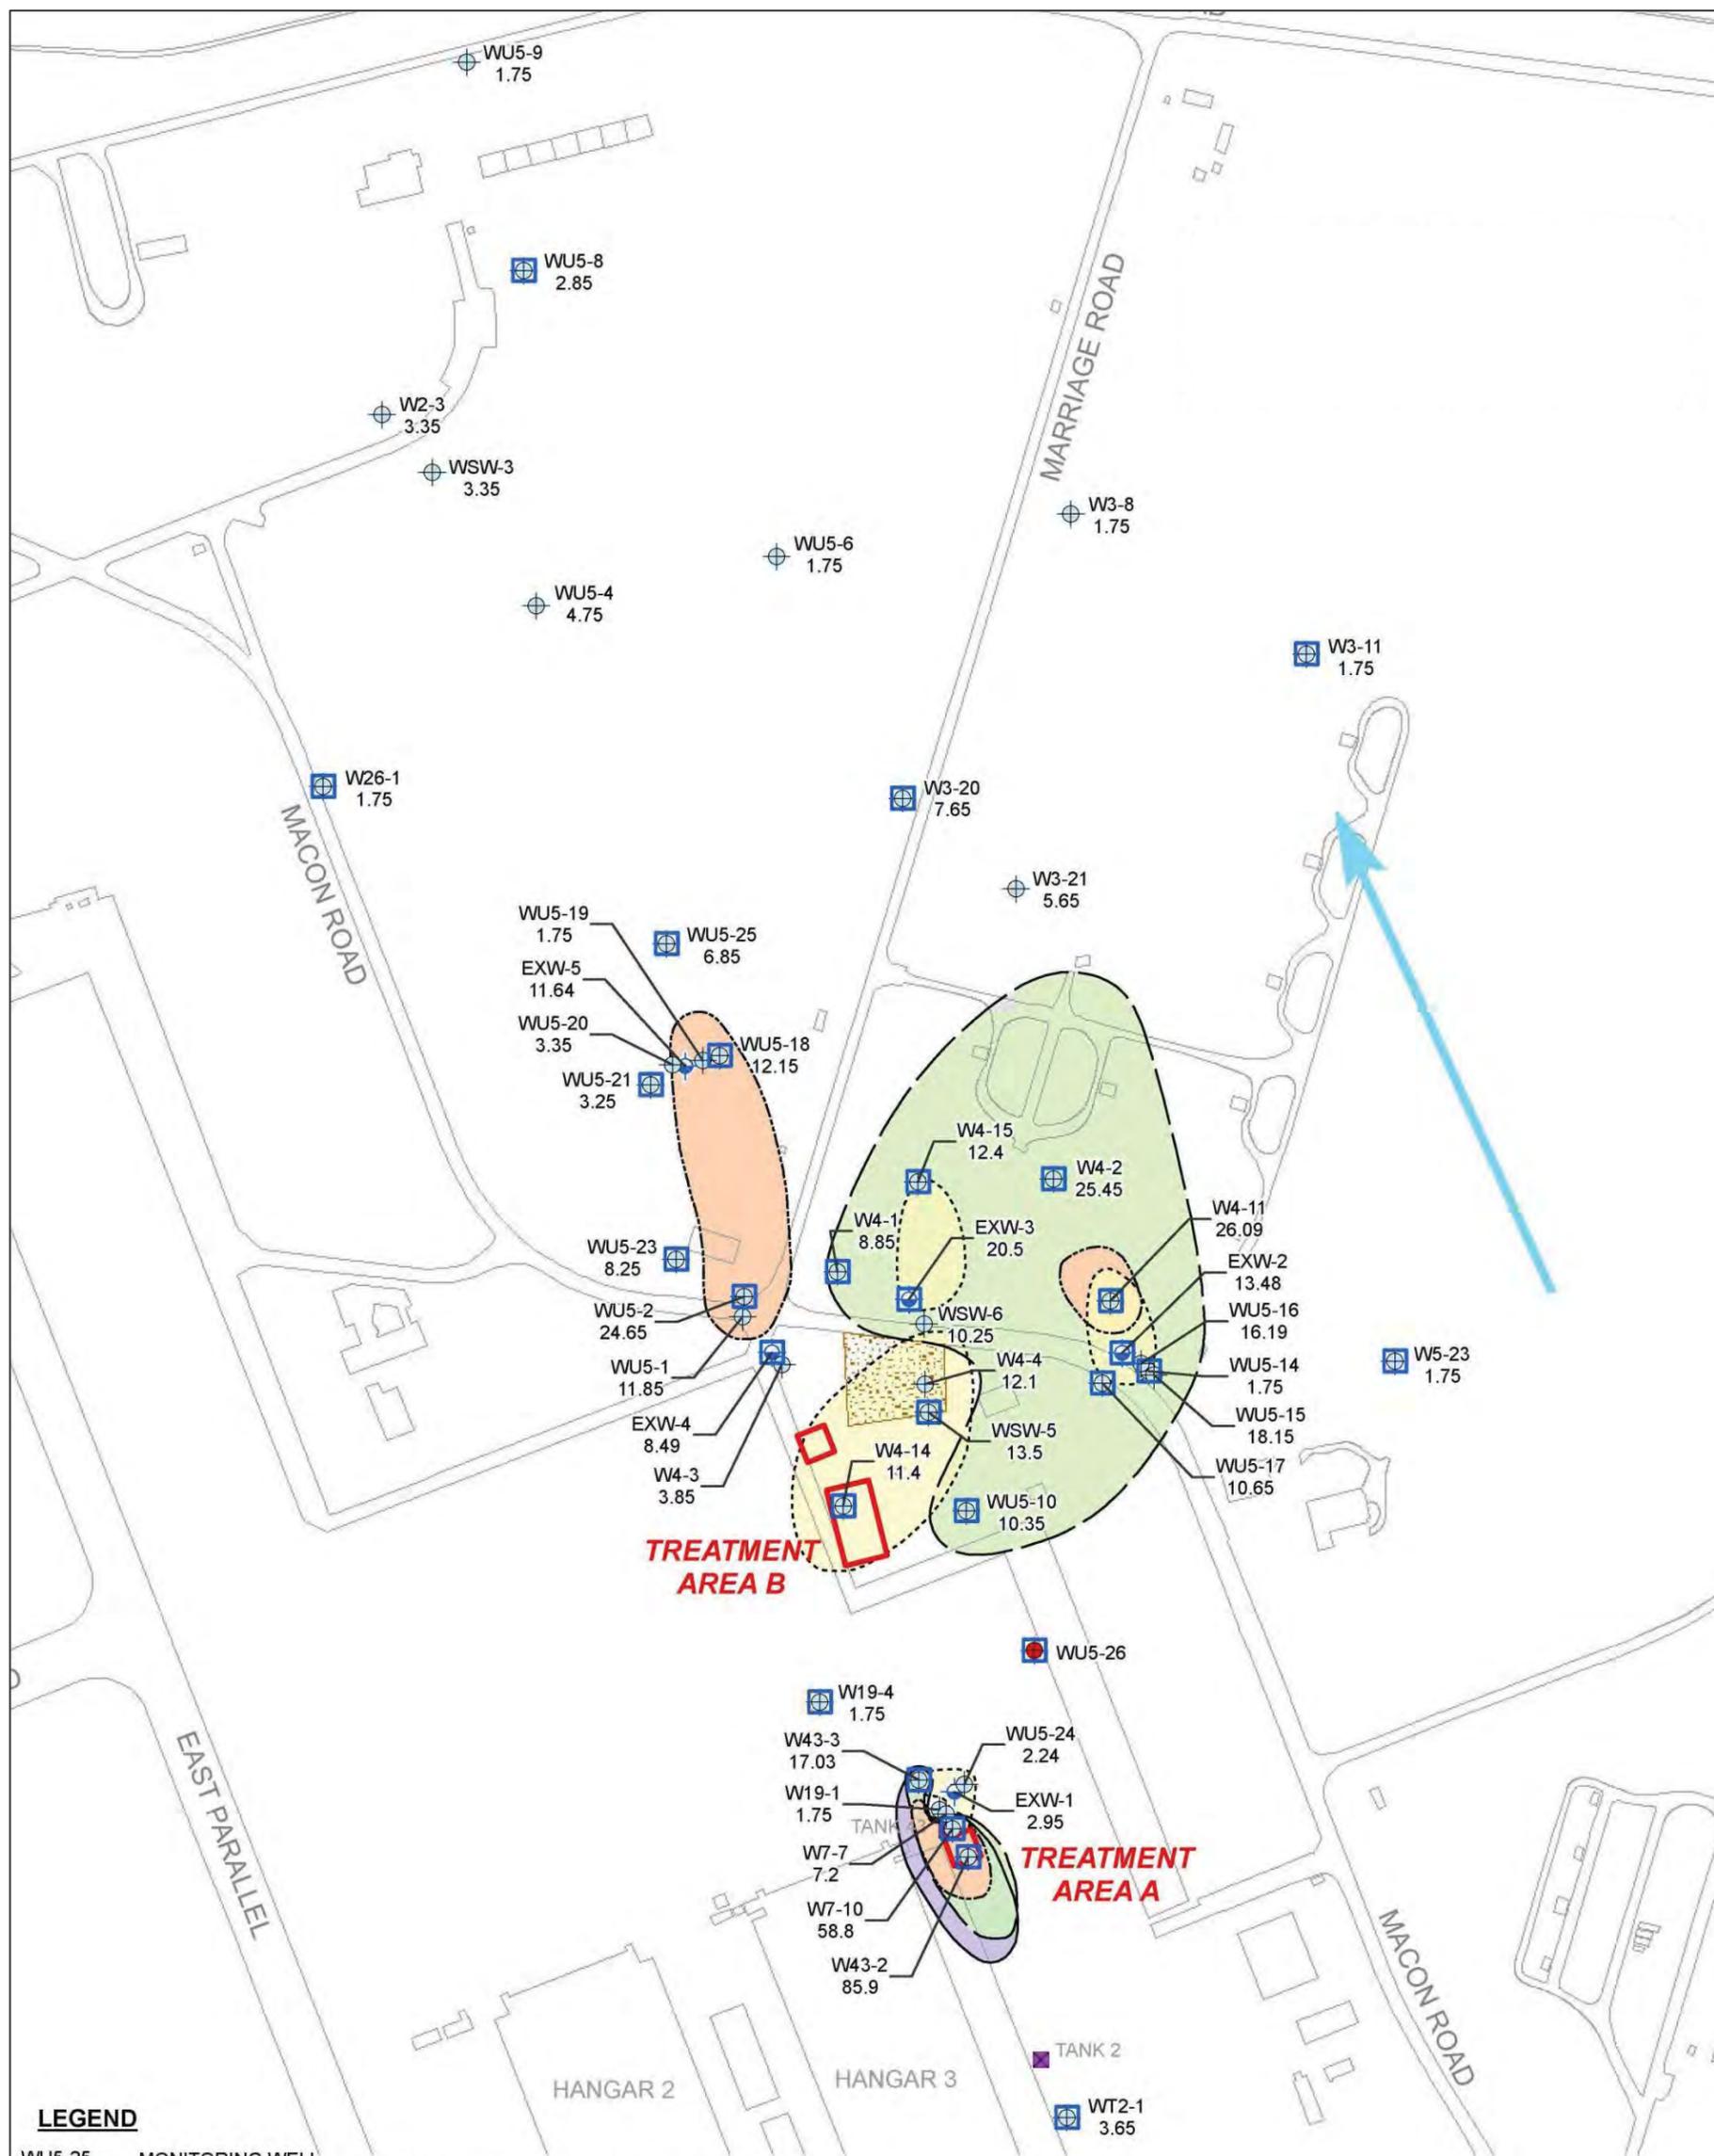
Source: Site 26 Focused Feasibility Study

The Navy completed a Focused Feasibility Study in 2012 to evaluate alternatives to improve or replace the remedy selected in the OU5 ROD. Figure 3 (2004 map, figure 6 in the ROD Amendment) illustrates the distribution of VOCs in November/December 2010. Five alternatives were considered (Table 2). The Navy proposed Alternative 5: Biostimulation/Bioaugmentation Treatment, MNA, and ICs to address the VOC plume at Site 26 (Figures 4-6). A ROD Amendment was completed on September 30, 2014. A future remedial design will determine the exact locations of wells and the specific equipment/activities associated with the final remedy for the site.

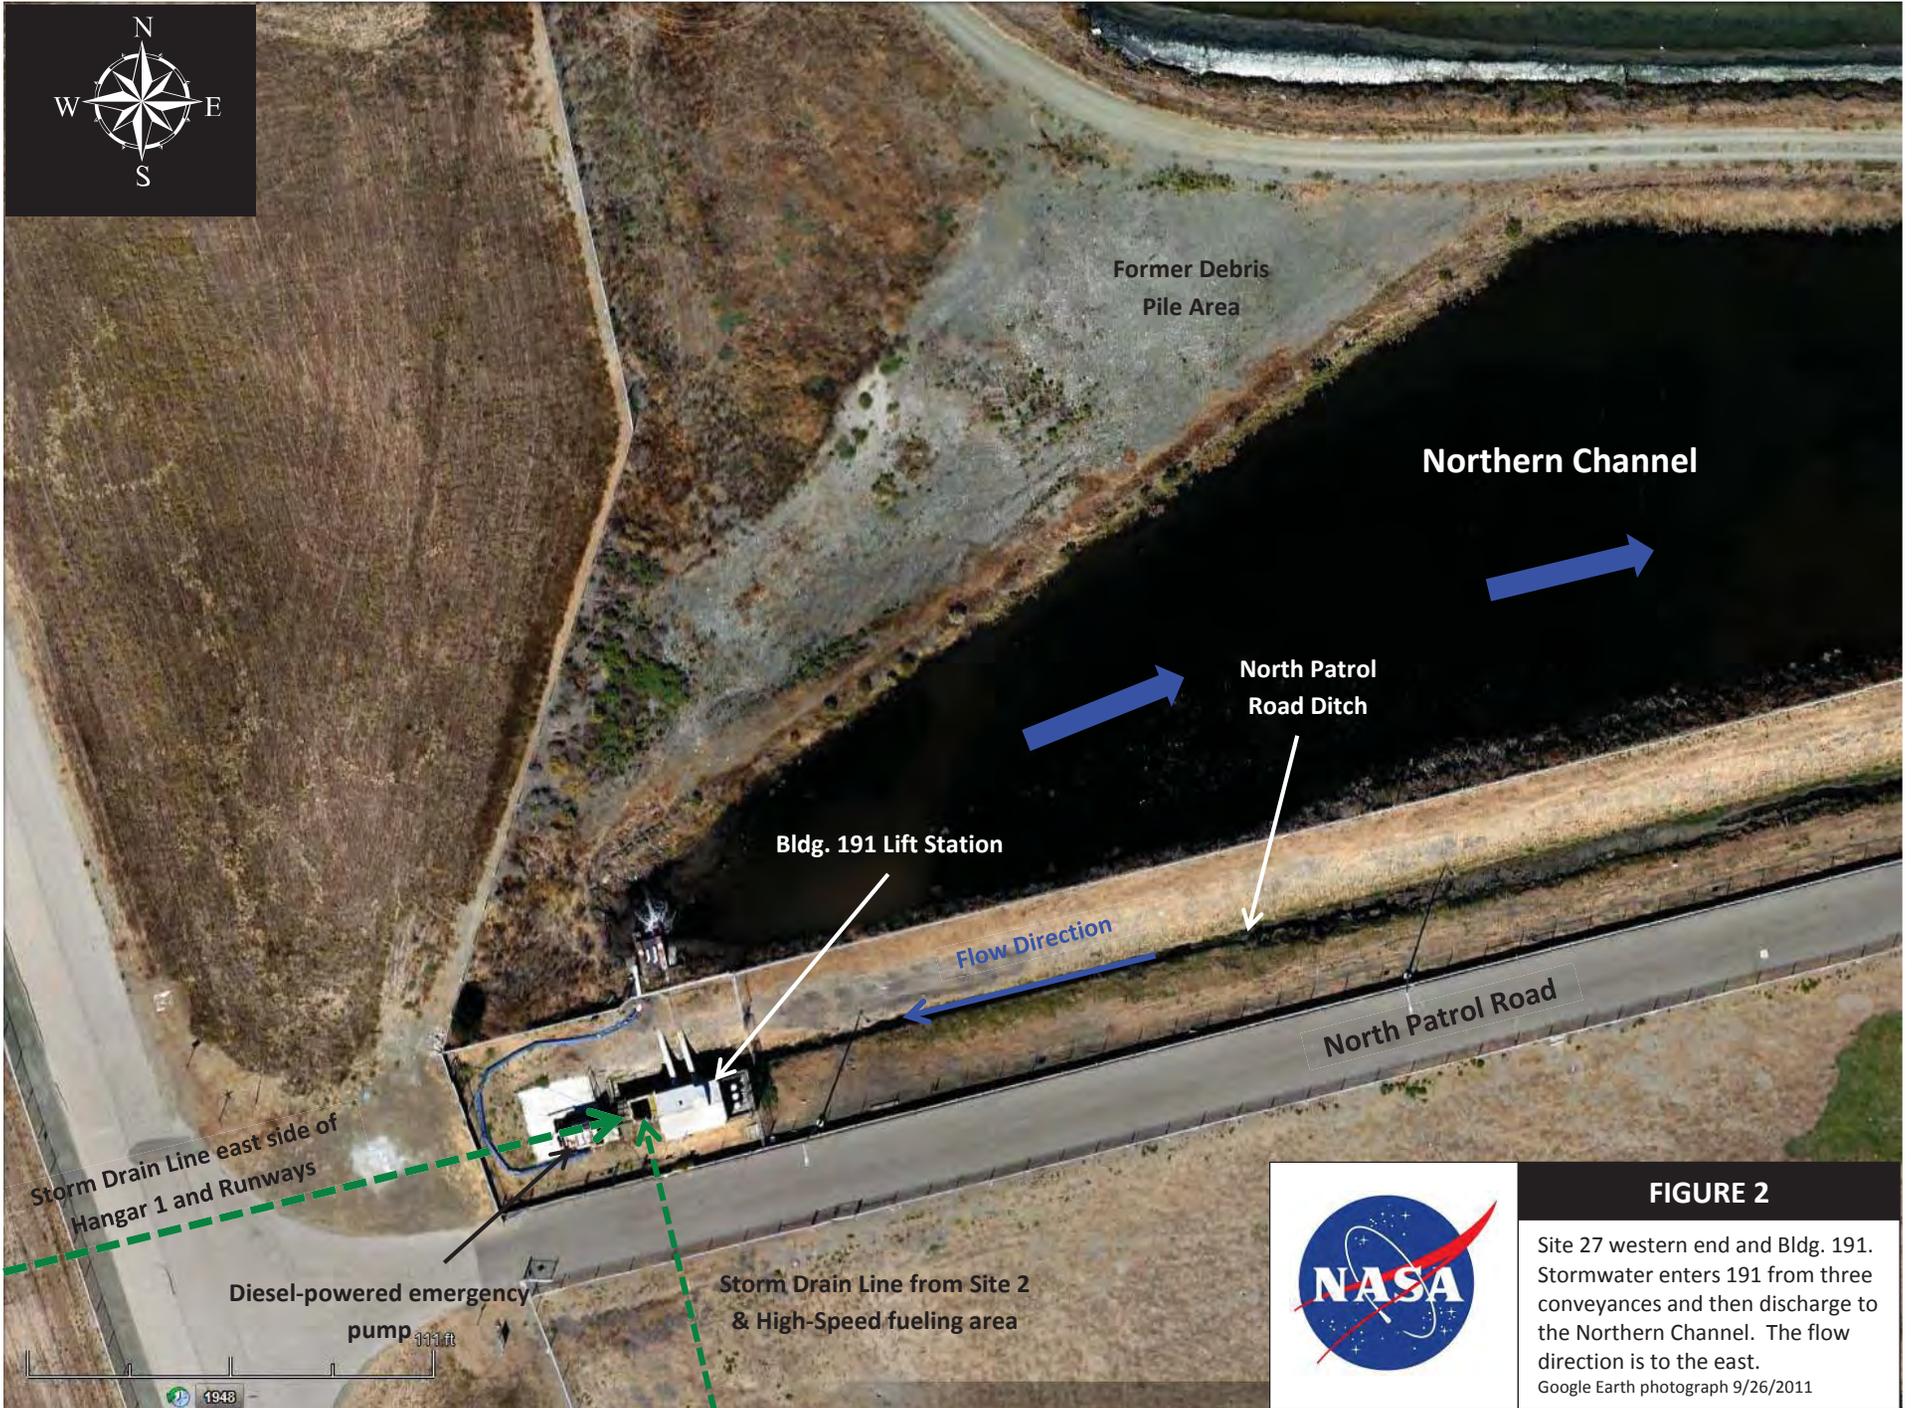
FIGURE 2

Site 27 western end and Bldg. 191. Stormwater enters 191 from three conveyances and then discharge to the Northern Channel. The flow direction is to the east.
 Google Earth photograph 9/26/2011

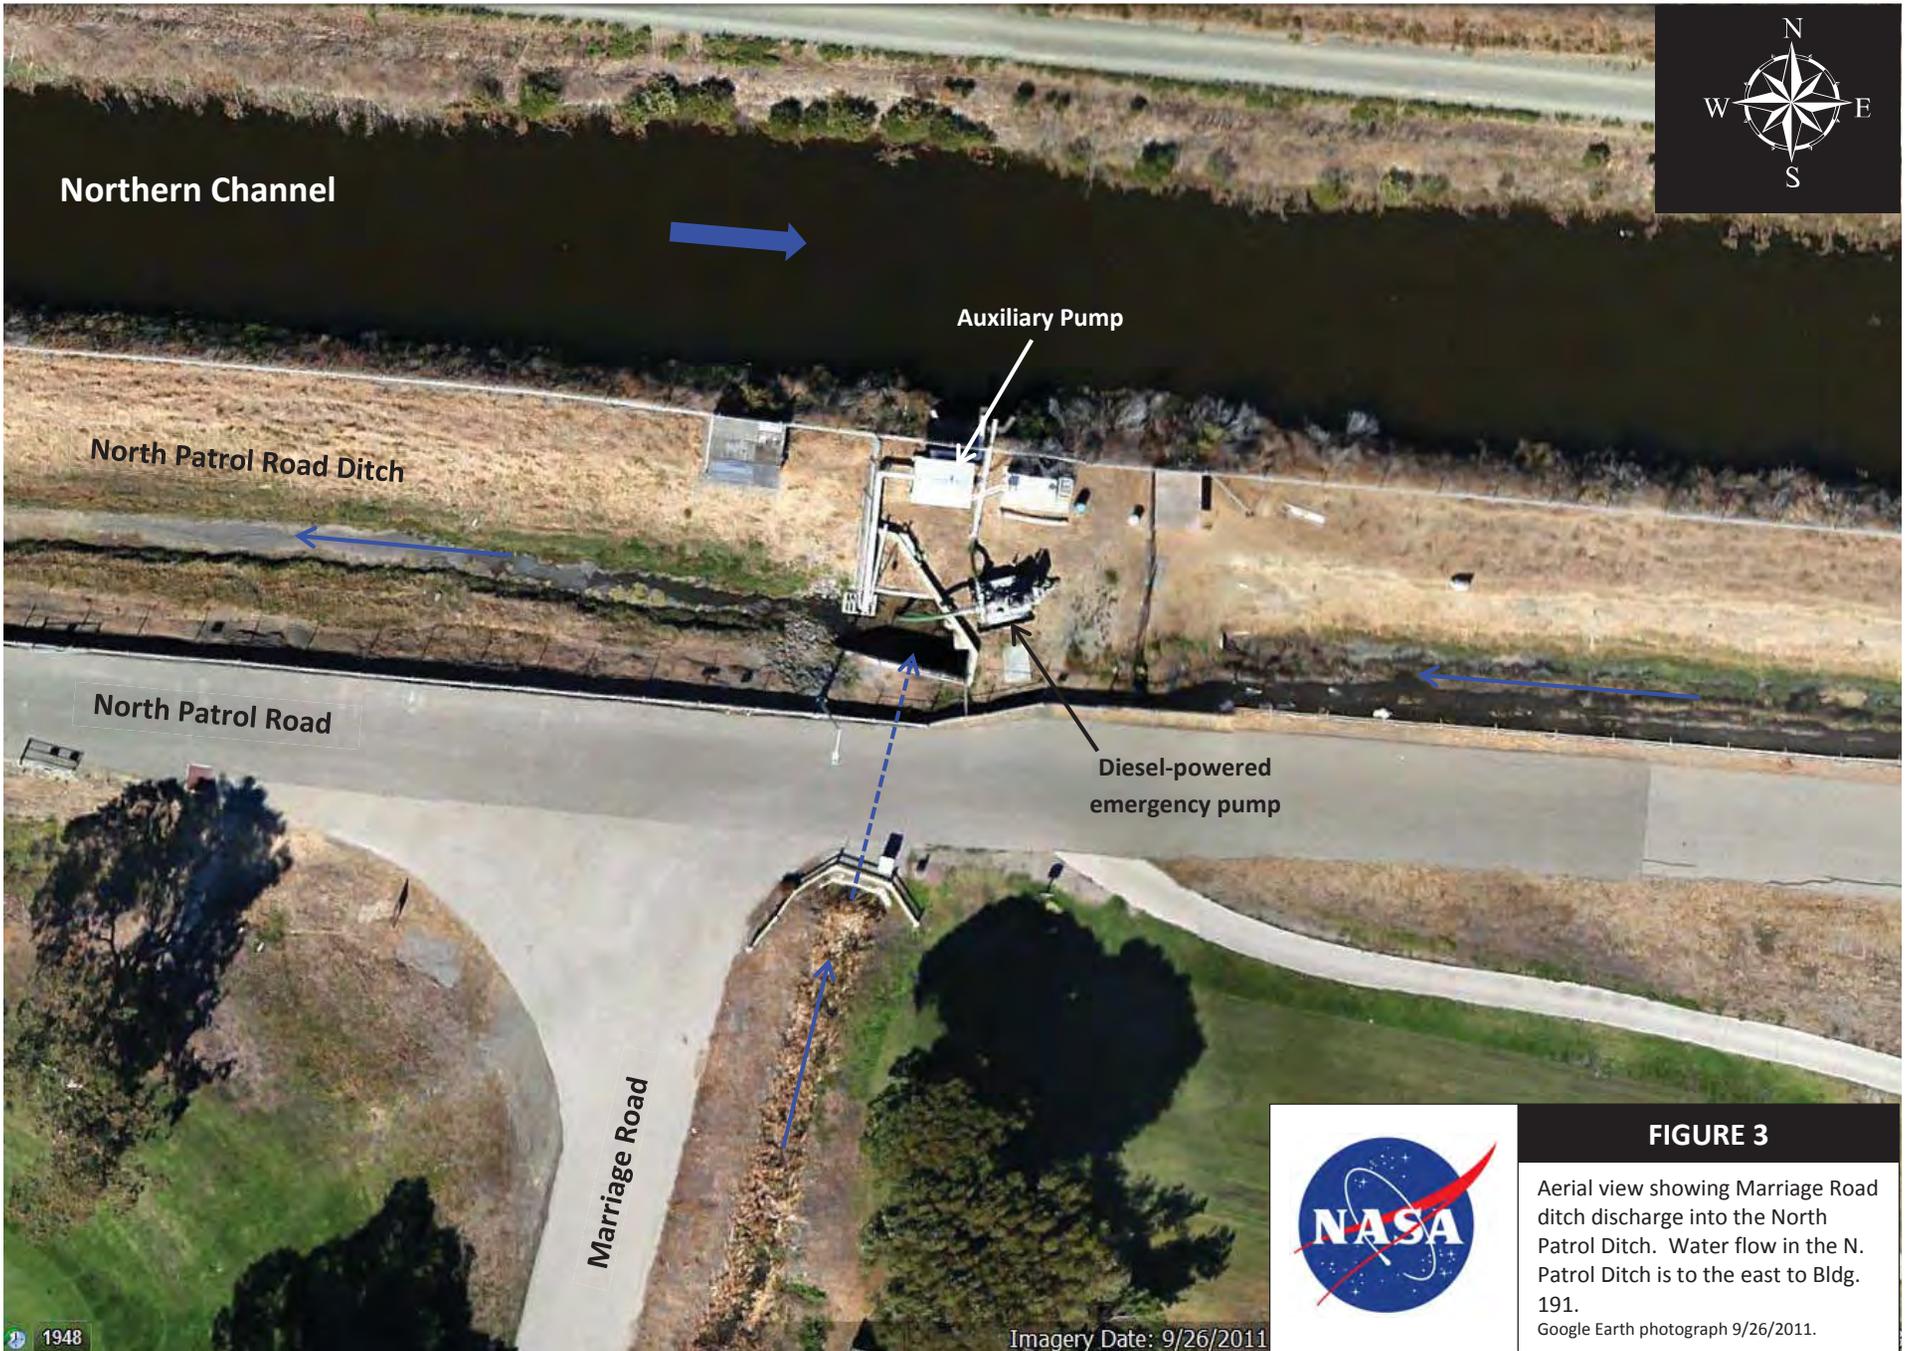
FIGURE 3
 Aerial view showing Marriage Road ditch discharge into the North Patrol Ditch. Water flow in the N. Patrol Ditch is to the east to Bldg. 191.
 Google Earth photograph 9/26/2011.

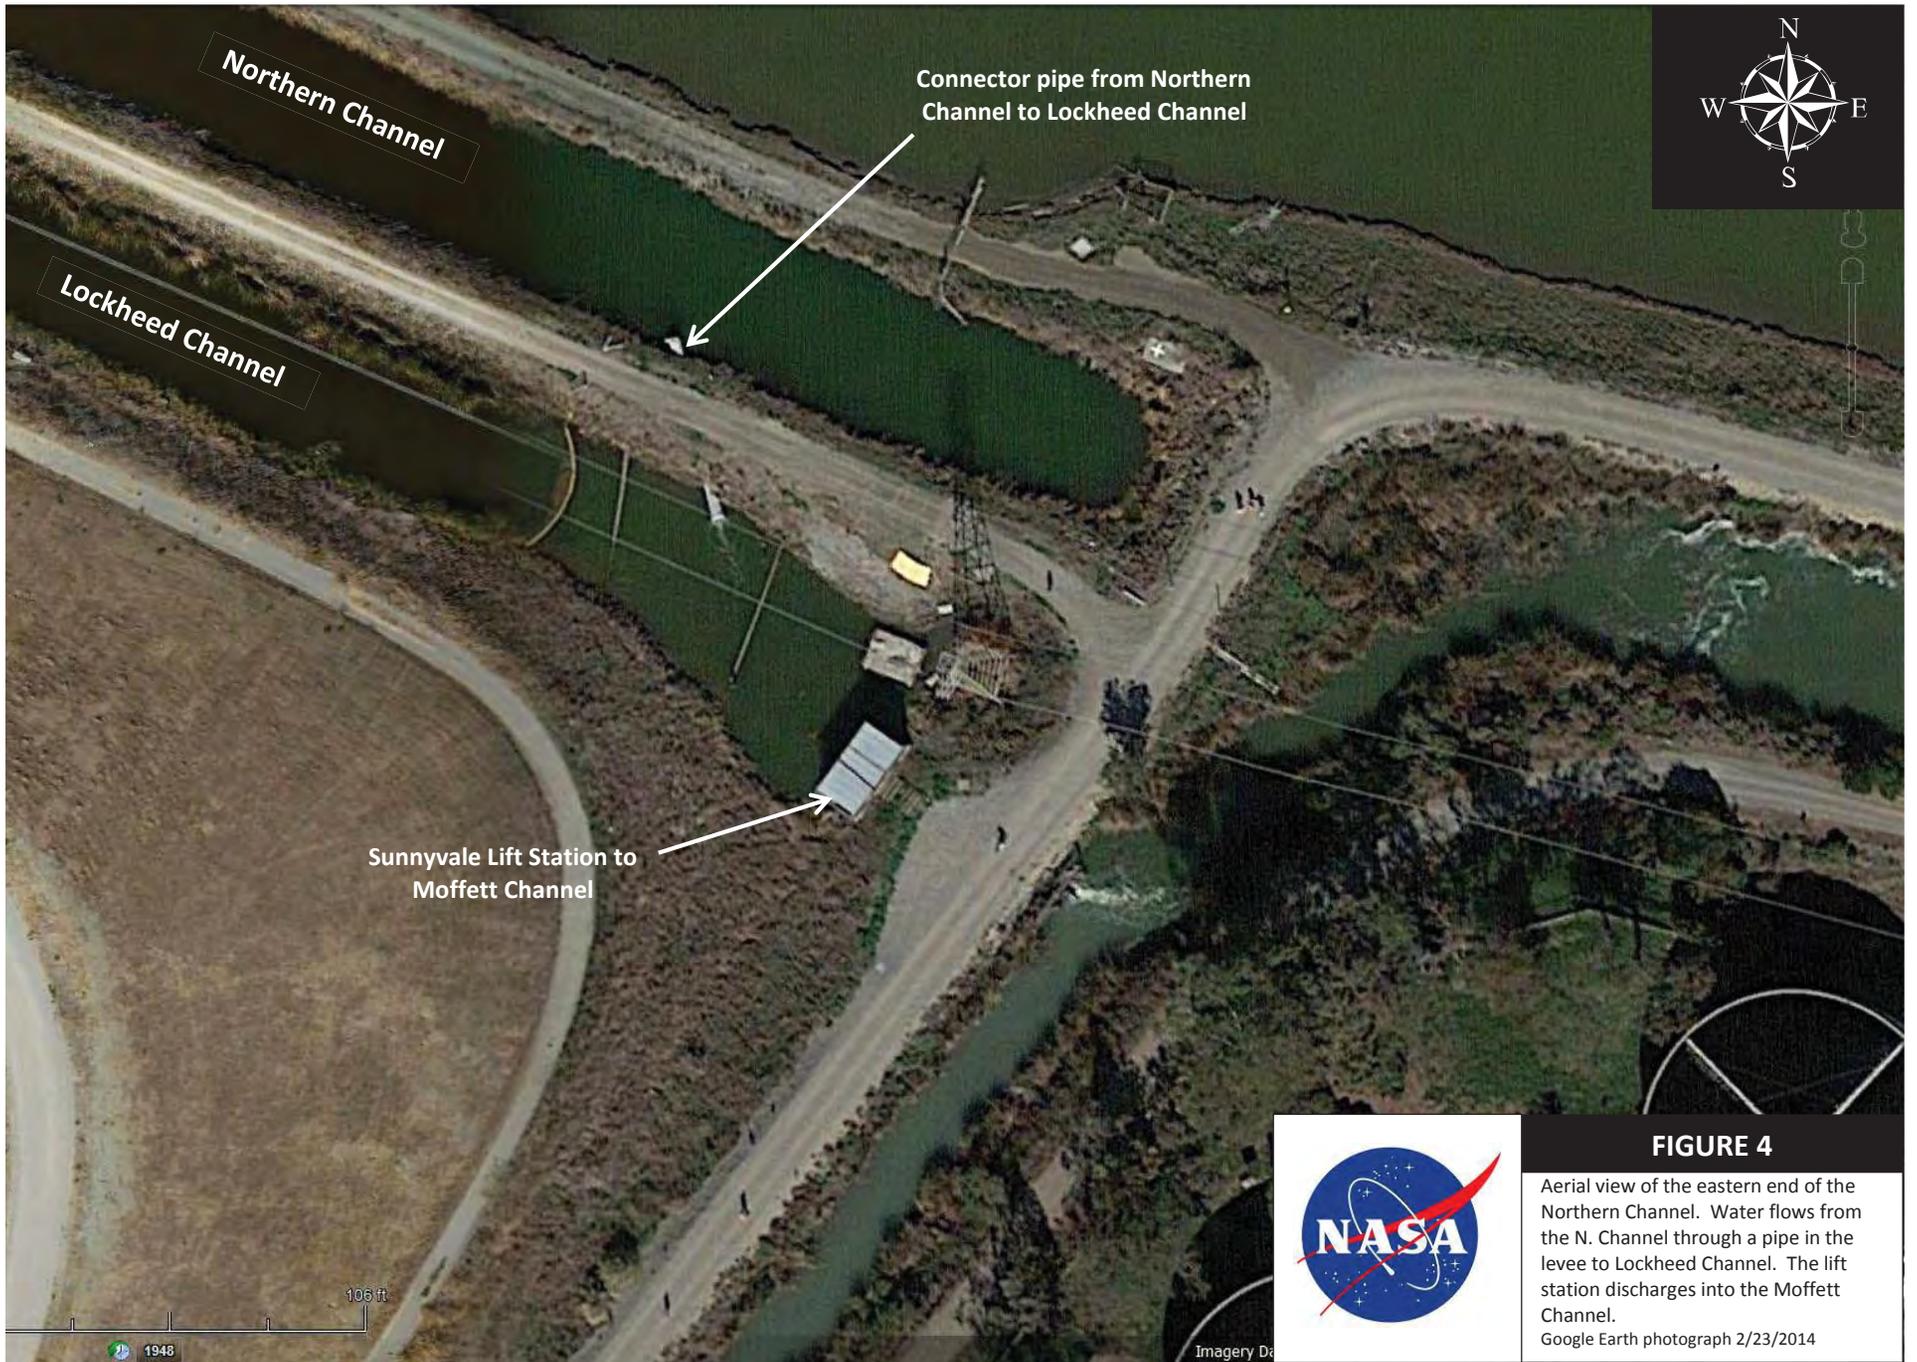
FIGURE 4

Aerial view of the eastern end of the Northern Channel. Water flows from the N. Channel through a pipe in the levee to Lockheed Channel. The lift station discharges into the Moffett Channel.
Google Earth photograph 2/23/2014

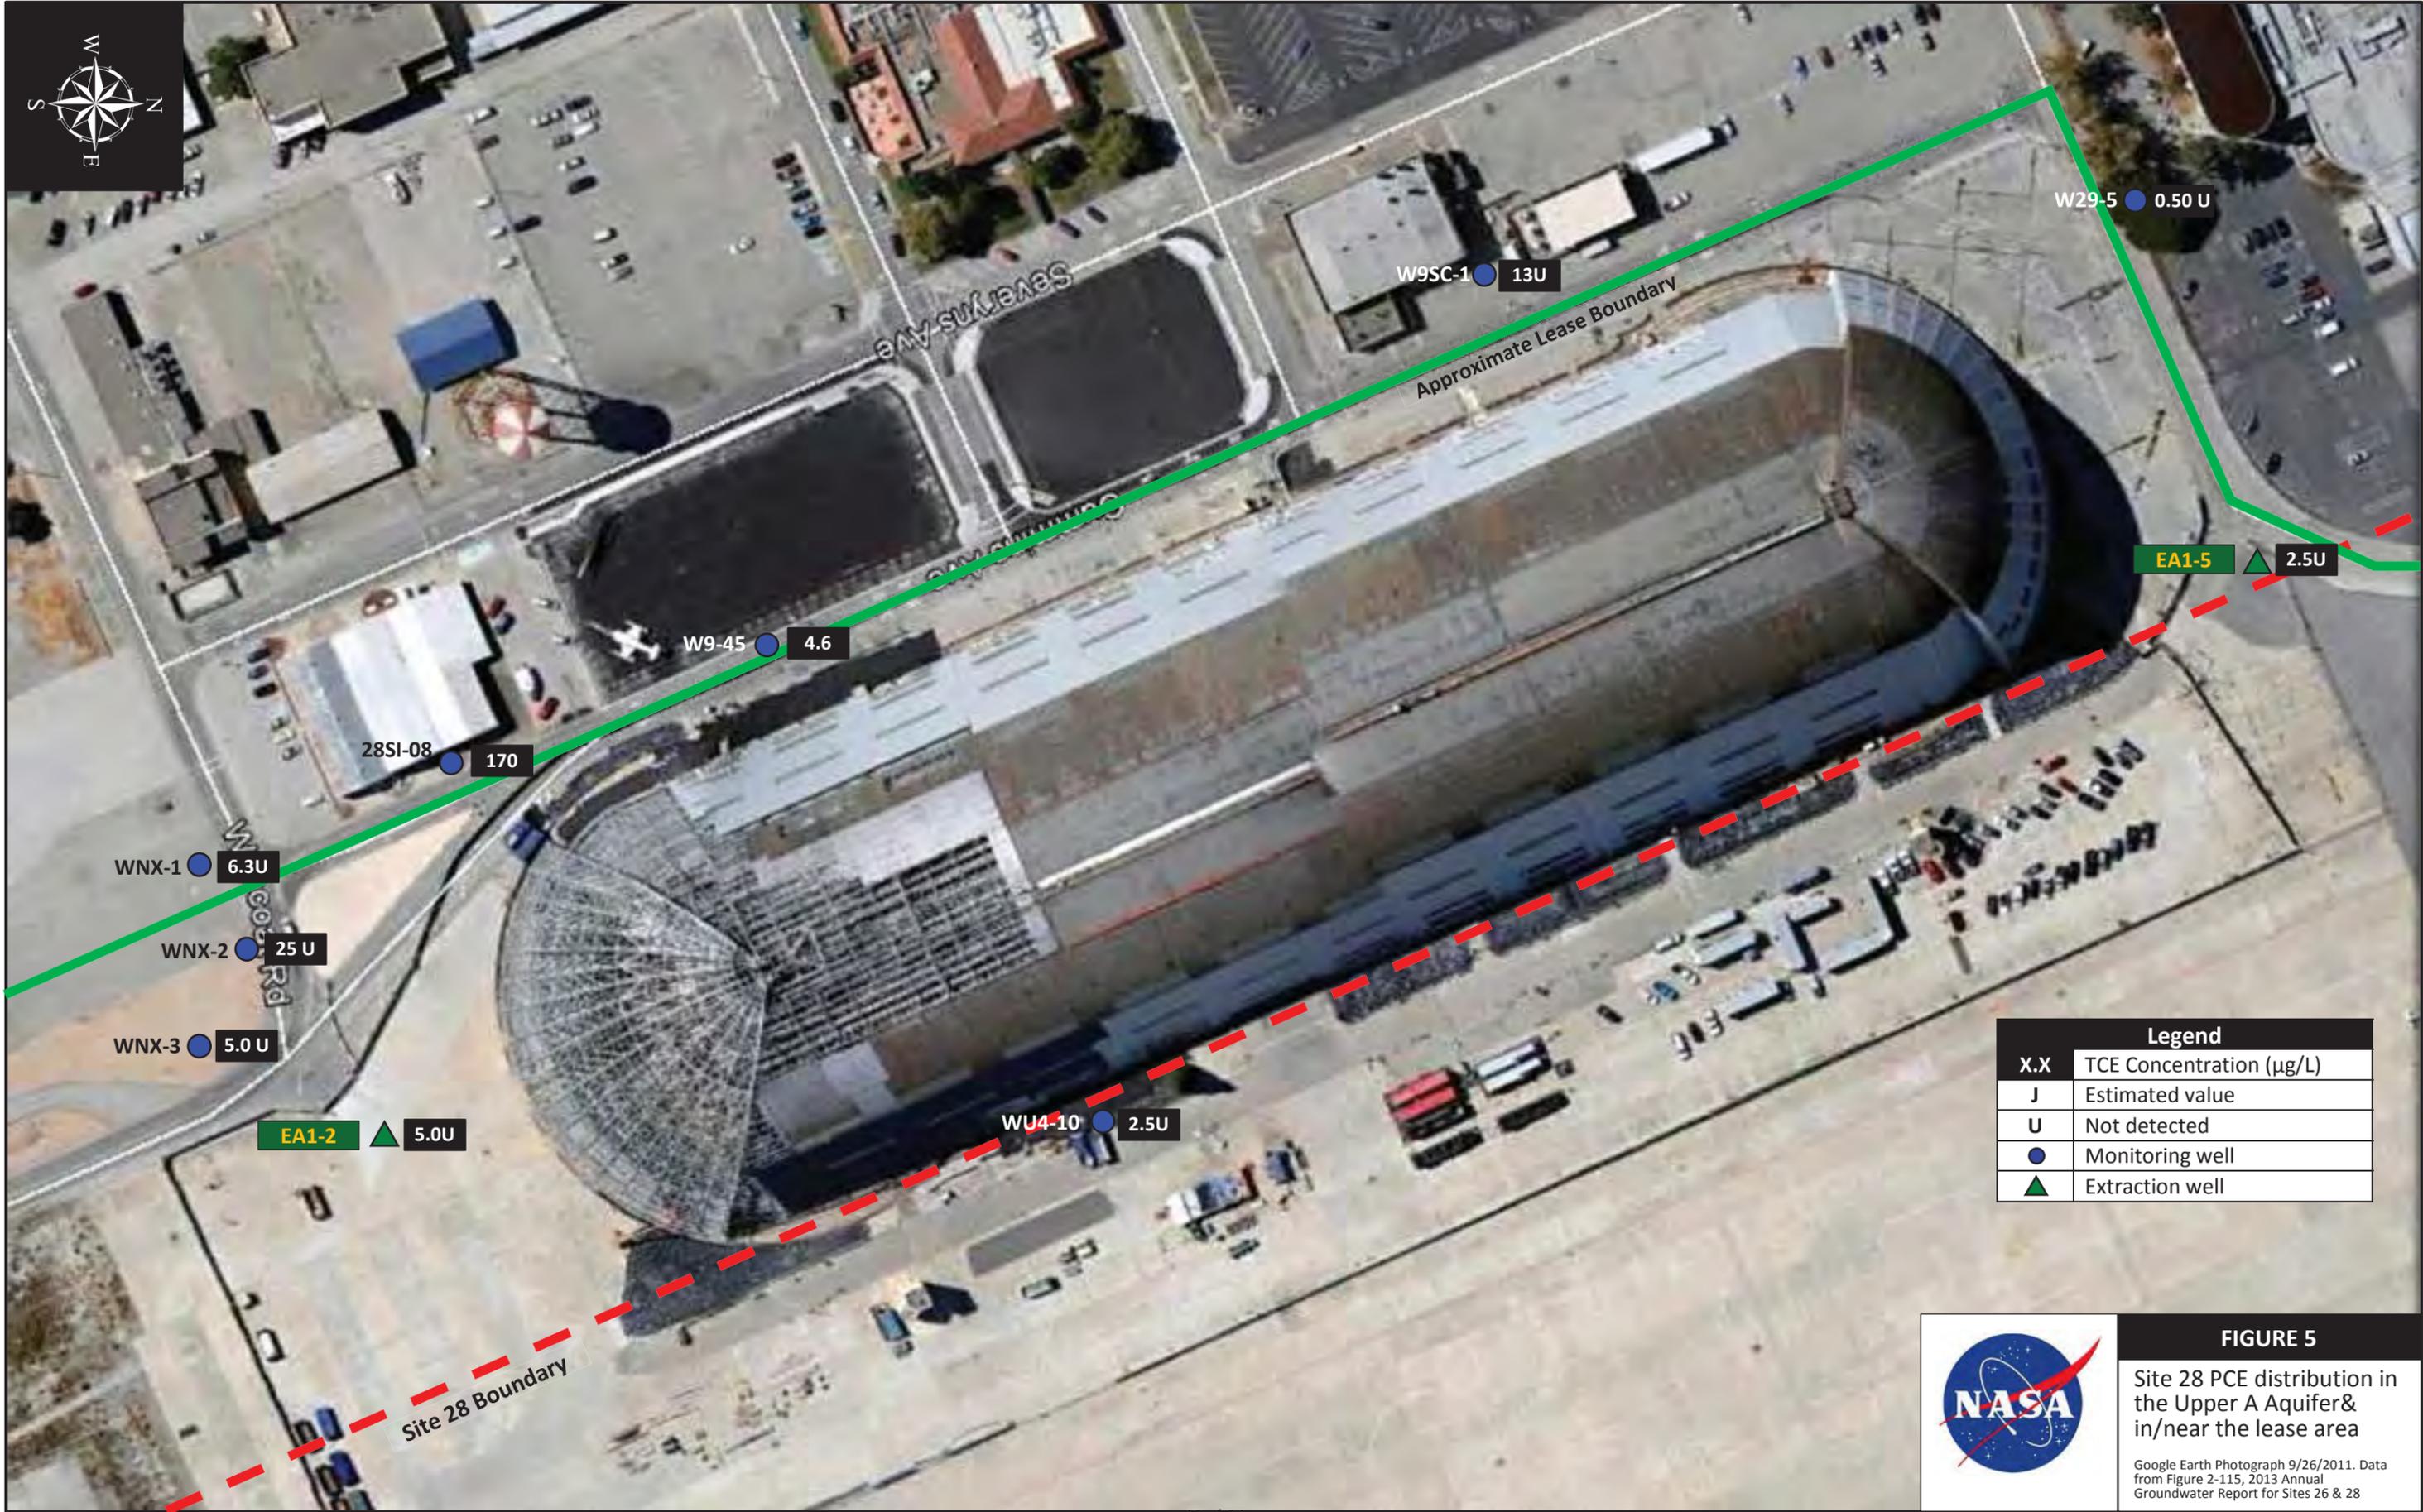
FIGURE 5
Site 28 PCE distribution in the Upper A Aquifer & in/near the lease area
Google Earth Photograph 9/26/2011. Data from Figure 2-115, 2013 Annual Groundwater Report for Sites 26 & 28

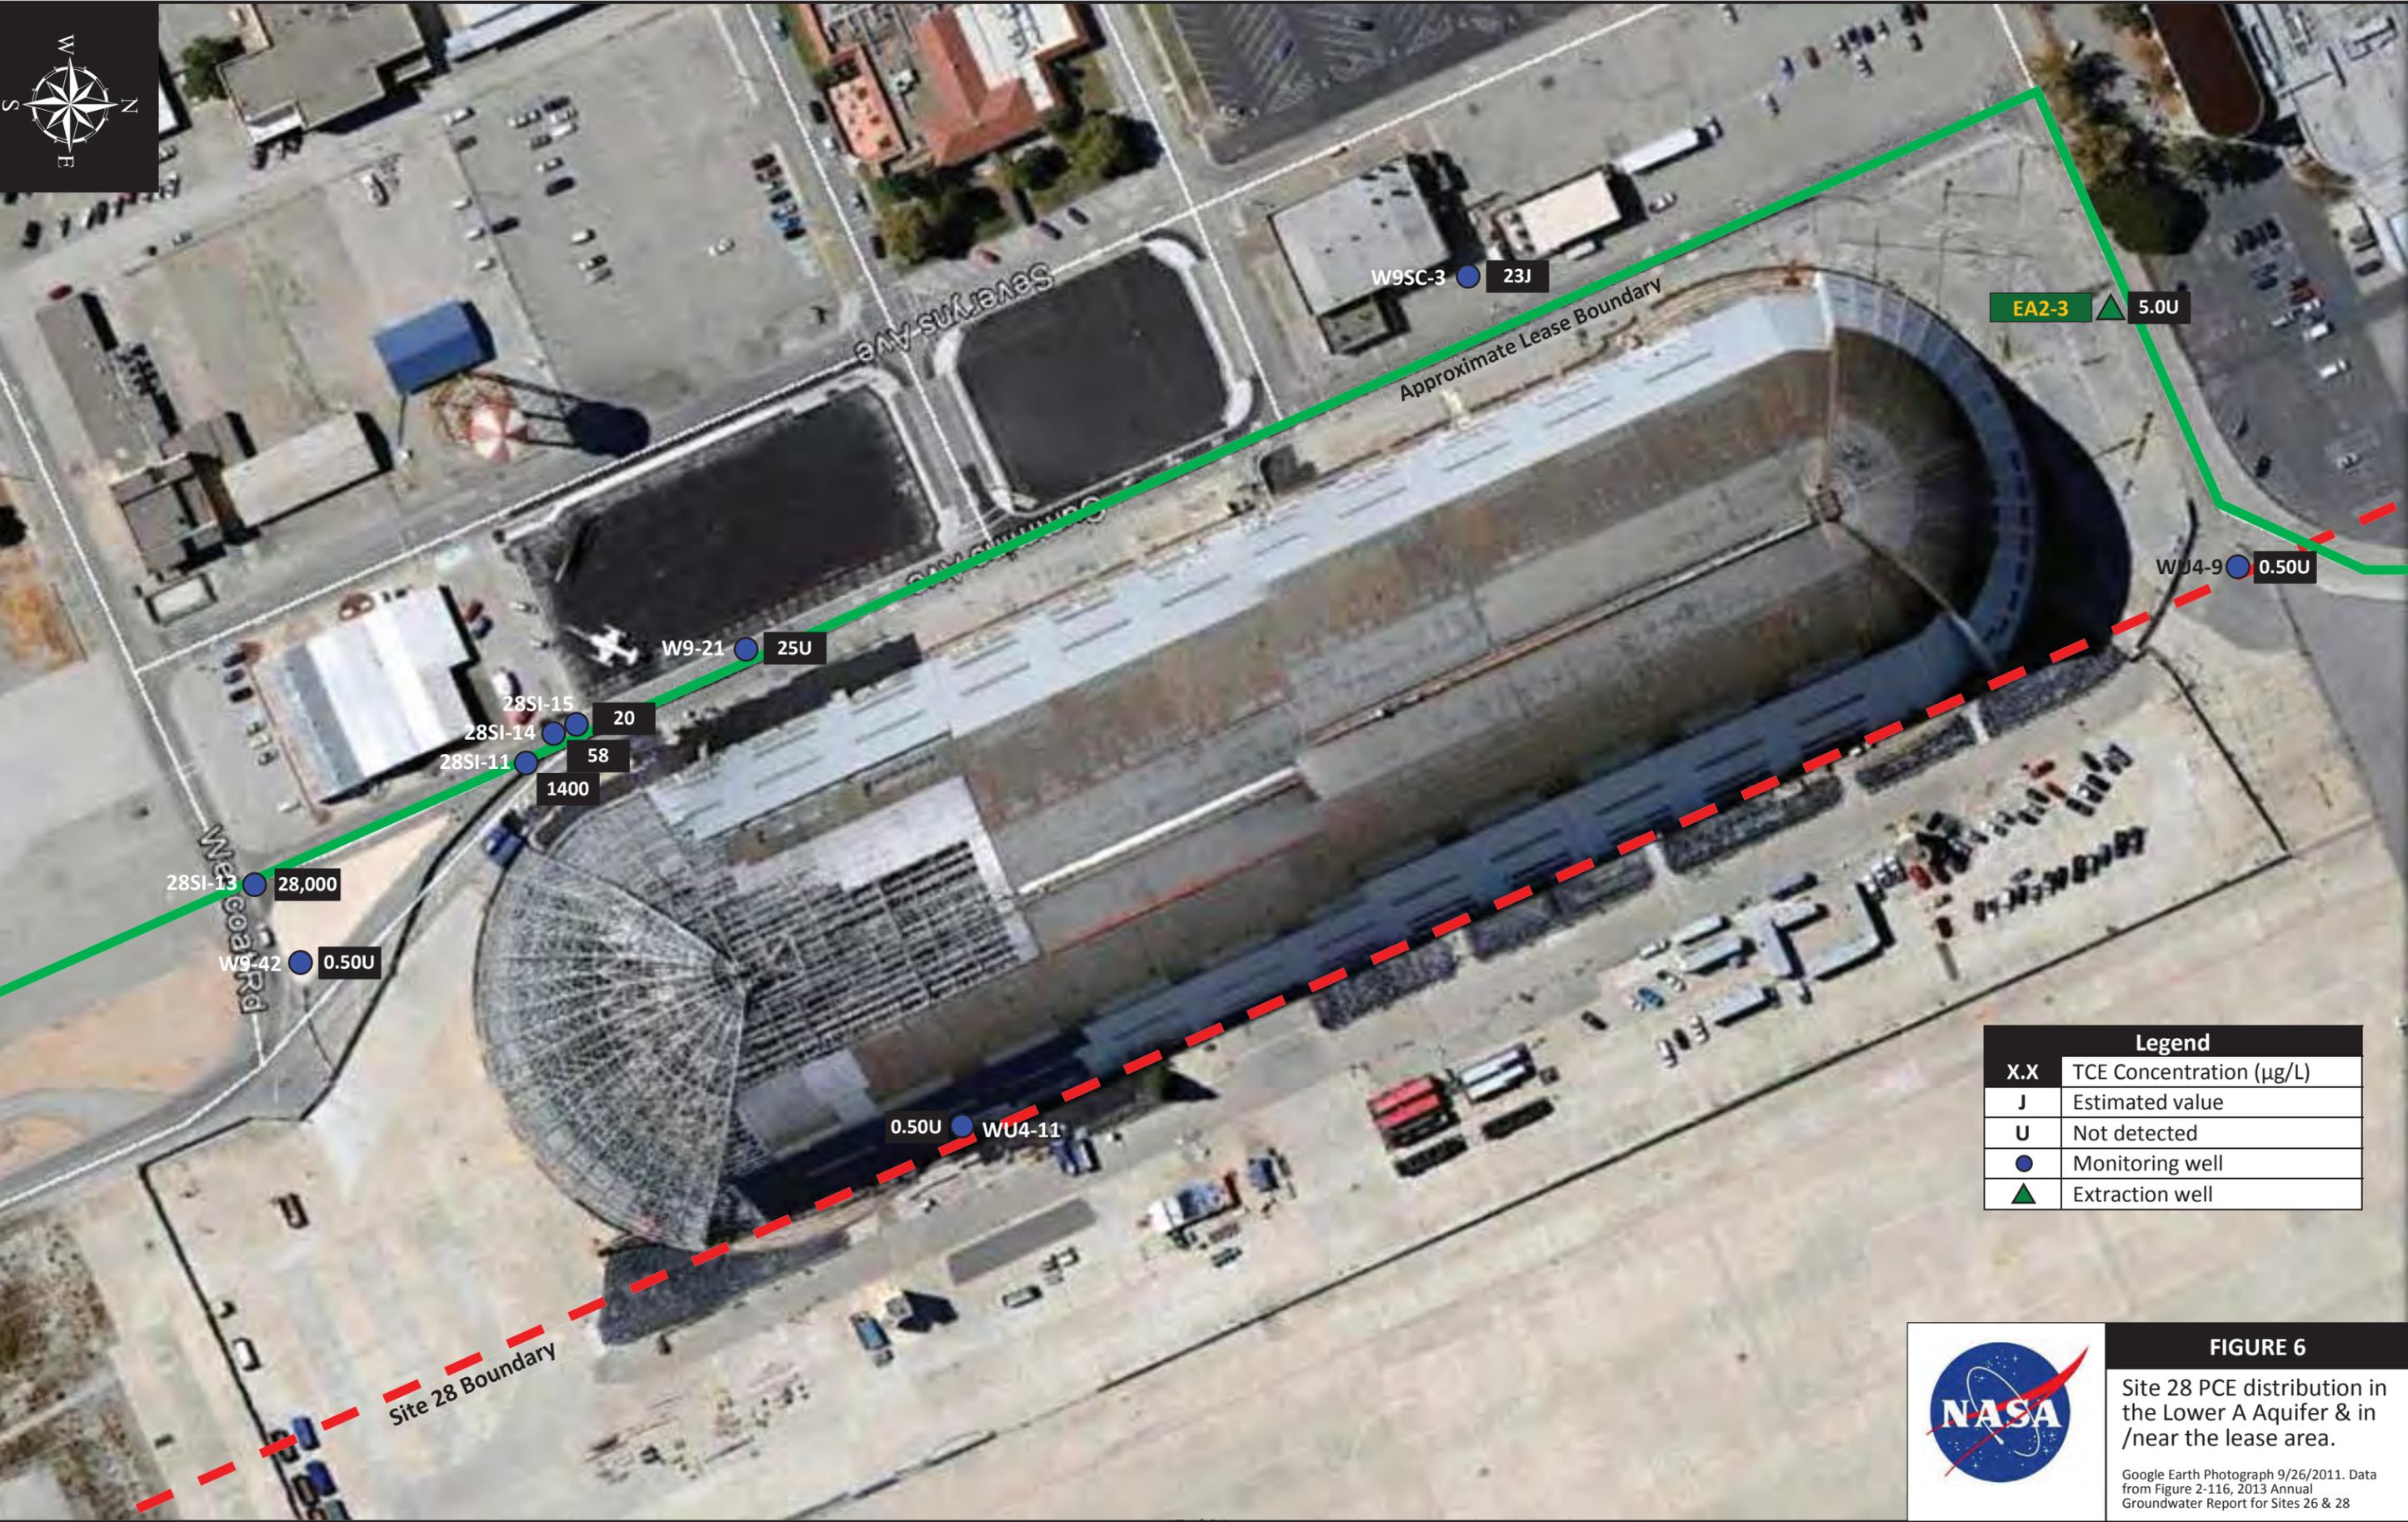
FIGURE 6
 Site 28 PCE distribution in the Lower A Aquifer & in /near the lease area.
 Google Earth Photograph 9/26/2011. Data from Figure 2-116, 2013 Annual Groundwater Report for Sites 26 & 28
