MFA Leasehold EIMP Appendix A - Part 2

3 March 2015

APPENDIX A

NASA EEC Statements

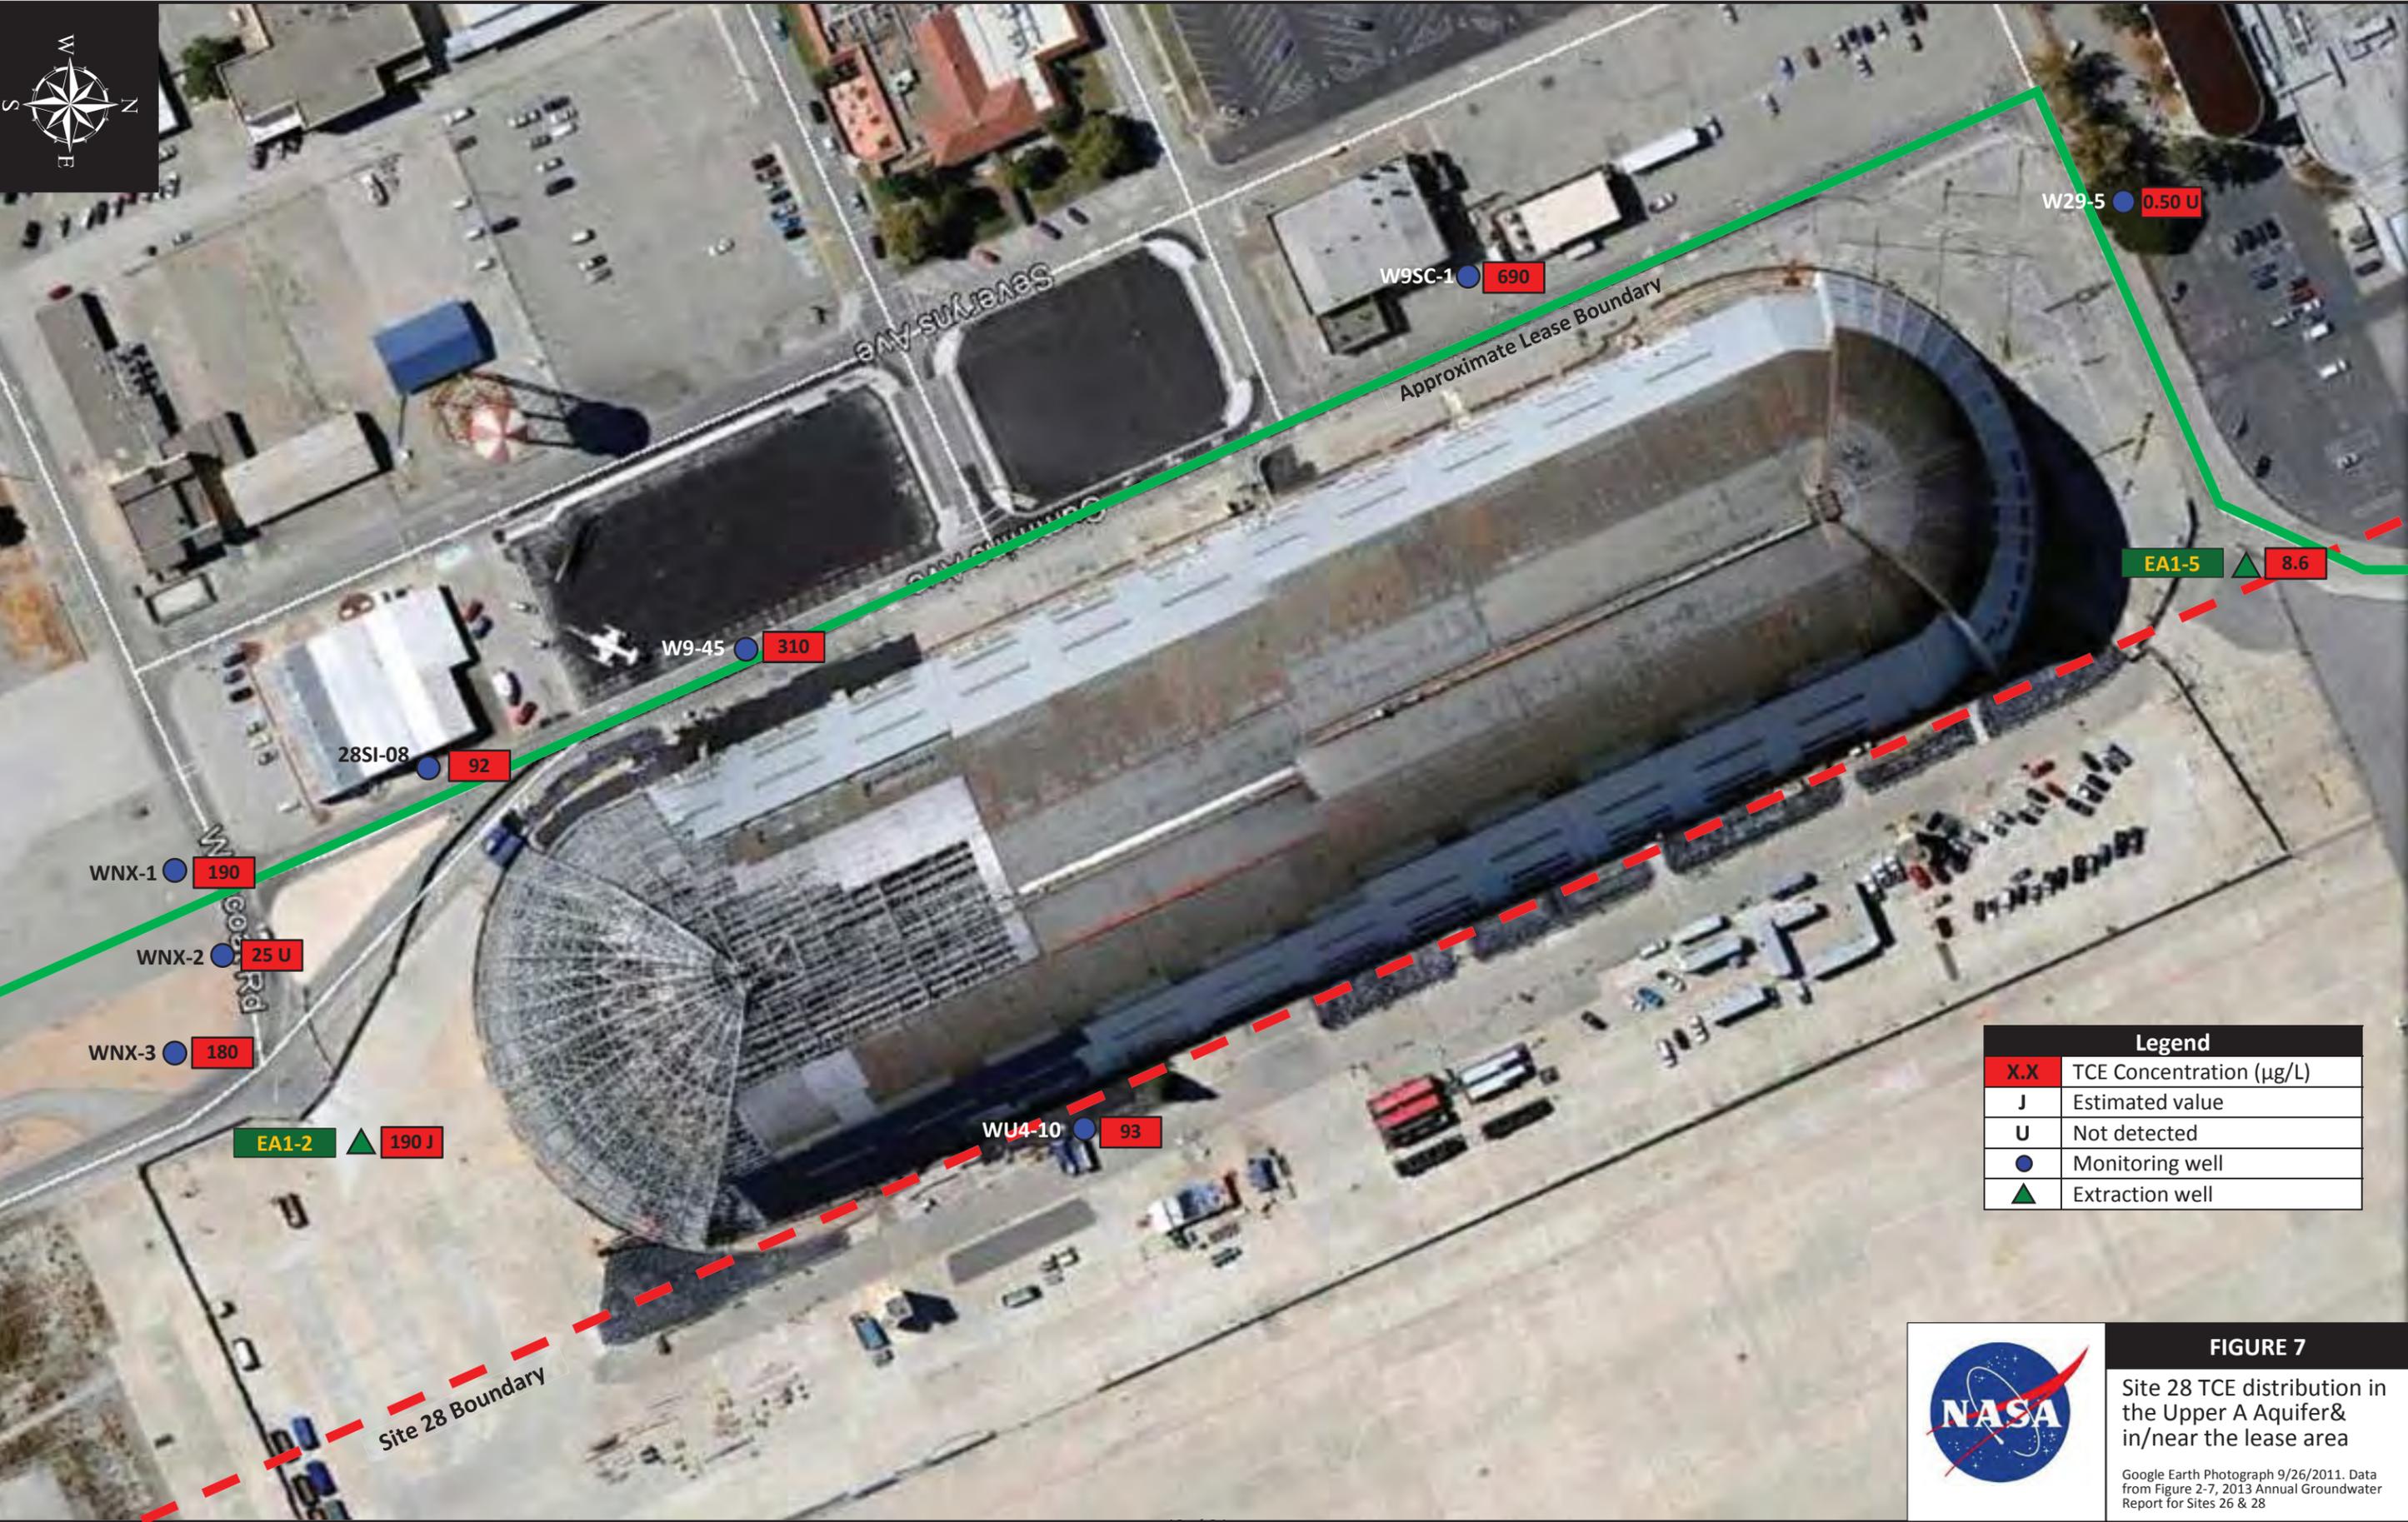
FIGURE 7
 Site 28 TCE distribution in the Upper A Aquifer & in/near the lease area
 Google Earth Photograph 9/26/2011. Data from Figure 2-7, 2013 Annual Groundwater Report for Sites 26 & 28

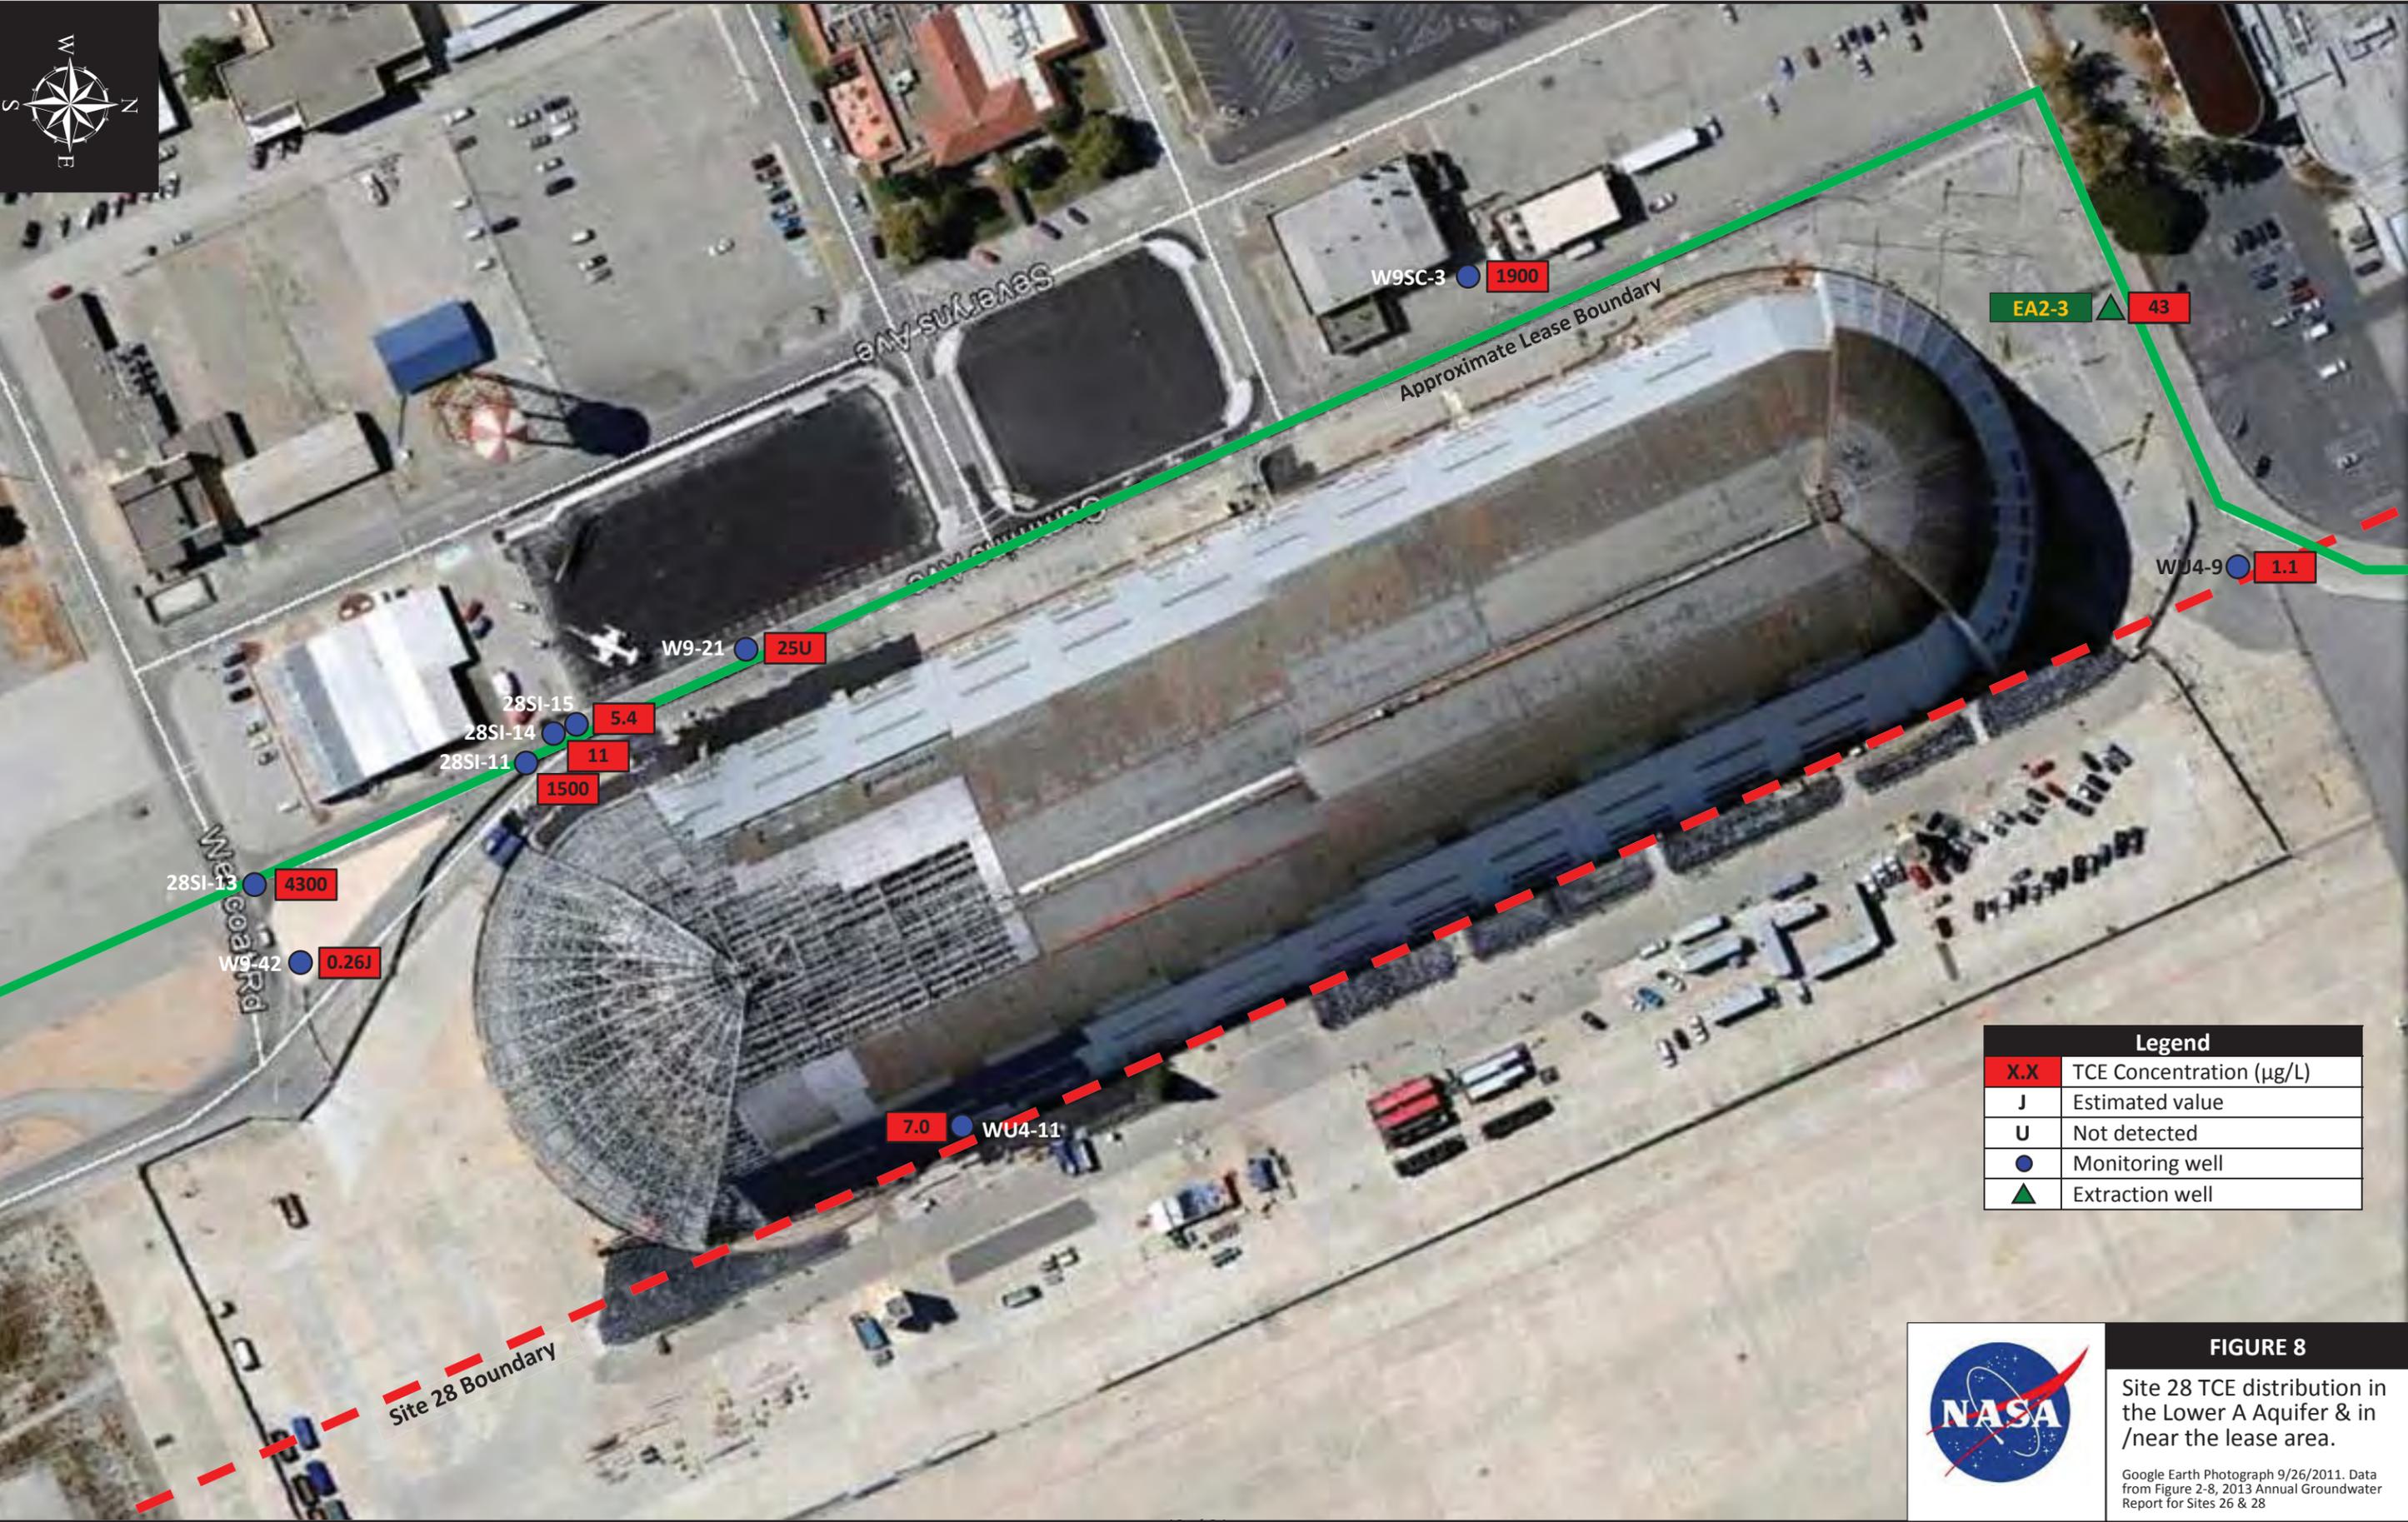
FIGURE 8
 Site 28 TCE distribution in the Lower A Aquifer & in /near the lease area.
 Google Earth Photograph 9/26/2011. Data from Figure 2-8, 2013 Annual Groundwater Report for Sites 26 & 28

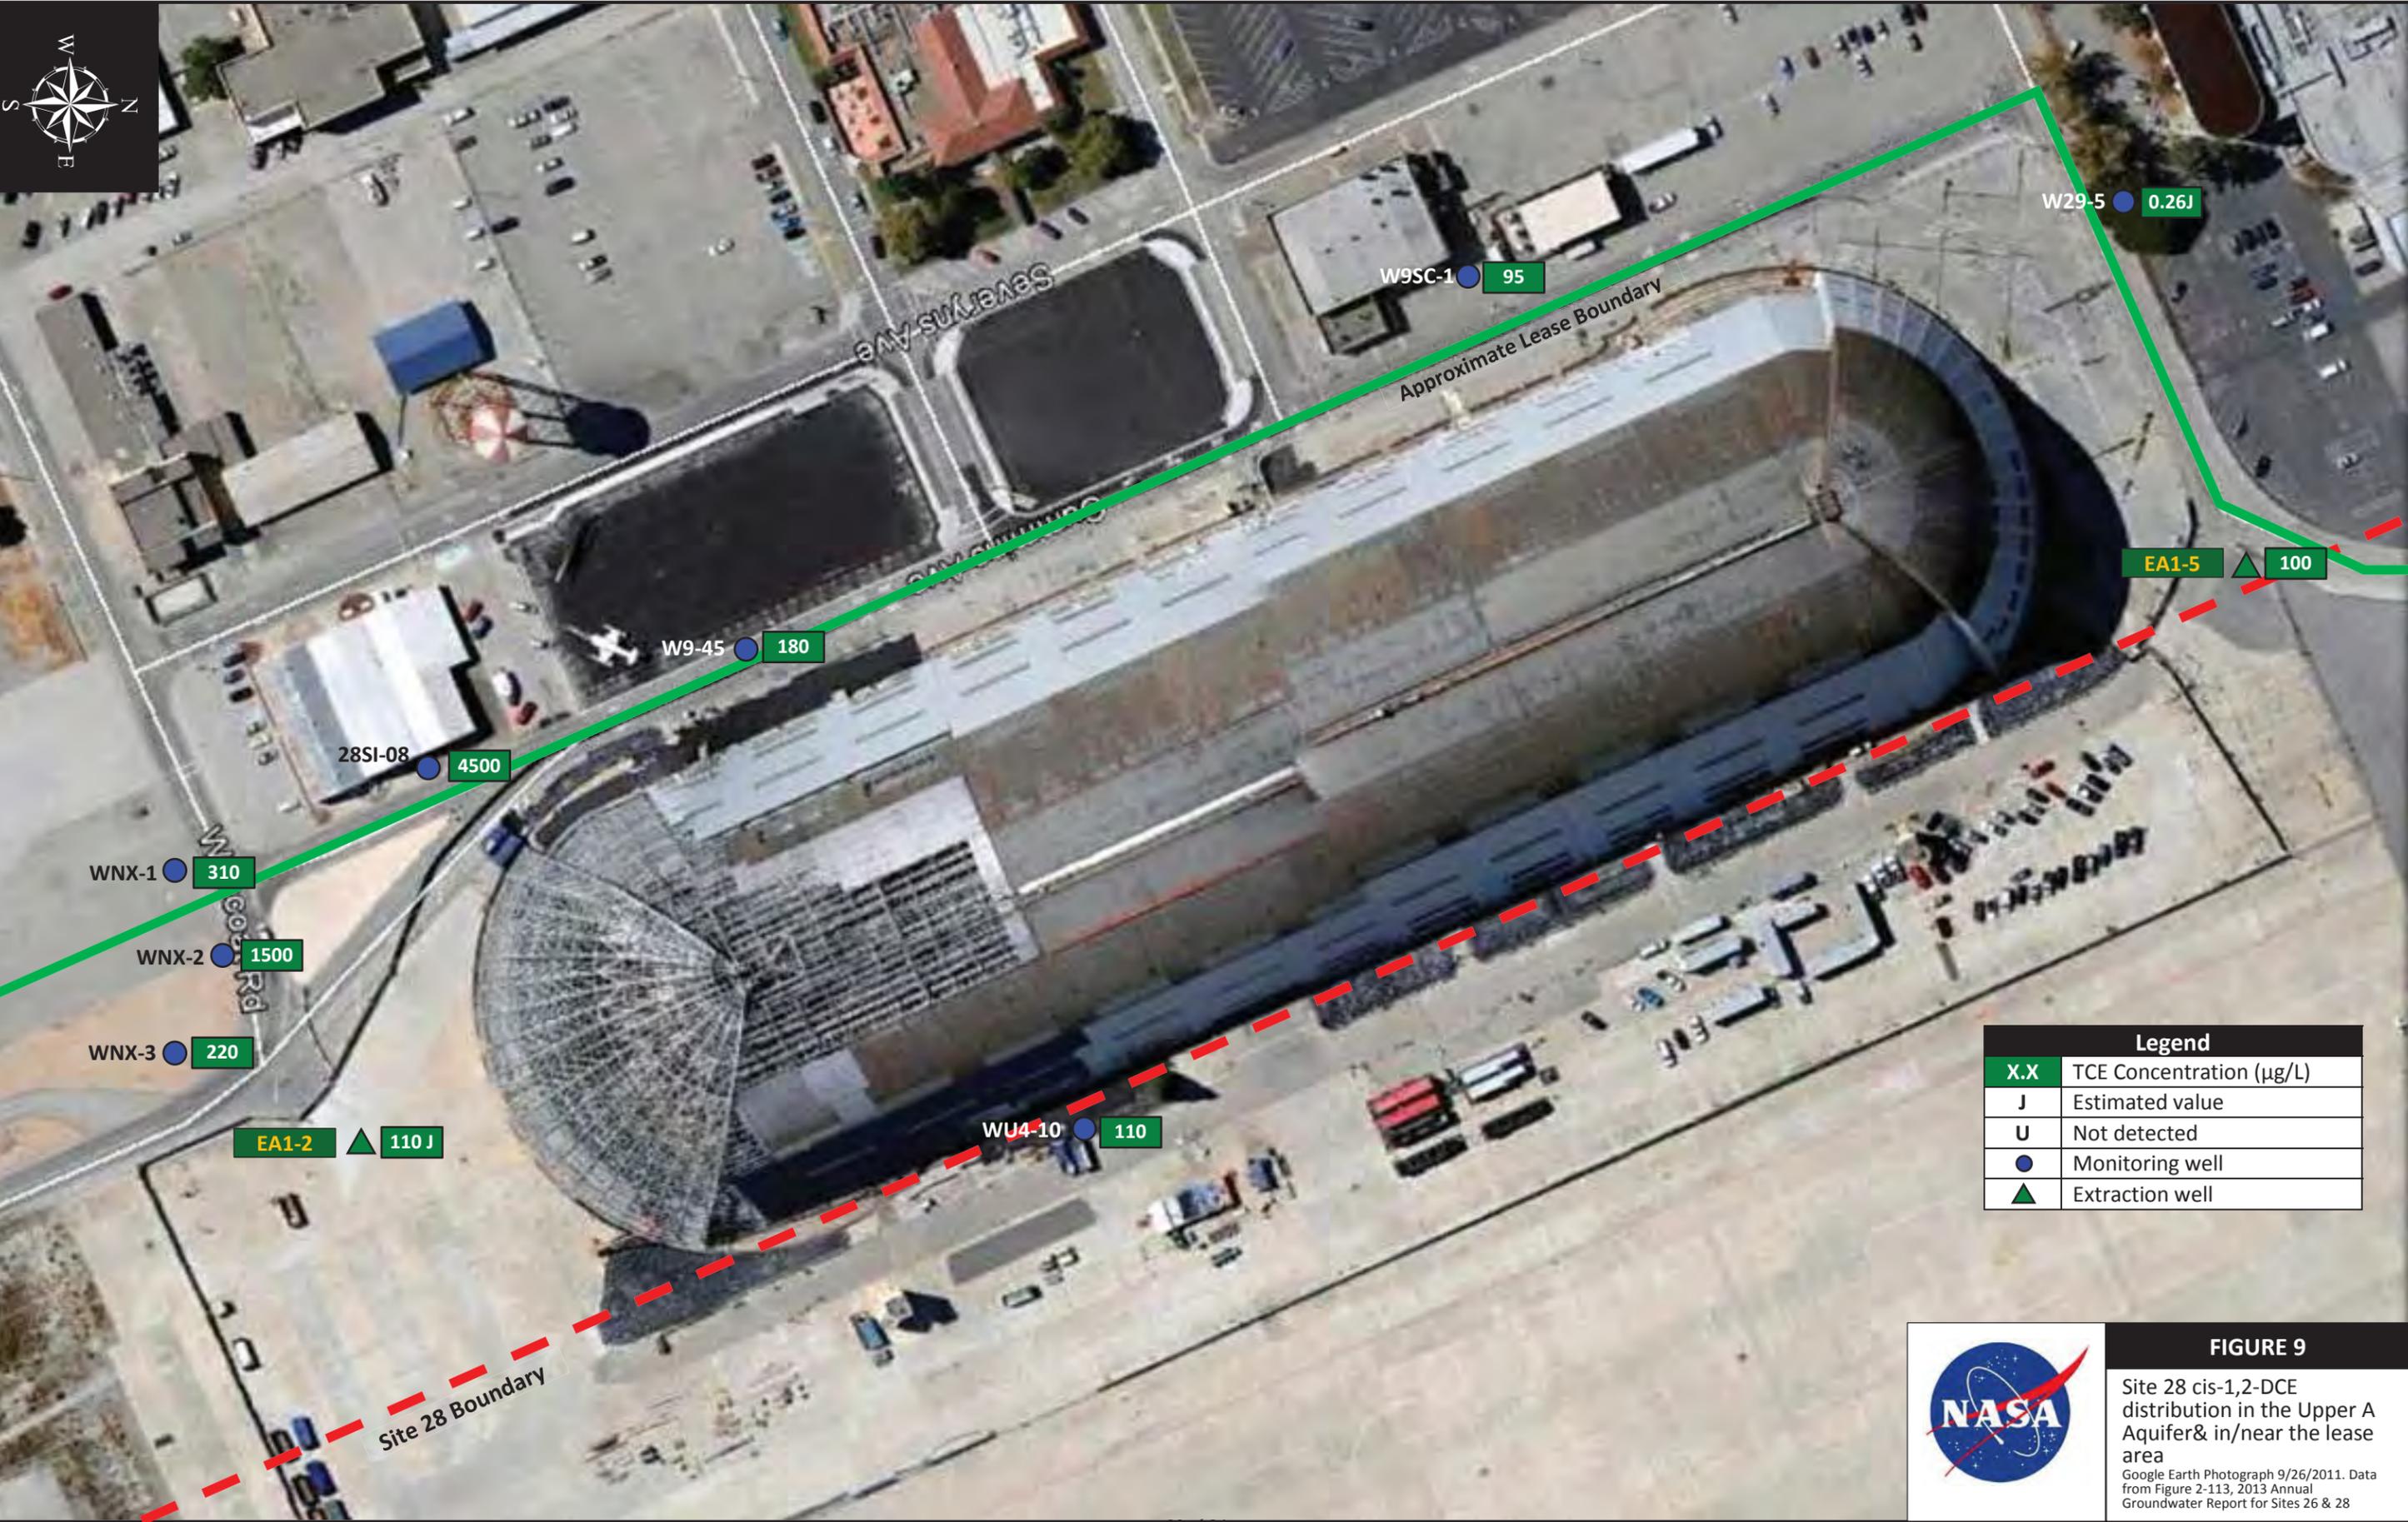
FIGURE 9
 Site 28 cis-1,2-DCE distribution in the Upper A Aquifer & in/near the lease area
 Google Earth Photograph 9/26/2011. Data from Figure 2-113, 2013 Annual Groundwater Report for Sites 26 & 28

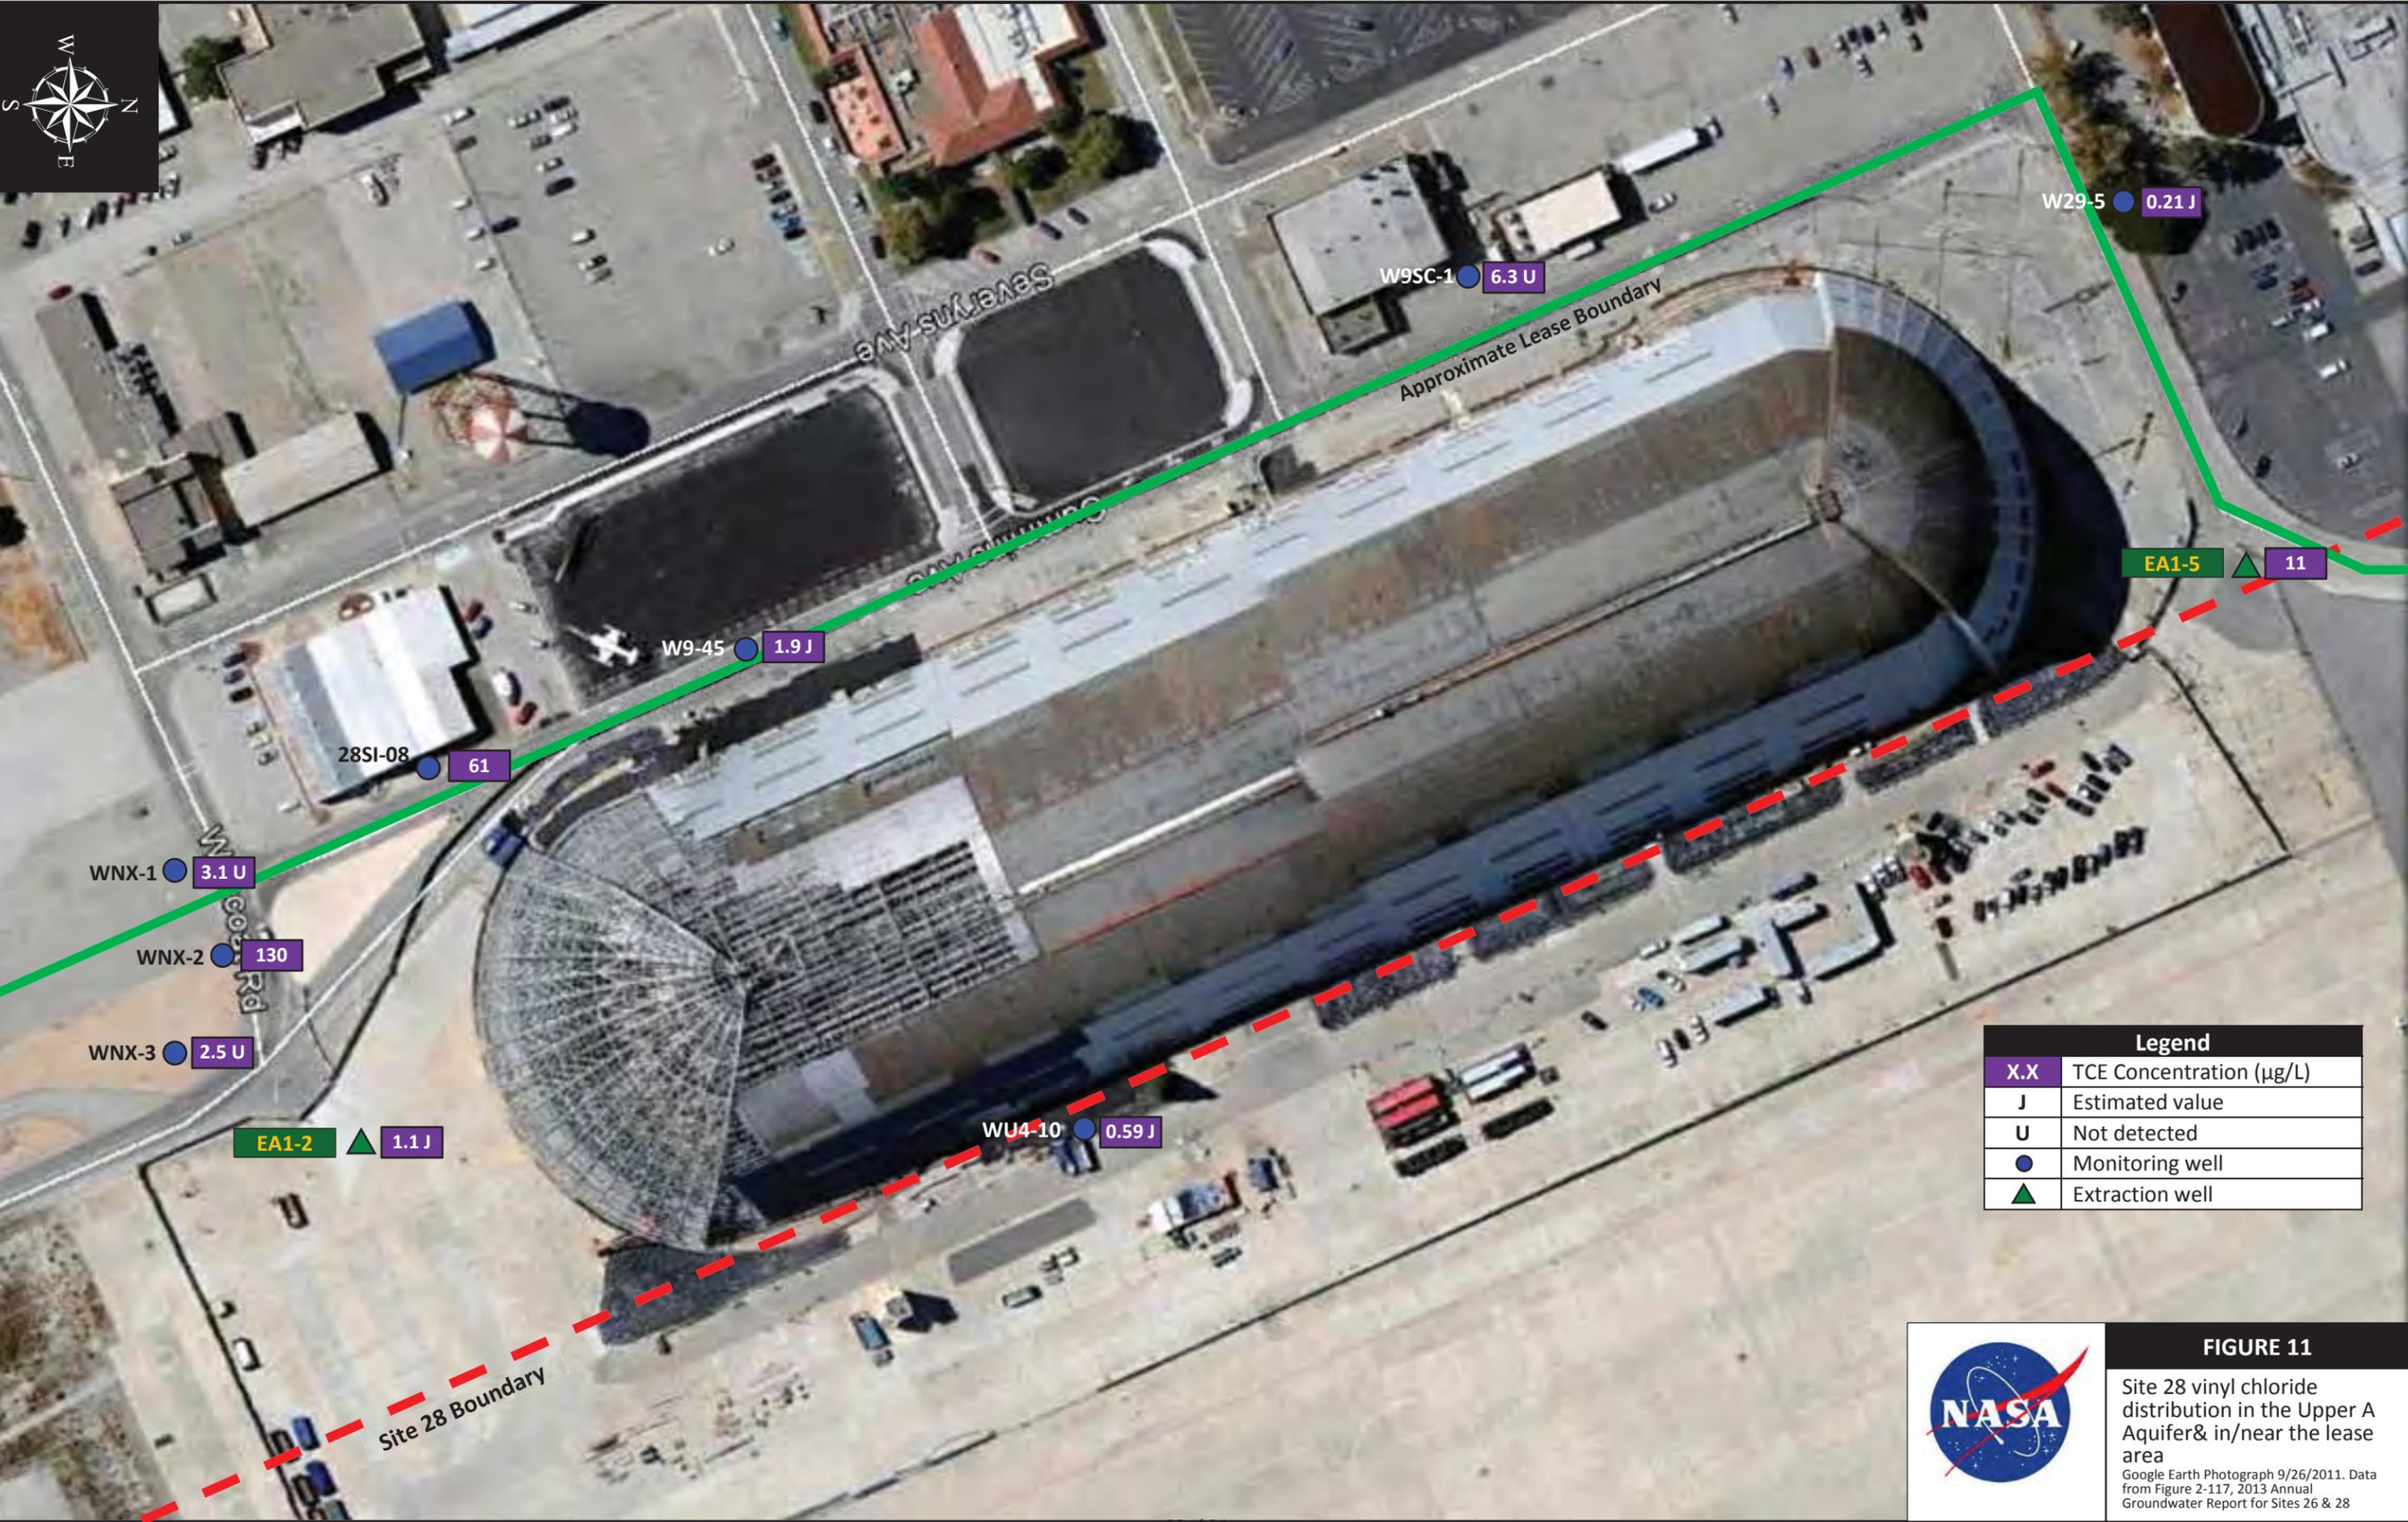
FIGURE 11
 Site 28 vinyl chloride distribution in the Upper A Aquifer & in/near the lease area
 Google Earth Photograph 9/26/2011. Data from Figure 2-117, 2013 Annual Groundwater Report for Sites 26 & 28

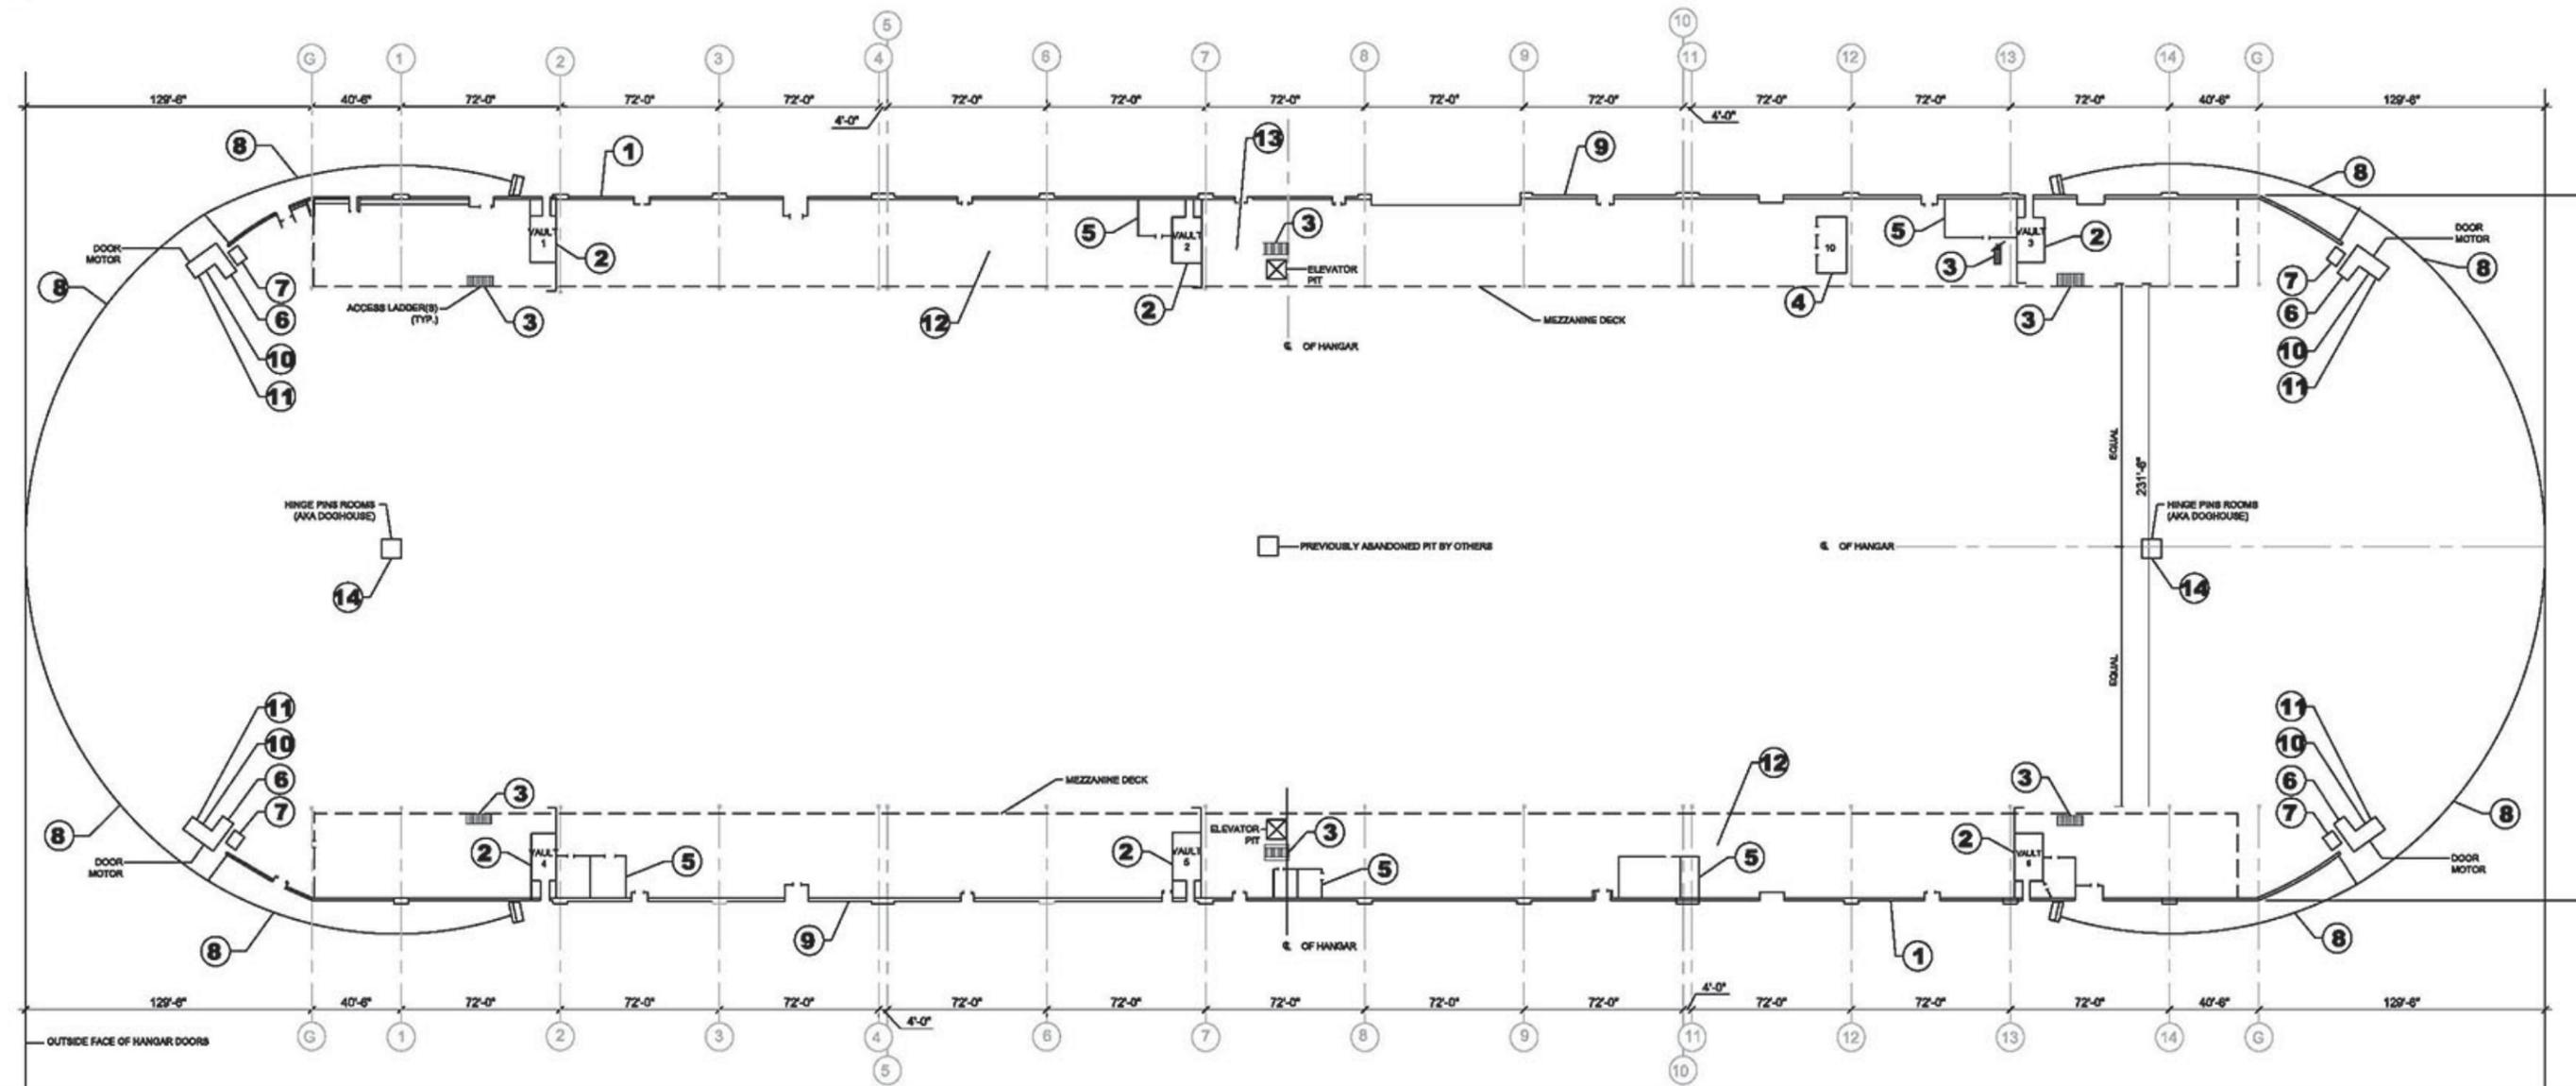
FIGURE 5

11	DOOR GEAR HOUSING	NEW CM15 OVERCOAT ON STEEL. ORIGINAL PAINT BENEATH CONTAINS PCBS.	INSPECT AND REPAIR CM15 COATING DURING LTMGMT INSPECTIONS.
12	TOP AND BOTTOM SURFACES OF MEZZANINE DECKS	NEW CM15 OVERCOAT ON STEEL. ORIGINAL PAINT BENEATH REMOVED COMPLETELY.	NO LTMGMT INSPECTIONS NEEDED. OWNER IS RESPONSIBLE FOR ROUTINE MAINTENANCE AND TOUCHUP OF THE COATING ON THE MEZZANINE DECKS.
13	ACCESS TO ROOF BETWEEN COLUMNS 7 AND 8	NEW CM15 OVERCOAT ON NEW GALVANIZED STEEL GRIP STRUTS. ORIGINAL PAINT ON HANDRAILS DOES NOT CONTAIN PCBS.	NO LTMGMT INSPECTIONS NEEDED. OWNER IS RESPONSIBLE FOR ROUTINE MAINTENANCE AND TOUCHUP OF THE COATING ON THE ROOF ACCESS.
14	HINGE PIN SYSTEM ON TOP OF ROOF (DOOR PIVOT POINTS)	NEW CM15 OVERCOAT ON STEEL. ORIGINAL PAINT BENEATH CONTAINS PCBS.	INSPECT AND REPAIR CM15 COATING DURING LTMGMT INSPECTIONS.

Maintenance and Inspection Plan (Fig. 3, LTMP)
