Appendix E
Pit Lake Photographs Showing Seeps and Transducer Installation
(Compact Disk)

Yerington Pit – West End

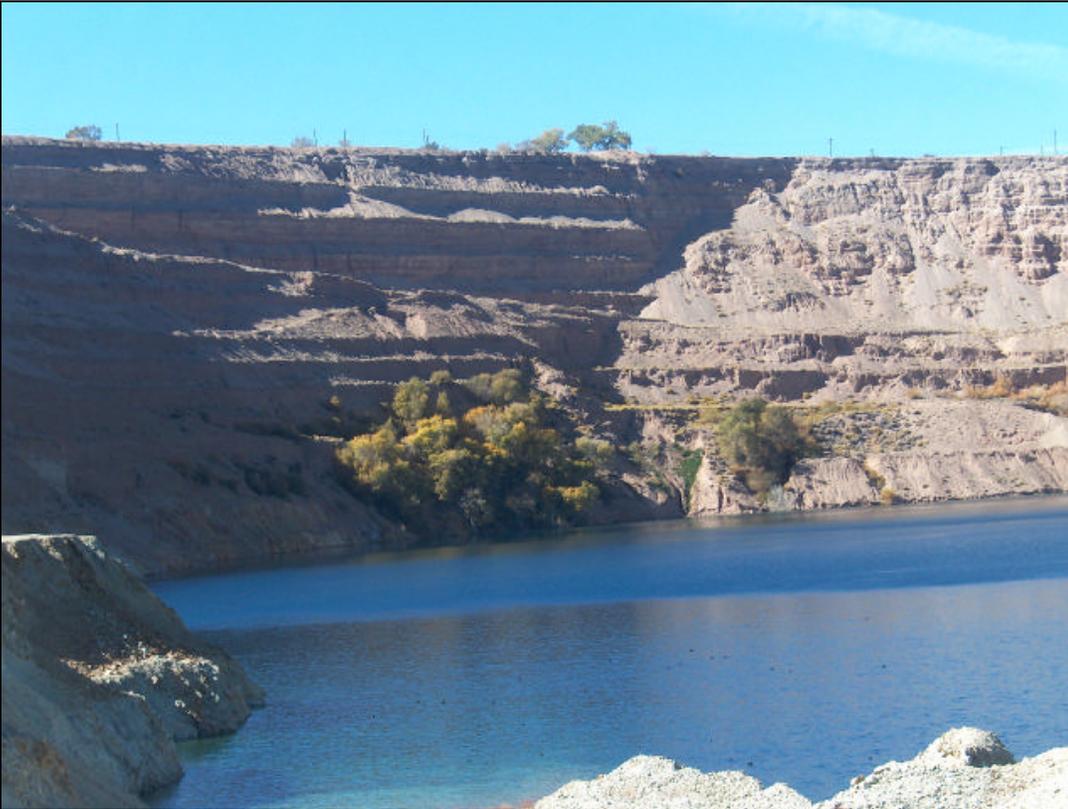
Photo 1.

Main seep west side below Weed Heights post office (ARC office). Bedrock-alluvium contact is at or slightly below current water level (4212 ft).

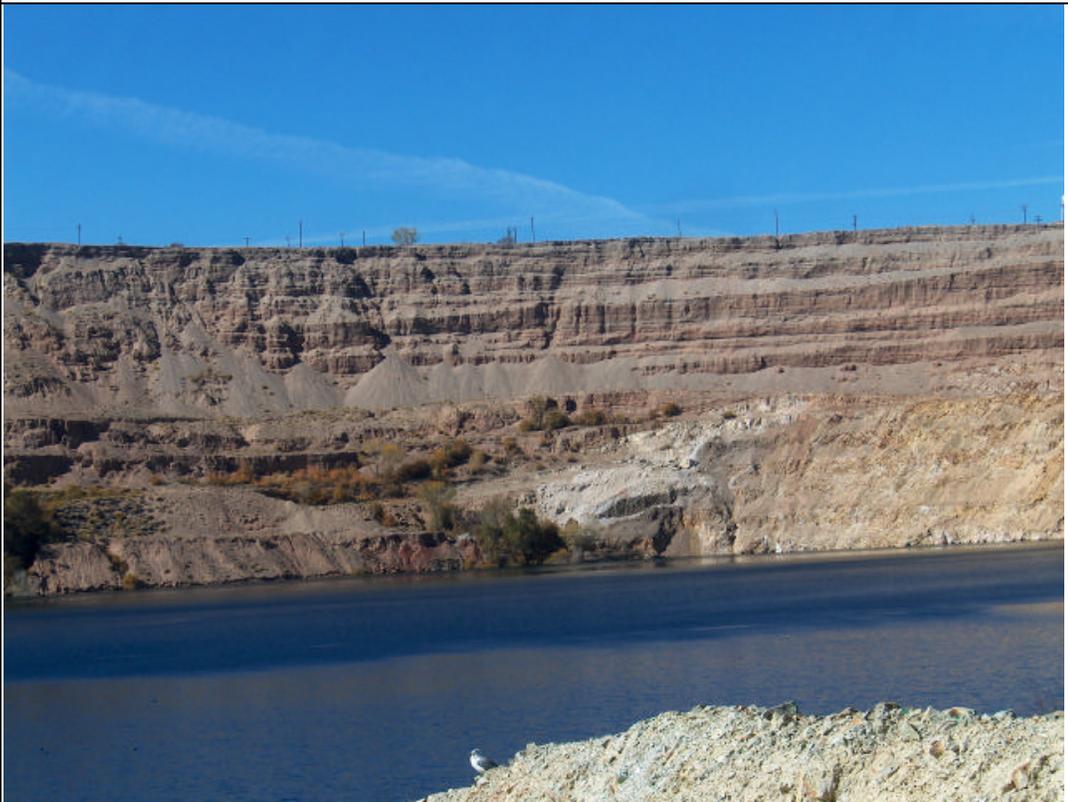
Photo 2.

Smaller seep on west side north of the large seep. Bedrock-alluvium contact just above white rock outcrop.

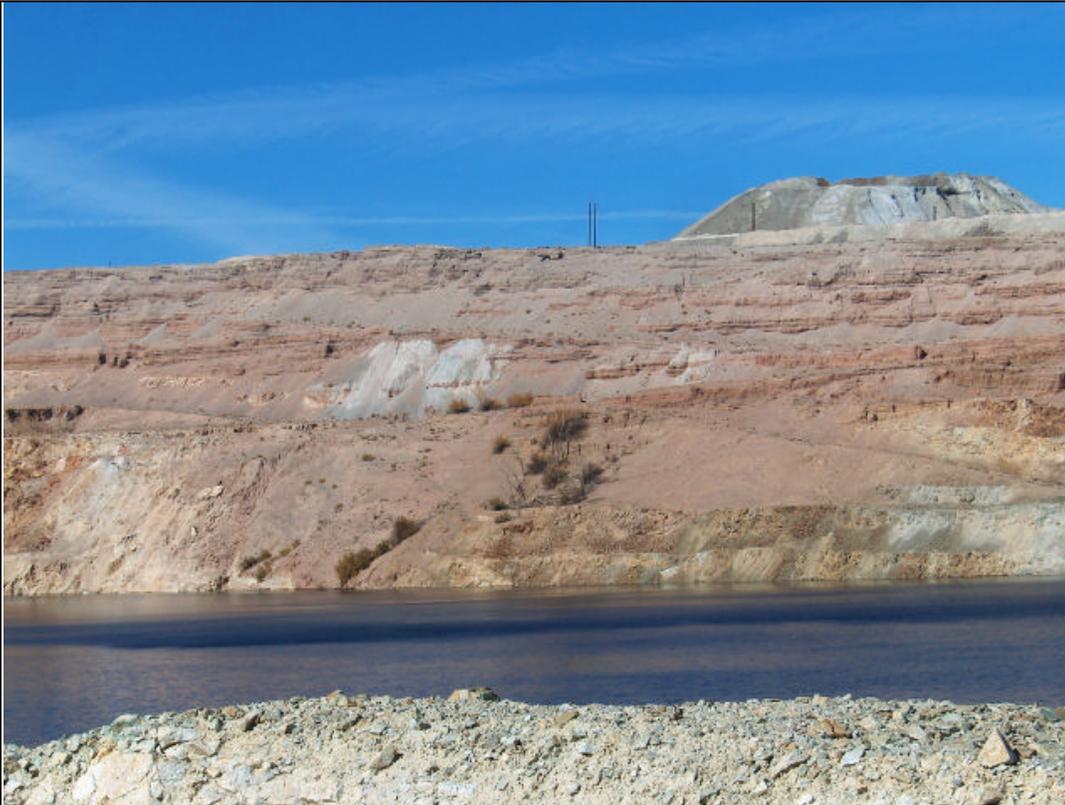
Photo 3.

Even smaller seep on north west side of pit located south of the S-32 low-grade sulfide ore stockpile (visible at skyline).

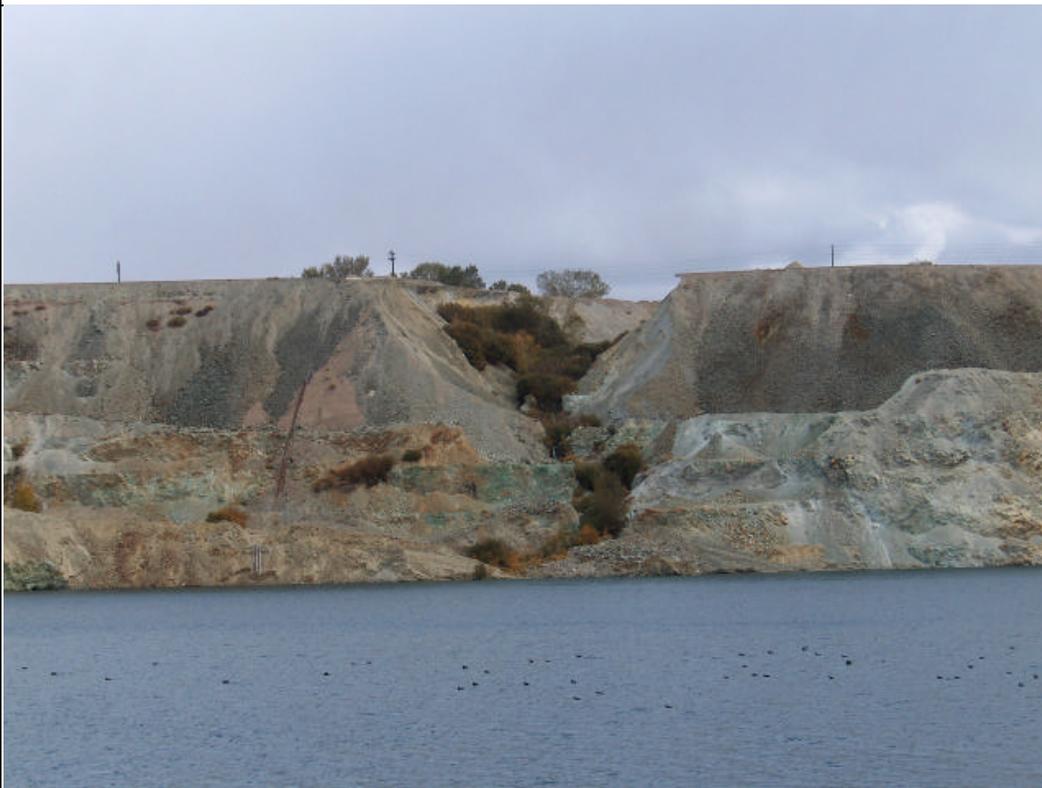
Photo 4.

East side seep from Walker River.

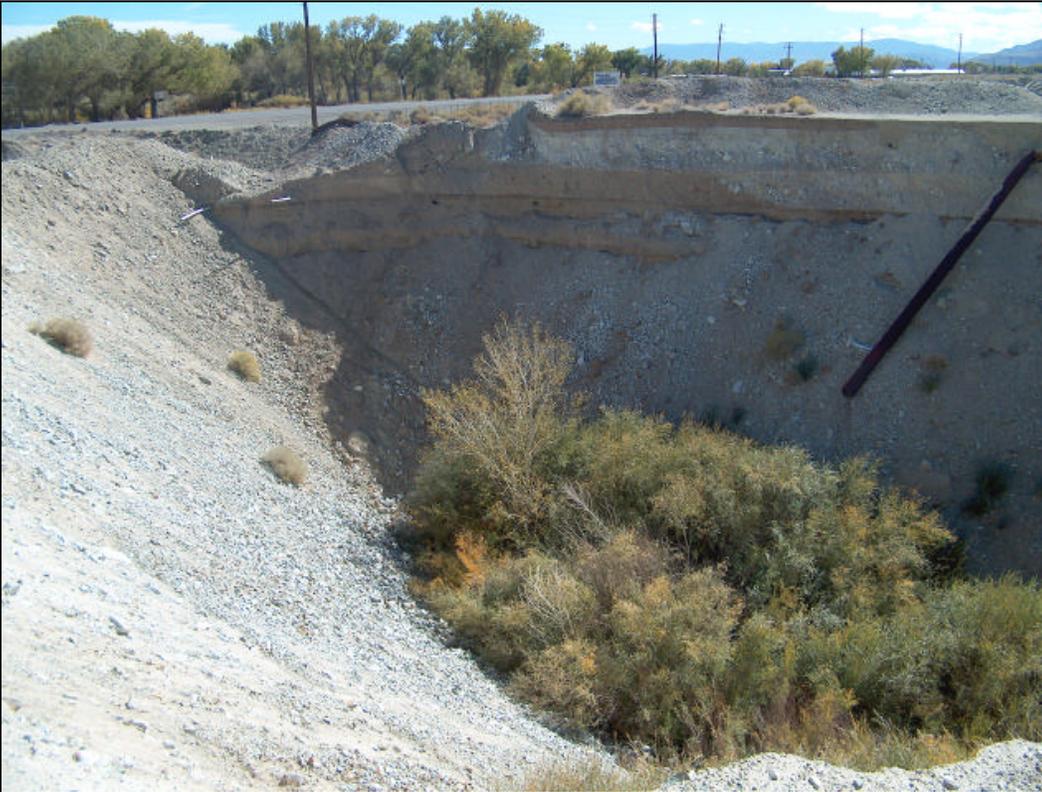
Photo 5.

East side seep from Walker River at pit rim elevation. Seep is located ~40-50 ft below ground surface.

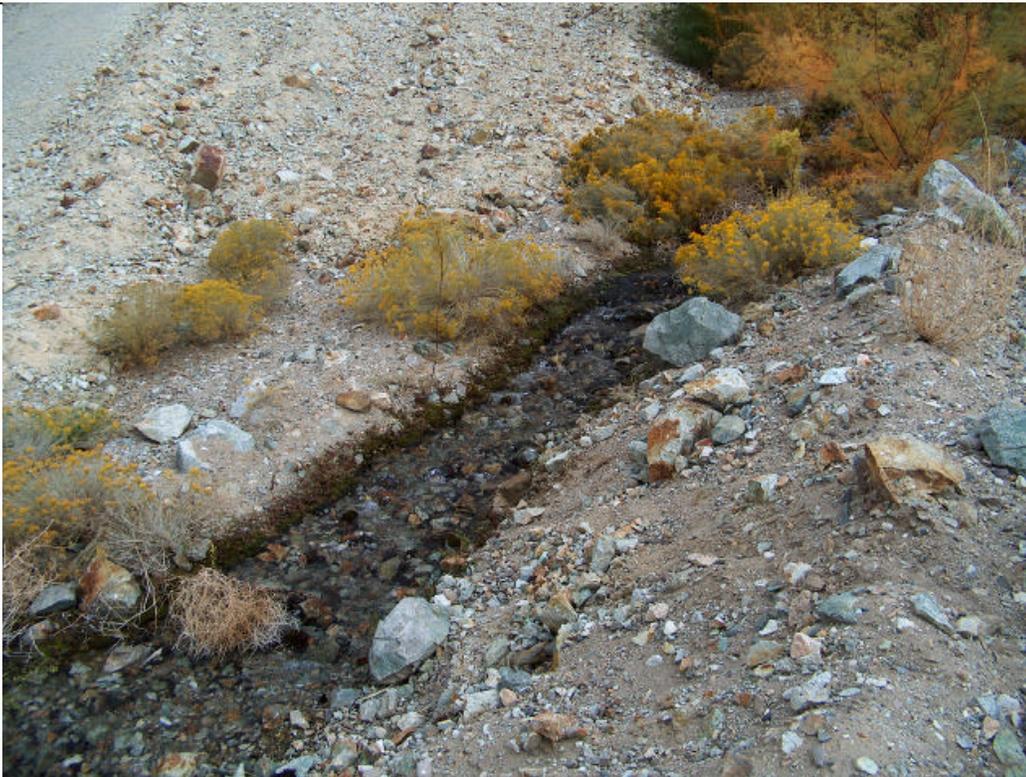
Photo 6.

East seep stream entering Pit Lake (10/5/2007)

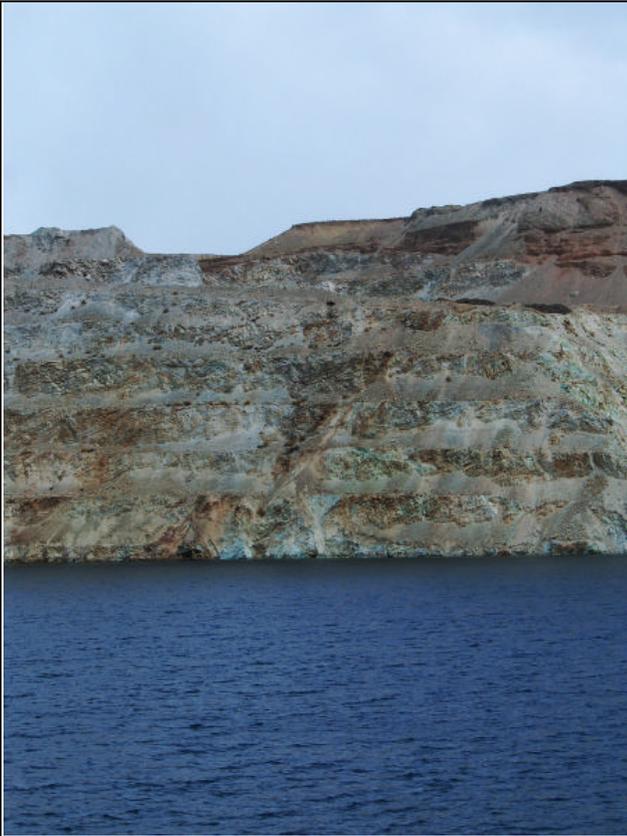
Photo 7.

Serecite Fault zone, north pit wall.

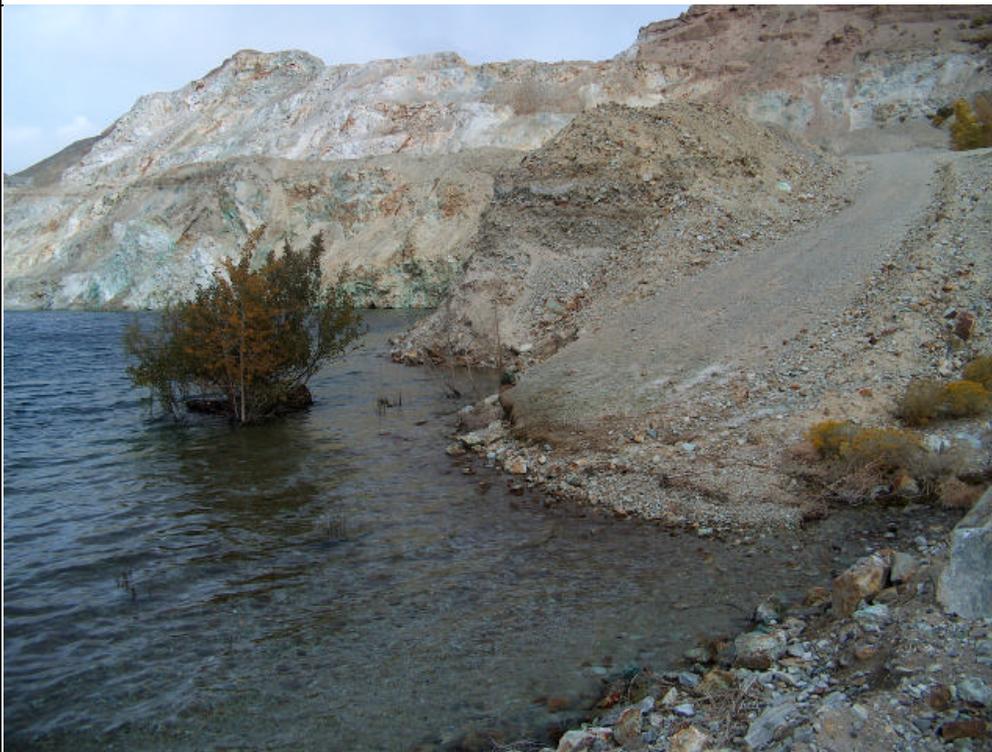
Photo 8.

Errosion of north haul road ramp due to wave action in pit lake. East seep stream is visible just to the right of the road.

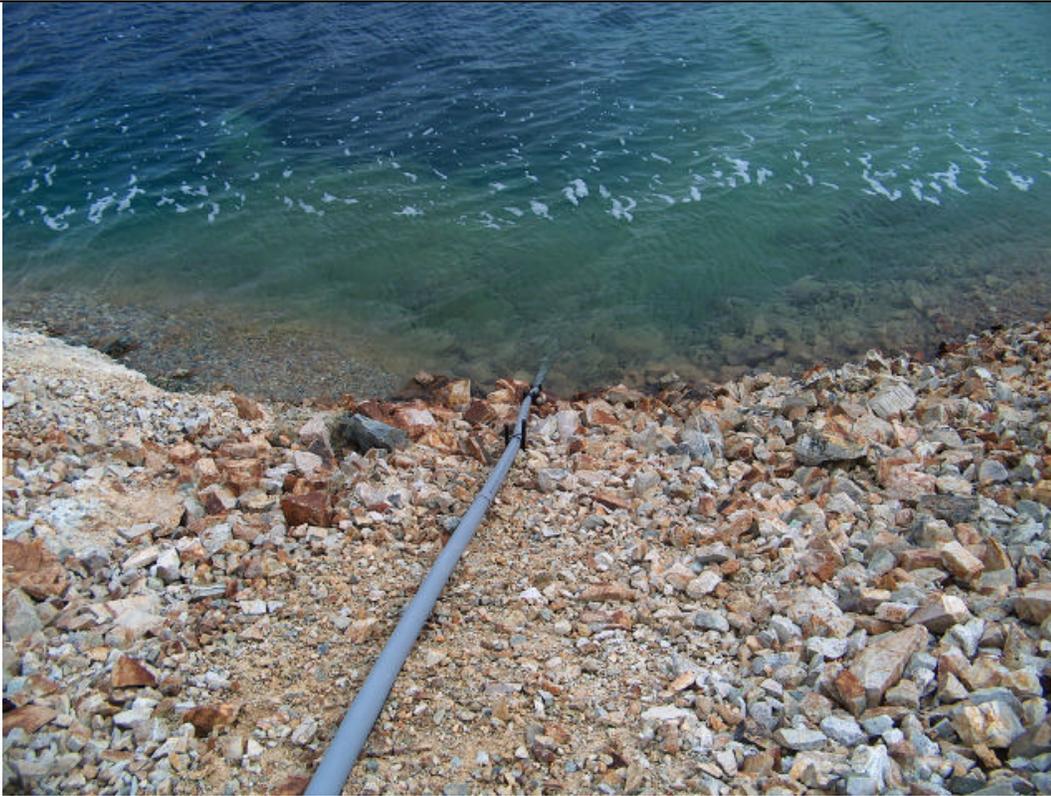
Photo 1.

Pit Lake water level transducer, installed 9/25/2007. Transducer is positioned inside conduit resting on bottom of endcap.

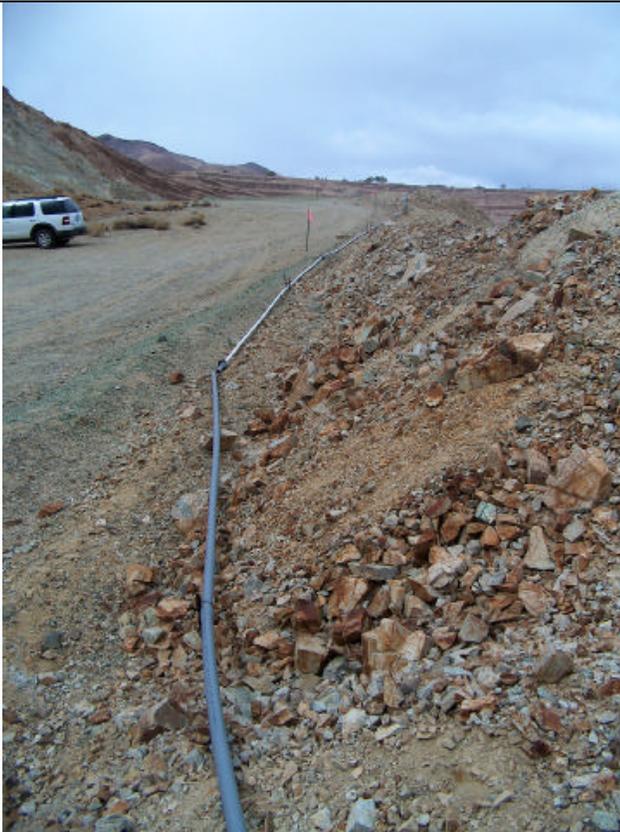
Photo 2.

Conduit from water to datalogger contains data cable. Data logger is positioned ~180 feet up the ramp and ~25 higher in elevation (4237.0 elev.) than current water level (4212.3 elev.)

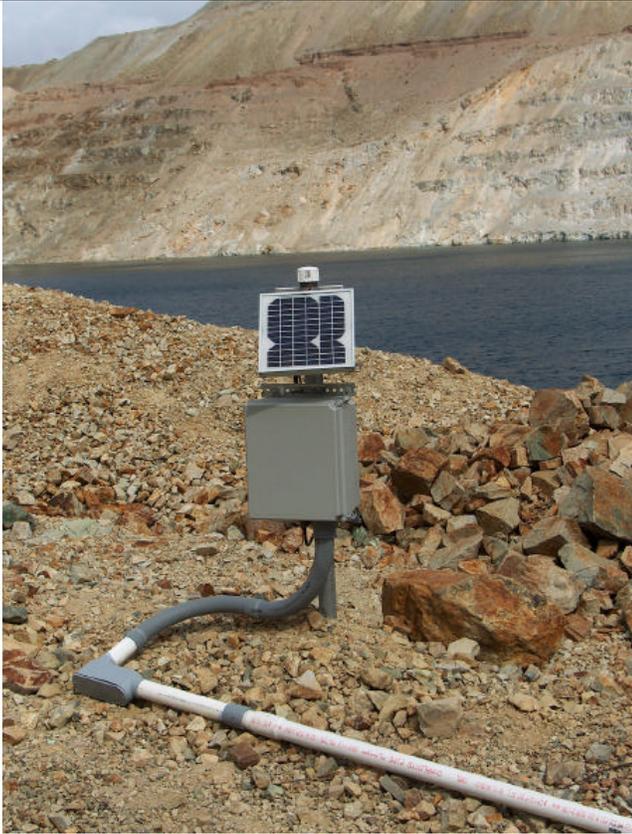
Photo 3.

Data logger with solar panel and radio transmitter for cable-less data download.

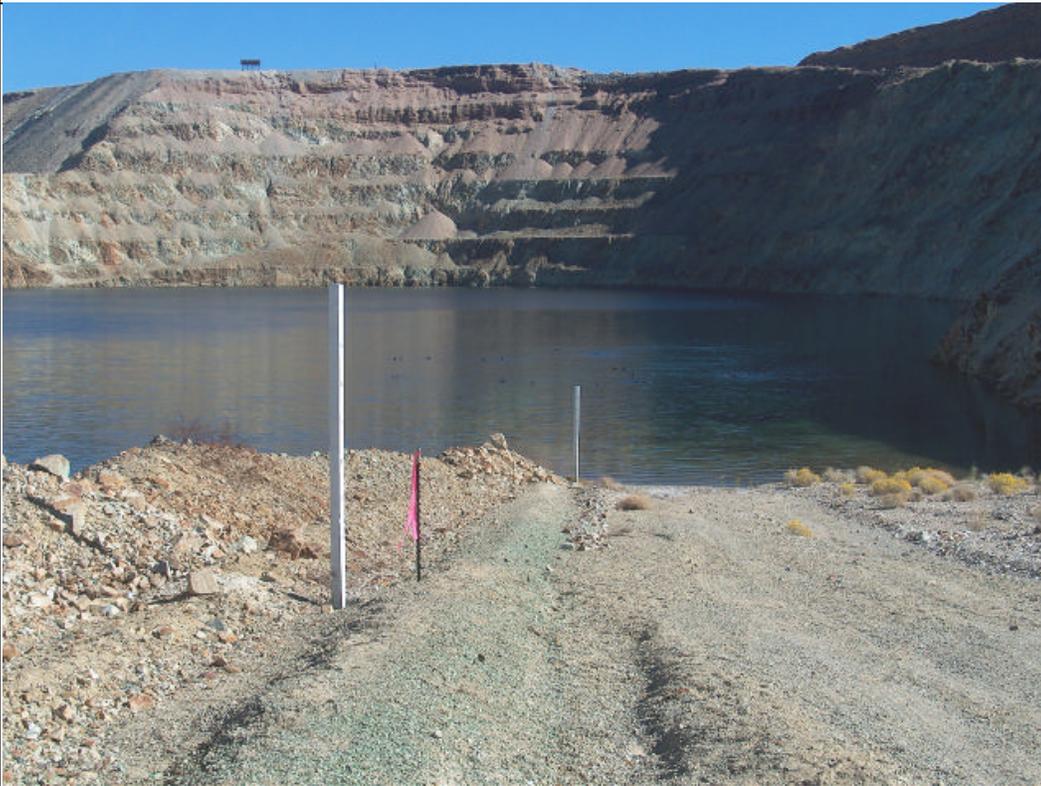
Photo 4.

Posts installed for visual confirmation of water level. Each post is marked with actual elevation marked in 1 foot increments. Installed and checked by surveyor on 10/11/2007.

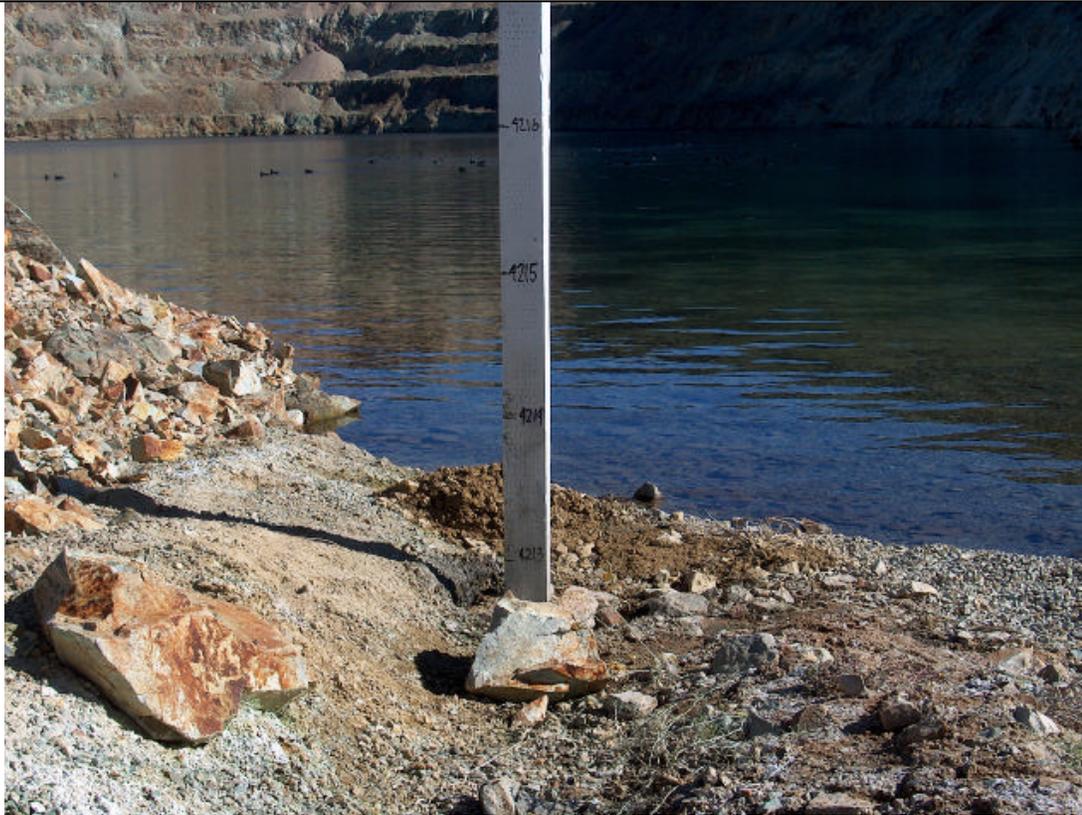
Photo 5.

Close-up of survey post closest to water level. Surveyed water level measured on 10/11/07 is 4212.40 ft and the bottom mark on the post is 4213 ft.

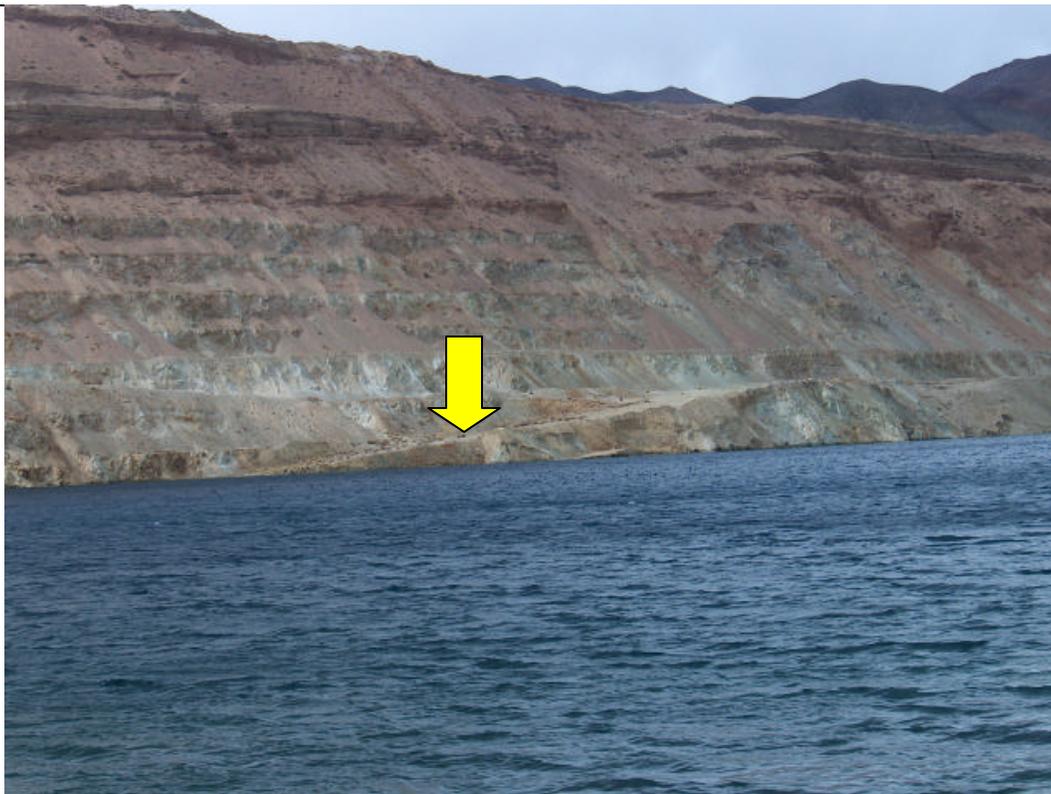
Photo 6.

Location of water level pressure transducer.

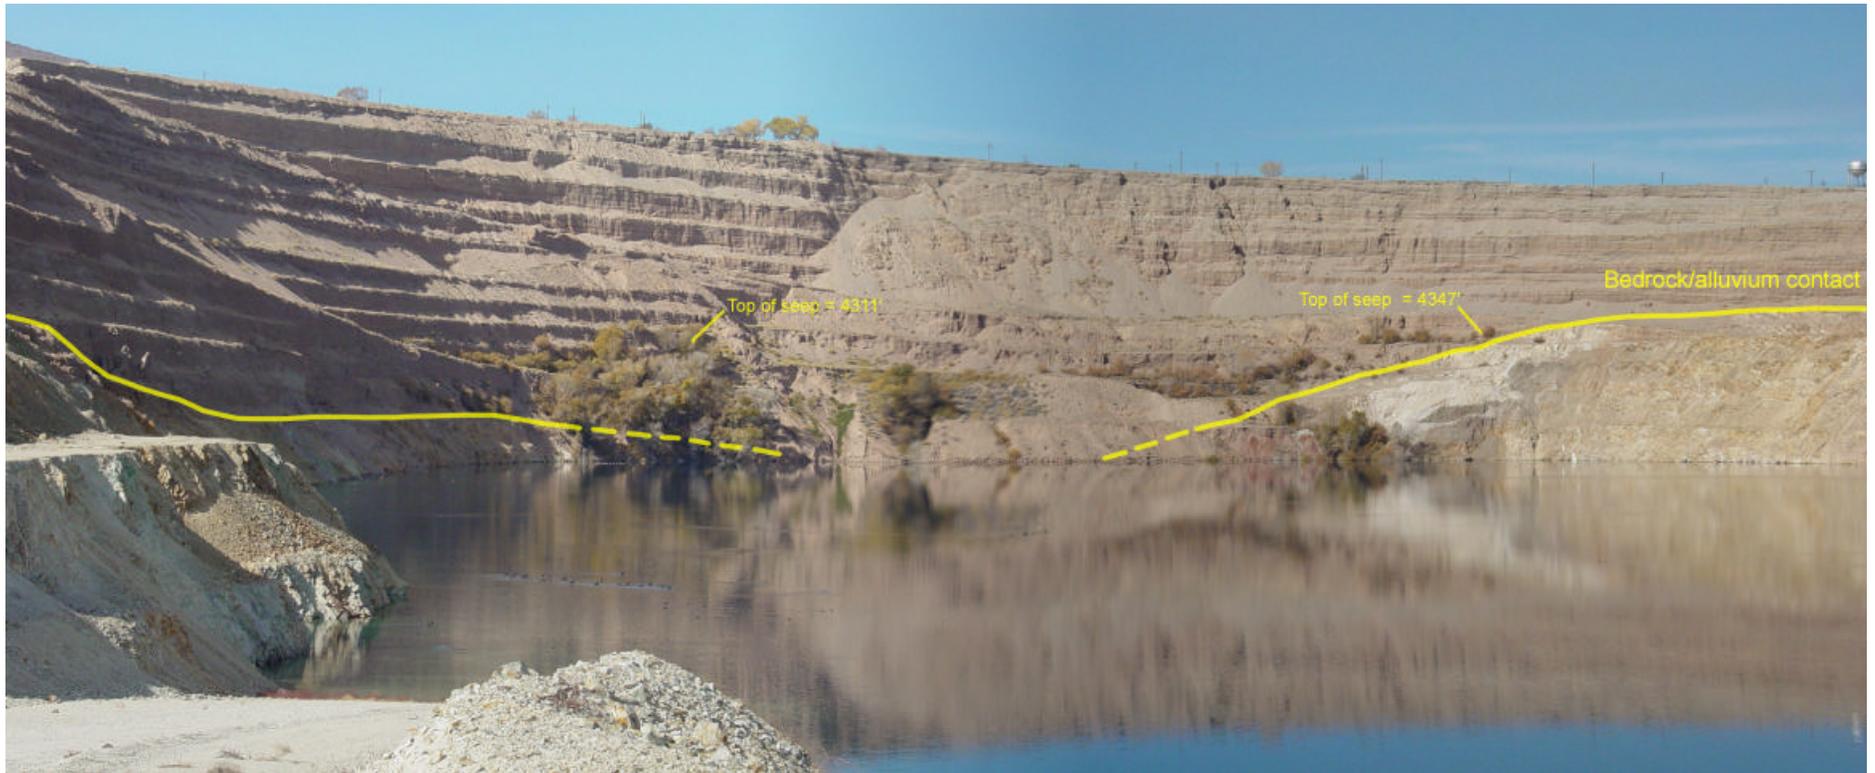
Bedrock/Alluvium Contact

- Contact is inferred where it is obscured by vegetation or loose slough/fill material; represented as a dashed line.
- Contact appears to be under water at current Pit Lake level (4212 ft amsl) as of October 2007; the depth of submersion is not known but likely to be less than 25 ft.
- Approximate survey elevations of top of seeps based on triangulation survey conducted by Tri-State Surveying on October 11, 2007. Elevations have an error rate of +/- 10 ft.
- Access to west wall and seeps is by boat only, area is not accessible from the pit roads.
