2008 ANNUAL PROGRESS REPORT

**Former Fairchild Buildings 1-4
515/545 Whisman Road and 313 Fairchild Drive
Middlefield-Ellis-Whisman Study Area
Mountain View, California**

June 15, 2009

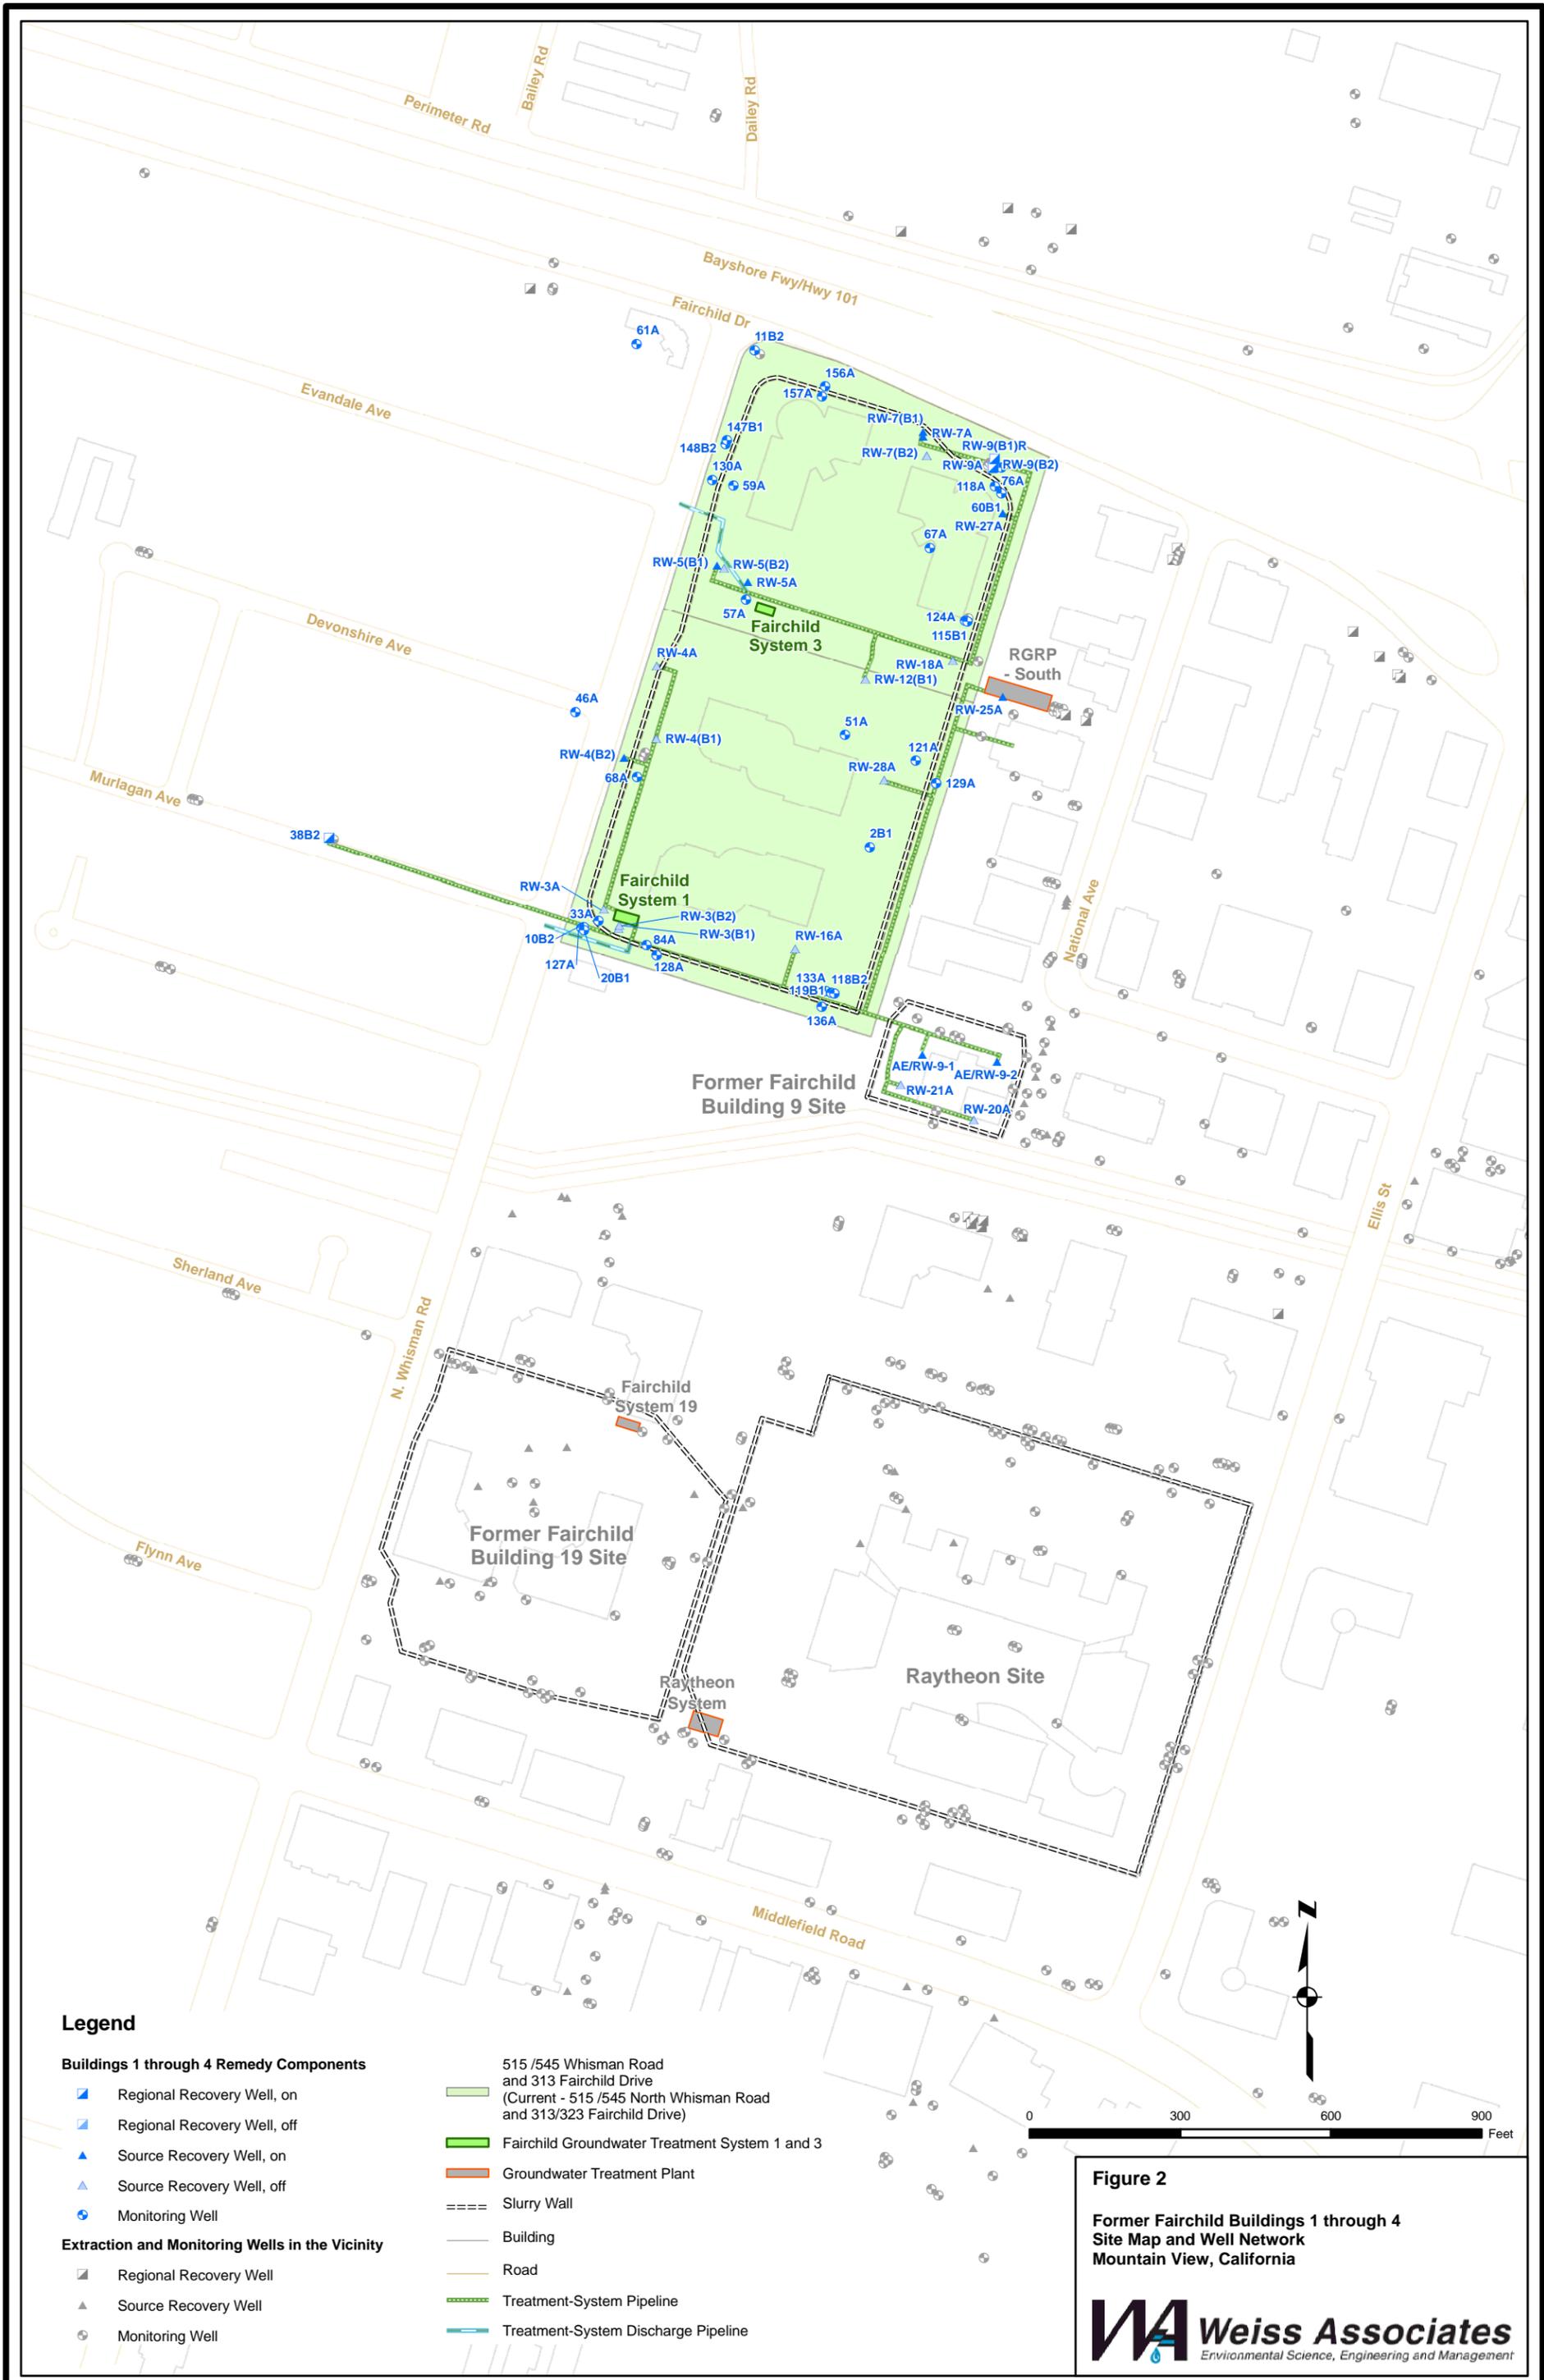
Figure 2

**Former Fairchild Buildings 1 through 4
Site Map and Well Network
Mountain View, California**
