Source Identification Study Report United Heckathorn Superfund Site

United States Environmental Protection Agency, Region 9

March 2014

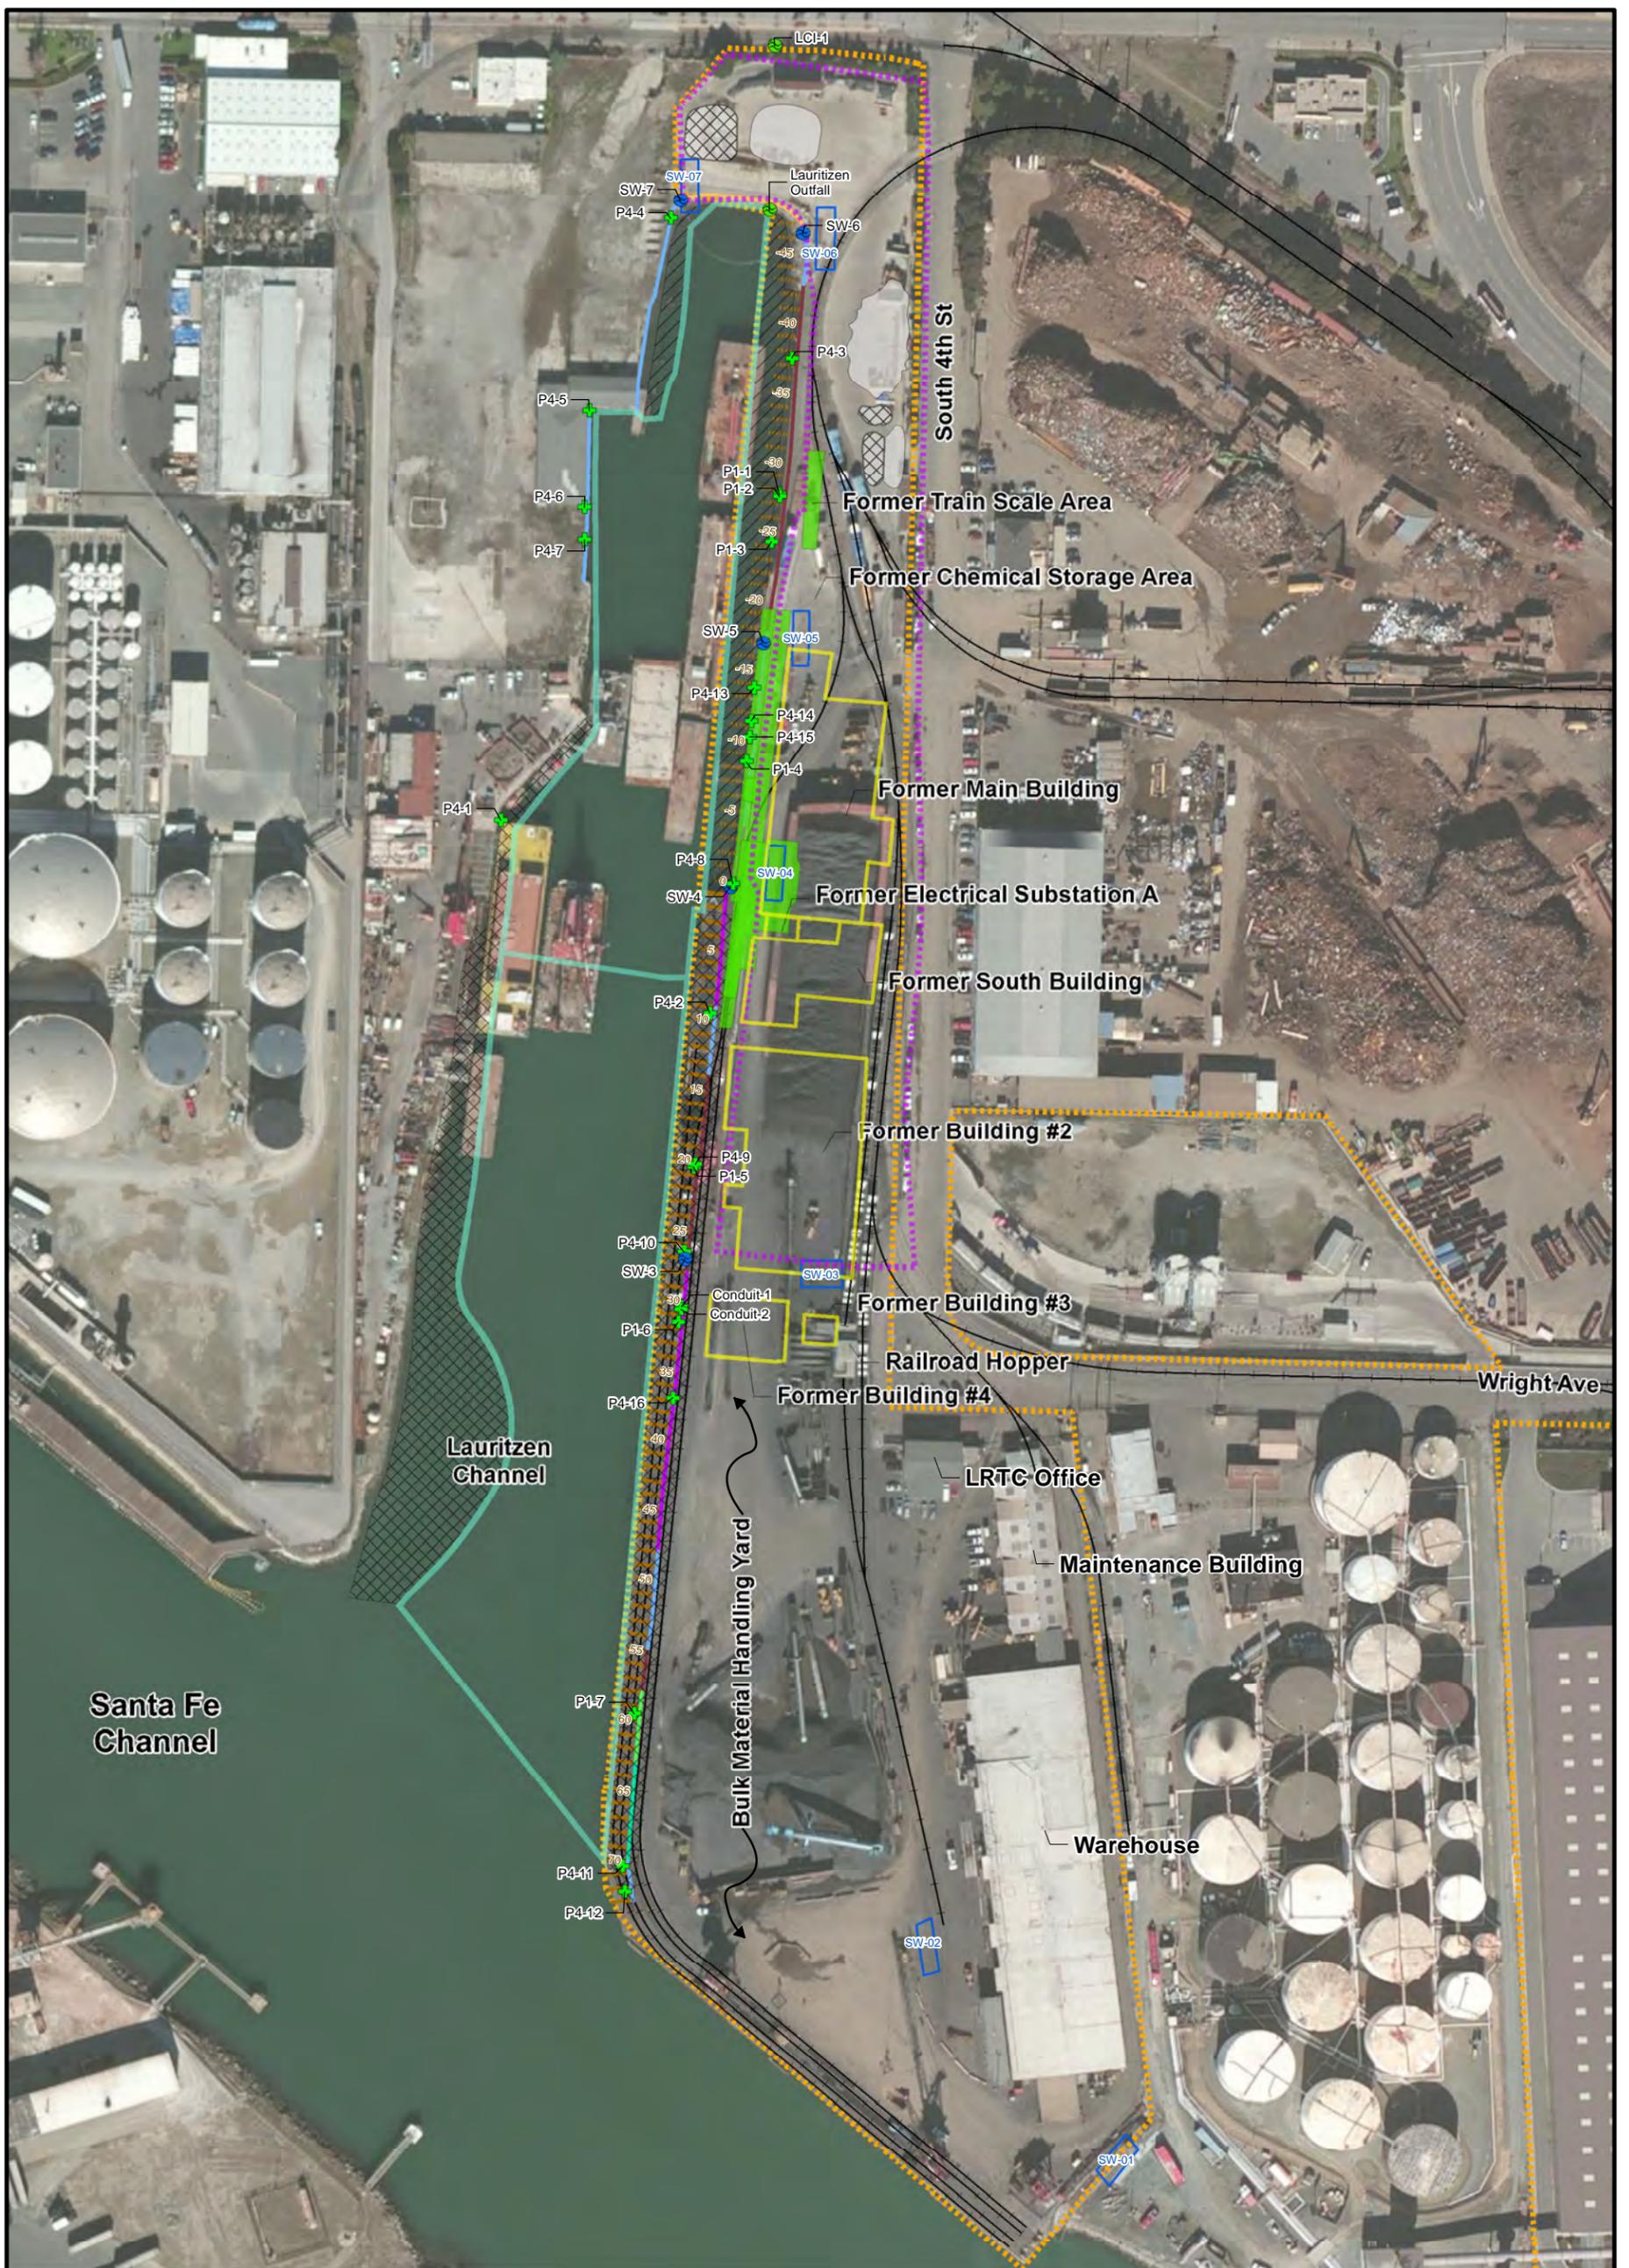
**Figure 3-1
Site Features
United Heckathorn Superfund Site,
Richmond, California**

<ul style="list-style-type: none"> ● LRTC Stormwater Outfalls ● Municipal Stormwater Outfall + Other Pipe and Seep Locations Former Pier Pilings Pier Pilings Levin Richmond Terminal Corp Property Line Railroad 	<ul style="list-style-type: none"> Former Buildings Approximate Extent of Upland Cap Dredged Area Partially Dredged Area Un-Dredged Area Approximate Location of Stormwater Interceptor Former Excavation Area 	<p>Shoreline Material</p> <ul style="list-style-type: none"> Concrete Rock/Rip Rap Rock/Rip Rap and Concrete Shotcrete Sheet Pile Sheet Pile and Concrete 	<ul style="list-style-type: none"> Historical soil stockpile with total pesticide concentrations greater than 1,000 mg/kg. Historical soil stockpile with total pesticide concentrations less than 1,000 mg/kg. <p>Note: Stockpile locations determined from Removal of Pesticide-Affected Soils, United Heckathorn Site, Richmond, California (Levine-Fricke, 1991). Prepared for Levin Richmond Terminal Corporation. May. Stockpiles were generated during interim remedial actions in 1990 - 1991.</p>

- Concrete outfall at T-8.5 – a concrete outfall on the eastern bank of the channel was found to be discharging a small volume of water during the Phase 1 sampling event. The water contained part-per-million levels of total DDT and Dieldrin. This feature is referred to as P1-4 on Figure 3-1.

- 8-inch outfall at T-27.5 – this outfall was recommended for further investigation because the data collected during the Phase 1 investigation were inconclusive and the outfall could not be ruled out as a potential source. No further investigation of this feature was performed in the Phase 2 source investigation. This feature is referred to as P1-1 on Figure 3-1.

A comprehensive site features map was compiled based on previous reports and field observations documented during the 2012 site survey. This map is provided in Figure 3-1. The eastern shoreline of the Lauritzen Channel is constructed of sheet pile (steel plates supported by railroad ties), concrete, rip rap, and/or shotcrete. Evidence of soil erosion was observed during the site surveys performed in 2012. Erosion under the sheet pile wall, observed as approximately 1- to 2-foot voids, was noted at the north end of the eastern bank of the channel. These features were noted between bent -37 and the head of the channel. Sink holes and exposed cap material were also observed on the Levin property in the vicinity of bent -24 and T-8.5 (embankment soils were not exposed in these locations). Additional information including photo documentation of the features described above is provided in the site survey field summary report (CH2M HILL, 2013b).

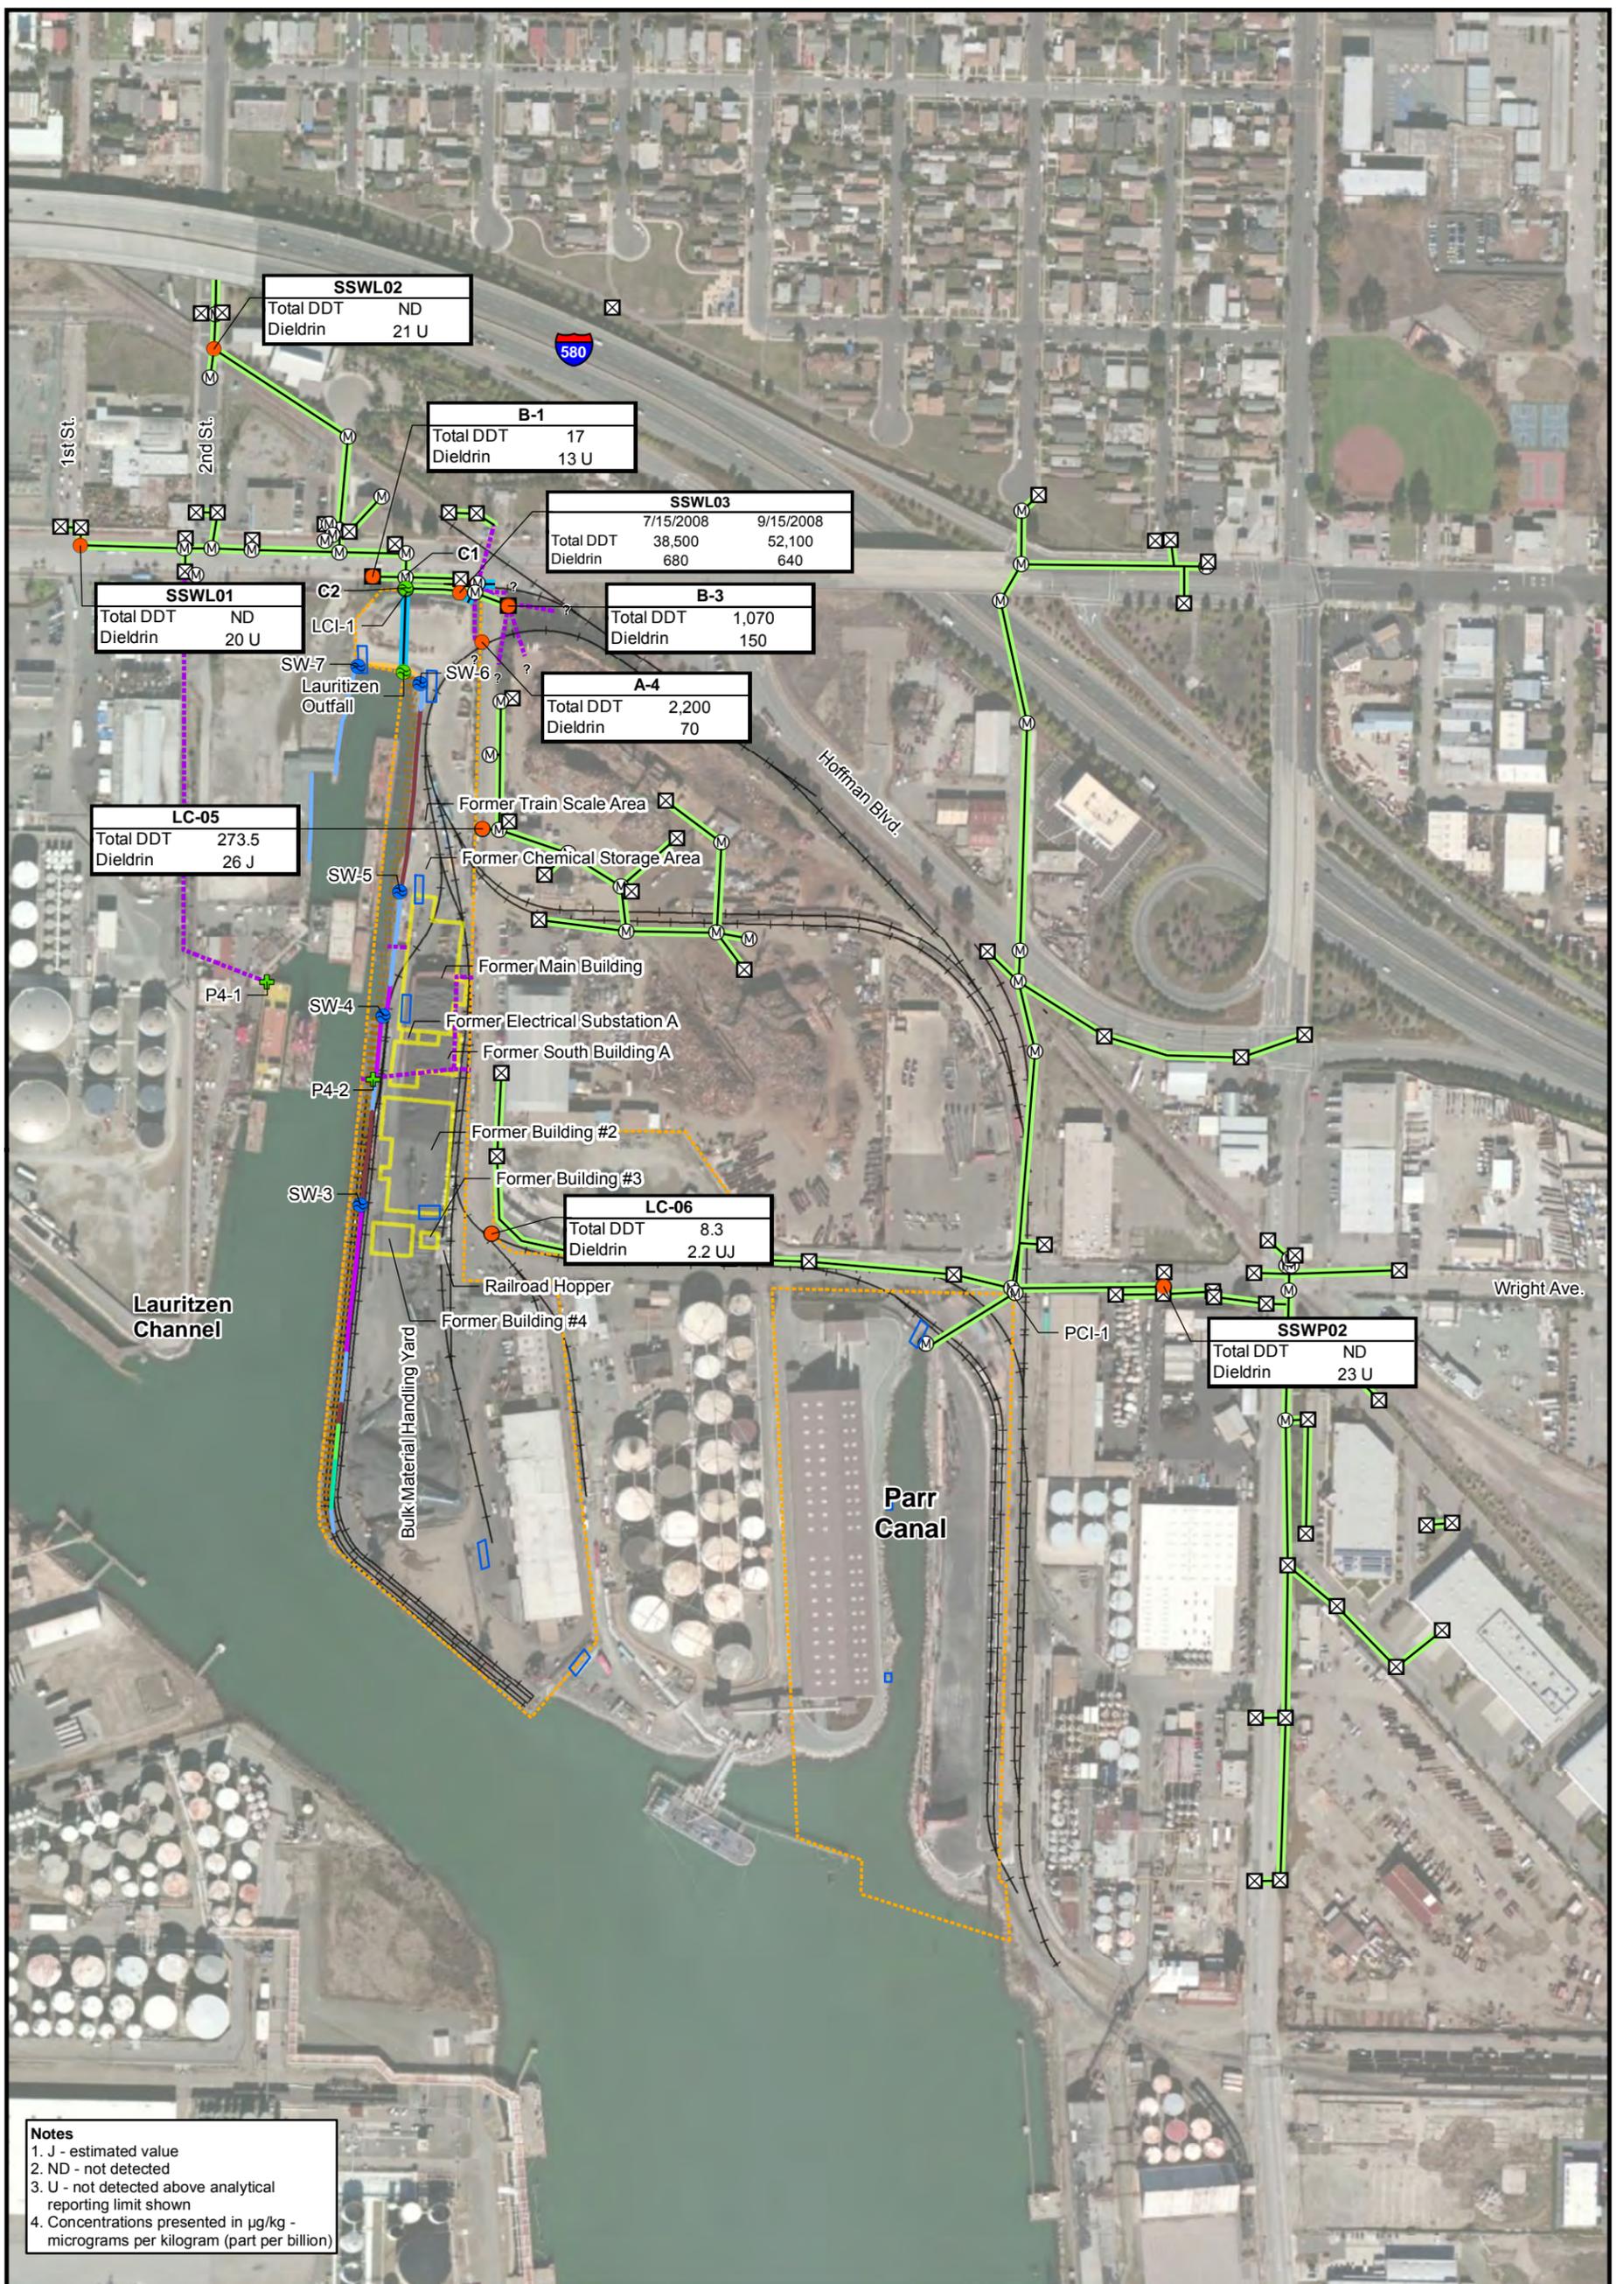
FIGURE 6-2
Storm Drain Sediment Analytical Results
 United Heckathorn Superfund Site
 Richmond, California

Notes
 1. J - estimated value
 2. ND - not detected
 3. U - not detected above analytical reporting limit shown
 4. Concentrations presented in µg/kg - micrograms per kilogram (part per billion)

The sampling results are presented in Table 6-1 and on Figure 6-2. Storm drain sediment samples collected from 2008 to 2012 contained total DDT concentrations ranging from below the detection limit to 52,000 µg/kg. Dieldrin concentrations ranged from below the detection limit to 680 µg/kg. The highest total DDT and Dieldrin concentrations were observed at location SSWL03, which was sampled in July and again during September 2008. These samples were collected from a manhole near the northeast end of the Lauritzen Channel. The SSWL03 structure was cleaned out in December 2008, and was determined to be a catch basin that was not part of the municipal storm drain system and was not connected to the Lauritzen Channel. The inlet to the catch basin was not identified.

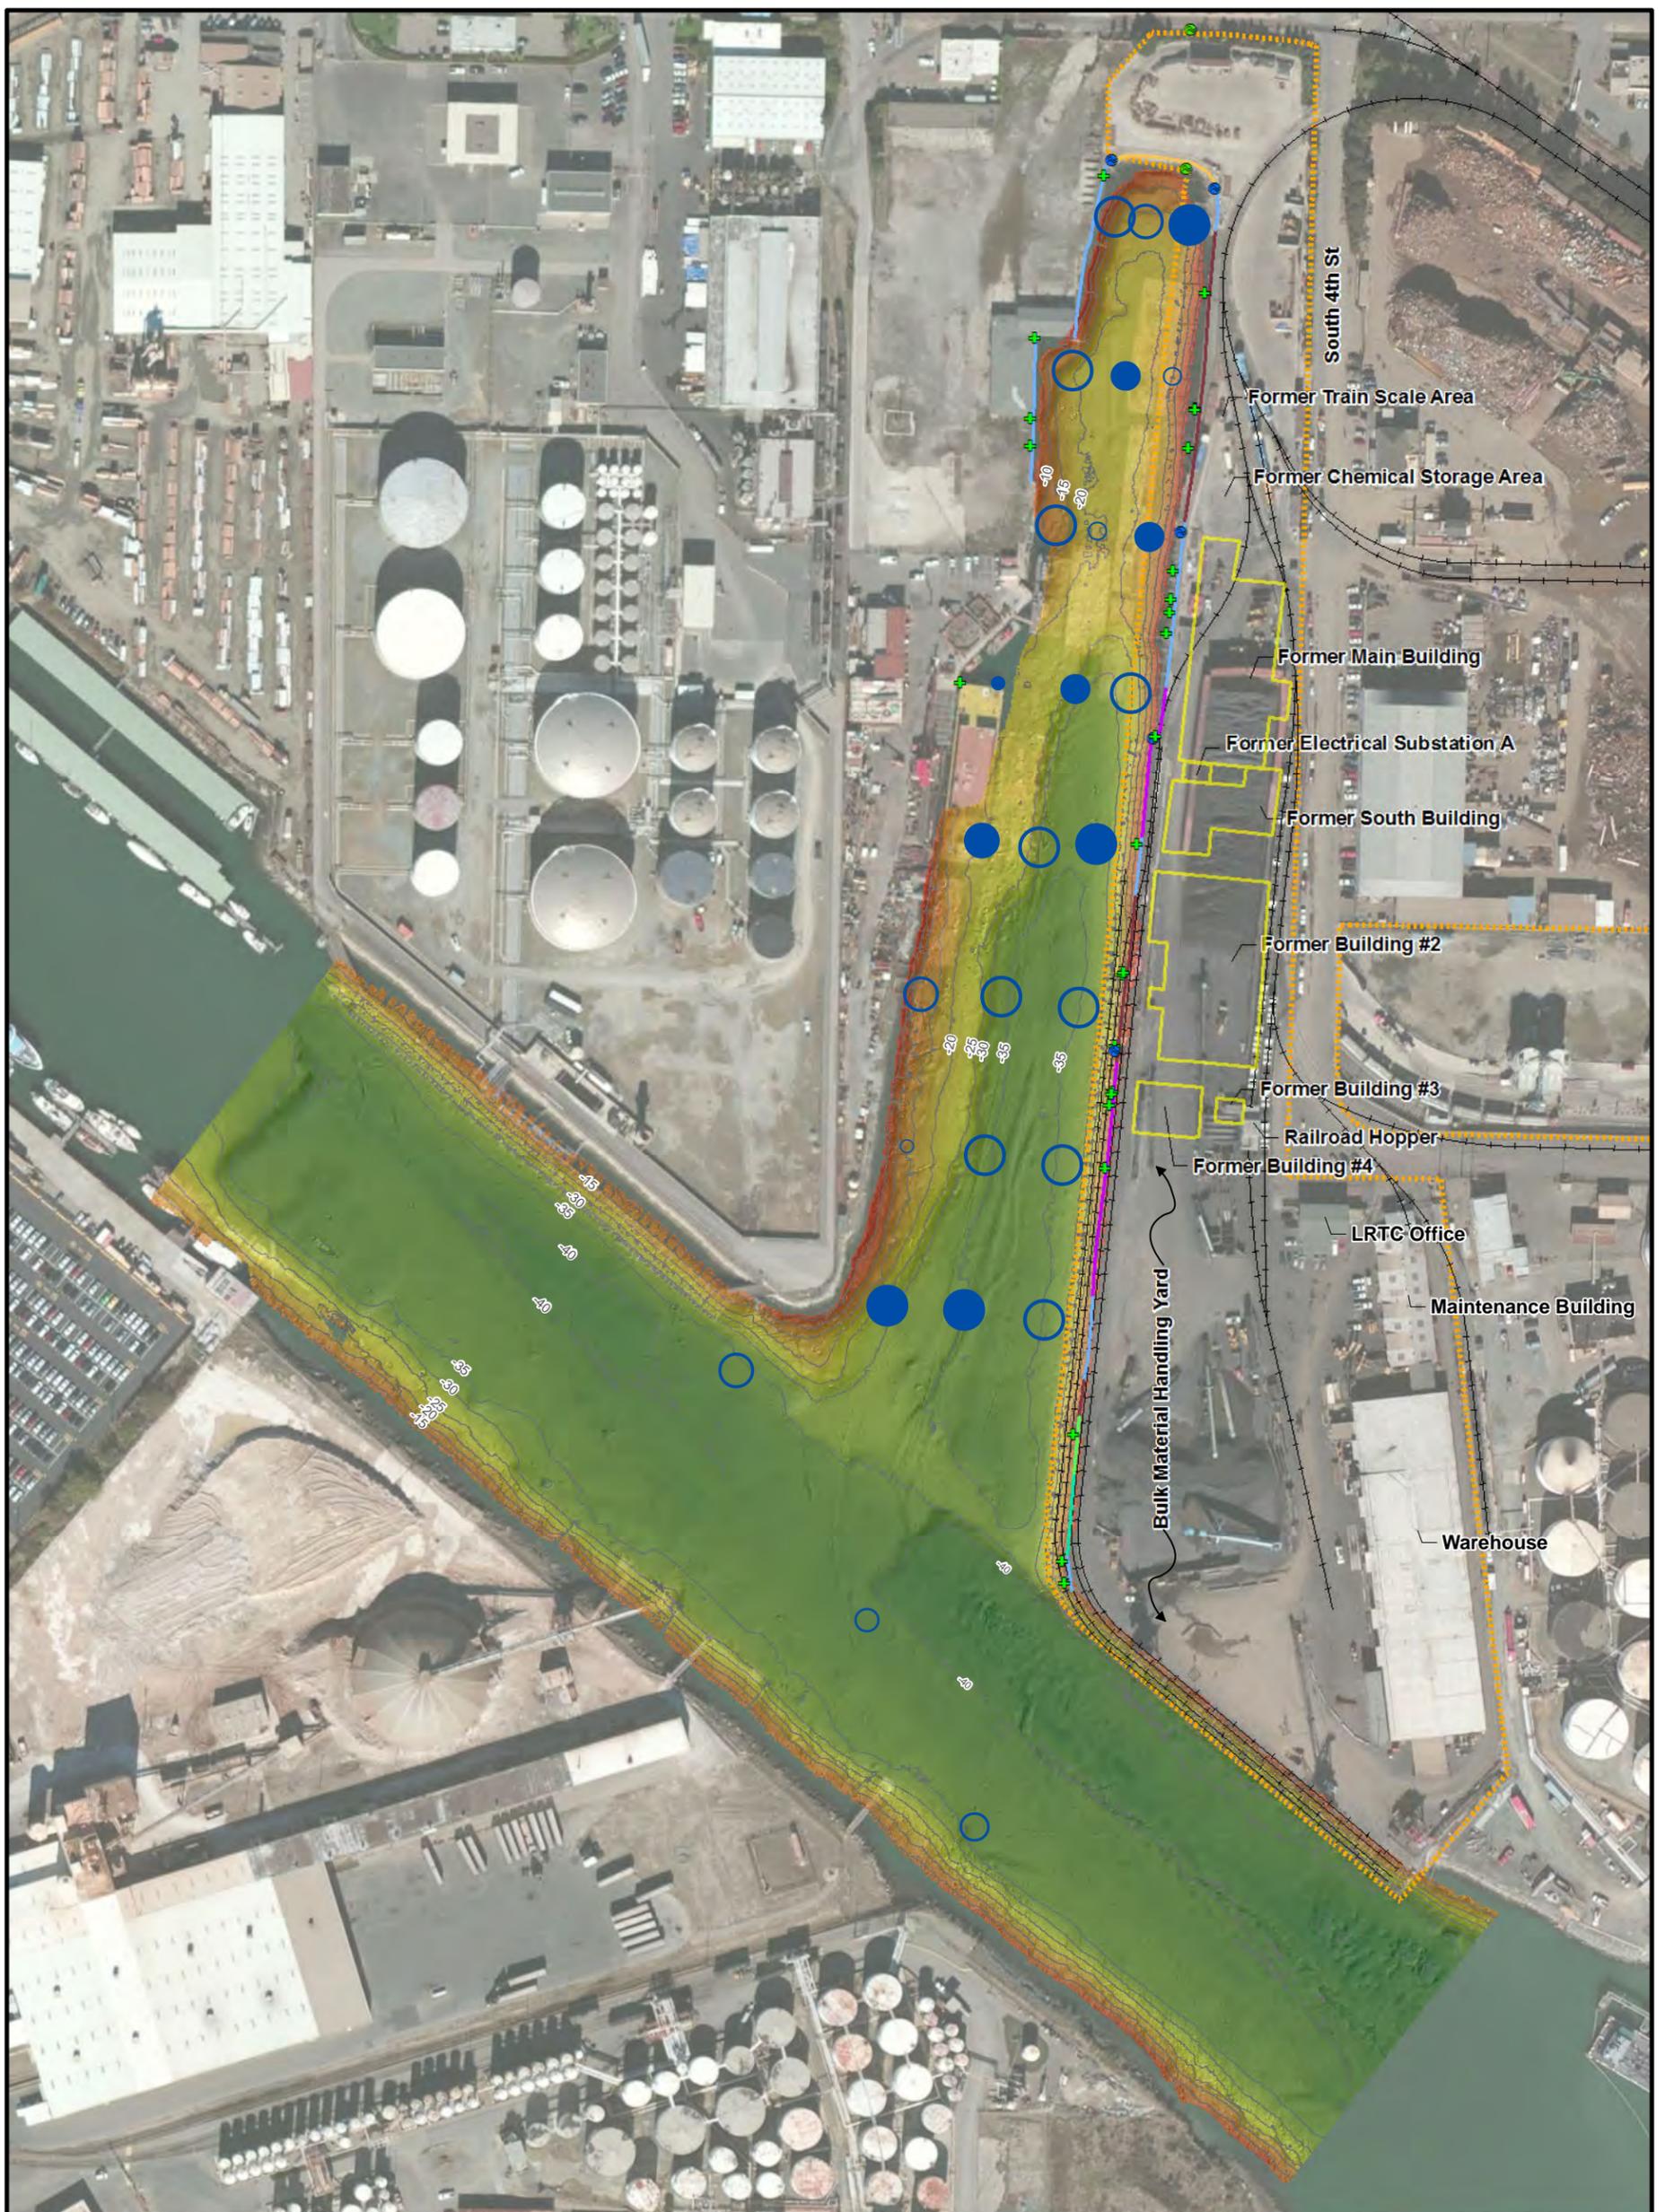
FIGURE 8-2
Younger Bay Mud Thickness and Evidence of Benthic Sand Layer
United Heckathorn Superfund Site,
Richmond, California

Data Notes:
Younger Bay Mud thicknesses have been corrected for less than 100 percent core recovery.

The sand layer was found in only a subset of sediment cores collected in the Lauritzen Channel in 1999, 2003, and 2007 (Kohn and Gilmore, 2001; Kohn and Evans, 2004; CH2M HILL, 2008). The distribution of the sand layer in

2013 is shown in Figure 8-2. In some instances, the sand was observed immediately above the OBM; in other cases, a sand layer was observed separating two intervals of YBM. The presence of YBM beneath the sand layer in some locations indicates that it was incompletely dredged in 1996-1997.

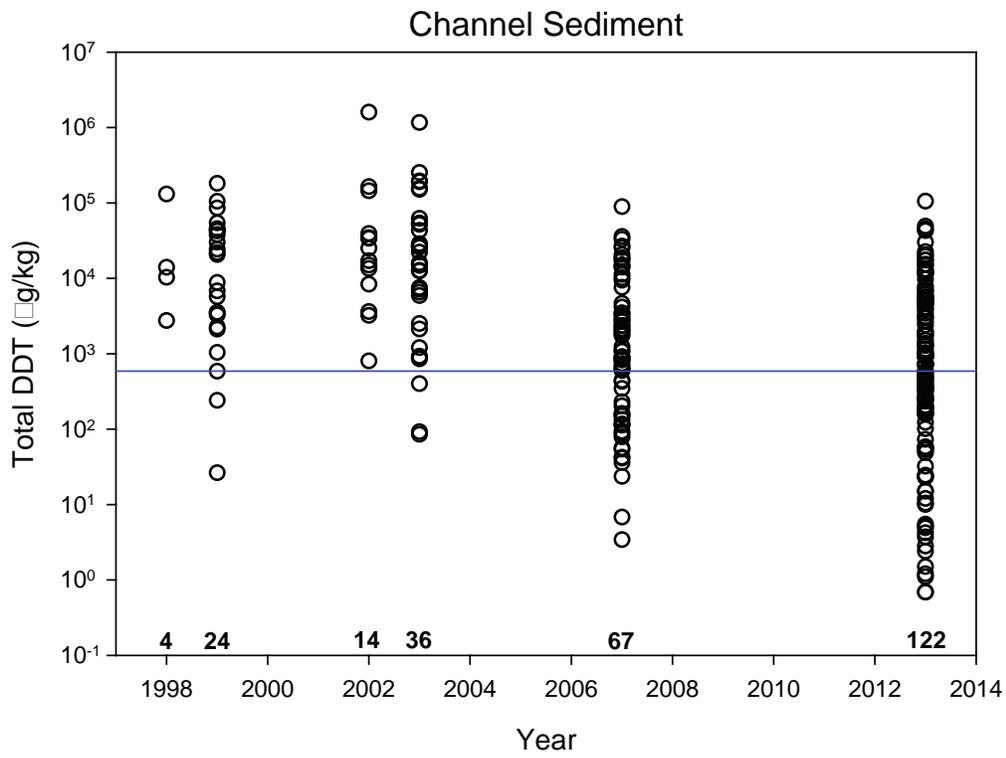
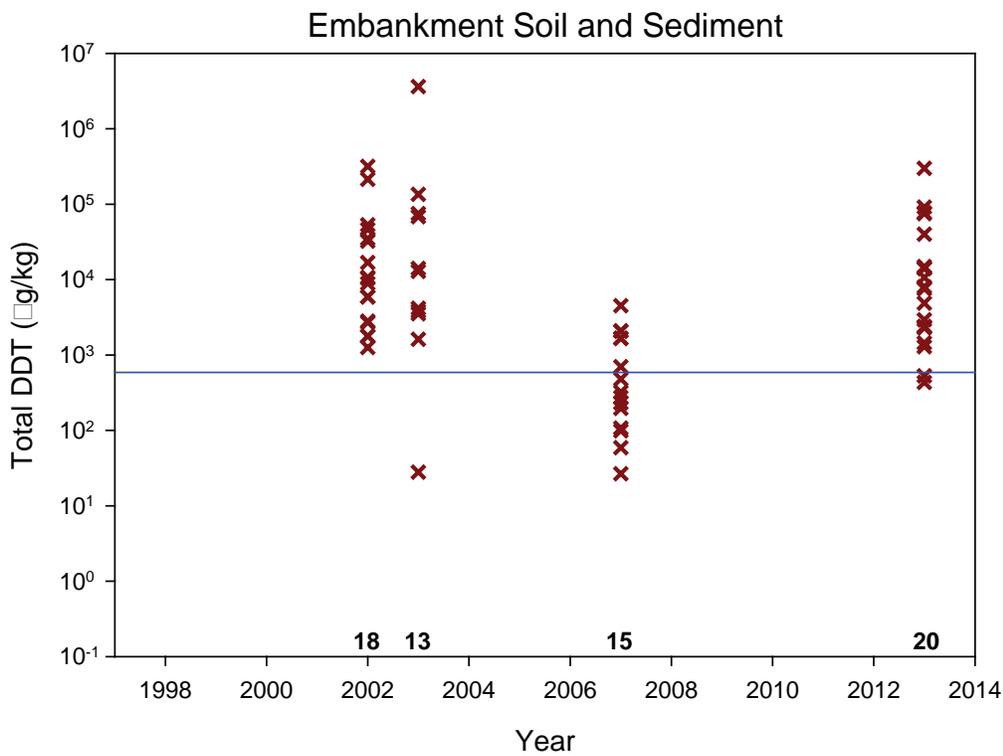
Figure 8-3
Total DDT Concentrations in Channel and Embankment Samples from 1998-2013
United Heckathorn Superfund Site, Richmond, California

— Remediation goal
 Bold - number of samples
