**PERIMETER AIR MONITORING REPORT
AUGUST 31, 2000 THROUGH MARCH 13, 2001
HUNTERS POINT SHIPYARD, PARCEL E
SAN FRANCISCO, CALIFORNIA**

**Environmental Remedial Action
Contract Number N62474-93-D-2151
Delivery Order 0109**

**Document Control Number 2421
Revision 0**

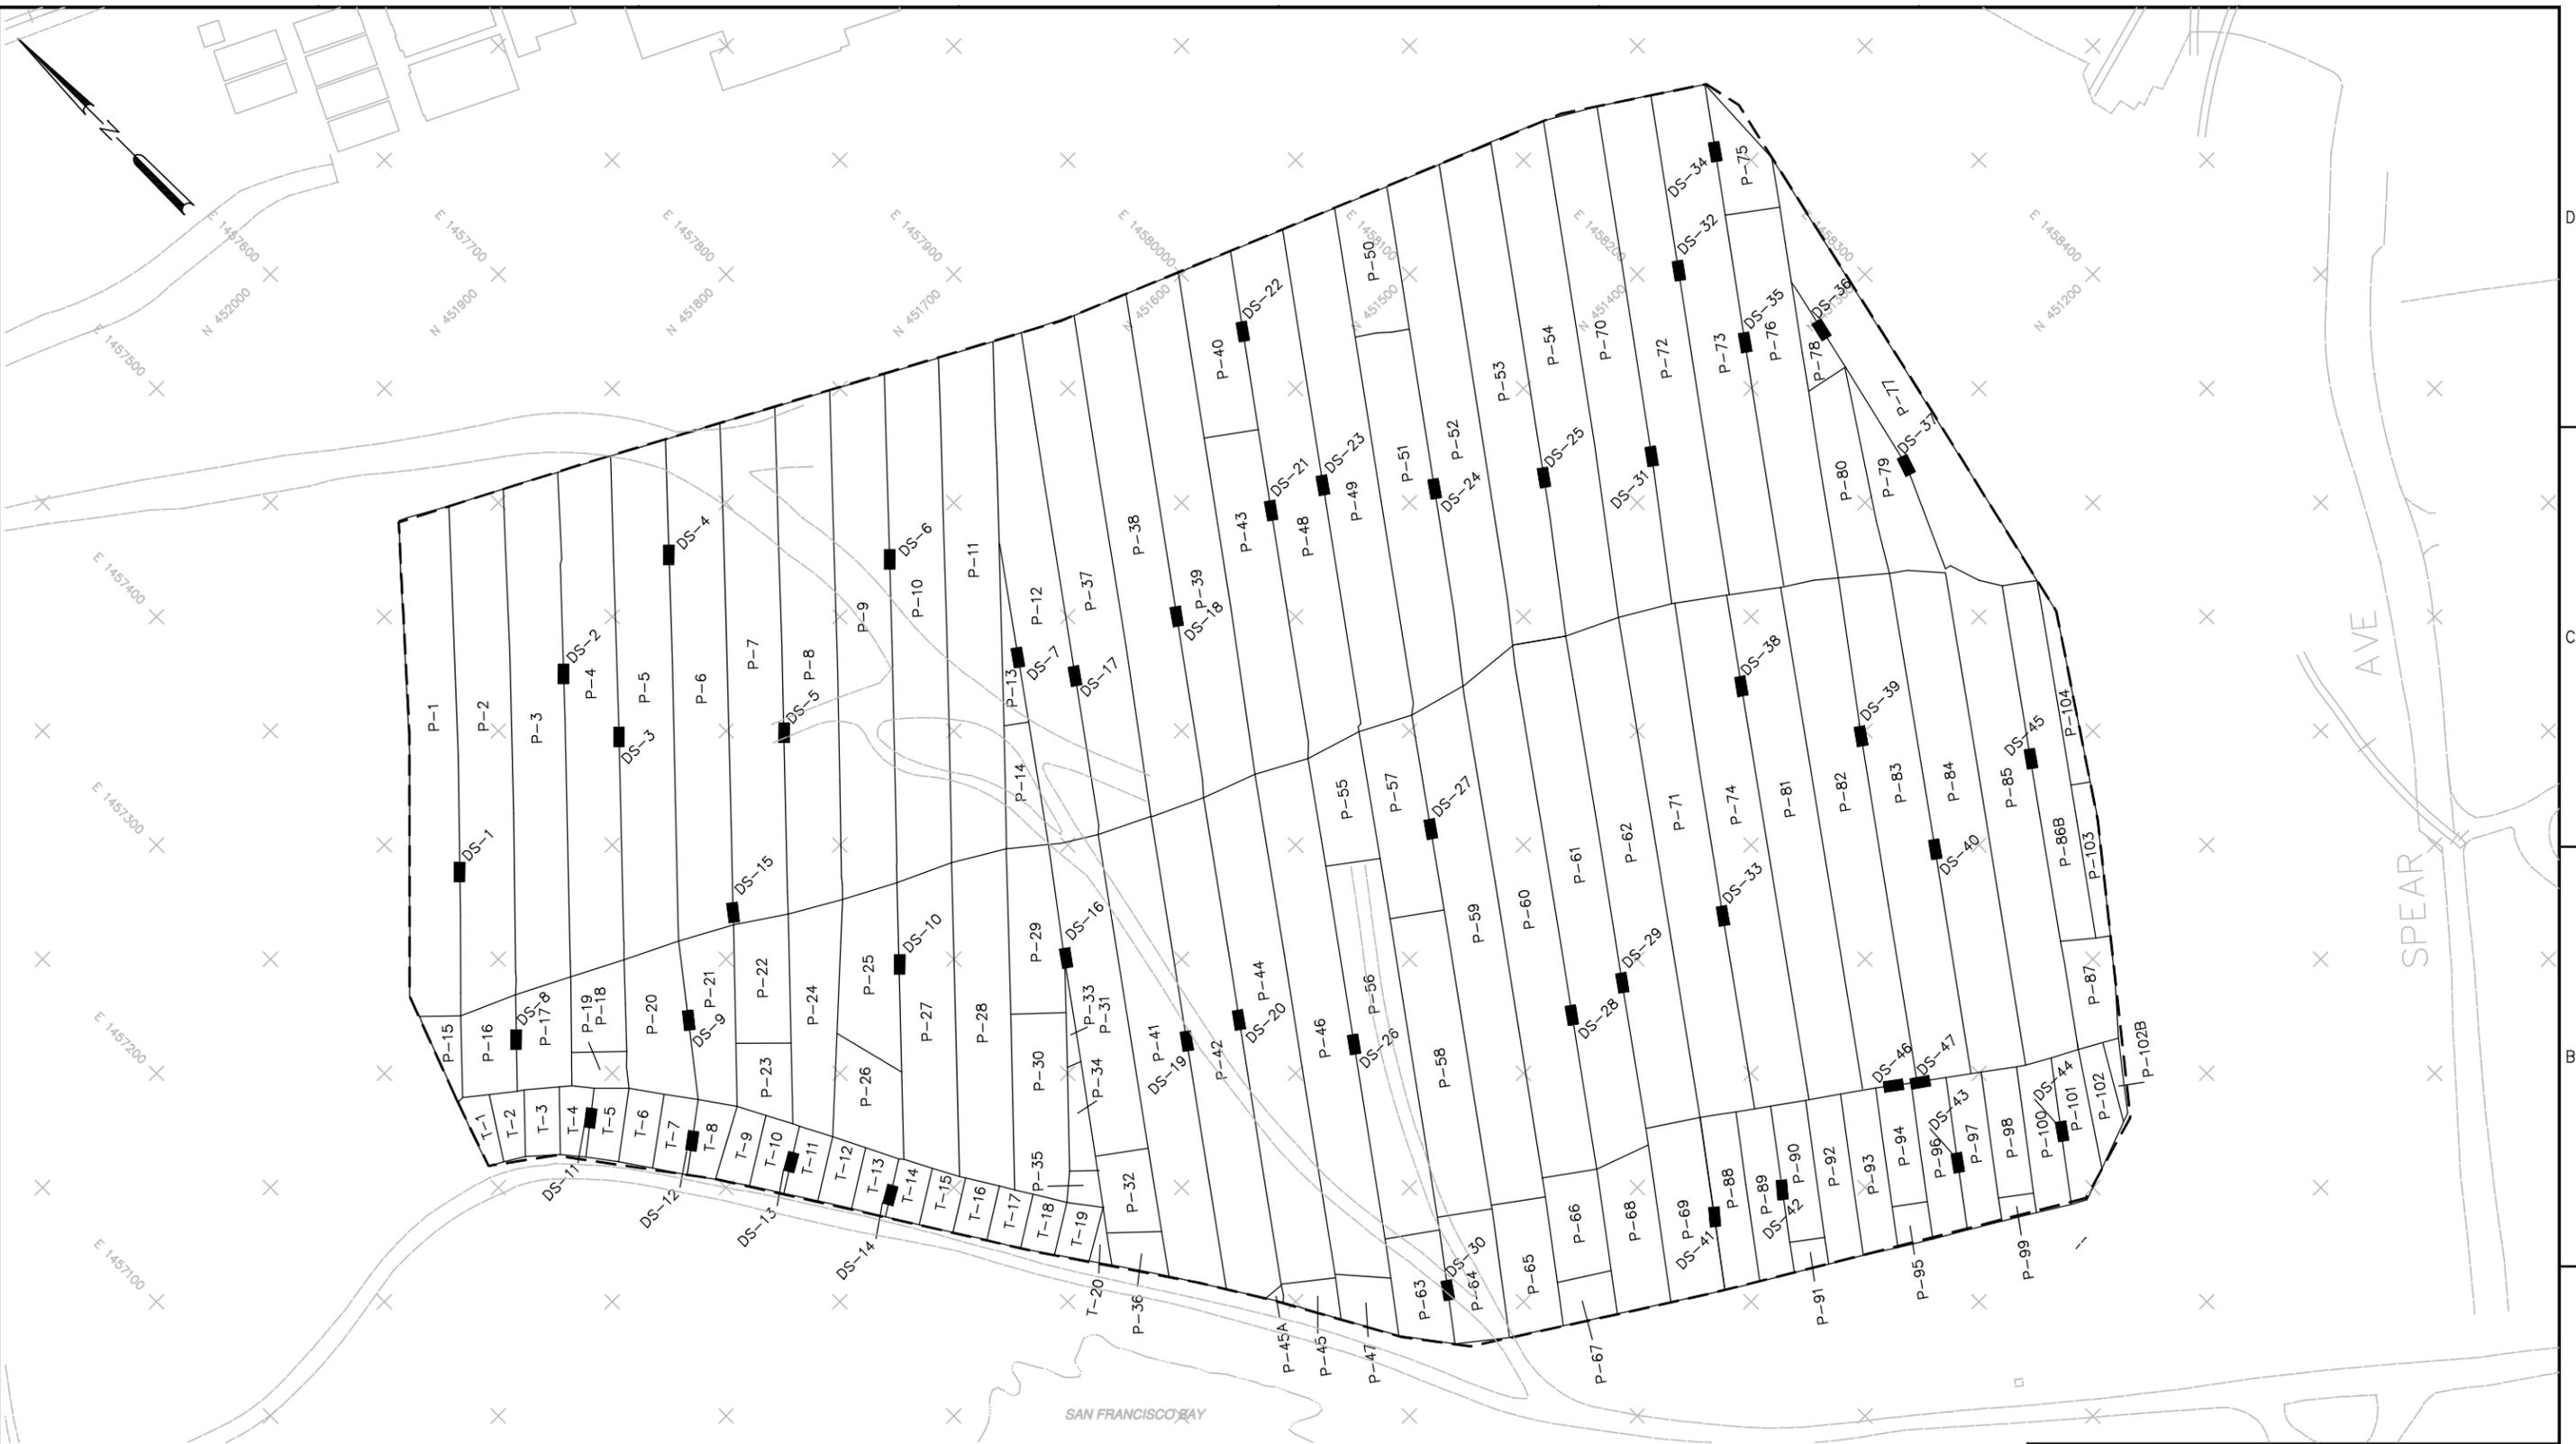
NOTES:
 T-# INDICATES TEXTURED HDPE GEOMEMBRANE.
 P-# INDICATES SMOOTH HDPE GEOMEMBRANE.
