## **2010 ANNUAL PROGRESS REPORT**

**Former Fairchild Buildings 1-4  
515/545 Whisman Road and 313 Fairchild Drive  
Middlefield-Ellis-Whisman Area  
Mountain View, California**

June 10, 2011

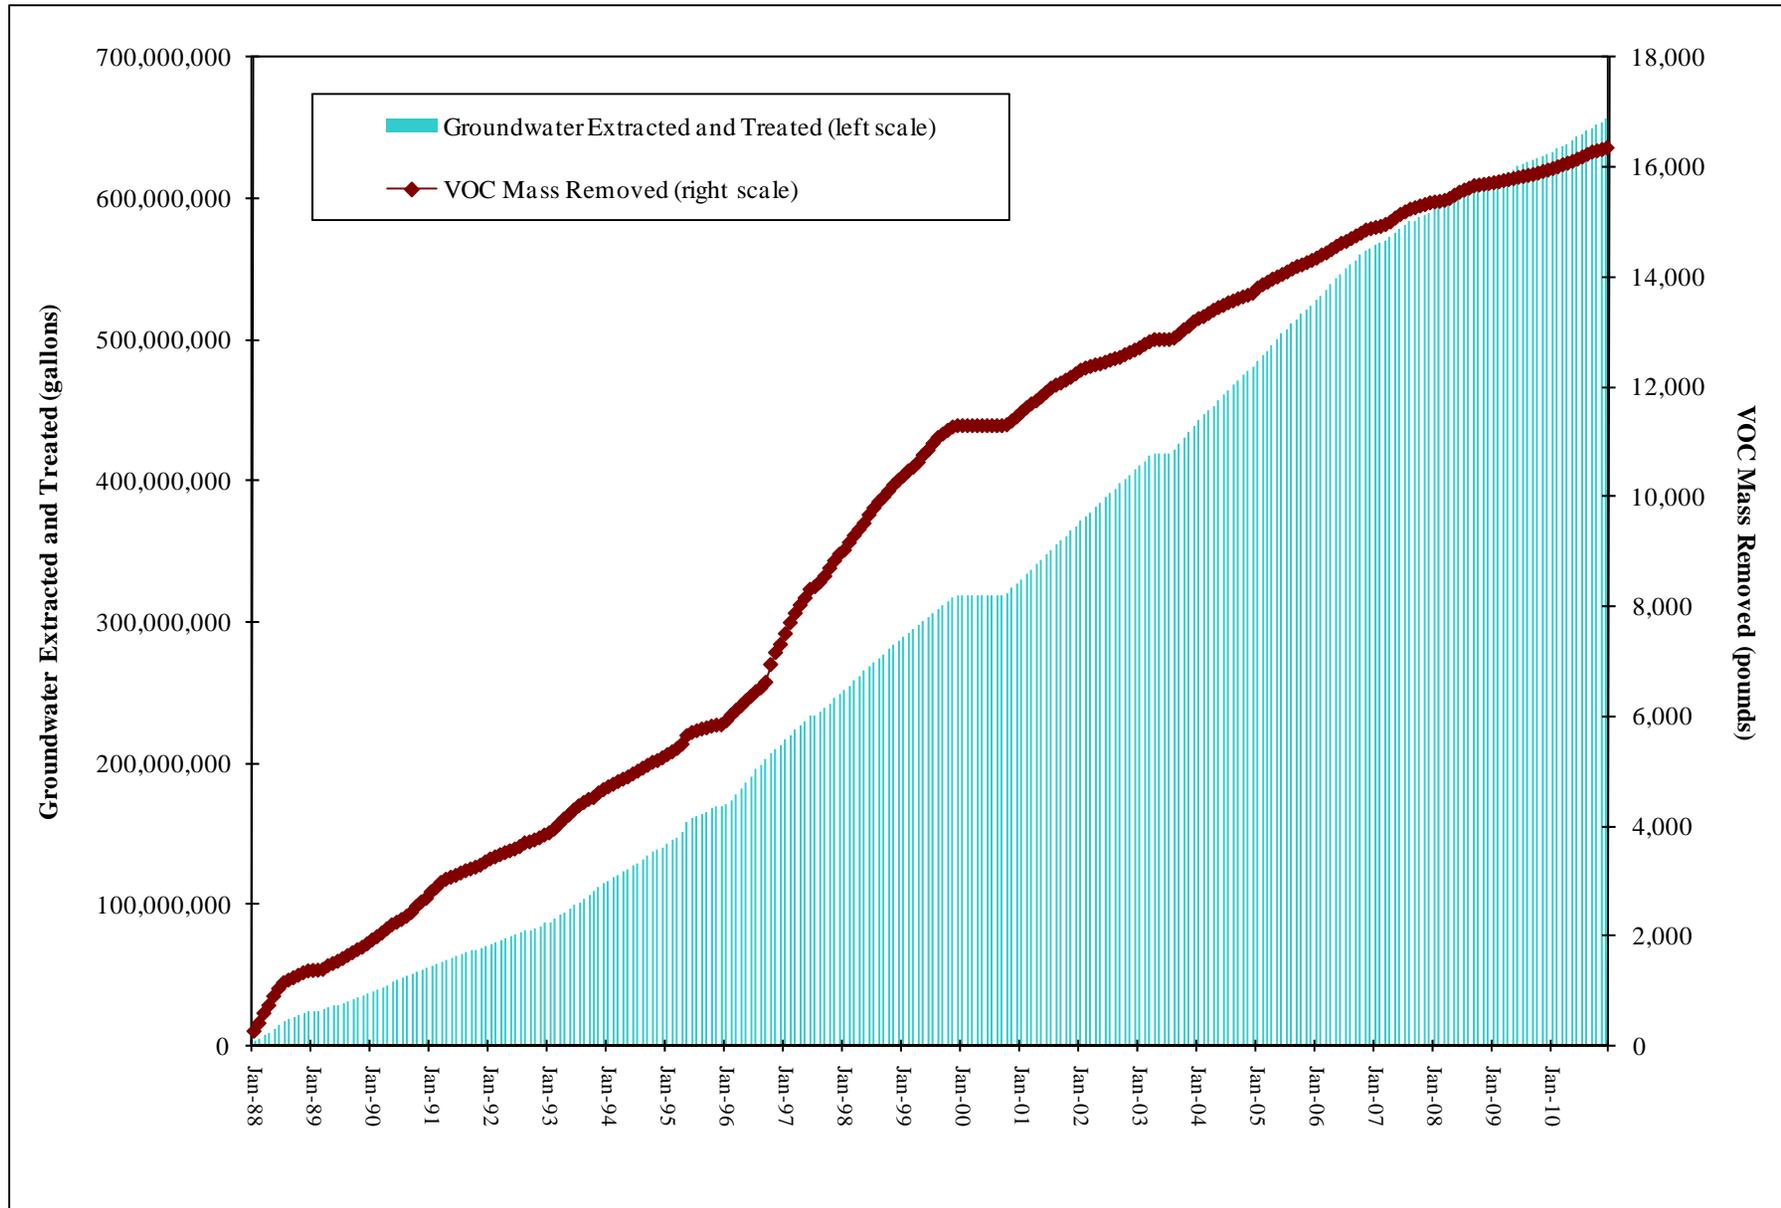
Figure 4. Cumulative Groundwater and VOC Mass Removal Summary, Fairchild System 1, 515 Whisman Road, Mountain View, California.

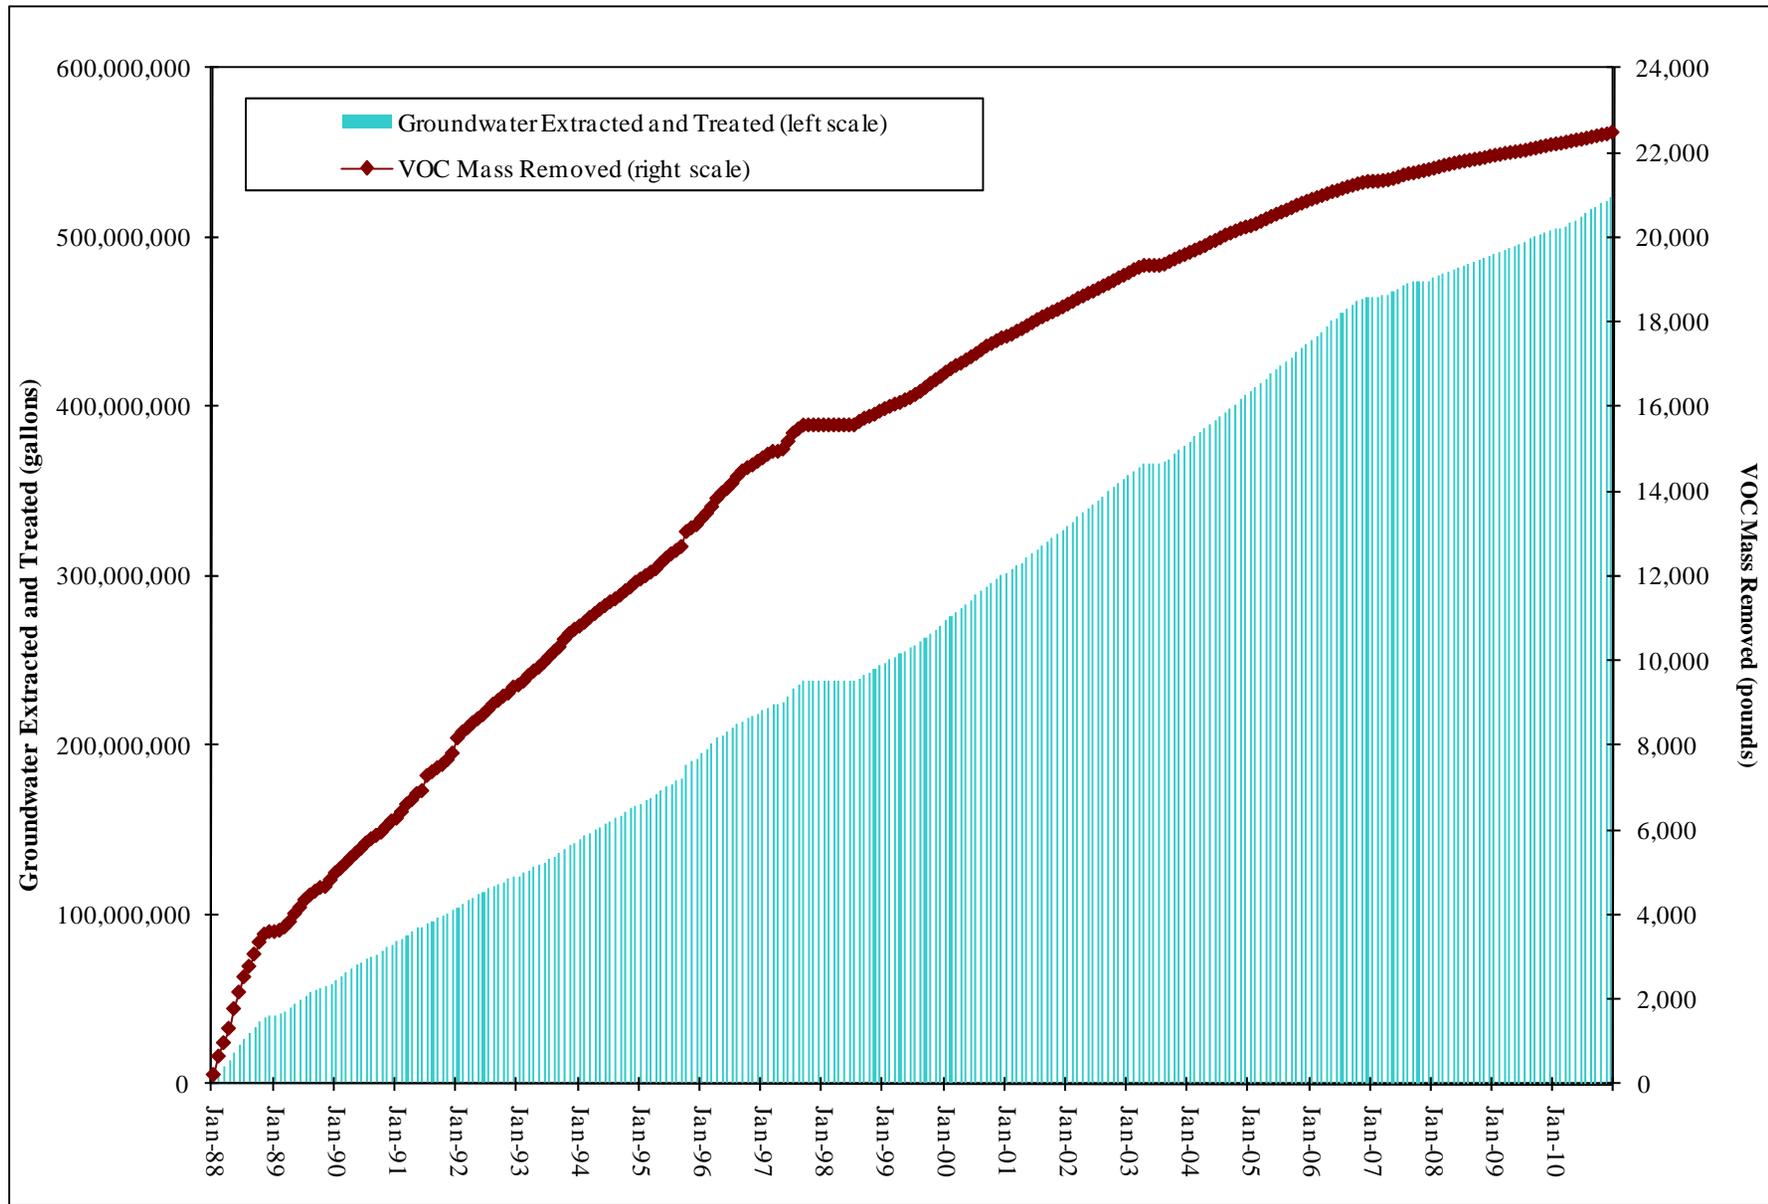
Figure 5. Cumulative Groundwater and VOC Mass Removal Summary, Fairchild System 3, 313 Fairchild Drive, Mountain View, California.

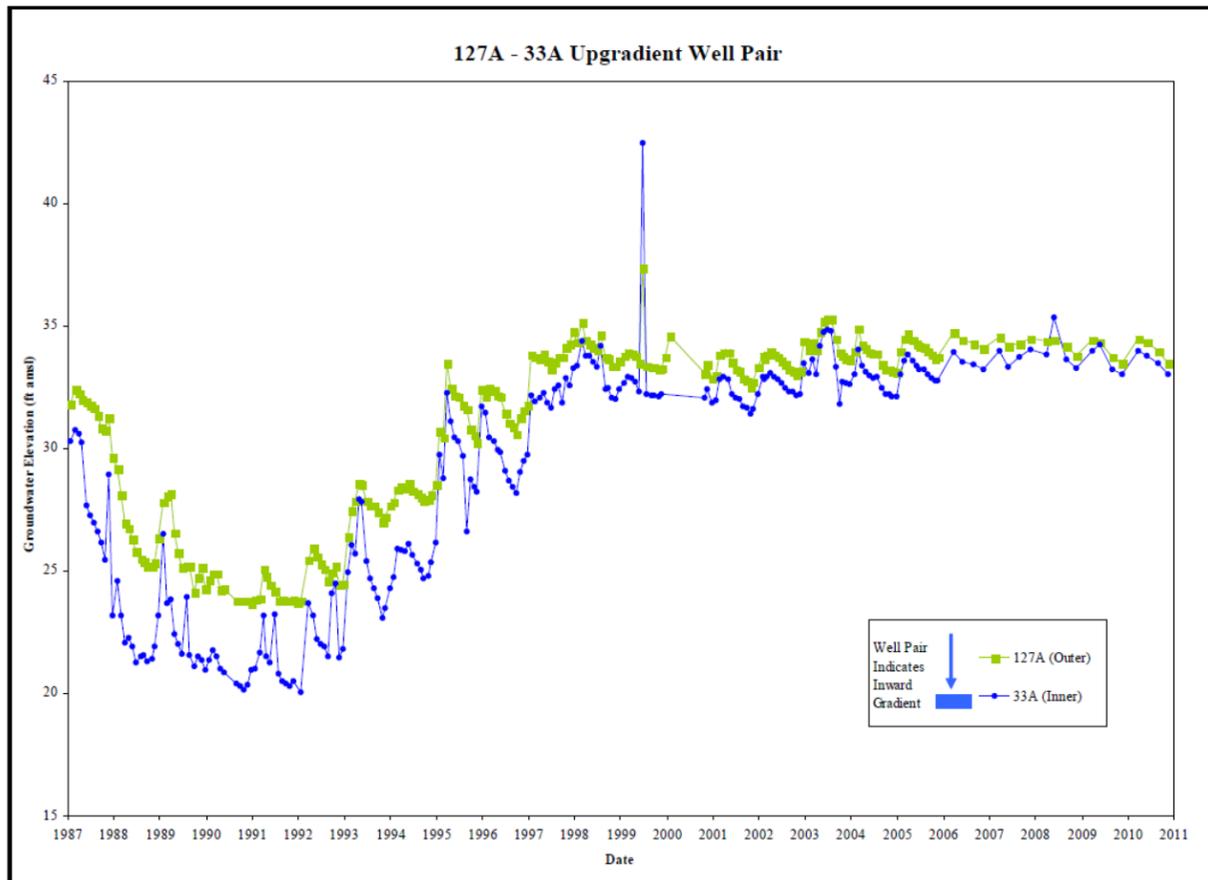
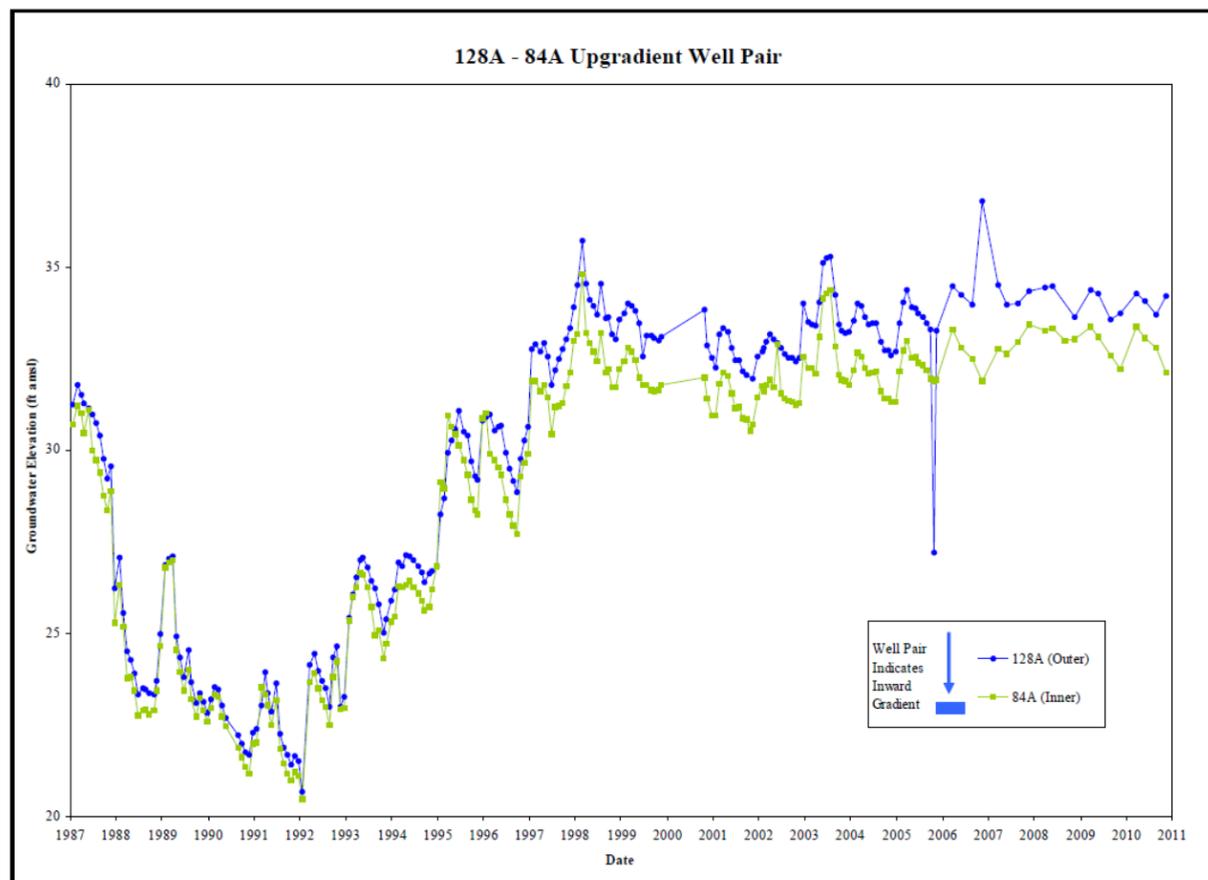
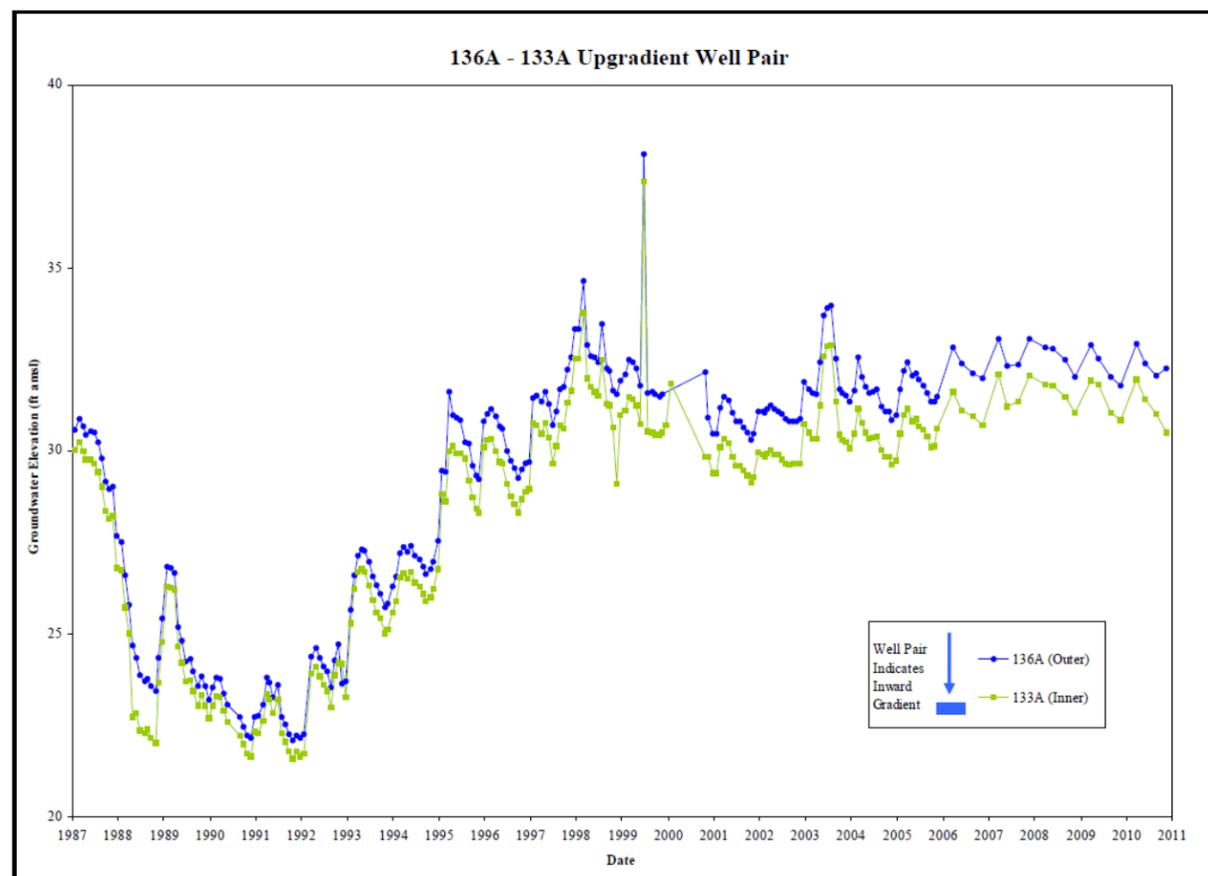
Figure 6. Hydrographs – Groundwater Elevation Measurements, Slurry Wall Well Pairs – Upgradient Wells, Former Fairchild Buildings 1-4, 515/545 Whisman Road and 313 Fairchild Drive, Mountain View, California

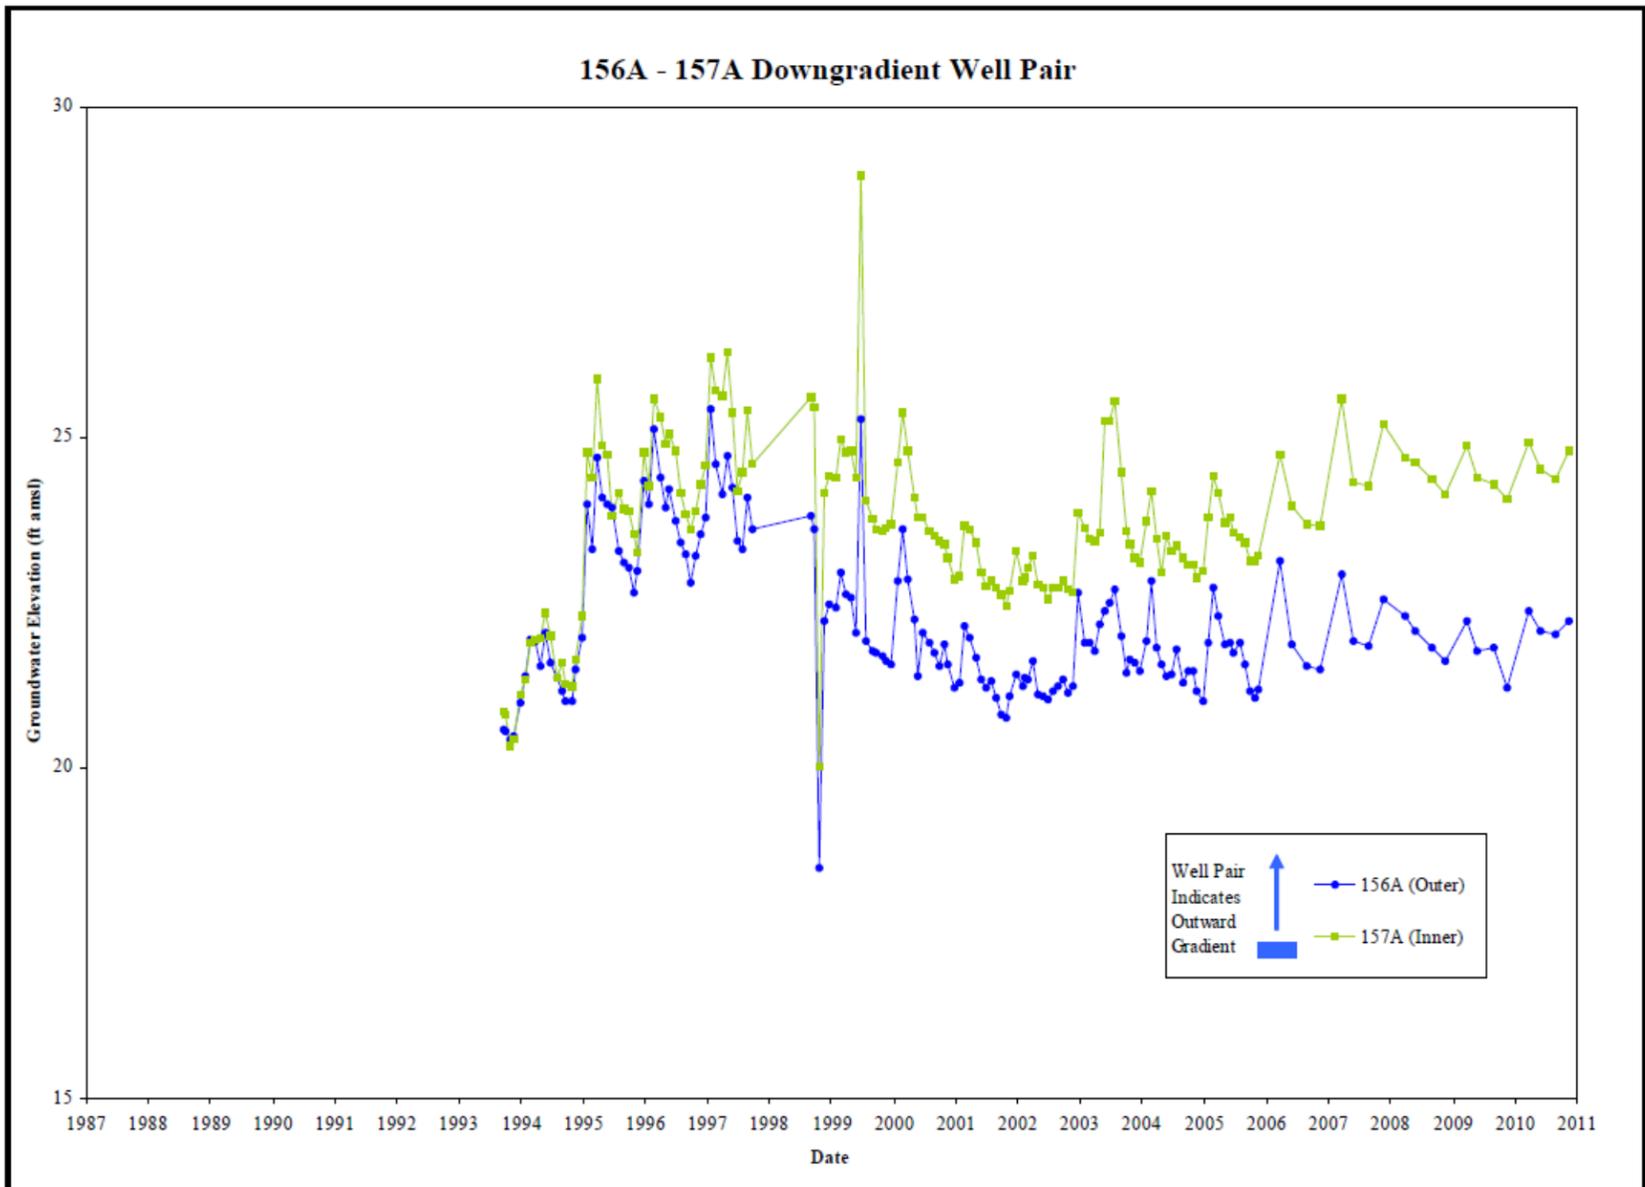
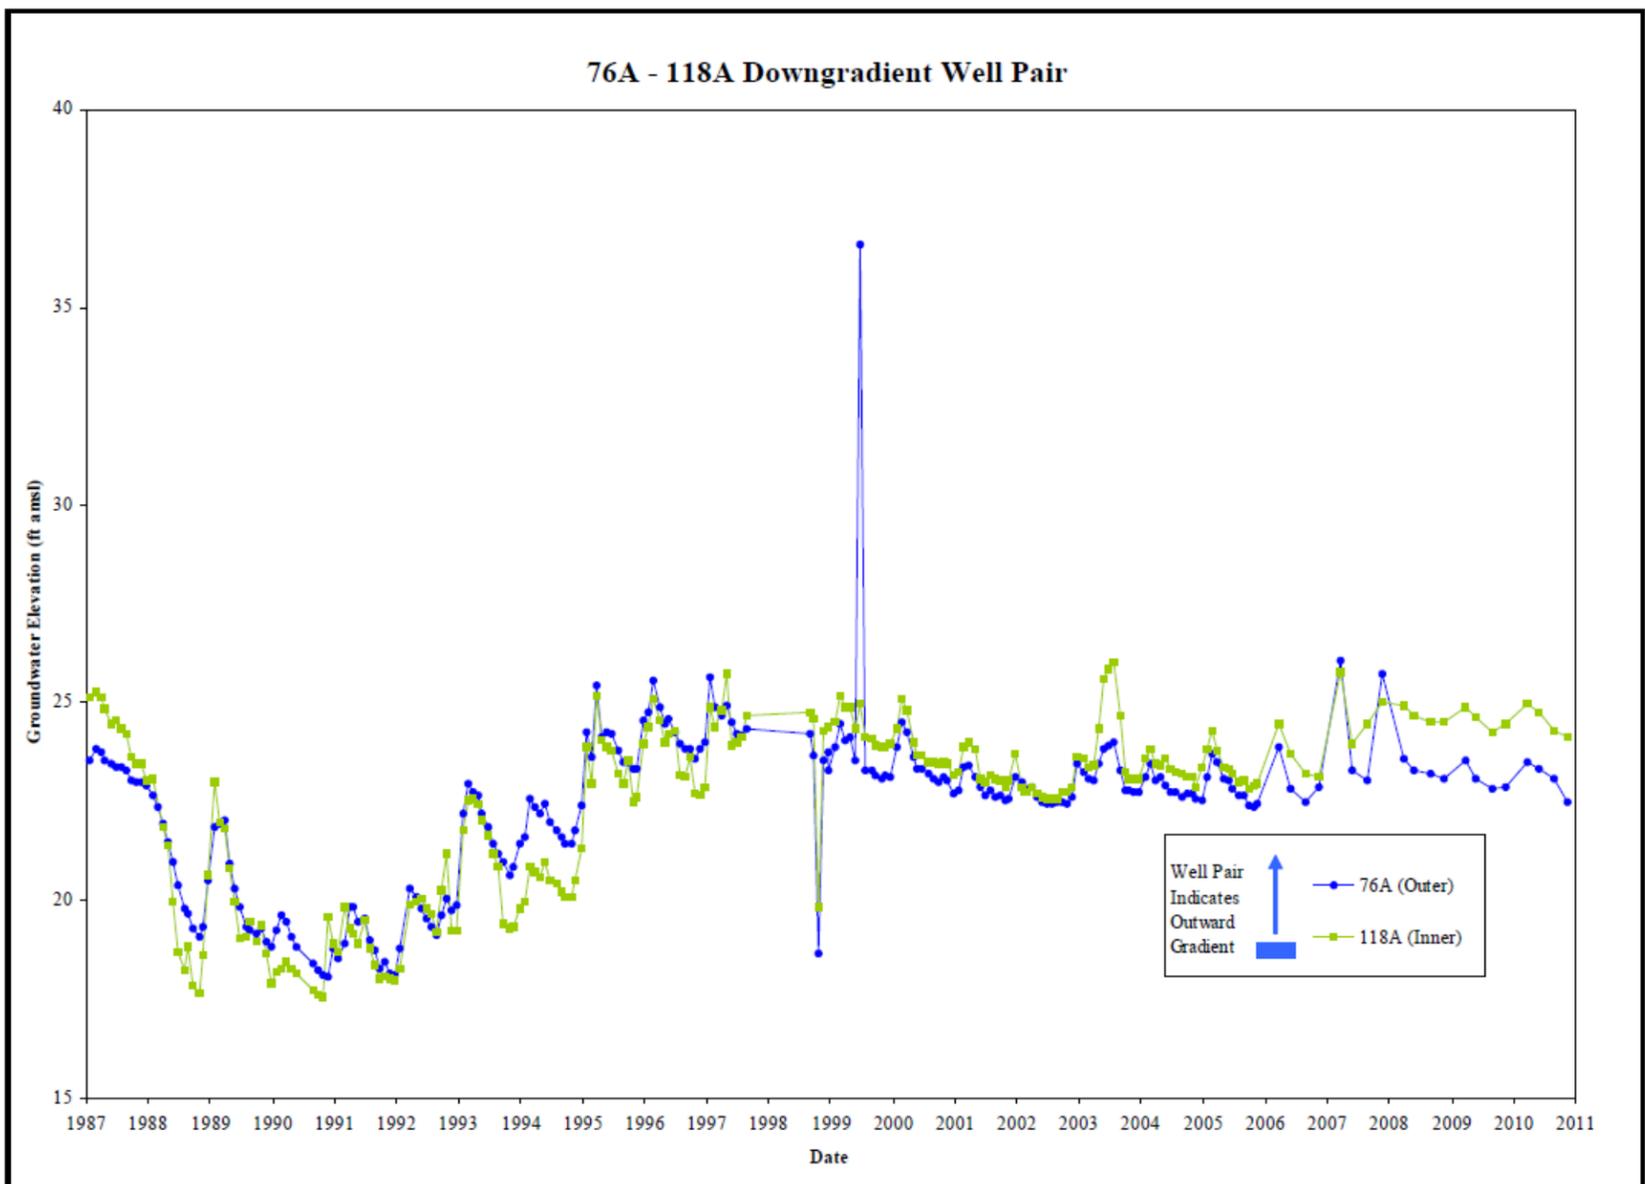
Figure 7. Hydrographs – Groundwater Elevation Measurements, Slurry Wall Well Pairs – Downgradient Wells, Former Fairchild Buildings 1-4, 515/545 Whisman Road and 313 Fairchild Drive, Mountain View, California

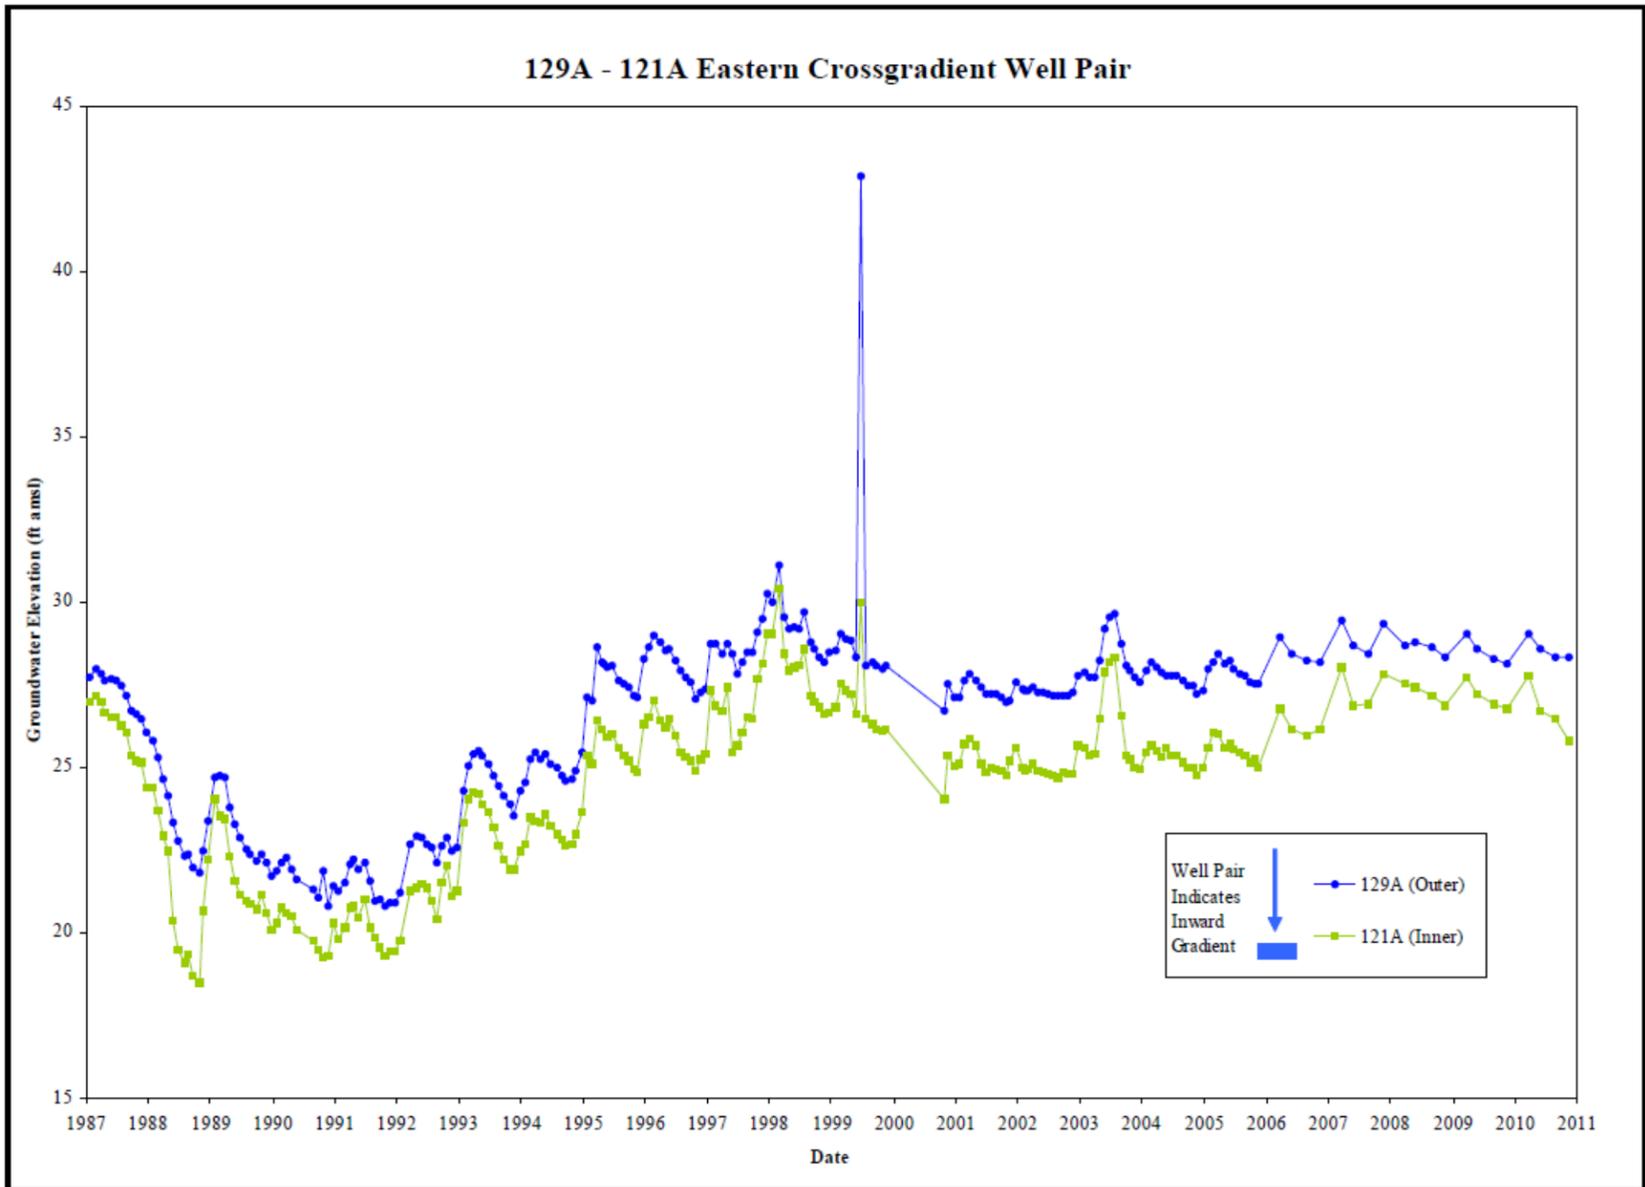
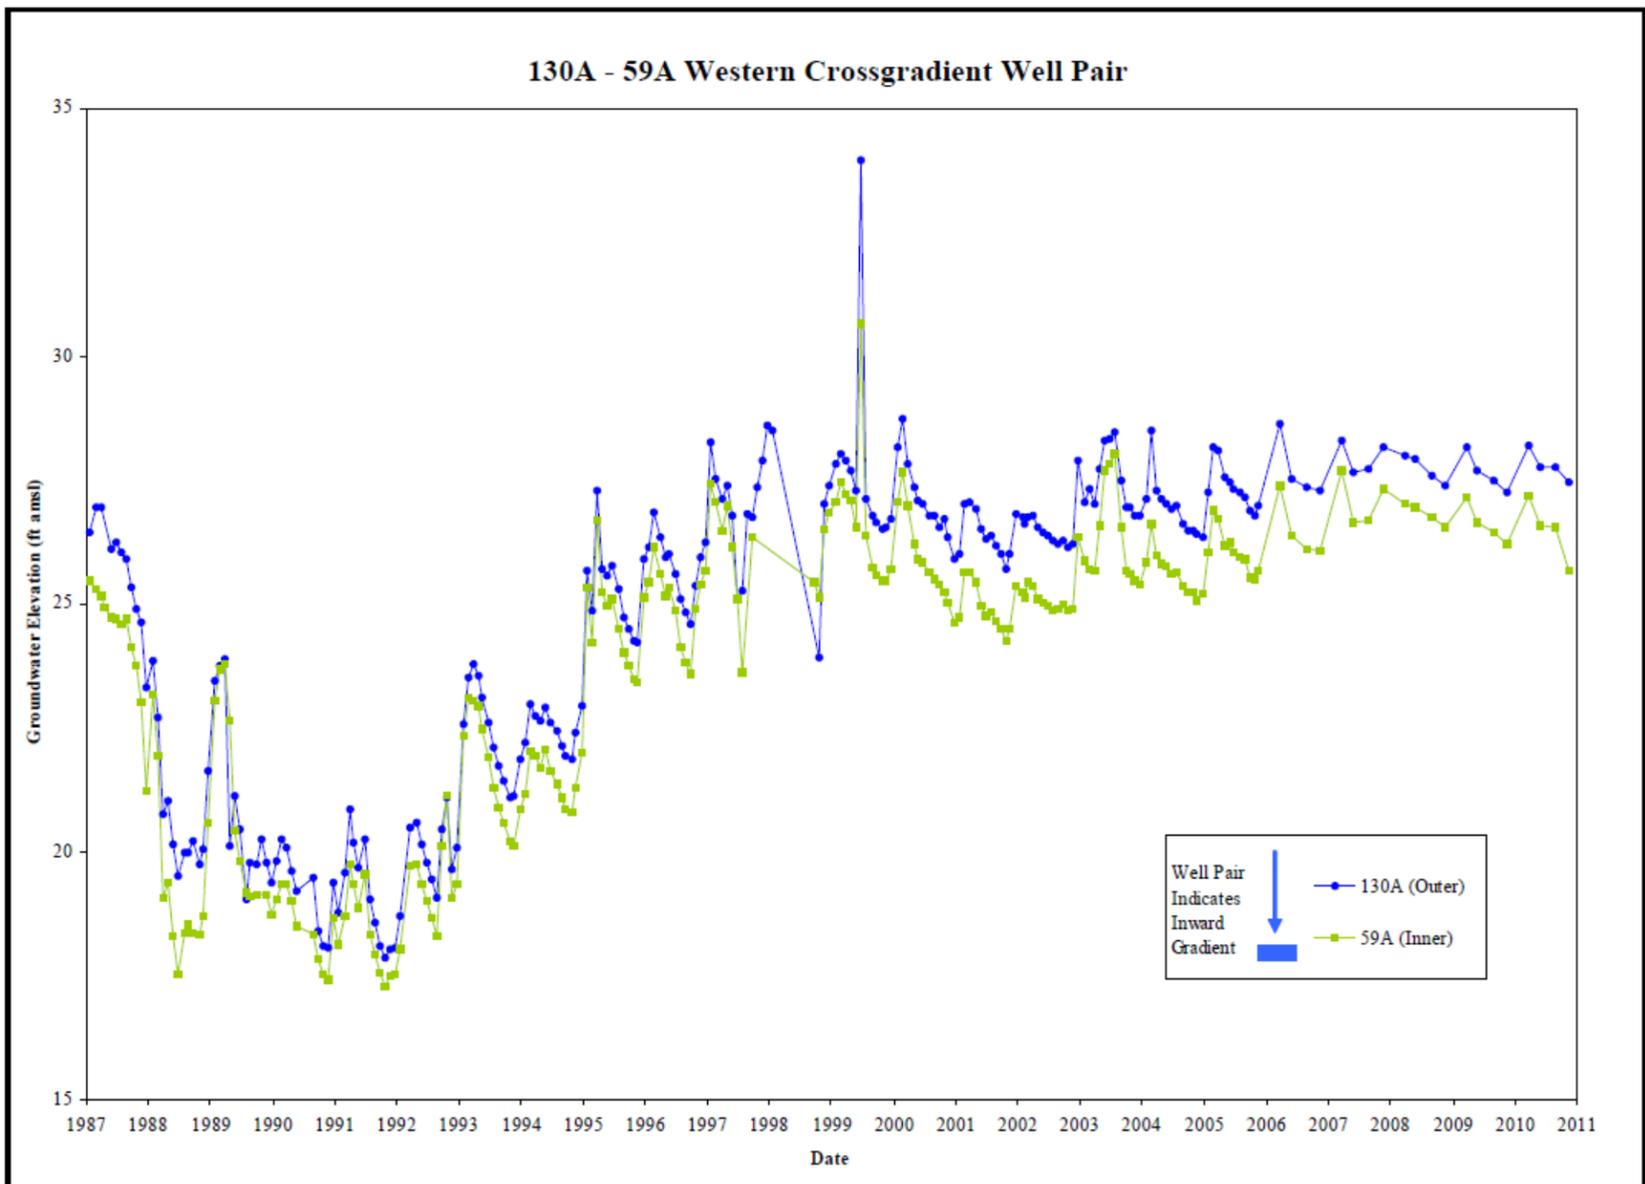
Figure 8. Hydrographs – Groundwater Elevation Measurements, Slurry Wall Well Pairs – Crossgradient Wells, Former Fairchild Buildings 1-4, 515/545 Whisman Road and 313 Fairchild Drive, Mountain View, California

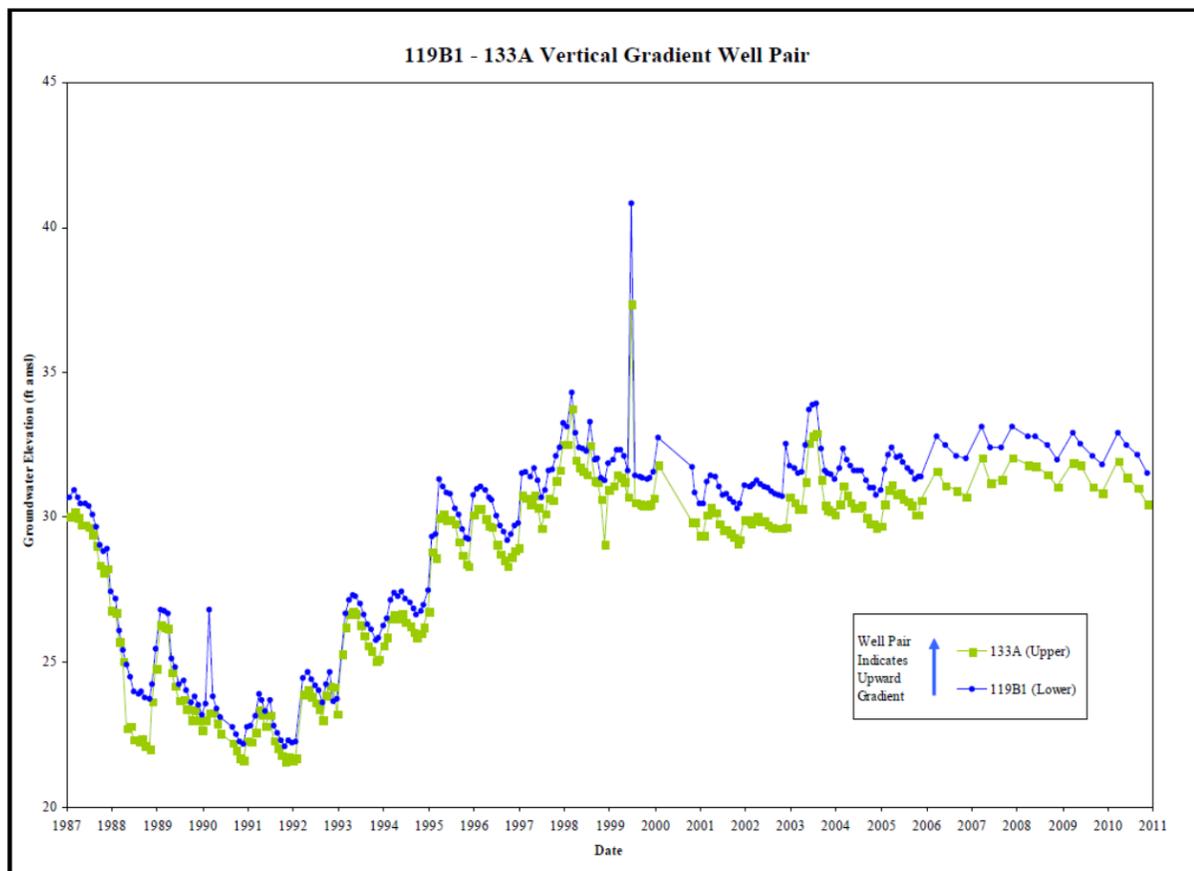
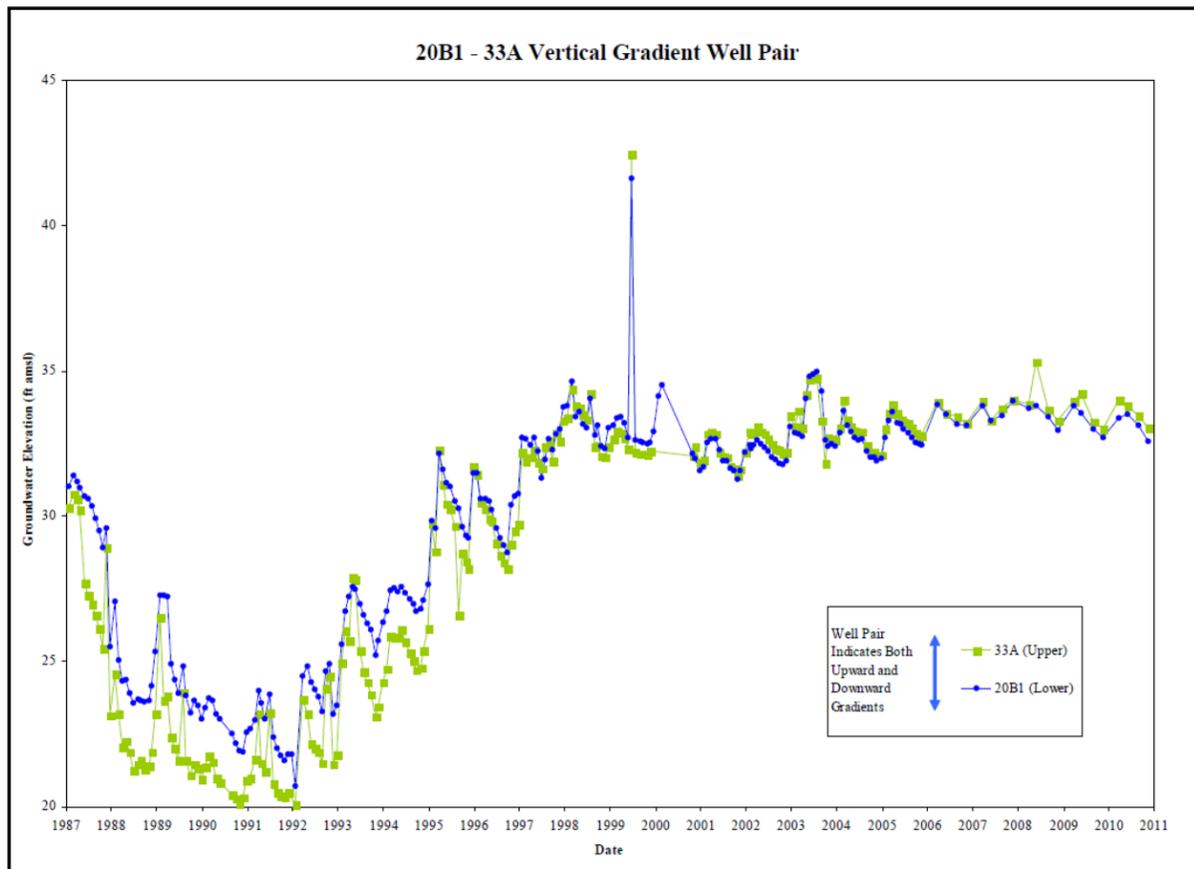
Figure 9. Hydrographs – Groundwater Elevation Measurements, Slurry Wall Well Pairs – Vertical Gradient Wells, Former Fairchild Buildings 1-4, 515/545 Whisman Road and 313 Fairchild Drive, Mountain View, California

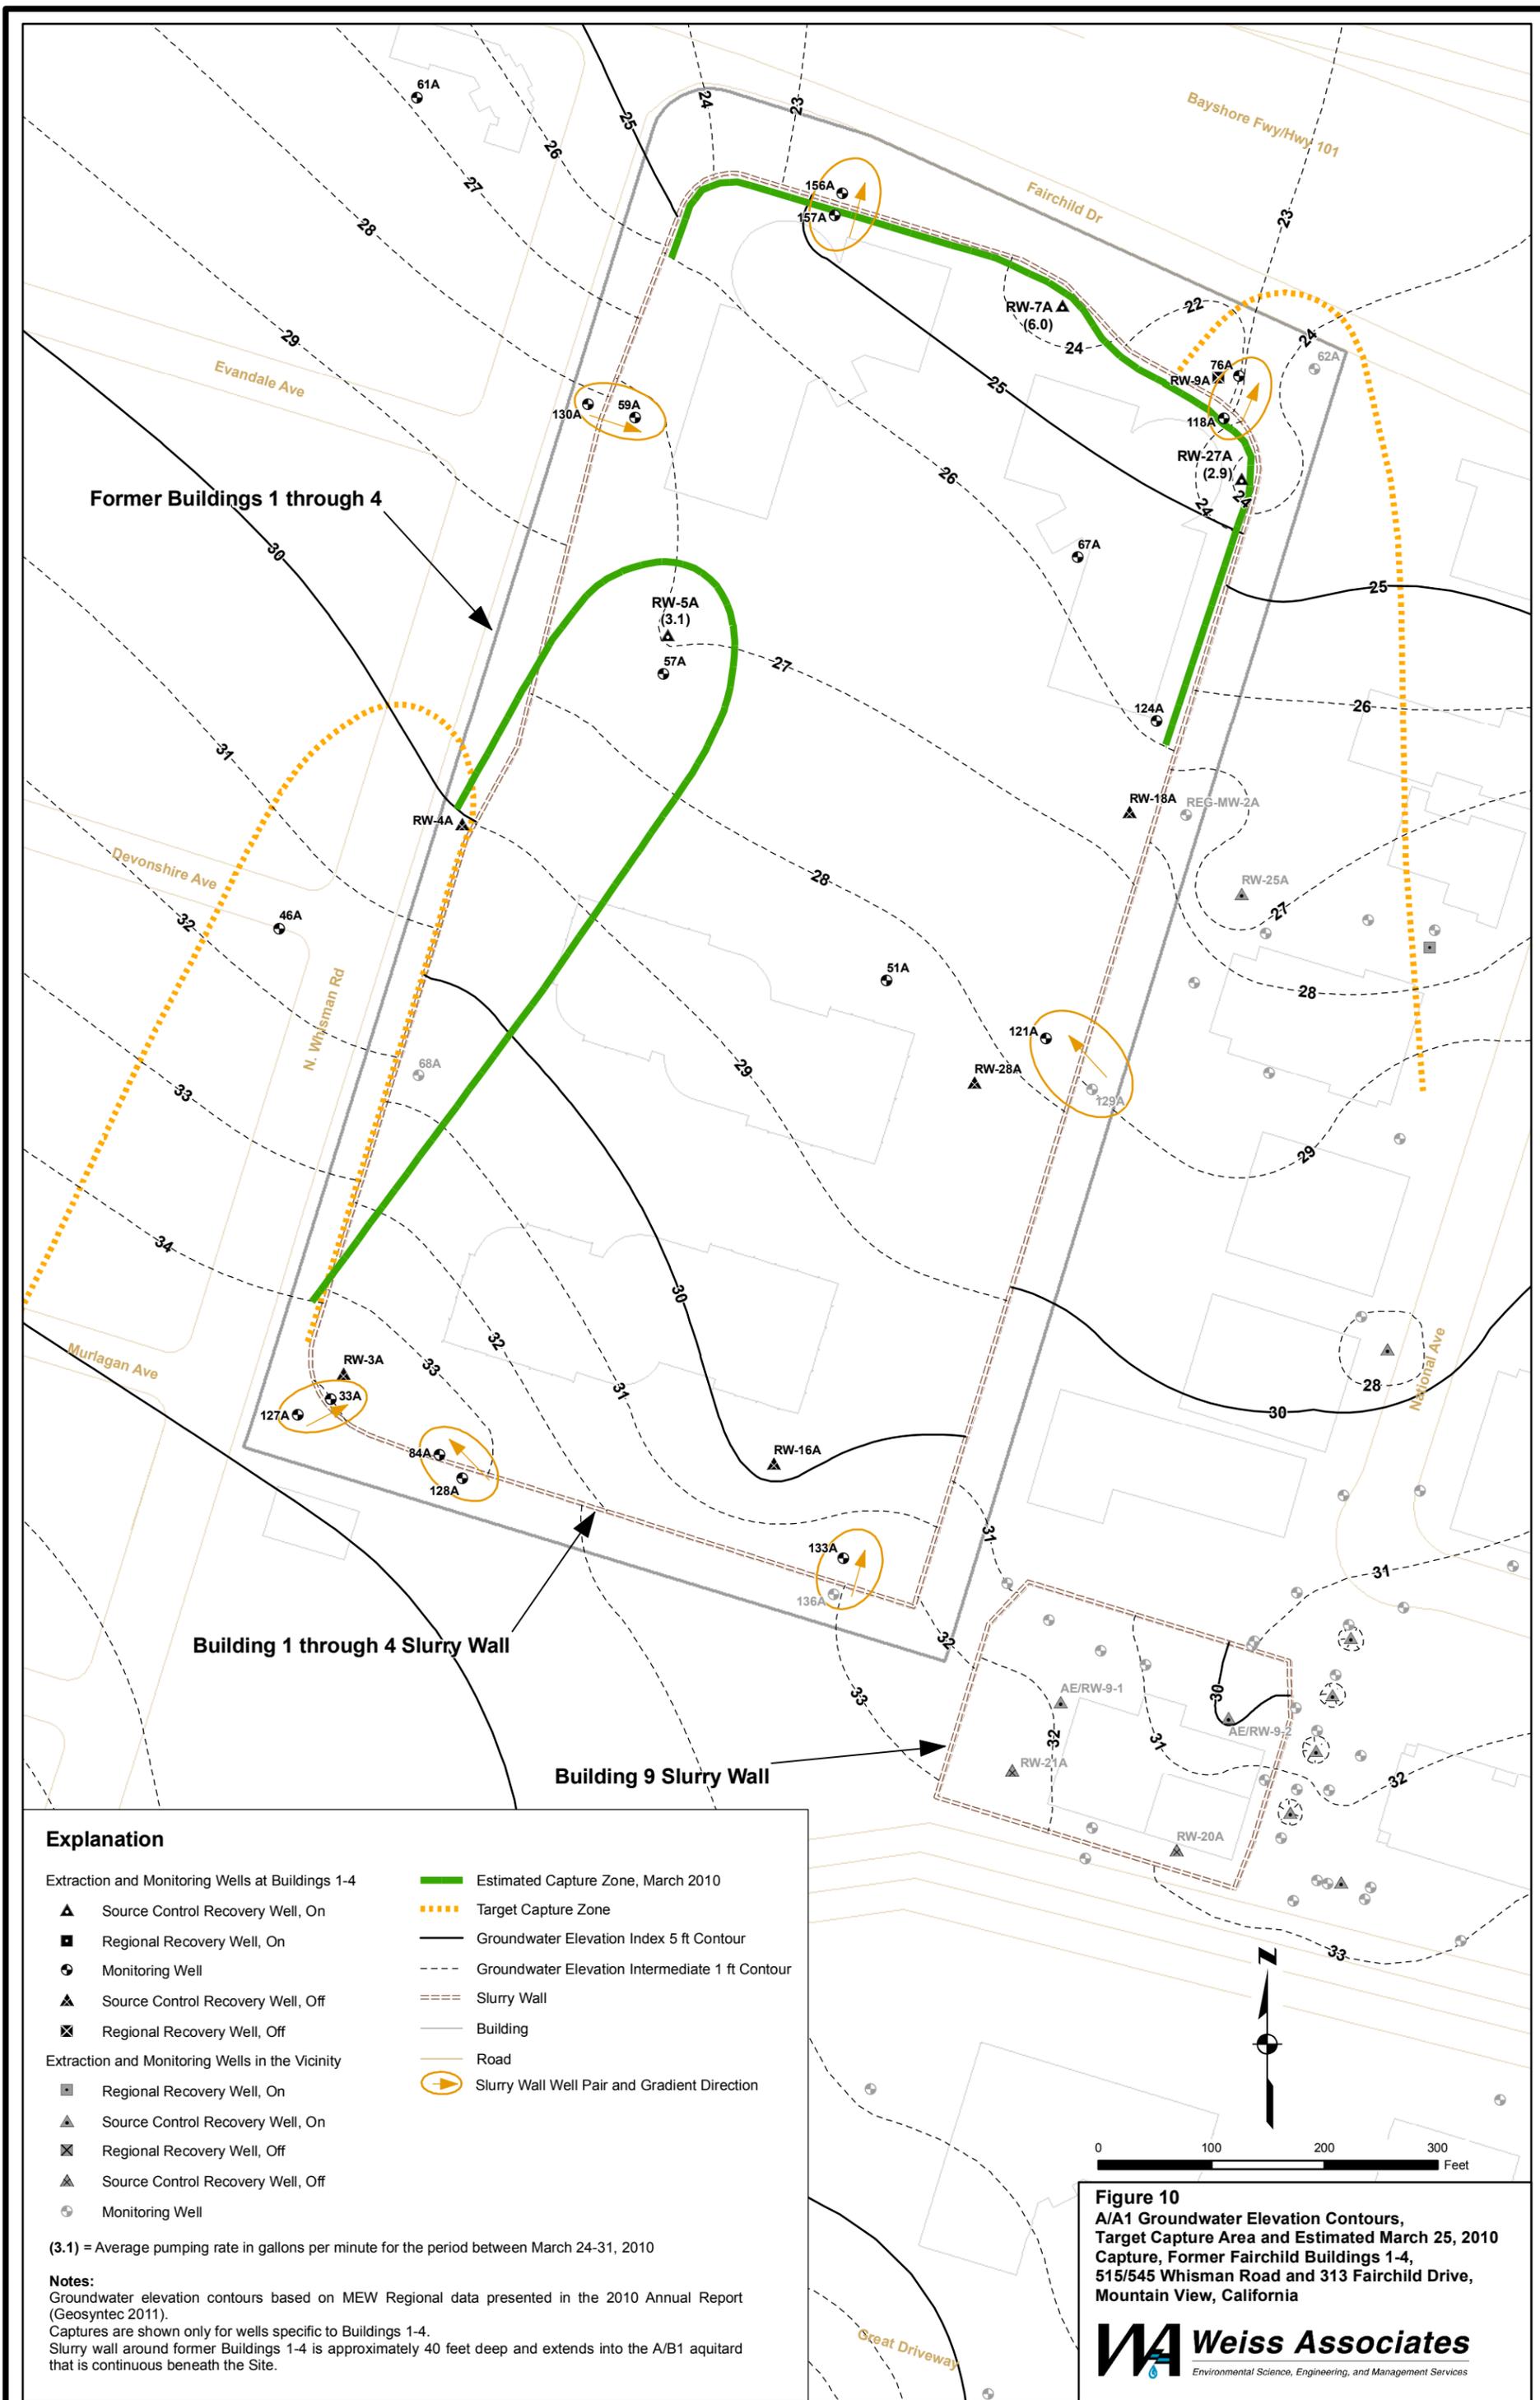
**Figure 10**  
 A/A1 Groundwater Elevation Contours, Target Capture Area and Estimated March 25, 2010 Capture, Former Fairchild Buildings 1-4, 515/545 Whisman Road and 313 Fairchild Drive, Mountain View, California
