## **2010 ANNUAL PROGRESS REPORT**

**Former Fairchild Buildings 1-4  
515/545 Whisman Road and 313 Fairchild Drive  
Middlefield-Ellis-Whisman Area  
Mountain View, California**

June 10, 2011

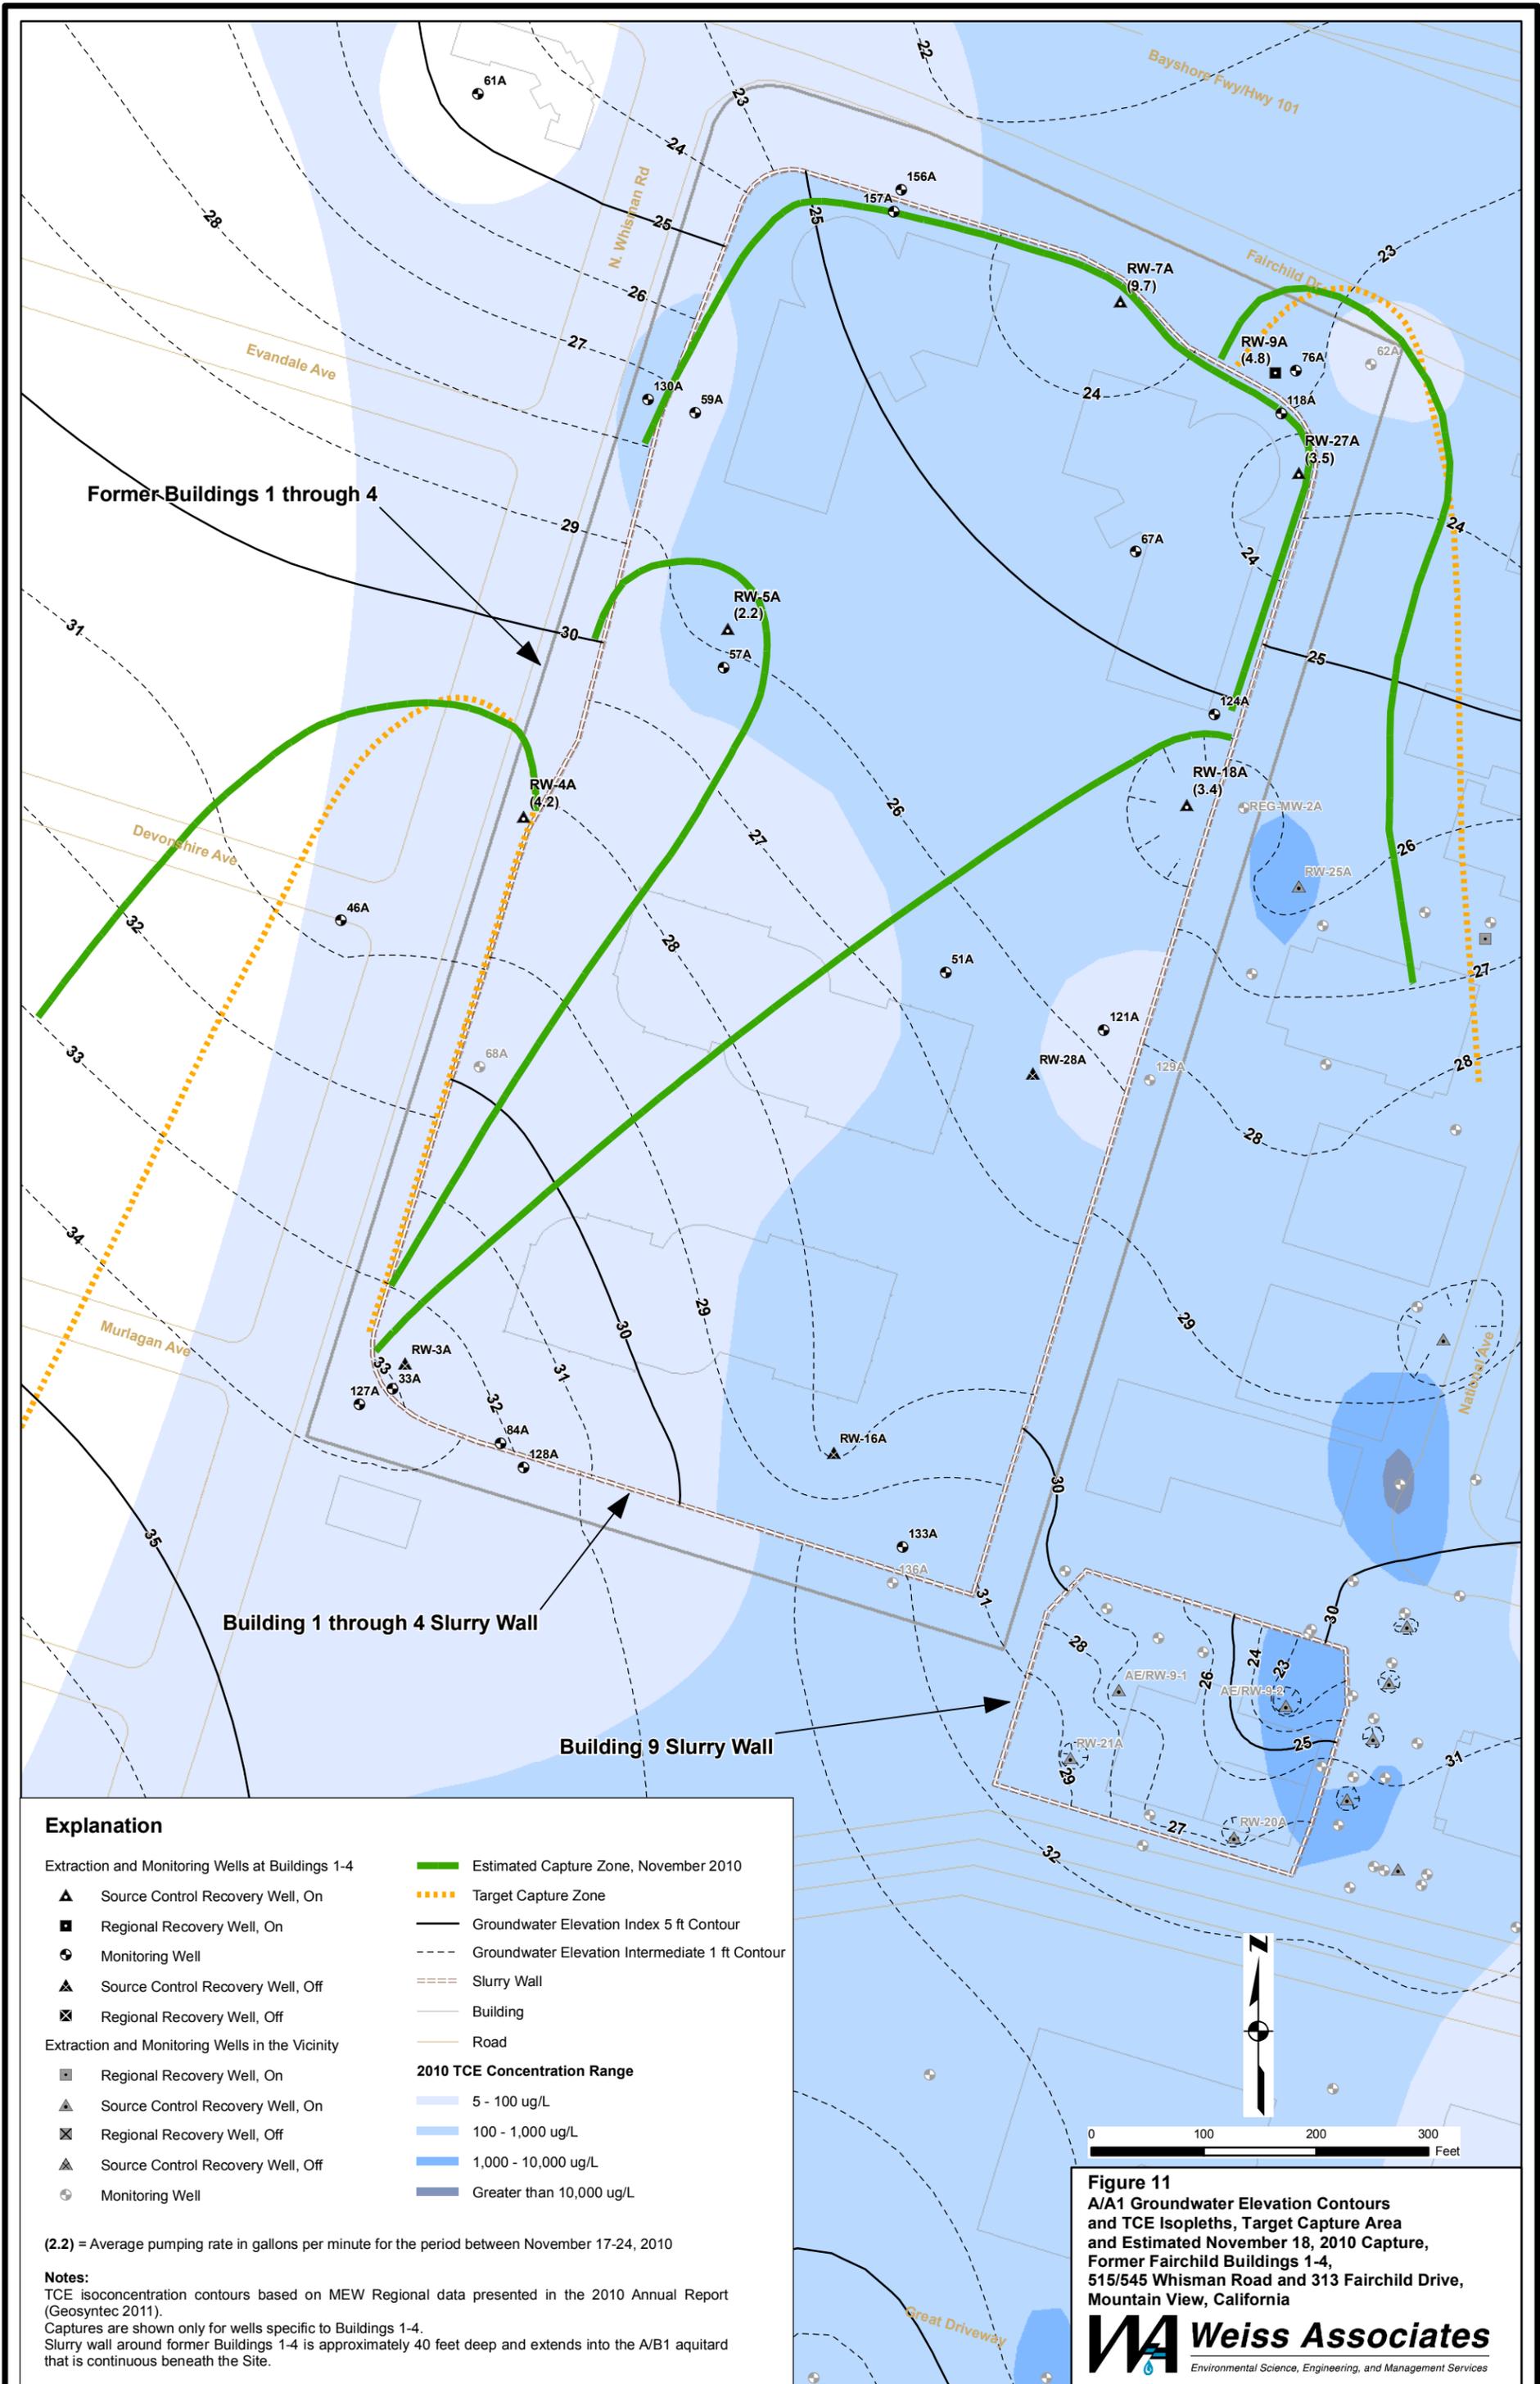
**Figure 11**  
 A/A1 Groundwater Elevation Contours and TCE Isopleths, Target Capture Area and Estimated November 18, 2010 Capture, Former Fairchild Buildings 1-4, 515/545 Whisman Road and 313 Fairchild Drive, Mountain View, California

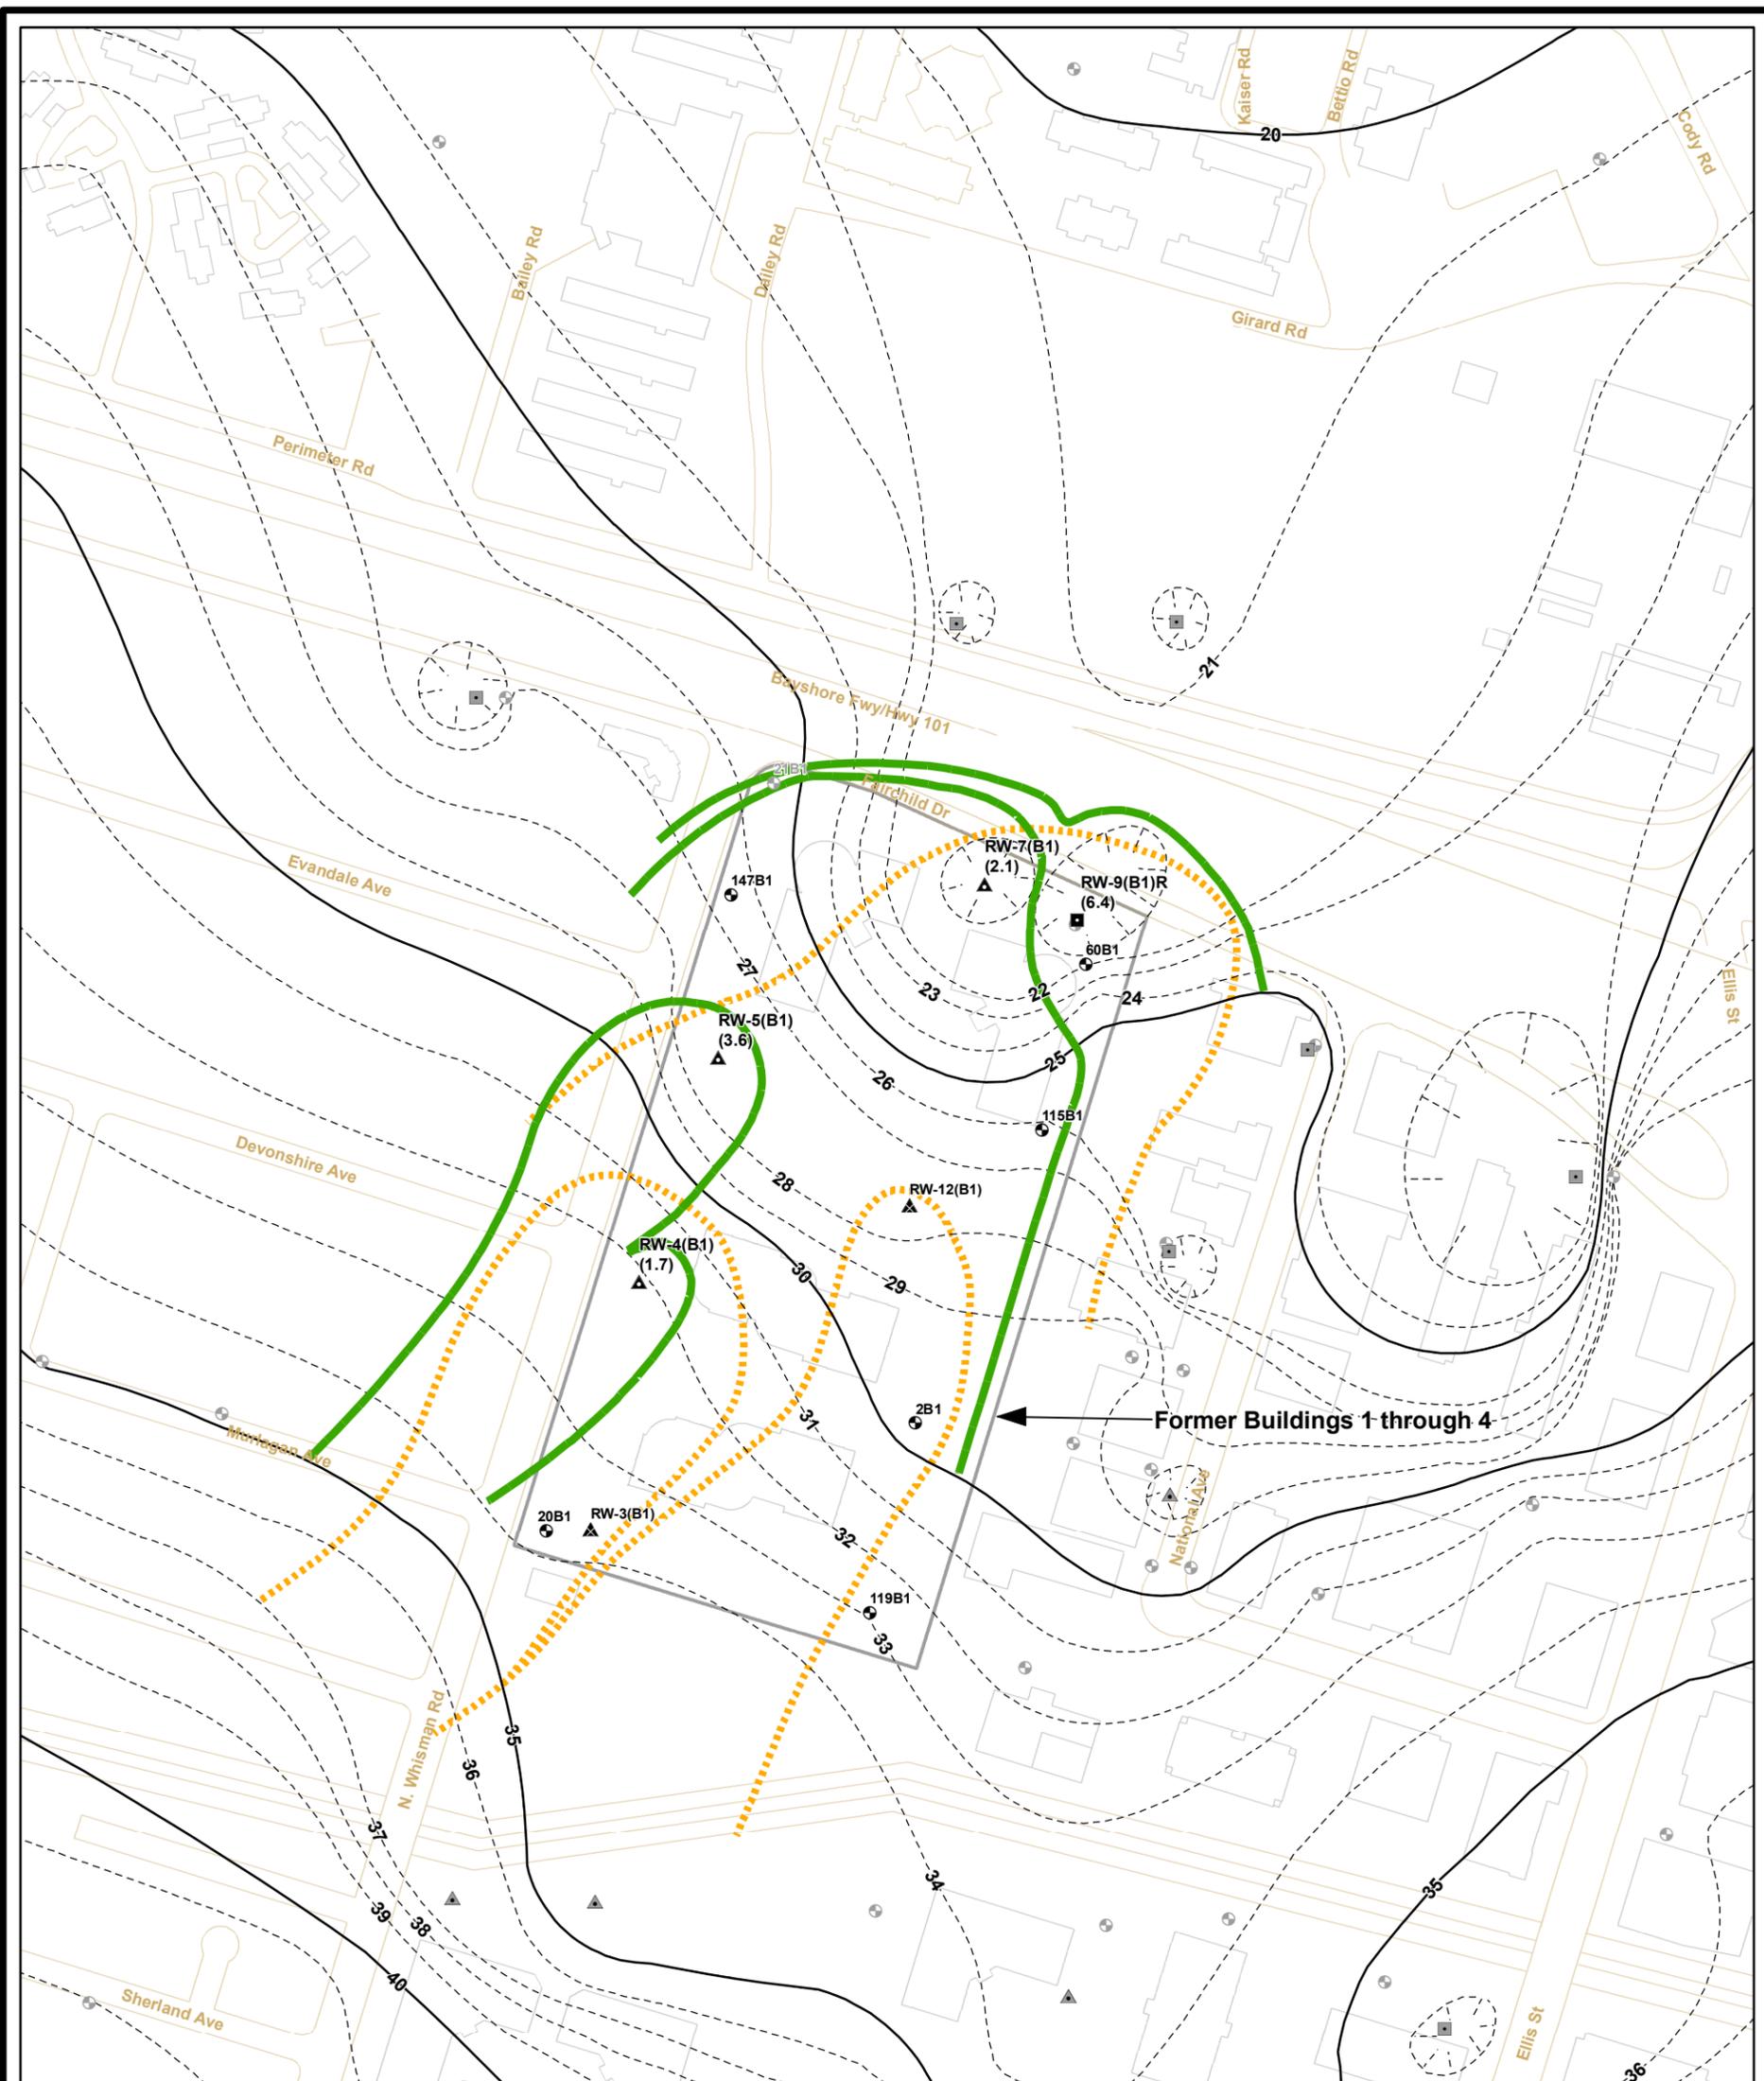
**Figure 12**  
**B1/A2 Groundwater Elevation Contours, Target Capture Area and Estimated March 25, 2010 Capture, Former Fairchild Buildings 1-4, 515/545 Whisman Road and 313 Fairchild Drive, Mountain View, California**

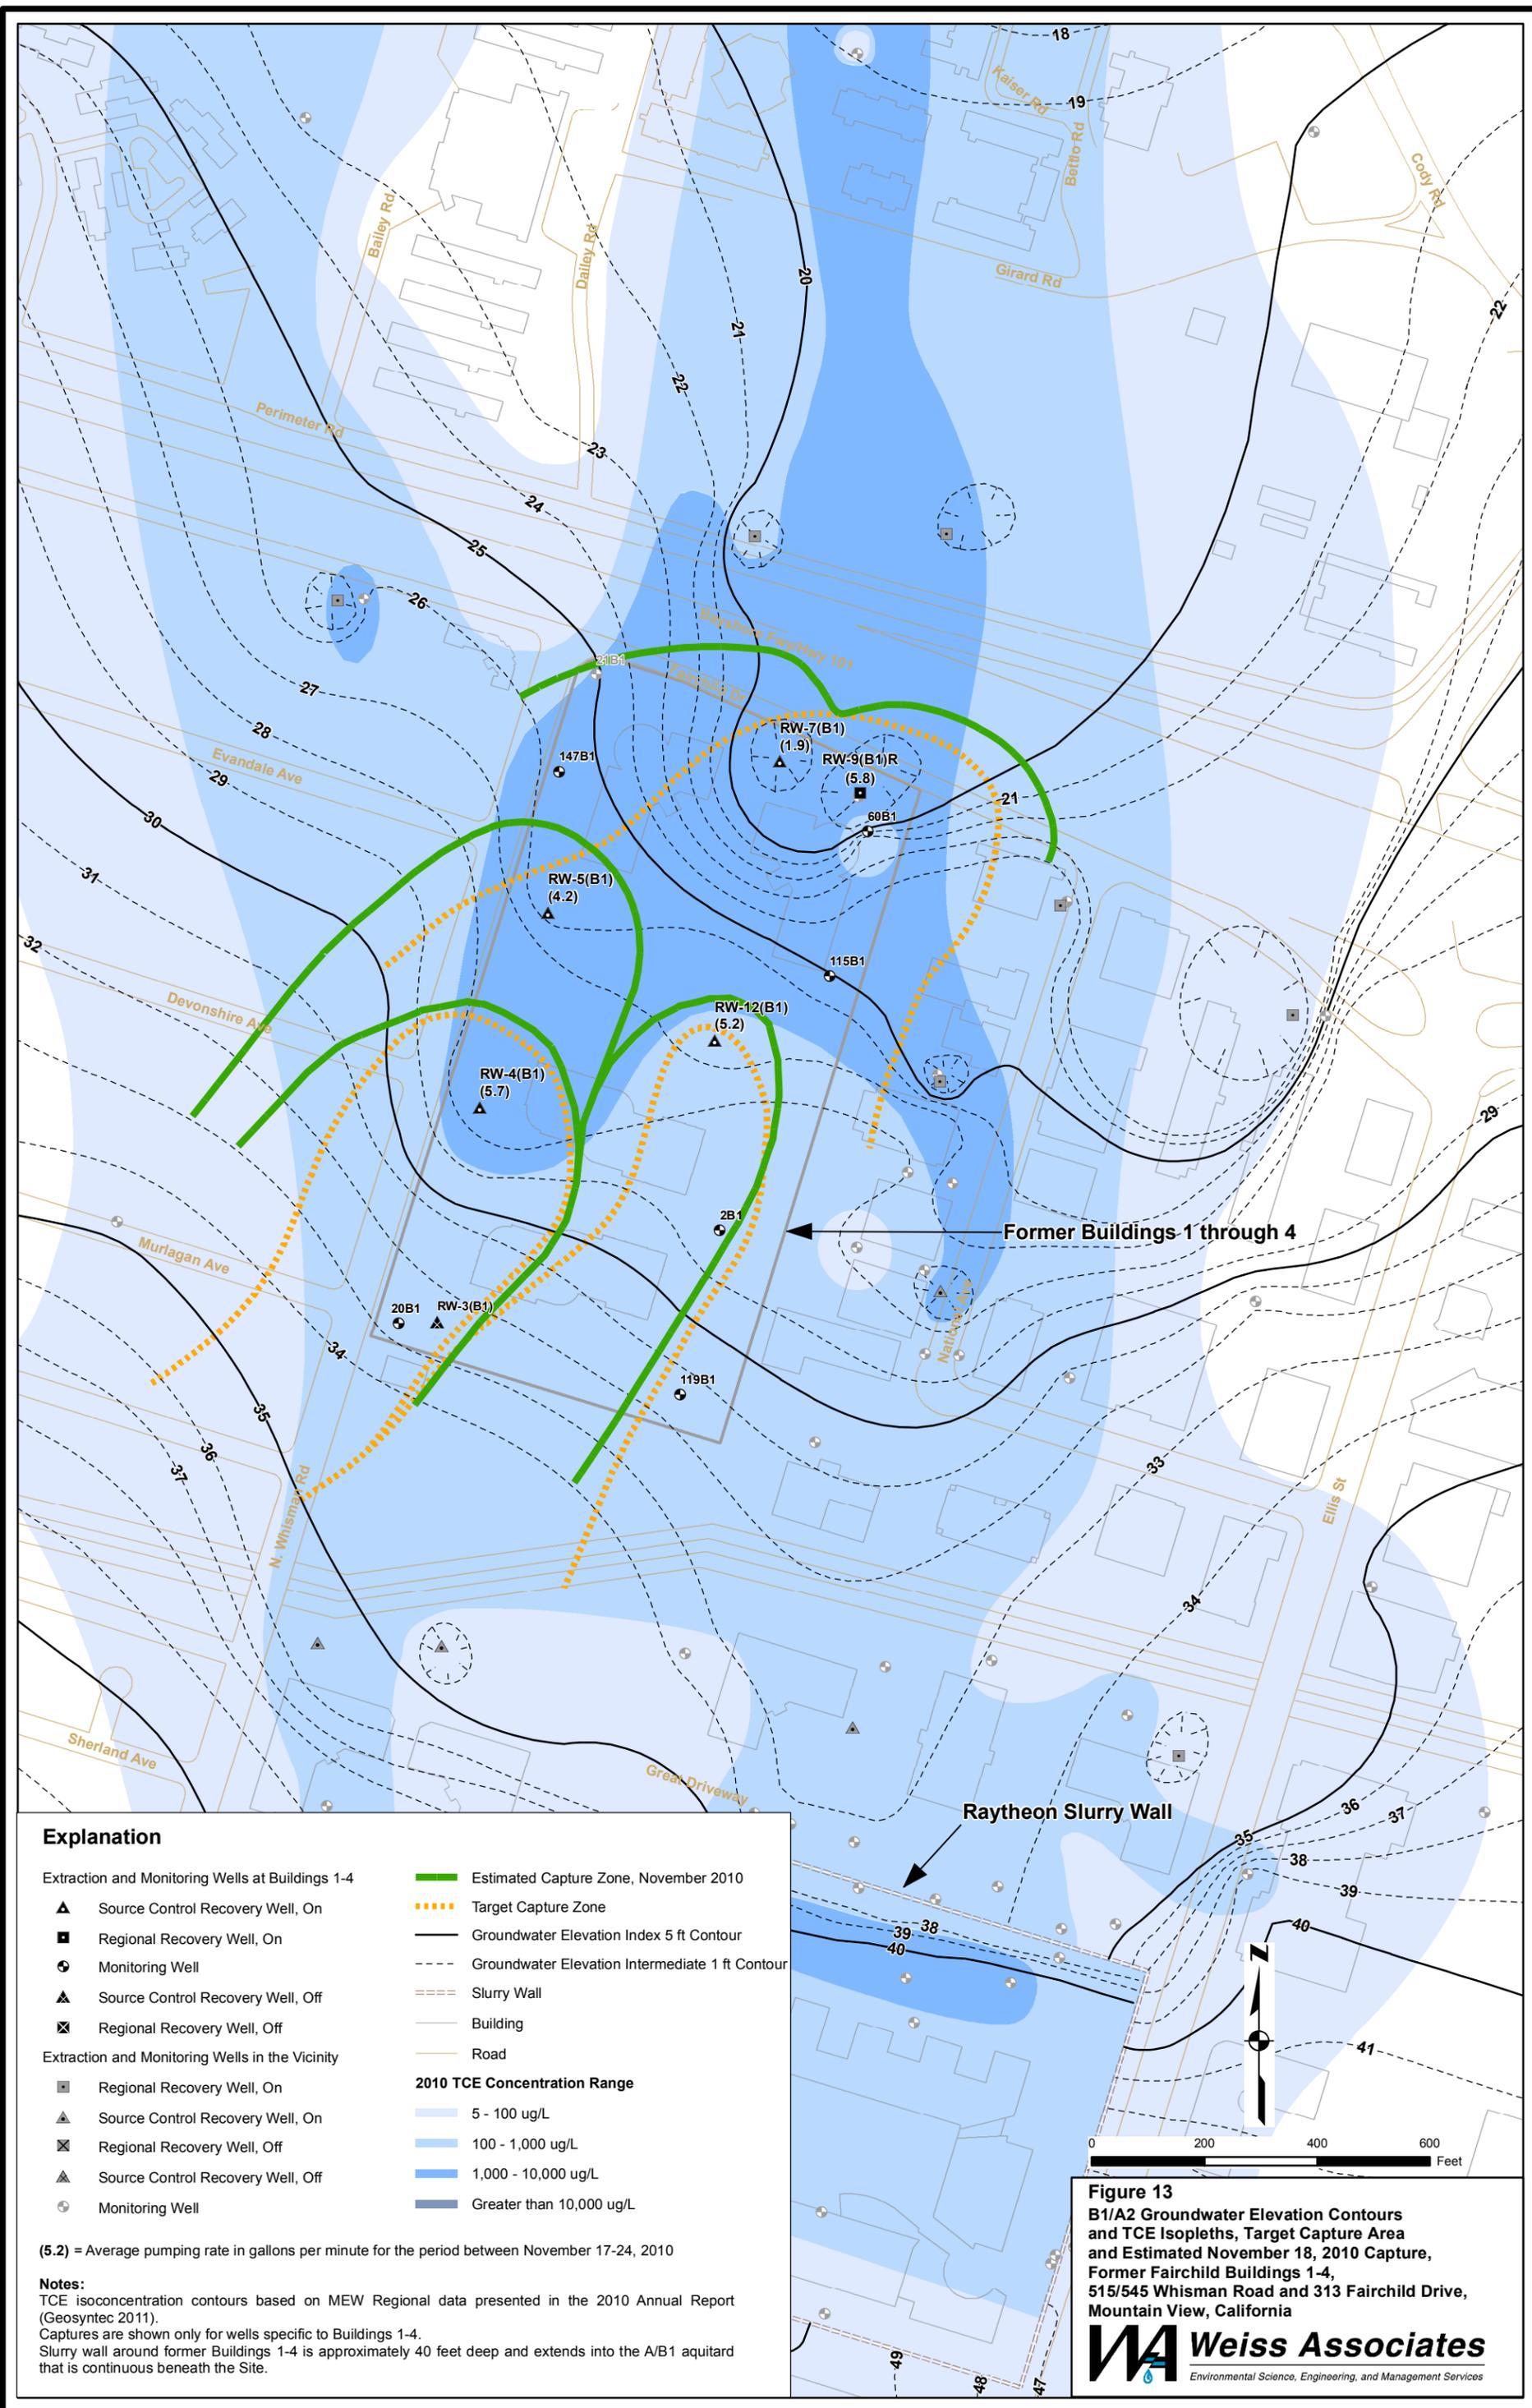
**Figure 13**  
 B1/A2 Groundwater Elevation Contours and TCE Isoleths, Target Capture Area and Estimated November 18, 2010 Capture, Former Fairchild Buildings 1-4, 515/545 Whisman Road and 313 Fairchild Drive, Mountain View, California

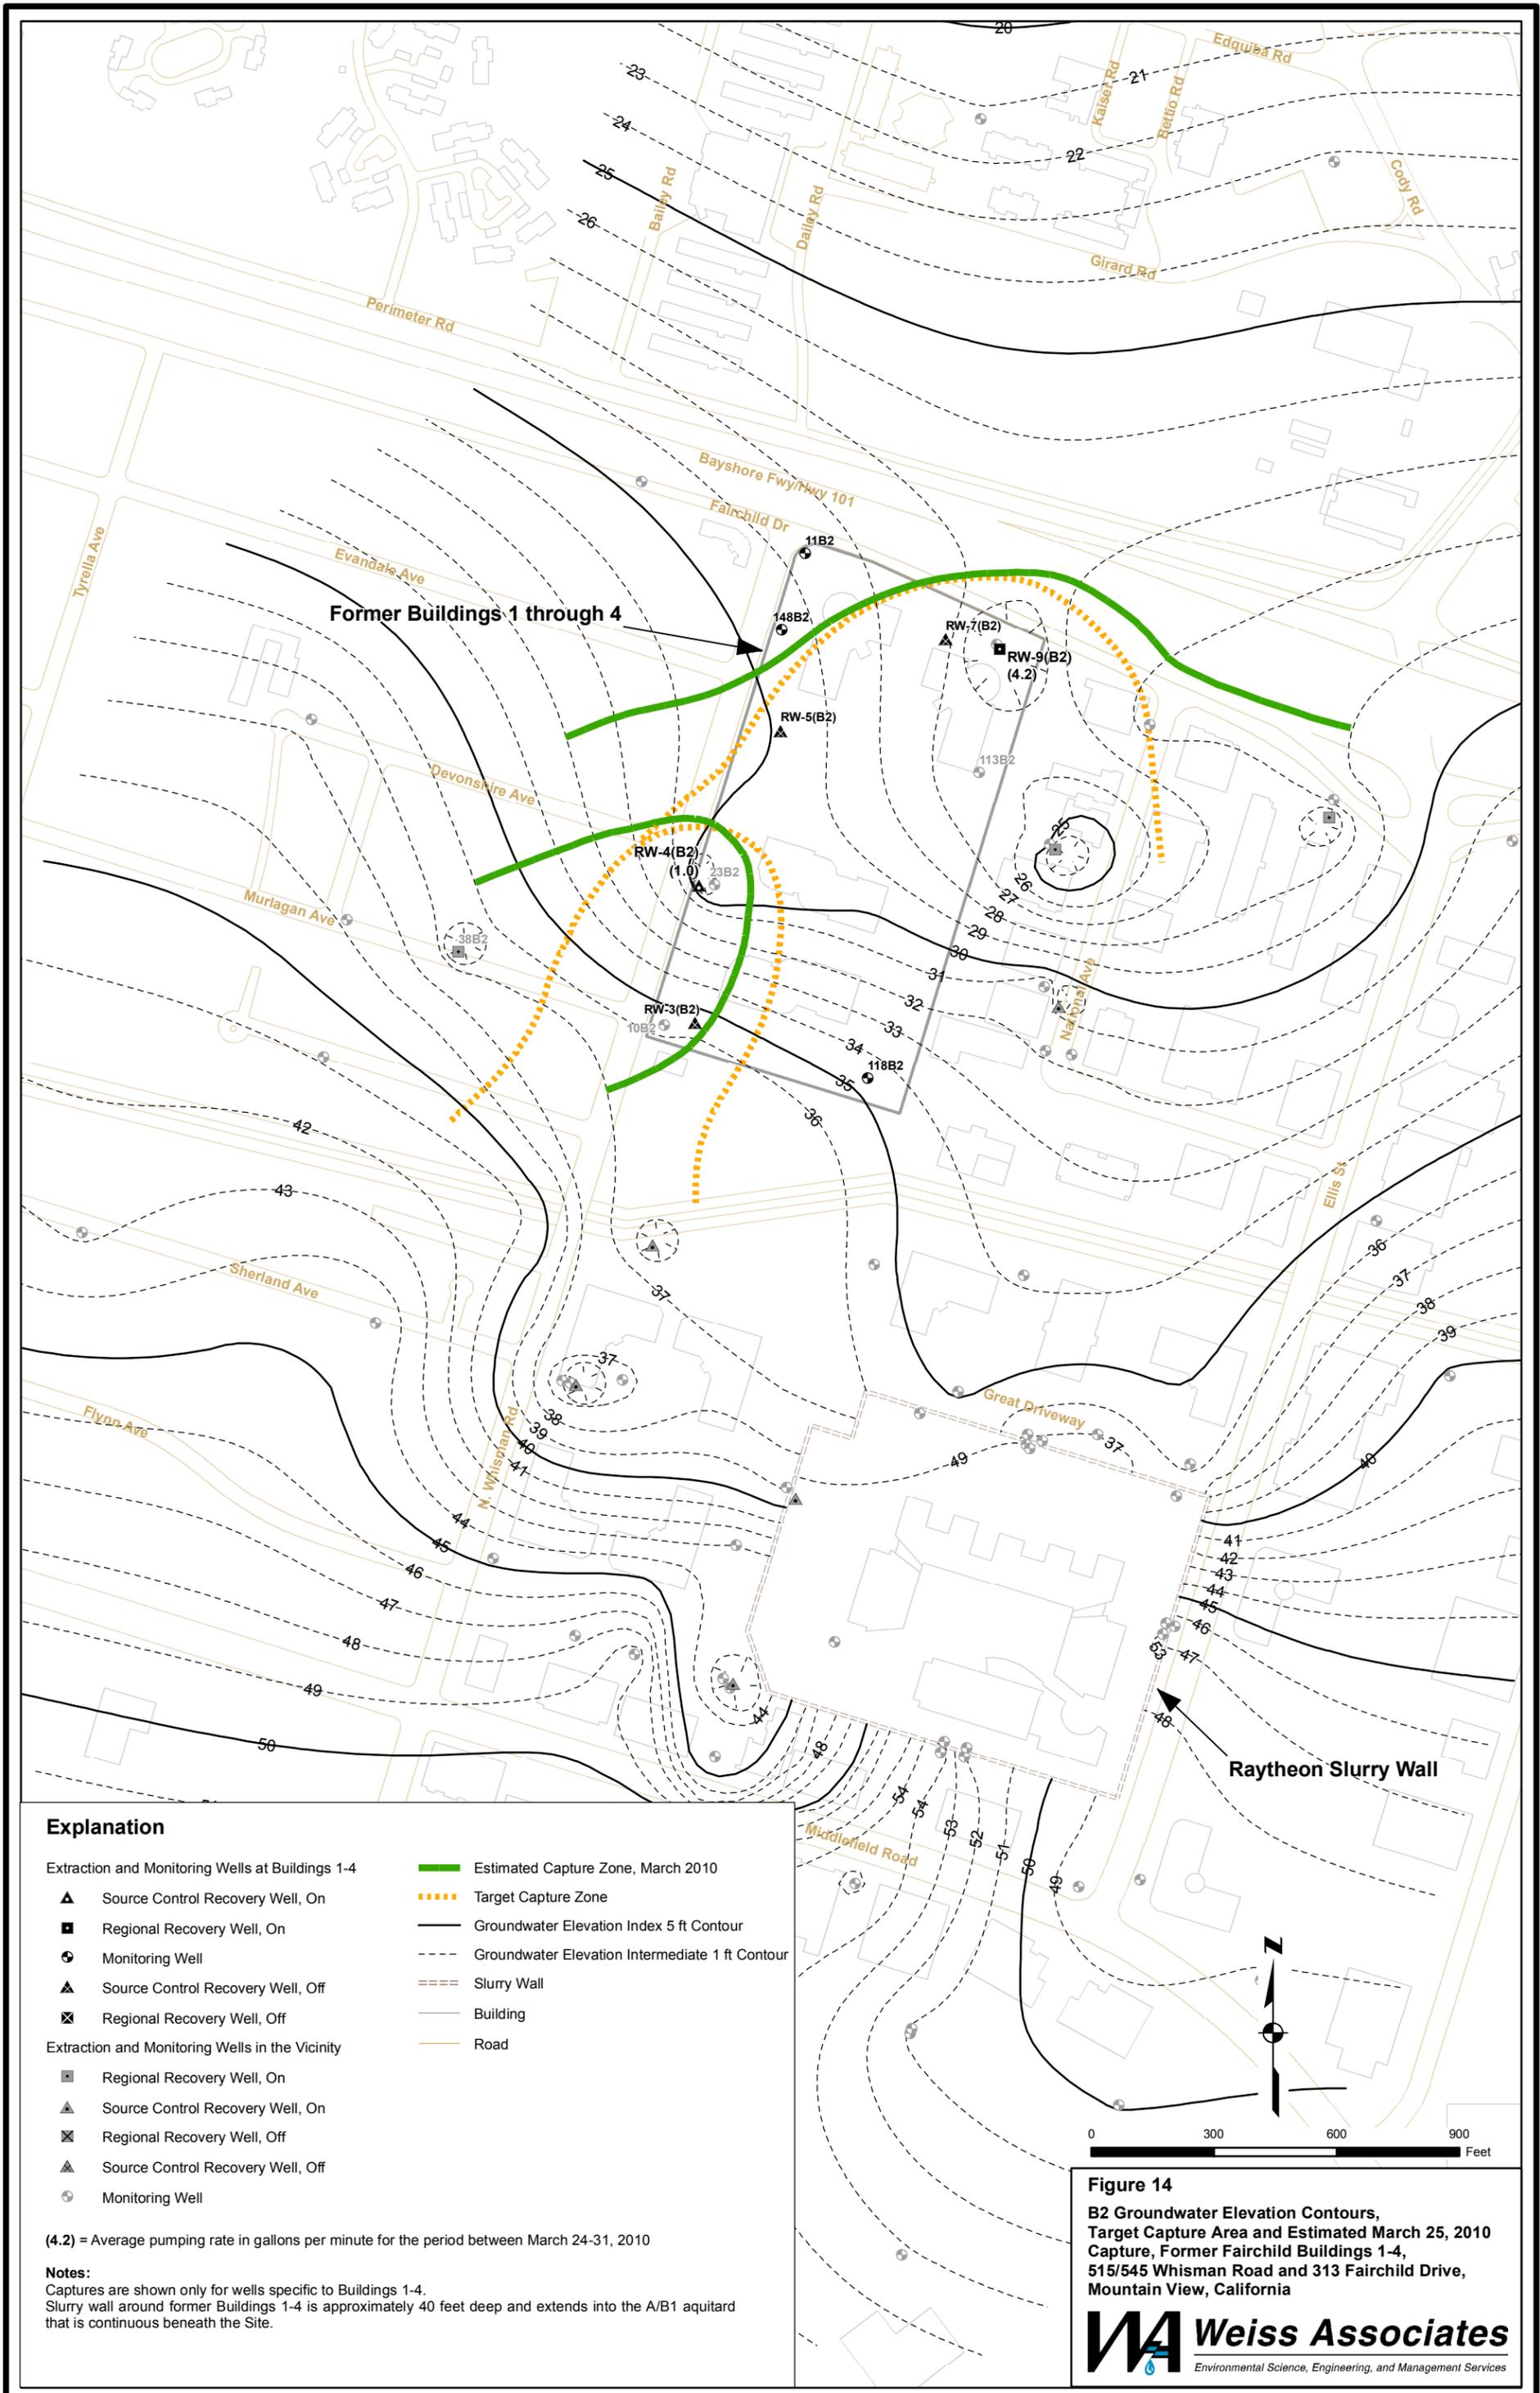
**B2 Groundwater Elevation Contours, Target Capture Area and Estimated March 25, 2010 Capture, Former Fairchild Buildings 1-4, 515/545 Whisman Road and 313 Fairchild Drive, Mountain View, California**
