**ASARCO LLC Hayden Plant Site:
Summary of Ecological Evaluation
Site Visit of April 27-28, 2006**

PREPARED FOR: U.S. Environmental Protection Agency, Region IX

PREPARED BY: Gary Santolo/CH2M HILL
Christine Arenal/CH2M HILL

DATE: January 5, 2007 (replacing draft version of October 25, 2006)

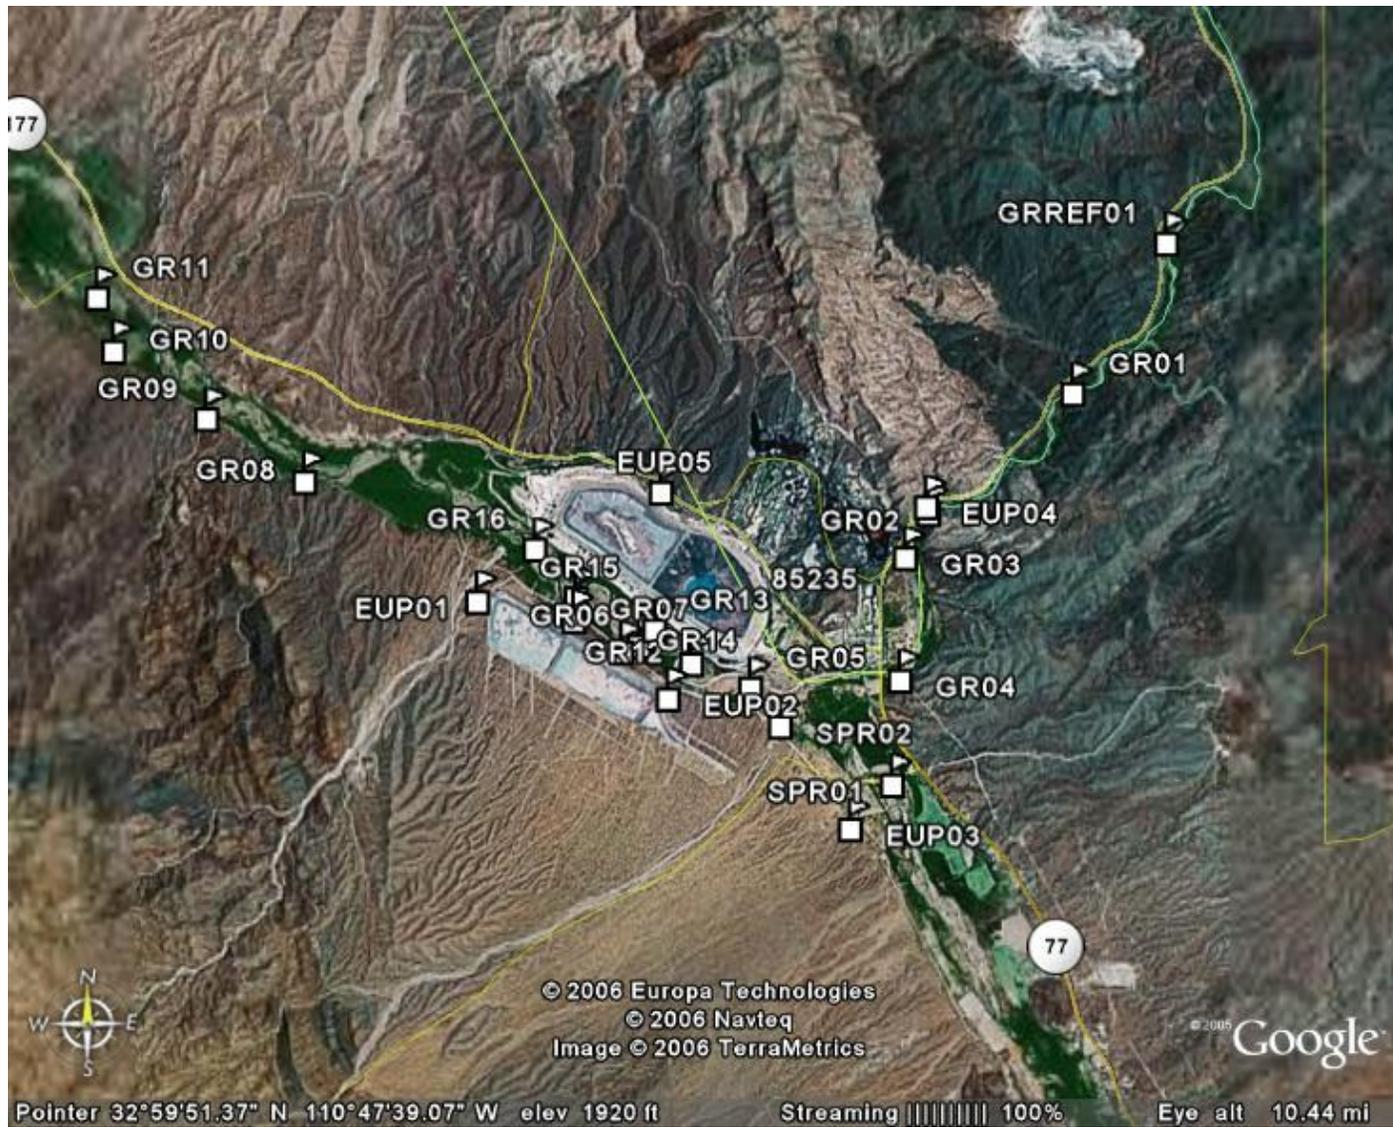
Figure 2. ASARCO surveys sites 27-28 April 2006

The locations of the sites surveyed and results of the cursory surveys conducted on April 27-28, 2006 are shown in Figure 2. The following descriptions recap the overall ecology of the site. Appendix A details the specific findings at each location:
