Figure J-2

Detail of Interpolated Limits of Clay Barrier and Coordinate Locations

Remedial Investigation Report
Casmalia Site
January 2010

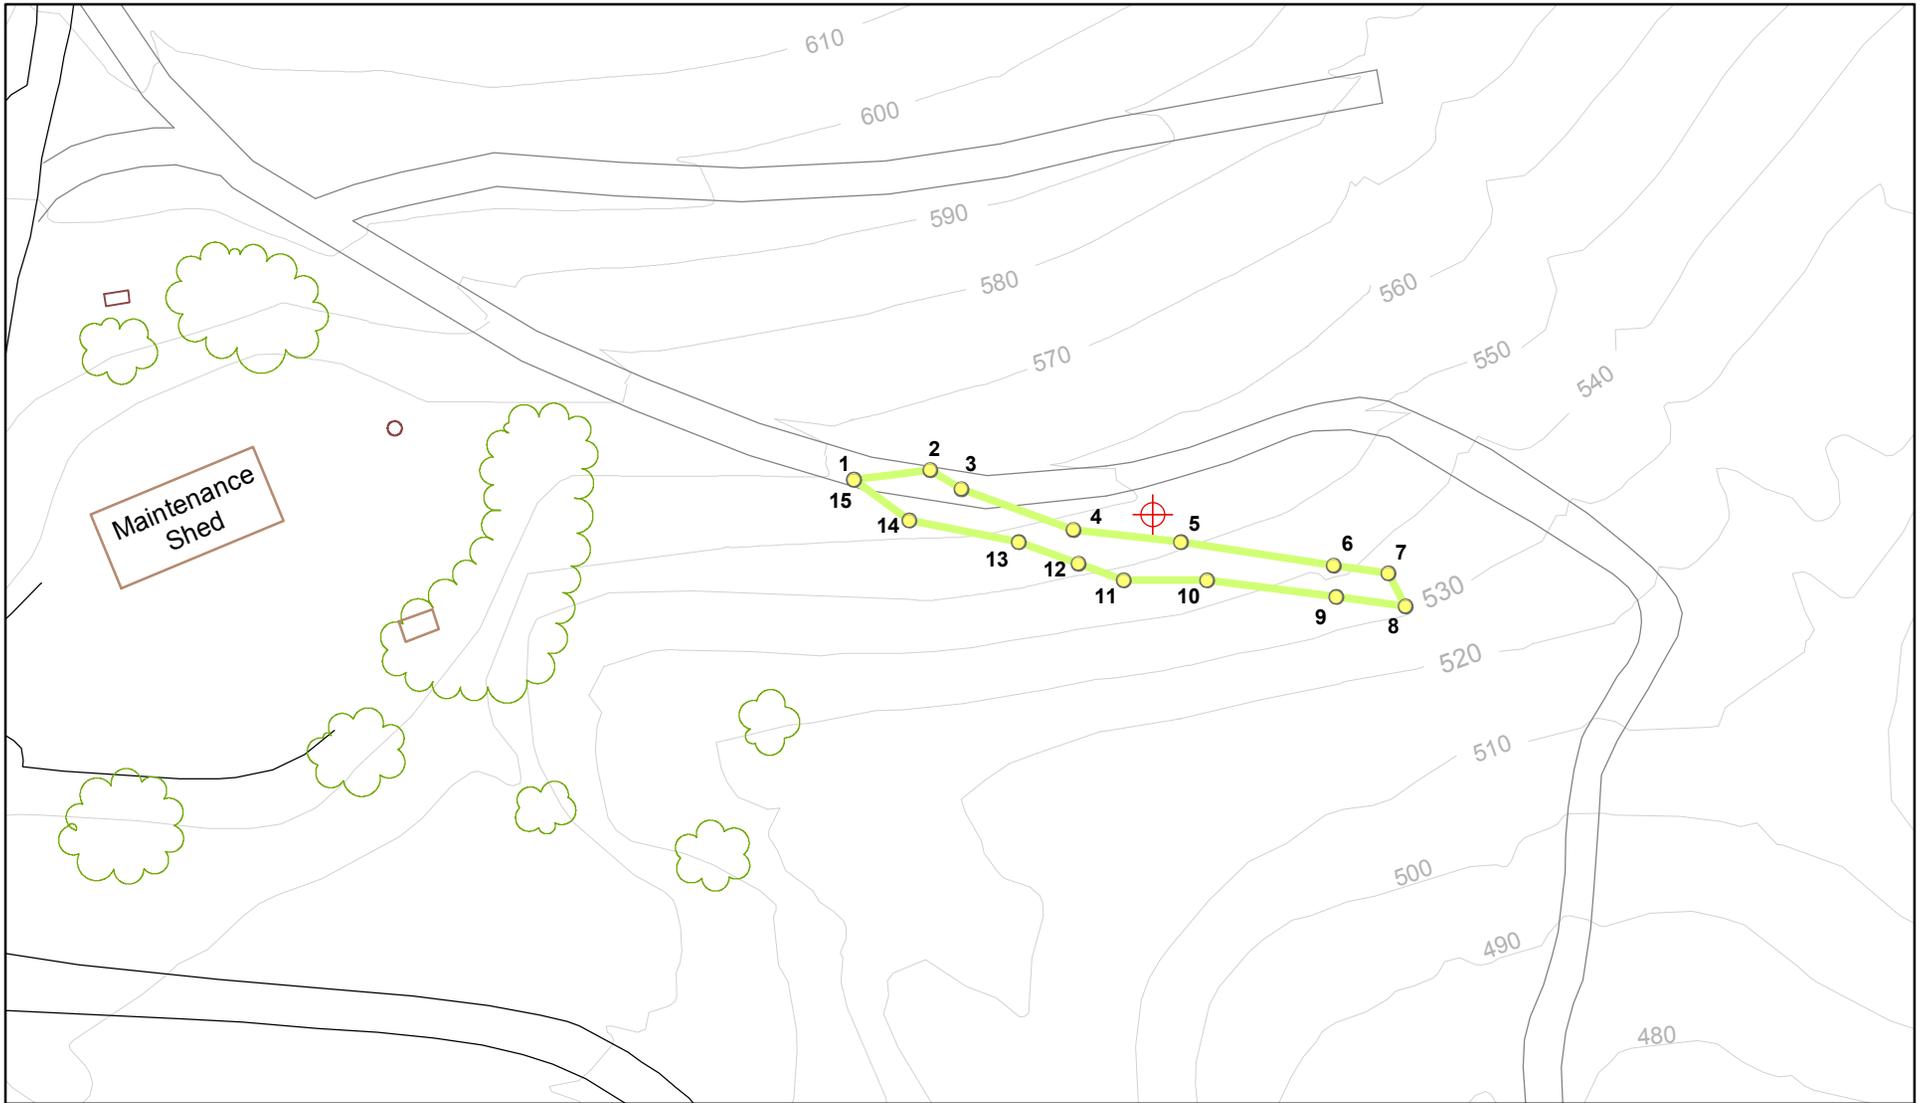
Survey Control Coordinate Location
-

Interpolated Clay Barrier Alignment
-

Gallery Well Location

Source: Topographic base map provided by Pacific Engineering, Inc. from aerial survey dated March 4, 2004.
