Subject: **2012 Annual Progress Report – Former Fairchild Buildings 13, 19, and 23**
Middlefield-Ellis-Whisman ("MEW") Area
Mountain View, California

**2012 ANNUAL PROGRESS REPORT
FORMER FAIRCHILD
BUILDINGS 13, 19, and 23
MOUNTAIN VIEW, CALIFORNIA**

**2012 Annual Progress Report Former
Fairchild Buildings 13, 19, and 23
Middlefield-Ellis-Whisman Study Area
Mountain View, California**

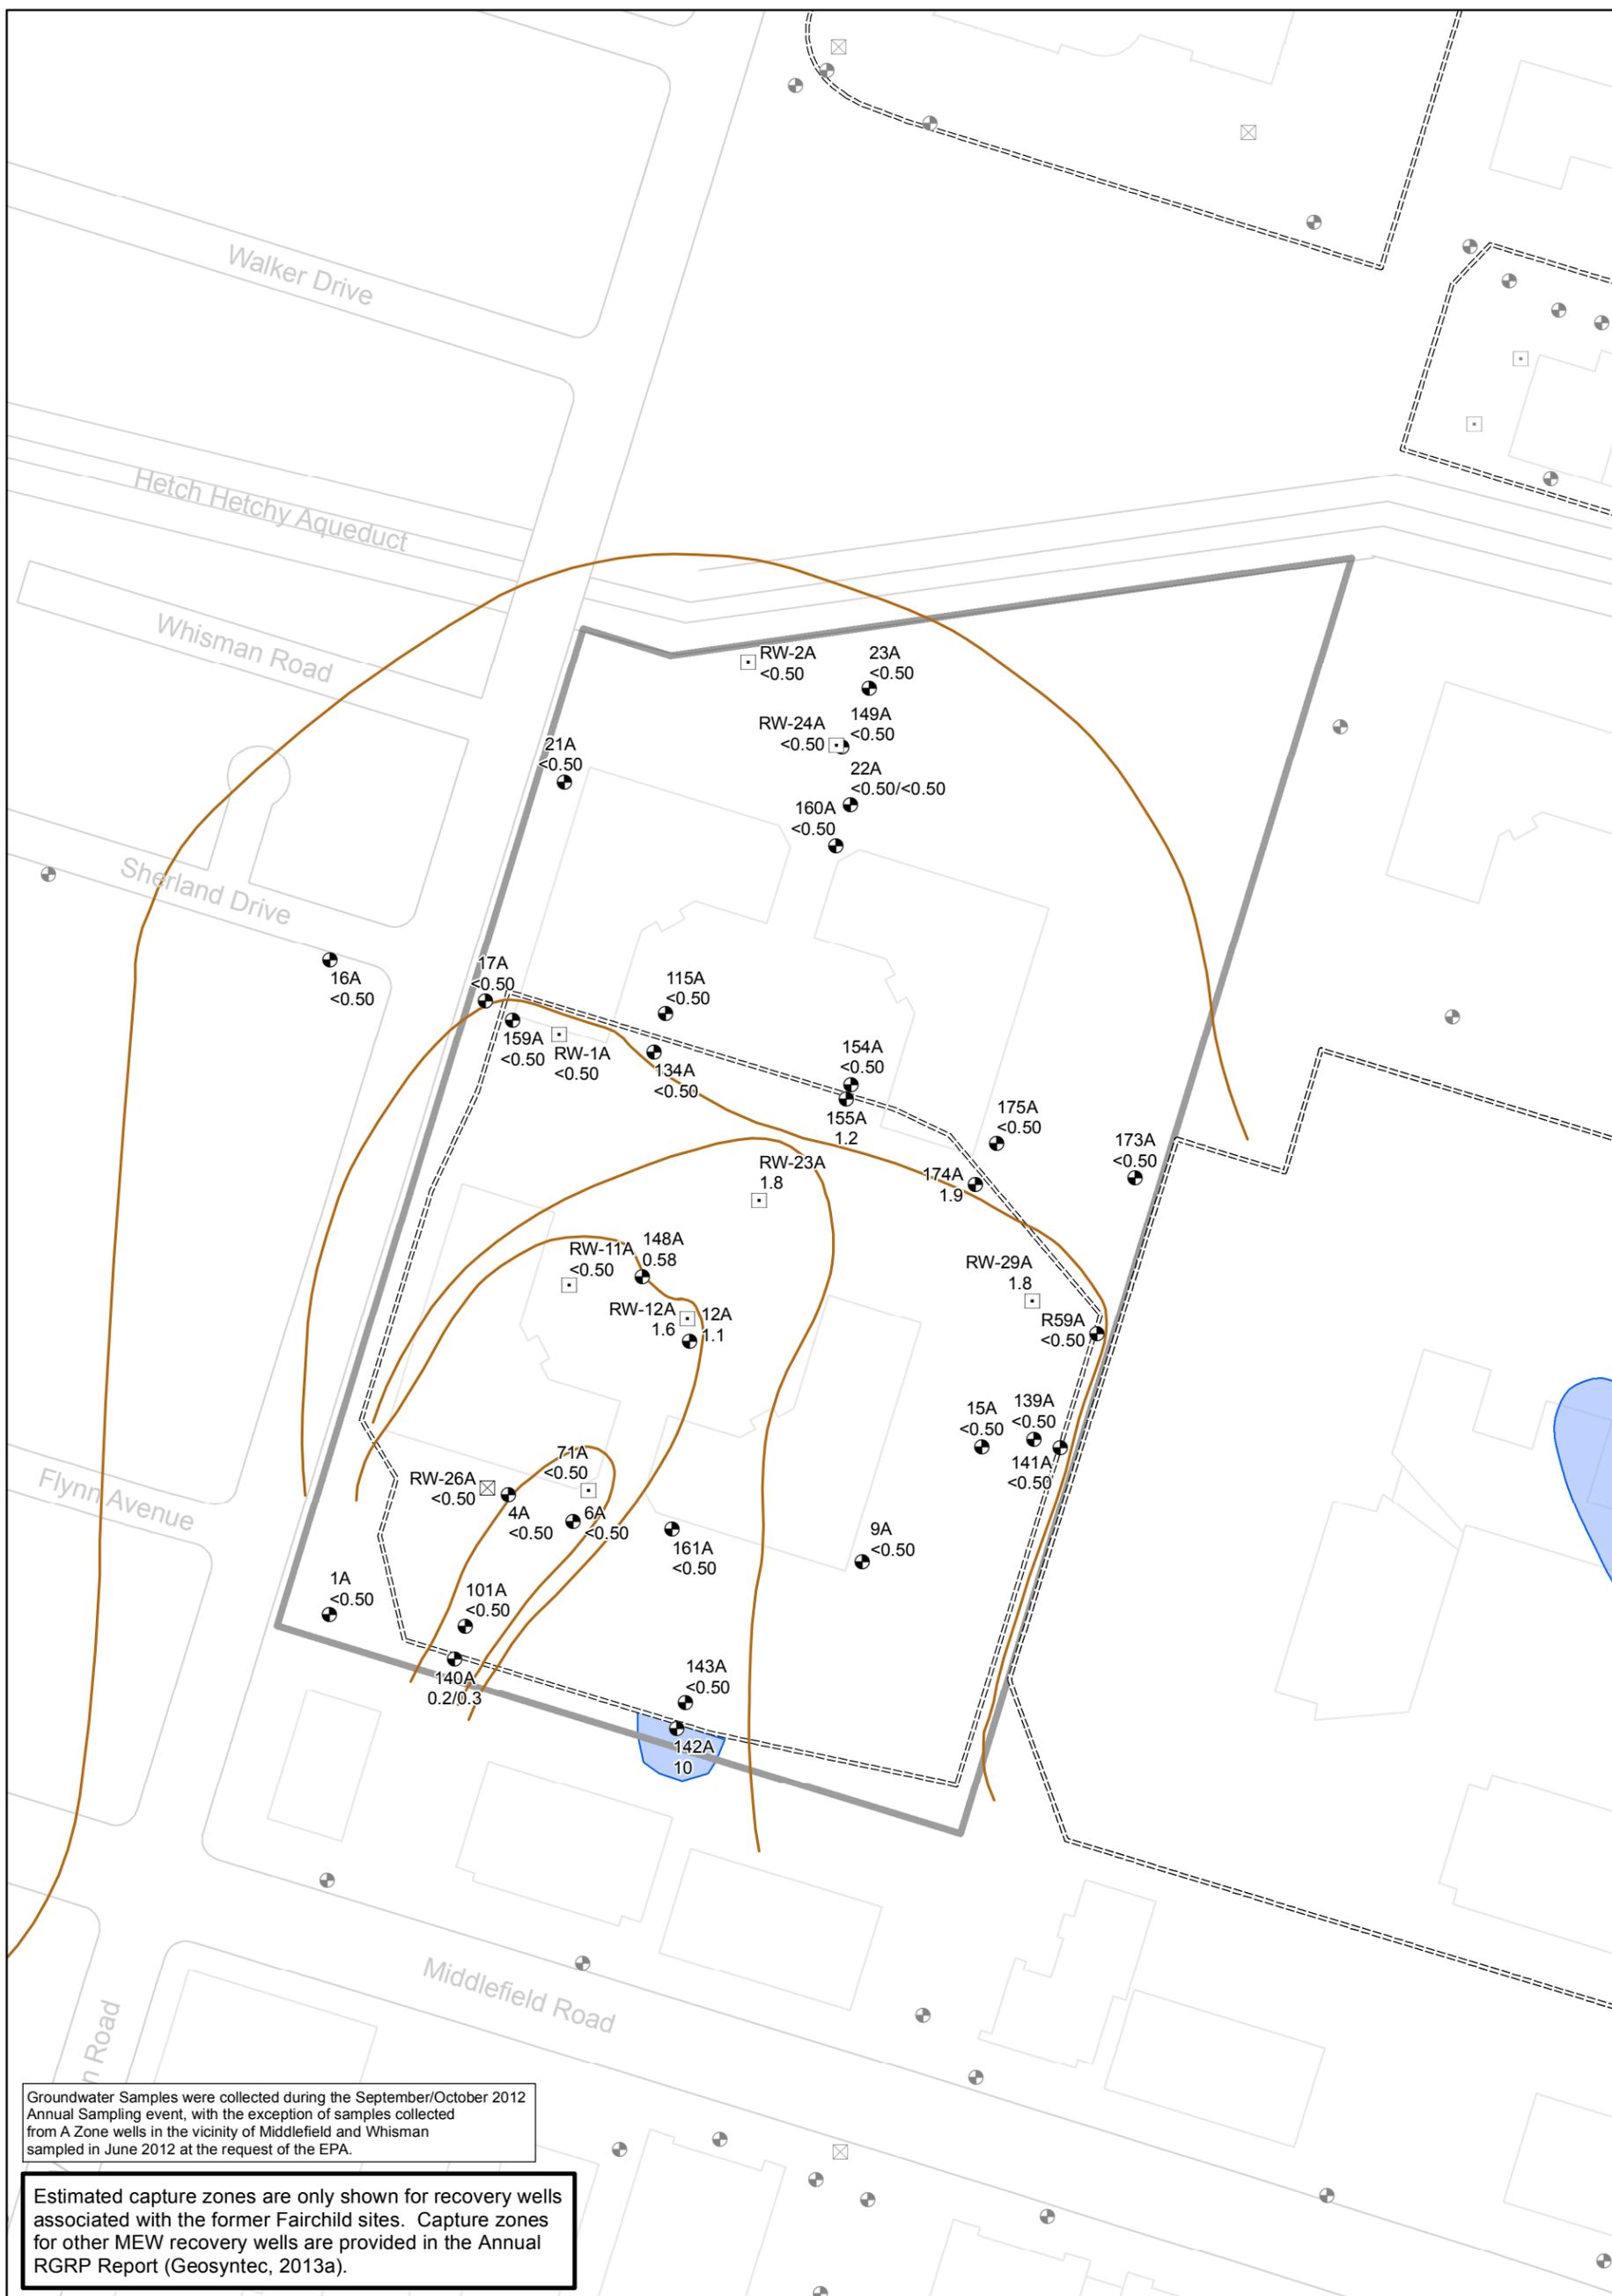
14

Groundwater Samples were collected during the September/October 2012 Annual Sampling event, with the exception of samples collected from A Zone wells in the vicinity of Middlefield and Whisman sampled in June 2012 at the request of the EPA.

Estimated capture zones are only shown for recovery wells associated with the former Fairchild sites. Capture zones for other MEW recovery wells are provided in the Annual RGRP Report (Geosyntec, 2013a).

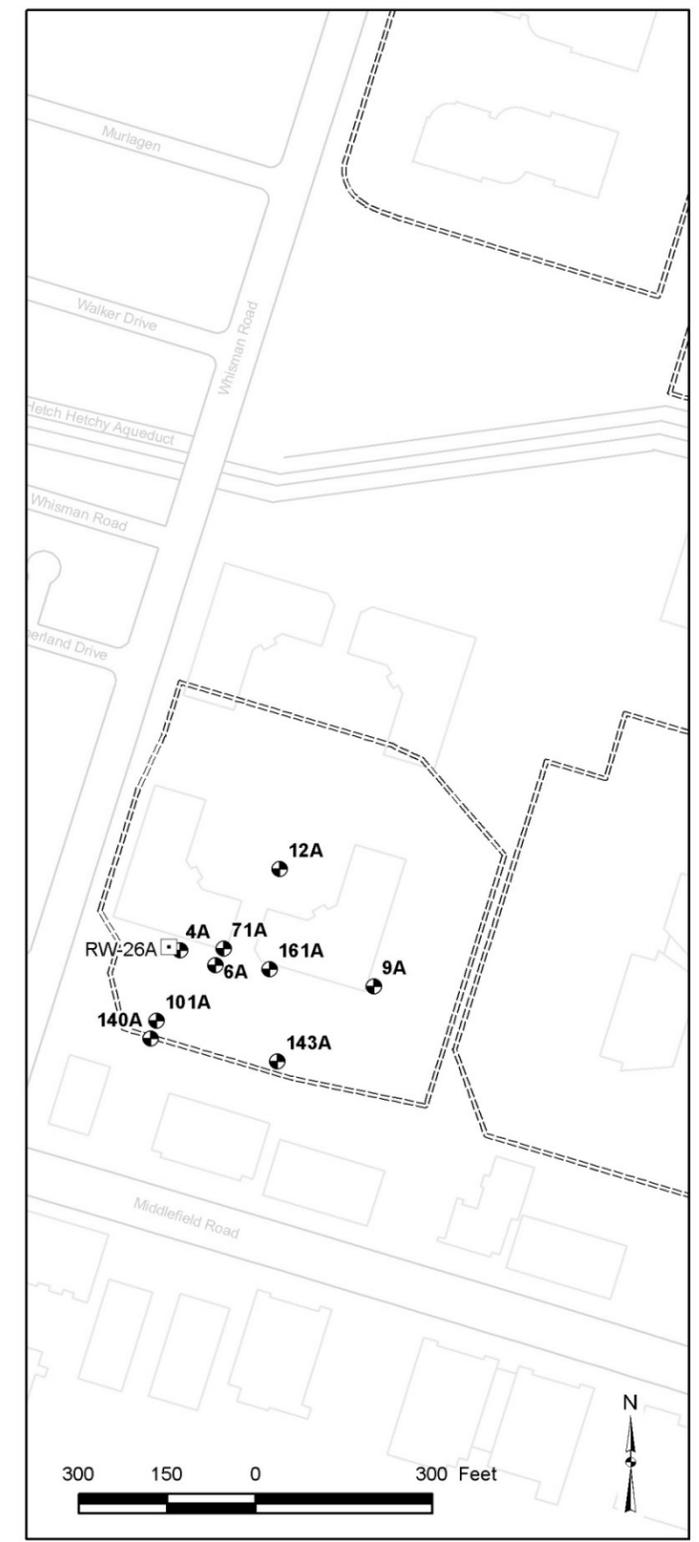
Note:
Open symbols are non-detects,
presented at limit of quantification
