**SUBAREA 3 FSP ADDENDUM**  
**SANTA SUSANA FIELD LABORATORY SITE**  
**AREA IV RADIOLOGICAL STUDY**

**TO:** Andrew Bain, EPA Region 9 RPM  
**FROM:** T. Stewart Williford, HGL Associate Manager  
**THROUGH:** L. Steven Vaughn, R.G., HGL Project Manager  
Rene R. Rodriguez, P.E., HGL Deputy Project Manager  
**CC:** Mary Aycock, EPA Region 9 RPM  
Gregg Dempsey, Technical Advisor  
**DATE:** September 13, 2011  
**SUBJECT:** FSP Addendum for Subarea 3  
**CONTRACT NO:** EP-S7-05-05  
**TASK ORDER NO:** 0038

**Figure 1**  
**Subarea 3 Sample Locations**  
**Santa Susana Field Laboratory**

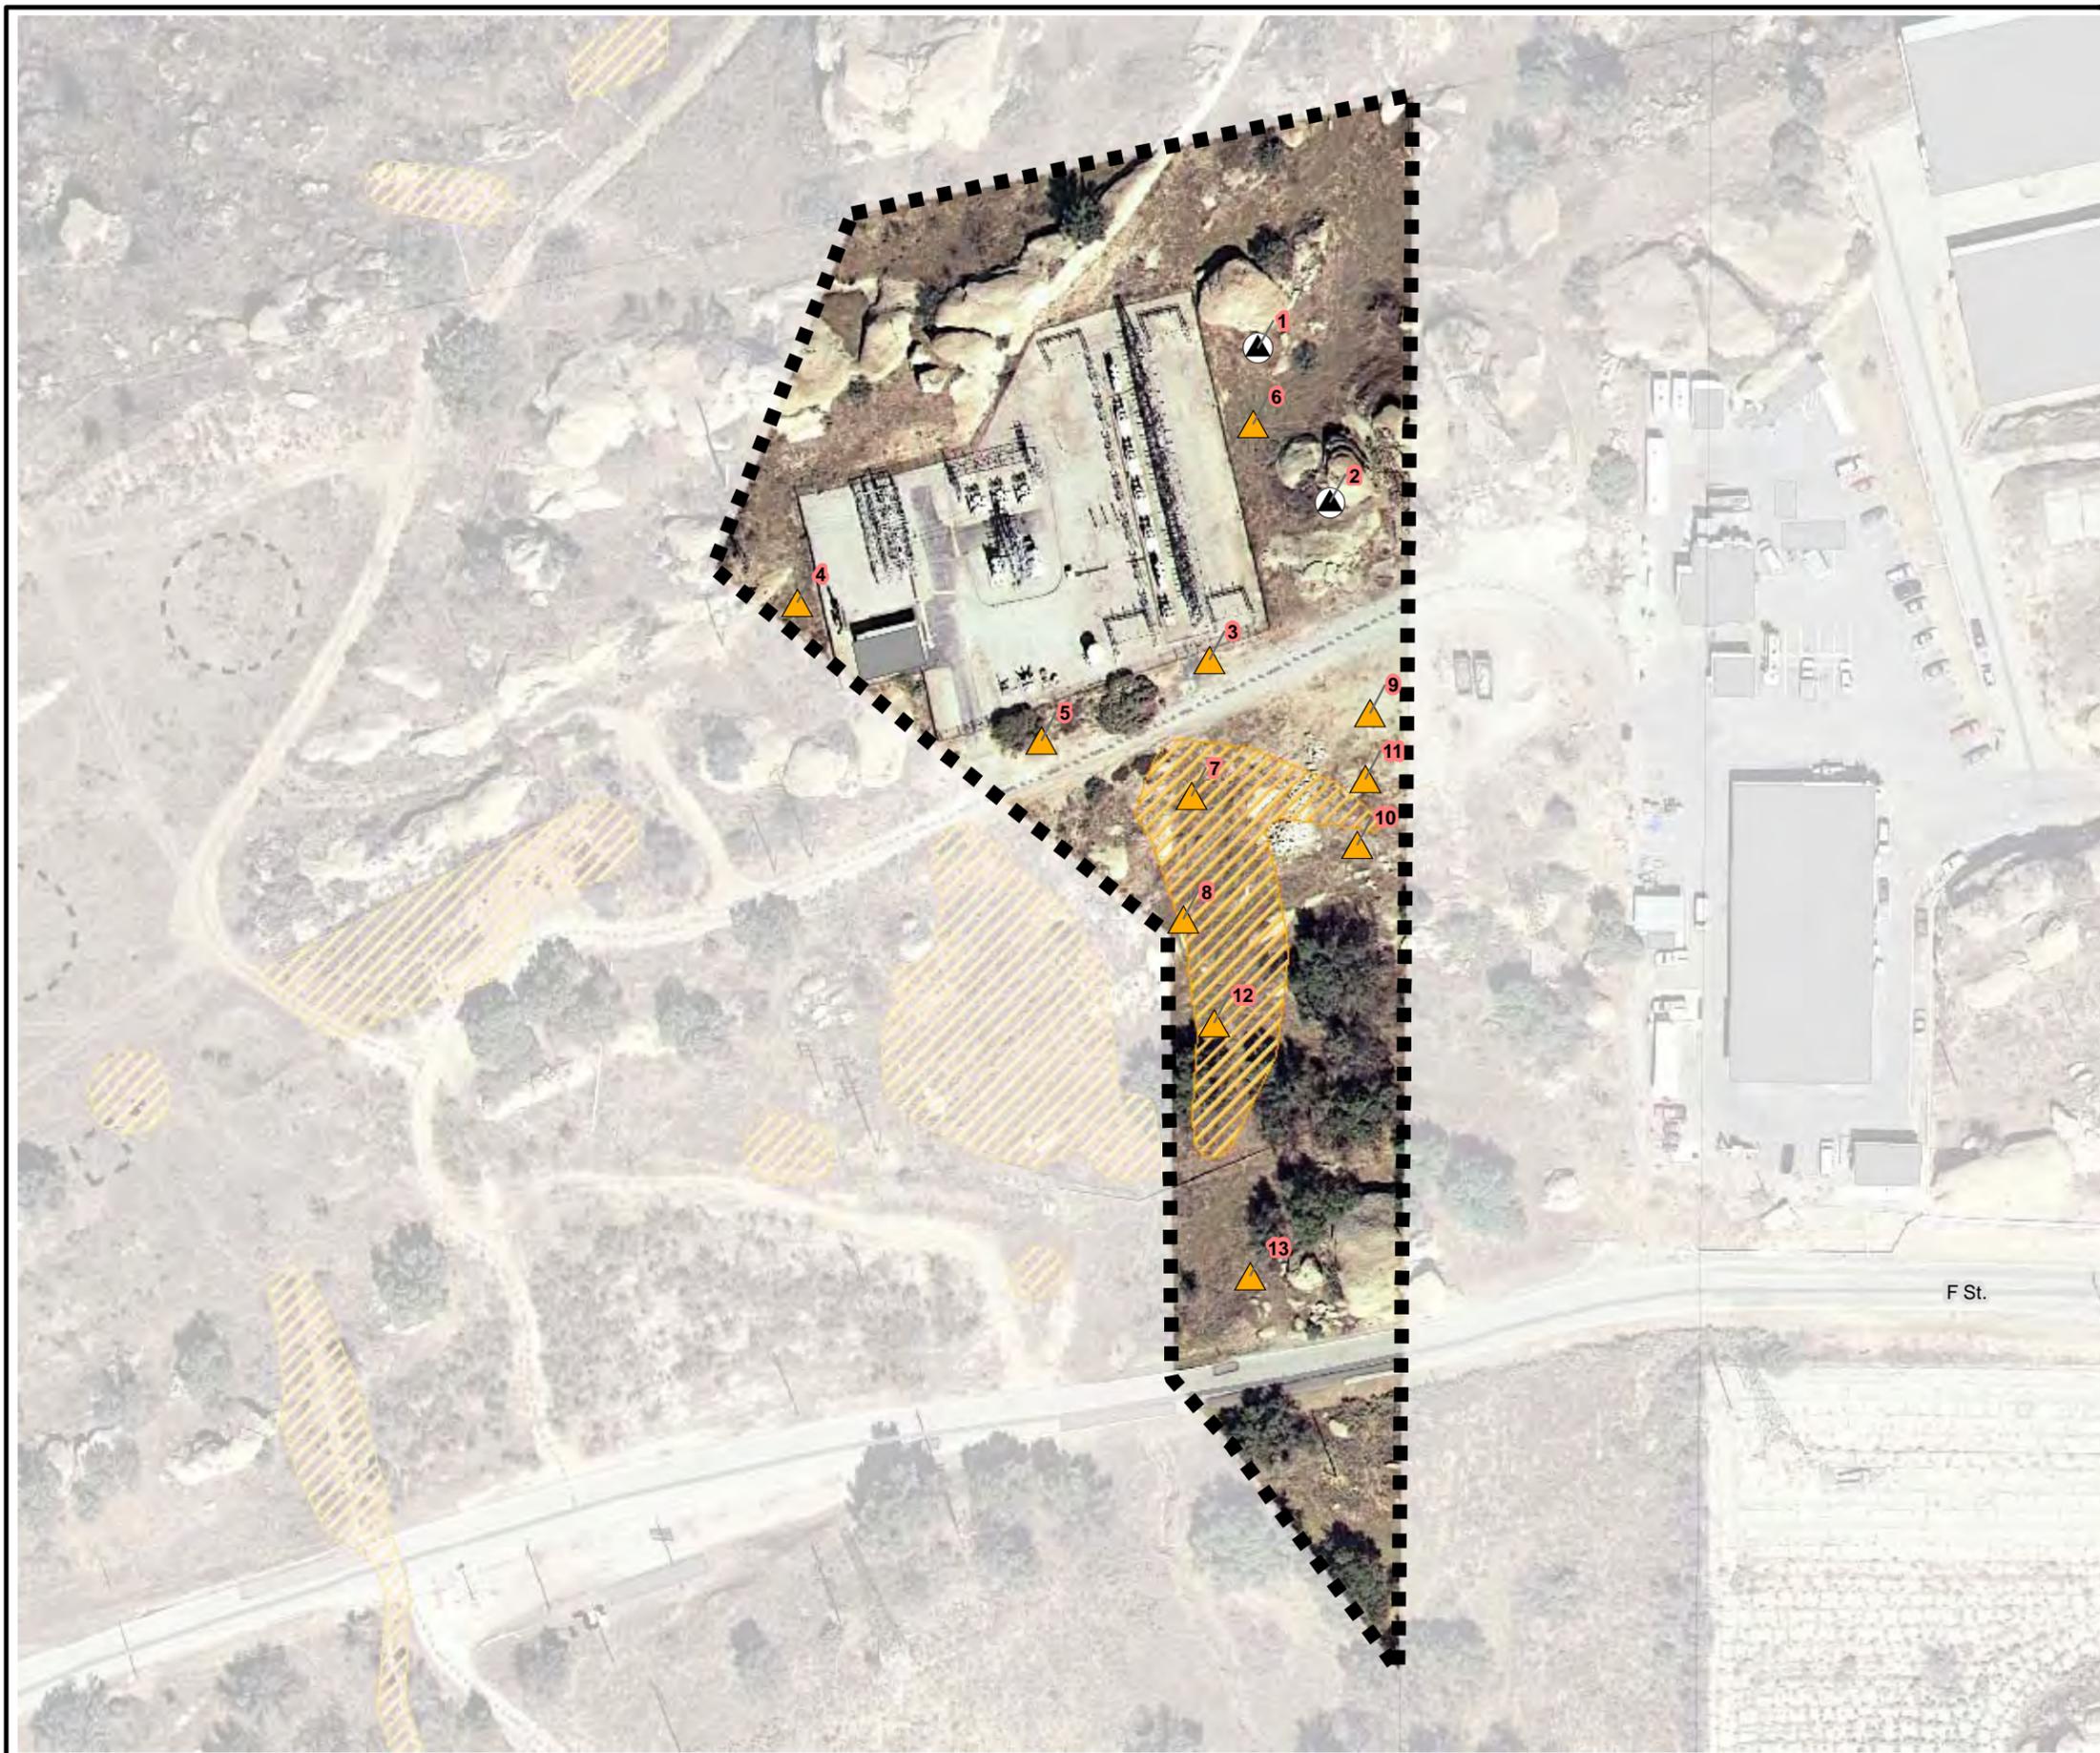
Figure 1 Subarea 3 Sample Locations

Figure 1 provides a map that shows the location and type (e.g. surface, subsurface, drainage) of each sample within Subarea 3 (Attachment 2). Table 2 below, provides a summary of sample numbers by sample type.

Table 1 in Attachment 1 provides the location for each soil sample that will be collected in Subarea 3 during Round 1 of the soil sampling investigation as well as the technical justification and rationale for the selection of each sample location. Also summarized in this table is the suite of radiological analyses that will be performed on every sample, as well as other field-pertinent information including sample identification number, type, and general proximity to radiological facilities.

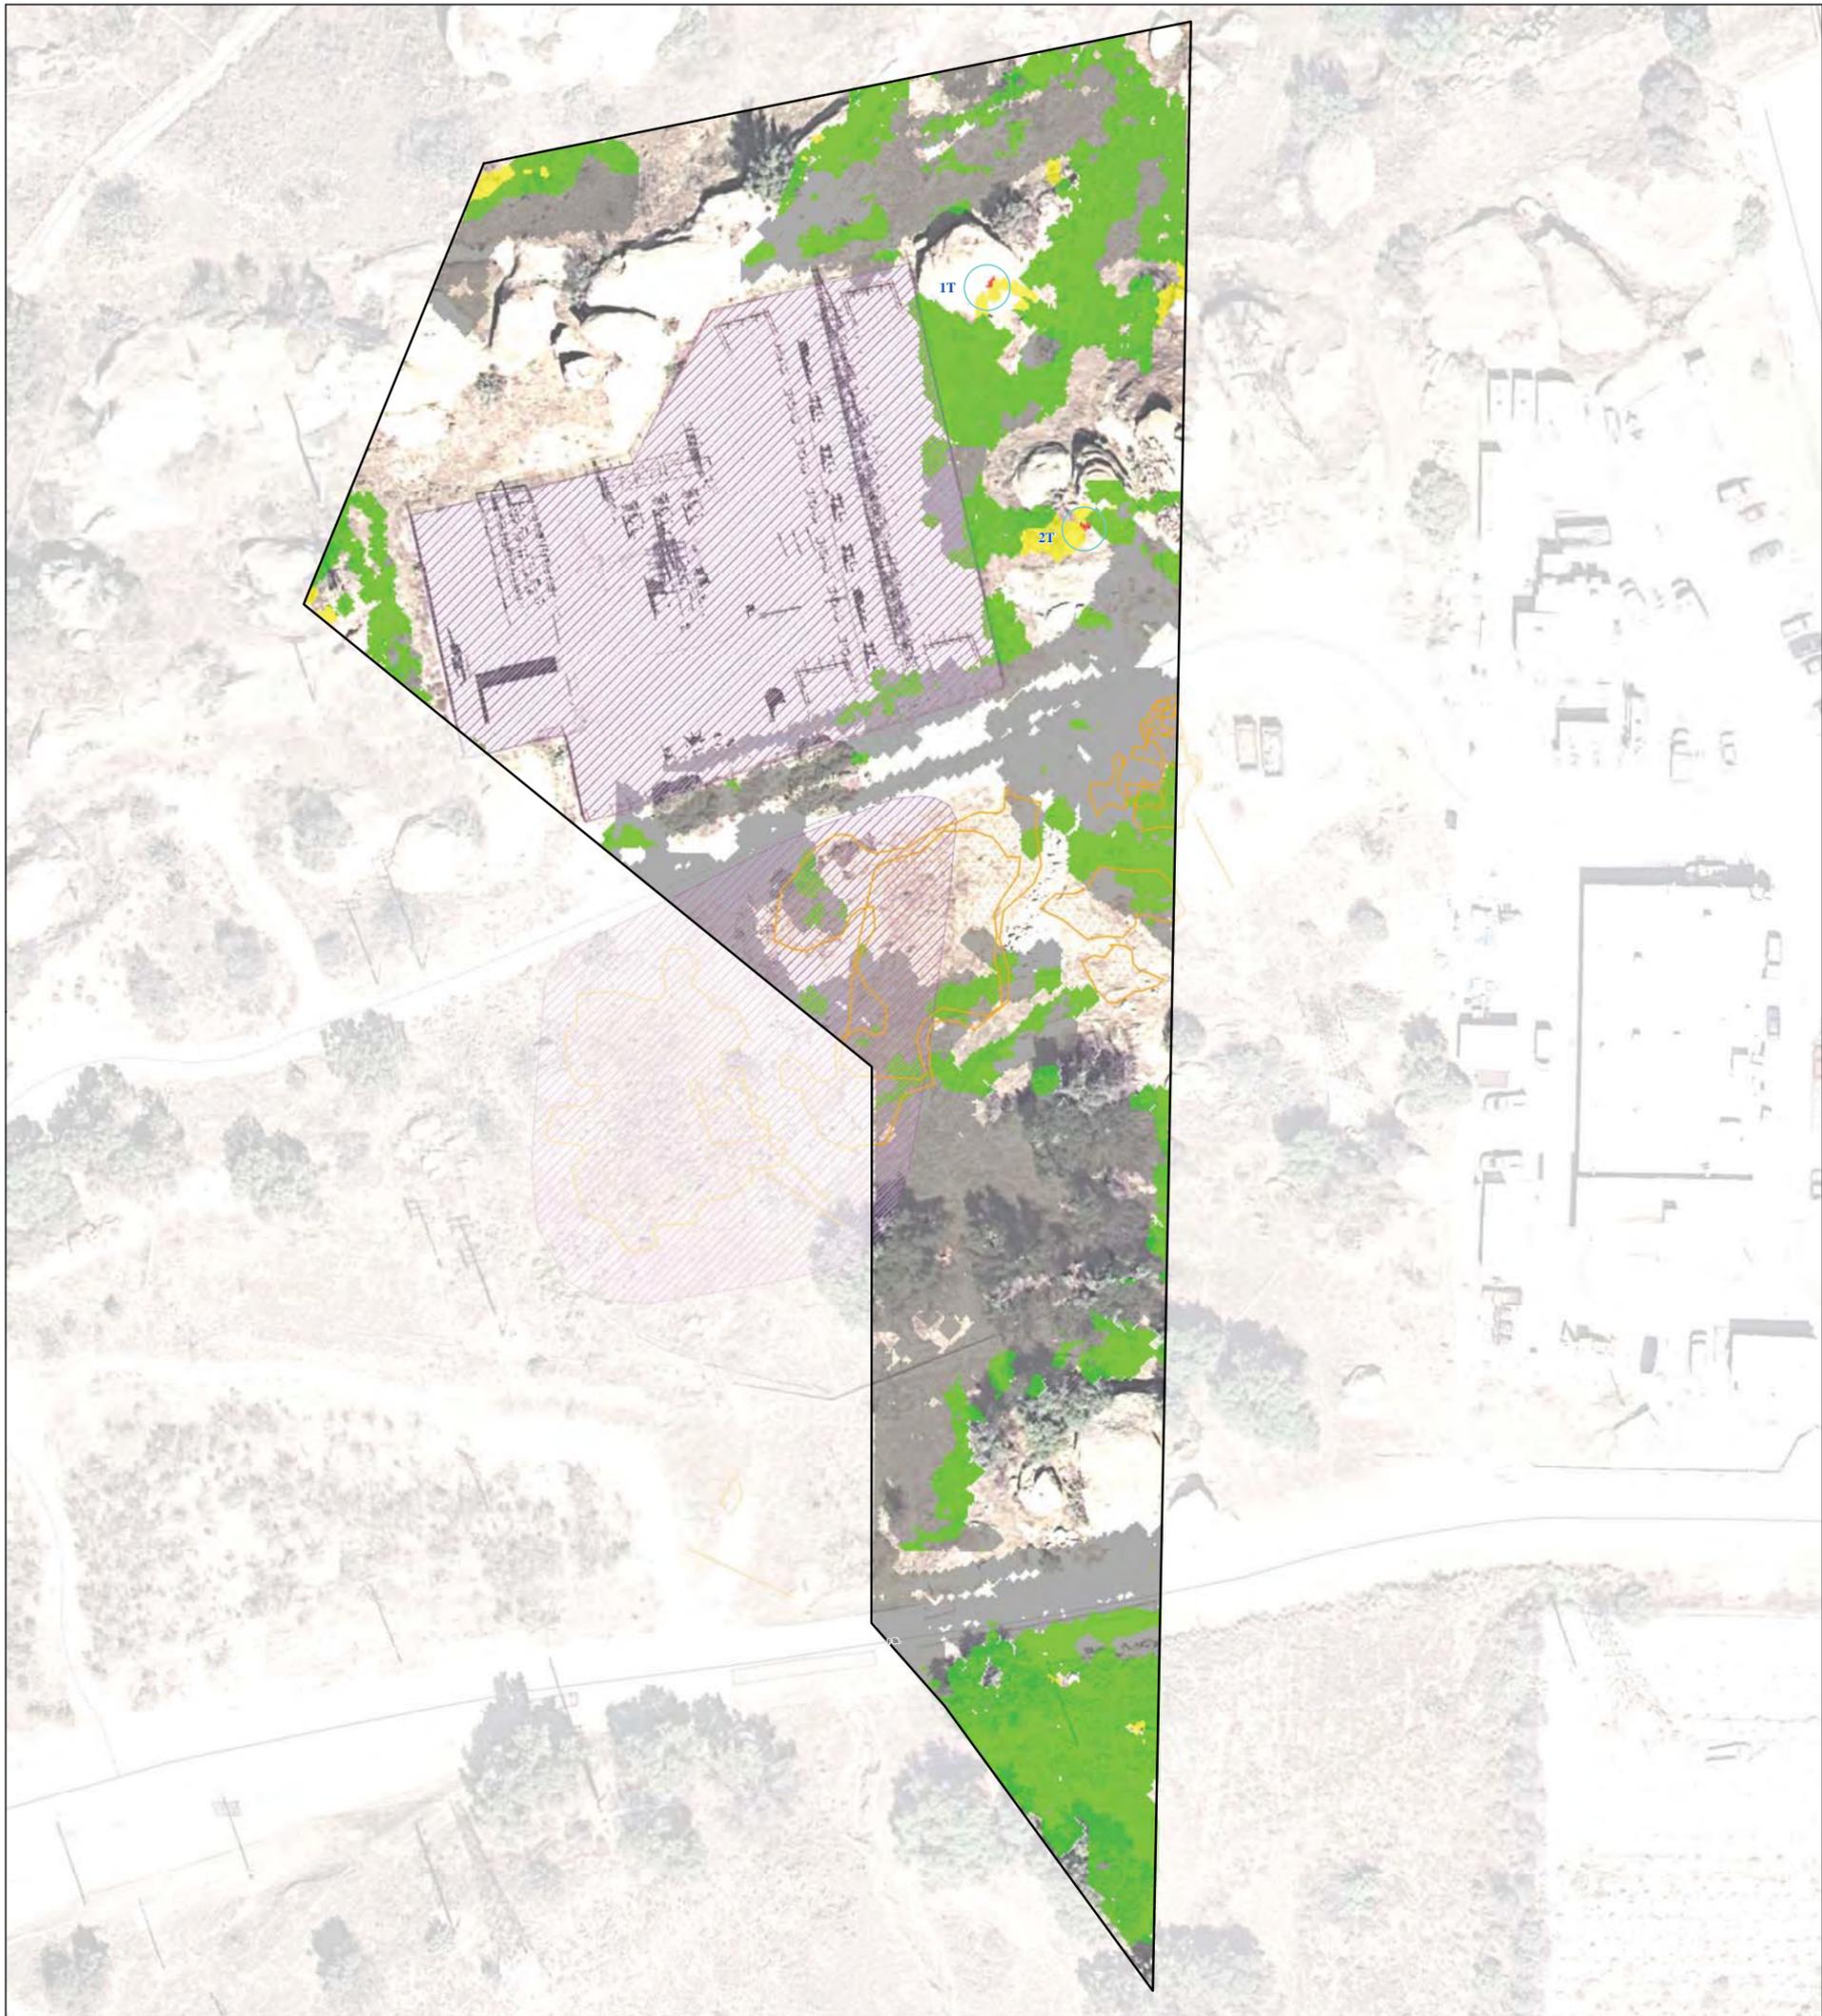
**Gamma Anomalies  
Static Count  
Subarea 3  
Santa Susana Field Laboratory**

Gamma Anomalies Static Count Subarea 3  
Geophysical Anomalies Subarea 3  
Plate 1 Subarea HSA-3

Attachment 3 provides key technical information that led to the selection of sample locations, sample interval selection, and the laboratory analysis that will be performed for each sample collected. The key information includes results of geophysical surveys, gamma surface radiation surveys and the findings summarized in the Technical Memorandum Subarea HSA-7, Subarea HSA-3, Subarea HSA-Northern Buffer Zone Historical Site Assessment (HGL, 2011). No results of past soil radiological investigations were found for Subarea 3, and therefore no past radiological soil sampling map has been included in Attachment 3.

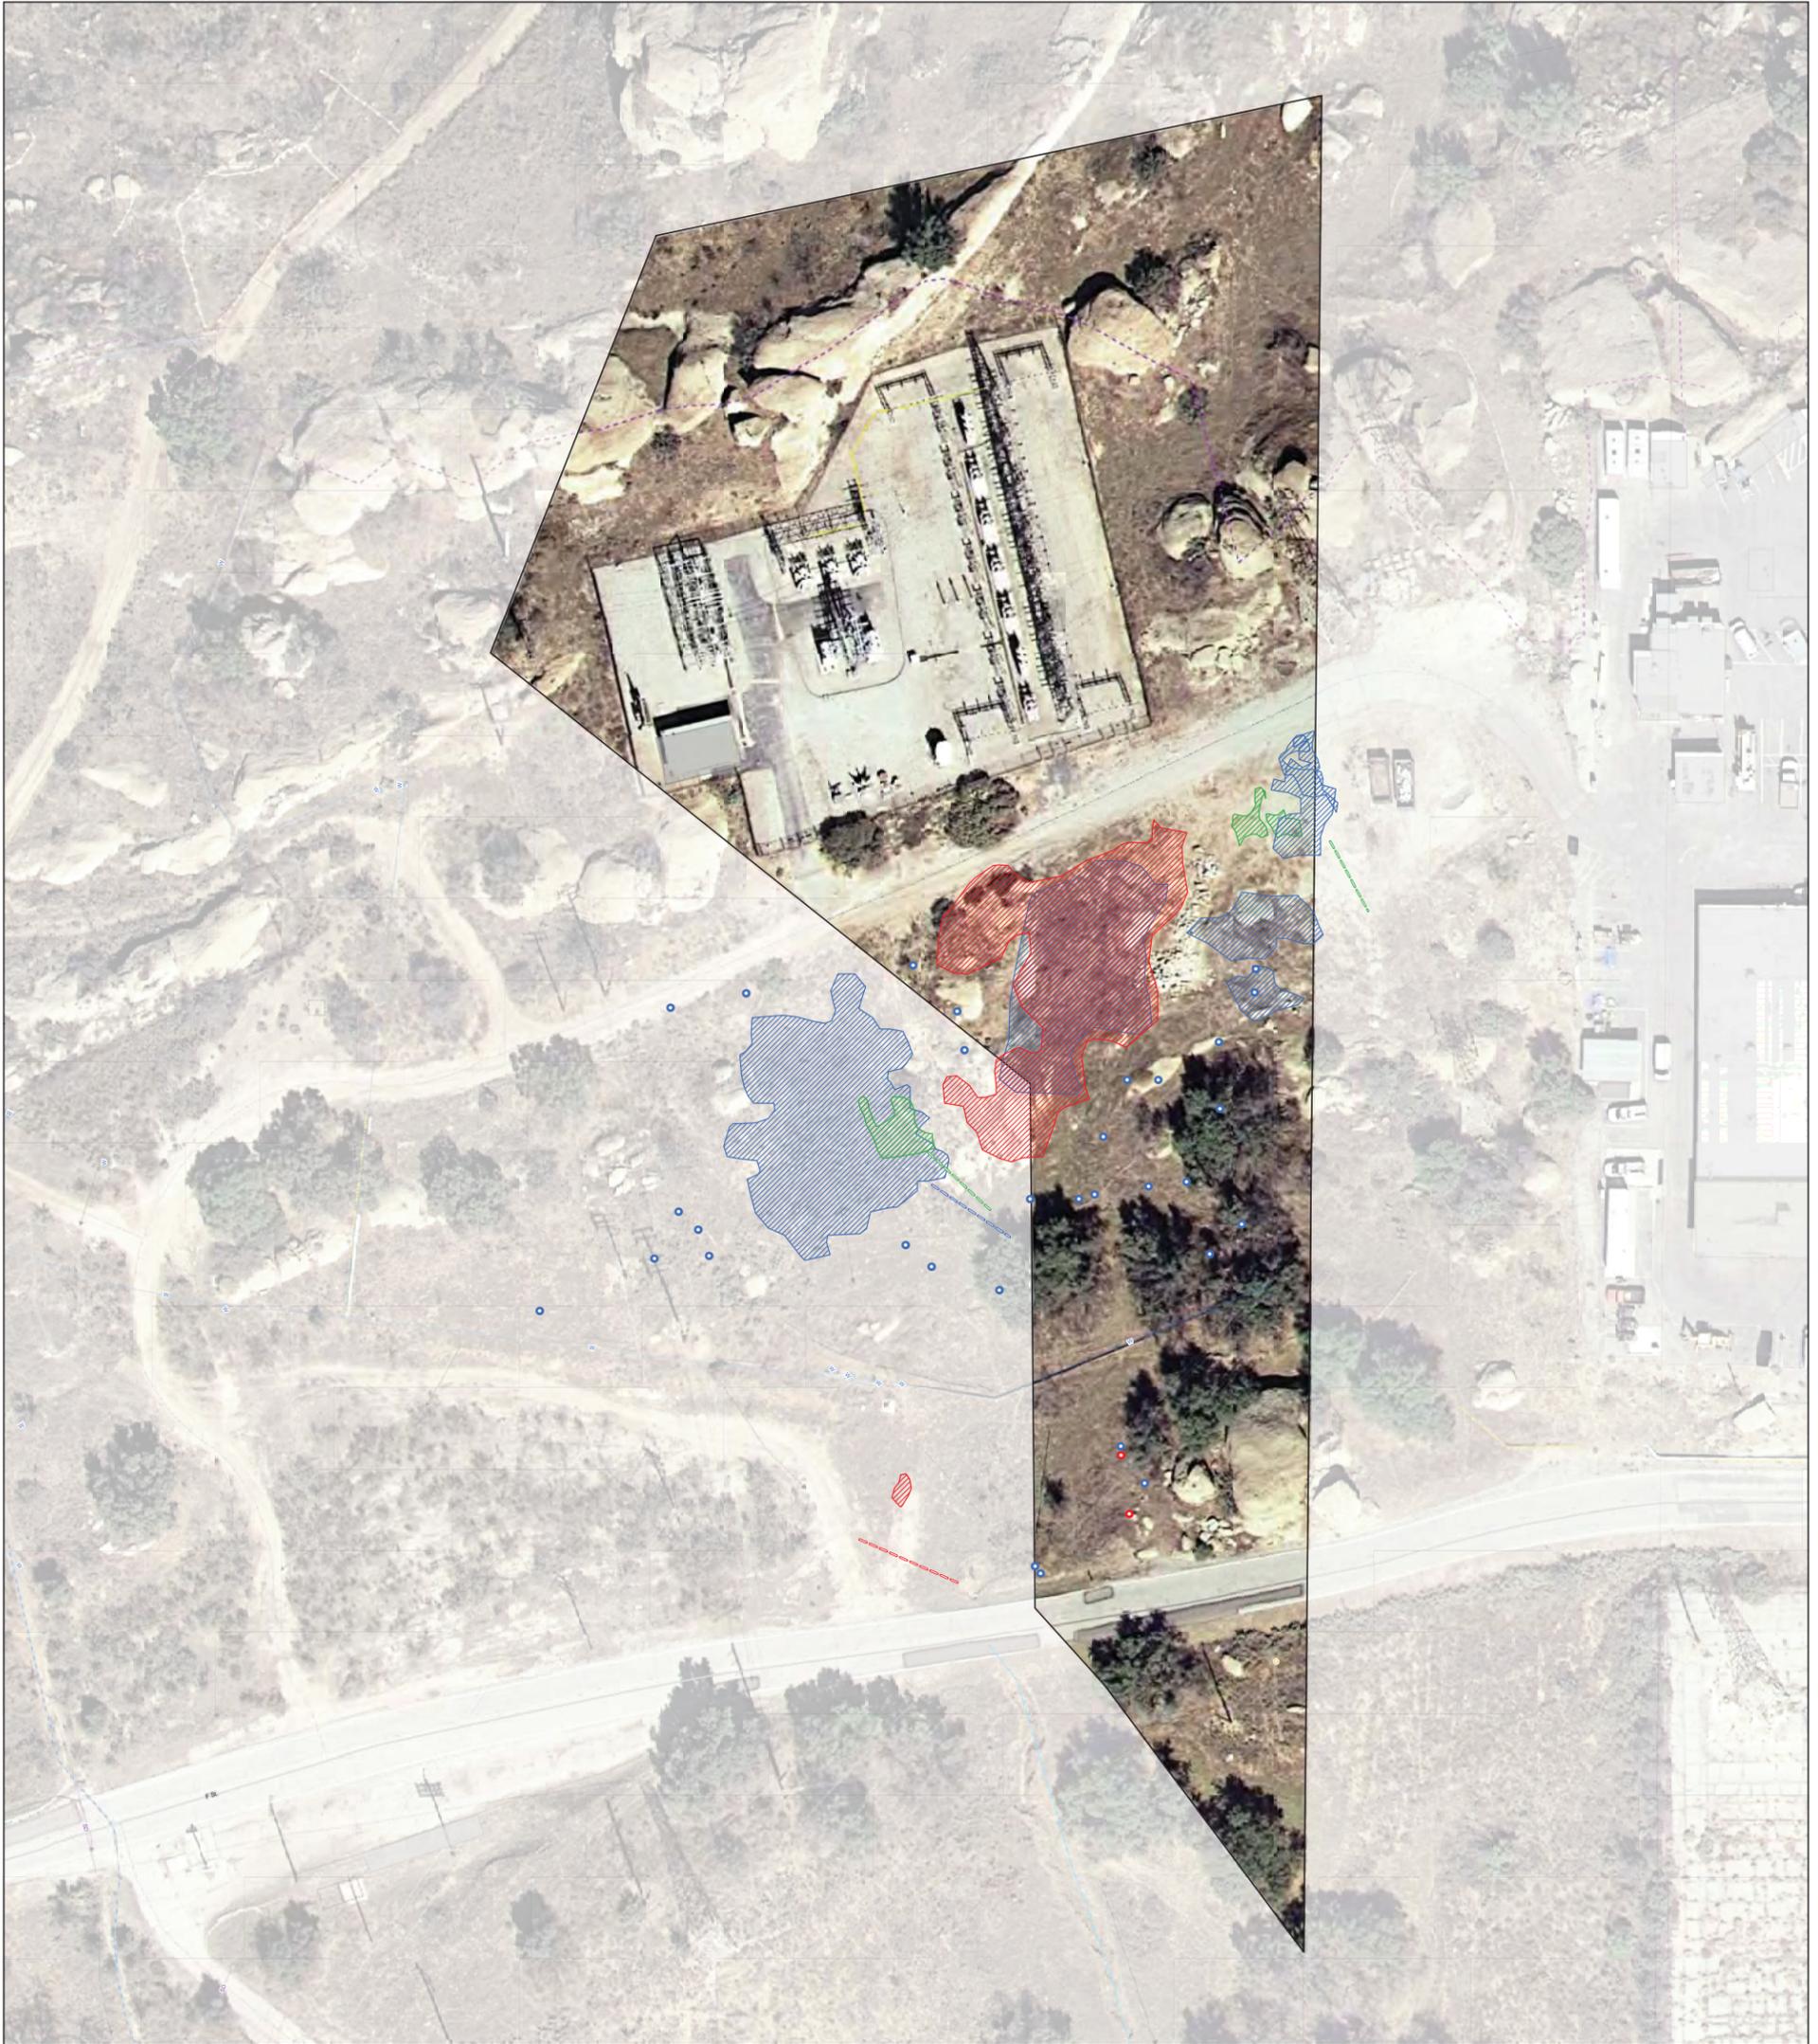
**Geophysical Anomalies  
 Subarea 3  
 Santa Susana Field Laboratory**

Magnetometer Anomaly Area

- Terrain Conductivity
- Magnetometer
- Ground Penetrating Radar
- Cut and Fill Boundaries
- Magnetometer Anomaly Linear
- Terrain Conductivity Anomaly Linear
- Ground Penetrating Radar
- Interpreted Drain Remnant
- Buried Metals

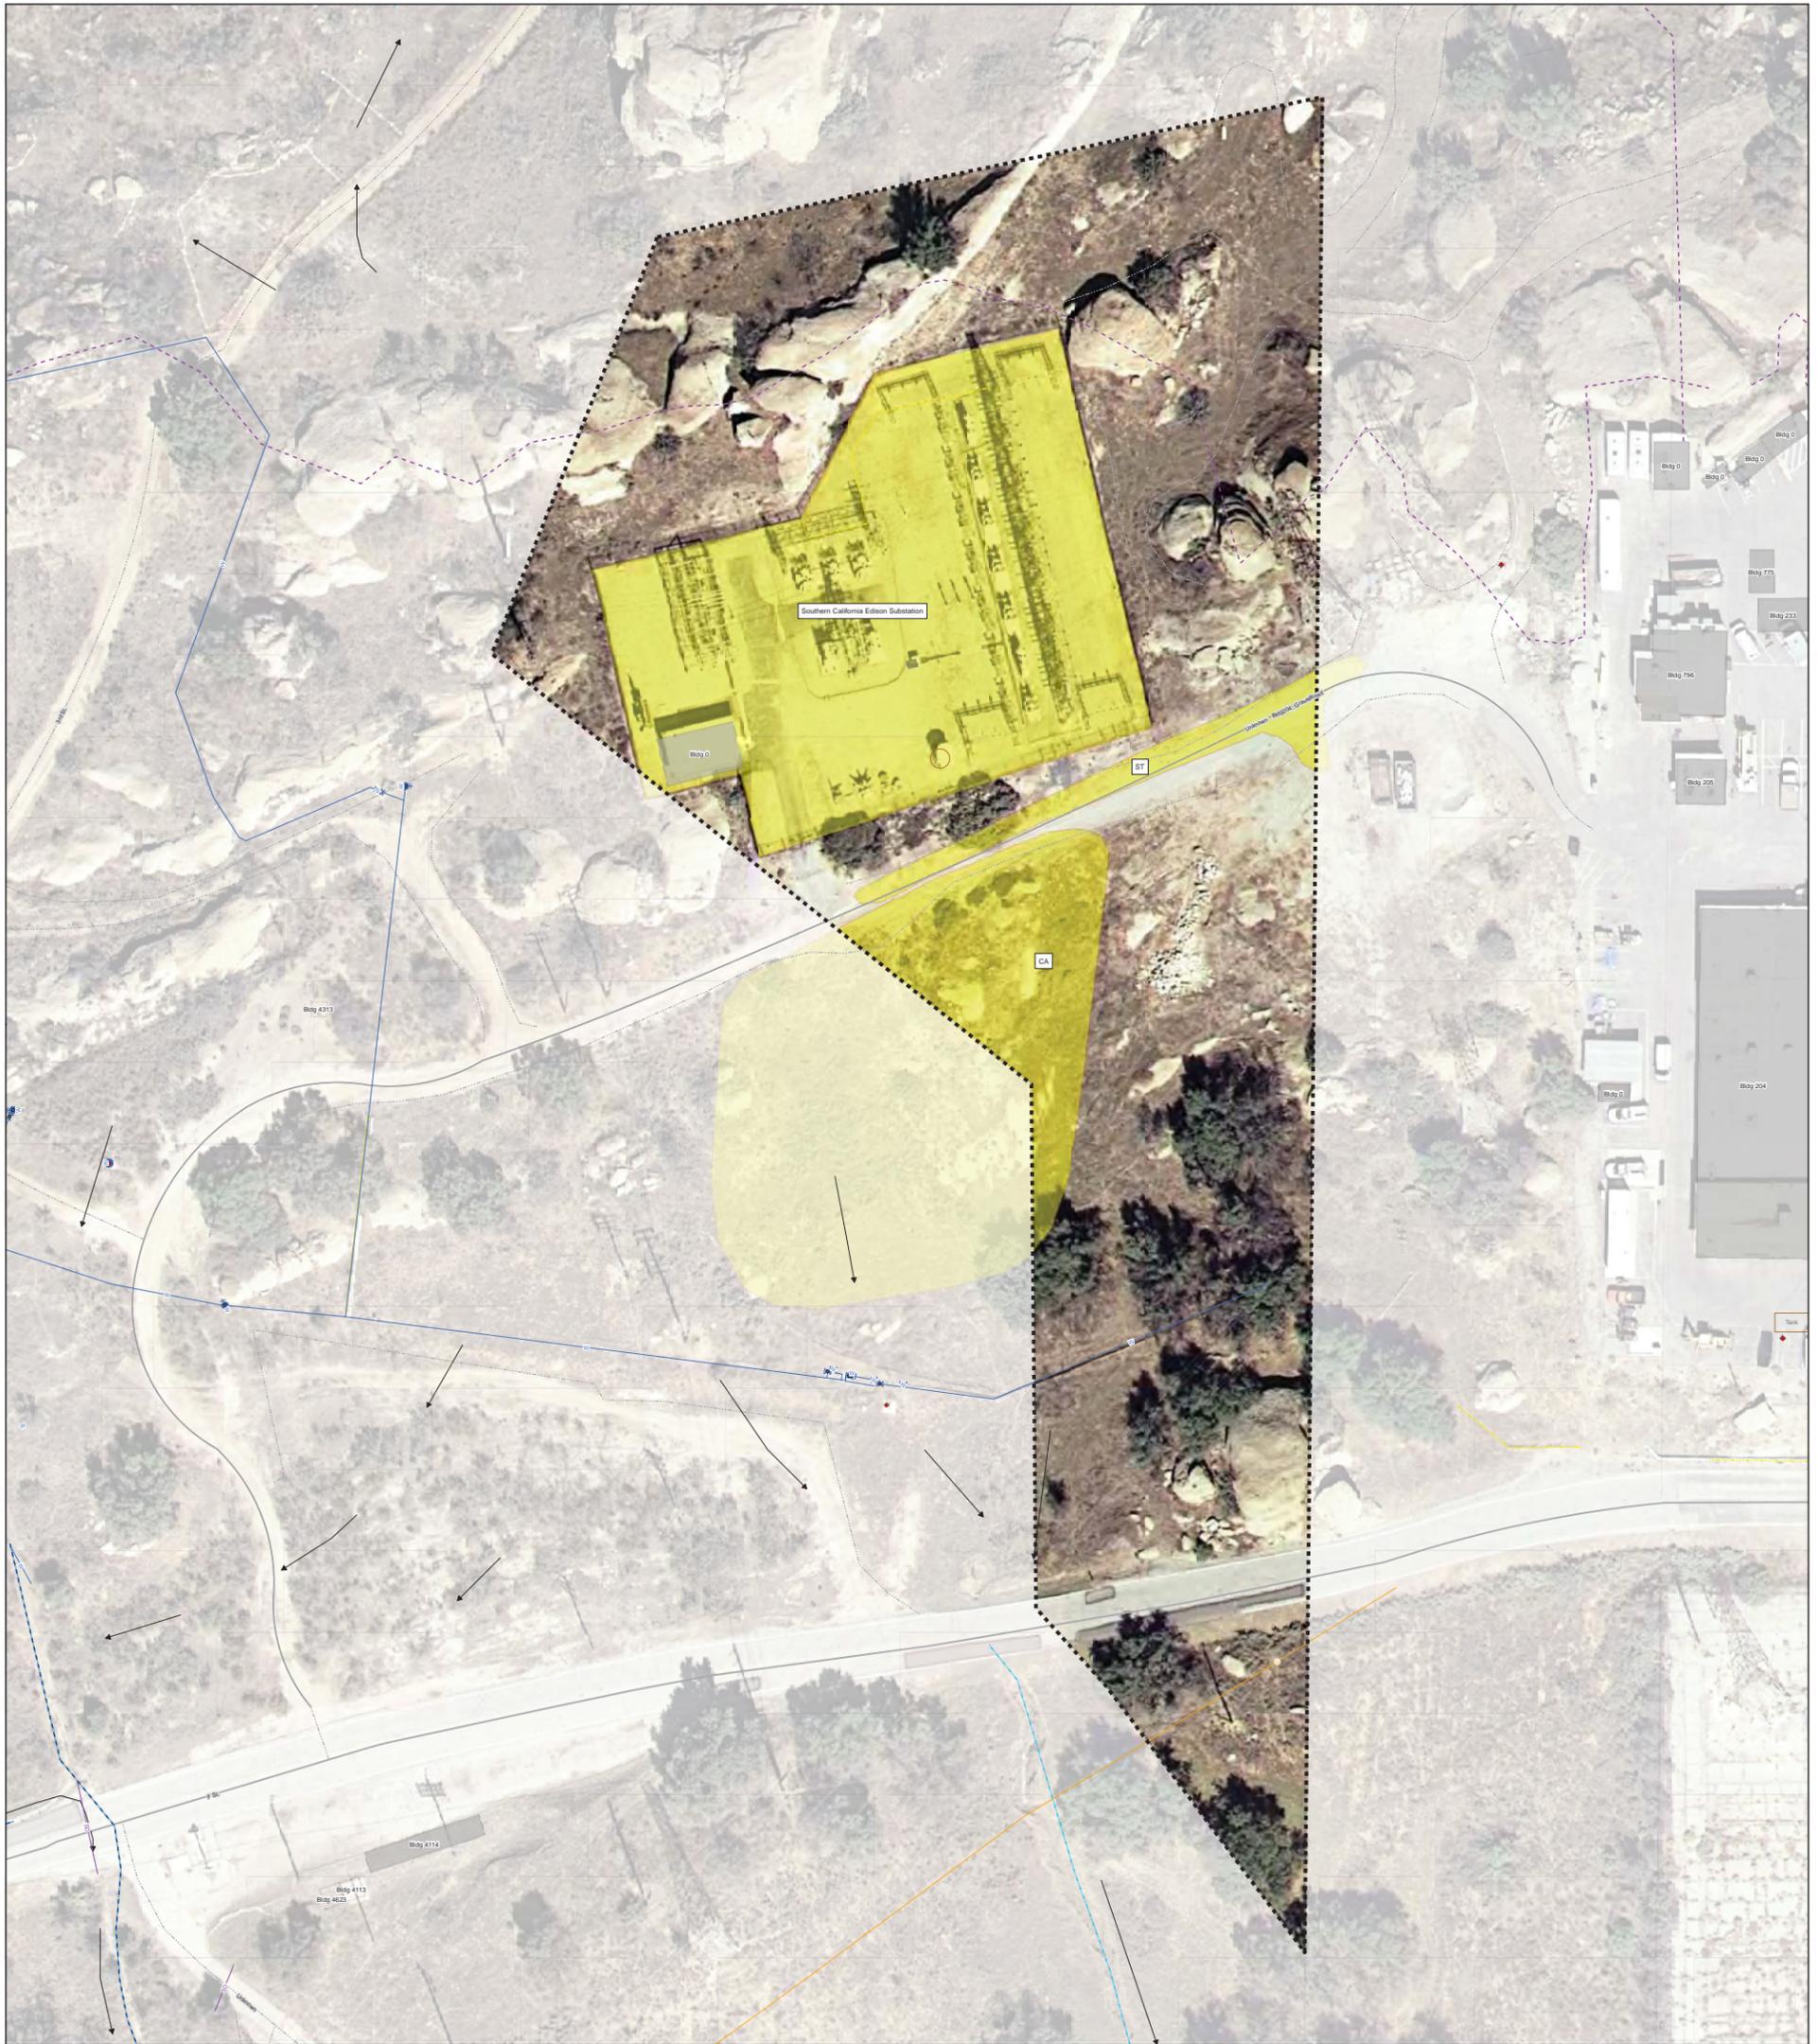
## Plate 1 Subarea HSA-3 Santa Susana Field Laboratory

Historical Site Assessment  
Draft Technical Memorandum - HSA-3
