## **2009 ANNUAL PROGRESS REPORT**

**Former Fairchild Buildings 13, 19 and 23  
369/441 North Whisman Road  
Middlefield-Ellis-Whisman Study Area  
Mountain View, California**

June 15, 2010

**Weiss Associates**  
350 E. Middlefield Road  
Mountain View, California 94043

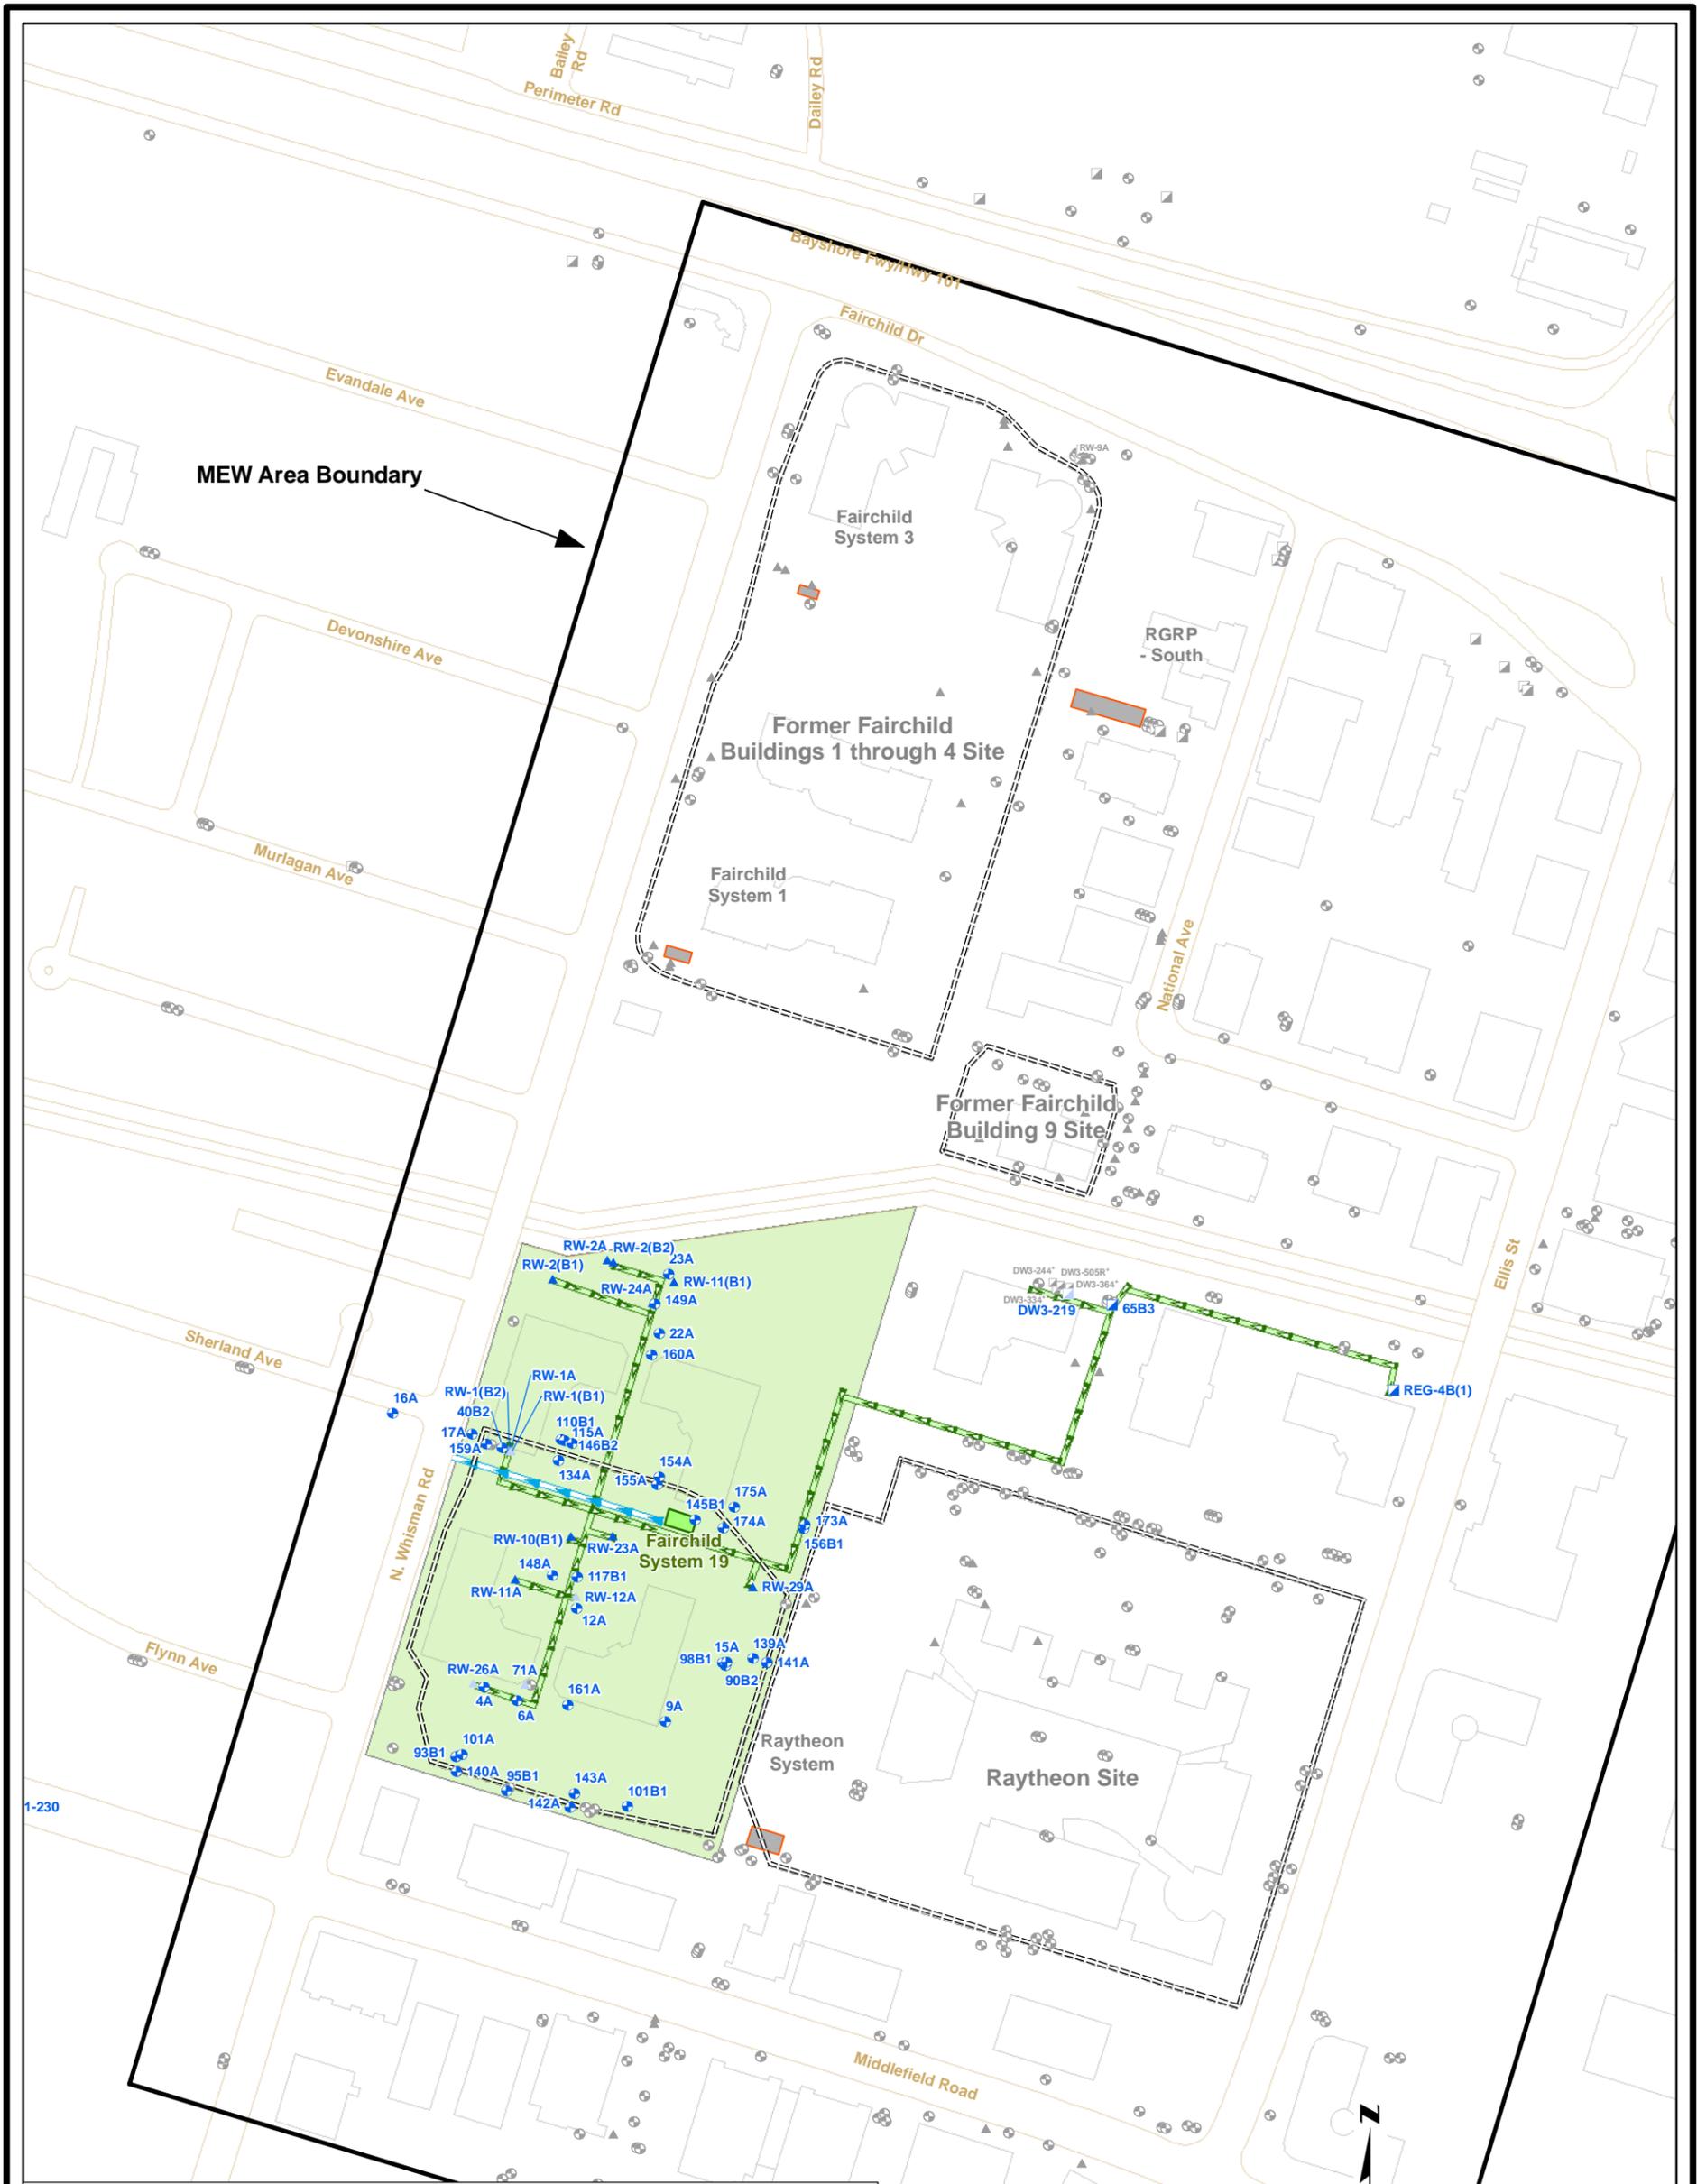
**Buildings 19, 13, and 23 Remedy Components**

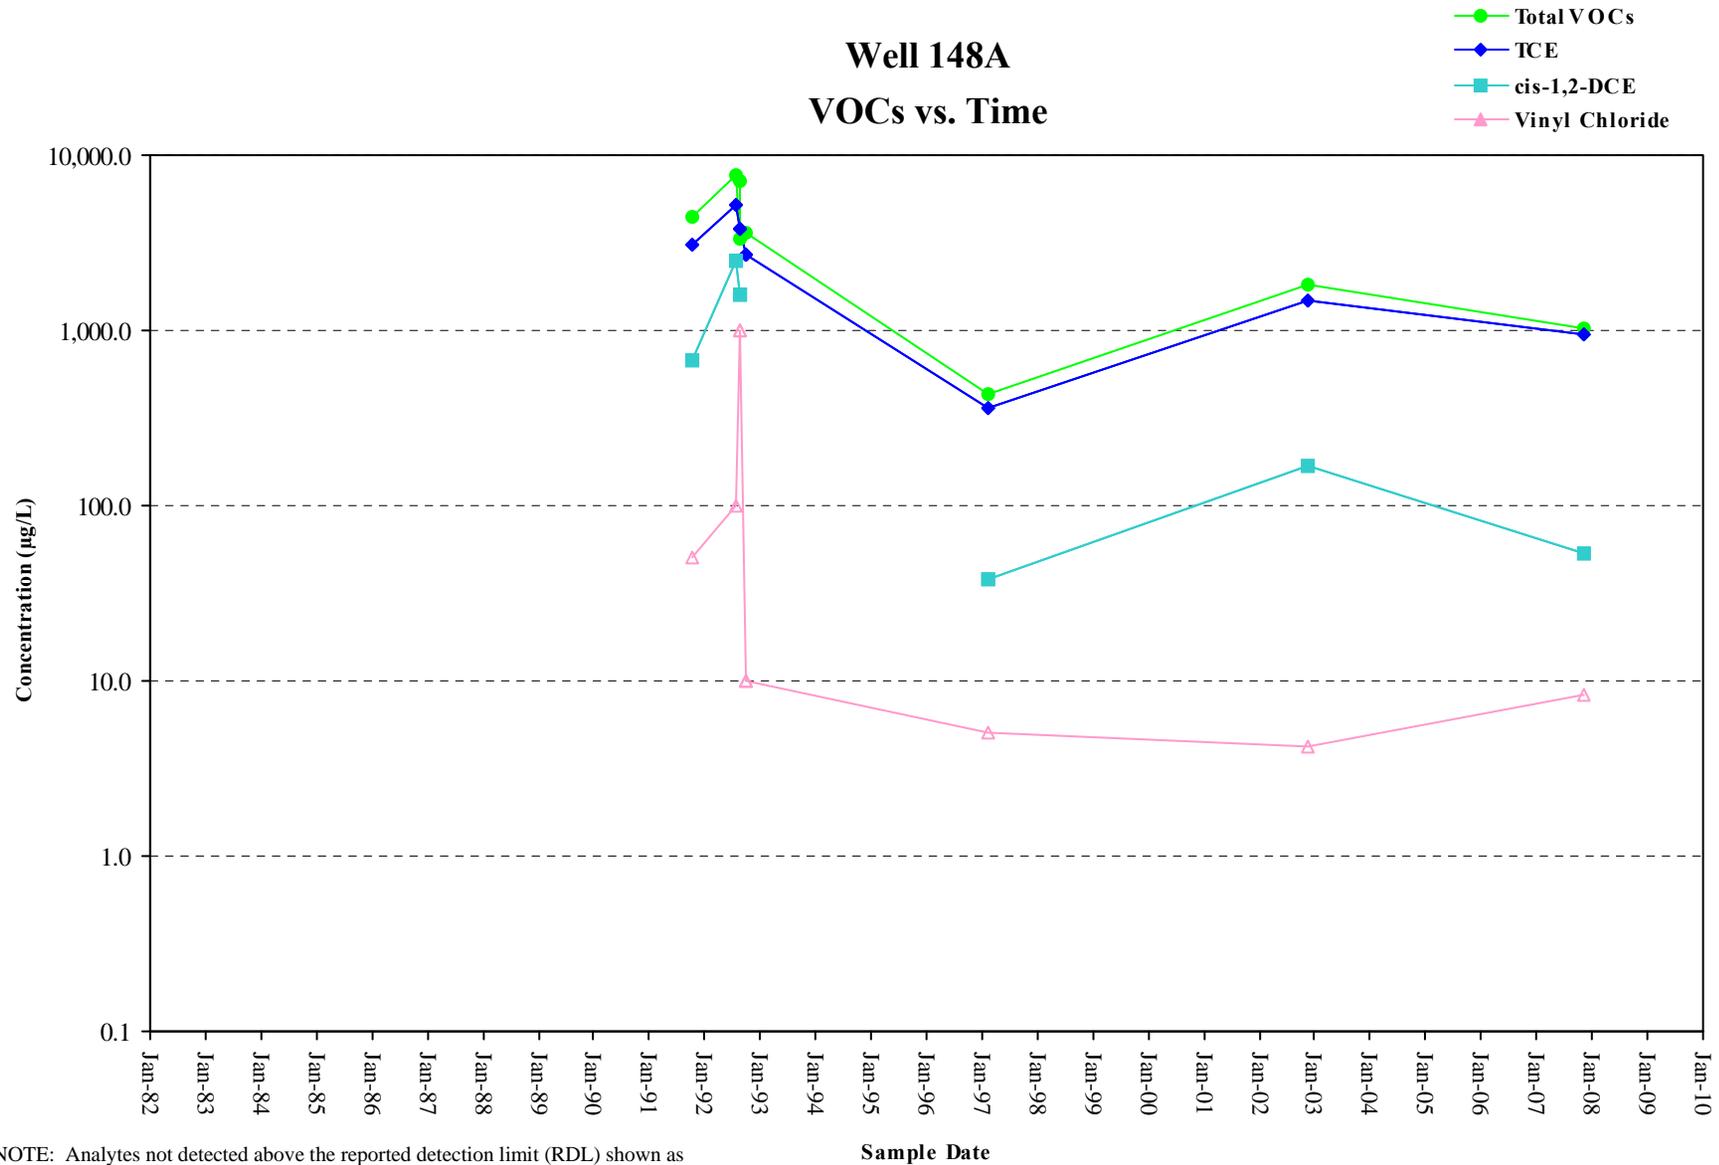
### Well 148A VOCs vs. Time

NOTE: Analytes not detected above the reported detection limit (RDL) shown as open chart symbols at the RDL.

Abbreviations: VOC = volatile organic compounds, TCE = trichloroethylene,  
DCE = dichloroethylene, µg/L = micrograms per liter

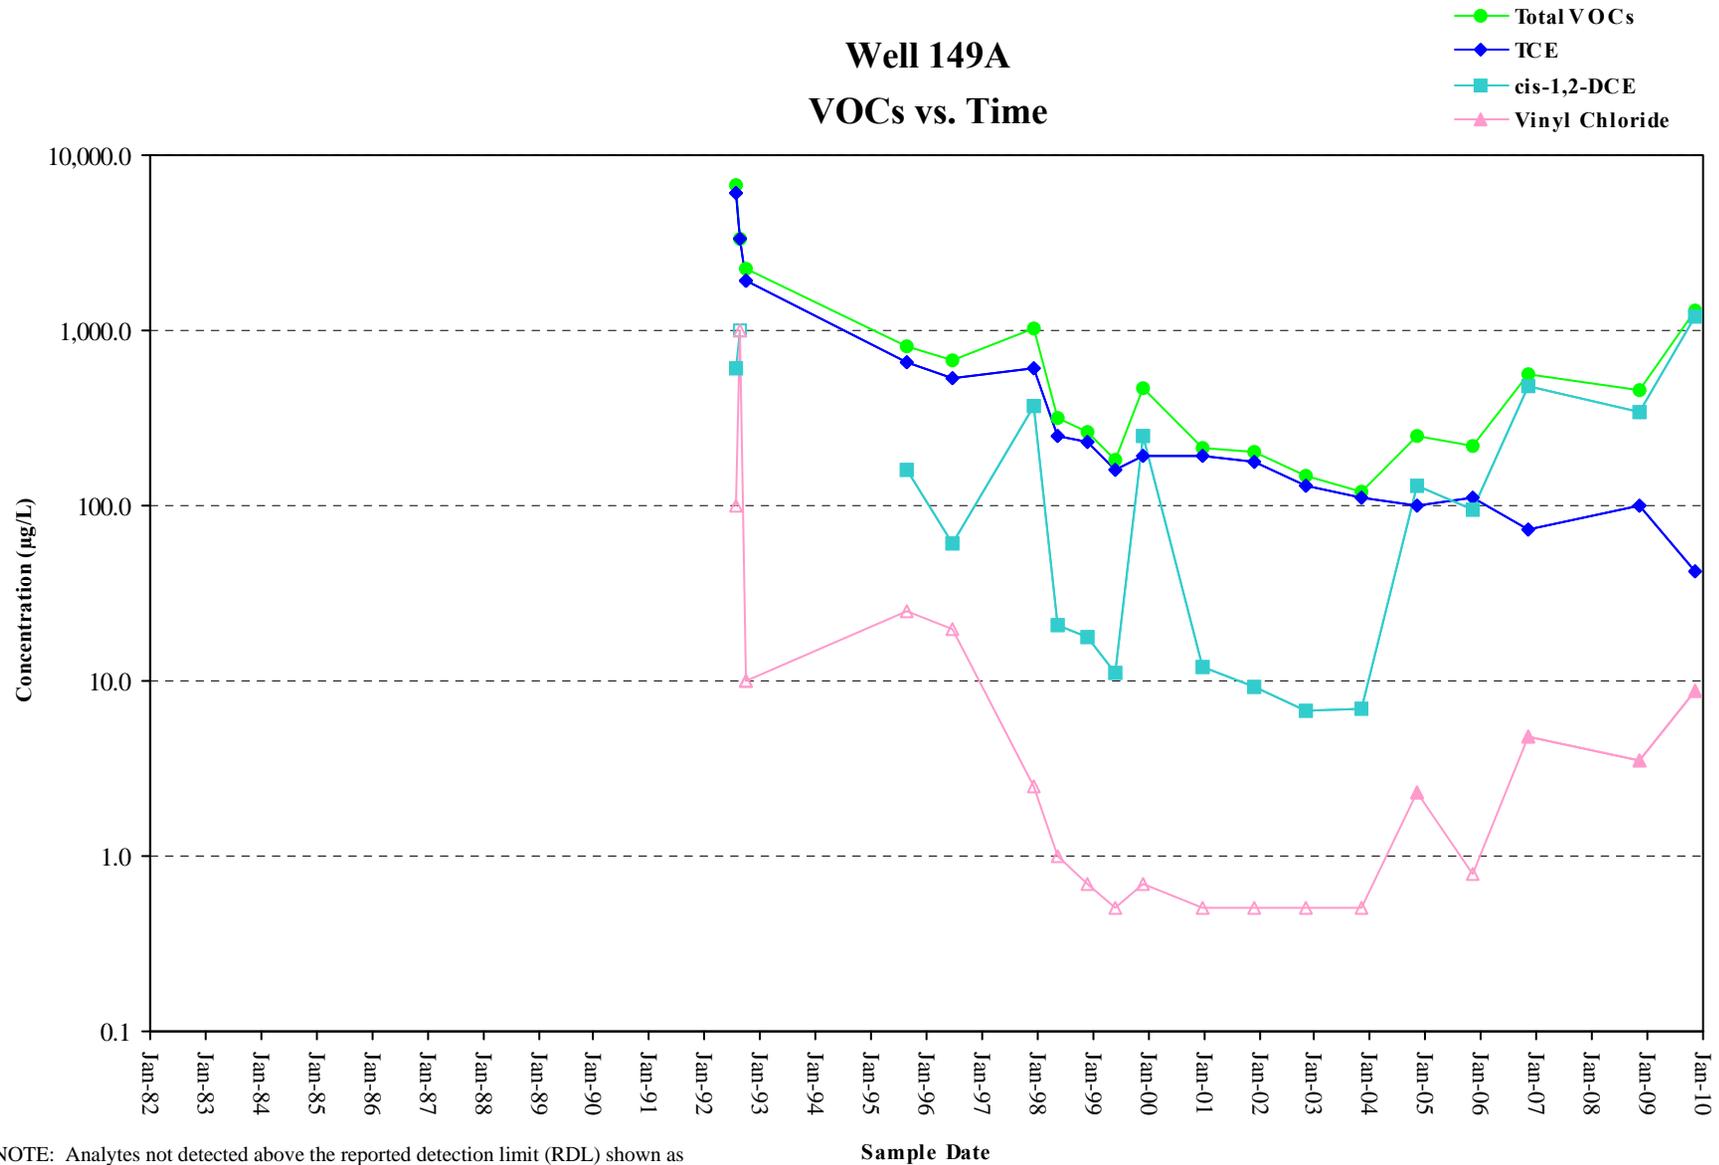
### Well 149A VOCs vs. Time

Abbreviations: VOC = volatile organic compounds, TCE = trichloroethylene,  
DCE = dichloroethylene, µg/L = micrograms per liter
