Subject: **2015 Annual Progress Report – Former Fairchild Buildings 1-4, 9, and 18**
Middlefield-Ellis-Whisman ("MEW") Area
Mountain View, California

**2015 ANNUAL PROGRESS REPORT
FORMER FAIRCHILD
BUILDINGS 1-4, 9, and 18
MIDDLEFIELD-ELLIS-WHISMAN AREA
MOUNTAIN VIEW, CALIFORNIA**

Project Number: WR1133D

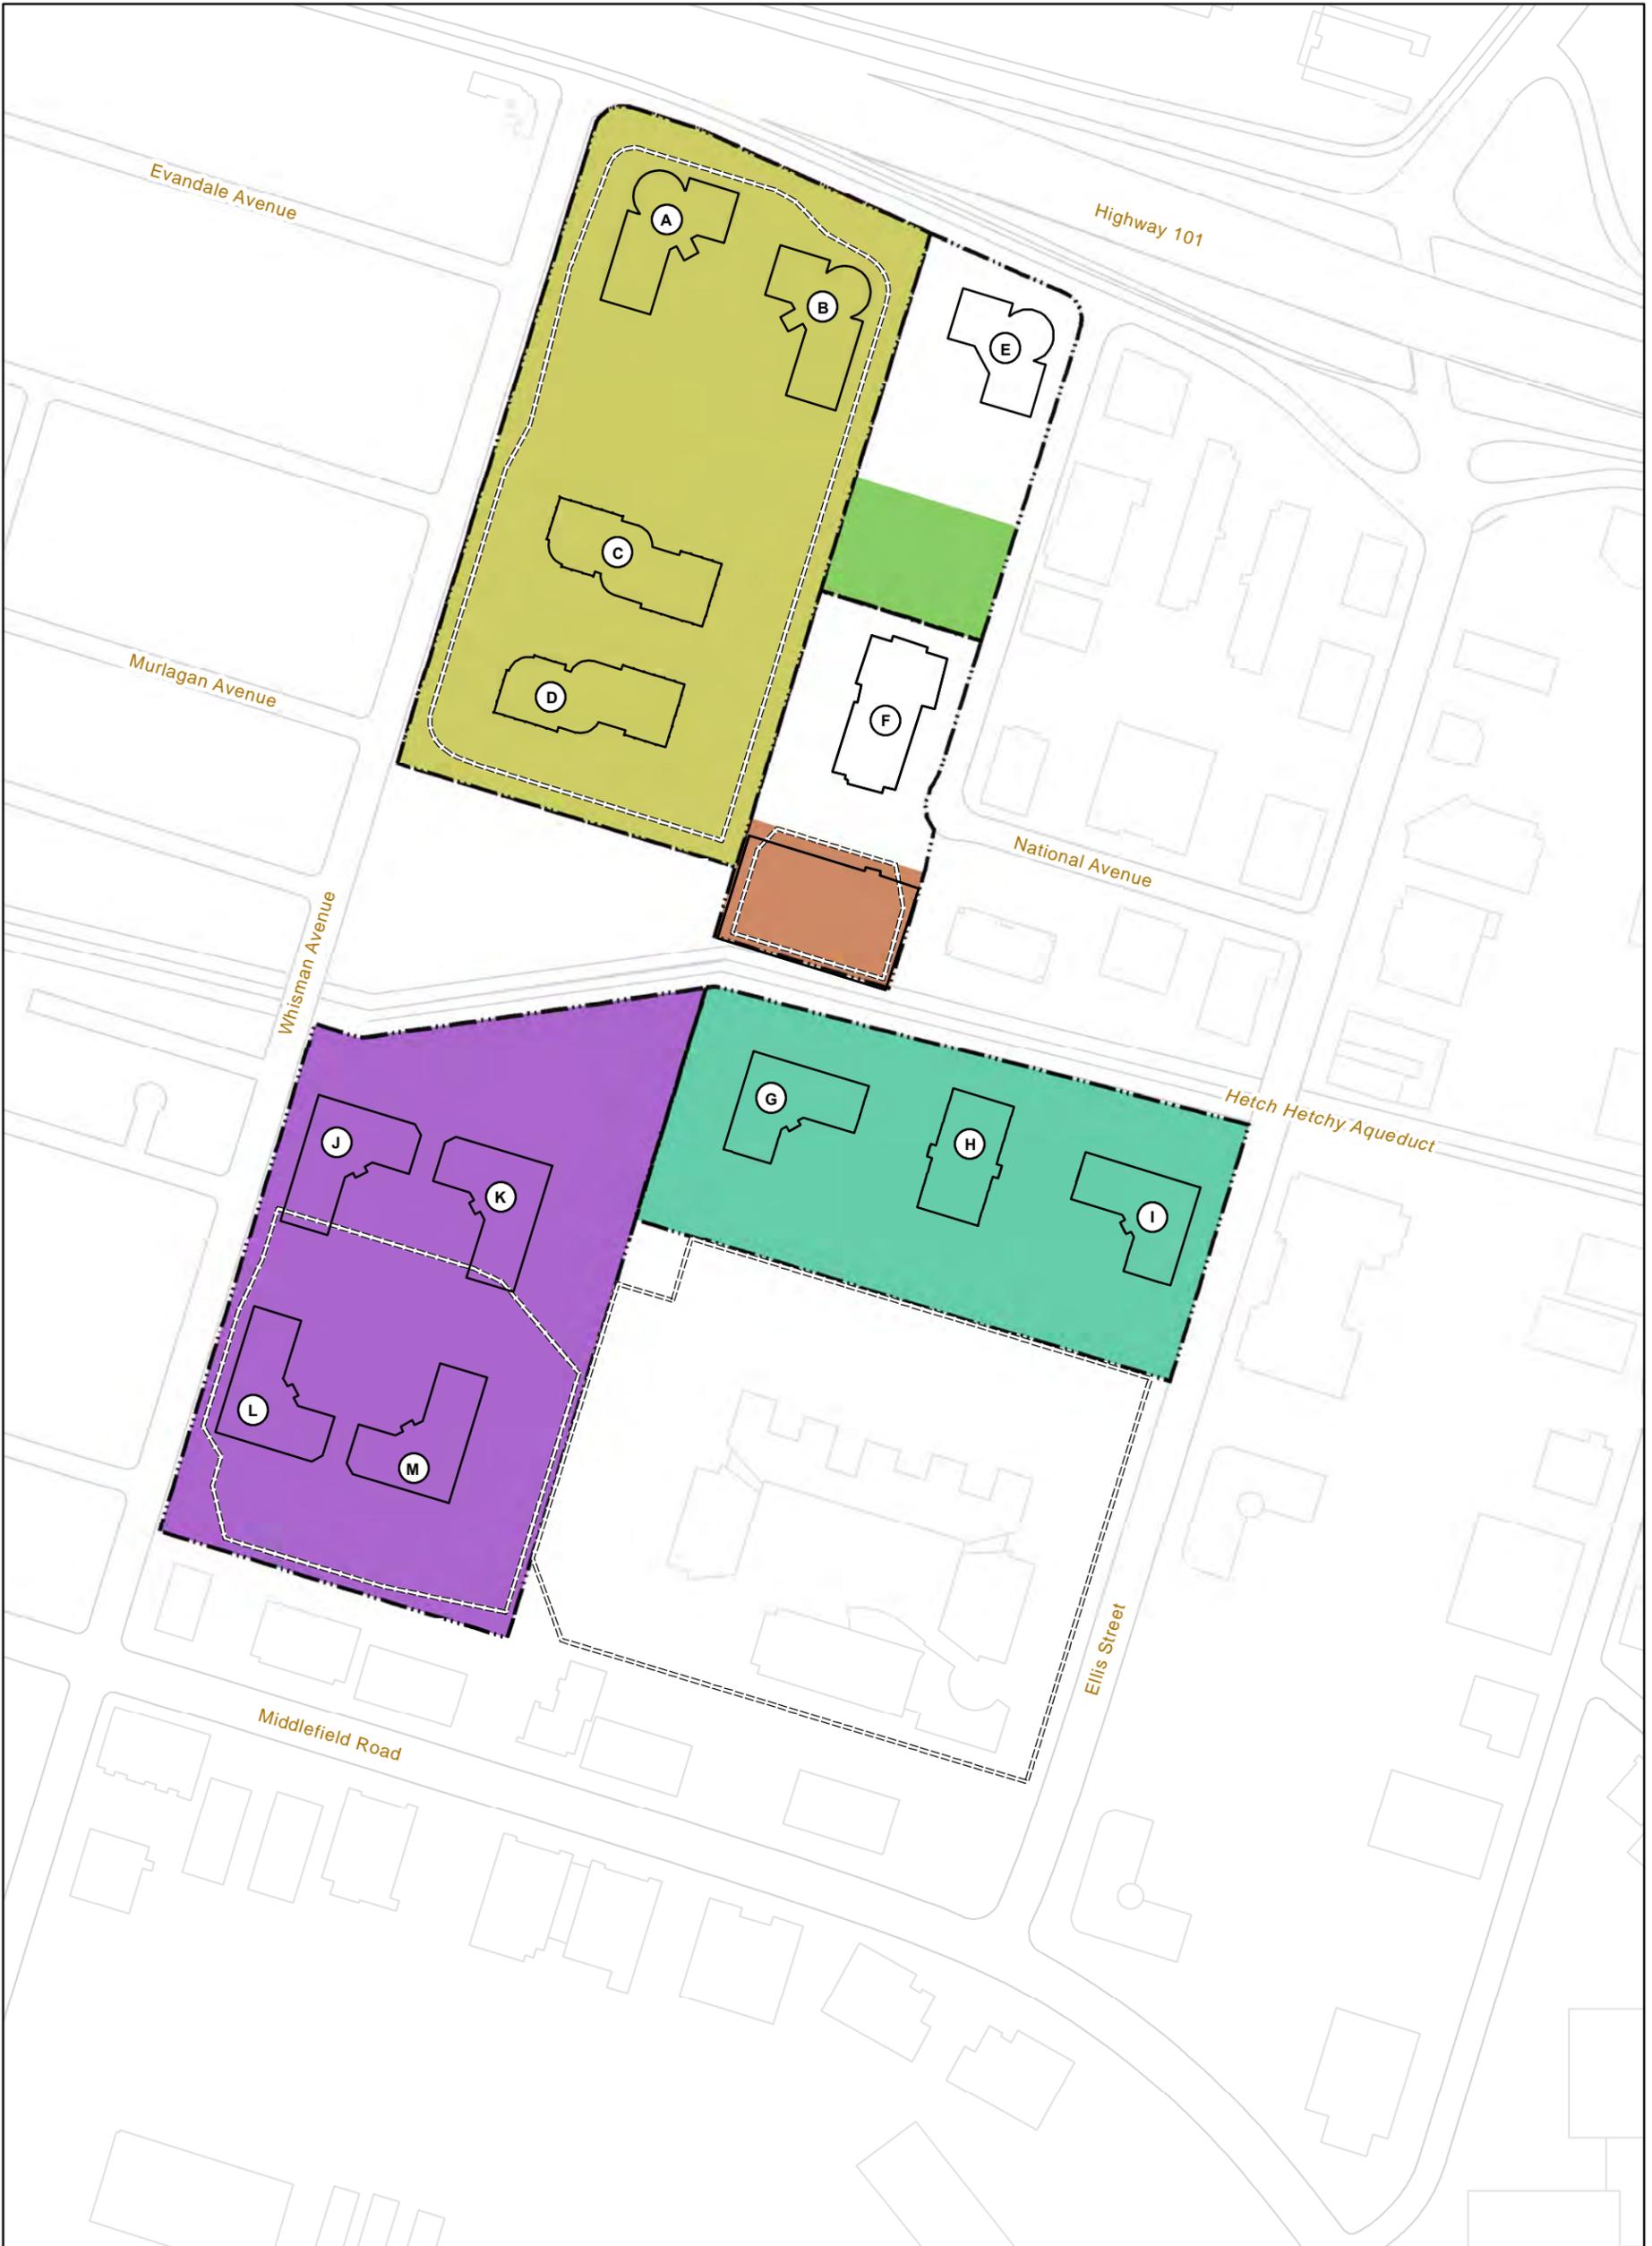
Oakland	April 2016
Figure 2

National Avenue) have been consolidated into a single address: 600 National Avenue (Figure 2).

The original Fairchild Building 18 structure was located at 644 National Avenue. The property was purchased by Carr America National Avenue, LLC in 2007. Redevelopment of the property began in 2012 and was completed in 2013. Redevelopment included demolishing the former Fairchild Building 18 and construction of a surface parking lot on the former Fairchild Building 18 Site. As part of the redevelopment, the former Fairchild Building 18 property was consolidated with properties to the north, and the new address is 331 Fairchild Drive (Figure 2).

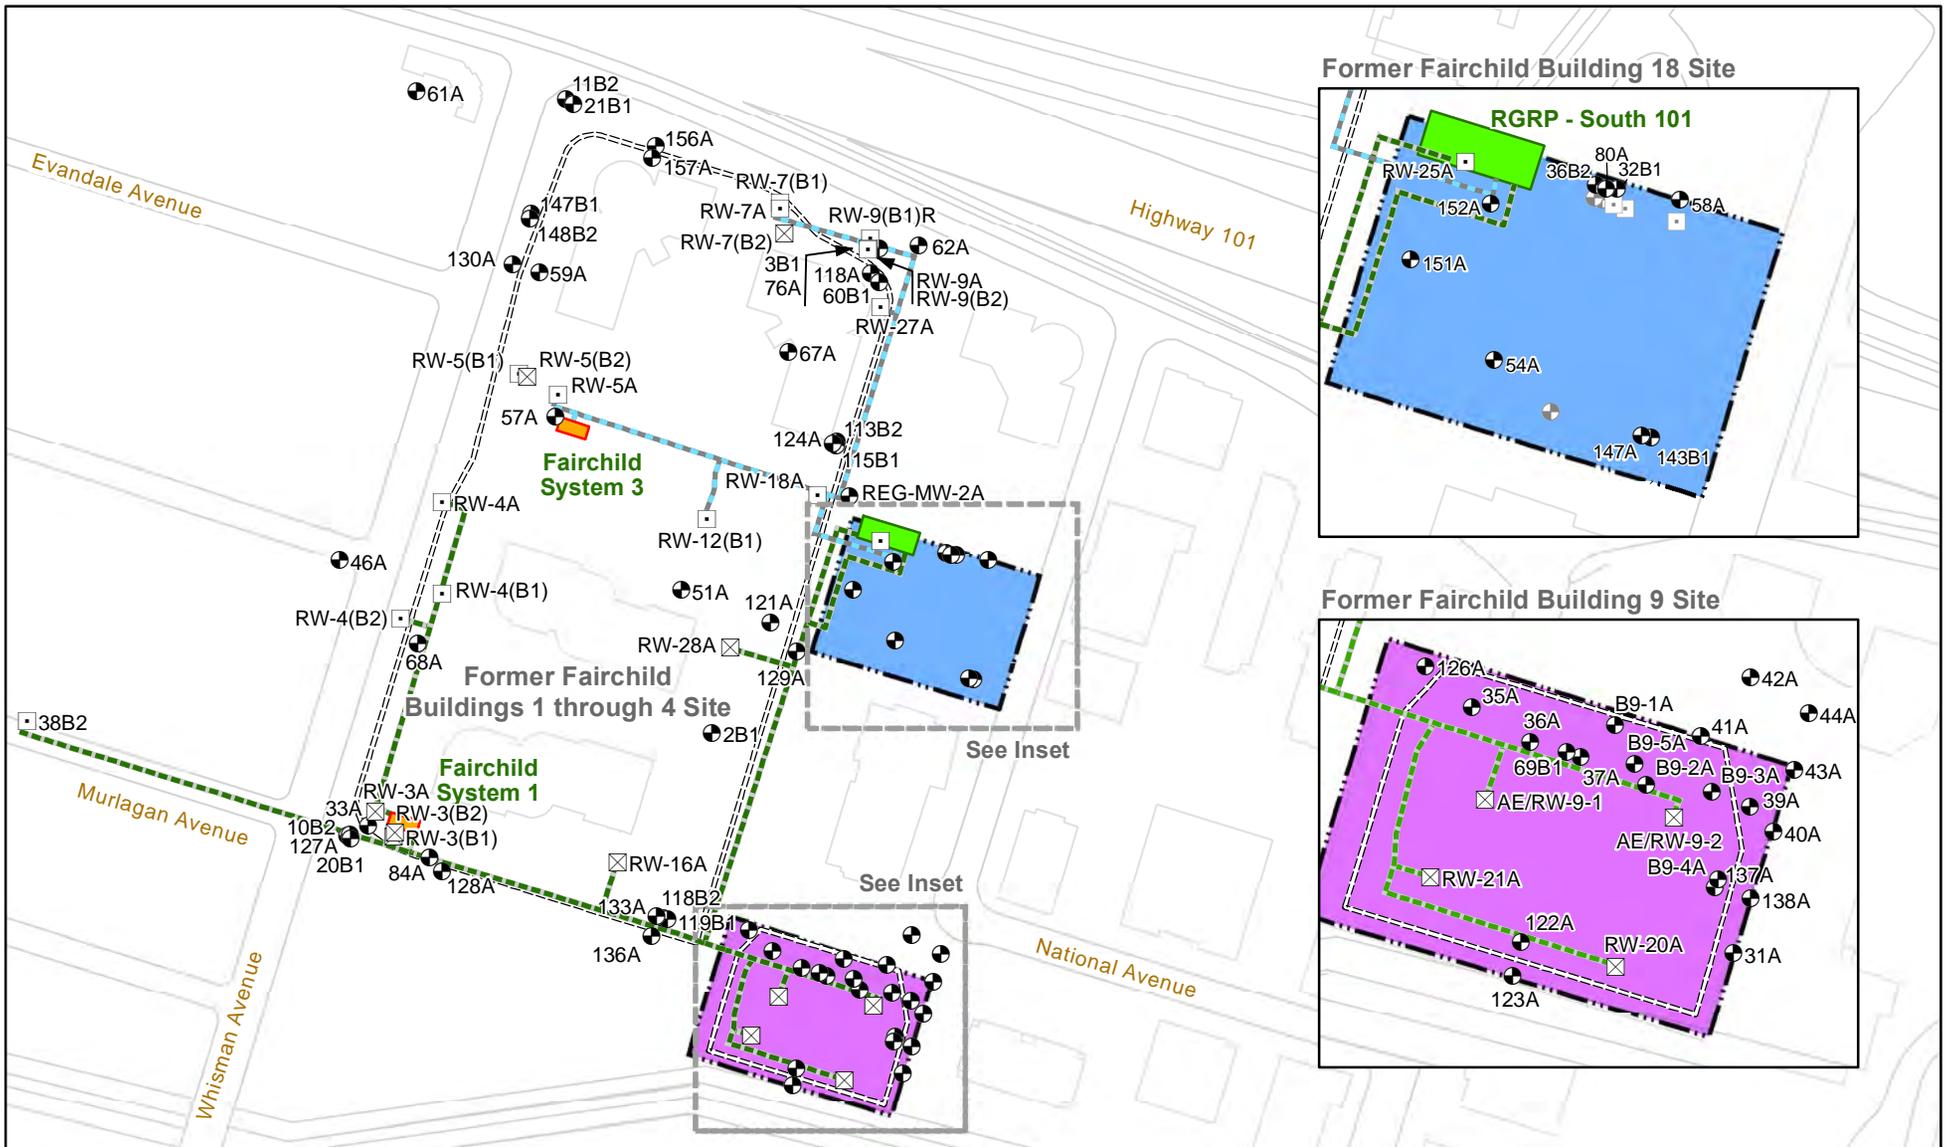
- Recovery and Monitoring Wells
- Monitoring Well
- Recovery Well, On
- Recovery Well, Off
- Former Fairchild Buildings 1-4 Site - 515/545 North Whisman Road and 313/323 Fairchild Drive
- Former Fairchild Building 18 Site - 331 Fairchild Drive
- Former Fairchild Building 9 Site - 401 National Avenue
- Fairchild Groundwater Treatment Systems 1 and 3
- Treatment System 1 Pipeline
- Treatment System 3 Pipeline
- Slurry Wall
- Building
- Road

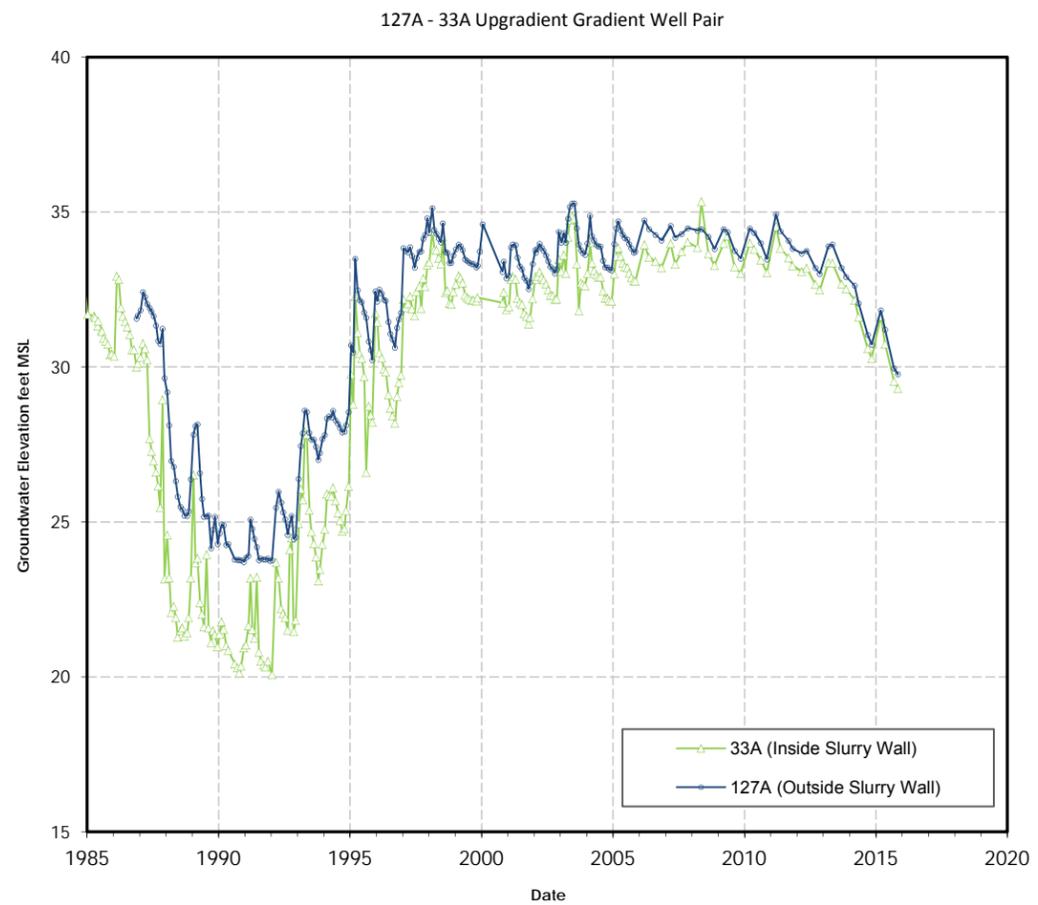
Hydrographs
Buildings 1-4 Upgradient A Zone Slurry Wall Well Pairs
 MEW Former Fairchild Buildings 1-4, 9, and 18 Groundwater Remediation Programs
 Mountain View, California

- **Horizontal Gradients:** During this reporting period, inward gradients were consistently observed at well pair 123A/122A located on the upgradient side of the slurry wall, and outward gradients were observed at well pair 138A/137A located on the eastern cross gradient side of the slurry wall and well pair 126A/35A located on the western downgradient side of the slurry wall.
- **Vertical Gradients:** During this reporting period, a downward gradient was observed between the A and B1 Zones at well pair 69B1/37A.

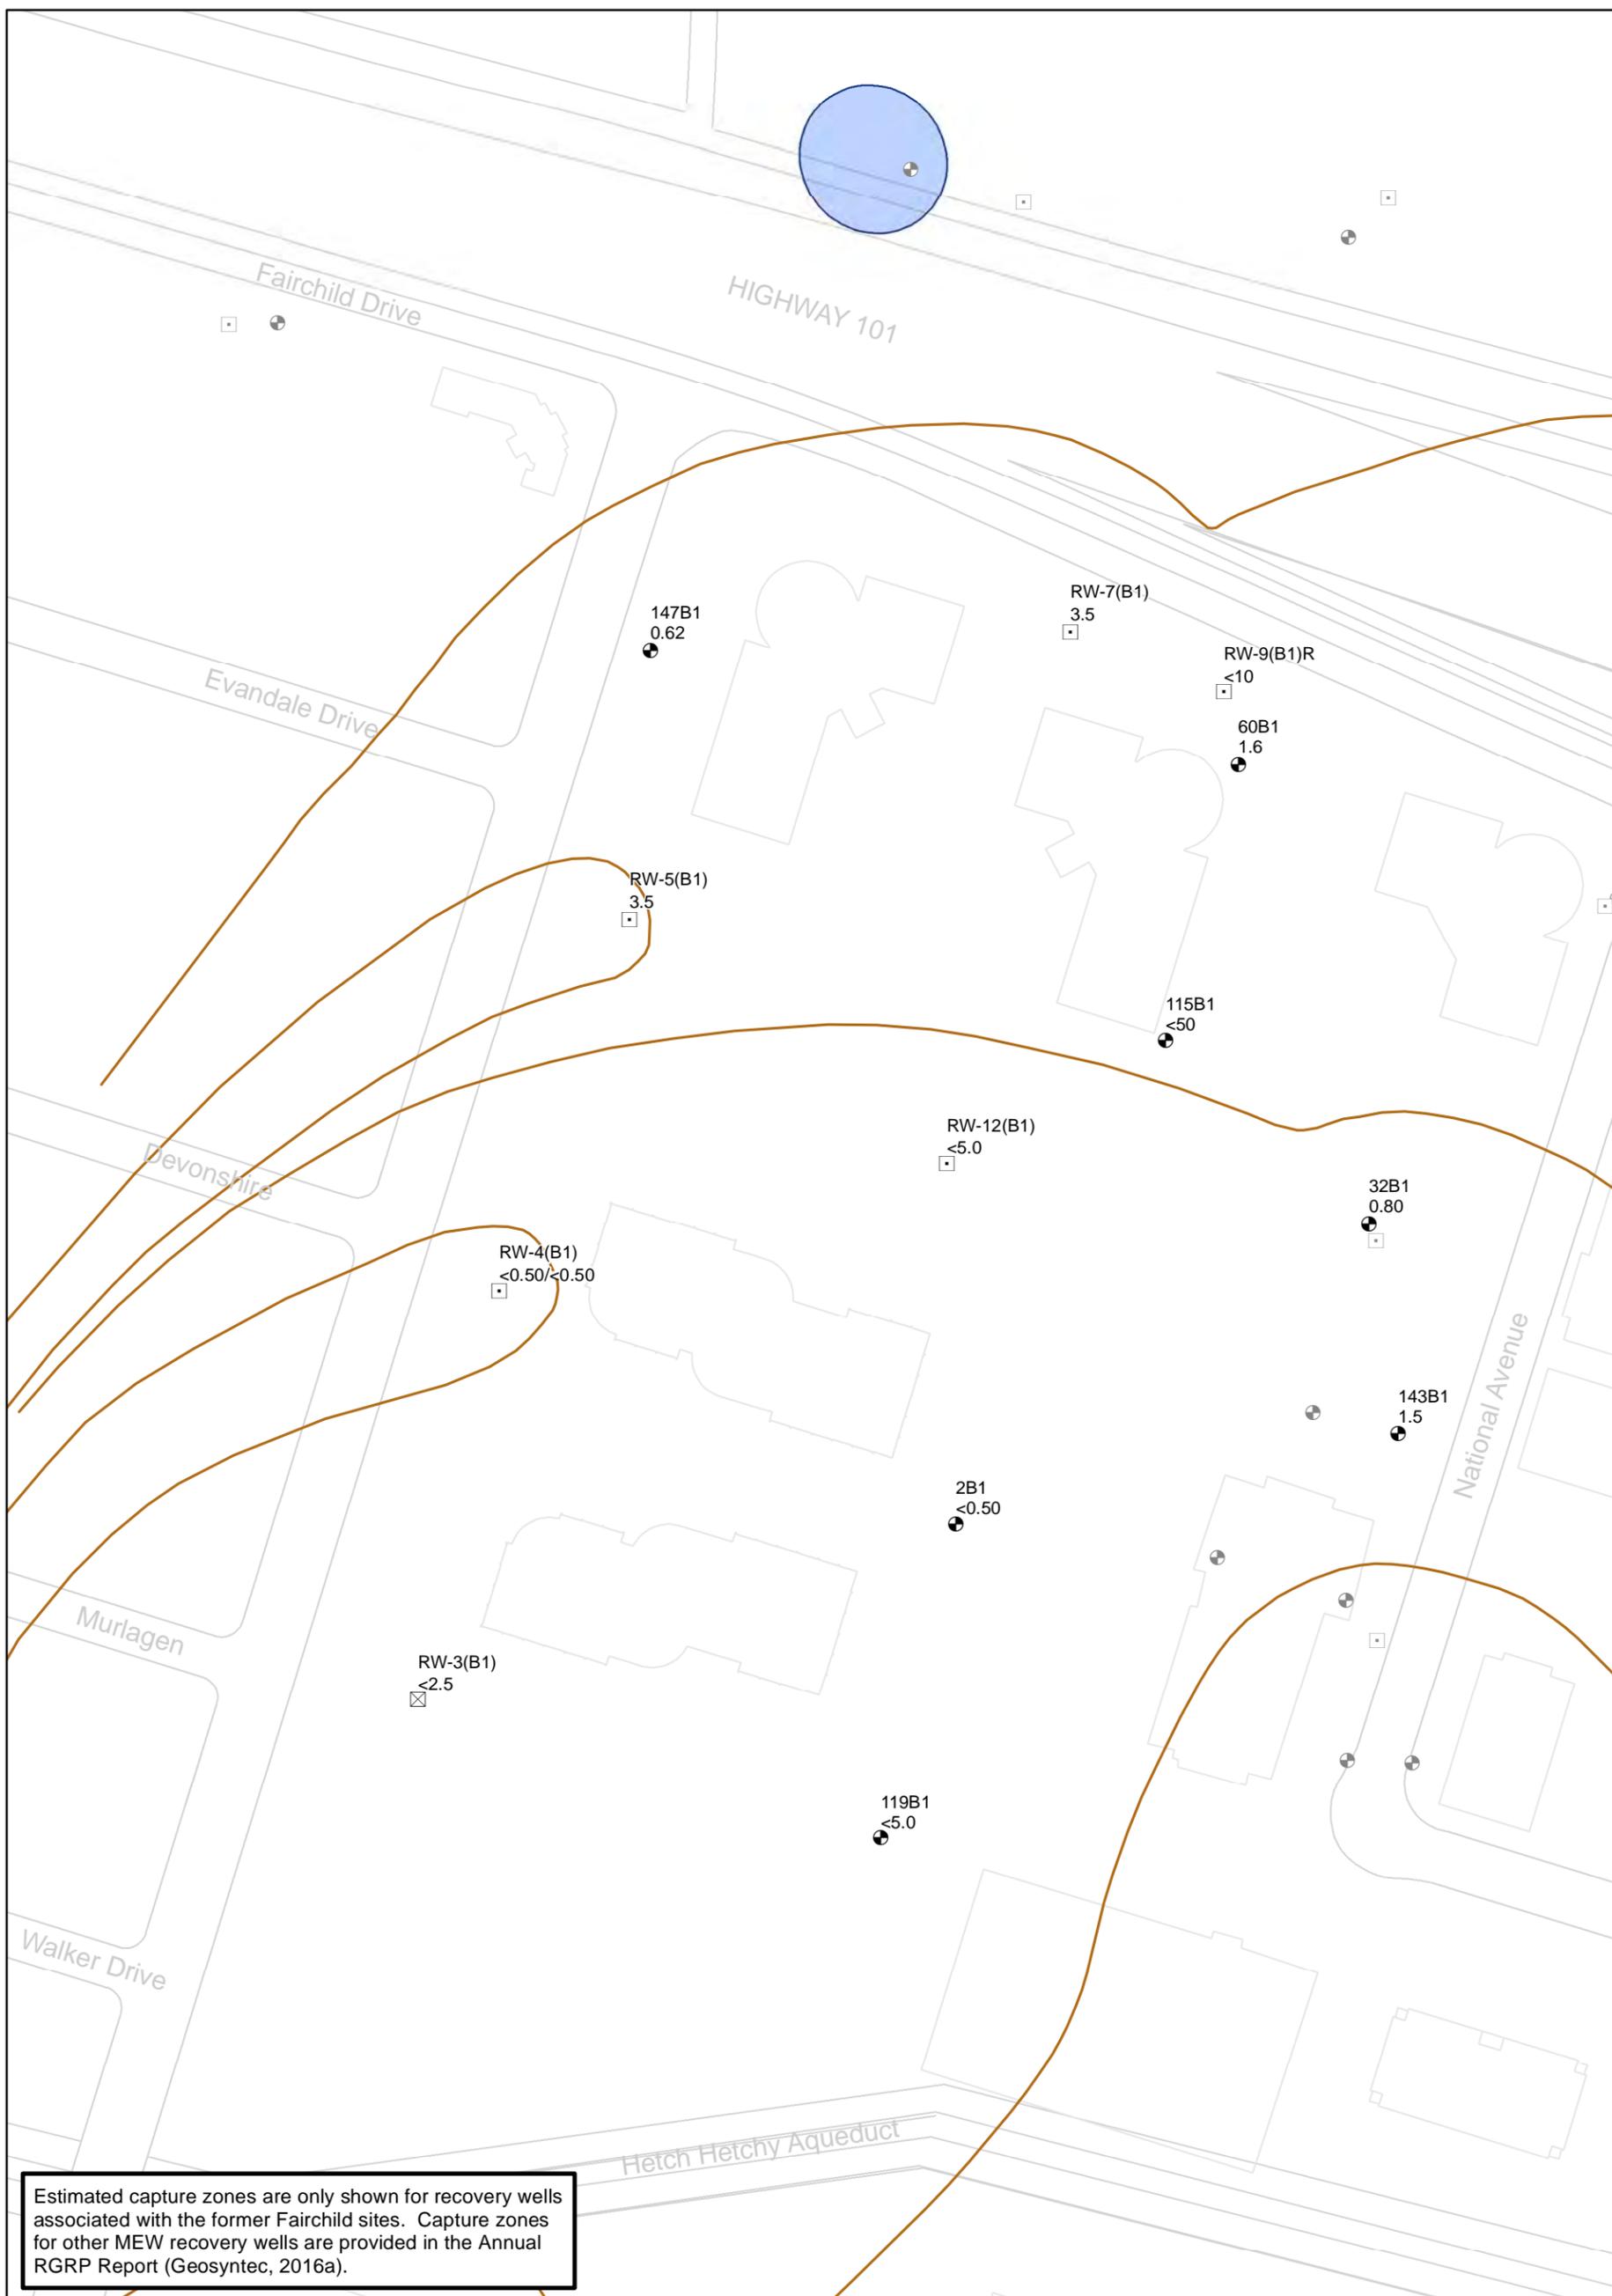
Estimated capture zones are only shown for recovery wells associated with the former Fairchild sites. Capture zones for other MEW recovery wells are provided in the Annual RGRP Report (Geosyntec, 2016a).
