**Studies Identified by EPA Office of Water for the
SAB Drinking Water Committee Lead Review Panel Meeting
(as of March 23, 2011)**

Mineralogical Evidence of Galvanic Corrosion in Domestic Drinking Water Pipes

Evaluation of Lead Corrosion Control Measures

LEAD OCCURRENCE AND THE IMPACT OF LSL REPLACEMENT IN A WELL BUFFERED GROUNDWATER

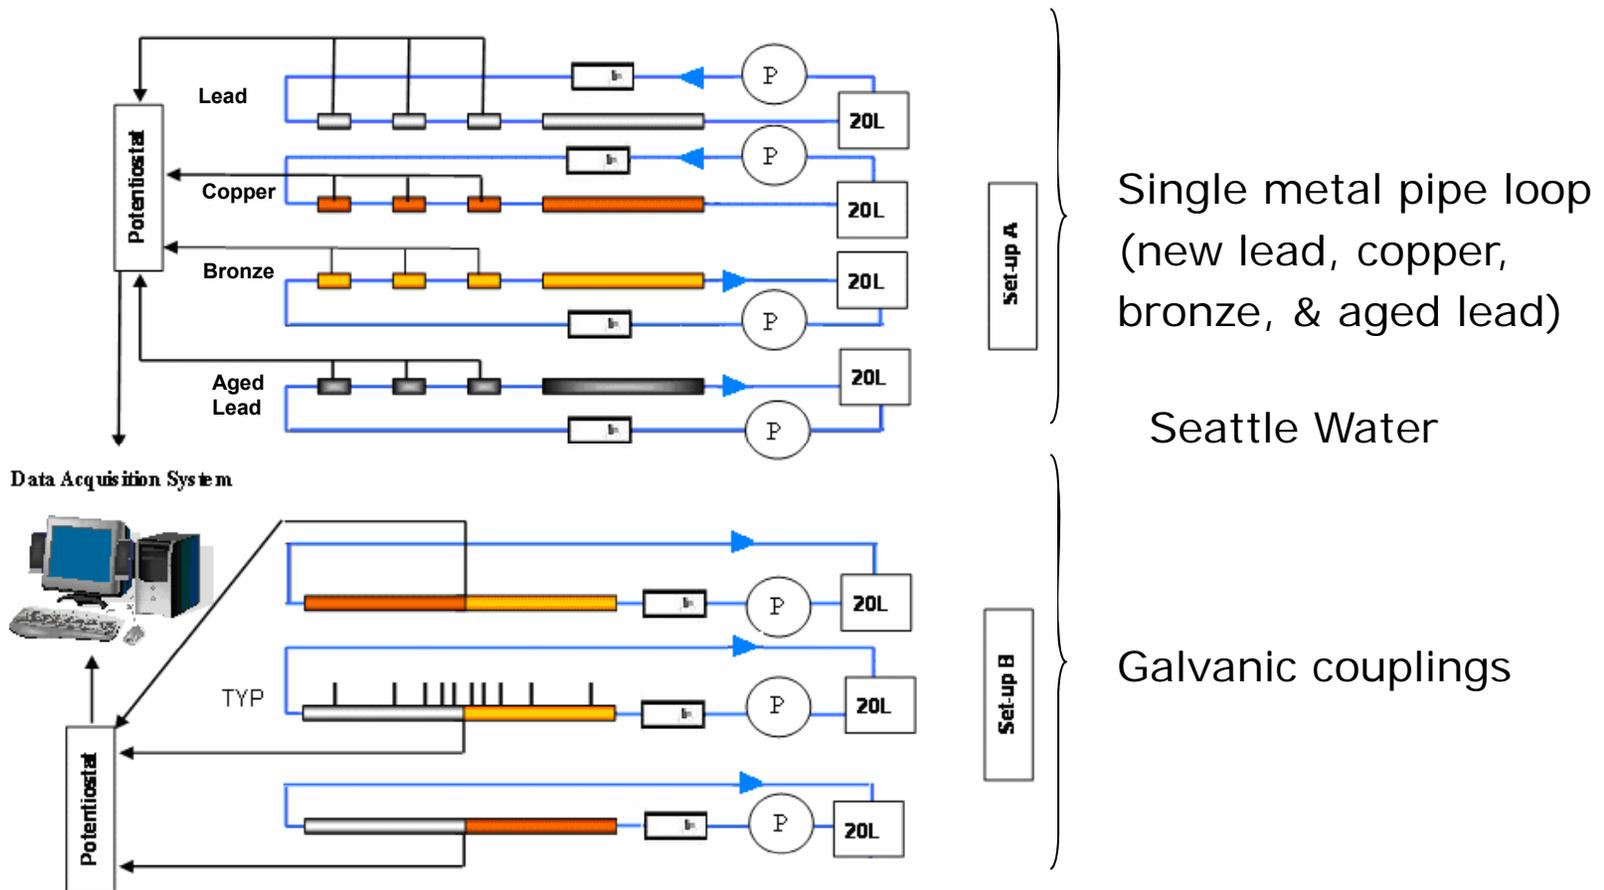
Methods Pipe Loop Testing

Single metal pipe loop
(new lead, copper,
bronze, & aged lead)

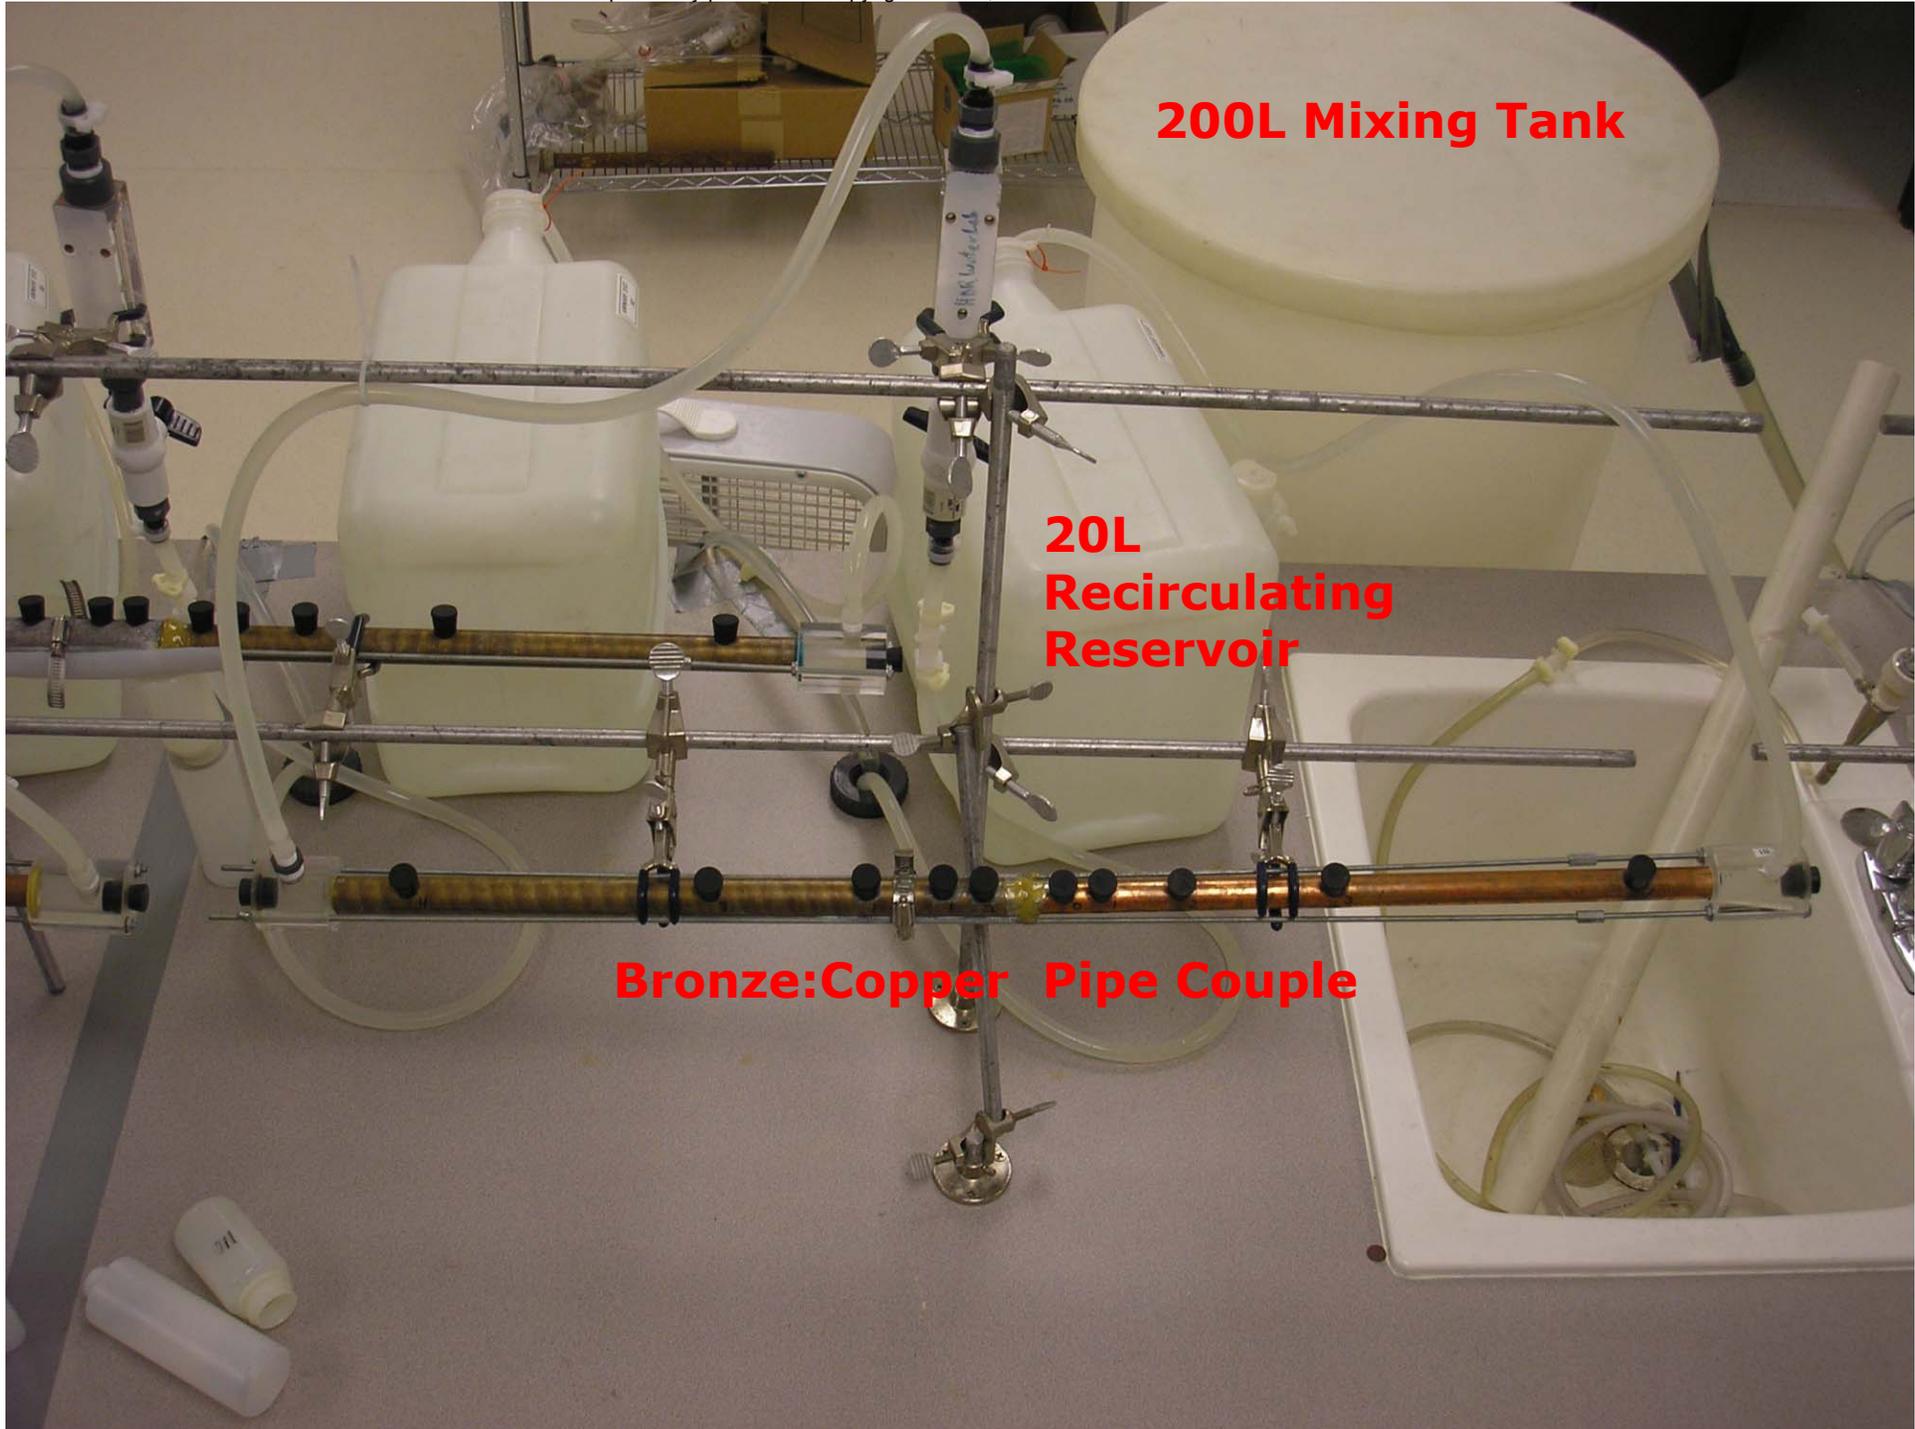
Methods Galvanic Pipe Loop Testing

Galvanic coupled pipe loops
(Cu:brnz, Pb:brnz, or Pb:Cu)

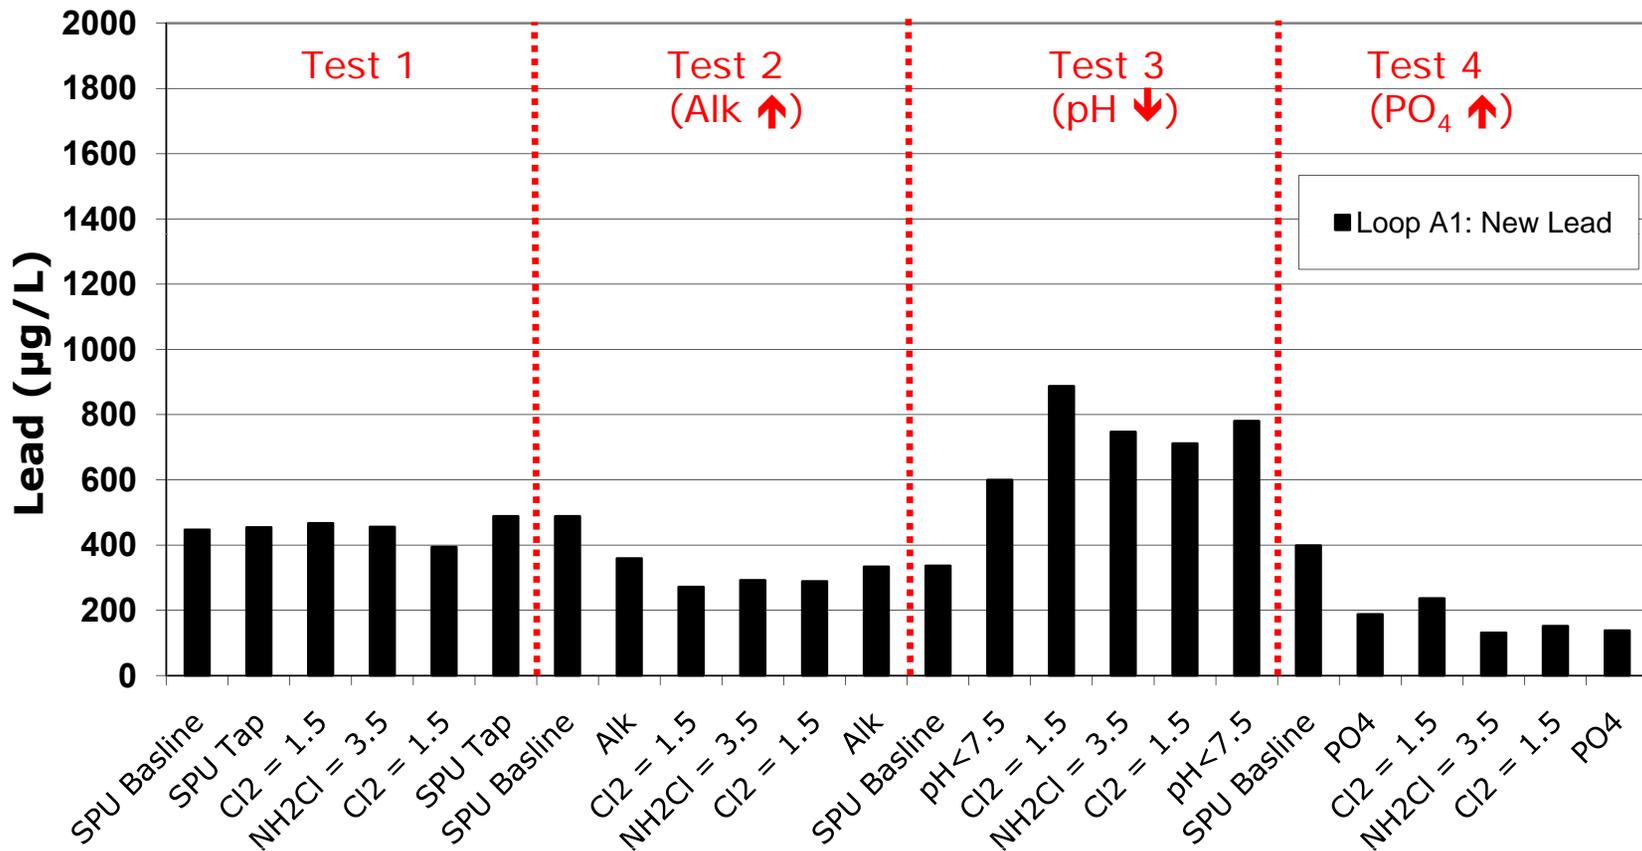
Single-Metal Lead Pipe

Average seventh-day lead measured in samples collected from new lead pipe loop (A1)

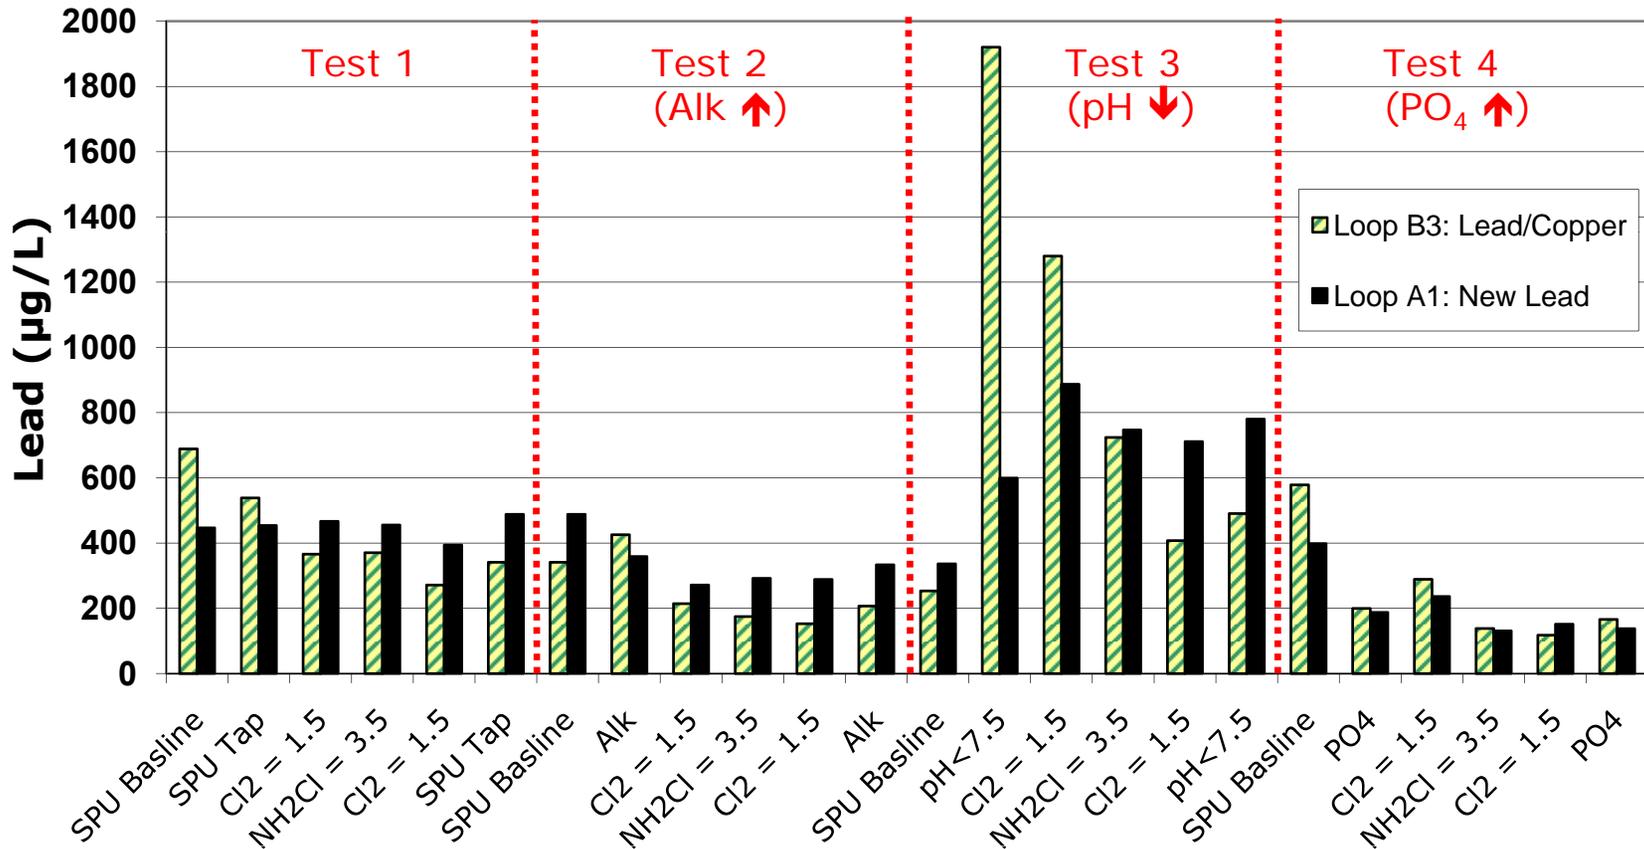
Results – Galvanic-Couple Pb-Cu vs. Single-Metal Lead Pipe

Comparison of average seventh-day lead samples

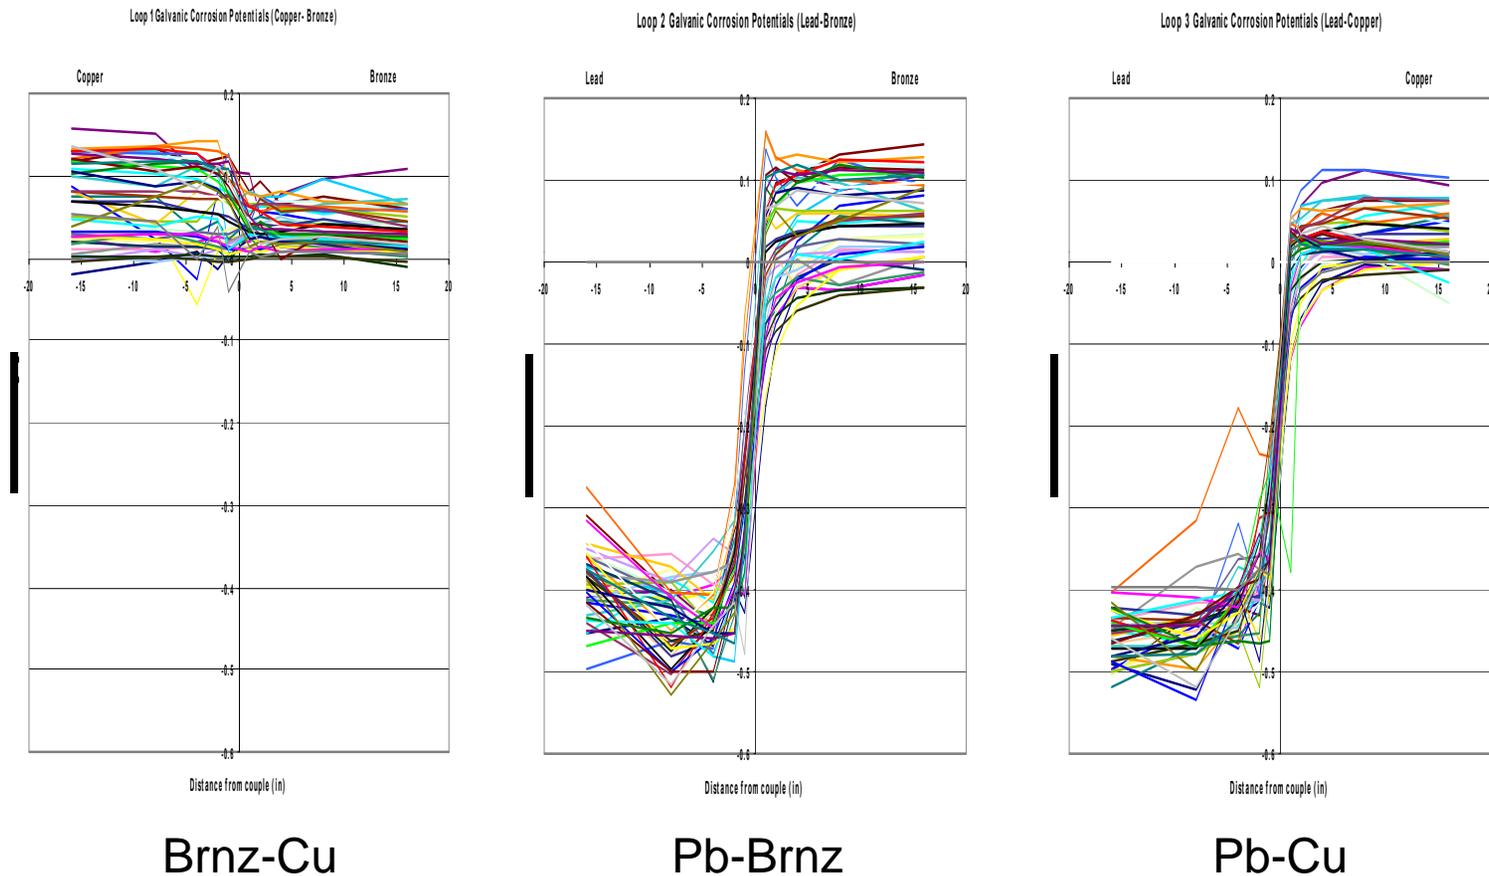
Open Circuit Potential Profiles

Notable galvanic effect (up to 600 mV) ; limited galvanic reach (<3") from juncture

- Open-circuit potential measurements revealed
 - Galvanic effect substantial (~600 mV)
 - Galvanic reach is limited (<3")
- Ongoing Studies – Preliminary Findings
 - Galvanic contact configuration (end-to-end vs. jumpered) potentially can impact corrosion and metals release

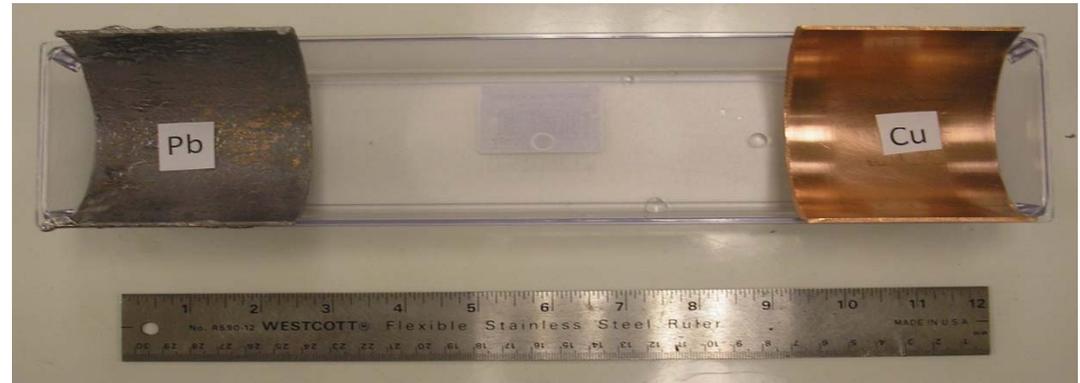
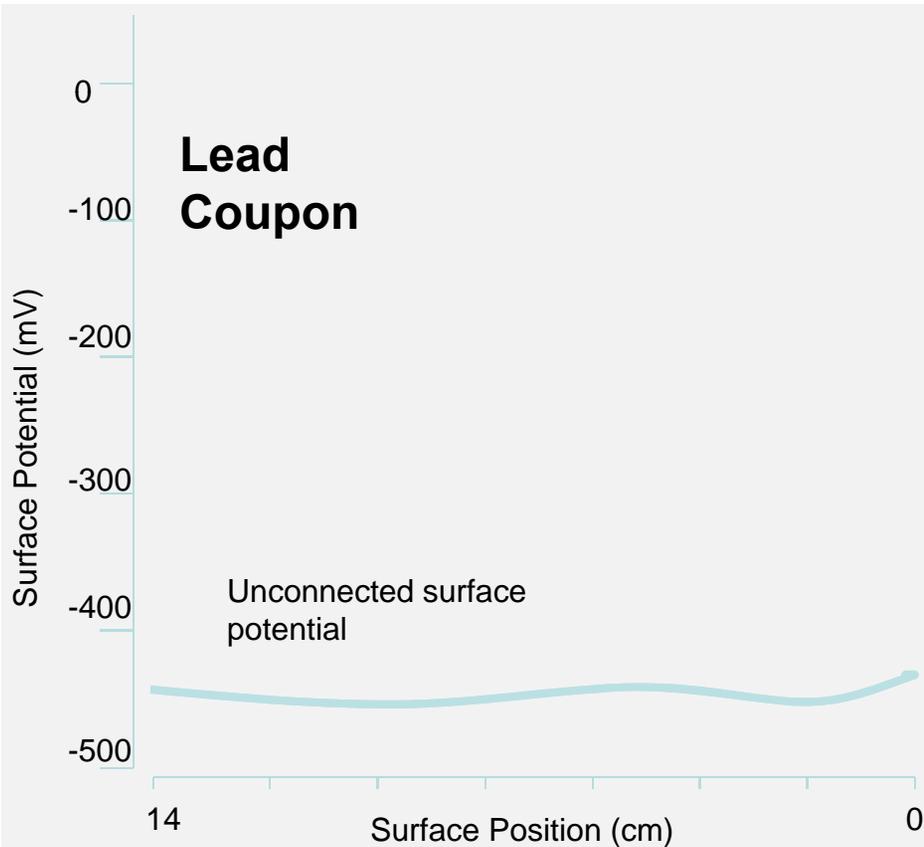
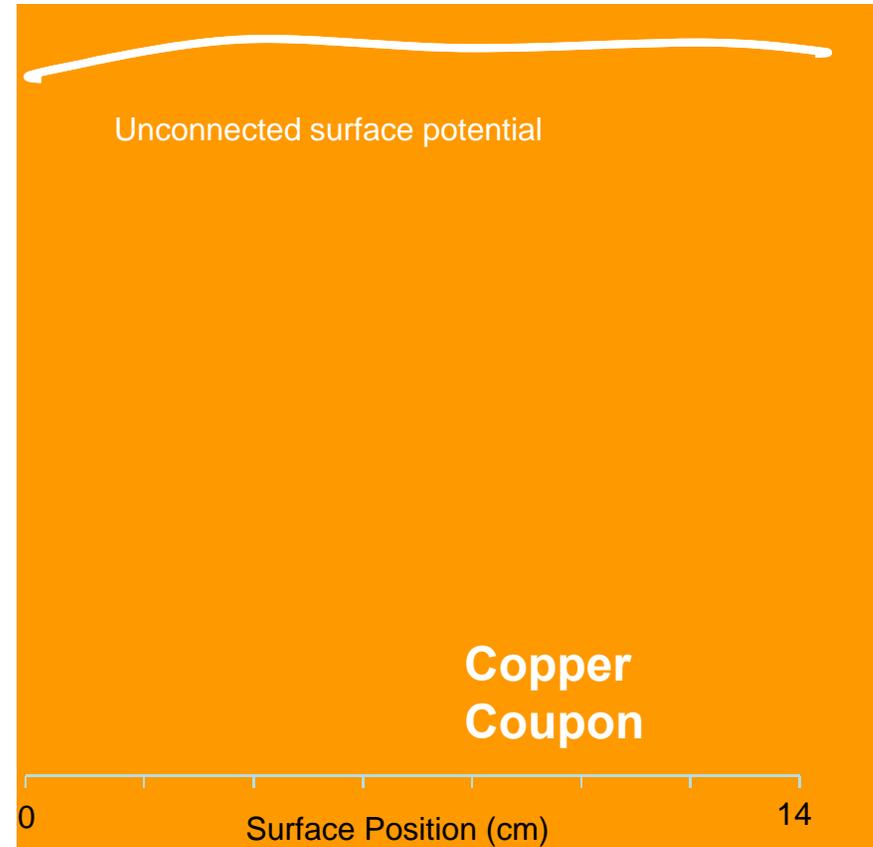
Independent Coupons

- Well defined and stable electrochemical surface potentials

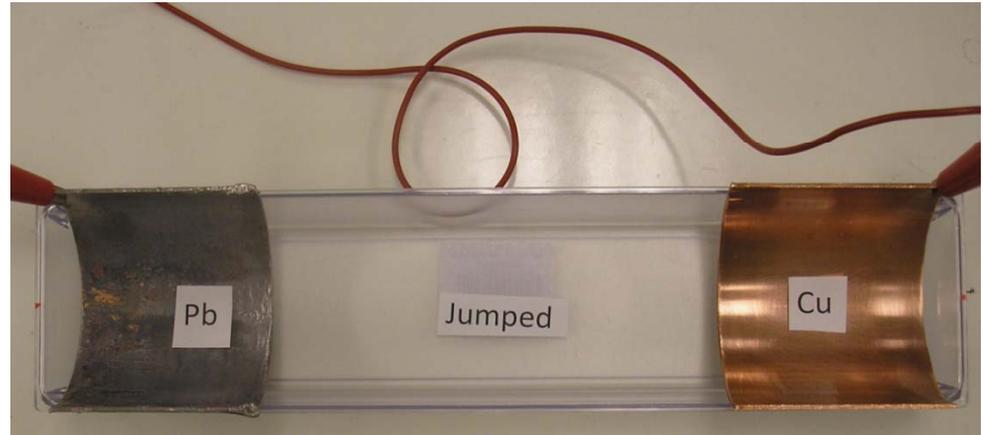
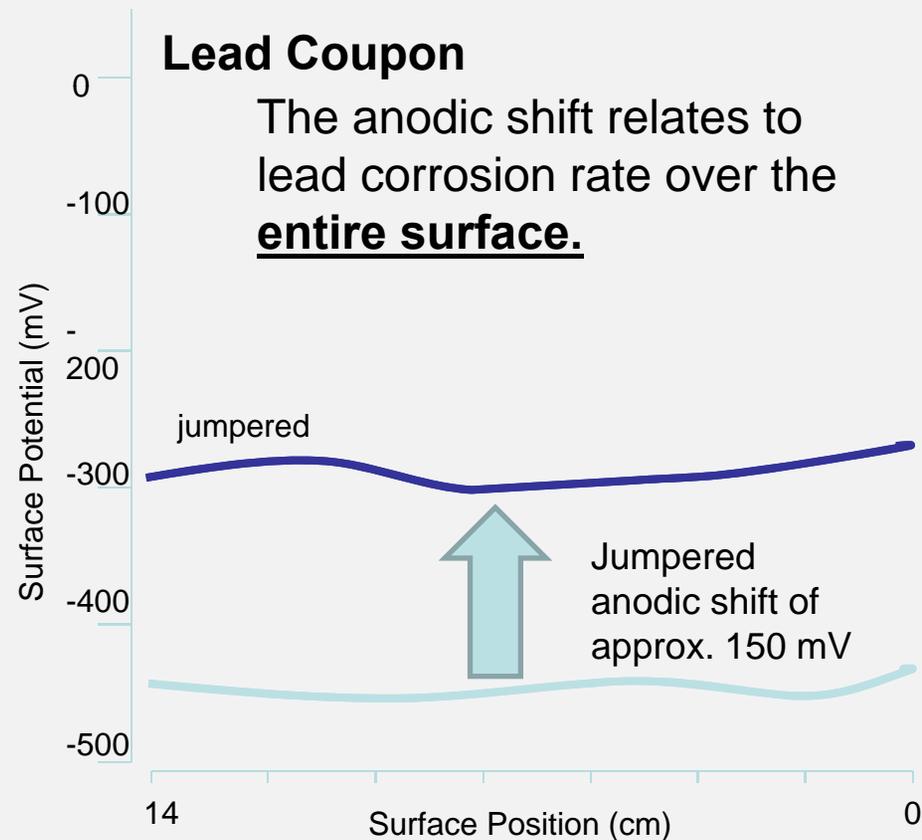
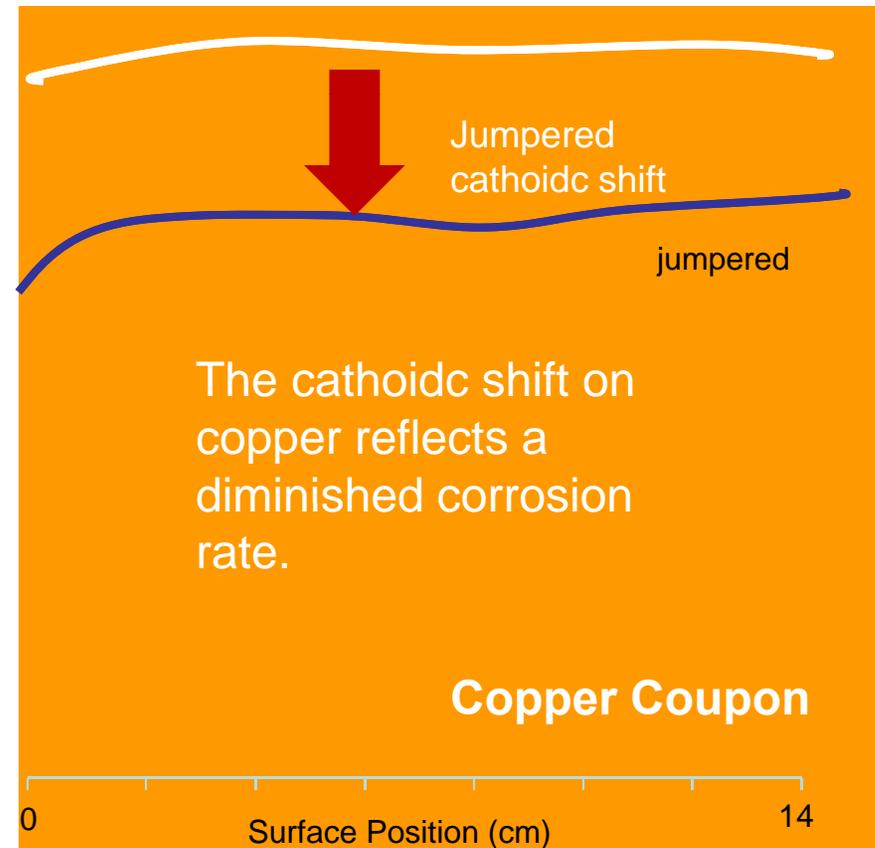
Jumpered (Wired) Coupons

- Anodic/cathodic shifts extend over the entire surfaces
- Shifts are substantial and reflect a meaningful lead corrosion increase

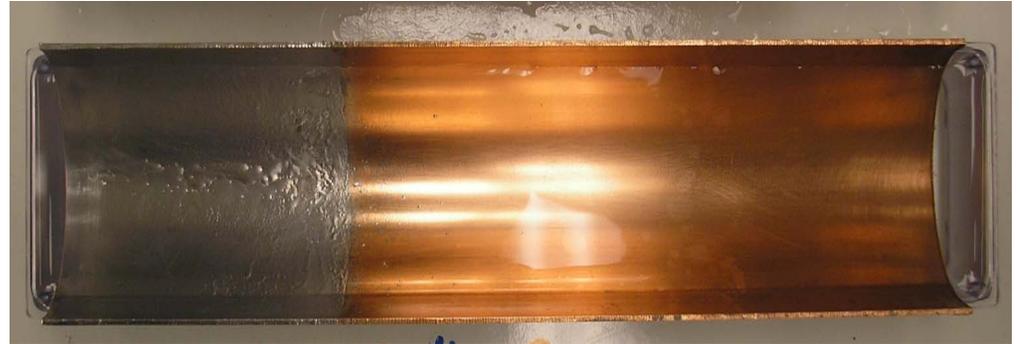
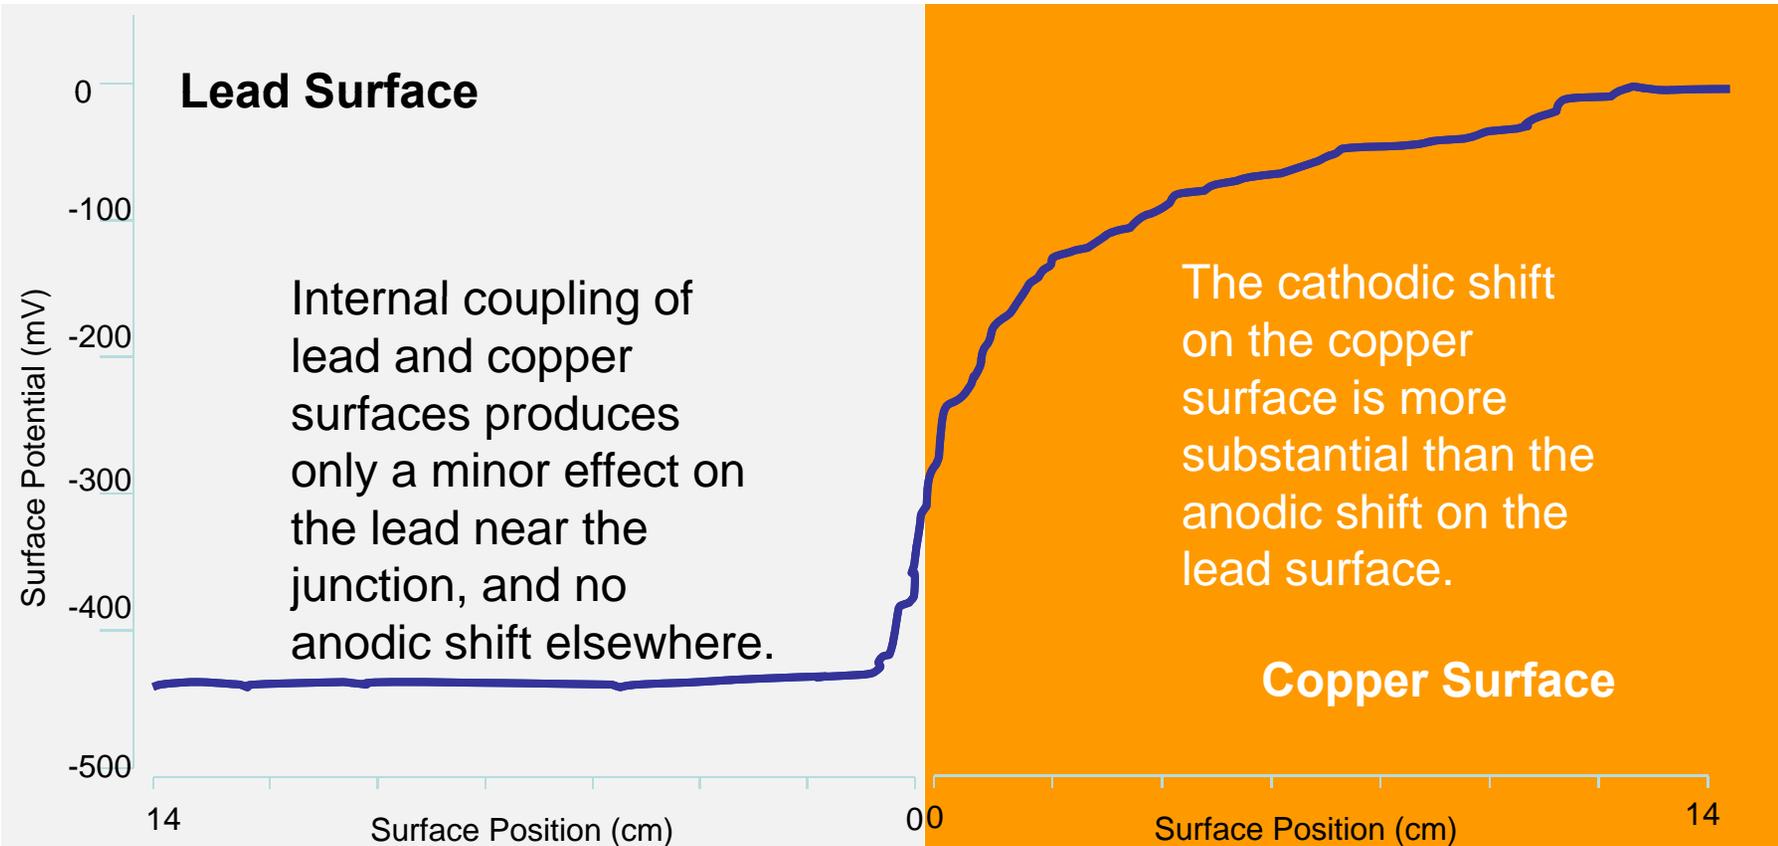
Jointed (End-to-End) Coupons

- Produces a minor increase in corrosion on the lead surface

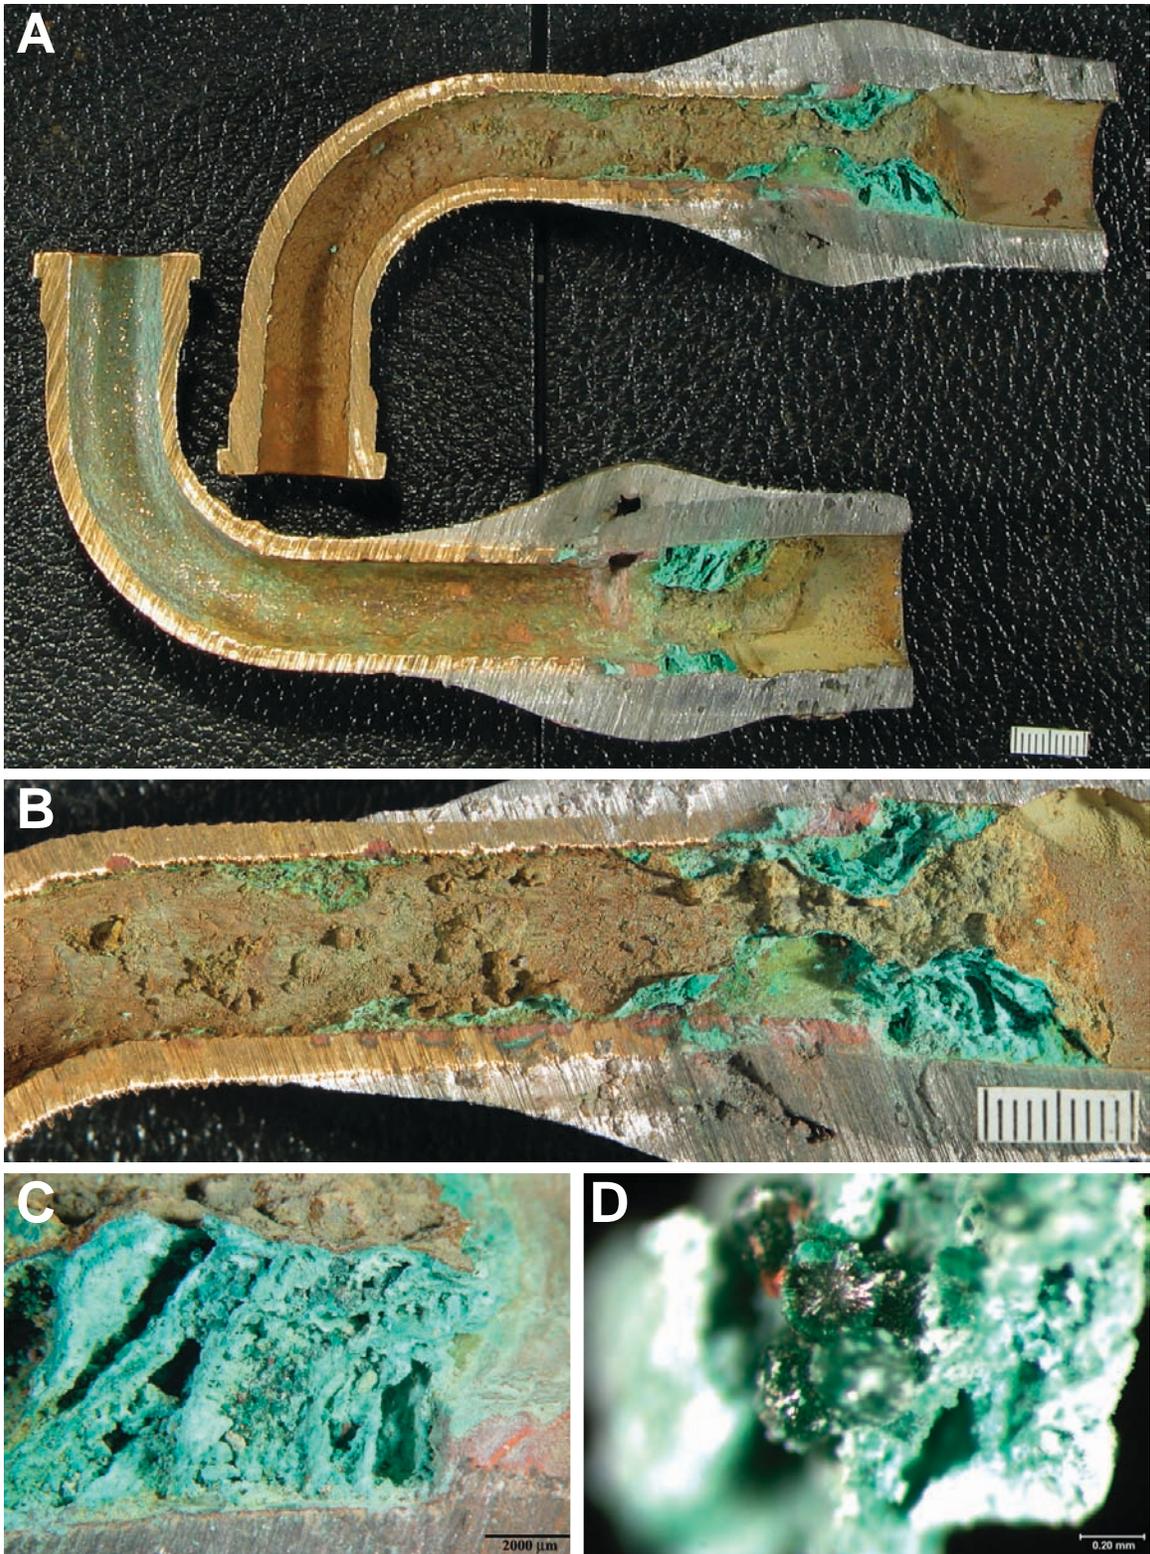
Figure 1. Photographs of pipe sample A_2. (A), (B): scale bar divisions are in mm. (C): scale bar = 2 mm. (D): scale bar = 200 μm.

Motif 1 (Galvanic corrosion of brass or copper pipe): Samples from two utilities fall into this motif. Figures 1 and 2 show representative photographs and powder X-ray diffraction patterns for Utility A. Figures 3 and 4 show a representative sample from Utility B.

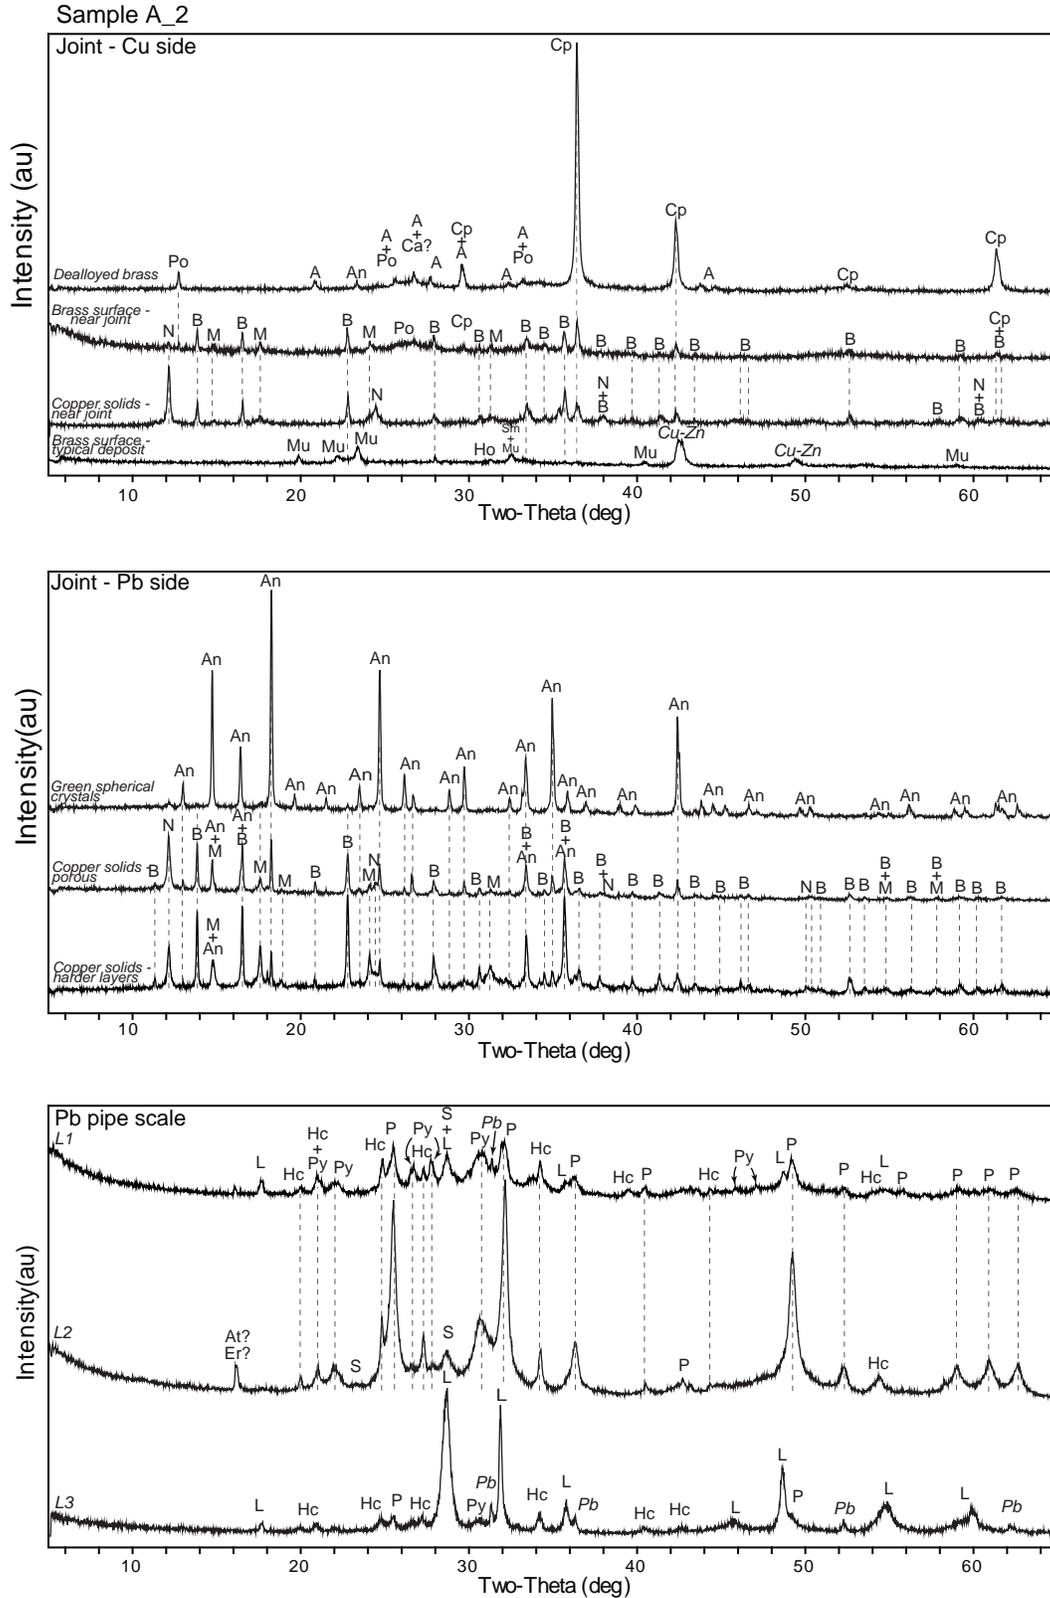
Figure 2. Sample A_2 powder X-ray diffraction patterns. Refer to Table 3 for key to mineral phase abbreviations.

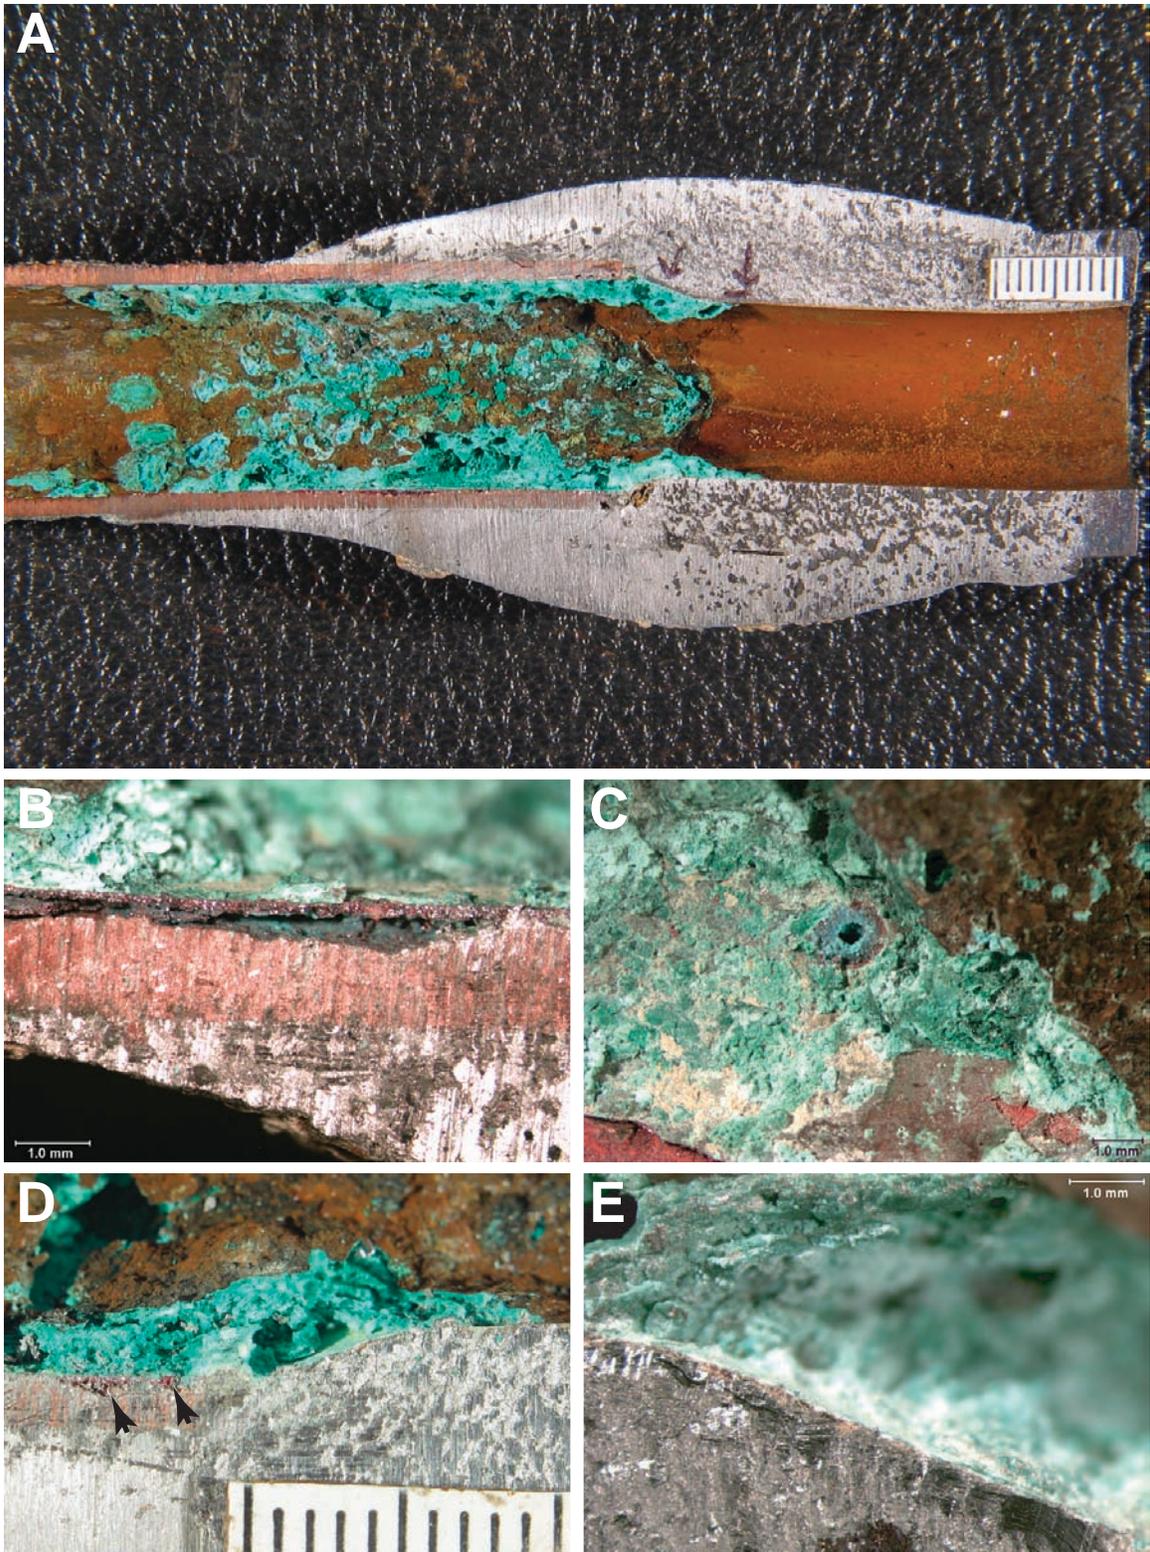
Figure 3. Photographs of pipe sample B_1. (A), (D) scale bar divisions are in mm. (B), (C), (E): scale bar = 1 mm.

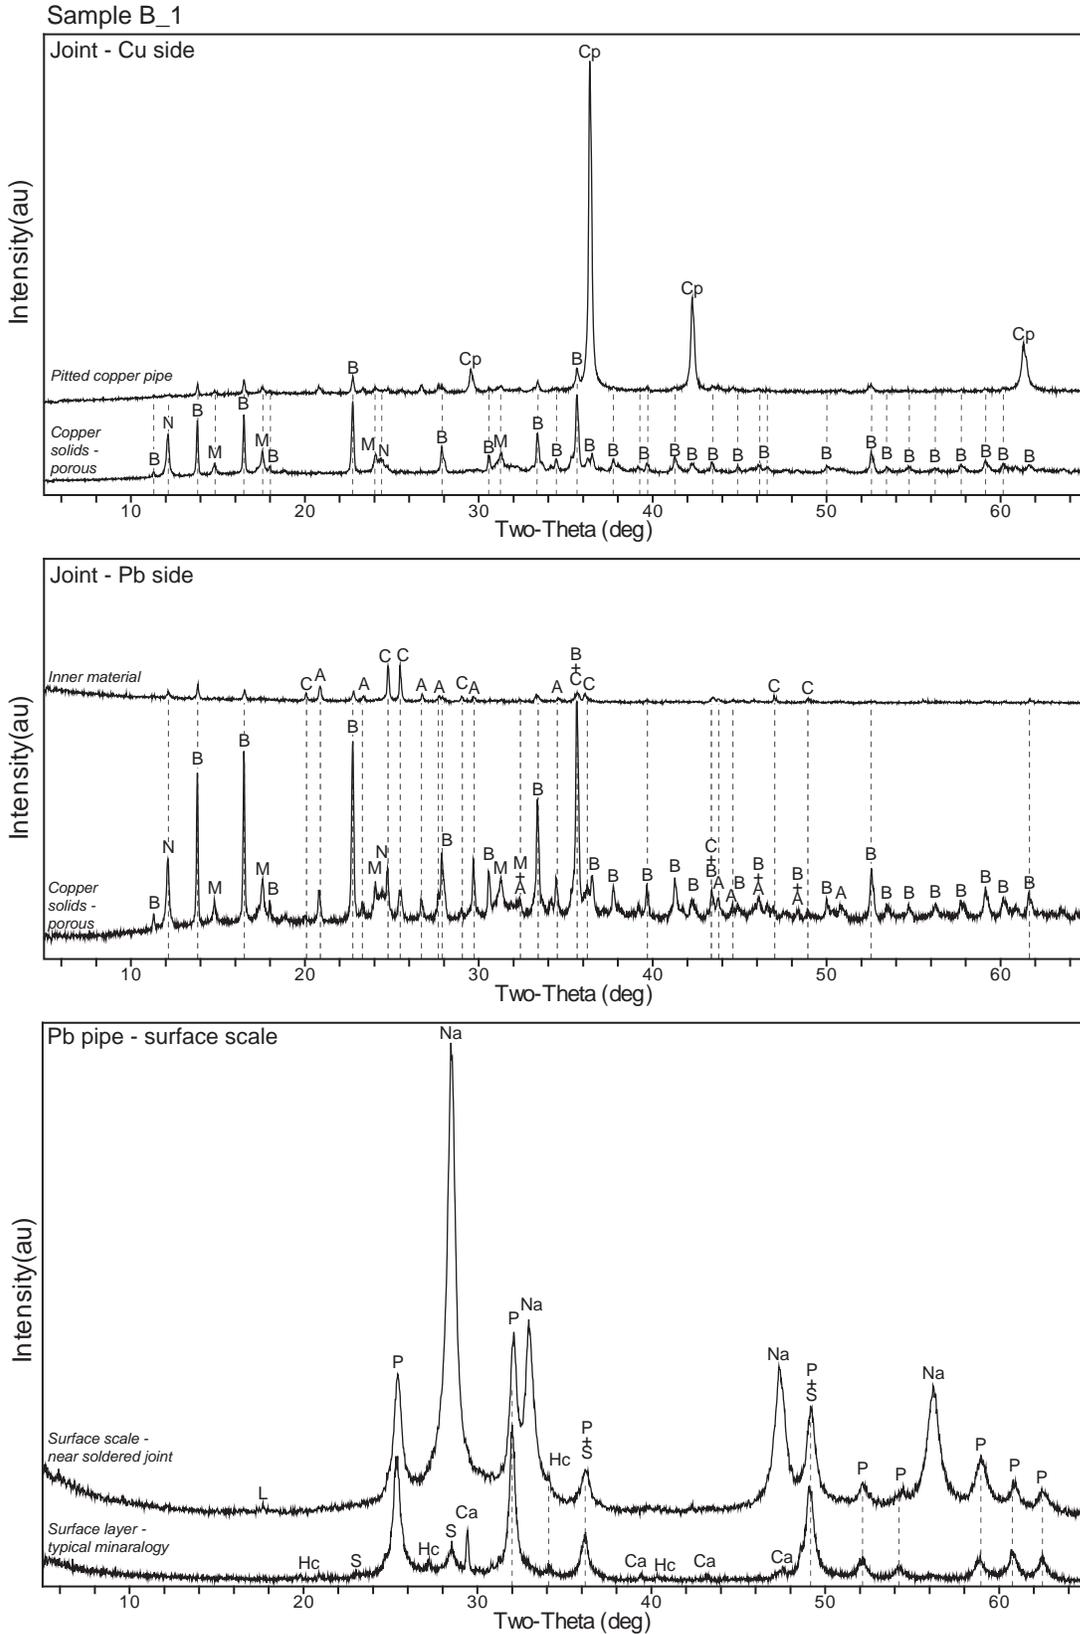
Figure 4. Sample B_1 powder X-ray diffraction patterns. Refer to Table 3 for key to mineral phase abbreviations.
