**Studies Identified by EPA Office of Water for the
SAB Drinking Water Committee Lead Review Panel Meeting
(as of March 23, 2011)**

Mineralogical Evidence of Galvanic Corrosion in Domestic Drinking Water Pipes

Evaluation of Lead Corrosion Control Measures

LEAD OCCURRENCE AND THE IMPACT OF LSL REPLACEMENT IN A WELL BUFFERED GROUNDWATER

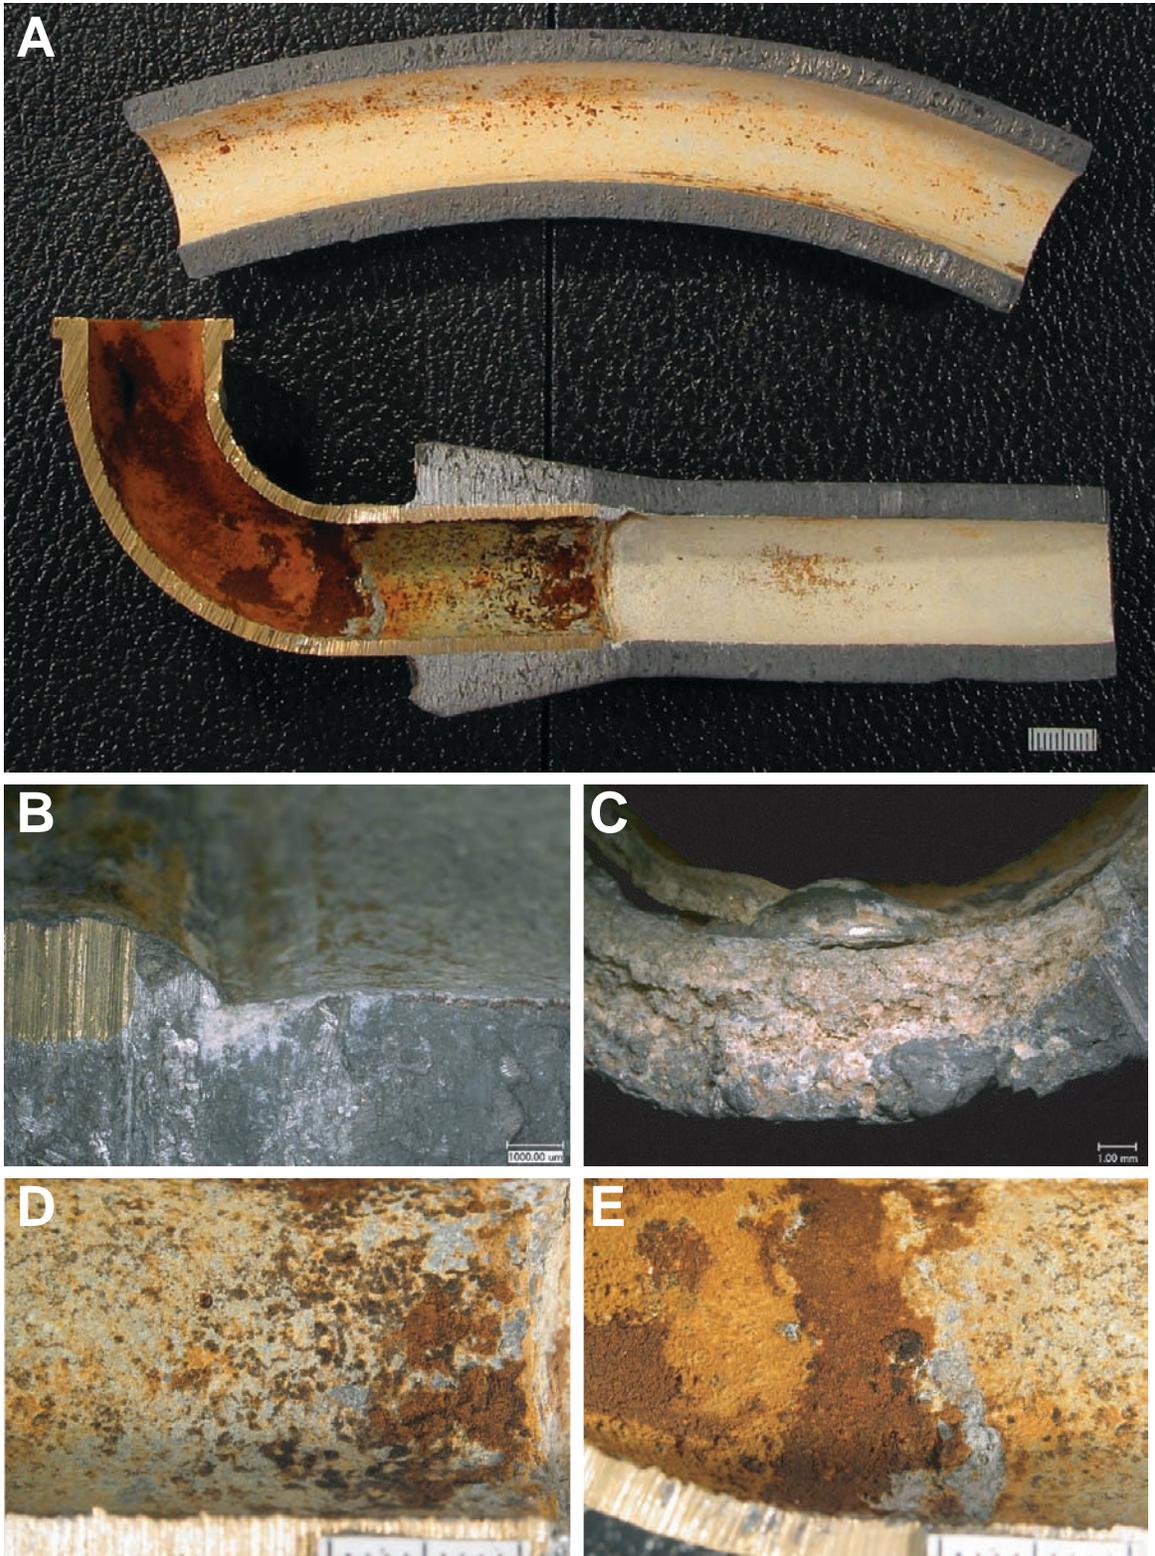
Figure 5. Photographs of pipe sample C_3. (A), (D), (E): scale bar divisions are in mm. (B), (C): scale bar = 1 mm

Motif 2 (galvanic corrosion of lead pipe): Motif 2 is characterized ten samples from Utility C (Figure 5). The typical lead pipe scale mineralogy consists of an outer layer (L1) consisting of cerussite and hydrocerussite and a lower layer (L2) of litharge. (Figures 5B, 6). Lead scales, developed in the 1-3 mm wide galvanic zone immediately adjacent to the soldered joint, were structurally distinct from the typical background deposits. The lower, litharge layer, is not present (Figure 5B) and the scale consists of lead hydroxychlorides, hydrocerussite, and cerussite (Figure 6). The depth of corrosion of the lead pipe in this zone ranged from 1mm (Figure 5B) to as much as 3 mm (Figure 5C), with the latter case weakening the pipe wall enough to cause a failure at the joint. On the brass pipe the mineralogy of thin scales over different regions of the surface (Figures 5A,D,E, 6) is complicated by a thin layer of Pb:Sn solder over part of the interior, outlined by the color change in the scale about 4 cm from the end of the joint in Figure 5A, E). Importantly however, the brass shows little evidence of the deep pitting and dealloying exhibited by samples from Utility A.

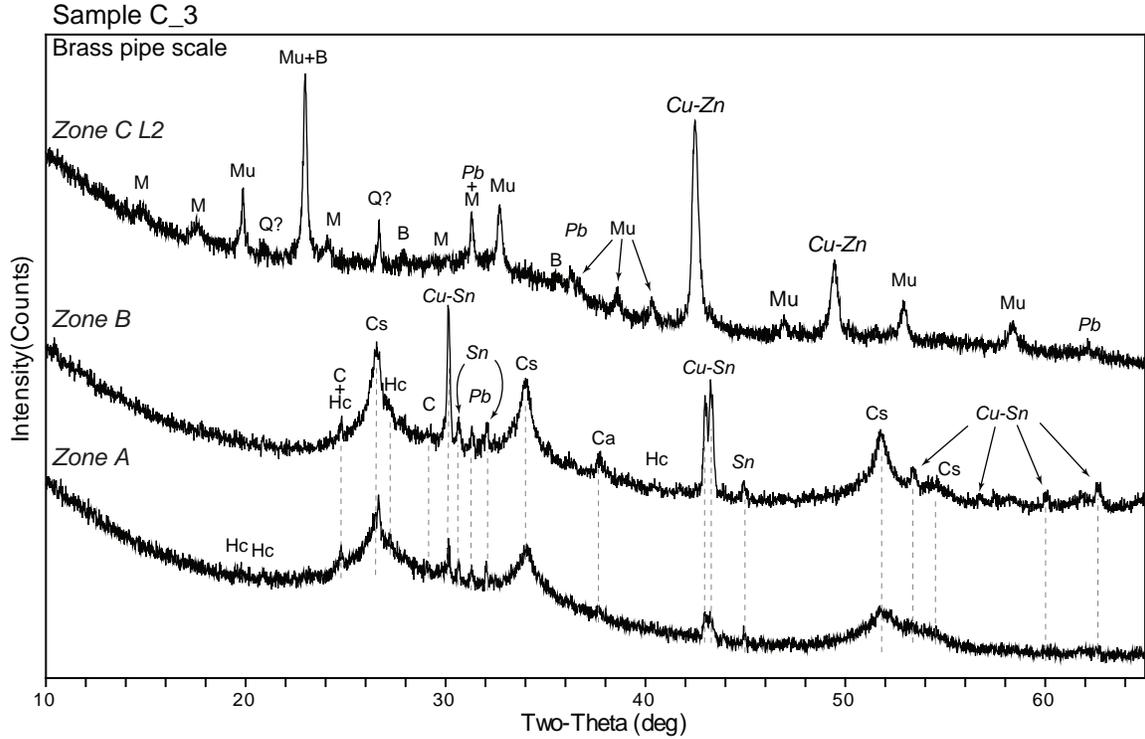
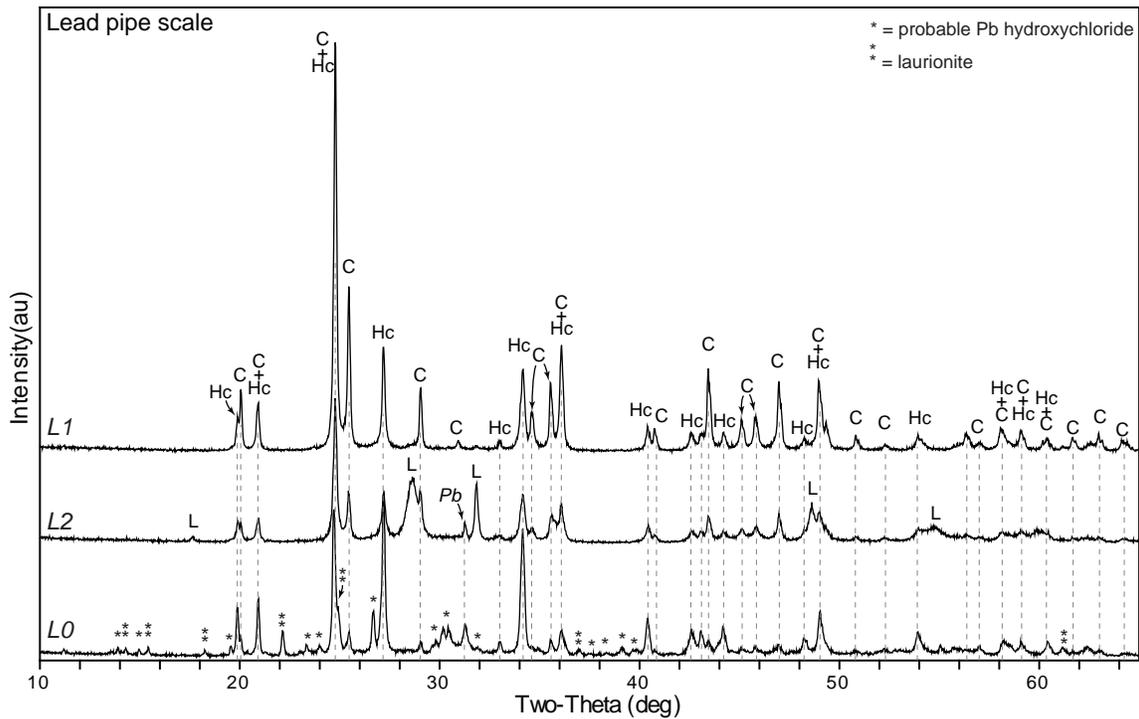
Figure 6. Sample C_3 powder X-ray diffraction patterns. Refer to Table 3 for key to mineral phase abbreviations. For brass pipe, Zones A and B are solder-coated brass located close to joint. For lead pipe L1 and L2 are typical mineralogy, L0 is galvanic zone scale deposit.

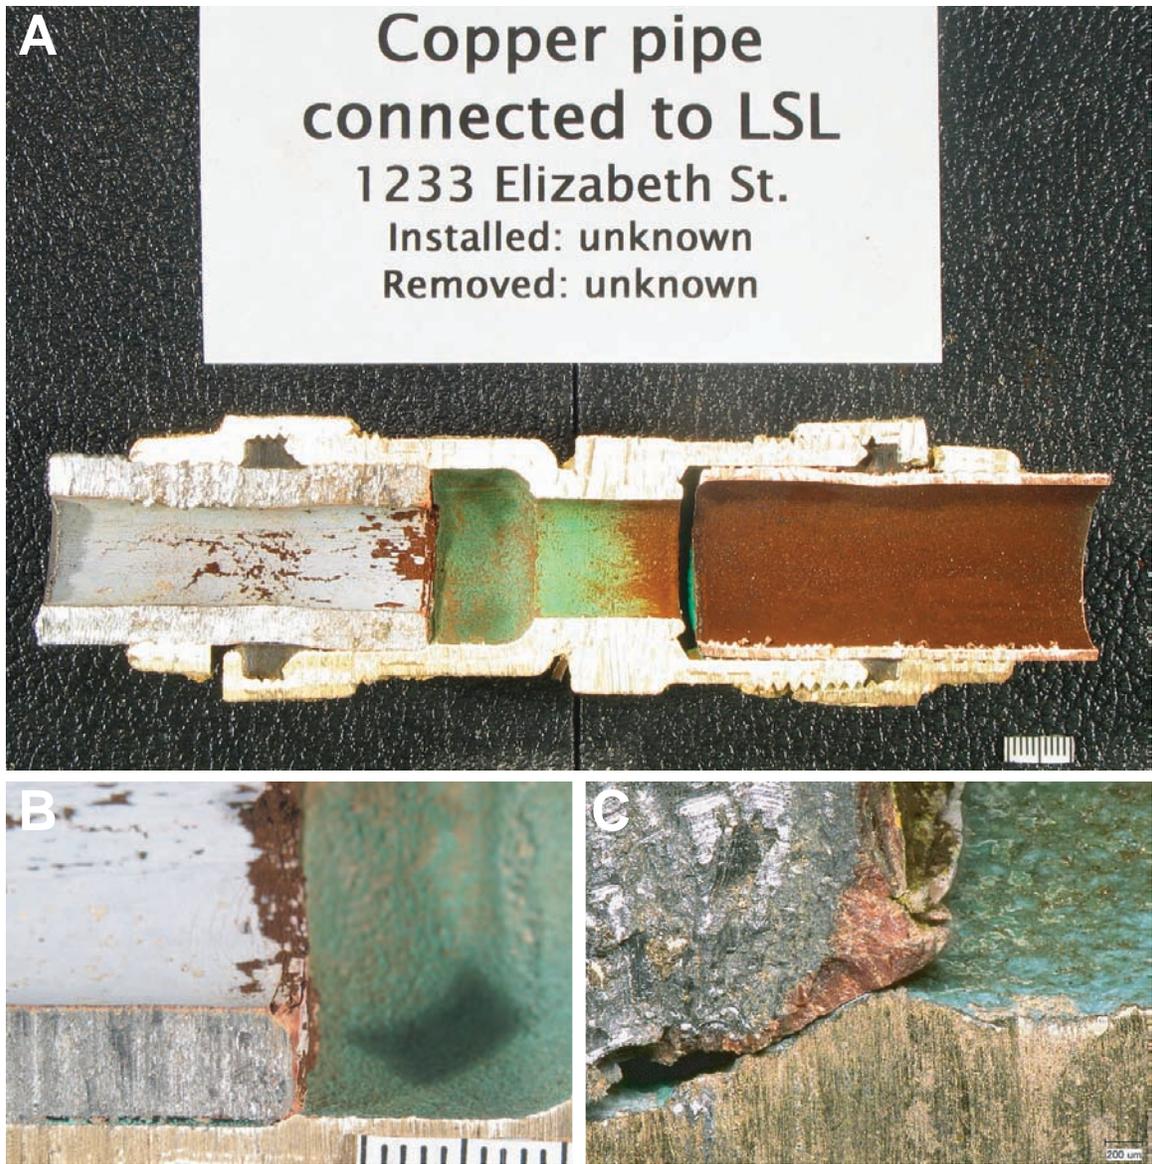
Figure 7. Photographs of pipe sample D_1. (A), (B): scale bar divisions in both images are in mm. (C): scale bar = 200 um.

Motif 3 (Minimal evidence of galvanic corrosion): One sample from Utility D falls into this motif. Figures 7 and 8 show representative photographs and powder X-ray diffraction patterns. The lead pipe mineralogy consists of a surface layer of cerussite, hydrocerussite, and plumbonacrite. Small residual patches of plattnerite are locally present in the surface layer. The lower layer is comprised of litharge (Figure 8). On the brass fitting the scale consists of malachite. Scales at the point of contact of these metals are mineralogically similar to those of the respective adjacent pipes. The lead pipe showed a thickened litharge (PbO) layer at the joint (Figure 7B, C).

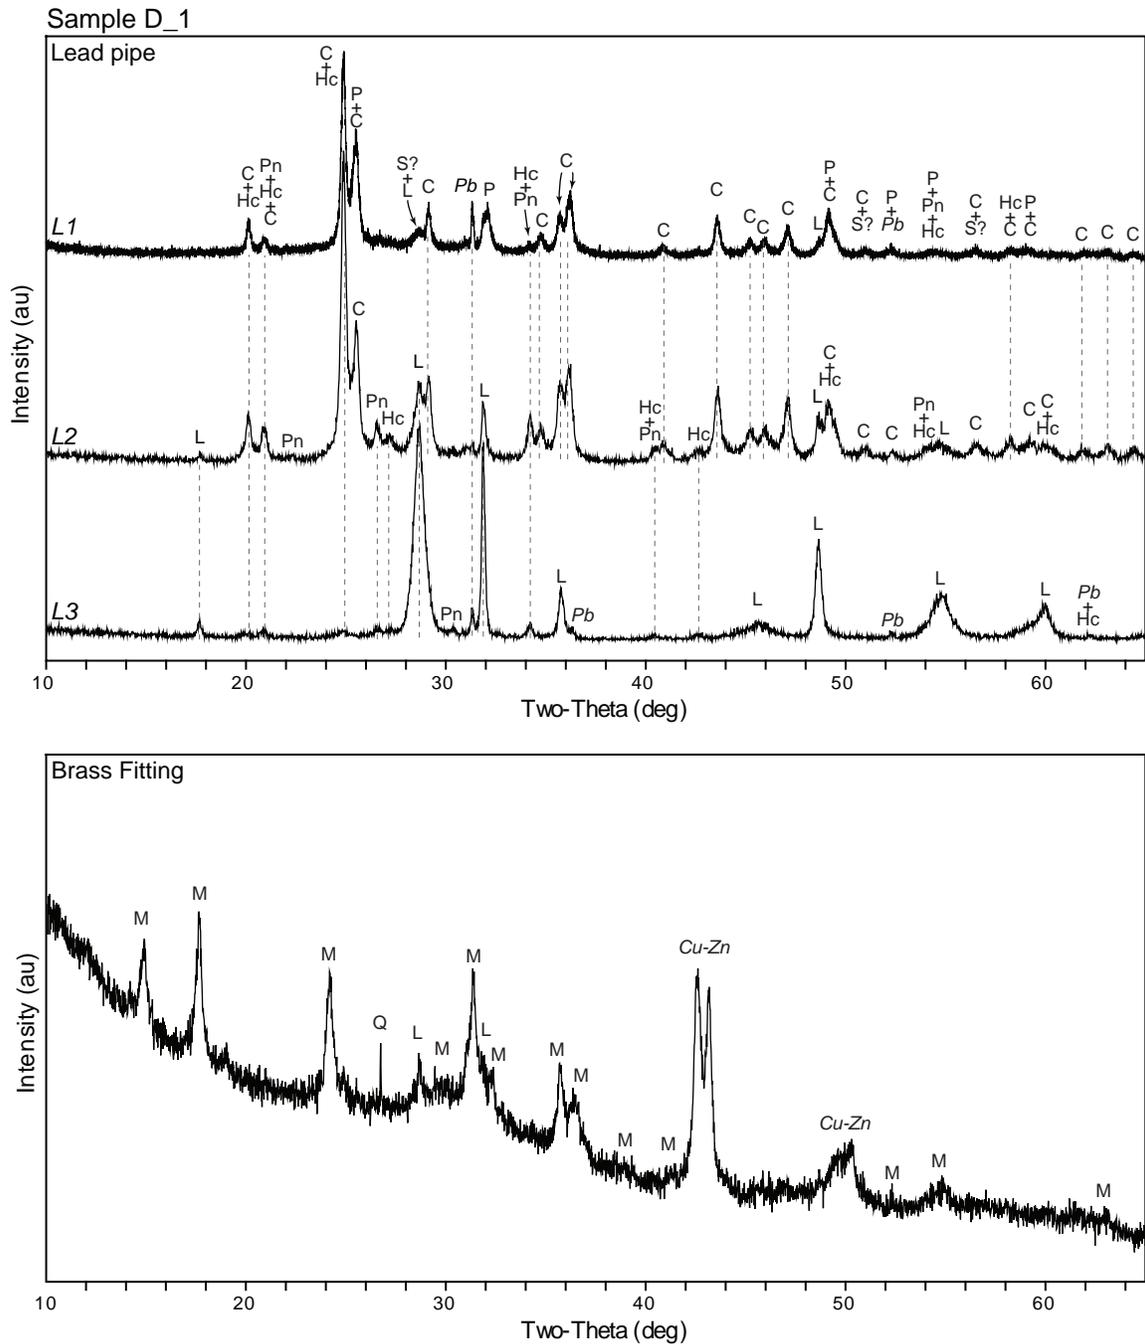
Figure 8. Sample D_1 powder X-ray diffraction patterns. Refer to Table 3 for key to mineral phase abbreviations.

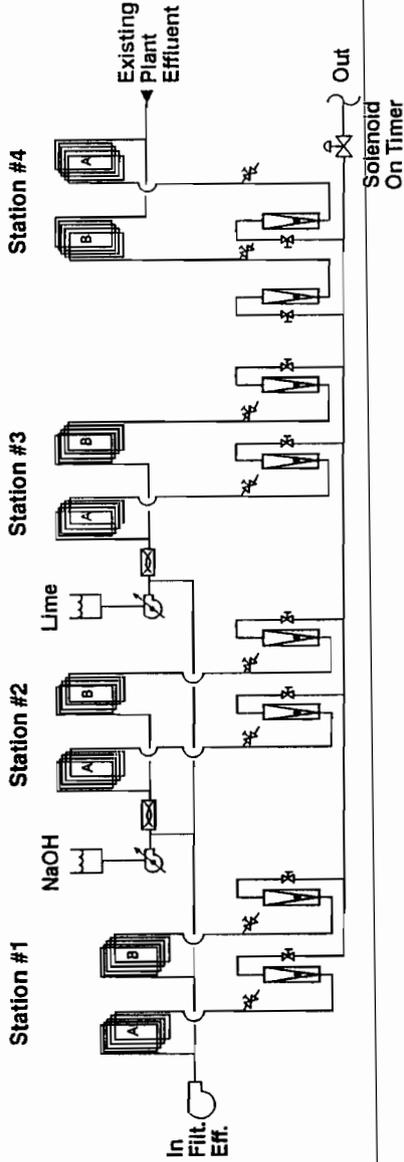
FIGURE 9

PROPOSED PIPE LOOP SCHEMATIC

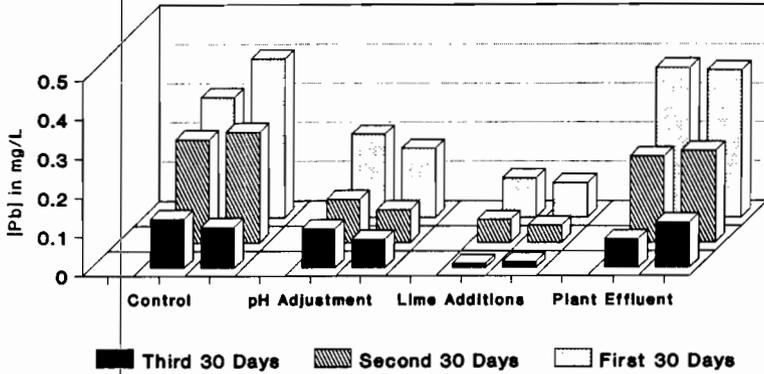
Figure 18
Crum Pipe Loop Corrosion Study - Lead
30 Day Averages

In the Crum Creek plant pipe loop study, testing for lead indicated that lime stabilization and pH adjustment outperformed both the untreated filter effluent and the plant effluent with existing treatment. Testing for copper showed the existing treatment to be reasonably effective in reducing copper corrosion.

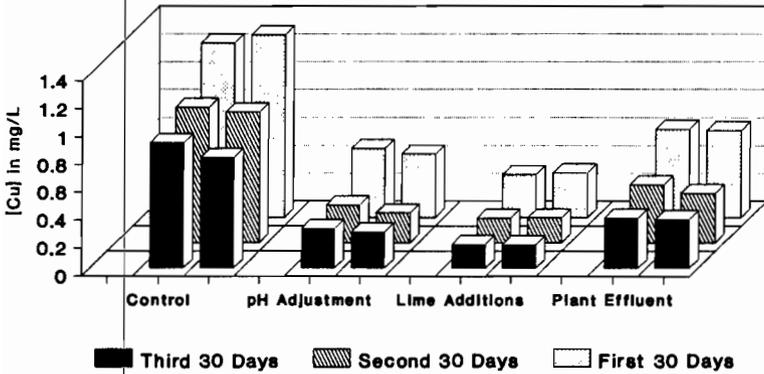
Figure 19
Crum Pipe Loop Corrosion Study - Copper
30 Day Averages

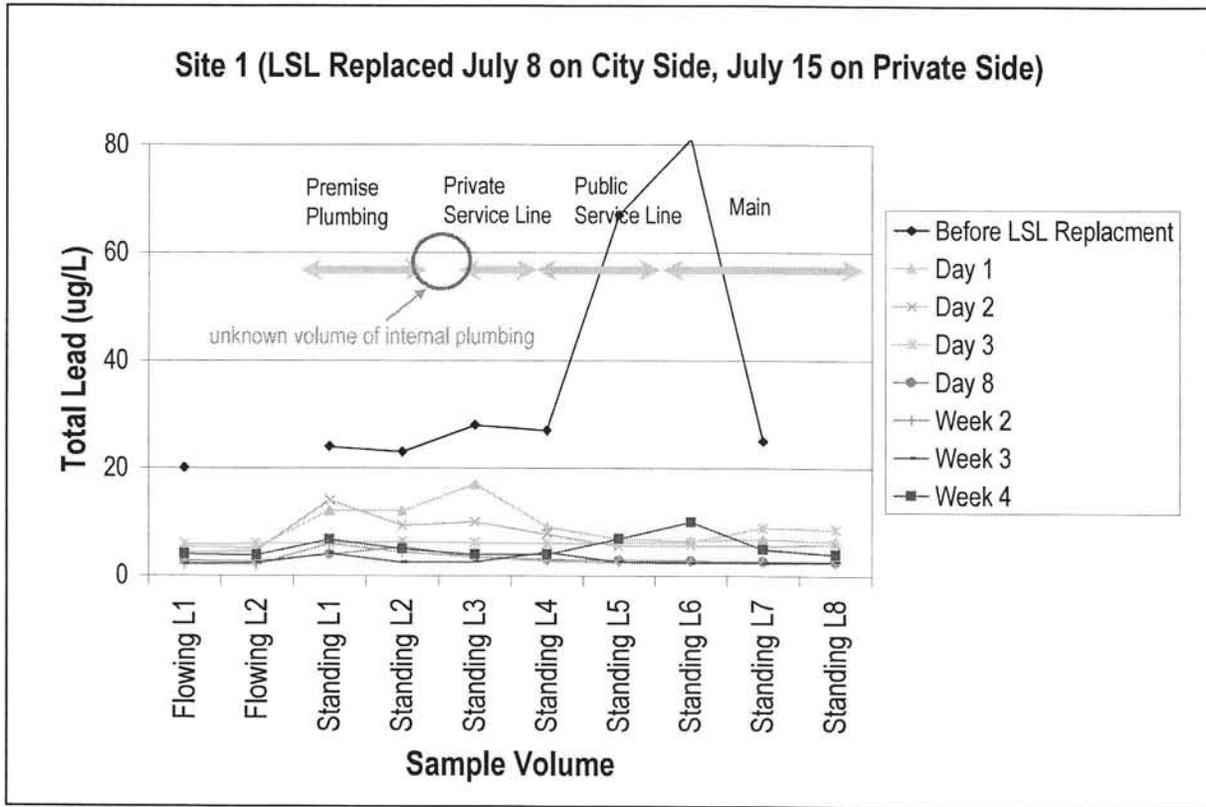
Figure 1: Site 1 (Full LSL Replacement), Lead Profile

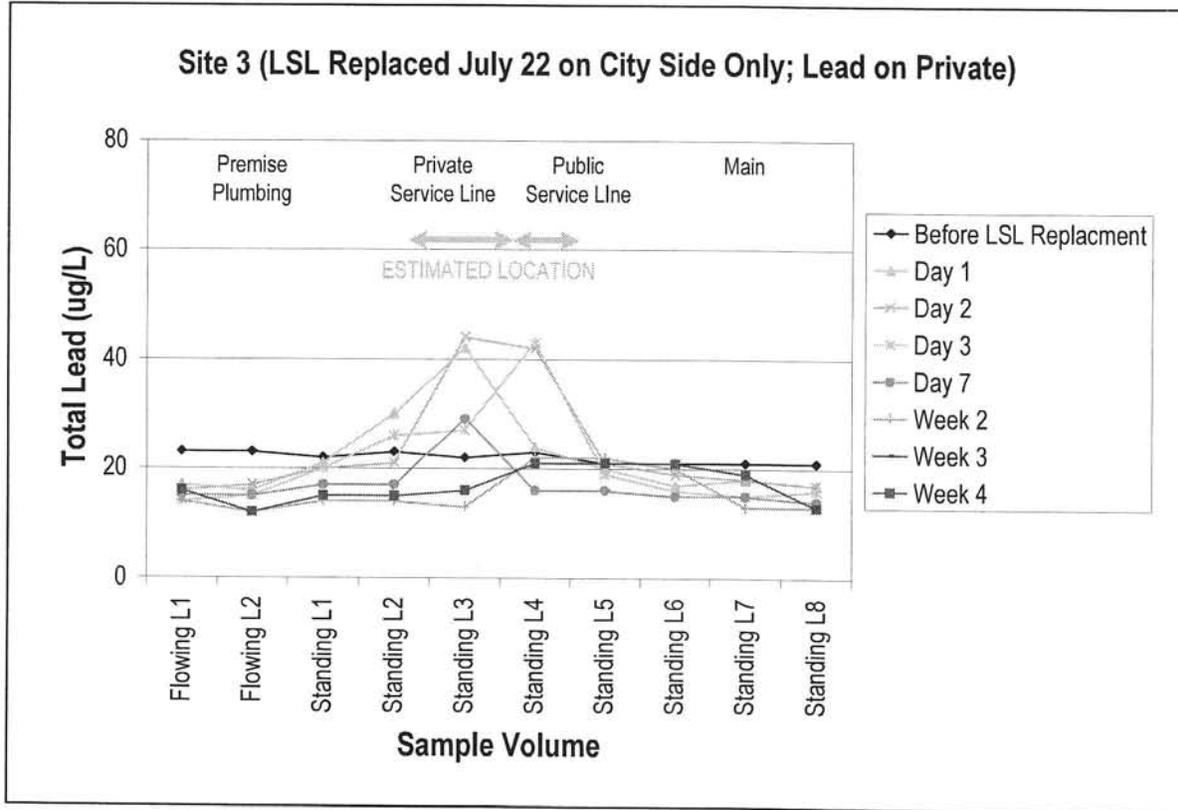
Figure 3: Site 3 (Partial LSL Replacement), Lead Profile

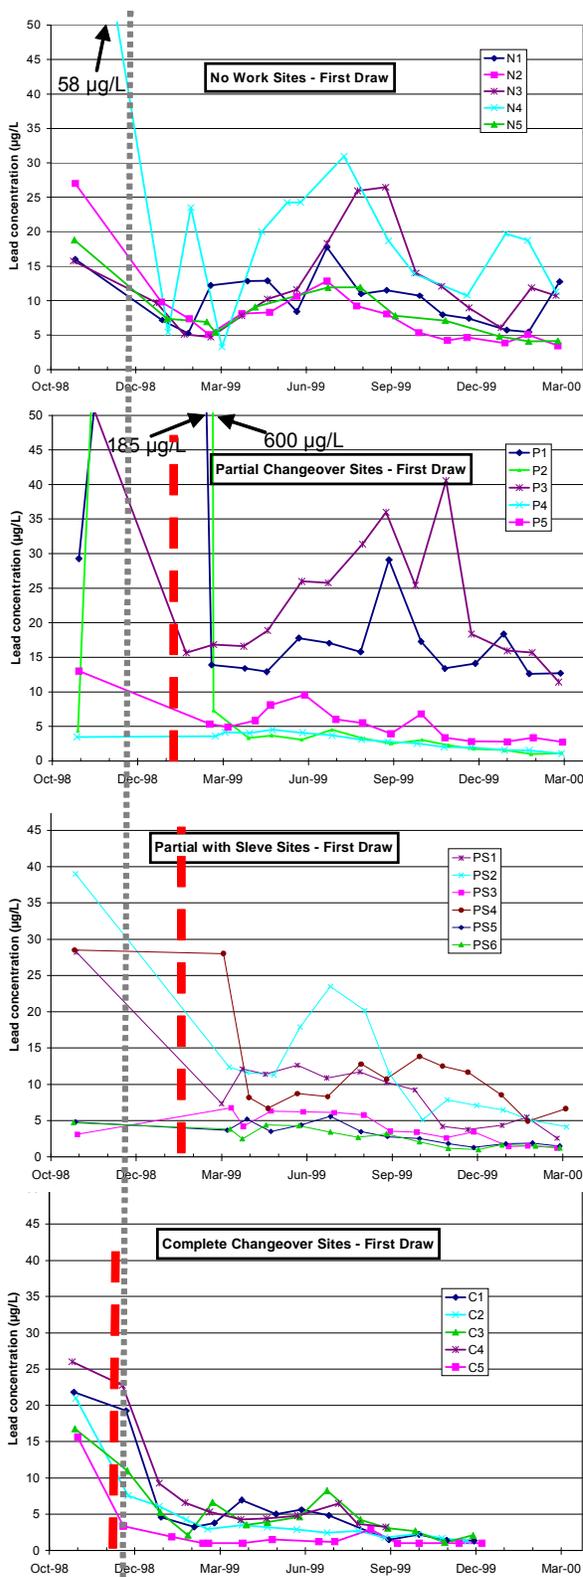
Figure 1: First draw lead concentrations from all study sites. The red dashed line represents the date of work on the service branches and the grey dashed line represents time of pH adjustment from 8.5 to 8.8.

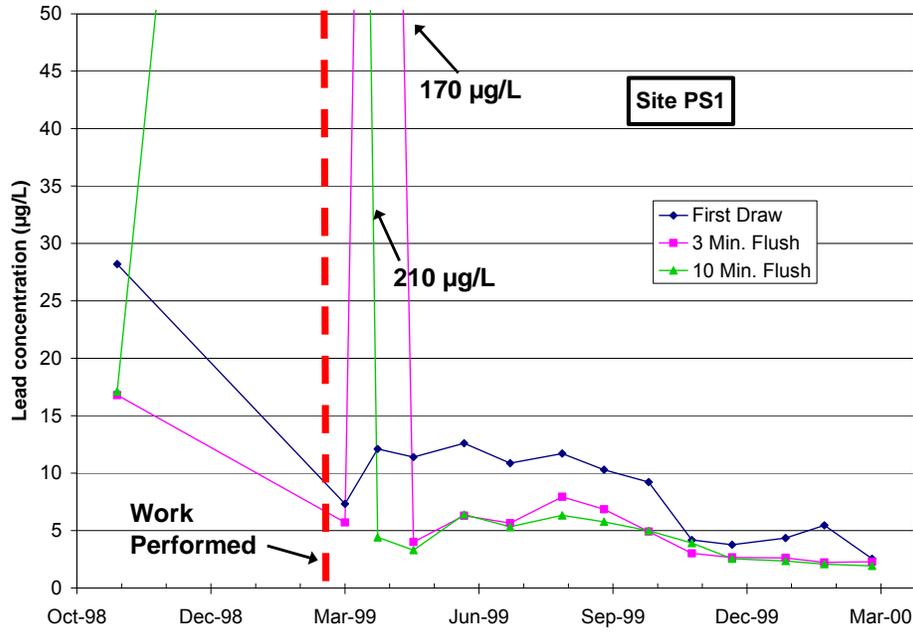
Figure 2: First draw, 3 minute flush, and 10 minute flush lead concentrations from site PS1.

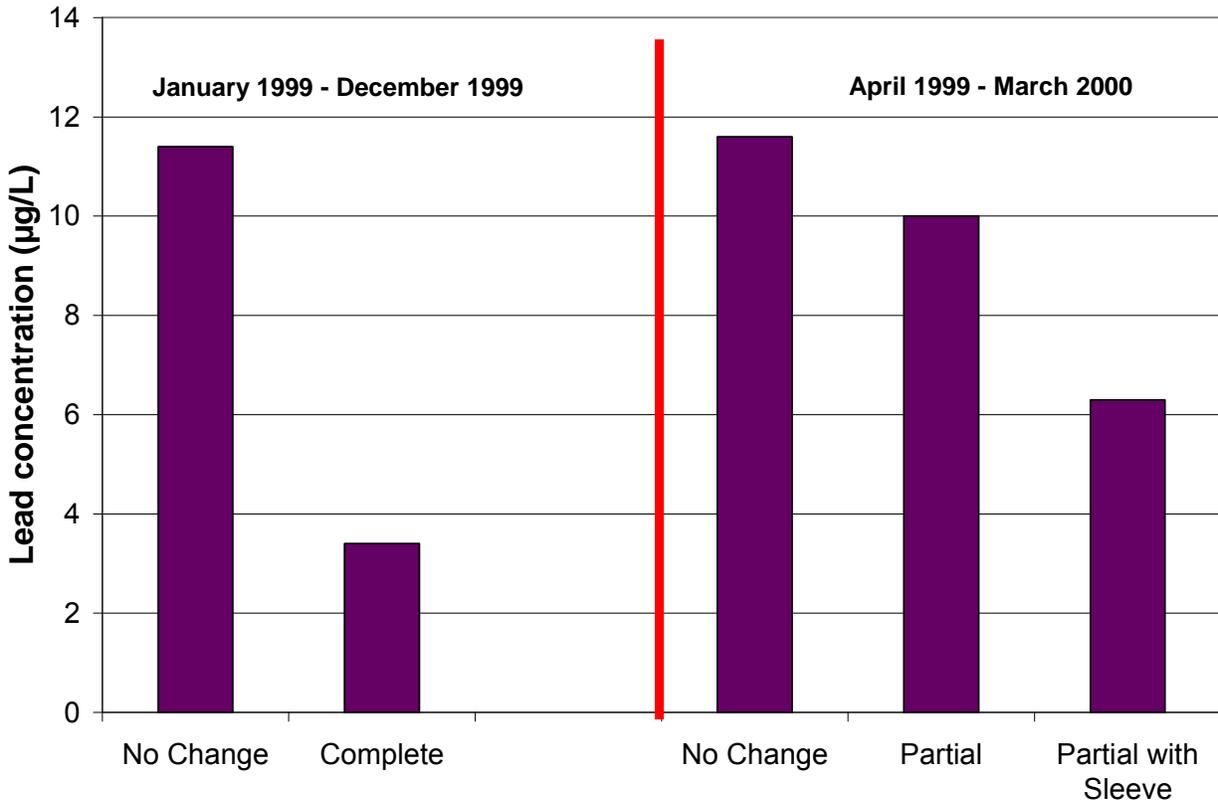
Figure 3: Steady state average data for first draw samples from each study group.
