**Presentation to the EPA SAB on Lead Service line Replacement**

# Lead Service Line Replacement – The New/Old Controversy

**PLSLs : Are they effective? Do they make the  
situation worse? Is galvanic action a public  
health threat? PLSLs and OCCT**

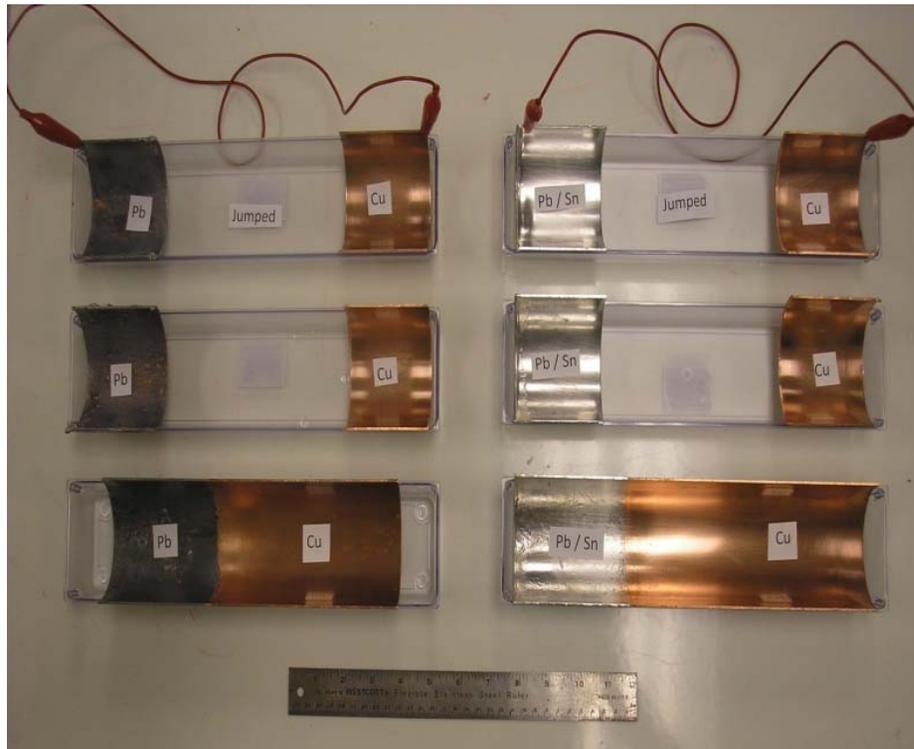
# Ongoing Electrochemical Studies: Cell Geometries and Current Path Determine the Nature and Extent of Galvanic Action

Compare potential profiles for lead and copper surfaces

1. Jumpered (wired) metals
2. Independent metals
3. Jointed (end-to-end) metals

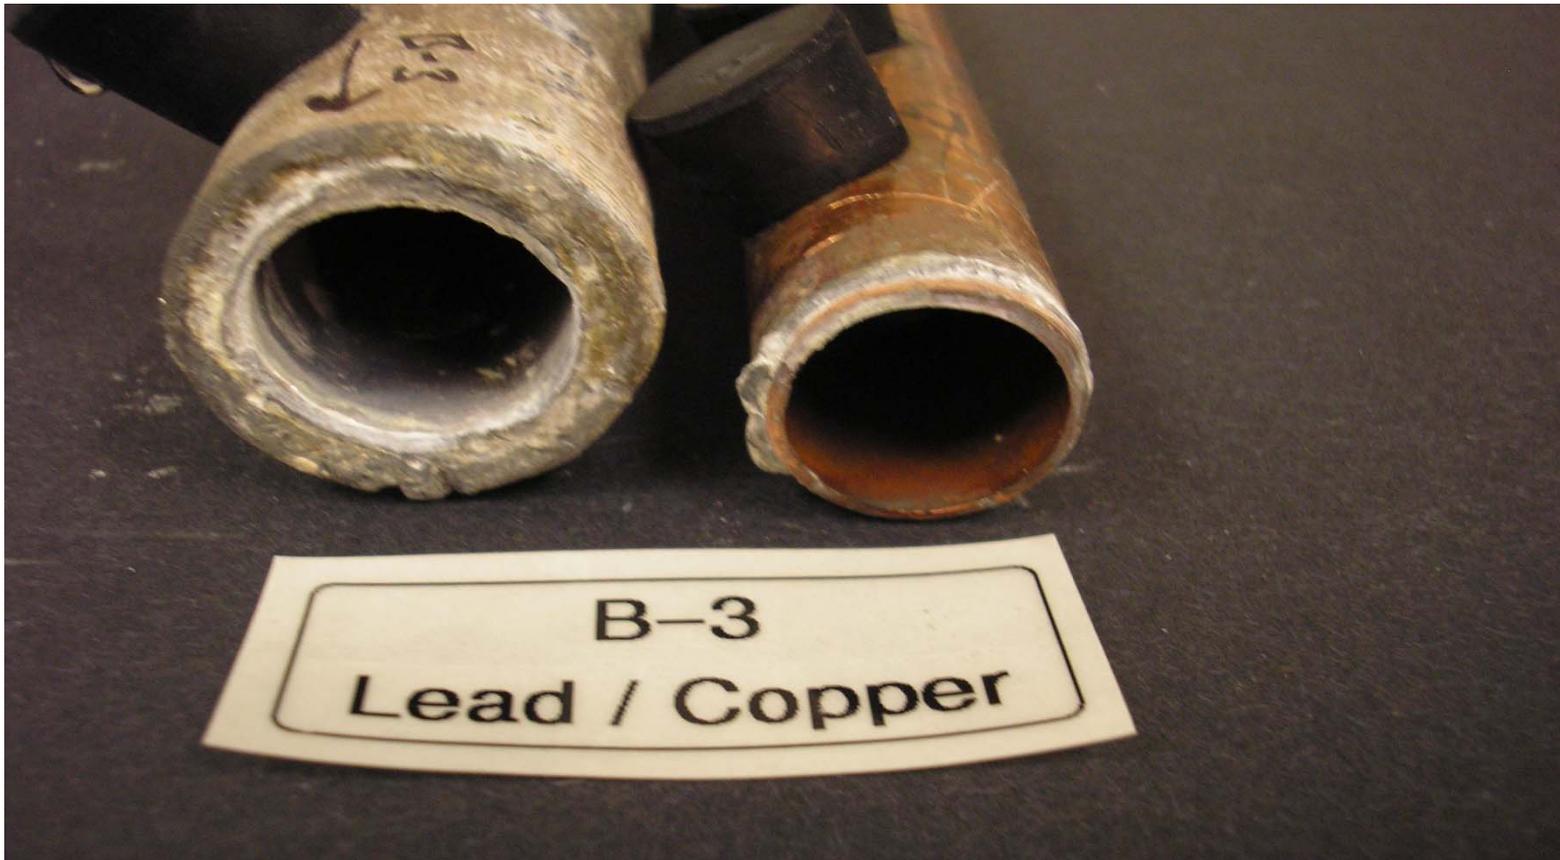
# Galvanic Couple Separated after One Year of Testing

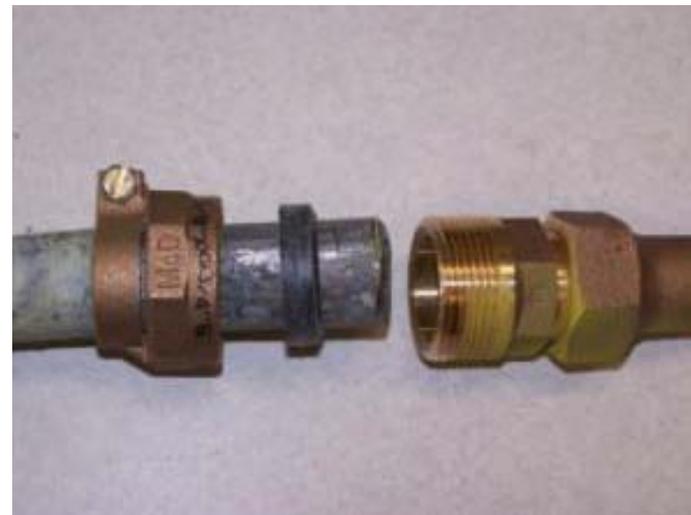
Conventional dielectrics are inadequate for LSL application – a specialized all plastic coupling is required
