1 Introduction

The United States Environmental Protection Agency (USEPA) Region 10 has completed its second, site-wide review of the Bunker Hill Mining and Metallurgical Complex Superfund Facility (the "Bunker Hill Superfund Site" or "Site") located within northern Idaho, sections of the Coeur d'Alene Reservation, and northeastern Washington. This review was conducted from August 2004 through April 2005.

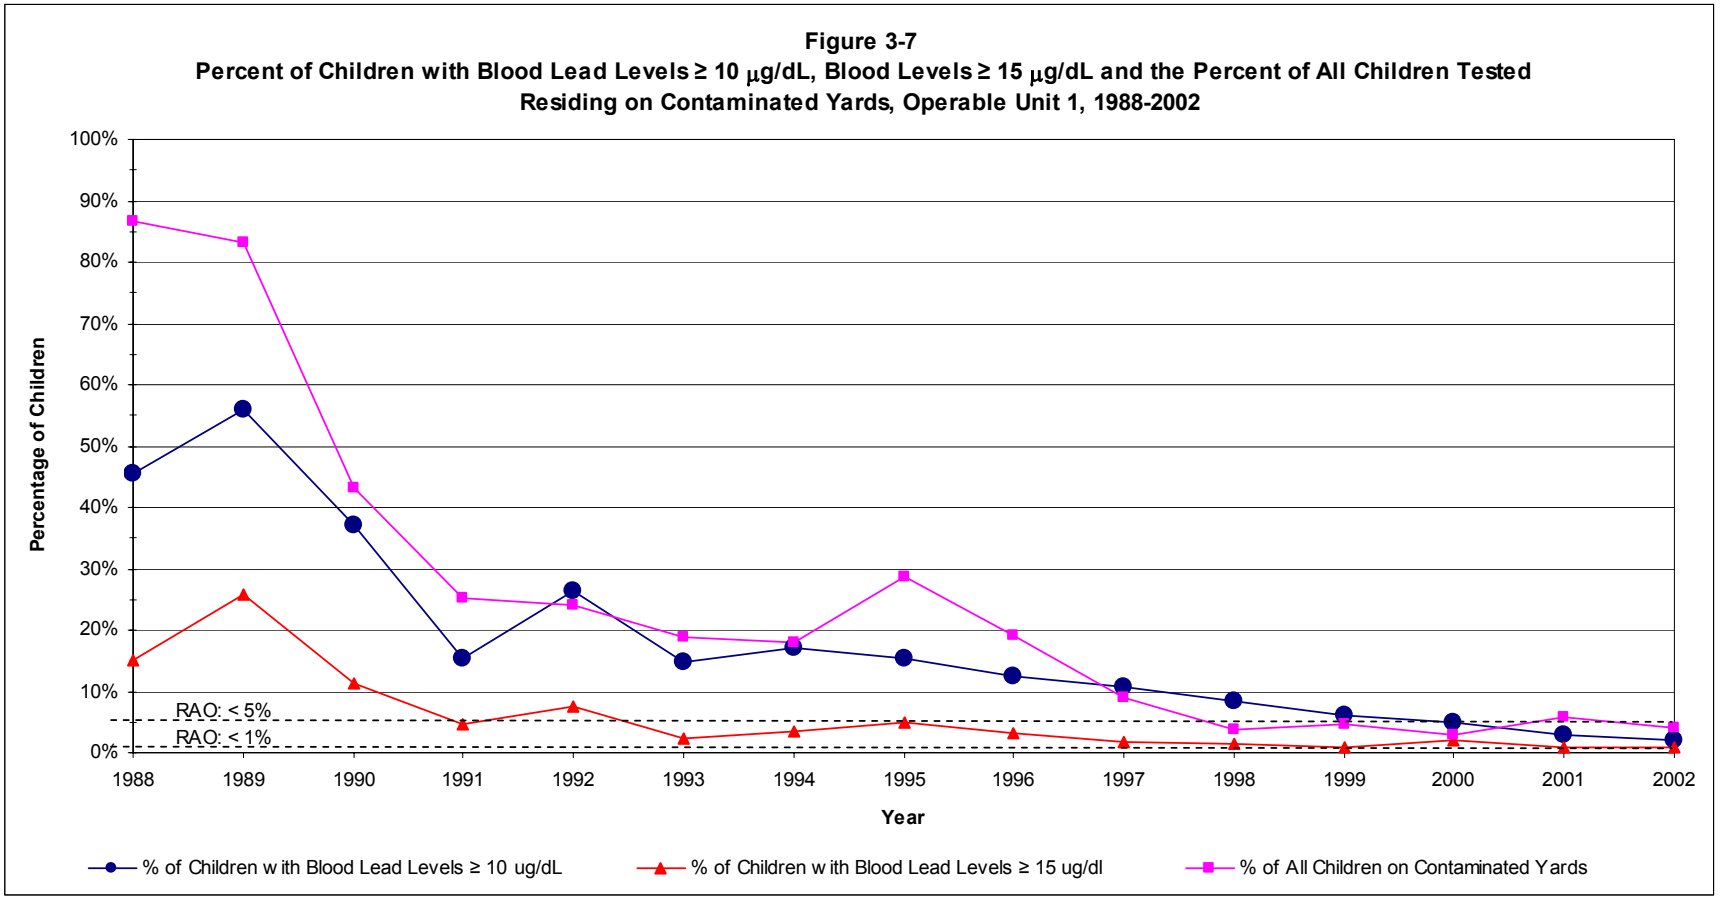
Figure 3-7
Percent of Children with Blood Lead Levels ≥ 10 μg/dL, Blood Levels ≥ 15 μg/dL and the Percent of All Children Tested Residing on Contaminated Yards, Operable Unit 1, 1988-2002
Percentage of Children
100%
90%
80%
70%
60%
50%
40%
30%
20%
10%
0%
RAO: < 5%
RAO: < 1%
1988
1989
1990
1991
1992
1993
1994
1995
1996
1997
1998
1999
2000
2001
2002
Year
% of Children with Blood Lead Levels ≥ 10 ug/dL
% of Children with Blood Lead Levels ≥ 15 ug/dl
% of All Children on Contaminated Yards

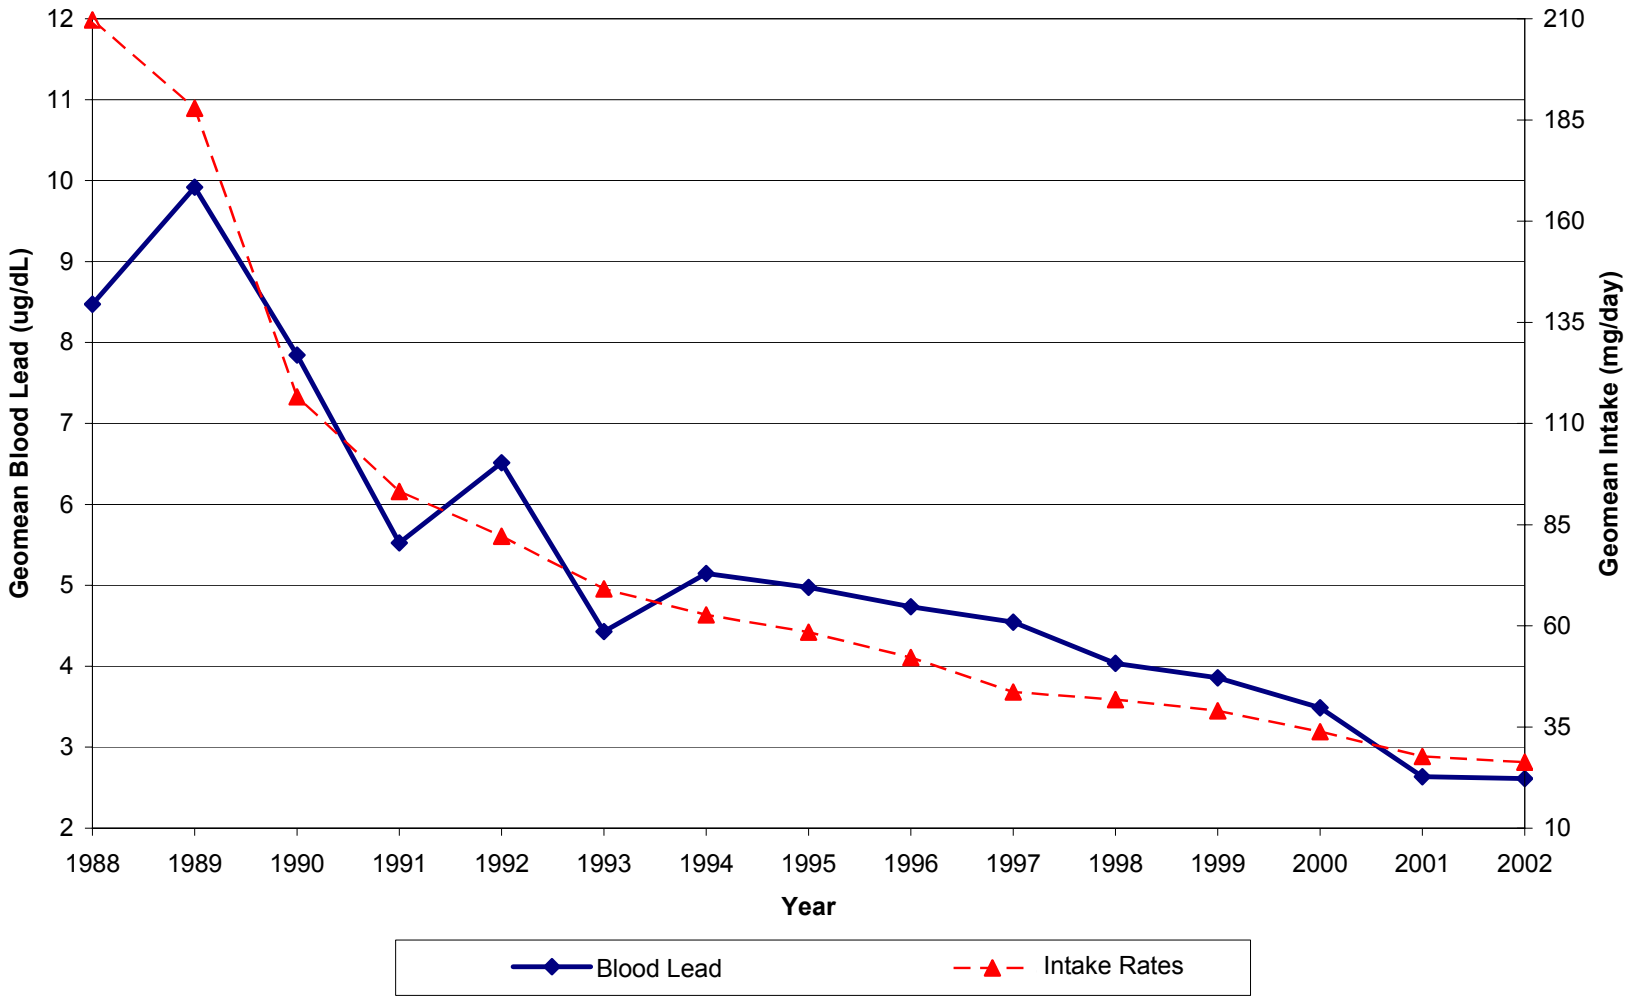
Figure 3-8
OU1 Lead Intake Rates and Geometric Mean Blood Lead Levels
