FIVE-YEAR REVIEW REPORT

First Five-Year Review Report
for
Fort Richardson, Alaska

April 2003

United States Army Alaska
Directorate of Public Works
ATTN: APVR-RPW
730 Quartermaster Road #6500
Fort Richardson, Alaska 99505-6500

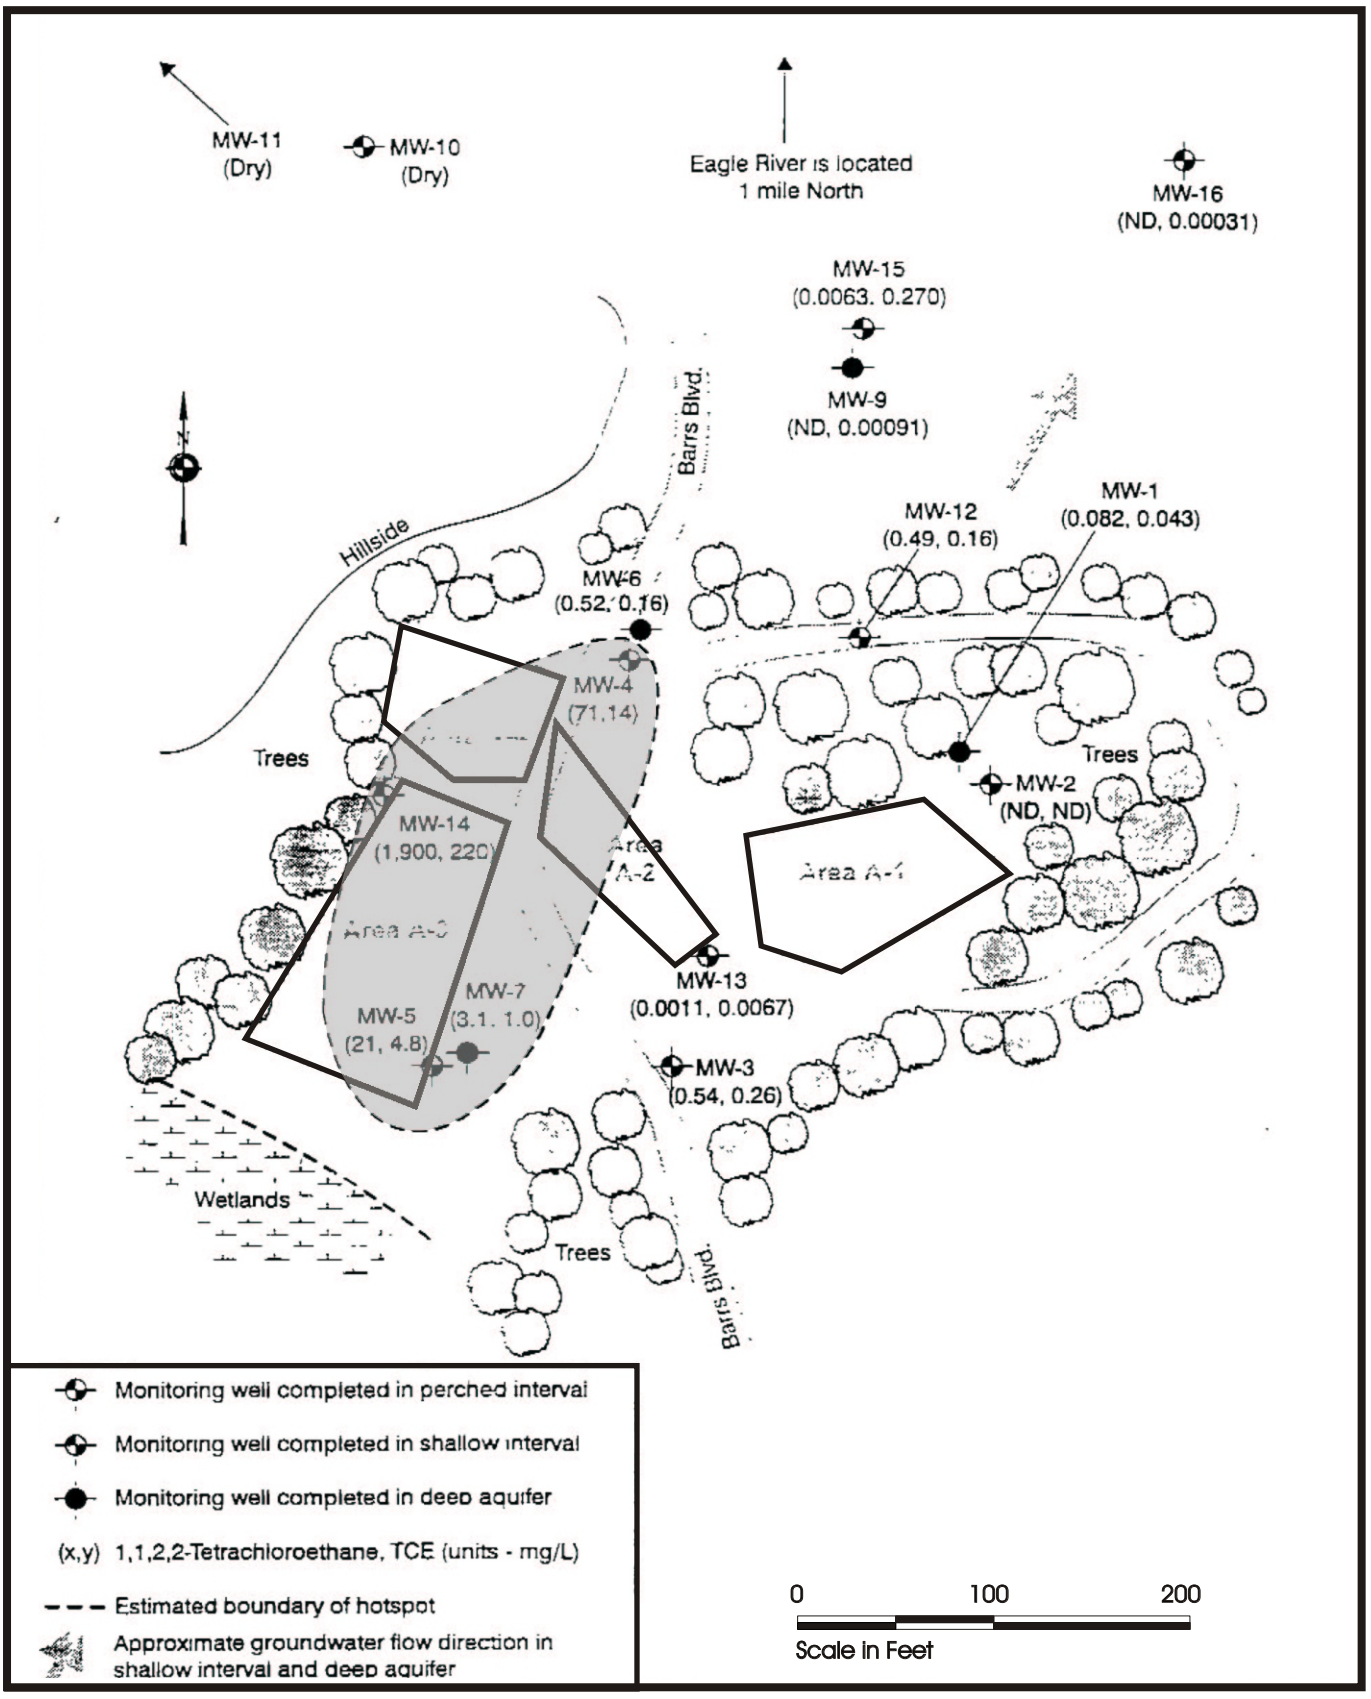
Figure: 5-2
February 2003

The area of greatest contamination identified at the source area during the RI was referred to as the "hot spot". The "hot spot" encompasses an area approximately 150 feet by 300 feet that is bounded by a 1 milligram per liter (mg/L) or greater concentration of 1,1,2,2-PCA in groundwater. The "hot spot", as estimated in 1999, is shown on Figure 5-2.

Hot Spot Identification from ROD

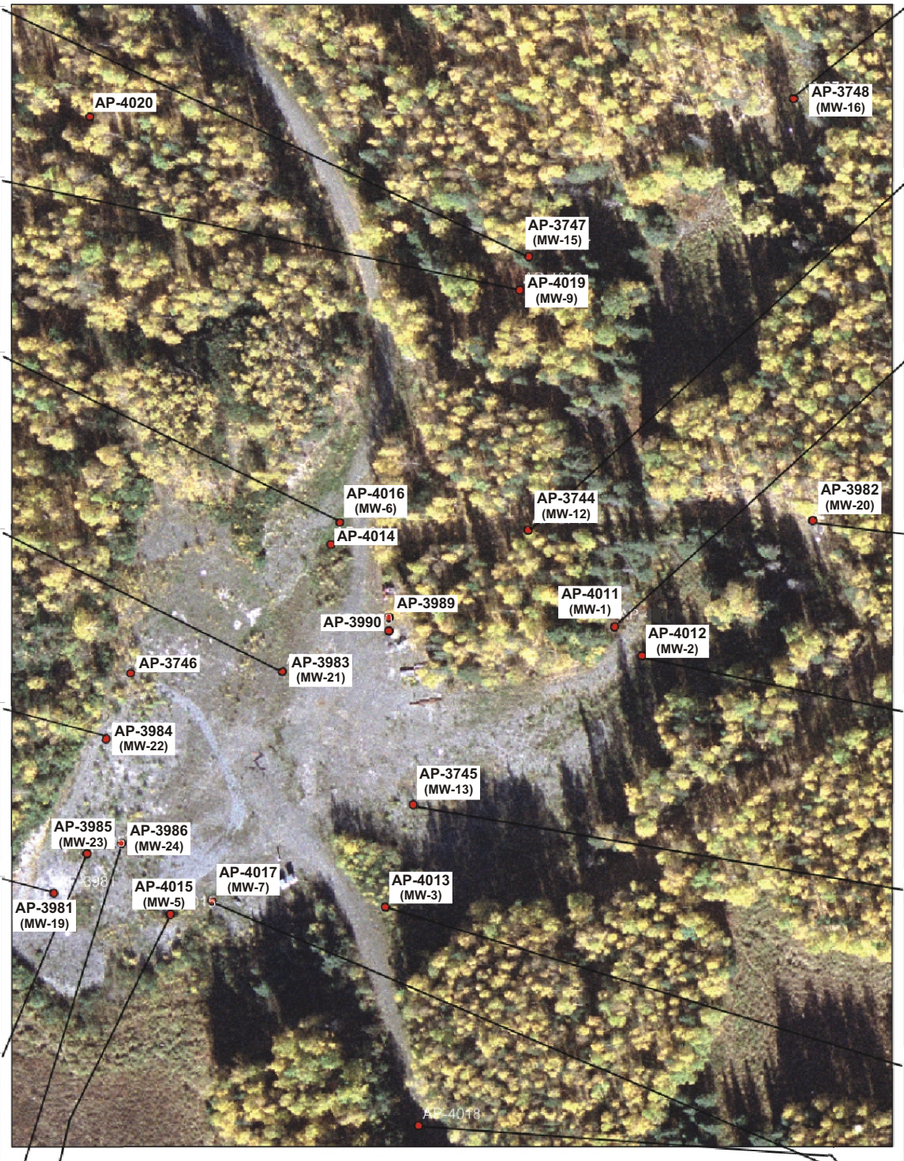
FIGURE 5-3. FORT RICHARDSON OPERABLE UNIT B POLELINE ROAD DISPOSAL AREA LONG-TERM GROUNDWATER MONITORING DATA FOR CHEMICALS OF CONCERN

Figure 5-3 summarizes the results of groundwater monitoring associated with the OUB Poleline Road source area through the end of the 2002 field season. Contaminant levels have remained consistent since the remedial system was shut down in 1999. Slight increases in contaminant concentrations noted during the 2002 sampling events are attributed to a change in sampling technique (switched to low-flow sampling in 2002) and not to a rebound in contaminant levels.

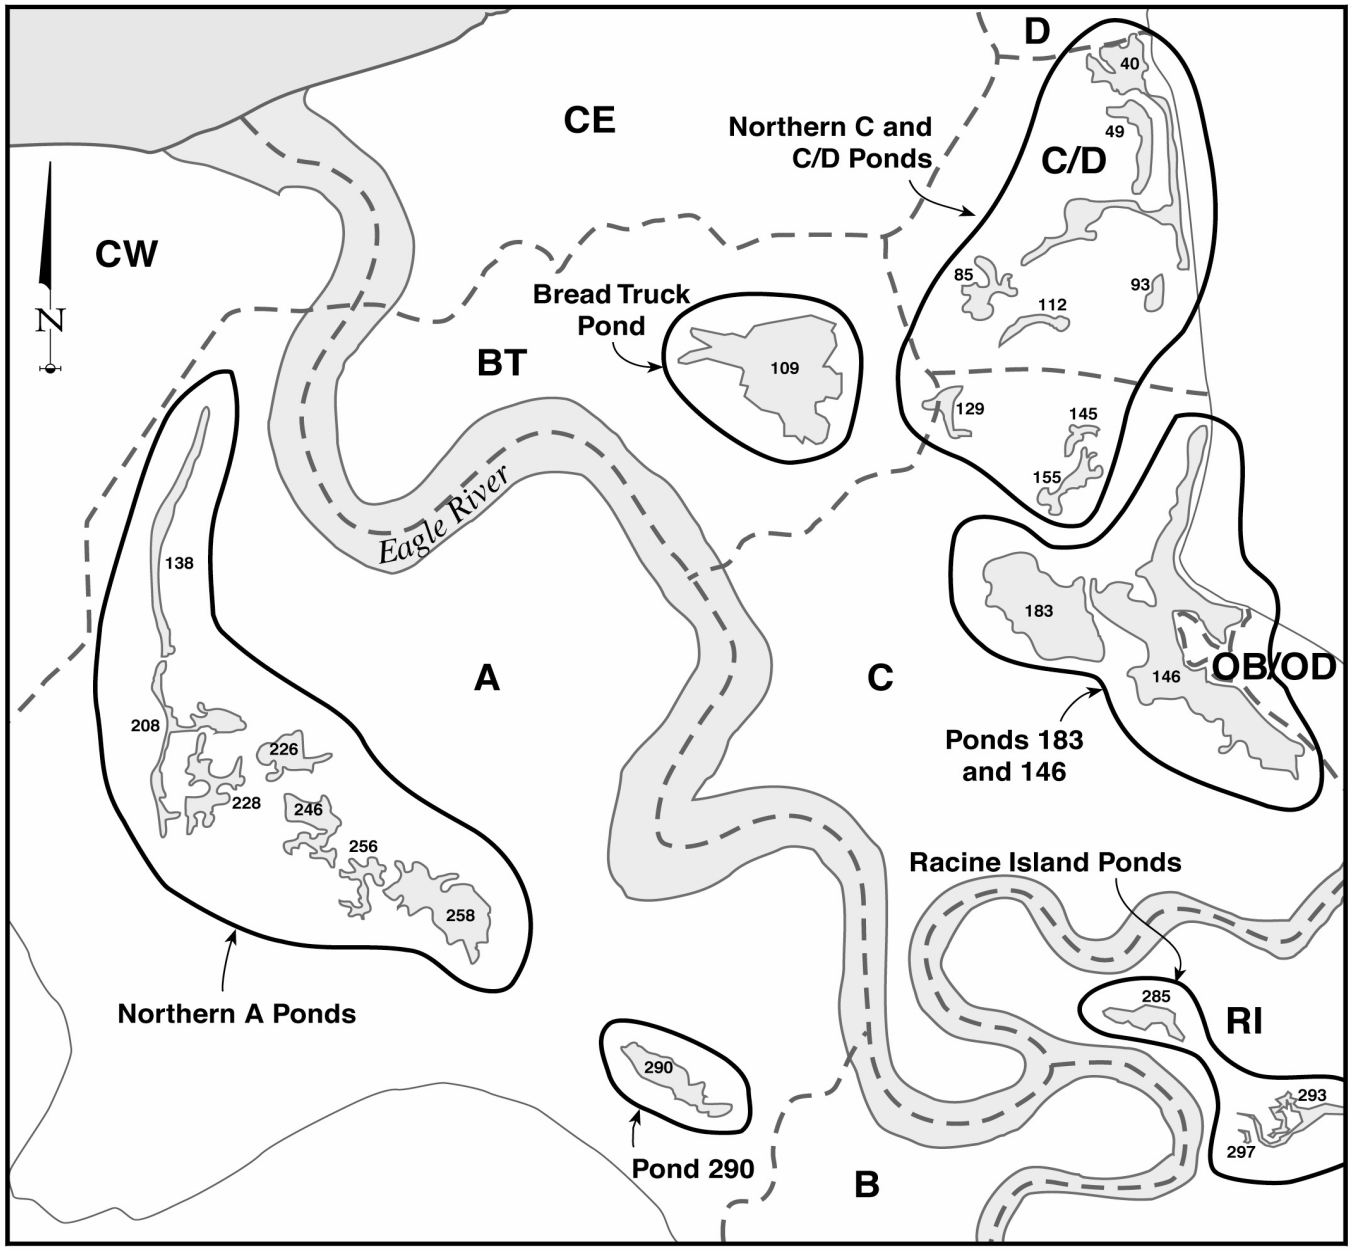
Figure: 6-2
February 2003

Investigations performed to define contaminant hot spots determined that the most significant areas of concern for exposure to white phosphorus were the sediments in ponds and some marshes. Twenty-two hot ponds were identified, covering 57 acres. Figure 6-2 illustrates the pond groups within the OU-C Areas.

Eagle River Flats Pond Groups

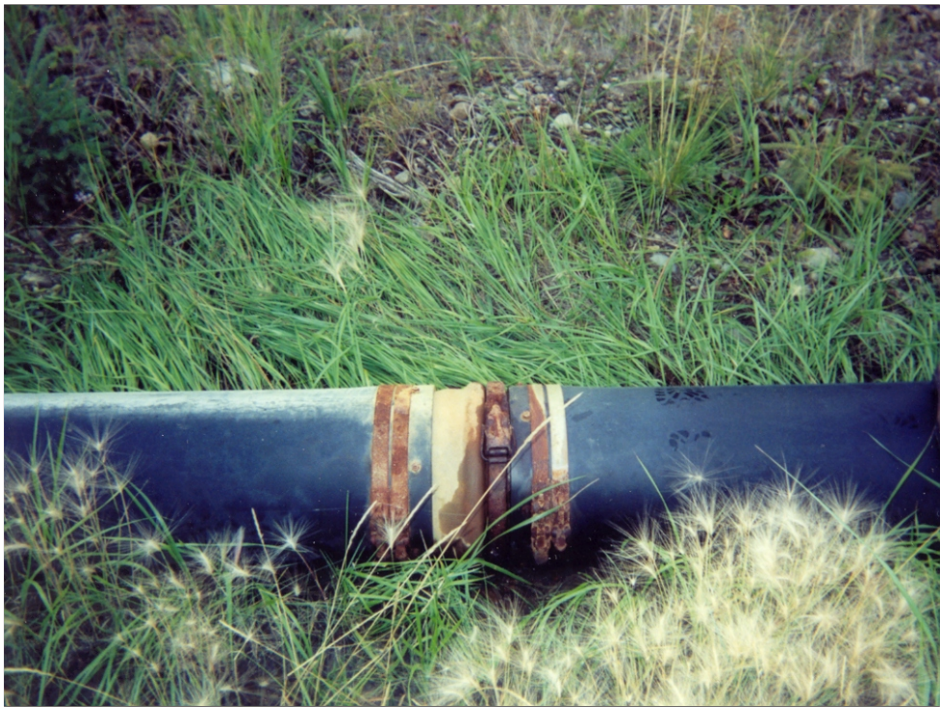
OUC: Eagle River Flats,
Typical Connection of Water Pipe.
